Article Healing of Fatigue Crack in 1045 Steel by Using Eddy Current Treatment

Abstract: In order to investigate the methods to heal fatigue cracks in metals, tubular specimens of 1045 steel with axial and radial fatigue cracks were treated under the eddy current. The optical microscope was employed to examine the change of fatigue cracks of specimens before and after the eddy current treatment. The results show that the fatigue cracks along the axial direction of the specimen could be healed effectively in the fatigue crack initiation zone and the crack tip zone under the eddy current treatment, and the healing could occur within a very short time. The voltage breakdown and the transient thermal compressive stress caused by the detouring of eddy current around the fatigue crack were the main factors contributing to the healing in the fatigue crack initiation zone and the crack tip zone, respectively. Eddy current treatment may be a novel and effective method for crack healing.

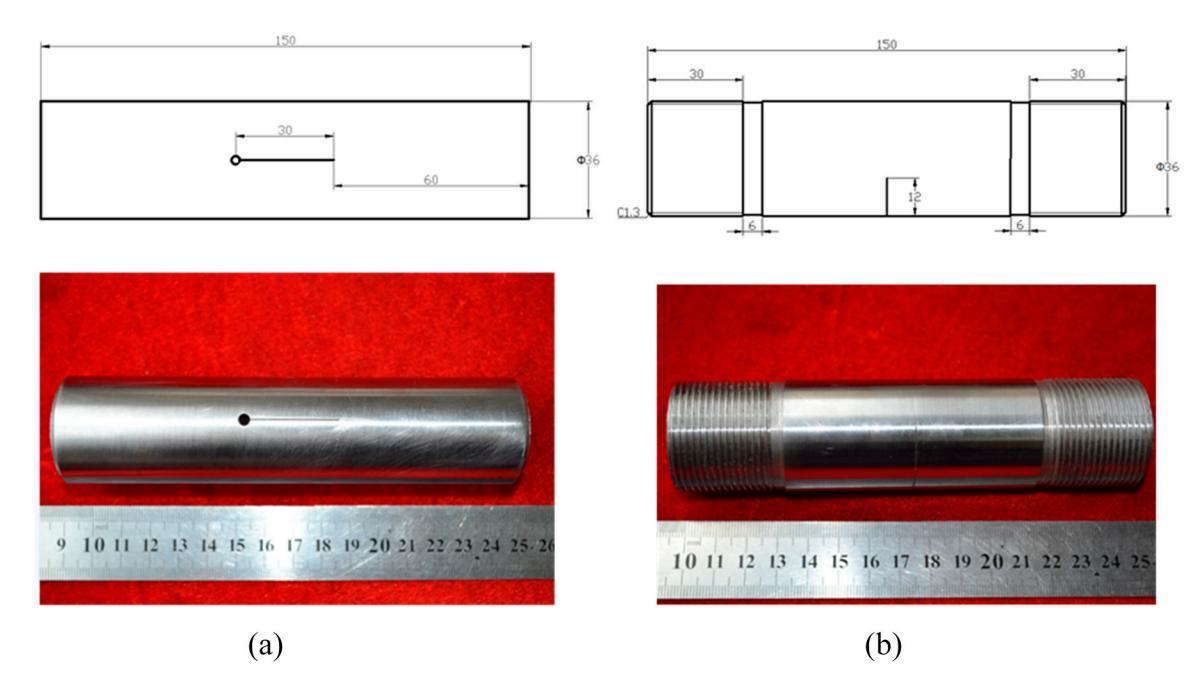
Figure 1. Schematics and photographs of specimens: (a) Group A; (b) Group B. (unit: mm).

The tubular specimens were cut from a 1045 steel tube and machined to 36 mm in outer diameter, 3 mm in thickness and 150 mm in height. Two types of cutting line were created in the tubular specimens through wire electrical discharge machining (WEDM, Ren Guang CNC Equipment Co Ltd, Suzhou, China), one along the axial direction and the other along the radial direction of the specimen, as shown in Figure 1. A cutting line 30 mm in length was created along the axial direction of the tubular specimen in group A, while a cutting line 12 mm in length was created along the radial direction of the tubular specimen in group B. Each group consisted of three specimens for different durations of the eddy current treatment. In order to introduce the fatigue crack, the fatigue tests were conducted at room temperature in atmosphere under the condition of dynamic load with a MTS 890 Axial/Torsional Test System (MTS Systems Corporation, Eden Prairie, MN, USA). All of the tests in group A were carried out at a stress ratio of R = 0.13, a maximum force of $F_{max} = 53$ KN and a frequency of f = 10 Hz for 10^4 cycle, while all of the tests in group B were performed at a stress ratio of R = 0.14, a maximum force of F_{max} = 21 KN and a frequency of f = 10 Hz for 5×10^3 cycle. The fatigue cracks initiated and propagated along the cutting lines during the fatigue tests. The morphologies of the fatigue cracks before and after the eddy current treatment were observed on an OLYPUS optical microscope and the fatigue crack photographs taken through the OLYMPUS optical microscope were stitched together to get full views of the fatigue cracks.

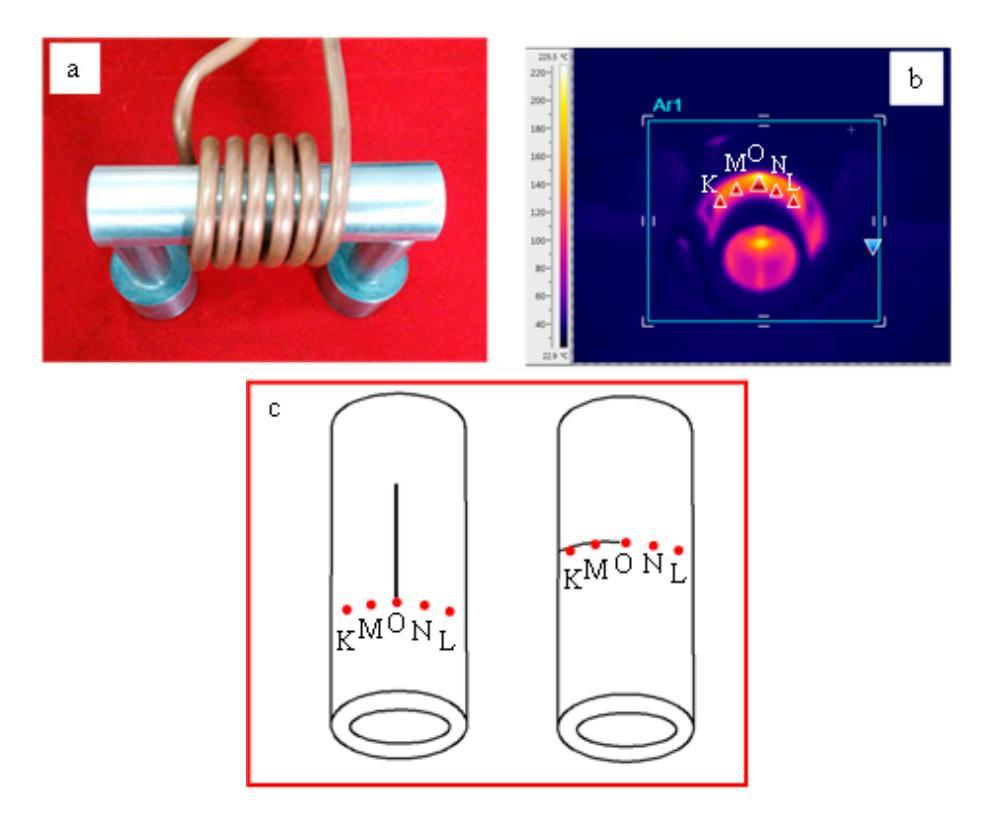
Figure 2. Photographs of the copper coil and specimen: (**a**) specimen within copper coils; (**b**) infrared temperature image of the surface of specimen; (**c**) measurement points on the surface of specimens.

After recording the morphologies of fatigue cracks, the eddy current was applied to the specimens with fatigue cracks under ambient conditions by a high frequency induction heating apparatus with a 60 KW rated power. The copper coils were connected with the high frequency induction heating apparatus and the specimens were fixed in the center of copper coils, as illustrated in Figure 2a. The copper coils were made from a copper tube 8 mm in diameter. The inner diameter of the copper coils was 45 mm, and the length of copper coils was 60 mm in order to cover the fatigue crack and cutting line area on the surface of the specimens. Different durations of the eddy current treatment were used in the two groups. Owing to the skin effect of eddy current, the eddy current density was the largest near the surface of the tubular specimen, so the outer surface temperature was the highest in the specimen, which was monitored by a FLIR infrared imager, as shown in Figure 2b. The maximum temperature of point O in the fatigue crack area (as shown in Figure 2b,c) was monitored to represent

the temperature change of the fatigue crack. The temperature of points M, N, K, and L was measured at the same time; the points were symmetrically distributed on the two sides of point O along the circumferential direction as shown in Figure 2b,c. The four points nearly covered the neighboring area of the fatigue crack, so the average temperature of points M, N, K, and L was calculated to represent the temperature of the metal matrix around point O.

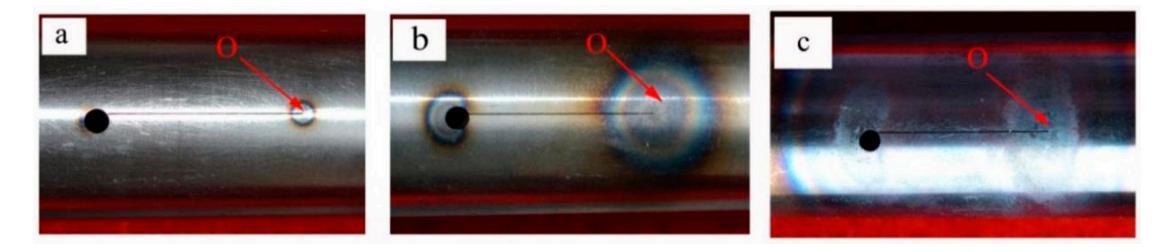
Figure 3. Photographs of specimens in group A: (a) A1; (b) A2; (c) A3.

Table 1 presents the temperature in the vicinity of the fatigue cracks during the eddy current treatment. It can be seen that the maximum temperature at point O of tubular specimens in group A increased from 226 °C to 781 °C with the increase of eddy treatment duration from 1 s to 3 s, while the average temperature of point M, N, K, and L increased from 90 °C to 451 °C at the same time. During the eddy current treatment, the temperature at point O was nearly the maximum temperature in the monitored area, which could also be verified by the pictures in Figure 3. As shown in Figure 3, the surface oxidation area was expanded as a result of the increase of the maximum temperature of point O with the increase of the heating time. All the surface oxidation areas were centered around the end of the cutting lines where the fatigue cracks initiated, indicating that the maximum temperature on the surface of the specimen appeared in the fatigue crack area. The local oxidation area may be explained by the influence of eddy current induced by the copper coil during the eddy current treatment process. According to Faraday's law of electromagnetic induction [19], the eddy current flows along a circular loop within the specimens under the ideal conditions, as illustrated in Figure 4a. When a crack appears along the axial direction, it disturbs the distribution of eddy current lines, as shown in Figure 4b. In this case, the eddy current lines detour around the crack tip and become denser on the crack tip, leading to the pronounced increase of the eddy current density there. The higher density of eddy currents produce more heat, resulting in much a higher temperature in the crack area.

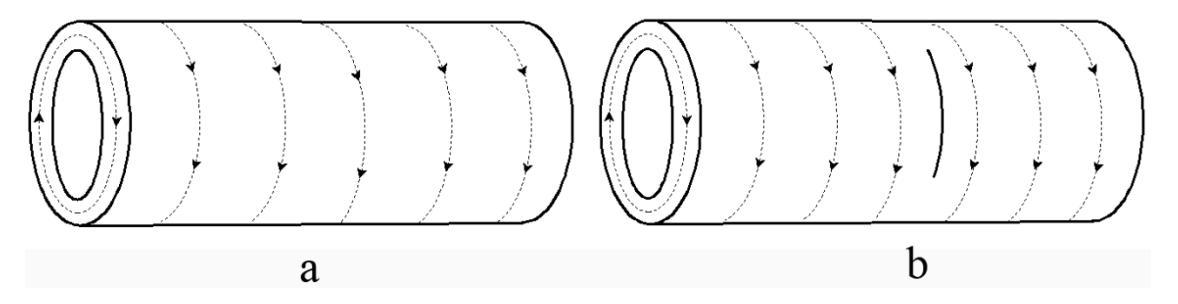
Figure 4. Schematics of eddy current within tubular specimens: (**a**) specimen without cracks; (**b**) specimen with axial cracks.

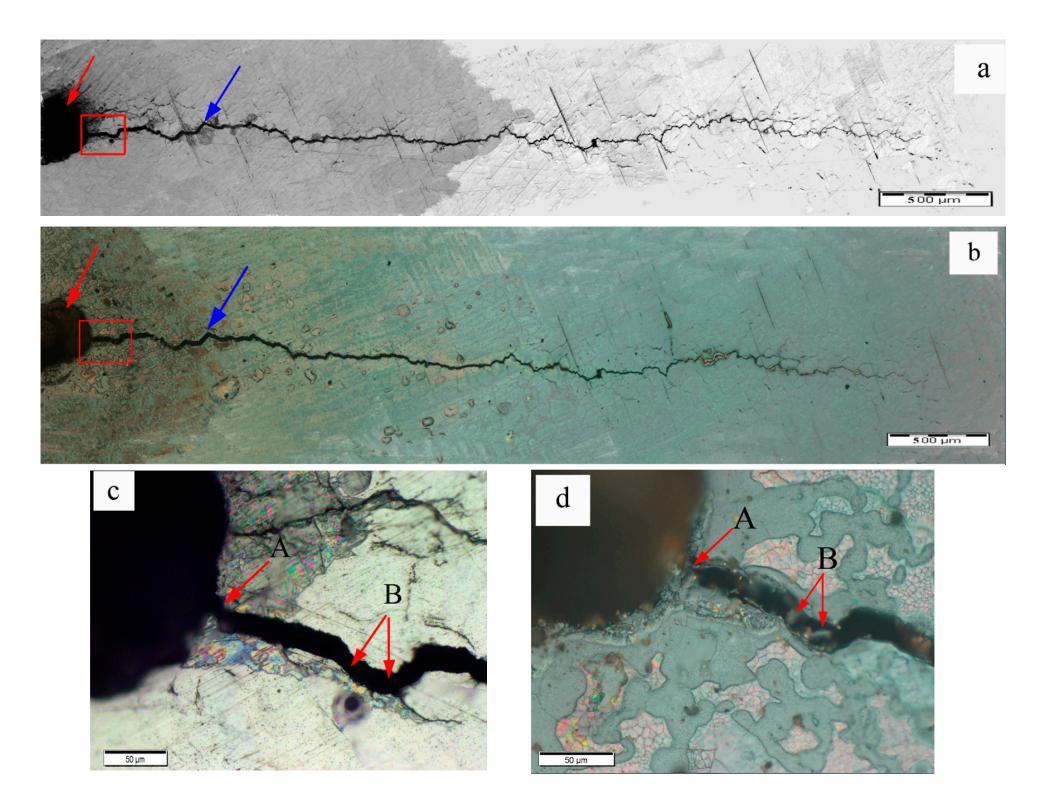
Figure 5. Optical microscope images for fatigue cracks of A1: (a) fatigue crack before the eddy current treatment; (b) fatigue crack after the eddy current treatment; (c) crack initiation zone of specimen A1 before the eddy current treatment; (d) crack initiation zone of specimen A1 after the eddy current treatment.

Further details were studied on the fatigue crack areas of the specimens. The optical micrographs of fatigue cracks of specimens A1, A2, and A3 before and after eddy current treatment are shown in Figures 5–7, respectively. The left, wider crack is the cutting line (as the red arrow indicates) and the narrow crack (as the blue arrow indicates) is the fatigue crack connected with the cutting line. The surface oxidation area is also visible in Figures 5–7. However, the lengths of the fatigue cracks remained almost the same after eddy current treatment when they were observed in the large scale, as shown in Figure 5a,b, Figure 6a,b and Figure 7a,b. The local areas of specimen A1 were further observed in small scale to confirm the difference between fatigue cracks before and after the eddy current treatment. The optical micrographs of the crack initiation zone of specimen A1 before and after the eddy current treatment are shown in Figure 5a,b. The crack initiation zone was the connecting zone of the cutting line and the fatigue crack. By comparing the Figure 5c,d, it could be seen that the crack initiation area was not filled, but that bridging appeared between two sides of the crack in the marked area A, which was very close to the position where the fatigue crack initiated. In addition, the marked area B near the marked area A also had a tendency to bridge, as shown in Figure 5d.

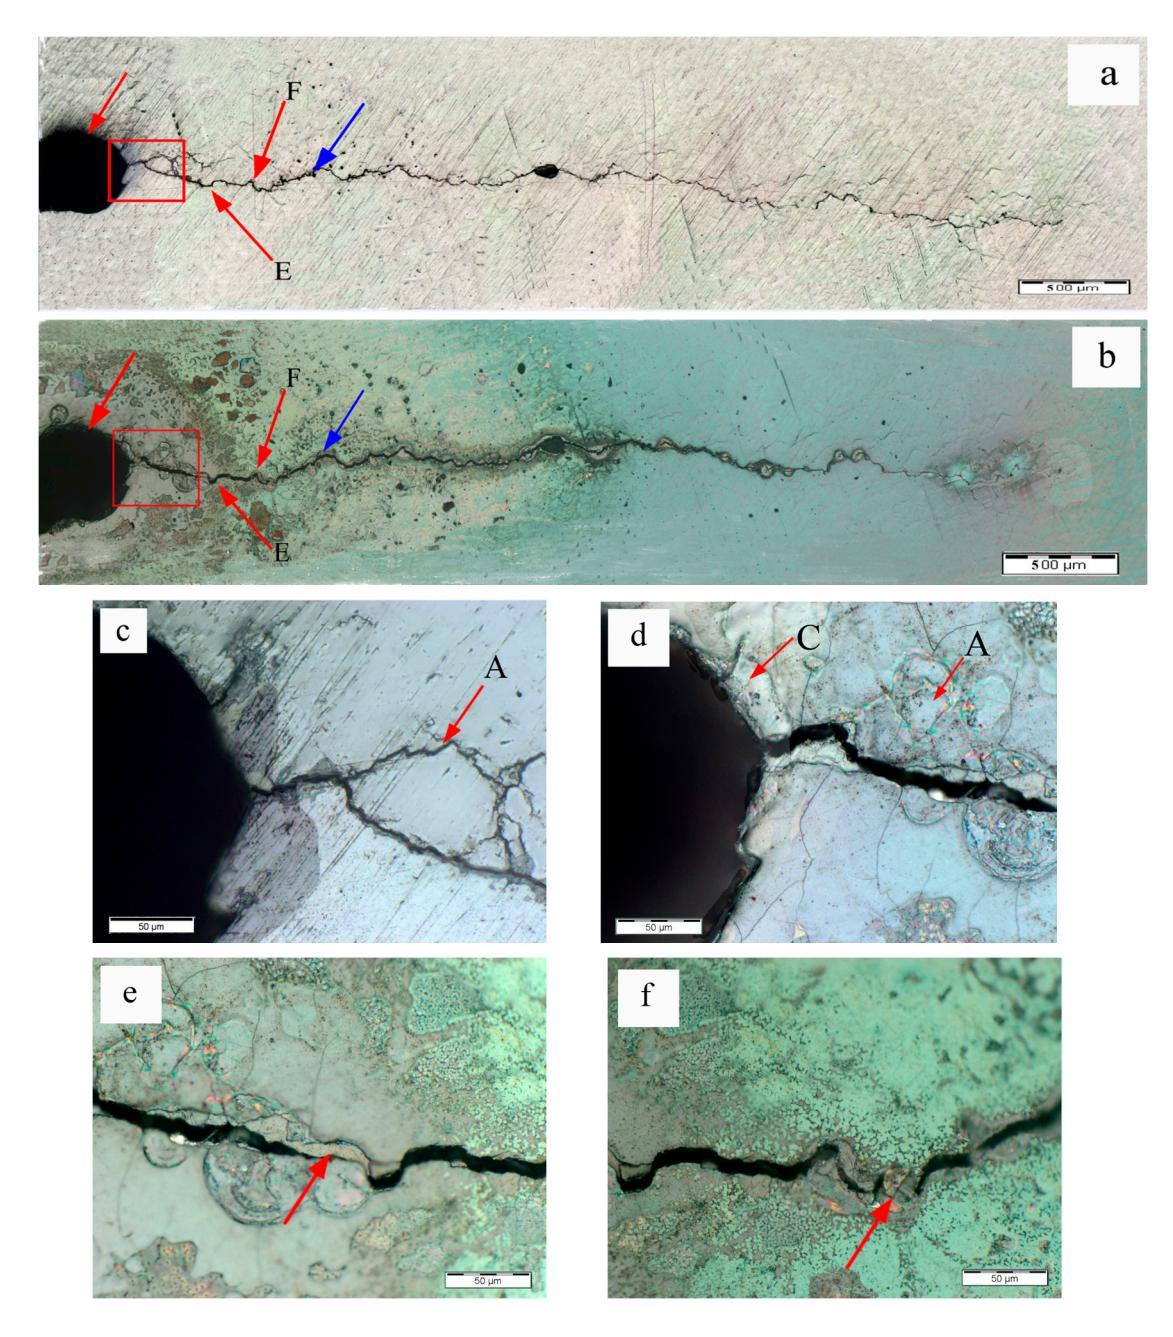
Figure 6. Optical microscope images for fatigue cracks of specimen A2: (**a**) fatigue crack before the eddy current treatment; (**b**) fatigue crack after the eddy current treatment; (**c**) crack initiation zone of specimen A2 before the eddy current treatment; (**d**) crack initiation zone of specimen A2 after the eddy current treatment; (**e**) marked area E in Figure 6b; (**f**) marked area F in Figure 6b.

The fatigue cracks in specimens A2 and A3 exhibited a higher degree of healing than in specimen A1 as shown in Figures 6 and 7. The local areas of specimen A2 were also observed in Figure 6. It is clear that the crack initiation zone was filled in marked area A shown in Figure 6d, which is the magnified picture of the area in the red rectangle in Figure 6b. Furthermore, the areas farther from the cutting line also exhibited the healing effect. The fatigue cracks in marked area E and F in Figure 6b were also partly filled, as illustrated in Figure 6e,f, respectively. Moreover, it was noted that the marked area C at the very beginning of the fatigue crack may have melted during the eddy current treatment, as depicted in Figure 6b,d, since the surface morphology in this area was quite different from the neighboring areas.

Figure 6b. In addition, the local melting probably occurred in the crack initiation zone of specimen A3, which showed different color and morphology from the neighbor area after the eddy current treatment. Moreover, this local melting area was larger than the marked area C which may melt in Figure 6d.

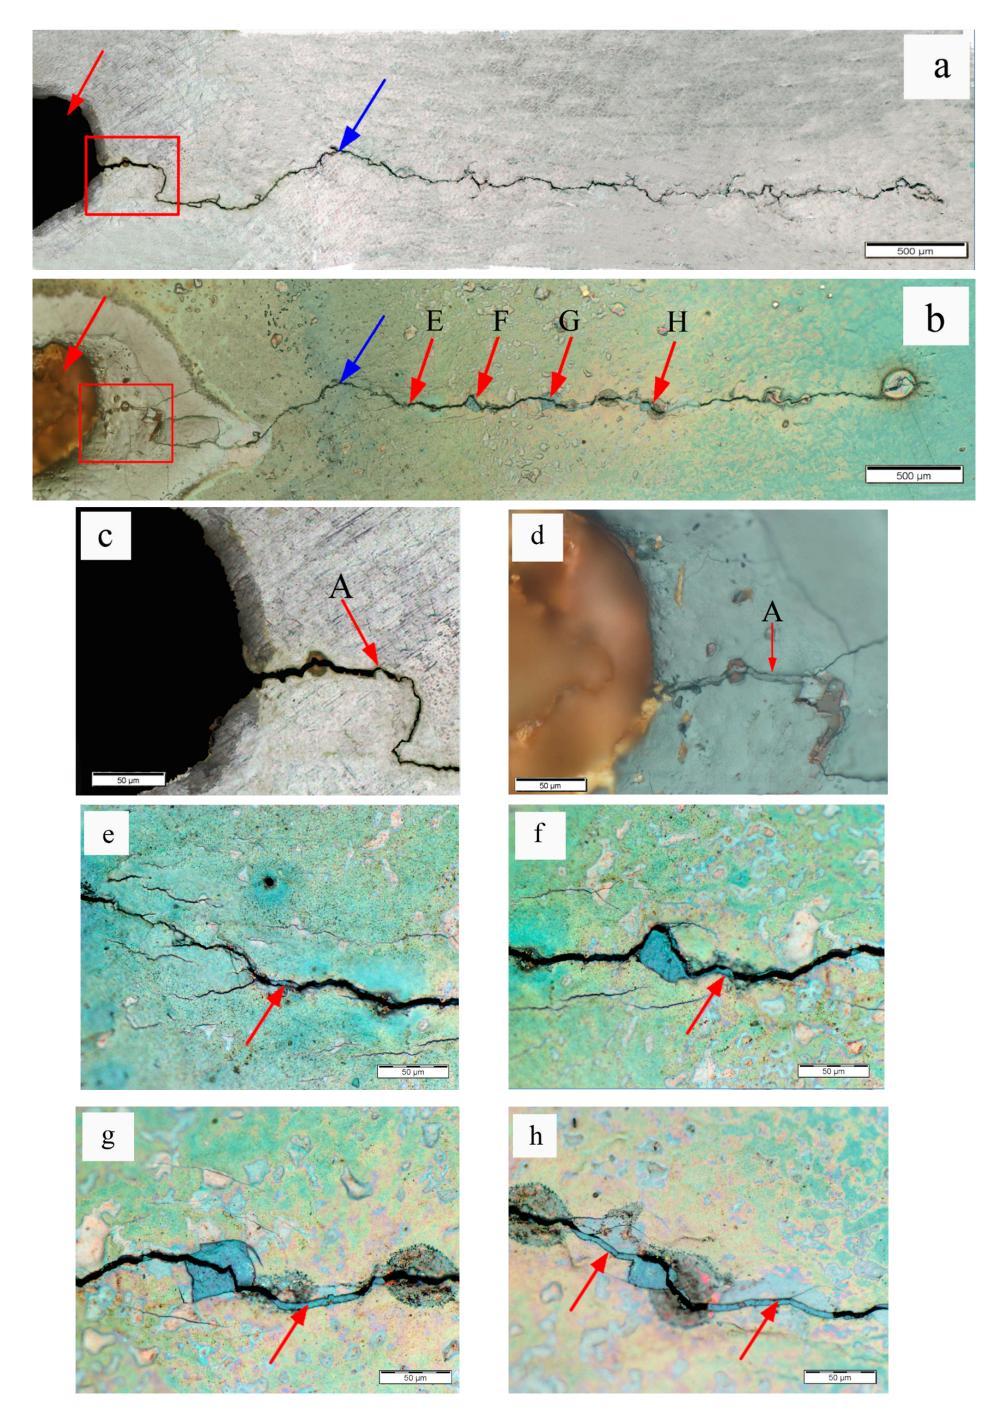
Figure 7. Optical microscope images for fatigue crack of specimen A3: (**a**) fatigue crack before the eddy current treatment; (**b**) fatigue crack after the eddy current treatment; (**c**) crack initiation zone of specimen A3 before the eddy current treatment; (**d**) crack initiation zone of specimen A3 after the eddy current treatment; (**e**) marked area E in Figure 7b; (**f**) marked area F in Figure 7b; (**g**) marked area G in Figure 7b; (**h**) marked area H in Figure 7b.

The specimen A3 exhibited the highest degree of healing, as shown in Figure 7. The Figure 7c,d are magnified pictures of the areas in the red rectangles in Figure 7a,b, respectively. It can be seen that the crack was completely filled and healed in the crack initiation zone after the eddy current treatment, and the filling level of specimen A3 in the crack initiation zone was much higher than that of specimen A2 and specimen A1. Furthermore, more filled areas were detected, as illustrated in Figure 7b. The fatigue cracks in marked areas E, F, G and H were also partly healed, as depicted in Figure 7e–h respectively. The marked area H was the farthest filled area from the cutting line in Figure 7b, and the distance between the marked area H and cutting line was much longer than the distance between the cutting line in Figure 6b, which was the farthest filled area from the cutting line in the cutting line in Figure 1 and marked area F in Figure 6b, which was the farthest filled area from the cutting line in the cutting line in Figure 1 and marked area F in Figure 6b, which was the farthest filled area from the cutting line in the cutting line in Figure 1 and marked area F in Figure 6b, which was the farthest filled area from the cutting line in Figure 1 and marked area F in Figure 6b, which was the farthest filled area from the cutting line in Figure 1 and marked area F in Figure 6b, which was the farthest filled area from the cutting line in Figure 1 and marked area F in Figure 6b, which was the farthest filled area from the cutting line in Figure 1 and marked area F in Figure 6b, which was the farthest filled area from the cutting line in Figure 1 and marked area F in Figure 6b, which was the farthest filled area from the cutting line in Figure 1 and marked area F in Figure 6b, which was the farthest filled area from the cutting line in Figure 1 and marked area F in Figure 1 and marked area F in Figure 1 and marked area F in Figure 1 and F a

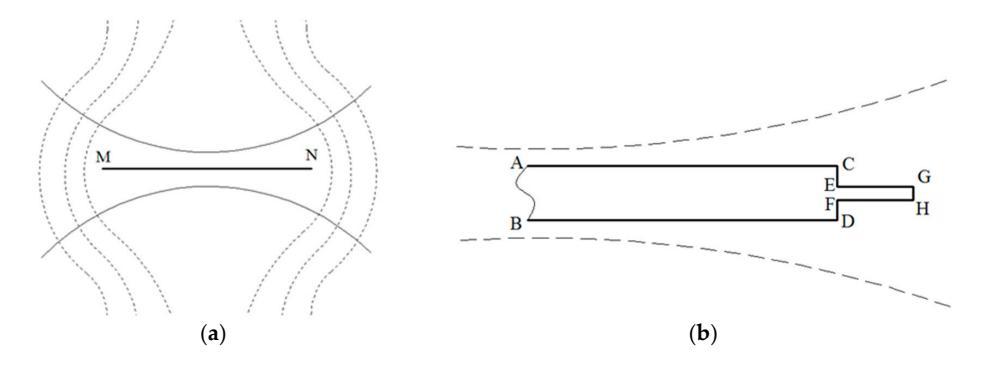
Figure 8. Schematics of eddy current around a crack: (a) whole crack; (b) the right end of whole crack.

around the crack tip because of the existence of fatigue cracks. Figure 8 shows the voltage distribution around the crack during the eddy current treatment. In Figure 8a, the line MN stands for the whole crack consisting of the cutting line and fatigue crack, and the dashed line and solid line stand for the eddy current line and the voltage equipotential line, respectively. The voltage equipotential lines were in arc shape, perpendicular to the eddy current lines according to the Faraday's law of electromagnetic induction [18]. As a result, the neighboring voltage equipotential lines were very close at the center of the crack, causing higher electric field intensity in this area. In order to describe the eddy current distribution around the fatigue crack, the magnified schematic of the right end of the whole crack in Figure 8a is shown in Figure 8b. The profiles of the cutting line and fatigue crack are simplified for the convenience of analysis, wherein the wide rectangle ABCD stands for the right end of the cutting line, the narrow rectangle EFGH stands for fatigue crack, and the connecting zone of the cutting line and fatigue crack was much shorter than the length of the cutting line, and the width of fatigue crack was also much smaller than that of the cutting line. According to the Paschen Law [19]:

where *U* was the breakdown voltage, *P* was the gas pressure, *d* was the gap distance between the two sides of the crack, γ was the secondary electron emission coefficient at the cathode, A was the saturation ionization in the gas at a particular E/p (electric field/pressure), and B was related to the excitation and ionization energies. Since the parameters A, B, and γ are roughly constant over a restricted range of E/P for a given gas in a stable atmospheric pressure environment, the breakdown voltage *U* of the air gap was only related to the gap width *d*. The wider the gap *d* is, the higher breakdown voltage U is needed. Although the cutting line was in the middle of the copper coil along the axial direction and withstood the highest voltage, the width of the cutting line was almost ten times of the width of fatigue crack, which was too wide for the cutting line to be broken down. Hence, the breakdown of the air gap was more prone to take place in the fatigue crack area (EFGH) rather than the cutting line area (ABCD). Moreover, the breakdown appeared first in the connecting zone of the cutting line and fatigue crack (close to EF) where the fatigue crack initiated, since the zone was closer to the center of the copper coil and withstood the highest voltage compared to other fatigue crack zones. The breakdown effect triggered the rapid temperature rise in the connecting zone, leading to melting and filling of metal in this area. Longer eddy treatment duration may contribute to more heat accumulation, and thus more metal would melt and fill the crack, resulting in a higher healing level, which was verified through the comparison of specimen A1, A2, and A3. Therefore, the area which may melt in the crack initiation zone of specimen A3 became larger than the area in specimen A2, and more filled areas appeared in specimen A3.

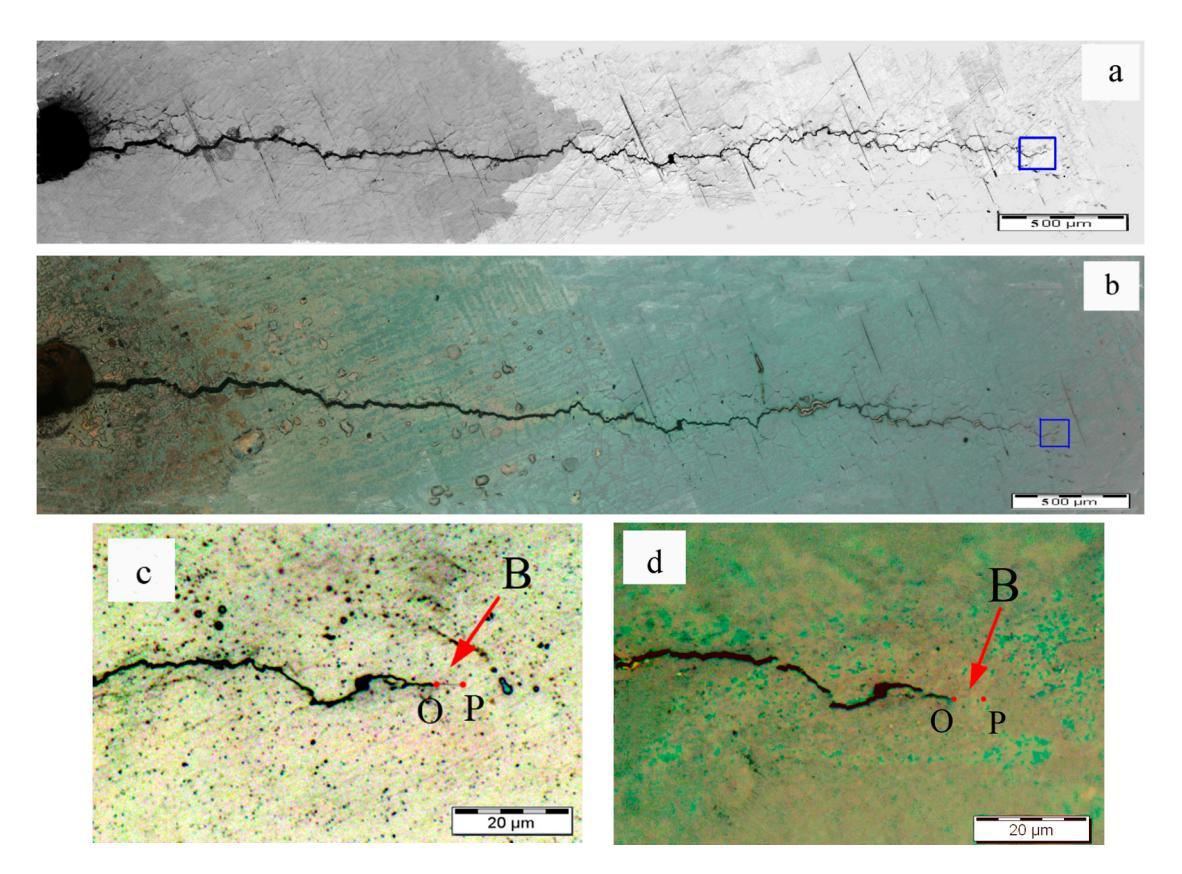
Figure 9. Optical microscope images for fatigue cracks of A1: (**a**) fatigue crack before the eddy current treatment; (**b**) fatigue crack after the eddy current treatment; (**c**) crack tip area of specimen A1 before the eddy current treatment; (**f**) crack tip area of specimen A1 after the eddy current treatment.

The connecting zone of the cutting line and fatigue crack was not the only area healed. The fatigue crack tip area was also healed after the eddy current treatment, as can be seen in Figures 9–11. The Figure 9c,d are the magnified pictures of fatigue crack tip areas in the blue rectangles in Figure 9a,b. When observed in large scale in Figure 9a,b, there was no obvious difference in the crack tip before and after the eddy current treatment. However, the marked area B in Figure 9a zoomed in Figure 9c presented the microcrack OP existing in this area before the eddy current treatment, while it disappeared after the eddy current treatment, as shown in Figure 9d, indicating that the crack tip area was healed after the eddy current treatment. The similar situation also occurred in the crack tip of specimen A2 and specimen A3. The Figure 10c,d are the magnified pictures of fatigue crack tip areas in the blue rectangles in Figure 10a,b, and the Figure 11c,d are the magnified pictures of fatigue crack tip areas in the blue rectangles in Figure 11a,b. Through comparing the crack tips before and after eddy current treatment (see the marked areas B in Figure 10c,d and Figure 11c,d), the microcrack GH in the fatigue crack tip of specimen A2 and the micro-crack KL in the fatigue crack tip of specimen A3 were healed after eddy current treatment. Because the profiles of the crack tips were quite different in different specimens, it was hard to quantitatively compare the healing lengths of crack tips. In order to simplify the calculation of crack length, the straight-line lengths of OP, GH, and KL were used to represent the healing lengths. The specimen A3 exhibited the longest length of crack healing (65.6 µm) in the crack tip area, while the specimen A2 showed only a slightly longer length of crack healing $(7.5 \,\mu\text{m})$ in the crack tip area than the specimen A1 (7.1 μ m), which indicated that the healing degree increased non-linearly with the increase of time duration in the present study.

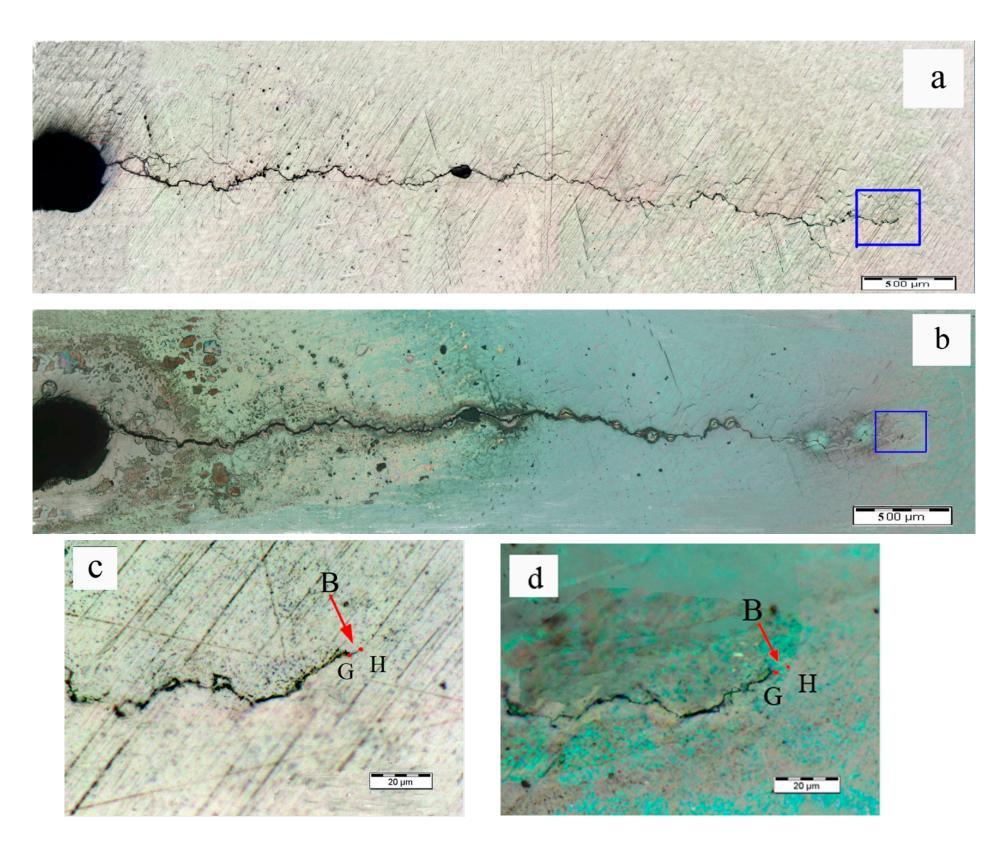
Figure 10. Optical microscope images for fatigue cracks of A2: (**a**) fatigue crack before the eddy current treatment; (**b**) fatigue crack after the eddy current treatment; (**c**) crack tip area of specimen A2 before the eddy current treatment; (**d**) crack tip area of specimen A2 after the eddy current treatment.

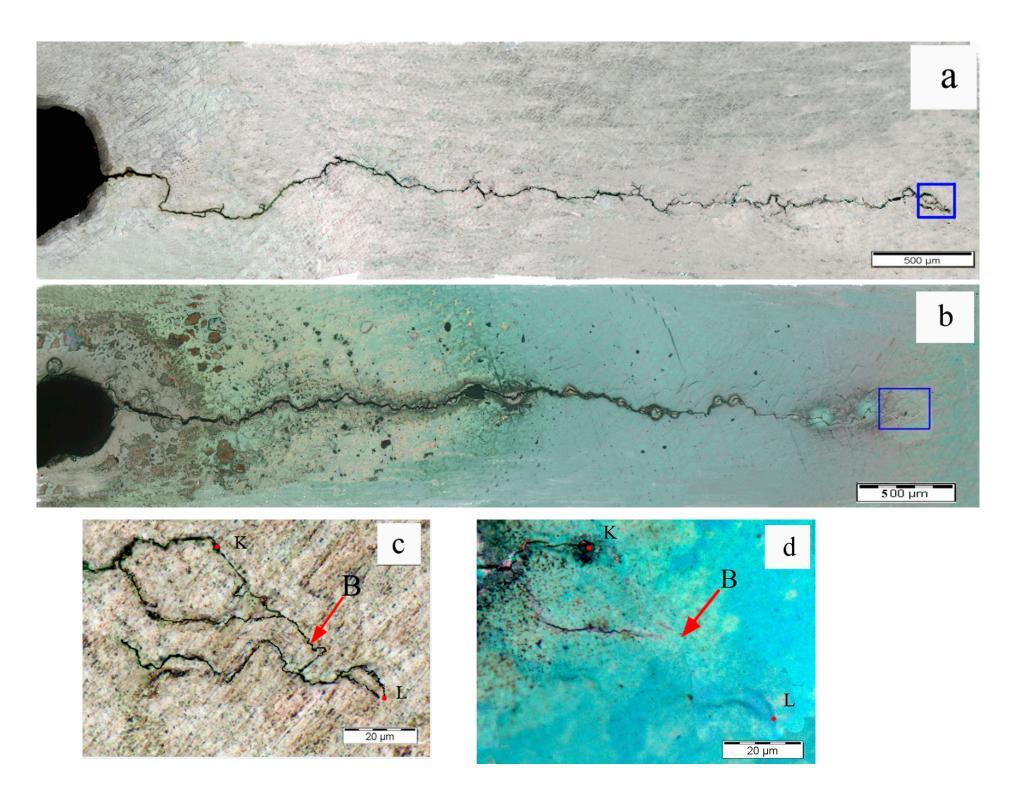
Figure 11. Optical microscope images in local area of specimen A3: (**a**) fatigue crack before the eddy current treatment; (**b**) fatigue crack after the eddy current treatment; (**c**) crack tip area of specimen A3 before the eddy current treatment; (**d**) crack tip area of specimen A3 after the eddy current treatment.

The mechanism for the crack healing in the crack tip caused by the eddy current treatment was not very clear until now; the possible reasons are compressive stress and local melting due to the detouring of the eddy current. When the eddy current flowed around the crack tip, it gathered in the crack tip area, leading to much higher current density in the crack tips than in other areas. The higher current density produced more heat and resulted in a significant rise in temperature, which causes metal melting in local areas and contributes to crack healing. In addition, the detouring of the eddy current around the crack tip made the temperature increase more quickly than in other areas, so a nonsynchronous change of temperature rise and thermal expansion would be generated there [18]. Since the thermal expansion rate of metal material is proportional to their temperature, the thermal expansion in the vicinity of the crack tip would be much higher than the thermal expansion in areas far from the crack tip, thus the thermal expansion of the crack tip due to the compressive force exerted by the surrounding area. The maximum theoretical thermal stress due to a nonsynchronous change of temperature size around the crack tip due to the compressive force exerted by the surrounding area. The maximum theoretical thermal stress law [20]:

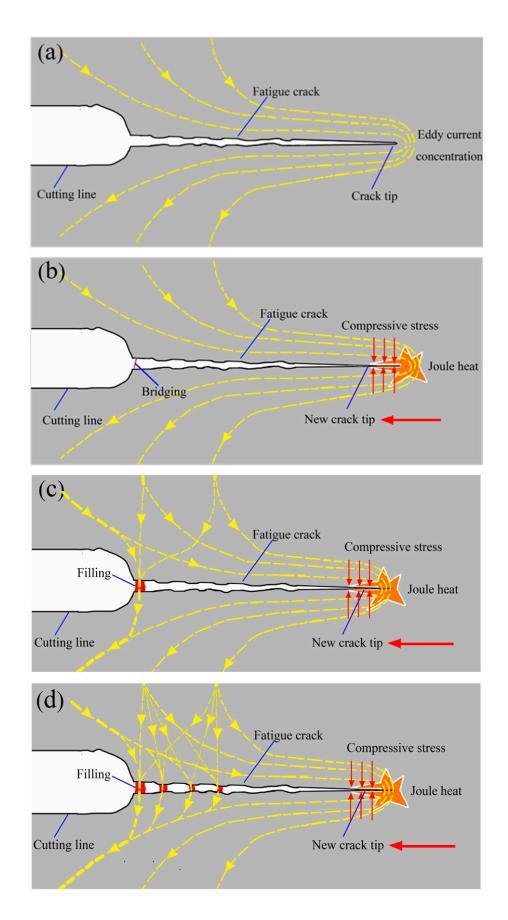
Figure 12. Schematics of the fatigue crack healing process. (**a**) the detour of eddy current; (**b**) the appearance of the compressive stress and the bridging; (**c**) the appearance of breakdown and crack tip healing; (**d**) continuous crack healing.

Based on the above analysis, the process of fatigue crack healing by eddy current treatment is summarized in Figure 12. The Figure 12a shows the beginning stage of eddy current treatment in which the eddy current (the dashed line) flowed around the fatigue crack and took a detour from the crack tip. As a result of joule heat generated around the crack tip, the local concentration of eddy current around the fatigue crack tip caused the closure or healing of the crack tip and subsequent movement of the new crack tip (as the red arrow indicates) toward the left side under compressive stress, as shown in Figure 12b. On the other hand, the voltage breakdown contributed to the bridging in the connecting zone of the cutting line and the fatigue crack in Figure 12b. As the treatment duration increased, the area where the bridging took place was filled due to the diffusion of metal material, as depicted in Figure 12c. After that, part of the eddy current that was detouring around the crack tip before would flow through the filled area, which decreased the current density detouring around the crack tip. Hence, the compressive stress around the new crack tip may be reduced because of the heat reduction in this area caused by the detour of the eddy current, which decreased the possibility of the new crack healing. However, the eddy current flowing through the filling area created a large amount of heat in the filled area, and the accumulation of heat resulted in the filling of more areas near the previously filled area. Therefore, some narrow areas were filled successively, as illustrated in Figure 12d.

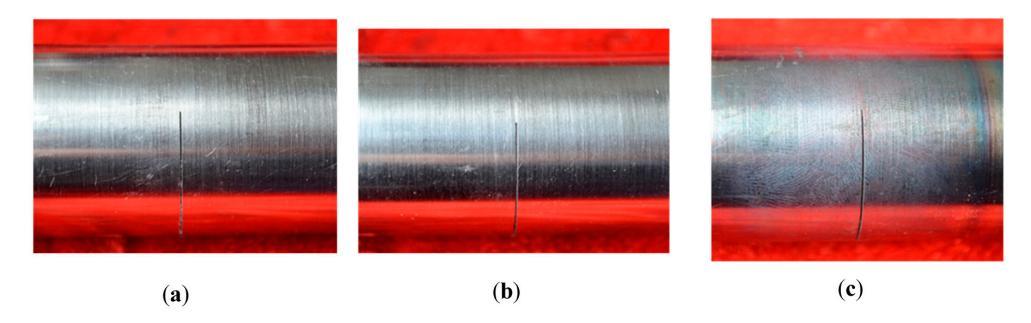
Figure 13. Photographs of specimens in group B after the eddy treatment: (a) B1; (b) B2; (c) B3.

The situation was totally different when the specimens in group B were subjected to the eddy current treatment. As can be seen from Table 1, the maximum temperature of point O of the specimens in group B increased from 155 °C to 496 °C with the increase of time duration from 1 s to 3 s, and the temperatures of point M, N, K, and L were always quite close to the temperature of point O. Although the treatment times for the two groups were the same, the maximum temperatures of the specimens in group B were much lower than that in group A, so no oxidation appeared on the surface of specimen B1 and B2, and slight oxidation uniformly appeared on the surface of specimen B3, as shown in Figure 13. Moreover, the crack area did not exhibit a higher oxidation degree than the neighboring areas. It indicates that the temperature was distributed almost evenly on the surface of tubular specimens during the eddy current treatment. In addition, the connecting zones of cutting lines and fatigue cracks were observed in Figure 14. It is clear that there was no healing in this area even when the maximum temperature reached 496 °C in specimen B3, which was even higher than the average temperature of specimens A1 and A2. Therefore, it could be speculated that the temperature of the metal matrix is not the decisive factor for crack healing of tubular specimens.

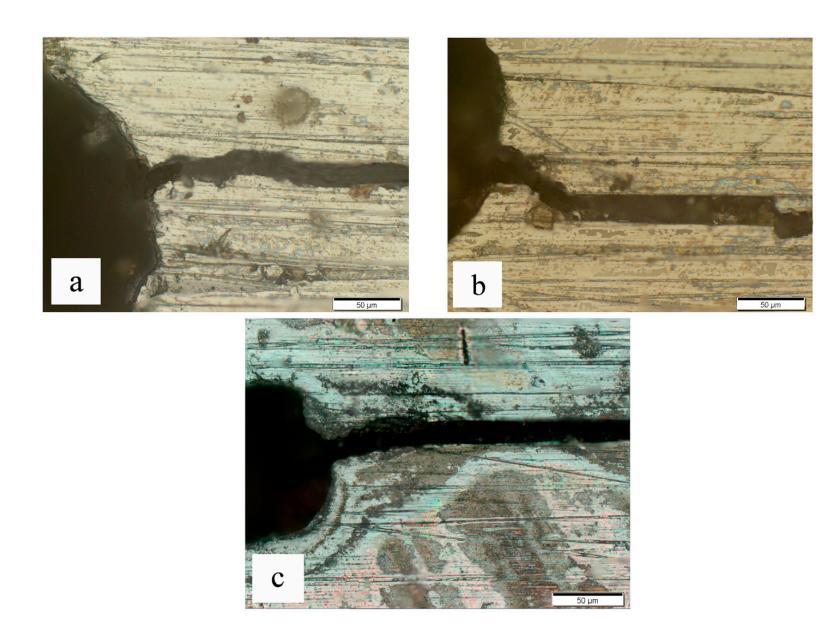
Figure 14. Optical micrographs of specimens B1, B2, and B3 after the eddy treatment: (**a**) B1; (**b**) B2; (**c**) B3.

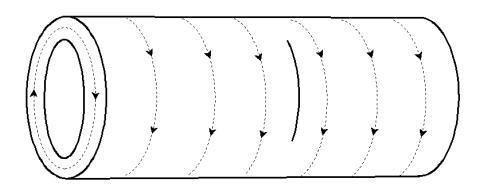
Figure 15. Schematic of the eddy current within specimens in Group B.

This phenomenon was also related to the eddy current distribution within the specimens in group B, as illustrated in Figure 15. When a crack along the radial direction appeared, it was not able to disturb the distribution of the eddy current lines along the hoop direction. The distribution of the eddy current lines was uniform and stable, and the joule heat induced by eddy current was almost

uniformly distributed. Therefore, the eddy current did not detour around the fatigue crack, and the eddy current lines did not gather around the crack tip. In this case, no obvious heat concentration appeared on both sides of the fatigue crack, thus no crack healing occurred.
