Damage Monitoring of Regularly Arrayed Short-Fiber-Reinforced Composite Laminates under Tensile Load Based on Acoustic Emission Technology

Abstract: Carbon-fiber-reinforced polymer (CFRP) composites are widely used in lightweight structures because of their high specific strength, specific modulus, and low coefficient of thermal expansion. Additionally, the unidirectionally arrayed chopped strand (UACS) laminates have excellent mechanical properties and flowability, making them suitable for fabricating structures with complex geometry. In this paper, the damage process of UACS quasi-isotropic laminates under tensile load was tested using acoustic emission detection technology. The mechanical properties and damage failure mechanism of UACS laminates were studied combined with finite element calculation. By comparing and analyzing the characteristic parameters of acoustic emission signals such as amplitude, relative energy, and impact event, it is found that acoustic emission behavior can accurately describe the damage evolution of specimens during loading. The results show that the high-amplitude signals representing fiber fracture in continuous fiber laminates are concentrated in

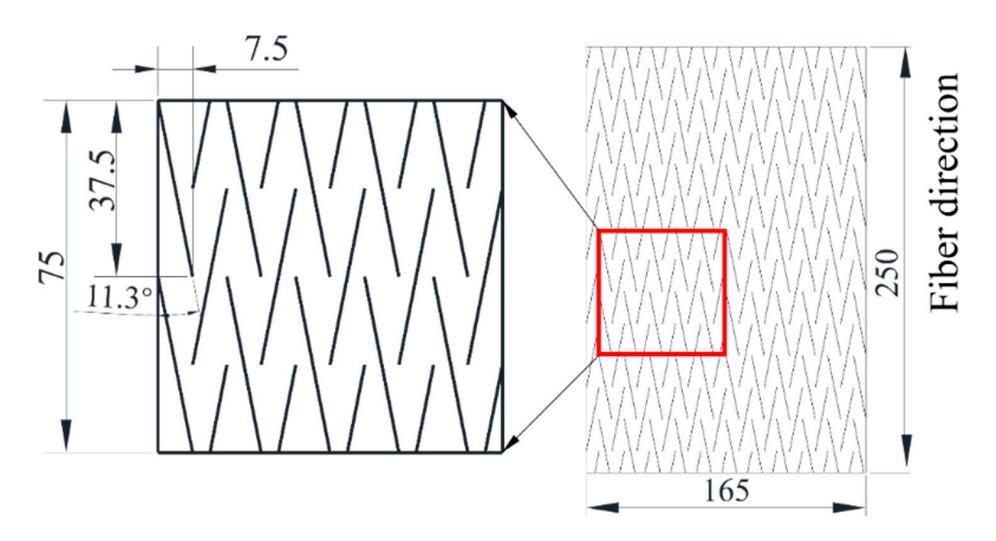
Figure 1. Dimension of prepreg layer for tensile specimens and slits of UACS prepreg.

The CFRP prepreg applied in this study is the standard thickness carbon fiber prepreg T800/7901 (thickness: 0.125 mm) produced by Weihai Guangwei Composite Materials Co., Ltd. (Weihai, China). The mechanical property parameters of the prepreg are listed in Table 1. Prepreg layers and bi-angled slits are cut by a CNC cutting machine to ensure dimensional accuracy. The cutting size of the prepred is 250×165 mm. The schematic diagram of UACS carbon fiber prepreg is shown in Figure 1. The prepregs are stacked in sequence according to the laying sequence of quasi-isotropic laminates $[45^{\circ}/0^{\circ}/-45^{\circ}/90^{\circ}]s$, then placed in the mold. According to whether the carbon fiber layer is continuous, it is divided into continuous specimens T-C-8 and UACS specimens T-U-8, where T stands for tensile specimen, C stands for continuous carbon fiber, U stands for UACS laminate, and 8 stands for the number of carbon fiber layers. In this study, the laminates are fabricated using hot pressing. During this process, the pressure and temperature parameters of the thermal press are adjusted, with a pressing time of 60 min, a temperature of 130 $^\circ$ C, and a molding pressure of 0.6 MPa. This ensures a stable hot pressing curing process, as shown in Figure 2, to guarantee the quality of the laminates. Once the curing process is complete, the heating is turned off while the pressure is kept constant. The laminate is cooled naturally to below 50 °C before pressure relief.

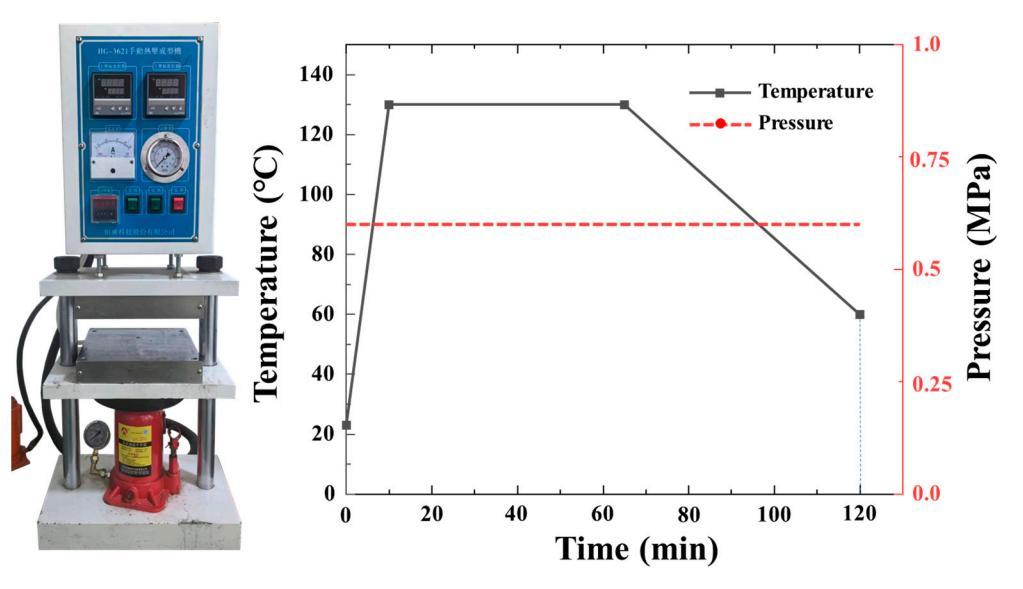
Figure 2. Curing curve of composite laminates.

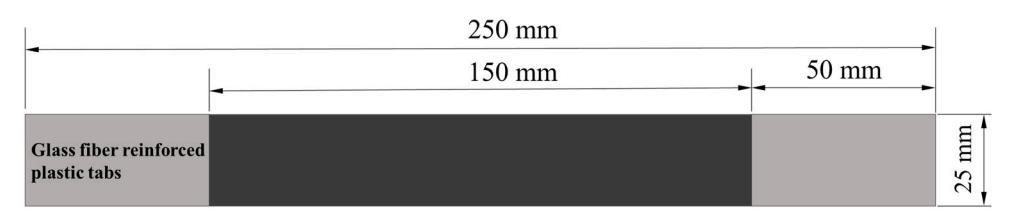
Figure 3. Dimensions of tensile specimen.

According to ASTM D3039M [32], the size of the tensile specimen is 250×25 mm; specimens are water-cut from the laminate to meet size requirements. The size of the tensile specimens is shown in Figure 3, the gauge distance is 150 mm, and a glass fiber reinforcement sheet has been attached to both ends of the specimens, the size of which is 50×25 mm.

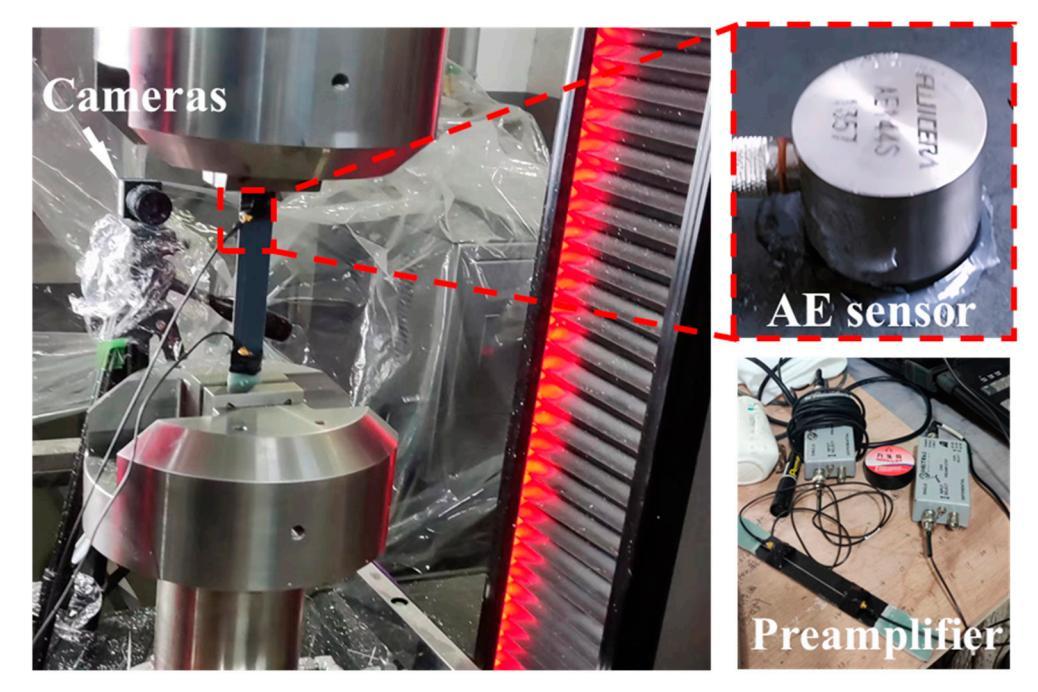
Figure 4. Experimental setup of tensile test including DIC and AE equipment.

The tensile test refers to the experimental standard ASTM D3039M, and the configuration of the experiment is illustrated in Figure 4, including a universal testing machine (LE5305, Lishi Shanghai Scientific Instrument Co., Ltd., Shanghai, China). The tensile speed is set at 1 mm/min, and the sampling frequency is 4 Hz. The speckle images were taken with an industrial camera (acA2500, Basler, Ahrensburg, Germany, with a frequency of 60 Hz), and the tensile strain field was calculated using VIC-2D V6 software. In addition, the strain data measured by a large-range extensometer (3542-050M-010-ST, Epsilon, Jackson, WY, USA) are compared with the results of the DIC method measurement. Continuous fiber laminates and UACS laminates were tested four times to ensure the accuracy of the test. The Mistras Micro-II digital AE system (Princeton Junction, NJ, USA) uses AEwin's PAC PCI-2 software for AE testing, with hardware components primarily consisting of AE sensors, preamplifiers, cables, and other related components. The considered quasi-static tensile test is stable and produces less noise interference. The two AE sensors were connected to the specimen surface using Vaseline as a coupling agent and secured with tape at a distance of about 120 mm. It can greatly reduce the signal attenuation on both surfaces and ensure better signal transmission performance between the specimen and the AE sensor. The speed of sound in each specimen is determined by a pencil break lead test prior to the AE test. Characteristic parameters such as time, impact event, amplitude, and relative energy are extracted from the AE signals collected by the AE system, and the corresponding coordinate images are sorted. Since AE signals are non-stationary signals, useful signals are easily interfered with. In order to ensure the validity of the analysis results, the pencil

breaking test was carried out. Breaking the pencil simulates small damage and produces AE signals, and filtering out the signal below the break lead test threshold can effectively separate the noise. This method is frequently used for calibrating AE sensors because of its excellent repeatability, easy implementation, and signal stability.

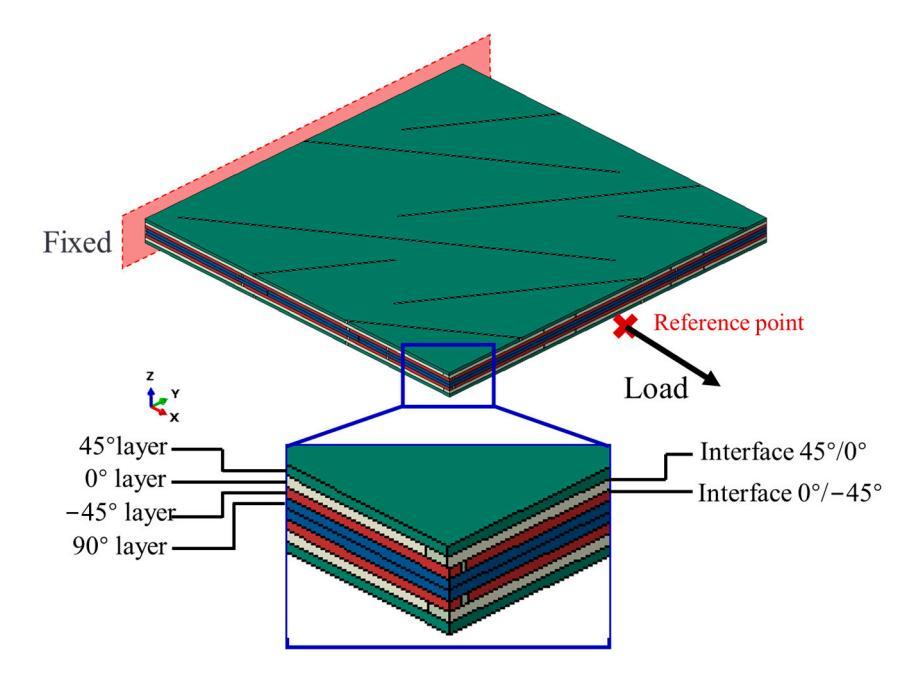
Figure 5. Finite element model of UACS laminates.

To simulate the tensile process of continuous laminate, a full-size finite element analysis model is created using ABAQUS 2021 software. Figure 5 shows the schematic diagram of the finite element model of the UACS specimen. The numerical model of UACS laminates divides each layer into two sections, each of which is assigned a certain material property. The rest region outside the slits is referred to as anisotropic CFRP prepreg, and slits are classified as resin as they are filled with resin during the curing process. The material direction of each layer model is consistent with the test, to establish a quasi-isotropic UACS model, and the model size is $25 \text{ mm} \times 25 \text{ mm}$. The thickness direction has been configured to consist of 8 layers, the stacking sequence is $[45^{\circ}/0^{\circ}/-45^{\circ}/90^{\circ}]$ s, and each layer is 0.13 mm thick. Material properties of the composite and cohesive elements are defined in the material manager, and the properties of epoxy resin are listed in Table 2. The mesh size is approximately 0.5 mm globally, taking into account the geometry of the prepreg and the slits; this size can meet the calculation accuracy and ensure good efficiency. For the capture of complex interactions within the UACS laminates, the extensively accepted Hashin's failure criterion was employed to distinguish and determine various damage modes, which is also in line with the complexity of damage influence on the material properties. The Hashin criterion is expressed as follows:

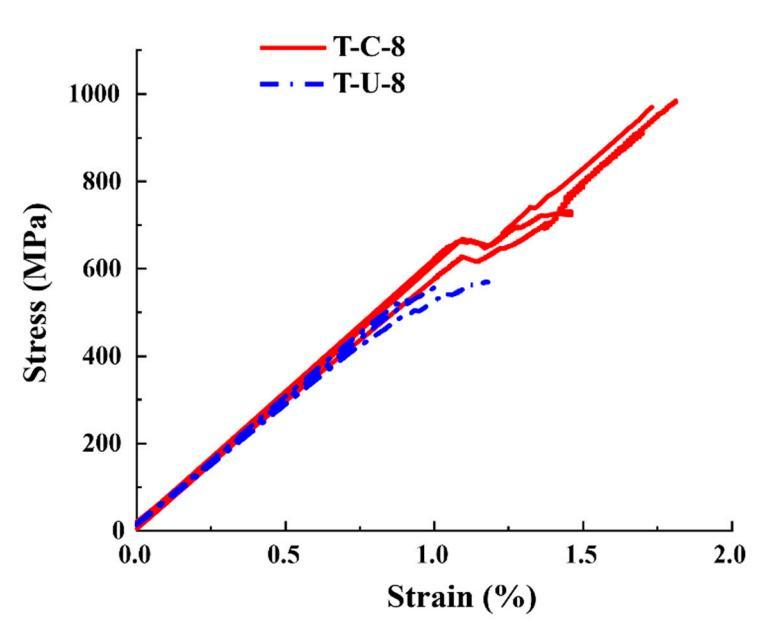
Figure 6. Tensile stress-strain curves of specimens of continuous fiber laminates and UACS laminates.

Figure 6 shows the tensile stress-strain results of continuous fibers and UACS specimens under quasi-static tensile load. The tensile strength and elastic modulus of T-C-8 and T-U-8 specimens are 951.66 MPa, 60.282 GPa, and 551.43 MPa, 59.241 GPa, respectively. Compared with specimen T-C-8, the average tensile strength and average elastic modulus of T-U-8 specimens decreased by 42.06% and 1.73%, respectively. This is because the slits in UACS laminates will significantly weaken the strength of the in-plane quasi-isotropic laminates while having little effect on their tensile modulus. All specimens show the linear elastic region in the early part of the curve, and the modulus of both specimens is almost the same in the linear stage. Until the late loading period, specimens T-C-8 and T-U-8 have slight progressive damage. It is worth noting that almost all T-C-8 specimens showed nonlinear load curve fluctuations at a strain of 1.1%, which continued to rise after a slight load drop, finally resulting in brittle failure at 1.9% strain. The stress-strain curves of UACS specimens show an obvious nonlinear response at the late loading stage, which indicates that the slits inside UACS have a positive effect on the progressive damage of the laminates. During the tensile process, the interface dislocation along the slits at different layers of UACS laminates will lead to progressive delamination propagation (nonlinear response on the stress-strain curve).

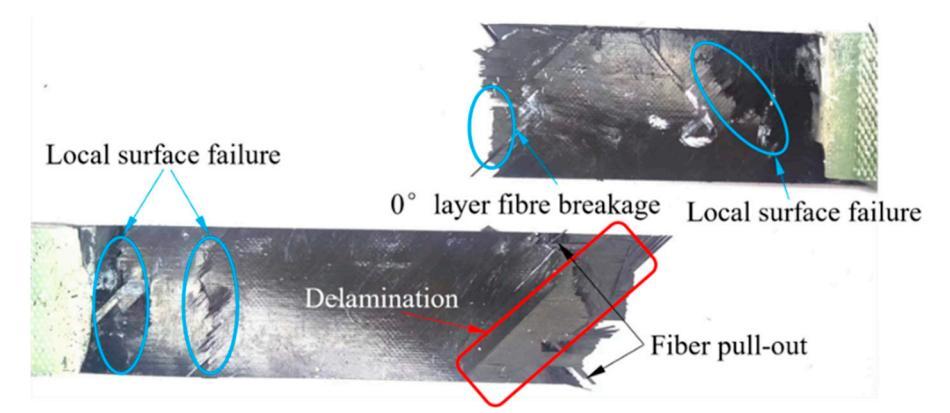
Figure 7. Typical image of the final tensile fracture pattern of continuous carbon fiber laminates.

Figures 7 and 8 display the typical fracture morphology of continuous carbon fiber laminates and UACS laminates after tensile failure, respectively. It is evident from Figure 7 that the continuous fiber specimen exhibited significant damage in several regions, mainly near the middle and end of the gauge length. The damage included delamination primarily at the 45° interlayer interface and local fiber fracture. However, there was only one final fracture. This can explain the load fluctuation at a strain of 1.1% in Figure 6. During the bearing process of the specimen, the local fiber fracture and delamination in the 45° surface layer resulted in an instantaneous decrease in the bearing property of the specimen, but the fiber in the 0° layer did not fracture and could continue to bear the load. It can be seen from the specimen fracture surface that a large area of delamination occurred between the 0° and 45° layers, and a large number of fiber fractures occurred in the 0° layer; eventually, this leads to a decrease in the load bearing capacity of the laminates.

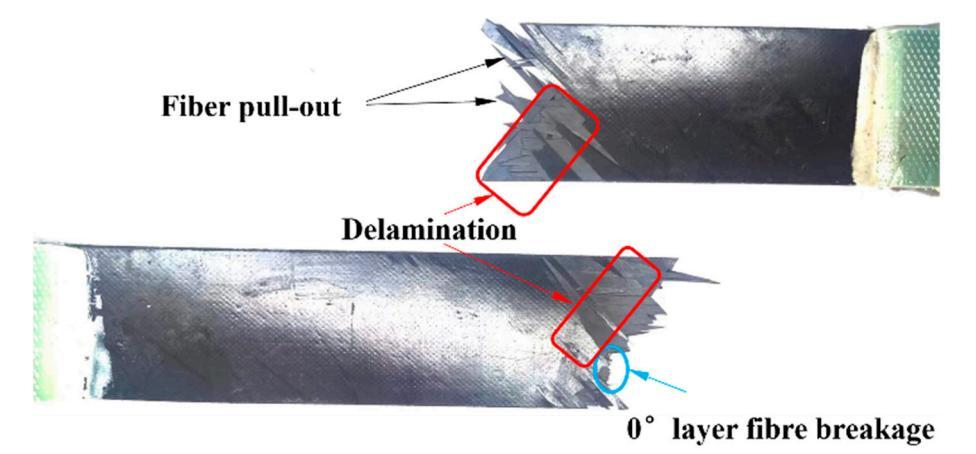
Figure 8. Typical image of the final tensile fracture pattern of UACS laminates.

However, it was observed that the UACS laminates experienced some nonlinear behavior before they ultimately failed during the experiment. In UACS laminates, delamination propagation is often concentrated at weak interfaces of slits and expand to the other side of the slits. Under external load, resin deformation in the slits promotes fiber flow on both sides, which means that UACS have a progressive damage process different from continuous fiber laminates. Through a comparison between Figures 7 and 8, it was observable that the fracture of continuous fiber specimens has continuous large-area delamination, while the delamination degree of UACS laminates is significantly smaller than that of continuous fiber specimens and shows more obvious dispersion and a more pronounced fiber pull-out phenomenon.

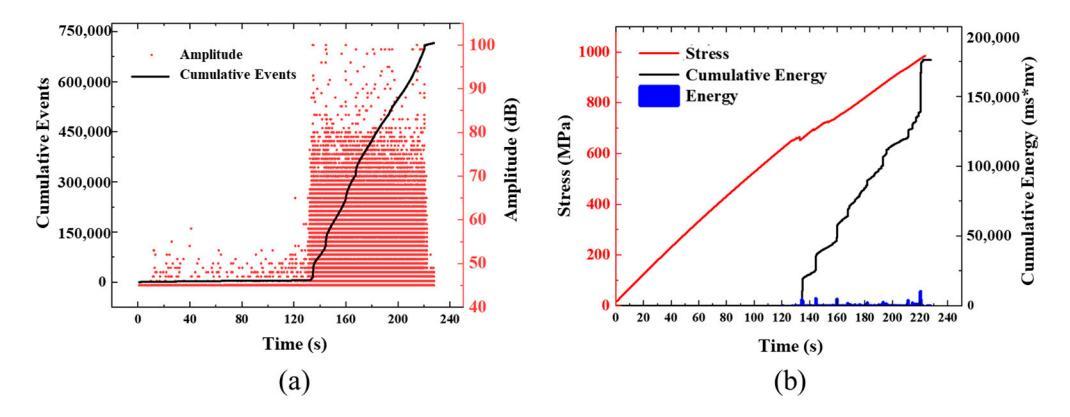
Figure 9. Typical acoustic emission signal of continuous fiber specimens under tensile load: (**a**) amplitude and accumulated events; (**b**) accumulated energy.

Due to the test's high repeatability, a single group of specimens was selected for further analysis. Figures 9 and 10 show the history curves of AE amplitude-impact cumulation-time, and load-cumulation energy-time of specimen T-C-8 and T-U-8, respectively, during the tensile test. For the specimens of T-C-8, the impact event increased slowly in the first 120 s, and the detected AE signal amplitudes were all between 45 and 60 dB. Until 130 s, the cumulative impact event reached 5398, accounting for only 0.75% of the total impact event. The cumulative relative energy reached 19 ms*mv, which was negligible compared with the total cumulative energy, indicating that no obvious damage occurred in the specimen during this period. From 130 s to 220 s, the cumulative count of impacts increased significantly at an approximate linear rate, with a large number of AE signals of medium and high amplitude appearing simultaneously. Impact events with relative energies exceeding 10,000 ms*mv also began to appear. The main failure modes at this stage are interlayer delamination and fiber/matrix debonding. From 220 s to 222 s, the cumulative relative energy increased by 36,943 ms*mv in less than two seconds, which indicates that the specimen suddenly dropped a load at the last moment of loading, namely, the complete fracture. For specimen T-U-8, the AE signals detected at the initial 80 s of loading are similar to those detected in specimen T-C-8, the cumulative impact event and cumulative relative energy grow very slowly, and the growth slope tends to a horizontal state. In 80 s, the cumulative impact event reached 1042, accounting for 1.38% of the total impact event, and the cumulative relative energy reached 25 ms*mv. From 80 s to 123 s, the cumulative impact event and relative energy increased rapidly, in which the cumulative impact event increased exponentially, and highamplitude and high-energy AE signals began to appear. Compared with Figures 9 and 10, it was observed that the impact events of the T-U-8 specimens were earlier than the T-C-8 specimens. This is due to the presence of slits that weaken the strength of the laminate, causing the specimens to fail at a relatively low load. Meanwhile, the cumulative impact event and relative energy of specimen T-U-8 are much smaller than that of specimen T-C-8, which is mainly due to the smaller failure strain of T-U-8 and fewer cumulative impact events caused by premature failure. In addition, it could be found that the high-decibel impact events of the continuous fiber specimens are concentrated in the last 41% of the tensile test, while the UACS specimens are in the last 30%, and the overall decibel value level of the impact event is significantly lower, indicating that there is more matrix and delamination damage. Therefore, it could be concluded that although the failure strain of the UACS specimens is lower than that of the continuous fiber, the existence of the slit does inhibit the damage expansion to a certain extent and delay the final failure.

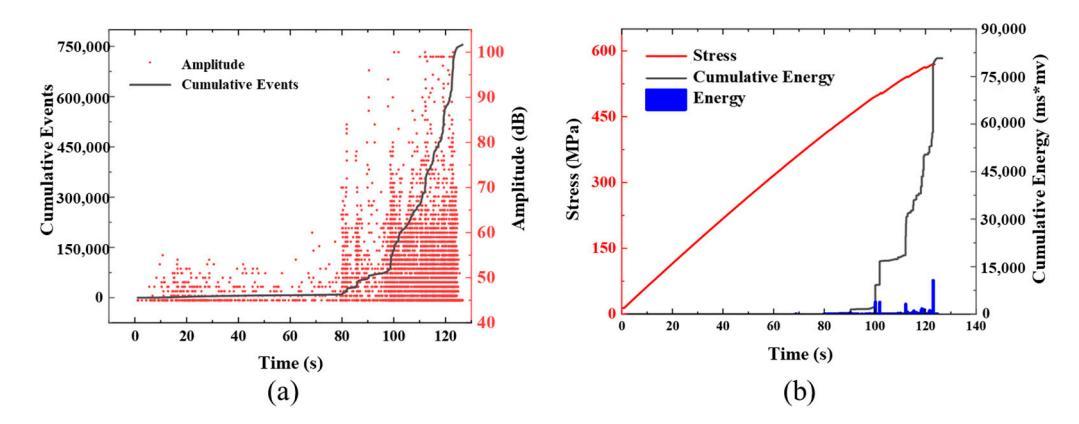
Figure 10. Typical acoustic emission signal of UACS specimens under tensile load: (**a**) amplitude and accumulated events; (**b**) accumulated energy.

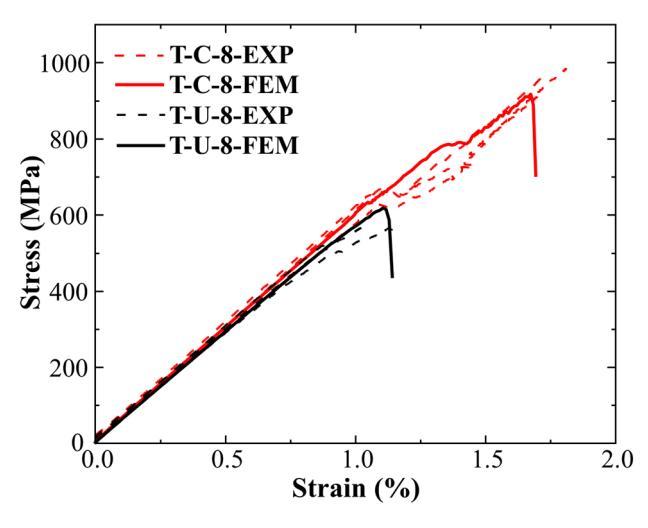
Figure 11. Experimental measurement and comparison of simulated stress-strain curves.

Figure 11 shows a comparison between the stress–strain curves of specimen T-C-8 and T-U-8 obtained from finite element analysis and the experimental results. It is evident that the stress–strain curves show a consistent variation trend between finite element simulation and experiment. The numerical simulation results of strength and modulus of continuous fiber specimens T-C-8 are 917.3 MPa and 61.498 GPa, respectively, which indicate a 3.58% lower strength and a 2.02% higher modulus than the experimental results. Meanwhile, the simulation also captures the nonlinear behavior before the failure. The simulation results of the strength and modulus of UACS laminates are 594.8 MPa and 60.452 GPa, respectively, which are 7.9% and 2.04% higher than the experimental values, showing the high accuracy of the finite element model in strength analysis.

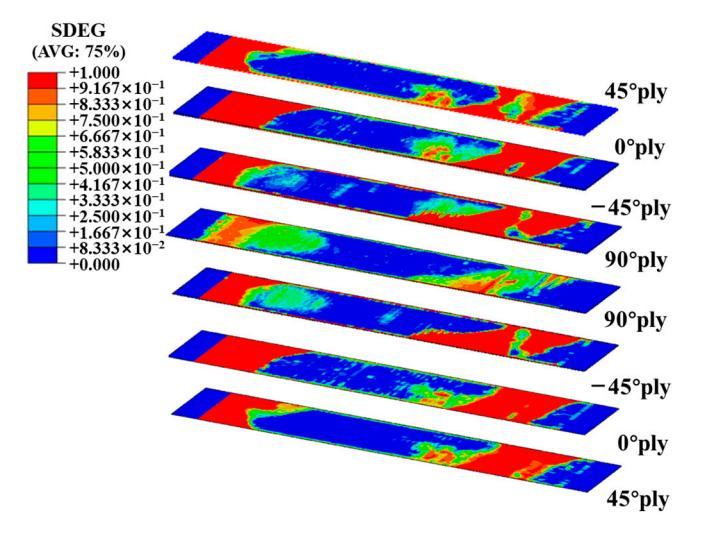
Figure 12. Interface element damage of tensile specimen T-C-8.

Figure 12 shows the interface damage between adjacent layers of continuous fiber laminates. Upon analyzing the results, it appears that the delamination damage is mainly concentrated at both ends and gradually propagates toward the center. All adjacent layers of the specimen exhibited different degrees of delamination damage, which showed a trend of diffusion from the edge to the center, and the delamination area was significantly affected by $\pm 45^{\circ}$ layers. Since the layers are $\pm 45^{\circ}$ relative to the tensile direction, the shear stress between the layers is the largest, resulting in the material slipping along the layers and delamination damage at the interface of the layers. This was consistent with the multiple failure and delamination morphology observed in Figure 7.

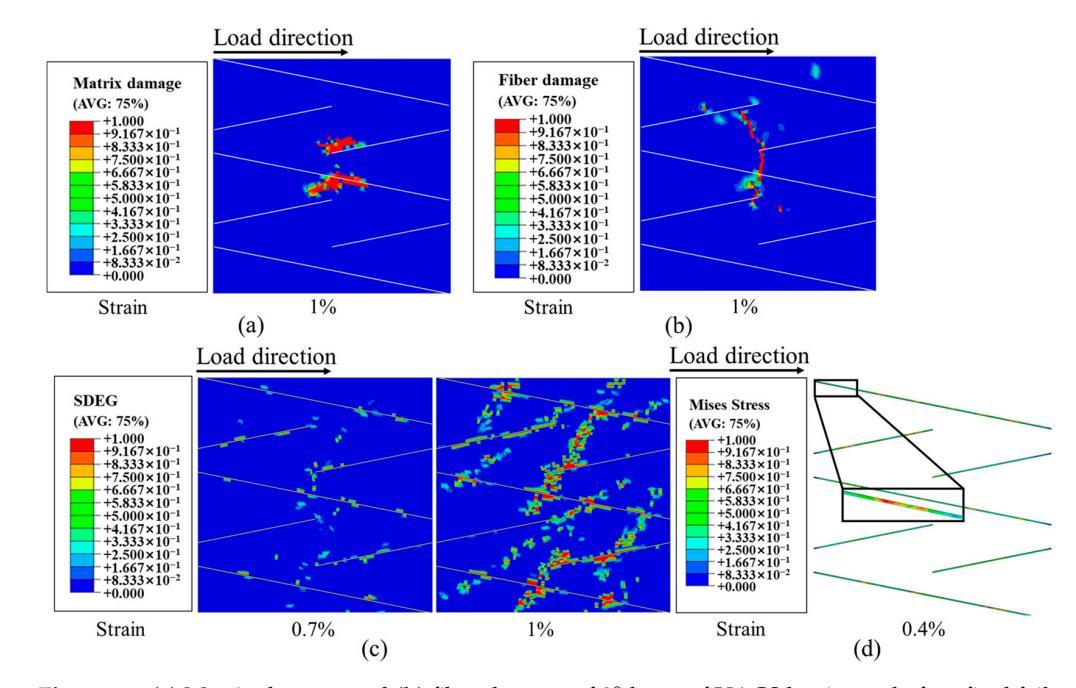
Figure 13. (a) Matrix damage and (b) fiber damage of 0° layer of UACS laminates before final failure; (c) damage development of $0^{\circ}/-45^{\circ}$ interface layer of UACS laminates; (d) von Mises stress of slits in 0° layer at the strain of 0.4%.

Figure 13 illustrates different damage processes that occur in UACS laminates when subjected to tensile loading. The damage to the fiber and matrix in the 0° layer before the

ultimate failure of UACS laminates is shown in Figure 13a,b. The primary tensile load was borne by the fibers in the 0° layer due to their consistency with the loading direction. Fiber fracture is the main cause of failure in the 0° layer, while other layers primarily experience matrix damage and localized delamination. The delamination of the UACS laminates began at the ends of the slits in the 0°/ -45° interface layer when the strain reached 0.7%, as shown in Figure 13c. After that, it spread in the 0° layer's direction of the slits. Most of the delamination took place between the 0° layer and -45° layer until the laminates experienced complete failure. In the case of UACS laminate, the slits in the 0° layer fail at a strain level of 0.4%, as shown in Figure 13d. The matrix of the 90° layer and $\pm 45^{\circ}$ layers experienced progressive damage as the load increased, reaching a tensile strain of 0.5% and 0.7%. It was found that matrix microcracks first appeared at the slits of UACS laminates. Therefore, as shown in Figure 13b,c, delamination is usually concentrated at the weak interface of the slits, and transverse through-delamination is generated with the increase in strain, so a relatively flat fiber fracture shape is easily formed.

The existence of slits leads to the change in stress distribution in the laminate, and the damage is mostly concentrated near the slits, which suppress the propagation of delamination damage. It is important to mention that the position of the matrix damage in the 45° layer shows a strong correlation with the slits present in the adjacent 0° layer. Once the strain reaches 1%, the occurrence of fiber fracture in the 0° layer ultimately leads to failure in UACS laminates.
