# **Clogging Impacts on Distribution Pipe Delivery of Street Runoff to an Infiltration Bed**

# Min-Cheng Tu \* and Robert Traver

Department of Civil and Environmental Engineering, Villanova University, Villanova, PA 19085, USA; robert.traver@villanova.edu

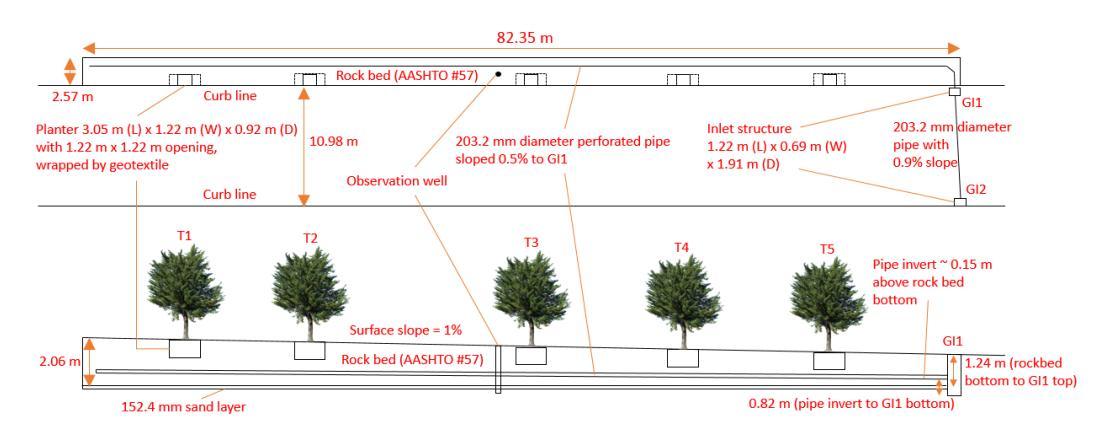
Figure 1. Plan view (top) and profile view (bottom) of the site under investigation.

As shown in Figure 1, this system is composed of five curbside planters, an underground rock infiltration bed in which the planters sit, two inlet structures (GI1 and GI2) collecting runoff from both sides of the street (with directly connected impervious drainage area of 2494 m<sup>2</sup>), and one distribution pipe delivering water collected by the inlet structures to the rock infiltration bed. The two inlet structures (GI1 and GI2 in the top section of Figure 1) are connected by a culvert with a diameter of 203.2 mm (sloped to GI1). Another perforated pipe with the same diameter (sloped to GI1) delivers water from the GI1 curb inlet structure to the rock bed (bottom section of Figure 1). Meshed trash guards (Figure 2) were installed in each inlet structure to reduce the amount of trash entering the distribution pipe. Inside the rock bed, the distribution pipe was uniformly perforated with an unspecified specification (personal communication with Philadelphia Water Department) and had an adverse 0.5% slope following the general design practice to bring debris towards the pipe entrance by gravity to facilitate maintenance cleaning. The only overflow points of the system were the street inlets GI1 and GI2, with GI1 located at a lower elevation. All dimensions were based on design drawings and post-construction invert measurements.

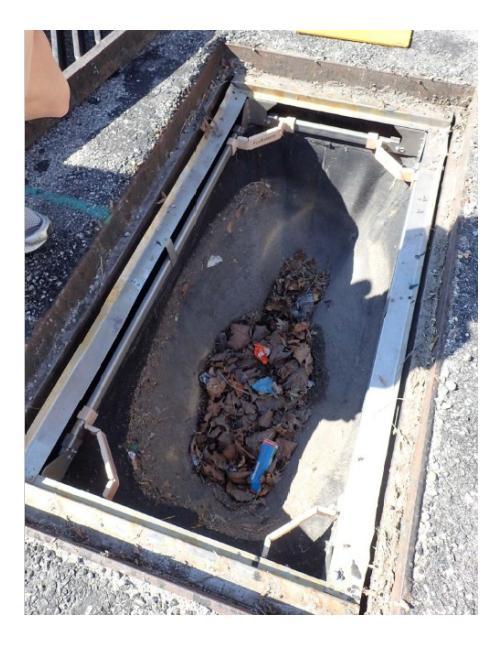
Figure 2. Trash guard installed in the GI1 inlet structure (Date: 18 October 2016).

In Figure 12a, it was visible that a significant portion of debris appeared to be leaves and paper with only a small portion being plastic, even though a trash guard had been installed in the inlet structure to minimize the amount of leaves entering the inlet structure with runoff. Due to the ample supply of fallen leaves in late autumn in Philadelphia, the debris pile would potentially continue to grow in winter if the leaves can get past the trash guard.

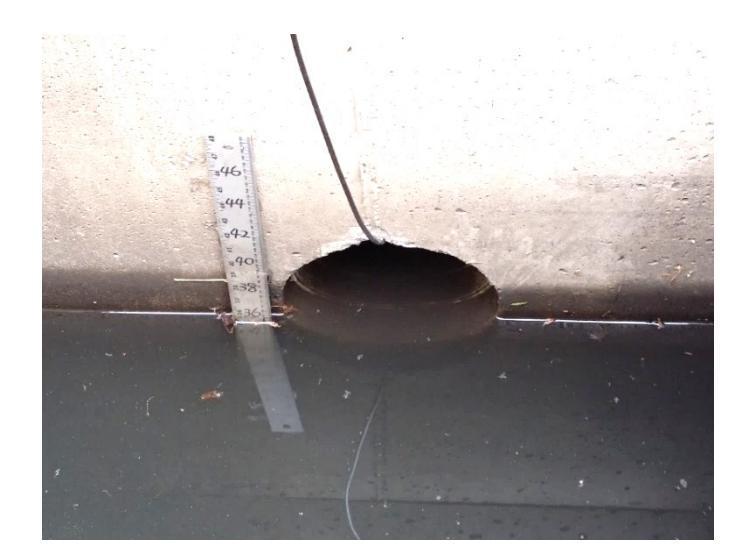
**Figure 3.** Ponding in the inlet structure due to partial clogging of the distribution pipe (Date: 30 March 2017).

During the period from June 2016 to April 2018, periodic ponding in the inlet structure that submerged part of the distribution pipe entrance was observed during several field visits. Figure 3 shows a typical situation of such partial clogging. Collected water depth data of the GI1 inlet structure provided a more holistic view for periods of such partial clogging in Figure 4. The overflow depth of the inlet structure and the invert of the distribution pipe inlet are marked with black horizontal lines in Figure 4.

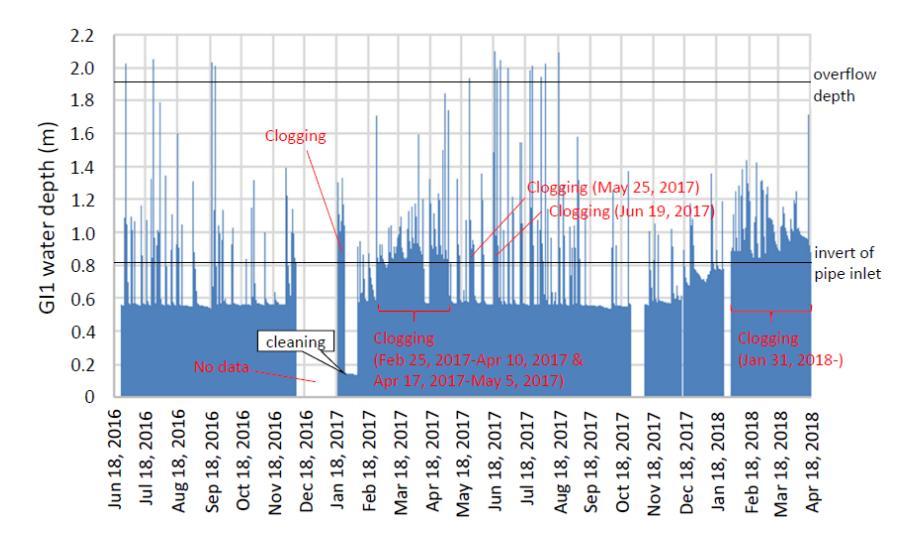
Figure 4. Water elevation in the GI1 inlet structure between June 2016 and April 2018.

Figure 4 shows several long episodes of partial clogging as exhibited by continuous ponding above the invert of the pipe inlet (0.82 m) during the following range of dates: 25 February 2017–10 April 2017, 17 April 2017–5 May 2017, and after 31 January 2018. Ponding was also observed before 25 January 2017, but data collection was interrupted in winter 2016–2017, so the beginning of that partial clogging episode could not be determined. On 25 January 2017, a subsurface distribution pipe cleaning was performed, comprising of the injection of pressurized water jets into the distribution pipe and subsequent vacuuming. This was the only subsurface cleaning during the observation period from June 2016 to April 2018. Following the cleaning, the partial clogging situation was solved for a short period of time, but reconstituted during the storm on 25 February 2017. Note that all long partial clogging episodes happened in winter or spring.

One phenomenon that was not explained in both Figures 4 and 5 was the low water depth in the inlet structure at the final balance state for periods without partial clogging. It was around 0.6 m from the bottom and significantly lower than the invert of the distribution pipe inlet (0.82 m), which could only have been caused by a leaking inlet structure. The leaking rate varied significantly. For example, based on the water depth recession rate from the invert of the pipe inlet (0.82 m) to the final depth (0.6 m), Figure 5 shows a much faster leaking rate for the first storm than that for the second storm. As excavation of the site was not possible, it could only be hypothesized as the result of the variation of soil moisture and groundwater level in the surrounding soil. Nevertheless, the leaking rate was very small at about  $8 \times 10^{-6}$  m<sup>3</sup>/s (based on the first storm of Figure 5) or less, so its effect could be ignored. Water recession was accelerated below the pipe invert in Figure 5 as the water surface area above the pipe invert (i.e., including water in the pipe) would be much larger than that between the invert of the pipe inlet and the leaking point (i.e., only water in the inlet structure). The leaking point in the inlet structure was located during the subsurface pipe cleaning on 25 January 2017 when the inlet structure was pumped dry, shown as the small stream of water circled by the red oval in Figure 6. In Figure 6, water flowed back into the inlet structure, which can only be explained by the saturated condition of the surrounding soil caused by the high ponding situation before 25 January 2017.

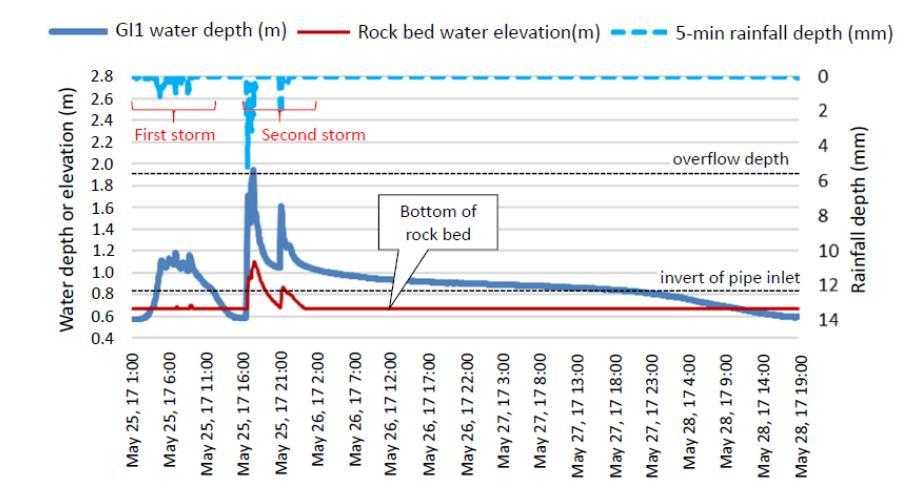
**Figure 5.** Rainfall depth and water depth (inlet structure and rock bed, with the bottom of the inlet structure as the datum) from events without (first storm) and with (second storm) partial clogging on 25 May 2017.

In addition to those long episodes, several short episodes of partial clogging (e.g., 25 May 2017 and 19 June 2017) were also evident during summer. The data from 25 May 2017 contained two events with the first event being free from and the second exhibiting significant partial clogging, as shown in Figure 5. Rainfall associated with the two storms was separated by more than six hours, so they were considered as two distinct storms. After the first peak of the second storm, the water depth recession

rate in the GI1 inlet structure after cessation of rainfall reduced significantly when compared to that of the first storm, showing partial clogging of the distribution pipe. For all storms, the water level in the rock bed was always lower than that in the inlet structure, as shown in Figure 5. In Figure 5, the bottom of the inlet structure was the datum for all water depths or elevations. As the bottom of the rock bed is higher than that of the inlet structure, the water depth in the rock bed showed a flat line when dry.

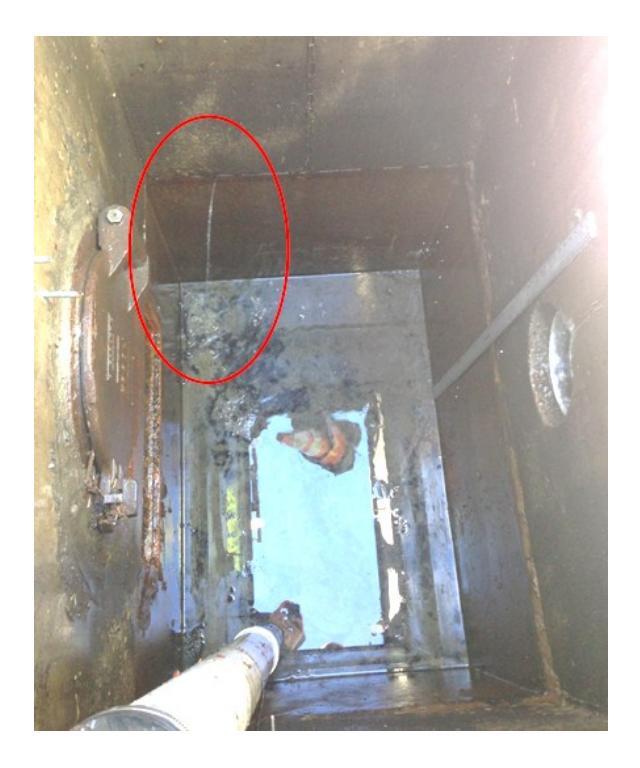
Figure 6. Leaking point in the inlet structure (Date: 25 January 2017).

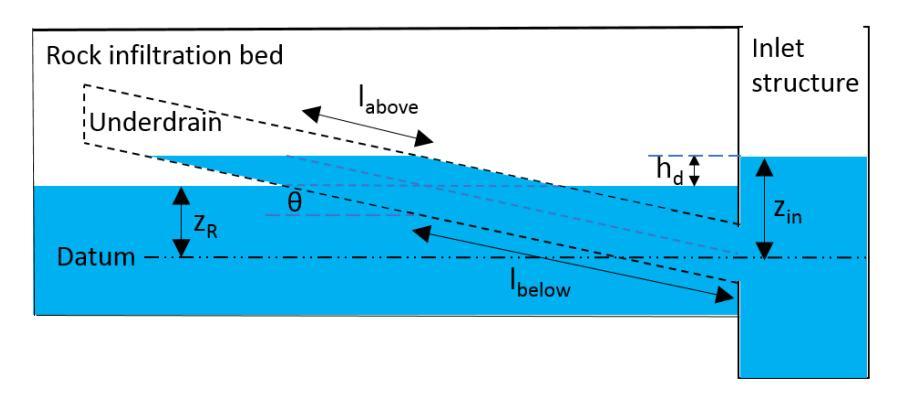
Figure 7. Profile view of a typical distribution system in this research.

Detailed definitions of parameters (for  $h_{d,mean}$  and  $l_{eff}$ ) for the performance index under various scenarios are discussed below. Figure 7 describes the operation of a typical distribution system. The datum was set at the elevation of the center of the distribution pipe at its inlet. Water elevation in the rock bed and in the inlet structure were  $z_R$  and  $z_{in}$ , respectively, with difference  $h_d$ . Along the centerline of the pipe (with inclination angle  $\theta$ ), the length of water (along the pipe centerline) above and below the water in the rock bed (elevation  $z_R$ ) was  $l_{above}$  ( $\propto h_d$ ) and  $l_{below}$  ( $\propto z_R$ ), respectively. For the condition considered by Figure 7,  $z_R$  and  $z_{in}$  were both lower than the top of the distribution pipe. Other conditions were analyzed as provided below.

From the recorded data, the water surface inside the distribution pipe and that in the inlet structure were very close to each other in elevation as the difference of the velocity head was proven to be negligible. This implied that the driving head was the water surface elevation difference  $h_d$ . The driving head was constant anywhere below the rock bed water surface  $z_R$ . The driving head above  $z_R$  was simply the hydrostatic pressure of the water column above  $z_R$ , with zero at the top of the water column and linearly increasing to  $h_d$  at the elevation of  $z_R$ . The mean driving head ( $h_{d, mean}$ ) acting on the pipe can thus be derived in Equation (6) below.

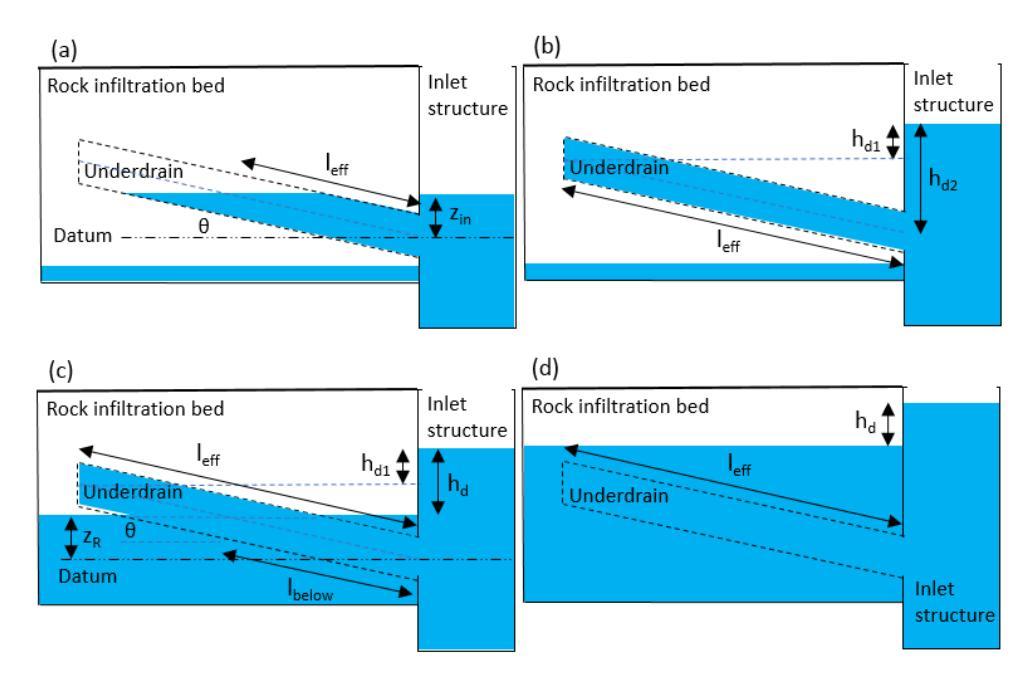
**Figure 8.** Conditions considered in the pipe performance determination in addition to the condition of Figure 7. (a) Water in the rock bed is lower than the whole pipe and the pipe is half-full; (b) water in the rock bed is lower than the whole pipe and the pipe is full; (c) water in the rock bed is between the lower and higher ends of pipe, and the pipe is full; (d) water in the rock bed submerges the whole pipe.

Other than the condition depicted in Figure 7, four other possible conditions were analyzed as illustrated in Figure 8. All items in Figure 8 were defined previously, except for  $h_{d1}$  and  $h_{d2}$ , which indicates the distance from the water surface in the inlet structure to the top and the inlet of the distribution pipe (along its centerline) in Figure 8b, respectively. Note that conditions with either  $z_R$  or  $z_{in}$  below the top of the distribution pipe inlet were excluded from consideration as the effective length of water in the pipe of such conditions cannot be based on the pipe length with a fully wetted perimeter like that of the other considered conditions.

Analyses based on Figure 8a were similar to those done for the water column above  $z_R$  in Figure 7, with the mean driving head and the effective pipe length calculated by Equations (8) and (9) below:

Intense storms created conditions depicted by Figure 8b–d, where the water elevation in the inlet structure builds up quickly. The distribution pipe was completely full, but water in the rock infiltration bed can still be relatively shallow. Similar to Equation (8), the mean driving head for Figure 8b was provided by Equation (10) below, and the effective pipe length  $l_{eff}$  is simply the length of the whole pipe.

Figure 8c has a form similar to that of Figure 7 with the mean driving head for Figure 8c provided by Equation (11) below, while the effective pipe length ( $l_{eff}$ ) is the length of the whole pipe ( $l_{pipe}$ ).

The last condition (Figure 8d) had a constant driving head throughout the distribution pipe because the whole pipe was submerged, thus  $h_{d,mean} = h_d$ , and the effective pipe length  $l_{eff}$  is the length of the whole pipe  $l_{pipe}$ .

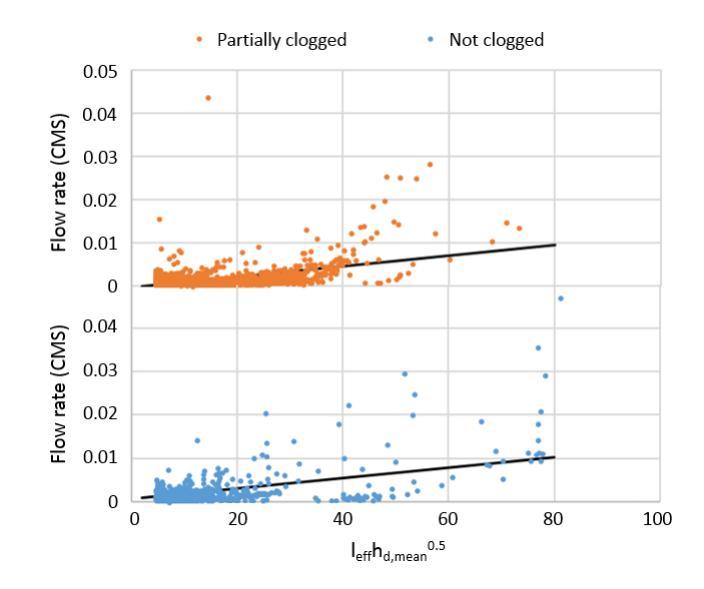
**Figure 9.** Performance plotted as flow rate vs.  $h_{d,mean}l_{eff}$  for all data.

Variations of orifice performance can be examined by plotting the measured flow rate against  $l_{eff}\sqrt{h_{d,mean}}$ , as shown by Figure 9 with the data with zero flow excluded. All data from November 2016 to April 2018 was utilized in Figure 9. According to Equation (4), the flow rate Q divided by  $l_{eff}\sqrt{h_{d,mean}}$  in Figure 9 represents performance. The dates of partial clogging and no clogging were determined from Figure 4. Thick black lines in Figure 9 represent the linear regression lines generated through ANCOVA, as discussed below.

$l_{eff}\sqrt{h_{d,mean}}$  appeared to be a strong predictor for flow rate with p < 0.0001 for both the non-clogging and partial clogging data. ANCOVA (ANalysis of COVAriance) was utilized to examine the effect of partial clogging on the distribution of the pipe performance. Similar to the popular

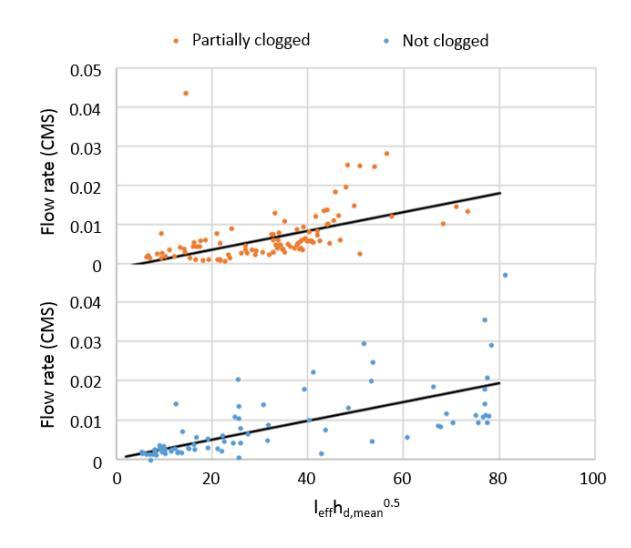
**Figure 10.** Performance plotted as flow rate vs.  $h_{d,mean}l_{eff}$  for all data with 5-min rainfall depth >0.65 mm.

Table 1 shows that even though partial clogging had a significant effect during dry periods or low-intensity storms, its effect declines as the storm intensity increases. When rainfall intensity was higher than approximately 0.65 mm/5 min, the effect of partial clogging was not statistically distinguishable, and thus did not impact system performance. The distribution of data with a rainfall intensity criterion of 0.65 mm/5 min is provided in Figure 10, while the distribution of data with a rainfall intensity lower than the criterion was provided in Figure 11 for comparison. Thick black lines represent the linear regression lines generated through ANCOVA. Please note that the scale on the *y*-axis in Figure 11 is different from that of Figure 9 or Figure 11. Again, the shift of linear regression lines due to the covariate of clogging appeared to be small in both figures through visual inspection; however, statistical analyses by ANCOVA provided clear evidence that the effects of clogging could not be distinguished (p = 0.152, Table 1) in Figure 10 but were significant (p < 0.0001) in Figure 11.

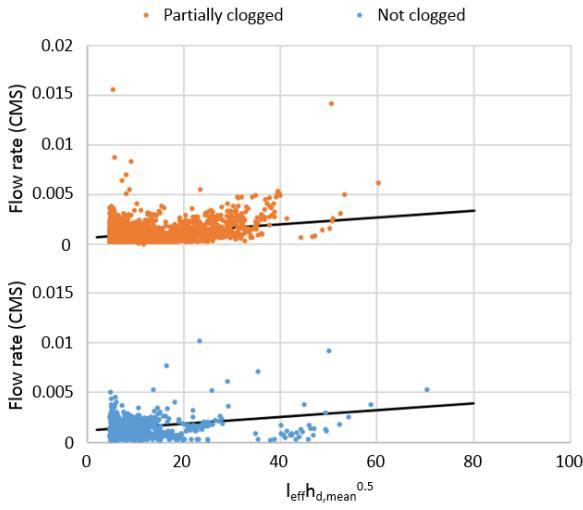
**Figure 11.** Performance plotted as flow rate vs.  $h_{d,mean}l_{eff}$  for all data with 5-min rainfall depth <0.65 mm.

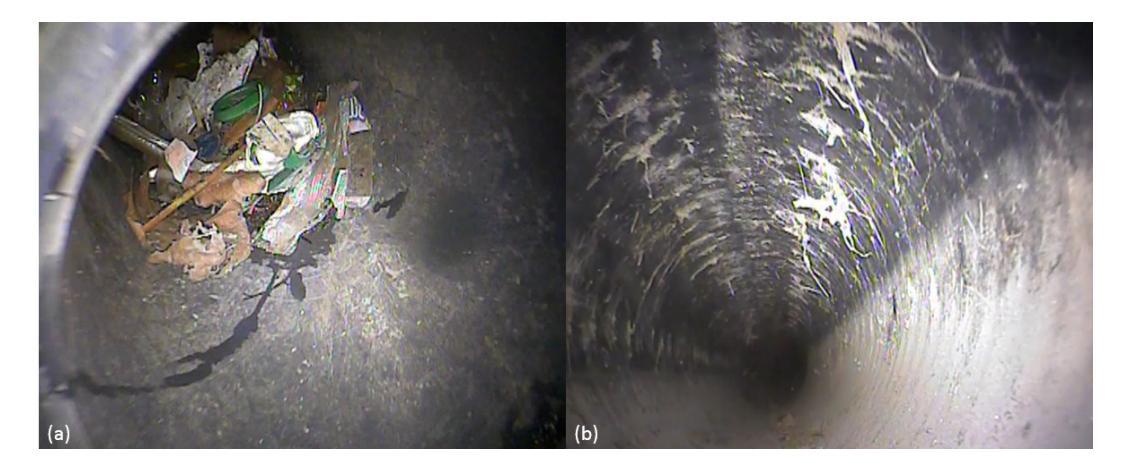
**Figure 12.** Images of debris deposition conditions before subsurface cleaning (Date: 20 June 2016). (a) Debris observed at the lower end of the pipe; (b) typical pipe condition above the lower end.

The records of subsurface maintenance done in the past were then examined to explain the results from the analyses. The archived video observation (20 June 2016) showed a significant quantity of debris deposited close to the 90-degree turn of the pipe near the entrance, as shown in Figure 12a. After passing the debris pile, the distribution pipe was generally clean, as Figure 12b shows. Another subsurface maintenance performed on 25 January 2017 found more debris, and the debris was piled mostly in the lower (i.e., close to the inlet) 30 m of the pipe. The spatially uneven distribution of debris might be explained by the reversed slope of the distribution pipe that would bring most debris back to the entrance.
