# The Effect of Soil Tillage Equipment on the Recharge Capacity of Infiltration Ponds

Abstract: The Dan Region Reclamation Project (Shafdan) reclaims ~125 millions of cubic meters per year (Mm<sup>3</sup>/year) of treated wastewater from the Tel Aviv Metropolitan area. Following secondary treatment, the effluent is recharged into a sandy aquifer for soil aquifer treatment (SAT). Over the past three years, a decrease in recharge capacity was noticed. Several operational causes were considered including reservations regarding the tillage procedure of recharge ponds. Tillage of the recharge ponds facilitates aeration, breaking surface crusts and the removal of vegetation. The procedure includes deep (40–60 cm) plowing and shallow (10–20 cm) sweep-knives (SK) cultivator or discus. In this research, the existing tillage equipment was compared to a new equipment, which includes a deep subsoiler and a chisel-knives (CK) cultivator. The effects of each tool on the infiltration rate (IR), recharge capacity, and soil compaction were examined. The results suggest a significant improvement in the recharge capacity, up to 95% and 15% on average following subsoiler and CK cultivator treatments,

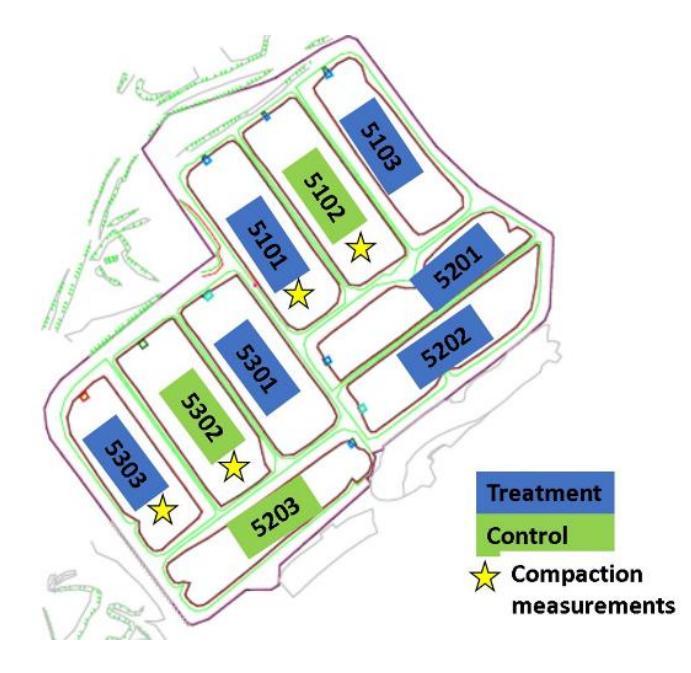
**Figure 1.** Schematic layout of the Yavne-2 recharge field with the operational pond's sub-divisions, tested treatments (new tillage tools), control treatments (existing tillage tools), and ponds with soil compaction measurements.

The research was conducted at Yavne-2, which is one of Shafdan plant's recharge fields. The Yavne-2 recharge field is located southwest of the city of Yavne, Israel, and is divided into nine operational recharge ponds of ~1.5 hectare each (Figure 1). In order to minimize the seasonal effects, the research was conducted during the late spring and summer periods only (i.e., between 29 May, 2019 to 3 September, 2019. During this period, four treatment stages were conducted, each of them lasting for a period of 3–4 weeks, as detailed in Table 1. The period between 1 May to 29 May was defined as a pre-experiment stage and was also used for comparative analyses. The first two stages of the experiment as well as the pre-experiment period included only the control treatment, that is, the operation of regular tillage equipment by the equipment's usual operator (contractor). The last two stages included a full comparison between the new tillage equipment that was employed in six recharge ponds (six replicates), and the regular tillage equipment that was employed in three recharge ponds (three replicates).

Soil compaction measurements were conducted in representative ponds (Figure 1) with a penetrometer device (Spectrum Technologies) equipped with a 0.75-inch diameter tip adapted for sandy soils. Measurements were conducted before and after each tillage and between recharge cycles. Each measurement campaign included some 20 measurements made along a 10 m long line at intervals of 0.5 m. The depth of the compacted layer was defined by reaching a pressure of 1380 KPa (200 psi).

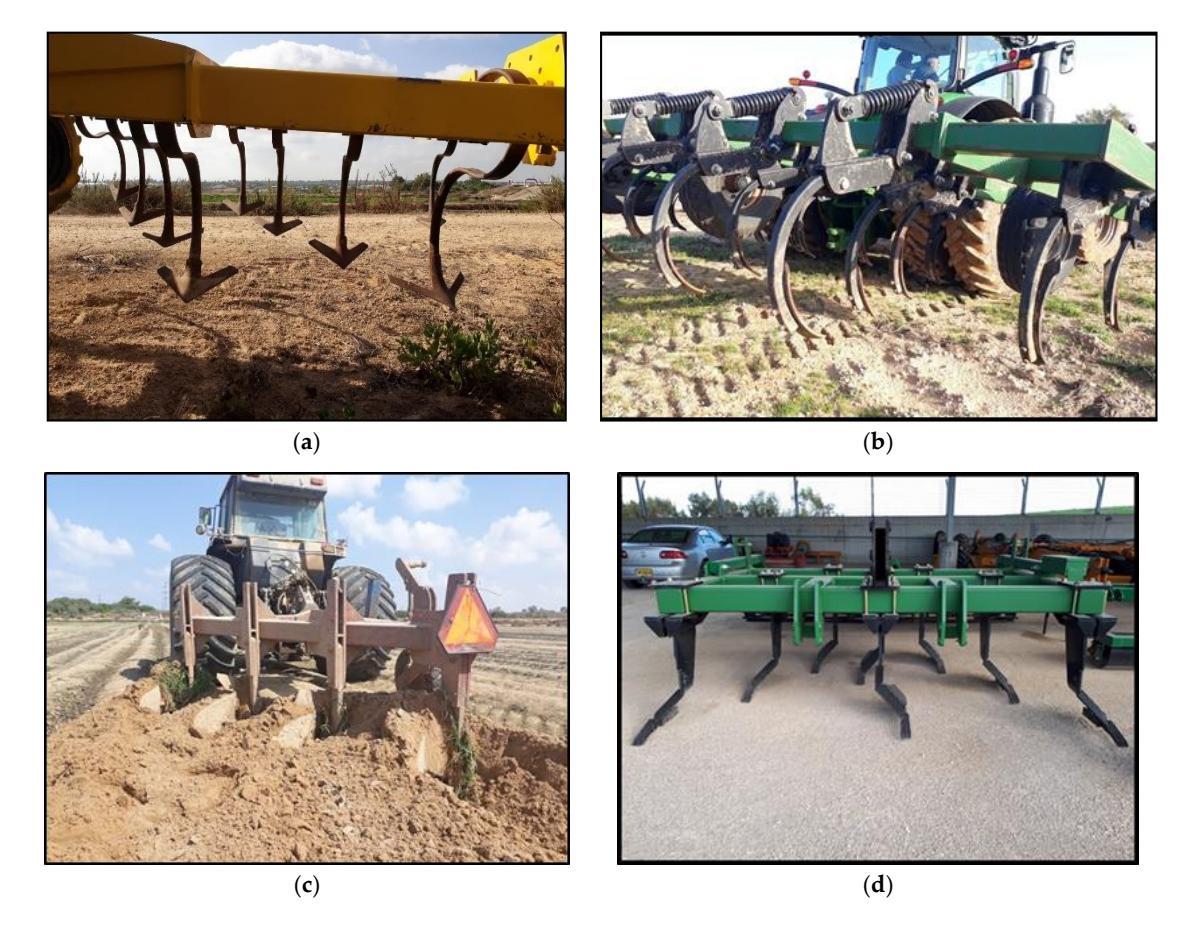
**Figure 2.** Tillage tools used during the experiment: (**a**) Sweep-knives (SK) cultivator; (**b**) Chisel-knives (CK) cultivator; (**c**) Plow; (**d**) Subsoiler (paraplow type).

*Sweep-Knives (SK) Cultivator:* The SK cultivator is a shallow (~20 cm) tool routinely used in the Shafdan facility for breaking the surface crust and the removal of seasonal vegetation. The SK cultivator employed in the Shafdan facility and in this experiment was 6 m wide and equipped with 24 blades arranged on four iron beams at average intervals of 25 cm between each (Figure 2a). Each blade was 30 cm in length and 25 cm wide (at its widest).

*Chisel-Knives (CK) Cultivator:* The CK cultivator is a shallow to medium depth tool (30–40 cm) that was tested as an alternative to the SK cultivator and for plowing. In this experiment, a 7 m wide cultivator was employed that was equipped with 30 chisel blades arranged on four iron beams at average intervals of about 23 cm between blades (Figure 2b). Each blade was 55 cm long and 8 cm wide (at its widest).

*Plow:* The plow is a deep (40–50 cm) tool routinely used in the Shafdan facility for breaking, mixing, and aerating compacted layers up to a depth of 40–50 cm. The plow used in the Shafdan

facility, and in this experiment, had four non-reversible curved blades (moldboards) arranged on a single 1.9 m wide diagonal beam (Figure 2c). Each moldboard blade was 115 cm long, and 55 cm high.

*Subsoiler:* The subsoiler is a deep (60–70 cm) tool that was tested as an alternative tool for the plow. In this experiment, a 4 m wide paraplow type subsoiler was employed, equipped with eight swept blades arranged on three iron beams at average intervals of about 50 cm between blades (Figure 2d). Each blade was 85 cm high and 25 cm wide (at its widest) and was equipped with special sand wings to increase the aeration channels.

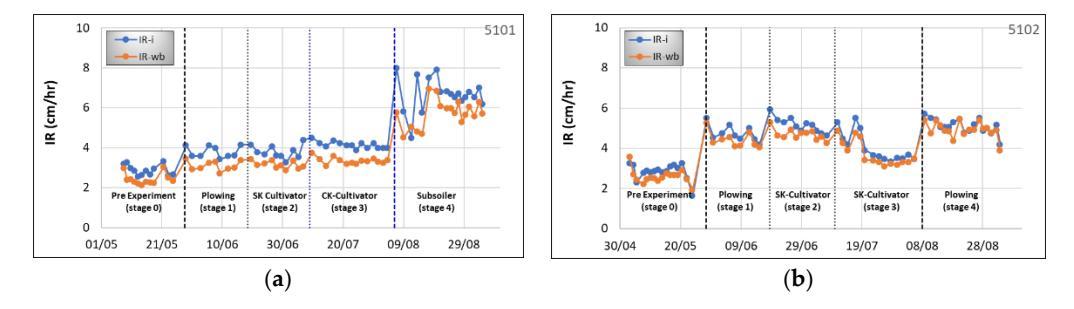
**Figure 3.** Infiltration rates measured in two representative ponds during the experiment: (**a**) Pond #5101 with new tillage tools at Stages 3 and 4 (treatment); (**b**) Pond #5102 with existing tillage tools only at all stages (control).

Continuous infiltration rate (IR) measurements from two representative infiltration ponds—treatment and control—throughout the experiment period are presented in Figure 3. The relative change in IR for each stage of the experiment was calculated in comparison to the average IR measured after plowing during the first tillage stage (28 May 2018–18 June 2018). A summary of the relative changes in IR for every stage and treatment, in comparison to its parallel control treatment at the same stage, is presented in Figure 4.

The results clearly show a significant increase in IRs in every recharge pond (replicate) where the new tillage equipment was applied (Figure 3) as well as in the integrated analyses for all replicates (Figure 4). During the experiment's third stage, relative IRs after the CK cultivator ranged between 1.01 to 1.39 with an average of  $1.15 \pm 0.13$  in comparison with 0.84 to 0.88 and an average of  $0.86 \pm 0.02$  after SK cultivation. The subsoiler showed an even greater effect. During the fourth stage of the experiment, relative IRs after use of the subsoiler ranged between 1.46 to 2.82 with an average of  $1.95 \pm 0.47$ , in comparison with 0.91 to 1.22 and an average of  $1.08 \pm 0.16$  after plowing. Thus, we can show an average improvement of 15% and 95% for the CK cultivator and for the subsoiler, respectively, in comparison with the usual plowing regime. When compared with the routine SK cultivator, the improvement was even greater.

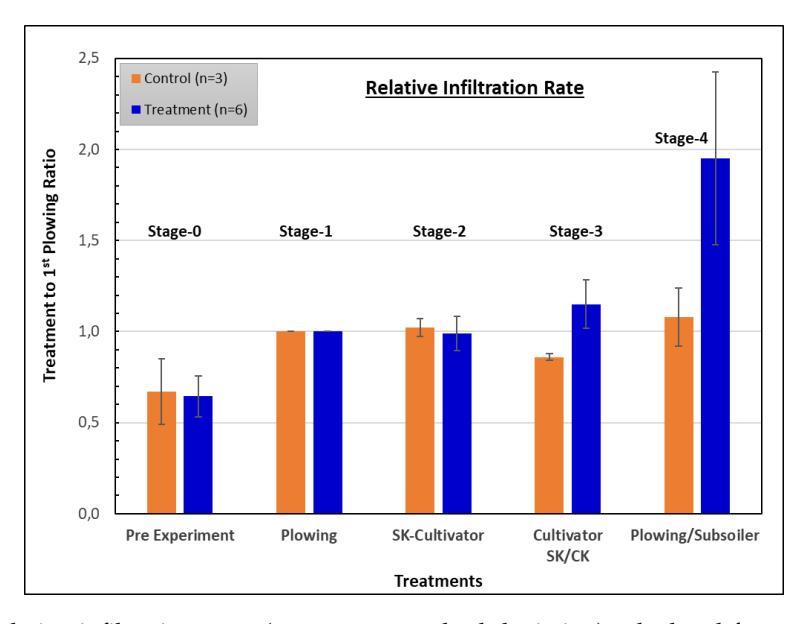
**Figure 4.** Relative infiltration rates (average  $\pm$  standard deviation) calculated for each stage and treatment, relative to the average IR measured during Stage 1 (first plowing).

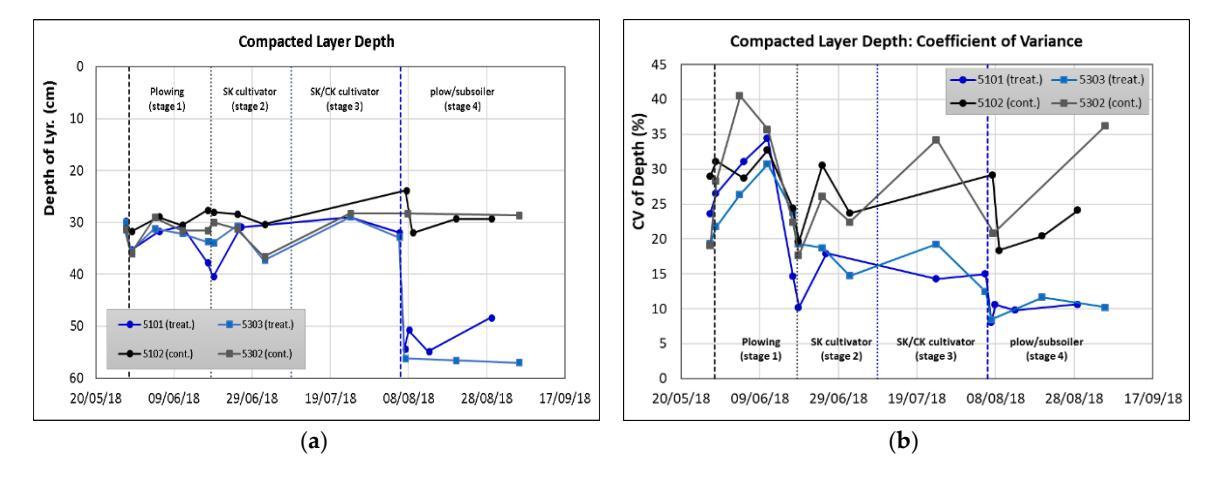
**Figure 5.** Soil compaction measurements in representative ponds during the course of the experiment. (a) Depth of the compacted layer; (b) Coefficient of variance between measurements (replicates) along the grid line.

Measurements of soil compaction indicated the presence of a compacted layer at a depth of approximately 30 cm during the first to third stages of the experiment. The presence of this layer was also indicated in the soil profile measurements in open holes, which are not presented and discussed in this paper. The evaluation and the nature of the compacted layer could be related to different factors such as leaching and accumulation of organic and inorganic colloidal material in the soil pores, compaction processes under the recharged water weight, soil erosion processes, and the routine operations in the ponds [18]. In fact, the results from the soil profile measurements and from other research studies in the Shafdan (e.g., [4,7,21]) indicate that each of these factors can be relevant, or even dominant, in different areas of the recharge ponds. Regardless of these factors, it can be assumed that the development of this layer was enhanced with the utilization of improper tillage tools (e.g., narrow plow) and due to the improper tillage regime (e.g., working over too wet soil).

After subsoiler tilling, the depth of the compacted layer increased to approximately 55 cm (Figure 5a). The significant increase in the IR and in recharge capacity after subsoiler treatment, accompanied by increases in the compacted layer depth, indicates the importance of this tool and its ability to break subsoil barriers in the recharge fields. The compaction measurements were conducted along a grid with horizontal orientation relative to the tilling lines. The uneven, ridged, soil surface effects, mainly caused by the plow, but also by the SK cultivator, resulted in relatively high variations between measurements. This variation tended to decrease along the course of the experiment, particularly after the use of the CK cultivator and subsoiler in the treatment ponds (Figure 5b). The elimination of the ridges, which creates a micro-topography of the soil surface, leads to a more balanced and effective tillage operation, and contributes to an increase of IR in the new tool's treatment ponds.
