Coastal Modification in Relation to Sea Storm Effects: Application of 3D Remote Sensing Survey in Sanremo Marina (Liguria, NW Italy)

Keywords: geomorphological coastal changes; sea storm effects; integrated 3D remote sensing surveys; sedimentary dynamics; western Ligurian sea

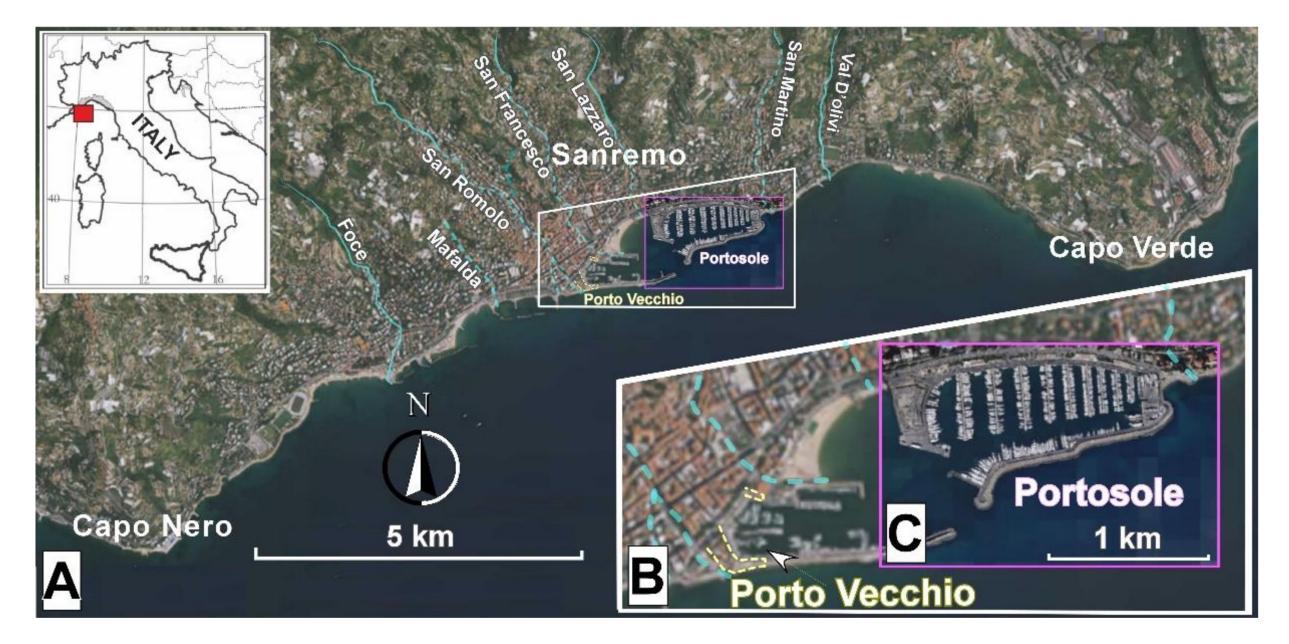
Figure 1. Location of Sanremo: Portosole study area. (**A**) The orthophoto of the Liguria Region (2016) shows how the narrow coastal plain of Sanremo and the course of the main streams crossing it (light blue dotted and continuous lines) are totally occupied by urban settlements. The zoom (**B**) shows the area of the Porto Antico and its ancient piers (dotted yellow line) and the Portosole area, where the morpho-bathymetric surveys were realized (**C**).

The study here presented concerns the breakwater of the Portosole Marina and the facing seabed (Figure 1, box C), with a total extent of about 850 m, together with the small artificial pocket beach immediately to the east.

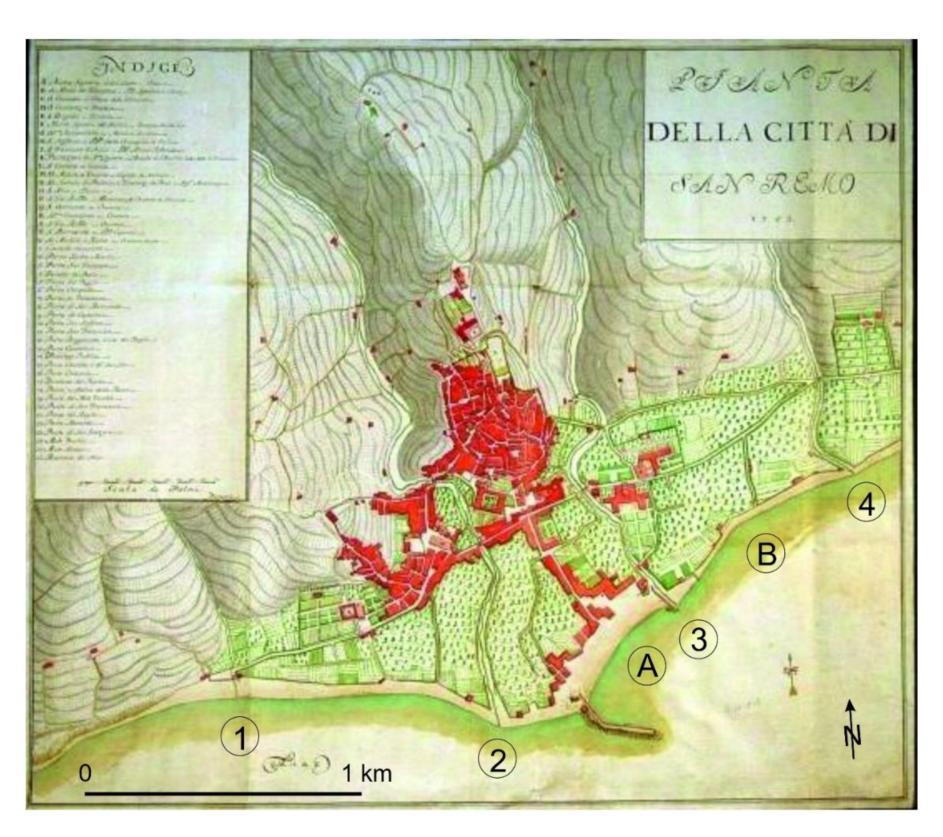
Figure 2. Historical map of Sanremo coast (1753): (1) Mafalda, (2) San Romolo, (3) San Francesco, (4) San Lazzaro streams; (A) and (B) represent the current locations of Porto Vecchio and Portosole, respectively (modified after [52]).

- Up to the middle of the 19th century, the coast was affected by a progradation of the beaches, thanks to the sedimentary input by the different watercourses and the erosional retreat of the sea cliffs. It is demonstrated by the historical map of Matteo Vinzoni [52], showing the former conditions of the coast in 1753 (Figure 2);

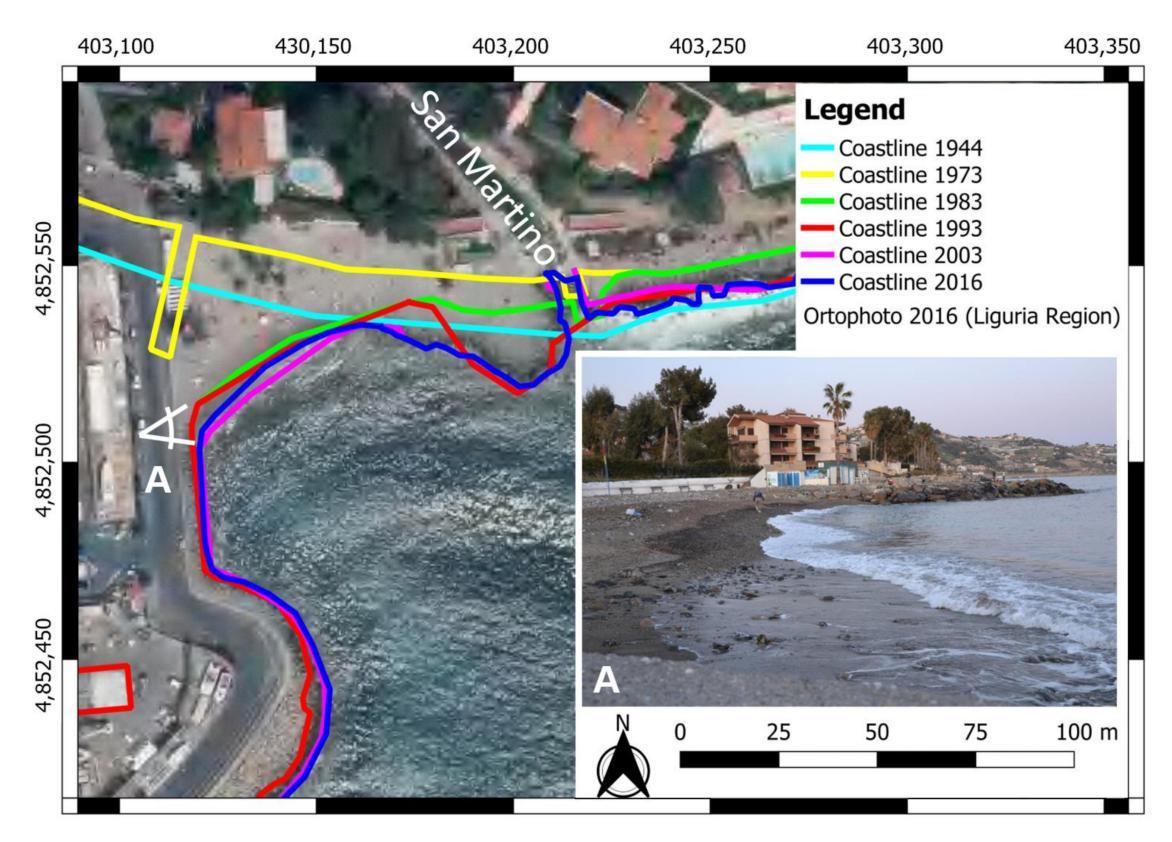
Figure 3. Variations of the position of the shoreline over the years 1944–2016 [58], Liguria Region orthophoto of 2016 used as background. (A) Photo taken from the west (the point of view is indicated in white on the main map) shows the features of the shoreline deposits. The coordinates are expressed in the ETRF2000–2008.0 reference system with UTM 32 projection.

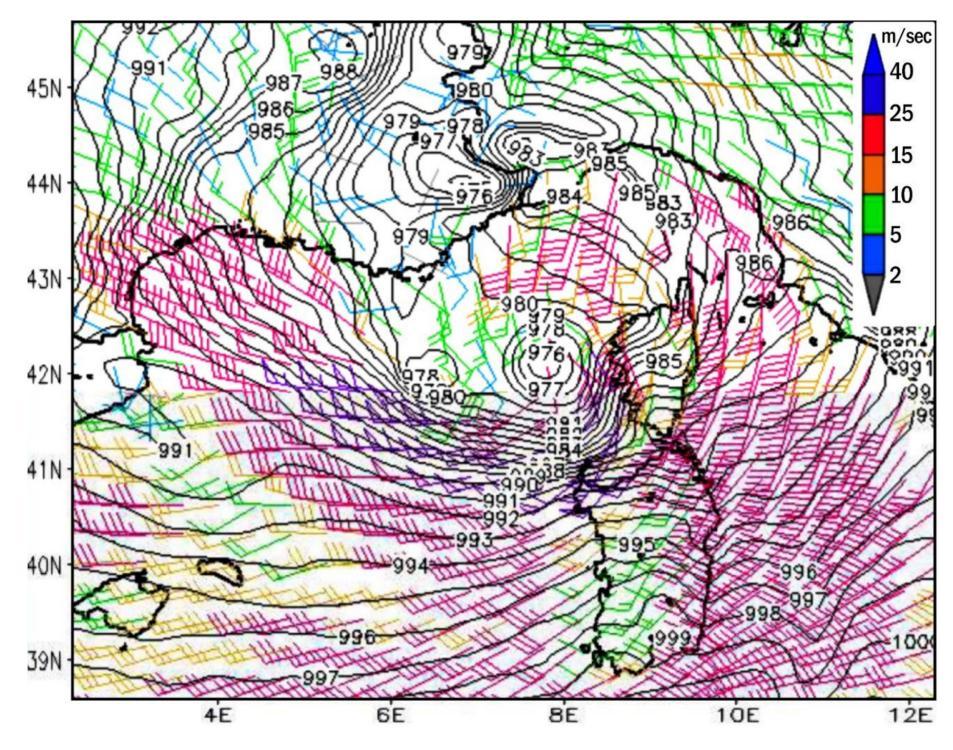
Figure 4. Wind at 10 m (m/s) and mean sea-level pressure (hPa) during Vaia Storm on 29 October 2018, 00 UTC (modified after ARPAL (Regional Agency for Ligurian Environment Protection) [34]).

This event was part of a wider meteorological event, known as the Vaia storm, which affected the entire Mediterranean basin with particular intensity on the Ligurian and North Adriatic Sea. The storm developed from 27 to 29 October 2018, generating a cyclonic circulation centered on the west of Corsica, with a drop in pressure up to 17 hPa in 18 h. This depression, moving towards Italy's northeast, caused extreme southerly winds with gusts up to 119 km/h at Genoa airport and 171 km/h at La Spezia weather stations [17]. This cyclogenesis, together with the collision of warm air masses from the south and the cold front over the Alps from the north, led to developing heavy rainfall, winds and storms (Figure 4).

Referring to the study area, at the Marina of Loano weather station, located about 52 km northeast of Sanremo, southerly winds from 230°, with gusts of 180 km/h and average velocity of 82 km/h, were recorded on 29 October 2018 [33,34]. It resulted from a baric minimum of 976 hPa and a gradient of 8 hPa between Provence and Corsica (Figure 4).

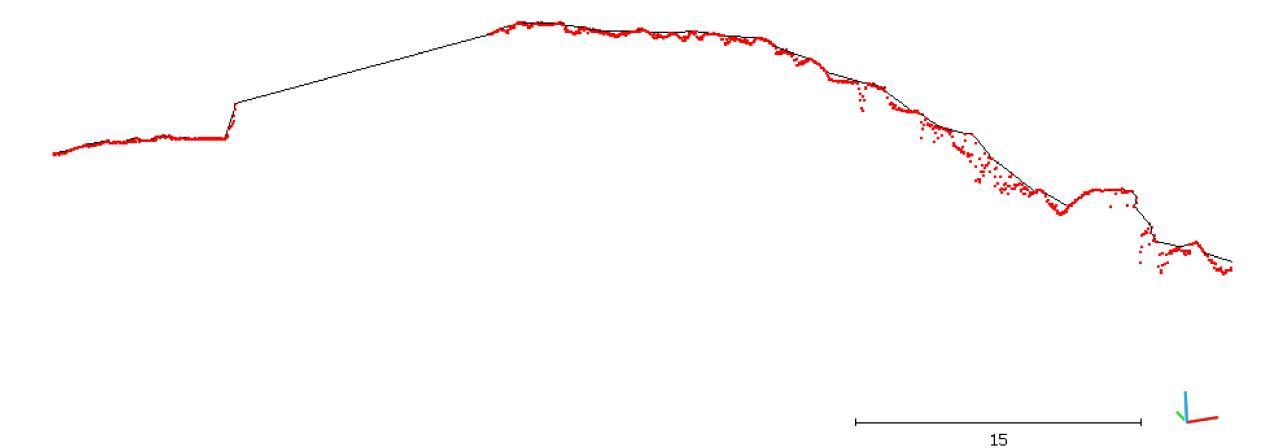
Figure 5. Profile (**black line**) and section cloud (**red points**) of a portion of a representative section on the head of the breakwater of Portosole.

A comparison was also performed along vertical sections oriented orthogonally to the pier. The sections were extracted starting from a directrix polyline following the pier development using the CloudCompare Extract sections along polylines tool, with a 10 m step between two consecutive sections, for a total of 75 sections. Each section trace is 250 m long orthogonally to the directrix, and it has a thickness of 0.2 m in the xy plane. The section thickness is a required parameter for the Extract sections along polylines tool in case, besides the linear sections (profiles), the corresponding point cloud portions (section clouds) are needed, as in the present case. For this purpose, a thickness of 0.2 m guarantees that the section includes at least one point of the DSM, as its spacing is 0.1 m. Thus, following the tool terminology, the section cloud is a set of points falling inside a parallelepiped of undefined height and base given by the section trace length and its thickness, whereas the profile is a line that approximates the points joining them. Since the profile, for its definition and construction, describes the points configuration using approximation, the section clouds were analyzed. Figure 5 graphically represents the difference between the profile (depicted as a black line) and the section cloud (depicted as red points), referring to a portion of a representative section on the head of the breakwater of Portosole.

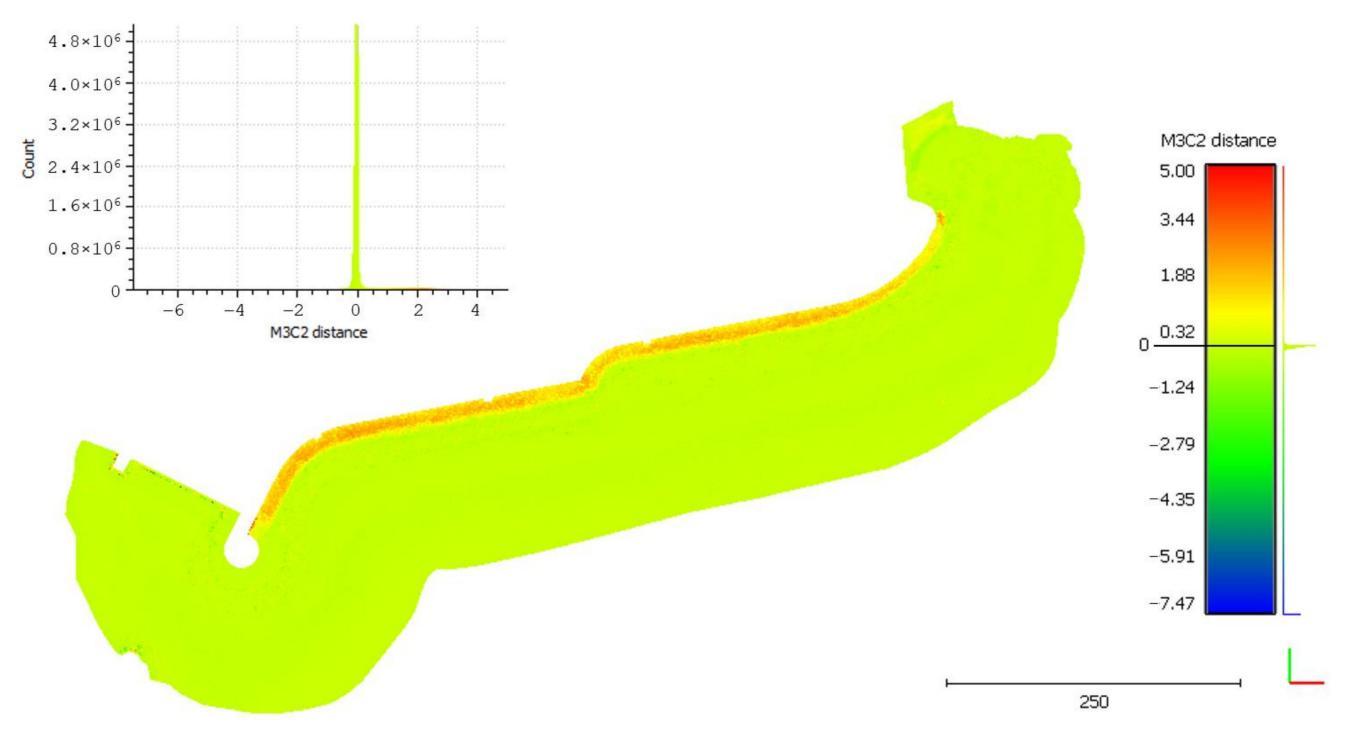
Figure 6. Comparison between digital surface model (DSM) 1 (reference surface) and DSM 2 (compared surface). The histogram shows the distribution of distance values.

First, a simple difference in elevation between the two entire DSMs was performed. The DSM 1 was taken as a reference, whereas the DSM 2 was assumed than the surface. The result is depicted in Figure 6. The distances between DSM 1 and DSM 2 range between -7.5 and 5 m, but most of the values are centered around 0 m, as shown in the histogram in the top left part of Figure 6. The resulting average value and standard deviations of different values are 0.06 m and 0.43 m, respectively.

Assuming a tolerance interval of $\pm 3\sigma$ in amplitude, the difference values must range between ± 1.3 m, centered on the average value (μ), and, at least theoretically, the distance values outside the tolerance interval should be considered as outliers. It is evident that this criterion is not applicable to the area surveyed as a whole because height differences due to changes over time, both in the sea bottom and in the breakwater, can be higher than 1.3 m, not being outliers.

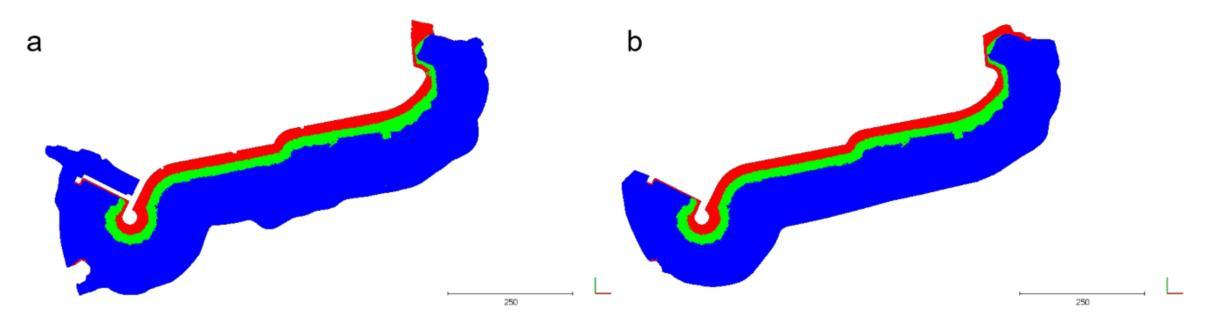
Figure 7. Sea bottom (blue), submerged breakwater (green) and emerged breakwater (red) for DSM 1 (a) and DSM 2 (b).

For this reason, three homogeneous regions were identified and analyzed separately: sea bottom, submerged breakwater and emerged breakwater. The obtained homogeneous regions of DSM 1 and DSM 2 are shown in Figure 7a,b, respectively.

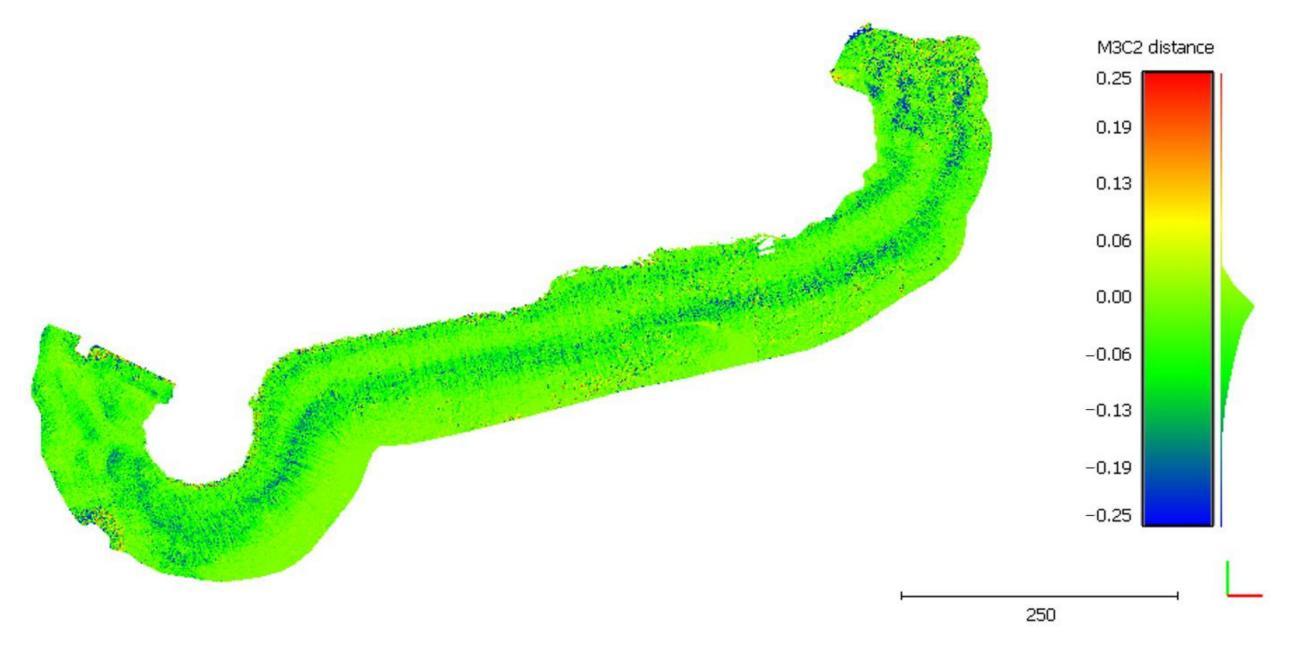
Figure 8. Comparison between DSM 1 (reference) and DSM 2 (compared) on the sea bottom, with distance values limited within the interval (-0.25; 0.25) m.

The differences in elevation between DSM1 and DSM2 relative to the three homogeneous areas (Figures 8–10), together with their average values (μ) and standard deviations (σ), were computed.

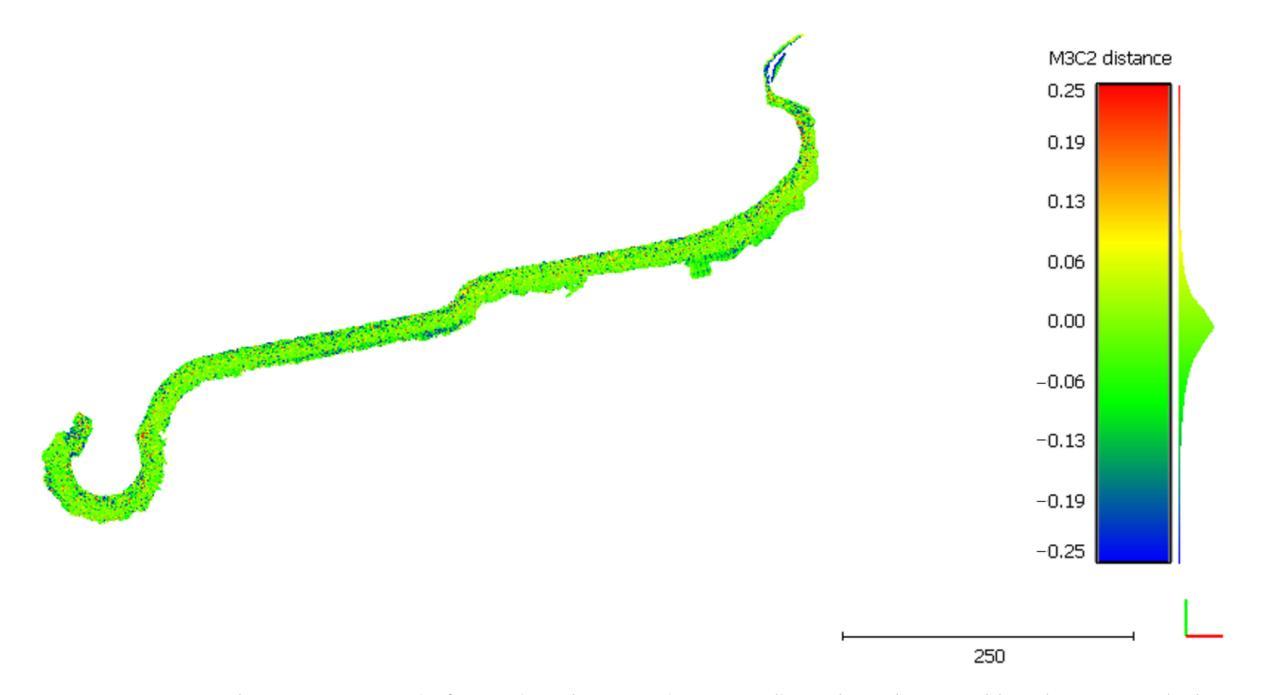
Figure 9. Comparison between DSM 1 (reference) and DSM 2 (compared) on the submerged breakwater, with distance values limited within the interval (-0.25; 0.25) m.

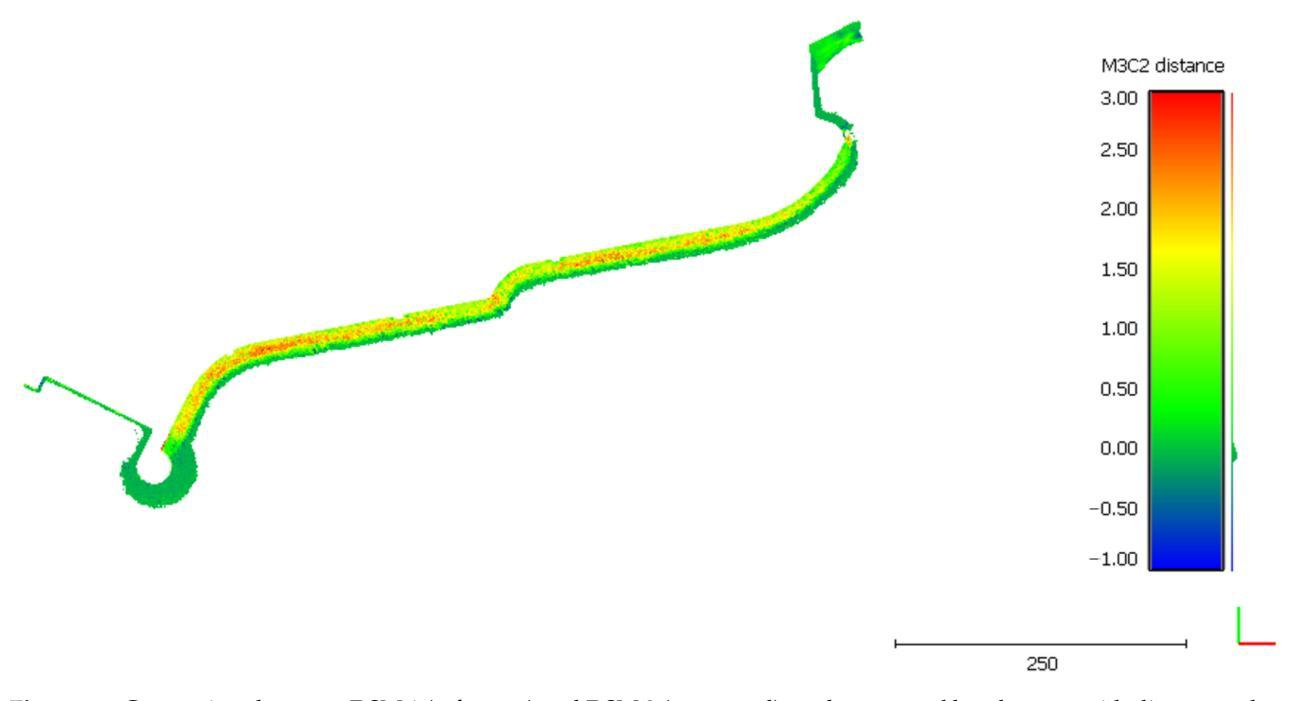
Figure 10. Comparison between DSM 1 (reference) and DSM 2 (compared) on the emerged breakwater, with distance values limited within the interval (-1; 3) m.

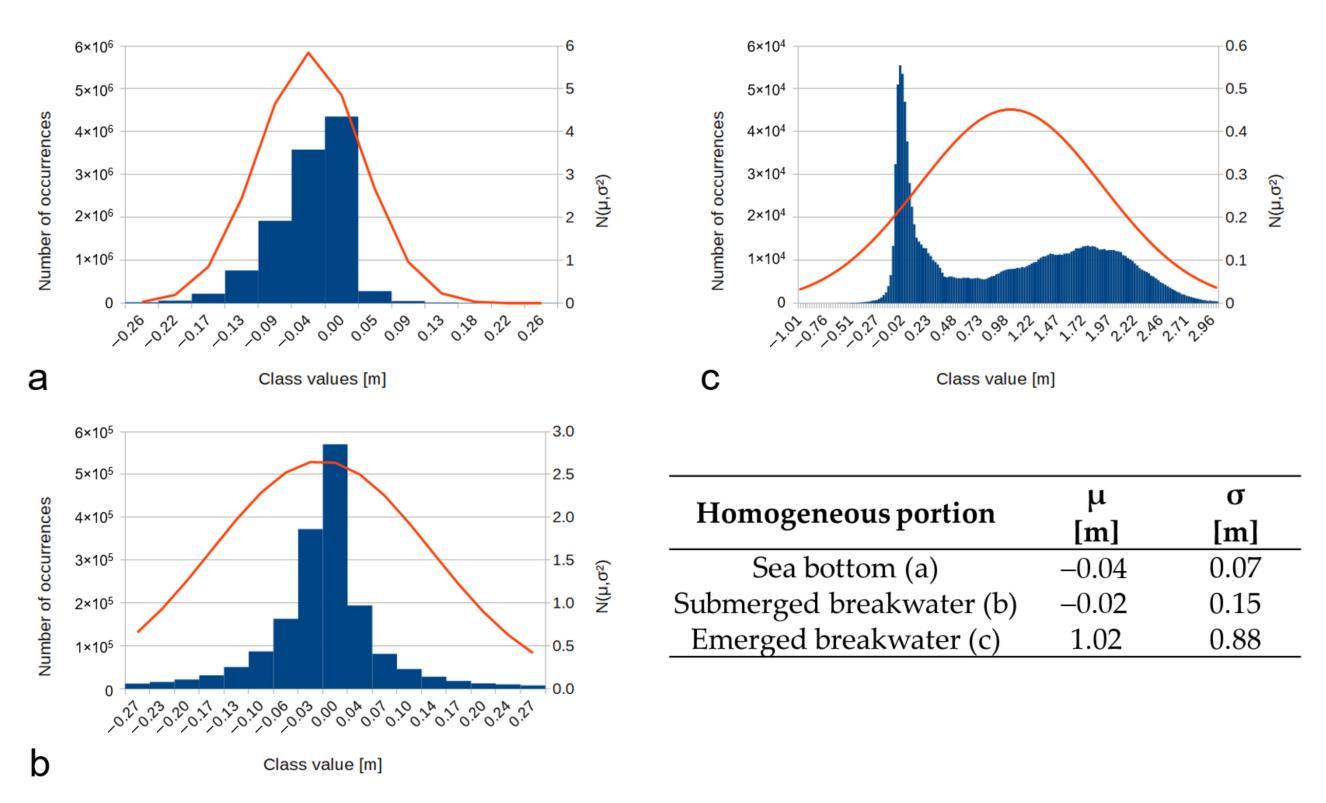
Figure 11. Fitting between a Gaussian function (red line) and the distribution of DSMs differences of sea bottom (**a**), submerged breakwater (**b**), and emerged breakwater (**c**). The distance values are limited within the interval (-1; 3) m, corresponding to the $\mu \pm 3\sigma$ confidence interval.

The Gaussian functions $N(\mu, \sigma^2)$ fitting the distribution of DSMs differences of the three homogeneous portions are represented in Figure 11. The differences between DSMs and Gaussian functions are represented by blue histograms and red lines, respectively, with their values, reported on the left and right y-axes, respectively. For all the three cases, the class values are limited within their confidence intervals (amplitude of 3 σ) to improve the readability of the graphs. The average values (μ) and standard deviations (σ) of DSMs distances in the three homogeneous portions are also reported in the table inside Figure 11.

Moreover, it is noteworthy to underline how the values of average values μ and standard deviations σ reported in the table inside Figure 11 are compatible with the ones computed using an independent method and contained in the following Table 1. Furthermore, in this case, the most pronounced variation is found in the emerged breakwater portion.

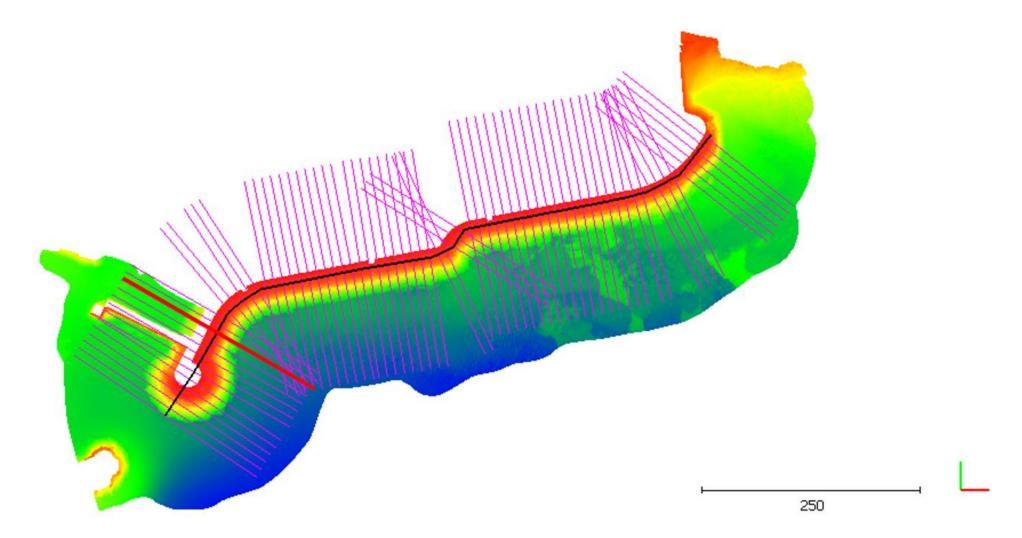
Figure 12. Sections traces (**pink**) and directrix (**black**) along the pier. Section trace number 12 is highlighted in red for considerations in the text.

For a more accurate comparison between the DSMs, 250 m long vertical sections and with a 10 m, for a total of 75 sections, were extracted. These section traces, represented in pink in Figure 12, are oriented orthogonally to the breakwater, whose directrix is represented as a black line in Figure 12.

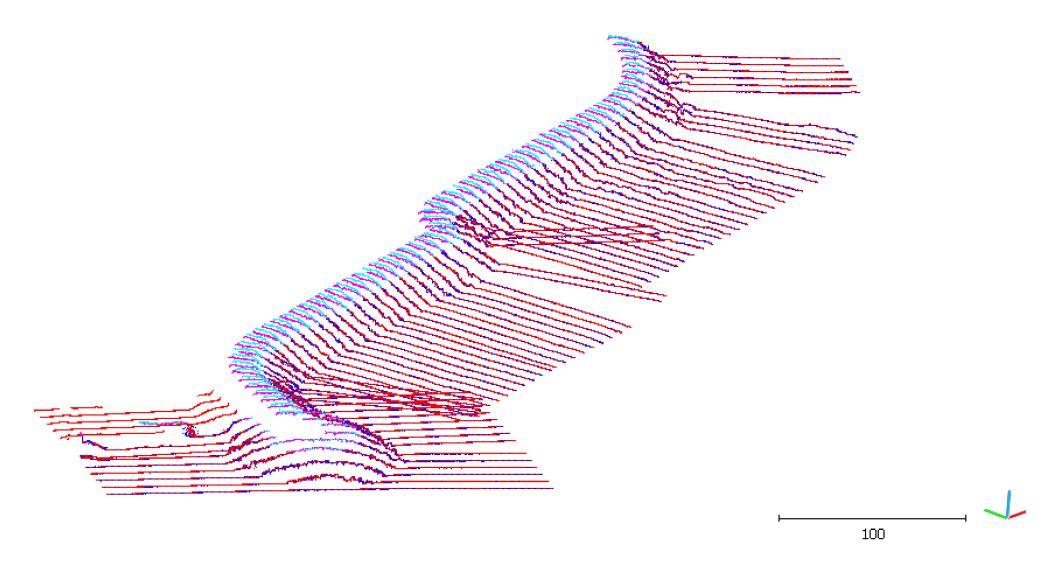
Figure 13. View of the section clouds of DSM 1 and DSM 2. The red and blue sections refer to the submerged portion of DSM 1 and 2, respectively, whereas the magenta and cyan sections are relative to the emerged portion.

Figure 13 represents a view of the section clouds (from the head of the breakwater, thus almost from southwest to northeast). The red-magenta and blue-cyan section clouds depict the submerged and emerged breakwater points for DSM 1 and DSM 2, respectively. To perform this, the CloudCompare Filter points by values tool was used to distinguish the points below 0 m from the points above it. Figure 14 represents a zoom of the extracted section clouds along the section trace number 12, highlighted in red in Figure 12, to better underline and quantify the distances between DSM 1 and 2.

As highlighted in the overall view of the section clouds (Figure 13) and in the zoom reported in Figure 14, and as expected from the previous analysis, the section clouds relative to DSMs 1 and 2 are almost undistinguishable over sea bottom and submerged breakwater areas, whereas a distance between them is noticeable concerning the emerged part of the breakwater.

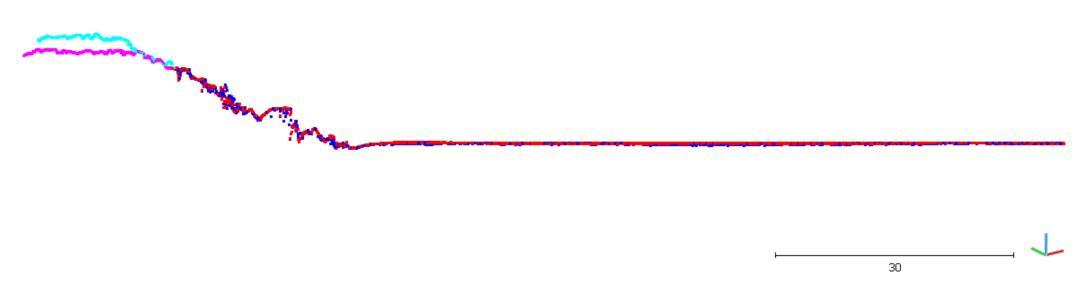
Figure 14. Zoom of the section cloud relative to section trace number 12.

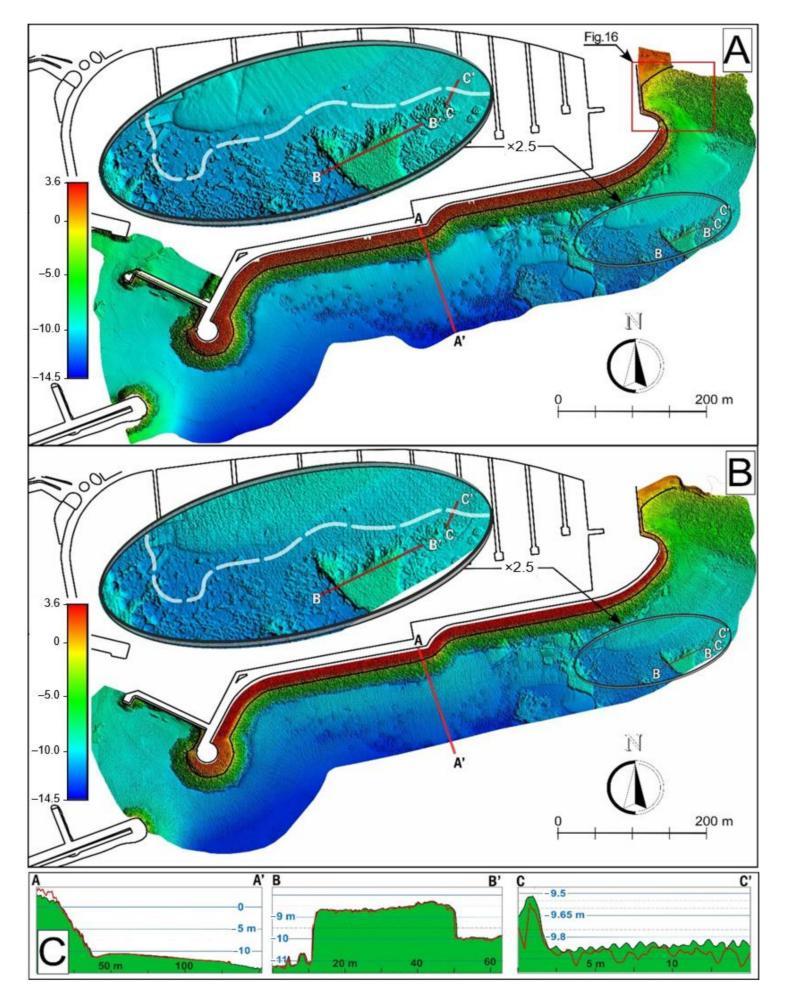
Figure 15. Morpho-bathymetry of the study area related to the two surveys: (**A**) February 2019; (**B**) November 2019. The zooms in (**A**) and (**B**) show the high detail of the acquisition; the white dotted line indicates the upper limit of the *Posidonia oceanica* seagrass after [58]. The red lines indicate the sections reported in (**C**), where the black and red lines refer to February and November 2019, respectively. The red box in (**A**) indicates the location of the zoom reported in Figure 16.

The survey conducted in February 2019 (Figure 15A), before the restoration of the breakwater, and the one in November 2019 (Figure 15B), when the restoration was completed, have allowed highlighting variations both in the emerged structure of the breakwater and in the morpho-sedimentary features of the seabed (Figure 15C).

The seabed morphology facing the breakwater shows a regular deepening (about 4%) of the bathymetry, between 10 m up to 14 m (section A–A' in Figure 15C).

Section A–A' in Figure 15C shows the erosion operated at the base of the breakwater by the reflection of the waves, highlighted by a depression between 0.5 and 0.8 m in-depth. The section B–B' in Figure 15C shows the presence of *Posidonia oceanica* matte partially affected by erosion [65–68]. The *Posidonia oceanica* upper limit, reported after [58,69], is mapped in the zoom of Figure 15.

As shown in the sections C–C' in Figure 15C, D–D' and F–F' in Figure 16, ripple marks of different sizes can be recognized, whose wavelengths range between 0.4 and 1 m, according to the hydraulic regime. Their structures indicate a vergence towards the coast.

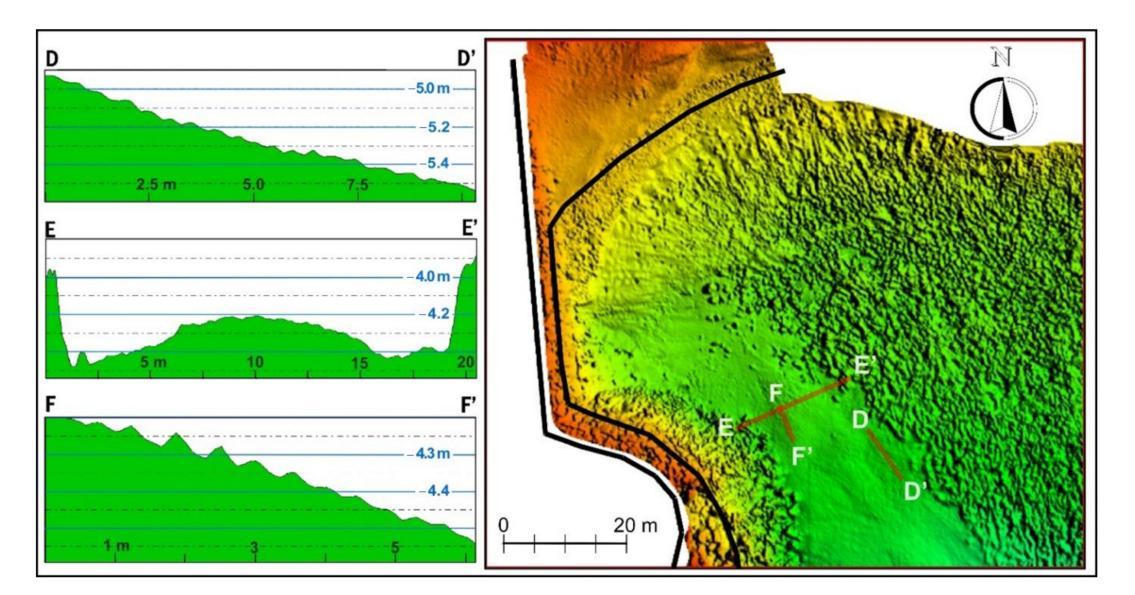
Figure 16. Zoom of the eastern sector of the study area (for location, see Figure 15): the red lines indicate the location of sections shown in the left box.

The section E-E' in Figure 16 indicates two erosive channels due to the backflow currents following the sea wave runup on the beach [51].
