Article Investigation of the Structural Dependence of the Cyclical Thermal Aging of Low-Voltage PVC-Insulated Cables

Semih Bal 🕩 and Zoltán Ádám Tamus *🕩

Department of Electric Power Engineering, Faculty of Electrical Engineering and Informatics, Budapest University of Technology and Economics, H-1111 Budapest, Hungary; semihbal@edu.bme.hu * Correspondence: tamus.adam@vik.bme.hu

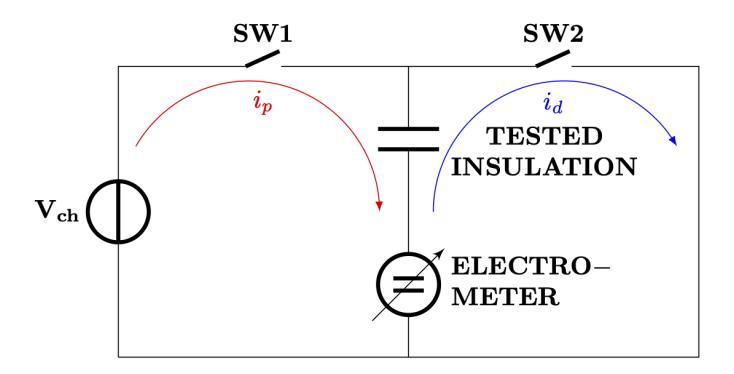
Figure 2. Circuit diagram of PDC.

The PDC measurement is based on two processes, charging and discharging the dielectric. The cable sample is charged with a voltage source for a defined period of time. Once the charging period is over, the cable sample is discharged again for a predefined discharging time. The PDC is measured, from which the conduction current is calculated. The polarization current is strongly dependent on the insulation conductivity. The circuit diagram of a PDC can be seen in Figure 2, while the timing diagram is shown in Figure 3.

The polarization current $(i_p(t))$ is measured when the tested insulation is connected to the voltage source (V_c) , the SW1 is in the ON position, and the SW2 is in the OFF position (Figure 2). The depolarization current $(i_d(t))$ measurement can be measured on the short-circuited test object by switching the SW1 to the OFF position and the SW2 to the ON position. The charging time is denoted by t_c , while the discharging time is denoted by t_d .

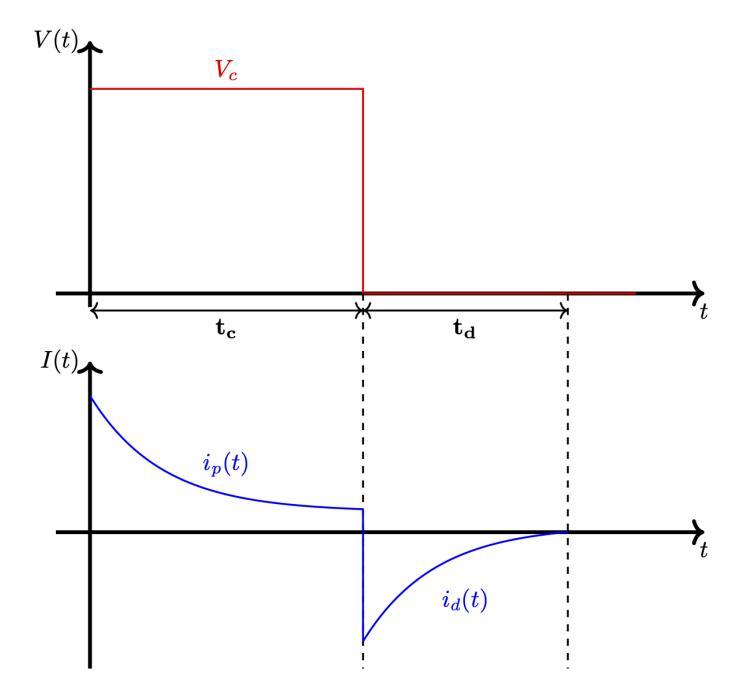
Figure 3. Timing diagram of PDC.

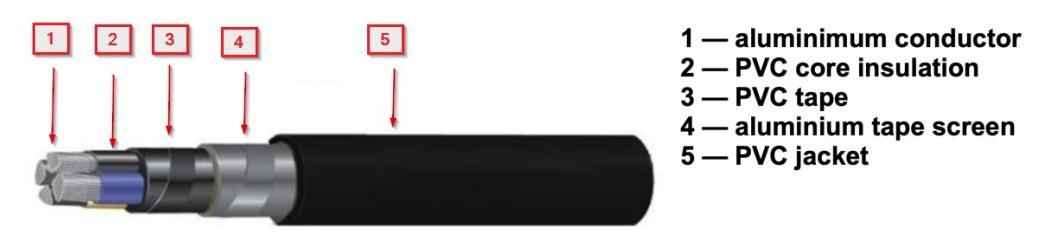
Figure 4. SZAMKAM cable structure.

- 1. 4 x Solid Aluminium Conductor.
- 2. PVC core insulation.
- 3. PVC tape.
- 4. Aluminium tape screen.
- 5. PVC jacket.

were produced according to the requirements of IEC 60502-1 [32]. The cable structure can be seen in Figure 4. According to the technical data, the maximum conductor operating temperature of the cable is 70 $^{\circ}$ C.

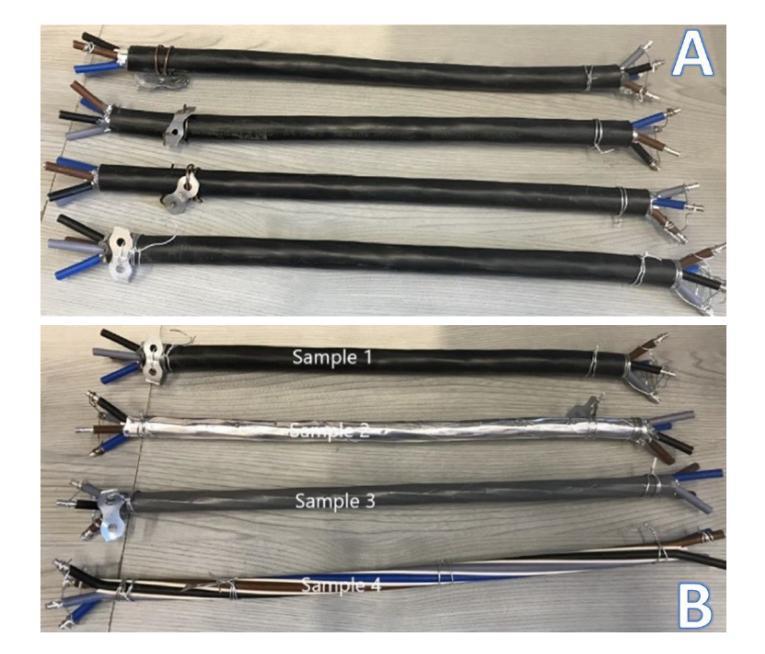
Figure 5. Cable samples before (A) and after (B) the structure changes.

As previously mentioned, this research aims to determine the effect of the cable construction on the dielectric characteristics that are impacted by thermal aging. Therefore, the layers of the cable were removed. It is worth emphasizing that the dielectric parameters were measured before changing the structure and thermal aging to ensure the sample homogeneity. Figure 5 shows the samples before and after changing the structure.

Table 1 depicts the leftover layers for each sample after changing the structure. Sample 1 was kept intact. The outer PVC jacket was removed from Sample 2. By comparing the measurements on this sample with those on the intact sample, it is possible to test whether the layers under the jacket (aluminum tape screen and PVC tape) adequately insulate the core insulations from the air. In the case of Sample 3, in addition to the PVC jacket, the aluminum screening tape was also removed. Only the PVC belt isolated the core insulations from the atmosphere of the aging chamber, while in Sample 4, the core insulations were not covered by anything. Hence, if the atmosphere affects the aging of the core insulations, it will be seen in the measurement results.

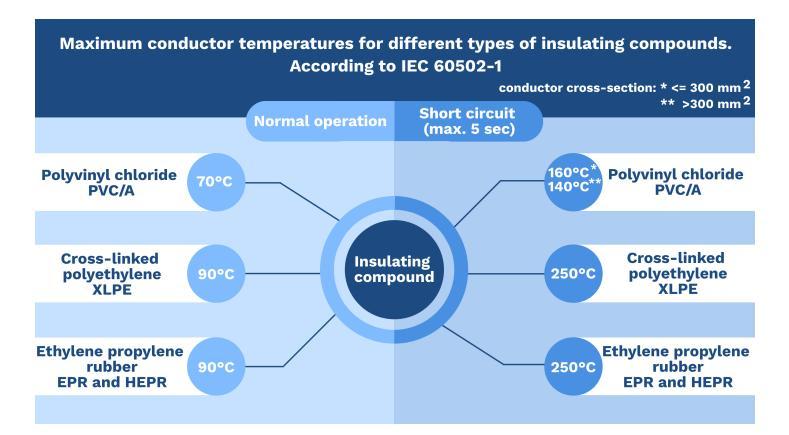
Figure 6. Maximum conductor temperature according to IEC 60502-1.

The cables are subjected to various stresses during operation. However, the dominant stress may be responsible for the majority of the degradation. A previous study showed that thermal stress can dominate, resulting in insulation degradation [33]. As mentioned in Section 1, the cable temperature may rise for a short time due to an overload, a short-circuit operation, and daily periodic generations. Especially in summer, the generation rate of photovoltaics is high at noon. Therefore, short-term cyclic thermal aging was used in this study. The cable samples were placed inside a temperature-controlled oven for three rounds (each of 6 h). According to IEC 60502-1, thermal aging should be carried out at at least 10 ± 2 °C more than the maximum conductor temperature, which is 70 °C during normal operation and 160 °C during a short-circuit operation [32]. The respective information can be seen in Figure 6.

The standard prescribes the maximum conductor temperature since, in real conditions, the heat is generated as Joule-loss in conductors by the loading current. Since the generated heat is conducted through the cable components to the soil, the temperature will not be the same in the different parts of the cables. In contrast, in a well-ventilated aging chamber, the temperature of the cable components can be considered the same, enabling investigation of the different aging behavior of cable components. The temperature for thermal aging was set to 110 °C. This temperature was chosen for easier comparison with previous studies, and it was intended to use a temperature higher than specified in the standard [13,18,19,25,34,35]. Eighteen hours of aging were achieved. Using the Arrhenius equation, this aging time would be equal to 330 h of service time at 70 °C.

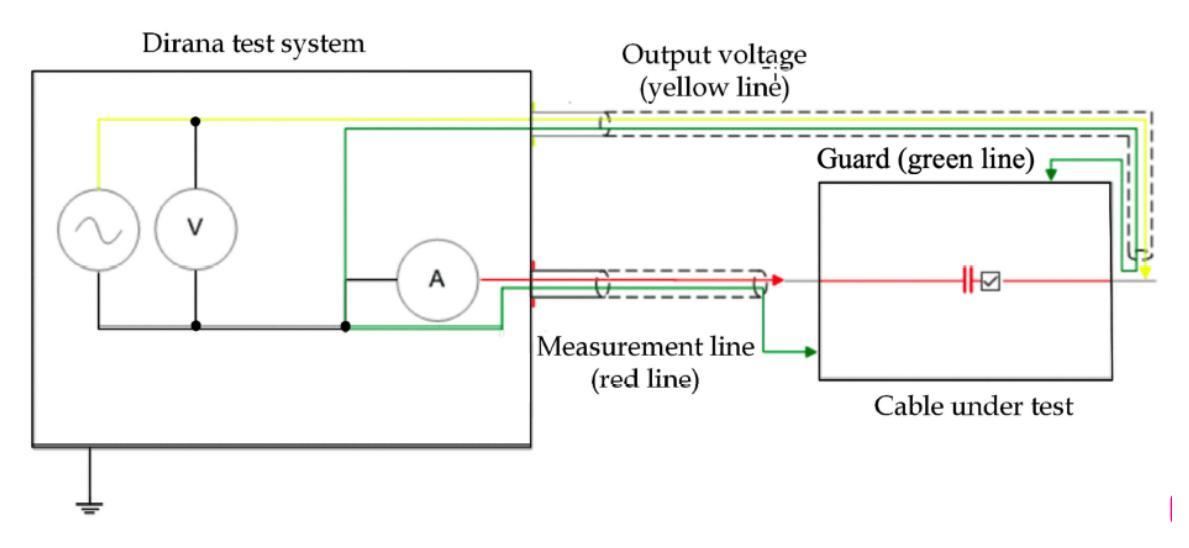
Figure 7. Measurement configuration from the DIRANA library.

The dielectric parameters in the time and frequency domains were measured by a DI-RANA Dielectric Response Analyzer, manufactured by Omicron Electronics Gmbh, Klaus, Austria. This equipment combines frequency-domain spectroscopy (FDS) and polarization– depolarization current (PDC) techniques to measure the dielectric response. The FDS method is applied at higher frequencies above 0.1 Hz. The time-domain PDC data are captured to measure the dielectric response in the lower frequency band. The collected PDC data are then transformed to the frequency domain using Fourier transformation [31,36–38]. The measurement setup can be seen in Figure 7. The general dielectric measurement configuration was chosen from the DIRANA library. The frequency range was given so that the interfacial polarization could be investigated [39]. The cable samples were placed inside a Faraday cage to avoid external electromagnetic disturbances. The measurement setup is depicted in Figure 8. In this investigation, the brown-colored insulation was measured against the others. Hence, one of the test leads was connected to the brown core. The other cores were connected to the aluminum armor, and the other test lead was connected to them.

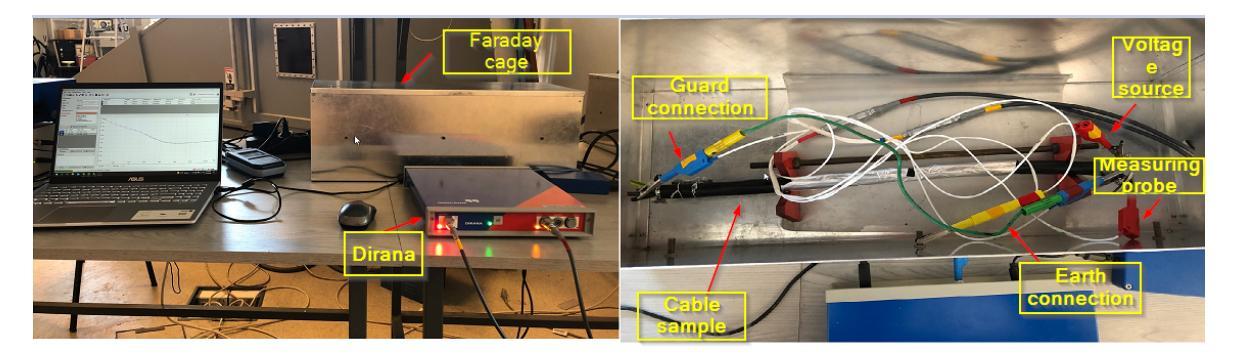
Figure 8. Measurement setup.

- Configuration: general dielectric.
- Test voltage: 100 V.
- Frequency range: 300 µHz–5 kHz.
- Charging time: 3333 s.
- Discharging time: 1000 s.

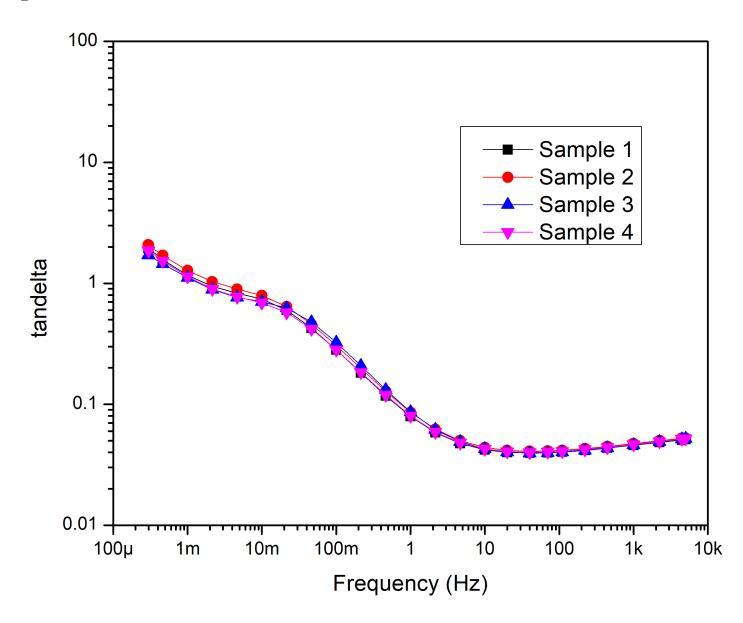
Figure 9. The results of the tan δ measurements on the intact samples before aging.

The homogeneity of the cable samples was checked by measuring them while unaged and intact. Figure 9 shows that there was no significant difference between the samples. Therefore, it can be considered that the samples were homogeneous. Hence, the different aging behavior of the samples was caused by only the various structures of the samples. The typical trend of the tan δ with frequency is that it decreases until it reaches the minimum point, from where it increases to 5 kHz.

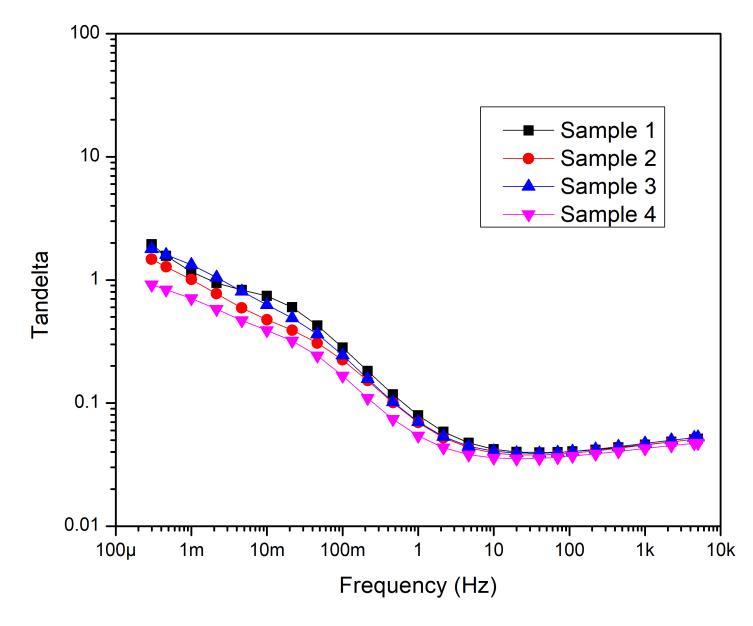
Figure 10. The effect of the structure changes on the tan δ before aging.

Table 1 shows that Sample 1 was the only sample kept intact during the measurement. However, the structure of Samples 2, 3, and 4 were changed before the thermal aging. The tan δ was measured after the structural change. The results are plotted in Figure 10. As shown before, the curves followed a similar trend over the frequency range, but removing the layers affected the tan δ . The cross comparison shows that the tan δ of Sample 4 decreased significantly compared to Sample 1, the intact cable, while Samples 2 and 3 did not show a drastic change. This is probably due to the distribution of the electric field changes inside the cable, as removing the layers decreases the compressing force on the cable structure, causing a minimal change in the cable geometry. Otherwise, recent studies

have revealed the compressing force can cause a significant increase in the dissipation factor at the low-frequency range [41,42].

Sample 2. The comparison before and after aging (Figure 13) showed a tendency similar to Sample 1. The tan δ increased after eighteen hours of thermal aging. It is also noted that the difference between the tan δ values in the 10 mHz...100 mHz range was higher than that of Sample 1. This difference is due to the different values of the loss factor before aging (Figure 10).

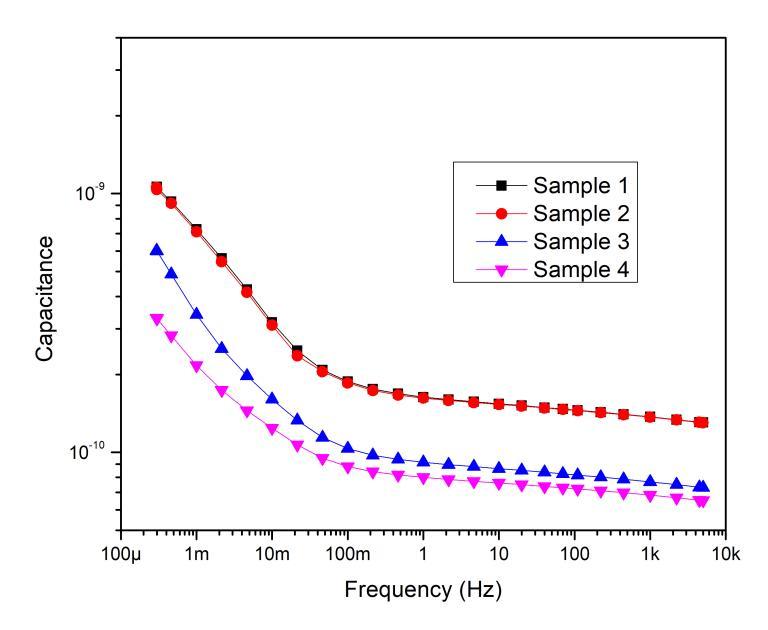
Figure 11. The effect of the change in structure on the capacitance [F] before aging.

Figure 11 shows how the capacitance changed by removing the layers. It is observed that removing the jacket did not show a considerable difference compared to the intact sample. However, the graph shows that the capacitance of Samples 3 and 4 dropped. The reason is that removing the aluminum tape screen reduces the electrode surface, which results in decreased capacitance values. Interestingly, the capacitance change between Samples 3 and 4 was relatively large despite only the thin PVC belt being removed from the cores. Thus, this layer significantly affects the field strength distribution within the cable.

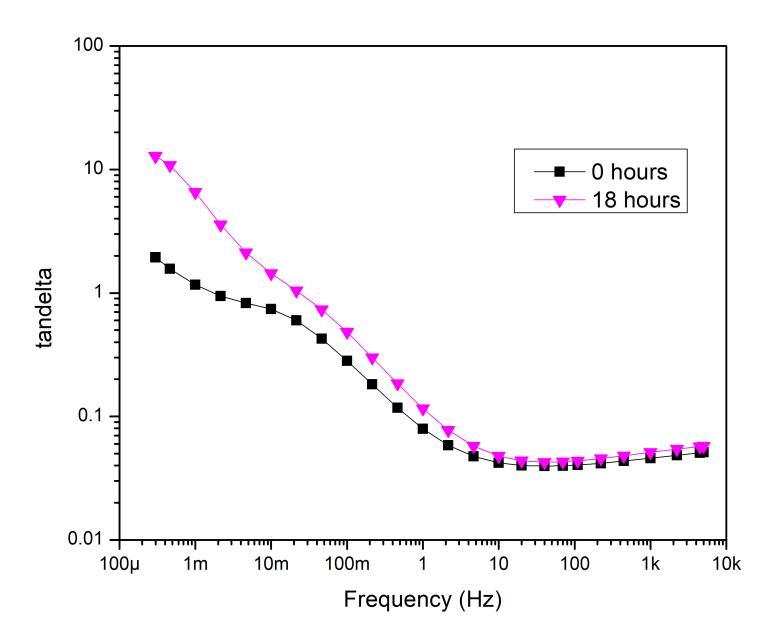
Figure 12. The change in the tan δ with aging, Sample 1.

Sample 1. As mentioned above, Sample 1 was the intact cable. Therefore, we expected to observe the general aging behavior from Sample 1. In addition, Sample 1 can be used as a reference for the other three samples. The results of 18 h of aging on the tan δ can be seen in Figure 12. It can be seen that the tan δ increased, especially at low frequencies from 300 µHz to 10 Hz, and the difference decreased with the increase in frequency. The increasing intensity of the interfacial polarization can explain this behavior due to the higher conductivity after aging.

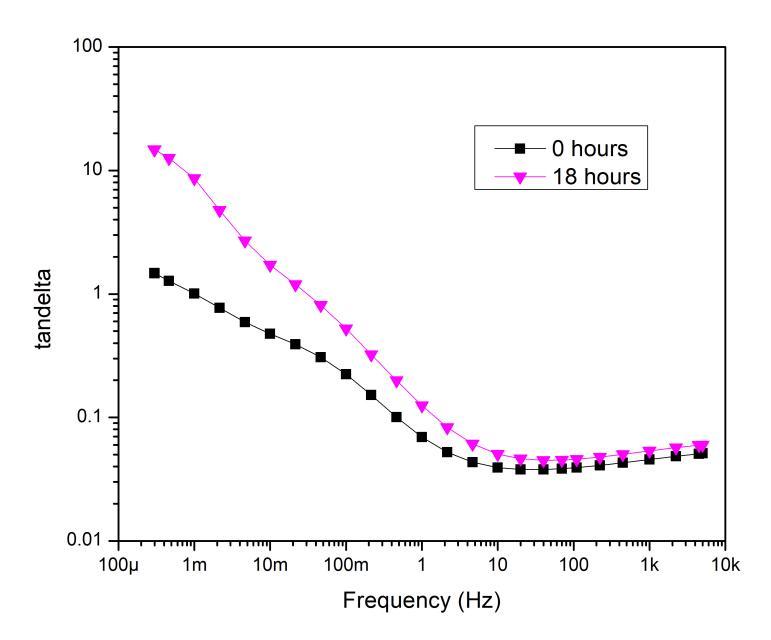
Figure 13. After aging, Sample 2.

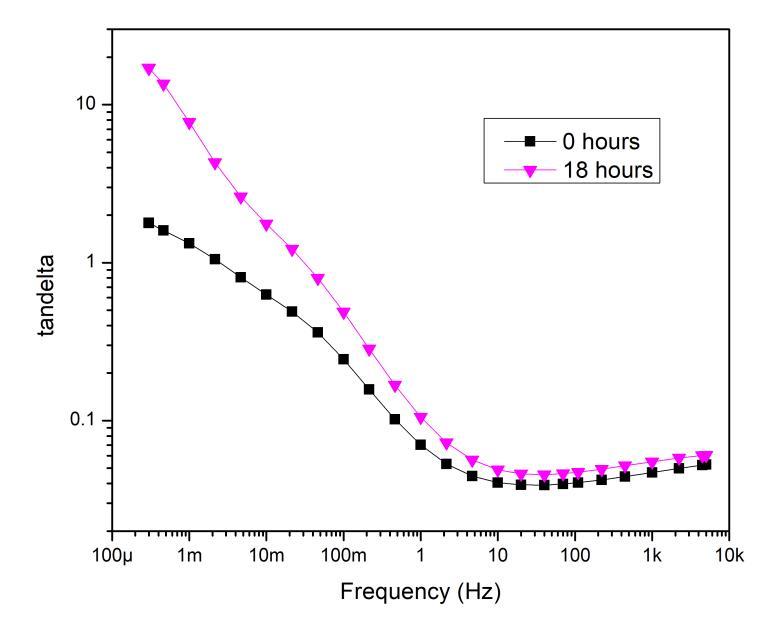
Figure 14. After aging, Sample 3.

Sample 3. Sample 3 showed a similar result to sample 2. The tan δ increased at the end of eighteen hours of aging (Figure 14). The results of the measurements suggest removing the aluminum tape screen did not significantly affect the tan δ .

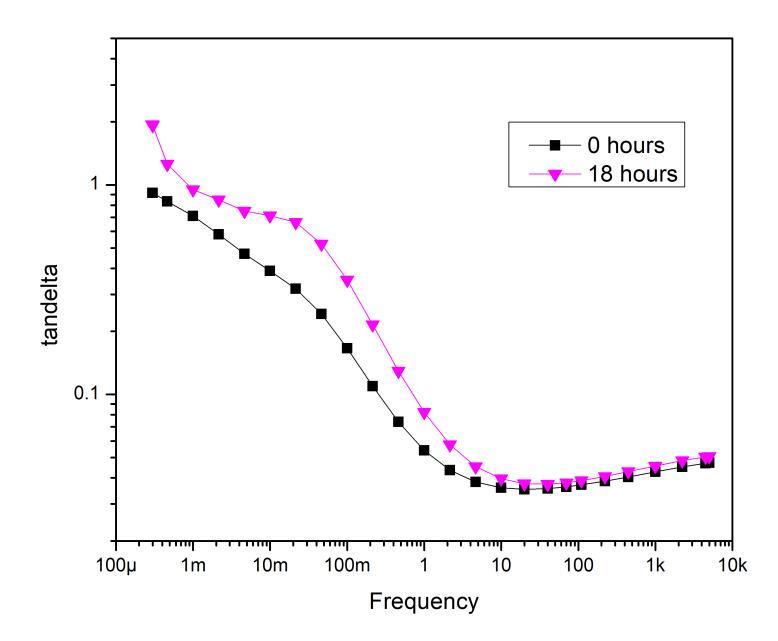
Figure 15. After aging, Sample 4.

Sample 4. Sample 4 is the sample that had only the conductors and the core insulations. The result can be seen in Figure 15. This sample's tan δ values also showed an increasing trend compared to before aging; even the shape of the curve was also changed. Nevertheless, while the loss factor decreased steadily over the 300 µHz...1 Hz range in the previous cases, there were two knee points around 1 mHz and 100 mHz of the tan δ curve of this sample. It can be stated that removing the PVC belt has the most significant effect on the electrical parameters changing due to aging.

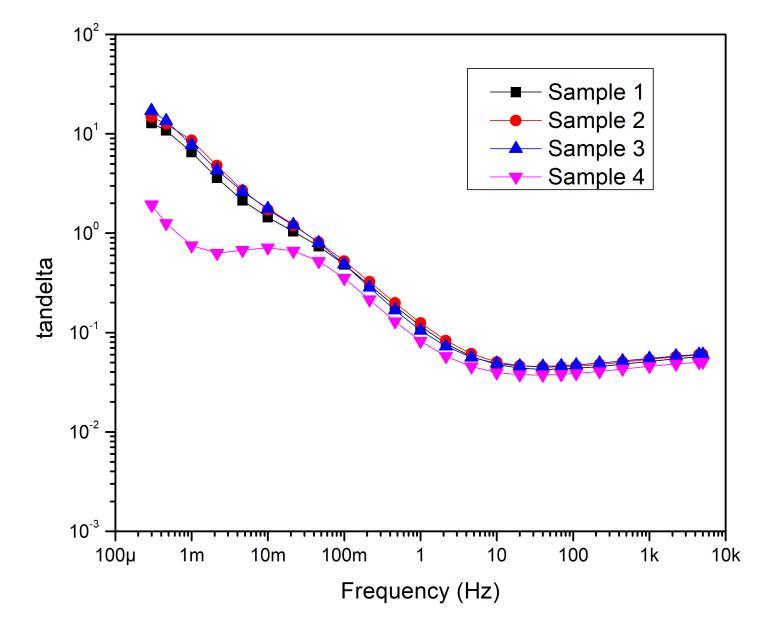
Figure 16. Cross comparison between the samples after aging.

Cross comparison. As shown in the previous section, all four samples showed a similar increasing trend when compared individually with their results. However, the cross

comparison gives interesting results. The tan δ of Sample 4 was noticeably lower than the other samples (Figure 16).

The reason for the difference is that in the case of Samples 1–3, the core insulations did not come into contact with air during thermal aging. Moreover, the result suggests that the PVC belt layer itself was enough to prevent the core insulations from coming into contact with the atmosphere of the aging chamber.

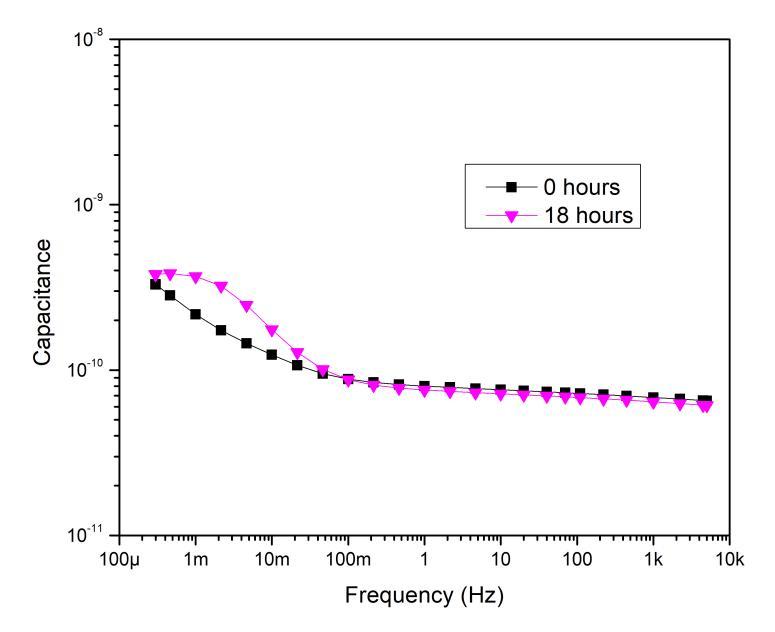
Figure 17. Capacitance of Sample 4 after aging.

A local peak in a tan δ curve is related to a dominant polarization process on a given frequency, resulting in a significant change in the capacitance–frequency curve [31,38]. Since the tan δ of Sample 4 had a local peak between 10 and 100 mHz (Figure 16), it is worth looking at its capacitance curve (Figure 17). Between 1 mHz and 30 mHz, the capacitance dropped below 100 nF from 300 nF. The reason for this capacitance decrease could be due to the appearance of a dominant interfacial polarization in this frequency range [26].

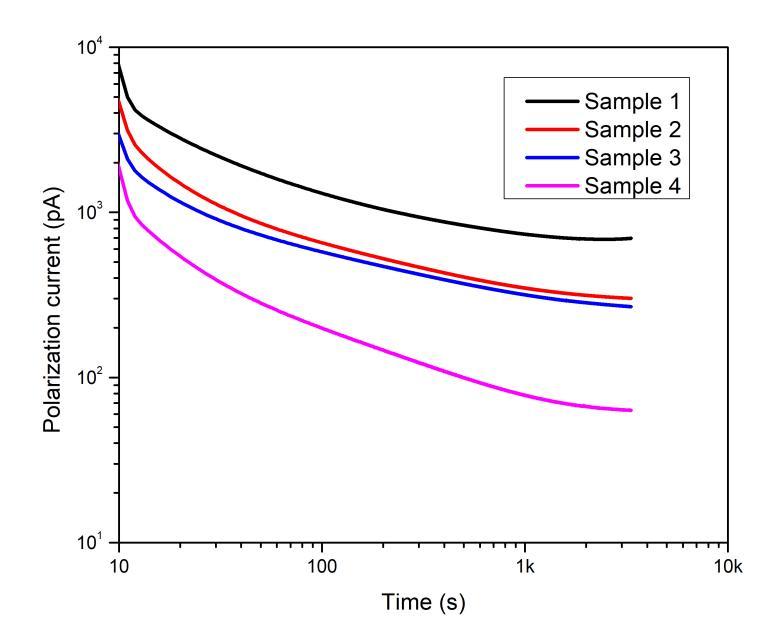
Figure 18. Polarization current.

The polarization and depolarization currents were measured after changing the structure of the cable samples. Figure 18 and Figure 19 show the polarization and depolarization currents before aging, respectively.

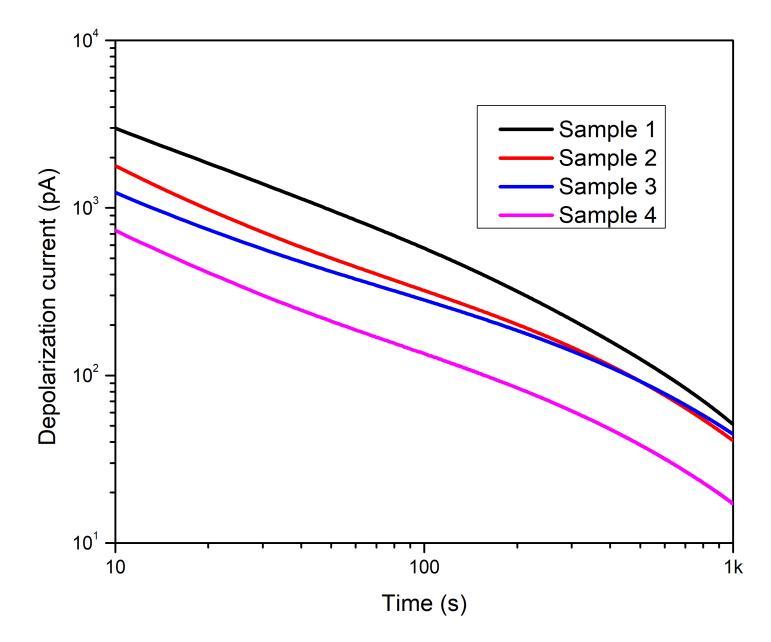
Figure 19. Depolarization current.

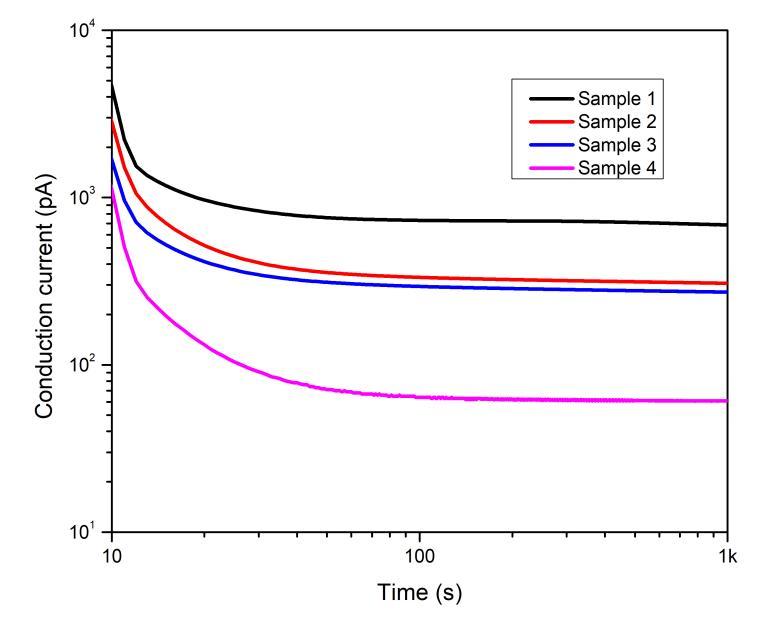
Figure 20. Conduction current.

The conductive current was calculated from the polarization and depolarization currents. Figure 20 shows how the conductive current was affected after the cable structure changed.

It can be seen clearly that Sample 1, which was the intact one, had the highest conductive current. The conduction current decreased with removing components, i.e., the jacket, aluminum tape, and PVC belt, of the cable. The current curves obtained were consistent with the previous findings that the difference between Samples 1 and 2 can be explained by the compression exerted by the jacket because the jacket removal decreases the contact area between the cable components, increasing the contact resistance between them [50]. The increased contact resistance lowered the conductive current, but the effect on the capacitance was negligible because the electrode arrangement was the same for both samples (see Figure 10). Surprisingly, a relatively small change was observed between Samples 2 and 3. This small change in the conductive current flowed between the aluminum tape and the cores. The determinant part of the current flowed between the core conductors. By comparing the conductive currents of Sample 3 and 4, the difference showed the PVC belt layer's significant role in the field distribution as previously assumed in Section 4.1.1 based on the results of the tan δ and capacitance measurements of the structurally changed samples before aging.

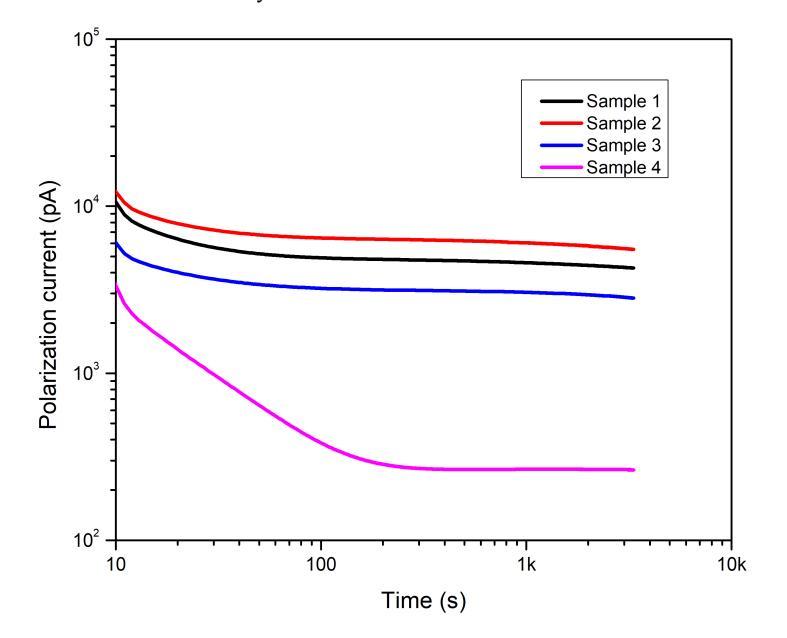
Figure 21. Polarization current of all samples after aging.

The polarization and depolarization currents were measured after each aging cycle, and the conduction currents were derived from them. Previous studies have shown that thermal aging affects the polarization level of the dielectric. The polarization current is increased by thermal aging. With the increase in the conductivity, the conductive current increases too. To summarize, only the results of 18 h of aging are presented here. Figures 21–23 depict the polarization, depolarization, and conduction currents for all four samples. It is understood that removing the cable layers affects the polarization, depolarization, and conduction currents. Therefore, the polarization process was affected by the structure change. The most significant difference can be seen in Sample 4 compared to the intact sample, namely, Sample 1. In the case of Samples 1, 2, and 3, the conductors were covered with a PVC belt. However, Table 1 indicates that in Sample 4 this PVC belt was removed. Removing the PVC belting could cause the easier movement of the plasticizer and evaporation from the core insulation. The lower the concentration of the plasticizer molecules, the lower the conductivity. Therefore, the conduction current decreased.

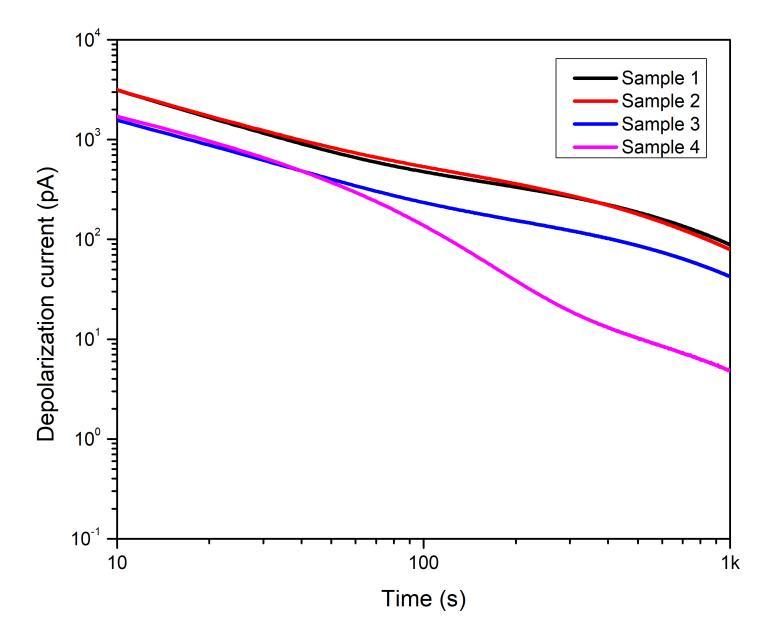
Figure 22. Depolarization current of all samples after aging.

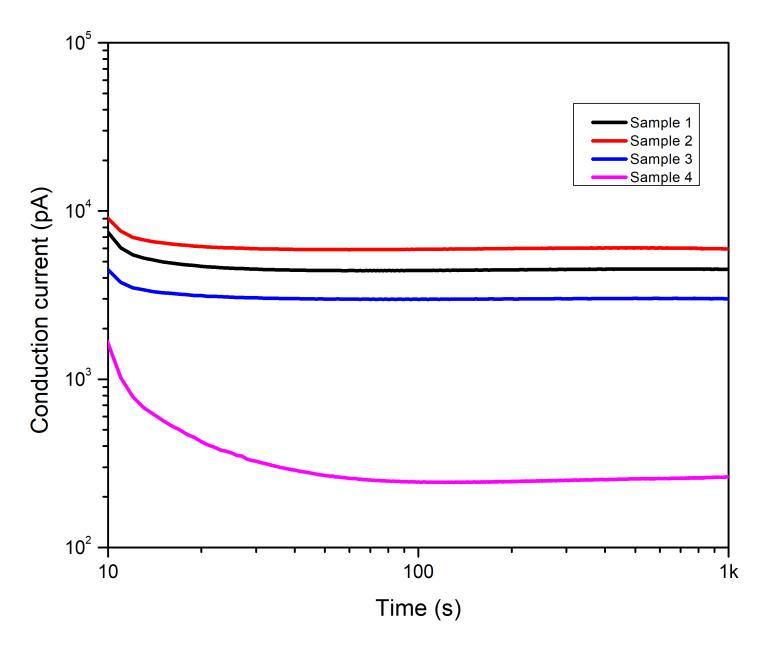
Figure 23. Conduction current of all samples after aging.

Since the specific conductivity cannot be calculated, each sample's before and after aging conductive currents must be compared to assess the conductivity change due to aging. Therefore, the rates of the conductive currents at 1000 s after and before aging were calculated. The results and the before and after aging conductive currents values at 1000 s are shown in Table 2.

The results show that the highest increase (by 19.37 times) in the conductive current can be observed in Sample 2, where the PVC jacket was removed, and both the aluminum tape and the PVC belting layers covered the cores. A 11.05 times increment in the conductive current was observed in Sample 3. In this sample, only the PVC belting layer covered the cores. In the intact sample, i.e., Sample 1, the conductive current increased by 6.55 times after aging, while in the case of Sample 4, with no covered conductors, the conduction current increased by 4.31 times.

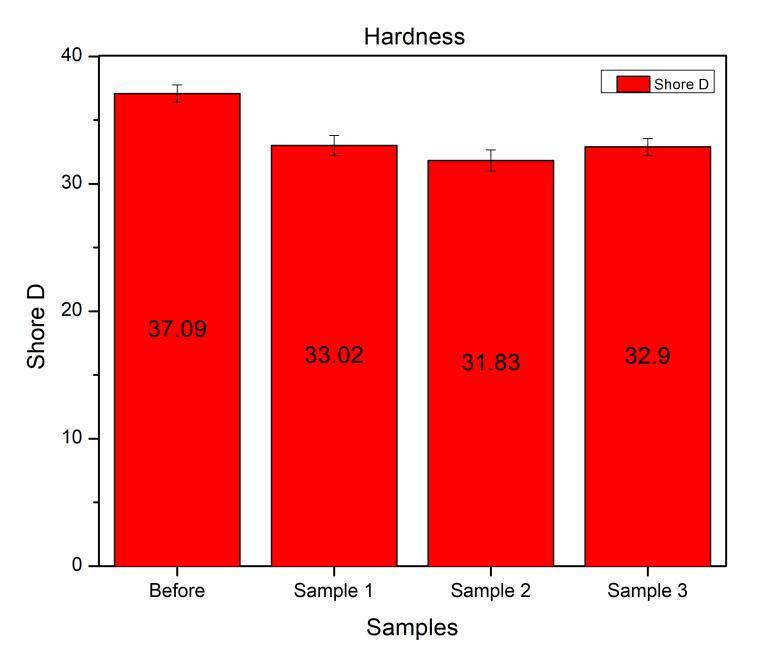
Figure 24. Results of the Shore D hardness measurements of the belting layers.

The results of the Shore D hardness measurements of the PVC belting layers are depicted in Figure 24. The sample before aging exhibited the highest hardness. In Sample 1, the hardness decreased after aging, and Sample 2 had the lowest Shore D hardness. Surprisingly, the hardness of Sample 3 was higher than that of Sample 2.

It is well known that long-term thermal aging increases the hardness of the PVC due to the evaporation of the plasticizer; however, earlier cyclical aging studies have shown softening of the PVC cable insulation at the beginning of the aging process before the hardness starts to increase [13]. In this experiment, the aging times were the same for all samples, but the belt layers of the different samples were exposed to the atmosphere of the aging chamber to different extents. In Sample 1, the belting layer was covered by the jacket and aluminum tape. Only the aluminum tape covered the belting layer in Sample 2, while Sample 3's belting layer could freely come into contact with air. Since the presence of oxygen increases the degradation of the PVC, it probably caused the different hardnesses of the samples after aging [48,49]. However, the softening of the PVC at the beginning of the thermal aging can also be caused by the annealing effect [51,52]. At the beginning of the aging process, the annealing and the plasticizer loss rise in parallel. At the same time, dehydrochlorination only takes effect in the later aging phase at the low temperature used for aging in this experiment. Therefore, the combination of the effects of annealing and the plasticizer loss determined the hardness of the PVC belting layer in the cable insulation system. Since the structure of the cable samples intensively affected the evaporation of the plasticizer, the structural changes affected the hardness of the PVC belt layer through this process. Nevertheless, the plasticizer evaporated most easily from the belting layer of Sample 3. Based on the earliest studies, at the beginning of aging, the effect of the annealing on the hardness of the PVC was stronger than the impact of the plasticizer loss. Later, the effect of plasticizer loss became more dominant; so, the material started to harden.

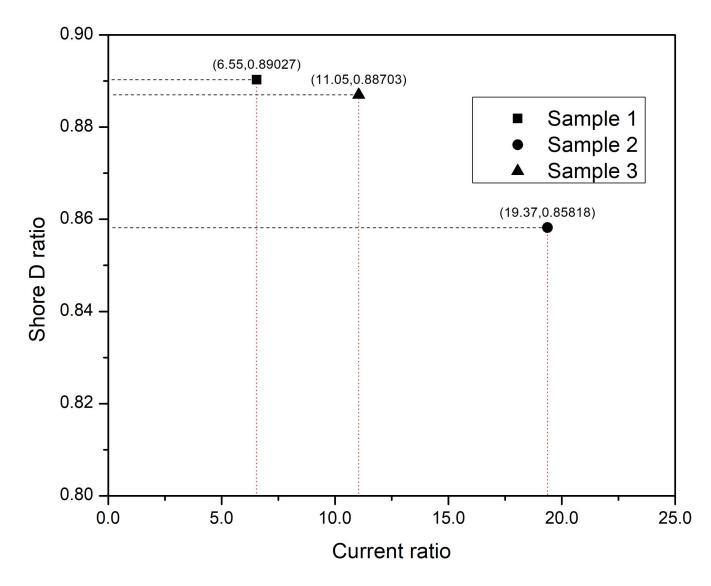
Figure 25. Comparison of the Shore D hardness and the conduction current after and before aging ratios.

The variables were plotted in a scatter plot to observe the relationship between the before and after aging ratios of the conductive current and the Shore D hardness (Figure 25).

The figure shows a clear relationship between the change in the conductive current and the Shore D hardness; however, the number of points was insufficient for correlation analysis. For this purpose, the experiments should be repeated with more aging rounds to reveal the link between the results of dielectric measurements and the mechanical properties of the belting layer. However, this kind of examination requires a large number of samples since the cable samples would have to be dismantled to test the hardness of the belting layers. Nevertheless, previous studies have shown clear evidence between the Shore D hardness and the dielectric properties of PVC cable insulation.

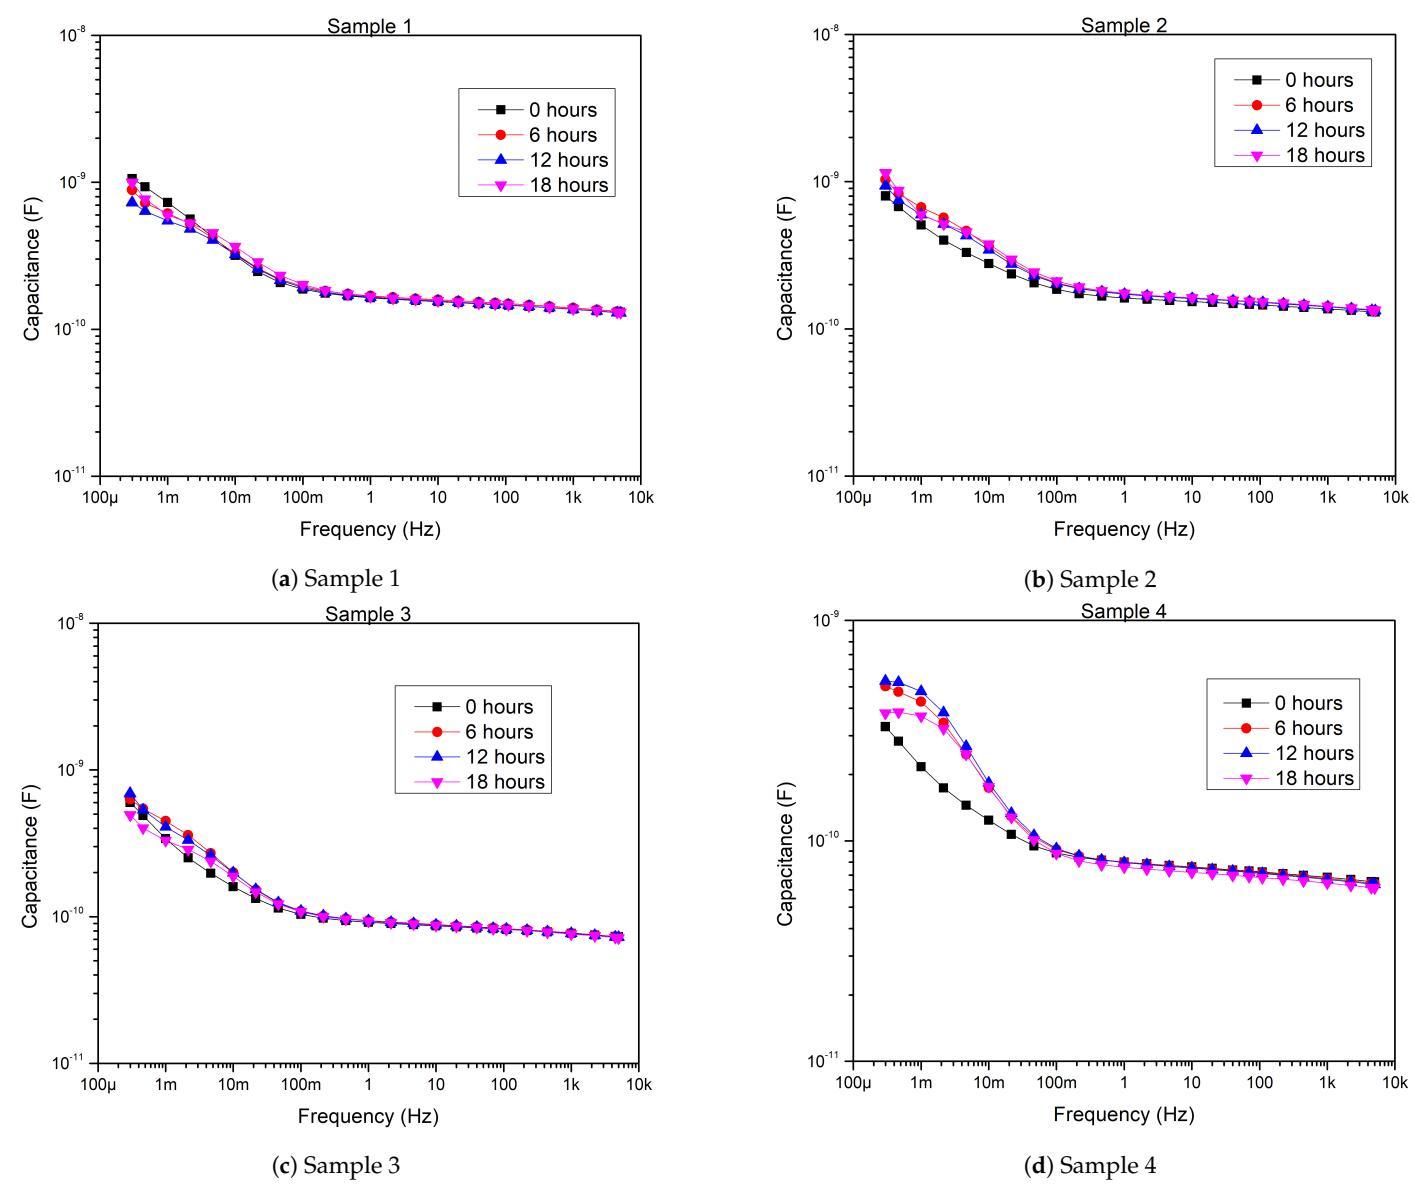
Figure A1. Capacitances of the samples after each aging round.

The other samples' capacitances showed a small increase below 0.1 Hz with aging (see Appendix A), due to the increase in the conductivity of the material with aging.

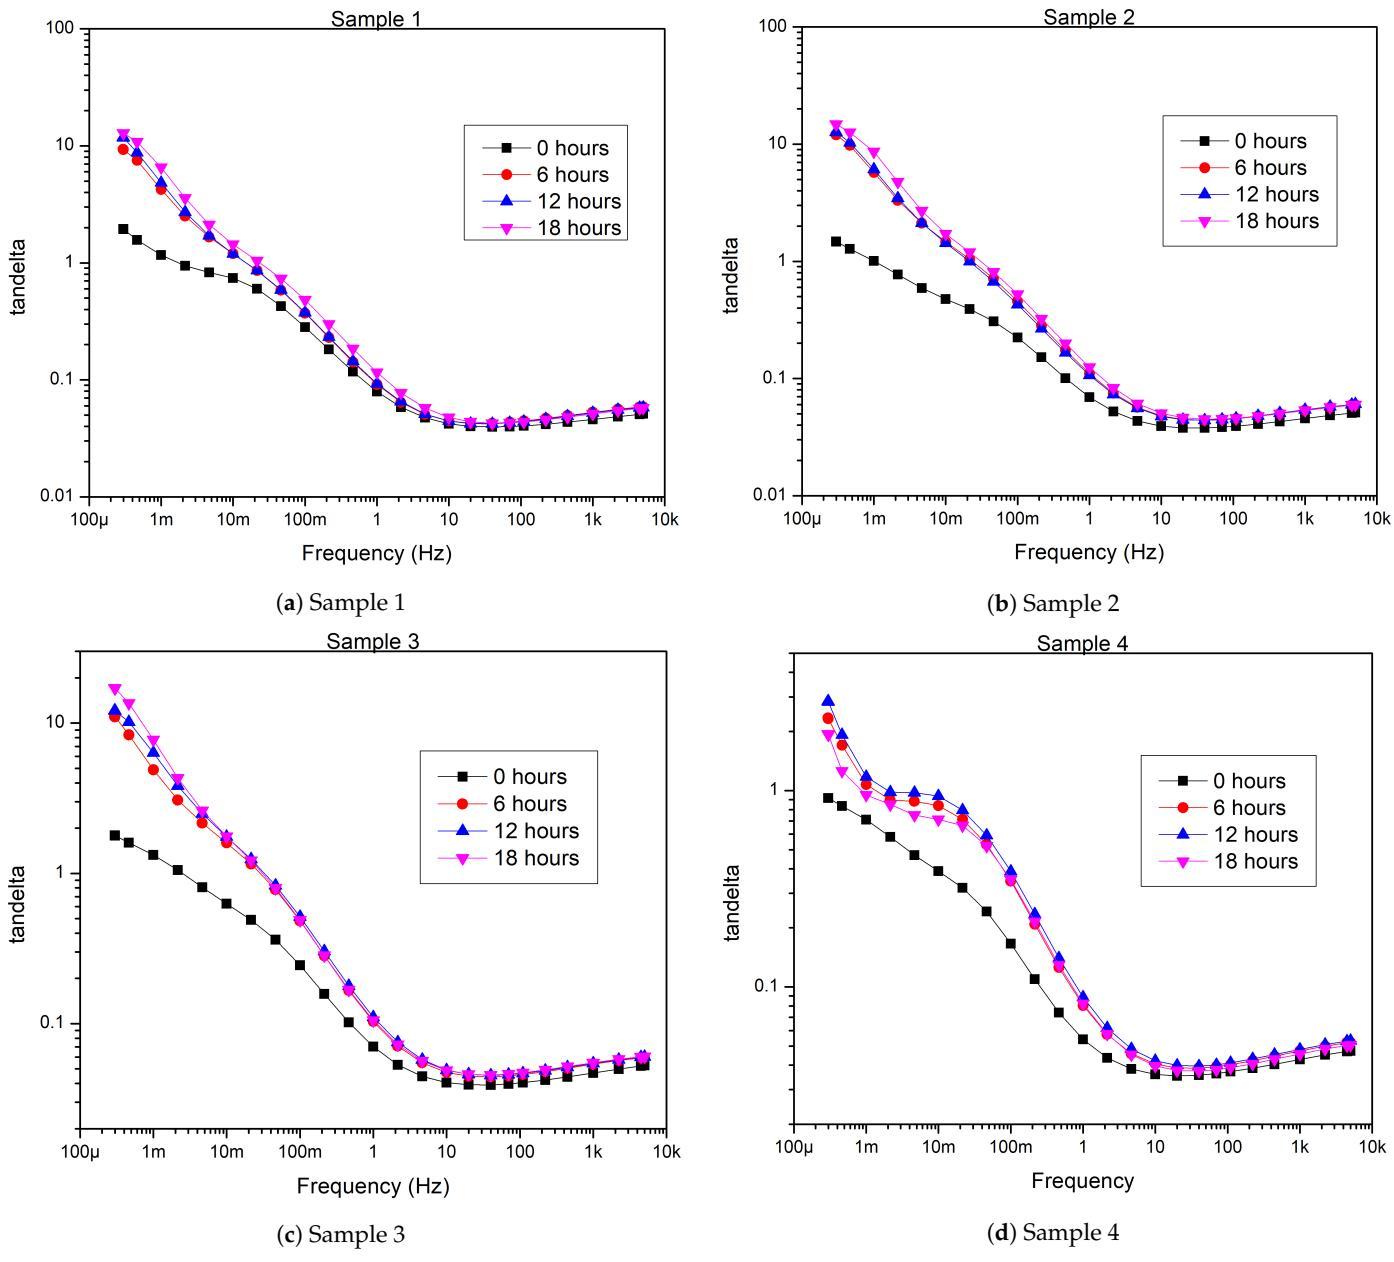
Figure A2. Tan δ values of the samples after each aging round.

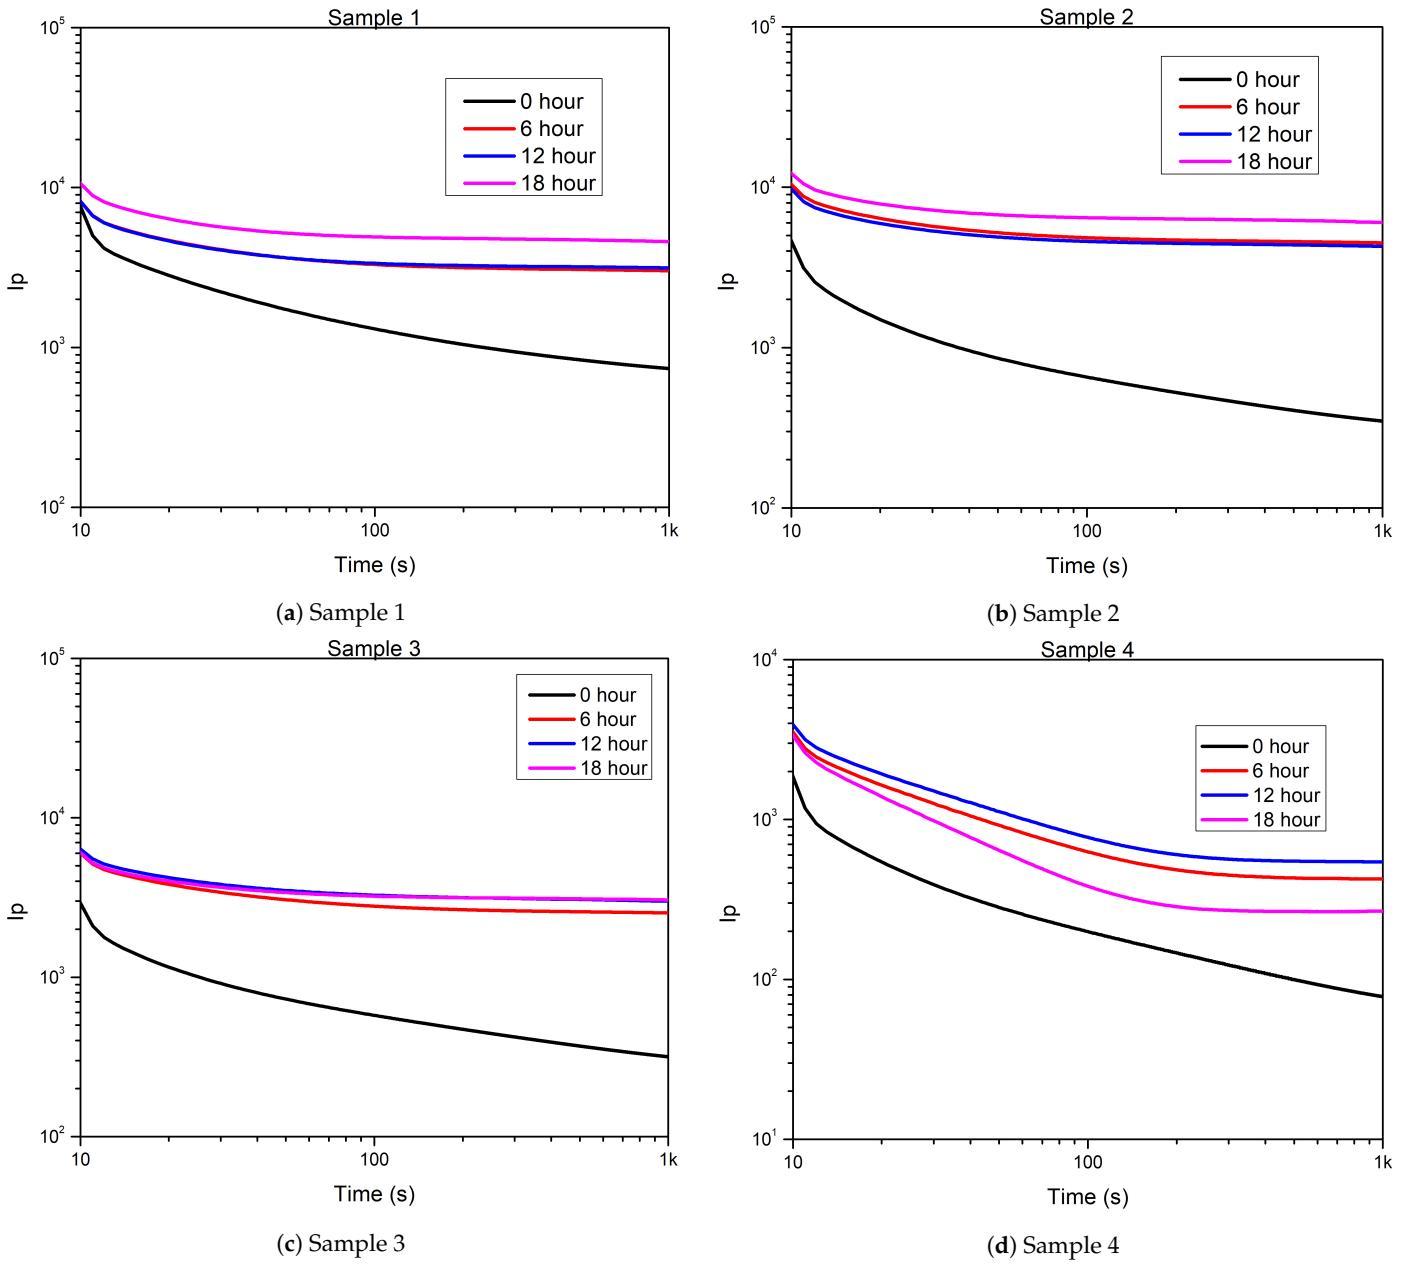
Figure A3. Polarization currents of the samples after each aging round [pA].
