Atmospheric-Induced Stress Corrosion Cracking of Grade 2205 Duplex Stainless Steel—Effects of 475 °C Embrittlement and Process Orientation

Abstract: The effect of 475 °C embrittlement and microstructure process orientation on atmospheric-induced stress corrosion cracking (AISCC) of grade 2205 duplex stainless steel has been investigated. AISCC tests were carried out under salt-laden, chloride-containing deposits, on U-bend samples manufactured in rolling (RD) and transverse directions (TD). The occurrence of selective corrosion and stress corrosion cracking was observed, with samples in TD displaying higher propensity towards AISCC. Strains and tensile stresses were observed in both ferrite and austenite, with similar magnitudes in TD, whereas, larger strains and stresses in austenite in RD. The occurrence of 475 °C embrittlement was related to microstructural changes in the ferrite. Exposure to 475 °C heat treatment for 5 to 10 h resulted in better AISCC resistance, with spinodal decomposition believed to enhance the corrosion properties of the ferrite. The austenite was more susceptible to ageing treatments up to 50 h, with the ferrite becoming more susceptible with ageing in ex

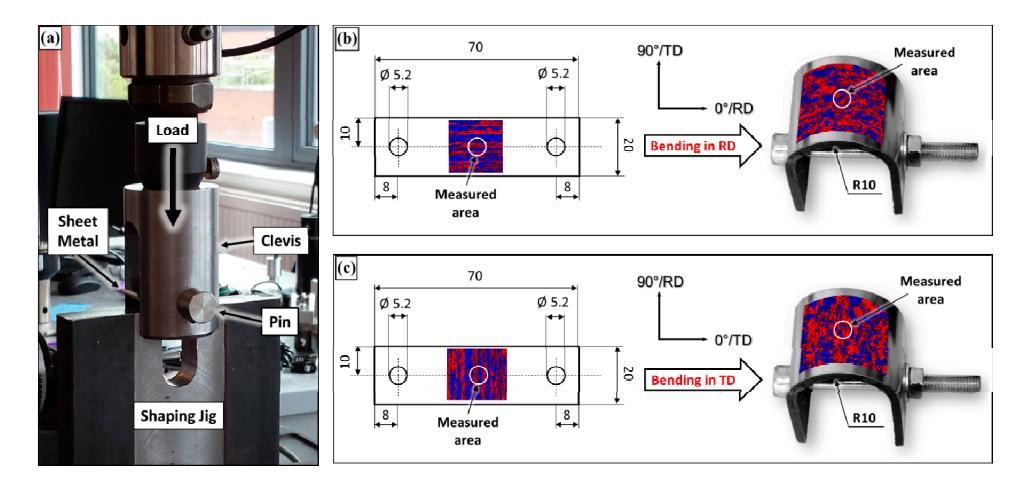
Figure 1. (a) U-bend shaping jig with (b) sheet dimensions and bending orientation in RD and (c) in TD. The circle in the centre of each specimen indicates the position of XRD stress measurements before and after bending. The angles indicate the measurement direction in 0° and 90° .

A solution-annealed (as-received) sheet of grade 2205 DSS (EN 1.4462, UNS S32205) manufactured by OutoKumpu (Torshälla, Sweden) of 2 mm thickness was used in this study. The sheet had a chemical composition (in wt. %) of 22.44Cr, 5.75Ni, 3.32Mo, 1.41Mn, 0.42Si, 0.015C, 0.155N, 0.006Nb, 0.21Cu, 0.12Co, and Fe (bal.). The sheet was then cut along RD and TD to produce rectangular strips with dimensions of 70 mm \times 20 mm \times 2 mm (L \times W \times T). Two holes of 5.2 mm diameter each were drilled on both sides of the strips, with samples exposed to heat treatments at 475 °C \pm 5 °C for 5, 10, 20, 50, and 255 h, followed by water quenching. The surface of all specimens was ground to 4000-grit using SiC paper. A schematic illustration of the strips, including their orientation with respect to RD/TD, and how these were further shaped into U-bend samples is shown in Figure 1. Bending was carried out using an Instron 5569 testing machine (Instron, Norwood, MA, USA) under compression with a load cell of 50 kN and a crosshead displacement rate of 10 mm/min. The U-bend samples were tightened using stainless steel bolts and nuts.

EBSD analysis was performed over a scan area of 711 μ m × 622 μ m of the samples before bending, and 728 μ m × 728 μ m of the bent specimens using an FEI Quanta 650 scanning electron microscope (SEM, Hillsboro, OR, USA) interfaced with a Nordlys EBSD detector (Oxford Instruments, Abingdon, Oxfordshire, UK) and AZtec V2.2 software for data acquisition from Oxford Instruments (Abingdon, Oxfordshire, UK). A 20 kV accelerating voltage with step sizes of 527 nm and 773 nm was used for microstructure analyses. Both EBSD maps were acquired over approximately the same area in both samples, located towards the centre of the strips, schematically shown in Figure 1b.

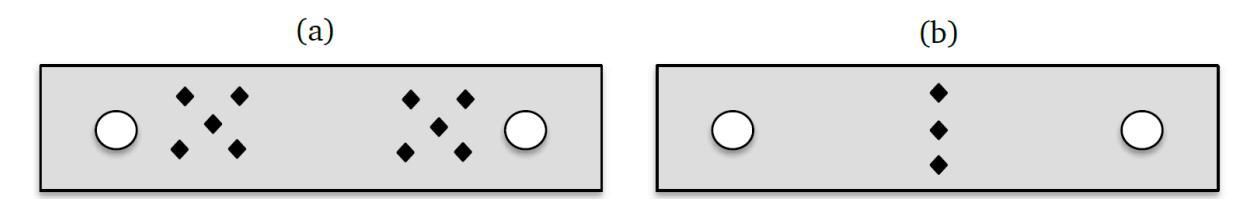
Figure 2. Schematic representation of the location of hardness indentations in (**a**) flat strips and (**b**) U-bend samples.

Macro-hardness measurements were carried out on a Georg Reicherter Briviskop 1875 Vickers hardness machine (Esslingen a.N., Baden-Württemberg, Germany) on all samples. Measurements were undertaken on flat strips and U-bend samples. For the samples before testing, 10 hardness indentations were produced with five indentations on each end of the samples, as seen in Figure 2a. Three indentations were placed on the apex of the U-bend samples after bending, as shown in Figure 2b. The corresponding hardness was then calculated from the mean of the hardness measurements.

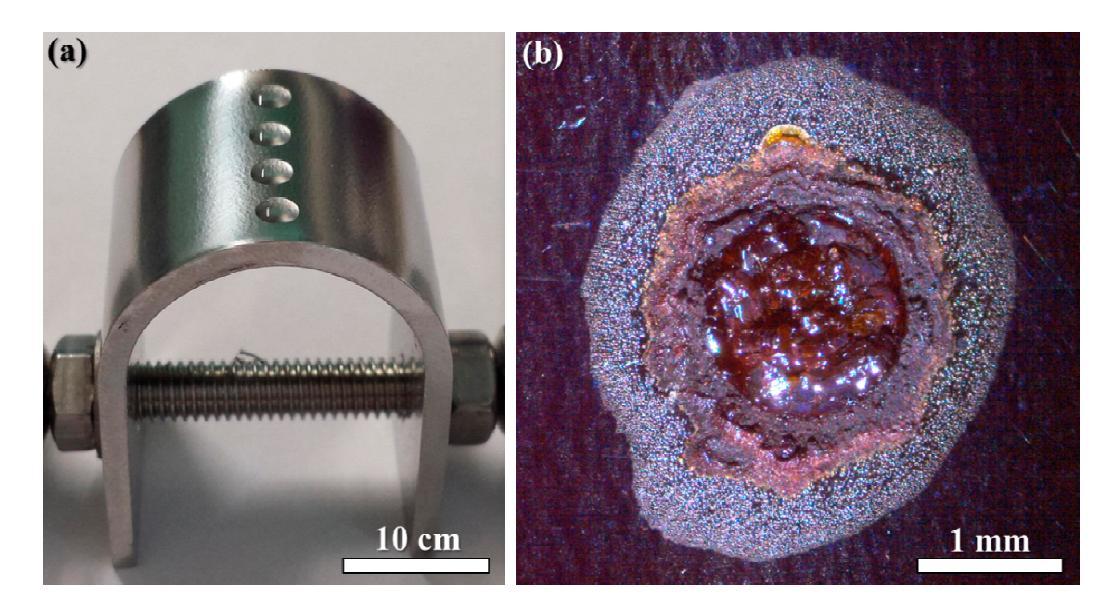
Figure 3. (a) Photograph of a U-bend specimen with salt-laden droplets containing MgCl₂; (b) stereo-microscopic image of one of the deposits after AISCC testing.

At the end of all tests, the exposed samples were imaged with a Zeiss stereo microscope (Jena, Thüringen, Germany). The samples were then cleaned in \approx 70 °C citric acid solution for 2 h to remove all corrosion products without attacking the metal substrate. A photograph of a U-bend specimen deposited with salt-laden droplets and a stereo-microscopic image of a deposit after 35 days exposure is shown in Figure 3.

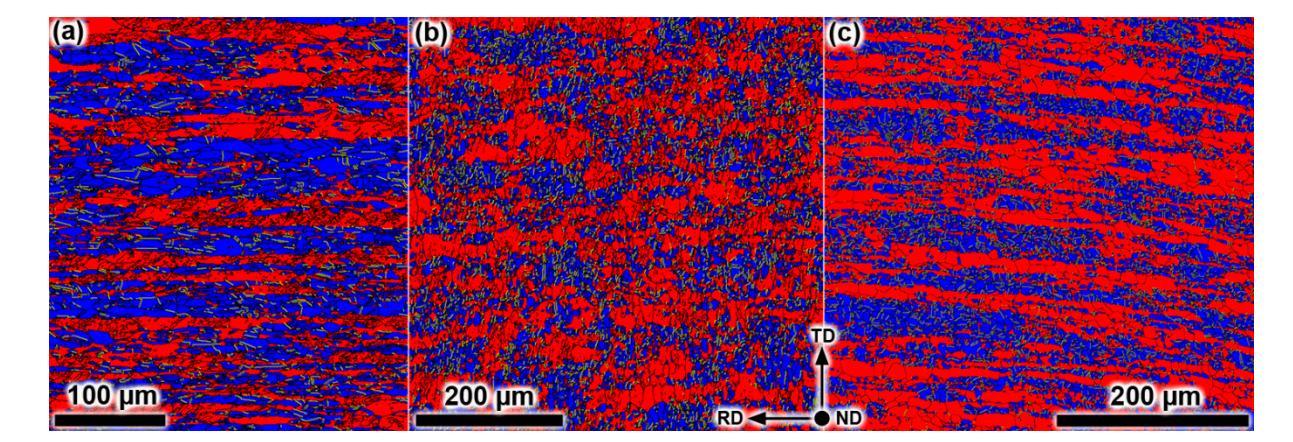
Figure 4. EBSD phase maps of (**a**) as-received 2205 DSS, and (**b**) after bending in TD and (**c**) in RD. Black lines are phase boundaries and HAGBs. The arrows indicate normal direction (ND), rolling direction (RD), and transverse direction (TD).

The as-received microstructure consisted of $54\% \pm 1\%$ austenite (γ) and $46\% \pm 1\%$ ferrite (δ). The average grain size of ferrite and austenite was $4.2 \ \mu m \pm 2.3 \ \mu m$ and $2.2 \ \mu m \pm 1.4 \ \mu m$, respectively. The austenite grains are arrayed in a band-like structure and embedded in the ferritic matrix, as shown by the EBSD phase map in Figure 4a. The microstructure has elongated grains along RD, with no intermetallic phases observed. The aspect ratio of ferrite and austenite was 0.84 and 0.93, respectively. Numerous LAGBs were present in the microstructure, and a summary of all EBSD results is listed in Table 2.

After bending the sample in TD, the phase fraction of austenite to ferrite changed to $48\% \pm 1\%$ versus $52\% \pm 1\%$, highlighting a clear reduction of the austenite content. The apex microstructure was heavily deformed with elongated ferrite and austenite grains towards the bending direction, as shown in Figure 4b. The band-like austenitic structure seemed disrupted after the bending process. The average grain size of ferrite and austenite increased to $5.1 \ \mu m \pm 2.3 \ \mu m$ and $3.7 \ \mu m \pm 1.7 \ \mu m$, respectively, with the aspect ratio of ferrite and austenite increasing to 1.61 and 1.71, respectively. This shows that austenite and ferrite grains were highly deformed in the bending direction (TD). The microstructure bent in TD shows far more disrupted grain morphologies, compared to the microstructure bent in RD.

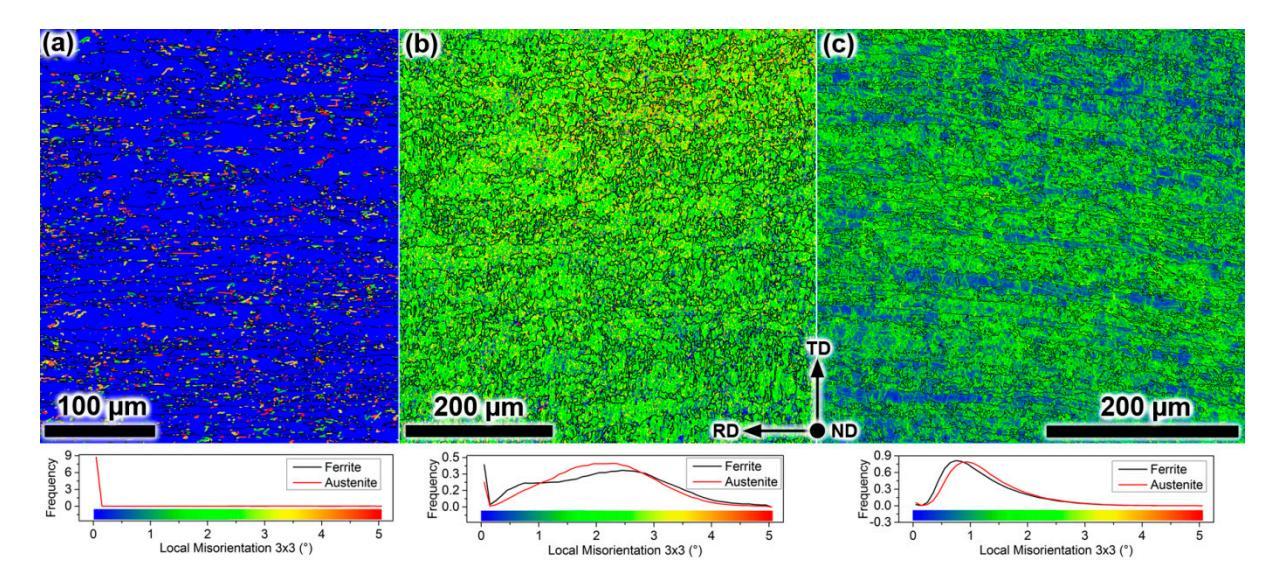
Figure 5. EBSD local misorientation maps of (**a**) the as-received microstructure, (**b**) after bending in TD, and (**c**) after bending in RD. Black lines are phase boundaries only. Note that the misorientation profiles of ferrite and austenite in (**a**) overlap with each other. The arrows indicate normal direction (ND), rolling direction (RD), and transverse direction (TD).

The LMO analysis of both U-bend samples showed the presence of elastic-plastic strain and deformation in austenite and ferrite, summarised in Figure 5a–c. The degree of local misorientation changed to values up to 5° , indicating the presence of large strains across the entire microstructure due to the bending deformation. The microstructure bent in TD had nearly twice the degree of LMO compared to RD, indicating a far stronger effect on microstructure changes when samples are bent in TD. The austenite seemed to have a somewhat larger LMO distribution in comparison to ferrite, which was observed in both bending directions. In the microstructure bent in RD, a local region with accumulation of high LMOs, indicative of elastic/plastic strain, was observed in austenite.

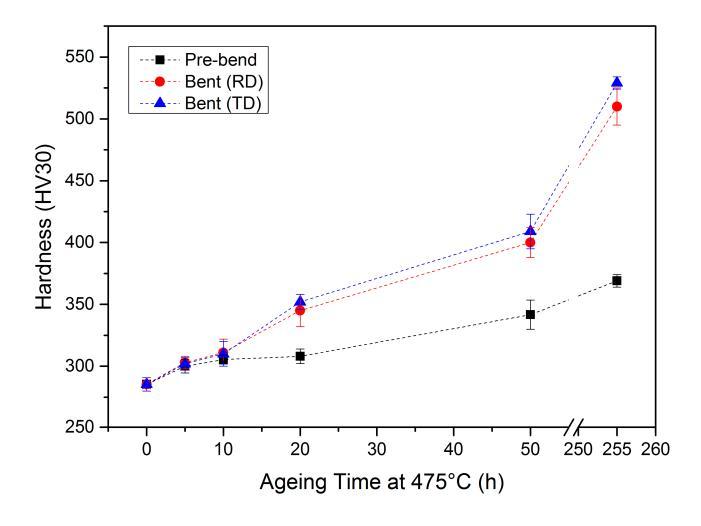
Figure 6. Hardness of flat strips (pre-bend) and U-bend samples in (RD) and (TD) as function of ageing exposure at 475 °C.

The hardness results of all samples as a function of ageing time at 475 °C are shown in Figure 6. The hardness increased from 285 HV30 \pm 5 HV30 to 369 HV30 \pm 5 HV30 after 255 h ageing. The same trend, but with significantly higher hardness values, was also observed for all U-bend specimens. The hardness after bending in RD and TD was 510 HV30 \pm 15 HV30 and 529 HV30 \pm 5 HV30, respectively. The hardness measured on U-bend specimens with 475 °C ageing treatment up to 10 h followed similar trends, as the hardness measured on as-received samples with the same heat treatment. This indicates only a minor effect of bending deformation on the hardness for short-term ageing treatments at 475 °C. Heat treatments in excess of 10 h showed a clear difference in hardness after bending.

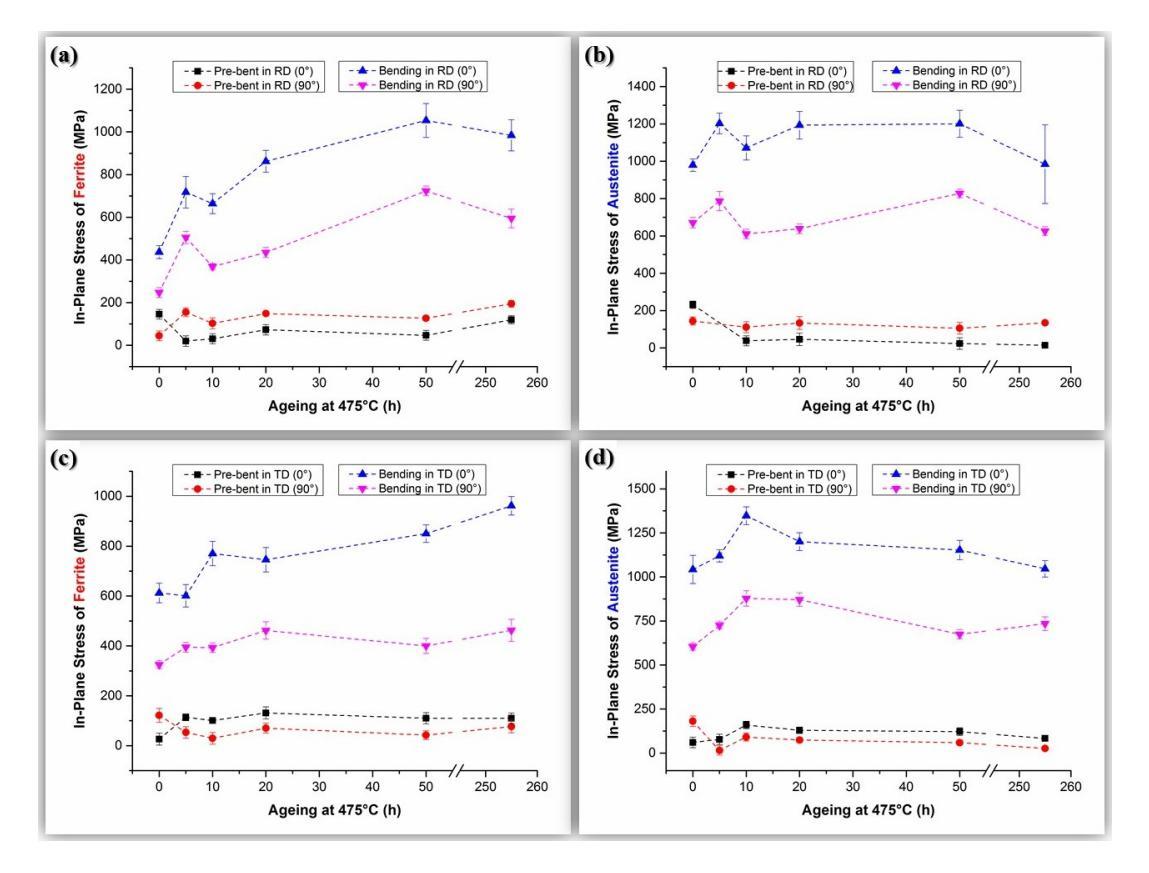
Figure 7. In-plane surface stress development in ferrite and austenite as a function of ageing at 475 °C: (**a–b**) before (pre-) and after bending in RD; (**c–d**) before (pre-) and after bending in TD.

The surface stresses of ferrite and austenite before and after bending in RD and TD as a function of ageing time at 475 °C are shown in Figure 7a–d. Bending deformation of the as-received specimens led to the formation of tensile stresses in austenite with respect to both measurement directions $(0^{\circ} \text{ and } 90^{\circ})$.

The surface stresses of austenite of the flat specimen (Figure 7b) decreased with ageing from 232 MPa \pm 20 MPa in 0° to 15 MPa \pm 10 MPa, whereas in 90° no significant stress changes were noticed. The in-plane stress of ferrite increased from 44 MPa \pm 23 MPa to 194 MPa \pm 15 MPa in 90°, with no significant changes in 0°. The measurement orientation 0° in RD corresponds to 90° in TD and vice versa, and obtained data in the different process orientations always showed similar trends with only small variations. In summary, the austenite seemed to be the phase with the highest stress in the as-received microstructure, but the stress in ferrite grew with ageing to values similar to those measured in the austenite after long-term ageing.

After U-bending, the surface stresses of all microstructures increased significantly. The stresses in austenite after bending in RD were 980 MPa \pm 33 MPa and 671 MPa \pm 29 MPa in 0° and 90°, respectively. The stress in austenite in the microstructure aged for 5 h was higher than the stress measured in the as-received condition, reaching tensile stresses of 1203 MPa \pm 55 MPa (0°) and 787 MPa \pm 51 MPa (90°). No significant change of the stress in austenite was seen with longer ageing times. The stress of ferrite, however, showed a steady increase as a function of ageing time, increasing from 437 MPa \pm 31 MPa (0°) and 247 MPa \pm 24 MPa (90°) to 984 MPa \pm 73 MPa (0°) and 595 MPa \pm 44 MPa (90°) after 255 h ageing, in line with expected microstructure changes in ferrite with 475 °C embrittlement. The highest stress was clearly concentrated along the bending direction for both, ferrite and austenite.

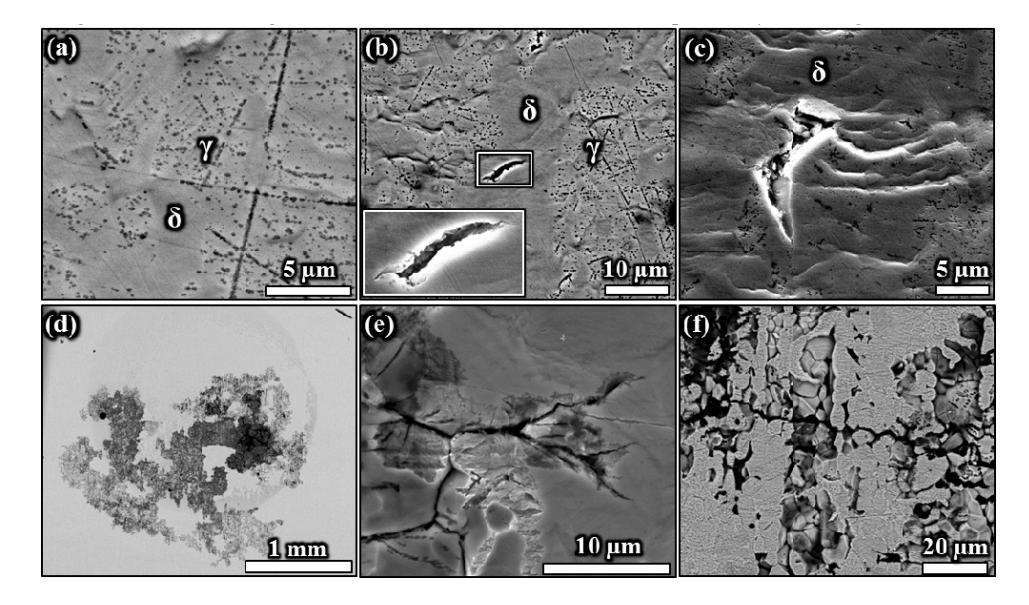
Figure 8. Corrosion morphology of as-received microstructure (in RD) with (**a**) "nano-pits" preferentially nucleated in austenite under Drop 1 (BSE-SEM image); (**b**) a micro-crack in ferrite with "nano-pits" in austenite under Drop 2 (SE-SEM image); (**c**) another micro-crack in ferrite under Drop 2 (SE-SEM image); (**d**) the entire attacked area under Drop 3; (**e**, **f**) small SCC cracks and crack-like regions under Drop 3. Bending direction is vertical to the images.

The corrosion morphology in (RD) after exposure to 20 μ g/cm² MgCl₂ (Drop 1) is shown in Figure 8a. Numerous nanometre-sized corrosion sites were present on deformed austenitic sites, whereas, the ferrite seemed unaffected. The deposit with 332 μ g/cm² of MgCl₂ (Drop 2) also resulted in nanometre-sized corrosion sites, which selectively nucleated in the austenite, possibly associated with deformation sub-structures (slip bands), as can be seen in Figure 8b,c. Furthermore, cracks were observed in the ferrite of 5–20 μ m length, either oriented parallel or ~45° inclined to the stress axis, as shown in Figure 8b,c. Under the droplet containing 3835 μ g/cm² MgCl₂ (Drop 3) far more corrosion attack was observed as well as small micro-cracks (Figure 8d–f). Selective dissolution of ferrite occurred at the droplet periphery, with dissolution of both ferrite and austenite observed in the droplet centre. Most cracks propagated along grain boundaries and stopped after encountering other grains, shown in Figure 8e. However, connected cracks of up to 100 μ m in length were found.

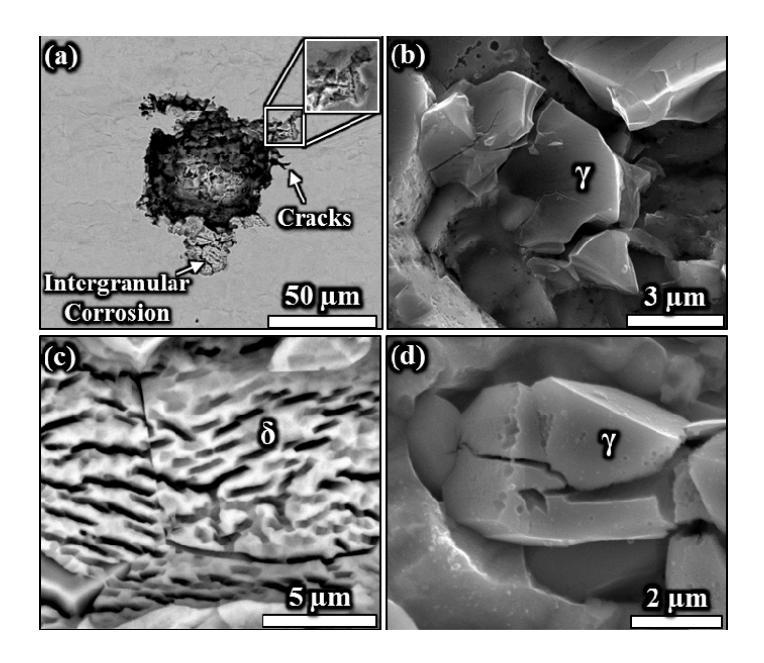
Figure 9. Corrosion morphology of the as-received microstructure (in TD) showing (**a**) corrosion sites with intergranular corrosion and some cracks emanating from the circumference of the pit wall under Drop 1 (BSE-SEM image); (**b**) cracked, disintegrated, and possibly fractured austenite grains under Drop 2 (SE-SEM image); (**c**) closely-spaced crack-like corrosion morphology in ferrite (BSE-SEM image), and (**d**) a branched transgranular micro-crack in austenite (SE-SEM image), both under Drop 3. Bending direction is vertical to all images.

On the U-bend specimen (TD), two corrosion sites with 50–60 μ m diameters were observed beneath Drop 1 (Figure 9a). Selective dissolution was identified as the main corrosion mechanism at those sites, shown in Figure 9a, especially at the circumference of the corroded region. Some intergranular corrosion and micro-cracks were also observed. These micro-cracks were branched with very narrow crack openings, and a maximum length of 10 μ m. Under Drop 2, minor selective attack on ferrite with disintegration and fracture of austenite grains was observed, as shown in Figure 9b. Corrosion and SCC was observed under Drop 3, with dissolution of both phases and numerous cracks in austenite. The micro-cracks in austenite were indicative of chloride-induced SCC, showing transgranular cracks with branching (Figure 9d). The cracks were perpendicular to the stress axis. In ferrite, however, multiple closely-spaced, parallel-arrayed crack-like morphologies were observed, indicating a hydrogen-embrittlement type of attack, as shown in Figure 9c.

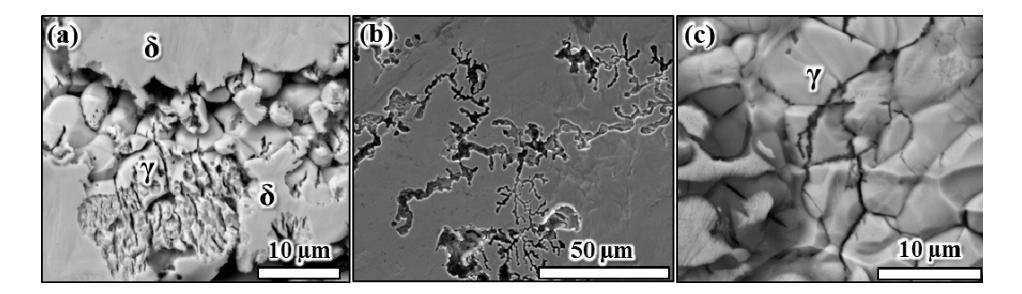
Figure 10. Corrosion morphology of microstructure aged at 475 °C for 5 h (in RD) with (a) closely-spaced micro-cracks and corrosion sites in austenite and ferrite under Drop 1 (BSE-SEM image), (b) filiform-type corrosion appearance under Drop 2 (SE-SEM image), and (c) corrosion with cracks in austenite under Drop 3 (BSE-SEM image). Bending direction is horizontal to all images.

Multiple closely-spaced corrosion and crack sites were observed, primarily in the austenite under Drop 1, as can be seen in Figure 10a. No selective dissolution was observed, indicating no difference between the anodic and cathodic corrosion behaviour of both phases. A filiform-like corrosion pattern was found under Drop 2, as shown in Figure 10b. This corrosion morphology was neither associated with microstructure nor process orientation. Dissolution of ferrite and austenite with SCC cracks in austenite were observed under Drop 3 (Figure 10c). The maximum crack length found was ~120 μ m.

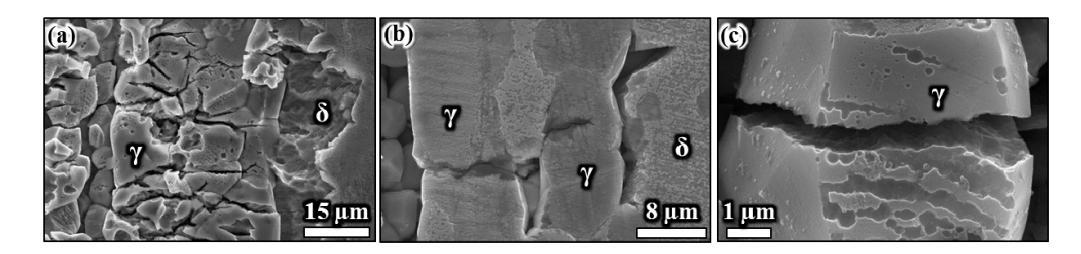
Figure 11. Corrosion morphology of microstructure aged at 475 °C for 10 h (in RD) under the deposit containing 3835 μ g/cm² magnesium chloride showing (**a**) multiple micro-cracks in austenite with selective dissolution of ferrite; (**b**) selective dissolution of ferrite and attack on γ/δ interface; (**c**) a fractured austenite grain (all SE-SEM images). Bending direction is vertical to these images.

Neither corrosion nor cracking was observed under Drop 1 and 2. Selective corrosion of ferrite had occurred with preferential dissolution along RD under Drop 3. Transgranular SCC was observed in austenite, with examples given in Figure 11a. Some SCC cracks had penetrated into ferrite grains, as shown in Figure 11b. Localised corrosion on slip bands and fractured austenite grains were observed (Figure 11c), suggesting slip-band dissolution-assisted SCC of the austenite.

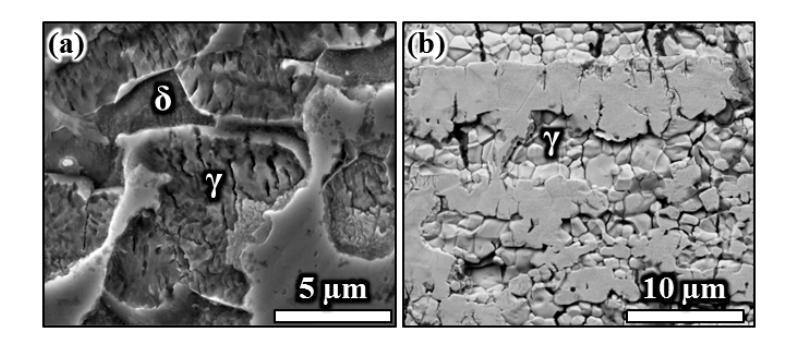
Figure 12. Corrosion morphology of microstructure aged at 475 °C for 20 h (in RD) showing (**a**) multiple closely-spaced fine-scale cracks formed in austenite under Drop 2 (SE-SEM image); (**b**) micro-cracks in austenite and selective dissolution of ferrite under Drop 3 (BSE-SEM image). Bending direction is horizontal to the images.

A few corroded nano-sites were found on ferrite and austenite grains with exposure to Drop 1. Under Drop 2, both austenite and ferrite seemed to have dissolved, as can be seen in Figure 12a. Multiple closely spaced and densely arranged micro-cracks were observed in the austenite. The dissolution of ferrite occurred beneath Drop 3 (Figure 12b). Multiple micro-cracks with transgranular pathways were observed in austenite, with a maximum length of ~100 μ m.

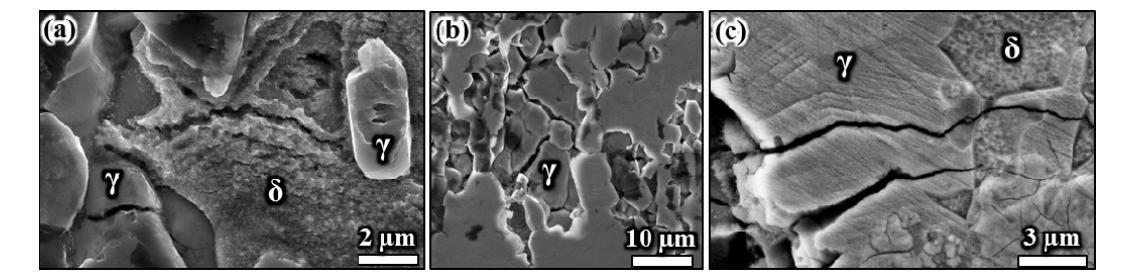
Figure 13. Corrosion morphology of microstructure aged at 475 °C for 50 h (in RD) showing (**a**) small cracks in ferrite and austenite under Drop 1 (SE-SEM image); (**b**) intergranular attack in austenite under Drop 2 (SE-SEM image); (**c**) transgranular micro-cracks with γ - δ - γ crack path (SE-SEM image). Bending direction is vertical to the images.

Corrosion and cracking in ferrite and austenite was observed under Drop 1 (Figure 13a). Despite the large number of micro-cracks, a maximum crack length of only 5 μ m was measured. In contrast, longer cracks were seen in the austenite under Drop 2, as shown in Figure 13b. The cracks seemed to be primarily of an intergranular nature, with a maximum crack length of 25 μ m. Severe SCC with multiple transgranular cracks were found all over the corroded region under Drop 3 (Figure 13c), with a maximum length of ~100 μ m.

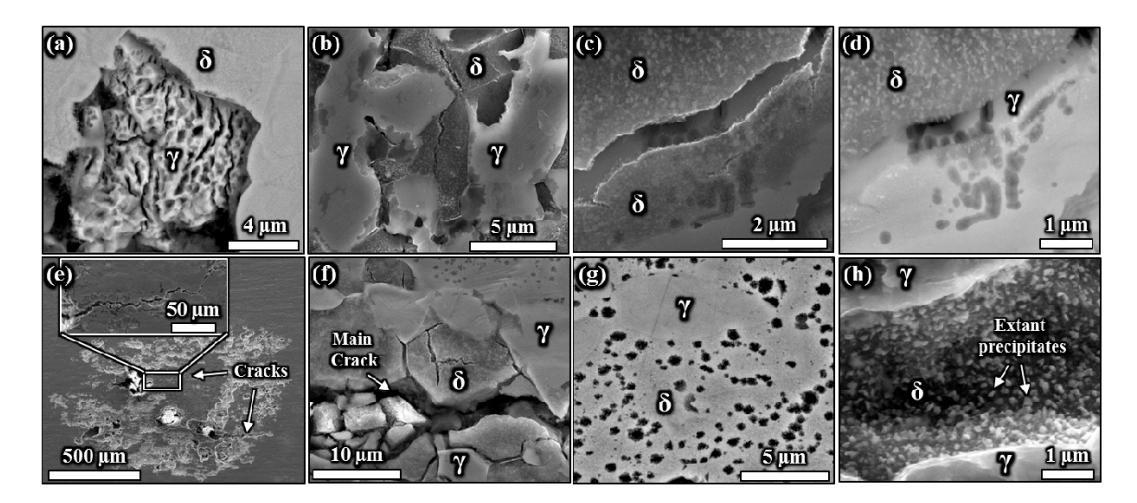
Figure 14. Corrosion morphology of microstructure aged at 475 °C for 255 h (in RD) showing (a) localised corrosion in austenite adjacent to a partially dissolved ferrite grain under Drop 1 (BSE-SEM image); (b) partially attacked austenite and embrittlement of ferrite under Drop 1 (SE-SEM image); (c) fractured ferrite grains (SE-SEM image); (d) localised corrosion on austenite underneath a ferrite grain under Drop 1 (BSE-SEM image); (e) cracks under Drop 2 (SE-SEM image); (f) multiple cracks in ferrite grains (SE-SEM image); (g) numerous corrosion pits in ferrite (BSE-SEM image); (h) precipitates at the crack wall under Drop 2 (SE-SEM image). Bending direction is vertical to all images.

The specimen aged for 255 h showed the strongest corrosion attack response. The corrosion morphology observed under Drop 1 is shown in Figure 14a–d, with localised corrosion on austenite grains, in the vicinity of partially dissolved ferrite regions (Figure 14a), indicating preferential dissolution of ferrite. However, an increased susceptibility to localised corrosion was noticed in the austenite, associated with long-term ageing at 475 $^{\circ}$ C.

In some areas, partially dissolved austenite grains and cracked ferrite regions were observed (Figure 14b). These cracks are clear evidence of the embrittlement of ferrite, with a preferred crack orientation towards the processing orientation. Moreover, in some austenite grains, local corrosion sites were observed beneath fractured ferrite grains (Figure 14c). This observation is supported by the SEM image in Figure 14d. The maximum crack length was ~250 μ m. The extent of corrosion and SCC was more pronounced under Drop 2. The maximum crack length was ~700 μ m, orientated perpendicular to the bending axis. The cracks could be noticed at low magnification, which can be seen in Figure 14f. Cracks were preferentially formed in the ferrite. Fractured ferrite grains were seen with multiple cracks, indicating microstructure embrittlement. The number and severity of cracks

in ferrite were higher than those formed in austenite. Numerous corrosion pits also nucleated in the ferrite and at interphase boundaries, indicating enhanced local corrosion propensity (Figure 14g). No SCC could be seen in the austenite. At the bottom of the main crack, protruding precipitates were seen at the surface of ferrite regions in the form of bright speckles, shown in Figure 14h. These precipitates seemed to have net cathodic character with respect to the decomposed ferrite matrix, and are believed to be associated with R-phase. Severe corrosion and cracking was observed under Drop 3. General dissolution of both ferrite and austenite beneath the entire exposed area was seen. Wide and long cracks with a maximum crack length of ~1500 µm were found.

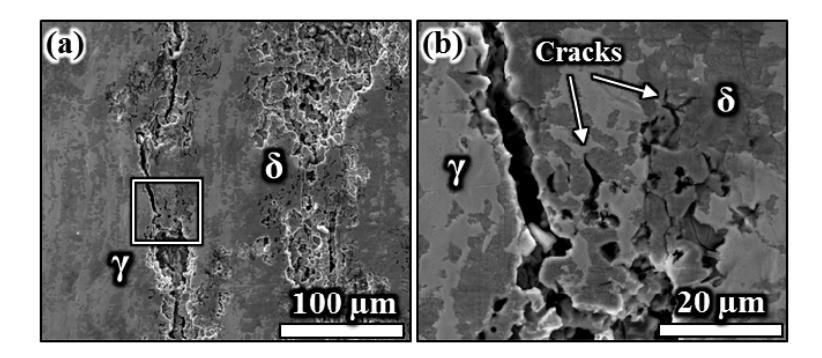
Figure 15. Corrosion morphology of 2205 DSS aged at 475 °C for 5 h (in TD) showing (**a**,**b**) long cracks in ferrite under Drop 3 (both SE-SEM images). Note that (**b**) is a magnified view of the highlighted region in (**a**). Bending direction is horizontal to the images.

No corrosion attack was observed under Drop 1, clearly showing better corrosion resistance of the specimen aged for 5 h only. Beneath Drop 2, only nanometre-sized corrosion sites were observed in both ferrite and austenite. However, SCC was found under Drop 3 (Figure 15a,b), with a preferential pathway of cracks aligned along the microstructure process orientation. Cracks seemed to have nucleated in ferrite, and either propagated transgranularly through ferrite grains or along interphase boundaries. No selective dissolution of either phase was observed, indicating a more balanced net anodic and net cathodic character of both phases. Long SCC cracks were observed with a maximum crack length of ~1700 μ m, oriented perpendicular to the stress axis.

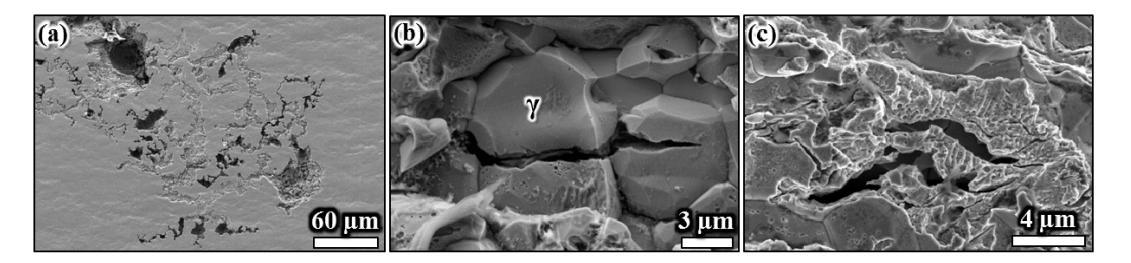
Figure 16. Corrosion morphology of microstructure aged at 475 $^{\circ}$ C for 10 h (in TD) showing (a) filiform-like corrosion of ferrite and austenite under Drop 2; (b,c) micro-cracks in austenite under Drop 3 (all SE-SEM images). Bending direction is vertical to the images.

Corrosion and SCC was observed beneath Drop 1, but with only shallow corrosion sites. A number of transgranular micro-cracks were found in the austenite with a maximum crack length of ~30 μ m. Filiform-type corrosion morphologies were observed under Drop 2 (Figure 16a), with transgranular SCC in austenite under Drop 3 (Figure 16b,c). The maximum crack length was ~50 μ m, oriented perpendicular to the stress axis.

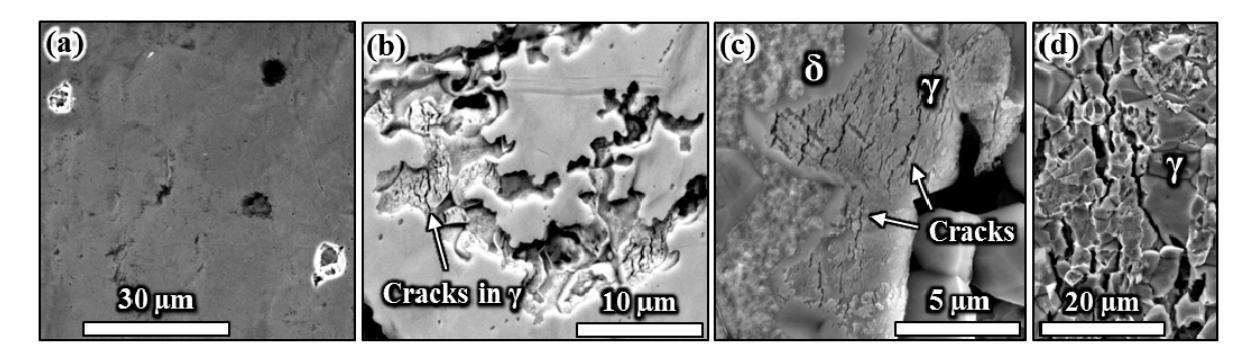
Figure 17. Corrosion morphology aged at 475 °C for 20 h (in TD) showing (**a**) pits formed under Drop 1 (SE-SEM image); (**b**) filiform-like corrosion with micro-cracks in austenite under Drop 2 (BSE-SEM image); (**c**) numerous closely-spaced fine-scale cracks in austenite under Drop 3 (SE-SEM image); (**d**) cracks in austenite under Drop 3 (SE-SEM image). Bending direction is horizontal to all images.

On the specimen aged for 20 h two corrosion sites with maximum lateral sizes of 10 μ m were seen underneath Drop 1 (Figure 17a). Significant surface attack was observed under Drop 2, indicating corrosion of both ferrite and austenite (Figure 17b). A few fine-scale micro-cracks were seen in austenite, but no cracks in ferrite. Under Drop 3, numerous fine-scale cracks were also found in austenite, whereas the ferrite seemed to have corroded only superficially (Figure 17c). In austenite, multiple SCC-containing sites were found (Figure 17d).

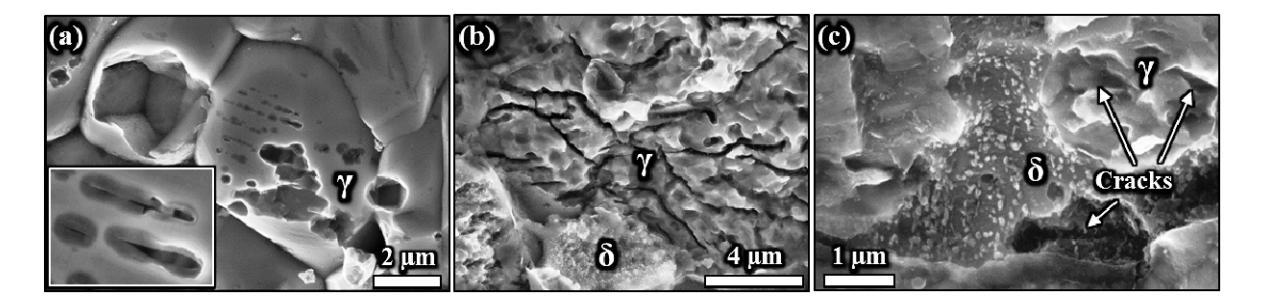
Figure 18. Corrosion morphology of microstructure aged at 475 °C for 50 h (in TD) showing (**a**) localised corrosion along slip planes on austenite under Drop 1 (SE-SEM image); (**b**) crack-like features in austenite under Drop 2 (SE-SEM image); (**c**) precipitates in ferrite (bright speckles) with cracks in ferrite and austenite under Drop 3 (SE-SEM image). Bending direction is vertical to the images.

Selective corrosion occurred on austenite grains under Drop 1 with slip planes acting as preferential nucleation sites, as shown in Figure 18b. General corrosion of ferrite and austenite was observed under Drop 2, with numerous crack-like features in the austenite (Figure 18b). Severe corrosion was observed under Drop 3, with cracks in ferrite and austenite (also summarised in Figure 18c). Bright features at the surface of ferrite were observed, indicating R-phase precipitates.

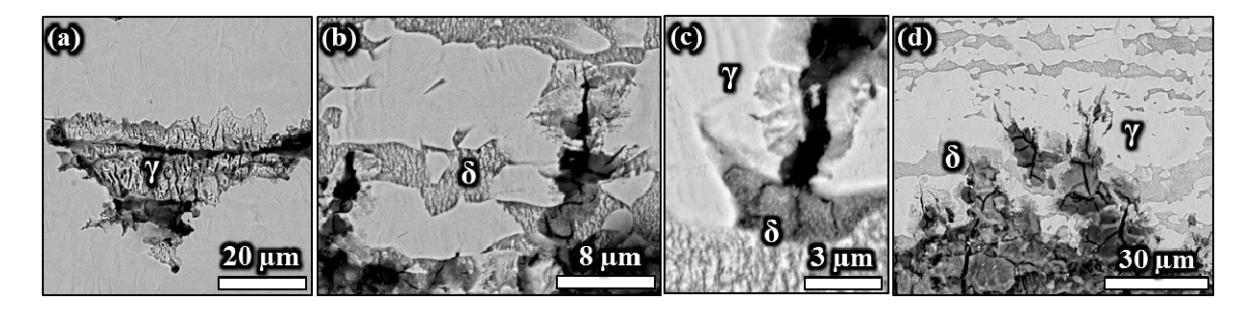
Figure 19. Corrosion morphology aged at 475 °C for 255 h (in TD) showing (**a**) selective dissolution of ferrite and multiple closely-spaced crack-like features in austenite under Drop 1 (BSE-SEM image); (**b**) transgranular cracks through ferrite and austenite under Drop 2 (BSE-SEM image); (**c**,**d**) cracks in ferrite and austenite under Drop 3 (both BSE-SEM image). Bending direction is horizontal to the images.

The specimen aged for 255 h showed localised corrosion in austenite under Drop 1 (Figure 19a), and selective dissolution of ferrite along the process orientation was also observed. This observation was different to the corrosion morphology observed on the specimen aged for 255 h and bent in RD. Multiple closely-spaced crack-like features were seen in austenite, as shown in Figure 19a, with numerous transgranular micro-cracks under Drop 2 (Figure 19b). Corrosion was observed

under Drop 3, with dissolution of both ferrite and austenite, as well as cracks seen in both ferrite and austenite (Figure 19d).

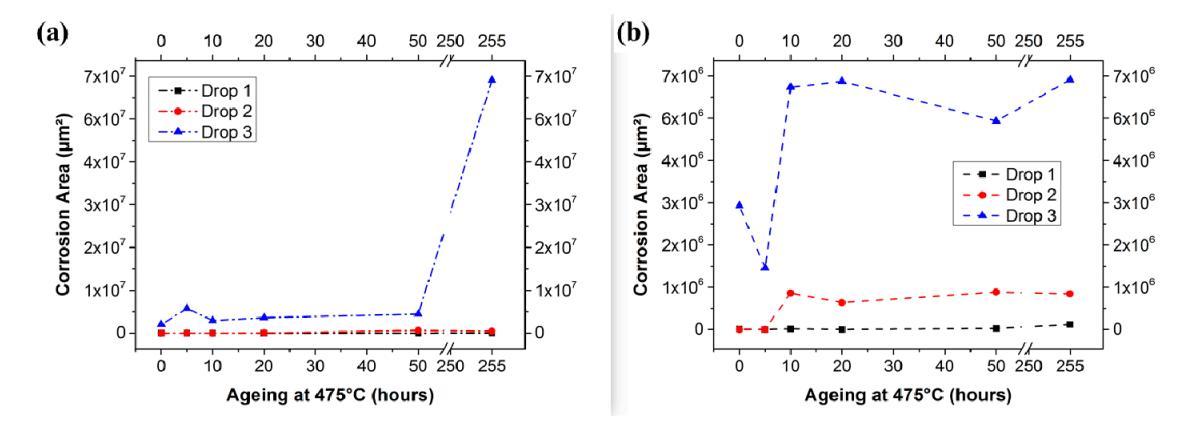
Figure 20. Measured surface area of corrosion as a function of ageing time at 475 $^{\circ}$ C of microstructures bent in (**a**) RD and (**b**) TD.

The measured corrosion area and corrosion volume as a function of ageing time and process direction are summarised in Figures 20 and 21, respectively. In general, the area and volume of corrosion increased with increasing chloride deposition density, and with 475 °C embrittlement heat treatment exposure time. Most corrosion was observed on specimens aged for 255 h. Furthermore, corrosion attack on specimens bent in TD was in general larger than those bent in RD. No corrosion was observed under Drop 1 for all heat treatment conditions and both process orientations. Only very little attack was present under Drop 2, with corroded areas in the order of ~ $10^5 \mu m^2$ and corrosion volume of ~ $10^6 \mu m^2$. The area of corrosion attack beneath Drop 3 was typically ~ 10^6 – $10^7 \mu m^2$, with a volume of ~ $10^7 \mu m^3$.

Temperature and RH play a key role in atmospheric corrosion, and the highest susceptibility to AISCC has been reported to occur on stainless steels at RHs at or close to salt deliquescence [47]. Up to 12 M chloride can be formed at the deliquescence point of MgCl₂ at room temperature [48,49], and this can be 15 M or even higher for \geq 50 °C [24,50]. Large droplet sizes (diameter, thickness) have also been reported to increase the extent of atmospheric corrosion [51,52]. There is a relationship between the extent of corrosion with the droplet size (ranking order Drop 3 > Drop 2 > Drop 1). Increasing the chloride deposition density from 15 µg/cm² (Drop 1) to 247 µg/cm² (Drop 2) increased the corrosion by more than six orders of magnitude, with a further increase of the chloride deposition density to 2856 µg/cm² (Drop 3) the extent of corrosion increased approximately by one order of magnitude (see Figures 20 and 21).

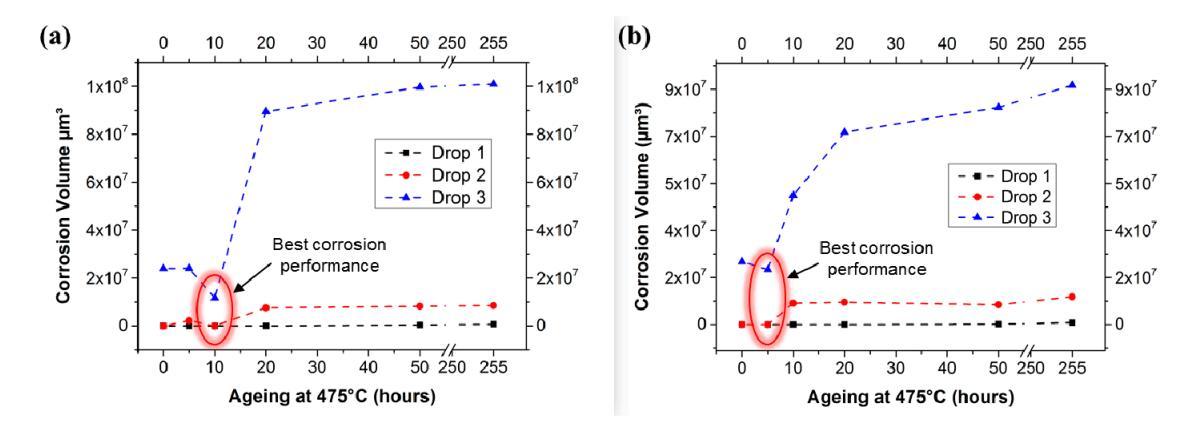
Figure 21. Measured volume of corrosion as a function of ageing time at 475 $^{\circ}$ C bent in (**a**) RD and (**b**) TD.

The extent of corrosion showed the lowest volume of corrosion for the 10-h-aged specimens bent in RD and the five-hour-aged specimen bent in TD. Corrosion under Drop 3 did not seem to have stopped or saturated, even for a microstructure aged for 255 h. The corrosion volume on the 255 h aged specimens was ~5-times larger compared to the as-received samples.

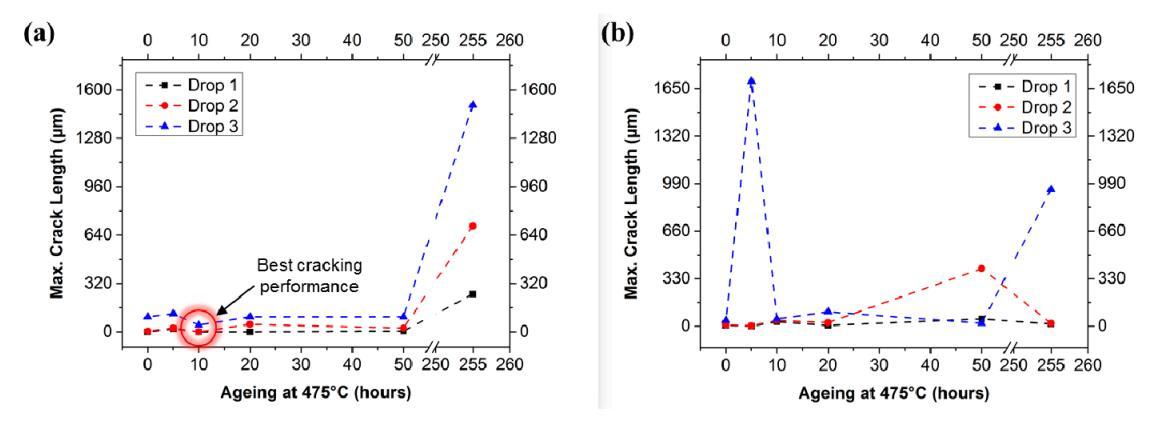
Figure 22. Measured maximum SCC crack length of 2205 DSS microstructure bent (a) in RD and (b) TD.

SCC cracks were also measured as a function of ageing time (Figure 22). The shortest cracks were found on the specimen aged for 10 h (in RD), indicating the best SCC performance. Severe SCC occurred on the 255-h-aged specimen, with maximum crack length measured under Drops 1, 2, and 3 of ~250, ~700, and ~1500 μ m, respectively. However, the U-bend specimens in TD showed a somewhat different crack length distribution. The longest crack with 1700 μ m length was measured under Drop 3 for the specimen aged for 5 h.

The AISCC behaviour was compared to corrosion area and corrosion volume measurements in Figure 22. The extent of SCC (length, number) in the microstructures along RD increased with ageing time, with the lowest susceptibility to cracking observed, in line with the smallest corrosion attack. The microstructure bent in TD, however, showed severe cracking beneath Drop 3 after ageing for 5 h. The extent of SCC and the corrosion volume of the microstructure after bending in TD did not seem to correlate with those after bending in RD, showing that microstructure plays a key role in the extent of atmospheric corrosion and SCC.
