Article

Experimental Investigation of Crack Propagation and Strain Fields Evolution around a Crack Tip in 5A05 Aluminum Alloy

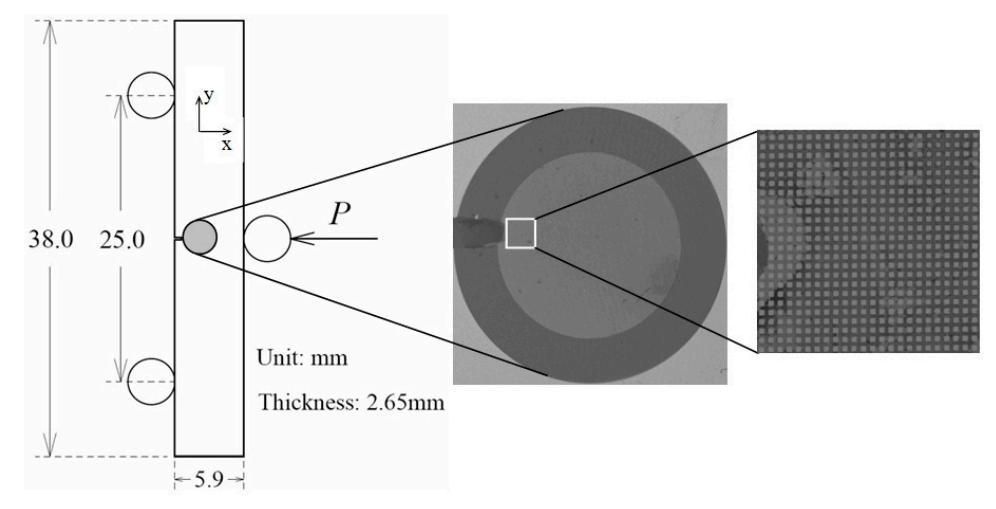
Figure 1. Geometry of the three-point bending specimen for the in situ SEM test and microscale grating pattern around its notch.

The material used in this study is the commercially available 5A05 aluminum alloy. Specimens were cut with electrical discharge machining out of a rectangular block. In order to observe the crack initiation in time, a through-thickness notch (depth: 1 mm; width: 0.3 mm; root diameter: 0.2 mm) was introduced at the center of one side as crack source, thereby resulting in stress concentration. After machining, the specimen was ground and mechanically and chemically polished to remove surface damage and residual stress. Lastly, the specimen was ultrasonically cleaned to produce an optically reflective surface.

In order to measure the deformation fields by GPA, sputtering deposition technology was adopted to generate a microscale grating pattern on the specimen surface [20]. A fine square mesh copper grid with 2000 mesh (G2000HS from Gilder Grids Ltd., Lincolnshire, UK) was first carefully laid over the 5A05 aluminum alloy specimen surface to cover the notch root. Special care was required to handle the mesh grid to ensure uniform flat contact between the mesh grid and specimen surface such that the grating pattern could be efficiently transferred onto the specimen surface. Thereafter, a thin layer of gold was deposited for 60 s by using an ion sputtering device (JFC-1600 from JEOL, Tokyo, Japan). Thus, the area underneath the mesh grating pattern was transferred onto the 5A05 aluminum alloy specimen surface. The hole and bar widths of the mesh are 6.5 μ m and 6 μ m, respectively. The pitch size, which is the sum of the hole and bar widths, is 12.5 μ m. Figure 1 shows the final geometry of the three-point bending specimen for the in situ SEM test and microscale grating pattern around its notch.

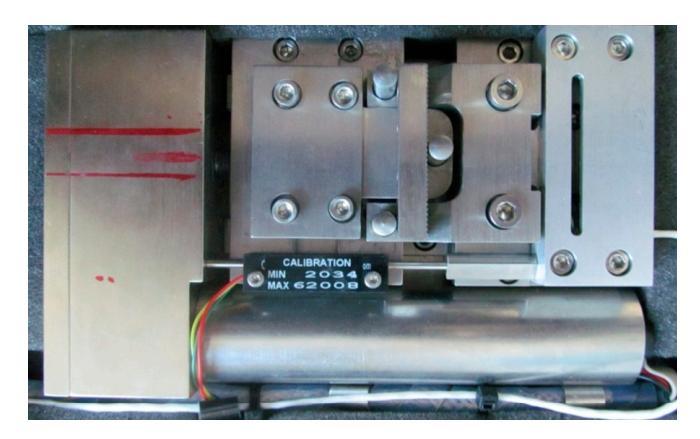
Figure 2. Deben MICROTEST three-point bending stage for the in situ SEM test.

In situ SEM three-point bending test was performed to observe the crack initiation and propagation, and acquire the images of the specimen with microscale grid. The set-up comprises a palm-sized three-point bending stage manufactured by Deben UK Ltd. (Suffolk, UK) (see Figure 2) and installed in a SEM (S-3400N from Hitachi, Tokyo, Japan) chamber.

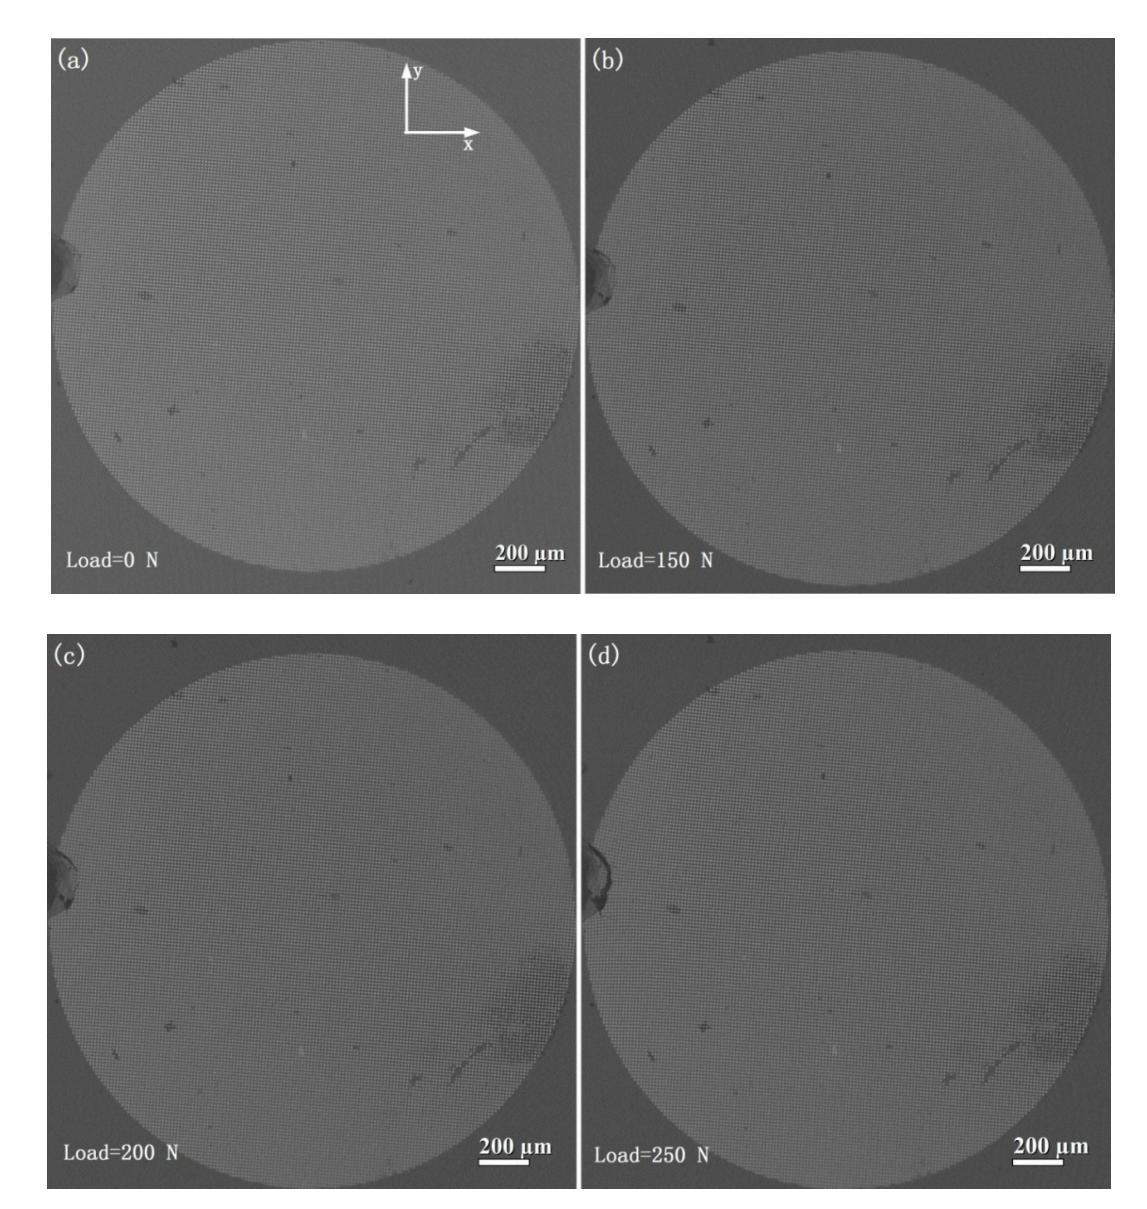
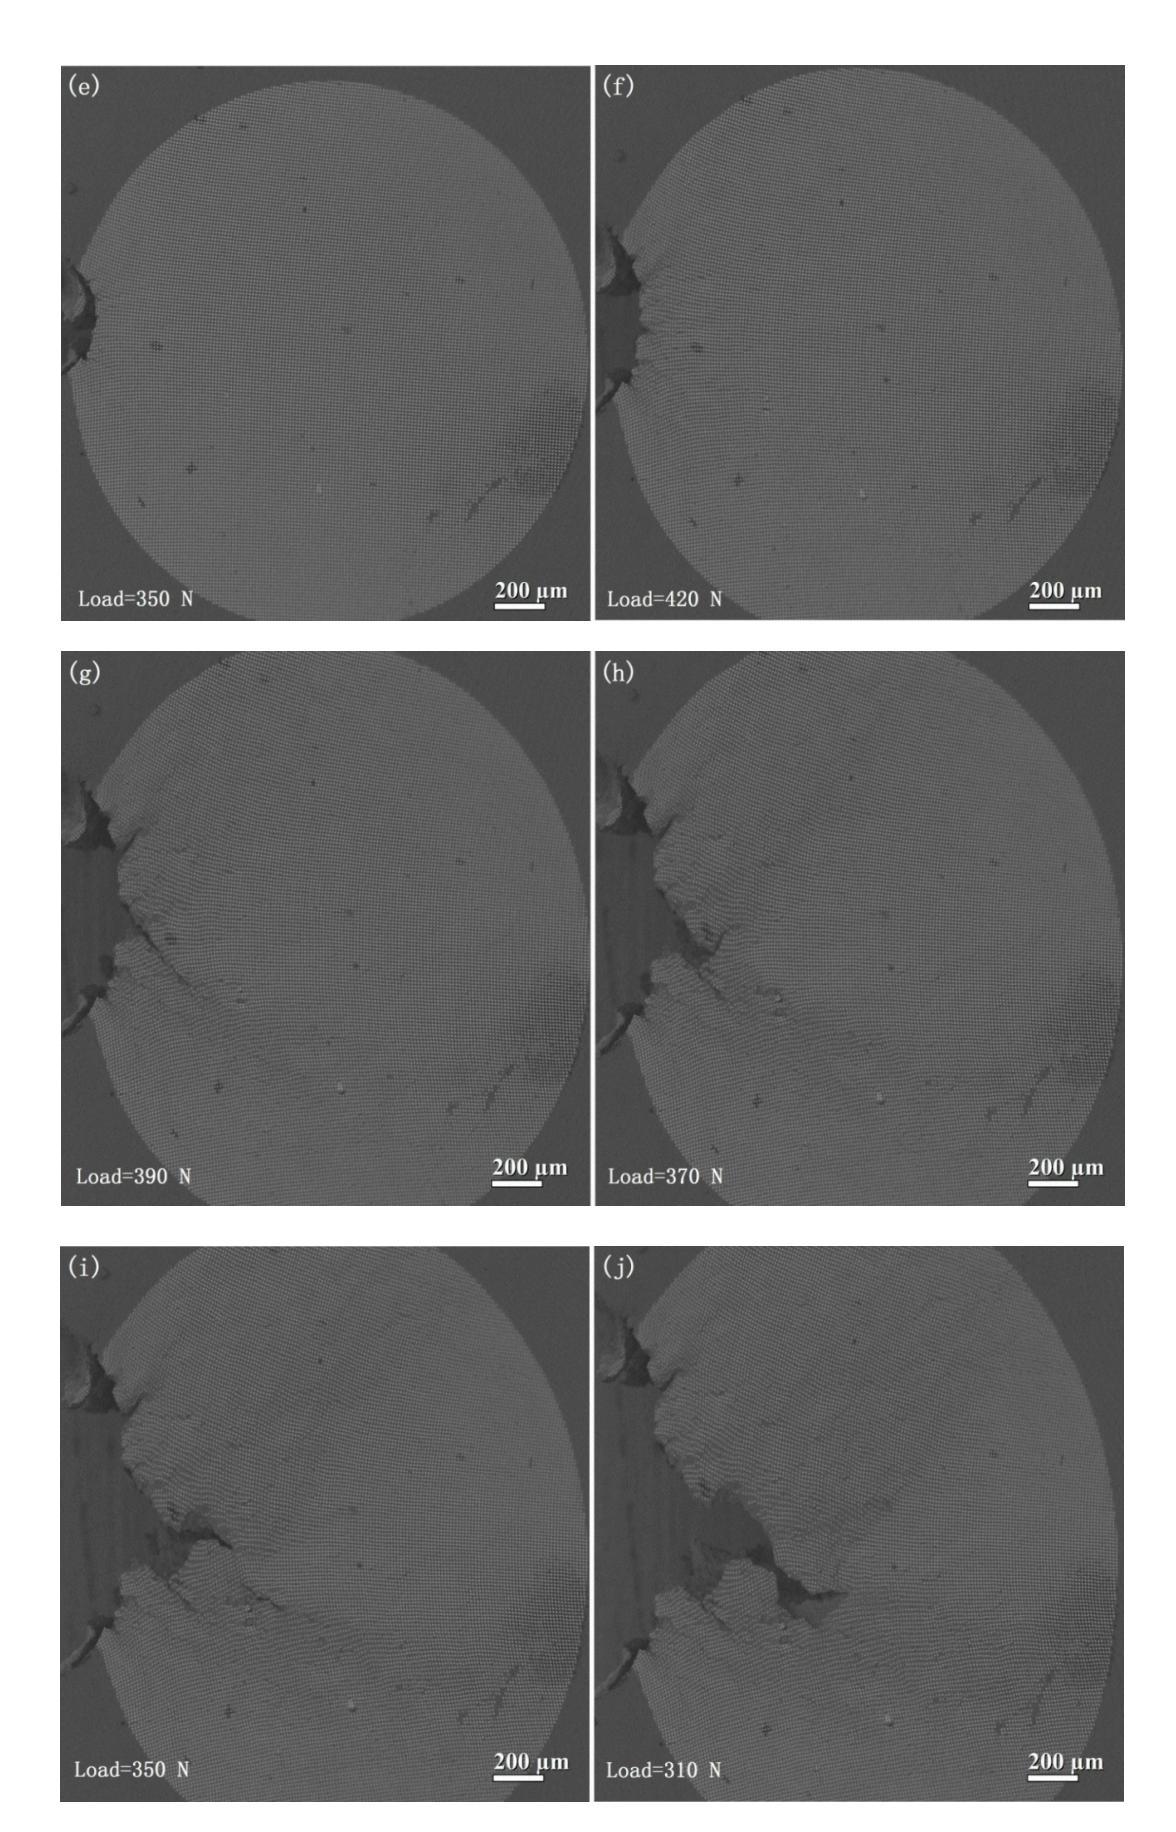
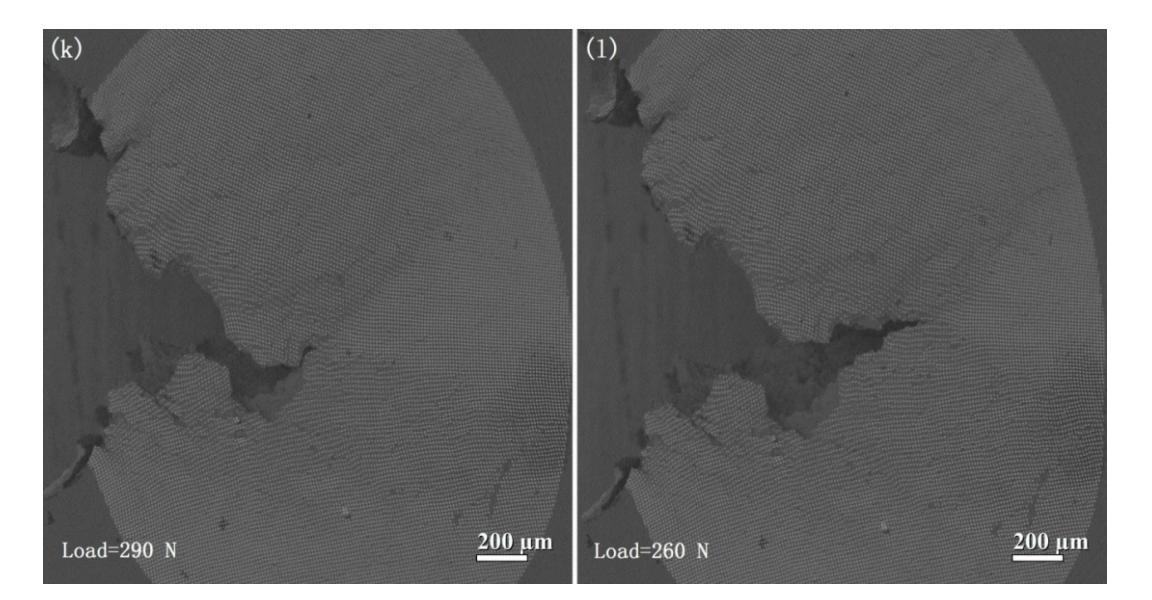
Figure 3. SEM images around the notch in the three-point bending test (**a**) before loading (0 N); (**b**) at 150 N during increasing load; (**c**) at 200 N during increasing load; (**d**) at 250 N during increasing load; (**e**) at 350 N during increasing load; (**f**) at maximum load 420 N; (**g**) at 390 N during decreasing load; (**h**) at 370 N during decreasing load; (**i**) at 350 N during decreasing load; (**j**) at 310 N during decreasing load; (**k**) at 290 N during decreasing load; (**l**) at 260 N during decreasing load.

Figure 3 shows a series of SEM images of crack initiation and propagation in 5A05 aluminum alloy. Figure 3a depicts the appearance of the region around the notch before the three-point loading. The notch root and microscale grid pattern was evidently observed. Figure 3b,c show the region around the notch when the load increased to 150 N and 200 N, respectively. It can be seen that no evident deformation of grids around the notch root was observed at the early stage of loading.

When the load increased to 250 N (see Figure 3d), the stresses at several sharp points at the notch root reached the breaking strengths, thereby leading to a few microcracks initiated at these points. Compared with Figure 3a, Figure 3d shows that the notch root was apparently stretched at this time. When the load increased to 350 N (see Figure 3e), these microcracks became more evident. Figure 3f shows the SEM image around the notch at a maximum load of 420 N. It can be seen that the grids around the notch root were distorted severely. The area covered with the grid was stretched in the vertical direction, and shortened in the horizontal direction. The original circle area covered with grids had turned into an ellipse. Compared with Figure 3e, Figure 3f shows that the microcracks at several sharp points at the notch root became wider and grew slightly to the right, particularly for the microcrack in the middle of the notch root.

The load began to decrease after applying a maximum load of 420 N. Figure 3g shows the SEM image when the load decreased to 390 N. It can be seen that the microcrack in the middle of the notch root grew rapidly to the lower right (i.e., approximately 45° from the horizontal direction) and evolved into the main crack. Meanwhile, the microcrack above the middle of the notch root grew rapidly to the upper right (i.e., approximately 45° from the horizontal direction) and became a secondary crack. The growth of the main crack was apparently faster than that of the secondary crack. From Figure 3h–l, it can be seen that the secondary crack did not grow in the subsequent loading process. Figure 3h shows the SEM image when the load decreased to 370 N. It can be seen that the main crack grew toward the upper right. With the increase in displacement and crack propagation, the main crack grew toward the lower right again (see Figure 3i), and a new microcrack initiated in the weakness region of mechanical strength ahead of the main crack. The main crack grew toward the right (see Figure 3j). Thereafter, the main crack grew toward the upper right (see Figure 3j). Thereafter, the main crack grew toward the upper right (see Figure 3j). Thereafter, the main crack grew toward the upper right (see Figure 3j). Thereafter, the end of the loading, an unstable crack propagation occurred, thereby resulting in the fracture of the specimen.

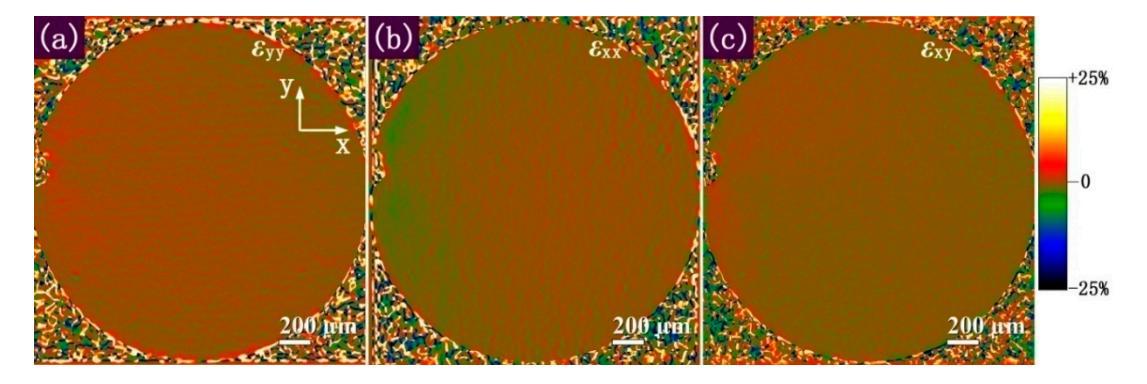
Figure 4. Strain fields at 150 N during the increasing load corresponding to Figure 3b measured by using the GPA method: (**a**) ε_{yy} strain field; (**b**) ε_{xx} strain field; (**c**) ε_{xy} strain field.

Figures 4 and 5 show the distribution of the strain fields around the notch before the crack initiation. The color scale indicates strain changes between -25% and 25%. Figures 4 and 5 depict the strain field maps for Figure 3b,c when the load increased to 150 N and 200 N, respectively. From Figure 4a, it can be seen that the normal strain ε_{yy} was nearly zero, while the slight tension strain only occurred around the notch root (its average strain was 0.91%) when the load was 150 N. With the increase in load, the tension strain around the notch grew, but the normal strain ε_{yy} in most areas remained relatively low (see Figure 5a). It can be seen that two inclined lobes of high strain emanating occurred and pointed to the direction of approximately 45° from the horizontal direction above and below the notch. The average strain in the inclined lobes of high strain emanating was 2.25%. Since both the geometry of the specimen and the applied load were symmetric in terms of the notch, the normal stresses σ_{yy} and σ_{xx} around the notch were symmetric in terms of the notch. Therefore, the $\varepsilon_{\eta\eta}$ map was symmetric in terms of the notch, which agreed with the result from the electronic speckle pattern interferometry [34]. Figure 4b shows that the normal strain ε_{xx} was nearly zero, while the slight compression strain only occurred around the notch root (its average strain was -0.96%) when the load was 150 N. With the increase in load, the compression strain around the notch root increased, but the normal strain ε_{xx} in most areas remained relatively low (see Figure 5b). It can be seen that two inclined lobes of high strain emanating occurred, and pointed to the direction of approximately 45° from the horizontal direction above and below the notch. The average strain in the inclined lobes of high strain emanating was -1.63%. The ε_{xx} map was also symmetric in terms of the notch, owing to the symmetric distribution of the normal stresses. Figures 4c and 5c illustrate that the shear strain ε_{xy} was nearly zero. The change in shear strain ε_{xy} was not evident with the increase in load.

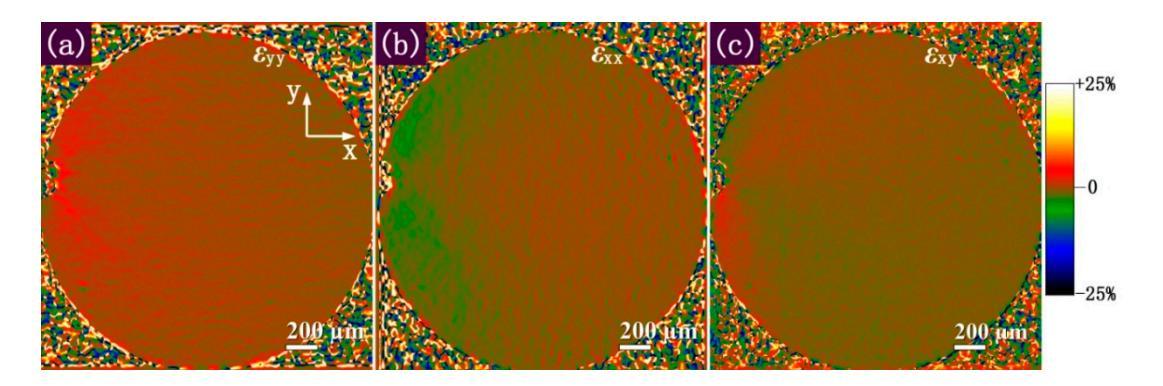
Figure 5. Strain fields at 200 N during the increasing load corresponding to Figure 3c measured by using the GPA method: (a) ε_{yy} strain field; (b) ε_{xx} strain field; (c) ε_{xy} strain field.

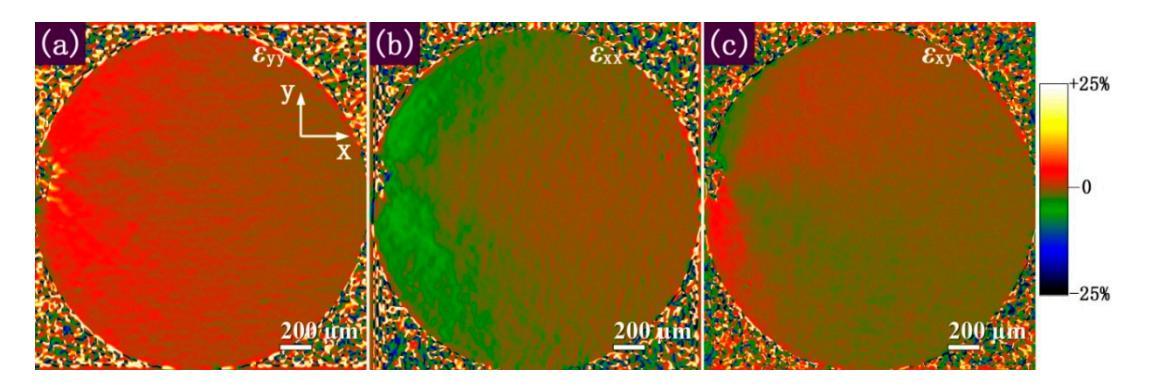
Figure 6. Strain fields at the stage of crack initiation corresponding to Figure 3d measured by using the GPA method: (a) ε_{yy} strain field; (b) ε_{xx} strain field; (c) ε_{xy} strain field.

Figure 6 shows the distribution of the strain fields around the crack tip at the crack initiation. From Figure 6a, it can be seen that the ε_{yy} map remained symmetric in terms of the notch. The two lobes of high strain emanating grew significantly (its average strain reached 3.97%), but maintained the same shape and orientation. Figure 6b illustrate that the ε_{xx} map remained symmetric in terms of the notch. The two lobes of high strain emanating grew significantly (its average strain reached -3.71%), but maintained the same shape and orientation. From Figure 6c, it can be seen that small areas of negative and positive shear strains were observed above and below the notch, respectively. Large areas of positive and negative shear strains were determined in the upper and lower right of the notch, respectively. Since both the geometry of the specimen and the applied load were symmetric in terms of the notch, the shear stress σ_{xy} around the notch. Since the shear stress σ_{xy} near the edge of the specimen was very small, the normal stresses σ_{yy} and ε_{xx} around the crack tip were much greater than the shear stress σ_{xy} . Therefore, the normal strains ε_{yy} and ε_{xx} dominated the strain fields around the crack tip at the crack initiation.

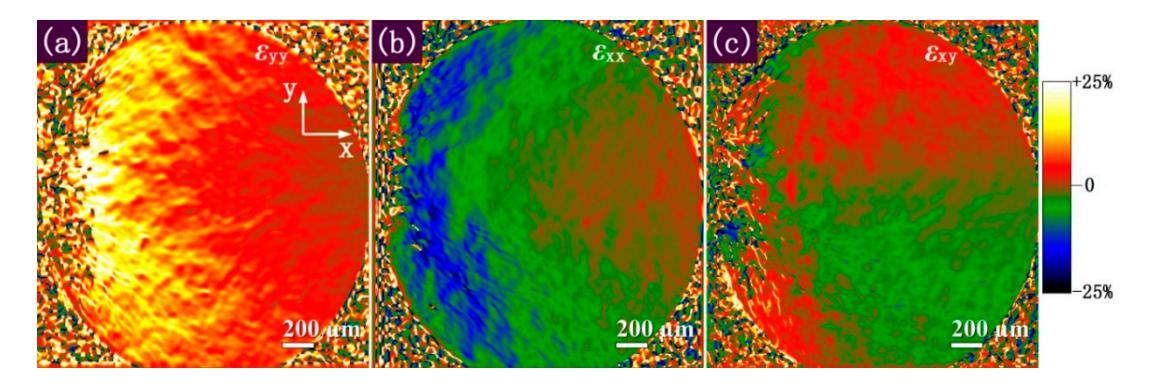
Figure 7. Strain fields at a maximum load 420 N corresponding to Figure 3f measured by using the GPA method: (a) ε_{yy} strain field; (b) ε_{xx} strain field; (c) ε_{xy} strain field.

Figure 7 shows the distribution of the strain fields around the crack tip when the load increased to a maximum 420 N. Figure 8 presents the distribution of the strain fields around the crack tip when the load decreased to 390 N. Comparing Figures 7a and 8a to Figure 6a, it can be seen that the two lobes of high strain emanating grew rapidly, but maintained the same shape and orientation in the crack propagation process. The average strain in the two lobes of high strain emanating reached 13.66% (see Figure 7a) and 17.25% (see Figure 8a), respectively. The ε_{yy} map remained symmetric in terms of the notch. A comparison of Figures 7b and 8b with Figure 6b indicates that the change in ε_{xx} was similar to that in ε_{yy} in the crack propagation process. With the increase in displacement and crack propagation,

the shear stress σ_{xy} increased rapidly. Therefore, in the comparison of Figures 7c and 8c with Figure 6c, the shear strain ε_{xy} increased rapidly in the crack propagation process. In addition, the ε_{xy} map remained antisymmetric in terms of the notch. A comparison of Figures 7 and 8 with Figure 6 shows that the normal strains ε_{yy} and ε_{xx} and the shear strain ε_{xy} increased rapidly. Thus, they dominated the strain fields around the crack tip in the crack propagation process. With the increase in shear stress σ_{xy} , a few slip bands occurred along the direction of the maximum shear stress, which were the preferential sites for crack propagation. When the crack encountered the slip bands, it grew along the slip bands which was reported as a low energy channel and would accelerate the crack growth propagation [35], thereby leading to a Z-form of crack propagation path in the specimen.

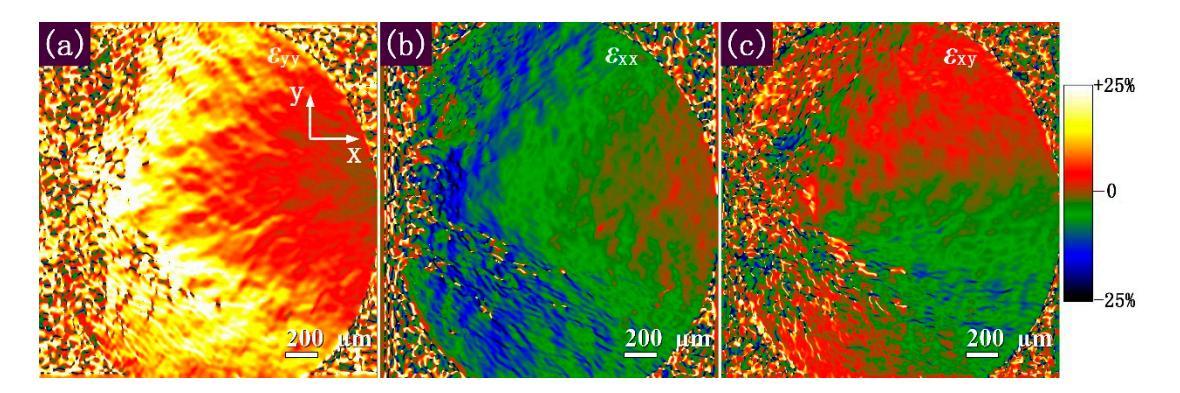
Figure 8. Strain fields at 390 N during the decreasing load corresponding to Figure 3g measured by using the GPA method: (a) ε_{yy} strain field; (b) ε_{xx} strain field; (c) ε_{xy} strain field.
