# Article Mitigating Blast Hazards: Experimental Evaluation of Anti-Shatter Films and Catcher-Cable Systems on Conventional Windows

**Abstract:** In light of terrorist attacks and accidents, the need for structural protection against explosive events has increased significantly in recent decades. Conventional unprotected windows pose a particularly high risk of injury to building occupants due to glass fragments and window frames being propelled into the interior and exterior of a building. This article addresses new experimental research on the protection of conventional single casement windows with insulating glass units (double-paned) and window frames made of un-plasticized polyvinyl chloride (uPVC) against blast loads. Entire window systems were tested in ten shock-tube tests using different retrofit-configurations. The retrofitted protective measures include anti-shatter films and catcher-cable systems. Furthermore, the influence of steel profiles inserted in the window frames is investigated. The applied blast loads met the requirements for ER1-certification according to EN 13541:2012 (tested at a reflected peak overpressure of 66.7 kPa and a reflected maximum impulse of 41

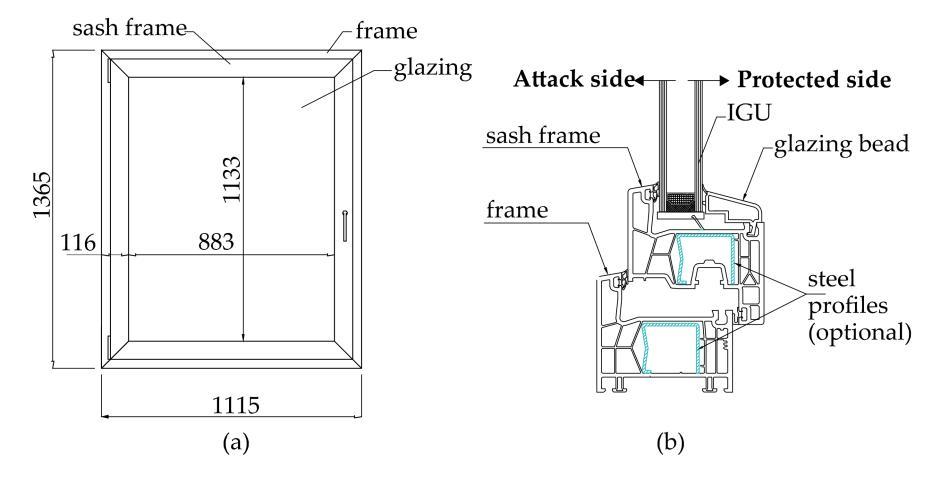
**Figure 1.** Tested conventional single-sash window with an insulating glazing unit; (**a**) front view and (**b**) cross section of the window.

The IGU consists of an outer 4 mm-thick float glass pane, a 16 mm-wide inter-pane cavity filled with an argon gas mixture, and an inner 4 mm-thick float glass pane. The dimensions of the IGU are 883 mm in width and 1133 mm in height (Figure 1a), which is consistent with the glazing dimensions of 900 mm  $\times$  1100 mm, as outlined in the EN 13541:2012 test method [10]. Therefore, the test results of these full-scale studies can be compared to the results of the ASF certification tests on single glazing units. But remarkable discrepancies at the glazing support conditions are valued in this test series.

In test U1 (Table 1), a basic unprotected configuration is tested. Figure 1 shows technical details on the components of the window. The conventional window consists of three main parts: the frame, the sash frame, and the insulating glazing unit (IGU).

Figure 1b shows a cross section of the window. The frames consist of multiple thinwalled hollow chambers that improve thermal efficiency. Optional in the test series are steel profiles that are fitted into the hollow chambers of the window frames during production. These steel profiles are typically used in uPVC-window frames to add strength and stability to the window system. However, they usually end several centimeters from the corner joints of the frames, thus adding no additional strength to the frame corners. The unprotected window in test U1 was designed without steel profiles, representing a window configuration with low frame strength.

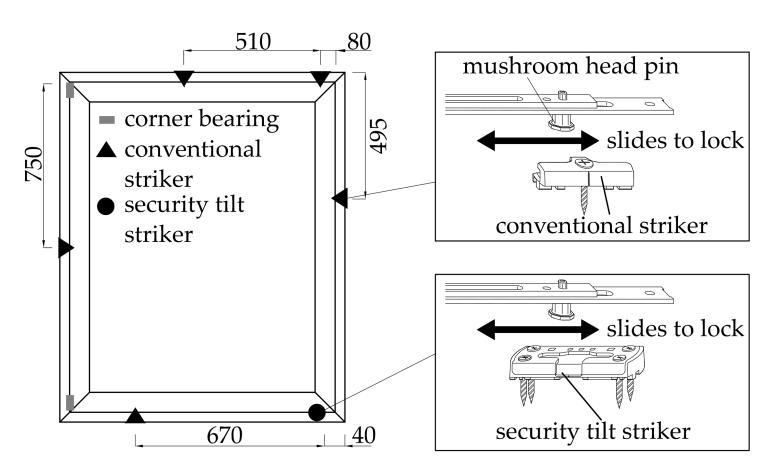
Fitting systems are required to open and lock sashes of casement windows. With the window locked, the fittings provide the mechanical load-bearing connection between the sash (the moveable part of the window) and the frame (the stationary part of the window). The tested windows are equipped with a conventional fitting system, which provides low resistance against burglary (resistance class RC1 N according to EN 1627:2021 [21]). Here, five conventional strikers, one security tilt striker, and two corner bearings are installed. The arrangement is illustrated in Figure 2. The counterpart of the strikers are mushroom head pins that can slide into the recesses of the strikers.

Figure 2. Arrangement of the fitting system.

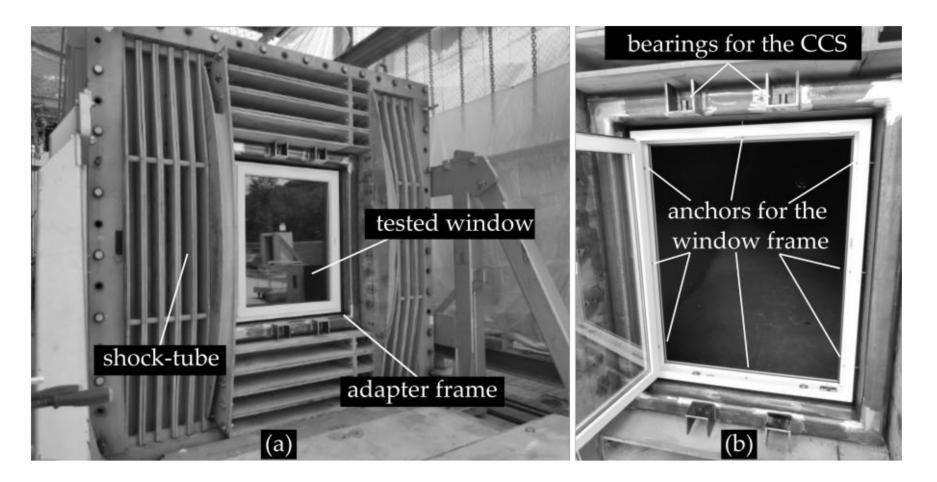
Figure 3 shows the window installed in the shock-tube. It is fixed with 8 anchor pins to a steel adapter frame that was firmly bolted to the mounting frame of the shock-tube (Figure 3a). The adapter frame also provides the bearings for the catcher-cable system (Figure 3b), which will be discussed in Section 2.3.

**Figure 3.** Tested window mounted to the adapter frame at the shock-tube; (**a**) front view on the shock-tube and (**b**) anchors of the window and bearings for the CCS.

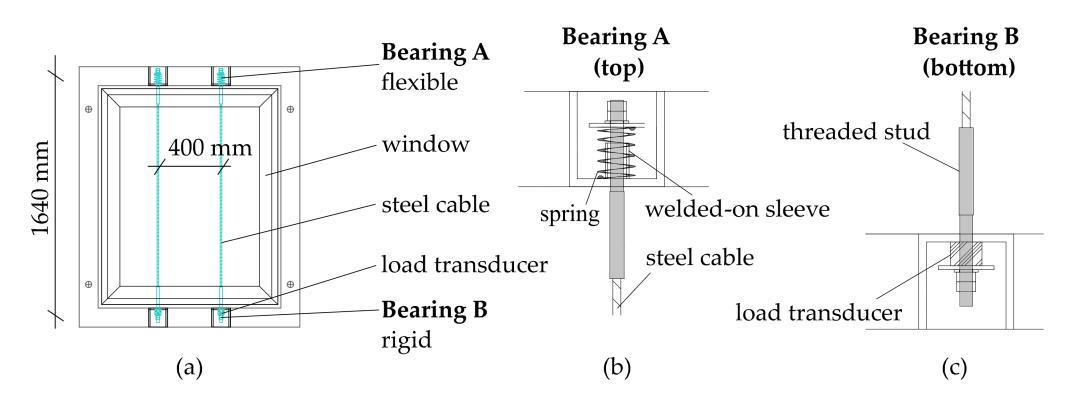
Figure 4 illustrates details of the CCS. At bearing A, located at the top, the steel cables are flexibly anchored by elastic compression springs (spring-supported). If tensile forces are applied to the cables, the springs are compressed. Lateral deflections of the springs are avoided by using welded-on sleeves. At bearing B, located at the bottom, the steel cables are rigidly anchored to the adapter frame (Figure 4). Here, the tensile forces are measured using cylindrical load transducers.

Figure 4. (a) Installed catcher-cables; anchoring (b) at bearing A and (c) at bearing B.

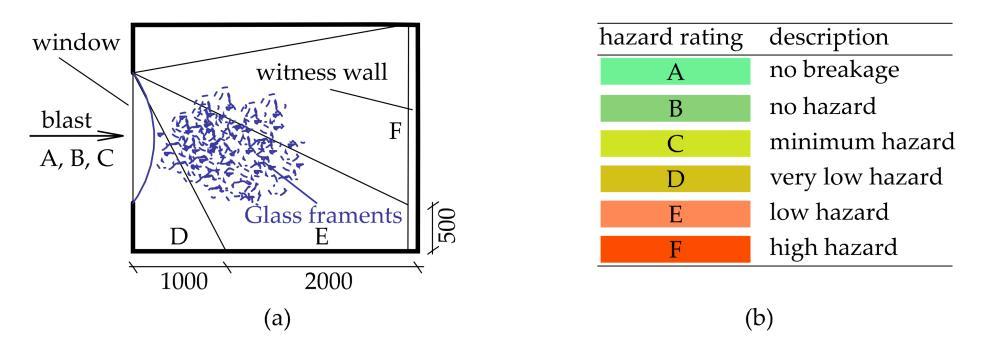
The method described in ISO 16934:2007 [27] is used to evaluate the hazard from fragments propelled into the protected area. The protected area (Figure 6) is subdivided into 6 hazard zones, A to F, respectively. More details on the procedure can be found in [11].

Figure 6. According to ISO 16934:2007 [27], (a) hazard zones and (b) hazard rating.

To assess the hazard posed to individuals, a witness wall is placed at a distance of 3.0 m to the specimen (Figure 6a). The witness wall consists of 15 individual witness panels made of extruded polystyrene foam (XPS). The material of the panels has an elastic modulus of 3.0 MPa and a mass density of 33.0 kg/m<sup>3</sup>. These properties comply with the recommendations of ISO 16934:2007 [27]. The total dimensions of the wall are  $3.75 \text{ m} \times 3.0 \text{ m}$  (width  $\times$  height).

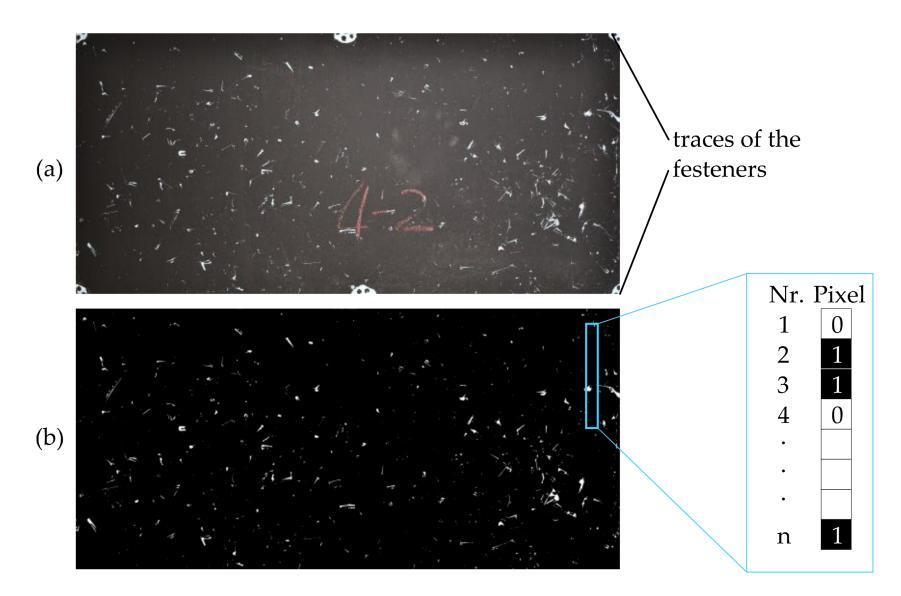
A novel approach was used to assess the impact of the window fragments on the witness wall. This includes taking high-resolution digital photographs ( $5570 \times 3710$  pixels) of the damaged panels after the tests (Figure 7a). The photographs are later digitally aligned and cropped to precisely correspond with the outer boundaries of the designated witness panels. The marks left by the fragments are clearly visible on the panel's surface, since the initially white witness panels were painted black prior to the test.

**Figure 7.** (**a**) Digitally aligned and cropped image of a witness panel, and (**b**) binary representation of a witness panel.

To ensure an accurate analysis, all traces of fasteners and labels on the panels (as seen in Figure 7a) were manually removed from the images. In addition, the captured damage is carefully compared visually with each photo of the witness panel. Figure 7b shows the result of the analysis.

By employing the image-analysis method, a binary representation of the panel is produced (Figure 7b). Black pixels represent undamaged regions, while white pixels indicate damaged regions. T proposed method not only locates damaged areas, but also helps quantify the hazard. This is performed by analyzing each row and column of pixels in the image and calculating the percentage of the damaged area.

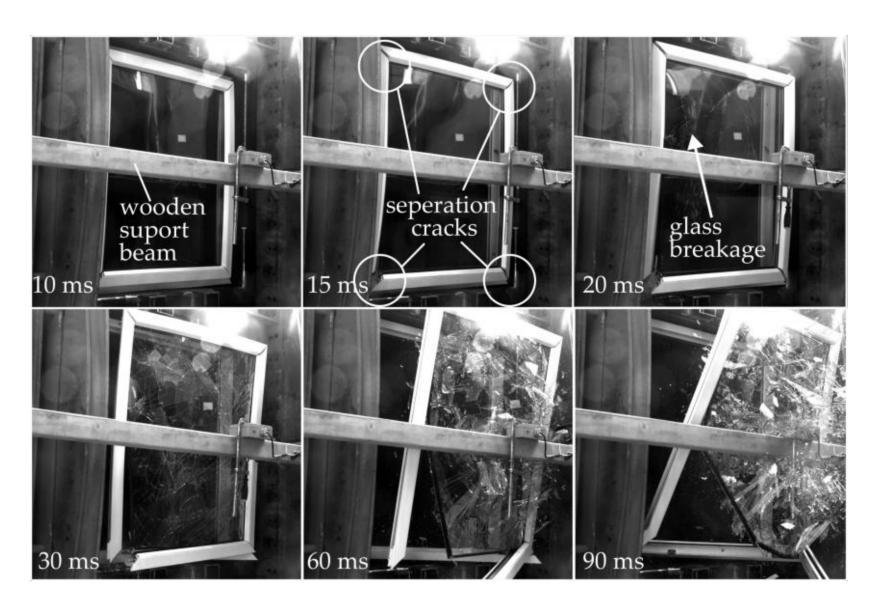
In test U1, the basic unprotected window was tested. Figure 8 shows the global failure mode of the window taken from the high-speed video recordings. The window sash was torn off from the frame by the blast load and propelled into the protected area. After about 39 ms, the torn-off window sash collided with the wooden support beam that was used to attach the laser rangefinders. While the sash frame was stopped by the wooden support beam, the glass fragments proceed unhindered into the protected area.

Figure 8. High-speed video recordings of the unprotected configuration in test U1.

The high-speed video recordings in Figure 8 suggest a combined failure of the frame corners and the fitting system of the window, which caused the window sash to be torn off. To detail the failure at the frame corners, Figure 9a depicts the lower right corner at 15 ms, during the overpressure phase of the blast. Along the connecting surfaces of the uPVC frames, significant separation cracks appeared almost simultaneously within a period of 6.0 ms to 6.7 ms. In comparison, as can be seen in Figure 8, the failure of the glazing occurs much later at approximately 20 ms. In conclusion, the frame corners can be identified as one of the vulnerable parts of the window that are currently not strengthened.

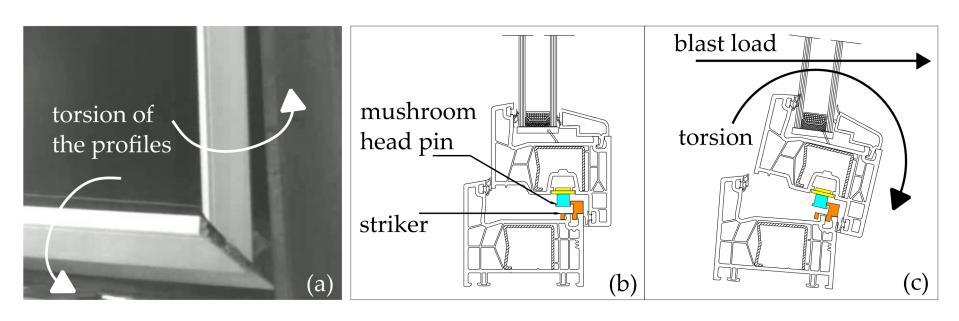
**Figure 9.** Failure mode at the frame corner; (**a**) high-speed video at 15 ms, (**b**) original unloaded condition, and (**c**) deformed window under the blast load.

To elaborate on the observed failure mode at the corners of the frame, Figure 9b,c shows cross-sections of the window, (b) in the original unloaded condition, and (c) deformed under the blast load. The deformation of the sash and frame profiles was primarily due to torsion caused by an eccentric load transmitted by the glazing unit. After exceeding the strength of the uPVC at the frame corners, smooth separation cracks appeared along the joint surfaces.

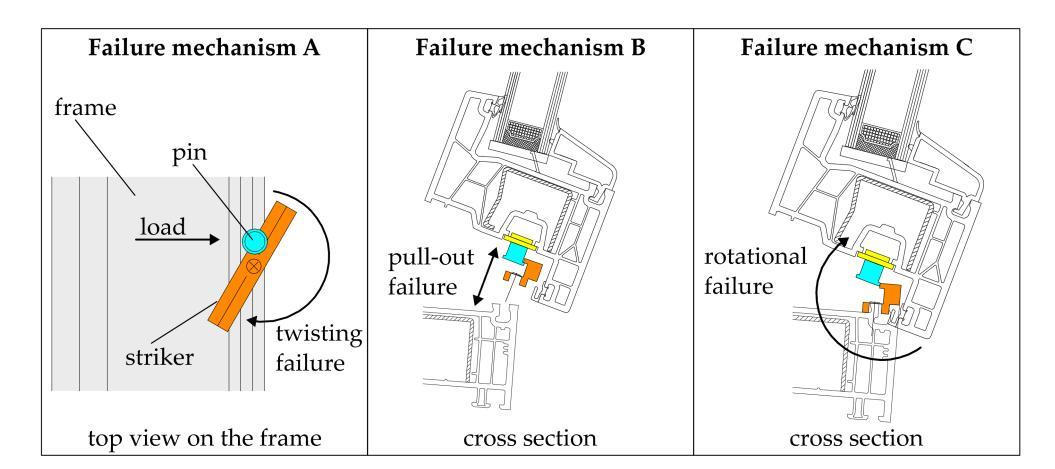
- **Failure mechanism A:** The centrally arranged screw and the interlocking connection to the frame cannot sufficiently prevent the striker from twisting.
- **Failure mechanism B:** The pull-out resistance of the screw is exceeded, resulting in the striker to be torn-off from the frame.

• Failure mechanism C: The mechanism unlocked due to the large rotational movement of the sash frame. In this case, the mushroom head pin disengages from its anchorage within the striker.

Figure 10. Possible failure mechanism of the fitting system.

The following failure mechanisms of the fitting system, or a combination of them, are possible. Schematic representations are given in Figure 10.

In all failure mechanisms of the fitting system described above, forces between the frame and the sash can no longer be transferred. The window sash tears off from the frame. In the test series conducted, it was observed that almost all conventional strike plates were torn from the frame, i.e., failure mechanisms A and B did most likely occur.

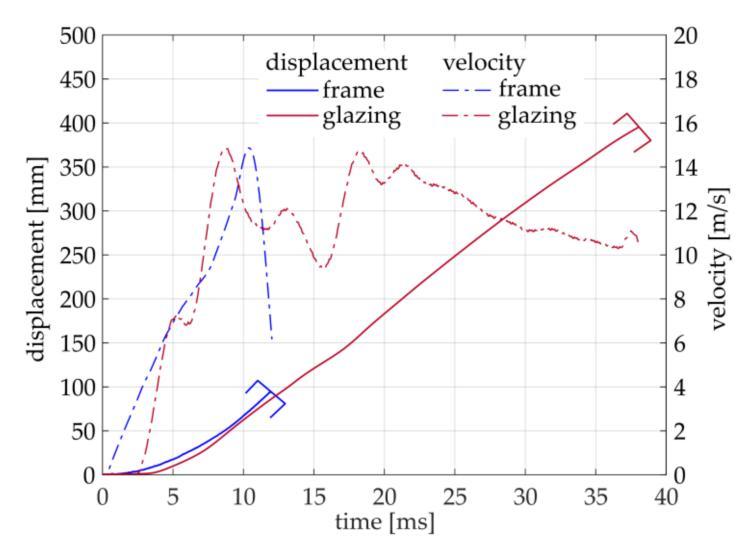
In the test U1 with an unprotected window, the displacements of the window were measured using two laser rangefinders, targeting the sash frame and the center of the glazing. Figure 11 shows the obtained displacement– and velocity–time histories at those two locations.

Figure 11. Measured displacements and velocities in the test with an unprotected window (U1).

Since the glazing and the sash frame were torn off simultaneously from the window frame (Figure 8), the measured displacements and velocities increase equally, as expected. The maximum velocity reached is about 15 m/s. The measurements stop abruptly due to the impact of the fragments on the laser rangefinders mounted on the wooden beam.

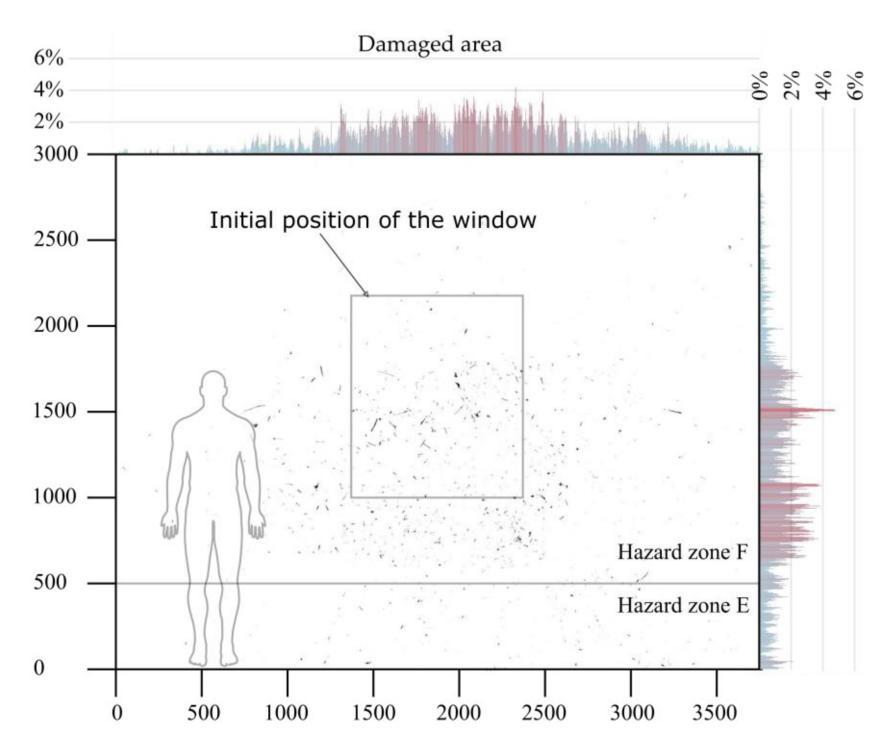
Figure 12 shows the witness wall, which was analyzed using the optical method described in Section 2.5.4. For orientation, the original position of the unprotected window and a person with a height of 175 cm are indicated. A very large number of glass fragments impacted the witness wall. Some of the glass fragments bounced off the panel-surface and left cut marks, and others penetrated directly into the witness panel. The penetrated glass fragments had a maximum length of up to 16.5 cm and a maximum mass of about 100 g.

Figure 12. Analyzed witness wall with impact damages after test U1.

About 0.99% of the total area of the witness wall was damaged in the test U1, which corresponds to a total area of about 1114 cm<sup>2</sup>. The most severe damage can be seen in the center of the witness wall at a height of about 1.5 m above the ground.

In summary, the evaluation of the witness panel concludes hazard level F according to ISO 16934:2007 [27]. It must be noted that the impact of the sash frame on the witness wall was prevented in this test by the wooden support beam for the laser rangefinders (see Figure 8). However, from the initial velocity of the sash frame of about 15 m/s (see Figure 11), it can be concluded that the sash frame would also hit the witness wall in hazard zone F.

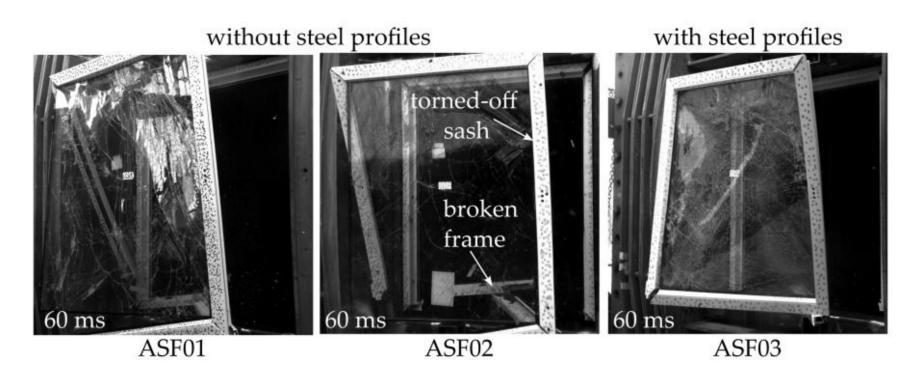
Three tests were performed on windows with ASF-retrofitted glazing units (ASF01, ASF02, and ASF03). Figure 13 shows the corresponding high-speed video recordings at 60 ms. In each test, the sash was torn off from the window frame. Again, the loss of structural integrity is attributed to separation cracks at the frame corners, as well as the failure of the fitting system.

Variation in the strength of the window frames was studied by using steel profiles. In the tests ASF01 and ASF02, the window frames were fabricated without steel profiles fitted into the window frames (Table 1). In test ASF03, the window frames were reinforced by additional steel profiles. When analyzing the high-speed video footage in Figure 13, it appears that the sash with steel profiles (tests ASF03) was propelled more compactly into the protected area than the sash without steel profiles (tests ASF01 and ASF02). In addition, the lower window frames without steel profiles were broken in the middle.

Figure 13. High-speed video recordings of the protected ASF-retrofitted configurations.

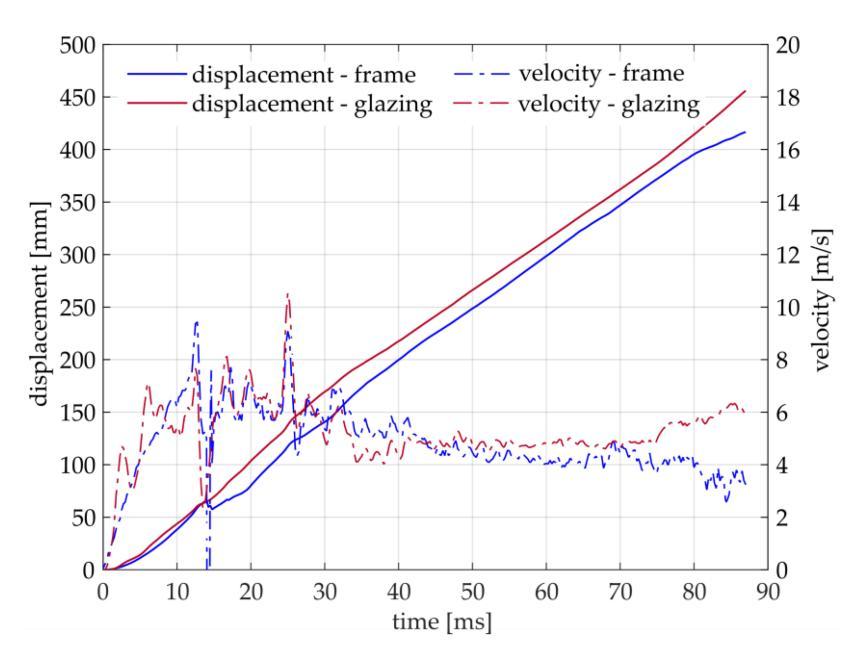
The displacements and velocities of the fragments were captured using the DIC method. The tracking was performed at several marker points located at the center of the glazing and at the sash frame. Figure 14 shows the measured displacement–time histories of test ASF01 and the corresponding velocity–time histories.

Figure 14. Measured displacement and velocity of the sash in test ASF01.

As expected, almost similar displacements and velocities are obtained at the sash frame and at the center of the glazing. The sash was accelerated up to a velocity of about 6 m/s to 8 m/s during the first 10 ms. Subsequently, the velocity–time history appears to reach a kind of plateau. With the onset of the negative-pressure phase starting at about 20 ms (Figure 5), the fragments of the window were decelerated. An average velocity of about 4 m/s was reached at about 40 ms. In test ASF02, the fragments reached a similar maximum velocity as in test ASF01. In test ASF03, no window displacements were determined since one of the two high-speed video cameras showed technical dysfunctionality.

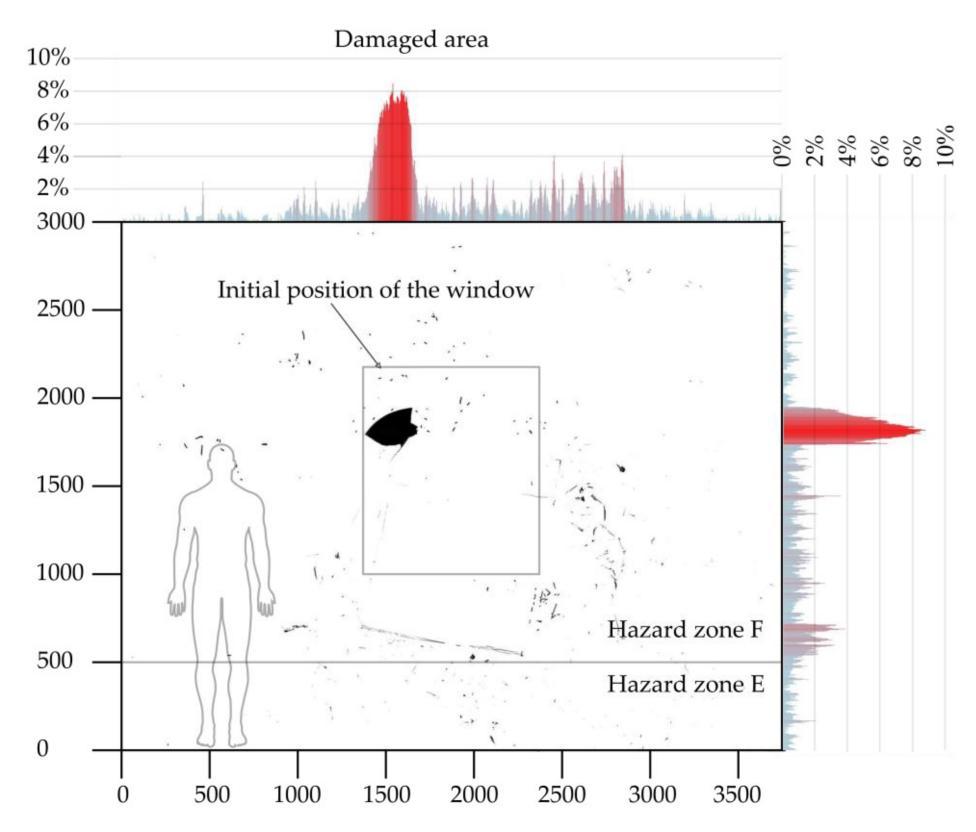
Note that in this test series, the ASF was only applied to the glass pane facing the protected area. The glass pane on the attacked side was not retrofitted by an ASF. Thus, hazards emanate from the torn-off sash frame, the ASF with adhering glass fragments, and the glass fragments from the non-retrofitted glass pane. Figure 15 shows the analyzed witness wall with traces of the impacting window fragments in test ASF01.

Figure 15. Analyzed witness wall with impact damages after test ASF01.

About 1.05% of the total witness wall area was damaged in the test (about 1181 cm<sup>2</sup>). Cutting marks of the impacting glass fragments were documented up to a height of about 290 cm. The impact of the sash frame is clearly visible by an ~20 cm  $\times$  20 cm punched area in the witness wall at a height of about 1.8 m above ground. The remaining relatively low density of impacts at the center of the wall indicates the impact of the ASF.

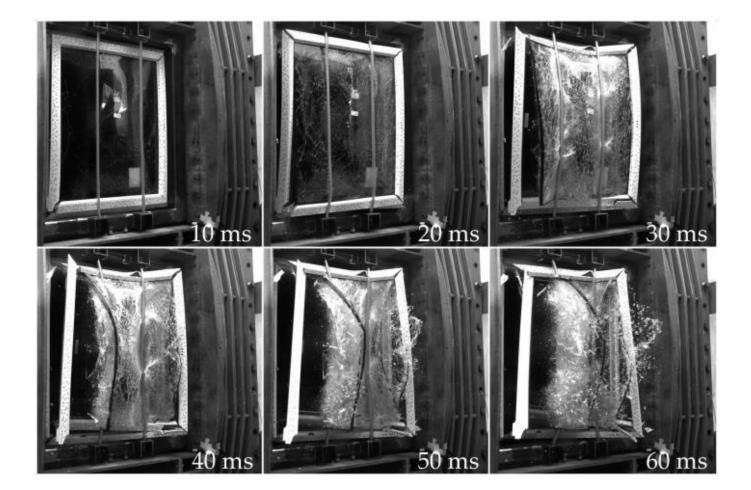
Figure 16 shows the high-speed video recordings of test CC02 over a period of 10 ms to 60 ms. As in the previous tests, the sash was torn off from the frame. However, the trajectory of the torn-off window sash was abruptly stopped by the CCS at about 16 ms. During the impact, the ASF was fully detached from the sash frame and wrapped around the two cables (at about 40 ms). On the one hand, the sash frame and the ASF are retained by the CCS. On the other hand, the glass fragments of the non-retrofitted pane are not retained by the cables, as can be seen at about 50 ms. They are propelled further towards the protected area (Figure 16, 60 ms). Similar mechanisms to those described above were observed in the other five tests with CCSs.

Figure 16. High-speed video recordings of test CC02 with a soft CCS configuration.

Figure 18 depicts the measured maximum cable forces  $F_{max}$  in each test. Cable S1 is located at the outer left side of the window (Figure 16). It tends to be generally subjected to slightly higher forces than the cable S2. This effect might be due to a slightly asymmetric impact of the sash on the CCS.

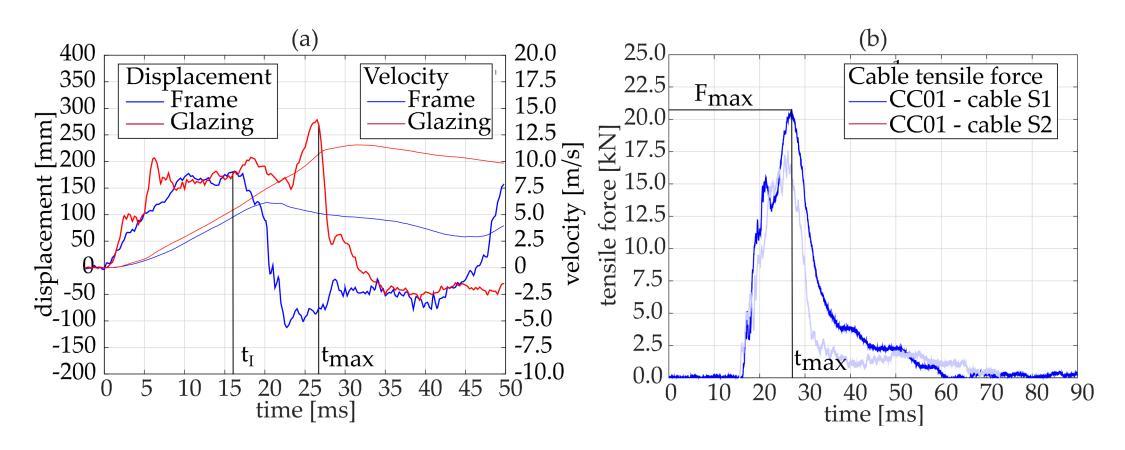
Figure 17a shows the measured displacement–time and velocity–time histories in test CC02 at the center of the glazing and at the sash frame. In test CC02, a soft CCS configuration was used. Impact velocities in the six tests ranged from 6 m/s to 15 m/s. The resulting force–time histories in the cables S1 and S2 are shown in Figure 17b.

**Figure 17.** (a) Measured displacement and velocity of the sash in test CC02; (b) measured tensile forces in test CC01 and CC02 conducted with a soft CCS–configuration.

The impact time  $t_I$  at about 16 ms (Figure 17a) can be correlated with the initial increase in tensile forces in the cables, at about 16 ms (Figure 17b). At the same time, it marks the onset of the velocity decay of the sash frame (Figure 17a). The velocity at the center of the glazing was abruptly reduced shortly after reaching the maximum cable force  $F_{max}$  (at about 26 ms), correlating with the unloading of the CCS. This verifies the measurements since cable tensile force and the deflection are directly related. Similar effects were observed in the remaining five CCS tests.

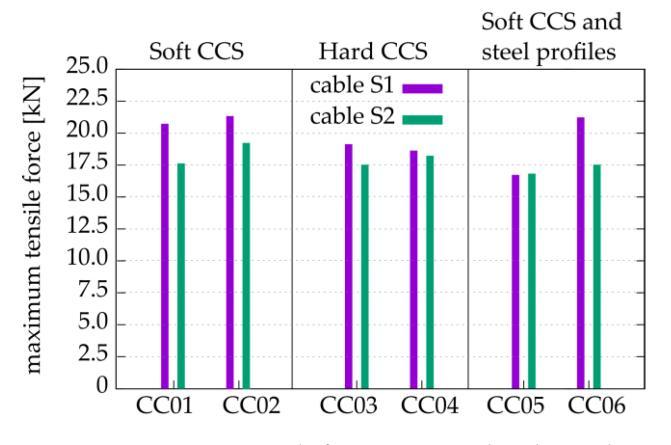
Figure 18. Maximum tensile forces measured in the catcher-cable systems.

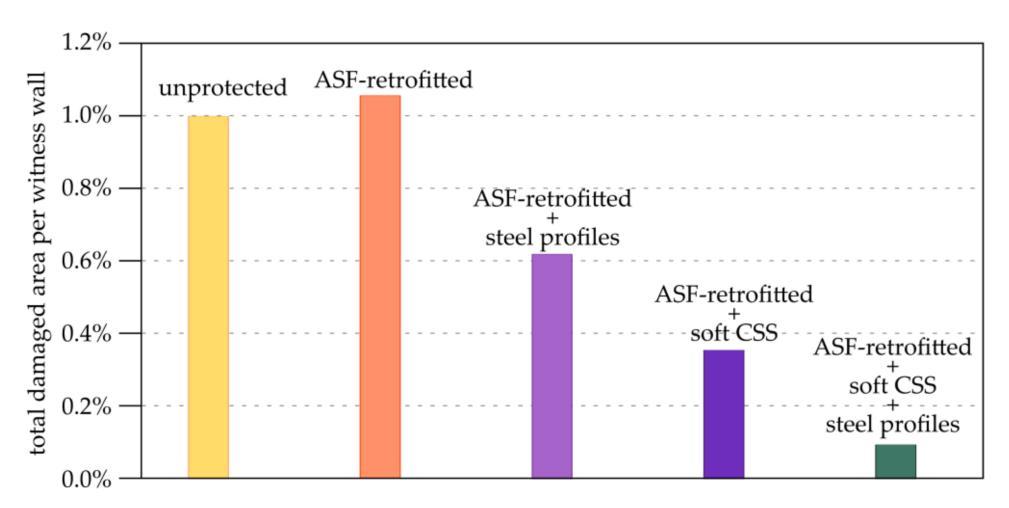
Nevertheless, when comparing the different sets of protective measures, a significant improvement in protection can be observed. As a benchmark for this improvement, the damaged area of the witness wall evaluated through the optical analysis can be used. Figure 19 shows the percentage of the total witness wall area damaged in each test.

Figure 19. Total damaged area of the witness wall.
