Cavitation Erosion and Jet Impingement Erosion Behavior of the NiTi Coating Produced by Air Plasma Spraying

Zhenping Shi^{1,2}, Jiqiang Wang¹, Zhengbin Wang¹, Yanxin Qiao^{3,*}, Tianying Xiong¹ and Yugui Zheng^{1,*}

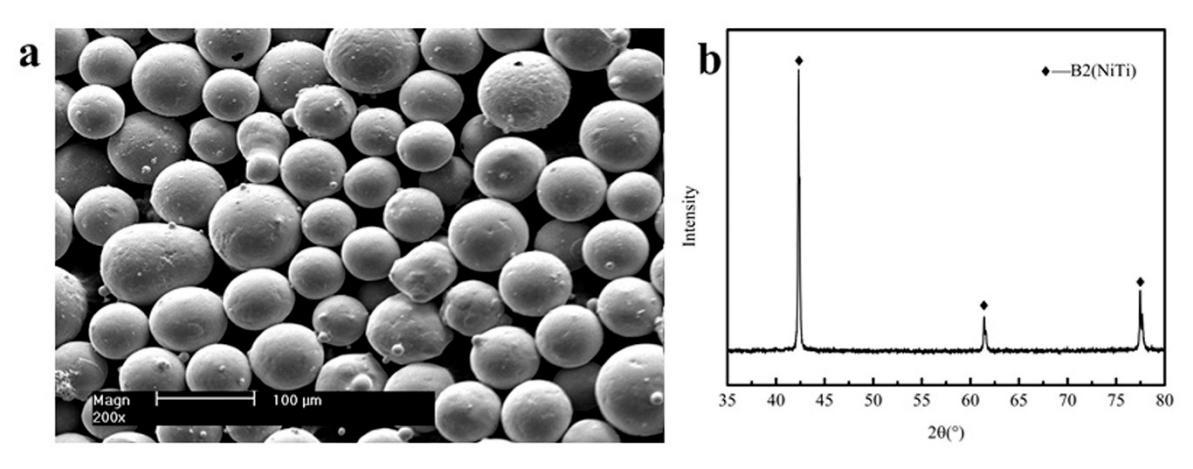
Figure 1. (**a**) Morphology of NiTi powder used as staring material for APS procession, (**b**) XRD pattern of NiTi powder.

In the present work, NiTi powder was used, which was obtained from Beijing AMC Powder Metallurgy Technology Co., Ltd. (Beijing, China). The powder was prepared using commercial NiTi rods by electrode induction inert gas atomization. The chemical compositions of NiTi powder are listed in Table 1. Figure 1b shows the XRD patterns of NiTi powder. The main phase is austenite B2 (NiTi). No other intermetallic compounds, carbides or oxides are found, which may be due to the low content of these impurities. Figure 1a shows the morphology of NiTi powder used as a starting material

for APS processing. The powder has a spherical shape, and its degree of sphericity is 0.89. That means excellent flowability for the powder feeding. The particle size of the powders was measured by the laser particle analyzer. The d_{10} , d_{50} and d_{90} values are 53.20 µm, 78.13 µm and 124.70 µm, respectively. These values are suitable for APS. The relatively large diameter of the powders can ensure the flowability of the powders and reduce the phenomenon of overburning.

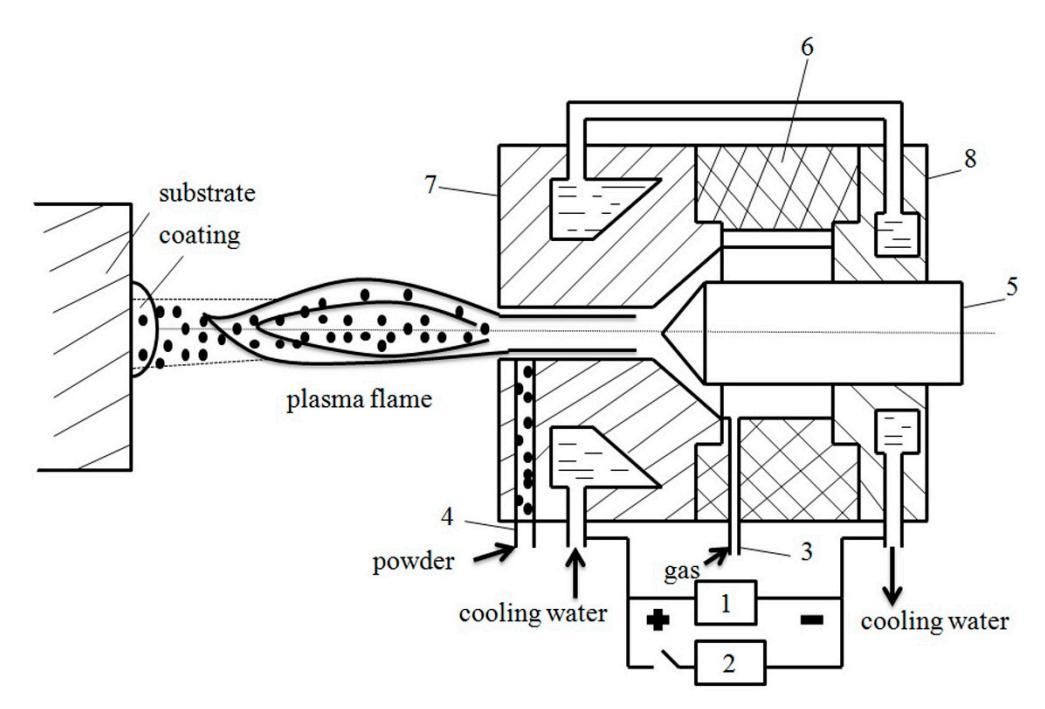
Figure 2. Schematic diagram of plasma spray system: 1. power supply; 2. high frequency generator; 3. intake pipe; 4. powder feeding tube; 5. tungsten; 6. insulator; 7. the front of the gun; 8. the rear of the gun.

The APS equipment is homemade, mainly including the power supply, control cabinet, spray gun, powder feeder, circulating water cooling and gas supply systems. The schematic diagram of the APS system is shown in Figure 2. The inert gases are taken to the plasma generator (plasma gun), and these inert gases are heated and activated when they pass through the direct current arc between positive and negative poles in the plasma gun. Therefore, this ionized the inert gases. This process produces high temperatures and a high-speed plasma arc flow. The temperature of the plasma arc is so high that the powders are heated to a molten or semi-molten state. These powders impact the substrate in the high speed plasma arc flow, resulting in the formation of the coating.

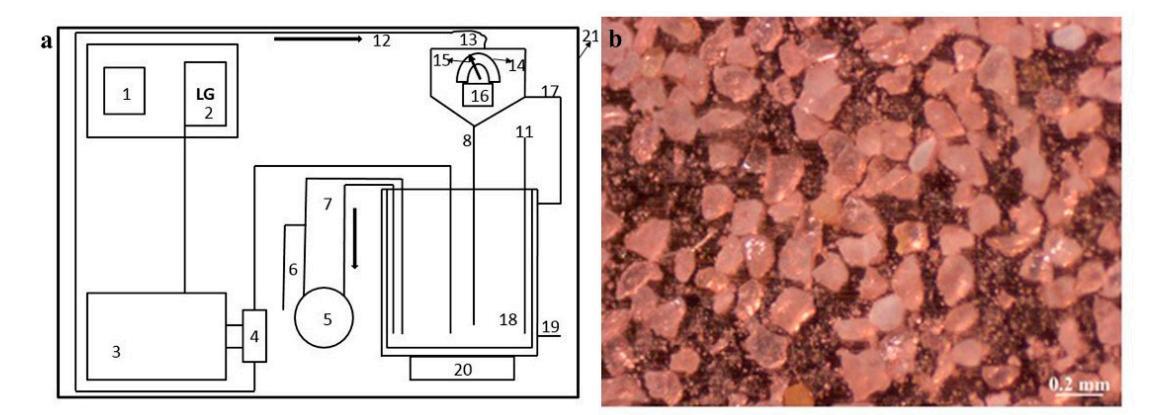
Figure 3. (a) Schematic diagram of the jet apparatus for erosion corrosion: (1) Control cabinet; (2) variablefrequency drive; (3) motor; (4) lobular pump; (5) stirring pump; (6–8) valves; (9) impingement cabinet; (10) thermocouple I; (11) thermocouple II; (12) electromagnetic flowmeter; (13) screw elevator; (14) impingement angle meter; (15) nozzle; (16) sample; (17) overflow tube; (18) slurry container; (19) cooling water; (20) heater; (21) frame [38], (b) Morphology of silica sand used for jet impingement erosion by stereomicroscope.

The jet impingement erosion equipment was homemade. The schematic diagram of the jet apparatus for erosion corrosion is shown in Figure 3a [38]. In the process of jet impingement erosion, the diameter of the nozzle was 3 mm. The sample was placed at 5 mm from the nozzle. The impact angle was set at 90°. Tap water containing 2 wt % silica sand (70–150 mesh) was used as the test medium. The shape of the silica sand was irregular and angled, as shown in Figure 3b. It is a recycled abrasive erosion test during each run and the new silica sand was used for each run. The flow velocity was 15 m/s throughout the whole process of the jet impingement erosion. Before the jet impingement erosion test, the samples were ground with SiC emery paper up to grade 2000 and washed in alcohol. The samples were dried before the tests, and weighed using an analytical balance with an accuracy of 0.1 mg. The erosion damage to the samples was evaluated in terms of the mass loss. Each test was repeated at least three times to determine reproducibility.

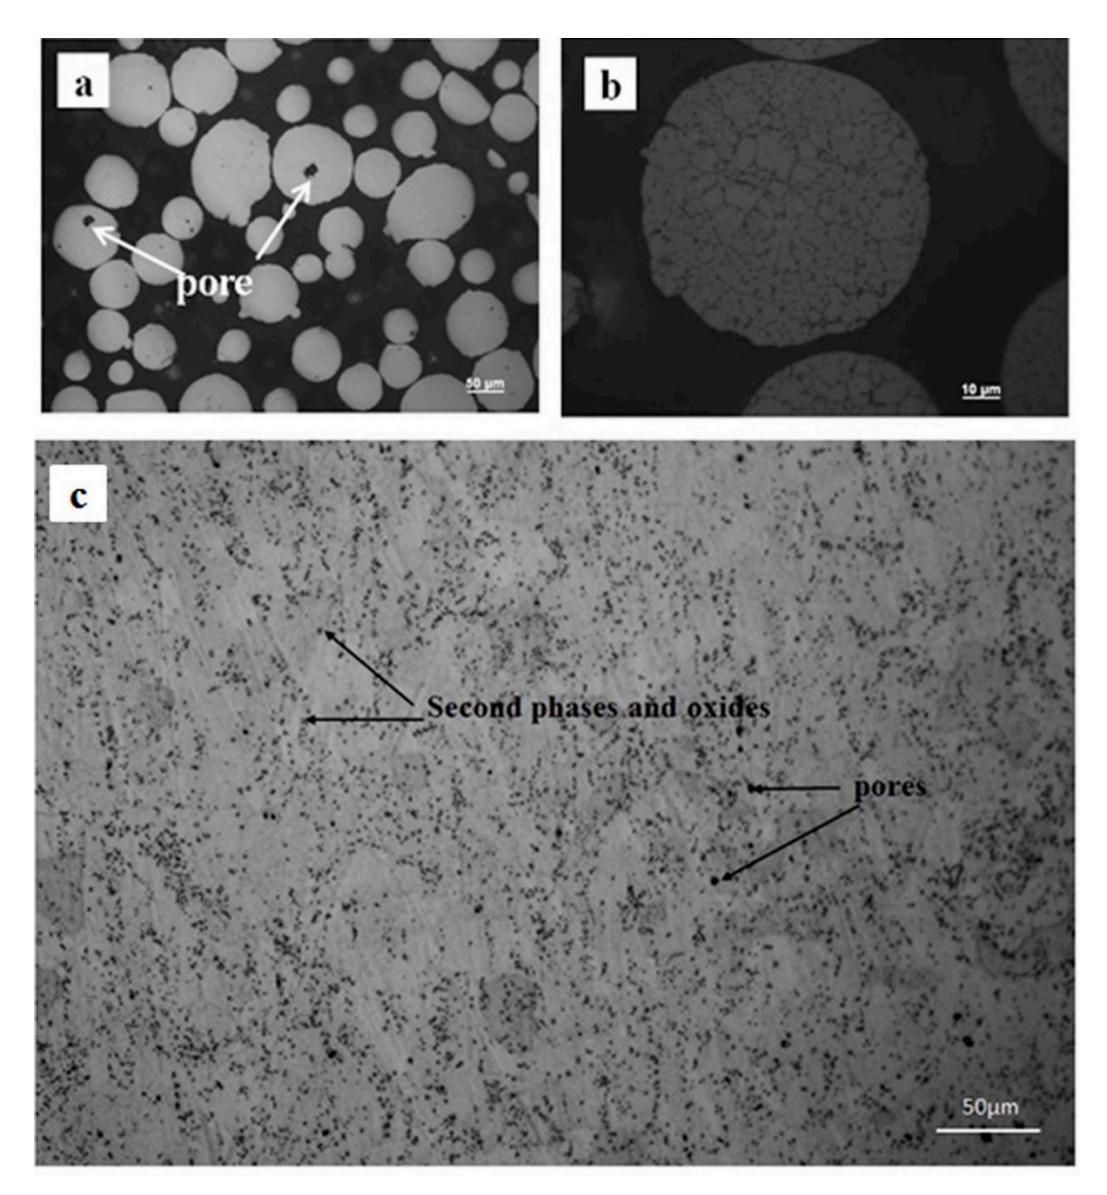
Figure 4. Cross-sectional microstructure of NiTi powder (**a**) without etching, (**b**) after etching and (**c**) surface microstructure of NiTi plate after etching.

The hardness profile was acquired by the means of a micro-hardness test. The hardness of the NiTi coating and the NiTi plate is 549.1 HV and 307.7 HV, respectively. Figure 4a shows the cross-sectional microstructure of the NiTi powder without etching by an optical microscope. Some pores exist in the interior of powder. These pores are formed in the process of the inert gas atomization of commercial NiTi rods using electrode induction. The molten powders have an affinity to the gas, and the gas dissolves into the molten powder. When the powders cool fast, the integrated gas has no time to escape completely. The residual gas causes the formation of these pores. The existence of these pores in the powders is taken as one of the reasons for the pores existing in NiTi coating, which will be shown later. Figure 4b shows the cross-sectional microstructure of NiTi powder after etching. The powders consist of equiaxed crystal. Figure 1b shows that the equiaxed crystal is austenite B2. Figure 4c shows the surface microstructure of the NiTi plate after etching. The second phases, oxides and pores are found on the surface of the NiTi plate before the cavitation erosion test.

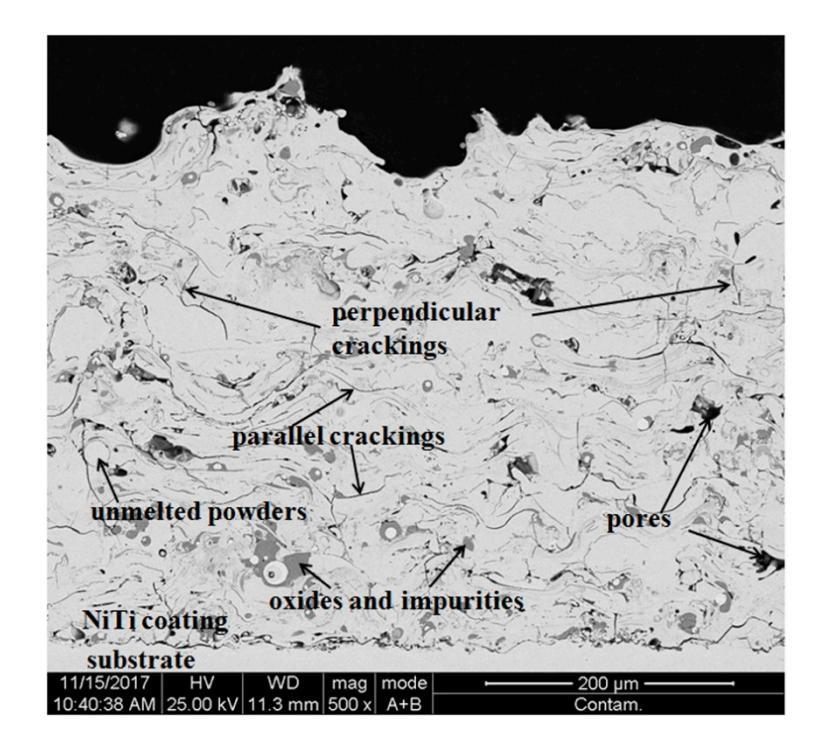
Figure 5. BSE microstructure of NiTi coating.

Figure 5 shows the back scattered electron (BSE) microstructure of NiTi coating, in which un-melted powders, parallel cracks, perpendicular cracks, pores, oxides and impurities can be found. The un-melted powders retain the state of the starting powders. The length of the plasma arc flow is short, making it very easy for air entrainment. Then, it can induce the heat inhomogeneity of the particles in the process of APS. As a result, the partial particles are melted while the other partial particles are semi-molten. Under the effect of the plasma arc flow, the melted particles form the lamellae when the particles hit the substrate. However, the un-melted particles are inlaid in the coating and keep the initial shape of the particles. The existence of pores has a great influence on the mechanical and corrosion properties of the coating. There are two kinds of pores, macropores and micropores. The macropores exist between the lamellae. The incomplete filling of the droplets when the droplets impact substrate and the insufficient flattening of the unmelted particles are the reasons for the forming of macropores. The micropores are formed for the following reasons. The first one is the insufficient wetting of the surface of the existing coating. The second is the existing pores in the inner of starting powders. The third is that the integrated gas has no time to escape when the droplets cool at a high velocity. The formation of oxides and impurities results from the metallic droplets reacting with the atmospheric oxygen during their flight to the substrate.

The cracks in the coating perpendicular to the substrate are through the individual lamellae and are perpendicular to the lamellae. The forming of these kinds of cracks is due to the cooling of the droplets at a high velocity. In the process of APS, the cooling and flattening of the droplets are two separate processes. When the droplets with high temperatures impact the previously deposited lamellae, cooling and flattening can happen. The cooled and flattened droplets will shrink, but the previously deposited lamellae will limit this shrinking. It will induce staining inside the coating, and cracks will form consequently so the stress can be released. The reason the cracks in the coating form parallel to the substrate is the sheer stress generating at the interface between the freshly impacted lamellae and the previously deposited surface.

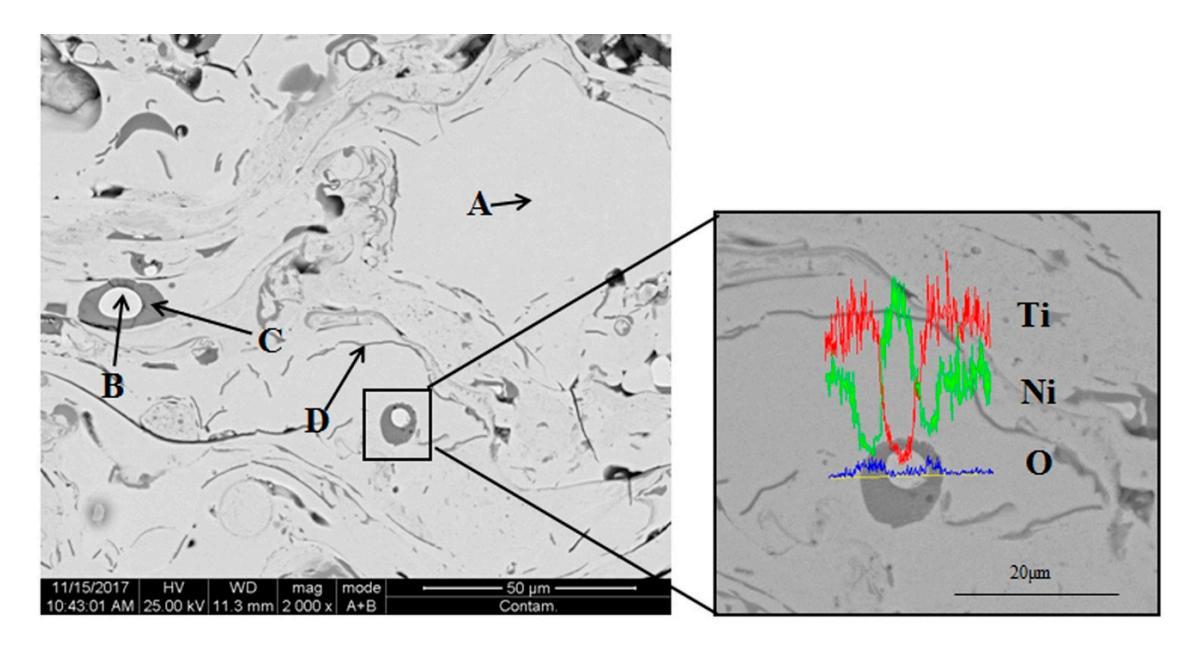
Figure 6. EDS analysis of NiTi coating and line scanning of the selected area from NiTi coating.

Figure 6 shows the EDS analysis of the NiTi coating. The dark grey areas C and D are the oxides. The oxide layer around each lamella can reduce the area fraction of intimate contact. The light grey area A is the austenite phase B2. The white area B is solid solution nickel with a very small amount of

Table 4 shows the chemical compositions of the selected area from the NiTi coating. Combining the results of the XRD patterns as shown in Figure 7, the areas C and D may be the TiO and NiTi₂/Ni₂Ti₄O₃. Line scanning of the selected area from the NiTi coating is shown in Figure 6, in which titanium, nickel and oxygen elements are the foci. Because the titanium has an affinity for oxygen, the oxygen content increases with the titanium content. In the dark grey area, the content of titanium is more than that of nickel. In the white area, the content of nickel is more than the content of titanium. The XRD pattern of coating shown in Figure 7 also confirms that Ni₄Ti₃ exists in the coating. It is not found in Figure 5 (BSE microstructure of NiTi coating with a magnification). The Ni₄Ti₃ may be very small and is only distributed in area A as shown in Figure 6. Compared with the diffraction peak of the starting powder, the diffraction peak of the as-sprayed coating is obviously broadened as shown in Figure 7. The starting powder impact the substrate in high speed during the process of APS. The particles with high temperatures have severe plastic deformation. These could result in dynamic recrystallization and the emergence of high deformation regions. The grain refinement phenomenon leads to a decrease in

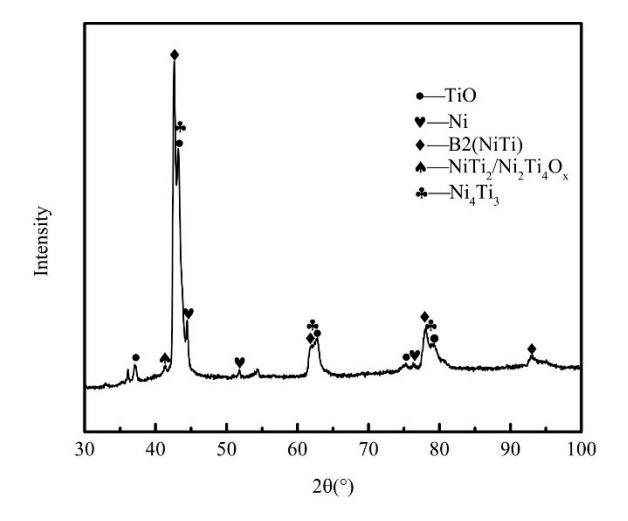
Figure 7. XRD pattern as-sprayed NiTi coating.

titanium. This result can be verified in the XRD patterns as shown in Figure 7. The austenite phase B2 of area A occupies the main part of the coating.

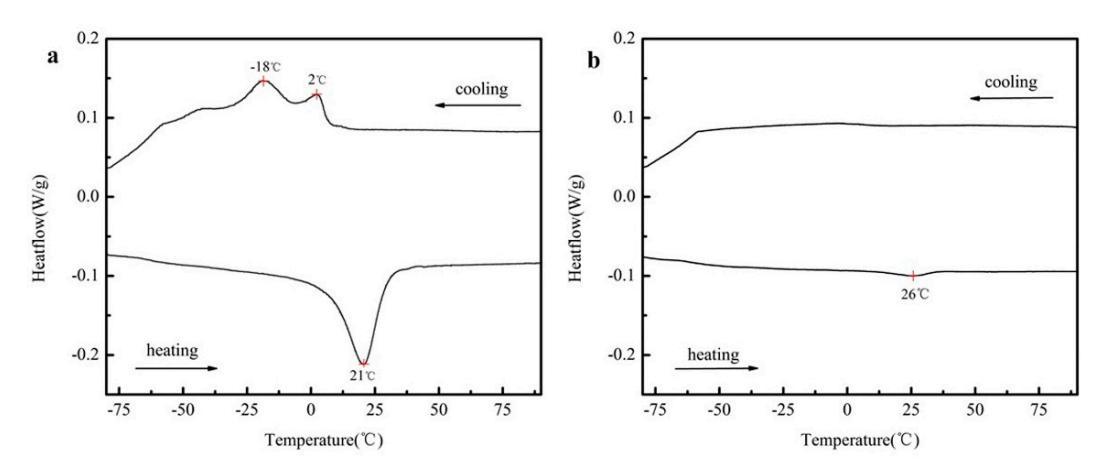
Figure 8. Phase transformation temperatures of the (**a**) NiTi powder and (**b**) as-sprayed NiTi coating measured by DSC with the heating and cooling rate of 10 K/min.

Figure 8 shows the DSC curve of (a) NiTi powder and (b) as-sprayed NiTi coating. The DSC peak of NiTi coating widens compared with that of the NiTi powder. Ni_4Ti_3 , $NiTi_2/Ni_2Ti_4O_3$, Ni and TiO, can induce the fluctuations of the Ni:Ti ratio. This could be the main reason for the broadening of the NiTi coating DSC peak.

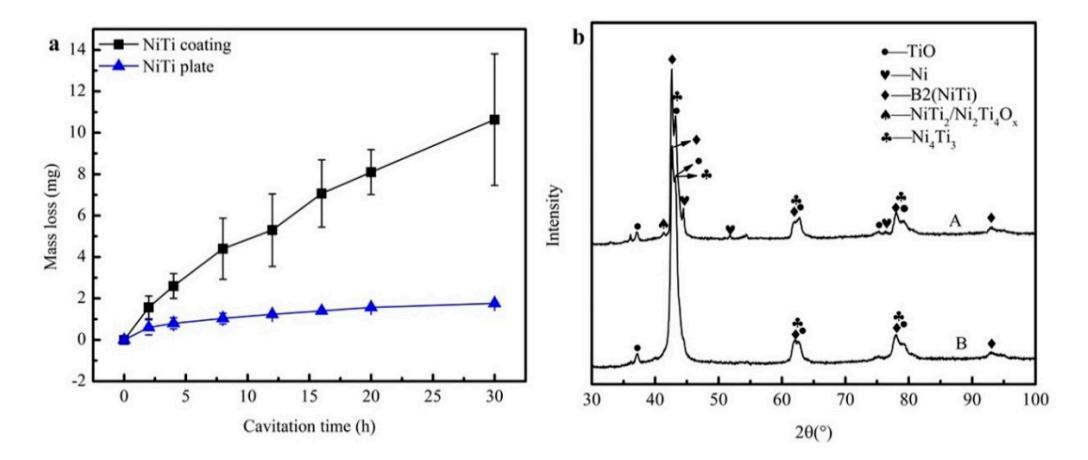
Figure 9. (a) Cumulative mass loss as a function of cavitation erosion time for NiTi coating and NiTi plate; (b) XRD pattern of (A) as-sprayed NiTi coating and (B) NiTi coating after 30 h cavitation erosion.

Figure 9a shows the cumulative mass loss with time for cavitation erosion of the NiTi coating and the NiTi plate. The mass loss of the NiTi coating was far greater than that of the NiTi plate. After testing for 30 h, the mass loss of the NiTi coating was 5.2 times that of the NiTi plate. There was no incubation period for the cavitation erosion of NiTi coating. In contrast, the mass loss of NiTi plate was still in the incubation period.

Figure 9b shows the XRD pattern of (A) as-sprayed NiTi coating and (B) NiTi coating after 30 h cavitation erosion. Compared to the as-sprayed NiTi coating, the NiTi coating after 30 h cavitation erosion had no Ni and NiTi₂/Ni₂Ti₄O₃. It indicated that Ni and NiTi₂/Ni₂Ti₄O₃ on the surface of the NiTi coating were removed after 30 h cavitation erosion. The austenite B2 is still in the main phase.

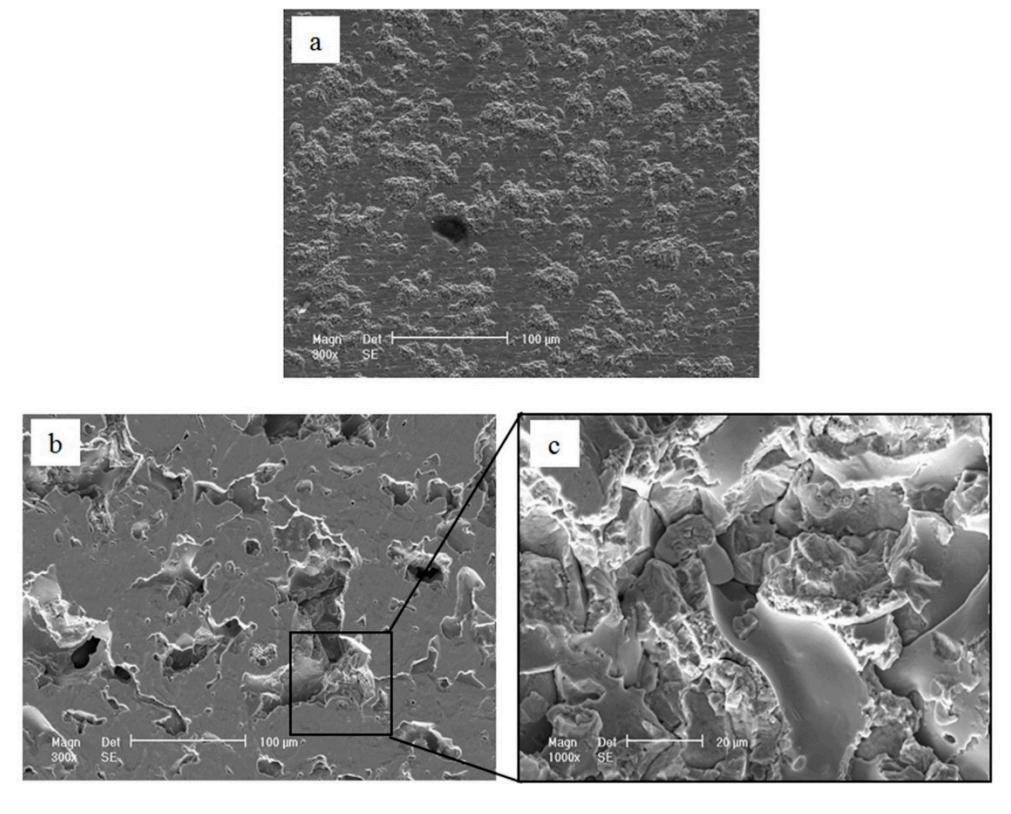
Figure 10. Surface morphologies of (**a**) NiTi plate, (**b**) NiTi coating and (**c**) magnification of the selected area for NiTi coating after 30 h cavitation erosion.

Figure 10 shows the surface morphologies of the NiTi plate and the NiTi coating after 30 h cavitation erosion. Some eroded areas and some little pits can be detected on the surface of NiTi plate. Even so, there are still some intact areas on the surface. The eroded areas look like popcorn. Some weak points like second phases and oxides in the NiTi plate (Figure 4c) could be removed easily in the initial stage of cavitation erosion. These little pores could be cavitation sources even when the quantity of the pores is small. Thus, the cavitation damages are mainly the location of these defects.

In Figure 10b, some huge and deep pits exist on the surface of the NiTi coating after 30 h cavitation erosion. There are also some intact areas on the surface. The diameter of some pits is more than 100 μ m. The magnification of selected areas for the NiTi coating after 30 h cavitation erosion is shown in Figure 10c. The shape of the fracture shows typical brittle features. Some cracks existed in the bottom of the pit.

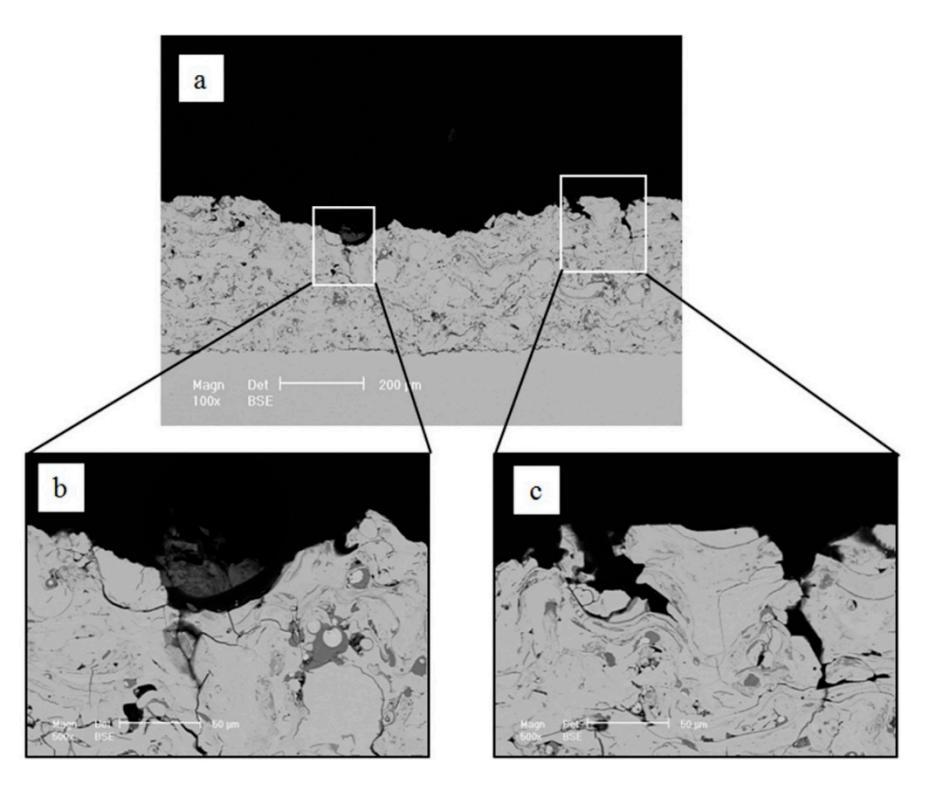
Figure 11. Cross-sectional microstructure of (**a**) NiTi coating and (**b**,**c**) magnification of the selected area from NiTi coating after 30 h cavitation erosion.

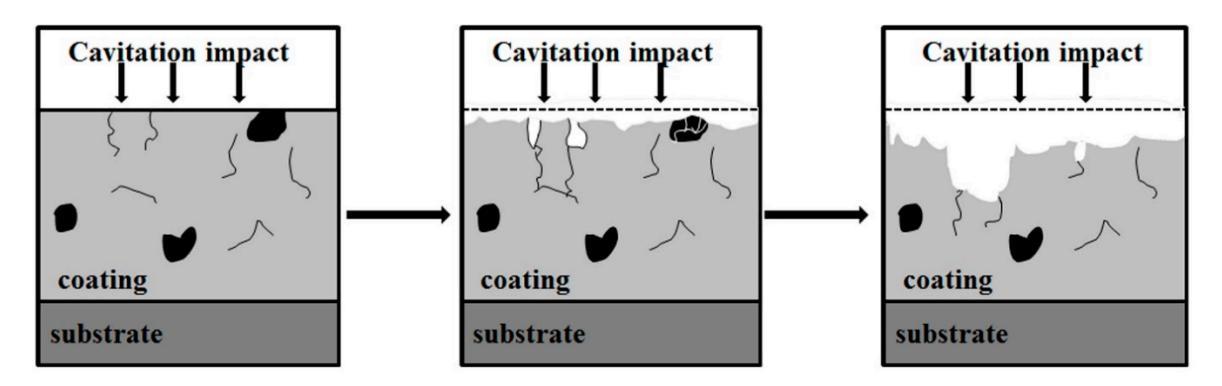
Figure 12. Schematic diagram of cavitation erosion for the NiTi coating.

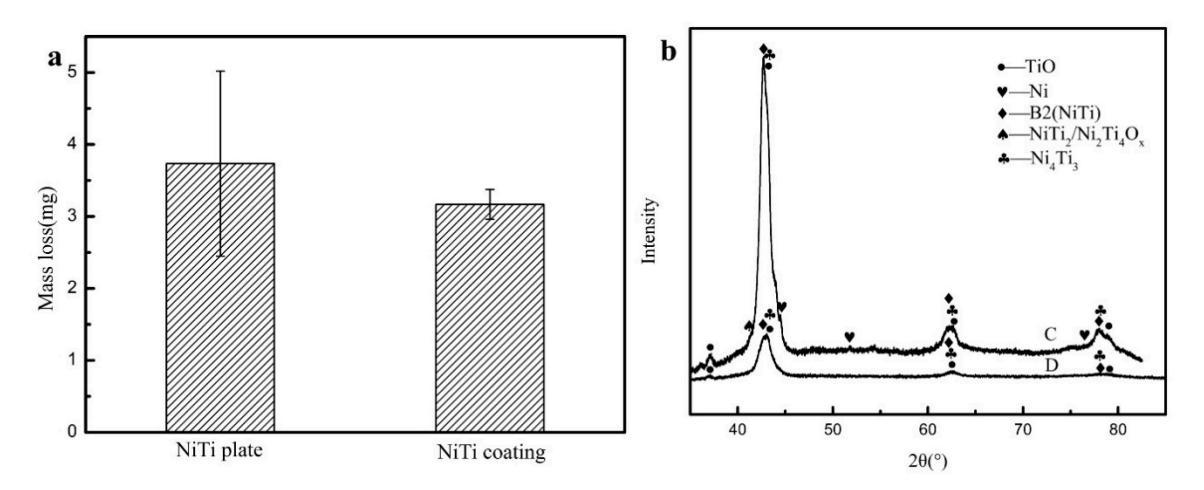
Figure 13. (a) Cumulative mass loss of jet impingement erosion for NiTi coating and NiTi plate in 12 h, (b) micro-beam XRD pattern of (C) as-sprayed NiTi coating and (D) NiTi coating after 12 h jet impingement erosion.

Figure 13a shows the cumulative mass loss of jet impingement erosion for the NiTi coating and the NiTi plate in tap water with 2 wt % silica sand for 12 h. From the data point of view, the jet impingement erosion resistance of the coating is slightly better than that of NiTi plate.

Figure 13b shows the micro-beam XRD pattern of the as-sprayed NiTi coating, and before and after the 12 h jet impingement erosion. The reason for using the micro-beam XRD pattern with cobalt as the target is that the eroded surface of the jet impingement erosion is so small that it cannot be detected by conventional XRD. The Ni and NiTi₂/Ni₂Ti₄O₃ are not found in the XRD pattern of NiTi coating after 12 h jet impingement erosion. The main phase is still austenite B2, and the TiO and Ni₄Ti₃ are also found in the XRD pattern. The peak intensity of austenite B2 of the as-sprayed NiTi coating after 12 h jet impingement erosion become weak compared to the original coating. The reason may be that the partial austenite B2 on the surface of the coating transforms to martensite B19' and partial B19' transforms to martensitic variant B19 after 12 h jet impingement erosion. The SRD pattern, which is probably due to the small amount of B19' and B19.

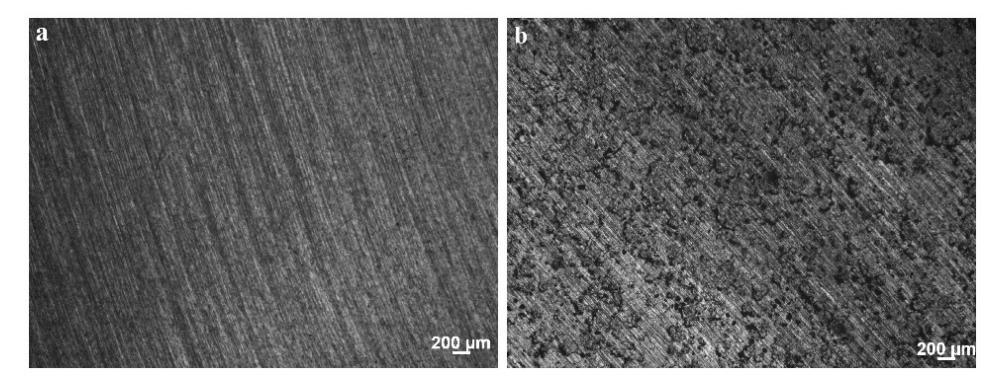
Figure 14. Surface morphologies of (a) NiTi plate and (b) NiTi coating before jet impingement test.

Figure 14 shows the surface morphology of the NiTi plate and the NiTi coating before the jet impingement test. Figure 15 shows the surface morphology of the NiTi plate and the NiTi coating after 12 h jet impingement erosion. The shape of impingement particles is irregular, which will cause severe damage. There is no intact place on the surface. It exhibits the typical damage features of ductile material in the jet impingement erosion. On the surface of the NiTi plate and the NiTi coating after 12 h jet impingement erosion, there is a small number of ploughed scratches, long furrows and ridges. But there are many overlaps and irregular concavities on the surface. At the high impinged angle, the material damage accumulation comes from fatigue, shear localization, microforging and extrusion processes. Lots of indented concavities and thin platelets will be partially impinged off by the subsequent impinged particles. When the material encounters the subsequent impinged particles, many overlapping irregular concavities attach on-to the nearby surface. In fact, these impinged surface morphologies are consistent with those reported for ductile materials [19,40].

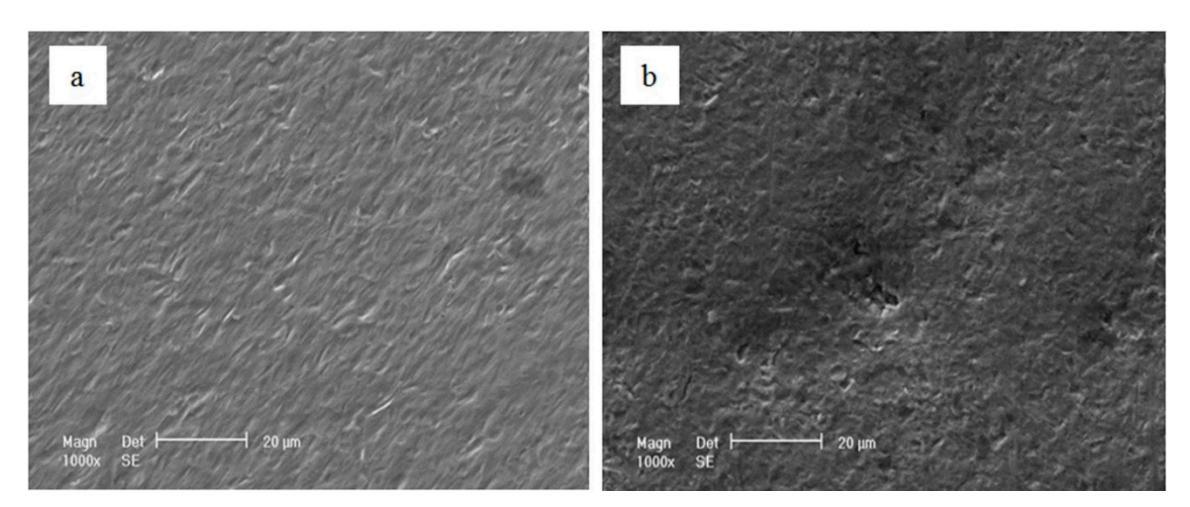
Figure 15. Surface morphologies of (a) NiTi plate and (b) NiTi coating after 12 h jet impingement erosion.

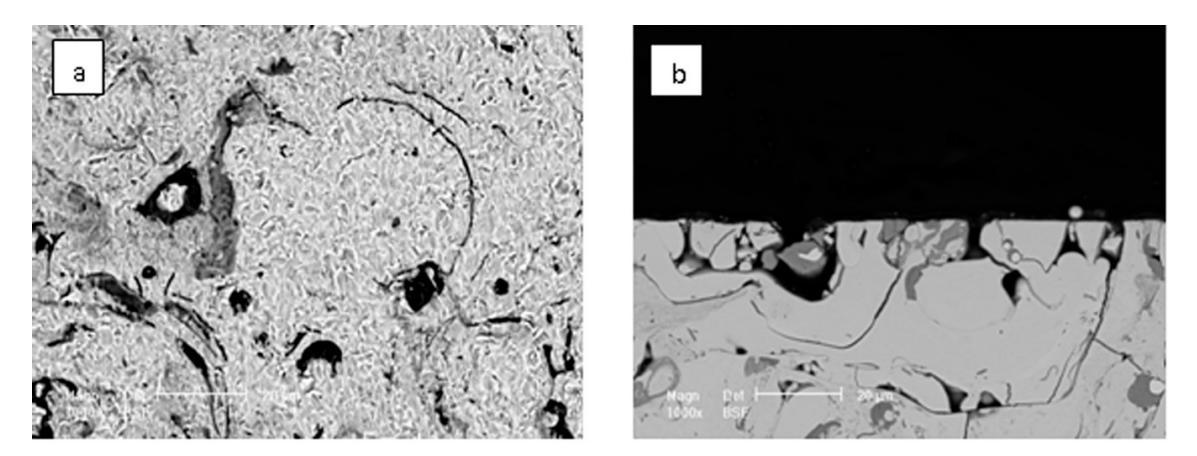
Figure 16. BSE micrograph of (**a**) surface and (**b**) cross-sectional microstructure of NiTi coating after 12 h jet impingement erosion.

Like the cavitation erosion test, the stress induced martensitic transformation occurs in the austenite phase under external stress during the jet impingement erosion test. When external stresses are applied, the stress-induced martensite transforms to the martensite variant that has the most favorable orientation through the formation of a martensite twin boundary slip. In the NiTi plate or NiTi coating, the austenite phase B2 is the main component. The superelasticity of the austenite would also stabilize the fatigue crack tips and hinder the crack propagation. This mechanism partially relieves the impact load and accommodates the impact strain elastically. Figure 16 shows the BSE surface micrographs and cross-sectional microstructure of the NiTi coating after 12 h jet impingement erosion. Some small pits can be detected. Some of these pits existed before the jet impingement erosion test, while some were formed due to the solid particle impacting. No apparent falling off the bulk material can be recognized. During the process of jet impingement erosion, the oxides and impurities are impacted by the solid particle impacting. Although the impacting will cause mass loss, the existence of brittle phases is discrete and does not allow pits to connect. The mass loss caused by the oxides and impurities is small. In addition, the existence of pores in the coating has a certain buffer effect on the impact of the particles. So, the jet impingement erosion resistance of the NiTi coating is equivalent of that of the NiTi plate.
