# **Review Review of Active IR Thermography for Detection and Characterization of Defects in Reinforced Concrete**

# Bojan Milovanović \* and Ivana Banjad Pečur

Department of materials, Faculty of Civil Engineering, University of Zagreb, Fra Andrije Kačića Miošića 26, 10000 Zagreb, Croatia; banjadi@grad.hr

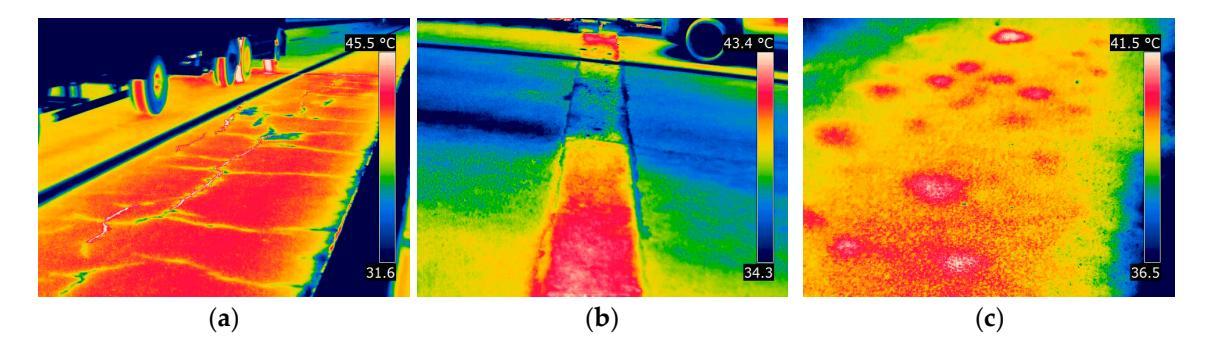
**Figure 1.** (**a–c**) Thermograms of the defected bridge deck of Krapina bridge [25] (courtesy of B. Milovanovic).

Although existing defects (cracks and inclusions) on the pavement of the bridge deck were visible from the thermograms presented in Figure 1, it is evident that there is an impact of the emissivity change on the surface even though the whole surface is of the same material (Figure 1b). These problems occur due to the ruts, accumulated rubber, and slight changes in the surface color, together with road markings.

Additionally, for the defects visible in Figure 1c, only qualitative analysis is possible, while the quantitative characteristics (size and depth) cannot be determined without having the additional

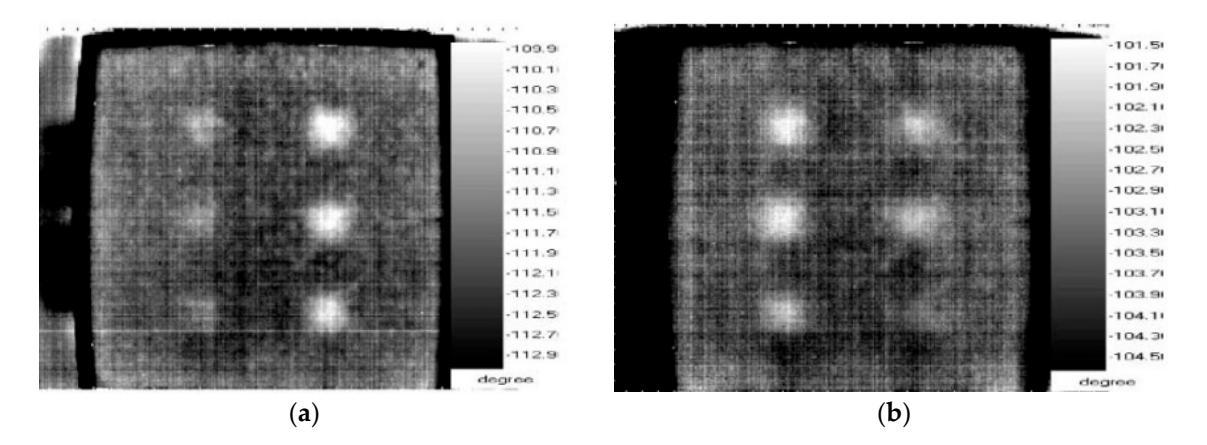
**Figure 2.** Phase delay images [31]: (**a**) heating period 15 min; and (**b**) heating period 35 min (courtesy of Elsevier).

Sakagami and Kubo [31] developed a testing technique for delamination defects in concrete structures. The technique is based on the phase delay measurement using a lock-in (LT) IRT under the application of periodical heating. Experimental studies were performed on the applicability of technique to the detection of artificial delamination defects in a  $1 \times 1 \times 0.3$  m<sup>3</sup> concrete block specimen. Sinusoidal reference signal for the lock-in measurement was generated to control 12 quartz lamps via heater control relay. Lock-in measurements were carried out for 11 different heating periods, which were set from 10 to 60 min with 5 min intervals. The modulation frequency, which was reciprocal of the heating period, was then set from  $1.67 \times 10^{-3}$  to  $2.78 \times 10^{-4}$  Hz, [31]. Additionally, lock-in measurements were carried out in [31] for three heating periods, *i.e.*, 10, 20 and 30 min on the actual *in-situ* delamination damage, where an oil-fired heater (28–38 kWh) was employed instead of the quartz lamp heater. It was found in [31] that the location and size of the delamination defects can be estimated by the area of contrast change in the phase delay images. Defect depth can be estimated using the relationship between phase delay and heating period (Figure 2). Sakagami and Kubo state that the defects of 10 cm in depth cannot be detected, by their method, while considering the heating period which was used, they have set the limitation of the detectable defect depth at 5 cm [31].

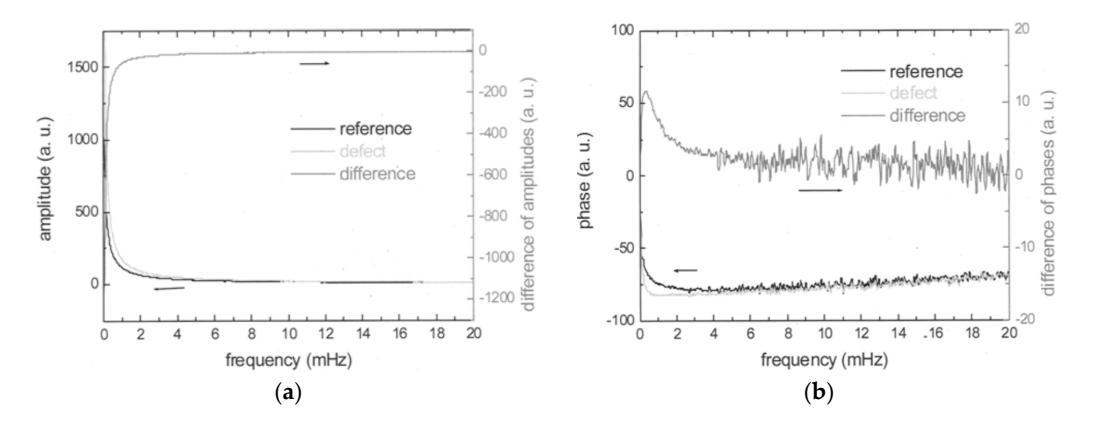
Figure 3. (a) Amplitude spectra; and (b) phase spectra of transient curves [7] (courtesy of Springer).

Maierhofer *et al.* and Weritz *et al.* showed the transient temperature curves for which the FFT was calculated. The amplitude spectra and phase spectra are shown in Figure 3 [7,32].

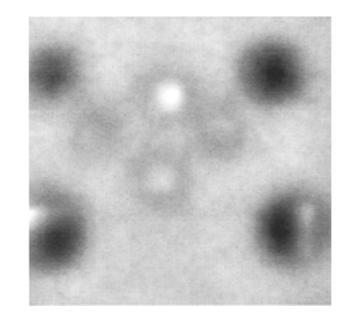
Figure 5. Phase image of the concrete specimen, frequency 0.14 mHz [7] (courtesy of Springer).

Both images, corresponding to the lowest frequency (0.14 mHz), provide the best visibility of all defect areas (Figures 4–6). For higher frequencies, deeper defects become indiscernible. Additionally, phase images show the defects with better contrast compared to amplitude images at the same frequency, especially the deepest defects [7]. Defects with a tilted orientation in respect to the surface were also identified in phase images, as they seem to be half black and half white (Figure 5).

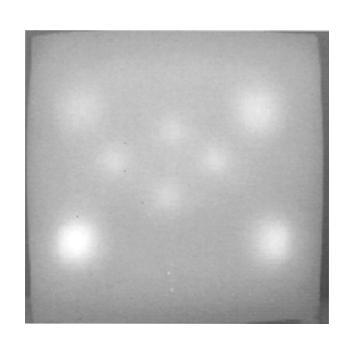
Figure 6. Thermal image of the concrete specimen, 39.7 min [7] (courtesy of Springer).

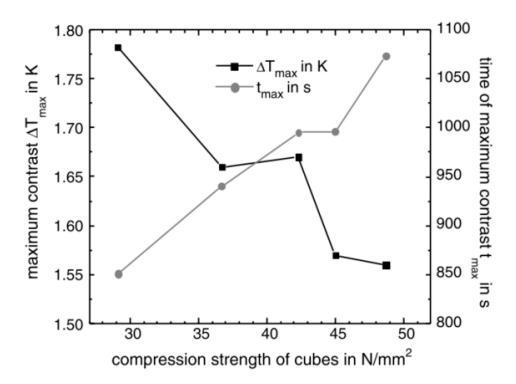
**Figure 7.**  $\Delta T_{max}$  and  $t_{max}$  as a function of compression strength, heating duration: 30 min [9] (courtesy of Elsevier).

In Figure 7,  $\Delta T_{max}$  and  $t_{max}$  are displayed as a function of compressive strength (for a heating duration of 30 min). It was shown that with increasing strength, the contrast decreases slightly while the time of the maximum contrast increases. This is more or less consistent with a decrease of thermal conductivity as outlined in the results of numerical simulation [9]. In Figure 8, the simulated maximum

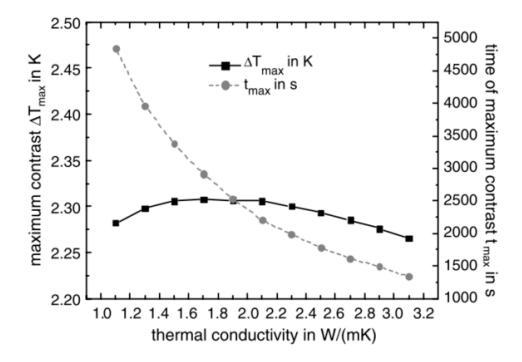
**Figure 8.** Simulated  $\Delta T_{max}$  and  $t_{max}$  depending on thermal conductivity of bulk concrete, simulated heating duration: 30 min [9] (courtesy of Elsevier).

temperature difference  $\Delta T_{max}$  and the time  $t_{max}$  at which this maximum contrast appears are presented for different thermal conductivities. Here (Figure 8), thermal contrast is nearly independent of the thermal conductivity. With decreasing thermal conductivity, the time of the maximum increases drastically. However, the quantitative values are different: simulated  $\Delta T_{max}$  as well as the  $t_{max}$  are larger than the measured ones shown in Figure 7.

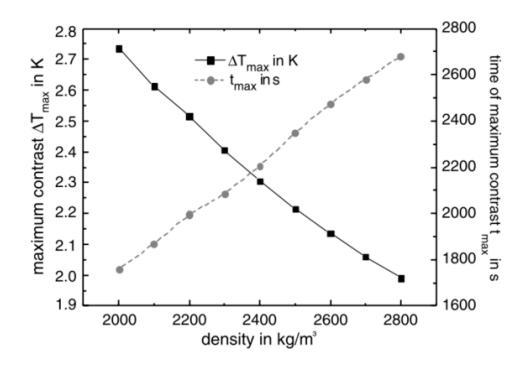
**Figure 9.** Simulated  $\Delta T_{max}$  and  $t_{max}$  depending on density of bulk concrete, simulated heating duration 30 min [9] (courtesy of Elsevier).

The influence of the density has also been simulated in [9], where the reduction of the density proved to have a larger influence on  $\Delta T_{max}$  and a smaller influence on  $t_{max}$  as shown in Figure 9. For specimen made with porous aggregates,  $\Delta T_{max}$  as well as  $t_{max}$  increase clearly (Figure 10). It is also shown that the effects of increased density and increased thermal conductivity superimpose each other [9].

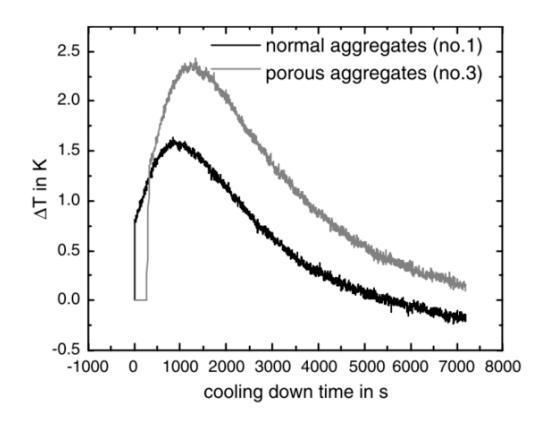
**Figure 10.** Temperature transient difference curves of same void, for test specimen with normal and porous aggregates recorded one year after concreting, heating time 30 min [9] (courtesy of Elsevier).

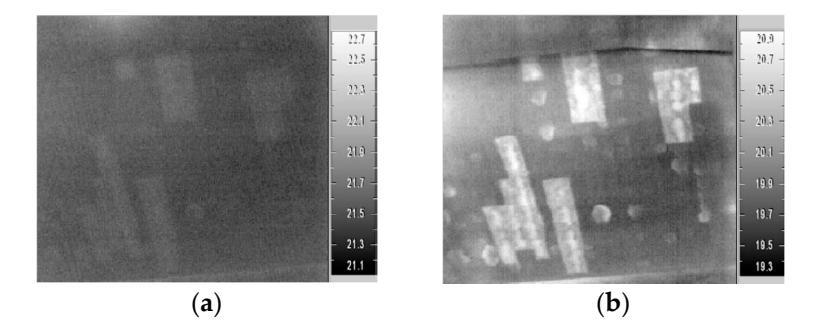
**Figure 11.** (**a**) "Passive" IR image obtained before irradiation. (**b**) Pseudo-temperature IR image [41] (courtesy of Elsevier).

IR images were obtained during irradiation time of 950 s. Figure 11 compares the image taken under natural excitation (in the literature, it is referred to as passive), and the pseudo-temperature image obtained after the image processing as described in [41].

It can be seen from paper [41] that the image processing procedure shown in the study is highly effective at obtaining a high-contrast IR image and is more useful than the conventional IRT method which uses natural excitation to conduct inspections of elevated structures. On the other hand, the authors cannot precisely know the depth and nature of the defects.

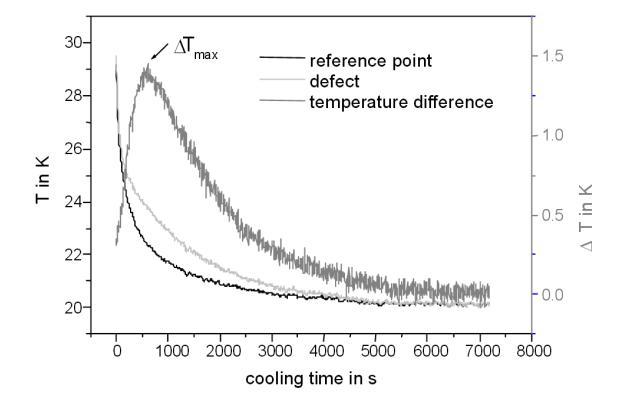
**Figure 12.** Transient curves above a reference point and above a defect and the respective difference curve with a maximum temperature  $\Delta T_{max}$  at a distinct time  $t_{max}$  [9] (courtesy of Elsevier).

inhomogeneities. These selected transient curves were compared and difference curves (difference between transient above the void and transient above the sound area) were calculated. The difference curves (Figure 12) usually have a maximum of the temperature difference  $\Delta T_{max}$  at a distinct time  $t_{max}$ , which depends mainly on the difference of thermal properties, depth of the void and the heating time [30].

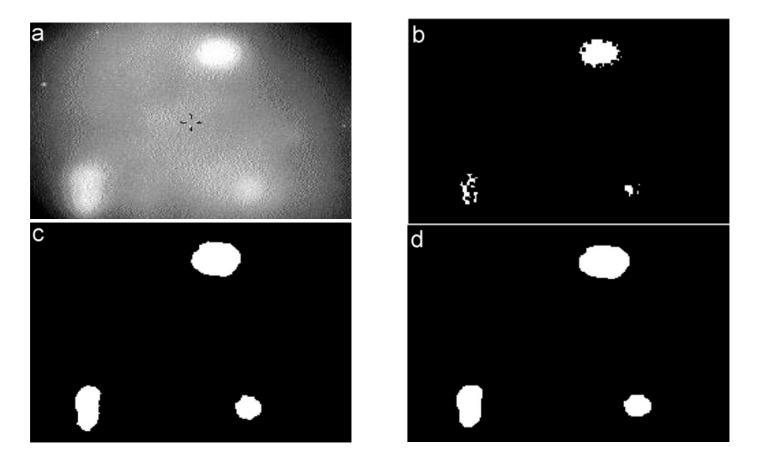
**Figure 13.** Segmentation results of: (**a**) original image; (**b**) seed image; (**c**) modified SRG algorithm; and (**d**) modified SRG with morphological operation [50] (courtesy of Elsevier).

approach, which segments the image and identifies the voids without human interference or prior knowledge of the conditions. The algorithm was tested on images collected from concrete bridge deck specimens containing various manmade defects and also on a defect-free control model. The experimental work successfully identified defects in concrete bridge decks up to 7.62 cm below surface using IRT (Figure 13 [50]).

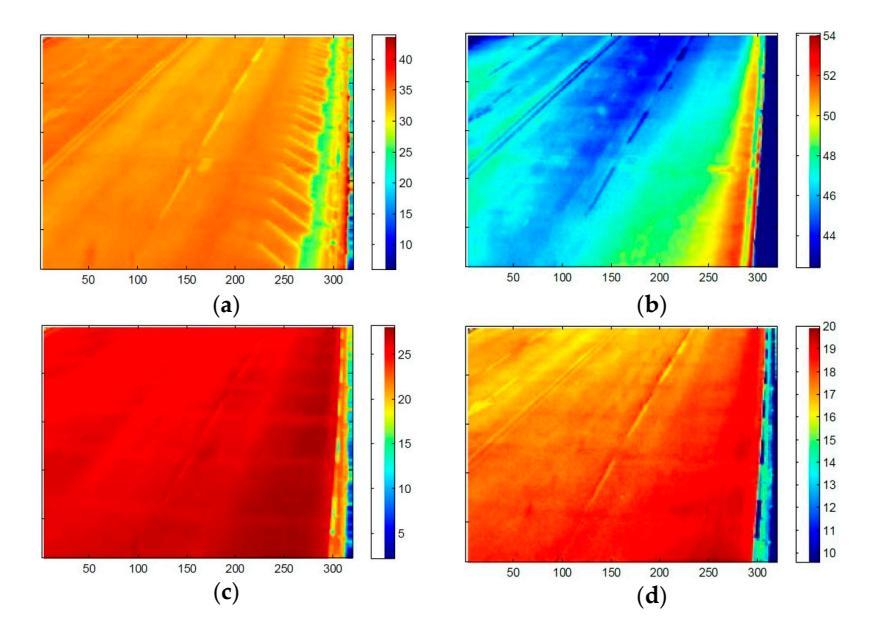
**Figure 14.** Example of Thermal images at different moment of the day-night cycle: (**a**) end of thermal relaxation; (**b**) end of temperature rising; (**c**) during thermal loading; and (**d**) during thermal relaxation [51] (courtesy of J. Dumoulin).

Dumoulin and Averty [51] developed a system which enables remotely controlled monitoring and surveillance as well as real time data imaging of the critical transport infrastructures. The data were gathered during four days (Figure 14), after which FFT was performed on the sequence of thermograms, which enabled the researcher to get an insight in the inner deck structure (Figure 15).

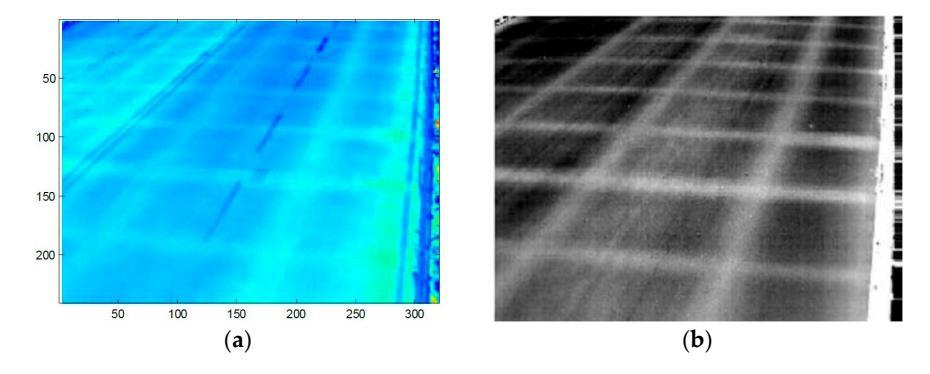
**Figure 15.** (**a**) Example of amplitude maps after FFT analysis; and (**b**) third empirical orthogonal function (EOF) after SVD analysis [51] (courtesy of J. Dumoulin).

Investigation on inner deck structure were also done by using Singular value decomposition (SVD), allowing to extract the spatial and temporal information from a thermal image sequence (Figure 15).

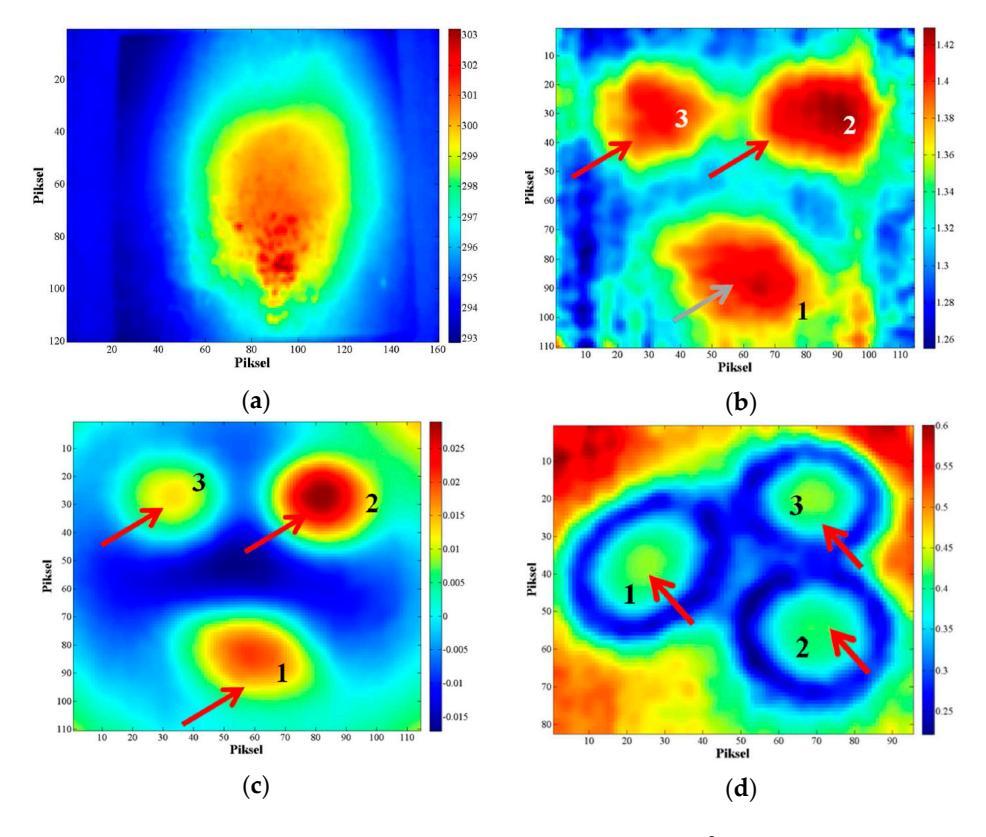
**Figure 16.** (a) Thermogram; (b) Phasegram,  $f = 1.301 \times 10^{-3}$  Hz; (c) PCT—EOF<sub>3</sub>; and (d) Correlogram [25] (courtesy of B. Milovanovic).

to thermograms (Figure 16). From the images presented by [25], it is evident that the existence of reinforcement affects the possibility of detecting defects and its characterization (size and shape). The contrast between the defect located behind reinforcement and the sound area is smaller thus decreasing its detection possibility.

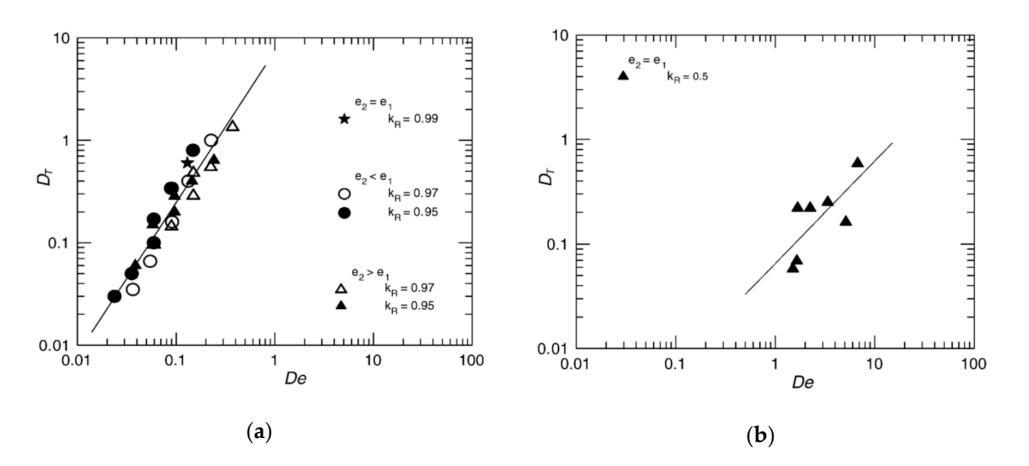
**Figure 17.**  $D_T$  against  $D_e$  for: (a)  $k_r = 0.95-0.99$  (*i.e.*, air in concrete); and (b)  $k_r = 0.5-0.9$  (*i.e.*, water in concrete) [57] (courtesy of Elsevier).

The practical significance and usefulness of  $D_e$  is that it allows a rapid estimation of the thermal contrast caused by a certain defect inside a specific material during the thermal stimulation [57].

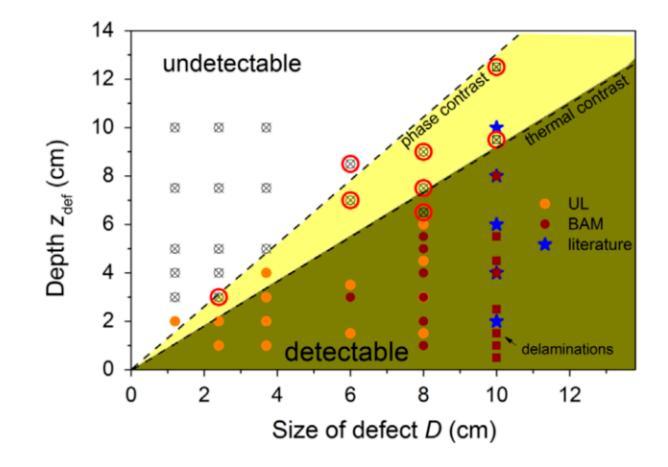
**Figure 18.** Detectability parameter pairs (D,  $z_{def}$ ) for void and delamination detection in concrete [58] (courtesy of Elsevier).

The applicability and limitations of void and delamination detection below concrete cover, using active IRT with the thermal contrast and phase contrast evaluation techniques, have been studied experimentally by [58]. It was concluded by Cotič *et al.* that the optimal heating time depends strongly on the experimental set-up used, and on the geometry of the investigated specimen. The main result of the work performed by [58] is the detectability graph shown in Figure 18.

The authors in [58] emphasize that this scheme (Figure 18) is only valid in the case of heating energies that are typically generated by the heat sources described in the paper, and for IR cameras having a medium performance range. It is also stated in [58] that by applying the thermal contrast method, it is possible to detect defects of size *D*, if the defect is covered by a layer of concrete cover having a thickness of 0.9*D* or less. On the other hand, by applying the phase contrast method, it is possible to observe defects beneath somewhat deeper layers of concrete ( $\approx 1.3D$ ), which represents an improvement of almost 50% compared to that achievable by the thermal contrast method [58].
