# Close Range Photogrammetry and Thermal Imagery in Monitoring of Soil Moisture in Dam Structures of Historical Fishponds <sup>+</sup>

**Abstract:** Degradation of reservoir dams can lead to water percolation through dam structure. Here, close-range photogrammetry and UAV (Unmanned Aerial Vehicle) thermal imagery can be used to monitor differences in dam moisture. The article presents a study of the dam of Podvinak Fishpond (Czech Republic). The TDR (Time Domain Reflectometry) data (soil moisture), the Theta probe data (soil moisture), and the temperature data of the dam top profile and the grassed area below the dam were compared. Analysis focused on the comparison between sampled data, and UAV data obtained by Optris TIM 450 (Portsmouth, USA) and Flir Tau2 336 (Wilsonville, USA) IR cameras. Based on the study, the spectral resolution, the accuracy of the results, and the reliability of both UAV monitoring systems is similar.

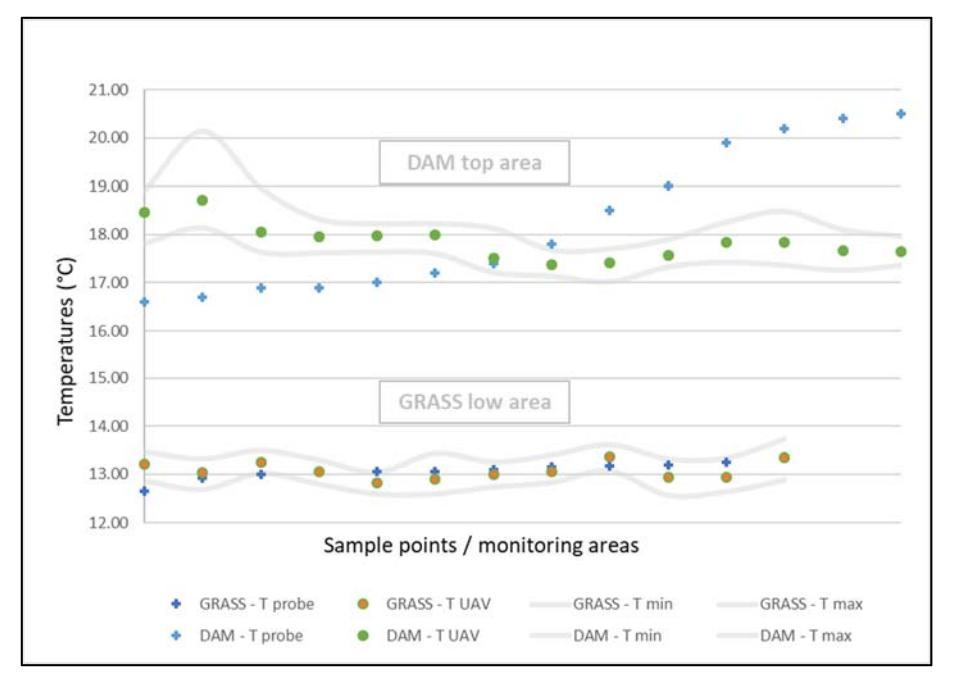
Figure 4. Comparison of measured/monitored temperatures.

The measured and monitored temperatures of the GRASS area relate relatively well. The grass in the area was low cut, with minimal color differences influencing the UAV monitoring, but also with low temperature variability (only 0.8 °C for probe data). The pixel-based analysis of UAV data showed range of temperatures in 1 m perimeter zones (grey lines in Figure 4). There we can see higher variability of pixel data, pointing to outliers in the images and warmer local grass sods. Much lower is the correspondence of the Probe data and UAV data for the DAM top. The problem here is with temperature dropping down significantly during sample taking just around the dusk time. The 5 sample replications in each area were time consuming and as the DAM top was dry and nonvegetated, the top-soil temperature was dropping down during profile measurement (total temperature change being about 4 °C shows the necessity to carefully control experiment conditions in every campaign of similar purpose). The UAV survey was made much faster. Therefore the DAM top temperature as monitored by UAV varies only in the range of 1.3 °C. Looking at variability on a pixel-basis we can see maximal difference of 3 °C in the monitored 1 m perimeter zones (grey lines in Figure 4).

The TDR data (soil moisture), the Theta data (soil moisture), and the temperature data of the DAM profile 1, along with the GRASS data were plotted together. To compare with UAV measured temperatures, instead of local values—that have high spatial variability and not exact spatial positioning as mentioned above—the average temperatures in 1 m buffer zones corresponding to probe positions were used (Figure 3). For thermal imagery one always must avoid sun-lit surfaces. Despite focusing on UAV monitoring during a dusk time, and with no direct sun light over the area, the original non-calibrated UAV IR signal differed to probe-measured temperatures on average by more than 3 °C in the GRASS area (Optris TIM 450 data), and even for more than 6 °C in the DAM area (Flir Tau2 336 data). The problem of the DAM area was that temperature dropped down during the probe measurement, while the UAV survey was performed quickly when the temperature was already consolidated during a sunset time. For comparing the relative differences, the UAV average temperatures in the zones were first corrected (normalized) as per the average temperature of the probe data from GRASS and DAM, respectively. Final temperature comparison of all datasets is presented in Figure 4.

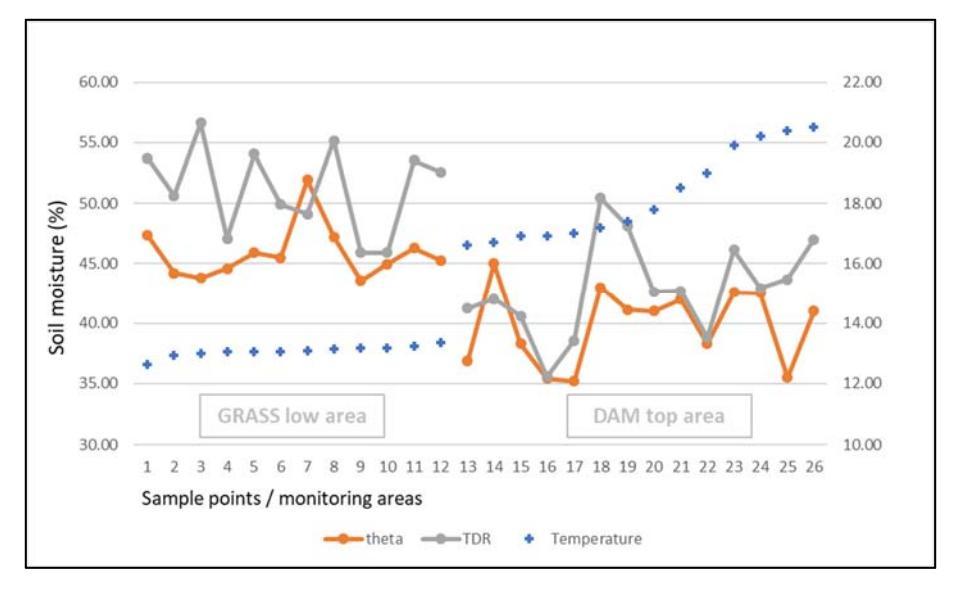
Figure 5. Comparison of soil moisture and temperature.

The results show rather high differences between the two moisture monitoring systems, but the general trend is followed by both devices. The moisture is also related to surface temperature as supposed, we can see the variability difference between the average temperature of the DAM top and the GRASS area. The trend is opposite to the water content; the dryer surface is generally warmer (Figure 5).

The TDR data (soil moisture), the Theta data (soil moisture), and the temperature data are presented as averages of 5 replications in each monitored sample area ( $0.5 \text{ m} \times 0.5 \text{ m}$ ).
