Article Impact Performance and Bending Behavior of Carbon-Fiber Foam-Core Sandwich Composite Structures in Cold Arctic Temperature

Abstract: This study investigates the impact performance, post-impact bending behavior and damage mechanisms of Divinycell H-100 foam core with woven carbon fiber reinforced polymer (CFRP) face sheets sandwich panel in cold temperature Arctic conditions. Low-velocity impact tests were performed at 23, -30 and -70 °C. Results indicate that exposure to low temperature reduces impact damage tolerance significantly. X-ray microcomputed tomography is utilized to reveal damage modes such as matrix cracking, delamination and fiber breakage on the CFRP face sheet, as well as core crushing, core shearing and debonding in the Polyvinyl Chloride (PVC) foam core. Post-impact bending tests reveal that residual flexural properties are more sensitive to the in-plane compressive property of the CFRP face sheet than the tensile property. Specifically, the degradation of flexural strength strongly depends on pre-existing impact damage and temperature conditions. Statistical analyses based on this study are employed to show that flexural performance is dominantly governe

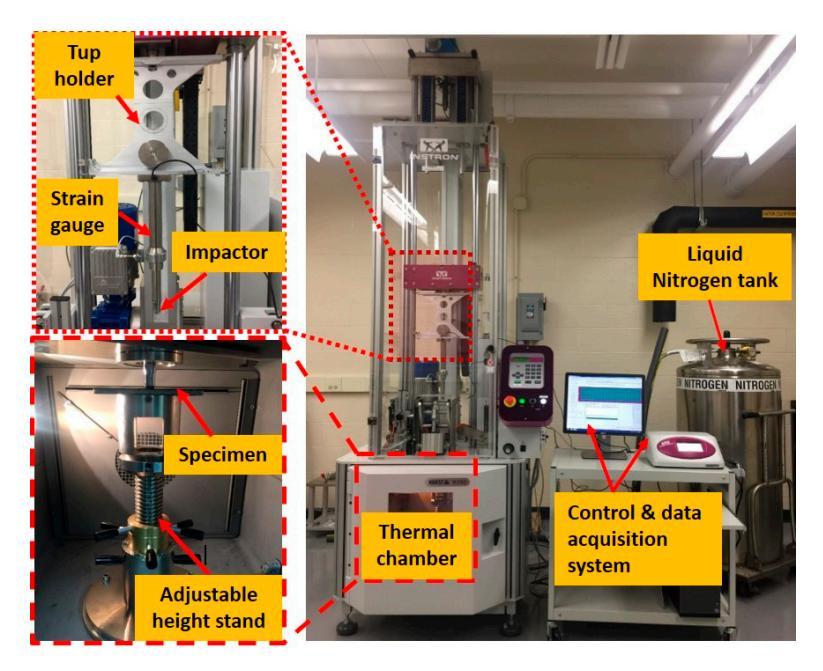
Figure 1. Experimental setup for impact test with Instron CEAST 9350 drop tower that is equipped with a thermal chamber for low-temperature testing and a control and data acquisition system to capture force, time, displacement and energy impact data.

The Instron CEAST 9350 drop tower, having a 16 mm diameter hemispherical impactor as shown in Figure 1, was used for the impact. The specimen was placed on a cylindrical support frame with a window of 76 mm diameter. Specimen was clamped with 100 N clamping force to avoid any tilt or distortion during impact. A 3.482 kg striker was raised to a height of 0.234 m and 0.117 m and subsequently dropped with impact velocities of 2.14 m/s and 1.52 m/s, respectively, to generate 8 J and 4 J impact energy. These energy levels were chosen such that the lower energy of 4 J damaged only the front face sheet, and 8 J impact penetrated the front face sheet and incurred damage to the core. Strain gauges were present inside the tup that was connected to the steel impactor. The strain measurements over the duration of the impact event provided the displacement of the impactor (deflection of the specimen), which were subsequently integrated to calculate the velocity and acceleration profiles, and thereby the force measurements. All these data were captured and measured by the DAS64K data acquisition system of Instron CEAST 9350 impact machine. Specimens were tested at 23, -30 and -70 °C. The temperature of 23 °C was selected as the benchmark case for room temperature, while -30 and -70 °C are the average and lowest temperature in the Arctic region, respectively [18]. A thermostatic chamber cooled by liquid nitrogen was used for low-temperature testing. At least four specimens were tested for each case.

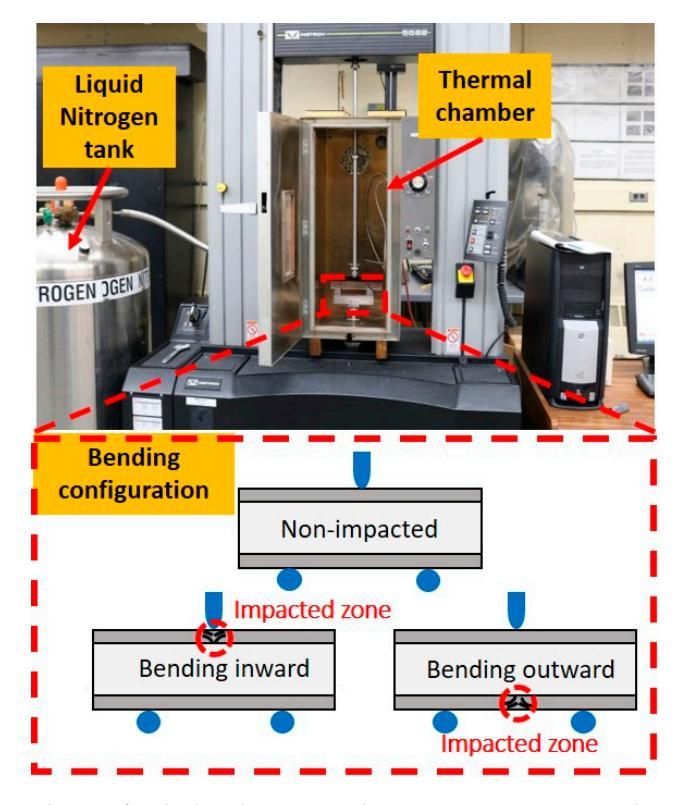
Figure 2. Experimental setup for the bending test with an Instron 5582 universal testing machine that is equipped with thermal chamber for low-temperature static testing. Schematic illustrates three bending configurations during bending test: nonimpacted case; bending inward case where impact damage is at top face sheet; bending outward case where impact damage is at bottom face sheet.

Post-impact bending tests were conducted to investigate the residual flexural strength of sandwich structures as shown in Figure 2, using the Instron 5582 machine following ASTM C 393 standard with a crosshead speed of 0.5 mm/min. Samples were tested at a room temperature of 23 °C and cold temperatures of -30 and -70 °C using an environmental chamber cooled by liquid nitrogen. The specimen was tested such that the impacted face sheet experienced either compression (inward) or tension (outward). These orientations were chosen to resemble actual service conditions, whereby depending on the supports, the composite structure could either bend concave or convex after being subjected to impact. In all cases, at least two specimens were tested under each condition.

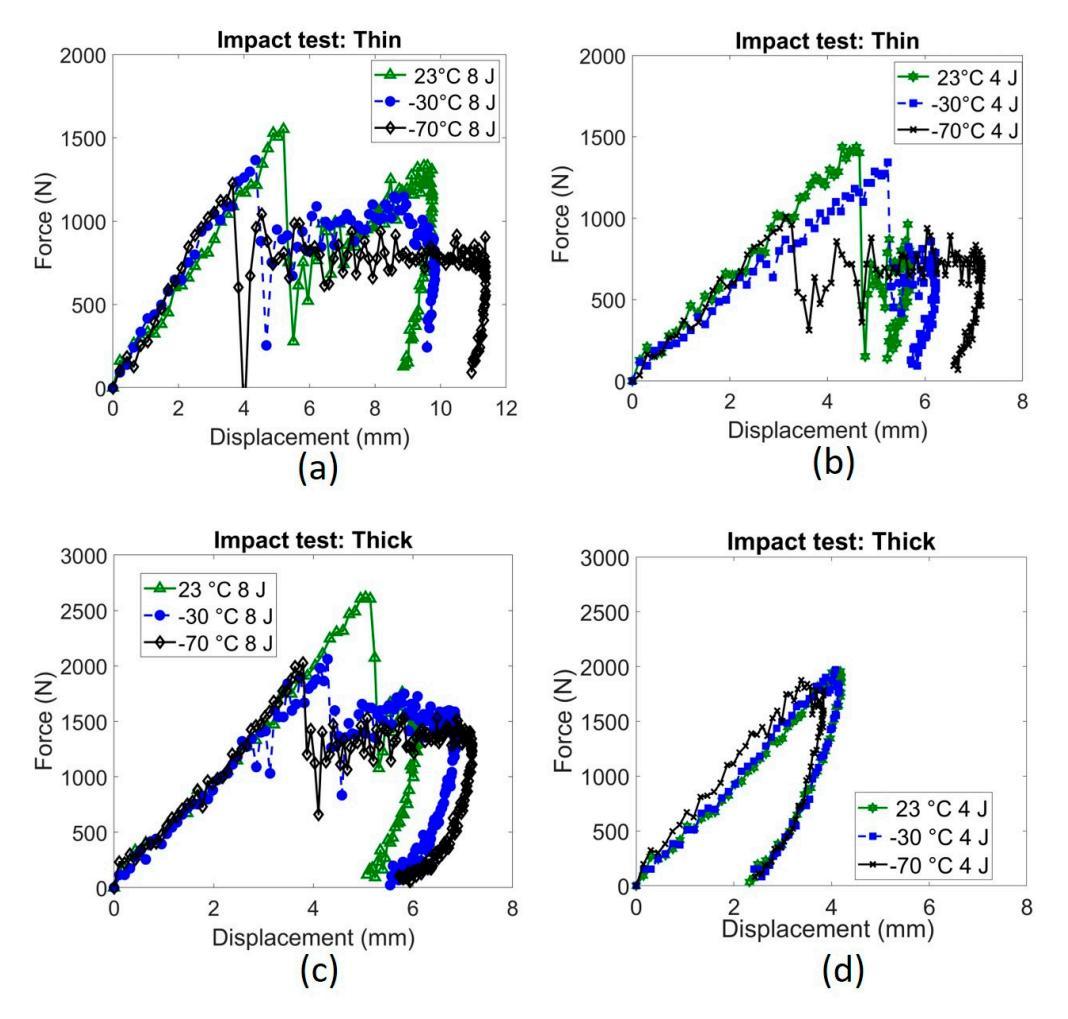
Figure 3. Impact force-displacement plots for (a) thin 8 J; (b) thin 4 J; (c) thick 8 J; (d) thick 4 J.

Representative force-displacement plots for both thick and thin specimens impacted with 4 J and 8 J at different temperatures 23, -30, and -70 °C are presented in Figure 3. The sampling rate used during the impact test was 100 kHz for data acquisition, which gave sufficient precision and accuracy in the measurement of low-velocity impact tests. The markers in Figure 3 are intentionally spaced out at fixed intervals to make the curves distinguishable for different temperatures. The force-displacement curves showed linear behavior up to a certain point (defined as critical force for front face sheet damage) whereby sudden load drop indicated the failure of the front carbon fiber/epoxy composite face sheet (Figure 3a–c), except in a thick specimen impacted with low and insufficient impact energy of 4 J (Figure 3d), in which significant recovery happened along the displacement axis due to rebound of the impactor. However, for thin specimens, 4 J energy was enough to fail the front face sheet (Figure 3b). The critical forces for front face sheet penetration are shown in Figure 4. As the temperature decreased the force required for front face sheet penetration decreased for both thick and thin specimens due to the increased brittleness of the carbon fiber reinforced polymer (CFRP) face sheet. Low temperature severely degraded the composite face sheet's impact tolerance, the epoxy matrix of face sheet became exceptionally brittle, thus requiring less force for matrix cracks and brittle fracture [14,15]. A thicker face sheet offered higher resistance than a thin face sheet [5], thus thin specimen front sheets were penetrated at lower force than thick specimens. After the sudden load drop, as seen in Figure 3a-c, impact force continued to rise over time due to foam densification and finally declined until the end of the impact event with significant permanent deformation (Figure 3a–c) and rebound (3d). Moreover, with a decrease in temperature, the permanent displacement induced by impact for thin (4 J and 8 J) and 8 J for thick specimens of force-displacement plots generally increased, indicating more damage at lower cold temperatures. The 4 J thick specimen did not show this trend because the impact did not induce sufficient damage to the front face sheet.

The area under the curve in Figure 3 represents the energy absorbed by the damaged specimen and is shown in Figure 5. With the increase of impact energy, Figure 5a, and a decrease in temperature, Figure 5b, the percentage of energy absorbed increased, thereby indicating greater damage induced by impact at low temperature. The absorbed energy was also more sensitive to temperature change at low impact energy level (4 J) compared to higher impact energy (8 J) (Figure 5b) where absorbed energy had reached a high consistent percentage of more than 90%.

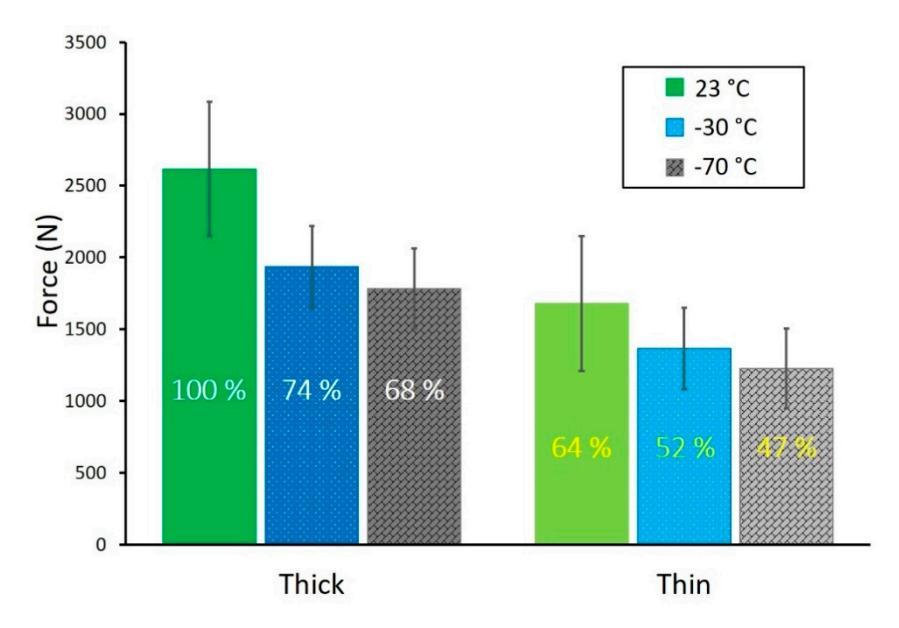
Figure 4. Critical front face sheet damage force for 8 J impact energy.

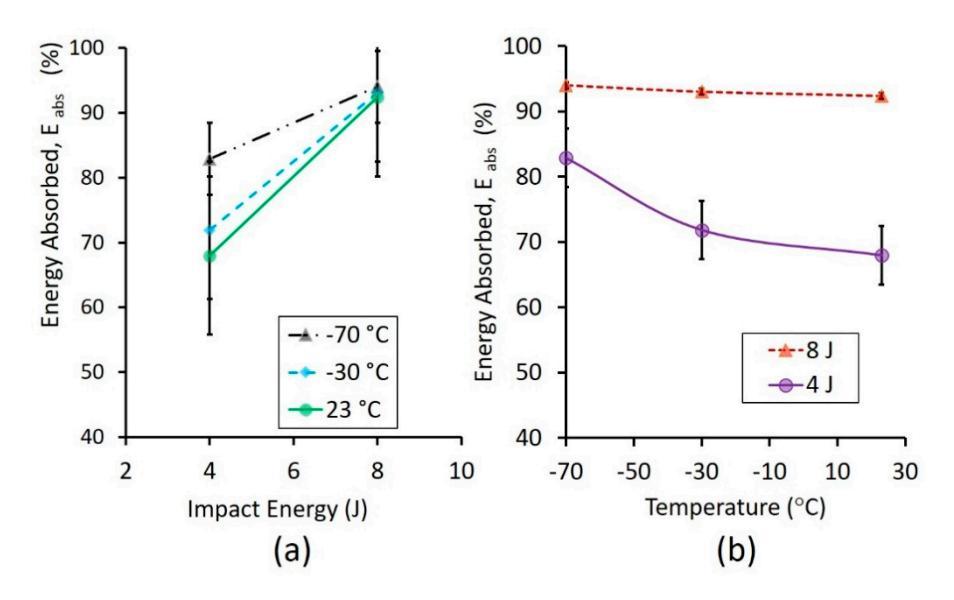
Figure 5. Thick specimens impacted with specified impact energy: (**a**) energy absorbed against impact energy; (**b**) energy absorbed against test temperature.

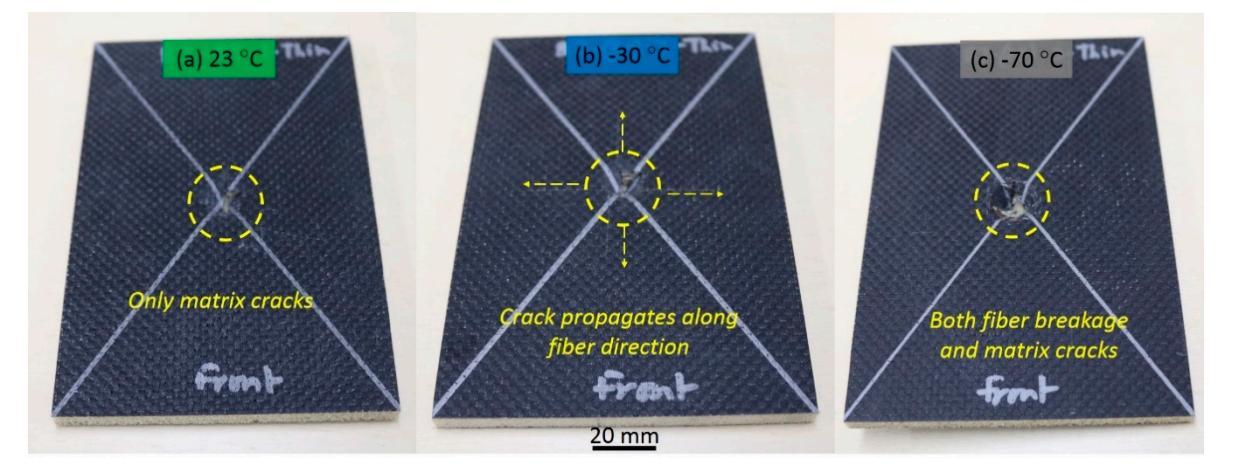
Figure 6. Impact damage (8 J) for thin face sheet sandwich composites at: (a) $23 \degree C$; (b) $-30 \degree C$; (c) $-70 \degree C$.

Visible impact damage for thin specimens impacted with 8 J impact energy are shown in Figure 6. At 23 °C (Figure 6a), the damage was limited to localized matrix cracking only; while at -30 °C, matrix cracks were propagated deeper and longer both vertically and horizontally along the 0/90° woven fiber directions of the face sheet (Figure 6b). At the most extreme condition of -70 °C (Figure 6c), severe damage of matrix cracks and fiber breakage occurred, indicating face sheet penetration. X-ray µCT images are exhibited in Figure 7. At 23 °C (Figure 7a) the front face sheet suffered delamination and matrix failure, though partial penetration was observable. This ultimately led to fiber breakage at the front face sheet. Beyond front face sheet penetration, foam core damage was characterized by two mechanisms: core densification and core shearing. Core densification occurs due to high compressive normal stress loading under the impact region. Core densification is induced either by front face sheet compression to the core or by impactor tip compressing the core.

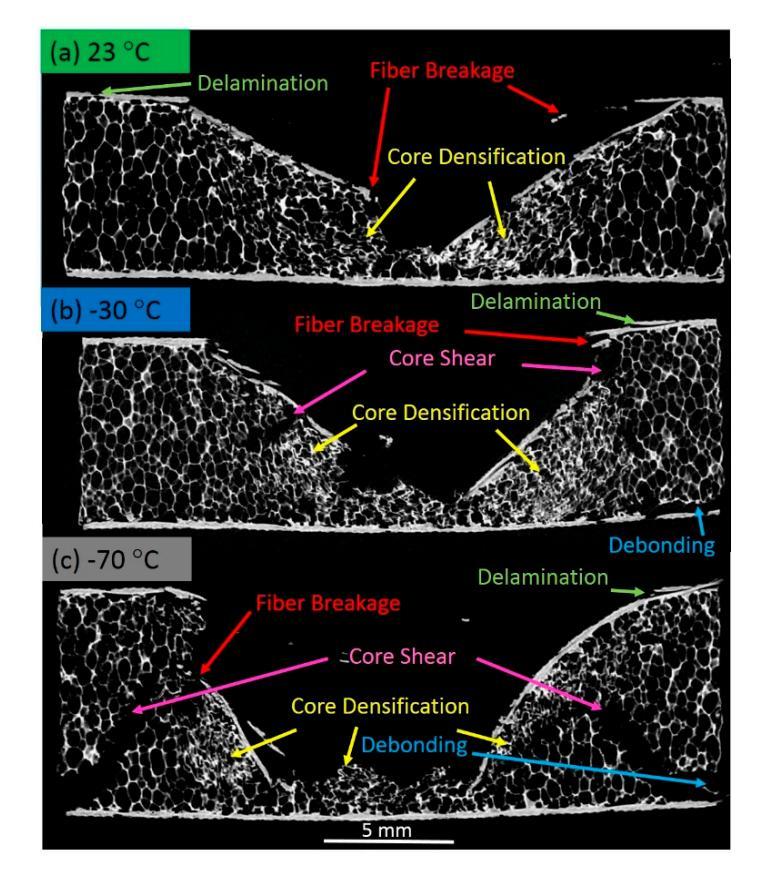
Figure 7. Post-impact μCT images of impact center for thin face sheet sandwich composites impacted with 8 J impact energy at (a) 23 °C; (b) -30 °C; (c) -70 °C.

As depicted in Figure 7a,b, core densification was dominated by the impacted front face sheet compression at 23 and -30 °C, whereas densification occurred near the bottom face sheet due to impactor tip compression (no severe back face sheet penetration) at -70 °C (Figure 7c). At -30 °C, core densification became prominent and led to the onset of core shearing (Figure 7b). Core shear is defined by the propagation of crack forming shear bands with a 45° angle across the core thickness. Thus, the shear bands propagate conically from the impact face sheet side into the foam core layer, as portrayed in Figure 7b,c. Core shear eventually results in debonding of the core from the back face sheet (Figure 7b,c). As the temperature decreases, foam core material becomes extremely brittle whereby cracks can propagate easily [22], and core shear stress increases [23], which subsequently leads to severe core shear failure at extreme low-temperature -70 °C (Figure 7c). The damage modes of core crushing and densification become more evident with the decrease of temperature. The debonding area also increases with the decrease of temperature in Arctic conditions as described by Elamin et al. [24]. It is worth mentioning that this study differs from [16] with the aim to relate core shear intensity to residual flexural strength after impact.

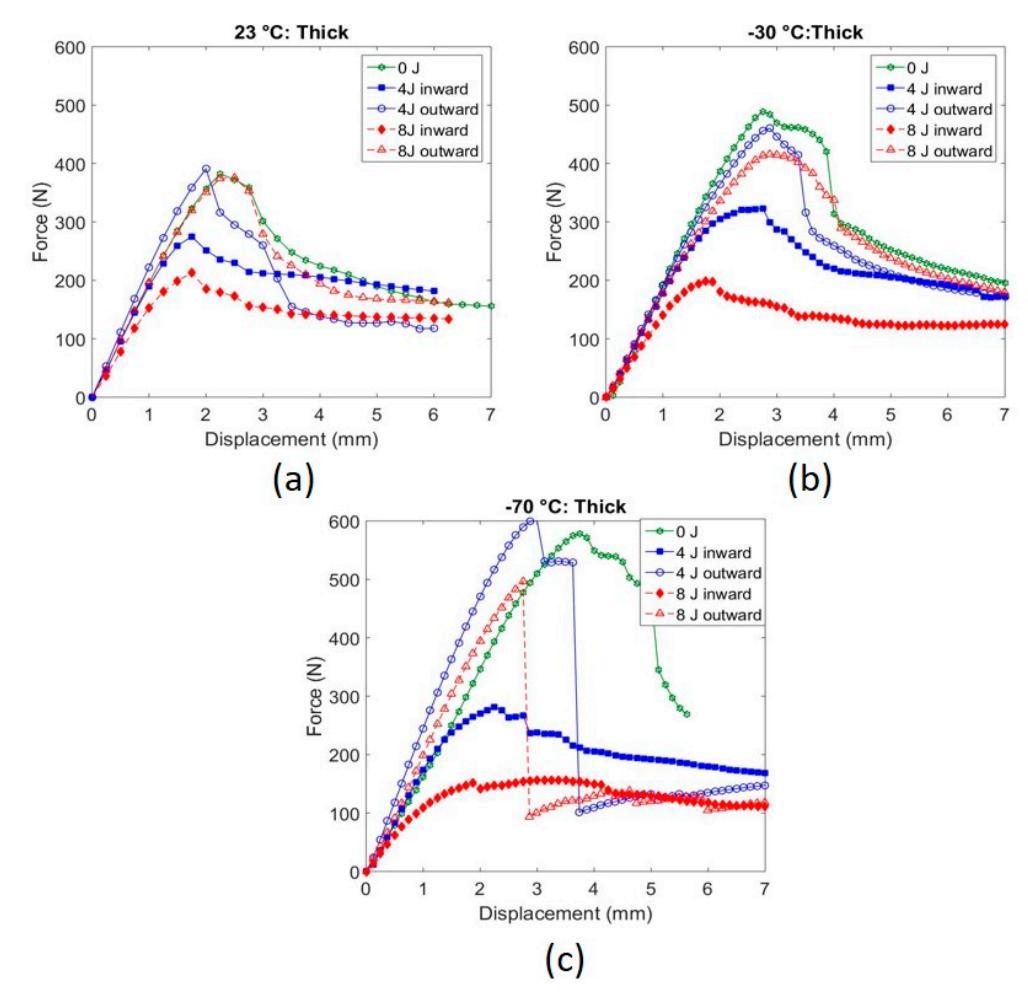
Figure 8. Force against displacement plots for thick specimens under three-point bending at (**a**) 23 °C; (**b**) -30 °C; (**c**) -70 °C.

The bending test results for post-impacted specimens compared to nonimpacted specimens are shown in Figure 8. The force-displacement curves were characterized by an initial linear elastic regime followed by a load drop. Nonimpacted specimens showed a trend of increasing peak force or flexural strength for decreasing temperature. The thick specimens broke catastrophically for bending outward cases at -70 °C (Figure 8c), while at other temperatures, the specimens typically exhibited a gradual decline in flexural force after the peak force. This is due to the embrittlement of the PVC core at low temperature -70 °C that facilitates core shear. Figure 9 plots the flexural peak load against pre-bending impact energy. Generally, when impact energy increases, flexural peak load decreases.

Bending outward cases perform better due to an undamaged top face sheet matrix, which can resist compressive load during bending. Although the bottom face sheet suffers impact damage, the damage is typically in the form of matrix cracking, thus the bottom face sheet can still withstand tensile load by the intact carbon fibers that are not severely damaged. However, for bending inward cases, the top face sheet has reduced compressive properties due to prior impact that damages the matrix. Therefore, the top face sheet was unable to withstand compressive stresses during three-point bending test and exhibited reduced flexural strength.

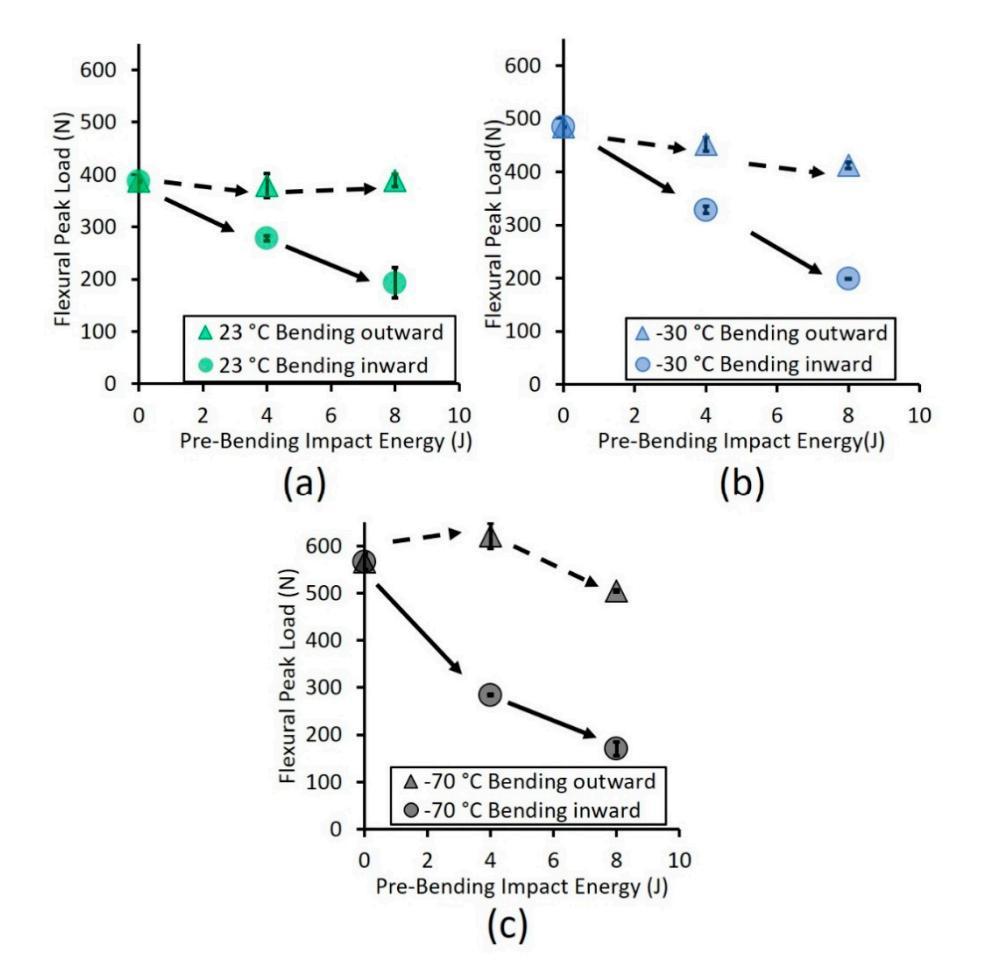
Figure 9. Effect of temperature on flexural peak load for thick impacted specimens at (a) 23 °C; (b) -30 °C; (c) -70 °C.

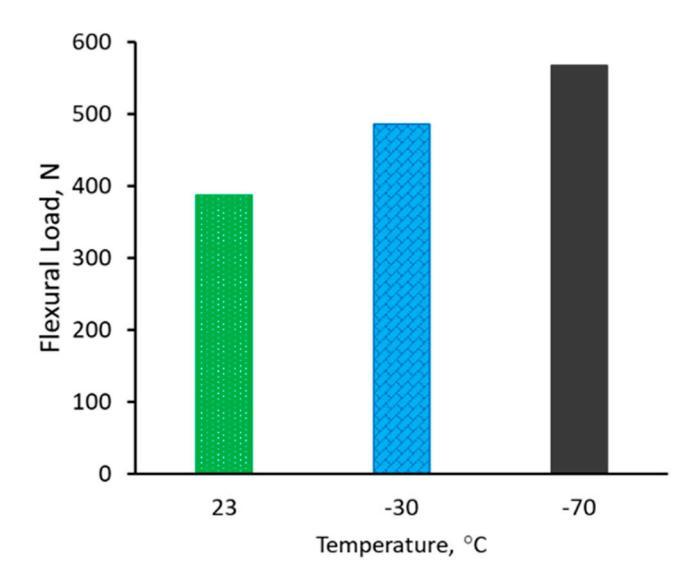
Figure 10. Flexural peak force against temperature for nonimpacted thick specimens at 23, –30 and –70 °C.

Figure 10 shows the effect of temperature on flexural peak force of the nonimpacted beams. It is interesting to note that the bending behavior seemed to exhibit more "resistance" with decreasing temperatures. This is attributed to the fact that at low temperature, the compressive strength of the front CFRP face sheet increases, which makes the nonimpacted materials perform better under flexural load. Flexural strength is also found to be increased at Arctic subzero temperature for foam structures [25].

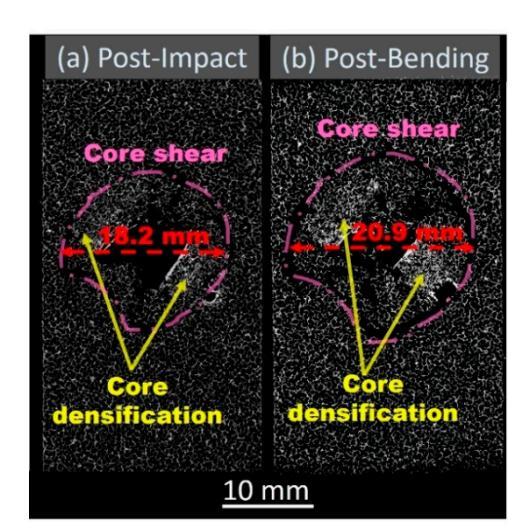
Figure 11. μCT images of foam core damage in thin face sheet composites (8 J, -70 °C): plan view at 3.5 mm from front face sheet for (**a**) post-impact; (**b**) post-bending condition.

Figure 11 depicts the plan view of μ CT images taken at 3.5 mm from the top face sheet, showing contrast in core shear intensity at impact and bending after impact cases. From the plan view, core shear appears as a ring of empty space with variable radius along the core thickness. This substantiates the previous discussion that at low temperature (-70 °C), prominent and severe core shearing occurs with an approximate diameter of 18.2 mm circulating the impact zone and gradually approaches to the back face sheet forming a 3-D conical shape (Figure 11a). However, after post-impact

bending the core shear front diameter has increased from 18.2 mm to 20.9 mm (Figure 11b), by a significant +15 %. This increase in core shearing is not associated with any new damage mechanisms. Rather, core shear front expansion occurs only due to flexural bending of the specimen.

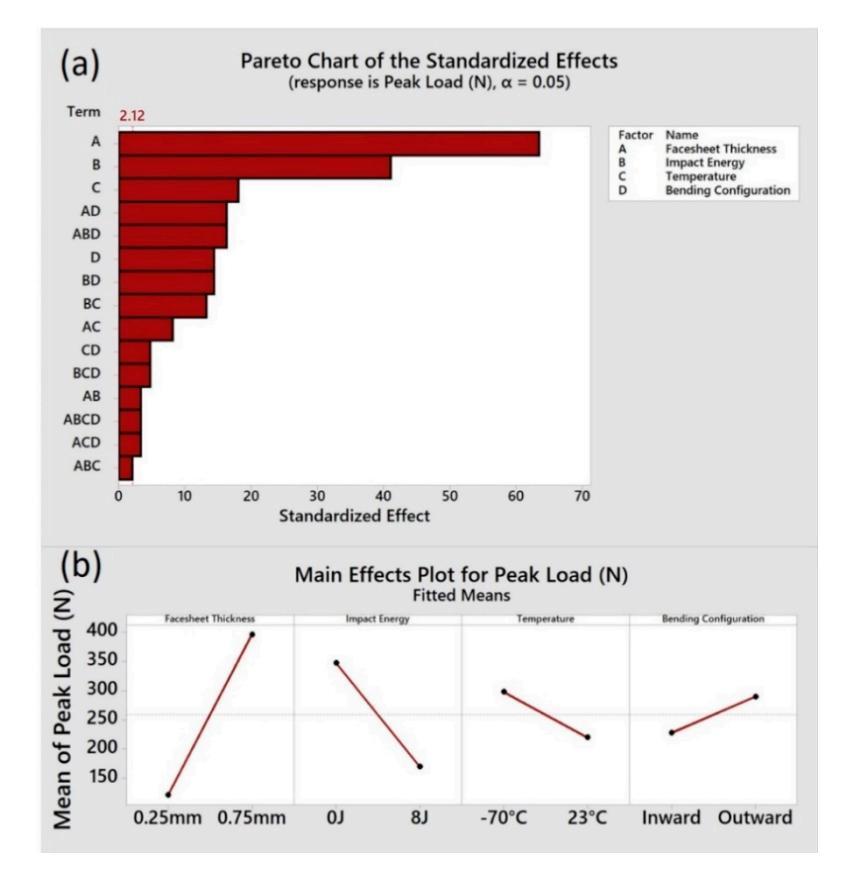
Figure 12. (a) Pareto chart; (b) main effects plot for post-impact flexural peak load.

The Pareto chart obtained from Minitab shows the absolute significance of the standardized effects from the biggest to the smallest. The reference line shows the effects which are statistically significant. Statistical software Minitab 18 yields the Pareto charts as shown in Figure 12a which indicates that face sheet thickness is the most significant factor that governs the flexural peak force, followed by pre-bend impact energy and temperature. Earlier observation in Figures 8 and 9 showed similar observations that these three factors were the prominent factors controlling flexural performance for the composite sandwich panel. Bending configuration had a much smaller effect than the other three.

The main effects plots, given in Figure 12b, which identified the influence of individual factors further validated the findings from the Pareto charts. The main effects plot provides the average data at the low and high factors. The gradient of the straight line corresponds to the significance of the factor directly. It is evident that the flexural peak force increases with increase in face sheet thickness (Th) whereas it decreases with increase in impact energy (Energ) and temperature. Inward bending shows inferior flexural performance compared to outward bending configurations. The flexural peak force is mainly influenced by face sheet thickness and impact energy whereas temperature and configuration (Conf) both have mild influences. Figure 13 portrays the interaction plot, which interprets the two-way interaction of the factors. If the slope of the two lines is not the same, there exists some interaction. It is concluded that apart from face sheet thickness and impact energy, which both are strong independent factors, all the other factors have interactions with each other.

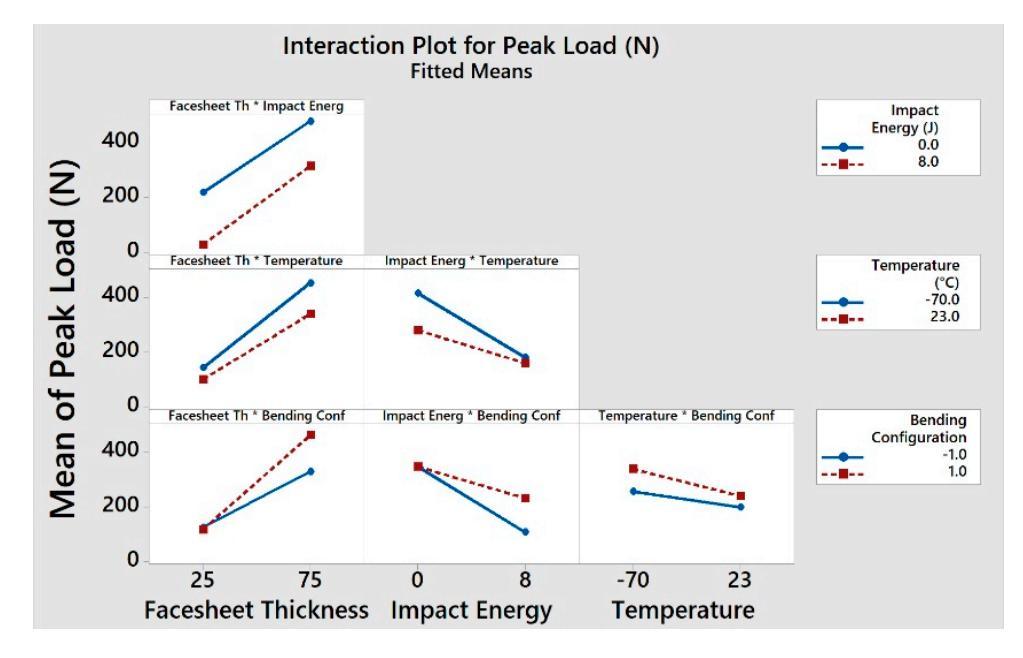
Figure 13. Interaction plot for flexural peak load, showing the interaction of face sheet thickness, impact energy and temperature on flexural force.

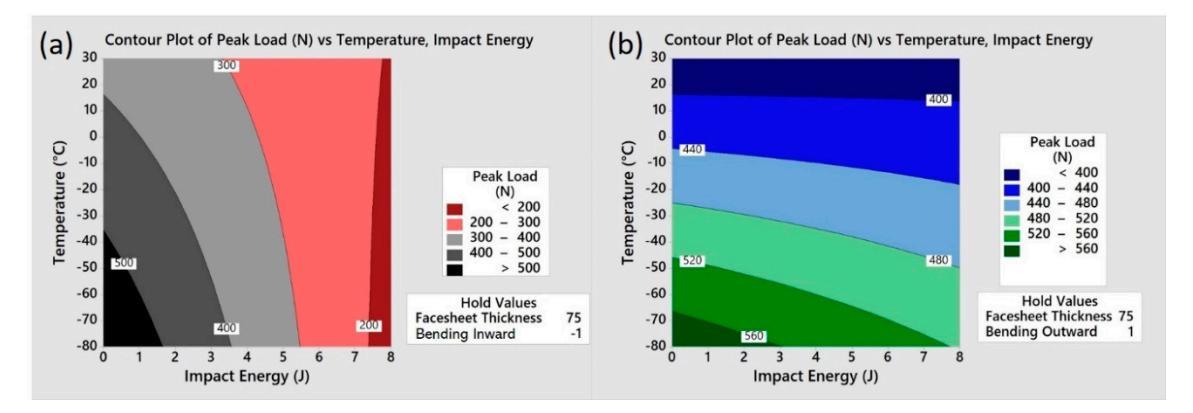
Figure 14. Contour plot prediction of flexural peak load for 0.75 mm face sheet sandwich composites under (**a**) bending inward; (**b**) bending outward configuration.

Contour plots are obtained by the constant response line projections from the response surface into the two-dimensional factor plane. Thus, the contour plot gives the prediction of impact energy and temperature on the x- and y-axes, respectively, along with contour lines for the peak load. At a specific impact energy, the contour plot can be used to graphically predict the flexural force for a particular temperature. Figure 14a shows that increasing impact energy will significantly reduce peak force for a given temperature for the bending inward case, whereas for the outward case, impact energy has a gentler influence (Figure 14b). This substantiates the experimental observation in Figure 9, as discussed earlier. Analysis of variance (ANOVA) is a statistical tool that calculates data based on the difference between two or more means. The variance within the groups and variances between the groups are compared. Subsequently, a regression equation can be obtained to describe the relationship between the response and the variables or factors. The algebraic representation of the regression equation for a linear model can be represented as:

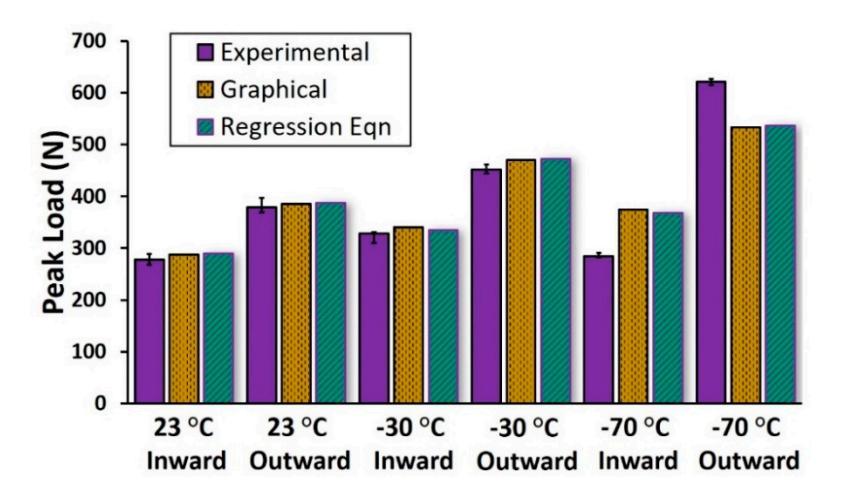
Figure 15. Statistical analysis and prediction of post-impact flexural peak load for 0.75 mm face sheet sandwich composites under 4 J impact energy.

here, *t* is the face sheet thickness, *IE* is the impact energy, *T* is the temperature and *C* is the bending configuration. Graphical prediction based on contour plot and statistical prediction based on regression Equation (3) are further compared with experimental results for flexural peak force for 4 J pre-bend impact energy at 23, -30 and -70 °C, as shown in Figure 15. Excellent agreement between experimental data and statistical prediction was observed. The greatest differences were for the -70 °C cases, where the statistical predictions deviate from experimental data. In reality, the impacted front face sheet matrix which was in compression during inward bending was severely embrittled at -70 °C [22,23] that led to flexural failure of the specimen at a much lower force. However, for the outward case, linear assumptions made by the statistical analysis underpredicted the experimental peak load, whereby the undamaged front face sheet compressive properties were enhanced at low temperature (-70 °C) and bottom face sheet tensile properties were uncompromised due to little or no damage during impact.
