# Article Stress Corrosion Cracking Behavior of Fine-Grained Al5083 Alloys Processed by Equal-Channel Angular Pressing (ECAP)

**Abstract:** In the present study, the stress corrosion cracking (SCC) behavior of ECAP Al5083 alloy was investigated in air as well as in 3.5 % NaCl solution using the slow strain rate tensile test (SSRT). The characteristics of grain boundary precipitates (GBPs), specifically the microchemistry of the SCC behavior of Al5083 alloys, both in "as-received" condition and when deformed by the ECAP process, were examined. The correlations between the SCC resistance and GBP microchemistry were examined. A microstructural evaluation was performed using an optical microscope. SCC tests were carried out using a universal tensile testing machine and the fracture surfaces were studied using scanning electron microscopy (SEM). A strain rate of  $1 \times 10^{-6}$  s<sup>-1</sup> was applied for the SSRT. As the passes increased, the SCC susceptibility of the fine-grained ECAP Al5083 alloy also increased. Moreover, higher ultimate tensile strength and greater elongation were observed. This was due to grain refinement, high-density separations, and the expanded extent

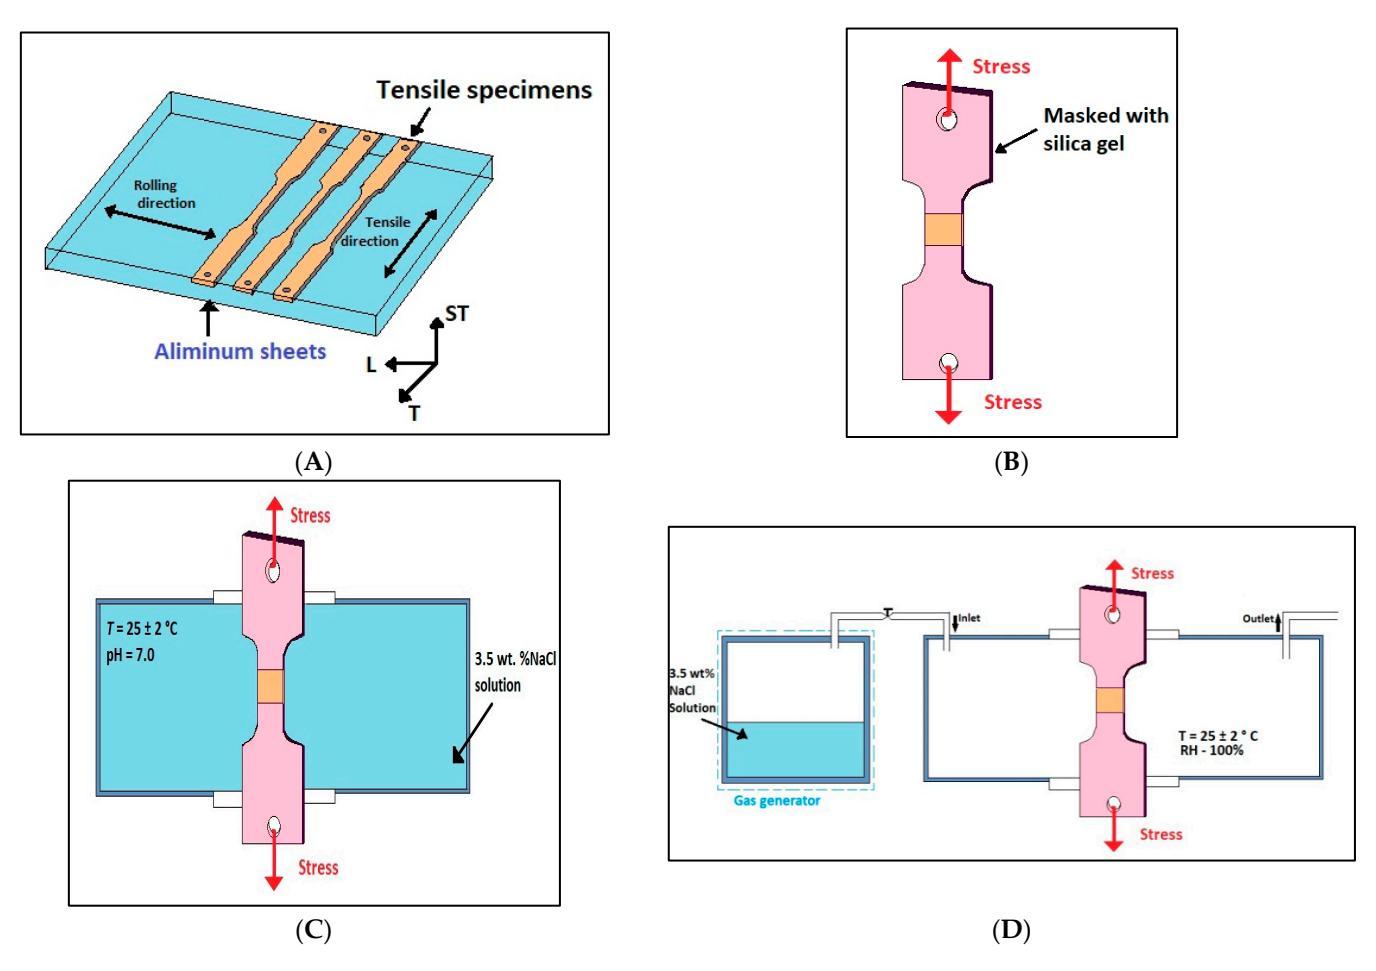
Figure 1. Schematic diagram of the sample processing (A) and preparation (B) for the SSRT tests, as well as the devices used in the tensile test for immersion in (C) air and (D) 3.5 wt% NaCl.

To test the mechanical properties and SCC characteristics, tensile samples were cut perpendicular to the rolling direction from Al alloy sheet plate, as shown in Figure 1.

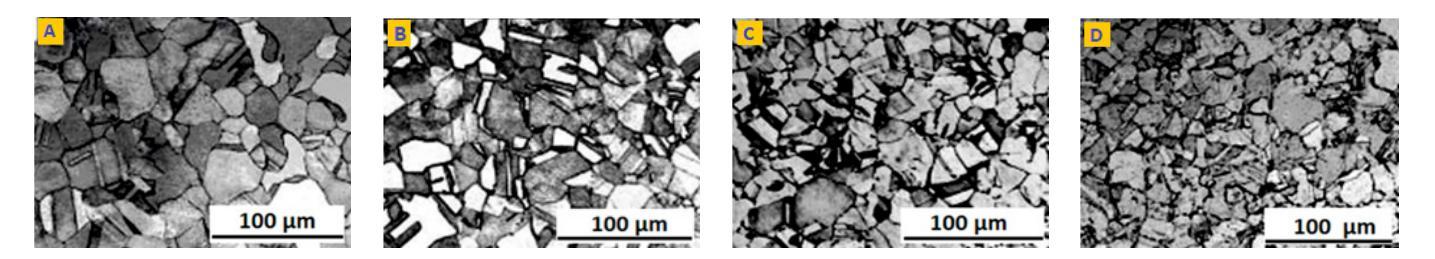
The microstructures of as-received and ECAP samples are given in Figure 2. The original alloy has a coarse grain structure. The microstructures demonstrate the fact that with a high deformation degree, microscopically homogeneous fine-grained structures are formed. A grain size of 145  $\mu$ m can be observed for the as-received sample. From there, the grain size decreases to 37  $\mu$ m after the 3rd pass. After the 1st and 2nd passes, the grain size reduces to 98  $\mu$ m and 56  $\mu$ m, respectively. The grain size determination and analysis were performed using image J software. In a previous study [58], it was shown that there was a huge expansion in elasticity of the material after ECAP. The distortion created by ECAP results in grain refinement.

**Figure 2.** Microstructure (**A**) as-received and ECAP samples of Al5083 alloy after the (**B**) 1st pass, (**C**) 2nd pass, and (**D**) 3rd pass.

In Figure 2, it can be seen that elongation occurs, while refinement of the grain is also visible. After an initial pass, there is a reduction of the grain size as the unique grains in the specimen separate into subgrain groups.

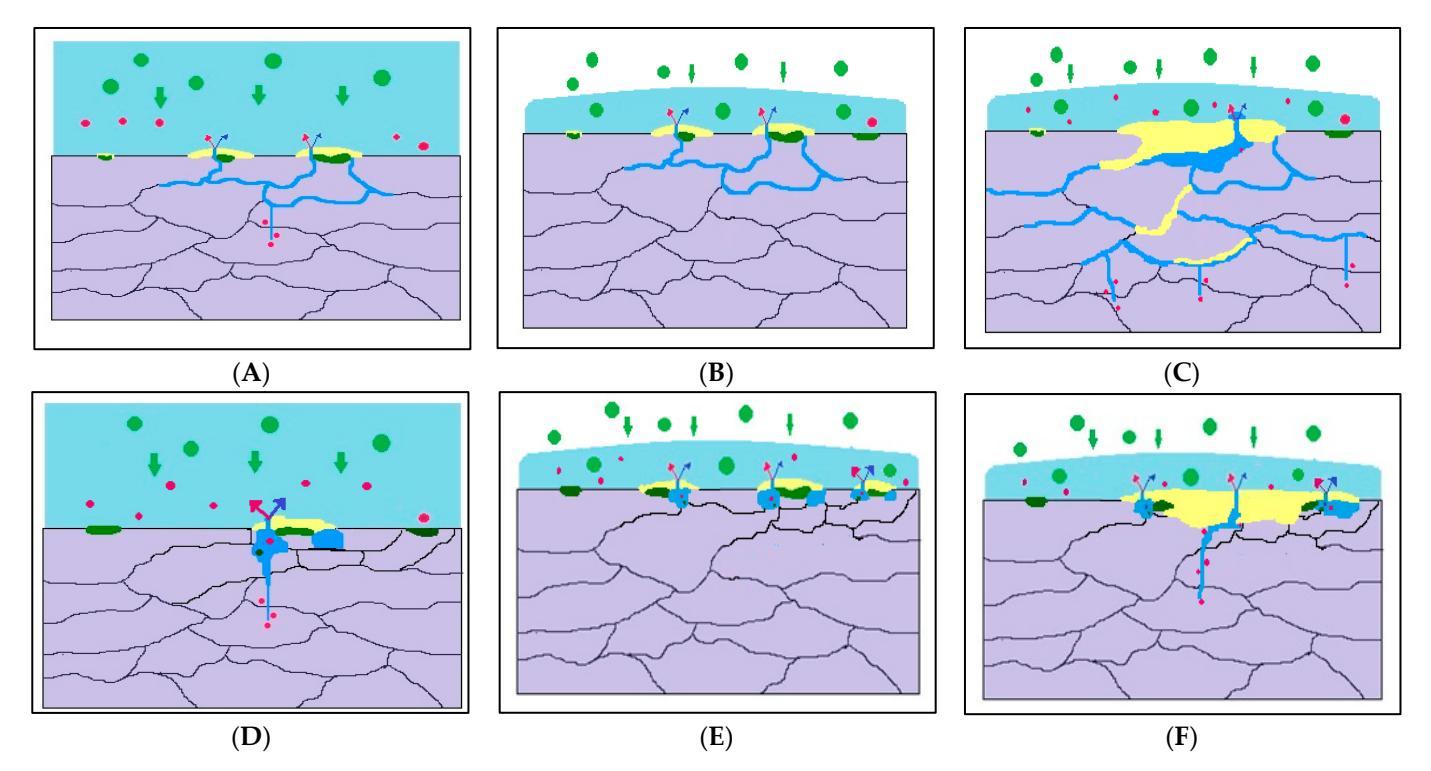
**Figure 3.** Schematic diagram of the corrosion and SCC processes of Al5083 alloy samples in 3.5 wt% NaCl solution and air environments: (**A**) microcracks are initiated under stress (**B**,**C**) subsurface attacks develop to a deeper depth (**D**) synergistic effect of stress, anodic dissolution, and hydrogen embrittlement (**E**) accelerates the anodic dissolution of aluminum alloy (**F**) Pitting groups coalesce together to form a larger corrosion site.

Kamoutsi et al. [34] reported that with the decrease in 'effective thickness', a small reduction in the UTS is observed in corroded tensile Al alloy specimens. This parameter reverts back to its original state when the corroded layer is removed [34]. In this research work, the primary corrosion product was observed. These seemed to be distributed independently in the corroded layer, causing the affected layer to remain mostly intact. The defects resulting from corrosion affected the UTS and YS (yield strength), although both UTS and YS were the same as for the Al alloy specimen in laboratory conditions. It should be noted that the reduction in 'effective thickness' does not indicate entire elongation, as the core difference is in the mechanical properties. Even after the complete removal of the corrosion layer, the elongation of the control samples was smaller than that of the corroded samples. Additionally, the removal of the corrosion was not able to restore the total deformation (elongation). The trapping of the hydrogen and the dissimilarity in the mechanical characteristics were due to the deep penetration of hydrogen in the corroded regions. Comparing the as-received sample with the more deformed sample, there were more and deeper cracks, which provided a higher volume of trapped hydrogen on account of the higher contacting surface area and the blocked environment [60]. From the results, we could predict and describe the main role of the electrochemical reaction induced by hydrogen in the environment. Initially, micro-cracks were initiated in the subsurface area of the corrosion network under stress, which was the reason for the stress concentration, then the subsurface attacks grew as the depth increased (Figure 3A). For the as-received sampled, as compared to the deformed sample, the attacks of the subsurface areas were greater, and these corrosion attacks developed to a deeper depth and enhanced the sensitivity of SCC (Figure 3B,C). Corrosion developed beside the grain boundary linkage with the production of hydrogen in the electrochemical reaction (Figure 3A-C) [34,61,62].

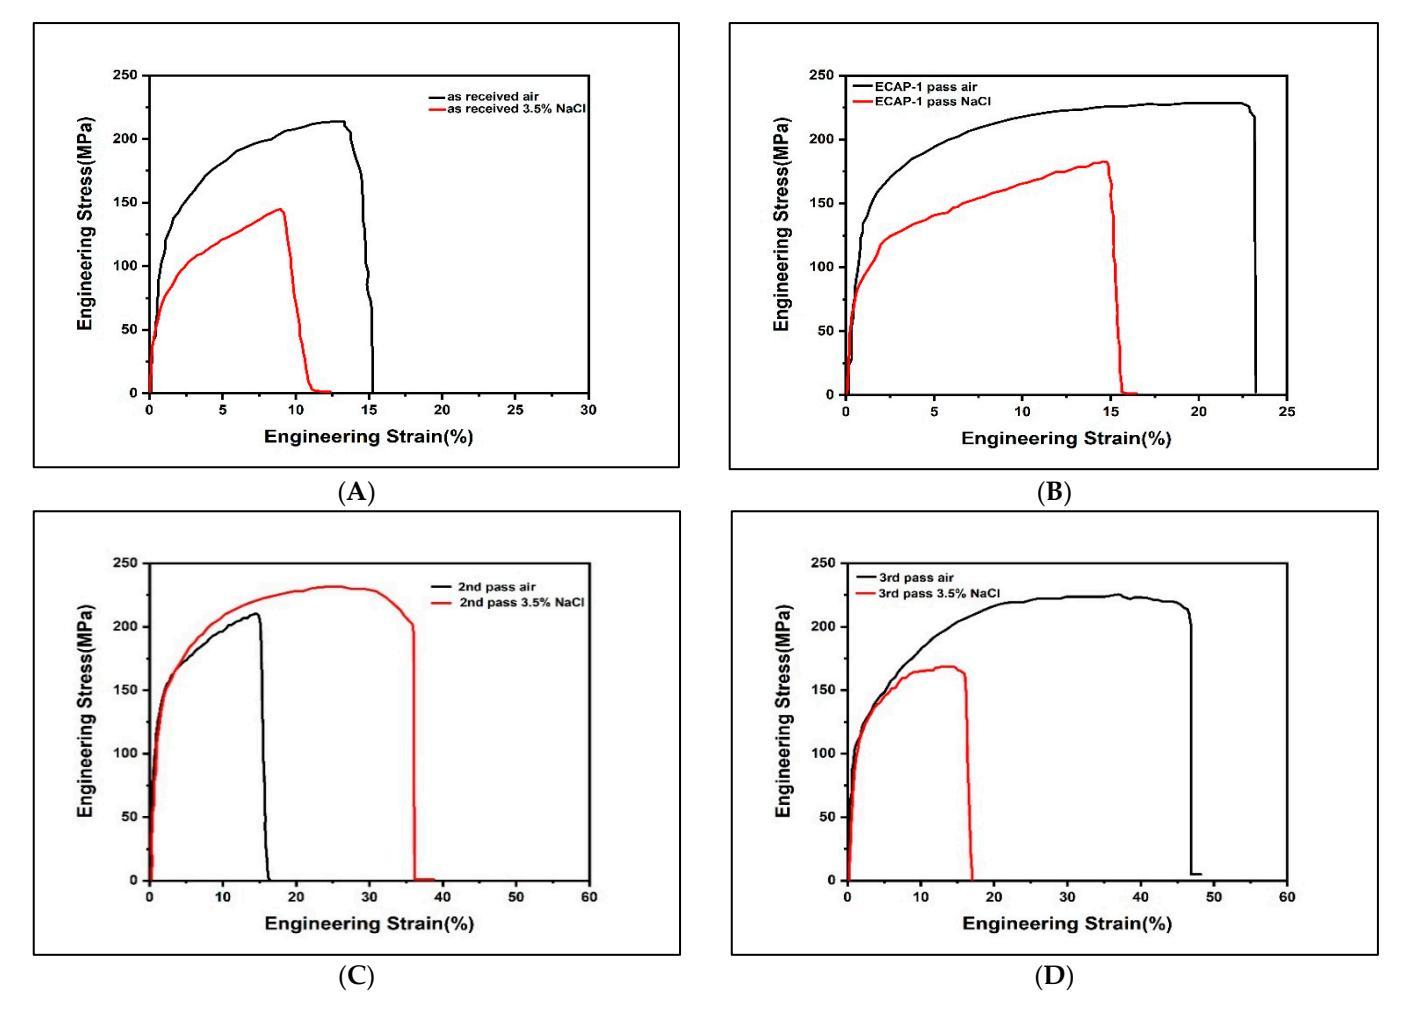
**Figure 4.** Stress–strain diagram of as-received Al5083 alloy (**A**) and ECAP after the 1st pass (**B**), 2nd pass (**C**), and 3rd pass (**D**) in air and 3.5% NaCl solution.

The SSRT stress strain curve for the Al5083 alloy is introduced in Figures 4 and 5, while Table 2 shows the yield strength, UTS, elongation, and SCC index ( $I_{scc}$ ) values for

the four distinct examples. Obviously, in contrast with the as-received sample, the yield strength and UTS were upgraded after ECAP processing to a great extent, starting from the reinforcing impact of the refined grains [52]. Furthermore, samples after the third pass exhibited good properties, with a mix of strength and elongation, both in air and 3.5% NaCl, in contrast with the other two examples processed by ECAP. The moderately favorable third pass ECAP samples were essentially ascribed to grain refinement and the similarly homogeneous structure. A remarkable resemblance among every one of the specimens was seen for the critical loss of UTS and elongation under 3.5% NaCl conditions in contrast with air conditions.

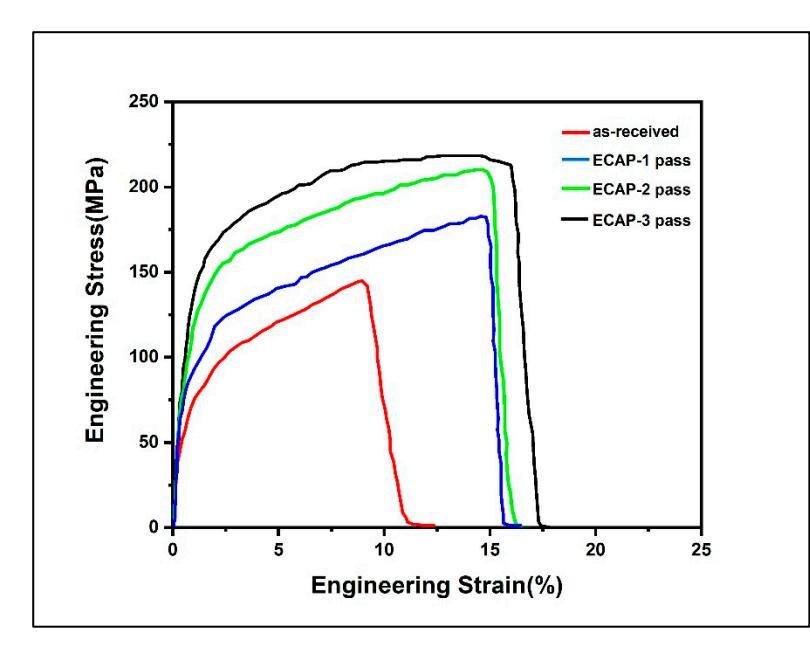
**Figure 5.** Comparison of stress–strain values of the samples tested in 3.5% NaCl solution with different passes.

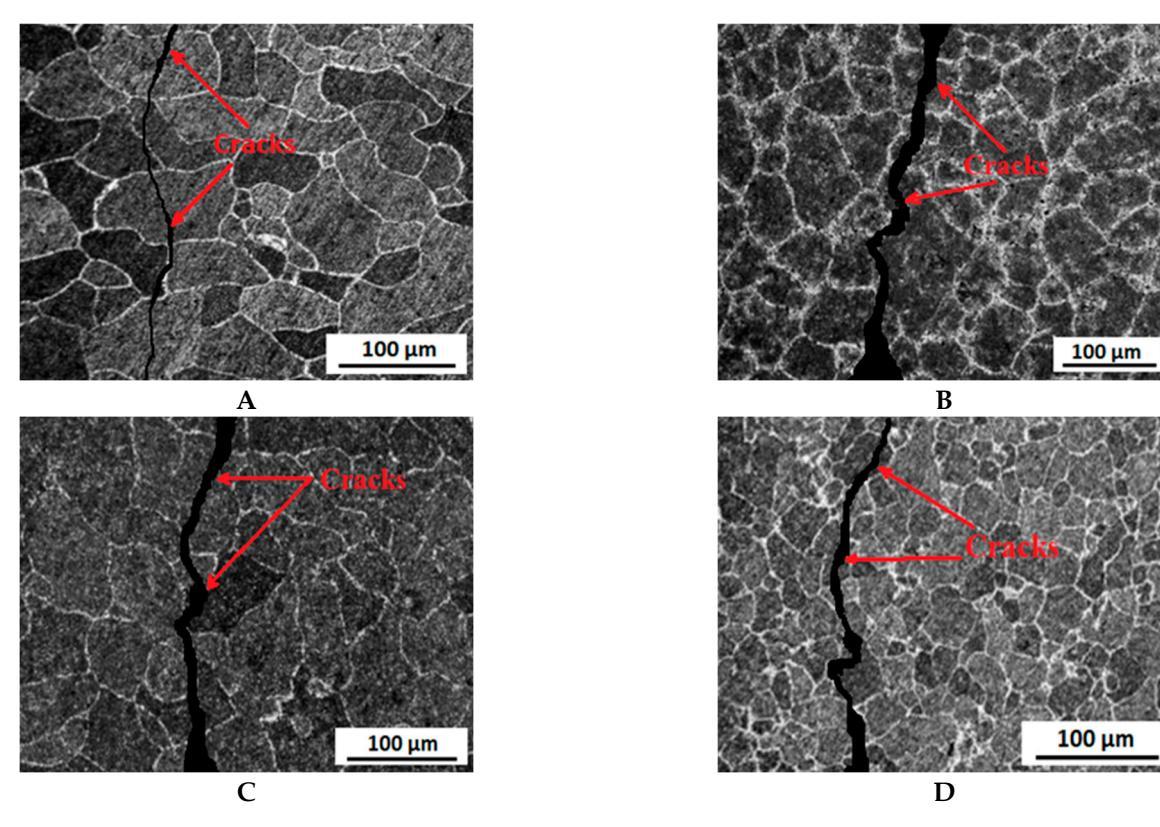
Figure 7. Microstructural analysis of the failed surfaces of Al5083 alloy tested in air for the (A) as-received sample and samples after the (B) 1st pass, (C) 2nd pass, and (D) 3rd pass.

SEM micrographs (Figures 7 and 8) revealed that the crack growth was divided into two stages, namely the steady-state crack growth stage and the incubation crack propagation stage. The steady-state stage corresponds to the hydrogen embrittlement mechanism, while a dissolution-controlled mechanism is found to be associated with the crack propagation stage. The dissolution-controlled phase, which is the initial phase, is presumed to cause the same amount of corrosion as in the 3.5 % NaCl solution conditions. However, there is an enormous difference in total elongation with the SSRT treatment of the as-received and deformed specimens. Regarding the tensile stress, different types of microcracks are formed in the bottommost areas of corrosion defects, causing breakage of the passive oxide film layer and penetration of the electrolytes into crevices. The crack tip of the testing specimen is dissolved, and with the electrochemical hydrolysis reaction an acidic environment is generated. Then, the Al alloy is corroded and dissolved as anodic sites and hydrogen bubbles are observed in the corrosion pit [64,65]. The crack tips show regions with precipitated Al(OH)<sub>3</sub> with a steady pH [65], while the hydrogen generated

After tensile testing was performed, the fractured surfaces of the specimens were observed using SEM. The fractured surfaces are shown in Figures 7 and 8. From the SEM images, it is quite clear that grain refinement occurs as the passes increase.

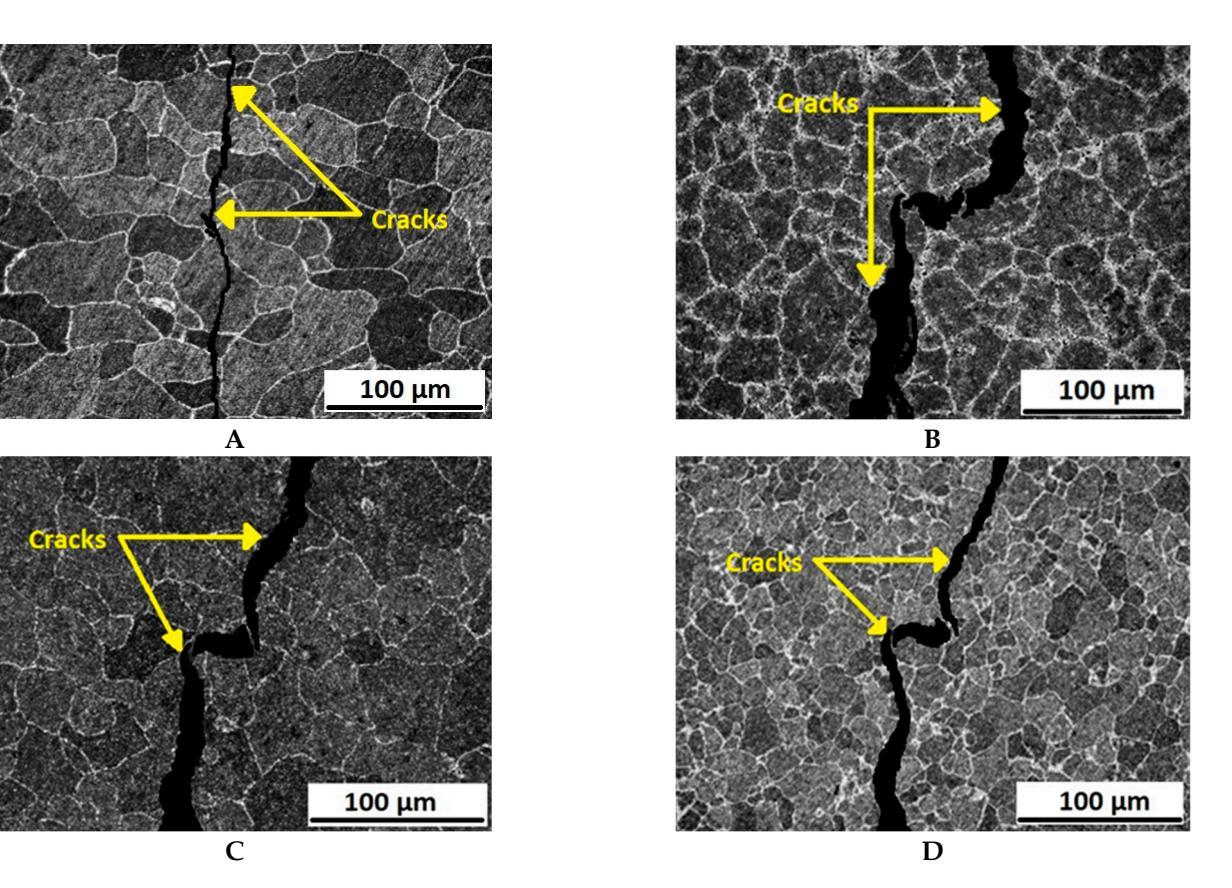
**Figure 8.** Microstructural analysis of the failed surfaces of Al5083 alloy tested in 3.5 wt.% NaCl solution for the (**A**) asreceived sample and for samples after the (**B**) 1st pass, (**C**) 2nd pass, and (**D**) 3rd pass.

The fracture properties on the surfaces also change as the passes increase. The fracture is quite brittle by nature in the 1st pass sample compared to other samples. The fractures are more ductile in the 2nd pass and 3rd pass samples. It is also noticeable that the fractures become narrower and less shallow as the passes increase. This is because the strength of the alloy increases as the passes increase.

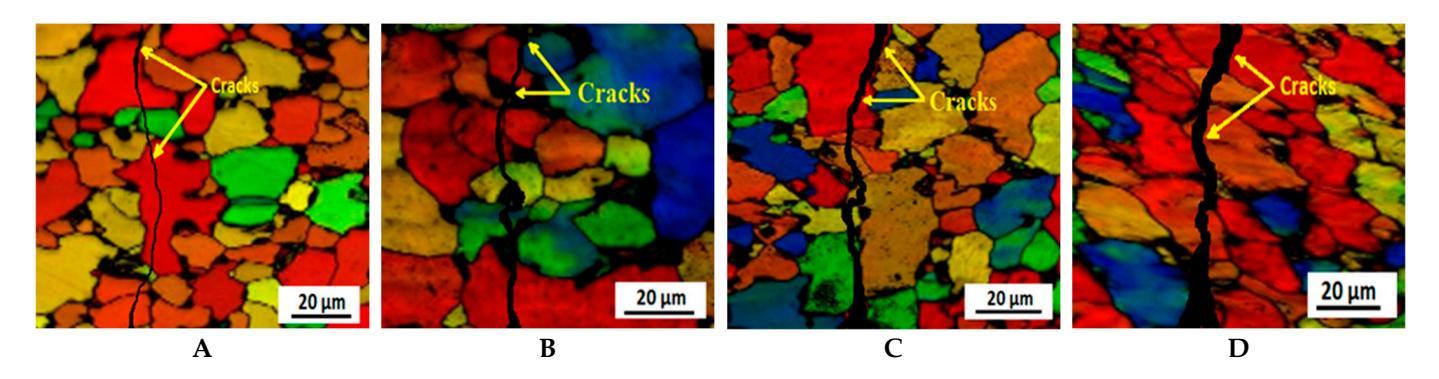
**Figure 9.** EBSD orientation micrograph of Al5083 alloy in air for (**A**) the as-received sample and samples after the (**B**) 1st pass, (**C**) 2nd pass, and (**D**) 3rd pass.

EBSD analysis was performed along the cross-sectional area of these four specimens to more clearly determine the nature of the cracking. The EBSD micrographs in air and in 3.5% NaCl solution are shown in Figures 9 and 10, respectively. In the previous micrograph, given in Figure 8, it is quite clear that the cracking nature is more ductile as the passes progress, although with EBSD this becomes clearer. The distinction as to whether grain or subgrain sizes are measured is completely independent from the EBSD data file, depending only on user-defined misorientation threshold values. A value of  $15^{\circ}$  misorientation is commonly used to define HAGBs (high-angle grain boundaries), which separate individual grains in aluminum alloys [69]. In this work, LAGBs between  $3^{\circ}$  and  $15^{\circ}$  were identified as grain boundaries separating individual subgrains. The lower limit of  $3^{\circ}$  was chosen to ensure a certain distance to the measurement inaccuracy for the EBSD technique, which lies in the range of  $1\sim 2^{\circ}$  and depends on the alloy composition and position of the focused electron beam inside the measurement area.

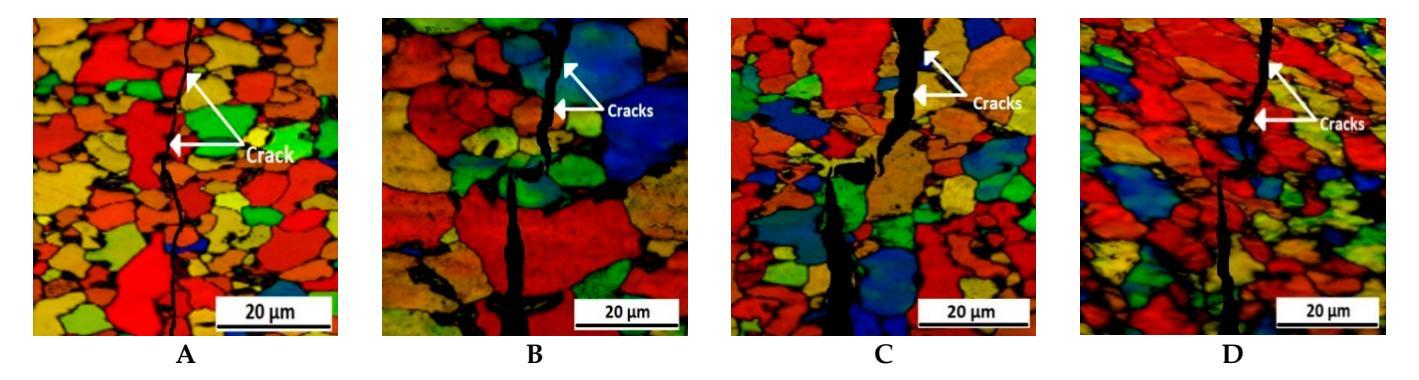
**Figure 10.** EBSD orientation micrograph of Al5083 alloy in 3.5% NaCl solution for (**A**) the as-received sample and samples after the (**B**) 1st pass, (**C**) 2nd pass, and (**D**) 3rd pass.

From these four structures, it is evident that the cracking mode and nature are both transgranular and intergranular in nature, although during the 2nd pass the cracking mode exhibits a slight transgranular nature. For EBSD measurements, the samples were slightly tilted at a certain angle, meaning the cracked morphologies shown in EBSD images are slightly different from the real morphologies, as shown in Figure 6. Moreover, the width of cracks is much larger than that of the grain boundaries. Therefore, it would be very difficult to confirm intergranular cracking on the surface of as-forged samples with a fine-grained structure. As the passes progress, grain refinement occurs, which has directly decides whether the crack propagation is trangranular, intergranular, or a mixture of both. Due to the smaller grain size in the high pass samples, cracks can easily meet with the grain boundaries. Thus, partially intergranular cracking can possibly occur in particular segments of some grain boundaries.

Figure 10 shows EBSD maps of the stress corrosion cracking observed on the side face of the fracture of the longitudinal specimen. The cracks are marked by the thick black lines

in Figure 10B–D. It can be observed in Figure 10A that the cracks are discontinuous and small, indicating typical intergranular cracking types. In Figure 10B, misorientation angles between the grains on both sides of the cracks were calculated using software to perform the EBSD analysis. The result shows that maximum sections of cracks propagated along with the HAGBs. As shown in Figure 10, the misorientation angles of more than 95% of the grains on the both sides of crack are larger than  $10^{\circ}$  and dominated by angles ranging between  $50^{\circ}$  and  $60^{\circ}$  (accounting for 36% of angles). Hence, the cracks propagate along the GBs, with a misorientation range of approximately  $50^{\circ}$ – $60^{\circ}$ .
