## Article

## Healing of Osteochondral Defects Implanted with Biomimetic Scaffolds of Poly(ε-Caprolactone)/Hydroxyapatite and Glycidyl-Methacrylate-Modified Hyaluronic Acid in a Minipig

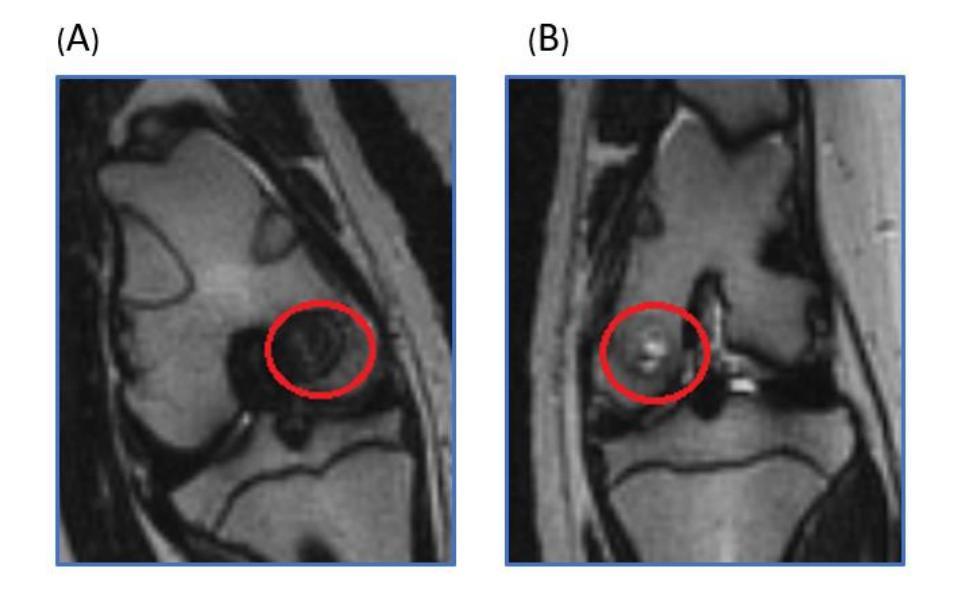
Under general anesthesia, the magnetic resonance imaging (MRI) of the minipigs was performed six months after scaffold implantation. In the experimental knee joint, the bone defect was fully filled without free fluid. The scaffold could still be identified and maintained its structure. In the control, the bone defect region was filled with joint fluid, and partial bony ingrowth was noted (Figure 1).

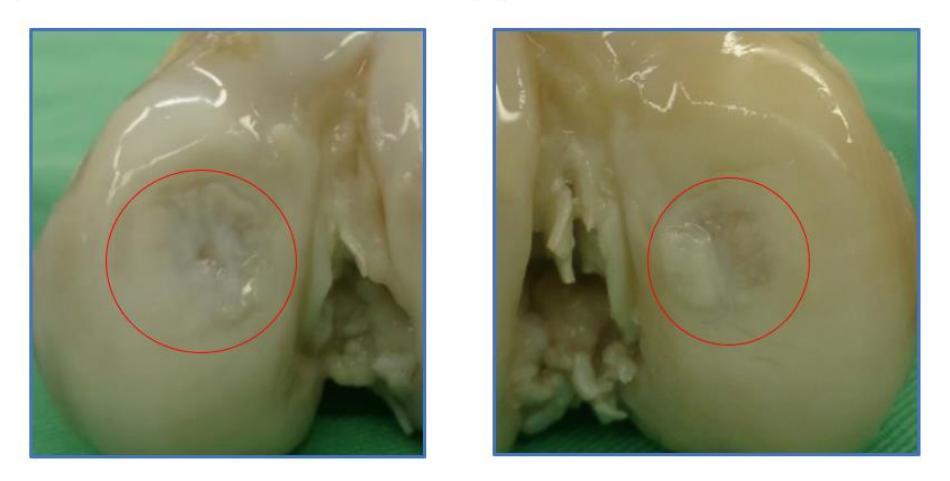
**Figure 2.** Gross observation of the repair of swine knees implanted with biphasic scaffolds of Poly(*ɛ*-caprolactone)/Hydroxyapatite and glycidyl-methacrylate-modified hyaluronic acid or without implants as the control group one year after surgery. The red circle was the operation area. (**A**) The scaffold implantation group showed successful regeneration of the previously removed cartilage. (**B**) The control group without implants showed soft tissue hypertrophy and cartilage defect.

Macroscopic observation provided a direct assessment of the cartilage defect repair. One year after engraftment, the minipigs were sacrificed, and their knees were harvested and analyzed. In the experimental group, near full-thickness defects were repaired with glossy white tissue (Figure 2A). The defects in the control group remained largely unfilled (Figure 2B). The International Cartilage Repair Society (ICRS) macroscopic score for the scaffold implantation group in terms of defect filling (3), integration to surrounding host cartilage (3), and macroscopic appearance (3) were all higher than those of the control group (3,1,1). The overall repair assessment of the experimental group was near normal (9, grade II), and the control group was abnormal (5, grade III).

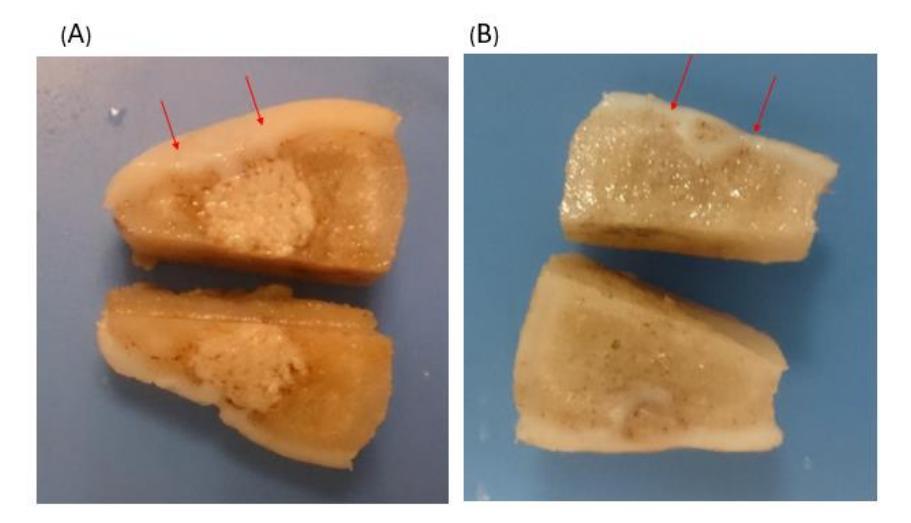
**Figure 3.** Cross-sectional view of the knee joint of the experimental group with scaffold implantation and the control group without implants. The operation area was between the red arrows. (**A**) With scaffold implantation, the defect of the surface was fully filled with hyaline cartilage, and subchondral bone regeneration was noted. Undegraded scaffold was noted in the deep layer. (**B**) Without implants, the defect region was filled with hypertrophic cartilage-like soft tissue with invasion to the subchondral bone area.

To observe the repair tissue at the defect region beneath the surface of the regenerated cartilage, each condyle was sectioned along the sagittal and frontal plane. In the experimental group, the cartilage layer and subchondral bone were successfully regenerated, and undegraded scaffold in the deep part of the femur condyle was noted (Figure 3A). In the control group, the defect site was observed to be filled with hypertrophic cartilage-like tissue with invasion to the subchondral area (Figure 3B).

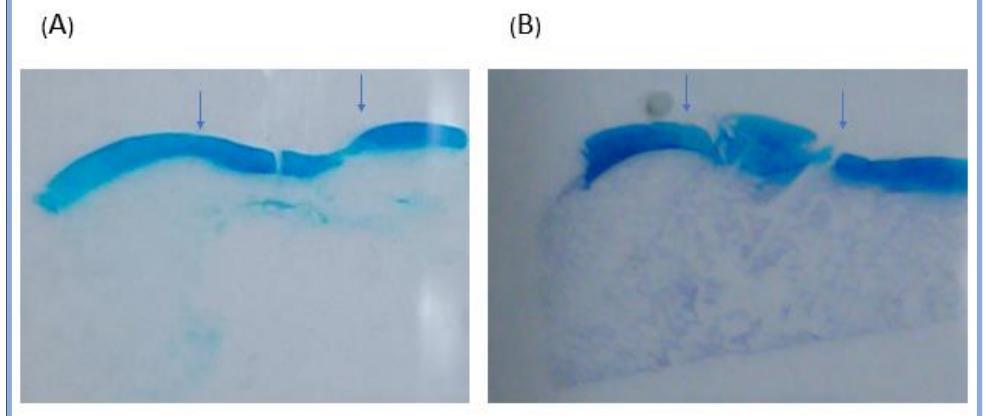
**Figure 4.** Alcian blue staining of the minipig knee joints one year after operation. The operation area was between the arrows. (**A**) The experimental group showed a smooth surface and an even thickness of the regenerated cartilage. (**B**) The control group presented a discontinuous and hypertrophic cartilage surface, and the subchondral bone area was replaced by cartilage-like soft tissue.

To identify the quality of the regenerated tissue, the experimental group and the control group were histologically evaluated. One year after implantation, the cartilage of the scaffold implantation group was successfully regeneration. Alcian blue staining was used to detect the presence of glycosaminoglycans, which parallels the degree of cartilage formation. The Alcian blue staining of the experimental group displayed an even concentrated blue color, the thickness was close to that of the surrounding normal

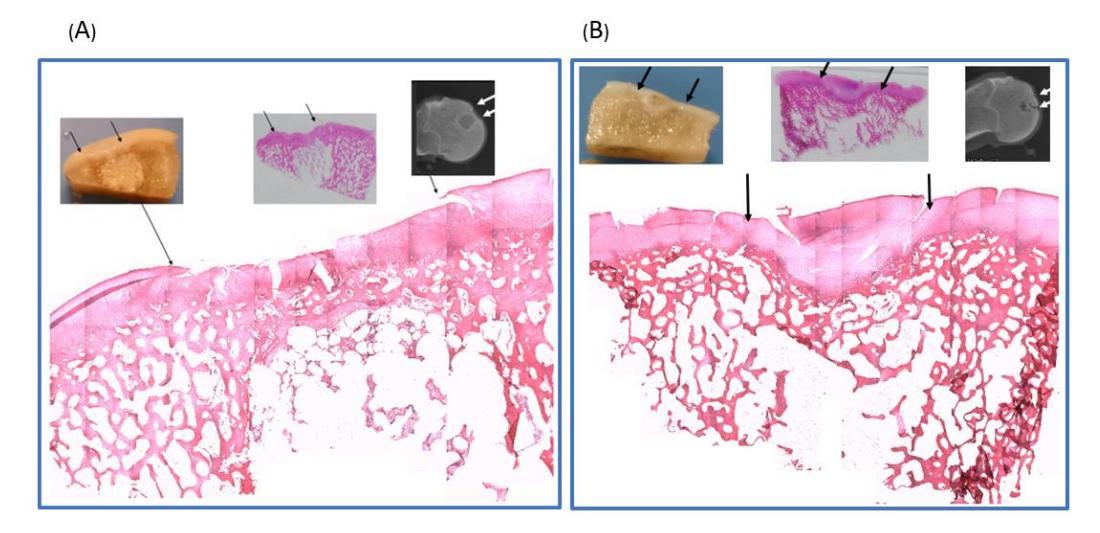
**Figure 5.** (**A**) Hematoxylin & Eosin staining of the biphasic scaffold implantation group( reorganized picture, original magnification ×5). The histology showed successfully cartilage regeneration over defect creating region (between two arrows). The repaired cartilage integrated well with the

surrounding cartilage. Good growth of the subchondral bone was observed. The defect in the lower panel was filled with undegraded scaffold, and partial bony ingrowth in the scaffold porous was noted. (**B**) H & E staining of the untreated control group. Untreated defects in the control group were filled mostly with disorganized fibrocartilage that did not restore a smooth articular surface with adjacent host cartilage. The subchondral bone region was replaced by fibrocartilage.

The second staining method, hematoxylin and eosin (H & E) staining, was used to show the distribution of the nucleus and cytoplasmic inclusions. The experimental group was shown in Figure 5A. Along the upper panel, cartilage successfully regenerated, and the displayed tissue morphology was resembled normal hyaline cartilage. The regenerated cartilage, compared to that of the control group, showed better columnar organization and integrated well with the surrounding cartilage. Good growth of the subchondral bone was also observed. However, the lower panel of the defect was filled with undegraded scaffold, with a partial ingrowth of bone tissue into the scaffold porous. In contrast, untreated defects in the control group (Figure 5B) were filled mostly with disorganized fibrocartilage that did not restore a continuous articular surface with adjacent host cartilage. The subchondral bone region was filled with fibrocartilage. These results suggest that an mPEG-PCL porous scaffold combined with GMHA hydrogel loading with TGF- $\beta$ 1 can help cartilage and subchondral bone formation and prevent fibrous tissue invagination.

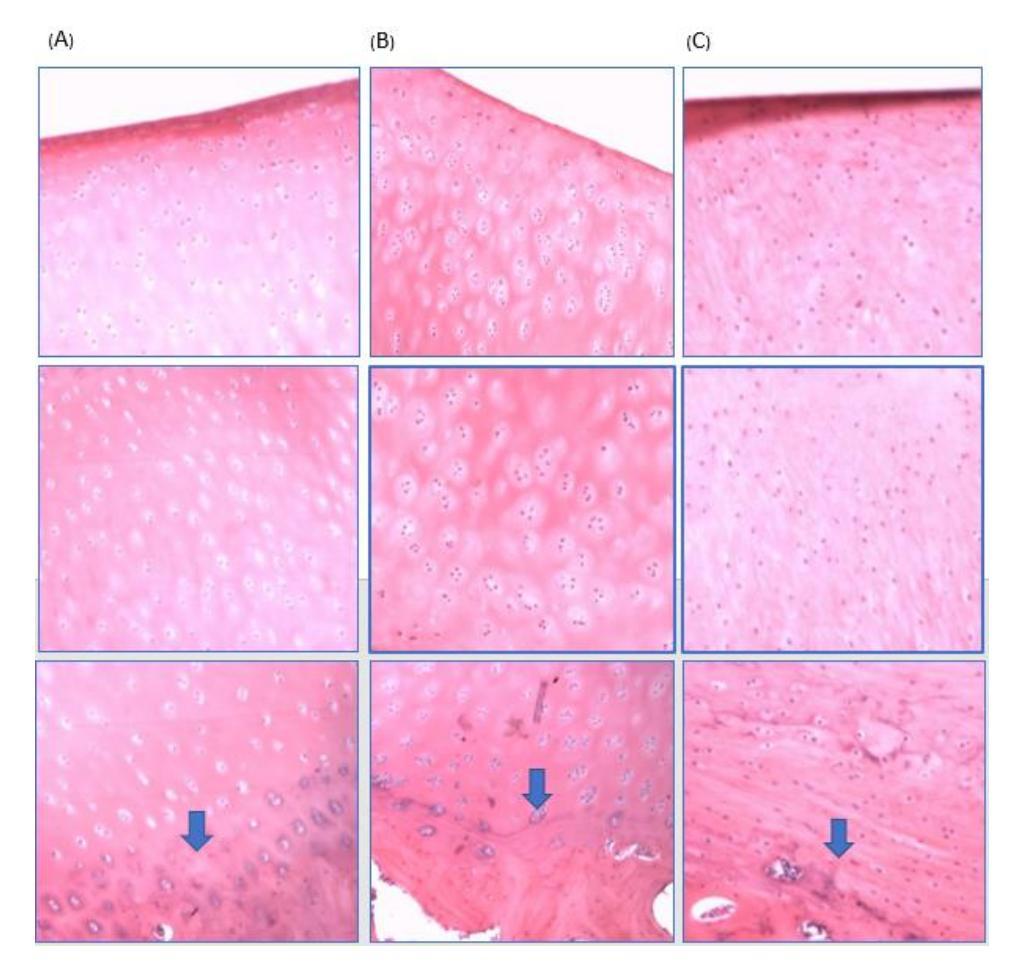
**Figure 6.** H & E staining (original magnification  $\times 100$ ) of (**A**) The normal minipig knee cartilage showed native hyaline cartilage cell morphology with round chondrocytes in the lacunae surrounding by the matrix. The tidemark is indicated by blue arrows. (**B**) The cell morphology of the regenerated cartilage from the biphasic scaffold implantation group was similar to the native hyaline cartilage with round chondrocytes in lacunae. The tidemark presented well. (**C**) The control group showed only spindle-shaped, fibroblast-like cells within the regenerated cartilage. The tidemark between calcified and uncalcified cartilage could not be well distinguished.

To identify the regenerated tissue type, the cell morphology and matrix structure were analyzed. H & E staining of the normal minipig knee cartilage, the experimental group cartilage, and the control group cartilage were analyzed. The normal minipig knee cartilage showed native hyaline cartilage cell morphology with round chondrocytes in the lacunae surrounded by the matrix. A tidemark between cartilage and subchondral bone was observed (Figure 6A). Chondrocytes in the tissue regenerated from the biphasic scaffold implantation group were round, clustered, and surrounded by a matrix that is similar to those found in the surrounding hyaline cartilage. However, there were more chondrocytes in the lacunae than that of native hyaline cartilage, suggesting that the regenerated cartilage was hyaline cartilage albeit not completely differentiated (Figure 6B). In the defect-only control group, an abundance of spindle-shaped, fibroblast-like cells within the defect site was observed, suggesting that only fibrous or fibrocartilaginous tissues were formed (Figure 6C). Moreover, the tidemark between calcified and uncalcified cartilage was clear in the experimental group, but that in the control group could not be well distinguished.

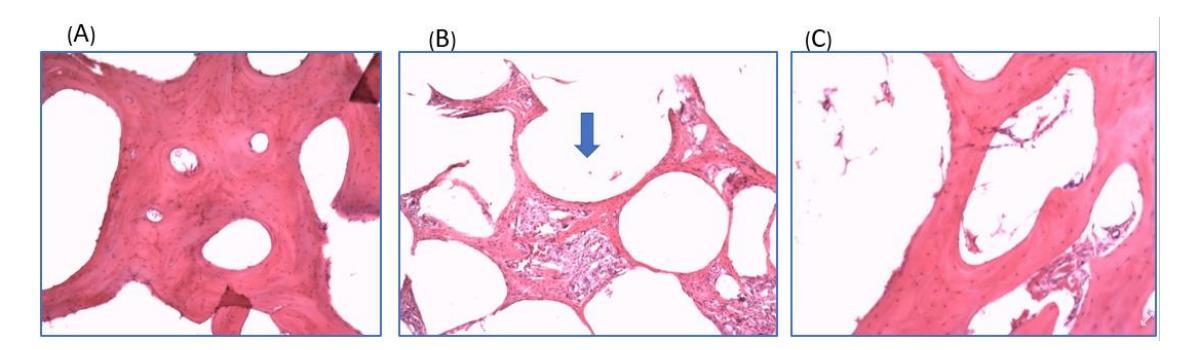
**Figure 7.** H & E staining (original magnification ×40) of (**A**) The normal minipig knee cancellous bone tissue showing the characteristic structure of cancellous bone with trabecular structure and numerous spaces containing bone marrow. (**B**) The experimental group showed undegraded scaffold (blue arrow) one year after implantation. The scaffold porous was filled with mixed bone tissue and fibrotic tissue. (**C**) The regenerated bone tissue of control group showed loose trabecular structure.

The regenerated bone tissue was also analyzed. With H & E staining, the normal minipig knee cancellous bone tissue showing the characteristic structure of cancellous bone with trabecular structure and numerous spaces containing bone marrow (Figure 7A). In the biphasic scaffold implantation group, the lower panel of the defect was filled with undegraded scaffolds. The scaffold porous was filled with mixed bone tissue and fibrotic tissue (Figure 7B). In the control group, the regenerated bone tissue showed a loose trabecular structure (Figure 7C).

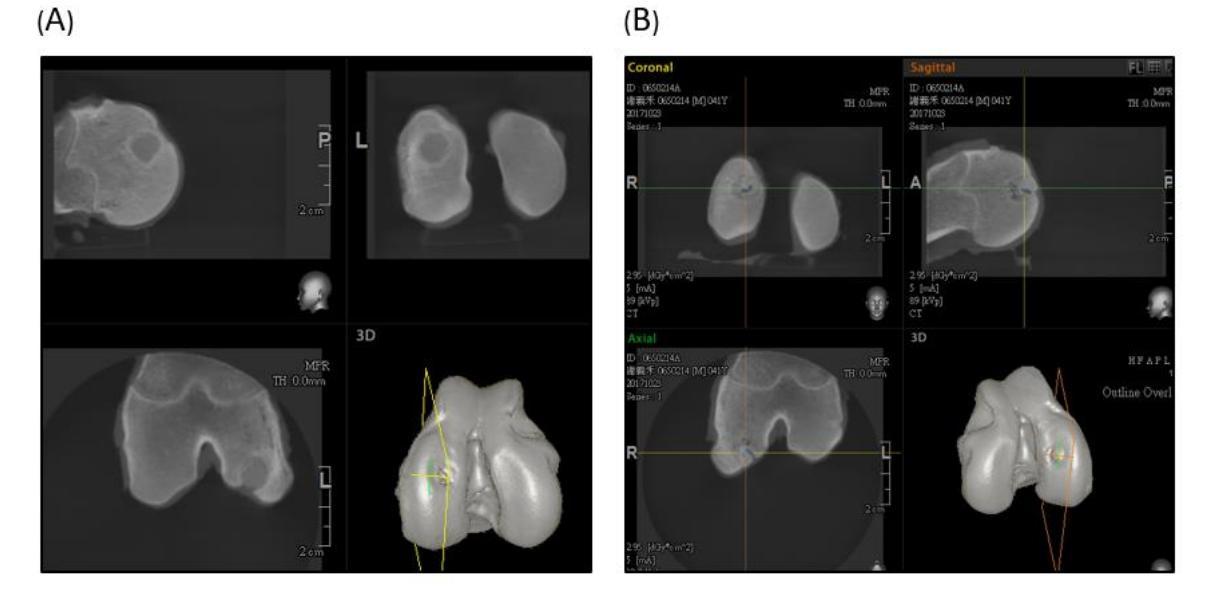
**Figure 8.** Sagittal, horizontal, and coronal view of the CT scan. (**A**) Experimental group showed an undegraded scaffold in the femur condyle. The articular part of the scaffold degraded well and was replaced by subchondral bone tissue. (**B**) The control group showed partial bony growth in the created defect region.

The CT scan of the experimental group illustrated that the articular side of the scaffold was successfully degraded, subchondral bone regenerated, and the deep area of the created defect was filled with undegraded materials (Figure 8A). In the control group, there was more new bone formation in the defect site, but still some defect without bony growth was noted (Figure 8B).
