Quantitative Evaluation of Pulsed Thermography, Lock-in Thermography and Vibrothermography on Foreign Object Defect (FOD) in CFRP

Abstract: In this article, optical excitation thermographic techniques, including pulsed thermography and lock-in thermography, were used to detect foreign object defect (FOD) and delamination in CFRP. Then, vibrothermography as an ultrasonic excitation technique was used to detect these defects for the comparative purposes. Different image processing methods, including cold image subtraction (CIS), principal component thermography (PCT), thermographic signal reconstruction (TSR) and Fourier transform (FT), were performed. Finally, a comparison of optical excitation thermography and vibrothermography was conducted, and a thermographic probability of detection was given.

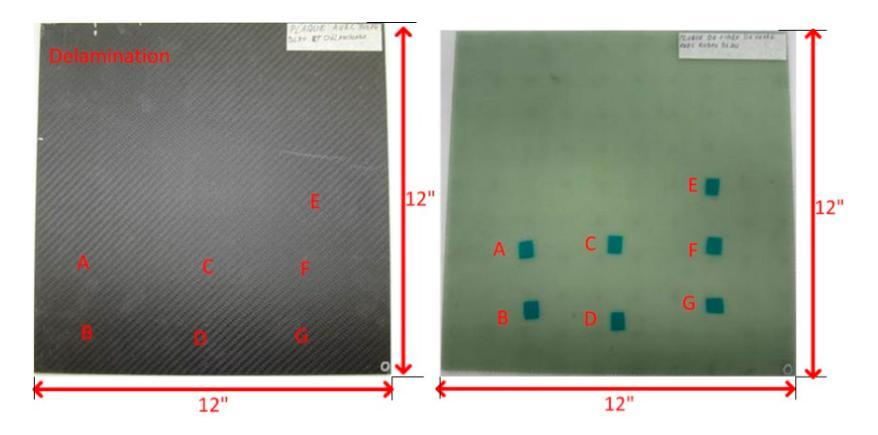
The experimental $12'' \times 12''$ CFRP specimen is shown in Figure 1a. Figure 1b shows the corresponding GFRP model, where the foreign object defect (FOD) can be seen clearly. For CFRP, twill 2×26 K carbon fiber was used. For GFRP, plain weave 7500 glass 9.60 oz/yd2 was used. Both the CFRP and GFRP specimens were made by infusion with epoxy resin. A post cure at 85 °C was conducted to ensure the complete crosslinking. The stacking sequence is 0 °C for everting.

Figure 1. (a) The experimental CFRP specimen; (b) The corresponding CFRP specimen.

The specimens contain eight plies. For the CFRP specimen, the thickness of each ply is about 0.0166", and for the GFRP specimen, it is about 0.0125". A Teflon sheet was used for the delamination. The thickness is 0.0025". After the infusion, the sheet was taken off to imitate a delamination. For the FODs, flash breaker tapes made of polyester with silicone surface coat were used. The flash breaker tapes were spaced against one of the layers of prepreg during the layup.

The FODs are between each ply. The eighth ply is on the surface of the mould, and the fist ply is the rough surface. The FODs are marked as follows:

- Defect A: between Ply 1 and 2
- Defect B: between Ply 2 and 3
- Defect C: between Ply 3 and 4
- Defect D: between Ply 4 and 5
- Defect E: between Ply 5 and 6
- Defect F: between Ply 6 and 7
- Defect G: between Ply 7 and 8

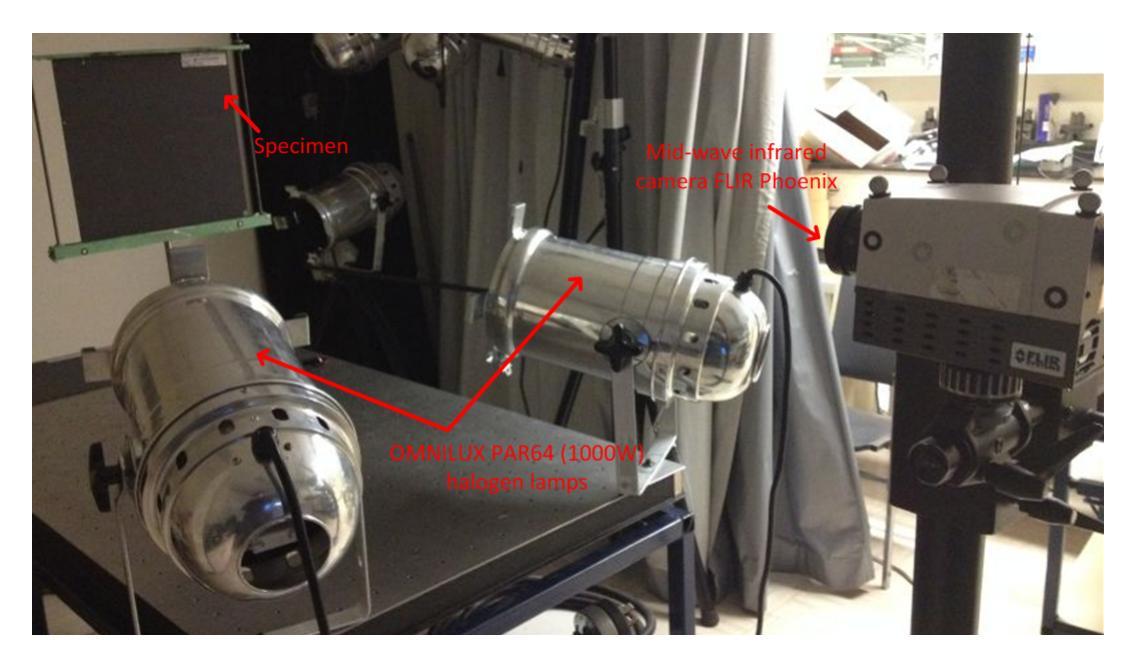
Figure 2 shows the experimental set-up for optical excitation thermography. In the setup, two 'OMNLUX PAR64' (1000 W) halogen lamps were used to generate sinusoidal or pulsed thermal waves. A mid-wave infrared camera 'FLIR Phoenix' was used to record the temperature profile. Table 2 shows the important technical specifications of the camera. The lamps and the infrared camera were located on the same side with respect to the specimen front surface.

Figure 2. The optical excitation thermography experimental set-up.

Technical Specification	Explanation/Value
Sensor type	InSb
Waveband	3–5 µm
Pixel resolution	640×512
Thermal sensitivity	20 mK

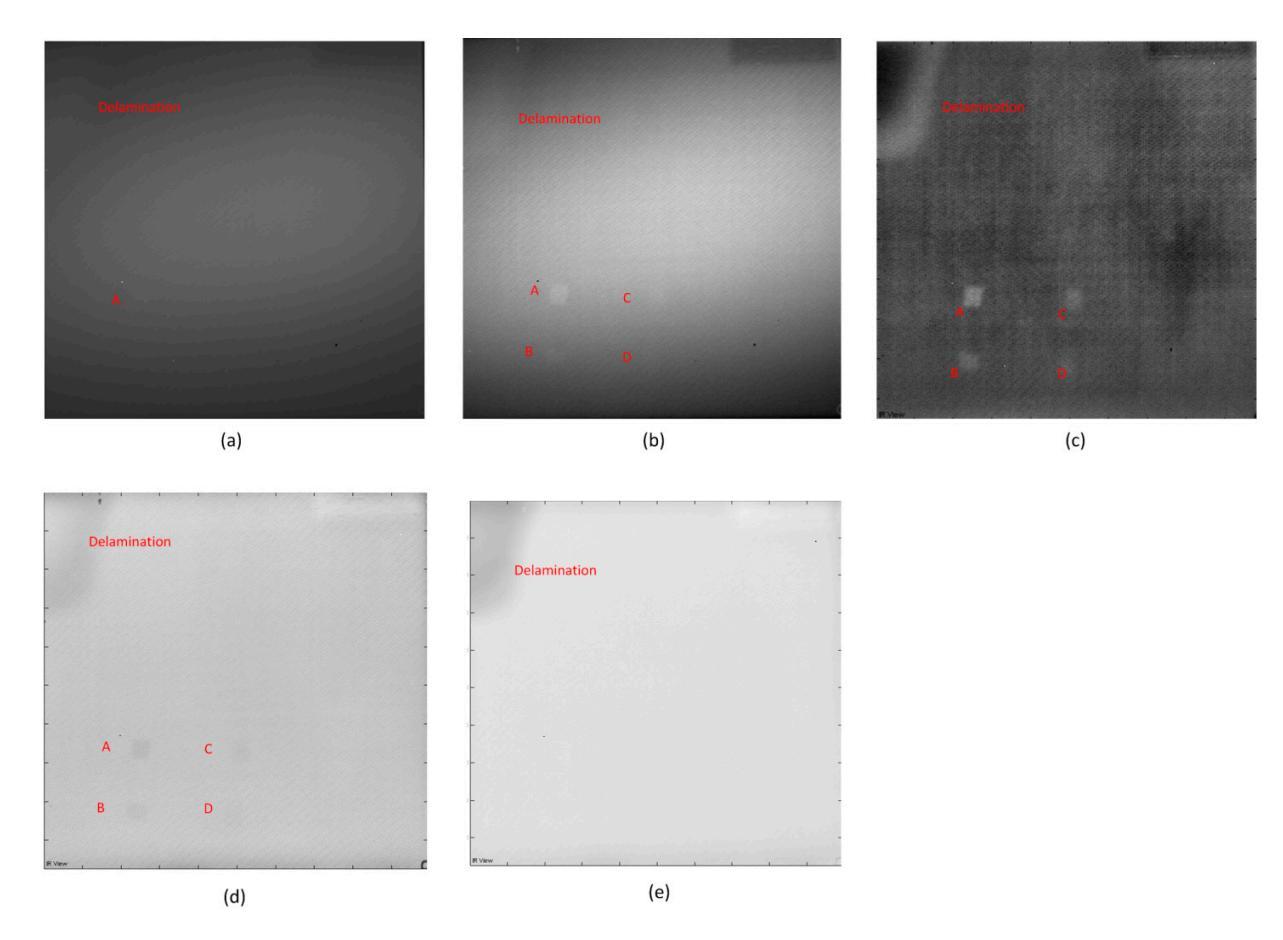
Figure 3 shows the pulsed thermography results. The experimental heating time (pulse length) is 30 s. Figure 3a shows the raw image, where only the blurry Defect A can be detected. In Figure 3b, more defects can be inspected after CIS. Figure 3c shows the image acquired from the fifth image (EOF 5) after PCT. In Figure 3c, these defects inspected in Figure 3b are clearer, and the position of the defect E is darker in color than other regions. This may indicate the probable existence of Defect E. Figure 3d,e shows the images after TSR. It is obvious that the 1st derivative result is clearer than the second derivative result, but PCT can provide the most inspection details and the best definition.

Figure 3. The pulsed thermography results: (**a**) Raw image; (**b**) After CIS; (**c**) PCT: EOF 5; (**d**) TSR: 1st derivative; (**e**) TSR: second derivative.

The authors increased the heating times to 120 s for pulsed thermography experiments. However, the longer pulse cannot provide better inspection results. According to the comparison of the images acquired from different image processing methods, PCT is the best solution for this type of defect using pulsed thermography.

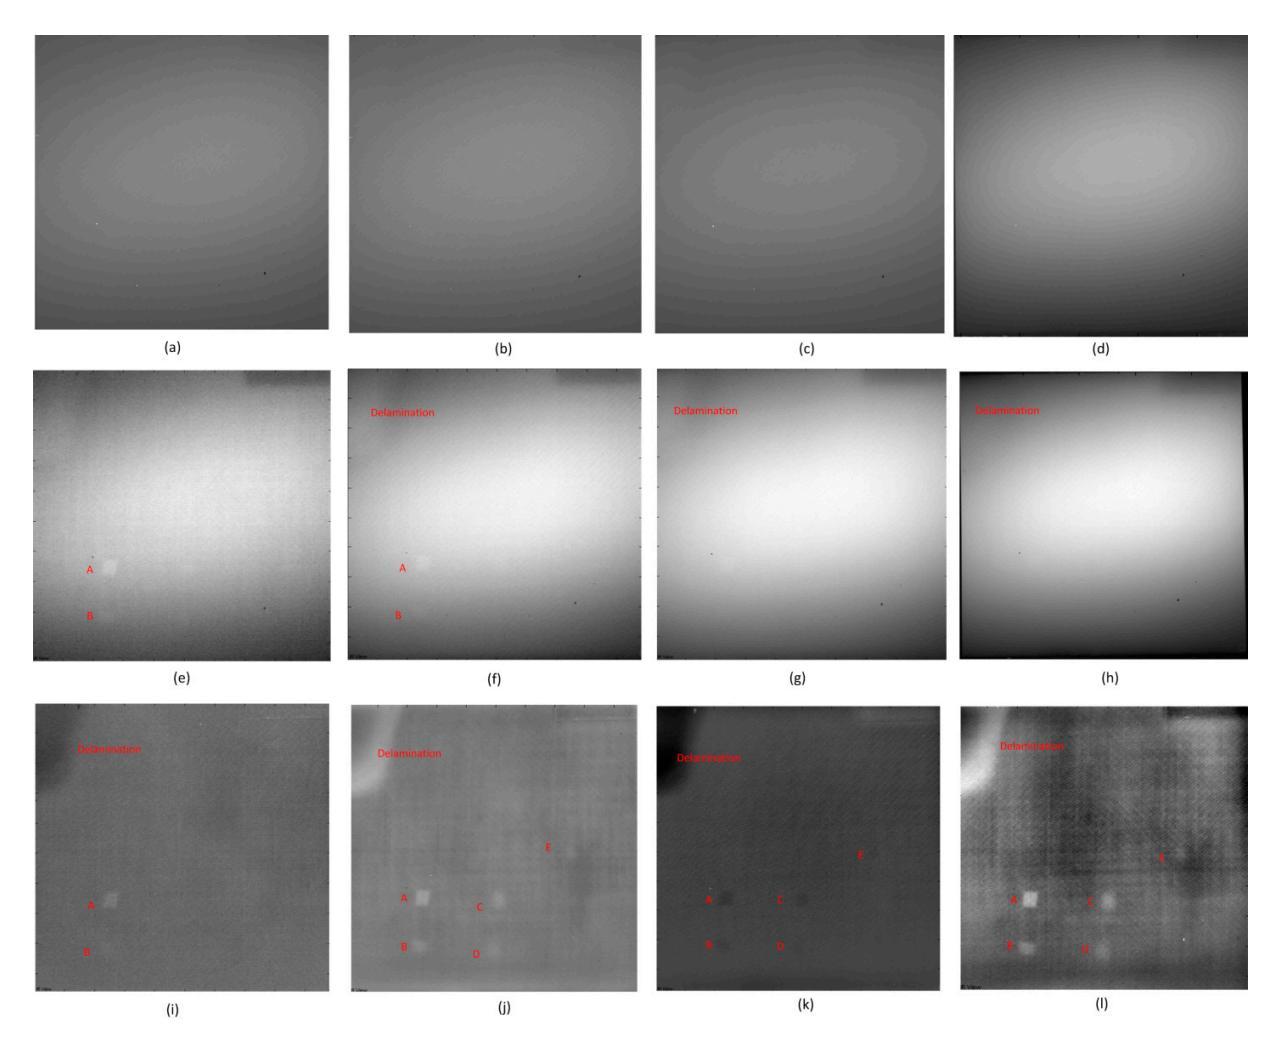
Figure 4 shows the lock-in thermography results. It is obvious that the images after PCT are the clearest, shown in Figure 4i–l. The images after CIS are clearer than the raw images. However, neither the raw images nor the CIS images can provide better inspection results. Similar to the pulsed thermography results, PCT can provide the most inspection details and the best definition.

Figure 4. The lock-in thermography results, (**a**) Raw image: 3 Hz; (**b**) Raw image: 1 Hz; (**c**) Raw image: 0.4 Hz; (**d**) Raw image: 0.05 Hz; (**e**) CIS: 3 Hz; (**f**) CIS: 1 Hz; (**g**) CIS: 0.4 Hz; (**h**) CIS: 0.05 Hz; (**i**) PCT: 3 Hz, EOF 4; (**j**) PCT: 1 Hz, EOF 5; (**k**) PCT: 0.4 Hz, EOF 4; (**l**) PCT: 0.05 Hz, EOF 7.

In particular, along with the lock-in frequencies decrease, less defects can be inspected in the images after CIS in Figure 4e–h. This phenomenon indicates that CIS is not a good solution to lock-in thermography, which can also be extracted from the corresponding theory of this image processing method. One the contrary, this phenomenon does not occur with PCT. Therefore, PCT should primarily be used to process the lock-in thermography results in practice, since it is fast and effective.

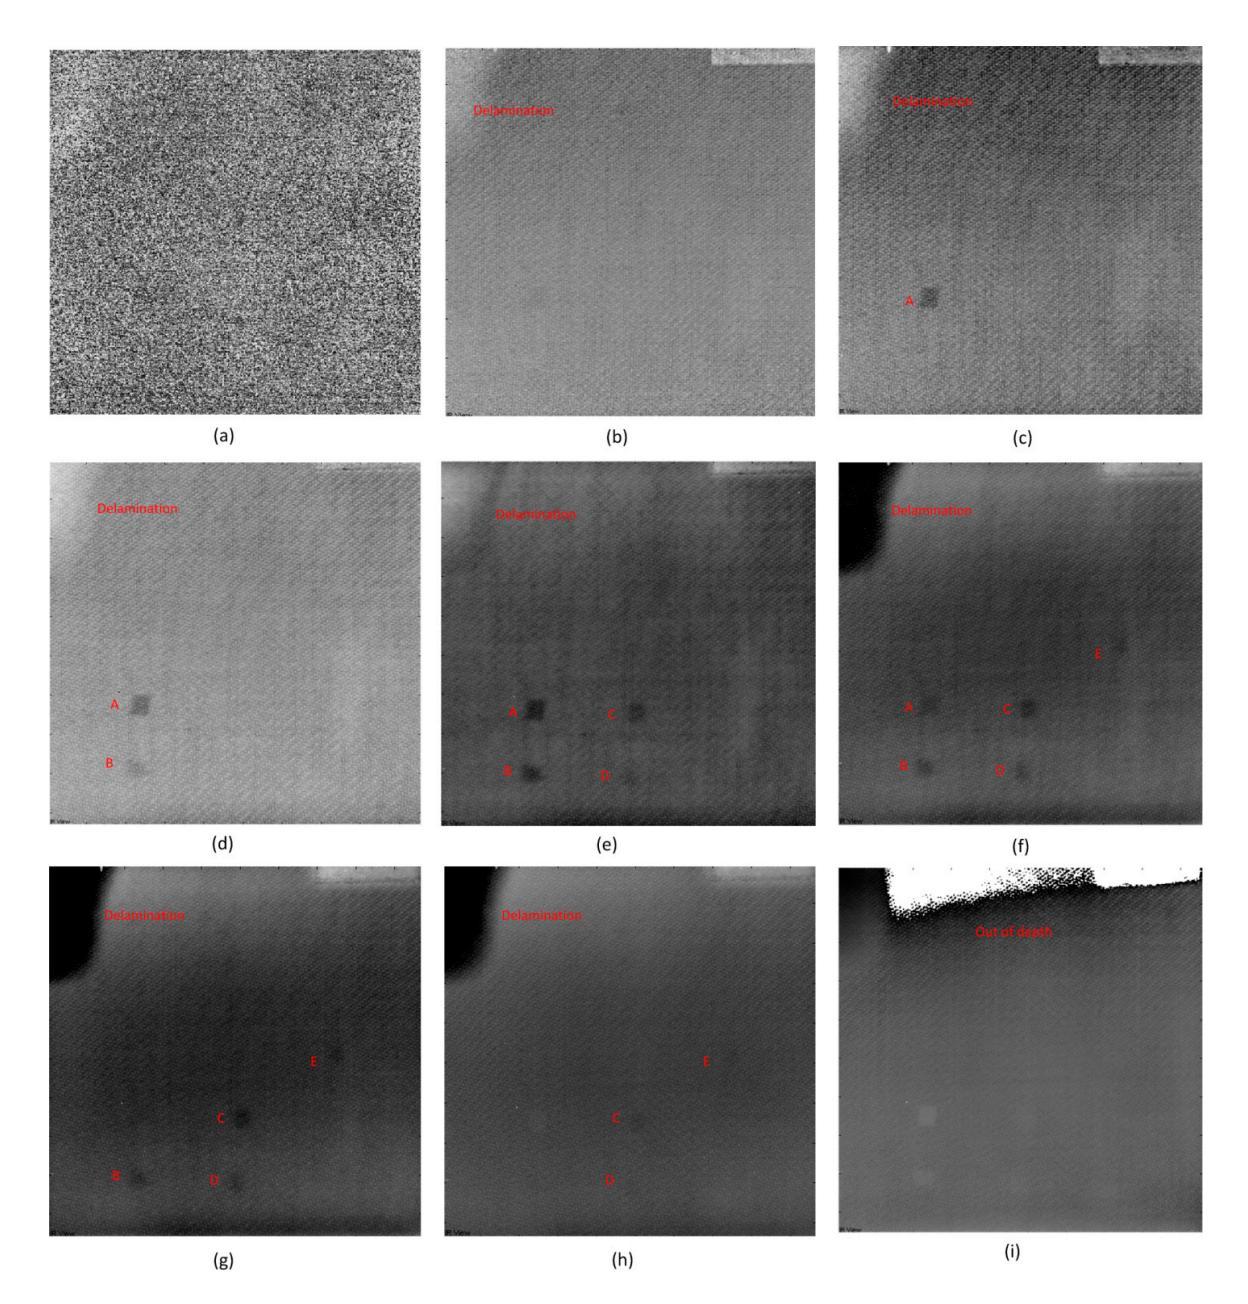
Figure 5 shows the phase images after Fourier transform with different frequencies, which are more tolerant to non-uniform heating. It is obvious that the non-uniform heating effects and noise (high frequency component) are reduced significantly in phase images. This image processing method can allow an estimation of the approximate detection depth.

In particular, when the lock-in frequency is 3 Hz in Figure 5a, the algorithm fails because the frequency is too high. When the frequency is 1 Hz in Figure 5b, Defect A is detected, but not clearly. This depth may be considered as the top surface of Defect A. When the frequency is 0.6 Hz in Figure 5c, Defect A is clearly detected. When the frequency is 0.2 Hz in Figure 5d, Defect B is also detected, but not clearly. This depth may be considered as the top surface of Defect B. In Figure 5e, Defect B is more clearly visible than in Figure 5d, and Defects C and D are also detected, but not clearly. In Figure 5f, Defects C and D are more clearly visible, but Defects A and B are not clear. Defect E is also detected in Figure 5f, but not clearly. This depth may be considered as the bottom surface of Defect A. When the frequency is 0.04 Hz in Figure 5g, Defect A disappears, and Defect E is still not clear. This depth may be

considered as the bottom surface of Defect B. When the frequency is 0.03 Hz in Figure 5h, Defect A and B both disappear, and Defects C, D and E are all not clear. When the frequency is 0.02 Hz in Figure 5i, the algorithm fails because the estimated detection depth is beyond the actual specimen thickness.

Figure 5. The phase images after Fourier transform: (**a**) Frequency: 3 Hz; (**b**) Frequency: 1 Hz; (**c**) Frequency: 0.6 Hz; (**d**) Frequency: 0.2 Hz; (**e**) Frequency: 0.1 Hz; (**f**) 0.05 Hz; (**g**) 0.04 Hz; (**h**) 0.03 Hz; (**i**) 0.02 Hz.

Through Figure 5, the maximum detection depth of lock-in thermography is up to the depth of Defect E. When the frequency is lower, the deviation is greater. This technique can offer results at estimated detection depths using different lock-in frequencies, but only works well on the defects that are not too far from the surface.

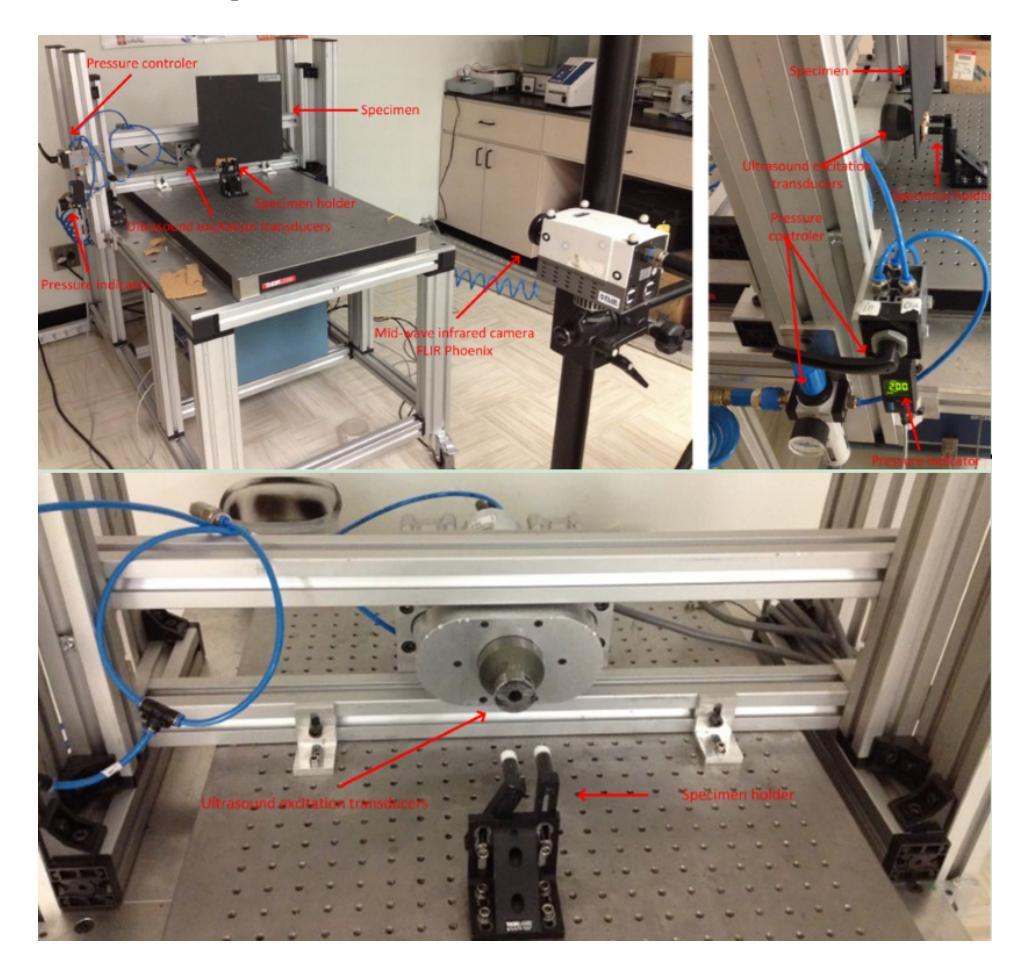
Figure 6 shows the experimental setup for vibrothermography. The IR camera 'FLIR Phoenix' with the technical specifications in Table 2 was used again to record the temperature profile. In the set-up, the ultrasound excitation transducers were pressed against the specimen, and a burst of ultrasound waves was delivered to the specimen. Table 3 shows the important technical specifications of the ultrasound excitation setup.

Figure 6. The vibrothermography experimental setup.

In this article, the pulsed ultrasonic excitation was used, and the excitation time is 10 s.

Technical Specification	Explanation/Value
Ultrasound frequency	15–25 kHz
Waveform	modulation or pulsed
Minimum modulation frequency	0.1 Hz
Maximum excitation time	10 s
Amplitude	0 to 100%

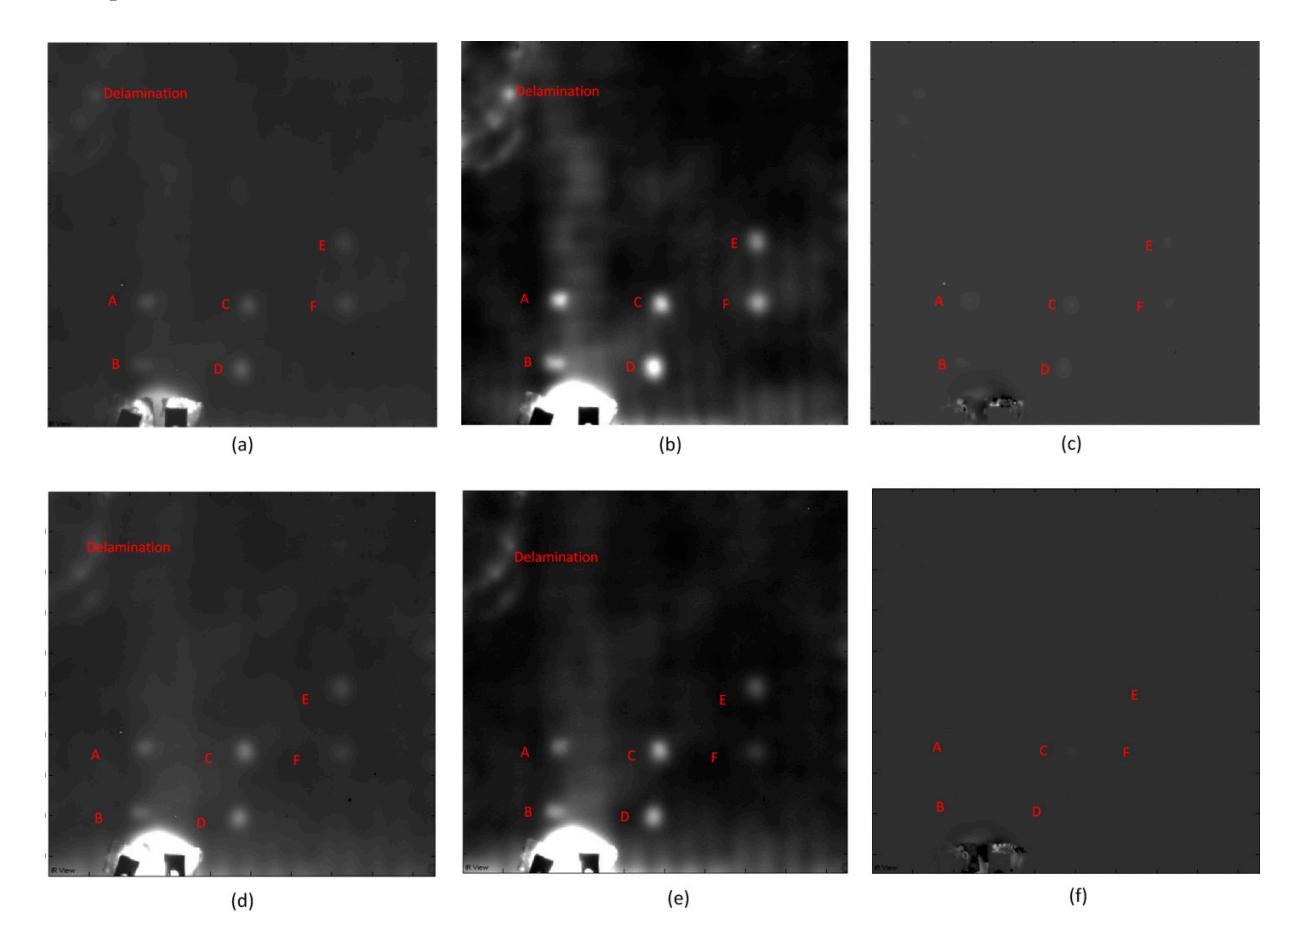
Figure 7 shows the vibrothermography results when the ultrasound excitation position is located at the left-bottom of the specimen. Contrary to the optical thermography results, the images after CIS are clearer. The images after PCT are blurry. When the ultrasonic excitation power is 50% of the maximum ultrasound excitation power, the defects A, B, C, D, E and F can be detected. A probable reason why Defect G cannot be inspected is that the ultrasound excitation power is low. Another probable cause is that the ultrasound excitation power to 80%. However, defect G still cannot be detected. The results are nearly the same as those with the 50% power. It is obvious that the increase of the ultrasound excitation position shown in Figure 8. Therefore, the authors turned to the other probable solution.

Figure 7. The vibrothermography results: (**a**) 50% power: raw image; (**b**) 50% power: CIS; (**c**) 50% power: PCT; (**d**) 80% power: raw image; (**e**) 80% power: CIS; (**f**) 80% power: PCT.

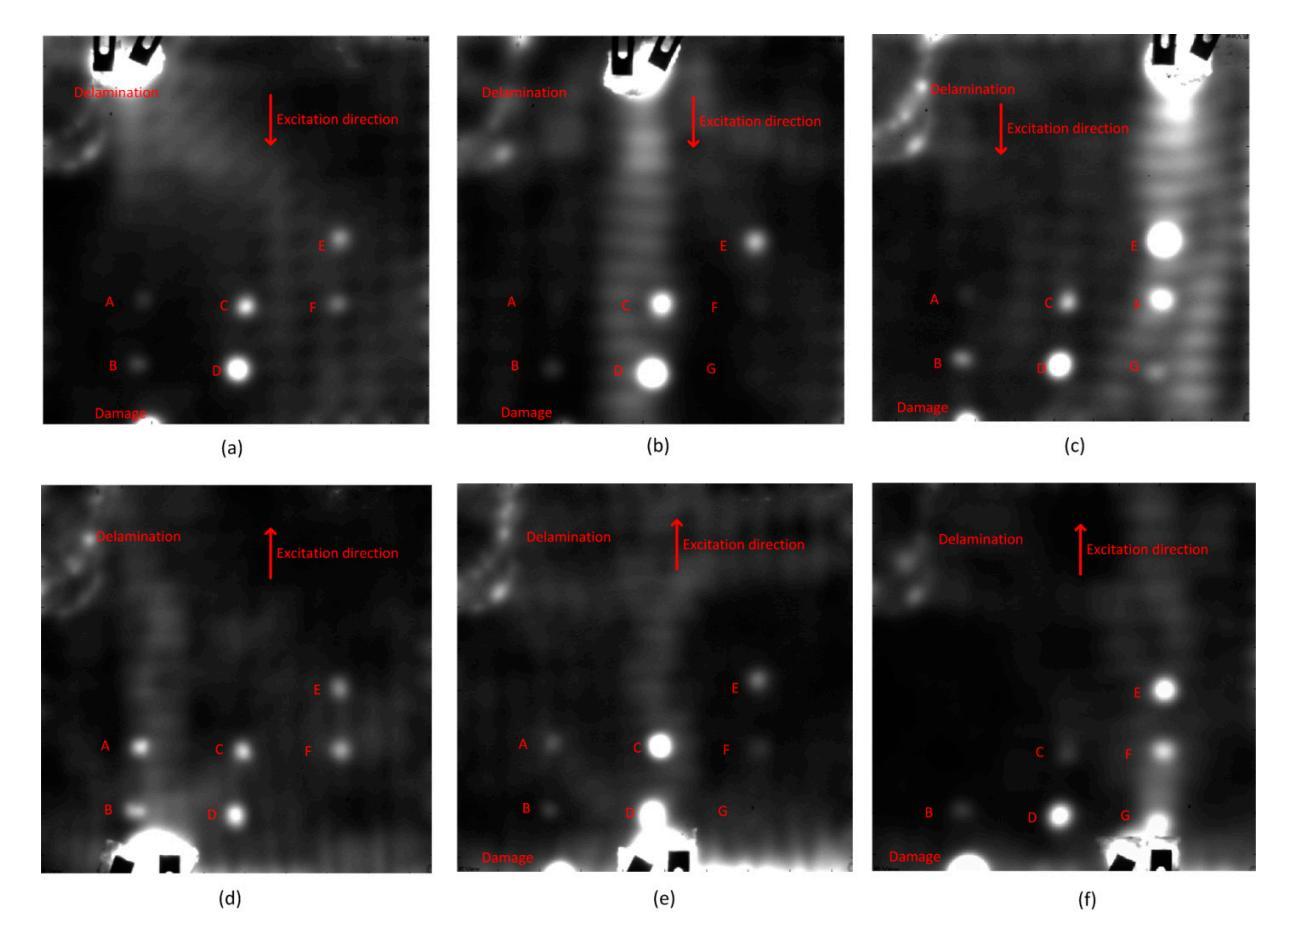
Figure 8 shows the complete vibrothermography results with 50% of maximum power after CIS. The ultrasound excitation positions are respectively left-top, middle-top, right-top, left-bottom, middle-bottom and right-bottom. The delamination can be detected wherever the ultrasound excitation position is. Some interesting heat diffusion routes can also be inspected.

In Figure 8, when the ultrasound excitation positions are at the left-top and left-bottom, Defects A, B, C, D, E and F are detected, shown in Figure 8a,d. The Defects A and B in Figure 8d are more clearly detected than in Figure 8a. The probable reason is that the ultrasound excitation position is closer. However, an interesting phenomenon is that Defect D is more clearly detected in Figure 8a than in Figure 8d, which is closer to the ultrasound excitation position. The other interesting phenomenon

is that Defects C and D in Figure 8a are more clearly detected than Defects A and B, which are closer to and in a line with the ultrasound excitation position.

When the ultrasound excitation positions are at the middle-top and middle-bottom, respectively shown in Figure 8b,e, Defects A, B, C, D, E, F and G are detected. Defects C and D are more clearly detected than the other defects. The probable reason is that defects C and D are closer to and in a line with the ultrasound excitation positions. Defect G is detected, but not clearly. Defects A, B, C, F and G are more clearly detected in Figure 8e than in Figure 8b. The probable cause is that they are closer to the ultrasound excitation position. However, an interesting phenomenon is that Defects D and E are more clearly detected in Figure 8b than in Figure 8e. This phenomenon also occurs when the ultrasound excitation positions are at the left-top and left-bottom, shown in Figure 8a,d. The other interesting phenomenon is that Defect F is not clear as in Figure 8a,d, although it is closer to and in a line with the ultrasound excitation positions.

Figure 8. The complete vibrothermography results after CIS: (**a**) Left-top; (**b**) Middle-top; (**c**) Right-top; (**d**) Left-bottom; (**e**) Middle-bottom; (**f**) Right-bottom.

When the ultrasound excitation position is at the right-top shown in Figure 8c, Defects A, B, C, D, E, F and G are detected. When the ultrasound excitation position is at the right-bottom shown in Figure 8f, Defect A cannot be detected. Defect G is more clearly detected in Figure 8f than in Figure 8c. The possible cause is that it is closer to the ultrasound excitation position. An interesting phenomenon is that Defects B, C, D, E and F are more clearly detected in Figure 8c than in Figure 8f, although they are closer to the ultrasound excitation position in Figure 8f.

Through Figure 8, when a defect, such as G, is deeper, the ultrasound excitation position should be closer. The vibrothermography results depend on the defect depths, positions and the specimen structures. A modulation ultrasound excitation can generate higher power and might lead to more
