Structure from Motion Multisource Application for Landslide Characterization and Monitoring: The Champlas du Col Case Study, Sestriere, North-Western Italy

Martina Cignetti ^{1,2}, Danilo Godone ^{1,*}, Aleksandra Wrzesniak ¹ and Daniele Giordan ¹

Abstract: Structure from Motion (SfM) is a powerful tool to provide 3D point clouds from a sequence of images taken from different remote sensing technologies. The use of this approach for processing images captured from both Remotely Piloted Aerial Vehicles (RPAS), historical aerial photograms, and smartphones, constitutes a valuable solution for the identification and characterization of active landslides. We applied SfM to process all the acquired and available images for the study of the Champlas du Col landslide, a complex slope instability reactivated in spring 2018 in the Piemonte Region (north-western Italy). This last reactivation of the slide, principally due to snow melting at the end of the winter season, interrupted the main road used to reach Sestriere, one of the most famous ski resorts in north-western Italy. We tested how SfM can be applied to process high-resolution multisource datasets by processing: (i) historical ae

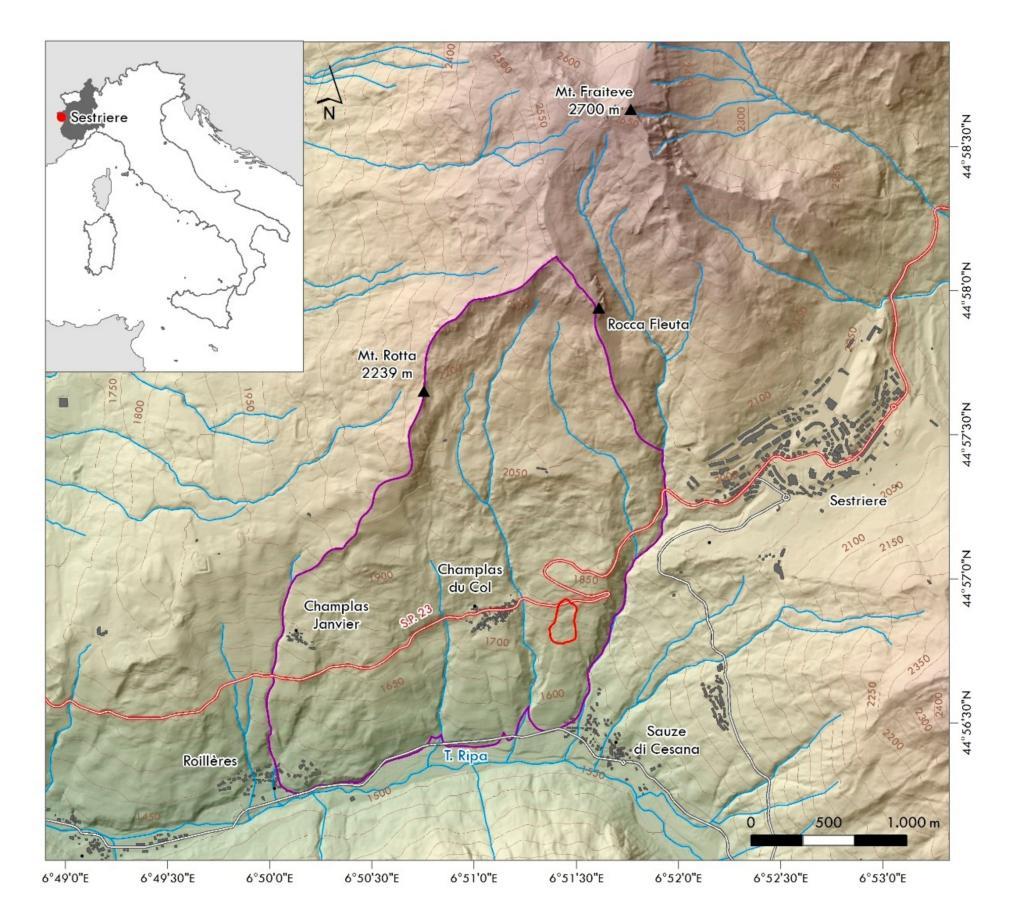
Figure 1. Geographic location of the area of interest, close to the Champlas du Col hamlet, Sestriere municipality (Piemonte, north-western Italy), red polygon corresponds to the May 2018 Champlas du Col landslide reactivation, while the purple one corresponds to the Champlas du Col deep-seated gravitational slope deformation (DsGSD).

The area of interest is located at the confluence of the Upper Susa Valley and the Chisone Valley (northern Cottian Alps), between the localities of Sauze di Cesana and Rollières, Sestriere municipality (Piemonte Region, north-western Italy). The study was carried out on the Champlas du Col landslide, located on the south-facing slope of Mt. Fraiteve (2700 m a.s.l.), close to the namesake hamlet (Figure 1).

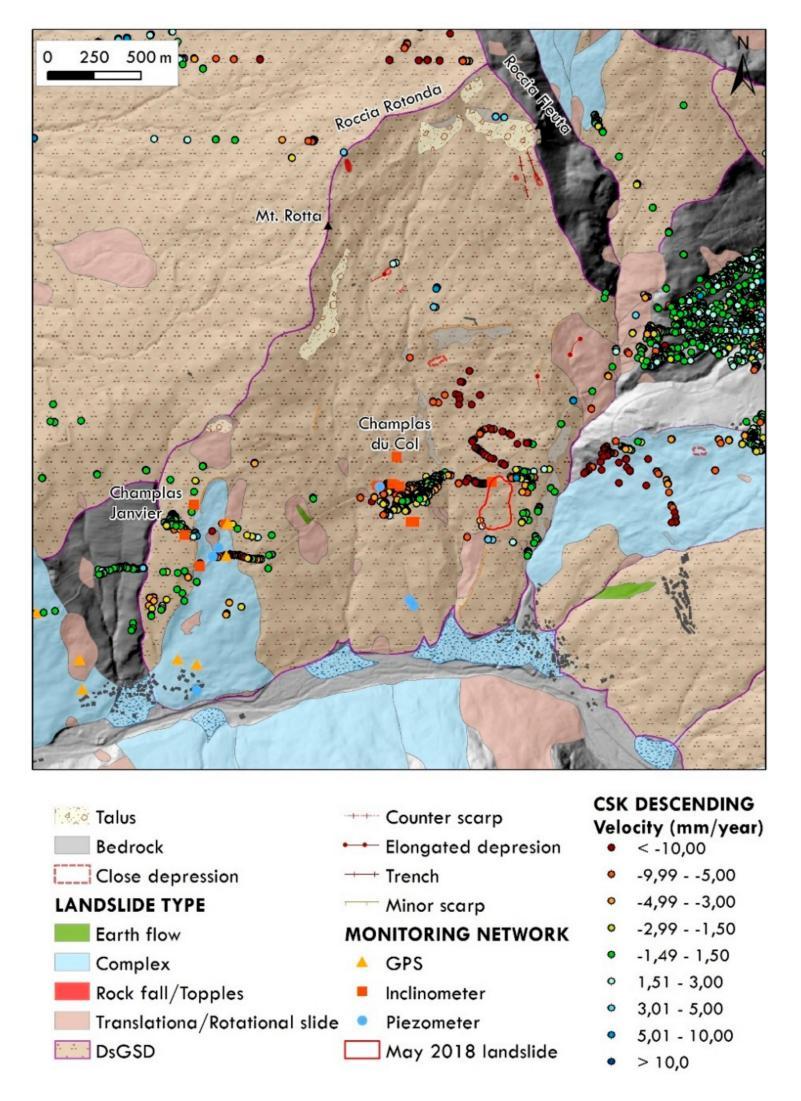
Figure 2. Geomorphological map of the Champlas du Col Deep-seated Gravitational Slope Deformation, landslides associated (landslide polygons source: SiFraP, Arpa Piemonte web-site [62]), in situ instruments (data source Arpa Piemonte web-site [62]) and remote sensing Cosmo-SkyMed (CSK) SAR data distribution (data source: Portale Cartografico Nazionale [63]); red polygon corresponds to the May 2018 reactivation and the purple one to the Champlas du Col DsGSD.

(i.e., inclinometers, piezometers) were carried out and some GPS benchmarks have been installed (Figure 2).

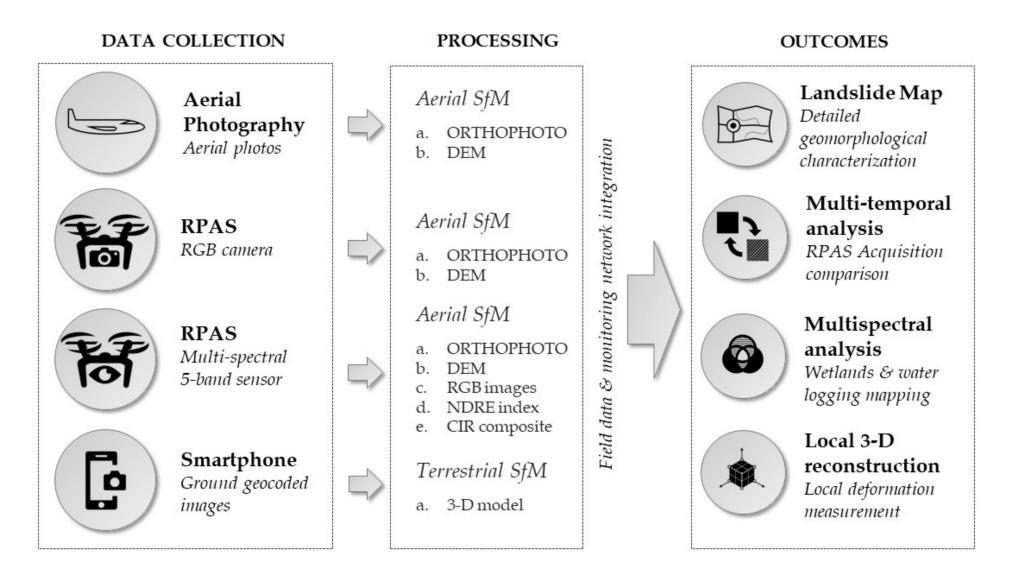
Figure 3. Flow chart of the Structure from Motion (SfM) multisource application methodology for landslide investigation.

Through a multiscale analysis, we developed a methodology that combines terrestrial and aerial image acquisitions (Figure 3). We generated a series of datasets composed of high-resolution images suitable for the SfM reconstruction process by using the Remotely Piloted Aerial System (RPAS), smartphone camera, and historical aerial photograms collected from diverse regional flights. The collected datasets are processed with Agisoft Photoscan, a commercial software that uses SfM to reconstruct the scene.

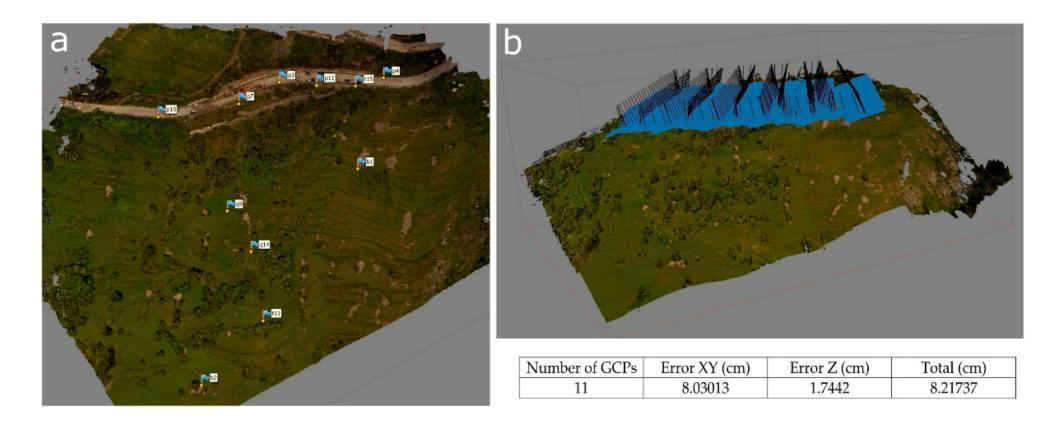
Figure 4. 14 June 2018 UAV flight planning: (**a**) Ground control points (GCPs) distribution, with XY and Z errors associated, and (**b**) camera positions.

affected area across the S.P. 23. Flight planning was carried out on site (Figure 4) in order to pick a safe location for take-off and landing and define the area to be observed. The flight altitude was about 70 m to provide a ground resolution of approximately 5 cm per pixel. Before the UAV survey, 12 square reference targets (GCPs) were placed outside the unstable area for georeferencing purposes.

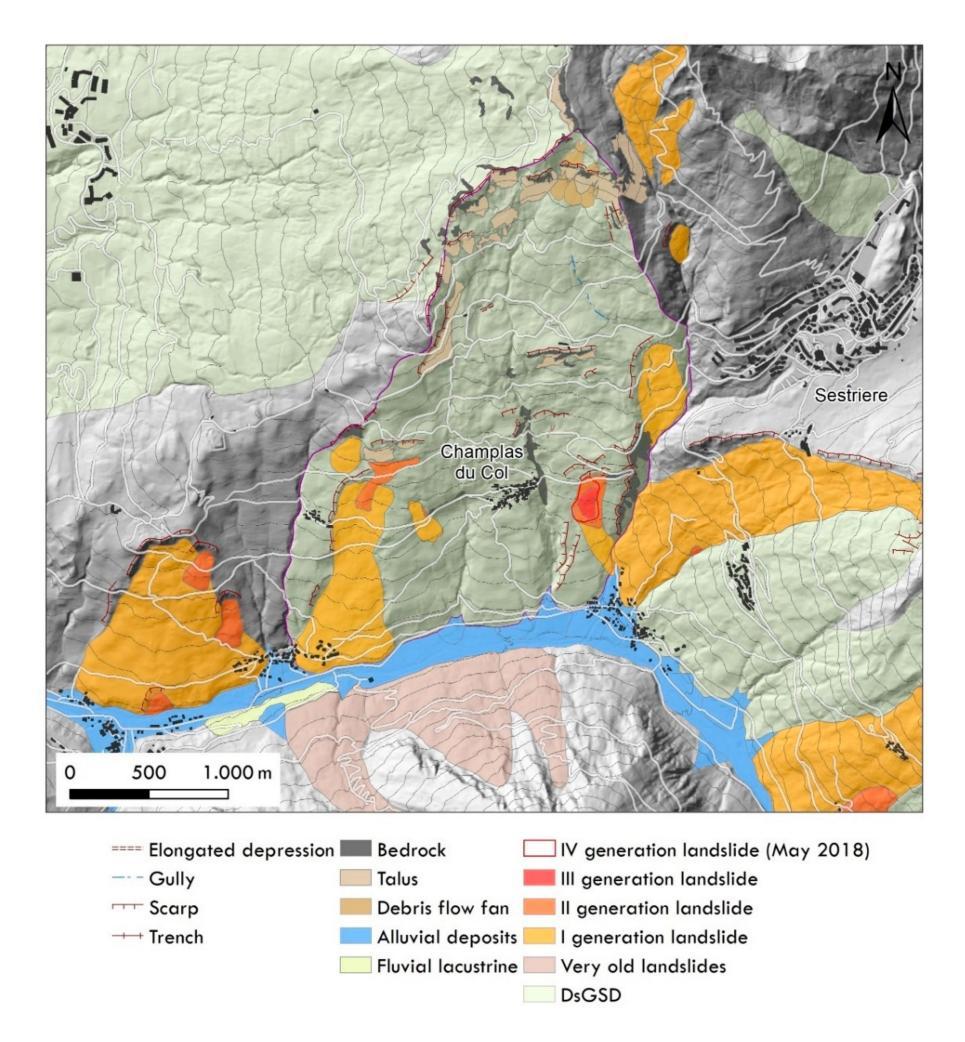
Figure 5. Landslide map of the area of interest distinguished on the basis of temporal hierarchy.

Figure 5 portrays the inventoried landslides spatial distribution on the whole area of interest, in association with some geomorphological features that are well recognizable and related with the evolution of the slope and prevalently due to landslides (e.g., main scarp, trenches, elongated depression). Within the first-generation landslides, we recognized two additional generations of landslides that have progressively altered or partially erased the morphology of these previous ones. The fourth generation is represented by the May 2018 landslide activation, who interrupted the main road.

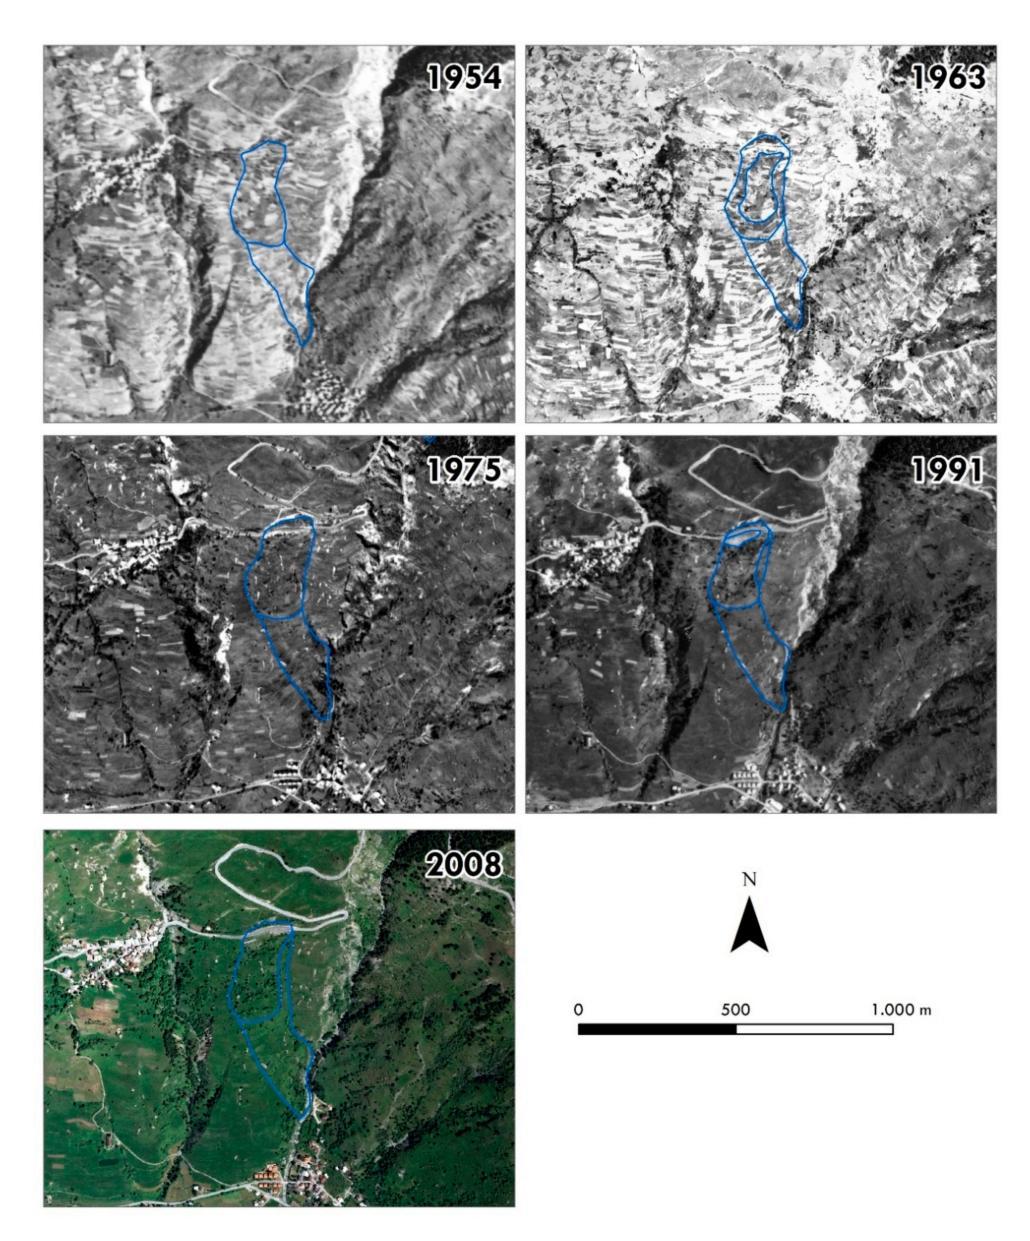
Figure 6. Orthoimages processed by SfM for the Champlas d Col area; the blue polygons represent the photo-interpreted Champlas du Col landslide bodies.

us to distinguish three chain-linked landslide bodies: (i) first-generation Champlas landslides; (ii) second-generation Champlas landslides; and (iii) third-generation Champlas landslides. The first and the second-generations bodies are already well recognizable in 1954 images, while the third-generation bodies were clearly detected in the 1963 aerial photos (Figure 6). Until 1963, the air photos clearly depict the complexity of the field pattern, which are mainly represented by agricultural land (i.e., pastures). In general, the agricultural parcels' orientation is regular, following the contour lines, while in the Champlas du Col landslide bodies, an irregular and uneven orientation is clearly visible. From the 1975 orthoimage, we can note a general abandonment of land in terms of agricultural practice. The most prevalent land use is pasture featuring the absence of tree cover. Only in correspondence to the landslide sector, small bushes and sparse trees are present. It should be noted that the 1975–1991 inter-period variation of the second-generation Champlas landslide, highlighted by a new 'fresh' scarp set in the downstream portion of the S.P. 23 road, is clearly visible in the 1991 orthophotos.

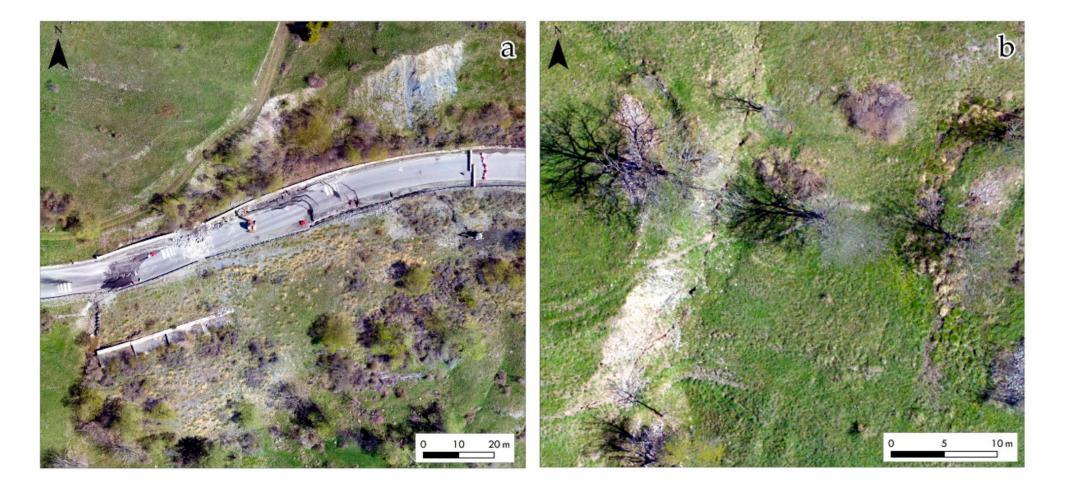
Figure 7. 15 May 2018 UAV orthoimage detail: (**a**) Main scarp of the crown area and road damage; (**b**) clearly visible latera fracture associated with a local fresh scarp, in the middle portion of the right-limit of the unstable area. On the right of the picture one of the wetlands is vividly discernible.

The crown area is evidenced by an ENE-WSW trending scarp extended around a hundred meters in length (Figure 7a), and it ranges from 1800 m to 1820 m a.s.l. in elevation. In correspondence of this scarp, there are outcrops of the highly schistose calcschists of the Cerogne-Ciantiplagna unit. The zone of visible depletion involves the surface of the S.P.23 national road, causing noticeable fractures and steps on the pavement. In the downstream sector, a series of transverse fissures with variable extension (from 5 to 30 m) were recognized. Across the slope, starting from the downstream sector of the road, two main lateral fissures of around 100–150 m in length and a noticeable gap in the range of decimeters were observed (Figure 7b).

These evident fractures are associated to en-echelon tensional cracks, related to the drag of the slide. The right-side fracture involves the already in-place retaining wall, which shows clearly visible deformations. In the halfway sector, this main fracture is associated to a "fresh" scarp, that extends from 1750 m a.s.l., for about 20 m and about 3 m in height (Figure 7b). On the left-side, at about 1760 m

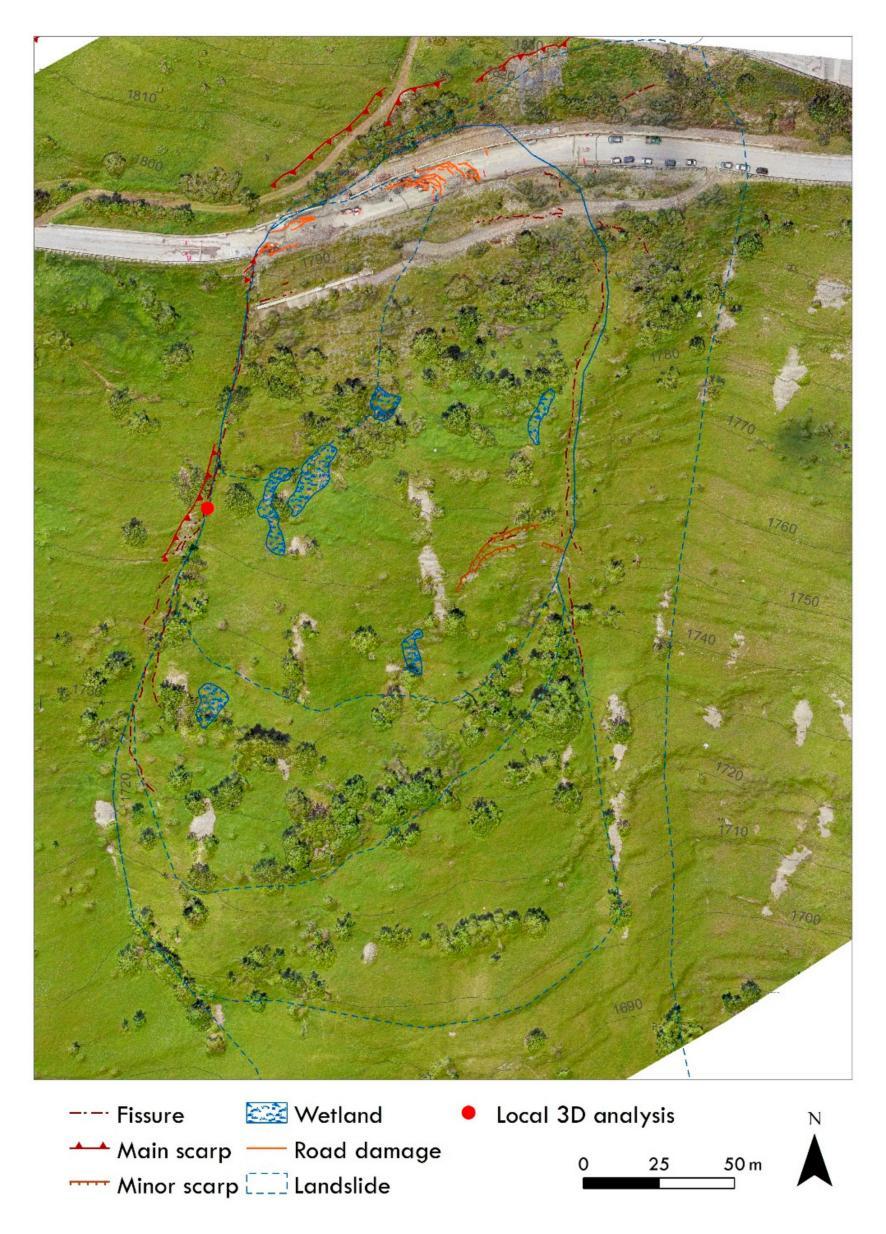
Figure 8. Map of the geomorphological evidence of the unstable area (Orthophoto source: 14 June 2018 UAV survey).

Within the unstable area, diverse wetlands highlighted by bright green grass and characterized by hummock-and-hollow surfaces were identified. The distribution of the wetlands area mainly corresponds to the outer limit of the toe bulging portion, clearly evident on the shaded relief and also highlighted by the trend in the contour lines. Figure 8 shows the map of all the morphological features and road damage recognized in the UAV orthoimages of the unstable area.

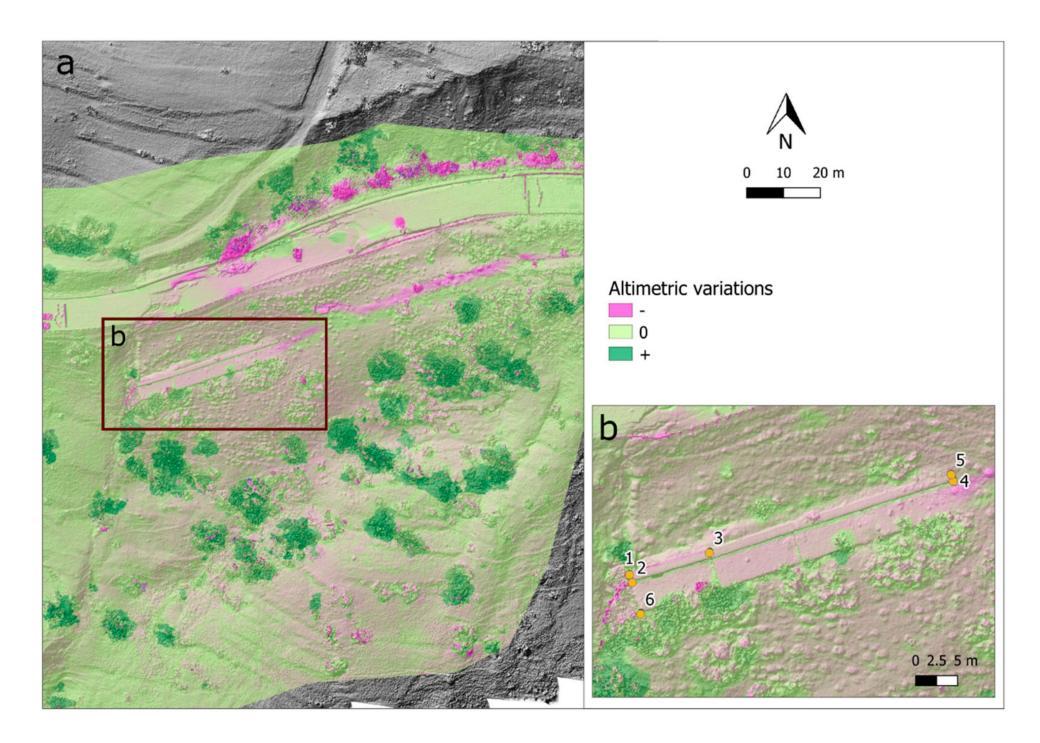
Figure 9. (a) Comparison of the altimetric changes from the 15 May 2018 and 14 June 2018 DEMs, illustrating the surface variations in the most damaged area, (b) with a focus on the retaining wall, highlighted by the red box, showing the selected points for the planar and height variations computation (see Table 3).

The multi-temporal analysis carried out on RPAS data allowed us to analyze the potential changes that occurred between the 15 May 2018 and the 14 June 2018 flights. It is important to note that both the UAVs flights followed the paroxysmal event and occurred in late April-early May. Therefore, at the time of the flights the main deformation has already occurred. For this reason, by a first visual inspection, we can appreciate that a weak variation occurred between the two UAV acquisition DEMs (Figure 9). The figure illustrates that in about one month, material was removed from the north-western portion of the unstable area, specifically, in correspondence to the pre-existing retaining wall (ENE-WSW oriented) and located in the sector just downstream of the main road. The digging on the road pavement and that for the creation of a runway for the remedial work activity is clearly visible.

We also focused on the pre-existing retaining wall by selecting some well-recognizable features and extracting their three-dimensional coordinates in order to compute both the planar and height variations (Table 3) between the two DEMs.

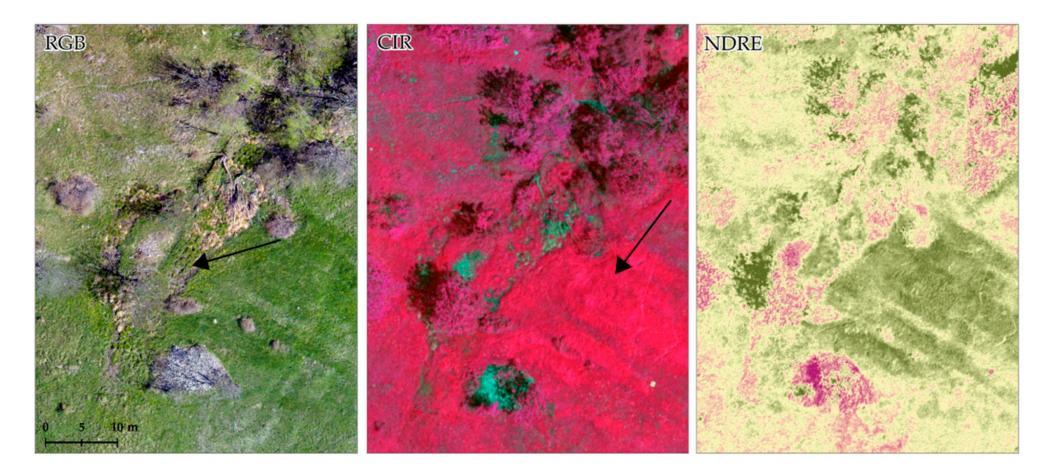
Figure 10. RGB (left), CIR (center) and NDRE (right) of a portion of the investigated landslides revealing hummock-and-hollow pattern (\leftarrow RGB) and long leaf grass lodging (\leftarrow CIR) as indicators of water abundance.

The interpretation of multispectral layers (NDRE and CIR maps) and its comparison with RGB data and field surveys revealed a complex pattern of springs and wetlands in the studied area (Figure 10). In particularly, the RGB and CIR composite has highlighted areas featuring hummock-and-hollow texture where, in the field surveys, the presence of springs has been confirmed. Moreover, in the NDRE layer, areas of long leaf grass are emphasized. Their colour suggests their vigor and their pattern indicates the abundance of water and the presence of a surficial flux causing plant lodging.

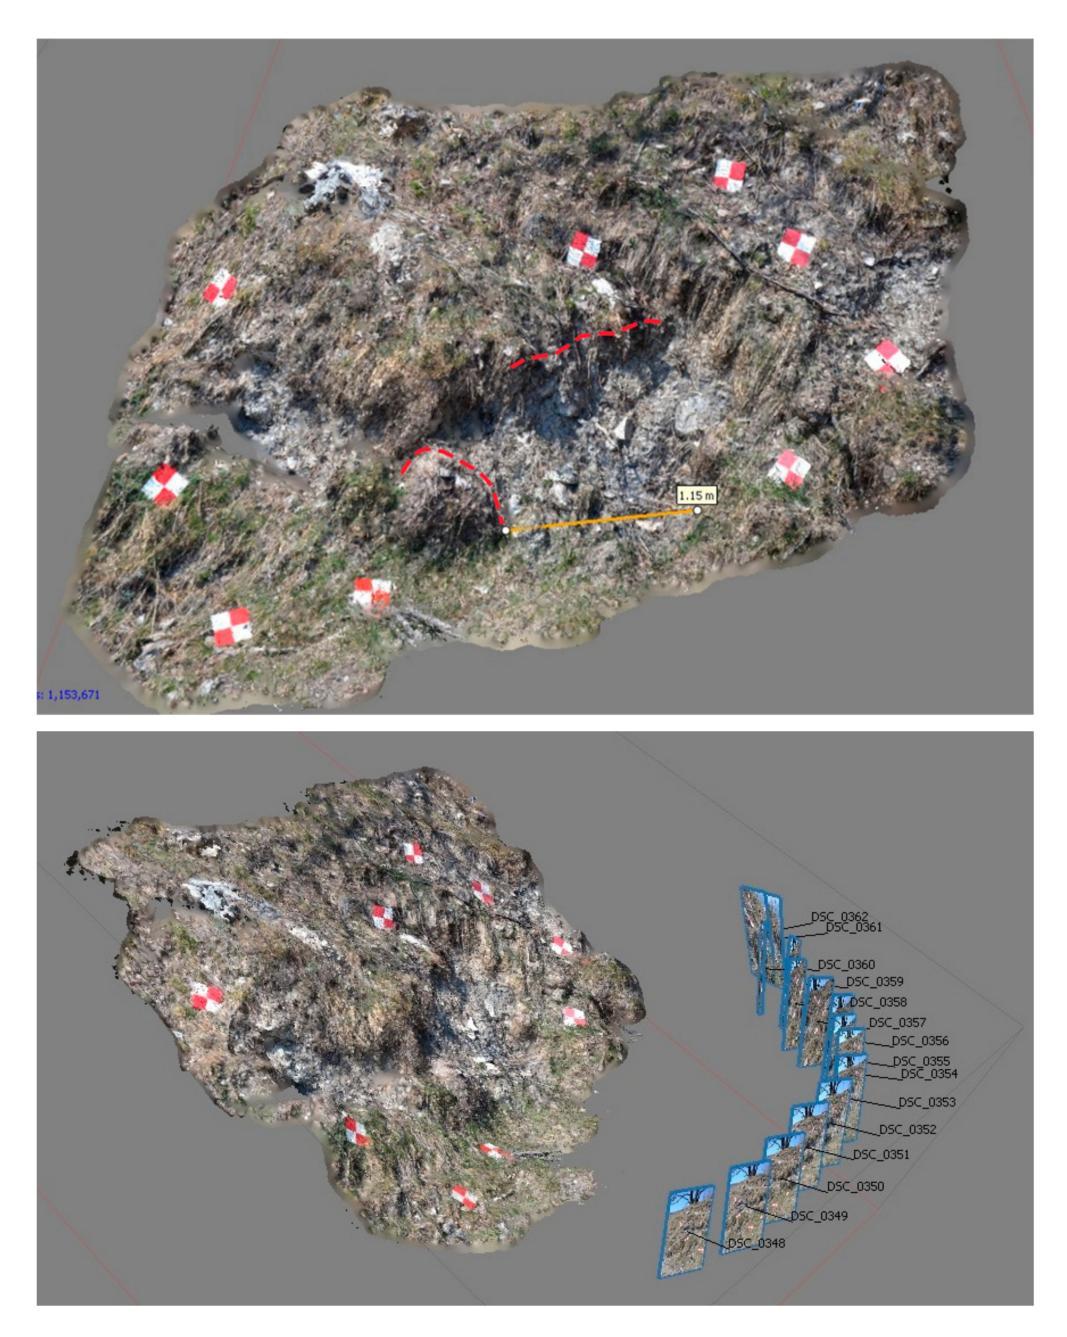
Figure 11. 3D-reconstruction of a local portion of the right-side fissure (see Figure 9 to locate the site), processing terrestrial photos (**Up**: manual displacement measure; **down**: positions of image captures).

Local 3-D reconstruction on a sector located along the main lateral scarp on the right side of the studied landslide was generated by taking a sequence of images by smartphone (Figure 11). We processed the acquired images, taking advantage of references of known size $(20 \times 20 \text{ cm})$ located within the scene. After aligning photos, we used the bench-markers as scale bars for the known distance, in meters, between the targets' edges. By updating the dataset geometry, the tool refines the scale of the entire model, thus allowing metric measurement.

The lateral fissure in the halfway sector (from 1750 m a.s.l.), is associated to a "fresh" scarp, along which local roto-translational movements are visible, and are materialized in small sods detached from immediately neighboring local scarps. The local displacement was measured in correspondence to a clearly recognizable sod, shown in Figure 11, by measuring the distance between its scarp and the top of the sod. A displacement of about 1.15 m was estimated, mainly due to the dragging effect of the landslide movement.

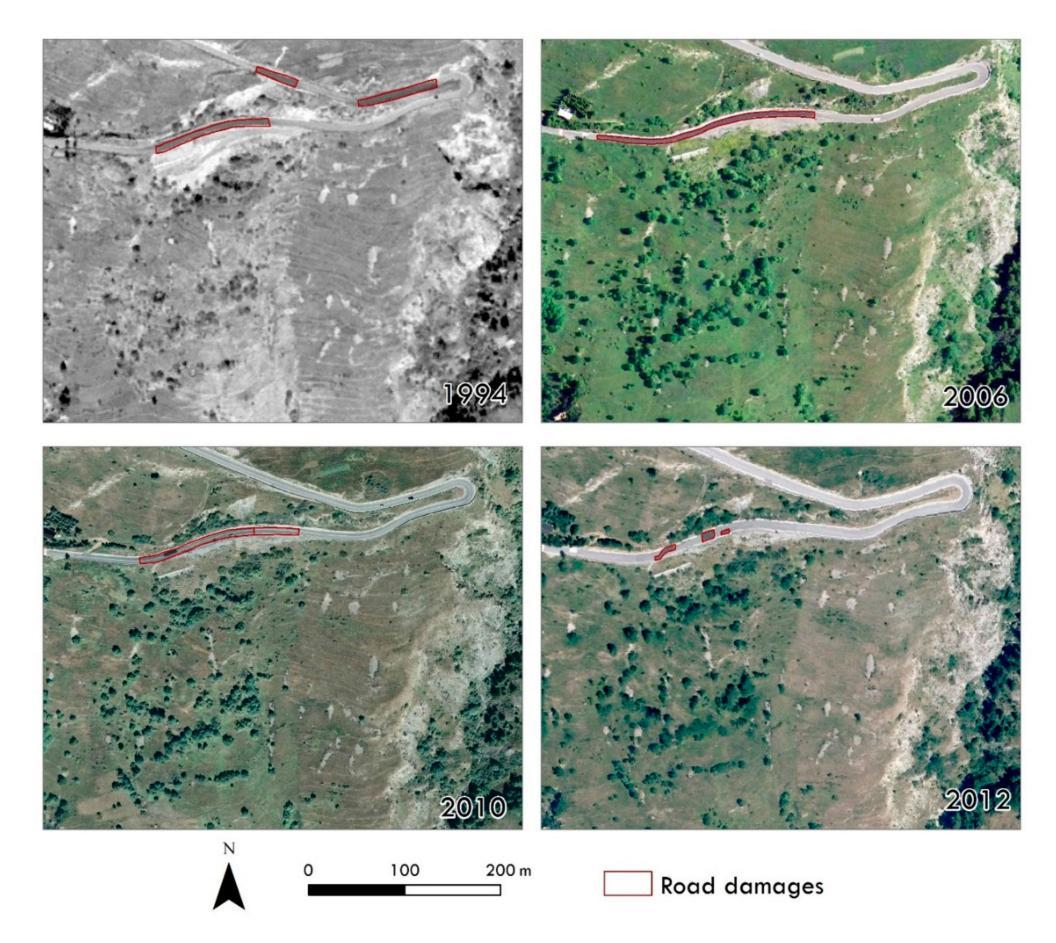
Figure 13. a. Evidence of road repaying visible on the orthoimages available on the "*Portale Cartografico Nazionale*" web-portal [63].

Evidence of road damage, e.g., road repaving (Figure 13) testifies to a long history of instabilities in the Champlas du Col area, which before the construction of the retaining wall involved the entire curvy road (see 1994 orthophoto in Figure 13). Currently, the area involved corresponds to the May 2018 reactivation.

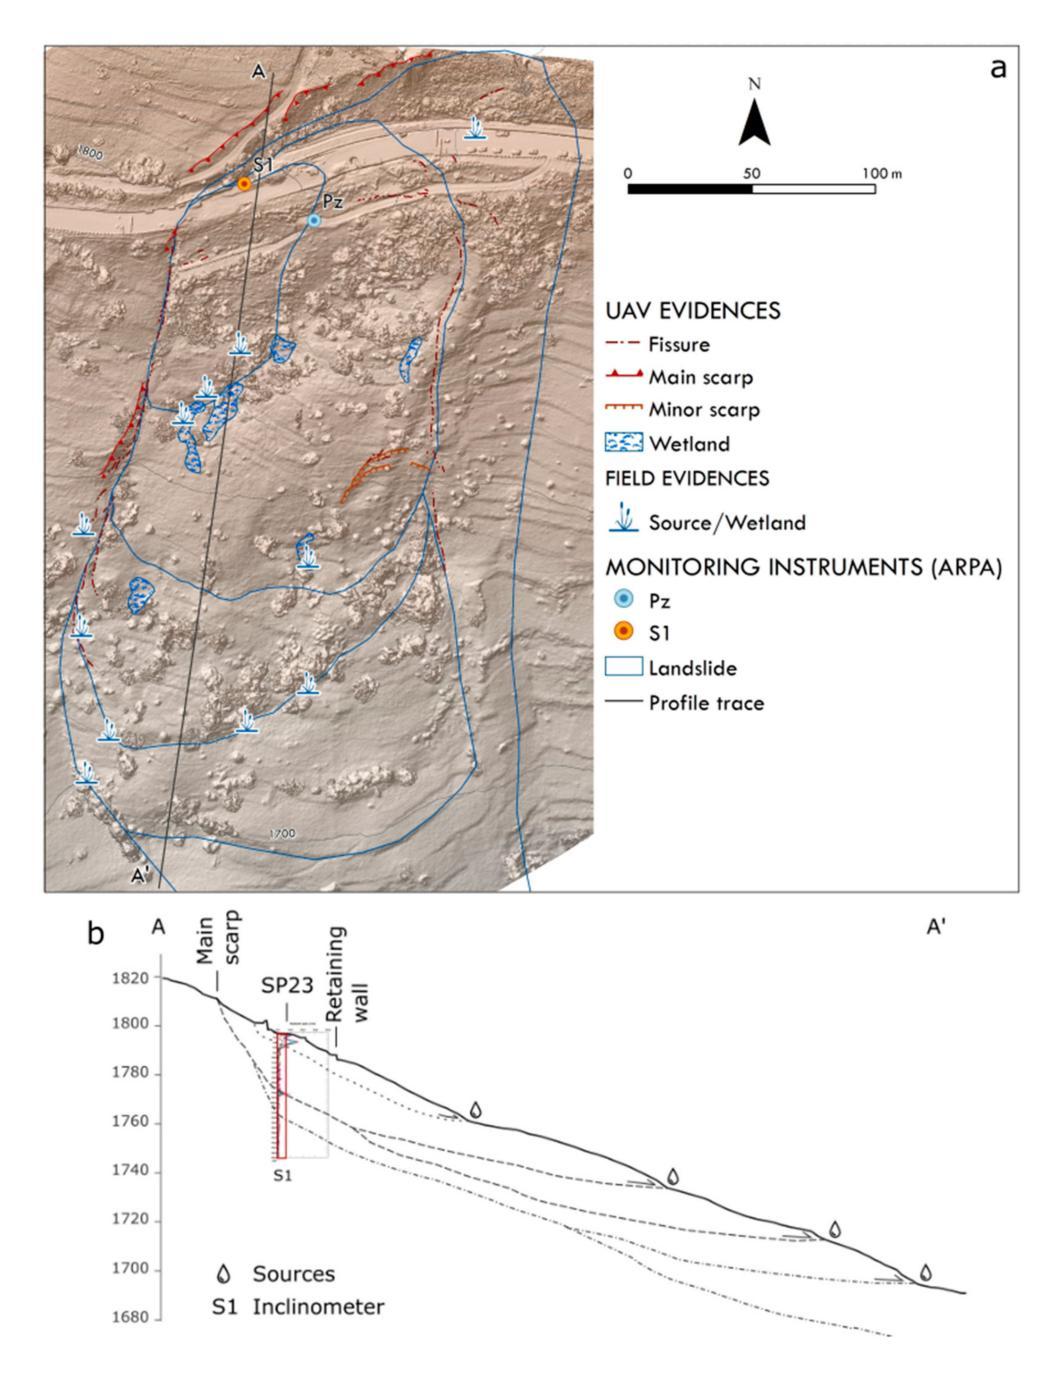
Figure 14. (a) Map of the Champlas du Col observed landslides associated with the main morphological features due to the spring 2018 reactivation, and (b) longitudinal profile associated with the resulting displacement graph calculated during June–November 2018.

Figure 14 shows the preliminary geomorphological model of the investigated landslide, highlighting the preferential distribution of springs and wetlands in the outer limit of the bulging portions, outlining the series of overlapped landslides, clearly bounded laterally by very open fissures.

The existence and the location of many sliding surfaces was confirmed by the inclinometer (S1 in Figure 14) measurements in the period 8 June–13 November 2018. The S1 located one sliding surface at a depth of about 3.5 m, with an initially high speed that gradually decreased almost to zero from early August; a second surface was observed at about 24.5 m, with an initial deformation of about 3.6 cm/year, although this decreased at the beginning of August and settled on values of about 1.4 cm/year.
