Article

Distributed Optical Fiber Sensing Bonding Techniques Performance for Embedment inside Reinforced Concrete Structures

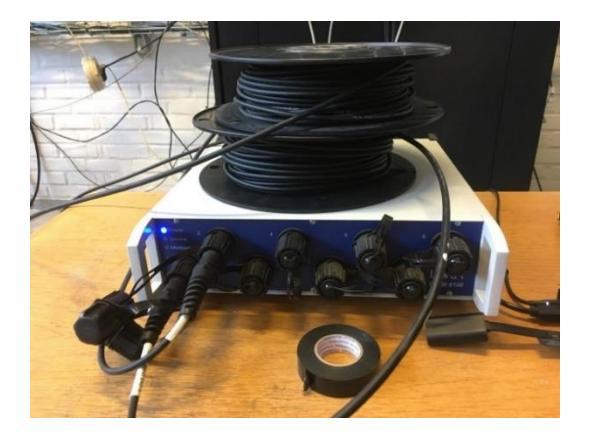
Figure 1. LUNA's ODiSI 6000 Optical Backscatter Reflectometer.

Distributed optical fiber sensors (DOFS) are modern-day cutting-edge monitoring tools that are quickly acquiring relevance in the structural and civil engineering field [3]. These are very thin glass wires able to accurately measure strains (down to 1 $\mu\epsilon$), temperature and vibration in 2 or even 3 dimension [4]. This can be achieved in a completely-distributed manner (modern interrogation units can attain a spatial resolution of 0.63 mm) and with measurement frequencies of 250 Hz [5]. Thus, direct detection and characterization (including recognition, localization, and quantification or rating) of local strain changes generated by structural damage are intrinsic properties of such sensors. Furthermore, optical fiber sensors have some inherent advantages such as corrosion immunity, high durability, resistance to electromagnetic interference, small size and light weight that elevate them beyond the classic monitoring tools [6]. The functioning of these sensors is based on the fact that, assuming the characteristics of the light transmission within a fiber well known and the latter properly calibrated, any alteration (due to temperature and strain) are detected through back-scattered light by the optical backscatter reflectometer (OBR) (see Figure 1) and are finally translated to strain variation in each of the DOFS' points [7].

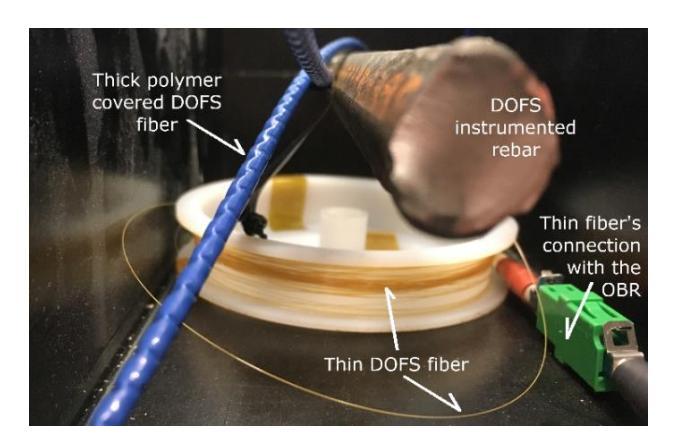
Figure 2. Thin polyamide cladded distributed optical fiber sensors (DOFS) (yellow) and thick polymer coated DOFS (blue).

The simplest DOFS sensor is a polyamide cladded glass wire which boasts a 125 μ m diameter (see Figure 2). Multiple commercially available variations cover the latter with differently sized coating layers which span from rigid and deformed polymeric coatings (blue thick fiber in Figure 2) to thin fabric-like covers that consent a large amount of fiber winding.

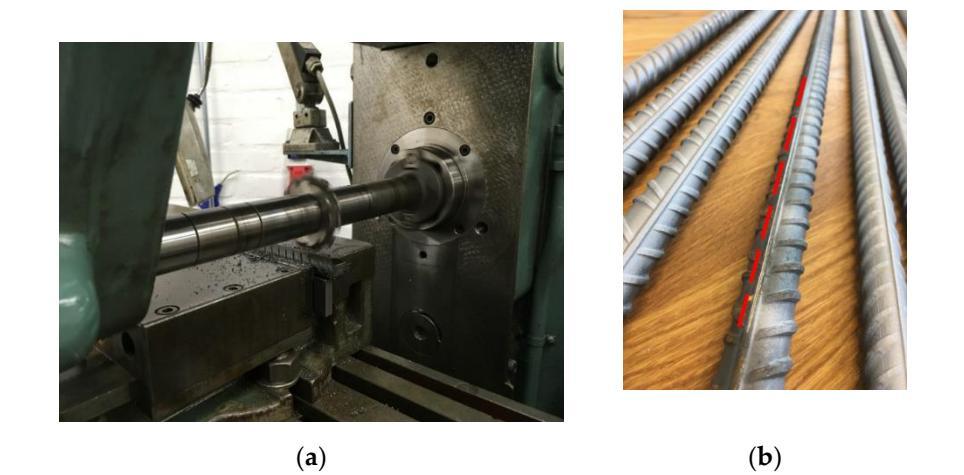
Figure 3. (a) Milling of the groove along the rebar's longitudinal rib and its (b) resulting incision marked with a dashed red line.

A rather novel and advanced DOFS protection technique establishes the incision of a groove on a rebar's surface (usually on the longitudinal rib as in Figure 3) which later welcomes the DOFS inside it. As will be visible in the following publications, this is believed to provide further protection compared to simply gluing the fiber to the rebar's surface (Quiertant et al. [24]). Yet, it is quite surprising that, despite this technique's non-negligible financial and time costs, a comprehensive study on the potential improvement that it brings to the table (in terms of DOFS reading quality) has yet to be performed. The present paper intends to perform such analysis.

It is worth mentioning that, in Figure 5c, the groove is hardly visible due to its small size (as evident in Figure 3b) and color similarity with the background. Additionally, hereafter rebars with an incised groove will be referred to as (w/groove) whilst the ones without it as (w/o groove).

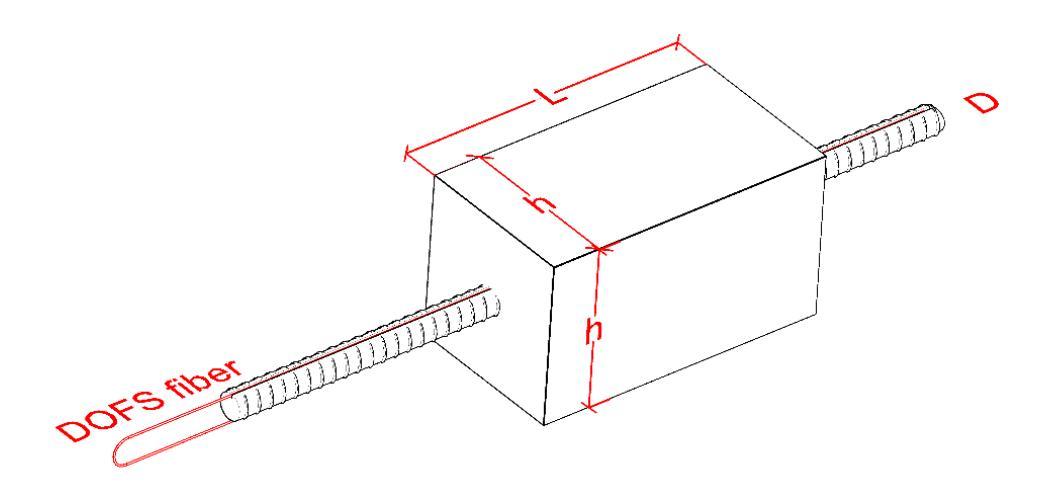
Figure 4. Reinforced concrete (RC) ties' general geometrical dimensions.

The present paper displays the results of an experimental campaign developed on multiple squared RC ties with DOFS-instrumented rebars. Each of the RC members will be indicated with a code such as 15D20_24 that should be interpreted in combination with Figure 4, which provides indications on the geometrical features of each RC member.

The first digits of the code are representative of the concrete prism's cross sectional size (h in Figure 4), the digits that follow the letter D are representative of the diameter of the rebars (D in Figure 4) whilst the digits following the underscore symbol (_) are representative of the length of the concrete prism (L in Figure 4). The geometrical design of these RC members satisfies the conditions necessary to perform a double pullout test-powered study [29] on the influence of the longitudinal

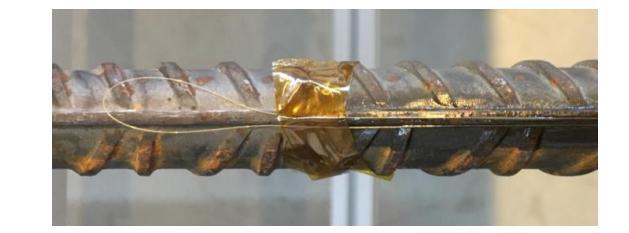
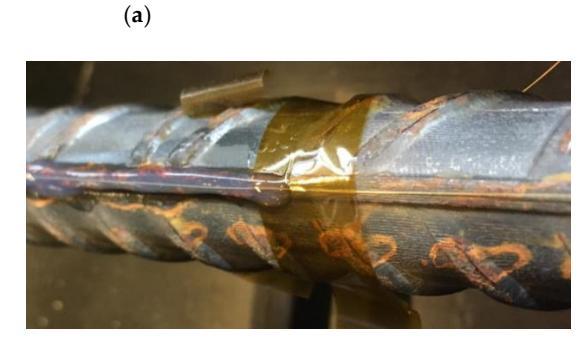
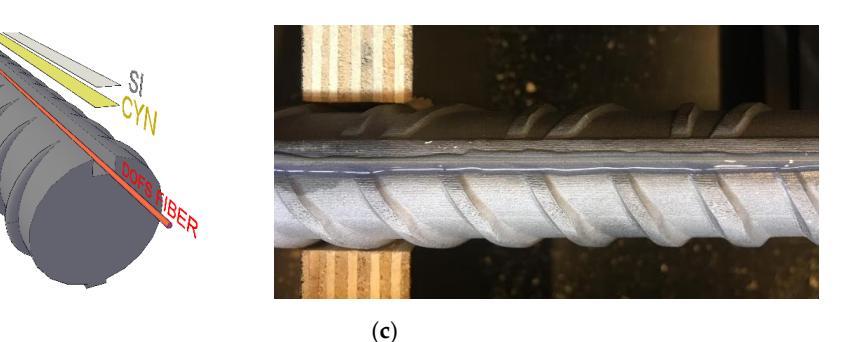
Figure 5. Graphical and photographical representation of the three tested bonding techniques (a) positioning of DOFS in an incised groove and bonding it with CYN (b) bonding it with CYN with an additional protective layer of SI (c) positioning of the DOFS in a groove, bonding through CYN and protection through SI.

The bonding technologies in use, illustrated in Figure 5, are the following ones:

- 1. DOFS positioned inside a groove and bonded with cyanoacrylate (CYN) as visible in Figure 5a;
- 2. DOFS glued to the rebar's surface with CYN with a protective layer of silicone (SI) on top, as visible in Figure 5b;
- 3. DOFS positioned inside a groove, bonded with CYN and further covered with SI. As visible in Figure 5c.

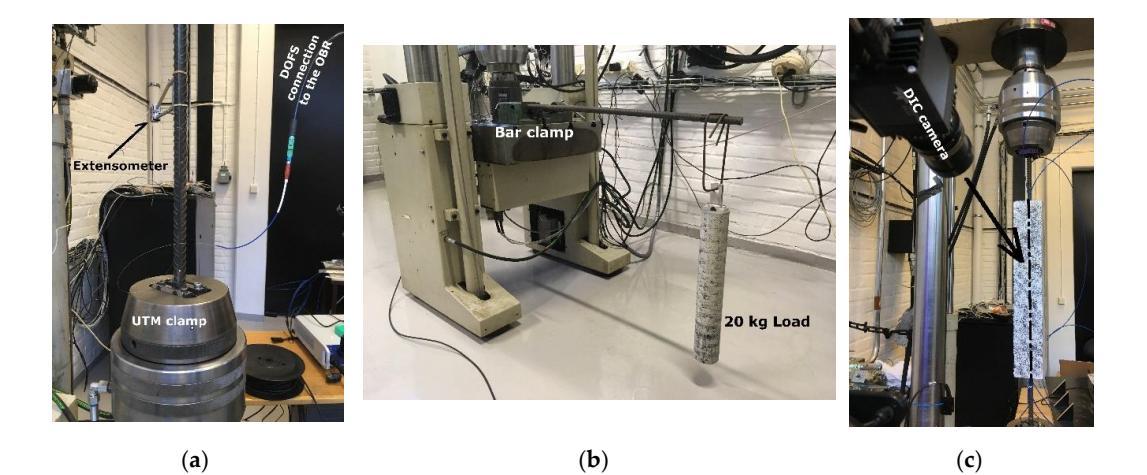
Figure 6. Test setup for the (**a**) universal testing machine (UTM)-assisted tensile test on a bare rebar (**b**) bending test (**c**) UTM and digital image correlation (DIC)-assisted tensile test on a RC tie.

The bending test is instead achieved by clamping one extremity of the rebars and applying on the opposite one (at a fixed distance) a 20 kg load (Figure 6b) in order to create a bending stress and a clearly distinguishable strain profile. Once again, this process is done twice in order to monitor the instrumented rebars strains with a CYN-bonded DOFS and later a CYN+SI bonded DOFS.

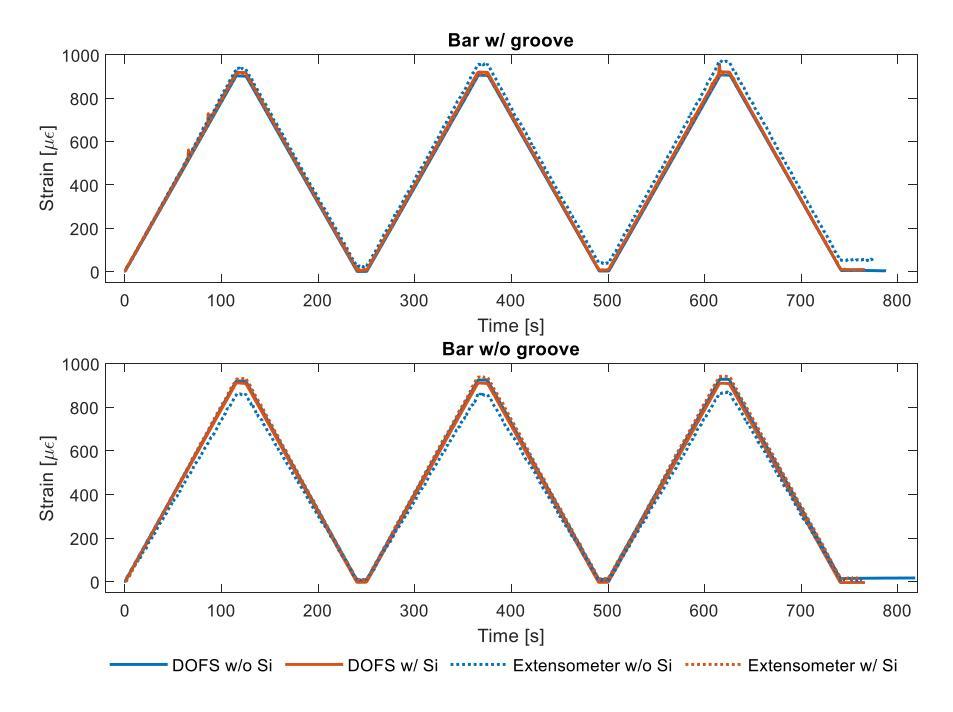
Figure 7. DOFS and extensometer output readings of the tensile test.

Figure 7 plots the strain measurements performed by the DOFS and by the extensioneters connected to the two rebars w/groove and w/o groove. As visible both graphs include two pair of readings, one (in blue) representative of the strains recorded by the DOFS glued with CYN and the other (in red) representative of the strains recorded by the same DOFS glued with CYN and covered with SI. An excellent agreement is present between the DOFS strain curves of both graphs indicative of the small influence that a layer of SI exercises on the tensile readings of a bare bar. Such agreement outshines the ones of the classic extensometer. Moreover, for the case of the bar w/groove, the extensometer even fails to detect that the zeroing of the applied load at the test's end whilst DOFS actually does. The extension of how/where the tool is attached on the rebar compared to its transversal ribs but, then again, it is an uncertainty that is entirely surpassed by DOFS. Figure 8 plots in more detail the strain reading differences of the two rebars when SI is present and when it is not. As DOFS' does not surpass 15 $\mu\epsilon$ in either bar (an amount possibly induced simply by a variation of the grip position), it can be safely stated that in tension the presence of SI does not influence the strain readings and thus it is safe to apply it for further protection of the fiber. For the extensioneter, instead, the reading variations are expectedly higher for both bars suggesting, once again, the greater reliability of DOFS. Finally, as can be seen in Figure 7, the presence of a groove also does not seem to alter the strain readings suggesting that it too, in tension, can be inserted sans souci as an extra protection for the fiber.

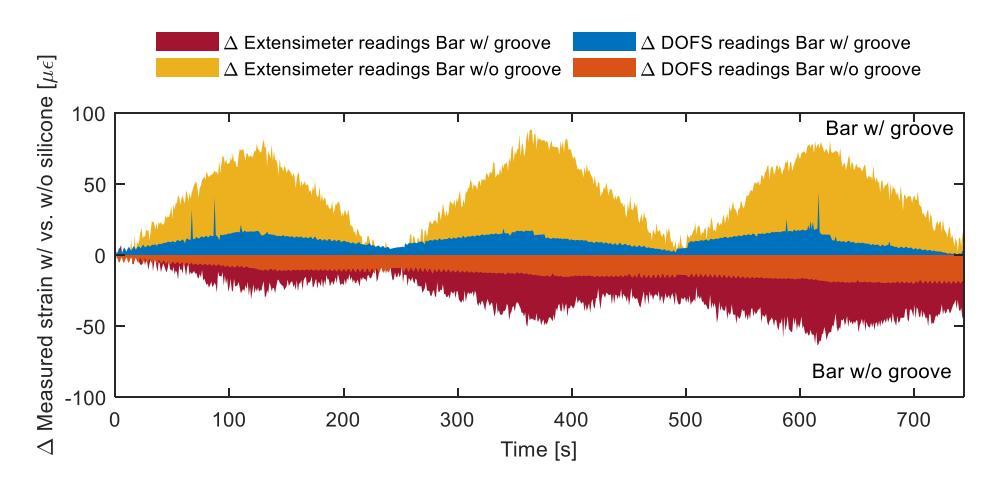
Figure 8. Bar w/groove and w/o groove's strain reading differences when DOFS + cyanoacrylate (CYN) are or are not covered by silicone (SI).

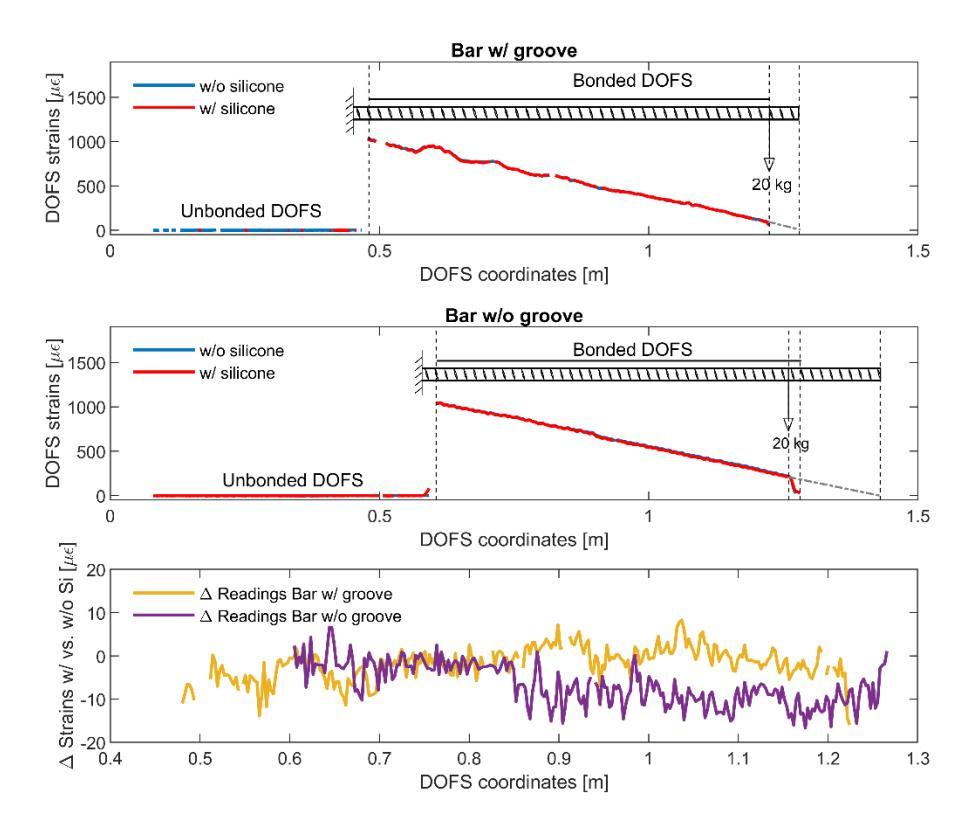
Figure 9. Strain profiles of the rebars (w/and w/o groove) under bending and the difference of values w/and w/o SI.

Moving on to the bending test, Figure 9 plots the DOFS strain measured in absence (in blue) and in presence of a SI protection layer for both bars w/and w/o groove. Due to the difference of DOFS bonding length in the two rebars, an illustration of the latter is inserted in both plots in order to help the reader better comprehend the shape of strain profiles.

It should be kept in mind that the initial segment of the graph, oscillating around the value of $0 \ \mu\epsilon$, is simply denoting the strains inside the un-bonded and loose section of the DOFS. Only once the first DOFS section of the fiber is bonded, then the profile jumps upwards reporting the rebar's highest strain. Once again, the presence of silicone is hardly perceptible, as confirmed by Figure 9's bottom graph, leading to quasi-identical strain profiles. Once again, the largest recorded strain measurement

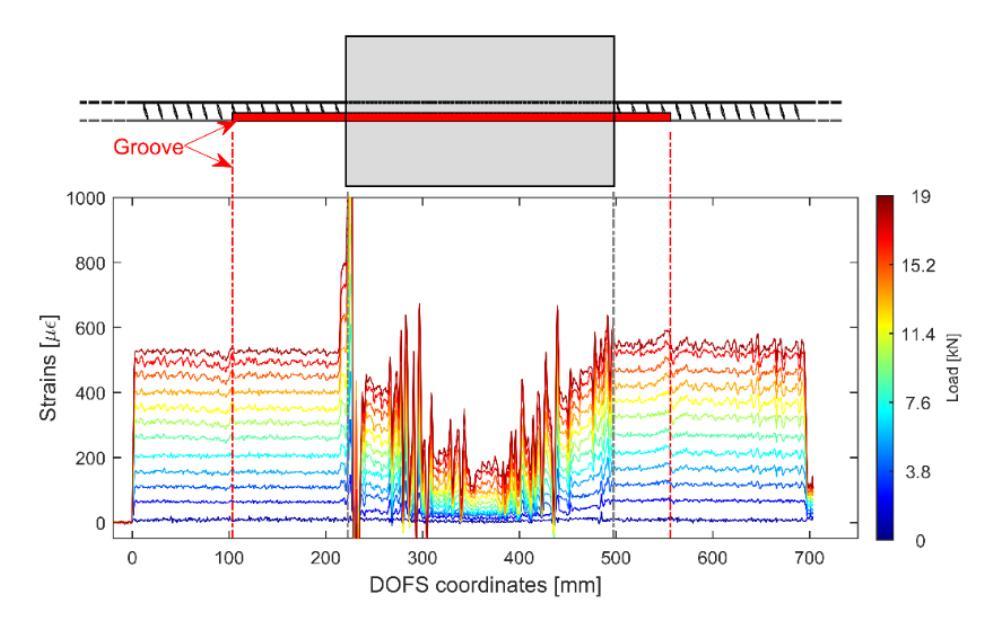
Figure 10. Strain profiles of a 15D20_27 RC tie test with the DOFS bonded with a combination of groove and CYN.

The first tested RC tie was a 15D20_27 member with its DOFS positioned in a groove and bonded with strictly CYN (no protection layer was placed). The test was intended to substantiate whether the mere presence of the groove could guarantee sufficient protection to the DOFS without requiring an extra protective layer. Figure 10 displays some of the strain profiles extracted from the aforementioned test along with an illustration of the member's geometry in order to properly correlate the plot data with the actual physical surface/surrounding in which the DOFS is located. As visible, the profiles' sections corresponding to the segment of the instrumented rebar embedded inside the concrete is full of SRAs (induced by the concrete's friction on the unprotected DOFS) making the actual profile barely readable. This is in line with multiple results reported in the literature review, thus leading to the conclusion that this technique most definitely is not recommended for this kind of DOFS-monitored testing. Yet, it should be mentioned that a possible influencing parameter could be the actual depth of the groove (quite shallow in the present test). It is possible that the deeper it is the better protection it provides to the rebar.

As can be seen in Figure 11 the profiles are much better than Figure 10's as a testament to the higher performance of its bonding technique. Indeed, hardly any SRAs are visible and the strains are monitored all the way to the yielding load (around 167.5 kN) and beyond. The peaks present at the higher loads are not SRAs (as was the case in Figure 10) but rather the physical representation of the rebar's different sections slowly plasticizing one after the other and therefore giving way to drastically higher strains than the non-plasticizing sections.

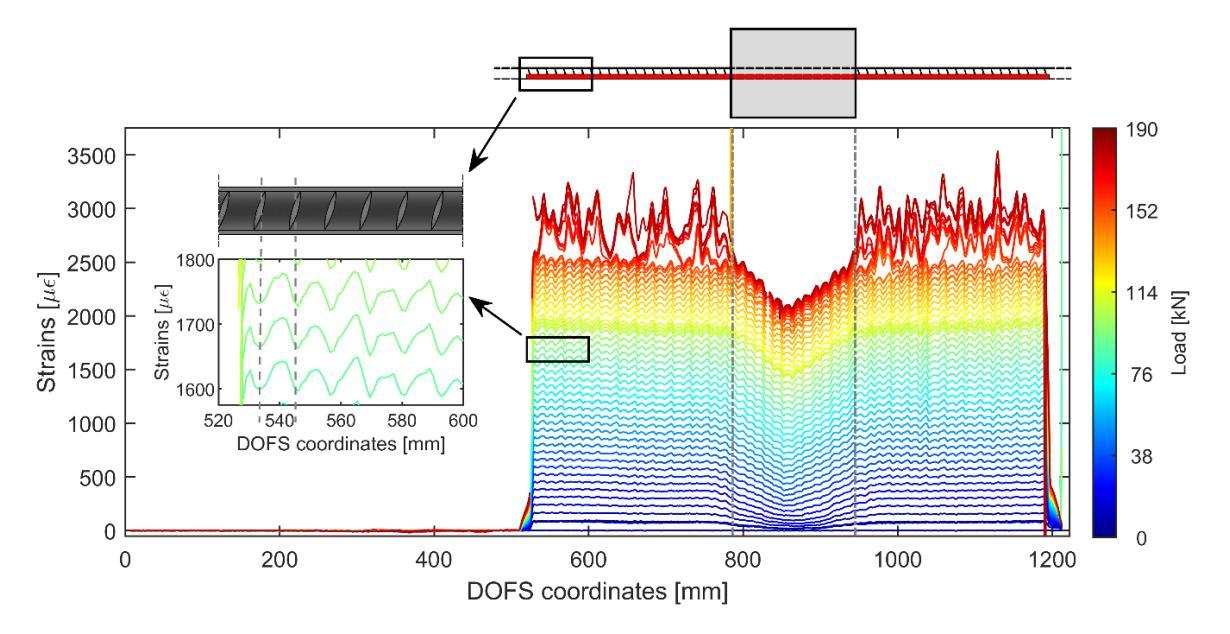
Figure 11. Strain profiles of a 15D20_21 RC tie test with the DOFS bonded with a combination of groove, CYN and SI.

Figure 11 displays the strain profiles of a 15D20_21 RC tie where the DOFS is first positioned in a groove and then bonded with CYN and SI.

Moving back to Figure 11, a small zoom is provided on its left of the rebar's strains profile outside of the concrete as reported by DOFS. An oscillation of the profile is visible which could easily be confused with signal noise. Yet, it is not noise but rather the influence of the transversal rib on the performance of the rebar. As a matter of fact, whenever a rib is present, the cross-section of the bar is automatically larger therefore the carried stress (and consequent steel strains) is inferior. Oppositely, whenever the rib is absent the carried stress is higher. The reiteration of this pattern leads to the abovementioned oscillating profiles. Yet, unless a researcher is interested specifically in the rib's influence on the bar's performance, the latter can be considered signal noise as the useful information signal that is usually pursued is strictly the global profile of the strain curve. As will be visible later on, this particular noise is also a function of the bonding technique in use, thus it is automatically elected as a study parameter for establishing the most performant bonding technique. In order to separate the noise from its original signal (as in Figure 13) a Fourier filtering solution can be used, thus relating a signal sampled in time or space to the same signal sampled in frequency, or a moving-average filter, thus sliding a window of customizable length along the data and computing the averages of the data contained in each window. For the scope of the current work the latter is deemed to be sufficiently performant, hence it is the used methodology.

What is also noticeable in Figure 11, is that the magnitude of such newly defined rib-induced noise becomes increasingly larger with the load thus increasingly disturbing the sought-after signal. Figure 13 shows its occurrence for member 15D20_21's six study case stages along its test. The latest of these stages has average noise peaks of height 27.5 $\mu\epsilon$ which, considering its corresponding load of 154 kN, is still very reasonable. As per the bottom graph of Figure 13, the average strain reading noise seems to be increasing at a regular pace with the load suggesting a correlation between the two.

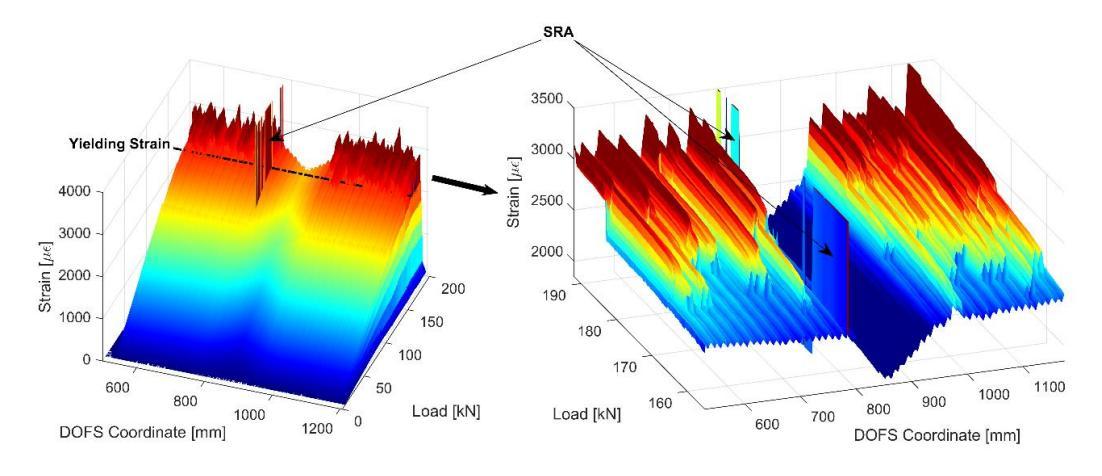
Figure 12. Three-dimensional representation of the strain evolution of member 15D20_21 with a zoom of the higher strains showing the progressive yielding of the different cross-sections of the rebar.

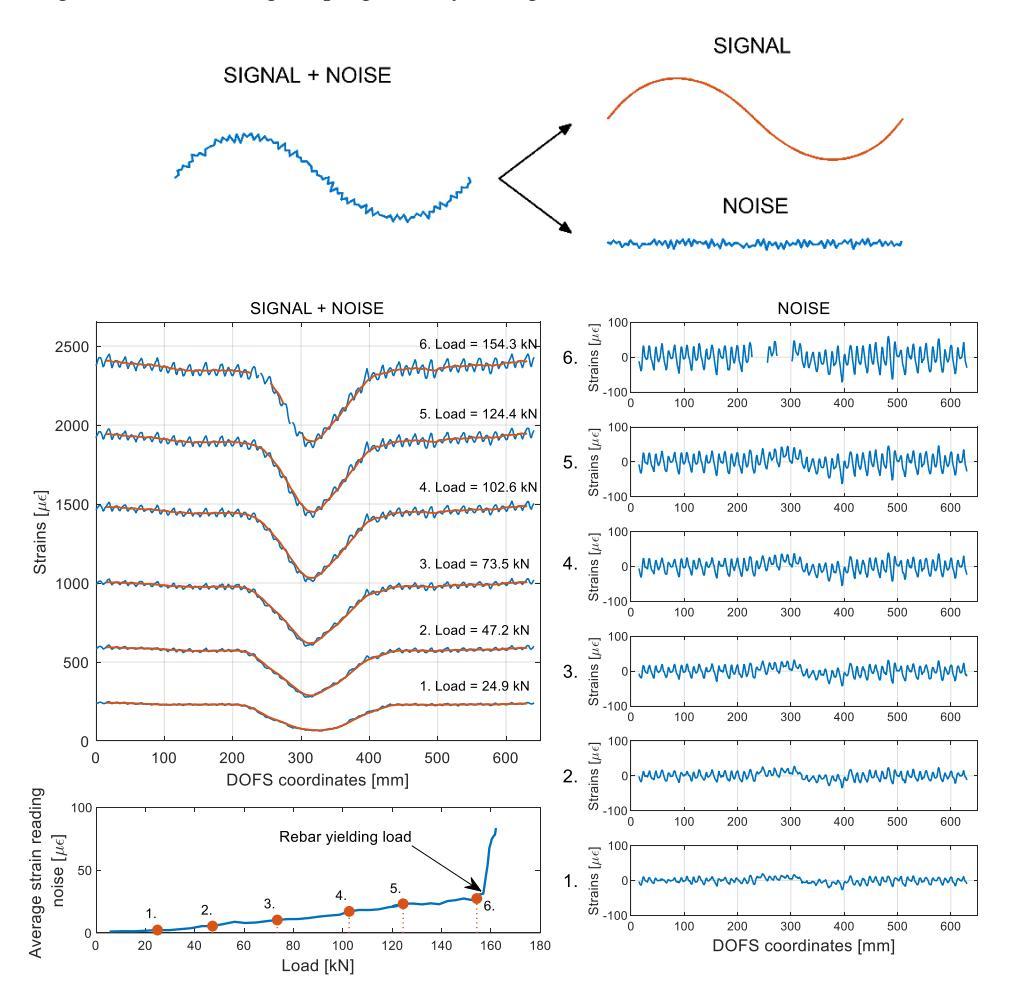
Figure 13. Distinction of signal and noise for an example curve (top) and evolution of the rib-induced noise with the load of member 15D20_21.

What is also on view is that, just like in Figure 13, the noise magnitude increases linearly up until the yielding load. Therefore, henceforward the noise level magnitude can be studied simply by means of a fitted straight line's slope coefficient. For example, Face A's versus Face B's average strain reading noise slope coefficient when inside the concrete is 0.3636 versus 0.0360, indicating the latter's higher quality. Now that the basic concepts of the rib-induced noise and its way of quantifying it have been introduced, the other members' analysis will be performed jointly at the end of this section.

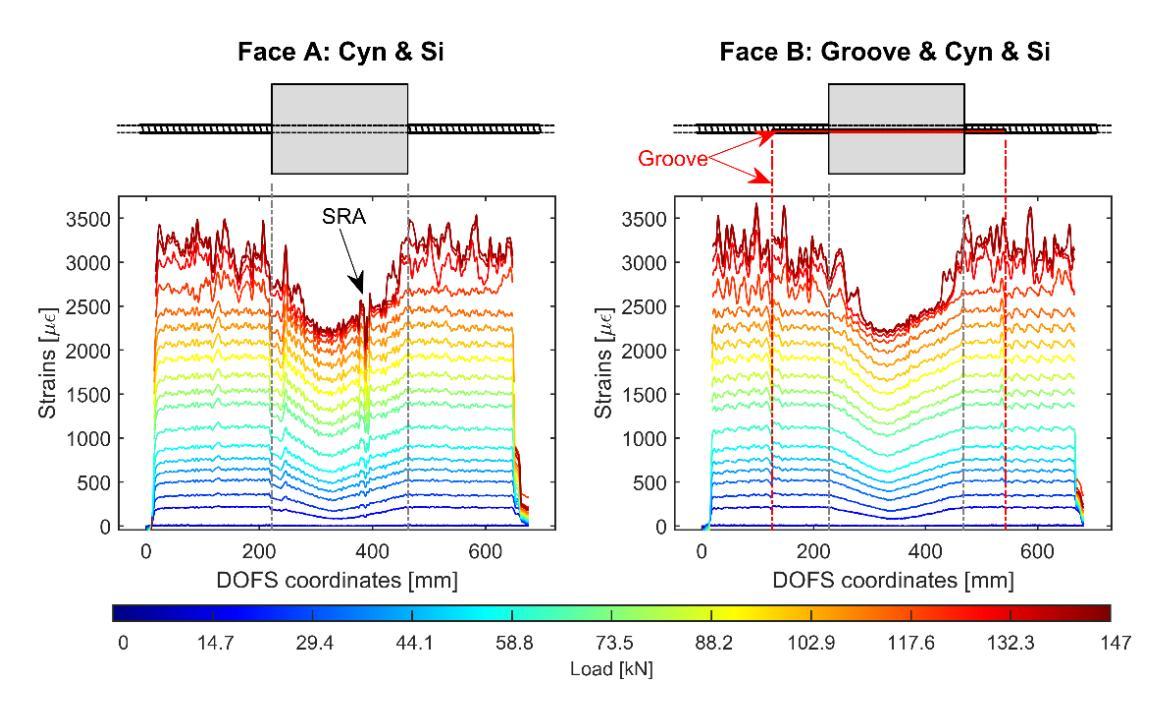
Figure 14. Strain profiles of 15D20_24_1 RC tie test with the DOFS bonded on both sides of the rebar by means of CYN and SI on one side (Face A—left) and a groove + CYN + SI on the other (Face B—right).

Moving on to the following RC tie, Figure 14 displays the DOFS strain readings of the first of two 15D20_24 members (henceforth referred to as 15D20_24_1) with its DOFS being bonded on its opposite faces. One face (henceforth referred to as Face A) uses CYN and SI whilst the opposite (Face B) adds a groove. The latter, though, is not as long as the rebar itself (see Figure 14's Face B RC tie illustration) therefore allowing to check, on a single face, the DOFS reading performance of two separate bonding techniques. What can be quickly spotted is the larger amount of noise that characterizes Face B's readings when performed outside of the groove versus inside it. Furthermore, along with a higher noise level of the signal, Face A's plots seem to include more SRAs. This is potentially due to the lack of a protective groove on its side.

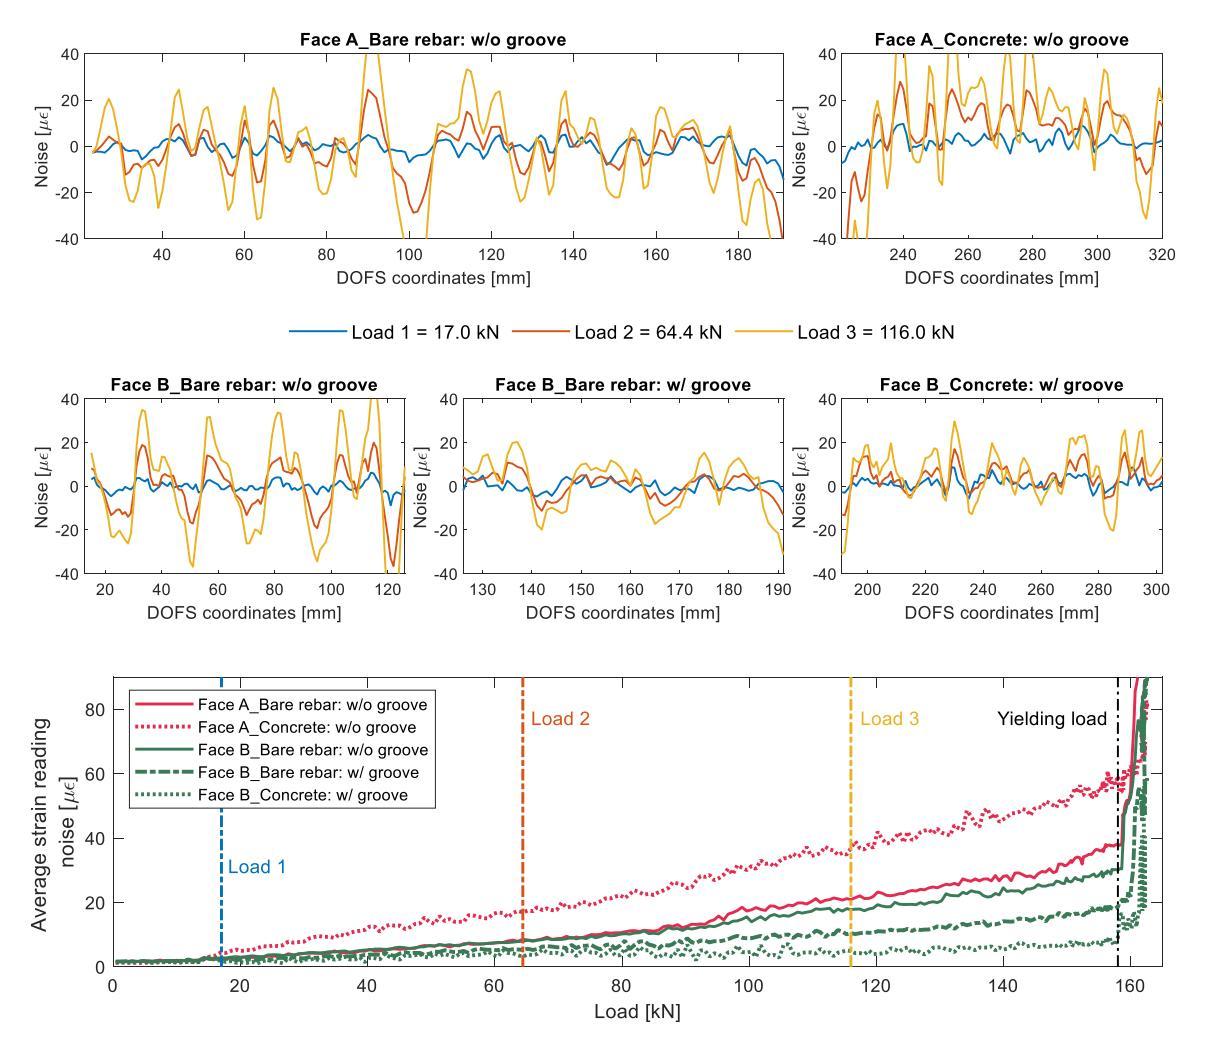
Figure 15. Rib-induced noise analysis of the outputs of member's 15D20_24's test (top five subplots) and of their relative average reading noises (bottom subplot).

Figure 15 dwells deeper in the DOFS' signal noise, displaying its values under three load levels. A discrete noise magnitude difference is noticeable according to the difference of DOFS/rebar bonding technique and according to the presence or absence of concrete. Figure 15's lower plot summarizes the increasing noise magnitude as a function of the load.

Both faces of the rebar report similar high noise levels whenever the DOFS is bonded outside of the groove whilst lower levels are consistently reported (both outside and inside the concrete) whenever the DOFS is positioned inside it. Once again it seems that the presence of the groove translates in an improved signal quality both from a noise and anomalistic point of view.

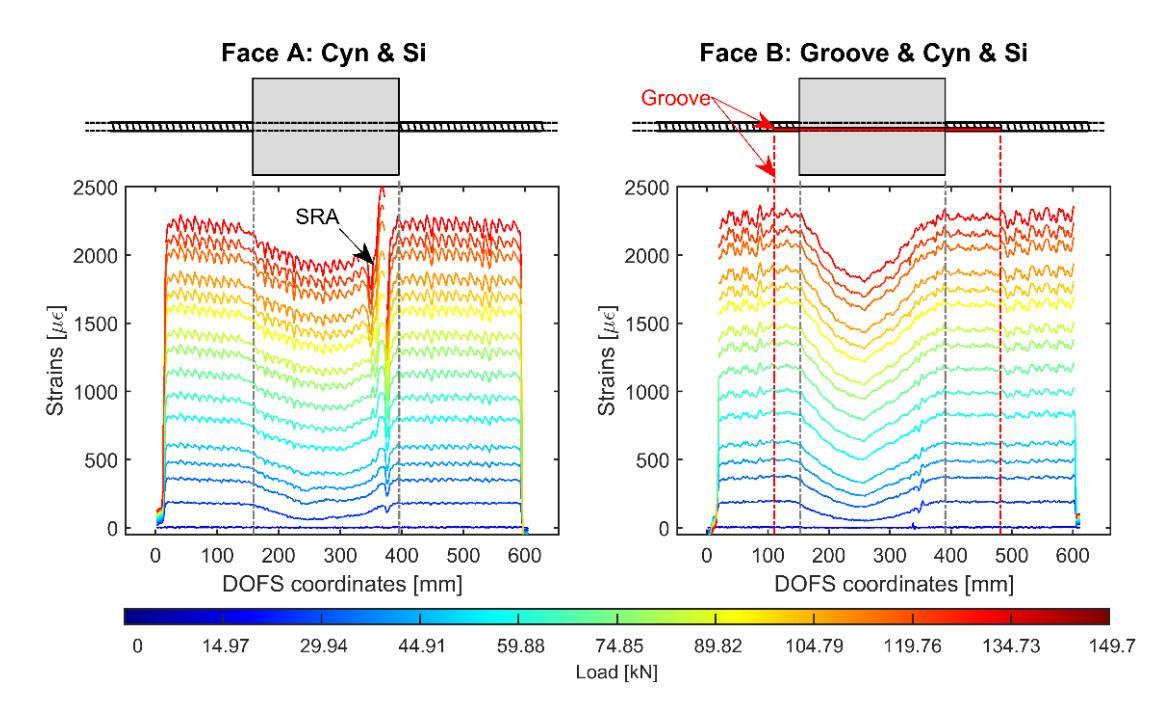
Figure 16. Strain profiles of 15D20_24_2 RC tie test with the DOFS bonded on both sides of the rebar by means of CYN and SI on one side (Face A—left) and a groove + CYN + SI on the other (Face B—right).

Figure 16 displays the DOFS strain measurement of an identical member, 15D20_24_2, with also identical bonding techniques.

The reason behind the testing of such member was the idea of attempting the replication of the previous member's results in order to consolidate them. While most of the above conclusions still apply to the present member (the presence of the groove providing the least noisy and anomalistic results both inside and outside the concrete), an unforeseen phenomenon also came up. Indeed, whilst in Figure 14 both faces provide similarly shaped plots, Figure 16's are quite different. Face A's profile inside the concrete loses the central pointy tip (expected in RC tie tests) and appears more curvilinear (instead of the expected pair of crossing linear profiles). Such difference can be attributed to a non-overlookable bending of the RC tie during the test, induced by a lack of straightness of the bar itself. Unfortunately, discrete amounts of bending occur in numerous RC tie tests due to the impossibility of having perfectly straight rebars. Whilst this is an accountable phenomenon, the effect of such bending on the DOFS (or on the adhesives bonding it) is unseen and deserving of further studies. A possible explanation to Face A's profiles could lay in the additional stretching that the bending-induced-tension of the concrete communicates to the adhesives (especially on the very deformable silicone) and thus to the fiber. Additionally, further studying should also be dedicated to assessing the effect of bending-induced-compression. This is in line with other researchers' results [11,16] that suggest a certain "strain relaxing" and "strain redistributing" influence of the silicone when it is used as a DOFS protecting material. Unfortunately, this phenomenon strongly influences the recommendability of the present bonding technique for this particular use. Furthermore, it should be kept in mind that such alteration is truly revealed only when monitoring multiple facets of the same rebar. Indeed, if only a single DOFS deployment is performed, all that is extracted from the test is such altered data is with no way of assessing its correctness.

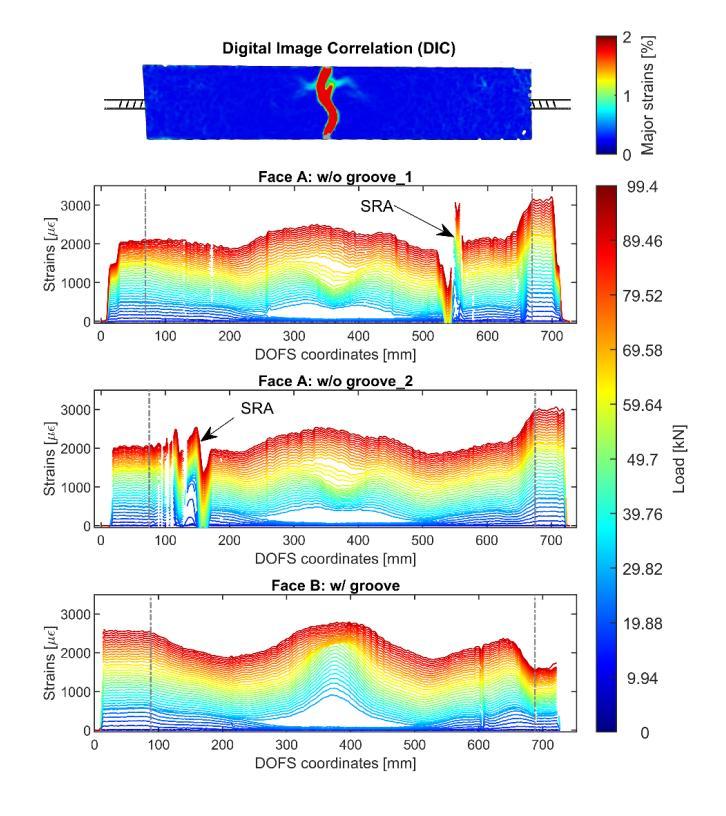
Figure 17. DOFS extracted profiles of member 12D16_60 as monitored by three runs of the same fiber, two on Face A and one on Face B.

The first RC cracking tie under scrutiny is 12D16_60. The member has the peculiarity of being monitored by three runs of the same fiber (possible thanks to its extended length) achieved through a simple twist, as shown in Figure 5a. Two DOFS runs are performed on Face A, where both bondings are achieved with CYN and SI w/o groove, and one on Face B w/groove (with CYN and SI). Their outputs are plotted in Figure 17 which includes a DIC illustration (on top) of the position of the crack in order to correlate it to the member's rebar strains.

Despite a relevant amount of bending is evident in each of three plots, a clear variation of the strain profile can be noticed in correspondence to the formed crack. Indeed, this variation takes the form of a single (Face B) or double pointed (Face A) peak whose axes coincides with the crack displayed in the DIC. Multiple SRAs can be seen in both of Face A's plots whilst only a small un-intrusive one can be spotted in Face B's suggesting the superiority of the latter's bonding technique. In line with what was concluded in the previous sub-section, also the noise produced by the combination of groove, CYN and SI is inferior to the bonding technique using just the last two elements.

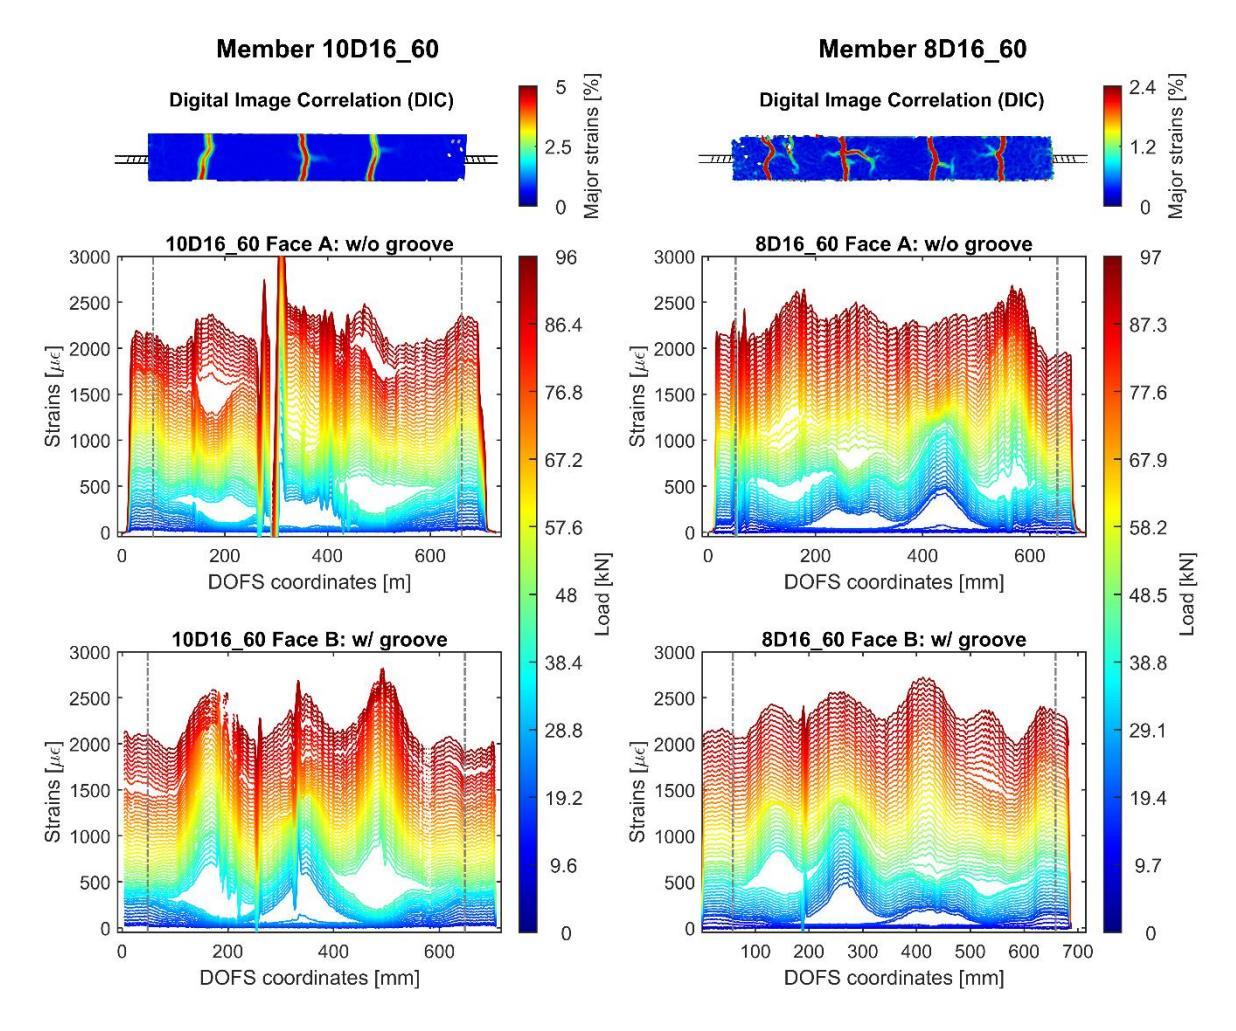
Figure 18. Member 10D16_60 (**left**) and 8D16_60's (**right**) rebar DOFS strain profiles for the latter's opposite faces, each welcoming different bonding techniques, and their DIC monitoring.

Figure 18 expands on the previous one showing the DOFS and DIC outputs of members 10D16_60 and 8D16_60. Just like before, the members' Faces A use simply CYN and SI whilst Face B adds a groove to the mix. Similar observations to the previous figure's can be performed. Indeed, strain peaks correspond well to DIC's cracks location and the signal noise level is inferior for DOFS positioned inside a groove versus outside one. Interestingly, though, member 10D16_60 displays a consistent amount of SRAs in both faces demonstrating that even the combination of groove, CYN and SI is not completely fail-proof.

- An unexpected phenomenon, possibly connected to the under-performance of the above bonding technique, causes an alteration of the DOFS strain readings whenever the fiber is in the presence of extra bending-induced tension (smoothened strain profiles as in Figure 16, Face A) and/or monitoring strains in cracked cross-sections (magnifying their amount as in Figure 18);

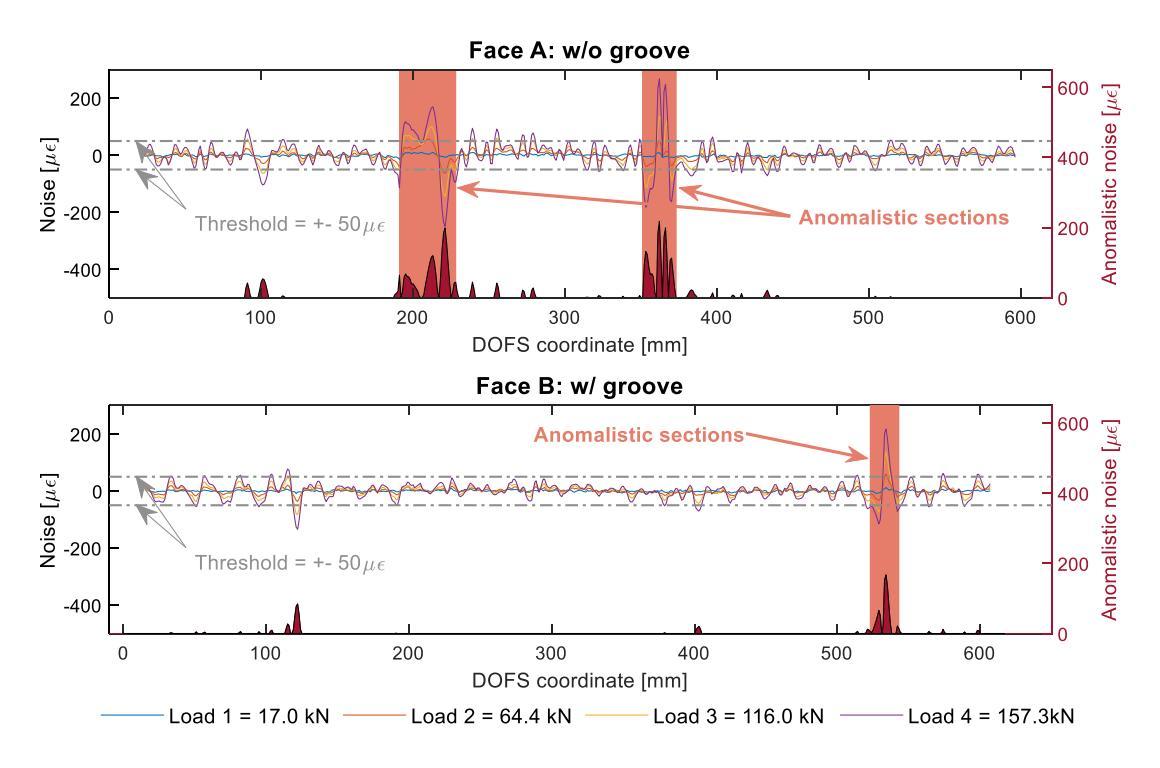
Figure 19. Member 15D20_24_2 Face A's (top) and B's (bottom) noise level study for SRA analysis.

In order to properly diagnose an SRA and clearly distinguish it from the signal's noise, a unique method is here presented. Taking as example member 15D20_24_2, Figure 19 analyses its DOFS signal noise level for four distinct loads.

level higher than the latter can be considered anomalistic. The selected threshold may vary according to the researchers' objectives, desired strictness and subjective sensibility on what should be labeled as anomalistic. Figure 19 adds an extra axis to each of the graphs where the amount of this newly-labeled "anomalistic noise" is represented providing a graphical representation of the location and gravity of the anomalies. Some anomalistic sections can be detected in both faces (despite the largest amount being on Face A) where most of the SRAs tend to concentrate.

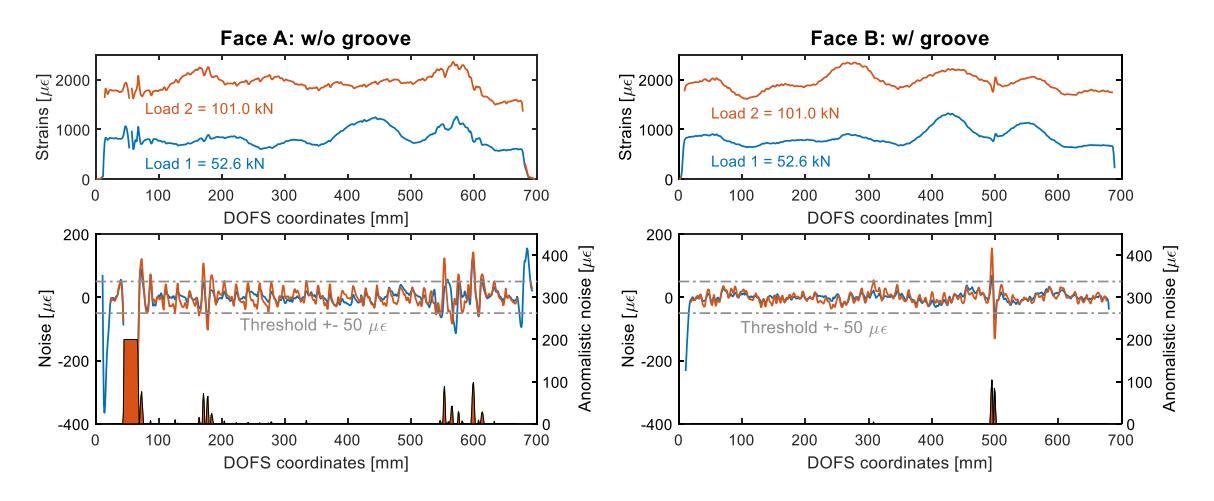
Figure 20. Member 8D16's strain profiles (top) and noise level (bottom) study for strain reading anomalies (SRA) analysis.

Whenever data is absent it can also be considered an anomaly as the viewer is also missing out on relevant information just like with an SRA. Except that, whilst with small SRAs a trend can still be distinguishable, with absent data no such thing can be done. Therefore, the used SRA detection code was tweaked to attribute an anomalistic noise of 200 $\mu\epsilon$ to any DOFS section with missing data (as visible in Figure 20).

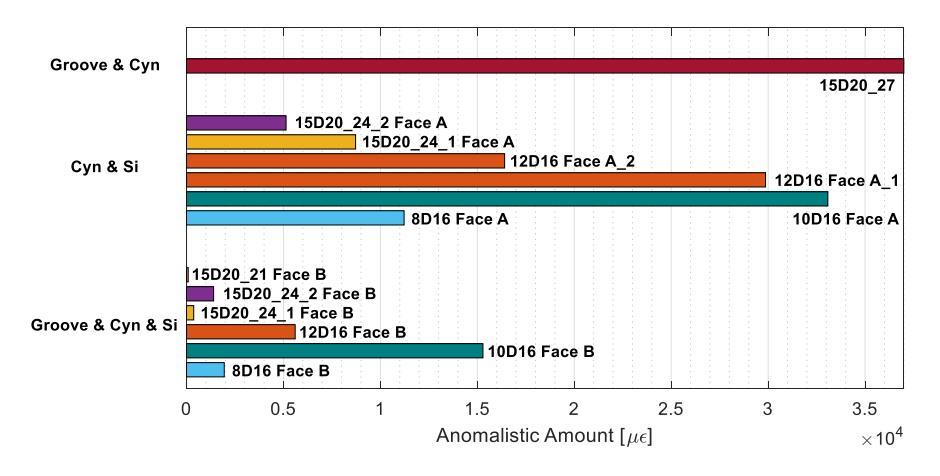
Figure 21. Total amount of anomalistic readings grouped per bonding technique used.

With these observations in mind a final calculation of the total amount of SRAs can be performed per every bonding technique. Its outcome, represented in Figure 21, shows a clear advantage of the groove, CYN and SI technique as it averagely welcomes a distinctly smaller amount of SRAs compared to the other two.
