Article Distributed Optical Fiber Sensor Applications in Geotechnical Monitoring

Abstract: We report the experimental application of distributed optical fiber sensors, based on stimulated Brillouin scattering (SBS), to the monitoring of a small-scale granular slope reconstituted in an instrumented flume and subjected to artificial rainfall until failure, and to the monitoring of a volcanic rock slope. The experiments demonstrate the sensors' ability to reveal the sudden increase in soil strain that foreruns the failure in a debris flow phenomenon, as well as to monitor the fractures in the tuff rocks. This study offers an important perspective on the use of distributed optical fiber sensors in the setting up of early warning systems for landslides in both rock and unconsolidated materials.

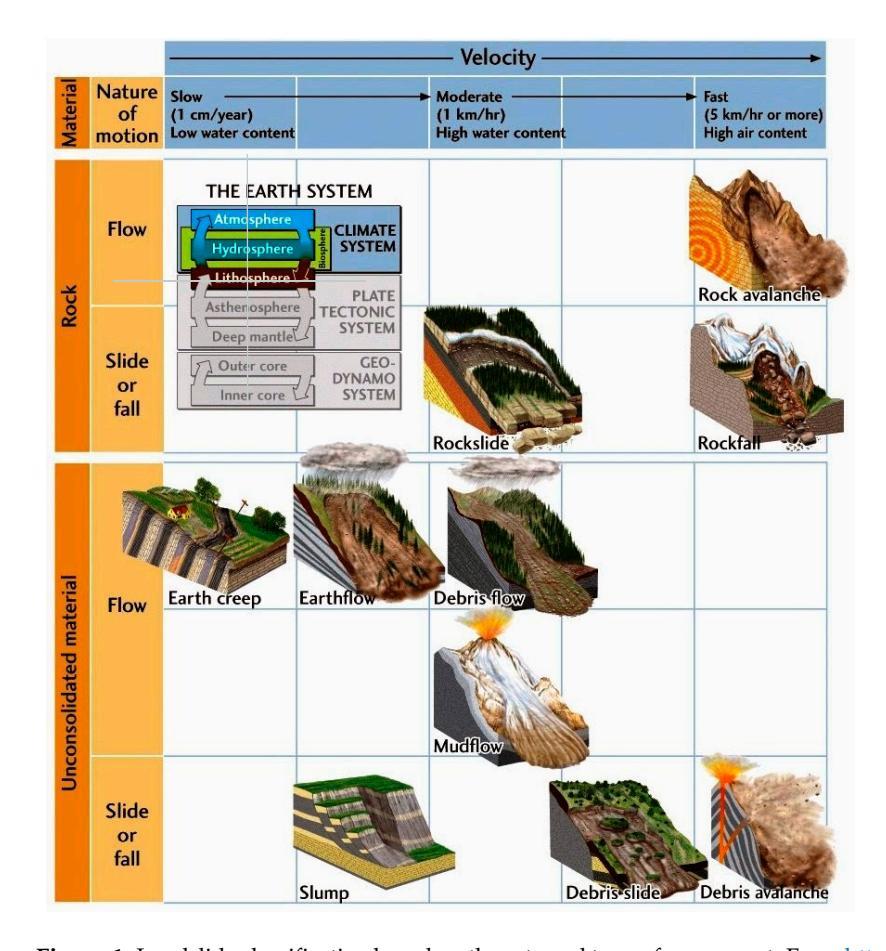
Figure 1. Landslide classification based on the rate and type of movement. From http://www.geologyin. com/2015/02/types-of-wasting-slump-rockslide-debris.html (accessed on 8 November 2021).

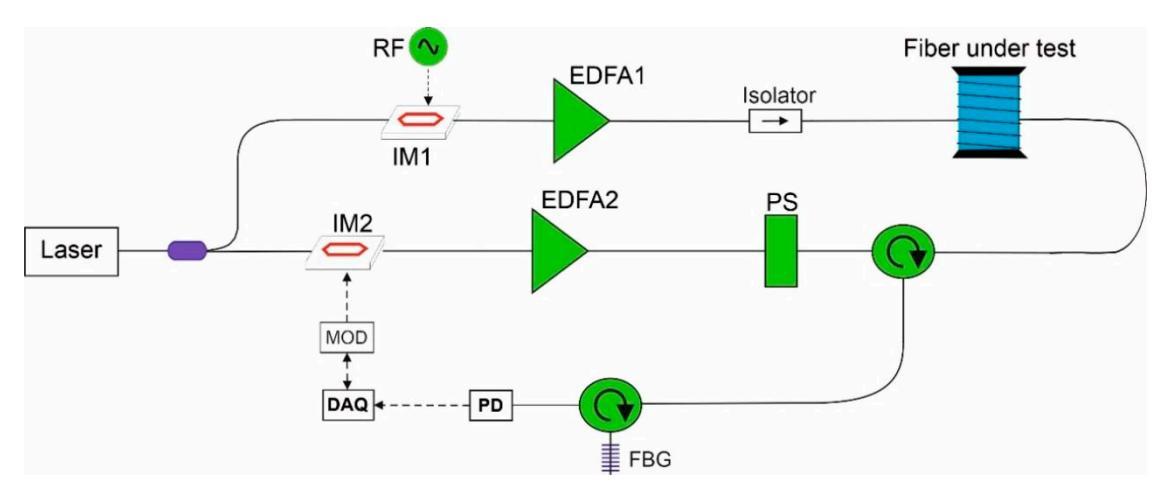
The setup shown in Figure 2 implements a generic scheme for BOTDA or BOFDA measurements. Light from a 1550-nm laser (CoBrite DX1, ID Photonics, Neubiberg, Germany) is split by a 50/50 optical coupler. In the lower branch, the light is modulated through an electro-optic intensity modulator (IM2), in order to impress either a pulsed or a sine-wave modulation, depending on the type of measurements to be made (BOTDA or BOFDA, respectively). The consequent pump signal is amplified through an erbium-doped fiber amplifier (EDFA2), polarization-switched and, finally, sent to one end of the fiber under test (FUT) through an optical circulator. The polarization switch (PS) rotates by 90°, alternately, the state of polarization of the pump wave, in order to implement a polarization-diversity scheme [9]. The upper branch shows the generation of the probe wave through a doublesideband suppressed-carrier modulation. In practice, the intensity modulator IM1 is biased at the minimum of its transmission, so that the applied radiofrequency (RF) signal (as provided by the microwave generator SynthHD, Windfreak Technologies, Port Richey, FL, USA), generates two sidebands in the probe wave spectrum, with the distance of each one from the laser frequency corresponding to the RF frequency. The probe wave is then amplified through the EDFA1 and injected into the other end of the FUT. The backscattered light is sent to a narrowband (~0.04 nm) fiber Bragg grating (FBG), which selects the sideband at the lower frequency (Stokes component) and, at the same time, filters out the amplified spontaneous emission noise of EDFA1. Finally, the light is converted to an electrical signal through a high-speed photoreceiver (PD) (1544-B, Newport Corporation, Irvine, CA, USA) connected to a data acquisition system (DAQ) consisting of a digitizer (FMC104, Abaco Systems, Huntsville, AL, USA), or a vector network analyzer (M9374A, Keysight, Santa Rosa, CA, USA) for BOTDA or BOFDA measurements, respectively.

Figure 2. Experimental setup. EDFA: erbium-doped fiber amplifier; PS: polarization switch; IM: intensity modulator; FBG: fiber Bragg grating; PD: photoreceiver; DAQ: data acquisition; MOD: modulating signal generator. The solid lines indicate the fiber-optic paths, while the dashed lines indicate the electrical paths.

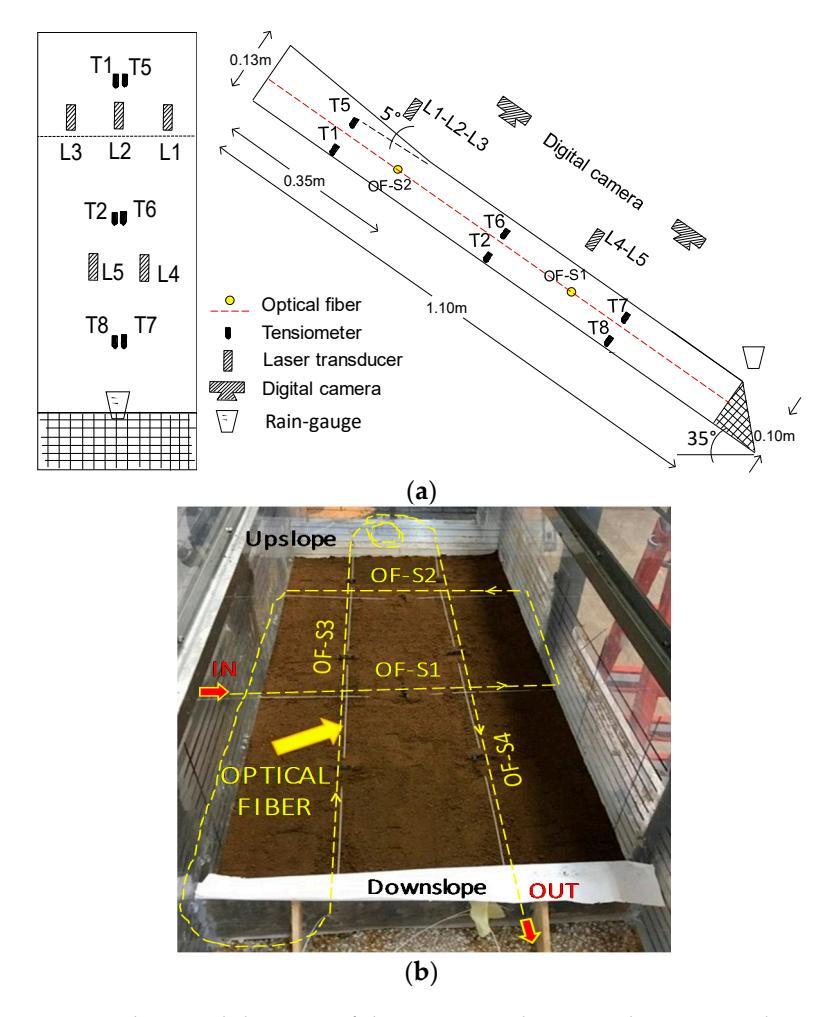
A 0.9 mm tight-buffered optical fiber was installed during the formation of the slope at a depth of 5 cm (i.e., at mid-depth), in order to measure the soil strain field (see Figure 3b). The optical fiber wire crossed the slope along two transversal sections (OF-S1 and S2 in Figure 3) and two longitudinal sections (OF-S3 and S4 in Figure 3). The fiber strands inside the slope were slightly pretensioned and fixed at the plexiglass walls of the flume by glue. To enhance the stress transfer between the sensing cable and the surrounding soil, small anchors were produced by using pieces of geonet located along the optical fiber each 25 cm.

During the test, other devices were used to monitor the slope's behavior: six miniaturized tensiometers installed at mid-depth (5 cm of depth) and at the bottom (10 cm of depth) of the slope at three different points for suction measurements (Figure 3a), and five laser sensors installed above the ground surface for monitoring soil settlements. In addition, two digital photo cameras were used to retrieve, through Particle Image Velocimetry (PIV), the displacement and velocity field of the ground surface, integrating the monitoring system. The two cameras, installed at a height of 1 m from the slope surface, allowed framing an area 50 cm wide and 100 cm long. A schematic cross-section and plan-view of the instrumented slope is reported in Figure 3.

Figure 3. Slope with location of the sensors: schematic plan-view and cross section (**a**), and fiber installation during the reconstitution of the slope (**b**).

During the wetting process, cracks began to appear on the ground surface (t \approx 18 min) in an area just below the slope change, slightly below the position of the OF-S2 (Figure 3b). At this point, the laser sensor transducers recorded settlements of about 5 mm all over the slope (t \approx 25 min) (Figure 4), which indicated that both volumetric and shear strains were occurring. Moreover, the soil suction recorded at the bottom of the slope (tensiometers installed at z = 10 cm in Figure 4) became lower than the suction recorded at mid-height (tensiometer at z = 5 cm in Figure 4), indicating that soil saturation was occurring, with the possible formation of a water table arising from the bottom of the slope. Indeed, the progressive soil saturation accompanied by volumetric and shear strains is the mechanical process leading to slope failure [18,19]. Afterwards, the settlements increased significantly and in a less uniform manner throughout the slope, up to failure, which occurred 29 min after the beginning of the rainfall.

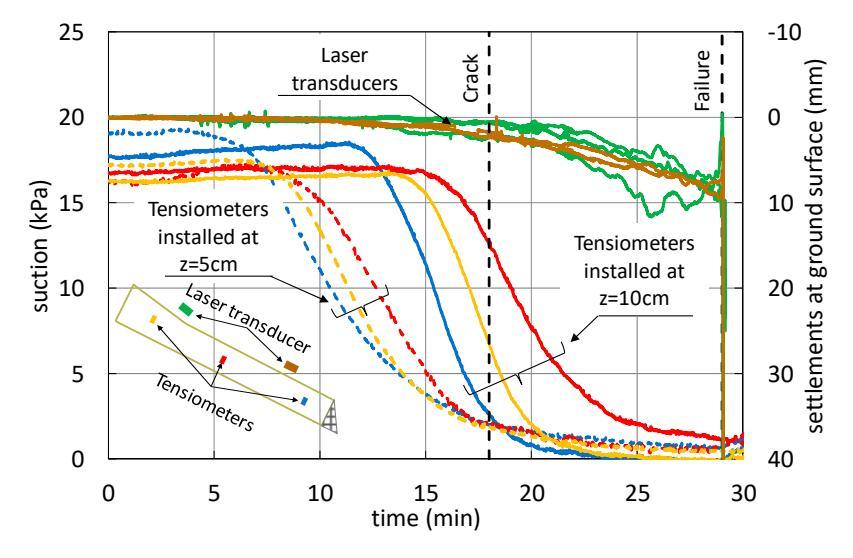
Figure 4 shows the effects of rainfall on soil suction (left axis of Figure 4) and deformation of the slope surface in terms of settlements (right axis of Figure 4). Note that the different colors of the lines in the plot refer to different positions of the sensors, as illustrated by the inset in the left bottom corner of the figure. Suction progressively reduces up to a nihil value (t ≈ 25 min), indicating soil saturation, as measured by tensiometers installed at the bottom of the slope (z = 10 cm).

Figure 4. Suction and settlement trends during the infiltration test. Suction values refer to tensiomenters installed at z = 10 cm (solid lines) or z = 5 cm (dashed lines).

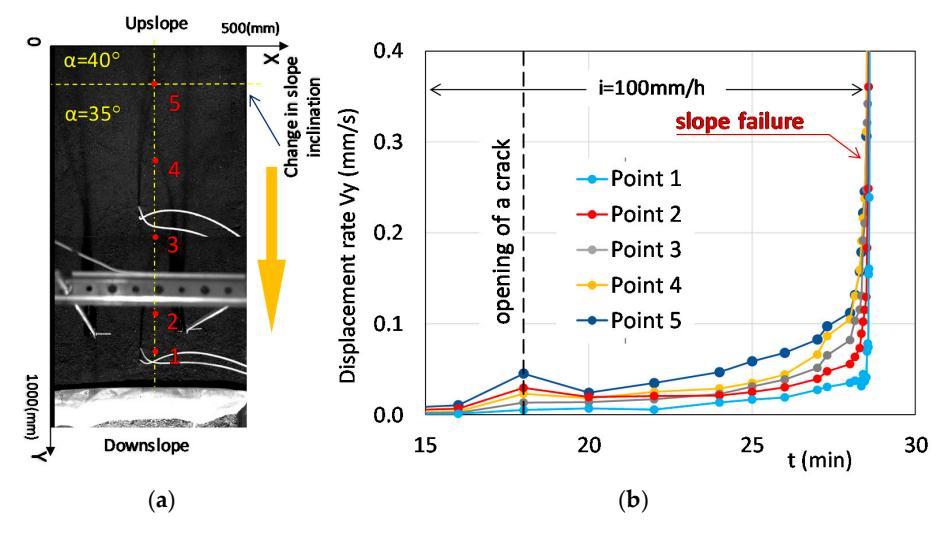
Slope deformation was also analyzed by camera recording and by optical fiber sensors. A progressive slope deformation was revealed by the displacement rates along the slope section A-A,' illustrated in Figure 5 and retrieved by PIV: the uppermost part of the slope, where the slope inclination was higher (point 5 in Figure 5), started to move earlier with a

higher velocity than the lowermost part of the slope and the deformation process remained characterized by a higher speed in the upper part of the slope during the entire experiment. As the toe of the slope was fixed, the displacement rate was clearly characterized by the smallest values at point 1.

Figure 5. Monitored points at ground surface (**a**) and displacement rate trends retrieved by PIV technique (**b**).

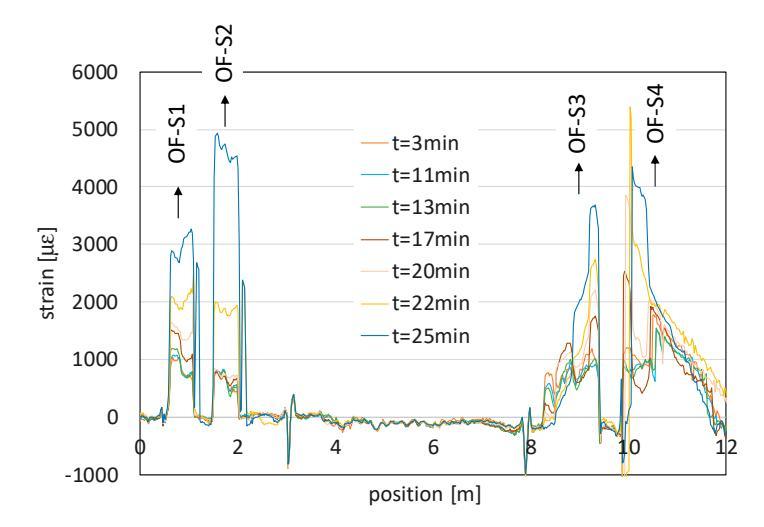
This was also confirmed by the optical fiber measurements, illustrated in Figure 6, in terms of strain trends along the entire length of the cable: the strands of fiber embedded into the slope are clearly distinguishable, since they are the only portions subject to strain. The strain values were extracted by first subtracting each BFS profile to the one acquired at the beginning of the test (i.e., at t = 0 min) and then converting the BFS changes in the strain values by adopting a conventional transduction factor of 0.05 MHz/ $\mu\epsilon$. The sensor followed the progressive soil deformation, which gradually increased with time everywhere in the slope. It also distinguished the different behavior of the upper part of the slope (OF-S2 and abscissa around 9.3 m and 10.2 m of OF-S3 and OF-S4 in Figure 6), characterized by strain values higher than those measured in the middle and lower part of the slope.

Figure 6. Strain trends measured by the optical fiber sensor along its entire length (sections OF S1-S4 indicate the strands embedded into the slope).

Looking at the part of the fiber sensor installed at the toe of the slope, corresponding to the abscissa around 8.2 and 11.3 in Figure 6, it is clear that although the fiber revealed

very small values of strains, the sensor was not able to distinguish the compressive strains expected at the toe of the slope. This was probably due to the imperfect stress transfer between the fiber and the surrounding soil.

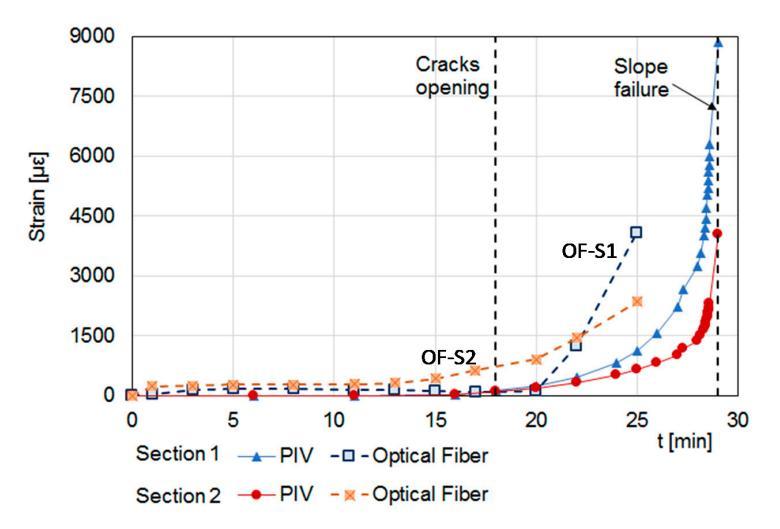
Finally, Figure 7 shows a comparison between the strains measured by the fiber sections disposed crosswise (transverse) in the flume (sections OF-S1 and OF-S2) and those retrieved by the digital camera using the PIV technique. The strain measured by the two types of techniques were in good agreement during the first part of the experiment while, after the opening of tension crack, only the optical fiber sensor revealed that the strain greatly increased from about 10 min before the slope failure. Moreover, the fiber strand OF-S2, located close to the area where the tension cracks occurred, was able to detect a soil strain higher than that revealed by the PIV at the same position (Section 2 in Figure 7) and at an early time (about 4 min): one minute before the opening of cracks on ground surface the OF-S2 recorded a soil strain of about 630 $\mu\epsilon$, whereas that revealed by the PIV was less than 100 $\mu\epsilon$. This indicates that the optical fiber sensor can be effectively used, not only to evaluate the slope strain field during a rainwater infiltration process, but also to detect in time the precursor signals of an incoming failure.

Figure 7. Strains measured by the transverse optical fiber strands and by digital camera at location of optical fiber OF-S1 (45 cm from downslope) and OF-S2 (30 cm from upslope).

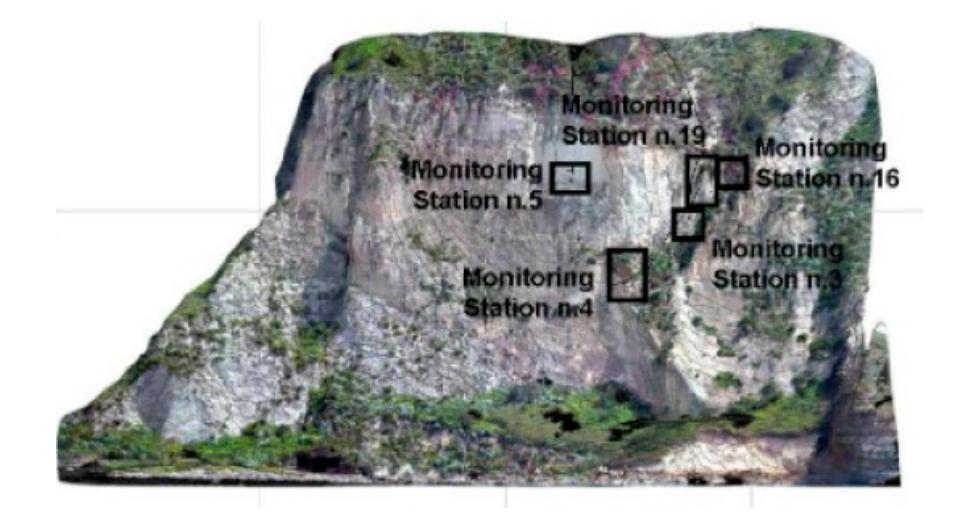
A 30 m long strain sensing cable was fixed to a number of nails across the tuff blocks located in the upper part of the cliff. In particular, two deployment zones were selected for optical fiber measurements (block n. 3 and block n. 19 in Figure 8). Block n. 3 is about 4 m high, 2 m wide, 1.2 m thick, being isolated behind fracture F1, and laterally from fracture F2 (Figure 10a). The F1 fracture is very open and contributes to the formation of a rocky wedge intersecting with the other present fractures. Block n. 19 is about 5 m high, 2 m wide, and 1.5 m thick; it is isolated behind fracture F1, which can cause overturning (Figure 10b). There are also lateral fractures (F3 and F5). The block appears thinned to the foot.

Figure 8. Frontal view of Coroglio cliff. The monitoring stations n. 3 and n. 19 were chosen for the distributed optical fiber sensor. The other monitoring stations were served by conventional crackmeters (Ref. [22]).

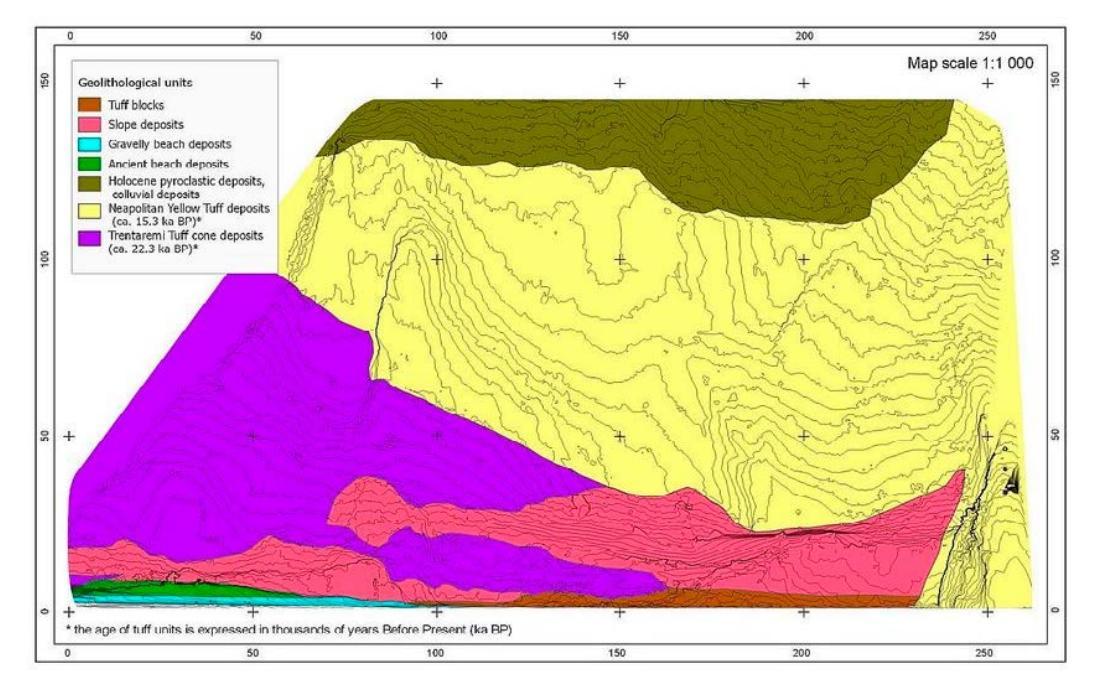
Figure 9. Geological map of Coroglio cliff (Ref. [20]).

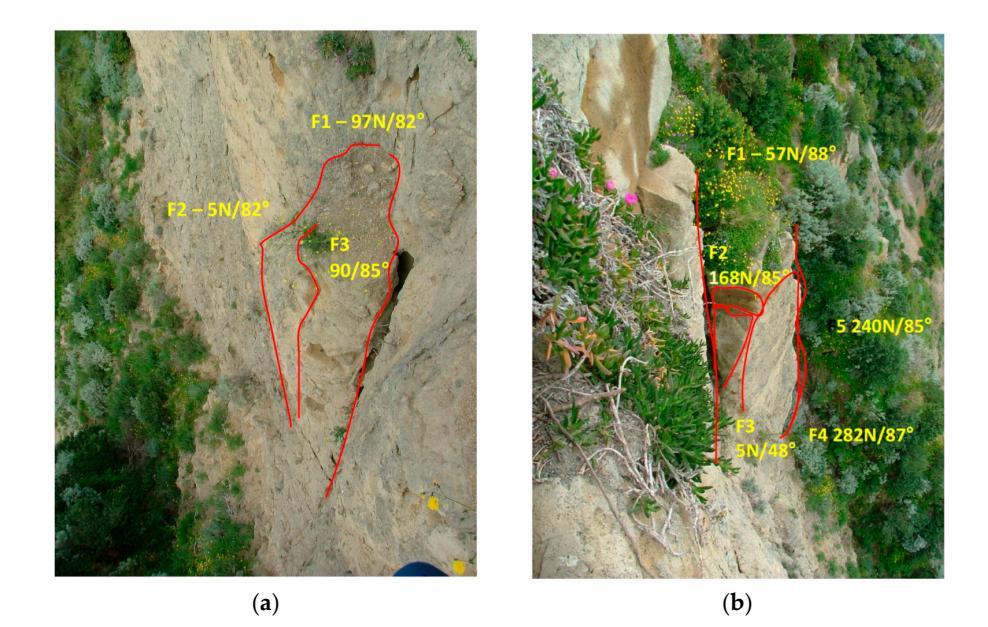
Figure 10. Tuff blocks monitored by the distributed optical fiber sensor: block n. 3 (a) and n. 19 (b).

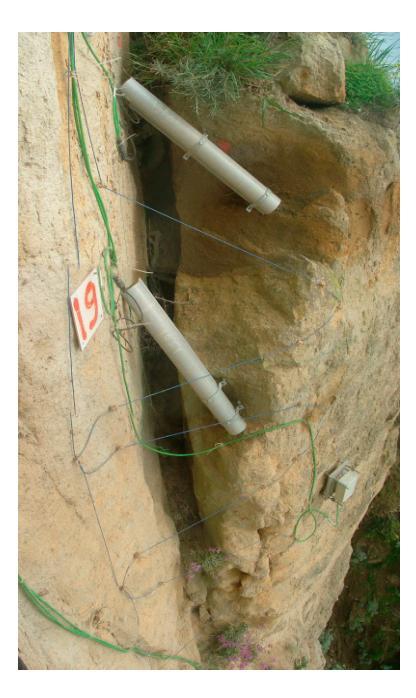
The sensing cable was a BRUsens V1 cable (Brugg Kabel AG, Brugg, Switzerland) characterized by a 2.8-mm Ethylene propylene rubber (EPR) outer sheet. The installation of the sensing cable was performed by anchoring the fiber in hairpin curves around the fracture to be monitored (see Figure 11). The anchors were produced by fixing 6 mm closing screws in the tuff, sealed with bicomponent epoxy resin inside drilled holes. The fiber was then fixed to the anchors with plastic clamps until it reached a sufficient tension; next, the cable/screw anchor point was definitively sealed with bicomponent epoxy resin (2-Ton Epoxy, ITW Performance Polymers, Danvers, MA, USA). Block n. 3 was monitored

Figure 11. Installation of the sensing cable in the tuff block n. 19.

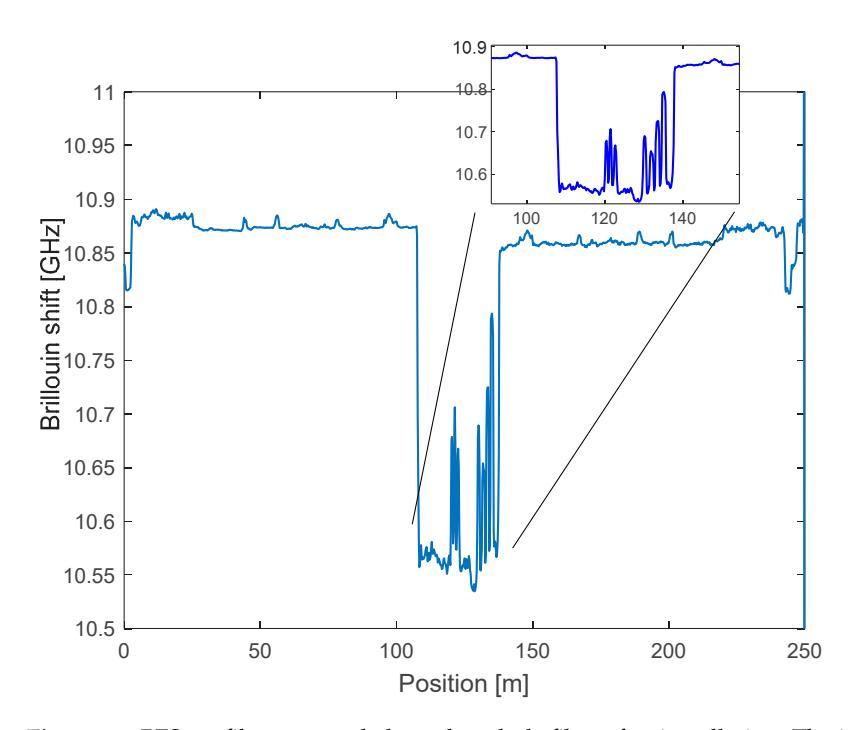
Figure 12 reports the Brillouin frequency shift (BFS) profile measured after the installation of the cable, as acquired at the spatial resolution of 50 cm. For these measurements, the less stringent requirement in terms of spatial resolution led us to the choice of a timedomain configuration (BOTDA). The figure highlights the composition of the cable: the first 105 m, characterized by a BFS of ~10.87 GHz, were only aimed at reaching the site of monitoring from the top of the ridge, where the interrogation unit was positioned; the following 33 m (from 105 m to 138 m), characterized by a BFS of ~10.59 GHz, comprised the V1 sensing cable; the final 105 m (from 138 m to 243 m) were required to close the loop configuration. The two 105 m fiber lengths used to carry the signal into the monitored region were composed of two fibers enclosed in a single, armored cable. Notably, the difference in the BFS between the V1 sensing cable and the armored cable should simply be attributed to a different concentration of dopant in the core.

Figure 12. BFS profile measured along the whole fiber after installation. The inset shows a zoom of the sensing region.

From the inset of Figure 12, the three peaks associated with tuff block n. 3 and the five peaks associated to tuff block n. 19 can be easily distinguished thanks to the pre-tension applied during installation.

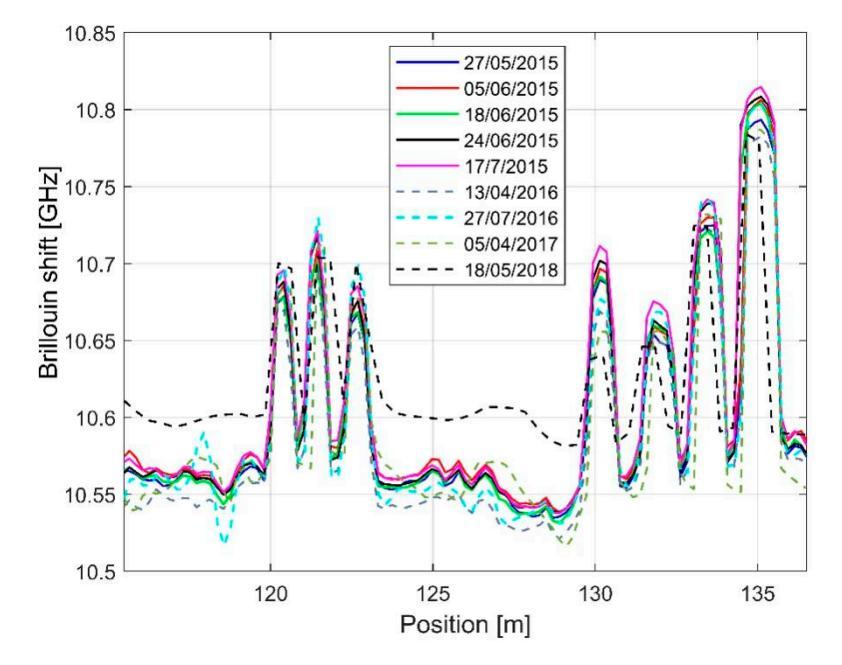
In Figure 13, we report the overall results of the monitoring campaign. In particular, the figure shows the BFS distribution in the monitored region, i.e., the points at which the

peaks associated to block n. 3 and block n. 19. The figure also reveals that the various curves shifted vertically, which can be attributed to the dependence of the BFS on the temperature (approximatively 1 MHz change of the BFS per °C). The effect of the temperature on the acquired measurements was compensated for by using free sections of the same sensing fiber cable. In fact, strands of the sensing cable were not anchored across the blocks but deployed in near proximity and free standing, so that they only sensed the temperature changes acting as temperature probes.

Figure 13. BFS profiles measured along the whole fiber during the monitoring campaign.

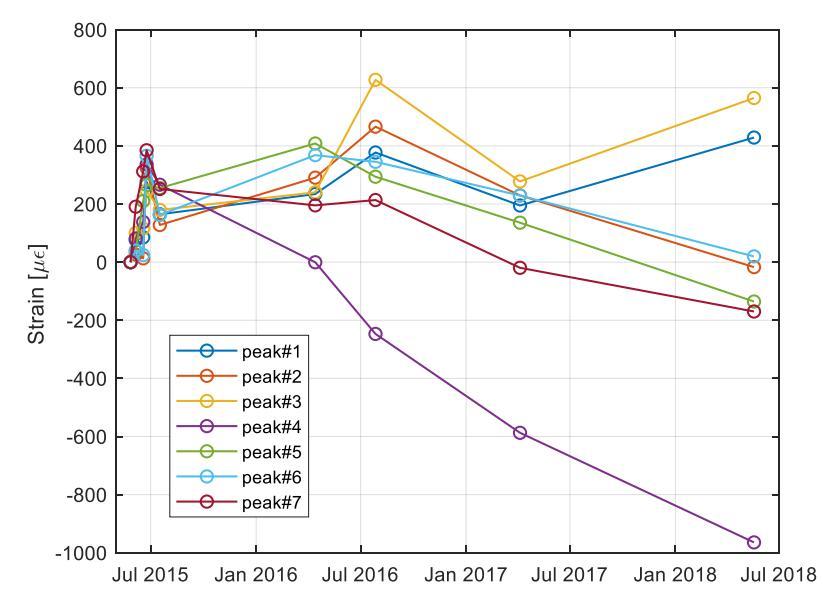
By comparing the various measurements taken during the survey, it was observed that the maximum BFS changes were in the order of 30 MHz, which correspond to about 600 $\mu\epsilon$. It can be recalled, as a reference, that a strain of 600 $\mu\epsilon$ over a length of 50 cm of stretched fiber corresponds to a longitudinal displacement of 300 μ m. The strain variations of the peaks during the monitoring campaign are illustrated in Figure 14.

Figure 14. Strain variation of the peaks during the measuring campaign.

The obtained results show that the sensing optical fiber system is able to follow the deformations of the blocks during the entire monitoring period, even though the small values recorded were mostly related to periodic, thermal dilations of the rock. In the specific case of block n. 19, the trend of peak 4 was also compatible with the progressive closure of the fracture. This is also confirmed by independent measurements performed with traditional crackmeters and reported in Ref. [23], where long-term (from 2014 to 2018) monitoring results from the same tuff cliff are reported. In particular, block n. 19 exhibited an alternating behavior (due to meteorological conditions), but with a clear prevalence of negative deformations, corresponding to a progressive closure of the fracture.
