Article Experimental Study on Vibration and Noise Characteristics of Steel-Concrete Railway Bridge

Keywords: vibration assessment; noise assessment; noise sources; steel-concrete bridge

Railway Bridge, Sensors 2021, 21, 7964.

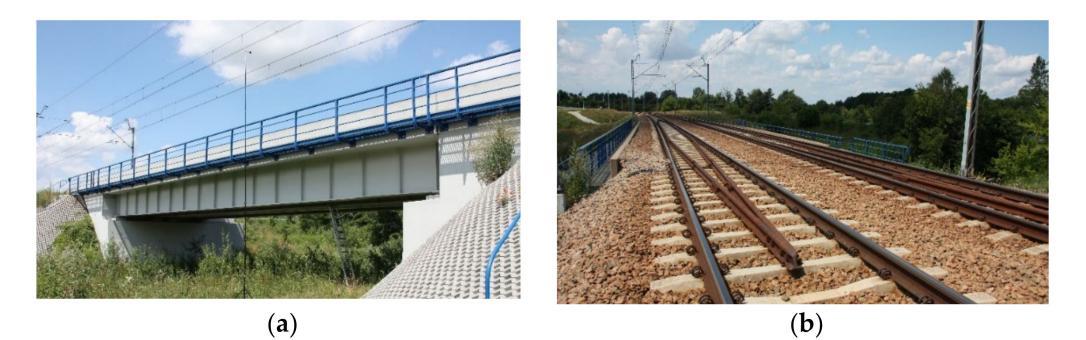
Figure 1. Side (a) and top (b) view of the tested bridge.

The structure subjected to a detailed vibroacoustic analysis was a plate girder railway bridge, located along the main line with a maximum train speed of 160 km/h. The bridge superstructure was designed as a single-span, simply supported, composite, steel-concrete structure. Side and top views of the bridge are shown in Figure 1. In the cross-section of the structure, a monolithic reinforced concrete slab was used with the thickness varying from 0.23 m above the supports to 0.25 m in the middle of the span. The slab was connected with steel girders with the height ranging from 1.82 m in the middle of the span to up to 1.56 m above the supports.

The girders were made of S355J2 steel, whereas the deck was made of C35/45 concrete. The bridge consists of two parallel structures connected by a dilatation joint, with one ballast trough. The longitudinal dilatation gap was secured with flexible sealing tape and galvanized steel sheet with the thickness of 4 mm. The ballast trough was lined with a waterproof membrane with a 12 mm thick protective layer, resistant to crushed stone ballast. There was no vibroisolation under the ballast. The railway track on the bridge consists of UIC60 rails with 49E1 check rails, PS94 concrete sleepers laid at a spacing of

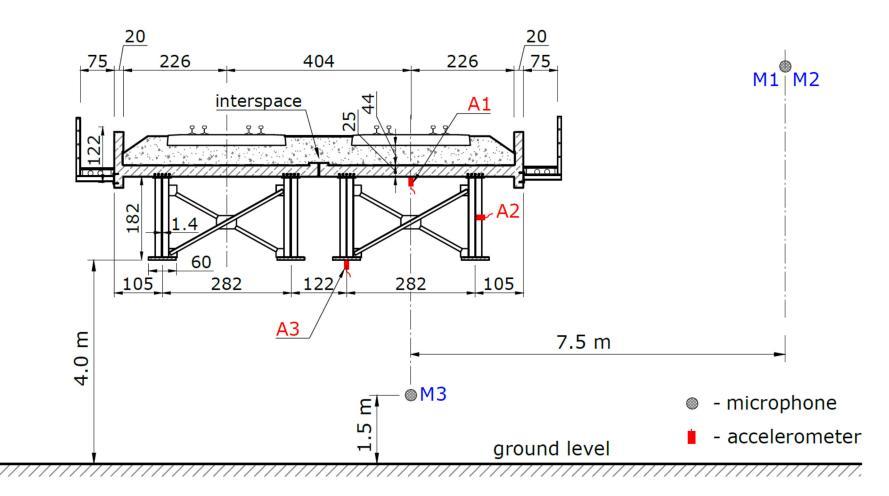
Figure 2. Cross-section of the tested bridge and measuring points.

The location of the measurement points is shown in Figure 2. Accelerometers were mounted on the deck slab (m.p. A1), girder web (m.p. A2), and bottom flange (m.p. A3).

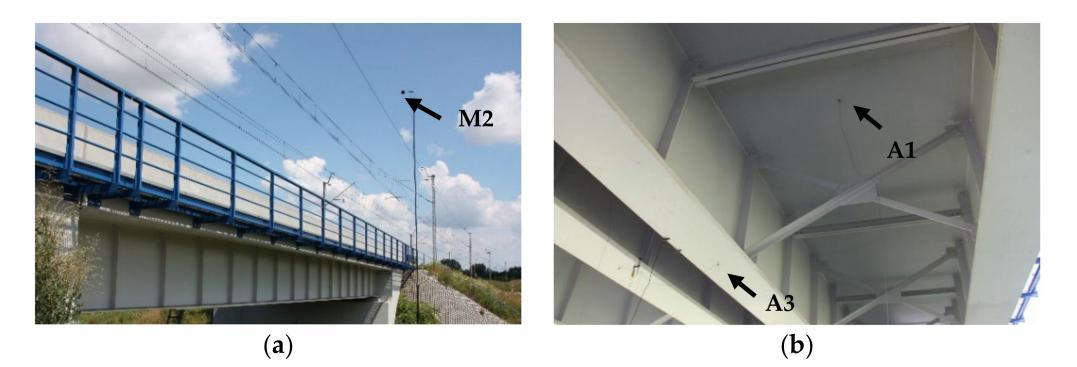
Figure 3. Measurements points: (**a**) microphone at point M2, (**b**) accelerometers mounted on the deck (m.p. A1) and the bottom flange of the girder (m.p. A3).

- at the distance of 7.5 m from the track axis and 1.5 m above the rail level but at a distance of 50 m beyond the bridge (m.p. M1),
- next to the bridge, at the distance of 7.5 m from the track axis and 1.5 m above the rail level (m.p. M2),
- under the bridge, 1.5 m above the ground level (m.p. M3).
 Selected measurement points are shown in Figure 3.

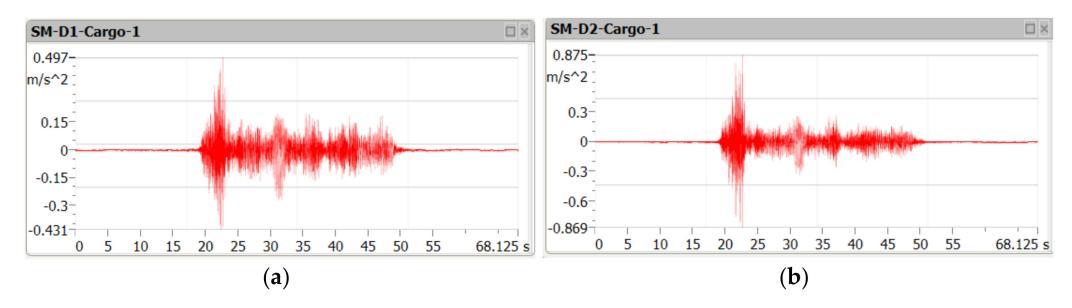
Figure 5. Amplitude of vertical vibration acceleration during the passage of the cargo train at the speed of 40 km/h, in the deck slab (**a**) and the bottom flange of the girder (**b**).

Figures 5–7 contain examples of vertical vibration acceleration characteristics as a function of time recorded in the deck slab (m.p. A1) and the bottom flange of the girder (m.p. A3).

The maximum vertical acceleration value measured during the experimental tests was 0.87 m/s^2 . Such accelerations were recorded during the passage of a cargo train. The passage of railbuses causes vibrations not exceeding 0.27 m/s^2 . Passenger trains cause vibrations not greater than 0.71 m/s^2 . All these accelerations are significantly lower than the values allowed by the standard [1], i.e., 3.5 m/s^2 . It is worth noting that during the passenger train passage the vibration acceleration was lower, even though the speed was higher. It should be noted that when a train is passing one structure, vibration is damped by the adjacent structure via crushed stone.

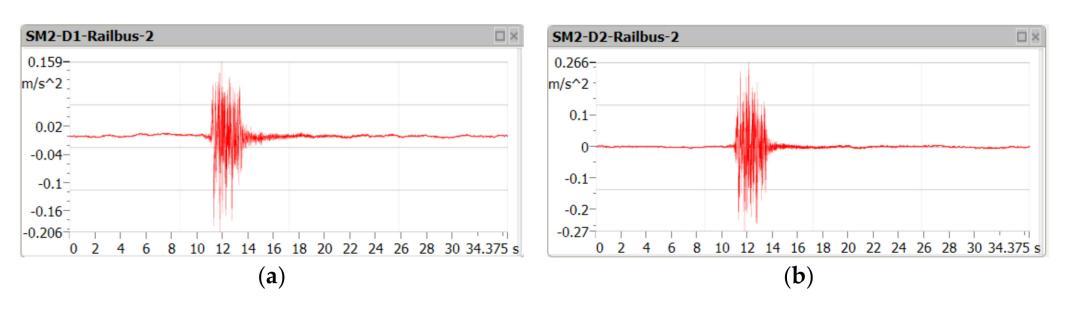
Figure 6. Amplitude of vertical vibration acceleration during the passage of the railbus at the speed of 115 km/h, in the deck slab (**a**) and the bottom flange of the girder (**b**).

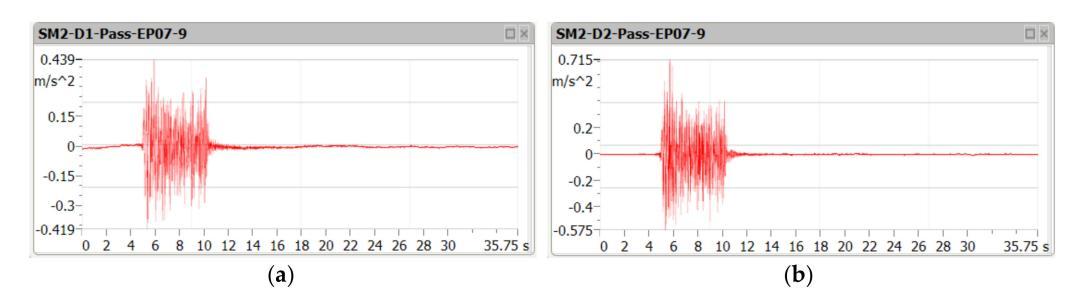
Figure 7. Amplitude of vertical vibration acceleration during the passage of the passenger train at the speed of 110 km/h, in the deck slab (**a**) and the bottom flange of the girder (**b**).

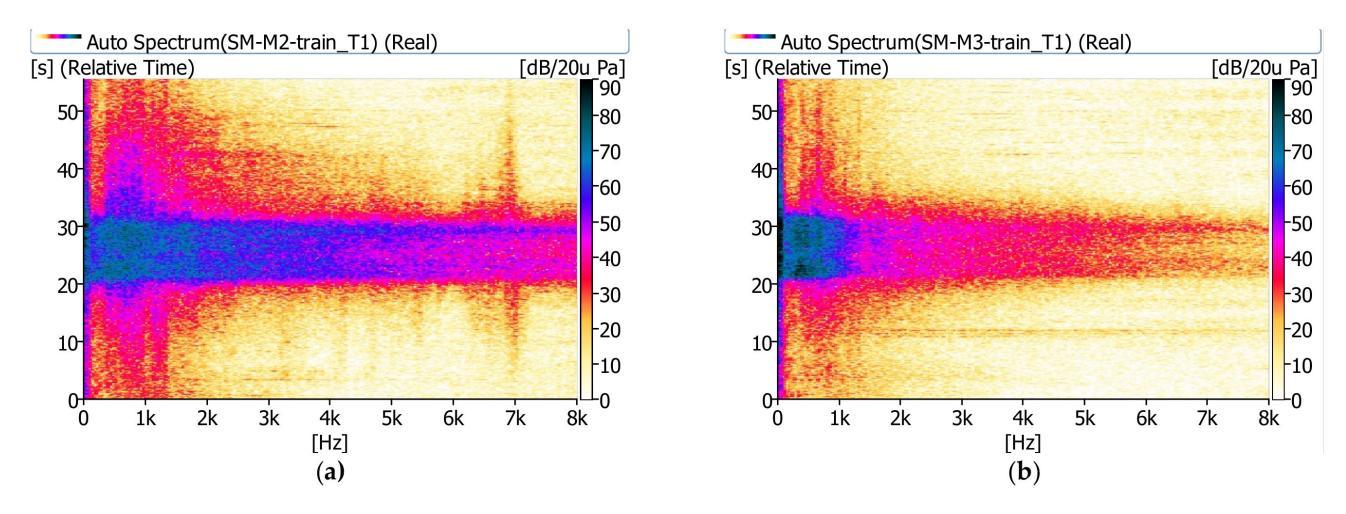
Figure 8. Spectrograms recorded during the passage of a cargo train (T1): (**a**) next to the bridge (m.p. M2), (**b**) under the bridge (m.p. M3).

In Figures 8–10, examples of measurement results in the form of spectrograms are shown. The sound pressure level next to the bridge (m.p. M2) shows significant values in the range up to 8 kHz. A relatively high sound pressure level is observed longer besides the bridge than under the bridge. The noise under the bridge disappears almost immediately after the train passes. It is clearly visible that under the bridge (m.p. M3) the sound pressure level has significant values in the range up to approximately 1.0 kHz.

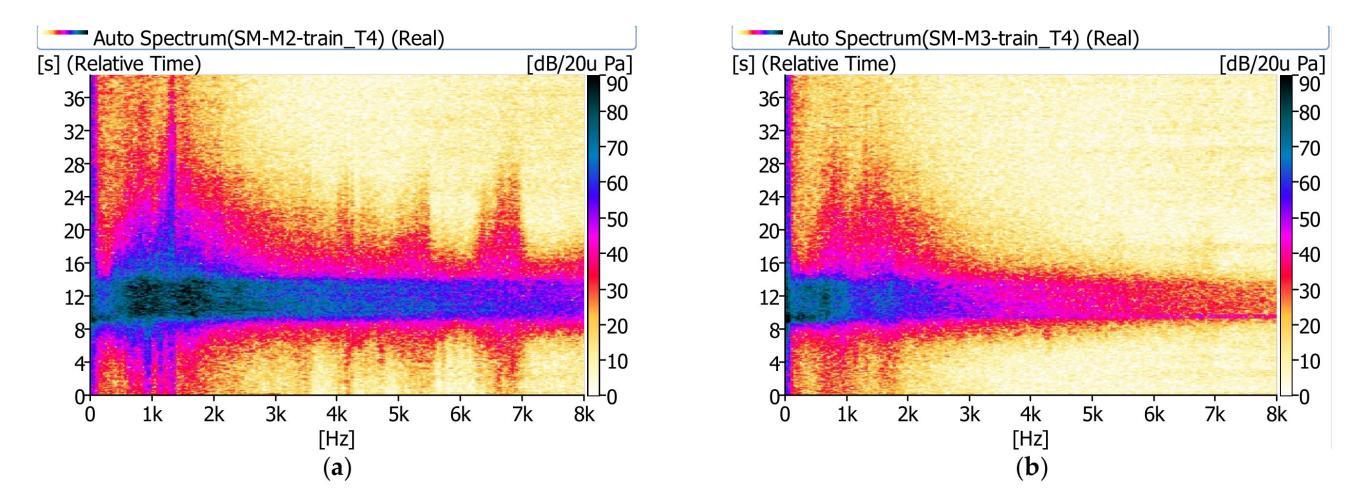
Figure 9. Spectrograms recorded during the passage of a passenger train (T4): (**a**) next to the bridge (m.p. M2), (**b**) under the bridge (m.p. M3).

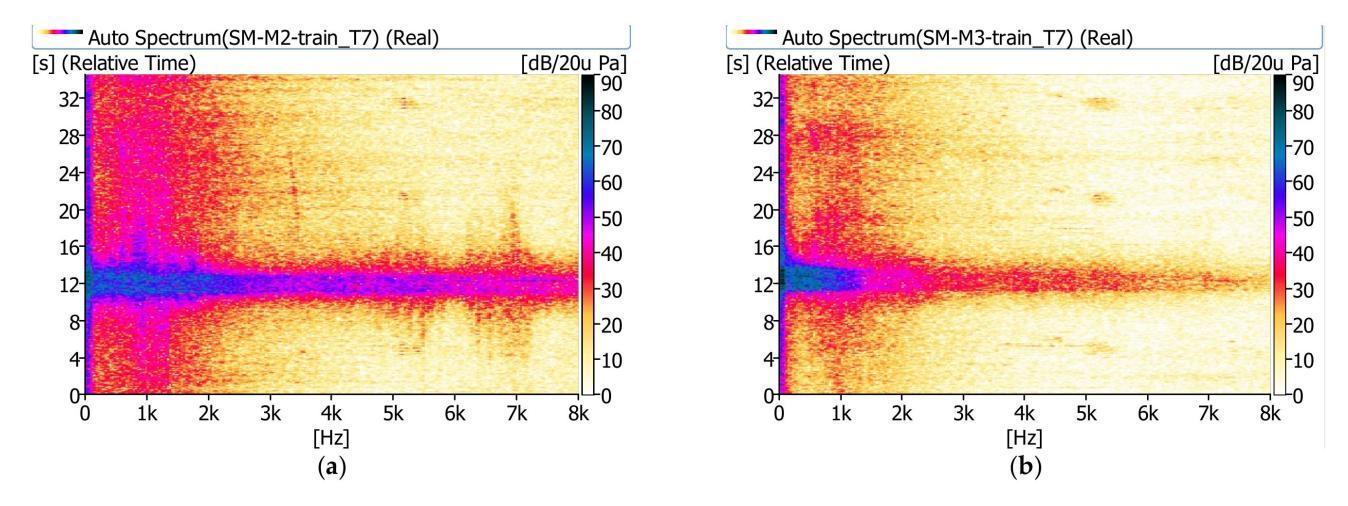
Figure 10. Spectrograms recorded during the passage of a railbus (T7): (**a**) next to the bridge (m.p. M2), (**b**) under the bridge (m.p. M3).

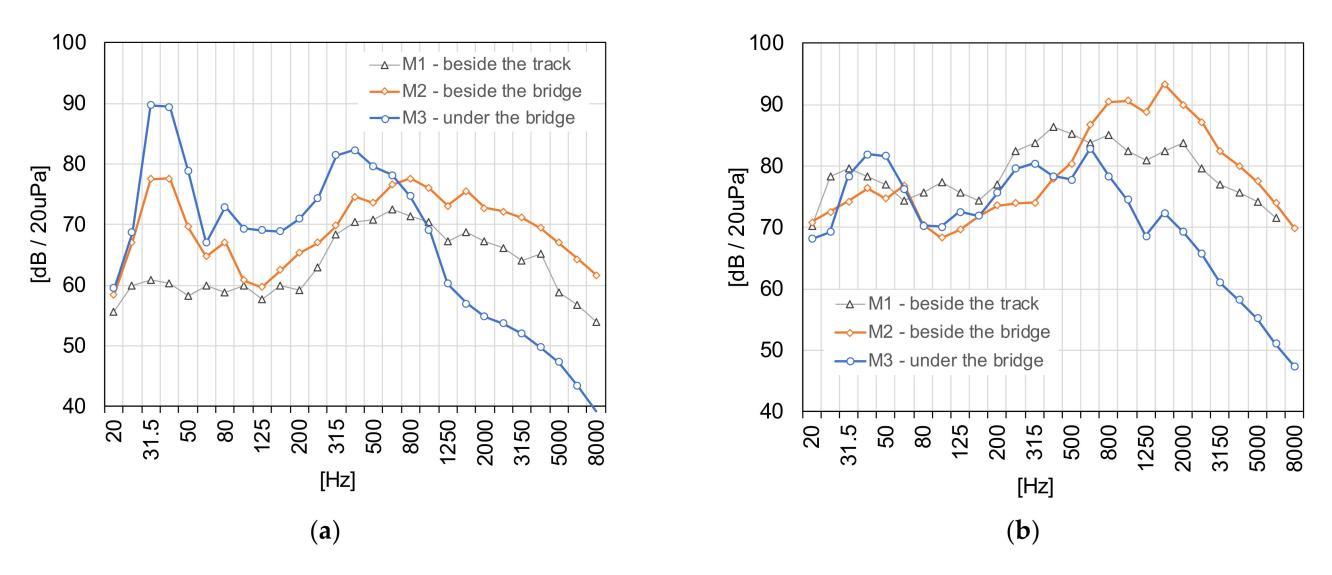
Figure 11. Levels of the acoustic pressure versus frequency bands during the passage: (**a**) cargo train (T1) at the speed of 40 km/h, (**b**) passenger train (T4) at the speed of 110 km/h.

Figure 11 shows examples of measurement results in the form of third-octave sound spectra.

In the case of the analyzed bridge, during the passage of a cargo train, the acoustic pressure level next to the bridge (m.p. M2) is larger in all frequency ranges than the level at the reference point, beside the track (m.p. M1). The acoustic pressure level under the bridge (m.p. M3) is larger in the range of 25–800 Hz than the level beside the bridge (m.p. M2) and lower than the acoustic pressure beside the track in high frequency (over 1000 Hz).

During the passage of a passenger train, the acoustic pressure level next to the bridge (m.p. M2) is greater in the range over 600 Hz than the level at the reference point, beside the track (m.p. M1). The acoustic pressure level under the bridge (m.p. M3) is lower above 400 Hz than the level beside the bridge (m.p. M2) and the lower than acoustic pressure beside the track in almost a whole frequency range. In order to explain the causes of such phenomena, vibroacoustic tests were carried out.

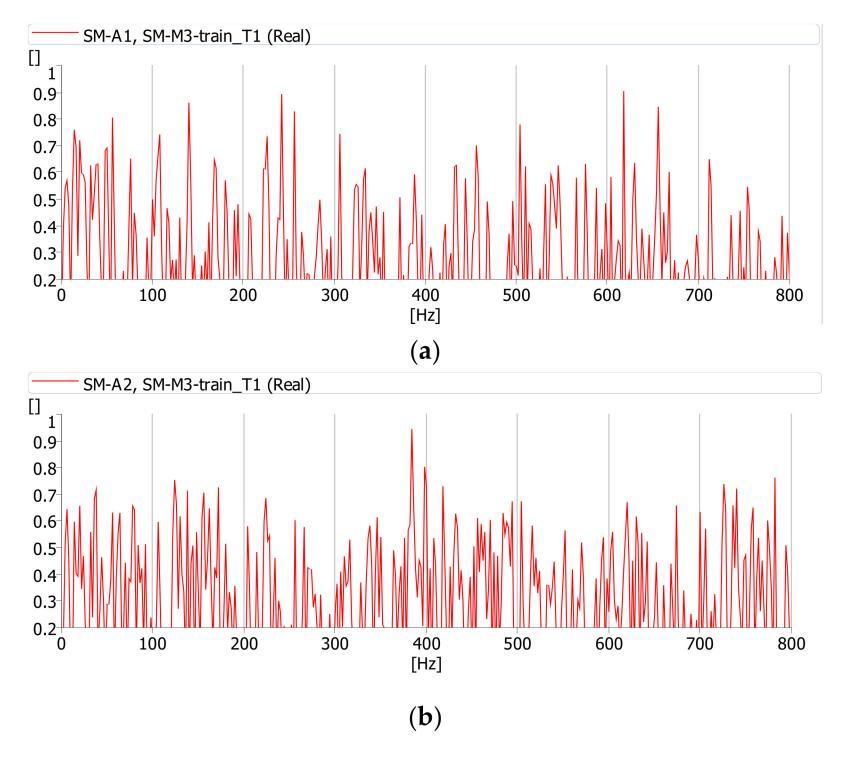
Figure 12. Coherence function between acoustic pressure at point M3 and: (**a**) vibrations at point A1 (deck slab), (**b**) vibrations at point A2 (girder web) during the passage of a cargo train (T1).

The coherence function was calculated during the journey of a cargo and passenger train. All functions were determined with the same parameters (averaging time, frequency range, etc.). This function has the highest values between the deck (m.p. A1) and girder web (m.p. A2) vibrations and noise (m.p. M3) while a cargo train passes (Figure 12). Therefore, it can be assumed that during the journey of a cargo train the source of the noise under the bridge is the deck slab and girder web vibrations. These interactions cause vibrations of the bridge components, which constitute the source of the sound. The

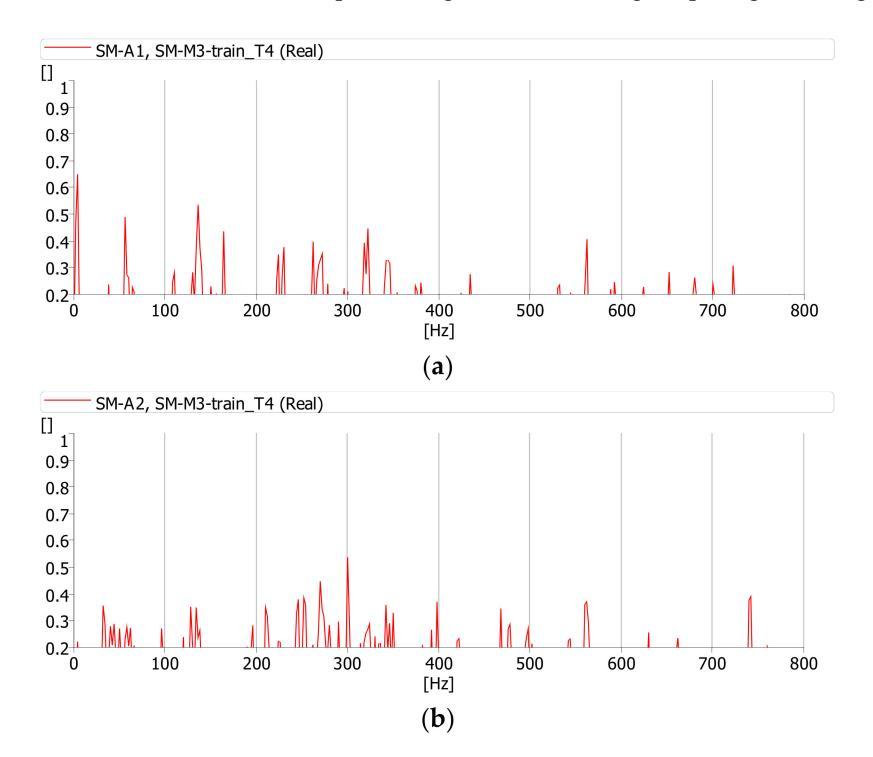
Figure 13. Coherence function between acoustic pressure at point M3 and: (**a**) vibrations at point A1 (deck slab), (**b**) vibrations at point A2 (girder web) during the passage of a passenger train (T4).

coherence between the vibrations of the deck and girder web is definitely smaller during the journey of a passenger train (Figure 13). Passenger trains are lighter and do not induce vibrations in the bridge structure, which may cause additional sound emission.

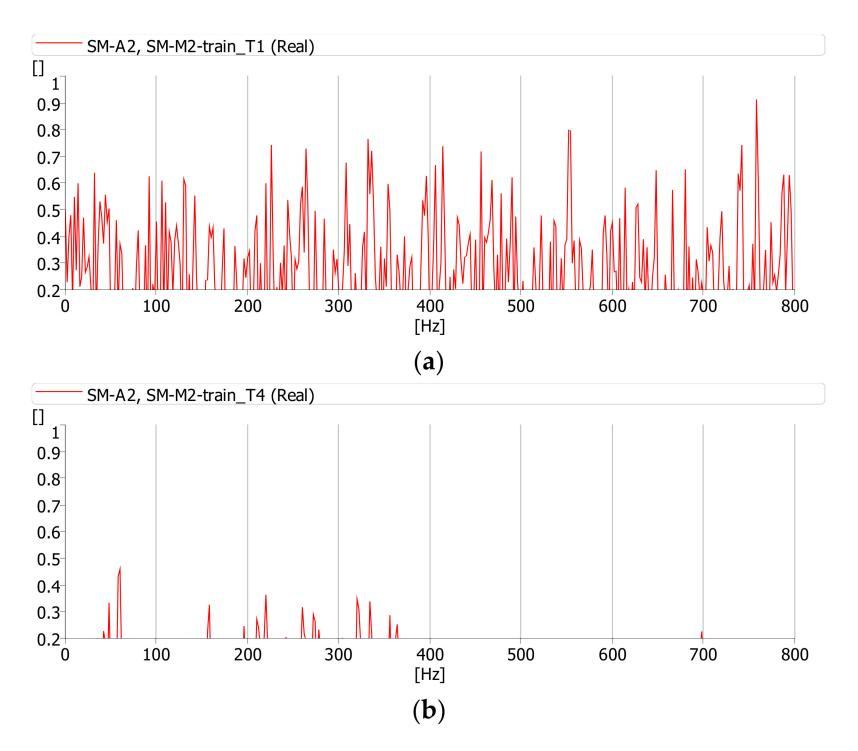
It can be seen that the only passage of a cargo train causes vibrations which contribute to the noise.

Figure 14. Coherence function between acoustic pressure at point M2 and vibrations at point A2 during the passage of a: (**a**) cargo train (T1), (**b**) passenger train (T4).

Figure 14 shows the coherence function between vibrations of the girder web (m.p. A2) and the acoustic pressure in point M2 for the passage of cargo and passenger trains.
