# Article Thermographic Fault Diagnosis of Shaft of BLDC Motor

**Abstract:** A technique of thermographic fault diagnosis of the shaft of a BLDC (Brushless Direct Current Electric) motor is presented in this article. The technique works for the shivering of the thermal imaging camera in the range of 0–1.5 [m/s<sup>2</sup>]. An electric shaver was used as the source of the BLDC motor. The following states of the BLDC motor were analyzed: Healthy BLDC motor (HB), BLDC motor with one faulty shaft (1FSB), BLDC motor with two faulty shafts (2FSB), and BLDC motor with three faulty shafts (3FSB). A new method of feature extraction named PNID (power of normalized image difference) was presented. Deep neural networks were used for the analysis of thermal images of the faulty shaft of the BLDC motor: GoogLeNet, ResNet50, and EfficientNet-b0. The results of the proposed technique were very good. PNID, GoogLeNet, ResNet50, and EfficientNet-b0 have an efficiency of recognition equal to 100% for four classes.

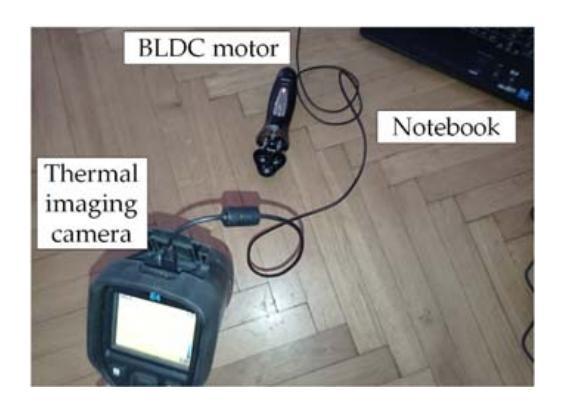
The proposed experimental setup (thermal imaging camera, computer, and implemented fault diagnosis technique) was placed in a room (Figure 2).

Figure 2. Proposed experimental setup.

A FLIR E4 camera was used to capture thermal images of the BLDC motor. The distance of the thermal camera to the BLDC motor was equal to 0.5 [m]. The shivering of the thermal imaging camera was in the range of 0–1.5 [m/s<sup>2</sup>]. The obtained thermal images were different. Thermal images were measured for an emissivity coefficient  $\varepsilon$  = 0.8. The emissivity coefficient  $\varepsilon$  = 0.8 was accurate for analyzed thermal images (Figures 3–6). White objects were clearly visible (Figures 3c, 4c, 5c and 6c).

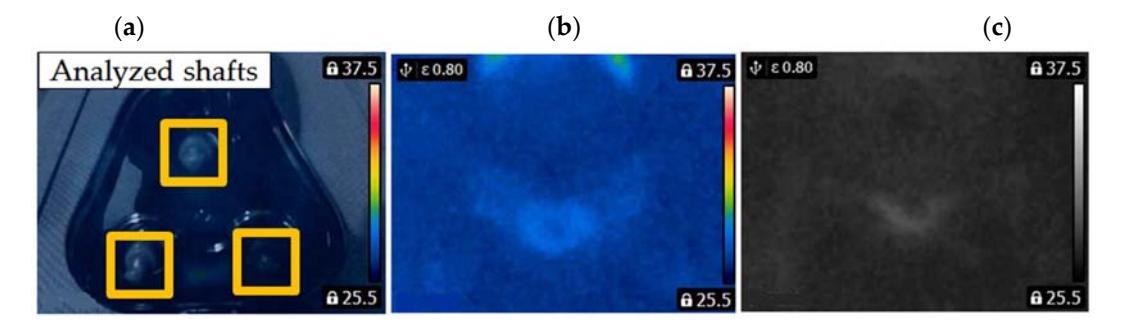
Figure 3. (HB) (a) Iron scale; (b) rainbow scale; (c) gray-scale.

The following states of BLDC were analyzed: Healthy BLDC motor (HB), BLDC motor with 1 faulty shaft (1FSB), BLDC motor with 2 faulty shafts (2FSB), and BLDC motor with 3 faulty shafts (3FSB). Thermal images of the analyzed states of the BLDC motor (Prime3 Men's Shaver SRS11) are presented (Figures 3–6). The thermal images of a healthy BLDC motor (HB) are shown in Figure 3.

State HB has a large number of cold areas (blue/gray color). State 3FSB has a large number of hot areas (red/white color).

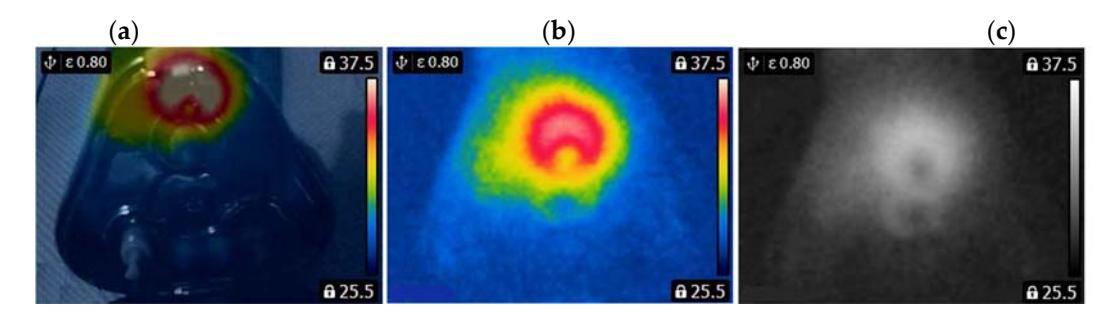
Figure 4. (1FSB) (a) Iron scale; (b) rainbow scale; (c) gray-scale.

The thermal images of the BLDC motor with 1 faulty shaft (1FSB) are shown in Figure 4.

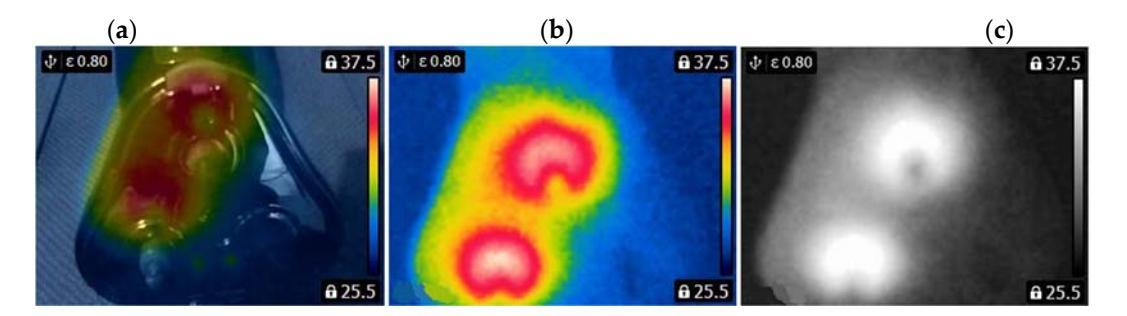
Figure 5. (2FSB) (a) Iron scale; (b) rainbow scale; (c) gray-scale.

The thermal images of the BLDC motor with 2 faulty shafts (2FSB) are shown in Figure 5.

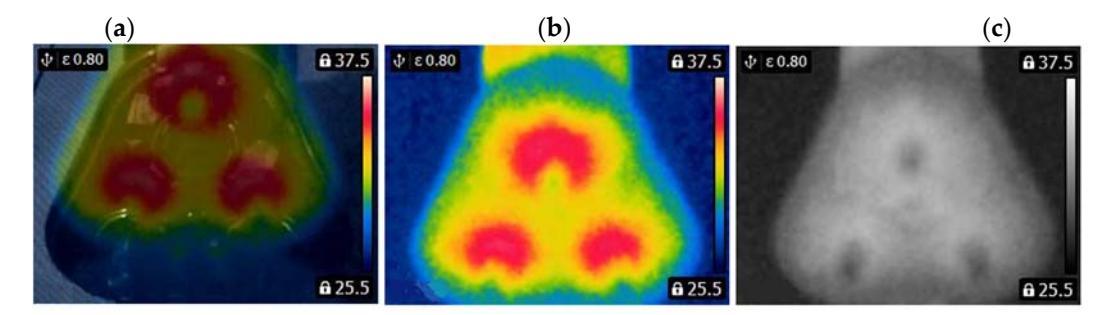
Figure 6. (3FSB) (a) Iron scale; (b) rainbow scale; (c) gray-scale.

The thermal images of the BLDC motor with 3 faulty shafts (3FSB) are shown in Figure 6.

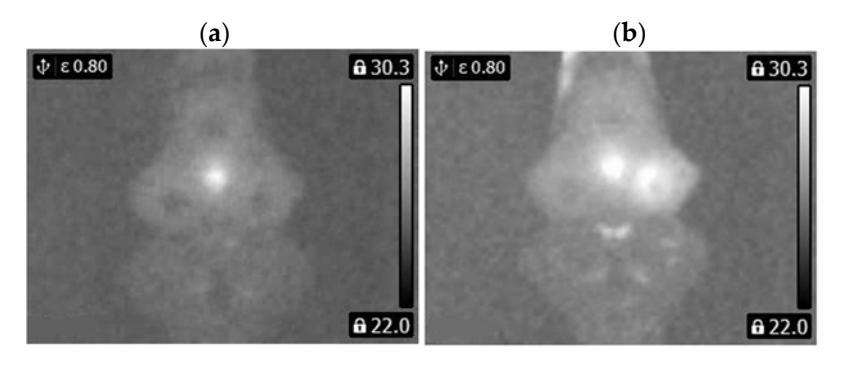
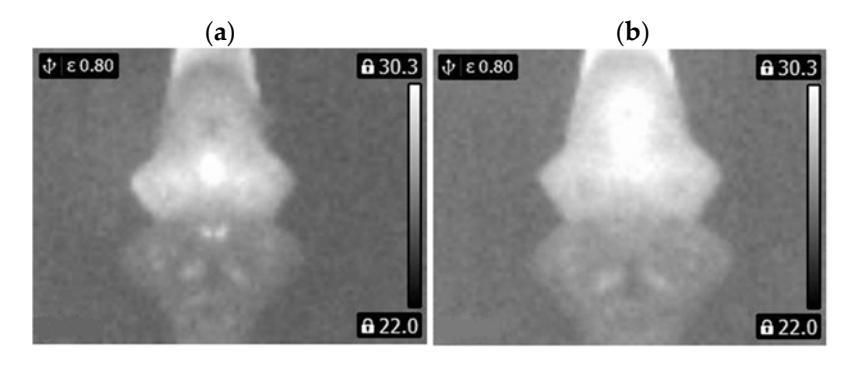
Thermal images of the analyzed states of the BLDC motor (Philips S5587/30) are presented (Figures 7 and 8).

**Figure 7.** (**a**) Gray-scale thermal image of HB state, (**b**) gray-scale thermal image of 1FSB state (Philips S5587/30).

**Figure 8.** (a) Gray-scale thermal image of 2FSB state, (b) gray-scale thermal image of 3FSB state (Philips S5587/30).

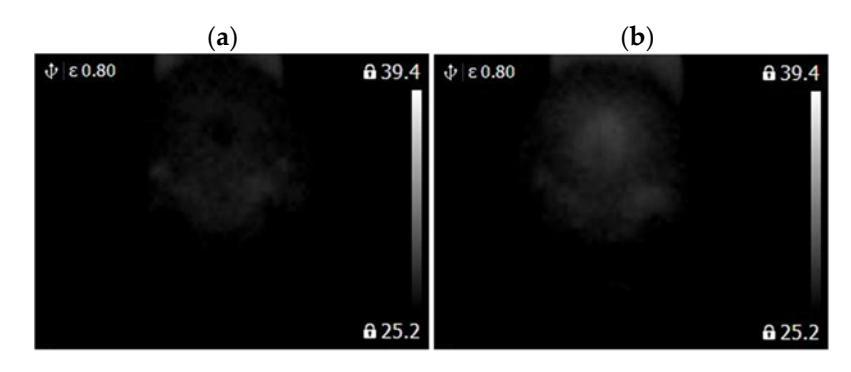
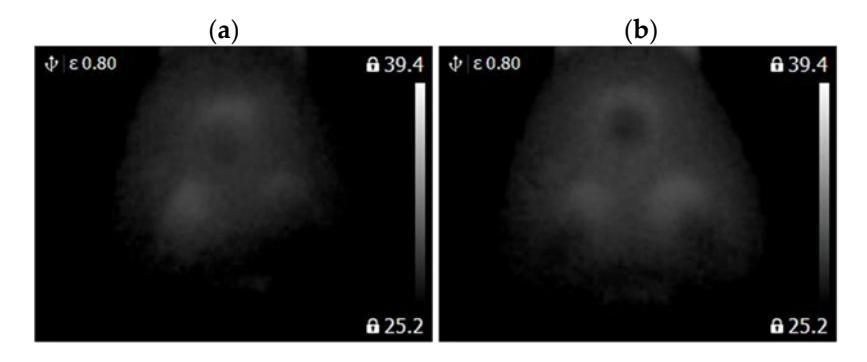
Thermal images of the analyzed states of the BLDC motor (Philips S1332/41) are presented (Figures 9 and 10).

**Figure 9.** (a) Gray-scale thermal image of HB state, (b) gray-scale thermal image of 1FSB state (Philips S1332/41).

**Figure 10.** (a) Gray-scale thermal image of 2FSB state, (b) gray-scale thermal image of 3FSB state (Philips S1332/41).

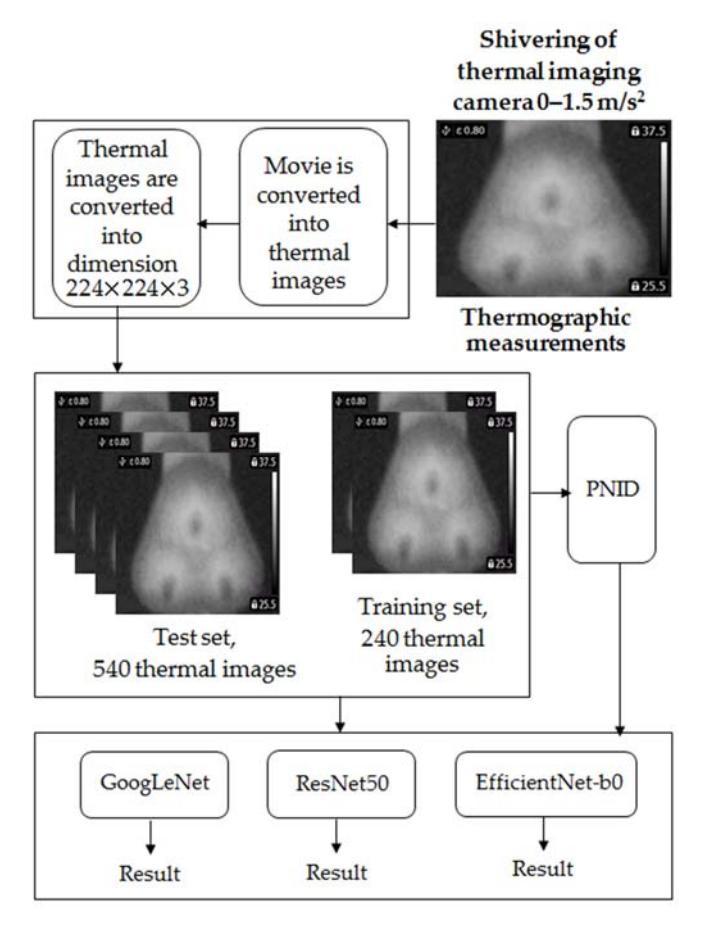
The thermographic fault diagnosis technique consists of six steps of image processing: Thermographic measurement, conversion of the movie into thermal images, conversion of thermal images into the proper dimensions of  $224 \times 224 \times 3$ , feature extraction using PNID (power of normalized image difference), training of the deep neural network, testing of the deep neural network, and additional verification using the deep neural network (Figure 11). The movie was captured using a FLIR E4 thermal imaging camera. The captured movie was converted into thermal images. Next, thermal images were converted into the proper dimensions of  $224 \times 224 \times 3$ . Dimensions of  $224 \times 224 \times 3$  were required for GoogLeNet, ResNet50, and EfficientNet-b0. Feature extraction was carried out using PNID. Training of the deep neural network was performed for training samples (240 training thermal images, 60 for each class). Testing of the deep neural network was performed for test samples (720 test thermal images, 180 for each class). Verification was carried out using GoogLeNet, ResNet50, and EfficientNet-b0. Matlab software was used for the implementation of the proposed fault diagnosis technique.

Figure 11. Thermographic fault diagnosis of the BLDC motor.

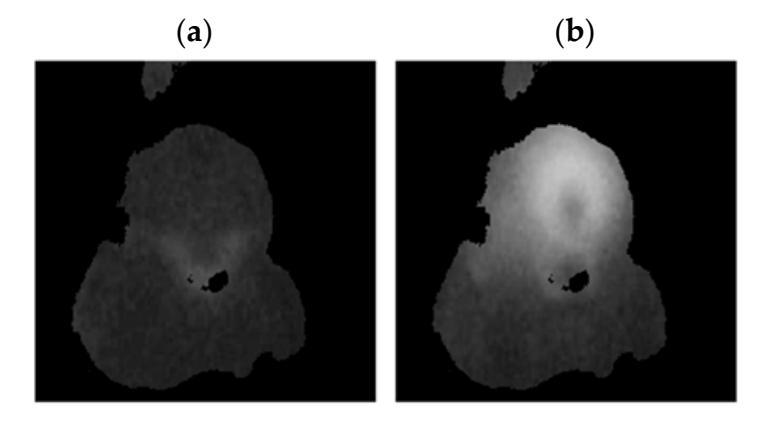
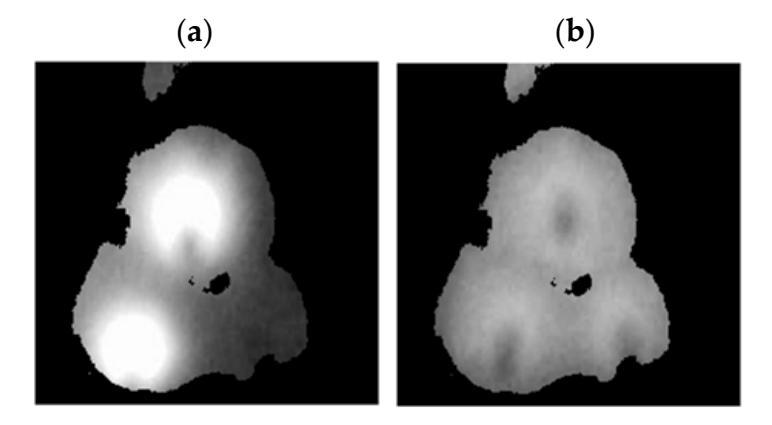
Matrices **Z** of the analyzed states for the PNID method are presented in Figures 13 and 14 (Prime3 Men's Shaver SRS11). The computed threshold of binarization t (step 8 in Figure 12) was equal to 0.3686 for the analyzed thermal images.

Figure 13. Matrix Z for PNID method: (a) HB, (b) 1FSB (Prime3 Men's Shaver SRS11).

Figure 14. Matrix Z for PNID method: (a) 2FSB, (b) 3FSB (Prime3 Men's Shaver SRS11).

The computed areas are well recognizable. We can note white areas for faulty states of the BLDC motor. Computed matrices Z are used as the input for convolutional neural networks.

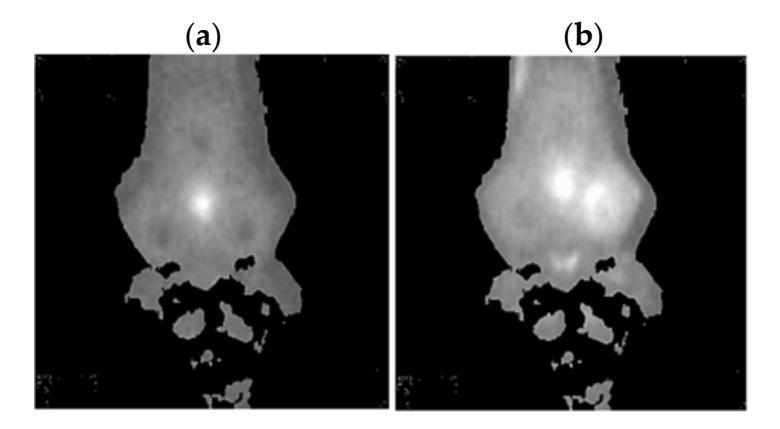
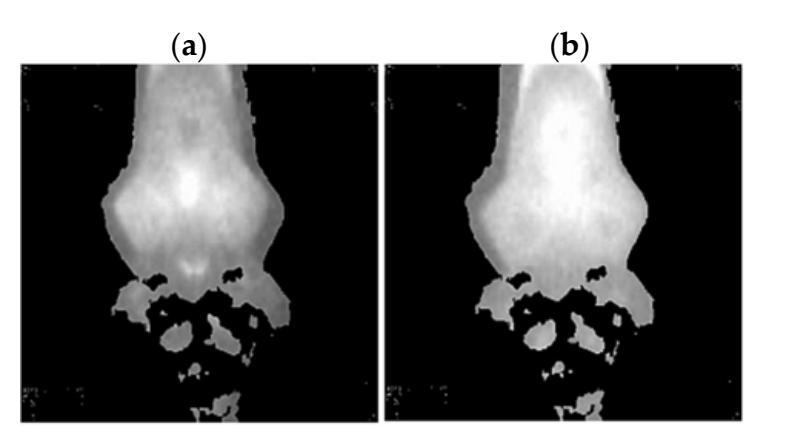
Matrices **Z** of the analyzed states for the PNID method are presented in Figures 15 and 16 (Philips S5587/30). The computed threshold of binarization *t* was equal to 0.2235 for the analyzed thermal images.

Figure 15. Matrix Z for PNID method: (a) HB, (b) 1FSB (Philips S5587/30).

Figure 16. Matrix Z for PNID method: (a) 2FSB, (b) 3FSB (Philips S5587/30).

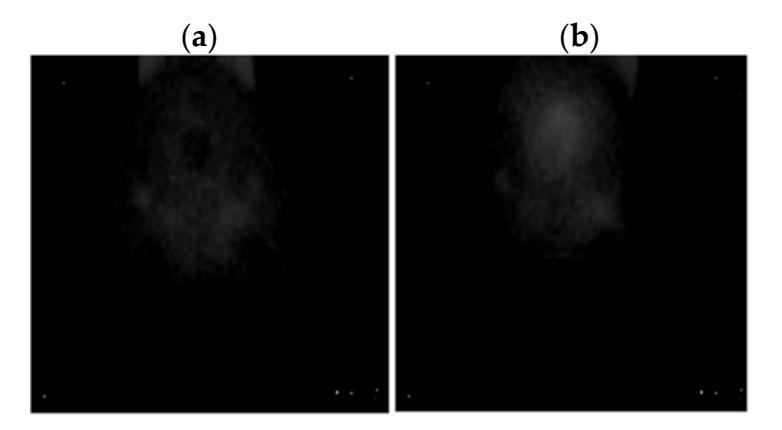
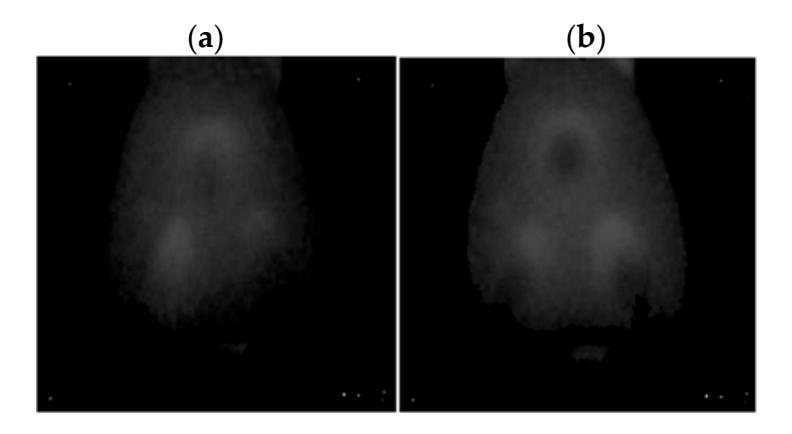
Matrices **Z** of the analyzed states for the PNID method are presented in Figures 17 and 18 (Philips S1332/41). The computed threshold of binarization t was equal to 0.2196 for the analyzed thermal images.

Figure 17. Matrix Z for PNID method: (a) HB, (b) 1FSB (Philips S1332/41).

Figure 18. Matrix Z for PNID method: (a) 2FSB, (b) 3FSB (Philips S1332/41).
