Article High-Definition Survey of Architectural Heritage Fusing Multisensors—The Case of Beamless Hall at Linggu Temple in Nanjing, China

Junwei Fang, Yingying Zhang, Yiru Zhang, Huayu Guo and Zheng Sun *🕑

School of Architecture, Nanjing Tech University, Nanjing 211800, China; 202061211026@njtech.edu.cn (J.F.); zhangying@njtech.edu.cn (Y.Z.); 202061211044@njtech.edu.cn (Y.Z.); ghy812@njtech.edu.cn (H.G.) * Correspondence: sunzheng@njtech.edu.cn

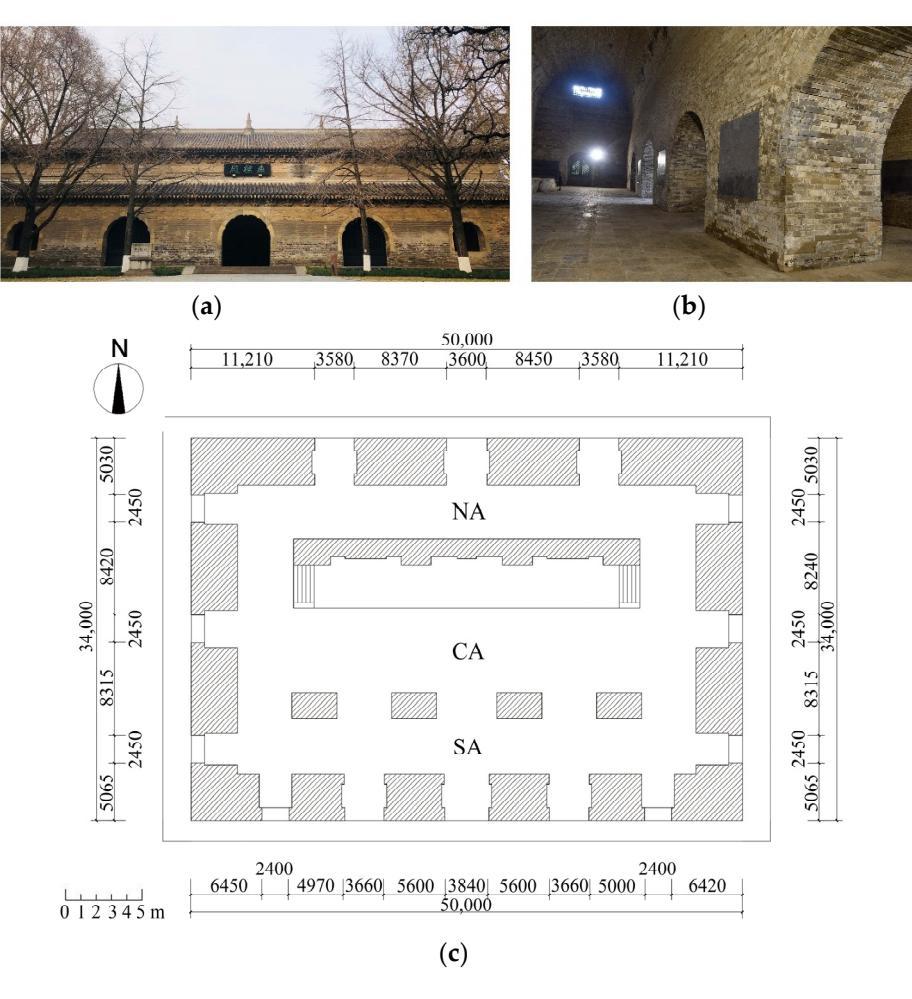
Figure 1. Beamless Hall at Linggu Temple: (a) exterior view, (b) interior view, and (c) floor plan.

The building studied in the present work (the Beamless Hall at Linggu Temple) is located in Nanjing in China (Figure 1). Beamless Hall is believed to have been built as a Buddhist temple in the 14th or 15th centuries. The volume of the building was pierced by a series of barrel vaults and arches made of bricks and mortar. Along the longitudinal axis, there are three parallel spaces with lengths equal to 40 m spanned by three-barrel vaults. The dominating central vault (CA) has a span > 11 m, one of the largest among similar brick-masonry vaulted structures built in the 14th to 15th centuries in China. Standing on the south and north of the CA are two smaller barrel vaults (south vault: SA and the north vault: NA). As a result of natural influences and human activities over the last hundred years, the Beamless Hall of Linggu Temple is suffering from material weathering, structural deformation cracks, and moisture [41].

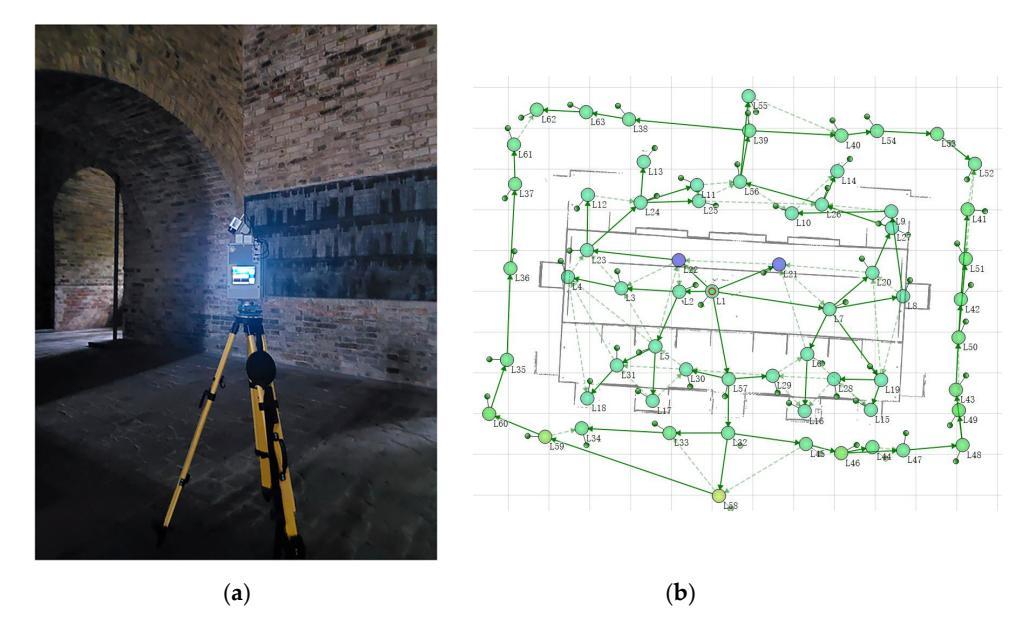
Figure 2. Terrestrial laser-scanner-based survey for the Beamless Hall. (**a**) Field survey with a Z + F Imager 5010X laser scanner. (**b**) Spatial distribution of 63 scan stations.

In recent years, 3D laser scanning technology has been increasingly used in architectural heritage conservation [42]. The device of terrestrial laser scanning used in this study is Z + F 5010X, and the scanner is also equipped with a thermal infrared camera (model: Z + F T-Cam) to collect infrared thermal image information of the Beamless Hall of Linggu Temple.

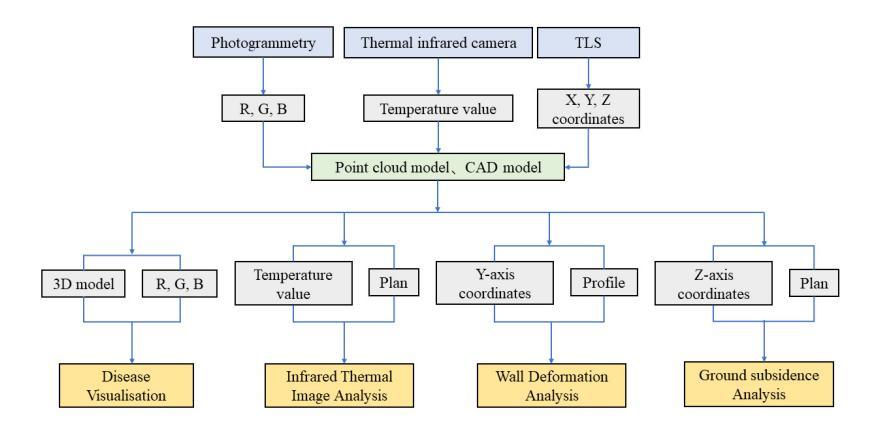
Figure 3. Pipeline of the proposed method.

The graphical representation used herein is a combination of 2D vector lines drawn in CAD programmes and the results of images processed through computer technology (Table 2). Among them, the plan and section of the Beamless Hall are drawn in AutoCAD with reference to the relevant data of the point-cloud model (Figure 3).

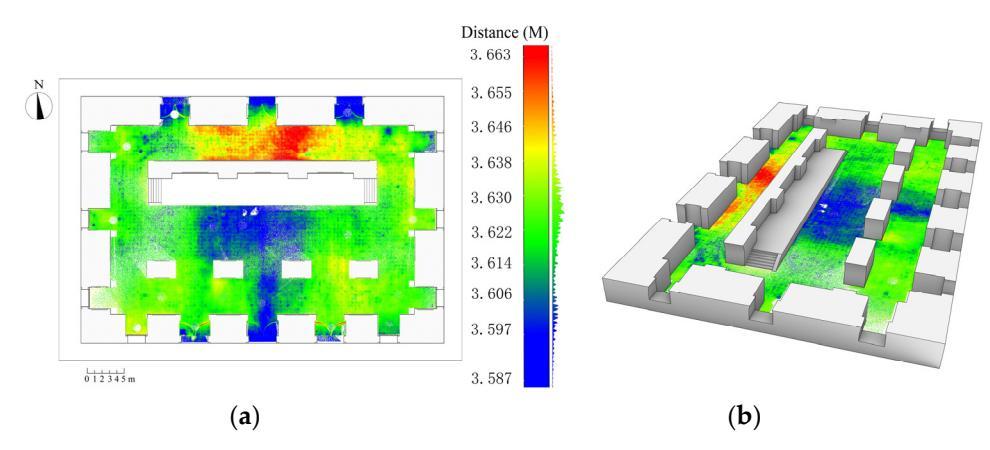
In addition, the representation of ground subsidence is significant in the expression of the plan. By converting the Z-coordinates (height) of the point-cloud model into a pseudocolour scale, an image showing information on the uneven ground subsidence of the Beamless Hall can be obtained and then superimposed on the plan. Moreover, by combining with the images of the 3D model, it can reflect the subsidence information more intuitively. From Figure 4, it can be observed that:

- (a) The most obvious uneven subsidence of the ground of the Beamless Hall is in the middle ground of the north arch (NA) and the section of the ground from the south arch (SA) into the central arch (CA); the difference between the two subsidence distances is approximately 8 cm.
- (b) There is an obvious ground subsidence at the three entrances of the SA and NA, and the value of ground subsidence at the entrance is approximately 5 cm compared with the average height of the interior floor of the Beamless Hall.

Figure 4. Ground subsidence analysis of the beamless hall of Linggu Temple. (**a**) Two-dimensional (2D) and (**b**) three-dimensional (3D) expression of subsidence analysis.

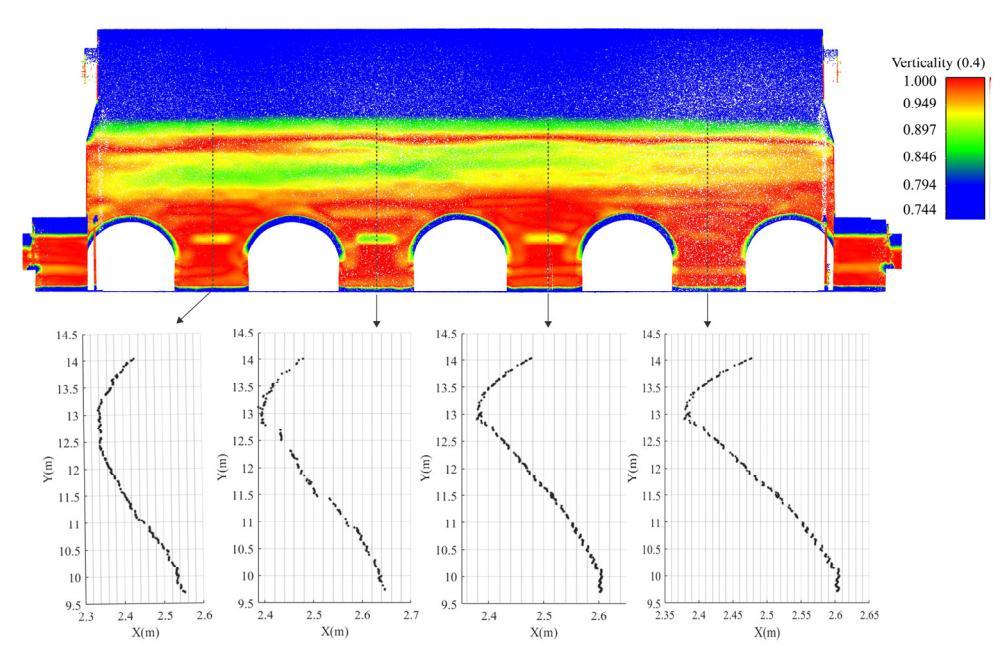
In addition, the corresponding information can be reflected by studying the geometric features of the point cloud. The pseudocolours in Figure 5 come from the calculation of the verticality (Equation (4)) of the wall, which is achieved by using the open-source software CloudCompare (Version 2.12 beta (windows 64-bit). 2021. Retrieved from http: //www.cloudcompare.org/, accessed on 26 July 2021) to calculate the geometric features of the point cloud that has a radius set to 0.4 m. The geometric features (i.e., flatness, perpendicularity, and sphericity) of the point cloud are described as a combination of eigenvalues ($\lambda 1 > \lambda 2 > \lambda 3$) [47] extracted from the covariance matrix. In this study, the wall verticality is calculated to represent the wall deformation of the SA in the Beamless Hall.

Figure 5. South wall deformation analysis of CA. The top of the image shows the verticality analysis of the wall surface, and the bottom shows the scatter diagram of the local section of the wall.

- (a) The verticality calculation of the six walls showed that the south wall suffered more extensive deformations than the north wall;
- (b) An S-shape distortion was observed at the south wall under CA (Figure 5). It is probably owing to the interacted thrust between SA and CA. The former thrust led to a lateral displacement (ca. 10 cm) around the springing of SA, and the latter led to a reverse displacement (ca. 15 cm) around the springing of CA.

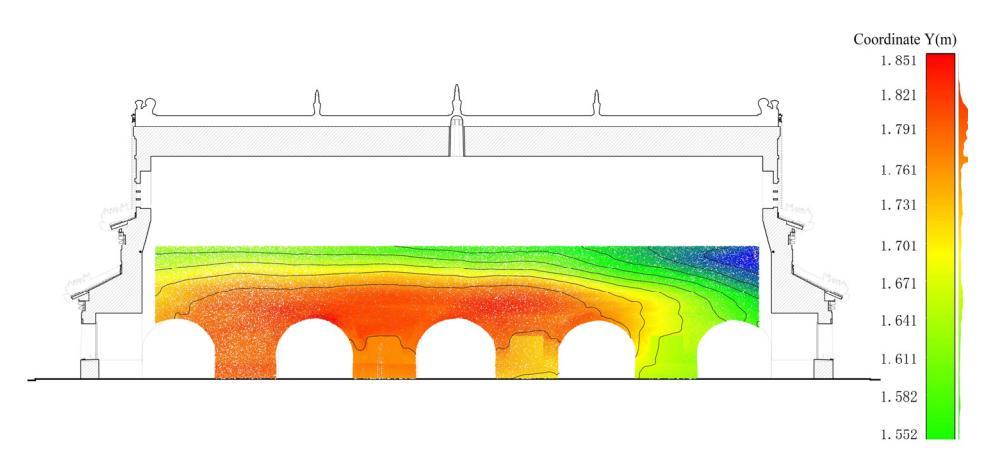
Finally, we tried to combine the 2D sections with the images to have a visual expression of the deterioration information. The pseudocolour in Figure 6 expresses the Y-axis offset value of the south wall of the CA, and the vector lines in Figure 6 are contour lines with a spacing of 0.05 m.

Figure 6. Horizontal displacement analysis of the south wall of CA (pseudocolour: offset value in the Y-axis direction; contour: contour spacing of 0.05 m).

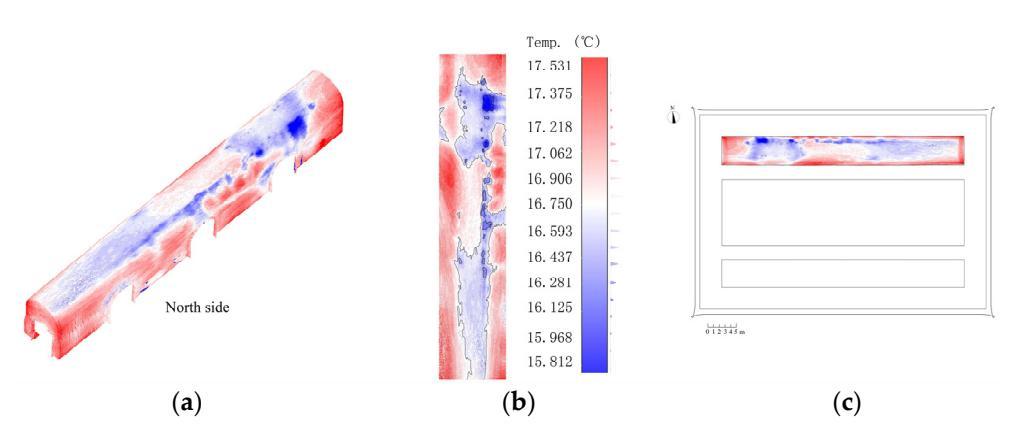
In this study, the distribution of moisture areas is analysed based on the infrared thermal image information contained in the point-cloud model of the NA. First, a combination of images and graphs was used to combine the indoor bottom view of the Beamless Hall with images containing infrared thermal image information. Moreover, the vault of the NA was expanded to convert 3D point-cloud model image into a 2D point-cloud model image. On this basis, the moisture distribution area is plotted by using vector lines so that a more intuitive expression of the moisture part of the NA can be made. From Figure 7, it can be observed that:

- a. The overall temperature range of the NA was between 15.5 °C and 18 °C.
- b. Moisture was prevalent in the top of the arch of the NA with the most severe part of the arch located on the north side of the west arch top of the NA.

Figure 7. Moisture distribution analysis at the top of NA (pseudocolours show the temperature values). (**a**) Three-dimensional point-cloud model. (**b**) View of vault expansion. (**c**) Bottom view.

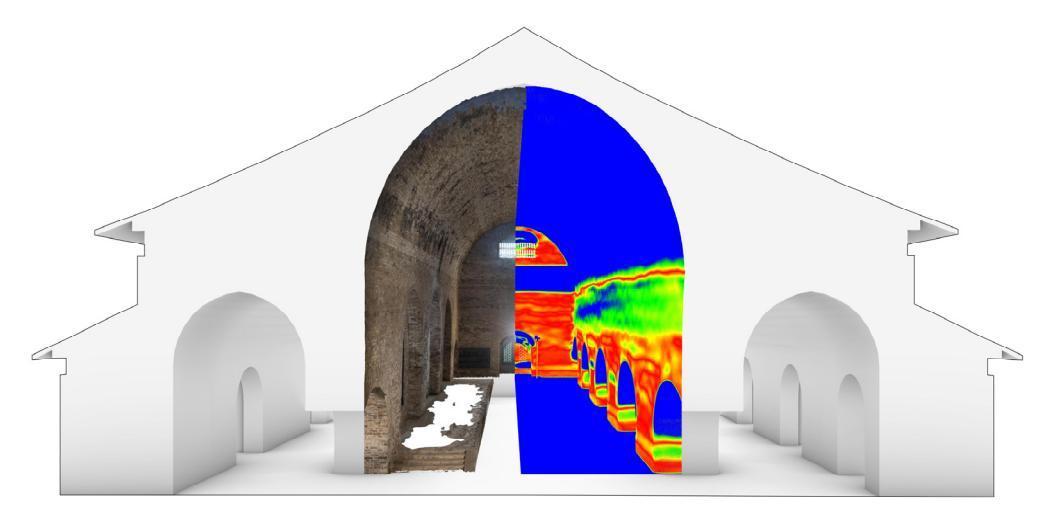
By combining the verticality calculation and the texture mesh obtained through photogrammetry, it is possible to visualise the area and extent of wall deformation (Figure 8). The expression form of deterioration visualisation is not limited to this, but it is important to illustrate the deterioration with vivid images. In practical applications, specific expressions can be made according to the disease condition of specific building types.

Figure 8. Visual expression of the deformation area of the south wall of CA (the true colour of CA in the figure is from photogrammetry, and the pseudocolour indicates the verticality of the wall).

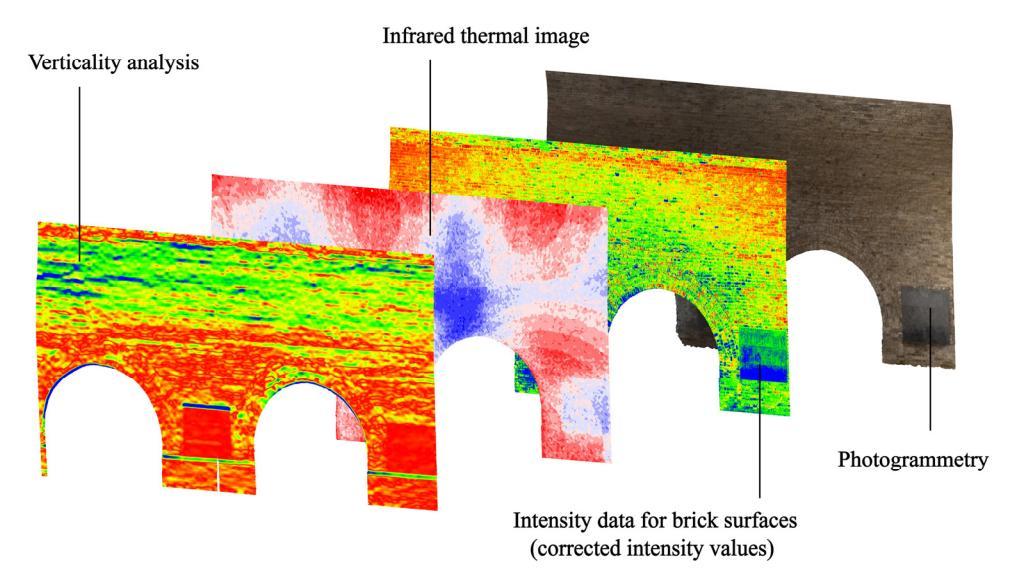
Figure 9. Expression of results using digital measurement technology.

The ground subsidence analysis allows the observation of the information on uneven ground subsidence. The deformation analysis of walls can meet the needs of studying the deformation of building structures. The integration of these two aspects provides clues for elaborated structural analysis coupled with historic restoration archives, finite element analysis, and other nondestructive testing, such as ground penetrating radar. Infrared thermal image analysis can provide the basis for quantitative analysis of moisture damage treatment of brick building heritage. The visual expression of the destruction is also intended to be able to convey more intuitive information about the destruction of the building. In addition, it is important to note that the measurement technology is always advancing, and the graphical representation of architecture should be improved.
