# Article Use of Different Types of Magnetic Field Sensors in Diagnosing the State of Ferromagnetic Elements Based on Residual Magnetic Field Measurements

Abstract: The early identification of micro-defects in ferromagnetic elements such as steel wire ropes significantly impacts structures' in-service reliability and safety. This work investigated the possibility of detecting mechanically introduced discontinuities using different magnetic sensors without magnetization of the tested object with a strong external field. This is called the passive magnetic testing method, and it is becoming increasingly popular. This research used differential sensors (measuring differences in field values at the nanotesla level) and absolute sensors (enabling the measurement of the magnetic field vector module or its components at the microtesla level). Each measurement result obtained from the sensors allowed for detecting discontinuities in the line. The problem to be solved is the quantitative identification of changes in the metallic cross-section of a rope.

Keywords: non-destructive testing; magnetic sensors; residual magnetic field; steel wire rope

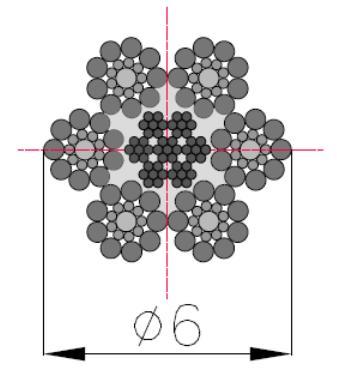
Figure 1. Cross-section and details of the measured steel wire rope.

The rope has a  $6 \times 19$  S + IWRC (7  $\times$  7) construction, which means that the rope consists of 6 strands of 19 wires each. The strands have a Seale construction. Thomas Seale patented this design in 1855 in the USA. The Seale strand is characterized by a layer of wires with smaller diameters laid directly on the core, with the next layer consisting of the same number of wires with the same but much more prominent (close to the core) diameters [26]. It causes an increase in fatigue resistance to bending and elasticity. These features are essential in industrial applications—mainly in the lifting industry. The independent wire rope core (IWRC) is also made of seven strands, with seven wires each. Using a steel rope as the core increases the tensile strength compared to a rope with a fiber core.

The correlations described in this article were found for many structures of the tested wire rope. This work focused on a test for a representative example of the tested object described here. The tested object was a steel rope with a diameter of 6 mm and a  $6 \times 19$  S + IWRC (7 × 7) construction. This structure is often used in industry due to its flexibility, especially in passenger lifts. The metallic cross-section of the tested object and the strength characteristics are shown in Figure 1.

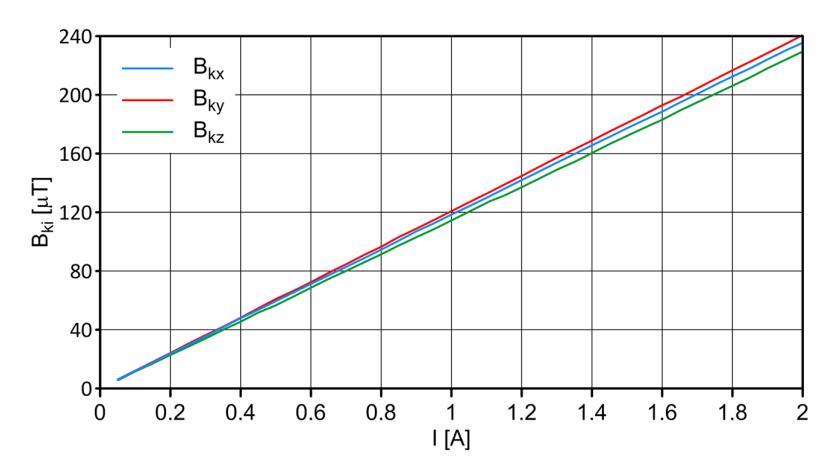
Figure 2. Helmholtz coil calibration curves.

To verify the indications of the S4 sensor, a Helmholtz coil with laboratory amplifiers was used to generate the appropriate current intensity values. The relationship between the coil's current and its magnetic field is shown in Figure 2.

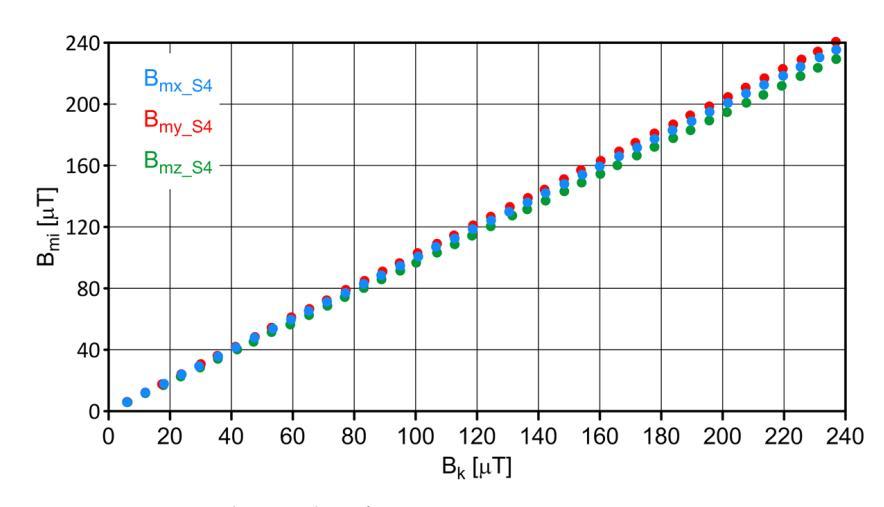
**Figure 3.** Measured B<sub>mi</sub> values for sensor S4.

The S4 sensor was placed in the center of the coil, and measurements were carried out on the changing magnetic field generated by the windings of individual coils. The influence of ambient conditions (the values of magnetic induction components at the measurement site resulting from the impact of the Earth's magnetic field and the immediate environment) was considered. The measurement results of the field values are shown in Figure 3, and the values of the absolute and relative errors are shown in Figures 4 and 5, respectively.

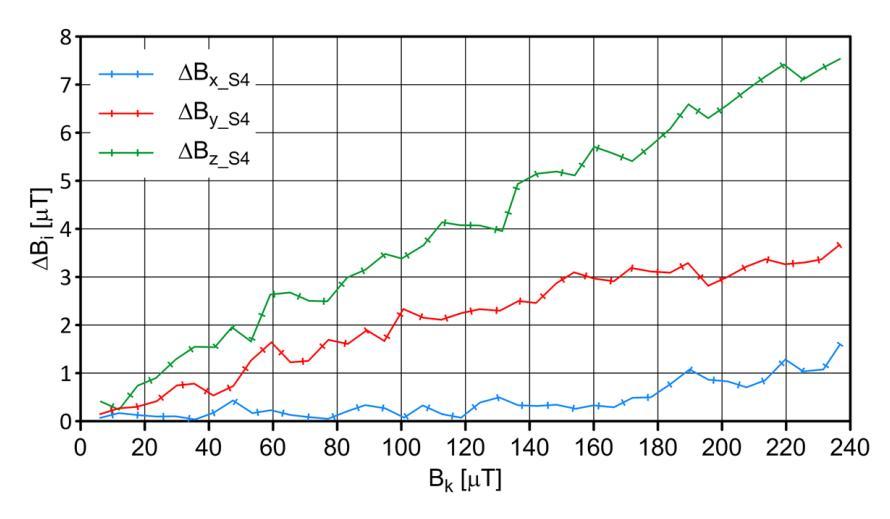
Figure 4. The absolute error of indications, which depends on the magnetic field's value for sensor S4.

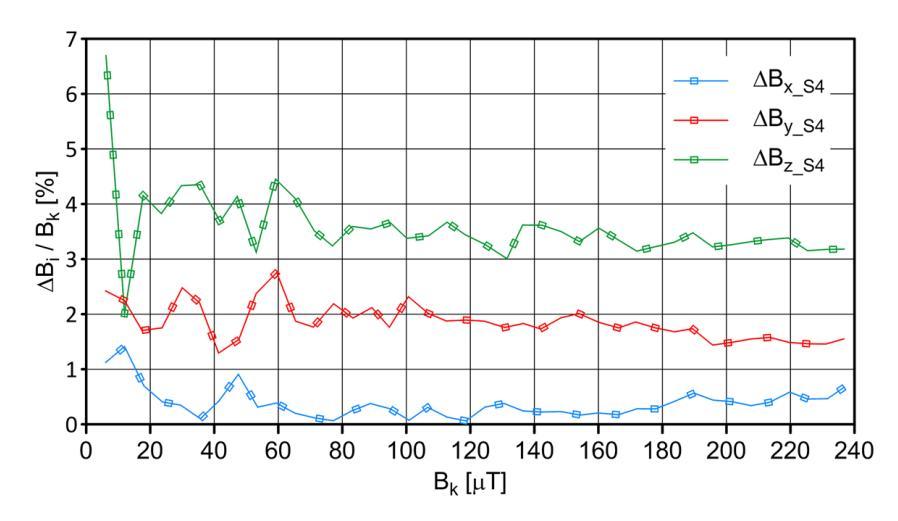
Figure 5. The relative error of indications, which depends on the magnetic field's value for sensor S4.

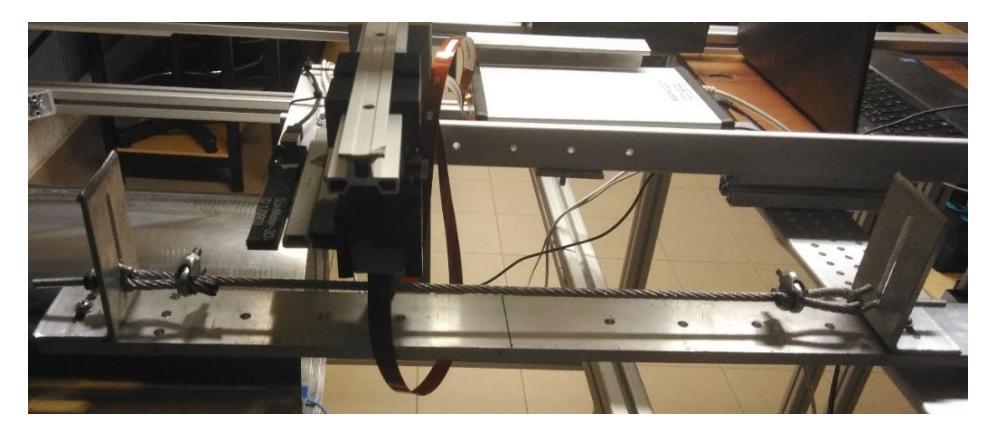
Figure 6. Real test stand.

Each of the sensors, i.e., S1, S2, S3 and S4, was used simultaneously for the magnetic field measurement (Figure 6). Sensor S4 was calibrated only once at the beginning of the rope at a distance of 25 mm (series 1—Figure 7). Each magnetic sensor was placed on a test strand (Figure 6). The rope was cut into pieces 700 mm long. Loops were formed at the ends

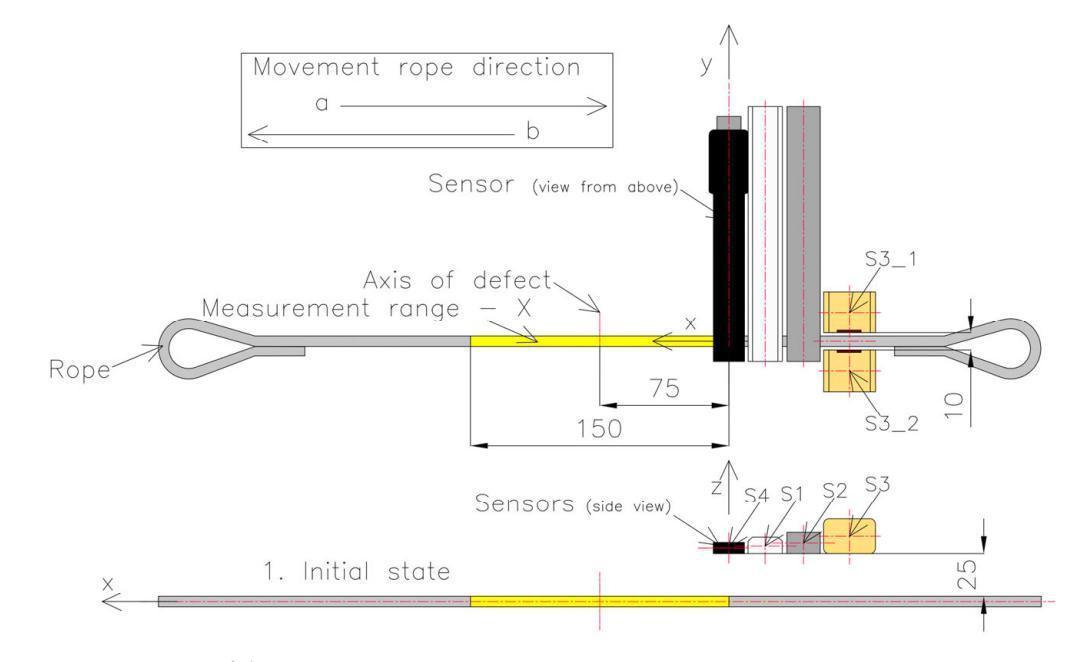
Figure 7. Setup of the measurement system in series 1.

In series 1 of the measurement, the steel wire rope was installed in its delivered state on the stand, according to Figure 7. The distance between the sensors and the rope was 25 mm in the z-direction and 0 mm in the x- and y-directions (Figure 7). The distance between sensors S3\_1 and S3\_2 was 10 mm.

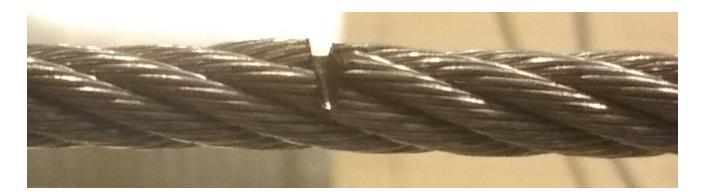
Figure 8. Real view of the artificially introduced discontinuity in the rope.

Series 2 consisted of measurements of the rope in which the test object was changed by introducing, in the middle of the rope, a discontinuity to a depth of approximately 2 mm (Figures 8 and 9). The localization of the sensors relative to the tested object stayed the same as that of series 1.

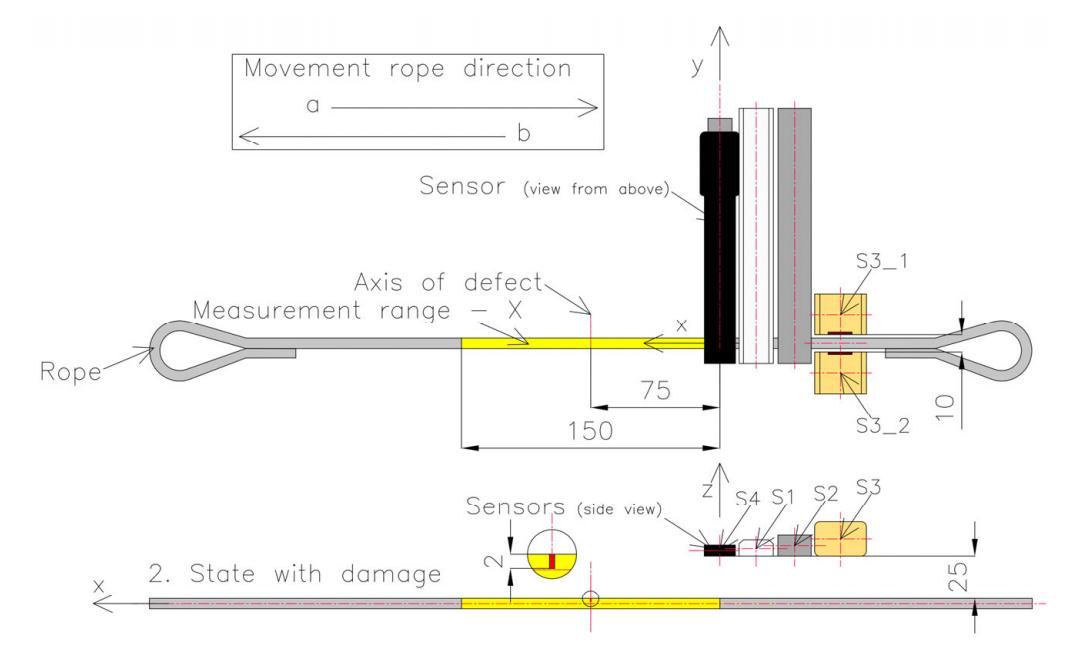
Figure 9. Setup of the measurement system in series 2.

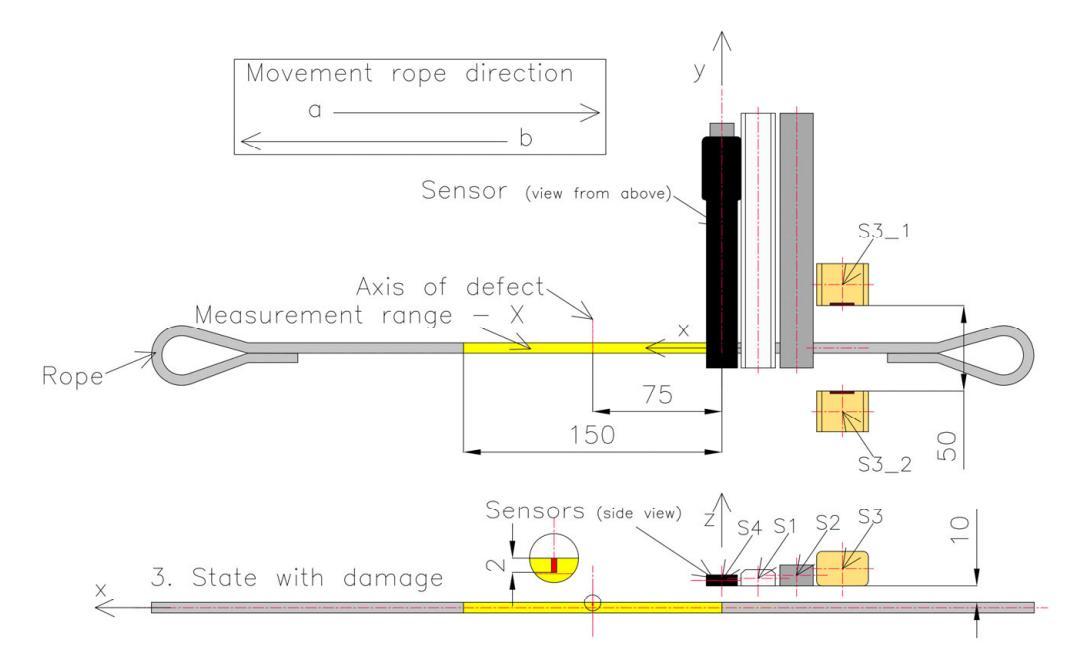
Figure 10. Setup of the measurement system in series 3.

The difference between series 3 and series 2 is the change in the lift-off value. The sensors were brought closer to the rope to a distance of 10 mm. At the same time, the S3\_1 and S3\_2 sensors were replaced, and the distance between them was set to 50 mm (Figure 10).

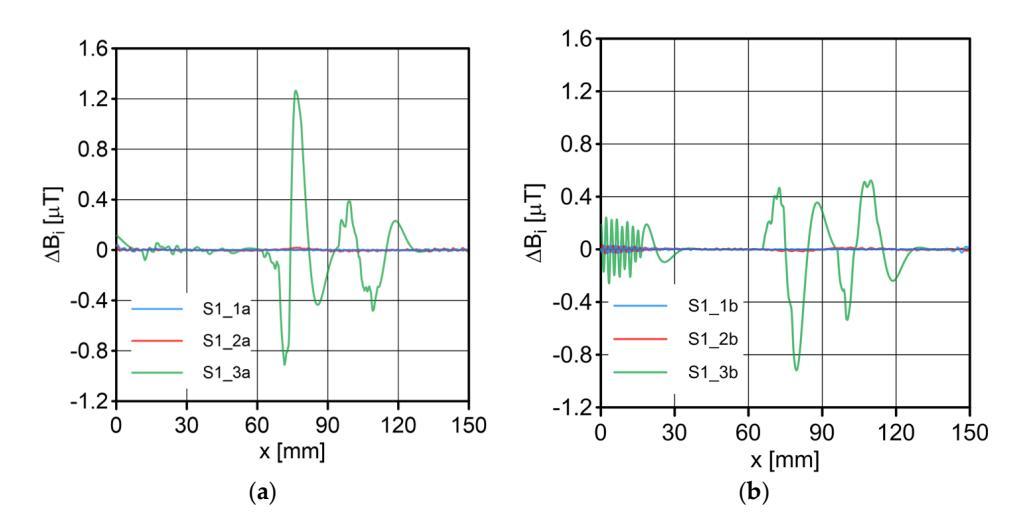
**Figure 11.** Distribution of induction difference  $\Delta B$  measured by sensor S1 along the rope: (**a**) forward direction; (**b**) backward direction.

- 1. S1 sensor (Figure 11): Compared to the other sensors, the obtained magnetic induction difference values were minimal—several dozen times lower. The change in the magnetic signal was not recorded at a distance of 25 mm from the sensor—only for a distance of 10 mm. The sensor registered changes in induction in the vicinity of the discontinuity, but these changes were still present in a large area behind the discontinuity. Near the discontinuity, the amplitude of the signal changes was the largest, which allowed for its localization. The recorded changes did not correspond to the natural changes in the induction value (which can be determined based on the measurement results of the S4 sensor). It is very puzzling that the signals differed in opposite directions, i.e., there were different amplitudes. There were additional disturbances in the signal waveform, the reasons for which we cannot determine; however, one of the reasons is probably the vibration of the sensor.

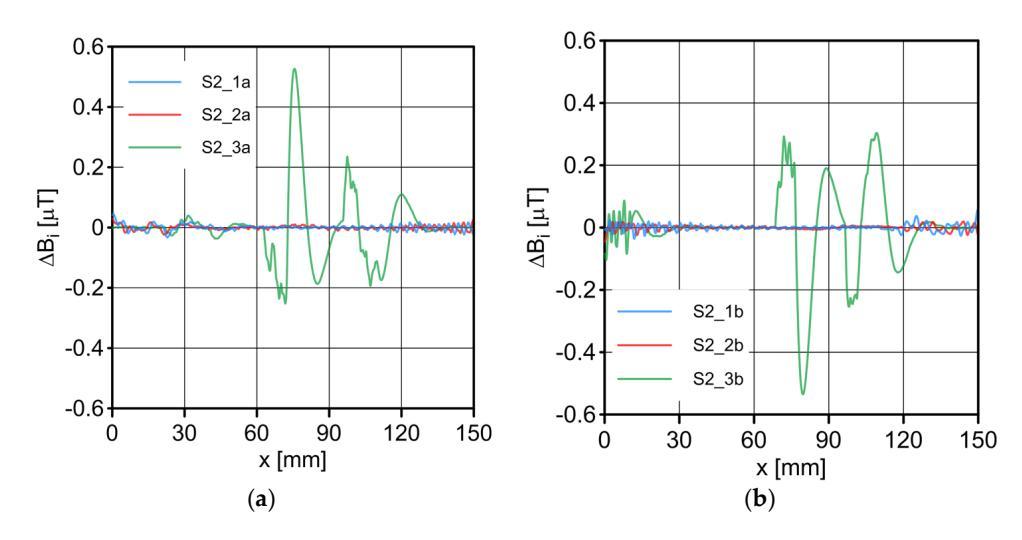
**Figure 12.** Distribution of induction difference  $\Delta B$  measured by sensor S2 along the rope: (**a**) forward direction; (**b**) backward direction.

- 2. S2 sensor (Figure 12): We can see an extensive analogy here regarding the comments concerning the S1 sensor, which uses the same measurement method. It is evident here, however, that the signal's amplitude was lower at this distance from the test object, probably due to the different designs and configurations of the measuring coils.

Qualitatively, the course of the recorded signal distribution was very similar to the distribution of the signal from the S1 sensor, but quantitatively, this signal was about twice as small. As in sensor S1, the discontinuity caused changes in the signal, and all the comments made for sensor S1 apply here.

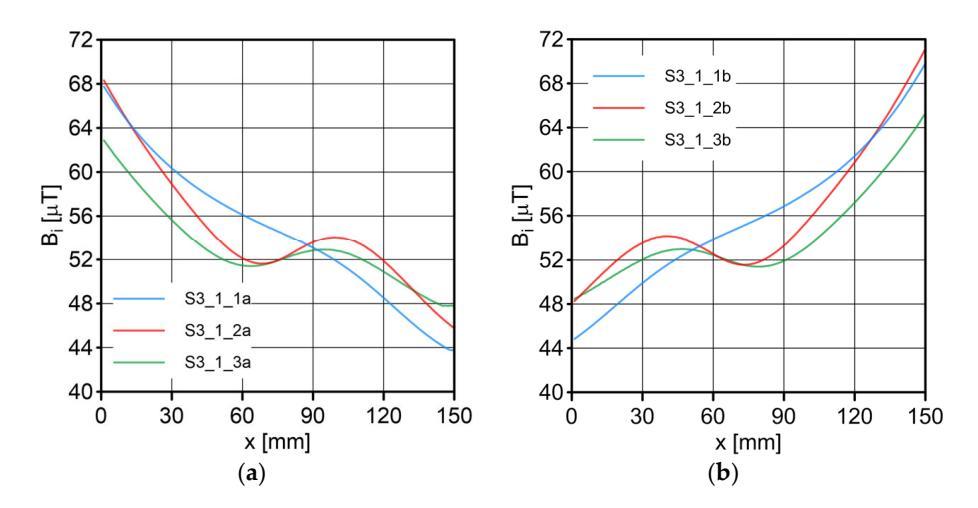
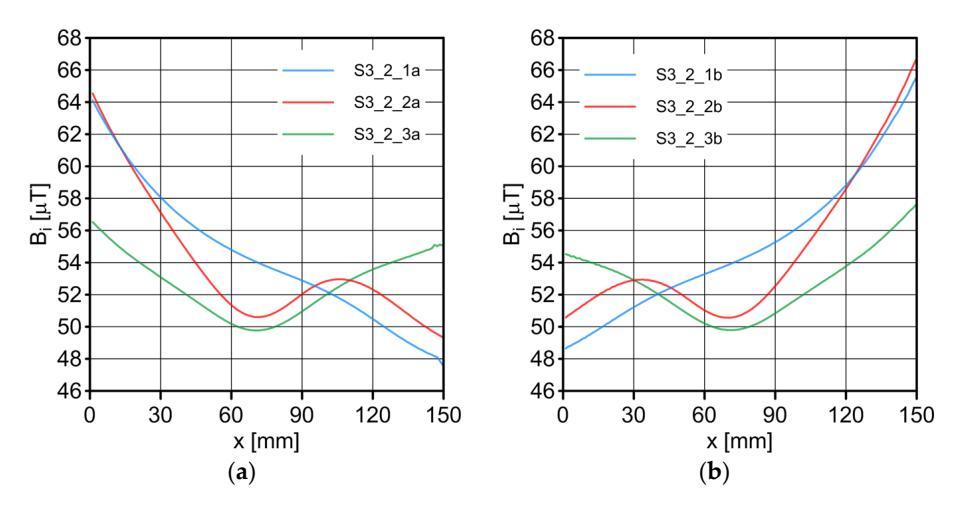
**Figure 13.** Distribution of the magnetic induction *B* components along the rope—sensor S3\_1: (a) forward direction; (b) backward direction.

**Figure 14.** Distribution of the magnetic induction *B* components along the rope—sensor S3\_2: (a) forward direction; (b) backward direction.

- 3. S3 sensor (Figures 13 and 14): In the case of the S3\_1 and S3\_2 sensors, we observed the high convergence and repeatability of the measurement. The S3 sensor, in contrast to the S1 and S2 sensors, measures the absolute value of the magnetic induction vector read at a specific point on Earth. The results were several dozen times higher than those of the S1 and S2 sensors. However, the sensor's sensitivity deserves attention the damage was detected at 25 mm from the rope (sensors S1 and S2 did not indicate damage at this distance). An apparent signal change could be seen concerning the signal for the rope with damage. Compared to the distribution of induction measured for the rope without discontinuities, the introduced discontinuity caused a change in the distribution in the form of a local anomaly of a sinusoidal function. The location of the discontinuity coincided with the local minimum of this anomaly. Unfortunately, this sensor also has its limitations. For the distance between sensors S3\_1 and S3\_2 equal to 10 mm (as in series 1 and 2) and the distance of sensors from the rope also equal to 10 mm (third series of measurements), the measurement range was exceeded, which made it impossible to obtain a physically possible induction distribution for this case. The sensors had to be moved horizontally to a distance of 50 mm, as shown in Figure 10 (series 3). In most measurement cases, the induction distributions measured by the S3\_1 and S3\_2 sensors were similar in quality, with quantitative differences. In one case, the results for sensor S3\_2 differed both qualitatively and quantitatively.

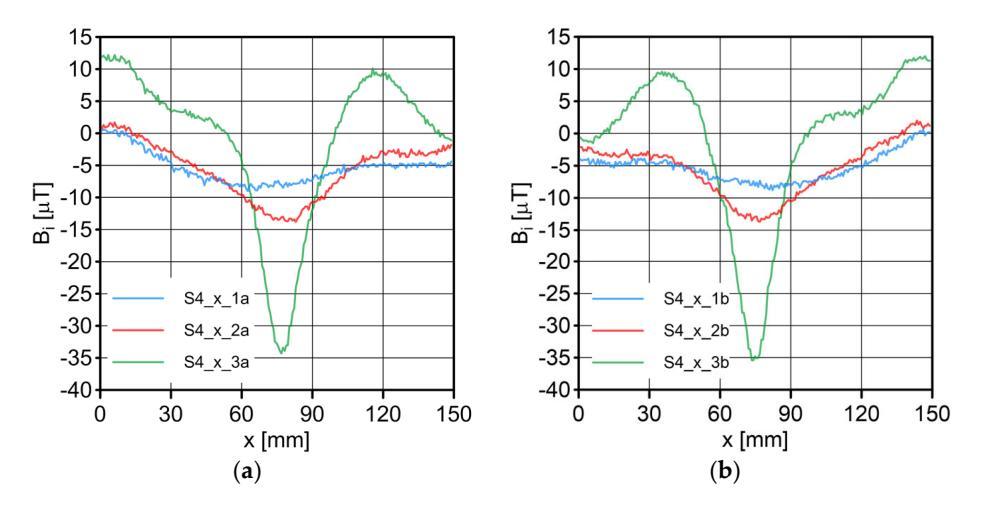
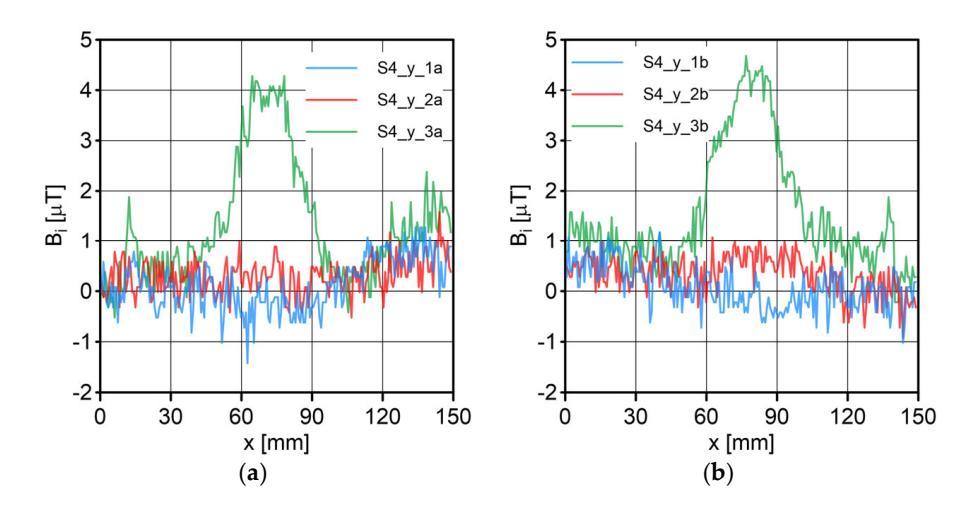
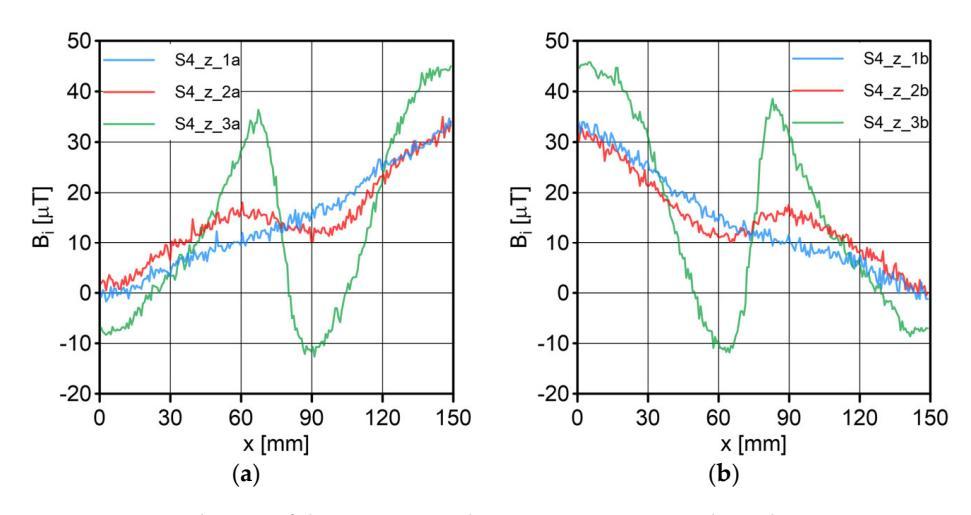
**Figure 15.** Distribution of the magnetic induction *B* components along the rope—sensor S4, along the x-axis: (**a**) forward direction; (**b**) backward direction.

**Figure 16.** Distribution of the magnetic induction *B* components along the rope—sensor S4, along the y-axis: (**a**) forward direction; (**b**) backward direction.

**Figure 17.** Distribution of the magnetic induction *B* components along the rope—sensor S4, along the *z*-axis: (**a**) forward direction; (**b**) backward direction.

- 4. S4 sensor (Figures 15–17): The S4 sensor seems to be the most promising in detecting discontinuities in wire ropes. It is worth noting that changes resulting from discontinuities in the steel rope were visible at 10 mm and 25 mm distances. Moreover, these changes were visible in every component of the signal. It is also worth noting that the direction of the measurement had no effect on the obtained result, which was the same for the two opposite directions. The magnetic anomaly caused by discontinuities for each component caused a characteristic distribution disorder. In the location of a discontinuity, tangential components (parallel and perpendicular to the axis of the rope—references) have local extremes. In the distribution of the normal component, there are two local extremes (maximum and minimum), and the distribution of values in its vicinity has a sinusoidal shape. The distributions of the tangent components parallel to the rope axis and the normal (radial) tangent provide the most visible diagnostic information.
