Article Durability Assessment of Bonded Piezoelectric Wafer Active Sensors for Aircraft Health Monitoring Applications

Abstract: This study conducted experimental and numerical investigations on piezoelectric wafer active sensors (PWASs) bonded to an aluminum plate to assess the impact of bonding degradation on Lamb wave generation. Three surface-bonded PWASs were examined, including one intentionally bonded with a reduced adhesive to create a defective bond. Thermal cyclic aging was applied, monitoring through laser Doppler vibrometry (LDV) and static capacitance measurements. The PWAS with the initially defective bond exhibited the poorest performance over aging cycles, emphasizing the significance of the initial bond condition. As debonding progressed, modifications in electromechanical behavior were observed, leading to a reduction in wave amplitude and distortion of the generated wave field, challenging the validity of existing analytical modeling of wave-tuning curves for perfectly bonded PWASs. Both numerical simulations and experimental observations substantiated this finding. In conclusion, this study highlights the imperative of a high-integrity bond for the proper funct

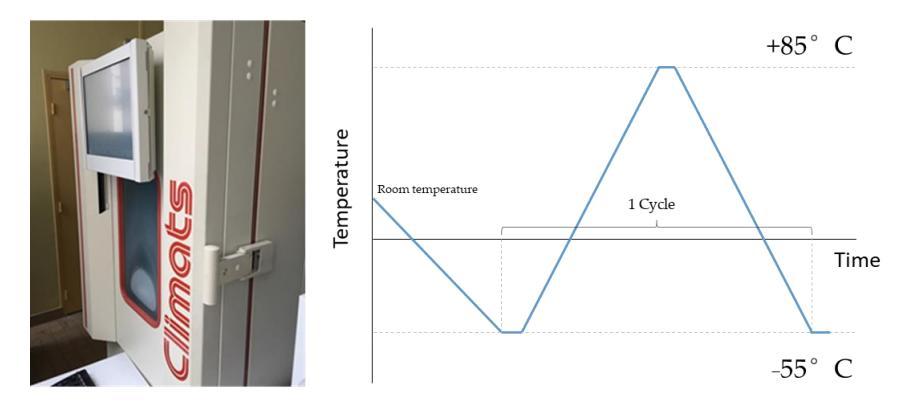
Figure 1. Schematic representation of the accelerated testing procedure in a climatic chamber.

Three piezoelectric lead-zirconate-titanate (PZT) sensors (Fuji C6, dimensions: diameter—20 mm and thickness—200 µm) were glued with a cyanoacrylate-based glue (Loctite® 454 (Düsseldorf, Germany)) onto a squared aluminum plate measuring 500 mm \times 500 mm \times 2.4 mm. Before applying the glue, the aluminum substrate was thoroughly cleaned with acetone and prepared with a surface neutralizer. Two PWASs (denoted henceforth as D1 and D2) were affixed to the aluminum plate with an adequate amount of cyanoacrylate glue to produce a uniform bond. The third one (denoted as D3) was purposely affixed with an insufficient amount of an adhesive to produce a defective (non-uniform) bond. The aluminum plate was then subjected to accelerated aging cycling according to the temperature extremes instructed by the standard DO-160 [10]. The aging cycle consisted of an initial preconditioning step from ambient temperature (~23 °C) to -55 °C in a climatic chamber and subsequent repeated cycling between -55 °C and 85 °C at a constant rate of ± 3 °C/min. The temperature was held for 10 min in between the temperature extremes; hence, a complete cycle lasted 1 h and 53 min. Figure 1 shows a schematic of the thermal aging protocol. The performance of the PWAS was initially evaluated at room temperature and after ~500 h (350 cycles) and ~750 h (525 cycles) of exposure to the accelerated aging conditions. The aluminum plate was conditioned at room temperature before testing.

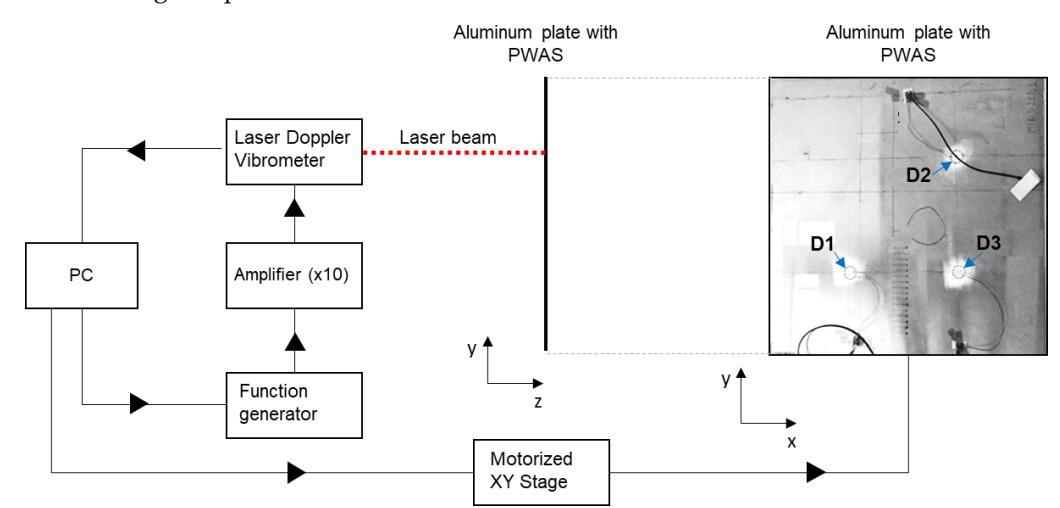
Figure 2. Wave field imaging testing configuration using a laser Doppler vibrometer. The positions of the three PWASs (D1, D2, and D3) are indicated with arrows.

A 25-kHz tone burst of 5 cycles was generated with an arbitrary function generator (Keysight 33500B (Santa Rosa, CA, USA)) and fed to an $\times 10$ amplifier, resulting in an output voltage amplitude of 40 Vpp. The plate was mounted on a testing rig comprising two micro-controlled linear positioning stages that allowed for the horizontal and vertical displacement of the laser spot over the inspected zone. The out-of-plane vibration promoted by every PWAS into the aluminum plate was sensed with a Polytech OFV-505 laser Doppler vibrometer. One scan of 10 mm \times 10 mm with a spatial resolution of 0.5 mm²/pixel was effectuated over a zone covering every PWAS. Figure 2 shows a schematic representation of the testing setup.

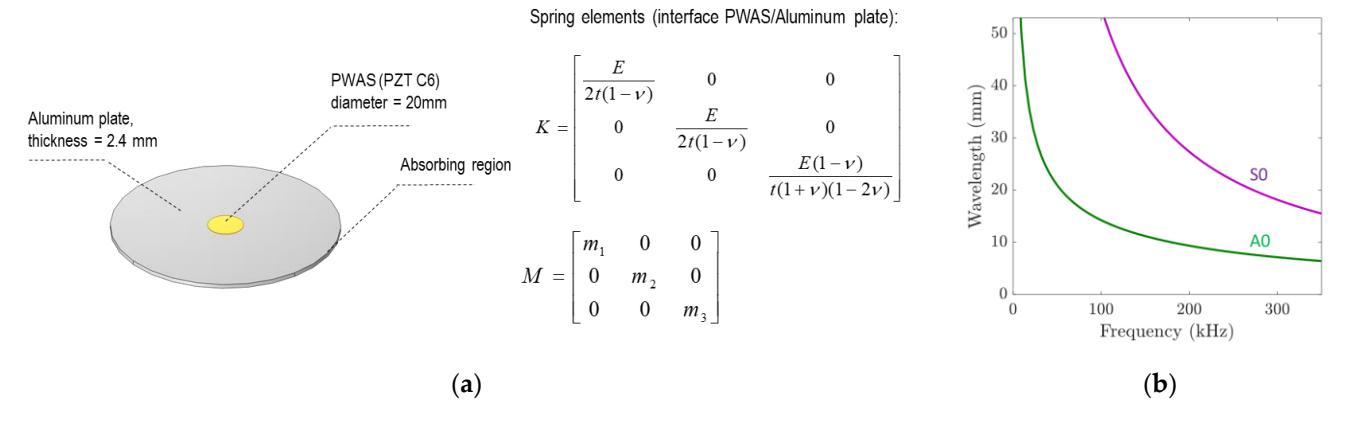
Figure 3. (a) Schematic representation of the FEM and (b) Lamb wave dispersion curves for the considered aluminum plate.

The effects of a degraded adhesive bond contact between one PWAS and the aluminum plate were further analyzed using the finite element method (FEM) in COM-SOL Multiphysics. Figure 3a presents the geometry and boundary conditions of the 3D FEM model. This model consists of an infinite elastic plate (region of study of 100 mm \times 100 mm \times 2.4 mm) and a PWAS (radius: 10 mm; thickness: 0.2 mm) mounted on the top of the plate surface. For a Fuji C6 ceramic, the strain–charge piezoelectric matrix (D) and relative permittivity matrix (e) were set to [50]:

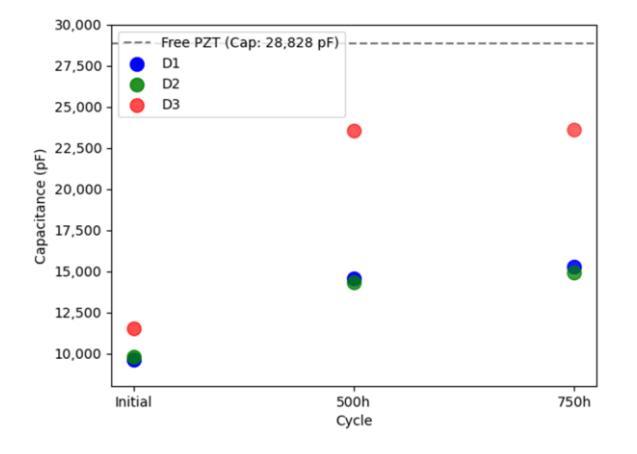
Figure 4. Evolution of the static capacitance of the three PWASs with aging. The dashed line shows the average static capacitance of the free PWAS measured experimentally.

Figure 4 illustrates the evolution of static capacitance for the three examined PWASs. All PWASs consistently exhibited a reduction in static capacitance values compared to their free counterparts. Notably, PWAS D3, initially displaying defective bonding, showed a relatively higher level of capacitance. With subsequent thermal cycling, there was a monotonic increase in capacitance values. The temperature range applied here is gentle enough to not produce meaningful variations in the constitutive piezoelectric properties of a C6 PZT ceramic. Previous studies applying similar thermal cycling [56] reported a reduction in the static capacitance of piezoelectric SHM sensors of $\sim -9\%$ after 500 cycles. However, it is important to note that the piezoelectric sensor used in those studies differed

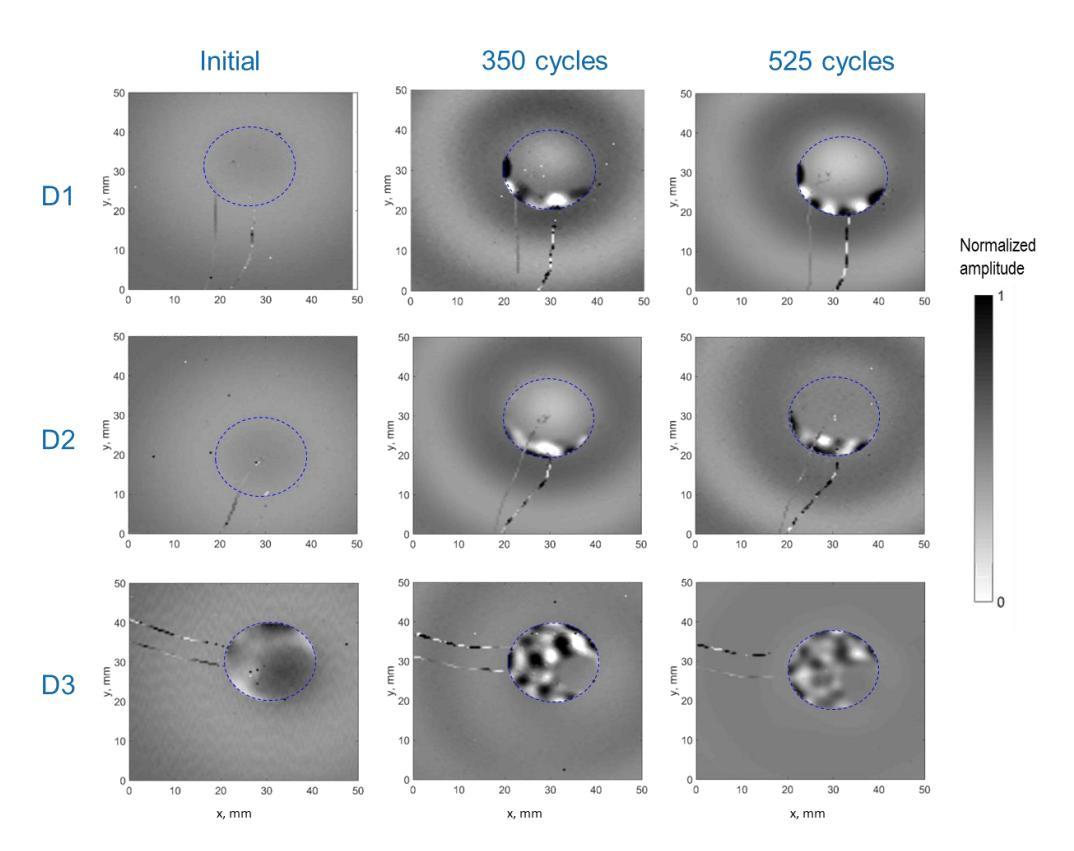
Figure 5. Out-of-plane velocity obtained experimentally for the PWASs D1, D2, and D3 through thermal aging. The dashed line depicts the PWAS perimeter.

Figure 5 compares the out-of-plane velocity scans generated using the PWASs (D1, D2, and D3) at 25 kHz during various aging stages (initial, 350 cycles, and 525 cycles). Note that since absolute values are presented, the minima correspond to the zero-crossing velocity of the waves. Uniformly bonded PWASs (D1 and D2) displayed nearly constant amplitudes across the scanning area, posing a challenge in distinguishing them from the plate. Additionally, a concentric wave field was generated, as was the expectation for a uniformly bonded circular PWAS. Contrariwise, defectively bonded PWASs displayed heightened amplitudes at debonded areas. As aging progressed, all three PWASs started to release at the borders, revealing distinctive resonance-like patterns within the zones, losing adhesion with the aluminum plate. Notably, the PWASs consistently initiated detachment at the position of the cabling electrodes. One potential explanation is stress concentration precisely at the electrode position, possibly influencing subsequent debonding upon thermal cycling. Alternatively, the bonding defects that were initially present could trigger debonding during the process of thermal cycling. These hypotheses require further experimental verification on a larger set of PWASs for validation. Moreover, due to debonding, the generated wave field was no longer concentric to the PWAS's position, and the amplitude was significantly reduced with increasing debonding area. These results are consistent with previous studies that used LDV scans to examine the health of PWASs bonded to metallic and composite plates [28,45].

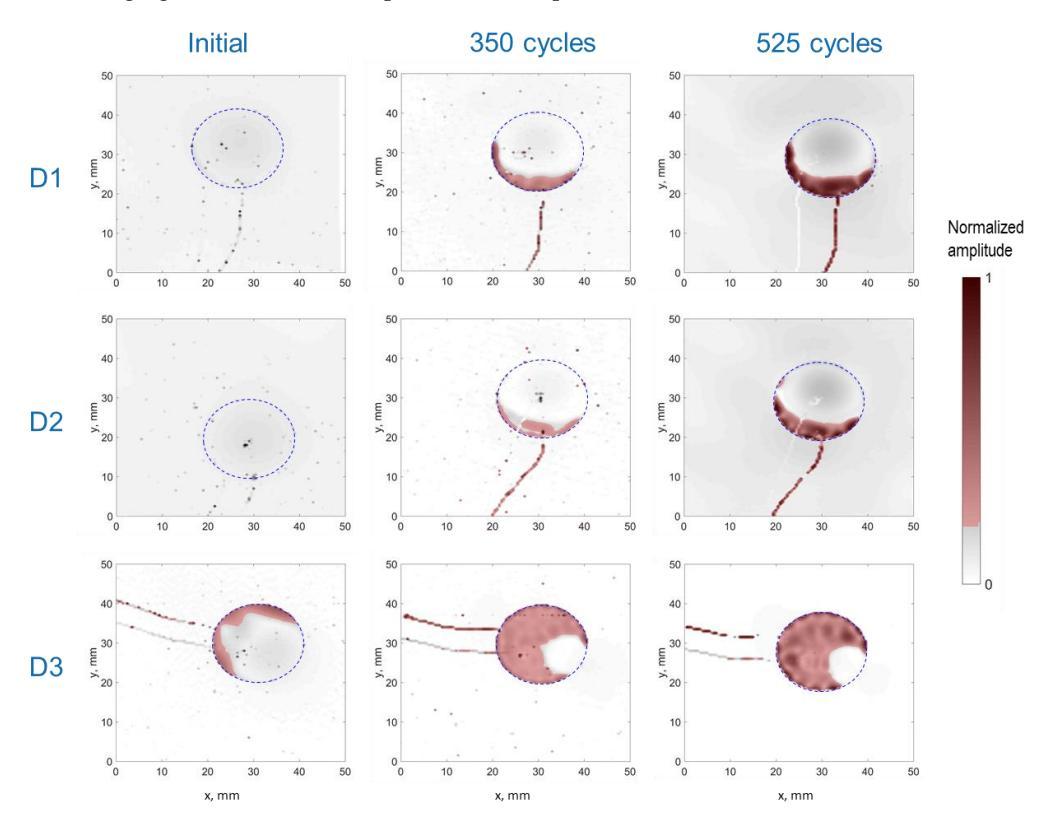
Figure 6. Post-processed RMS amplitude LDV scans obtained for the PWASs D1, D2, and D3 at different ages (the thresholded and binarized images are shown as a red overlay). The dashed line depicts the PWAS perimeter.

The experimental LDV scans were binarized and thresholded to estimate the debonded area, as detailed in Section 2.2.2. Figure 6 displays the RMS amplitude scans, illustrating the applied filtering process to these scans (note the difference in RMS amplitude representation compared to Figure 5). These results were subsequently used to define the adhesive layer (spring elements) between the PWAS and the aluminum plate in the FEM. Figure 7 provides a quantification of the debonded area for each case based on this filtering approach. Interestingly, the estimated debonded areas exhibit a similar trend to that obtained from the static capacitance measurements (Figure 4), suggesting that the measured static capacitance walue scales to the debonding extent. Moreover, according to both the static capacitance measurements and the analysis of the LDV scans, the onset of degradation after 350 cycles was more pronounced for the initially defectively bonded PWAS D3, underscoring the significance of the initial bonding quality on the long-term behavior of the bonded sensors.

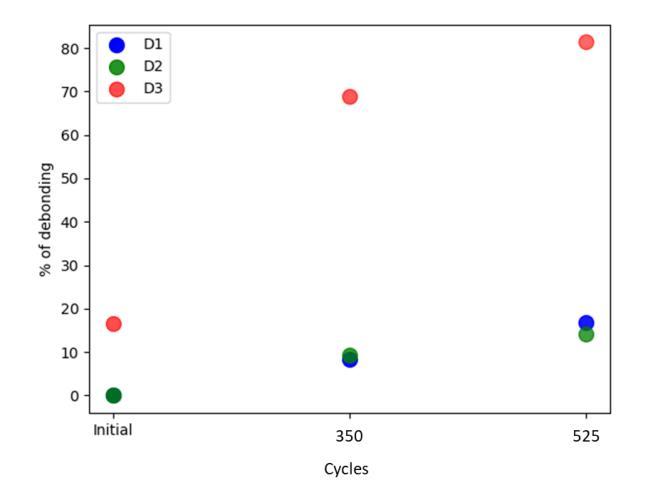
Figure 7. Estimation of the debonded area for all the PWASs according to the filtered RMS amplitudes displayed in Figure 6.

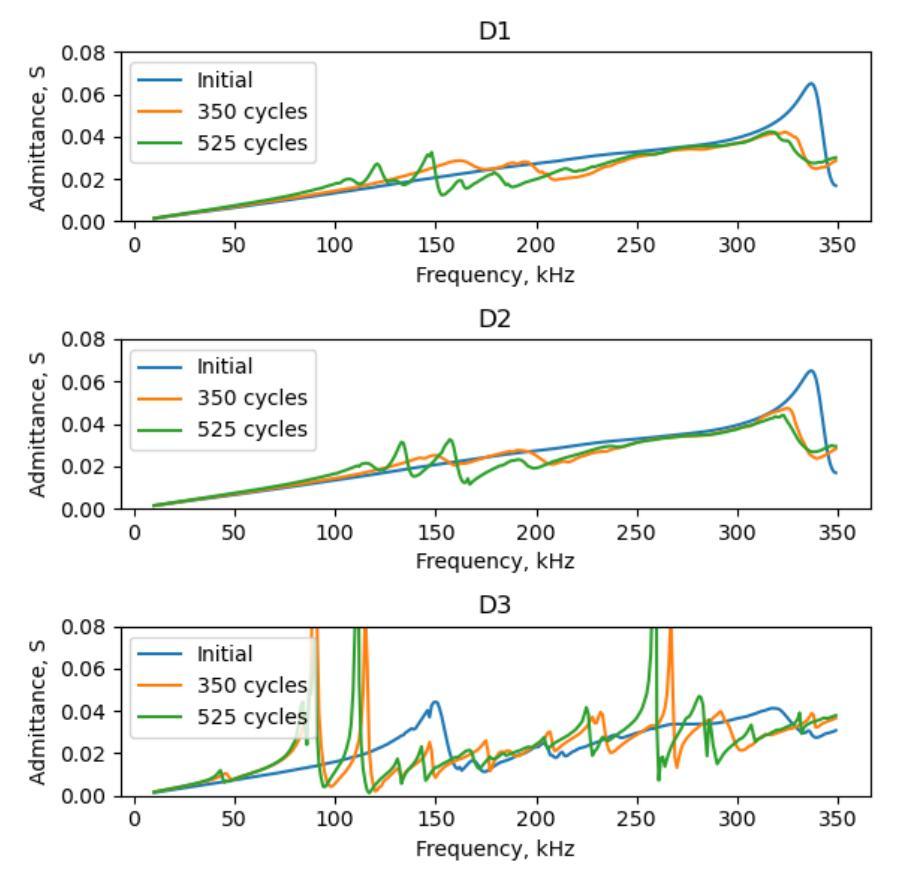
Figure 8. Admittance spectra from FEM simulations: healthy and deteriorated scenarios of the PWASs D1 (top), D2 (middle), and D3 (bottom).

Numerical modeling provided additional insights into the impact of bonding degradation on Lamb waves emitted in a plate. The binarized LDV scans were used to reproduce the different damage scenarios observed during the experimental accelerated aging campaign. In these scenarios, the interfacial elements were selectively positioned solely on the remaining bonded PWAS area. The use of such synthetic scenarios facilitated a more nuanced understanding of the interplay between the bonding conditions and the resultant emitted Lamb waves and PWASs' admittance spectra. Figure 8 presents three plots, each corresponding to the admittance spectra resulting from the recreated bonding conditions of the PWASs D1, D2, and D3. For perfect bonding conditions, the results indicate that admittance increases proportionally with frequency before the first resonance of the piezoelectric disc (occurring above 300 kHz). In all instances (other than perfect bonding), distinctive resonance peaks are identified, which intensify as the debonding extent increases.

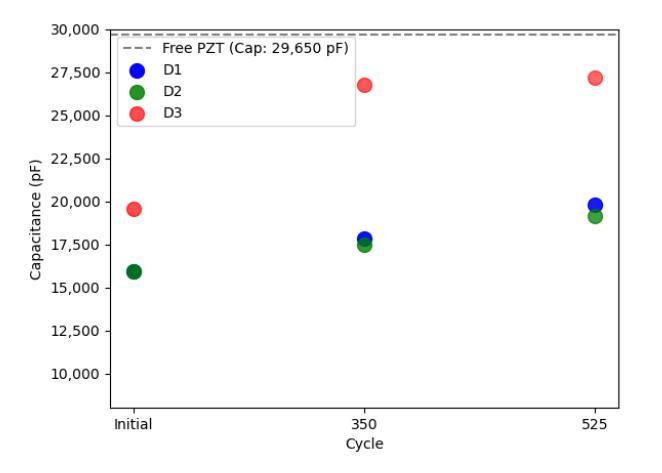
Figure 9. Static capacitance of the three PWASs obtained through the FEM (considering the data sheet properties of the Fuji C6 PZT given in Section 2.3) at the different aging scenarios. The dashed line shows the static capacitance of the free PWAS.

For reference, the static capacitance values of the PWAS obtained from the FEM are shown in Figure 9. Once again, the static capacitance values increase monotonically with the extent of debonding, as was substantiated experimentally. However, the static capacitance values obtained from the FEM were observed to be higher than their experimental counterparts (those shown in Figure 4). In practice, by updating the input parameters of the FEM, similar values can be obtained. Notably, setting the initial adhesive's stiffness to a higher value (increasing Young's modulus and decreasing adhesive thickness) and adjusting the constitutive properties of the piezoelectric element and substrate can achieve this. Note that data sheet properties were considered for the PWASs and that the adhesive properties were not experimentally ascertained. Another interesting observation was that the relative changes in static capacitance with thermal cycling obtained experimentally were more prominent than those determined through the FEM. For example, the experimentally measured static capacitance values after 350 cycles for the PWAS D3 exhibited a significant increase, nearly doubling the initial measure. In contrast, the FEM-estimated increase for the same case was only approximately ~35%. Several factors may plausibly account for this observed discrepancy. One is an underestimation of the actual debonded area that was used as an input to configure the adhesive layer in the FEM analysis. Additionally, the evolving physical properties of the adhesive, such as elastic properties and density, are likewise expected to evolve with aging. These changes may progressively result in a less constraining boundary condition on the PWAS and manifest as an increased static capacitance value. Similarly, the constitutive piezoelectric properties of the PWASs may undergo variations with thermal aging. Past studies have documented variations in constitutive piezoelectric properties after exposure to similar temperature conditions. The interplay between these counteracting phenomena during environmental aging cannot be

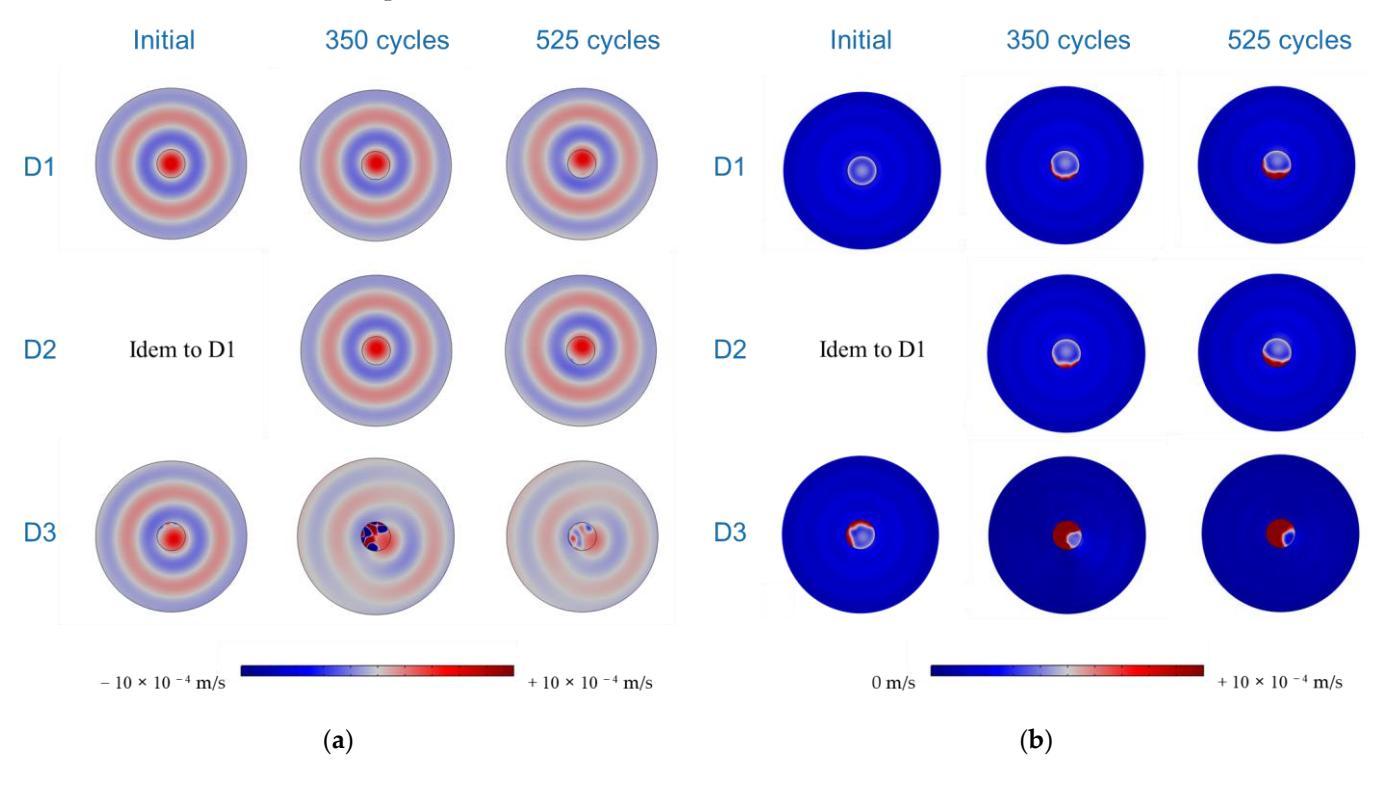
Figure 10. Simulated LDV scans for (**a**) out-of-plane velocity and (**b**) RMS amplitudes, obtained at 25 kHz for all the PWASs and considered damage scenarios.

In Figure 10a,b, the out-of-plane displacement and RMS amplitudes obtained from numerical simulations at 25 kHz (akin to the experimental configuration) are presented. The results exhibit qualitative similarities to the experimental results reported in Section 3.1.

The harmonic radiation field for the out-of-plane velocity becomes considerably distorted for the debonded PWAS scenarios, deviating from the expectations for a uniformly bonded PWAS. Moreover, heightened amplitudes and resonance-like patterns also manifest within the debonded PWAS areas, alongside an overall reduction in wave amplitude within the plate.

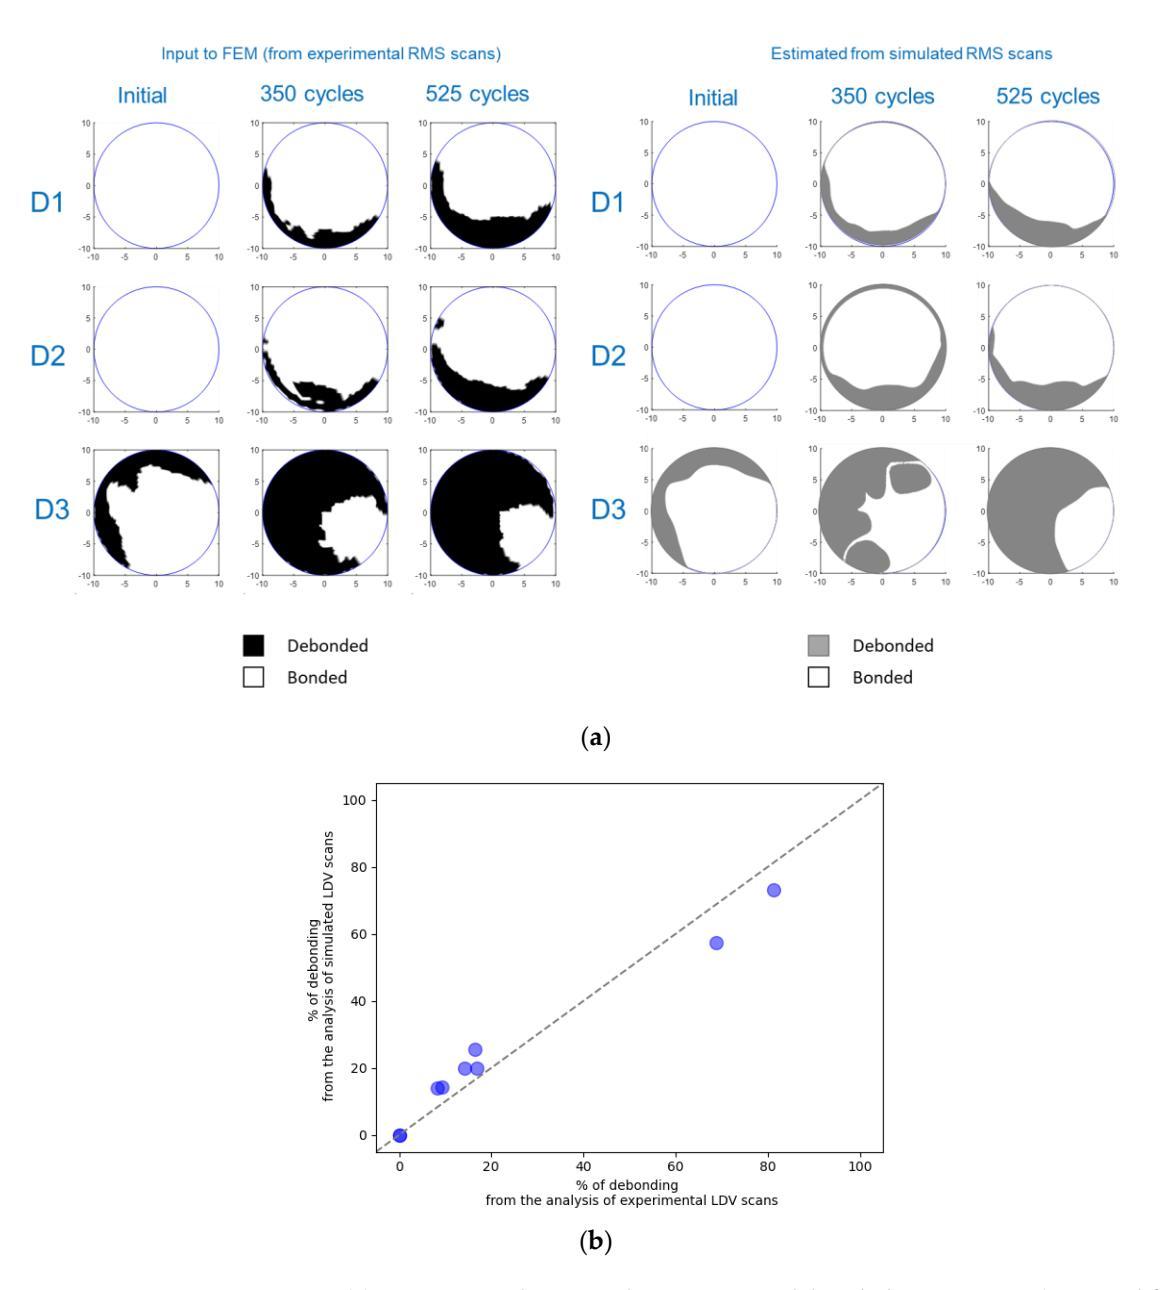
Figure 11. (a) Comparison between the input FEM-debonded PWAS areas (retrieved from experimental RMS scans) and their posterior estimates using similar filtering on simulated RMS scans. (b) One-to-one comparison of the percentage of debonded area estimates.

An additional analysis was performed to validate the filtering process employed for configuring the adhesive layer in the FEM. Figure 11a,b show the identical filtering process used on the experimental RMS amplitude scans applied to the FEM results (shown in Figure 10b) and compare the one-to-one correspondence between the input debonded area and the output debonded area resulting from the FEM computation. The results indicate that the filtering approach reproduces the debonded area quite well, offering valuable insights into the extent of debonding. Likewise, the shape of the retrieved debonded areas closely matches the input shapes, indicating a fairly good agreement between both of them. Notably, the outcome of this analysis is contingent upon the chosen excitation frequency, which, herein, was arbitrarily set at 25 kHz. Consequently, opting for a different excitation frequency may yield slightly different results, potentially inducing resonance in the PWAS and amplifying the displayed amplitude on its surface. A more comprehensive understanding of the impact of PWAS bonding deterioration can be gained by checking the behavior across a spectrum of frequencies, as was substantiated through the analysis of the admittance spectra. The same allows a more nuanced examination of the effects of deteriorated PWAS bonding on the generated Lamb waves, with a focused exploration of antisymmetric and symmetric modes generated within the plate.

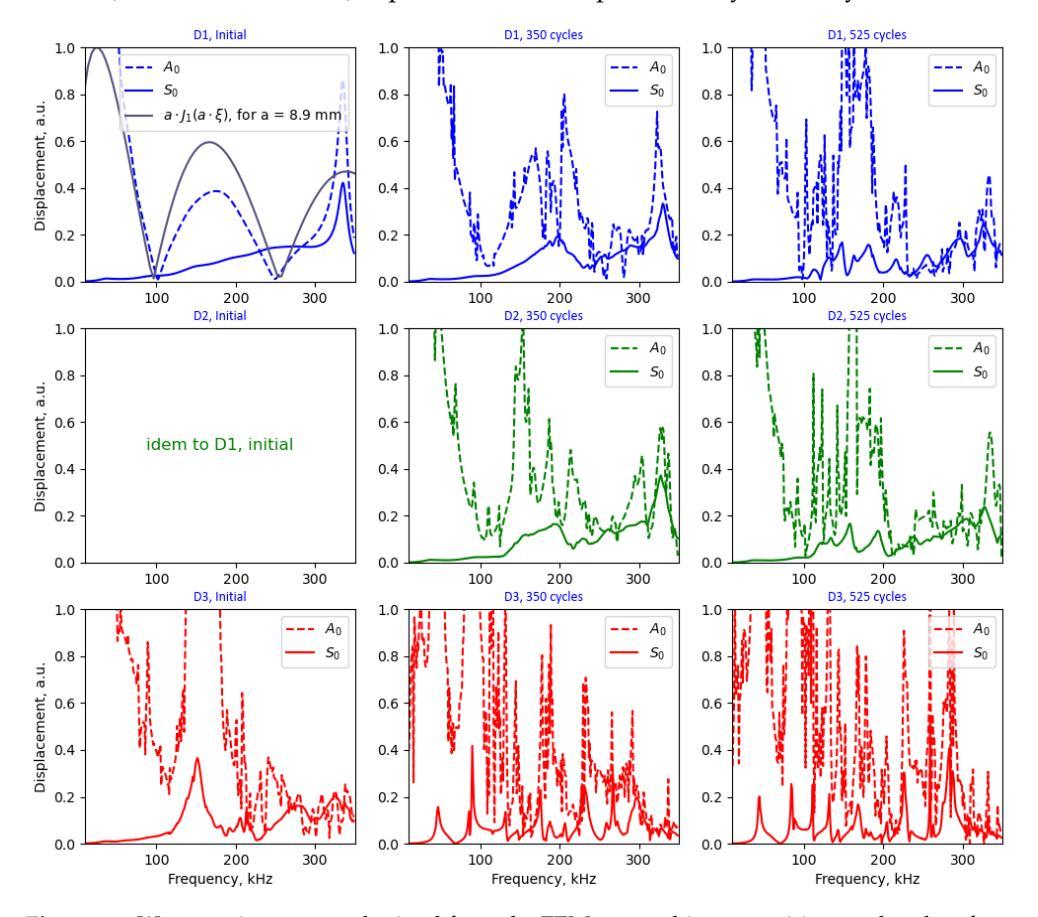
Figure 12. Wave-tuning curves obtained from the FEM at an arbitrary position on the plate for perfect and aged PWAS bonds (retrieved from the post-processed LDV scans shown in Figure 6).

Figure 12 illustrates the wave-tuning curves retrieved at one arbitrary position within the plate for the zeroth-order antisymmetric (A₀) and symmetric (S₀) modes. It is important to note that, except for the perfect bond case, the wave-tuning curves are positiondependent on the plate. The FEM results for a perfectly bonded system align with their expected behavior, almost coinciding with the analytical formulae obtained from the mechanistic modeling of a perfectly bonded circular PWAS provided elsewhere [46,58]. According to the formulae provided therein, the amplitude of the A₀ mode scales to $|a \cdot J_1(\xi a)|$, where ξ is the wavenumber, and *a* denotes the PWAS radius. For reference, the analytical result is shown in Figure 12 (only for the perfectly bonded case—PWAS D1). The primary discrepancies between the FEM and the analytical model can be attributed to deviations from the pin force model that forms the basis of the analytical model. As discussed in previous studies [40,58], the validity of the pin force model is perfect when the shear lag parameter used in their formulation approaches infinity. The latter condition is deemed reasonable for very thin and stiff bonding layers. Alternatively, when the shear lag parameter value is small (as is the case in the FEM results presented herein), the force transfer between the PWAS and the plate only takes place over a finite length at the edge of the PWAS, resulting in an effective PWAS dimension smaller than its actual physical one. An effective PWAS radius of 8.9 mm was determined to best fit the wave-tuning curve obtained from the FEM. The results displayed in Figure 12 reveal 'sweet spots' for the S₀ mode near ~100 kHz and ~250 kHz, along with a maximum amplification spot for the A₀ mode at ~180 kHz. Additionally, a significant observation is the coupling of the first resonance of the bonded PWAS (well above 300 kHz), a phenomenon not predicted by the analytical model.

The results shown in Figure 12 demonstrate that the degradation of the bonding results in a considerable distortion of the wave-tuning curves, aligning with the apparition of PWAS resonances in the admittance spectra (as depicted in Figure 8). The emergence of PWAS resonances generates a complex interplay with the emitted wave and resulting Lamb wave modes in the plate. This phenomenon was already ventured in previous studies [37] and substantiated herein by separately analyzing the A₀- and S₀-tuning curves on the plate. Notably, these observations could explain the disparity of pitch–catch results obtained in the literature in what concerns variations in the amplitude and phase of the received waveforms with debonding extent [35–38]. It is important to note that the tuning curves shown in Figure 12 were obtained for a specific position on the plate, and they differed for other positions. This suggests that the emitted waves undergo a significant level of variation with debonding and that the results are dependent on the relative position of the debonding along the propagation pitch–catch path.
