# **Cold Ironing Galvanic Corrosion Issues with Regard** to a Shore-to-Ship Medium Voltage Connection

# Maciej Kozak<sup>1,†</sup> and Jarosław Chmiel<sup>2,\*,†</sup>

**Abstract:** Cold ironing refers to the usage of less polluting power supply sources to deliver electricity to the moored ship. Such a shore-to-ship system is used when the ship is at a port so the auxiliary combustion engines may be turned off. This paper presents the numerical simulation results of a medium voltage cold-ironing system with regard to the currents flowing between the ship's hull and grounding busbar. The IT electrical inland system with a neutral grounding resistor, as commonly used in shore-to-ship systems, is investigated. Parasitic capacitances present between the phase-to-hull and phase-to-ground in real-world applications can vary from each other. The direct and alternating currents flowing across the hull, seawater and the pier structure are amongst the causes that can lead to premature reinforced concrete degradation. Chosen cases of phase-to-ground or hull unequal capacitances influencing AC stray currents were considered.

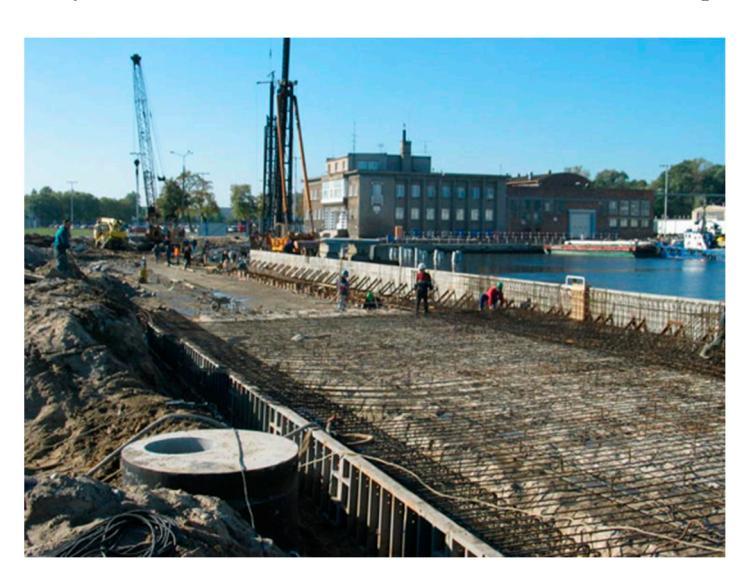
Figure 1. Pier made from steel-reinforced concrete under construction.

A typical pier facility made of reinforced concrete (under construction) is presented in Figure 1.

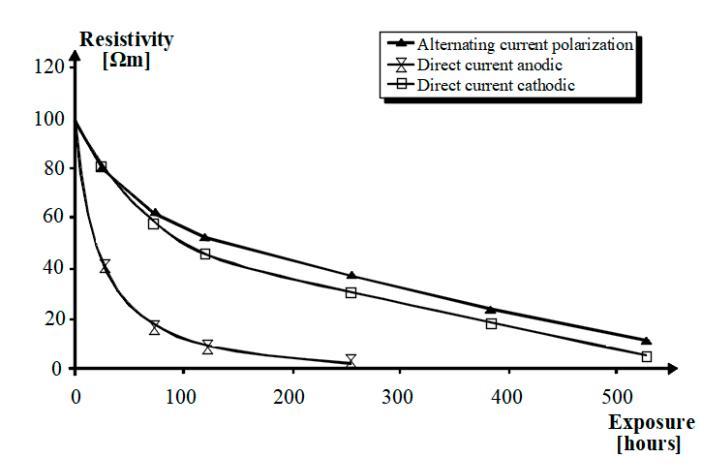
**Figure 2.** The change in bulk electrical resistivity of reinforced concrete samples in the case of different polarization treatments. In all cases current values equal to 3 mA/cm<sup>2</sup>.

It can be noted (Figure 2) that with prolonging current flow across reinforced concrete its electrical conductivity increases. With a given voltage, the current flow will raise over time and the internal structure of the concrete will get further corrosion damages. As can be seen in Figure 2, unwanted conductivity increases take place during the flow of a direct current, which is not used to power moored vessels. Analyzing the influence of alternating current on the concrete properties, it can be seen that the electrical resistance drops to about 60% after just 100 h of a 2 mA current flow.

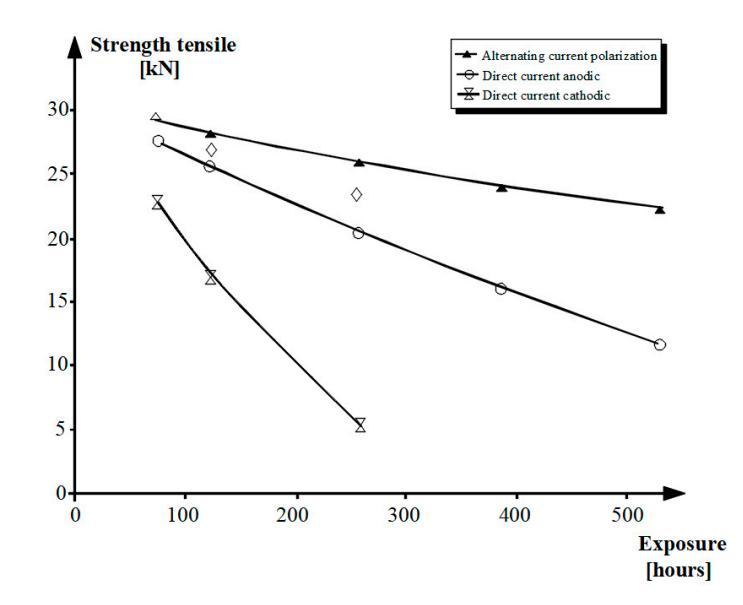
**Figure 3.** The change in tensile strength of reinforced concrete samples subjected to different polarization treatments. In all cases current values equal to 3 mA/cm<sup>2</sup>.

The concrete structure degradation affects not only the electrical parameters (which are by products of the current flow) but most importantly causes a mechanical weakening of the structure, especially decreasing the tensile strength about 10% after 150 h of exposure to AC current flow (see Figure 3). Due to the fact that maneuvering ships use high-power thrusters during port maneuvers, the water pressure on concrete quays is significant and, in case of a weak pier structure, it can cause them to collapse or slide down.

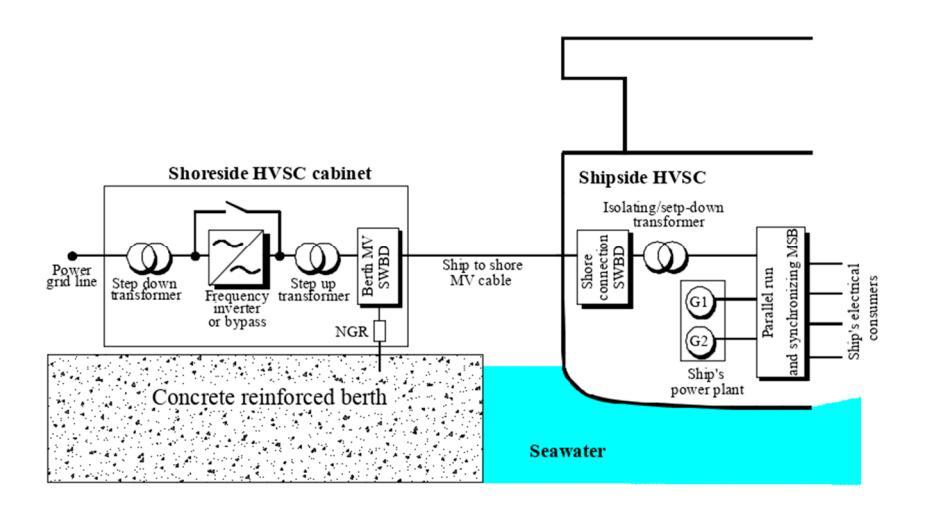
Figure 4. Scheme of a typical cold ironing system with a frequency converter.

As the main source of supply, medium voltages of 6.6 kV and 11 kV and frequencies of 50 or 60 Hz can be delivered to the ship's electrical system. For the sake of inland and vessel power grid frequency combability, there must be converter installed that usually is insulated from the ground and connected to the ship thorough a step-up transformer (Figure 4). Such a connection prevents shoreside supply from injecting unwanted DC currents along with some of harmonics. It must be pointed out that the medium voltage, high power electrical connections in a shore-to-ship system may generate risks, especially for electric shocks or arc fault explosions while connecting the medium voltage plug into the socket. These concerns regard not only the safety of the operators, as the ground fault interferences may cause transferred touch potentials. In addition, such connection can increase the rate of a galvanic corrosion both of the hull of the vessel and steel rebars in the concrete pier. The corrosion of steel-reinforced bars is the major cause of premature failure of reinforced concrete structures, especially in chloride environments.

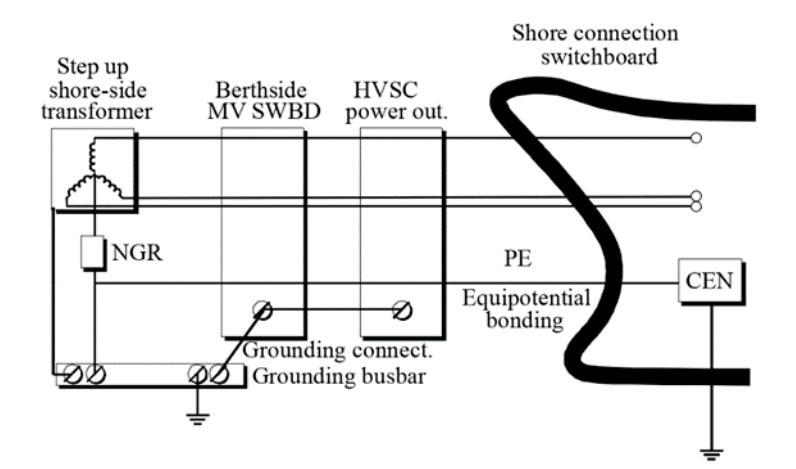
**Figure 5.** Neutral point connection to ground via a neutral grounding resistor (NGR) [16], where CEN is the common equipotential node and SWBD is short for switchboard. Reprint with permission [4927171511527] from Conference Proceedings: 2016 IEEE Industry Applications Society Annual Meeting; published by IEEE, Oct. 2016.

As it can be seen in Figure 5, one of the most important connections is the equipotential bonding that ties the equipotential node mounted in the hull through the NGR with the neutral point just like in Figure 5. The neutral grounding resistor limits the fault current to a value that is safe for components of electrical grids and prevents any possible mechanical damages caused by strong magnetic fields occurring during high short-circuit currents flow.

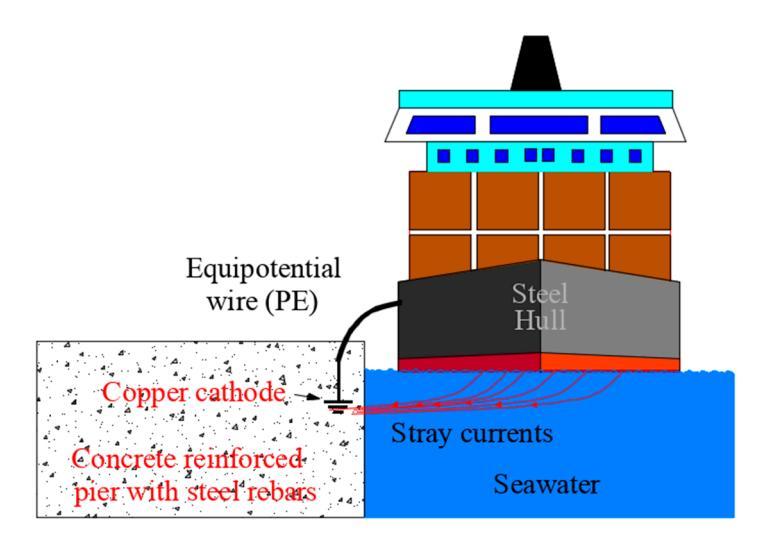
Figure 6. Galvanic cell created by elements of the ship's hull, the pier and the seawater.

Every seagoing ship is equipped with some kind of hull protection system whose main task is to neutralize electrochemical reaction when the ship is moving. Interestingly the same electrochemical processes occur between the steel hull and quay [18] in the presence of electrolytes, which in this case is seawater (Figure 6).

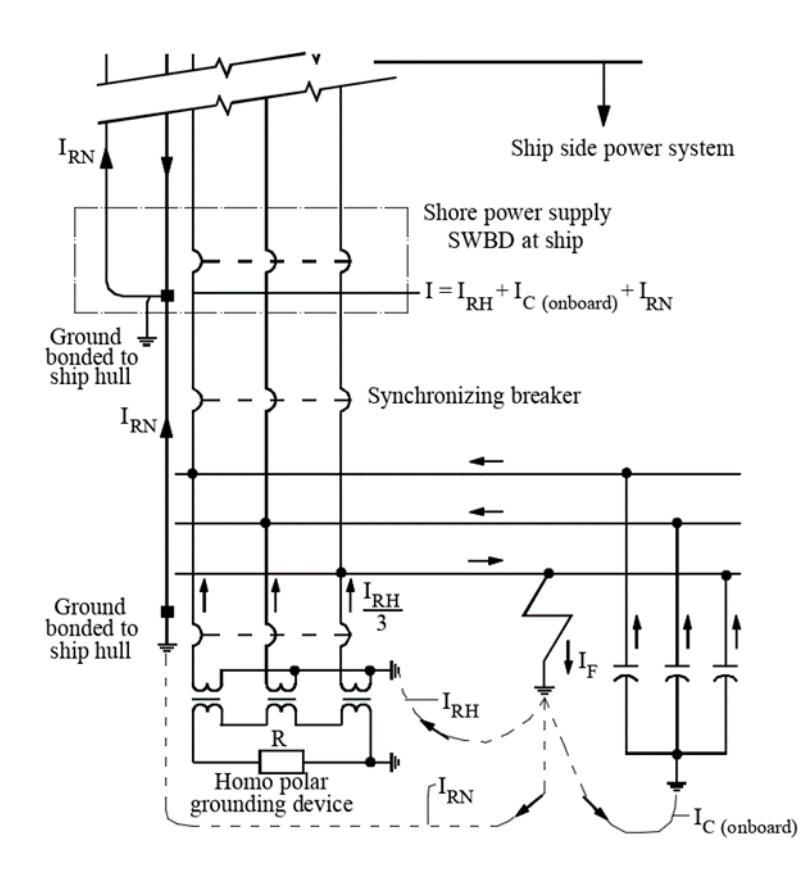
**Figure 7.** Current path between a ship's electrical installation capacitances and the hull and pier [14]. Reprint with permission [4926950096338] from 2009 IEEE Proceedings; published by IEEE; October 2009.

These protective systems are of passive and active types and they are commonly known as cathodic protection systems. For smaller vessels there are the so-called sacrificial anodes used, made out of zinc, aluminum, magnesium or their alloys. These anodes decay with time, but this process protects the construction elements like iron and steel, which forms the cathode. What is worth noting is that these protective anodes are efficient only for direct currents "compensation" during electrochemical corrosion. Because of this property, such a system cannot be used for shore-to-ship AC voltage supply purposes. More interesting seems to be the refine solutions using Impressed Current Cathodic Protection (ICCP) systems. As shown in [18], these systems are sufficient to neutralize DC currents flowing across the PE bonding wire even when the ship is moored. Unfortunately, the currently used ICCPs are not designed to minimalize the AC currents that are also present while cold-ironing. As it turns out, quite some amount of alternating currents is transferred between the hull and pier in the presence of obligatory equipotential bonding, which significantly reduces the shock hazard (touch potential). Cold ironing utilizes long medium voltage cables that can be over 200 meters in length. Such cables have capacitances to the ground that are reactances for alternating currents; thus, its path can be shorted to the ground through a steel hull. Some part of the inland installation (with its capacitances) is present onboard of the vessel so the isolating transformer is not the first device closest to the onboard shore connection box. These capacitances create a path for equalizing and stray currents and a hull becomes an electrical conductor (Figure 7).

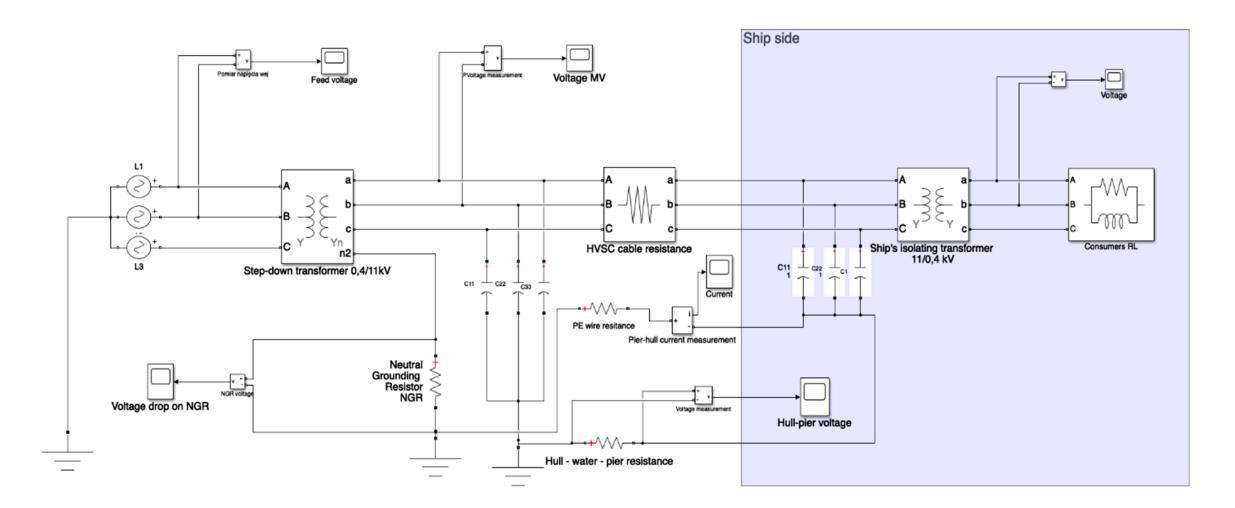
**Figure 8.** Simulink Model #1 of a ship's ungrounded LV system and stray currents flowing from the hull to the pier through seawater.

MATLAB–Simulink environment. The numerical model of isolated low voltage ship system is depicted in the Figure 8, while the chosen experimental results are presented in Figures 9–11. The layout of direct ship-pier HV connection is shown in the Figure 12 and in the Figure 13 are depicted waveforms of stray currents present in such type of ship supply.

The electrical structure presented in Figure 8 is a 11 kV HVSC system with NGR on the shore side. There is an assumption made of sinusoidal voltages incoming (no frequency converters). Such a situation occurs when the inland and ship power grid frequencies are aligned (60 Hz in this particular case). Because of notable medium voltage cables lengths, the resistance of the HVSC cable was taken into account and arbitrarily set to a value of 24 milliohms per phase. The cable-to-hull capacitances (of 0.01  $\mu$ F per phase) on the ship side was added just to depict its presence in all the wiring.

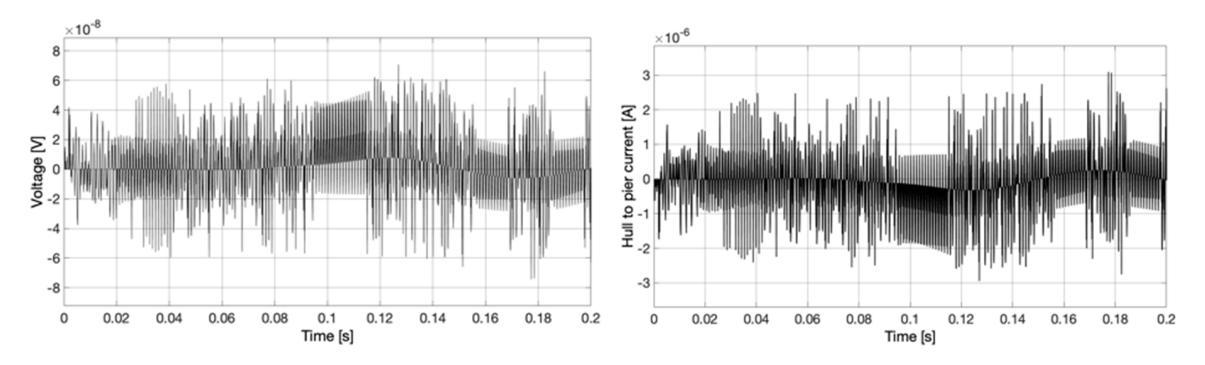
**Figure 9.** Simulink Model #1 numerical experiments results for symmetrical capacitances (0.030  $\mu$ F per phase shore line), symmetrical supply voltages and stray current path resistance equaling 0.024 ohms. Hull—pier voltage (**left**), stray current waveform (**right**).

As can be seen, the symmetrical voltage supply and the same per phase capacitances are causing a very low pier hull voltage drop that, in turn, causes flow of negligible stray alternating currents. It can be concluded that, in the case of ideal, symmetrical line parameters, there is no danger of significant corrosion current flow across the hull and concrete structures. Next, the experimental results are

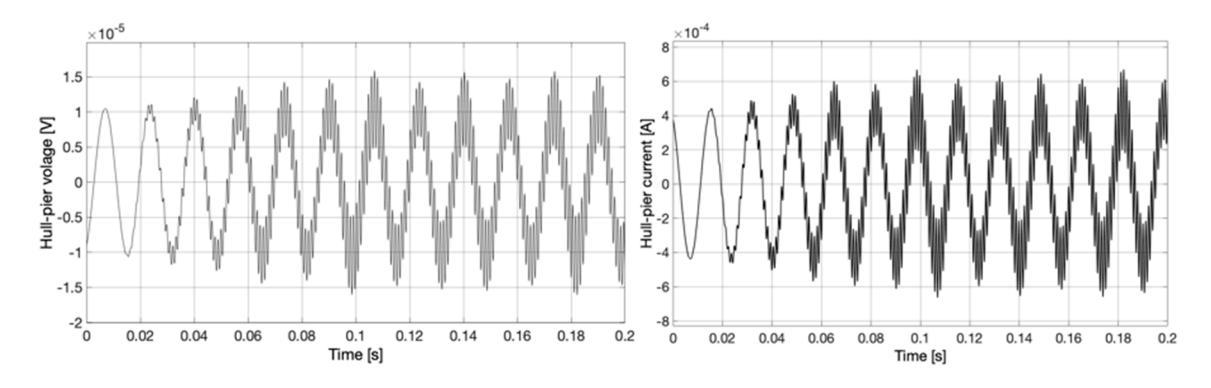
**Figure 10.** Simulink Model #1 numerical experiments results for asymmetrical shore cables of 100 m in length and hull capacitances (0.030, 0.028, 0.033  $\mu$ F), symmetrical supply voltages and stray current path resistance equaling 0.024 ohms. Hull—pier voltage (**left**), stray current waveform (**right**).

indicating that any disturbance in symmetry of the electrical parameters leads to an increase in the stray currents. The presented model includes 100 m wiring to the ship and in this scenario the stray currents are getting close to 0.6 mA.

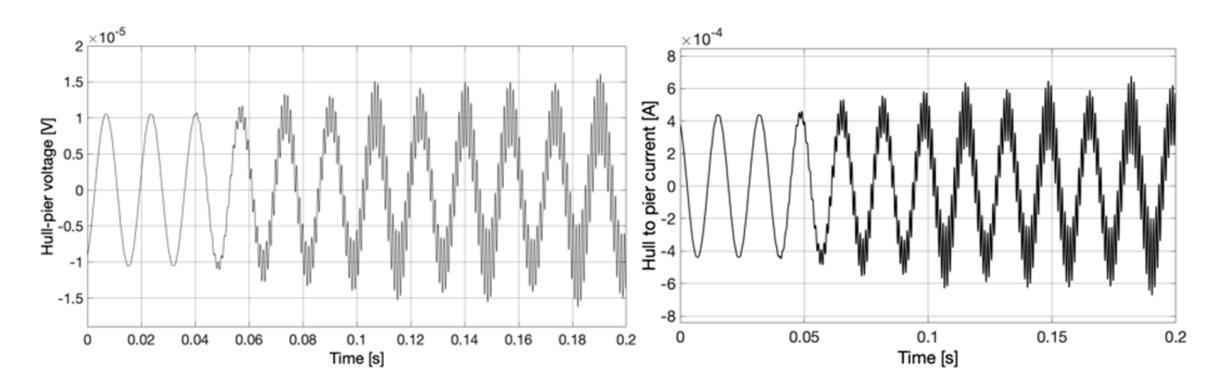
**Figure 11.** Simulink model #1 numerical experiments results for asymmetrical shore cables capacitances (0.030, 0.028, 0.033  $\mu$ F), asymmetrical vessel cables capacitances (0.0030, 0.0028, 0.0033  $\mu$ F), asymmetrical supply voltages (±3 V) and stray current path resistance equaling 0.024 ohms. Hull—pier AC voltage (**left**), stray alternating current waveform (**right**).

In the worst-case scenario (Figure 11), the shore-side cable capacitances are varying with the ship's MV cables and there is asymmetry in the incoming voltages. Such a cold-ironing operation is almost impossible for a long-time, steady state, but it would happen while transient, like connecting or disconnecting other vessels to the HVSC.

Interestingly, introducing some asymmetry in the supply voltages have less impact on the hull–pier voltages and currents than the capacitance difference. This is because of the use of a symmetrizing transformer windings connection. This very situation is presented in the simulation results in Figure 11.

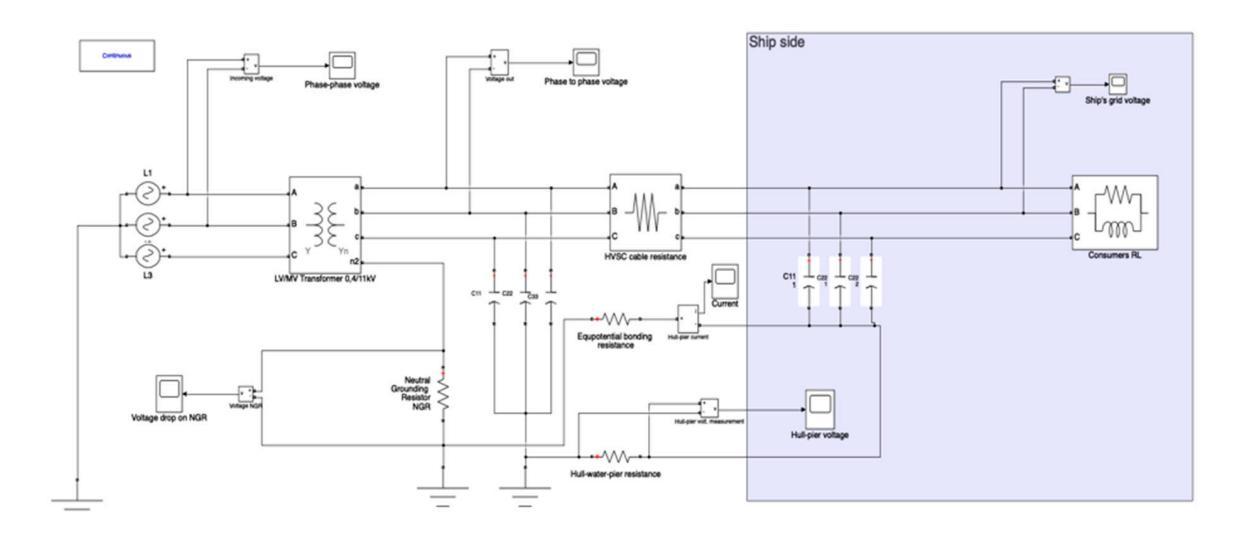
**Figure 12.** Simulink Model #2 of the ship HV system and stray currents flowing across seawater from the hull to pier.

Such a simple connection may be found in the case when the voltage amplitude and frequency in the ships electrical system is the same as that incoming from the inland power grid. As it was aforementioned, the value of NGR is small, thus causing a low insulation alarm to be set off. Nonetheless, this kind of ship MV grid is preferred onboard of different types of tankers and chemical carriers.

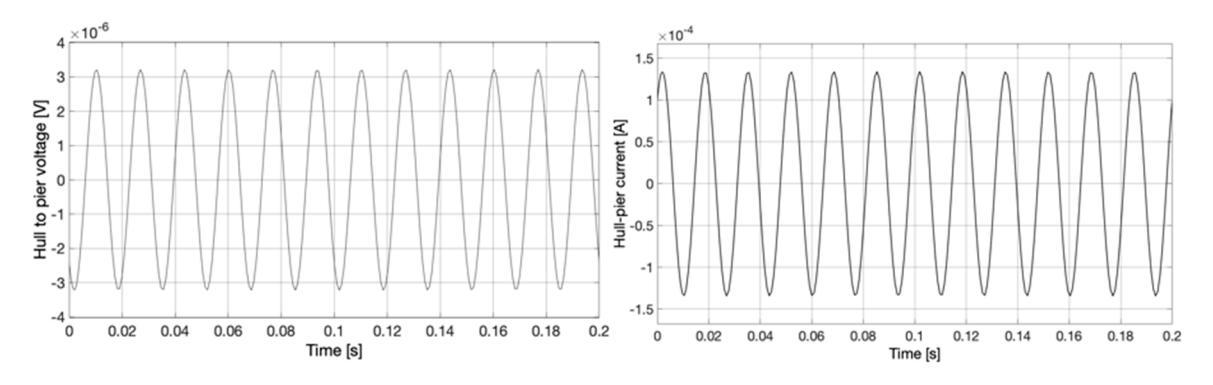
**Figure 13.** Simulink Model #2 numerical experiments results for asymmetrical shore cables capacitances (0.030, 0.028, 0.033  $\mu$ F), asymmetrical vessel cables capacitances (0.0030, 0.0028, 0.0033  $\mu$ F), asymmetrical supply voltages (±3 V) and stray current path resistance equaling 0.024 ohms. Hull—pier AC voltage (**left**), stray alternating current waveform (**right**).

In such a system, the steady-state current flowing between the hull and pier reaches about 0.13 mA. A particular hazard is the loss of plasticity of the iron alloys as a result of hydrogen diffusion stimulated by short-term stages of cathodic polarization (Figure 14).

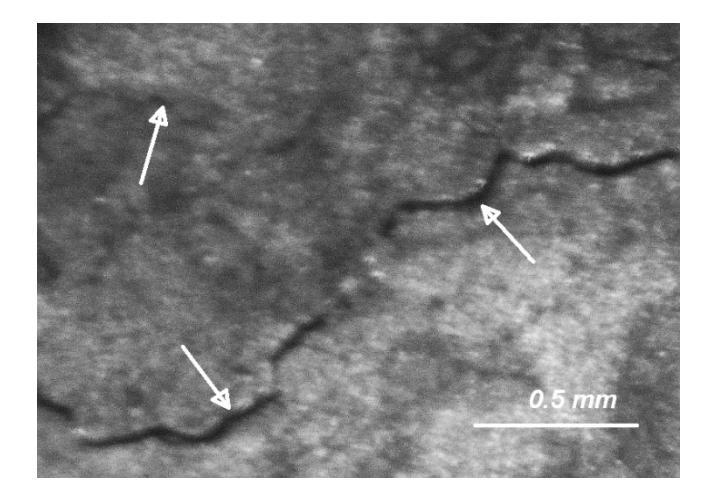
**Figure 14.** Brittle intercrystalline cracking caused by hydrogen diffusion stimulated by short-term cathodic polarization phenomena.
