# Arc Discharge–Induced Ignition of Combustibles Placed on a Damaged AC Power Supply Cord

**Abstract:** One of the major causes of unintentional electrical fires is short circuit of an electrically and/or mechanically damaged alternating power supply cord. Detecting of such an event and interrupting the power supply may be beyond the capability of a conventional electro-mechanical circuit breaker. A lot of research papers have been published related to arc fault of wiring and its detection method. Furthermore, arc fault circuit interrupters have been put into practical use. The objective of the present paper is to understand fault of damaged power supply cord under two selected situations observed in practical use or considered suitable to understand fire ignition. Using two kinds of samples similar to but different from samples prescribed in UL1699 standard, the ignition mechanism of combustibles is discussed based on the results of laboratory experiments. The findings herein underscore the important role of the arc in the ignition of combustibles that are placed on the damaged part of a power supply cord, which is normally followed by a short circuit of broken element conductors

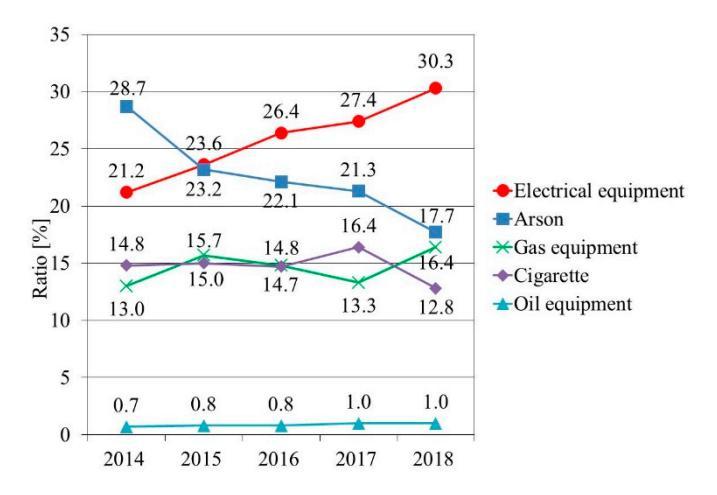
**Figure 1.** Major causes of fire accidents within the jurisdiction of Tokyo Fire Department in Japan from 2014 to 2018 [1].

Statistics show that, out of the 3972 fire incidents that occurred within the jurisdiction of the Tokyo Fire Department in Japan in 2018, 1205 originated from electrical equipment in domestic and industrial environments [1]. Moreover, the total number of annual electric fire incidents has increased gradually in the past five consecutive years (2014–2018), as depicted in Figure 1, eventually reaching 30.3% in 2018 [1]. Table 1 points out that one of the major causes of these fires was the wirings of electrical equipment, which include power supply cords and interior wirings. In fact, it has been reported that 38 out of the 448 fire occurrences that broke out from electrical appliances were due to faulty power supply cords, mainly from damaged or deteriorated electrical insulation, disconnection of element conductors by mechanical force, and/or aging [1].

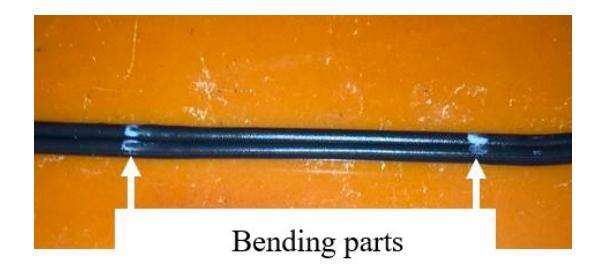
Figure 2. A typical power supply cord after bending test.

Appearance of the cord after bending test is shown in Figure 2. The white marks on the cord in Figure 2 do not indicate damage, but are indication of the location of bending. A microfocus X-ray computed tomography (CT) system (Shimadzu Corporation, SMX-225CT) enabled the nondestructive inspection of a sample. Condition of the element conductors in the sample was observed clearly without removing the PVC. Figure 3 shows an example of X-ray CT image.

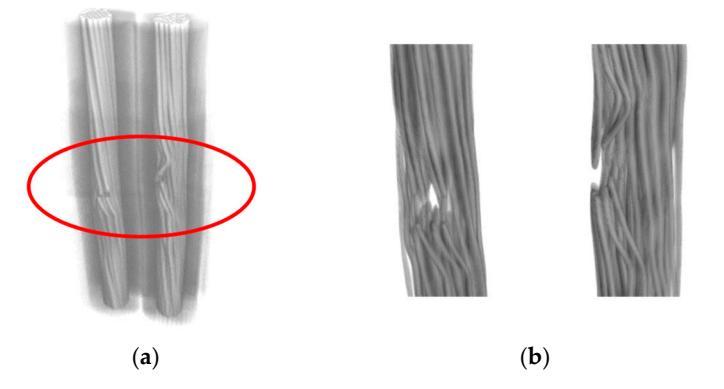
**Figure 3.** Example of X-ray computed tomography image. (**a**) overall image (**b**) magnified image of circled part in (**a**).

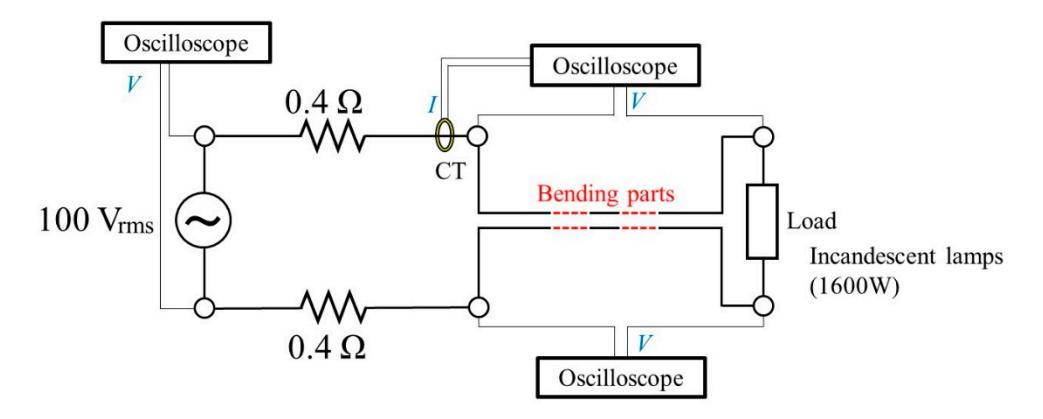
Figure 4. Experimental circuit for samples with the partially broken element conductors.

The experimental circuit is shown in Figure 4. Here, an AC voltage of 100 Vrms and 60 Hz was supplied to the sample from a distribution board in the laboratory. The resistance of the internal wirings was simulated with two 0.4  $\Omega$  resistors. A 45 cm long sample cord was laid straight and flat, with the load being eight incandescent lamps (1600 W in total). Combustibles cut from a cushion were placed on the sample to cover the two partially broken parts. The principal component of the combustibles was dry cotton.

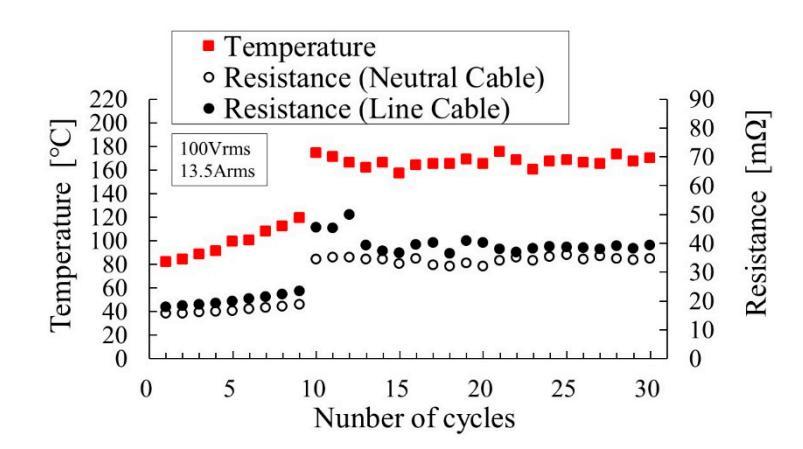
**Figure 5.** Temperature on the polyvinylchloride (PVC) near the partially broken part and the resistances of the cables with the partially broken element conductors.

Figure 5 illustrates the temperature variation on the PVC surface with respect to the number of cycles. Here, temperature means the highest value reached in a cycle. At the beginning, the temperature increased gradually with the number of cycles. Then, a sudden increase was distinctly observed during the 10th cycle, when the temperature rose to approximately 180 °C, before becoming almost constant afterwards. A remarkable variation in the resistance of each cable could also be confirmed at the 10th cycle; it is worth noting that such variation of resistance was slight before and after the 10th cycle. Similar changes in the temperature and resistance of cables, such as the ones depicted in Figure 5, were observed in other samples.

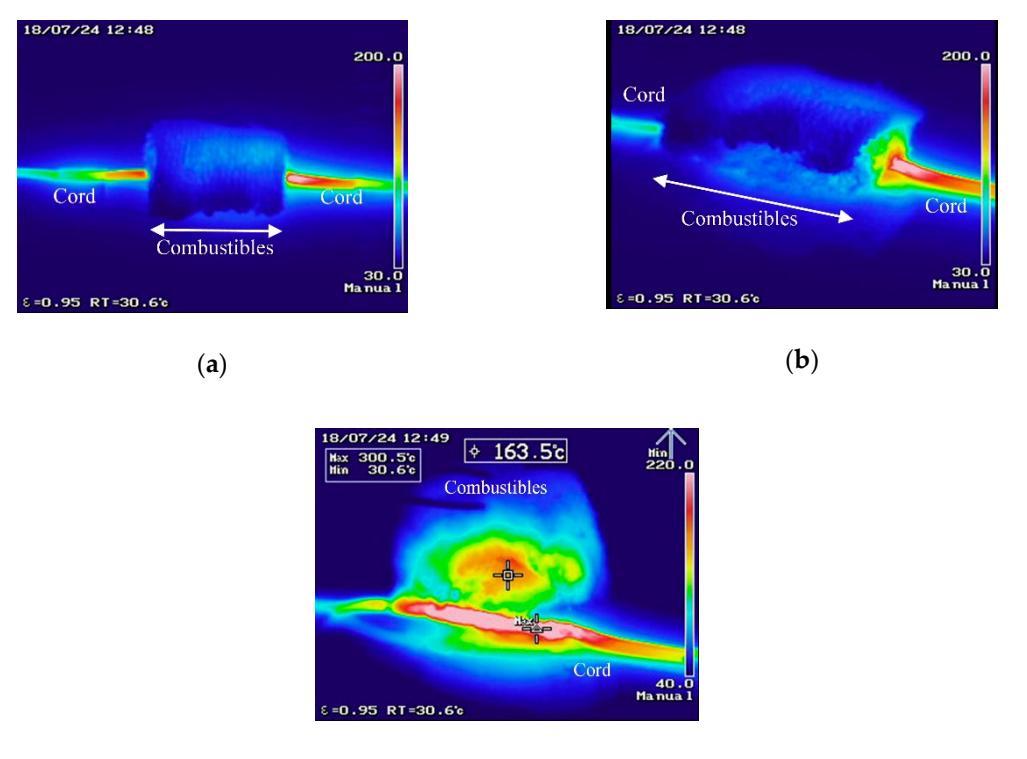
**Figure 6.** Temperature distribution around the partially broken part (Voltage 100 Vrms, Current 13.5 Arms). (a) External appearance (front view); (b) External appearance (oblique view); (c) Surface of combustibles and power supply cord (combustibles are removed and turned over).

Figure 6 shows temperature distribution around the partially broken part measured with an infrared thermometer. Note that the steep rise in temperature of the power supply cord is observed in a limited region, as shown in Figure 6a. The temperature on the outside surface of the combustibles is almost the same as the ambient temperature, as shown in Figure 6b. Moreover, Figure 6c shows the temperature distribution when the combustibles are turned over. It is confirmed that the temperature of the power supply cord and the surface of the combustibles in contact with it reaches approximately 200  $^{\circ}$ C.

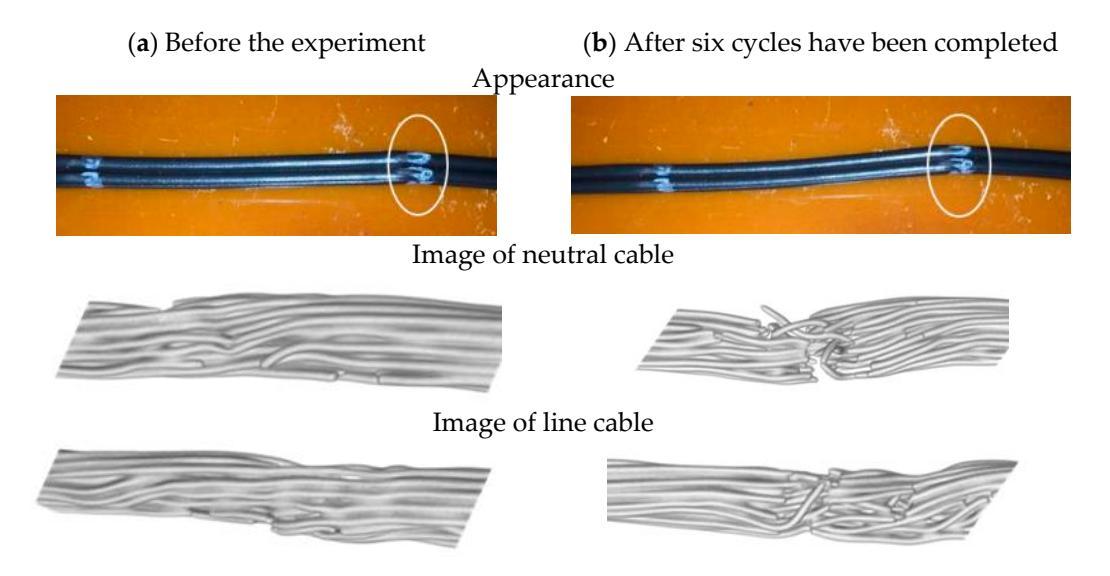
**Figure 7.** Appearance of partially broken power supply cords and images of element conductors in cords obtained with the microfocus X-ray CT system.

Figure 7 shows X-ray computed tomography images, which clearly show the condition of the element conductors at a partially broken part of the sample before the start of the experiment and after the 6th cycle has been completed. The broken element conductors were tightly bundled together and assumed contact with other element conductors prior to the onset of the experiment. On the contrary, the element conductors were seemingly loosely bundled after being subjected to a temperature of

approximately 150 °C for six cycles. A large space was also found between the broken element conductors. Considering that the glass transition temperature of PVC is within 70–80 °C [20], these changes in the condition of the element conductors have probably been formed by thermal expansion and shrinkage of PVC during the cycles. Although different samples were used in Figures 5 and 7, it is suggested that the sudden increase in temperature and resistance, as illustrated in Figure 5, may be explained by such a change in the condition of the element conductors.

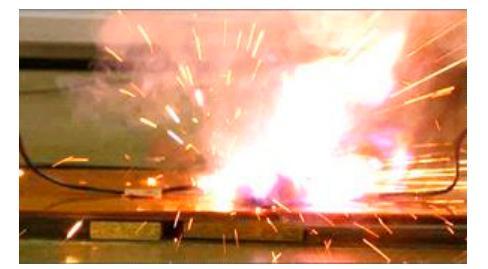
Figure 8. Ignition of combustibles.

For the sample shown in Figure 5, the arc occurred just after the commencement of current flow in the 31st cycle; thus, ignition of the combustibles in Figure 8 was observed. At the partially broken part of the sample, the current concentrates on the remaining intact element conductors and causes the generation of a large amount of Joule heat. Accordingly, the PVC is softened and expanded. Because the PVC contracts in the cooling process when the current flow pauses, a broken element conductor in one cable of the cord may pierce and break through the PVC between cables by shrinkage stress. When the element conductor comes into contact with that in the other cable, a short circuit occurs by bridging conductors of cables. Thereby, an arc may be generated when current is supplied again in the next cycle. This hypothesis is probably supported by a small hole found sometimes in thermally deformed PVC.

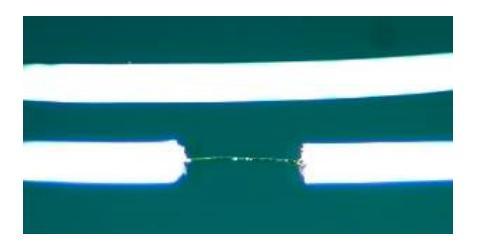
Figure 9. Appearance of a sample with one intact element conductor.

Two cables of the sample cord were separated from each other. After partially removing the PVC of one of the cables, 49 element conductors were broken artificially and also removed. Thus, only one element conductor remained intact, as shown in Figure 9. No treatment was given in the other cable. The sample was 10 cm long, and its partially broken part was 1 cm long.

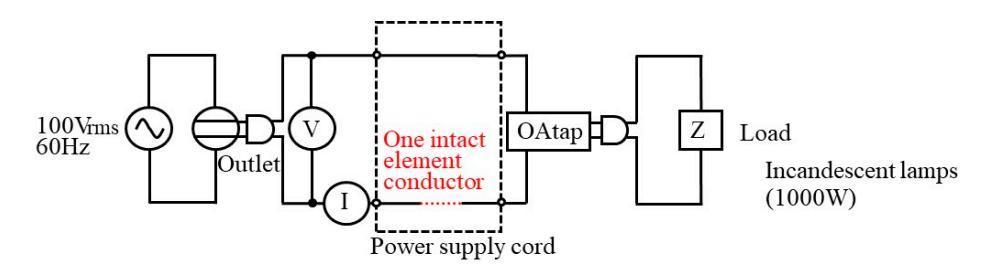
Figure 10. Experimental circuit for sample with one intact element conductor.

The experimental circuit is shown in Figure 10. The sample was connected to a load of 10 incandescent lamps (1000 W in total), with 100 Vrms (60 Hz) and 9.7 Arms being supplied continuously to the sample from a wall outlet in the laboratory. As the ignition of the combustibles was investigated by arc discharge, they were placed on the sample to cover the intact element conductor, as shown in

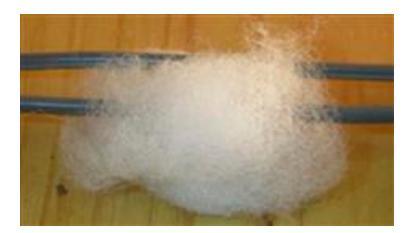
Figure 11. Combustibles placed on the sample cord.

Figure 11. The principal component of the combustibles was dry cotton cut from a cushion: the same material used in the experiments in Chapter II.

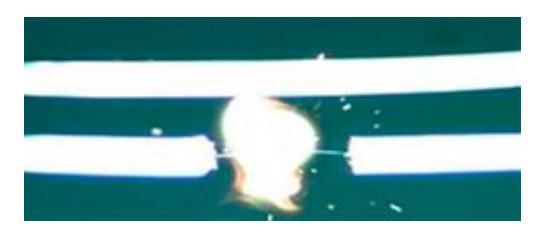
Figure 12. Arc observed at the time of breakage of an element conductor.

Figure 12 shows a photograph at the time of arc generation in the case of no combustibles. Continuous current flowing in the intact element conductor resulted in a rise in its temperature by Joule heating. Finally, the element conductor melted and arc occurred. The arc ceased within a few milliseconds with the breakage of the element conductor. Dispersion of high-temperature pieces of the melted element conductor is confirmed in Figure 12.

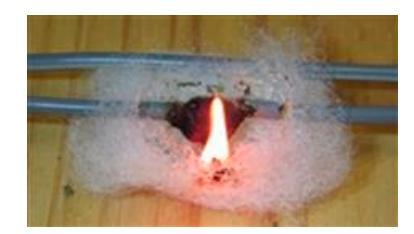
Figure 13. Ignition of combustibles.

When there were combustibles, their ignition, as illustrated in Figure 13, could be observed occasionally. However, note that the probability of ignition of the combustibles was much lower than that described in the experiment in Chapter II, which could be attributed to the weak and short-duration arc in the present experiment. Nevertheless, the ignition probability might increase with the increase in the number of intact element conductors. The thermal circuit breaker (20 Arms) installed in the distribution panel did not trip.

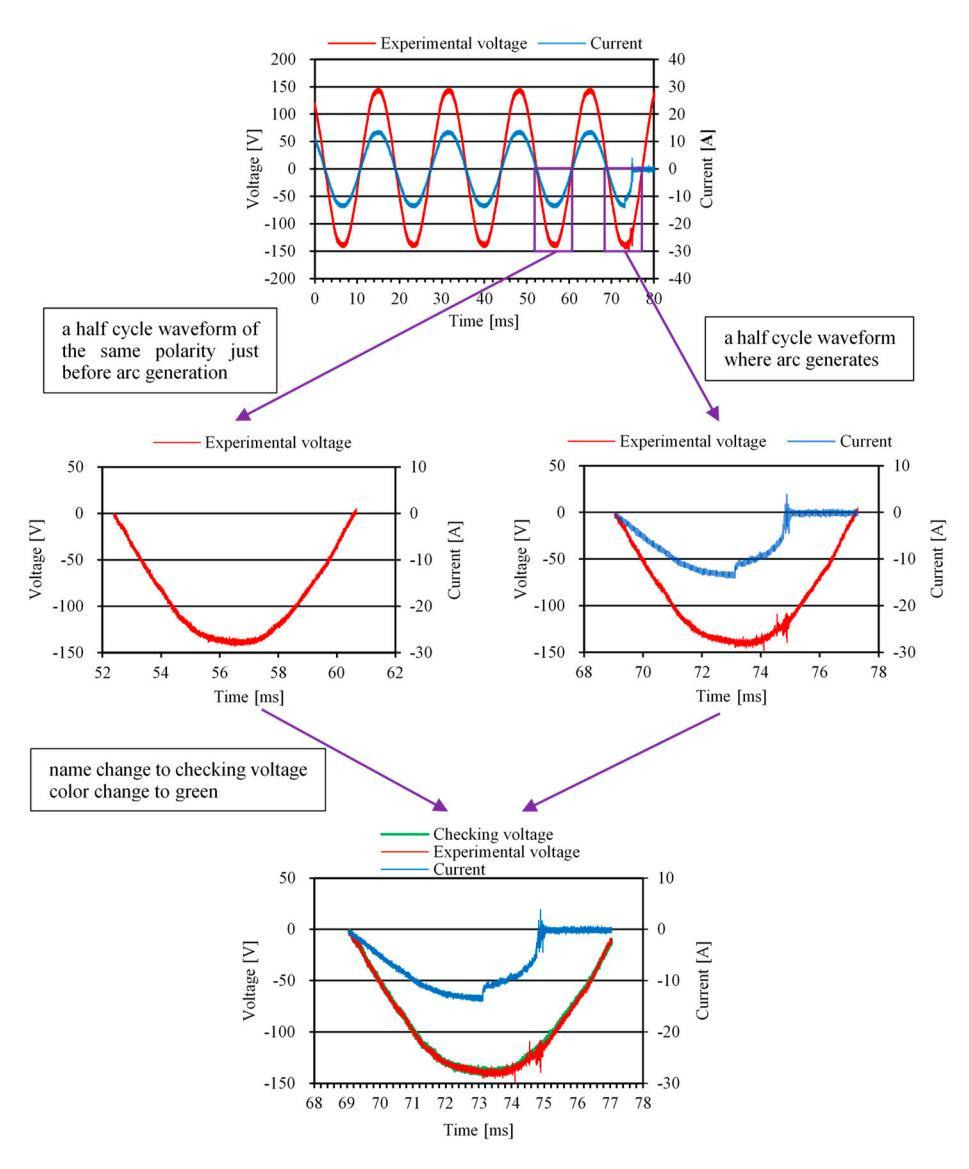
Figure 14. Procedures to obtain checking voltage.

The checking voltage is the voltage in the absence of arc. It is obtained by the following procedures; (1) the arc is detected by the proposed criteria described below, (2) a half-cycle voltage waveform at arc generation is extracted, (3) a half-cycle voltage waveform of the same polarity with that obtained in (2) just before arc generation is called form recorded data, which is named checking voltage; (4) the two voltage waveforms are superimposed so that the zero cross points coincide with each other. The procedures are illustrated in Figure 14. In the practical case, the checking voltage can be obtained by continuous recording of voltage at an outlet or at a distribution panel.

In the case of nonlinear loads, it is considered that the checking voltage is obtained by the same procedures as the case of a resistive load shown in Figure 14. It was confirmed that the checking voltage was obtained for a vacuum cleaner. Further examination will be necessary using other nonlinear loads.

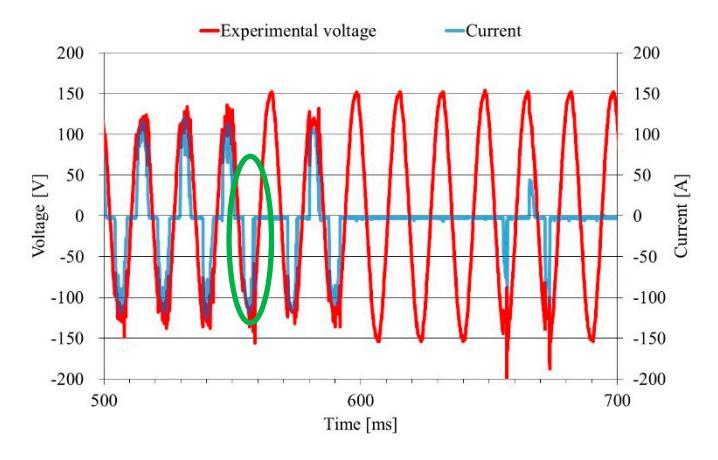
Figure 15. Sample voltage and current waveforms at a short circuit.

The criteria will be applied to detection of two kinds of arc described in Chapters II and III. To begin with, the case of arc at a short circuit caused by contact of broken element conductors is considered. Figure 15 shows waveforms recorded under a condition similar to that obtained Figure 8. The experimental voltage waveform showed a line voltage between line and neutral, which was distorted from the sinusoidal during arc. At arc extinction, the current ceased and voltage got restored to the sinusoidal. The waveform during the arc (surrounded by a green ellipsoid in Figure 15) is shown in a magnified view in Figure 16. Note that the amplitude of the current exceeded 100 A for one period and that the distortion of the voltage waveform is clearly confirmed. Figure 17 is a magnified view of the waveforms that were surrounded by a yellow ellipsoid in Figure 16, which is used to calculate deviation time. Here, the experimental voltage is drawn in red, while the checking voltage and the range of checking voltage  $\pm 6$  V are shown in green and light green, respectively. Moreover, the arrows in Figure 17 indicate the durations when the experimental voltage has exceeded the checking voltage  $\pm 6$  V. The deviation time defined by the sum of the durations is 4300 µs, which is longer than 70 µs. This case satisfied both of the criteria above, which implies that detection of the arc is possible.

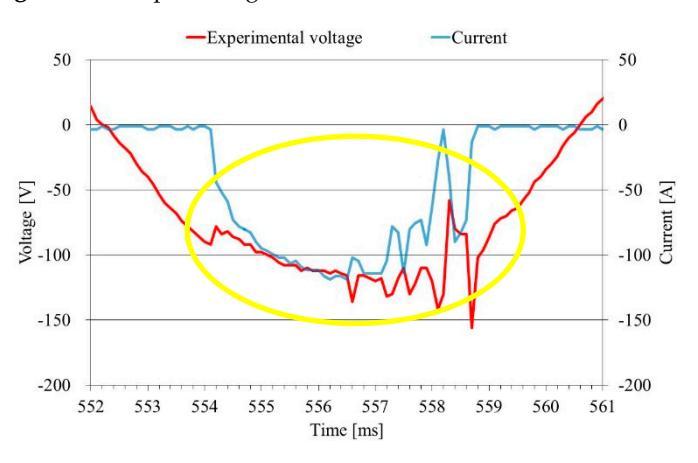
Figure 16. Magnified view of the part surrounded by a green ellipsoid in Figure 15.

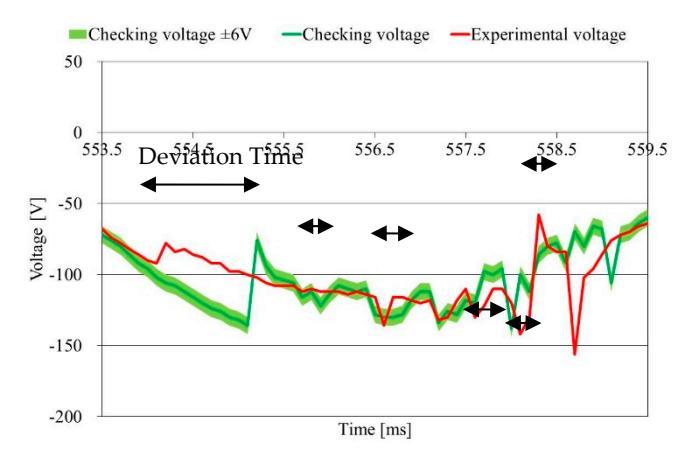
Figure 17. Magnified view of the part surrounded by a yellow ellipsoid in Figure 16.

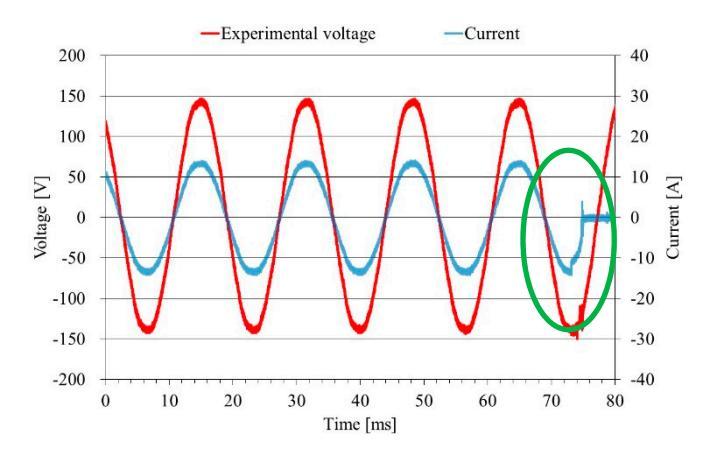
Figure 18. Sample voltage and current waveforms at disconnection of the intact element conductor.

The next discussion will underscore the case of arc at the breakage of the intact element conductor. Figure 18 shows the waveforms recorded under a condition similar to that in Figure 13. Based on the figure, the arc would result in a distortion in both waveforms with a smaller degree than in the first case, because only one element conductor is broken in the present case. The current ceased and the voltage waveform got restored to the sinusoidal at arc extinction, within a cycle after the onset of voltage distortion. Figure 19 shows a magnified view of the waveforms during arc (surrounded by a green ellipsoid in Figure 18), in which a distortion of the voltage waveform is clearly confirmed. The deviation time could be obtained from Figure 20, which is a magnified view of the waveforms surrounded by a yellow ellipsoid in Figure 19. The experimental voltage is drawn in red, while the

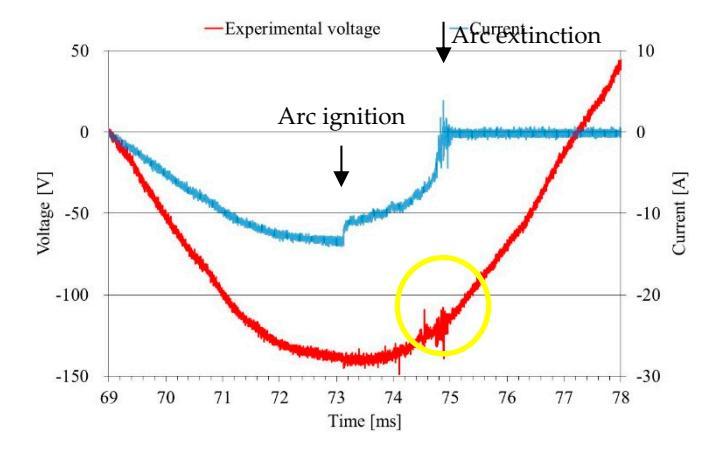
Figure 19. Magnified view of the part surrounded by a green ellipsoid in Figure 18.

checking voltage and the range of checking voltage  $\pm 6$  V are in green and light green, respectively. The arrows in Figure 20 indicate the durations when the experimental voltage exceeded the checking voltage  $\pm 6$  V. The deviation time is 276 µs, which is longer than 70 µs. This case satisfies both of the criteria above, which implies that detecting the arc is possible.

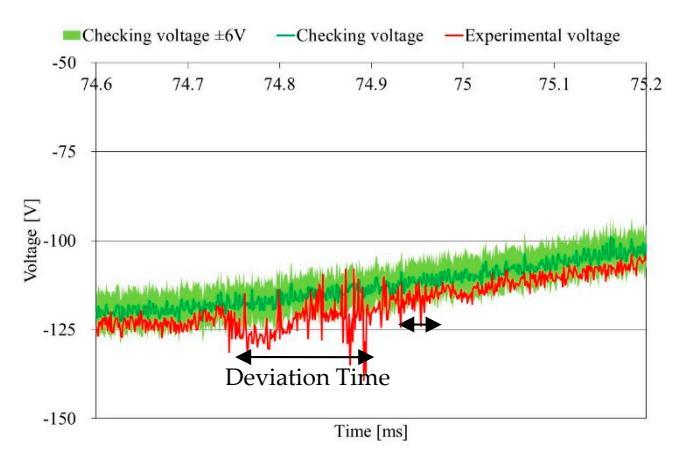
Figure 20. Magnified view of the part surrounded by a yellow ellipsoid in Figure 19.
