# Drone-Assisted Image Processing Scheme using Frame-Based Location Identification for Crack and Energy Loss Detection in Building Envelopes

Abstract: This paper presents improved methods to detect cracks and thermal leakage in building envelopes using unmanned aerial vehicles (UAV) (i.e., drones) with video camcorders and/or infrared cameras. Three widely used contour detectors of Sobel, Laplacian, and Canny algorithms were compared to find a better solution with low computational overhead. Furthermore, a scheme using frame-based location identification was developed to effectively utilize the existing approach by finding the current location of the drone-assisted image frame. The results showed a simplified drone-assisted scheme along with automation, higher accuracy, and better speed while using lower battery energy. Furthermore, this paper found that the cost-effective drone with the attached equipment generated accurate results without using an expensive drone. The new scheme of this paper will contribute to automated anomaly detection, energy auditing, and commissioning for sustainably built environments.

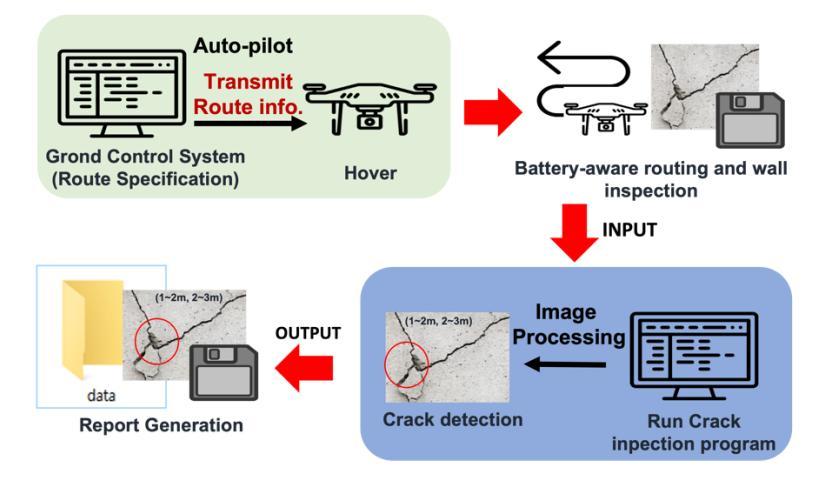
This section includes a brief description of the drone used for this study and an overall procedure of the drone-assisted image scheme. The framework proposed in the paper is illustrated in the Figure 1. The components are ground control system, drone with camera, wall inspection program, and report generator. Ground control system manages the routes of a drone. Once the route information is fed into the drone, it flies against the wall and takes video. The video feed is used as input to the inspection program. The program generates the report, including the image of crack and the location of the crack.

Figure 1. Wall crack inspection framework.

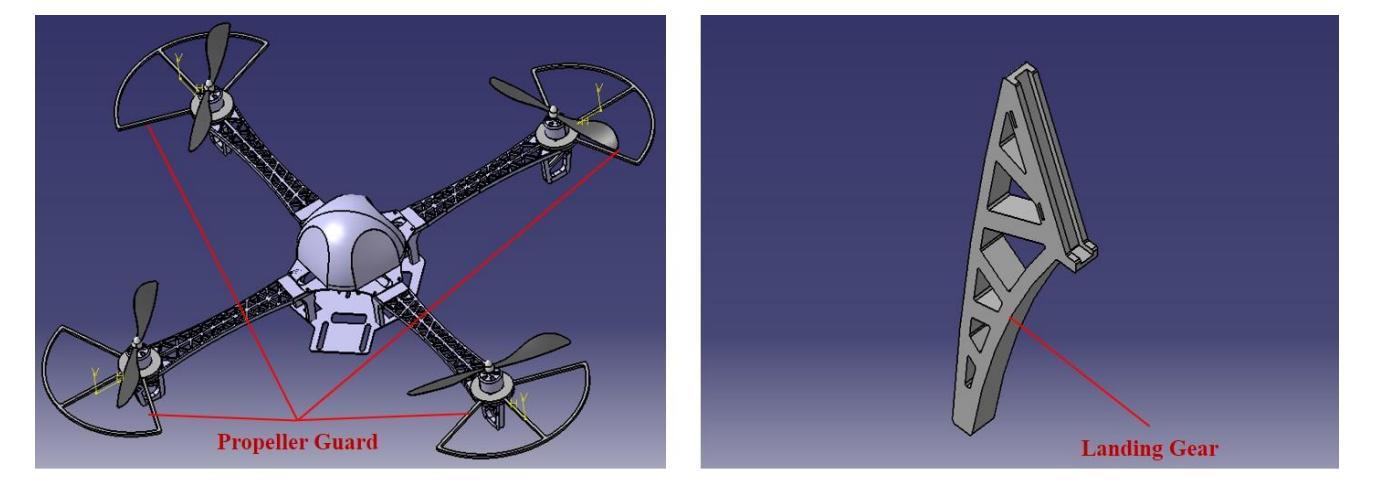
In this paper, we chose DJI F450 quadcopter drone as the base frame with four 920 KV motors because of its small form factor and reliability. The CATIA software (CATIA V5, Dassault Systèmes, Vélizy-Villacoublay, France) [22] was used to create the 3D models of the drone as well as propeller guards and landing gears (Figure 2). The propeller guards and landing gears were created using a 3D printer to protect the four propellers of the drone arms and to protect the battery and camcorder located at the center of the drone, respectively. Finally, the drone equipped with the battery and camcorder was produced with the propeller guards and landing gears, as shown in Figure 3. The camcorder angles of horizontal and vertical views were 170 and 60°, respectively, and the camcorder had video resolution of 2.7k@30FPS. In addition, a FLIR thermal camera was additionally equipped with the drone. Hardware components are described in Section 4.

Figure 2. CATIA modeling for the drone along with the propeller guard (left) and the landing gear (right).

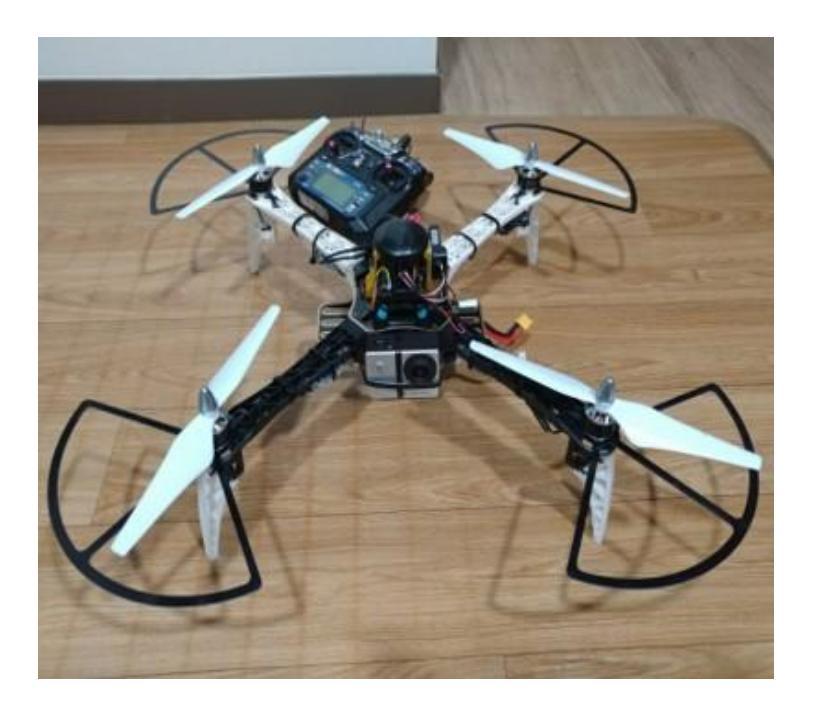
Figure 3. The drone equipped with the battery, video camcorder, propeller gears, and landing gears.

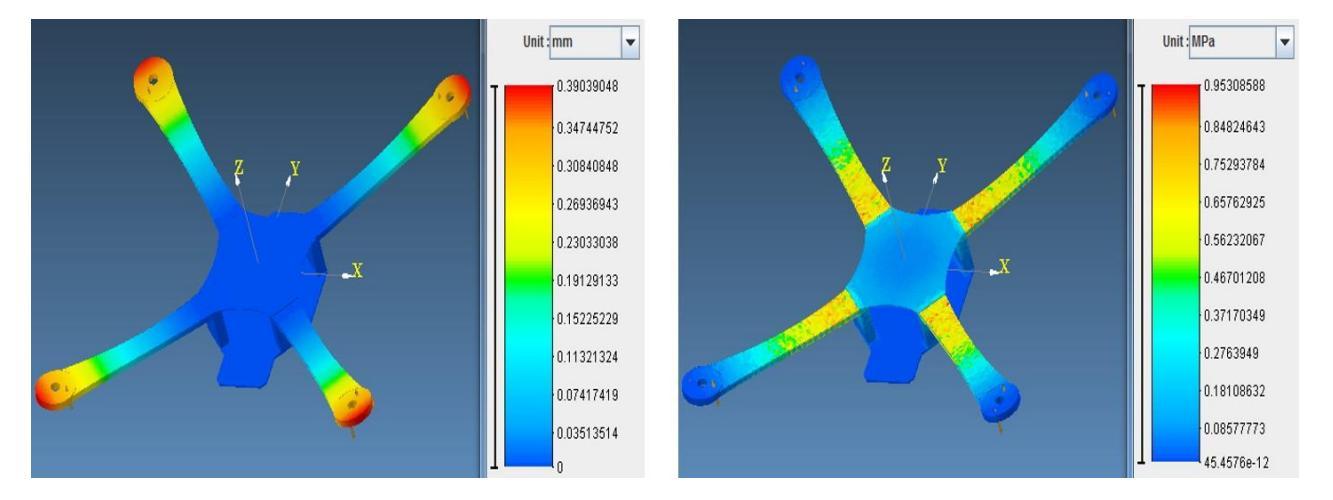
the thrust generated by four motors was able to lift up to 3.8 kg. Another important analysis that had to be carried out was stress and deformation of the frame because the thrust deforms the arms of the drone. We used SAMCEF [23] to analyze the deformation of the four arms and the stress of the center when the drone was in flight (Figure 4). The simulation results showed that the maximum deformation of the four arms was 0.39 mm, and the maximum stress of the center was 0.95 MPa. The arm was able to withstand stress of 270 Mpa. The result of deformation and stress test assured the safety of the drone. In addition, the stability during the drone flight was also tested. The test results showed that the drone was returned to a hovering flight status within one second after the roll/pitch was maximized. The cost for the development of the drone used in this study is also identified in Section 4, which shows that the total cost was significantly lower than the previous studies.

Figure 4. SAMCEF analysis for the deformation of the four arms (left) and the stress of the center (right).

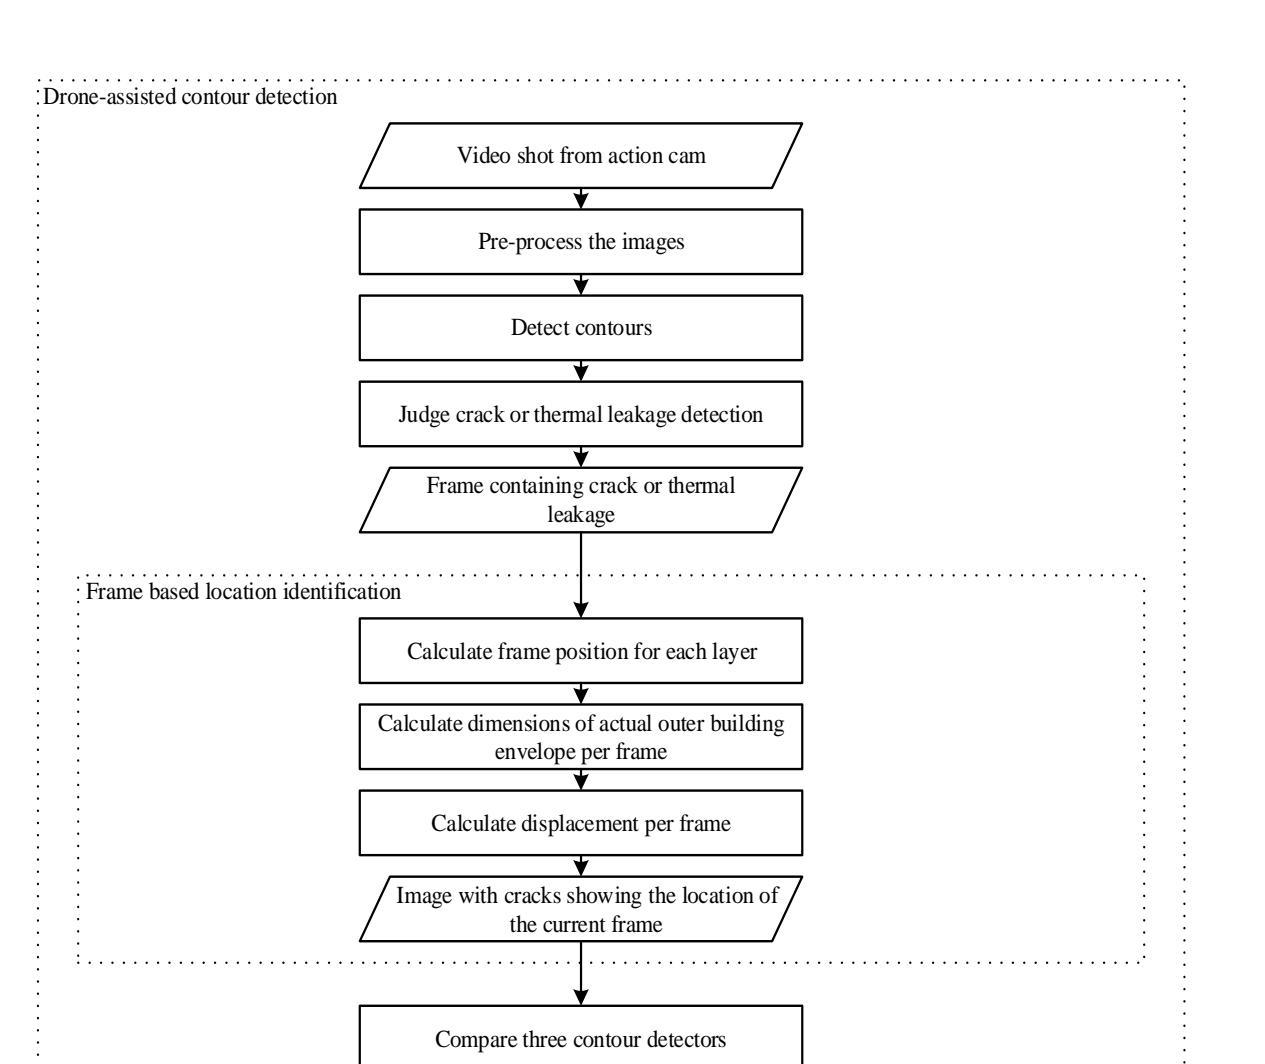
Figure 5 illustrates an automated framework for the anomaly contour detection. First, once the video data of building envelope was acquired, the captured data is processed by the contour detection algorithms after pre-processing images to remove noises using the Gaussian blur and binarization. Then, the contour detector identified cracks on a wall and/or window. Since all contours may not be cracks, based on the guideline provided by Korea Land Housing Corporation, cracks on a concrete wall with a width larger than 0.3 mm were identified as cracks. For infrared thermal images, the highest temperature contours were considered as thermal leakage because it was assumed that the weather conditions when the research was conducted did not introduce acknowledgeable bias in detecting the thermal leakage in the building envelope using the highest temperature. In addition, it was assumed that the building surface temperature was not significantly affected by the building wall structure.

Figure 5. Flowchart for the overall anomaly contour detection.

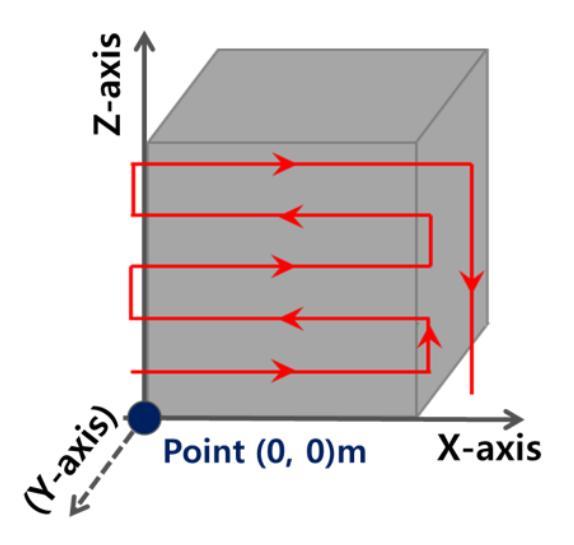
distance with lowest possible battery usage, we developed a flight plan as in Figure 6 to minimize the prolonged upward thrust motion.

Figure 6. Battery Utilization optimized routing coordinate.

To calculate the position using the number of frames, it was considered that the direction of drone moves as it travels back and forth in *x*-axis as shown in Figure 6. The number of turns, *T*, was counted to find whether a frame is in even or odd turn, that is Equation (5).

The flight plan, as shown in Figure 6, was used to designate the way points of the drone. The power of the battery was measured after a round trip flight of 10 m with vertical and horizontal routes. The total round-trip distance for the vertical and horizontal directions was 100 m. The tests were repeated several times to obtain the average power dissipation in each direction. Figure 8 shows that the power dissipation of the vertical route was greater than the horizontal route. In the vertical route, the power decreased by 0.36 V on average, which was about 2.9% of the total power. On the contrary, in the horizontal route, the power decreased by only 0.11 V on average, which was about 0.8% of the total power. It was found that the horizontal movement was at least 3.3 times better than the vertical movement. A simple linear regression analysis was conducted, and the results showed that the vertical and horizontal oriented flights can travel about 4.1 km

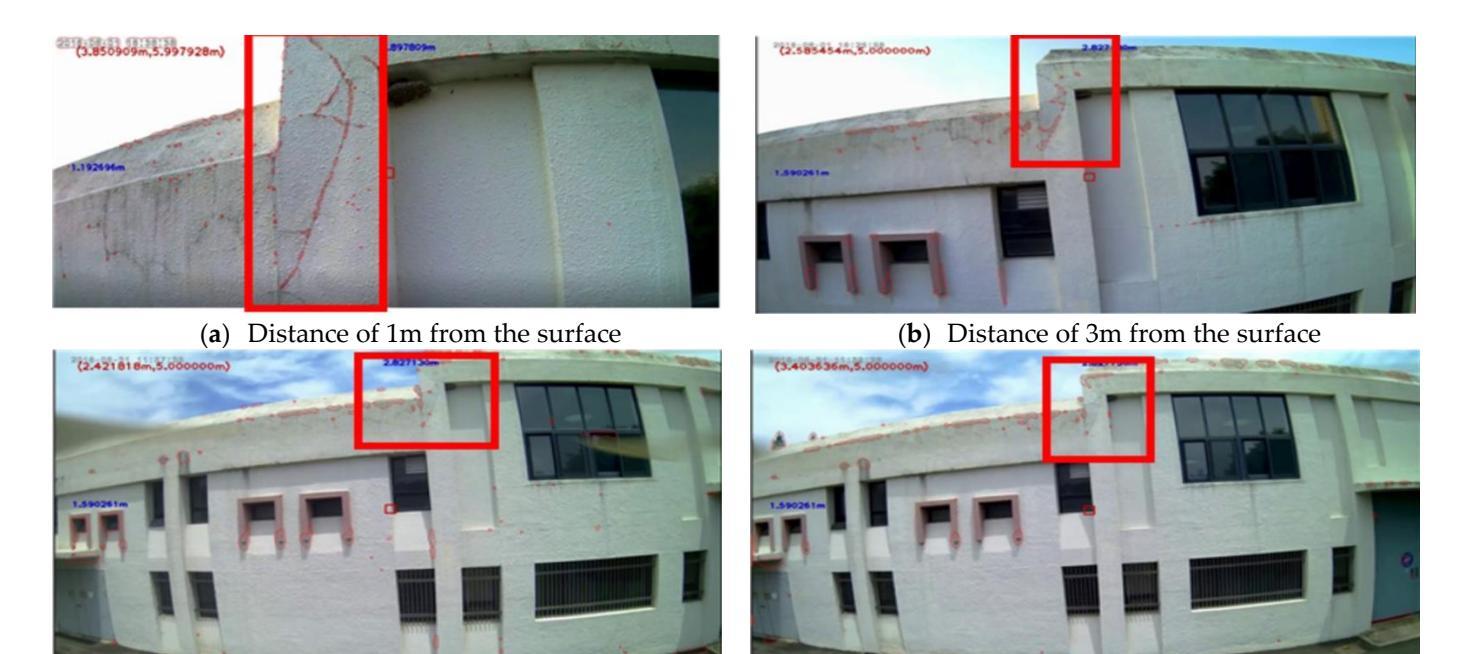
The drone used the battery of a lithium polymer with 14.8 V (5200 mAh), and it was able to fly for 17 min in average. The drone flew perpendicularly to the wall at a distance of 1 m distance. Then, the drone captured the dimension of 4 m  $\times$  2 m in a frame. The distances of 3 m, 5 m, and 7 m were also tested as shown in Figure 7. We considered the resolution and the distortion in the captured image while deciding the drone's distance from the wall. Note that resolution and distortion of captured images are primarily dependent on the specification of a camera and the lens it uses. The distance must be decided with respect to the specification. For this study, the images from the distance of 1 m were used. It was observed that the maximum distance for accurate images with less errors was 5 m. The distance of 7 m did not provide a reliable drone image. It is because resolution of the camera is fixed; however, it must capture a larger area, which means a larger area has to be compressed into a pixel in the image.

**Figure 7.** Detection results by distance (**a**) 1 m from the surface, (**b**) 3 m from the surface, (**c**) 5 m from the surface, and (**d**) 7 m from the surface. As the drone flies further away from the building, the distortion increases and the resolution of the crack decreases.

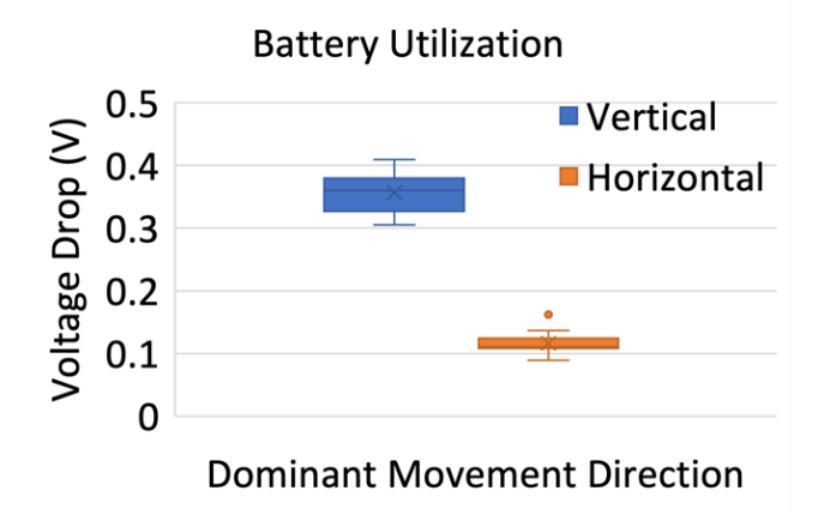
Figure 8. Boxplot of battery utilization with respect to direction.

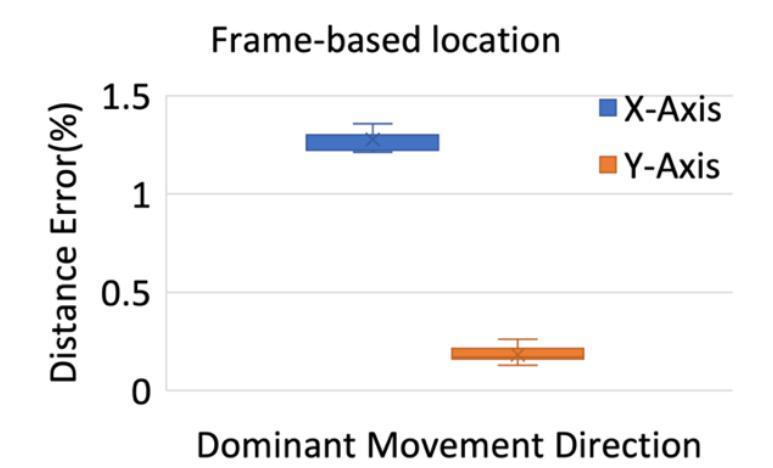
The accuracy of the frame-based position was tested (Figure 9). The drone started flying at coordinates of (2.5, 0). It flew 4 m up, which was on (2.5, 4), and moved 5 m to the right (7.5, 4). Then, the drone flew up 1 m reaching at the final point of (7.5, 5). The actual coordinates against estimated coordinates via FPS at each turn were compared. The average error rates of the frame-based position on *x*- and *z*-axis were 1.3% and 0.17%, respectively. It was found that maintaining constant speed was important to calculate an accurate position.

Figure 9. Boxplot of accuracy of frame-based location identification.

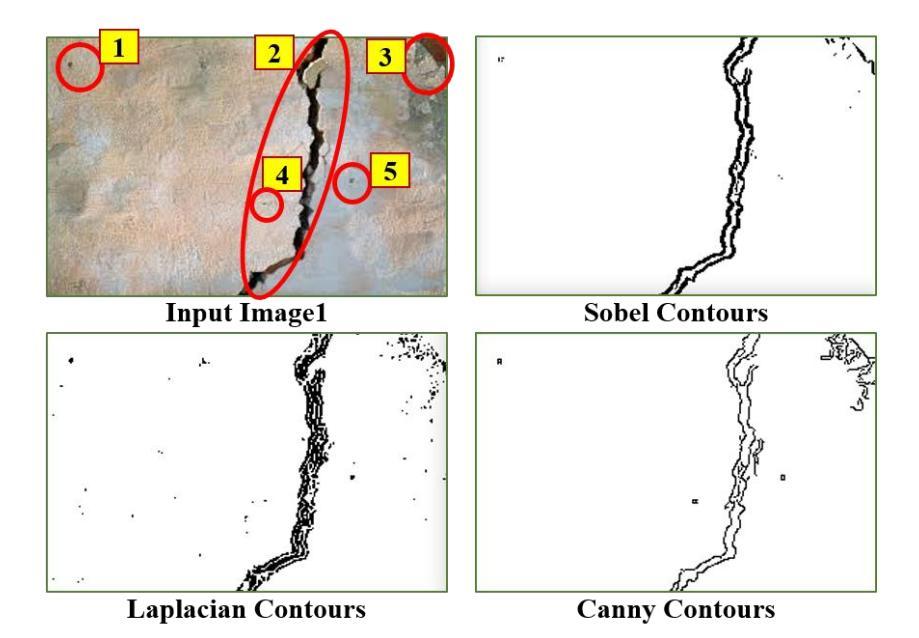
Figure 10 shows the result of the three contour detectors. The building used for the crack detection was built in year 2000 within Gyeongsang National University, Jinju, South Korea. The purpose of this two-story building is to accommodate and incubate startup companies of various sizes. The reasons for the cracks on the building surface [26] are irregular stress from a long-term overload [27], deformation and corrosion by the weather conditions [28], decrease in bearing capacity [29] and damage from earthquakes [30]. The dimensions of cracks numbered in Input Image 1 of Figure 10 was as follows: (1, 4, and 5) circular shape with radius of 3 to 5 mm; (2) 20 cm long and 1 cm wide; and (3) triangular shape with a base of 2 cm and a height of 2 cm. The widths of cracks shown in the Input Image 2 of Figure 11 was as follows (length and width): (1). 11 cm and 4 mm, (2) 9 cm and 8 mm, (3) 15 cm and 10 mm, (4) 3 cm and 6 mm, (5) 12 cm and 3 mm, and (6) 7 cm and 3 mm.

Figure 10. Comparison of the contour detectors with 5 cracks.

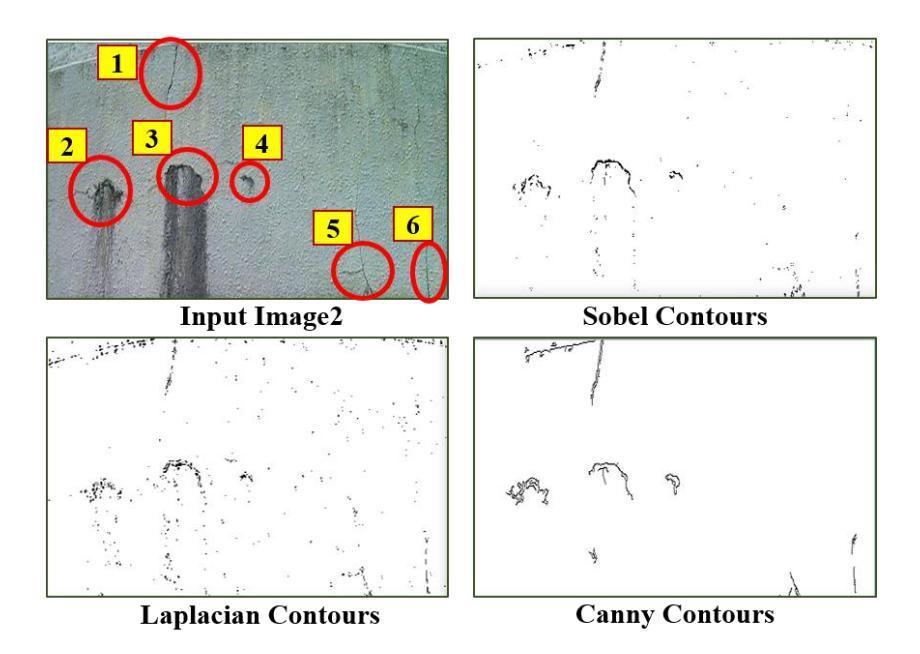
Figure 11. Comparison of the contour detectors with 6 cracks.

In the case of the Sobel detector, the detection results were not reliable when the texture of the wall was not smooth (see Figure 11). Sobel required a lot of preprocessing to reduce the noises. As a result, it showed a high false positive rate. The Laplacian detector showed a higher false positive rate in Figure 10. On the contrary, the Canny detector successfully identified all the edges on the wall regardless of the texture or the dimension of the cracks.

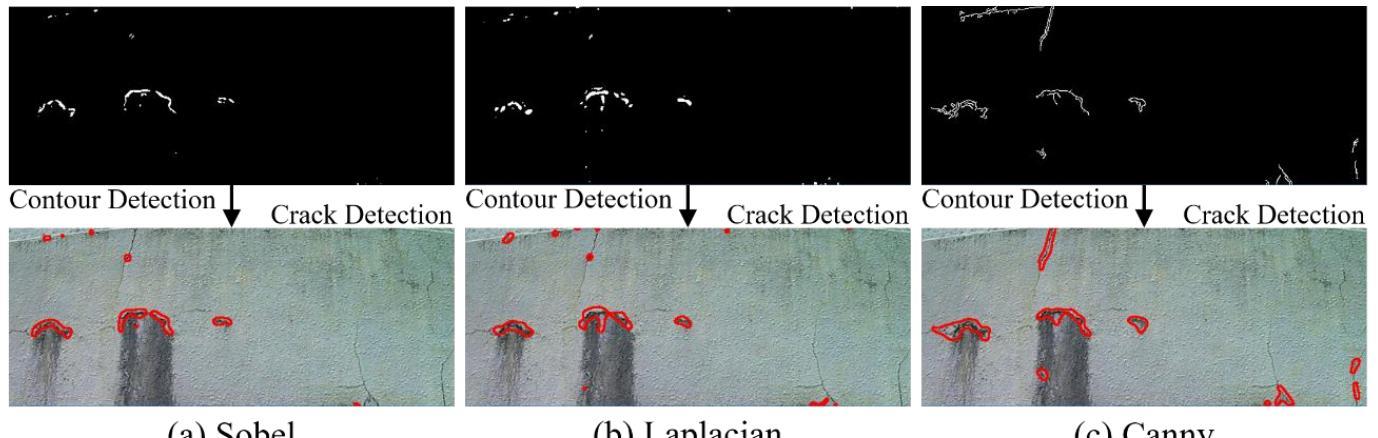
Figure 12 shows the result from the three contour detectors adopted in the proposed crack inspection program. In the automated scheme, the dimension of a crack had to be large than 0.3 mm  $\times$  0.3 mm to be actually counted as a crack. An image with the dimension of  $627 \times 239$  pixels (46.4 Kb) was used to measure the run time of executed algorithms. Since only Canny found the cracks on given criteria, low frequency filters and binarization were added for a fair comparison of the performance of the anomaly detection system (see Figure 12).

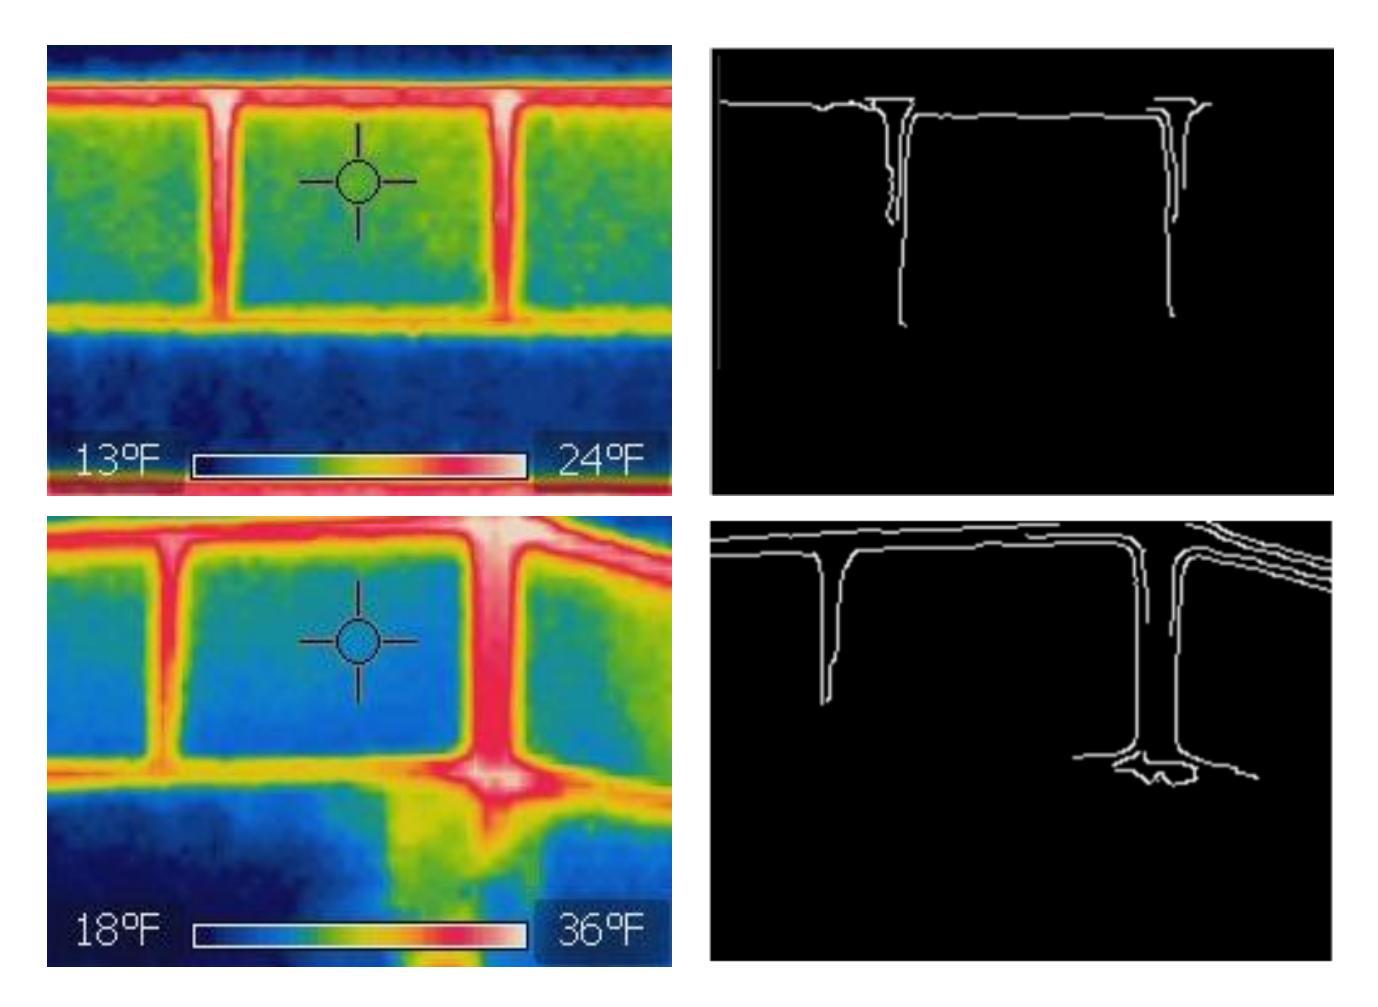
In addition, the Canny detector was used to analyze thermal images captured with an infrared camera. The aim for using Canny detector in thermal image was to provide easy solution to locate the leakage in the built environment due to cold bridges, missing insulation, moisture ingress, etc. More specifically, we were interested in finding the area quickly where the thermal leakage was the highest. The building used for the thermal leakage study was a two-story office building built in the 1980s in Boise, Idaho, the US. A particular aspect of the building is that the windows of the building were replaced with new, lower SHGC (solar heat gain coefficient) windows in 2015 [31]. Regardless of the retrofit of the window, the thermal image shows high thermal transmittance in the frames of the window.

For this experiment, both the camcorder and the infrared cameras were mounted on the drone, thus the automated scheme can be used using the frame-based location identification. Figure 13 shows the results from the Canny detector. It was effective to detect the highest temperatures (i.e., thermal leakage through the window frames) on the images. The images were taken when the outside temperature was -4.0 °C and the sky condition was cloudy, for the better results.

Figure 13. Results from the thermal images using the Canny contour detector.
