# Article Shallow Permafrost at the *Crystal* Site of Peaceful Underground Nuclear Explosion (Yakutia, Russia): Evidence from Electrical Resistivity Tomography

Citation: Artamonova, S.; Shein, A.; Potapov, V.; Kozhevnikov, N.; Ushnitsky, V. Shallow Permafrost at the *Crystal* Site of Peaceful Underground Nuclear Explosion (Yakutia, Russia): Evidence from Electrical Resistivity Tomography. *Energies* 2022, *15*, 301. https:// doi.org/10.3390/en15010301

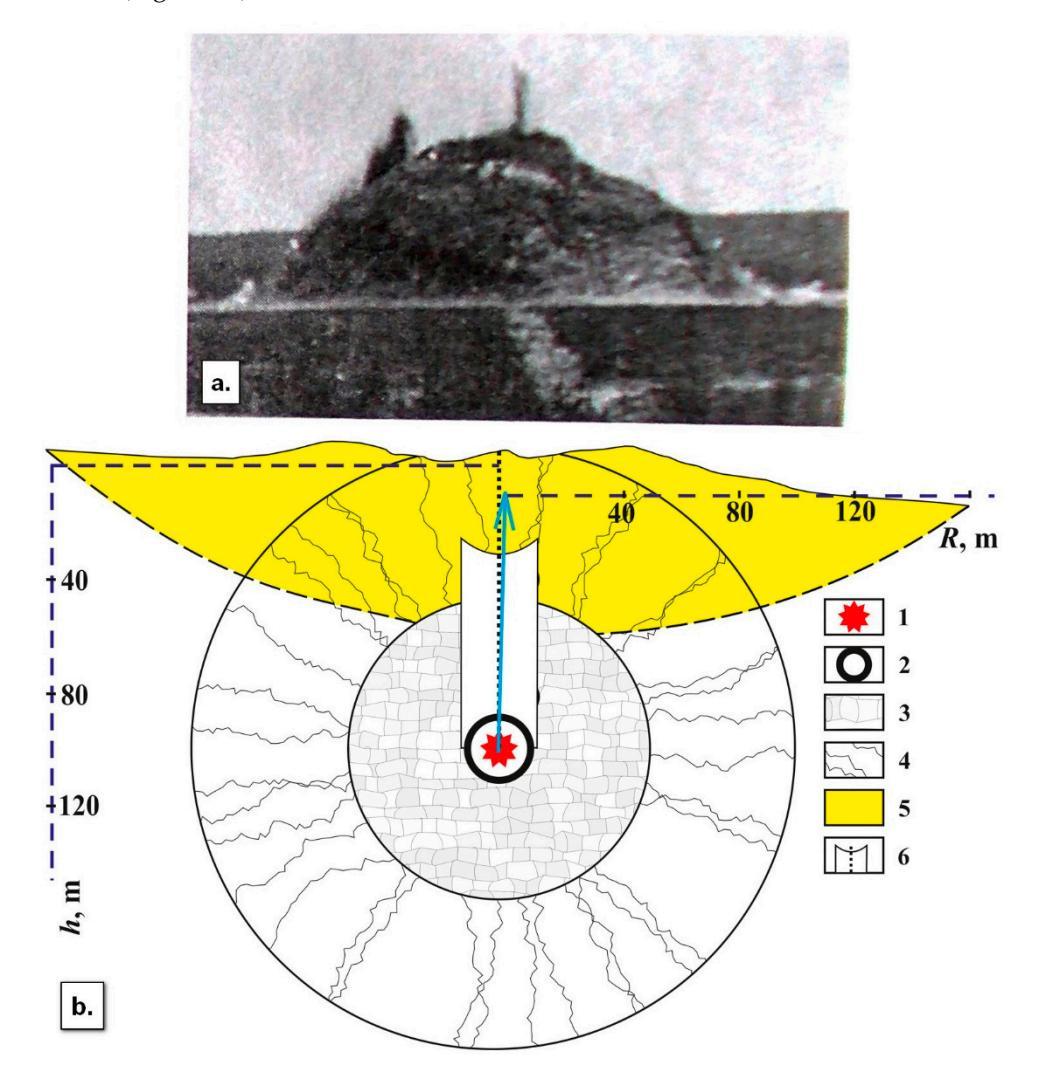
**Figure 2.** (a): Snapshot of the PUNE *Crystal* site about 3.5 s after detonation, when the upthrust dome reached its maximum height of ~60 m, at a base width of 200 m (the PUNE *Crystal* filming was conducted from a location situated south–south-west of the explosion epicenter [1]). (b): Sketch of the confinement cavity with crushed and cracked zones around. (1) Shot point; (2) confinement cavity with a hardpan of molten rock; (3) crushed zone; (4) cracked zone; (5) spalled zone, with contours of the dome-shaped mound, according to the field topographic surveys; (6) chimney (dashed line in the middle is the emplacement hole). Arrow shows the direction of shock pressure wave.

The explosion produced an upthrust dome with a diameter of 160–180 m, which rose to a maximal height of 60 m (Figure 2a) in 3.5 s after detonation (Figure 2a) and then settled back due to gravity. Strong underground thumps were noted 17 h after the explosion. Finally, the dome-shaped mound was formed with a diameter of 200 m and an average height of 10 m above the original surface (locally 14 m in the western side), which was twice as low as anticipated (Figure 2b). For that official reason, the remaining seven explosions were cancelled.

Parameters of rock deformation at the *Crystal* site (Figure 2) were estimated with reference to patterns of UNE-induced rock failure studied in field experiments [1]. The radius of the confinement cavity is related to the explosion yield (E, kt) as  $R_{cav} \sim a_1^{-1}E^{1/3}$  (the factor  $a_1$  is proportional to the rock strength and the buried depth of the device). The radius  $R_{cav}$  of the *Crystal* PUNE was about 9.5–14.6 m [1,11,16] (Figure 2b). The damage zone consisted of a crushed zone, with its radius ( $R_{crush}$ ) directly proportional to  $E^{1/3}a_2R_{cav}$  (factor  $a_2$  depends on the strength and compressibility of rocks and is 4.2–5.3 for the geological conditions of the *Crystal* site),  $R_{crush} = E^{1/3} \cdot (4.2–5.3) R_{cav} \sim 48–92$  m; a cracked zone, with the radius ~105 m ( $R_{crack} = 2R_{crush}$ ) exceeding the burial depth and extending to the ground surface; and a spalling zone of the radius  $R_{spall}$  on the land around the epicenter, estimated ~160 m from the depth and yield of the explosion as  $R_{spall} = W + H_{spall}$ , where W is the burial depth,  $H_{spall}$  is the spalling depth,  $H_{spall} = C_p \cdot \tau_+/2$ , C and  $\tau_+$  are, respectively, the velocity and arrival time of compression waves [1]. The upthrust dome rose at a rate

of 34 m/s for 3.5 s [1], while the spalling depth was 59.5 m and the spalling radius was  $\sim$ 160 m (Figure 2b).

Since the blasting works toward the ground surface, all zones of deformed rocks became superposed one upon another to form the one integral damage zone around the emplacement hole (Figure 2). At a small slope of the surface, the explosion epicenter almost coincided with the emplacement hole head (turquoise arrow in Figure 2b).

Recall that the shallow PUNE *Crystal* explosion produced a damage zone consisting of a rubble chimney and crushed, cracked and spalled zones around the emplacement hole (Figure 2b). The damage zone had a radius of about 160 m on the land surface according to

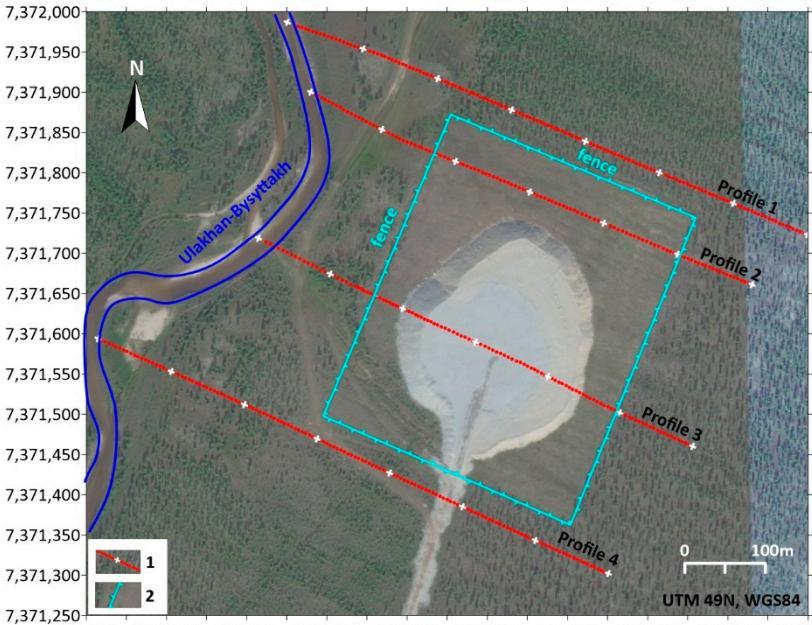
**Figure 3.** ERT profiles (1) of 2019 at and around the *Crystal* site on a Google map; (2) the fence of the site. The artificial cover above the dome-shaped mound and embankment road are in light gray.

Electrical resistivity tomography (ERT) monitoring is widely used in permafrost studies [20–22]. At the *Crystal* PUNE site, ERT surveys were first carried out in 2019 along four profiles (Figure 3), using the SKALA-48 multielectrode system (designed jointly by teams from the Electrometria design office and the A.A. Trofimuk Institute of Petroleum Geology and Geophysics SB RAS, Novosibirsk, Russia). The system, with its multicore cables (streamers), switches successively to different combinations of 5 m-spaced electrodes (grounded metal rods), which are connected to 48 streamer outputs (Figure 4). The resistivity structure along the profiles was imaged by an offset pole–dipole array, with one current electrode set 1 km off the profile, and a dipole–dipole array, which was used in profile 3 for checking the data quality and resolution (Figure 4). The two arrays ensured penetration to depths of 80 m and 40 m, respectively. In total, 2620 m of profiles were collected, plus 300 m of repeated measurements.

The permafrost of the area was studied along four ERT profiles that ran in the SEE– NWW direction (Figure 3), from a forested slope of the Ulakhan-Bysyttakh left bank, at an elevation about 330 m asl, then downslope into the river valley, to 300 m asl. Profiles 1 and 4 were 715 m long each, and were located outside the PUNE site, among Larix gmelinii taiga: 40 m north of the fence and 300 m far from the emplacement hole (profile 1); 30 m south of the fence and 200 m from the emplacement hole (profile 4).

Profile 1 crosses the winter road in the river valley, whereas profile 4 crosses the winter road on a forest slope (Figure 3). In the field, we observed thermokarst-like thaw features on the winter road, which were more prominent in the river valley segment (525–560 m, profile 1), with water-filled ruts, than on the slope (280–380 m, profile 4) where the ruts were almost dry. This difference showed up in the ERT data (see insets in Figure 5): the active layer beneath the winter road was almost four times less resistive and twice as thick as that in the valley (profile 1): 74–145 Ohm·m as compared to 275–540 Ohm·m and up to 2 m as compared to 1 m, respectively. Note that the thickness of the active layer beneath winter road along profile 4 remained invariable though its resistivity was markedly lower than in the neighboring areas (Figure 5).

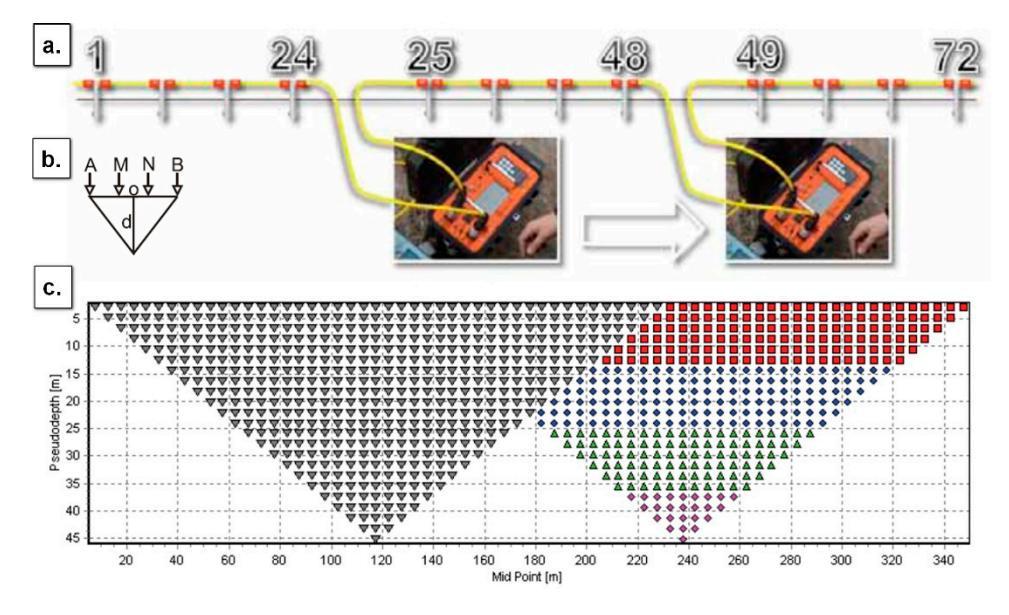
**Figure 4.** ERT measurements. (a): Electrodes and cables connected to the SKALA system. (b,c): Symmetrical sounding array (b) and resistivity data points (c).

The data quality was checked by measuring the relative rms error (data with >1% error were culled out) and by replica measurements, with an average reproducibility no worse than 5%. Then, the raw resistivity data were processed manually. The ERT data inversion was carried out using the *Res2Dinv* program, with terrain correction, using the conventional Gauss–Newton robust method. As recommended in the *Res2Dinv* manual [20], the inversion was carried out on a dense grid with cells, the size of which was half the distance between the electrodes. This grid spacing improved the resolution of shallow subsurface responses affected by the metal fence and buried iron fragments. The 2D

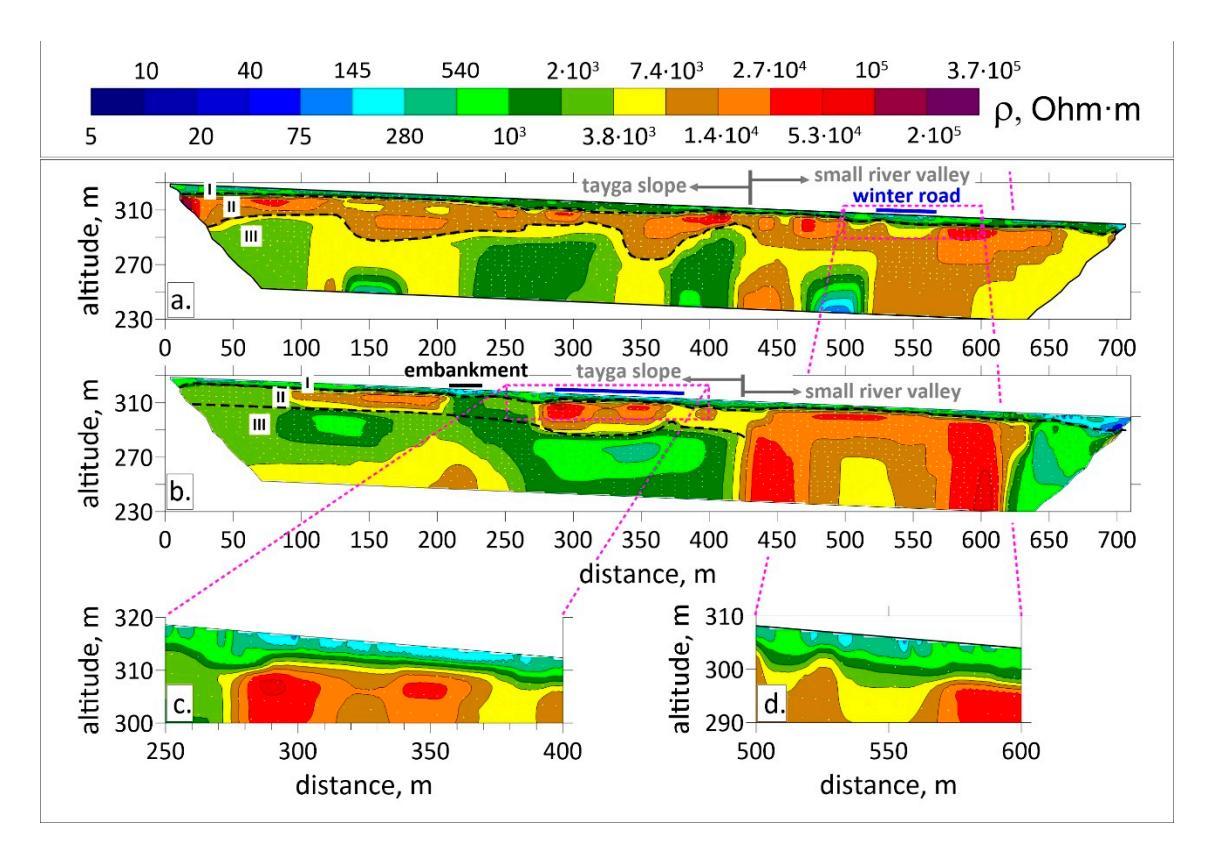
**Figure 5.** Inverted resistivity section (Ohm $\cdot$ m) along profile 1 (**a**) and 4 (**b**), and their large-scale insets within winter road cross segments (**c**,**d**). Complete pole–dipole measurements. White dots are resistivity data points used in inversion.

The ERT surveys along profiles 1 and 4 made it possible to assess the state of the permafrost under conditions of nearly undisturbed (profile 1) and slightly disturbed (profile 4) natural landscape; profile 1 was found to cross only the winter road, whereas profile 4 crossed the winter road and the embankment road (Figure 3). The inverted resistivity section of the slope segment between 0 m and 430 m along profile 1 consisted of three layers (Figure 5a): the 1–2 m thick layer I of low resistivity (145 to 1000 Ohm·m, or locally up to 2000 Ohm·m); the 15–30 m layer II of high resistivity (7400 to 27,000 Ohm·m, locally up to 100,000 Ohm·m or more); and layer III with relatively high resistivity of 2000– 7400 Ohm·m, locally 280 to 1000 Ohm·m, up to the maximum penetration depth (80 m).

The river valley segment between 430 and 715 m along profile 1 showed high resistivity up to the 80 m depth, from 7400 Ohm·m or higher beneath the thin conductive layer I. The high-resistivity zone encloses conductive patches of 2000 to 75 Ohm·m in the 470–510 m segment, the lower section part (Figure 5a), and within 145 Ohm·m near the river (segment 690–715 m), from 0 to 7 m depths.

The inverted resistivity section of profile 4 was found to be similar to that of profile 1 (Figure 5b), with three resistivity layers beneath the slope (segment 0–410 m), but layer II was less prominent while layer III enclosed low-resistivity patches of 280–540 to 1000 Ohm·m, as well as a nearly vertical 1000–2000 Ohm·m zone merging with layer III, beneath the embankment road.

The inverted resistivity section in the river valley segment of profile 4 consisted of the thin conductive layer I above the high-resistivity subsurface, mostly 7400 to 100,000 Ohm·m (Figure 5b), except for slightly lower values (3800 Ohm·m) within 500 to 540 m, below 40 m. The resistivity was low near the river, in the 620 to 715 m segment: from 1000 Ohm·m in the lower part of the section to 40 Ohm·m in the shallow part. The transition between the high- and low-resistivity zones was sharp and almost vertical.

The slope parts of profiles 1 and 4 show layered resistivity patterns of permafrost (Figure 5), which may be mainly controlled by lithology. The high-resistivity layer II (7400 to 27,000 Ohm·m), 15–20 m or locally 30 m thick, apparently corresponds to undeformed limestones at depths 10 to 25 m. Layer III, which was found to be of lower resistivity (2000–7400 Ohm·m), may represent interbedded clayey and dolomitic limestones. The frozen clay-bearing marly limestone is less resistive than the pure limestone variety, because large surface areas of clay particles increase the contents of bound (commonly saline) pore water.

The gravel embankment road leading to the artificial cover above the dome-shaped mound caused a stronger warming effect on permafrost than the winter road (profile 4). The resistivity beneath the embankment road did not exceed 2000 Ohm·m and corresponded to an unfrozen zone that merged with another such zone in the central part of the profile (Figure 5b).

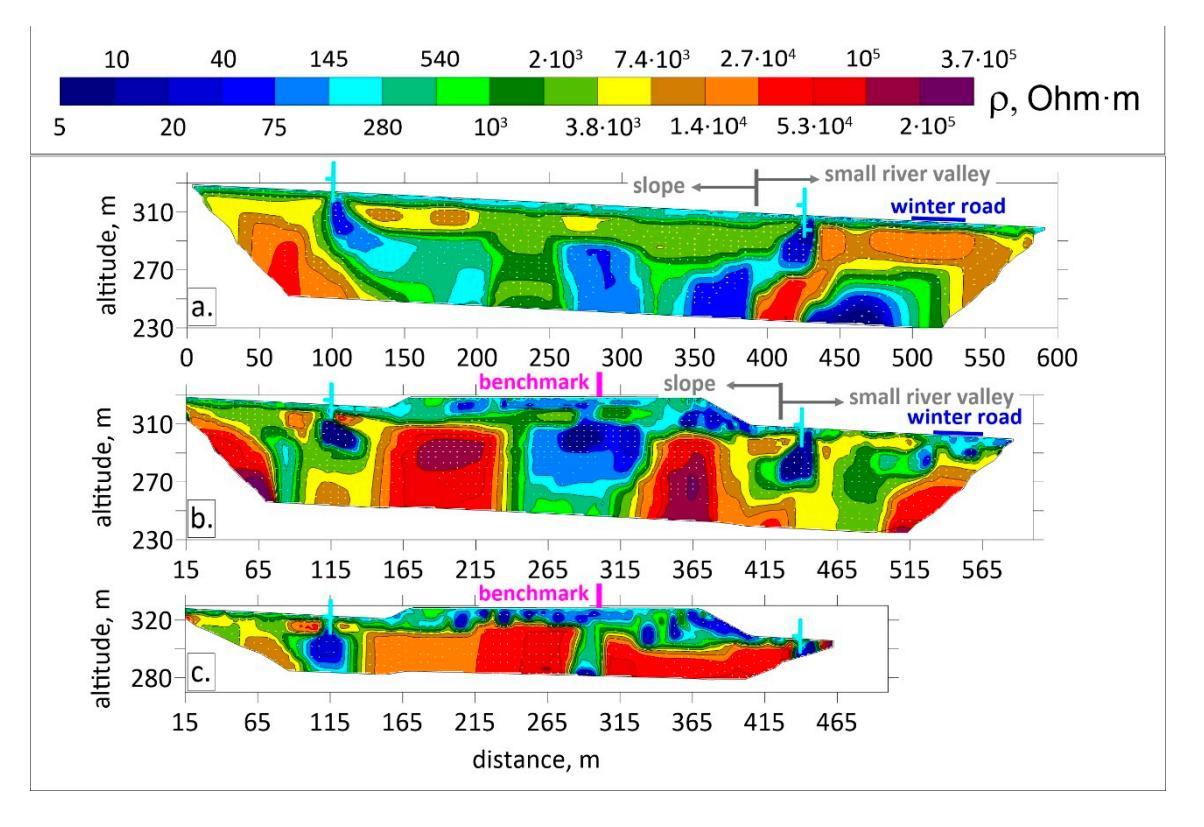
**Figure 6.** Inverted resistivity section (Ohm $\cdot$ m) along profiles 2 (**a**) and 3 (**b**,**c**). Pole–dipole (**a**,**b**) and dipole–dipole (**c**) arrays.

The inverted resistivity section along the profile 2 was quite intricate (Figure 6a), but shared some features of similarity with that of profile 1. It included the low-resistivity top layer I (280–540 Ohm·m), which was 2–3 m to 4–5 m thick; the 20–30 m thick layer II (1000 to 3800 Ohm·m, or locally to 14,000 Ohm·m) in the slope segment, at 0 to 390 m; and a high-resistivity zone of 7400 to 27,000 Ohm·m or higher reaching the section base, within the 390–595 m segment (river valley). However, unlike the pattern of the undisturbed landscape, the high-resistivity zone enclosed a large conductor with an extremely low resistivity, decreasing from 145 down to 5 Ohm·m with depth.

The extreme low of 10–40 Ohm·m produced by the fence, as well as the anomalies below it, widened with depth, while the resistivity increased. At the depth of 30–40 m, the anomalies merged with 40 to 280 Ohm·m conductive patches.

Profile 3 crosses the artificial cover above the emplacement hole and, thus, represents the most heavily disturbed part of the *Crystal* site (Figure 6b). The inverted resistivity section within the 0–100 m profile segment corresponding to the natural landscape outside the fence was similar to those along profiles 1 and 4, with a 2–3 m thick layer I of 280–1000 Ohm·m, whereas the resistivity inside the fence within the site was heterogeneous.

The upper ~20 m of the inverted resistivity section (corresponding to the artificial cover thickness) was low resistive: 20 to 280 Ohm·m, though being up to 540 Ohm·m and higher locally. In the middle of the profile, the resistivity was extremely low (5–75 Ohm·m) at depths from 20 to 60 m, but increased to 280–540 Ohm·m at larger depths. The conductor was about 80 m wide and was surrounded with highly resistive rocks of 27,000–53,000 or even up to 200,000 Ohm·m.

The 420–595 m profile segment within the river valley showed low to moderate resistivity of 540 to 3800 Ohm·m up to the section base, with two small coalescent resistivity lows near the river: 40–540 Ohm·m at a depth of 0–22 m in segment 515–535 and 40–280 Ohm·m at 0–13 m between 535 m and 575 m. Local anomalies of extremely low resistivity also appeared at 30–40 m depth beneath the fence, such as in profile 2.

The ERT data showed a resistivity of 75–540 Ohm·m in the upper 4 m within the *Crystal* site as compared to 280–1000 Ohm·m in the undisturbed slope and river valley areas and, thus, confirm that the active layer's thickness increased to 3–4 m inside the fence (Figure 6a). For example, layer II was also less resistive within than around the site: 1000–3800 Ohm·m as compared to 7400–27,000 (locally up to 100,000) Ohm·m and 3800–53,000 Ohm·m along profiles 1 and 4, respectively. Therefore, permafrost at the site is being degraded under the warming post-explosion effects. However, the fact that a line tracing distinct change in resistivity and thickness of both active layer I) and layer II followed along fence, indicated that land removal in 2006 played the decisive role in the degradation of the near-surface permafrost (Figure 6a).

The well-pronounced features of extremely low resistivity can be related to the metal fence and the warming effect of the stakes (Figure 6). Cyclic freezing and thawing of the active layer at the site caused fence tilting, while the stakes were pushed up ~70–80 cm from their initial position in the ground (Figure 8). The ground around the stakes thawed and the sinkholes became filled with water. Therefore, the stakes conducted heat to deeper permafrost and produced thermokarst effects.

The anomalously low resistivity values due to the fence effect were filtered from the ERT data manually. The filtering reduced the noise but did not eliminate the extreme lows beneath the fence (Figure 6); they retained the same size in the dipole–dipole data that were sensitive to vertical interfaces (Figure 6b,c).

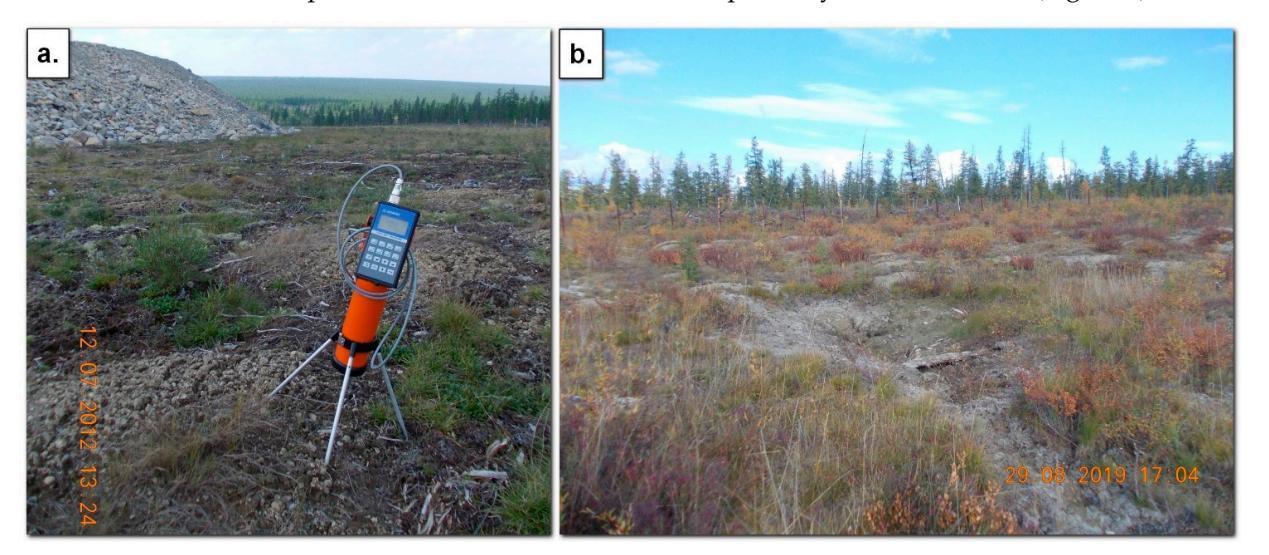
**Figure 7.** Patterned ground in the northeastern part of the *Crystal* site, in July 2012 (**a**) and in August 2019 (**b**). The pile of stones in the top left corner of the left panel is the artificial cover above the dome-shaped mound. Photograph by S. Artamonova.

The removal of land cover, especially moss and lichen, changes the solar radiation budget and disturbs the natural thermal insulation, thus accelerating the degradation of permafrost [26]. The active layer in wildfire areas is known [26] to be twice as thick as that of undisturbed forests. In 2006, the PUNE site was cleared of soil, trees, shrubs, moss and lichen, and became spontaneously overgrown with grass, shrubs and few young larches afterwards. This led to the formation of patterned ground and thaw sinkholes, of up to 1 m depth, witnessed in 2012 and 2019, respectively, inside the fence (Figure 7).

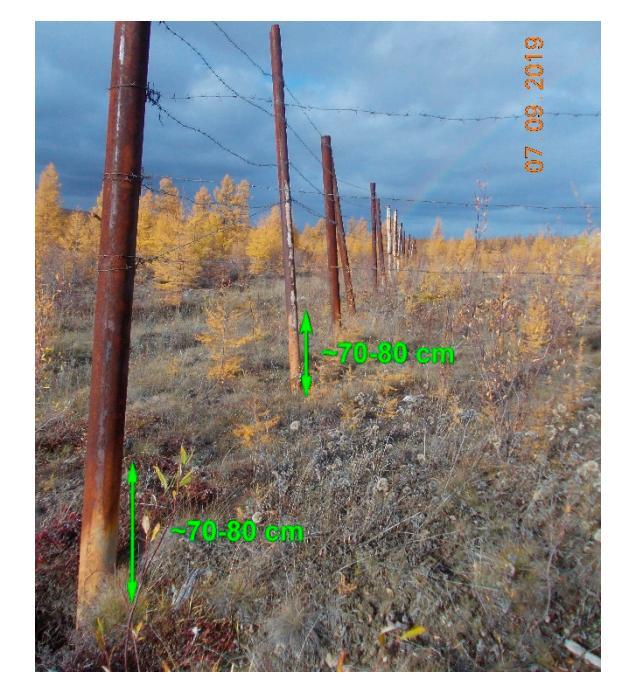
Figure 8. Stakes emerged from the subsided ground (September 2019).

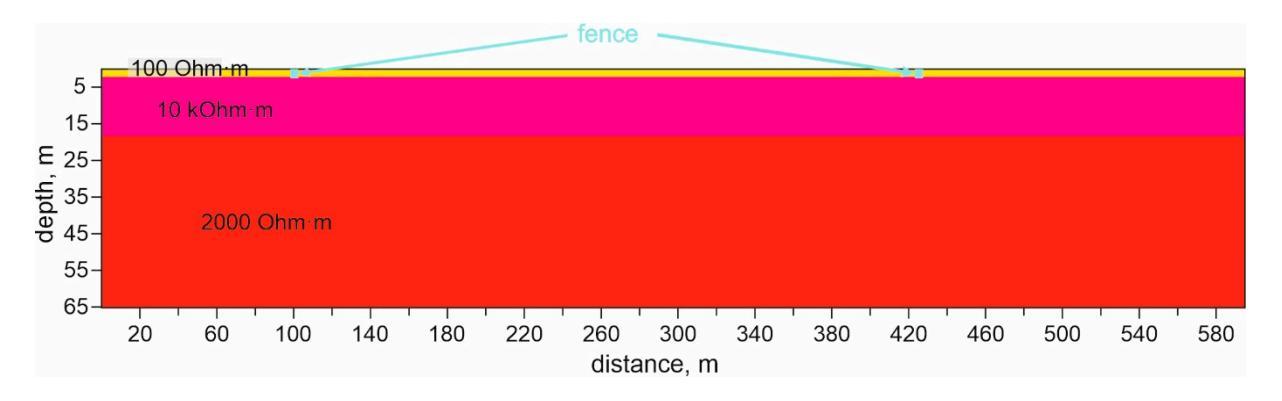
**Figure 9.** Layered-earth resistivity model with conductors (simulating a fence) embedded into the top layer.

The fence effect on the inversion results was checked by *ZondRes2D* and *Res2DInv* simulation using a layered-earth model corresponding to the natural taiga landscape (profile 1, Figure 5a). The model (Figure 9) consisted of a 2 m thick active layer on the top, with a resistivity of 100 Ohm·m; a 20 m thick resistive layer II, of 10,000 Ohm·m; and a lower-resistivity (2000 Ohm·m) layer III. The fence was simulated by two 0.1 Ohm·m conductors, of 4 m width and 2 m height, embedded into the active layer (Figure 9).

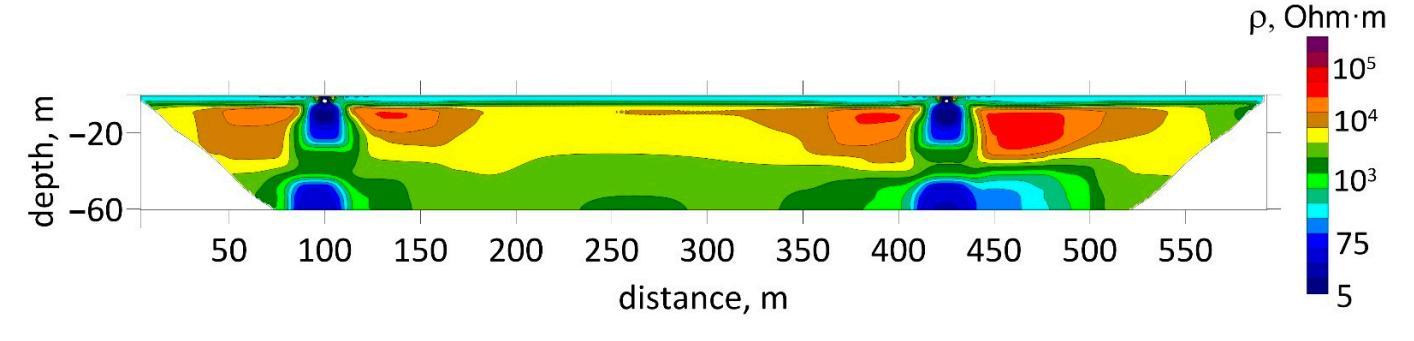
**Figure 10.** Resistivity model obtained by inversion of synthetic data, with well-defined low-resistivity features beneath the fence.

The forward solution was obtained in *ZondRes2D* for a three-electrode array with the parameters as in the field layout (spacing 5 m, cable length 595 m), and the synthetic responses were then inverted in *Res2DInv* (Figure 10). The resulting 2D inverted resistivity section included low-resistivity zones associated with the fence, which resembled the features we observed in the field data from the *Crystal* site (Figures 6 and 10).

Thus, the simulation confirmed that the extremely low-resistivity features in the ERT data were mainly produced by the metal stakes and apparently included a contribution from thermokarst sinkholes around them.
