Article Stress Corrosion Cracking Susceptibility of 304L Substrate and 308L Weld Metal Exposed to a Salt Spray

Abstract: 304 stainless steels (SS) were considered as the materials for a dry storage canister. In this study, ER (Electrode Rod) 308L was utilized as the filler metal for the groove and overlay welds of a 304L stainless steel substrate, which was prepared via a gas tungsten arc-welding process in multiple passes. The electron backscatter diffraction (EBSD) map was used to identify the inherent microstructures in distinct specimens. U-bend and weight-loss tests were conducted by testing the 304L substrates and welds in a salt spray containing 5 wt % NaCl at 80 °C to evaluate their susceptibility to stress corrosion cracking (SCC). Generally, the weight loss of the ER 308L deposit was higher than that of the 304L substrate in a salt spray in the same sample-prepared condition. The dissolution of the skeletal structure in the fusion zone (FZ) was responsible for a greater weight loss of the 308L deposit, especially for the cold-rolled and sensitized specimen. Cold rolling was detrimental and sensitization after cold rolling was very harmful to the SCC resistance of the 304

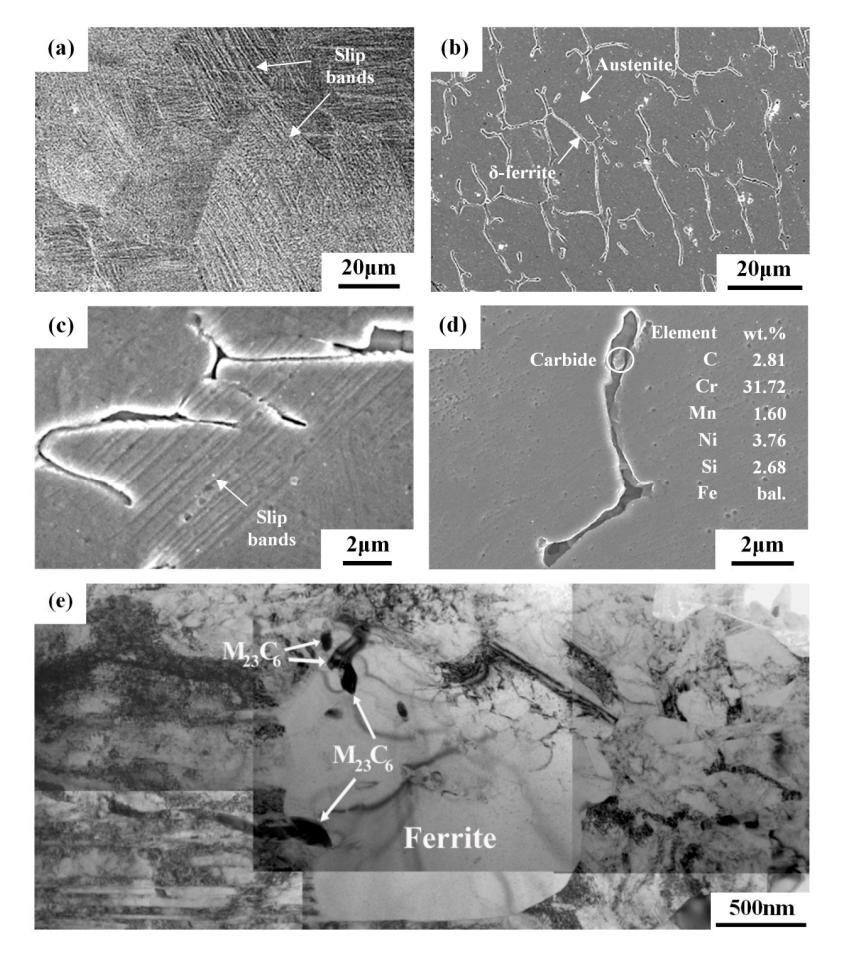
Table 3 and Figure 1 show the hardness and microstructure of various specimens, respectively. The 304L base metal (304L-BM), which had a hardness of 165 HV0.3, revealed the microstructures of equiaxial grains with twins inside the austenite matrix. Rolling caused strain-hardening (340 HV0.3), which was accompanied by the introduction of slip bands and martensites in the specimen (Figure 1a). Sensitization treatment diminished the density of slip bands, hence, reducing the hardness to 278 HV0.3. The hardness of the as-welded FZ was similar to that of 304L-BM. In contrast, skeletal structures with vermicular ferrite in the austenite matrix were observed in the as-welded FZ (Figure 1b). Moreover, the cold-rolled FZ showed a lesser degree of hardening (306 HV0.3) than the 304L-BM (340 HV0.3). The cold-rolled FZ had fewer slip bands (Figure 1c) than that of the 304L-CR specimen. Recovery during sensitization treatment led to a decrease in hardness to 261 HV0.3 for the 308L-CRS specimen. Sensitization of cold-rolled 308L deposit also enhanced the Cr-rich carbides to precipitate in the interfaces between the δ -ferrite and transformed austenite matrix, which were confirmed by EDS analysis (Figure 1d) and TEM examinations (Figure 1e). Similar results were observed in the sensitized 304L weld after cold rolling [31].

Figure 1. SEM micrographs of the (a) 304L-CR; (b) 308L-AW; (c) 308L-CR; (d) 308L-CRS specimens, and (e) TEM micrograph of 308L-CRS specimen.

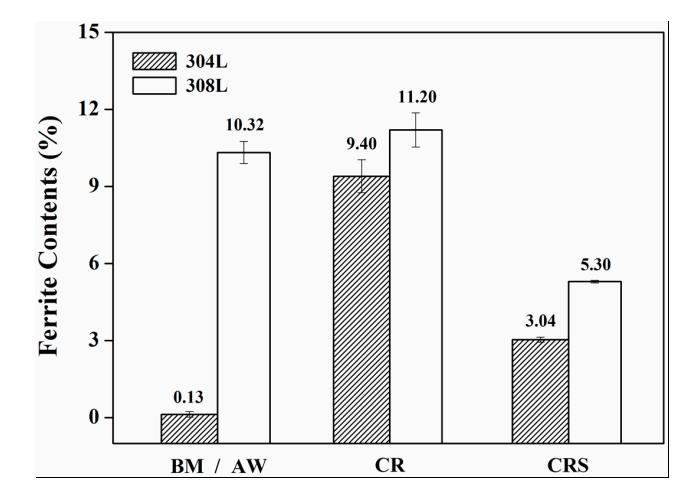
Figure 2 shows the ferromagnetic phase in the specimens as determined by the ferritescope, which could be either the δ -ferrite formed in the solidified structure in the FZ or the induced α' -martensite in the specimen after cold rolling. The ferromagnetic phase content of the 304L substrate (304L-BM), which had been subjected to solution treatment at 1050 °C/0.5 h, was rather low (0.13%). The as-welded 308L deposits (308L-AW) consisted of 10.32% ferrite, which could effectively prevent hot cracking of the FZ. Cold-rolling the 304L substrate (304L-CR) induced the formation of α' -martensite content of 9.4%; however, a minor increase in ferromagnetic phase content (by less than 1.0%) was observed in the weld deposits after rolling (308L-CR). This implied that the induced α' -martensite was less likely to be formed in the 308L deposit than in the 304L substrate. Sensitization caused about 6.4% of the induced α '-martensite in the cold-rolled 304L to revert to austenite (304L-CRS). It was clear that induced α' -martensite in the 304L was very sensitive to heating at elevated temperatures. Furthermore, the ferromagnetic phase content was reduced to approximately 5.3% in the sensitized 308L deposit (308L-CRS). The result indicated that some of the δ -ferrite was also transformed into austenite during the sensitization treatment. It is pointed out that strain-induced martensite increases with tensile pre-strain of 304 SS, while more carbides precipitate intragranularly in the strained specimens after sensitization at 948 K for five hours [32]. Such a significant change in microstructure was expected to cause a marked decline in corrosion resistance.

Figure 2. The ferrite contents of the 304L substrates and 308L deposits in distinct conditions.

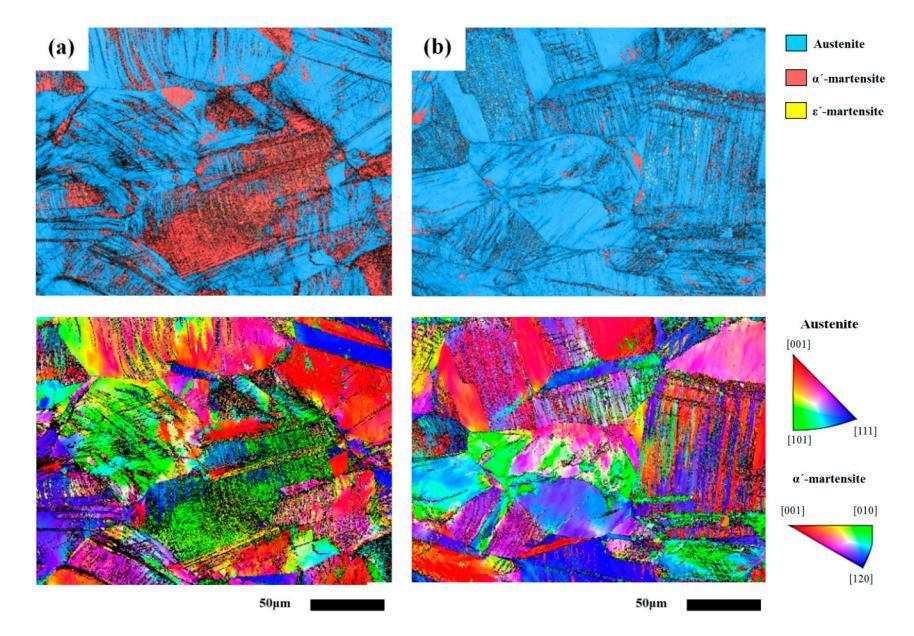
Figures 3 and 4 are the EBSD maps showing different microstructures in the cold-rolled 304L steel plate or 308L weld overlay, with or without sensitization treatment. For the ease of inspecting the induced martensite in the samples after cold rolling, the samples were subjected to cold rolling with a thickness reduction of 30%. The results indicated that cold rolling caused the transformation of austenite to marteniste (Figure 3a-top). The α '-martensite was more likely to be formed in the intense slip regions. With a cold rolling of a 30% reduction in thickness, the as-rolled 304L showed a slight distortion of grain profile and the occurrence of multiple slips in different grains, as shown in Figure 3a-bottom. Sensitization treatment led to a significant decrease in the amount of α '-martensite (Figure 3b-top), which was confirmed by the measurements of ferrite content. Moreover, tortuous slip bands were replaced by straight ones in the cold-rolled 304L after sensitization. In addition, the grain boundaries of the sensitized specimen could be defined more clearly relative to the as-rolled one (Figure 3b-bottom).

Figure 3. The Electron Backscatter Diffraction (EBSD) image (top) and the corresponding inverse pole figure IPF (Inverse pole figure) (bottom) of (**a**) 304L-CR and (**b**) 304L-CRS specimens.

In comparison with the granular structure of the 304L substrate, the dendritic structure consisted of a certain amount of δ -ferrite in the 308L deposit. The EBSD map showed that only a few α' -martensite particles were induced in the intersection zones of slip bands in the 308L deposit, as indicated by the arrow in the Figure 4a-top. Such characters were responsible for the minor increase

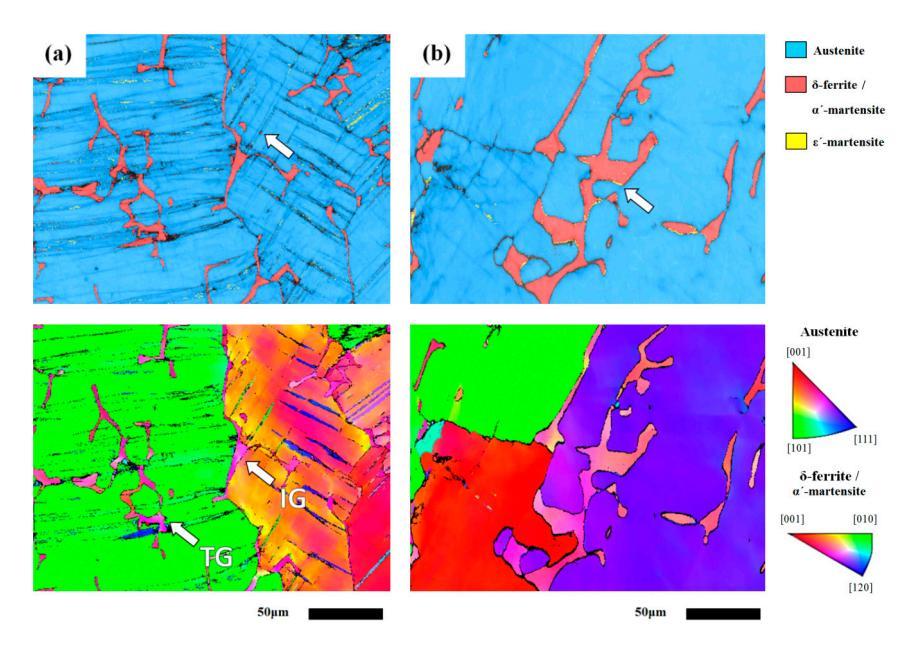
All 308L weld-metal specimens were wire-cut from the overlay welds, and subjected to rolling with/without sensitization treatments. The EBSD map is reported to be able to identify the inherent microstructure and orientation in distinct regions of a 304L weld deposited by 308L filler metal [33]. As shown in Figure 4a-top, cold rolling only caused the formation of sparse slip bands in the as-rolled 308L deposit. Additionally, the EBSD map could be used to distinguish the grain orientation and the location of δ -ferrite in the 308L deposit (Figure 4a-bottom). The results revealed that skeletal δ -ferrite could be formed in the deposit intra-(TG) and intergranularly (IG), not all of the δ -ferrite was located at the dendrite boundaries. With the sensitization treatment, the reversion of δ -ferrite and martensite to austenite accounted for the decrease in ferrite contents of the specimen. The great reduction in slip bands together with the ϵ -martensite located at the interfaces between the δ -ferrite and γ matrix was obtained in the 308L-CRS specimen, as indicated by the arrow in Figure 4b-top.

Figure 4. The EBSD image (top) and the corresponding IPF (bottom) of the (**a**) 308L-CR and (**b**) 308L-CRS specimens.

in ferrite contents of the 308L-CR specimen, in contrast to an obvious rise in the ferrite contents of the 304L-CR one. As shown in Figure 4a-bottom, skeletal δ -ferrite in the 308L deposit could be located intra- and intergranularly. Within one grain, the slip bands were found to cross over the δ -ferrite. Furthermore, multiple slips were less likely to be seen in the deposit. It was deduced that those intragranular δ -ferrites might act as barriers to dislocation slips, resulting in less strain-hardening and martensite formation relative to the 304L substrate.

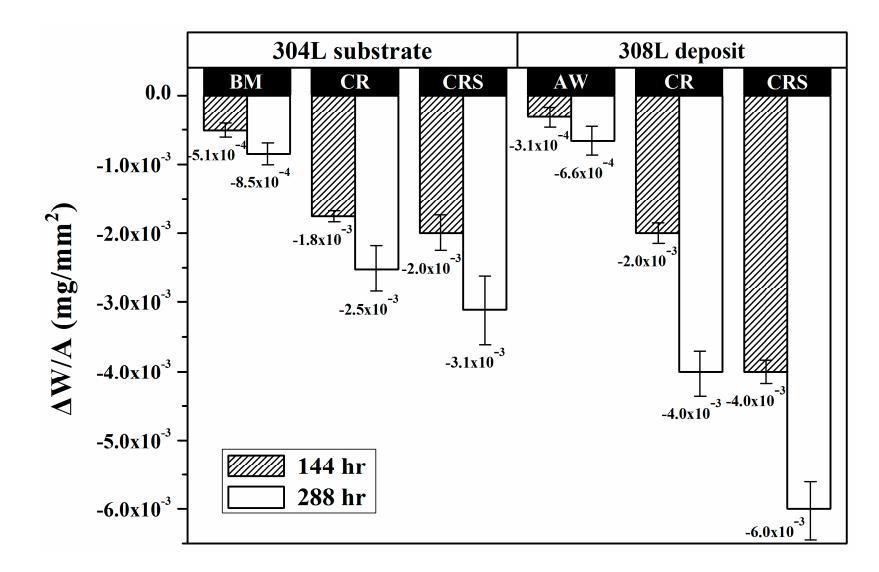
Figure 5 shows the weight loss per unit area of the specimens, which was used to evaluate the corrosion resistance in a salt spray. The results indicated that the sensitized specimens had the highest weight loss of all the specimens of each group. The 304L-BM and the 308L-AW specimens were more resistant to saline corrosion in each group. The 308L-AW specimen had slightly less weight loss than the 304L-BM, possibly due in part to the higher Cr and Ni contents of the former. The results also indicated that rolling caused an obvious increase in weight loss and sensitization made it worse, especially for the 308L deposits. The 308L-CRS specimen had the greatest weight loss of the tested specimens. Cold work was harmful, and sensitization treatment after cold rolling was quite detrimental to the corrosion resistance of the specimens in a salt spray, regardless of the specimen.

Figure 5. The weight loss of the 304L substrates and 308L deposits in distinct conditions after exposure to a salt spray.

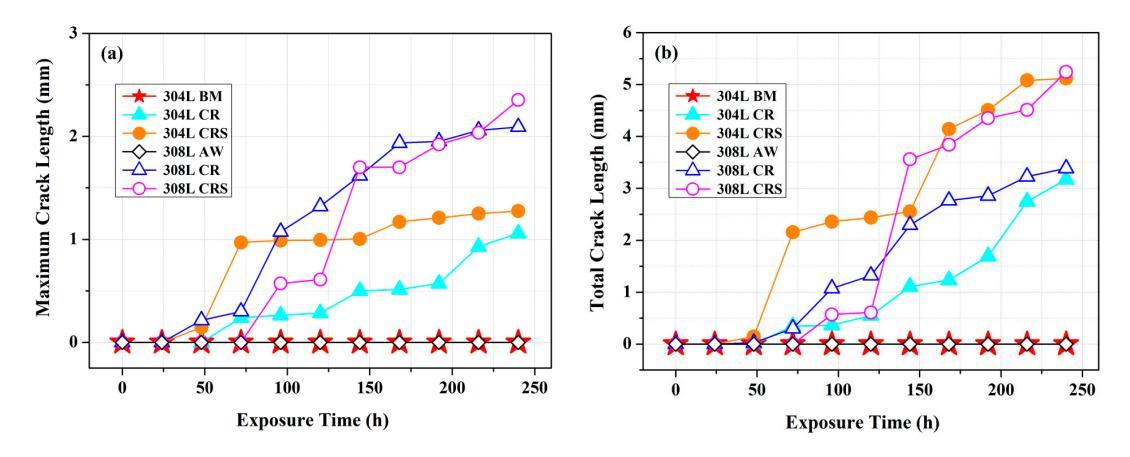
Figure 6 shows the variations in the maximum crack length (MCL) and total crack length (TCL) of the U-bend specimens as a function of the exposure time to a salt spray. The 304L-BM and 308L-AW specimens had a lack of visible cracks over the testing period, indicating that they were more resistant to SCC in a salt spray than the other specimens in each group. Regarding the MCL (Figure 6a), the longest crack lengths of the 308L-CR and 308L-CRS specimens were similar at the end of the test. The difference between them was the shorter incubation time and initial faster crack growth rate of the former. Overall, the cracking susceptibility of the 308L deposit was higher than that of the 304L substrate under the same specimen-preparation conditions. The 304L-CR specimen was expected to have higher residual tensile stress than the 304L-CRS specimen, that higher stress levels were expected to increase the SCC susceptibility. However, the MCL of the 304L-CR specimen was obviously shorter than that of the 304L-CRS specimen if the testing period was shorter than 200 h. Inevitably, the sensitization increased SCC susceptibility of the cold-rolled 304L substrate.

Figure 6b shows the SCC susceptibility of distinct U-bend specimens ranked according to their TCLs. In each group, the CRS specimen was more sensitive to SCC than the un-sensitized specimens. The 304L-CRS and 308L-CRS specimens seemed to have equivalent SCC susceptibility in a salt spray. The difference between them were cracks tending to emerge in the 304L-CRS specimen shortly after the start of testing. Despite of ranking methods, the ease of material dissolution at the slip bands and grain boundaries, which were available crack nucleation sites, accounted for a shorter crack incubation period of the 304L-CRS specimen than the other specimen (discussed later in the text). Furthermore, the TCLs of the 308L-CR and 304L-CR specimens were also similar at the end of the test. Regarding the cracking susceptibility of the 308L-CR and 304L-CR specimens, the difference in character between them was that the longest crack grew much faster in the 308L-CR than that in the

304L-CR specimen, as shown in Figure 6a. Furthermore, the TCLs of the 308L-CR specimen were longer than those of the 304L-CR while testing within 200 h. The presence of greater residual tensile stress in the 308L-CR specimen might play an important role for such differences between them.

Figure 6. The variation in crack length of the U-bend specimens vs. the testing period in the salt-spray environment: (**a**) maximum crack length; and (**b**) total crack length.

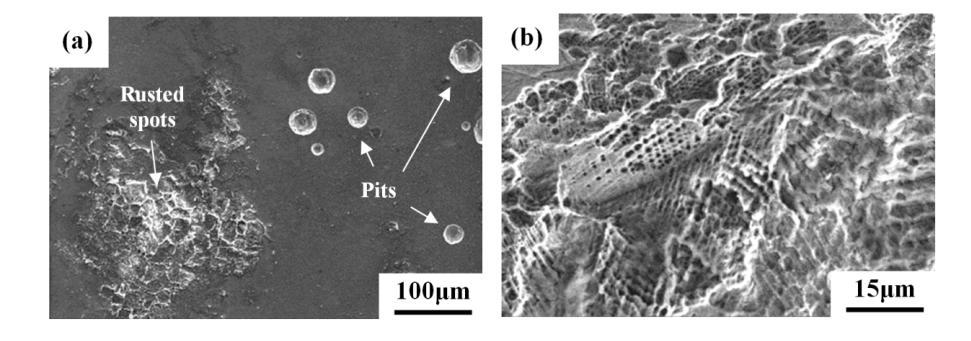
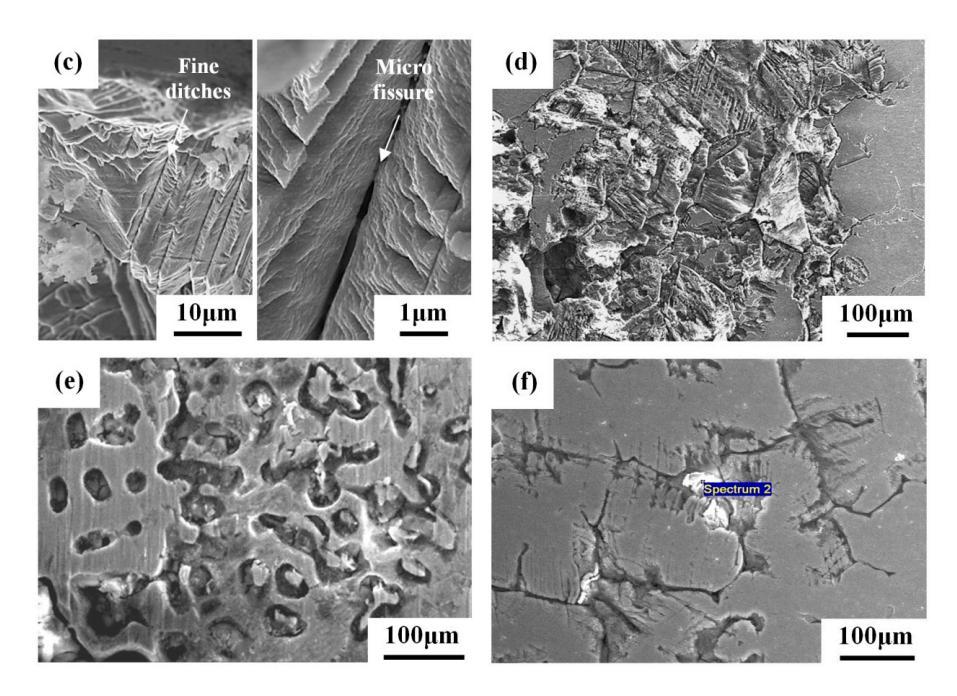
Figure 7. Cont.

The damaged surface morphologies of weight-loss specimens examined by SEM are shown in Figure 7. The results indicated that round surface pits were more likely to occur in the 304L-BM specimen (Figure 7a). Agglomeration of individual pits formed rusted spots on the surface of the 304L-BM specimen. In the 304L-CR specimen, surface damage preferentially selected the area with intense slip bands (Figure 7b). The intersections of slip bands corroded more severely and formed micro-pores therein. In addition to the surface corrosion, severe corrosion at the slip bands formed fine ditches, which were likely to turn into micro-fissures cutting into the specimens (Figure 7c). The surface features of the 304L-CRS specimen exhibited severe corrosion at the slip band, as with the 304L-CR specimen, and induced the growth of fine cracks along austenite grain boundaries (Figure 7d). In contrast, the metal dissolved preferentially at the interfaces between the skeletal structures and the austenite matrix, and some residual debris remained in the solidified structures in all of the 308L deposits (Figure 7e). Thus, metal dissolution at the interfaces of the skeletal structures of all the 308L deposits at different levels was responsible for the weight loss of the specimens in a salt spray. In addition to corrosion along the solidified boundaries, the slip bands in the 308L-CR specimen also corroded preferentially, just as what occurred in the 304L-CR specimen, as shown in Figure 7f. Furthermore, the large spall area in the solidified boundaries of the 308L-CRS specimen led to it having the highest weight loss of the specimens being tested.

Figure 7. SEM micrographs showing the surface morphologies of weight-loss specimens: (**a**) 304L-BM; (**b**,**c**) 304L-CR; (**d**) 304L-CRS; (**e**) 308L-AW; and (**f**) 308L-CR specimens.

With salt deposited on the surface, the sensitized 304/304L (650 °C/1 h) has a shorter rupture time than the unsensitized one at 80 °C at RH = 35% in the low applied stress region [3]. SEM morphology of the 304L-CRS specimens showed that severe corrosion occurred at the slip band and induced the growth of fine cracks along the austenite grain boundaries (Figure 7d) in the weight-loss tests. Furthermore, mainly transgranular cracks initiated at the slip band might then propagate in an intergranular manner in the 304L-CRS specimen in U-bend tests (Figure 9c). In prior studies, the cracks propagating along the austenite grain boundaries of sensitized 304L SS are associated with the formation of α' -martensite therein as the cracks grow [6,36]. As shown in Figure 6, the CRS specimen was more sensitive to SCC than the other specimens in each group. The CRS specimens were also known to have the highest weight loss of the specimens in each group (Figure 5). Therefore, the metal dissolution at the slip bands, austenite grain boundaries, or δ -ferrite/austenite interfaces in the CRS specimens were responsible for the crack initiation of SCC in a salt spray. Thus, the high SCC susceptibility of the 304L-CRS SS and 308L-CRS deposits are associated with the high weight loss of the alloy in a salt spray.

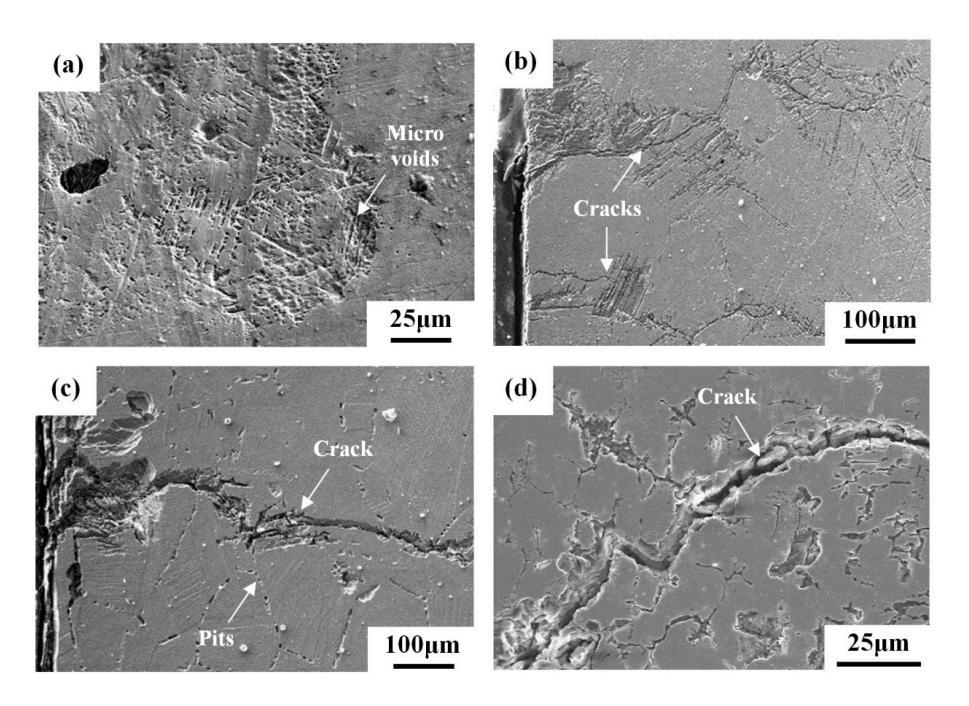
With the applied five percent strain in the U-bend specimens, the occurrence of deformation would introduce slip bands into the 304L-BM and 308L-AW specimens. A small sample was cut from the U-bend specimen and subjected to metallographic preparation for further inspection of the SCC cracks. Figure 8 shows the superficial crack path of the U-bend specimens after salt spray. The slip bands of the 304L-BM specimen assisted the formation of oriented microvoids (Figure 8a). The linking of microvoids in the 304L-BM specimen was expected to turn into microcracks if the testing interval had been prolonged. For the 304L-CR specimen, cracks initiated at the slip bands and might propagate parallel or transverse to the slip bands (Figure 8b). Stepwise crack growth was seen in the prior work studying the SCC of 304L in the salt-spray environment [6]. In the case of the 304L-CRS specimen, the cracks tended to initiate at the slip band and then might propagate along the prior austenite grain boundaries (Figure 8c). Furthermore, corrosion pits at the grain boundaries were more likely to be seen in the 304L-CRS specimen. Intergranular corrosion seemed to promote intergranular SCC of the 304L-CRS specimen. The surface morphology of the 308L deposit in the U-bend test was similar to that of its counterpart specimen in the weight-loss test. All 308L deposits exhibited crack growth mainly along the skeletal structure, irrespective of the specimen preparation (Figure 8d). Therefore, the dissolution of the skeletal structure to different degrees was the main cause of SCC of the 308L deposits. The large weight loss of the 308L-CRS specimen was confirmed by severe spalling of the skeletal structure in Figure 8d and was related to its high SCC susceptibility.

Figure 8. SEM micrographs showing the surface morphologies of U-bend specimens: (**a**) 304L-BM; (**b**) 304L-CR; (**c**) 304L-CRS; and (**d**) 308L-CRS specimens.

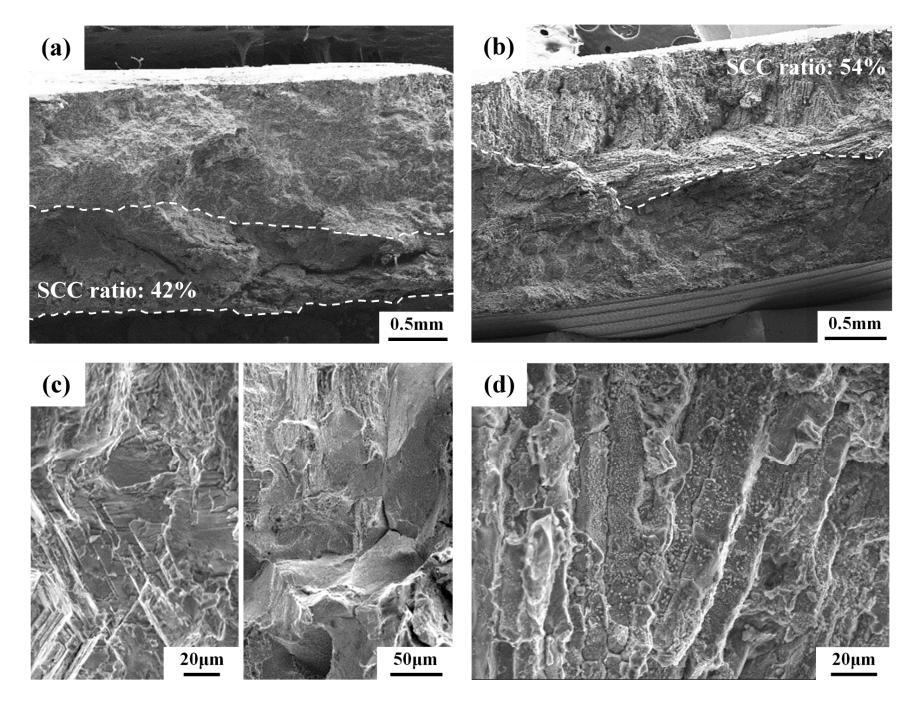
Figure 9 presents SEM micrographs showing the typical fracture morphology and the crack path of the U-bend specimens. After salt-spray tests, assorted specimen sizes were sliced from the tested specimen and then bent into two pieces after immersion in liquid nitrogen for a few seconds. Figure 9a,b reveal the halves of the broken specimens symmetrical to the centerline of the drilled hole. The SCC ratio is defined as the SCC region over the fracture surface inspected by SEM. The macroscopic fracture appearances of the 304L-CR and 304L-CRS specimens were similar (Figure 9a), showing mainly transgranular fracture at the crack initiation stage. Moreover, the fracture appearances of the 308L-CRS specimens were also alike, showing the features of an elongated solidified structure (Figure 9b). Inspection of the fracture surfaces of the U-bend specimens at higher magnifications by SEM, transgranular cracks initiated and propagated along the slip bands in the 304L-CR specimen (Figure 9c left), and mainly transgranular fractures mixed with fewer intergranular fractures were observed in the 304L-CRS specimen (Figure 9c right). In addition, the stress corrosion cracks of the 308L-CR and 308L-CRS specimens propagated along the solidified

boundaries (Figure 9d). It was obvious that the dissolution of the skeletal structure was the cause of the SCC of 308L deposits in a salt spray.

Figure 9. The SEM fractographs of the U-bend specimens after exposure to salt spray: macroscopic features of the (a) 304L-CRS and (b) 308L-CR specimens; microscopic features of the (c) 304L-CR (left) and 304L-CRS (right); and (d) 308L-CR specimens.
