# Article Pitting Initiation and Propagation of X70 Pipeline Steel Exposed to Chloride-Containing Environments

# Zixuan Yang <sup>1</sup>, Bo Kan <sup>1</sup>, Jinxu Li <sup>1,\*</sup>, Yanjing Su <sup>1</sup>, Lijie Qiao <sup>1</sup> and Alex A. Volinsky <sup>2</sup>

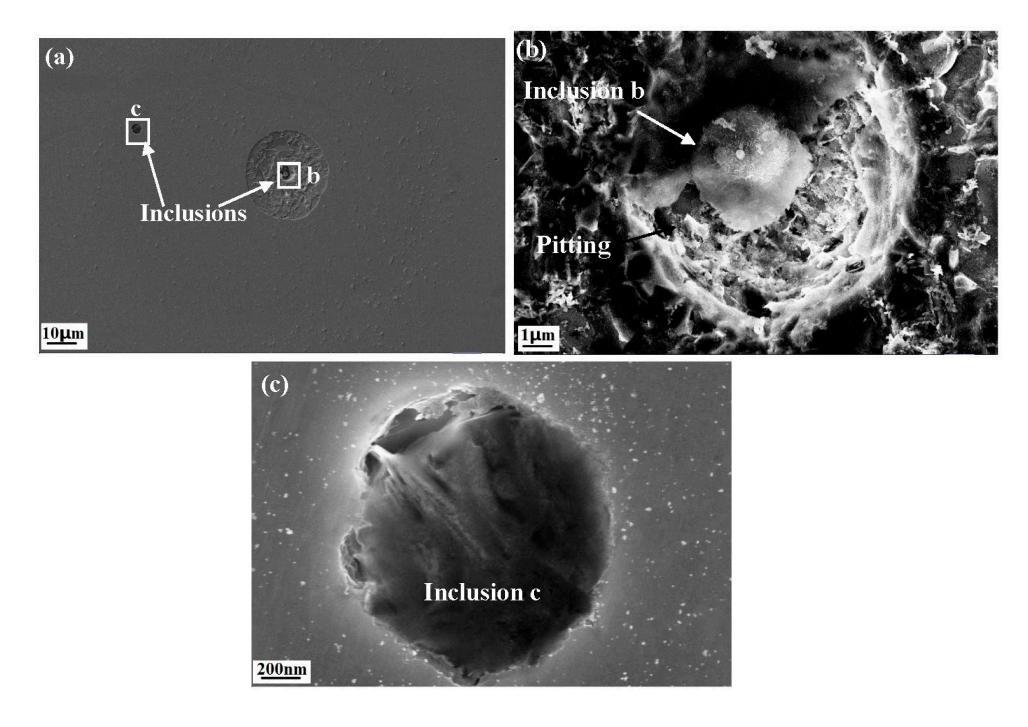
Figure 1 shows the X70 steel surface after 5 min immersion in 0.5 mol/L NaCl solution at 25 °C. There are two inclusions in the image, one of which had induced pitting, but the other did not. Figure 1a shows that corrosion initiates from the inclusion site and the corrosion products precipitate around the inclusion. Two inclusions are enlarged in Figure 1b,c. The elemental percentages of the two types of inclusions in Figure 1, obtained by EDS, are listed in Table 2. Based on the chemical composition, inclusions at the b position contain more sulphide, although it had been partially dissolved. These results indicate that different inclusions have different pitting resistance. The content of sulphide in inclusions plays a critical role in pitting initiation. Inclusions have both active and non-active components, and an active inclusion is an anode, which gets dissolved first. These results show good agreement with the pitting behavior of inclusions in steel [11,13].

**Figure 1.** Corrosion morphology of the X70 steel after 5 min immersion in 0.5 mol/L NaCl solution: (a) overall morphology; local morphology of (b) inclusion b and (c) inclusion c.

Table 2. Element percentages of the inclusions in Figure 1, obtained by EDS.

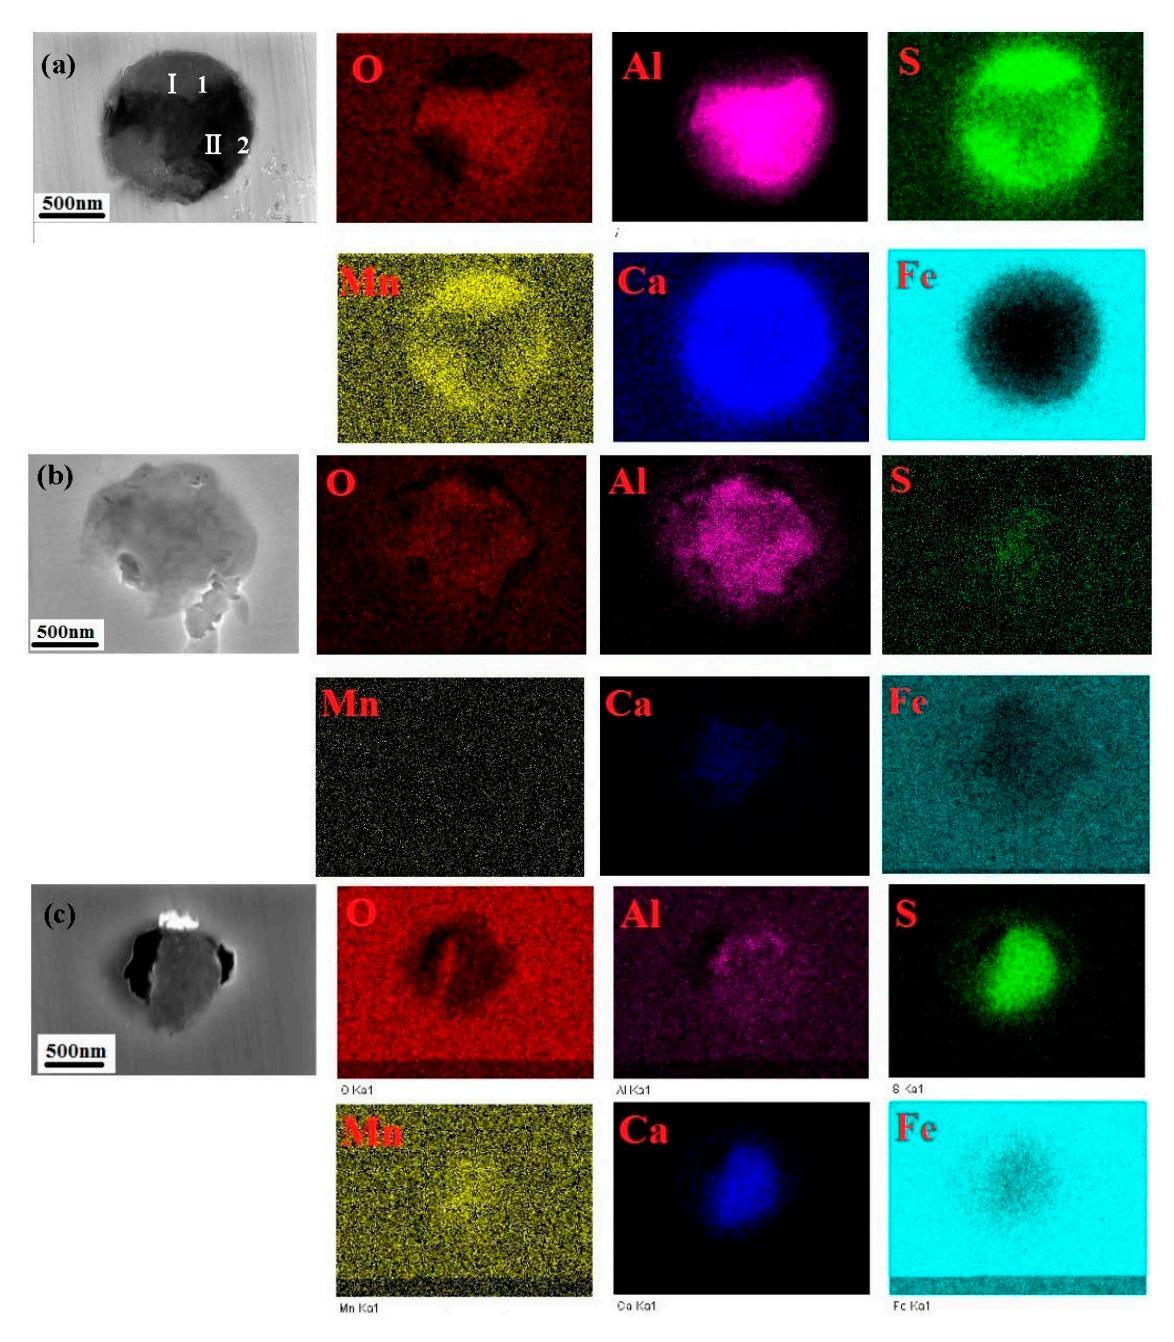
The elemental mapping analysis results of the inclusions in the X70 steel are shown in Figure 2. There are three inclusion types in the steel. Figure 2a shows that the type A inclusion consists of two parts; one part of the inclusion is rich in Mn, Ca and S, and the other part of the inclusion is rich in Al, Ca and O. Two part inclusions can be clearly distinguished from the morphology. This distribution of chemical composition and thermodynamic calculations [3,11] indicates that the complex inclusion is composed of the two different particles: (Al, Ca)O and (Mn, Ca)S.

Figure 2b shows that the type B inclusion is rich in Al, Ca and O. In addition, small amounts of Mn and S elements are embedded in the inclusion. The type B inclusion is named the (Al, Ca)O inclusion. Figure 2c shows that the type C inclusion is rich in Mn, Ca and S. Small amounts of Al and O are embedded in the inclusion, and the type C inclusion is named the (Mn, Ca)S inclusion.

Figure 2. EDS composition maps of the inclusions in X70 steel: (a) Type A; (b) Type B and (c) Type C.

Table 3 shows the chemical composition of the inclusions shown in Figure 2. The three types of inclusions all contain Mn, S, Ca, Al and O, but the amounts of these elements in the inclusions are obviously different. Type B inclusions contain more oxides, while type C inclusions contain more sulphides.

Figure 2 shows that there are three inclusion types in the X70 pipeline steel. Their pitting corrosion resistance is very different, according to the corrosion test results in Figure 7: type A < type C < type B. AFM results indicate that there is a potential difference between the inclusion and the metal matrix. The (Mn, Ca)S inclusion potential is higher than the matrix, while the (Al, Ca)O inclusion potential is lower than the matrix. Galvanic corrosion occurs at inclusions sites. Researchers have reported that inclusions induce galvanic corrosion in stainless steel [3,6].

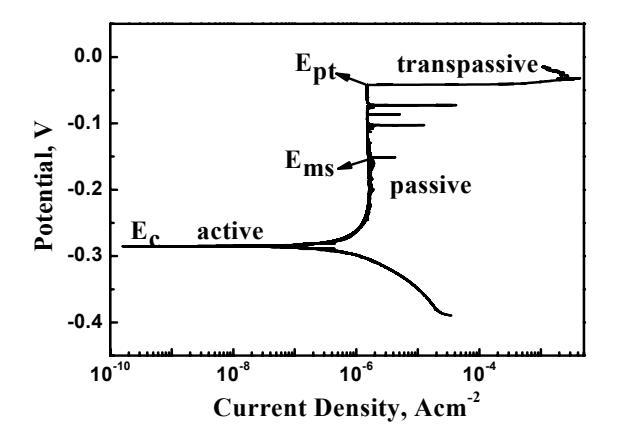
Figure 3 shows the representative potentiodynamic polarization curve of the X70 steel in  $0.1 \text{ mol/L NaCl} + 0.5 \text{ mol/L NaHCO}_3$  neutral pH solution. Active, passive and transpassive regions were identified in the potentiodynamic polarization curve. The appearance of current fluctuations in the passive region provides evidence that passivity is not stable, indicative of pitting corrosion [25]. This transience indicates active and repassivation processes of metastable pits. In the polarization curve, the potential corresponding to the first peak is referred to as the metastable pitting potential  $E_{ms}$  and the potential from which the current increases continually is denoted as the pitting potential  $E_{pit}$ .

**Figure 3.** Potentiodynamic polarization test results of the X70 steel in 0.1 mol/L NaCl and 0.5 mol/L NaHCO<sub>3</sub> neutral pH aqueous solutions.

According to the potentiodynamic polarization test results, the dissolution and passivation of inclusions are in competition. The inclusion dissolution rate is much slower than passivation. The inclusion is protected by passive film and not dissolved (Figure 4a). When the dissolution rate of the inclusion is much higher than the passivation, the inclusion will gradually dissolve, leading to the metal matrix being exposed to the corrosive solution (Figure 4c). The active process occurred. The metal matrix can still be passivated at this passive region potential. The repassivation process occurred.

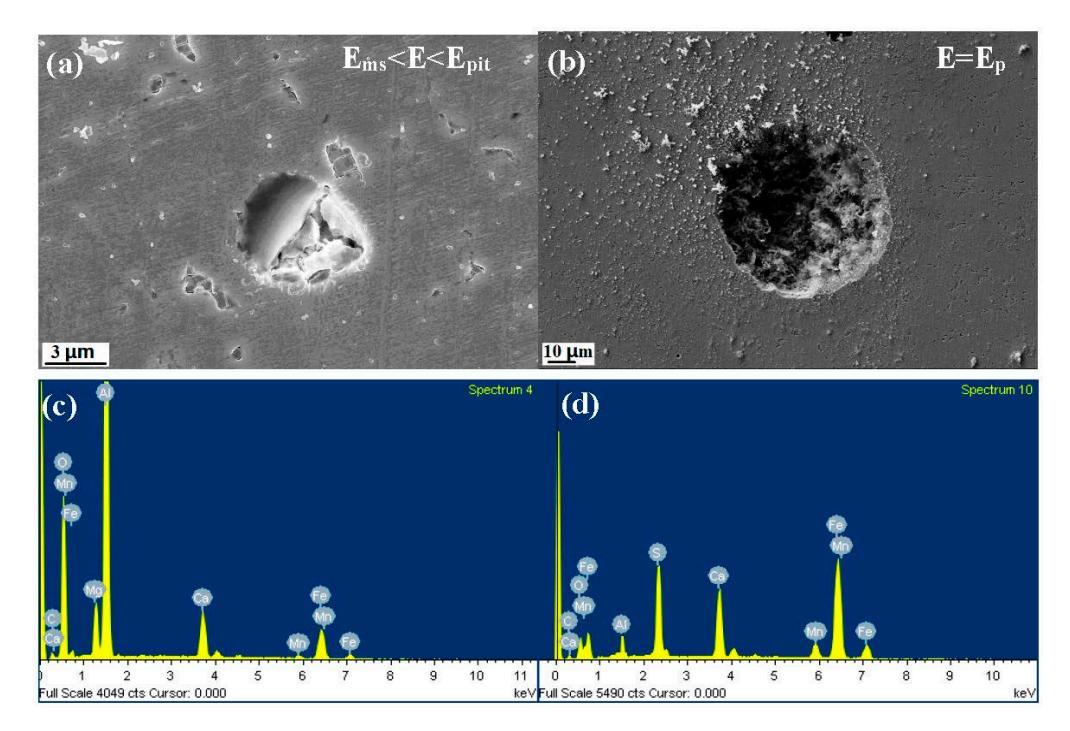
Figures 4–6 show the morphology and EDS analysis of metastable pitting at inclusion sites after potentiodynamic polarization tests. When the polarization potential E is 30 mV above  $E_{ms}$  ( $E_{ms} < E < E_{pit}$ ), pitting was clearly generated at the inclusions' positions. The passive film of the type A inclusion is broken at the site rich in Mn, Ca and S, as seen in Figure 4a,d. As seen in Figure 5a,c, the type B inclusion is rich in Al, Ca and O, and the passive film of the type B inclusion is intact. Figure 6a,c show that the type C inclusion is rich in Mn, Ca and S, the passive film of the type C inclusion is broken through and the inclusion is partially dissolved. The passive films of the type A and C inclusions are easier to break than the metal matrix surface.

With the increase of anodic potential, the inclusions were observed at the  $E = E_p$  potential. The type A inclusion had induced stable pitting (Figure 4b). The passive film of the type B inclusion began to rupture inside the inclusion and at the interface between the inclusion and the metal matrix (Figure 5b). The type C inclusions had induced stable pitting, where smaller inclusions were residues, as seen in Figure 6b,d.

**Figure 4.** The morphology and EDS analysis of metastable pits at type A inclusion sites after the potentiodynamic polarization test. (**a**,**c**):  $E_{ms} < E < E_{pit}$ ; (**b**,**d**):  $E = E_{pit}$ .

Previous work found that metastable pits can be induced by inclusions. Meanwhile, Punckt et al. found that some metastable pits are active, but others are inactive. Active pits can remain metastable during the sharp rise in the corrosion rate [13]. The result shows that type A and C inclusions can lead to continuous metastable pitting corrosion. Type B inclusions cannot lead to metastable pitting corrosion generated continuously because stable passivation film is formed at the type B inclusion position. Thus, type A and C are active inclusions and type B is an inactive inclusion.

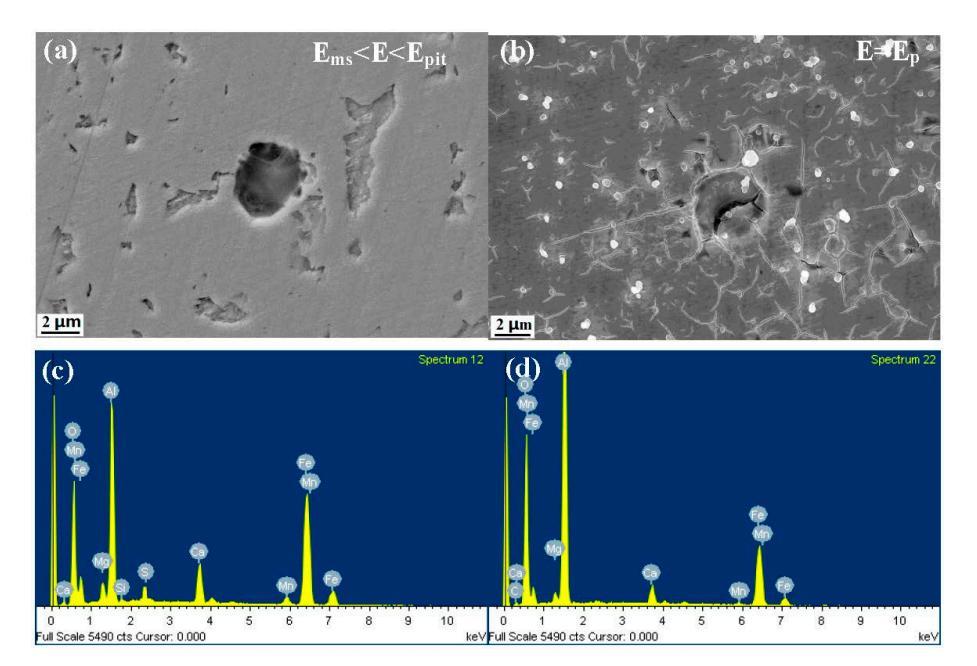
**Figure 5.** The morphology and EDS analysis of metastable pits at type B inclusion sites after the potentiodynamic polarization test. (**a**,**c**):  $E_{ms} < E < E_{pit}$ ; (**b**,**d**):  $E = E_{pit}$ .

These results, obtained from the SKPFM Volta potential images, indicate that the (Al, Ca)O inclusions have a lower corrosion tendency compared with the matrix and the (Mn, Ca)S inclusions have a higher corrosion tendency compared with the matrix. These results are in agreement with the corrosion tests (Figure 5a).

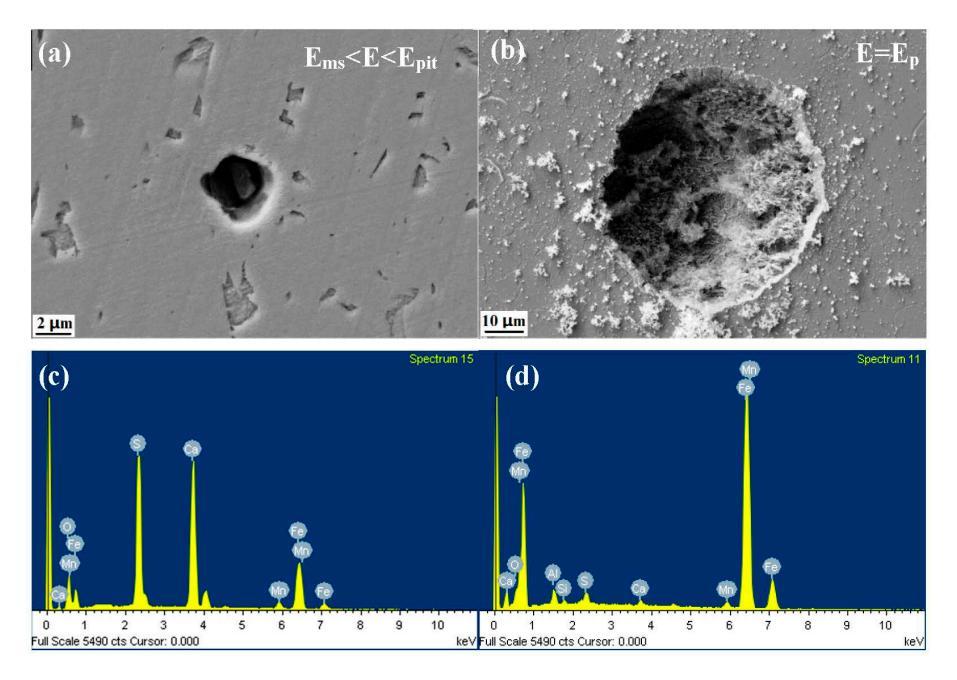
**Figure 6.** The morphology and EDS analysis of metastable pits at type C inclusion sites after the potentiodynamic polarization test. (**a**,**c**):  $E_{ms} < E < E_{pit}$ ; (**b**,**d**):  $E = E_{pit}$ .

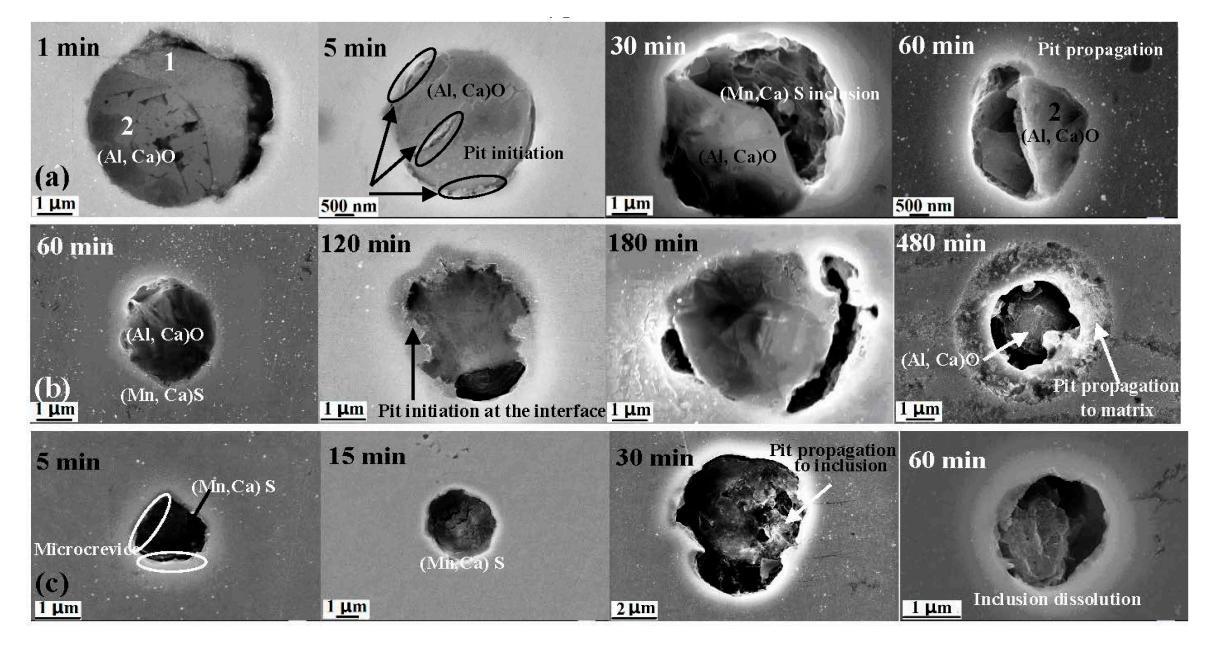
Figure 7 shows images of the three types of inclusions in the X70 steel after immersion corrosion tests in 0.1 mol/L NaCl and 0.5 mol/L NaHCO<sub>3</sub> solutions at 25 °C. As seen in Figure 7a for the type A inclusion, pitting corrosion was first initiated at the interface between the metal matrix and the (Mn, Ca)S inclusion part when the immersion time was 1 min. When the immersion time was prolonged to 5 min, pitting corrosion of the type A inclusion did not propagate from the interface into the matrix, but propagated to the (Mn, Ca)S inclusion. When the immersion time was prolonged

to 60 min, pitting corrosion began in the matrix, but did not propagate to the (Al, Ca)O inclusion. Therefore, this indicated that in the X70 steel, the resistance to pitting corrosion for inclusions rich in Mn, Ca and S was lower than the metallic matrix and the type A inclusion was lower than the metallic matrix.

**Figure 7.** SEM images of three types of inclusions after initiation and propagation of pitting corrosion in X70 steel: (**a**) Type A; (**b**) Type B and (**c**) Type C.

However, for the type B inclusion, pitting did not initiate when the immersion time was 60 min, as seen in Figure 7b. Pitting corrosion began to initiate at the interface between the metal matrix and the (Al, Ca)O inclusion when the immersion time was 120 min. The pitting initiation time of the type B inclusion was much longer than the type A inclusion. When the immersion time was prolonged to 180 min, the pitting corrosion of the X70 steel did not propagate to the stable (Al, Ca)O inclusion, but propagated to the metal matrix. The corrosion of the (Al, Ca)O inclusion and the metal matrix became more serious. When the immersion time was prolonged to 480 min, the residual inclusion was in the metal matrix, and pits propagated further into the metal matrix. This indicated that the resistance to pitting corrosion of the type B inclusion was higher than the metal matrix.

For the type C inclusion, pitting corrosion had initiated at the interface area between the metal matrix and (Mn, Ca)S inclusion when the immersion time was 1 min. When the immersion time was prolonged to 5 min, pitting corrosion of the X70 steel did not propagate from the interface area into the matrix, but propagated to the sulfide inclusions. When the immersion time was prolonged to 30 min, the metal matrix was exposed in solution when the manganese sulfide inclusions were dissolved further. Therefore, this indicated that in the X70 steel the resistance to pitting corrosion for inclusions, such as (Mn, Ca)S, was lower than the metal matrix.

Table 4 shows the element percentages of the three inclusion types after immersion for different times. For the type A inclusion, Mn, Ca and S percentages of the rich (Mn, Ca)S part were greatly reduced, while the element content of the (Al, Ca)O part showed little change after immersion for 60 min. For the type B inclusion, the element content did not significantly change after immersion for 480 min. For the type C inclusion, Al and O percentages were slightly reduced, while Mn, Ca and S percentages were greatly reduced. These results indicate that Mn, Ca and S elements are easily dissolved. These results obtained from the corrosion attack tests indicate that the pitting corrosion resistance type A < type C < type B; (Mn, Ca)S inclusion < matrix < (Al, Ca)O inclusions.

Table 4. Element percentages of inclusions in Figure 7, obtained by EDS.

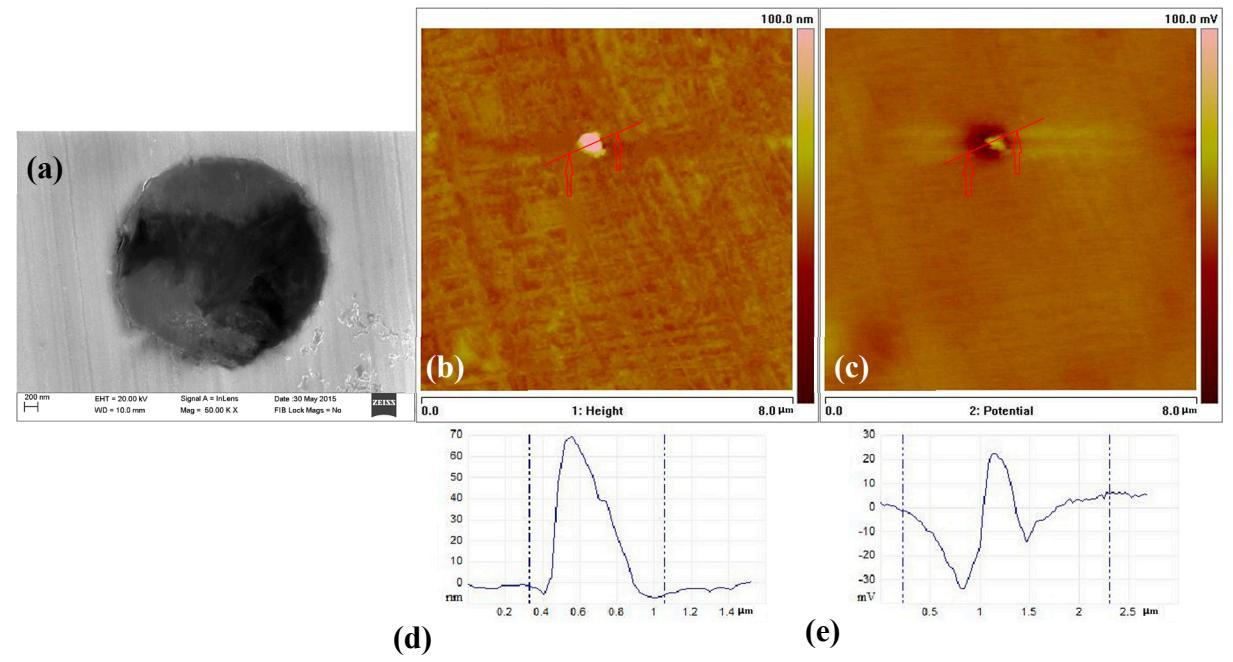
AFM morphology and Volta potential images of the type A inclusions are shown in Figure 8. The height variation in the surface was less than 2 nm with a spike and a little scratch in Figure 8d. Thus, the surface of the specimen can be considered flat. The higher (brighter) surface of the area was of the type A inclusion with a maximum height of 66 nm (Figure 8d). The inclusion slightly protruded after polishing because of the difference in hardness. On the other hand, variations in the Volta potential are clearly seen in Figure 8c. Both lower and higher potentials were observed around the inclusion. Low Volta potential indicates low relative corrosion resistance, while higher Volta potential indicates higher relative corrosion resistance. It is clearly seen that the (Al, Ca)O inclusion part had higher potential and the (Mn, Ca)S part had lower potential.

**Figure 8.** SEM and SKPFM images around the type A inclusion: (**a**) SEM image; (**b**) AFM topography image; (**c**) Surface potential distribution of the same area; (**d**) Topography section analysis and (**e**) Section analysis of the surface potential.

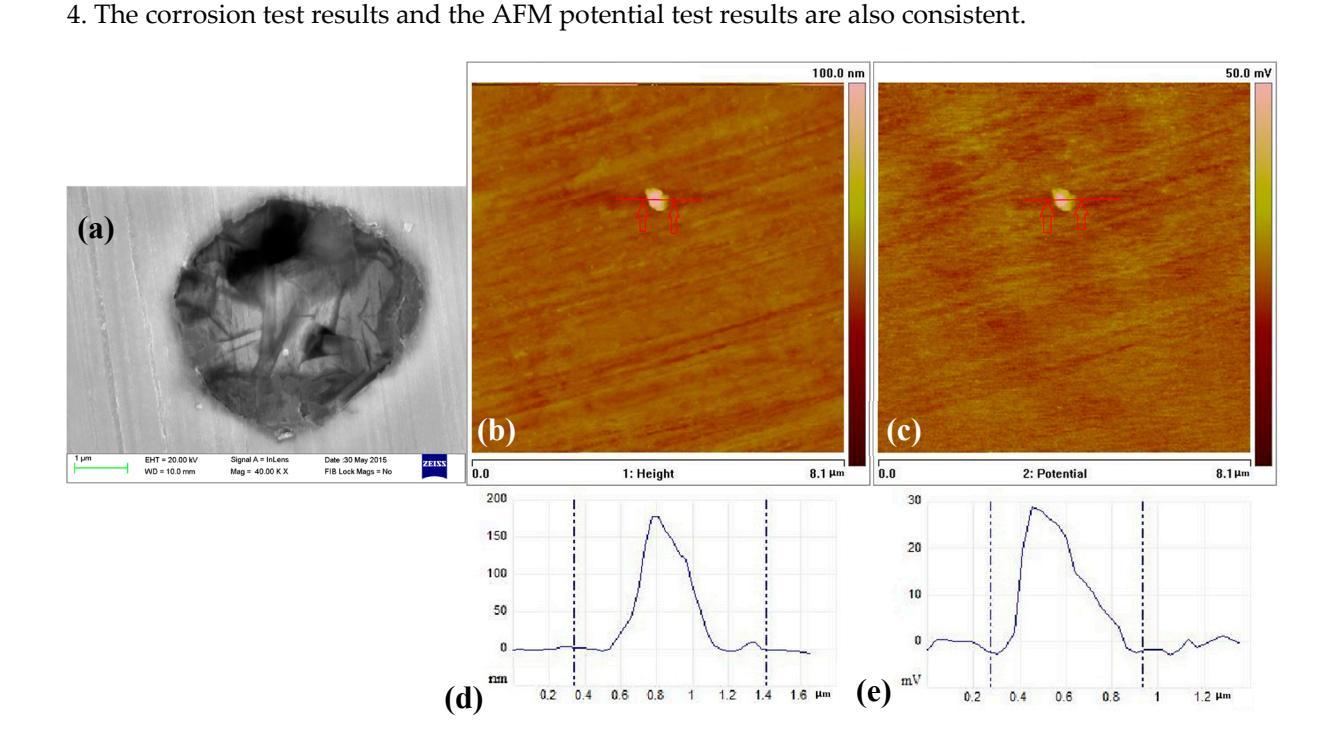
Figure 9 shows the AFM morphology and Volta potential images of the type B inclusions. The higher (brighter) surface of the area was of the type B inclusion with a maximum height of 175.7 nm (Figure 9b). On the other hand, higher potential was observed around the type B inclusion. This indicates that the type B inclusion has higher relative corrosion resistance than the metal matrix. A lower potential was observed around the interface between the inclusion and the matrix. This indicates that the interface has lower corrosion resistance than the metal matrix. Figure 6b shows that the pitting corrosion began to initiate at the interface between the metal matrix and the inclusion. Suter and Böhni [30,31] demonstrated via microelectrochemical capillary investigations that the electrochemical reactivity was highest at the inclusion and metal interface, and not in the inclusion and the matrix. The metal matrix. The metal surface near the inclusion is rougher than the surface of the metal matrix. Thus, metal near the inclusion has higher energy than the metal matrix. The corrosion resistance near the inclusion is much worse than the metal matrix, as seen in Figure

**Figure 9.** SEM and SKPFM images around the type B inclusion: (**a**) SEM image; (**b**) AFM topography image; (**c**) Surface potential distribution of the same area; (**d**) Topography section analysis; (**e**) Section analysis of the surface potential.

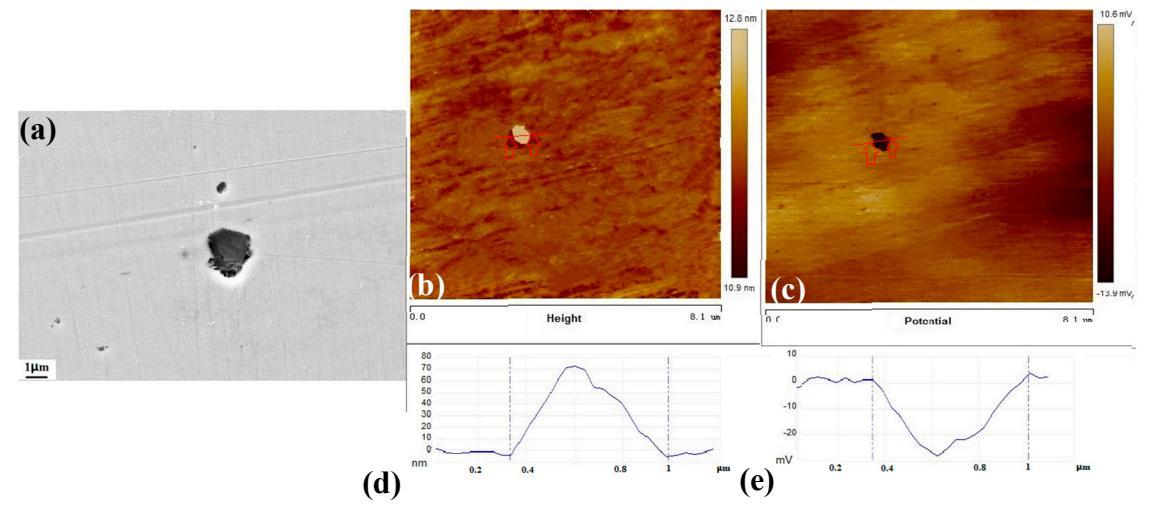
Figure 10 shows the AFM morphology and Volta potential images of the type C inclusions. The higher (brighter) surface of the area was of the type C inclusion with a maximum height of 71.7 nm (Figure 10b). On the other hand, lower potential was observed around the type C inclusion. This indicates that the type C inclusion has lower relative corrosion resistance than the metal matrix. This result is in agreement with the corrosion test (Figure 7c).

**Figure 10.** SEM and SKPFM images around the type C inclusion: (**a**) SEM image; (**b**) AFM topography image; (**c**) Surface potential distribution of the same area; (**d**) Topography section analysis; (**e**) Section analysis of the surface potential.

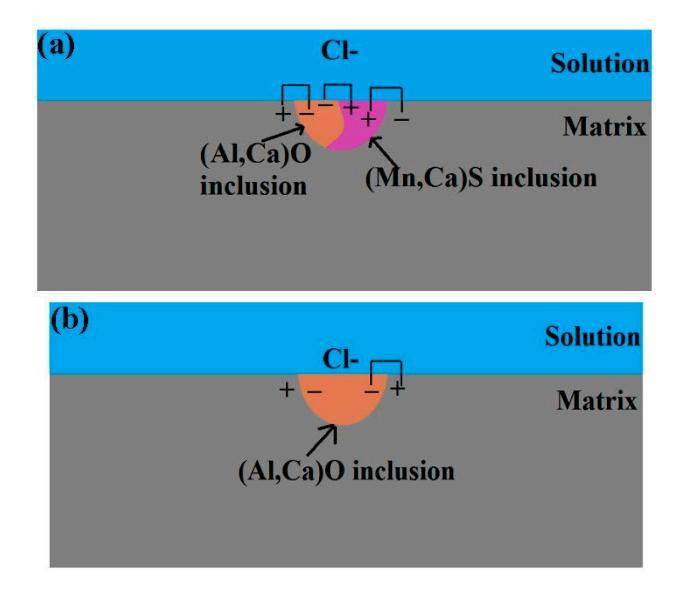
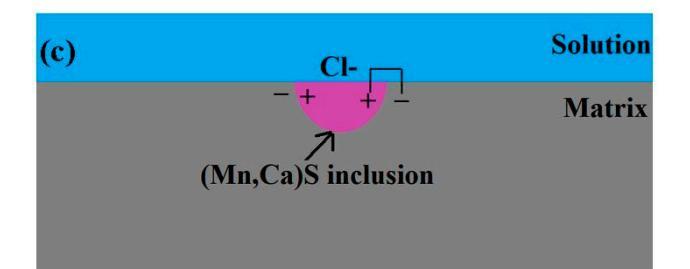
According to the above results and analysis, the mechanisms for the initiation and propagation of pitting corrosion in the X70 steel are schematically presented in Figure 11. For the type A inclusion, the inclusion potential is as follows: (Mn, Ca)S inclusion < matrix < (Al, Ca)O inclusion, with the three galvanic cells in the type A inclusion area. The potential difference is the largest between the (Mn, Ca)S and (Al, Ca)O inclusions. Thus, the first (Al, Ca)O part is the cathode and the (Mn, Ca)S part is the anode. Pitting would initiate in 30 min at the (Mn, Ca)S inclusion part, as shown in Figure 7a. When the (Mn, Ca)S inclusions were dissolved, another galvanic corrosion occurred, where the (Al, Ca)O part is the cathode and the matrix is the anode. Pitting corrosion began to propagate to the matrix, as seen in Figure 7a. The pitting corrosion process includes pit initiation and propagation at the (Mn, Ca)S inclusion, followed by pit propagation to the interface between the (Al, Ca)O inclusion and the matrix, and pit propagation to the matrix, forming a stable pit.

**Figure 11.** Schematic diagram of the inclusions' effects on pitting corrosion initiation in X70 steel: (a) Type A; (b) Type B and (c) Type C.

Figure 7 shows that higher potential was observed around the type B inclusion and a lower potential was observed around the interface between the inclusion and the matrix. The schematic diagram includes only one galvanic cell in the type B inclusion area, where the inclusion is the cathode and the metal matrix is the anode. The pitting corrosion process includes pit initiation at the interface between the (Al, Ca)O inclusions and the matrix, followed by pit propagation to the matrix, forming a stable pit.

In the case of the type C inclusion, the pitting corrosion process includes pit initiation at the interface between the (Mn, Ca)S inclusion and the matrix, followed by pit propagation to the (Mn, Ca)S inclusion and the matrix, forming a stable pit.
