Article Effects of CTC_P Modification on Microstructure and Wear Behavior of CTC_P-NiCrBSi/Heat Resistant Steel Composite Layer

Jianjun Zhang ^{1,2,*} and Shuzeng Hou ^{3,*}

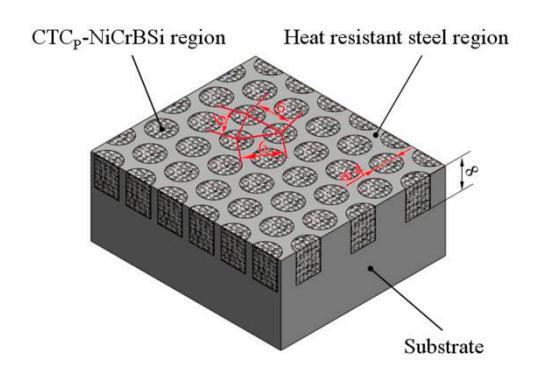
Figure 1. Schematic diagram of the CTC_P-NiCrBSi/heat resistant steel composite layer (Dimensions are in mm).

In the present work, a CTC_P-NiCrBSi/heat resistant steel composite layer similar to concrete in architecture was designed and fabricated by vacuum fusion sintering. Figure 1 presents the schematic diagram of the composite layer. The CTC_P-NiCrBSi/heat resistant steel composite layer was composed of many discrete circular reinforced regions distributed uniformly in the heat resistant steel region. The discrete reinforced region was comprised of the CTC_P-NiCrBSi composite. The continuous heat resistant steel region extended down into substrate. In this architectural structure, the discrete CTC_P-NiCrBSi regions could better strengthen the layer and the softer continuous heat resistant steel region could better toughen the layer, simultaneously. The effects of CTC_P modification on the microstructures and wear behaviors of the CTC_P-NiCrBSi/heat resistant steel composite layers are carried out below.

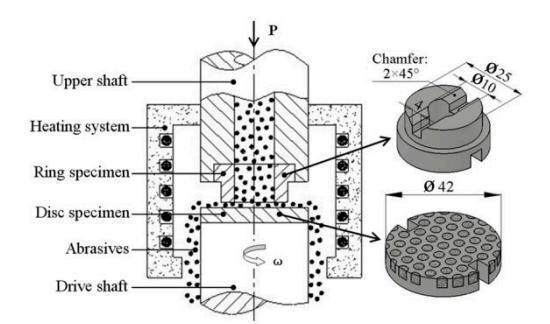
Figure 2. Schematic diagram of the abrasion test rig and the specimens (Dimensions are in mm).

Abrasion tests were conducted in a ring-on-disc rig with interfacial abrasive particles at a temperature range of room temperature (RT) to 800 °C in air. The schematic diagram of the abrasion test rig and the specimens are shown in Figure 2.

The ring material used in this study was high Cr white cast iron with a hardness of HRC55. The disc specimens were made from the CTC_P-NiCrBSi/heat resistant steel composite layers. Angular quartz sand (HV980~1100) [15] with a grain size between 180 and 380 μ m was used as the abrasive. The ring and disc rotated with a relative speed of 50 rpm (giving a linear speed of 0.04579 m/s) under a load of 20 N. After a wear distance of 82.422 m, the tests were stopped and the mass losses of the disc were measured using an electronic balance with an accuracy of 0.0001 g. From the mass loss of the disc and the length of wear path, wear rate W_a was derived according to the following equation:

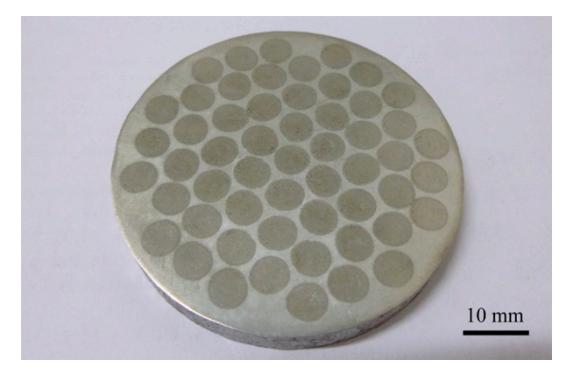
Figure 3. Macrograph of the CTC_P-NiCrBSi/heat resistant steel composite layer fabricated.

Shrinkage of the powder mixture in the holes led to a wavy surface of the CTC_P -NiCrBSi/heat resistant steel composite layer during fusion sintering. Figure 3 shows the macrograph of the CTC_P -NiCrBSi/heat resistant steel composite layer fabricated in this study after the wavy surface was planned. It can be seen that the CTC_P -NiCrBSi/heat resistant steel composite layer fabricated is the composite layer had no obvious defects such as cracks and pores.

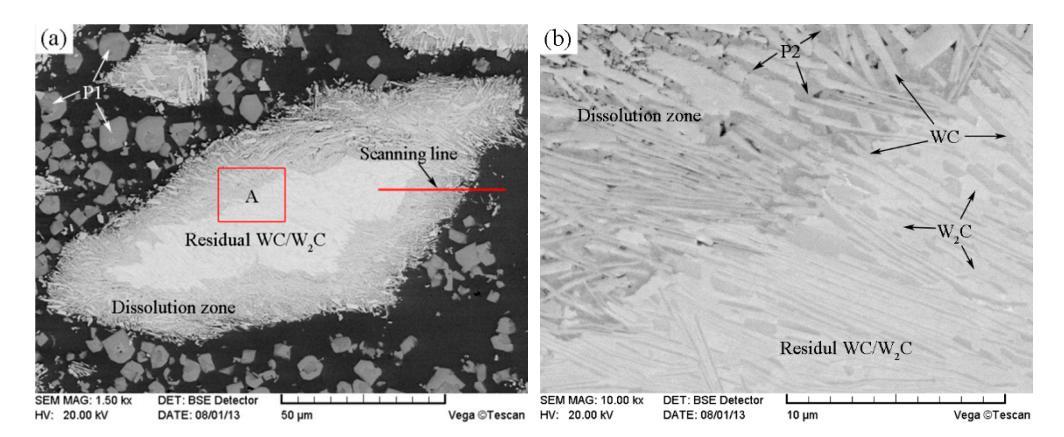
Figure 4. (**a**) SEM image of the unmodified CTC_P-NiCrBSi, and (**b**) magnified SEM image of the zone "A" in (**a**).

Figure 4 shows the SEM images of the unmodified CTC_P -NiCrBSi region in the unmodified CTC_P displayed CTC_P -NiCrBSi/heat resistant steel composite layer. It is evident that the unmodified CTC_P displayed considerable dissolution and a small amount of primary CTC was left in the core. A considerable number of blocky precipitates (marked as P1) away from the CTC were formed in the NiCrBSi matrix (Figure 4a). EDS spot analysis confirmed that they were (W, Ni, Cr)-rich carbides. The magnified image shows more details of the CTC and the dissolution zone (Figure 4b). The lamellar dual-phase structure of the CTC can be clearly distinguished where the brighter phase containing approximately 66 at. % W was W_2C ; and the slightly darker phase containing approximately 50 at. % W was WC. In the dissolution zone, the slightly darker strip phase containing approximately 50 at. % W was WC, which should be the residual phase from the CTC; the darker phase (marked as P2) was (W, Ni)-rich carbide, which should be the reaction product of W_2C with a NiCrBSi matrix. The result of the EDS line scan through the dissolution zone, the Ni, Fe, and Cr contents increased and the W content decreased from CTC to the NiCrBSi matrix and the gradient of concentration was gradual, which indicates that strong elemental diffusion occurred in the dissolution zone.

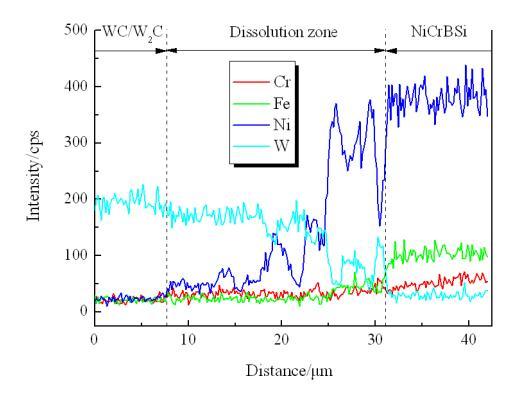
Figure 5. EDS line scan from unmodified CTC_P to NiCrBSi.

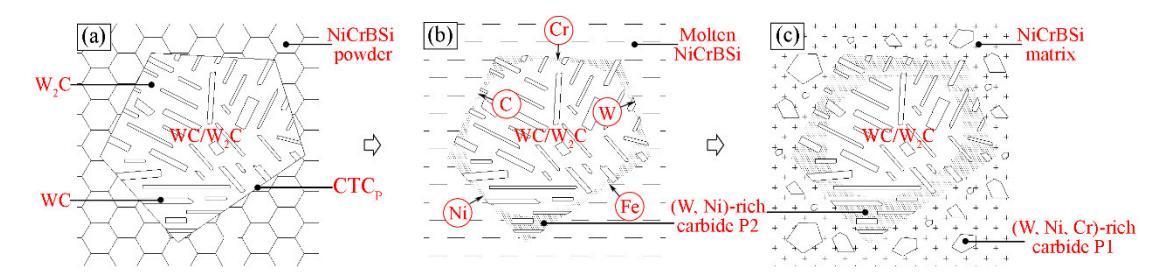
Figure 6. Dissolution schematic diagram of the unmodified CTC_P in NiCrBSi alloy: (**a**) Before sintering; (**b**) Interdiffusion of elements and (W, Ni)-rich carbide forming; (**c**) (W, Ni, Cr)-rich carbide precipitating.

In the following, we would like to explain the dissolving behavior of CTC_P in the NiCrBSi matrix. Figure 6 describes the dissolution mechanism according to the above results. Before vacuum fusion sintering, the CTC_P was surrounded by NiCrBSi alloy powder (Figure 6a). During the sintering, the NiCrBSi alloy powder became a liquid phase because of its low melting point, and element interdiffusion occurred between molten NiCrBSi and CTC_P . Elements such as Ni, Cr, and Fe diffused from the molten NiCrBSi to CTC_P while the W and C diffused in the opposite direction. In the diffusion process, the W_2C phase in CTC_P reacted with Ni, Cr, and other elements diffusing from the molten matrix to form (W, Ni)-rich carbide, while the WC phase remained mostly intact (Figure 6b). Elements such as Ni, Cr, and Fe in molten NiCrBSi reacted with W and C diffusing from CTC_P to form (W, Ni, Cr)-rich carbides, which were precipitated from the melt during subsequent cooling (Figure 6c). This diffusion reaction is similar to the work of Molina [16].

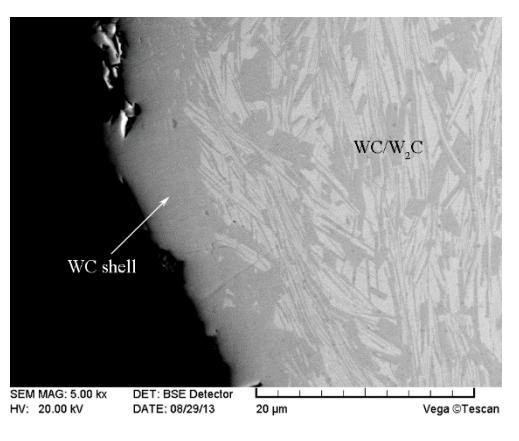
Figure 7. SEM image of the modified CTC_P.

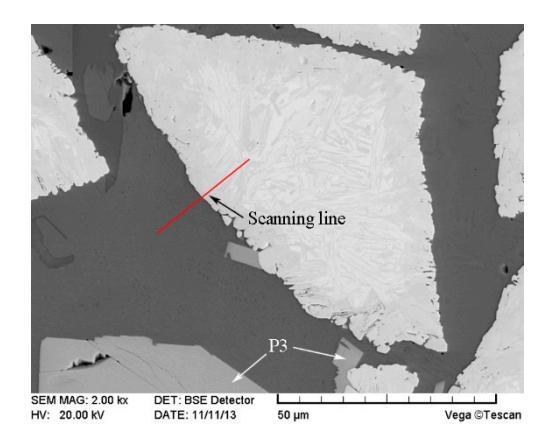
Figure 8. SEM image of the modified CTC_P-NiCrBSi.

The SEM image of the modified CTC_P -NiCrBSi region in the modified CTC_P -NiCrBSi/heat resistant steel composite layer is shown in Figure 8. It is evident that the dissolution of the CTC_P was largely suppressed. The result of the EDS line scan through the interface between the modified CTC_P and NiCrBSi matrix is shown in Figure 9 (scanning line see Figure 8). It is evident that both the outer shell and inner core of the modified CTC_P were W-rich with no evidence of nickel. There was a clear boundary between the modified CTC_P and the NiCrBSi matrix due to the steep decline in Ni, Fe, and Cr contents and the sharp rise in W content at the interface. A small amount of blocky precipitates (marked as P3) still formed in the matrix. EDS analysis showed that they were also (W, Ni, Cr)-rich carbides which contained more Cr and less W, Ni when compared with that of P1. The formation of P3 might be related to free carbon increasing in the modified CTC_P during the carburizing process.

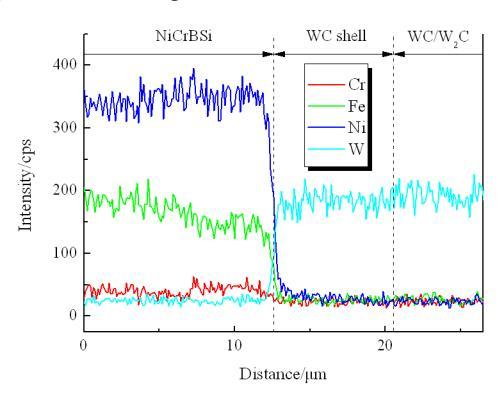
Figure 9. EDS line scan from NiCrBSi to the modified CTC_P.

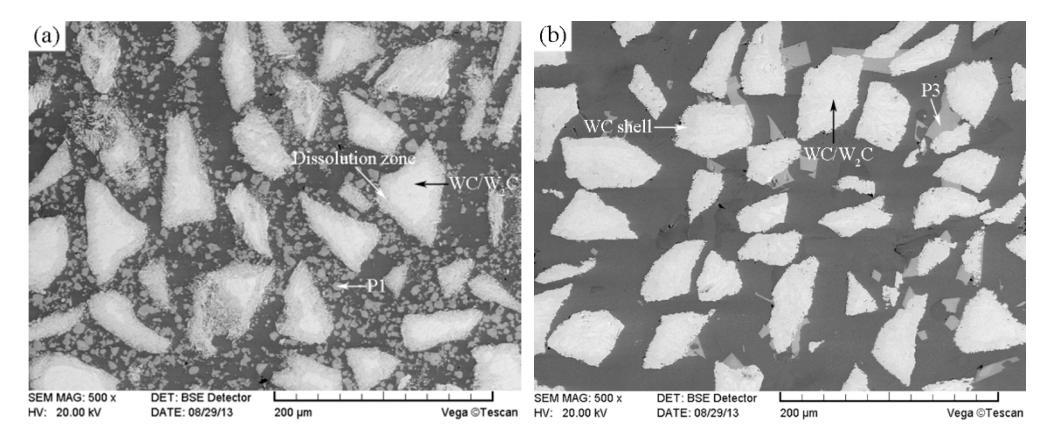
Figure 10. Typical SEM images of (**a**) the unmodified, and (**b**) the modified CTC_P-NiCrBSi used for quantitative image analysis.

The volume fraction and microhardness of the microstructure constituent in CTC_P-NiCrBSi region were determined as they are key factors affecting the abrasion resistance of the CTC_P-NiCrBSi/heat resistant steel composite layers. Figure 10 shows typical SEM images of the unmodified and the modified CTC_P-NiCrBSi regions, which were used for image analysis. It can be seen that the unmodified CTC_P displayed excessive dissolution. The microstructure of the unmodified CTC_P-NiCrBSi was composed of WC/W₂C, dissolution zone, precipitate P1, and the NiCrBSi matrix (Figure 10a). The modified CTC_P were not affected by dissolution. The microstructure of the modified CTC_P-NiCrBSi was composed of WC/W₂C, WC shell, precipitate P3, and the NiCrBSi matrix (Figure 10b). The volume fraction measurement results of the microstructure constituents are listed in Table 1. In the unmodified CTC_P-NiCrBSi region, the dissolution zone of the CTC_P reached 32.7 vol. % and the residual WC/W₂C eutectic left in the cores was only 7.5 vol. % and the blocky precipitate P1 was up to 18.2 vol. %. In the modified CTC_P-NiCrBSi region, the WC shell took up 20.1 vol. % and the WC/W₂C eutectic occupied 19.5 vol. % and the blocky precipitate P3 was only 3.2 vol. %. Compared with the unmodified CTC_P-NiCrBSi region, an increase of about 12.0 vol. % was achieved in the content of the WC/W₂C eutectic remaining in the modified CTC_P-NiCrBSi region.

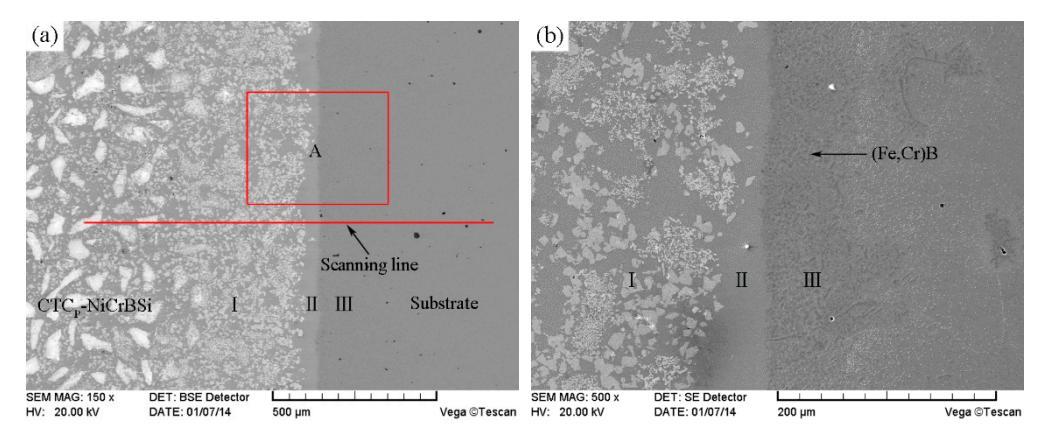
Figure 11. (**a**) SEM image of the interface between unmodified CTC_P-NiCrBSi and substrate and (**b**) magnified SEM image of the zone "A" in (**a**).

Figure 11 shows the SEM images of the interface between the unmodified CTC_P-NiCrBSi and the substrate. It can be seen that a transition layer consisting of three zones formed, which indicates the existence of metallurgical bonding in the interface. From the element distribution profile of the interface in Figure 12 (scanning line see Figure 11a), it is clear that there was a gradual increase in the Fe and Cr contents and a gradual decrease in the W content when the location transited from the unmodified CTC_P-NiCrBSi to the substrate. This indicates that the dissolution of the substrate and the interdiffusion of elements might take place in the interface. Starting from the unmodified CTC_P-NiCrBSi and crossing the transition layer, the first zone (labeled as I) was characterized by the unmodified CTC_P being completely dissolved where not only the W_2C , but also the WC in CTC_P was dissolved. The excessive dissolution of the unmodified CTC_P in this zone might have been caused by the increasing content of Cr and Fe elements which are relatively strong carbide formers. The second zone (labeled as I) was narrower and was constituted by a single phase. EDS analysis results indicated that it was a layer of γ -Ni solid solution rich in Fe, Cr. Therefore, the second zone should belong to the isothermally solidified zone. The third zone (labeled as II) was characterized by many precipitating fine granules (Figure 11b). The fine granules were rich in Cr and Fe elements and their microhardness reached HV900. The fine granules could be (Fe, Cr)B precipitates [17]. So, the third zone should belong to the diffusion affected zone. Figure 13 shows the SEM image of the interface between the modified CTC_P-NiCrBSi and substrate. It can be seen that the interface also consisted of three zones, but the first zone narrowed down a lot as the modified CTC_P had a higher chemical resistance.

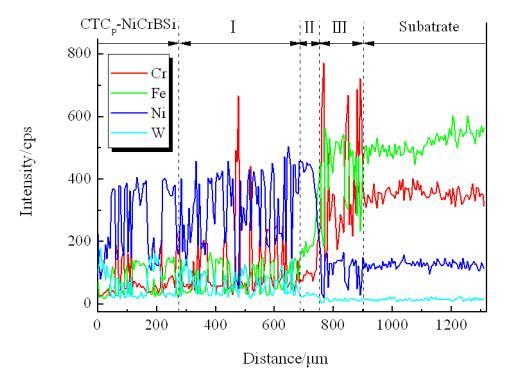
Figure 12. EDS line scan from unmodified CTC_P-NiCrBSi to substrate.

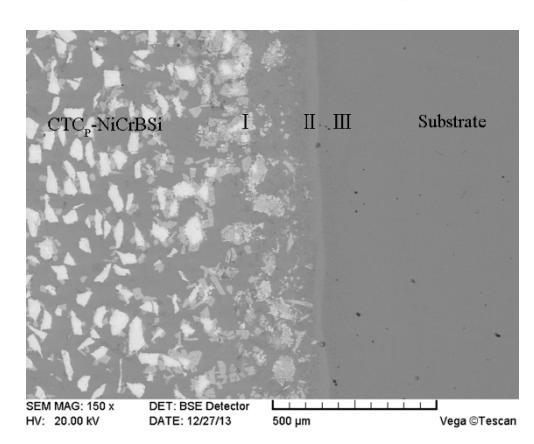
Figure 13. SEM image of the interface between modified CTC_P-NiCrBSi and substrate.

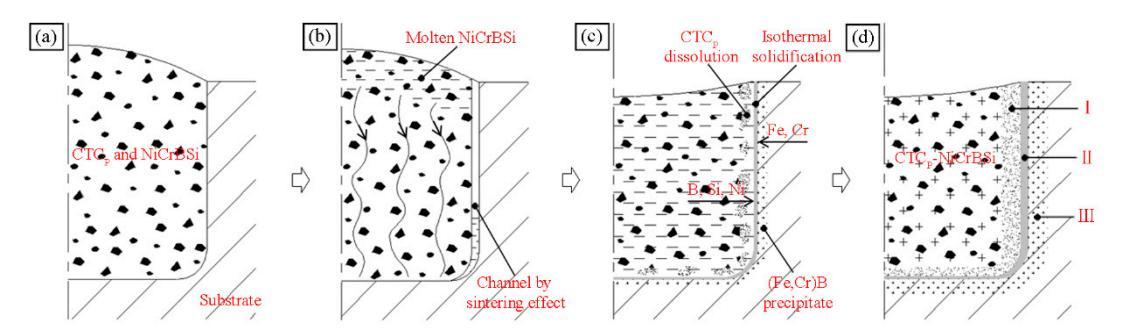
Figure 14. Formation schematic diagram of the interface between CTC_P -NiCrBSi and substrate: (a) before sintering; (b) sintering shrinkage and molten NiCrBSi filling channel; (c) elements interdiffusion, CTC_P dissolution, isothermal solidification, and (Fe,Cr)B precipitation; and (d) interface formation.

Figure 14 describes the physical model of the interface microstructure formation mechanism. The mixture of NiCrBSi and CTC_P filled the holes of the substrate and compacted under pressure before the vacuum fusion sintering (Figure 14a). During heating to the sintering temperature, the mixture shrank toward the midsection due to the sintering effects, leaving behind a relatively large channel adjoining the faying surface of the substrate. When the NiCrBSi powder deposited at the mouth of the hole became molten, it was drawn into the gap and flowed toward the bottom of the hole preferentially through the capillary passages in the partially sintered mass of mixture. The large channel adjacent to the faying surface of the substrate was filled after the fine capillary passages in the mixture were filled (Figure 14b). In its wake, the molten NiCrBSi dissolved some of the substrate and element interdiffusion occurred in the interface (Figure 14c). In the CTC_P-NiCrBSi zone near the interface, the Fe and Cr elements resulted from the dissolution of the substrate and the diffusion could

promote the dissolution of unmodified CTC_P , which led to the formation of zone I. As the melting point decreased, elements Si and B diffused outward from the molten NiCrBSi to the substrate, and the melting point of the liquid near the substrate increased, which induced the isothermal solidification resulting in the formation of γ -Ni solid solution layer (zone II). Si and B preferred to diffuse along the grain boundaries in the substrate. However, due to the small size of B atoms, the intragranular diffusion of B was essential [18]. As the diffusion continued, the substrate near the interface was enriched with Fe, Cr, and B, so the diffusion affected zone III consisting of (Fe,Cr)B precipitates was formed (Figure 14d).

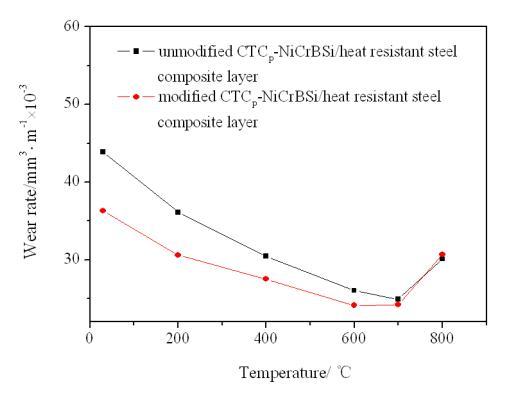
Figure 15. Wear rates of the CTC_P-NiCrBSi/heat resistant steel composite layers as a function of testing temperature.

The wear rates of the CTC_P-NiCrBSi/heat resistant steel composite layers investigated at different temperatures are given in Figure 15. It can be seen that the wear rate of the modified CTC_P-NiCrBSi/heat resistant steel composite layer was lower than that of the unmodified CTC_P-NiCrBSi/heat resistant steel composite layer between RT and 700 °C, and almost equal above 700 °C. The wear rates of both layers decreased with increasing temperature from RT to 700 °C, and increased above 700 °C.

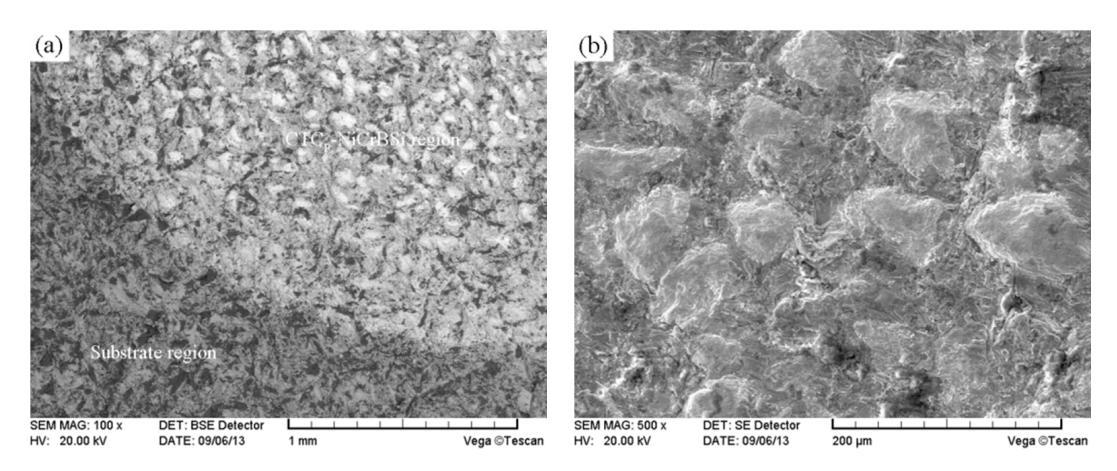
Figure 16. (a) Worn surface morphology of the modified CTC_P -NiCrBSi/heat resistant steel composite layer, and (b) magnified worn surface morphology of the CTC_P -NiCrBSi region at 600 °C.

The worn surfaces were observed after the wear tests. As previously mentioned, there were two kinds of regions distributed in the composite layer, namely the continuous substrate region and the discrete CTC_P -NiCrBSi regions (Figure 16a). During the abrasion process below 700 °C, the hardness of the substrate region was far lower than that of abrasive and the abrasion loss of the substrate region was larger. In contrast, the abrasion loss of the CTC_P -NiCrBSi regions was lower because of the existence of high-hardness CTC_P . The abrasive was unable to scratch the CTC_P and the wear was

concentrated on the NiCrBSi matrix, which led to the protruded CTC_P . The protruded CTC_P had a protective effect on the NiCrBSi matrix, further on the substrate region (Figure 16b).

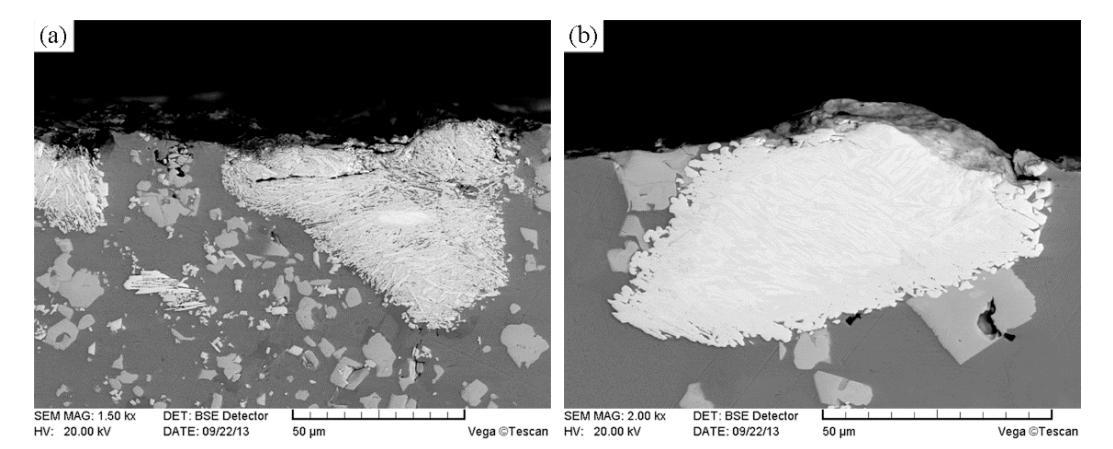
Figure 17. Cross-sections morphologies of (**a**) the unmodified, and (**b**) the modified CTC_P-NiCrBSi at RT.

Figure 17 shows typical cross-sections of the CTC_P-NiCrBSi regions in composite layers at RT. Similar features were also observed after tests from 200 °C to 700 °C. It can be seen that the unmodified CTC_P did not obviously protrude out of the NiCrBSi matrix as there was less WC/W₂C left in the core as well as the lower hardness and toughness of the dissolution zone (Figure 17a). Therefore, the protective effect of the unmodified CTC_P on the NiCrBSi matrix and substrate region deteriorated. Though a lot of carbides (P1) precipitated in the NiCrBSi matrix because of the dissolution of the CTC_P, the carbides in size were too small to reduce abrasion. The modified CTC_P obviously protruded out of the NiCrBSi matrix and substrate region because more fraction of high hardness WC/W₂C was retained (Figure 17b). Therefore, the wear rate of the modified CTC_P-NiCrBSi/heat resistant steel composite layer was lower than that of the unmodified CTC_P-NiCrBSi/heat resistant steel composite layer between RT and 700 °C.

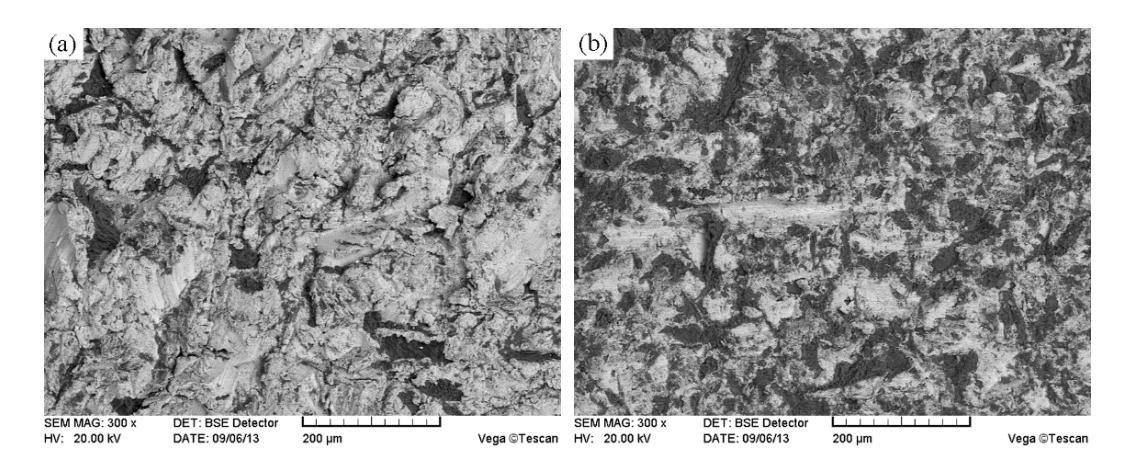
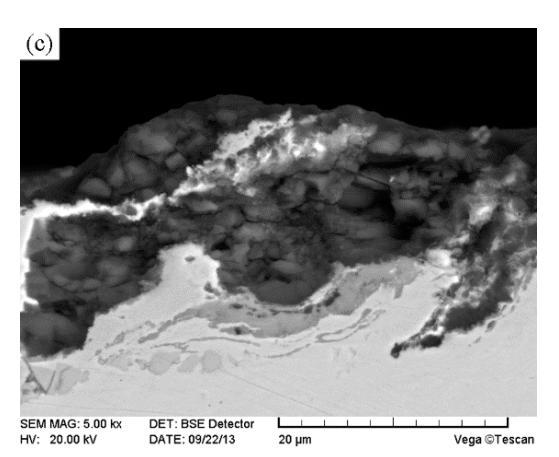
Figure 18. Worn surface morphologies of the substrate regions: (**a**) at RT; (**b**) at 600 $^{\circ}$ C; and (**c**) cross-section morphology of the substrate region at 600 $^{\circ}$ C.

Comparing the worn surfaces of substrate regions in the composite layers after tests from RT to 700 °C, it can be seen that the amount of attaching abrasive fragments rose with increasing temperature (Figure 18a,b) and laminated structures consisting of abrasive fragments and wear chips formed on the worn surfaces above 400 °C (Figure 18c). These observed features were in agreement with other studies [19,20]. The higher the temperature, the softer the substrate and the more abrasive fragments penetrated the worn surfaces. The formation of the laminated structures could be due

to metal chips formed by cutting, which were then compacted back on to the disc [21]. In the CTC_P -NiCrBSi regions, only a few abrasive fragments and laminated structures formed in the NiCrBSi areas between the protruding CTC_P , which may be due to a higher hot hardness of the NiCrBSi matrix. The abrasive fragments and laminated structures act like hard phases and protect the surfaces against wear. In addition, when the fragments are loose, they may act as a fluidized bed that also reduces friction and wear [22]. Therefore, the wear rates of both composite layers decreased with increasing temperature from RT to 700 °C.

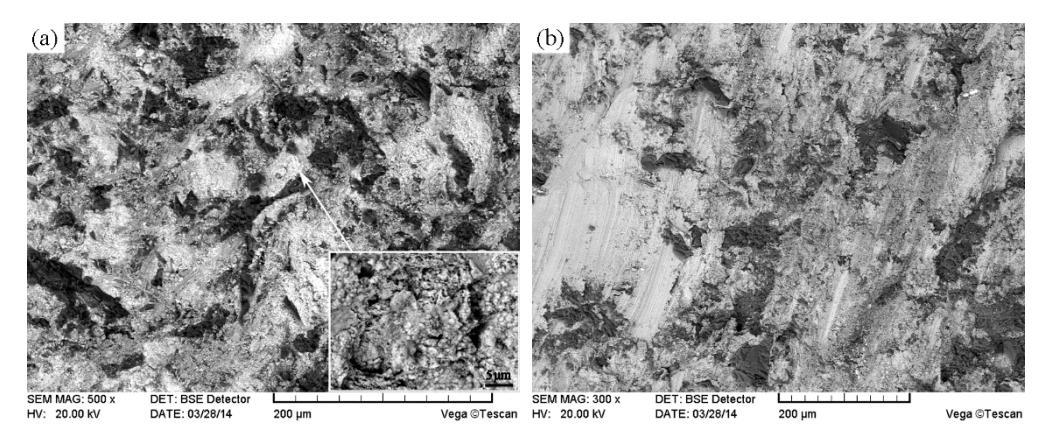
Figure 19. Worn surface morphologies of the modified CTC_P -NiCrBSi/heat resistant steel composite layer at 800 °C: (**a**) CTC_P -NiCrBSi region, and (**b**) substrate region.

Typical worn surfaces of the modified CTC_P -NiCrBSi/heat resistant steel composite layer at 800 °C are illustrated in Figure 19. Similar features were also observed for the unmodified CTC_P -NiCrBSi/heat resistant steel composite layer. It can be seen that the white flakes were generated due to CTC_P fracture. These wear debris were randomly distributed on the worn surface. The CTC_P in SEM high magnification mode showed cracks and pores (Figure 19a). EDS analysis showed that the oxygen concentrated on the surfaces of the CTC_P was up to 68.73 at. %, which indicates that excessive oxidation of CTC_P occurred. In addition, massive grooves formed on the worn surface of the substrate region (Figure 19b). Below 600 °C, the oxidation of CTC_P during the abrasion process in air was moderate [23] so they provided good wear protection. While above 600 °C, the oxidation of CTC_P increased rapidly with temperature. The porous oxides offered no resistance to abrasion in air. Additionally, as the depth of the grooves produced by the abrasive particles was larger than the thickness of the laminated structures and the sizes of the CTC_P by oxidation and the massive ploughing effects resulting from the softening of the matrix were responsible for the increase of wear rates in Figure 15.
