Article Residual Tensile Strength of the Multi-Impacted Scarf-Repaired Glass Fiber-Reinforced Polymer (GFRP) Composites

Abstract: The effect of multiple/repeated impacts on a repaired composite was investigated using a low-velocity impact test. The composite samples were fabricated through a vacuum resin infusion method (VARI) and repaired by a scarf repair technique. Later, a repeated low-velocity impact test was performed on the original and repaired composites samples. Performance of the multi-impacted repaired and original samples was evaluated and compared by measuring maximum contact force, maximum displacement, maximum time duration, absorbed energy and damage area. Photographs of the post-impacted samples were taken to observe the multi-impact damage progression through visual inspection. The results showed that each repeated impact subjected the samples to more damage. Tensile tests revealed that the scarf repair restored 81.23% strength. It was also observed that the sample obtained the highest damage dent in the low-velocity impact test that failed early during a tensile test and carried the lowest ultimate load.

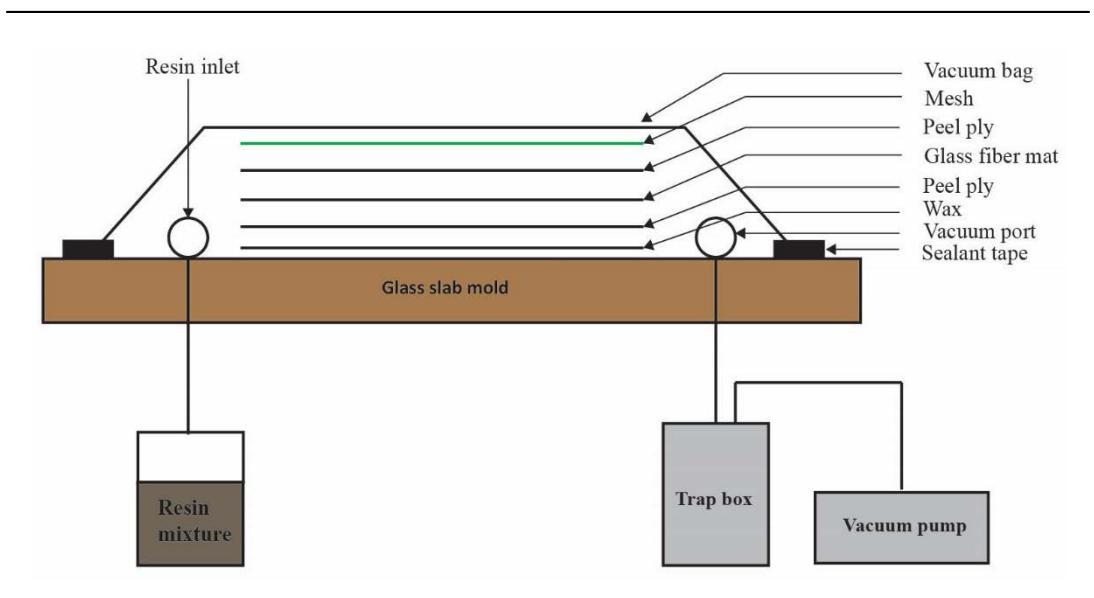
Figure 1. Schematic diagram of VARI.

Unidirectional glass fiber and vinyl ester resin were used to manufacture the parent and scarf patch composite laminates. A glass table was selected as mold and manufacturing of the GFRP was done on it. E-glass fiber fabric with 430 GSM (gram square meter) was purchased from the Chongqing Polycomp International Corporation, Chongqing, China. Before being used, it was cut and dehydrated in an oven at 40–50 °C for 5–7 min to remove any moisture present in the fabric. The 16 layers of glass fiber fabric were stacked together following $[0/90/90/0]_{2s}$ stacking sequence and fabricating through VARI (vacuum resin infusion) technique [29] and details are shown in Figure 1. The weight ratio of glass fiber to resin mixture (60:40) was selected according to the manufacturer's suggestion. The resin mixture was prepared using vinyl ester (sw905-2 supplied from SWANCOR IND. CO., LTD., Shanghai, China), hardener (methyl ethyl ketone peroxide (NOROX KP-925H) from United Initiators, Stockholm, Sweden) and initiator (accelerator cobalt salt 1305 from SWANCOR IND. CO., LTD., Shanghai, China). The same amount (0.5% weight of the resin) was used for both. The resin transfer took 45–50 min for impregnation through all 16 layers of fibers fabric. After the insertion of resin impregnated glass, the fiber system was left to cure for 24 h at ambient pressure and temperature. The uniform thickness of 4.8 mm was obtained after curing with 300×100 mm dimension [6,13], marked on the GFRP and 33 samples were trimmed by water wafering saw from the composite plate, 15 for original and 15 for repairing procedure. Water absorption was removed during trimming process through drying

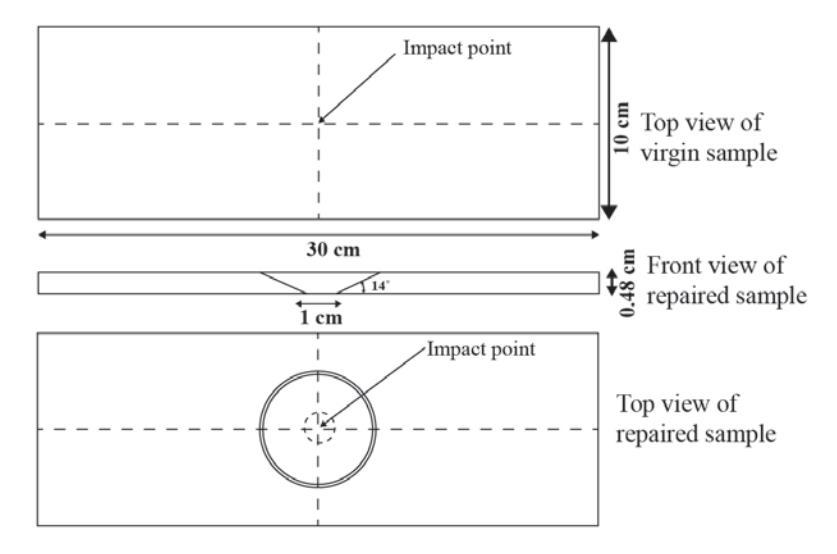
Figure 2. Dimensions of the repaired and original composite samples.

After cleaning, trimmed samples (15) were marked with 10 mm diameter hole at the center (Figure 2) of the GFRP samples and drill operation was performed using CNC (computer numerical control) machine. The dust on the samples was cleaned using cotton that was soaked in acetone. The 14° scarf angle was marked on the samples and scarfing was done carefully using the rotatory sad paper tool. The scarfed region was polished for a good bonding strength. For each scarfed sample, the patch was cut out from GFRP containing same architecture and thickness as in parent laminate according to the scarfed size and scarfing was done same as the parent laminate. Before doing repair operation, the surface of the patch and scarfed samples were wiped with acetone with help of cotton to avoid any contamination such as oil, grease, dust particle and residual as per American society for testing and materials (ASTM) [30]. The patch was applied to the scarfed region of the composite sample. The patch fully covered the scarfed region, to get the best results of bonding between the patch and scarfed samples. Resin mixture (vinyl ester, hardener, and initiator) was prepared with the same weight proportion as of parent manufacture. The mixture was kept in a pressure vassal for 3-4 min to avoid the formation of bubbles during the mixing process. A small amount of resin mixture was applied to the scarfed region with the help of the brush and covered with the patch. While putting the patch, the patch axis angle was kept same as parent laminate, and to remove the excess resin, little weight was applied on it and left for 72 h to cure. After that, the weight was removed from

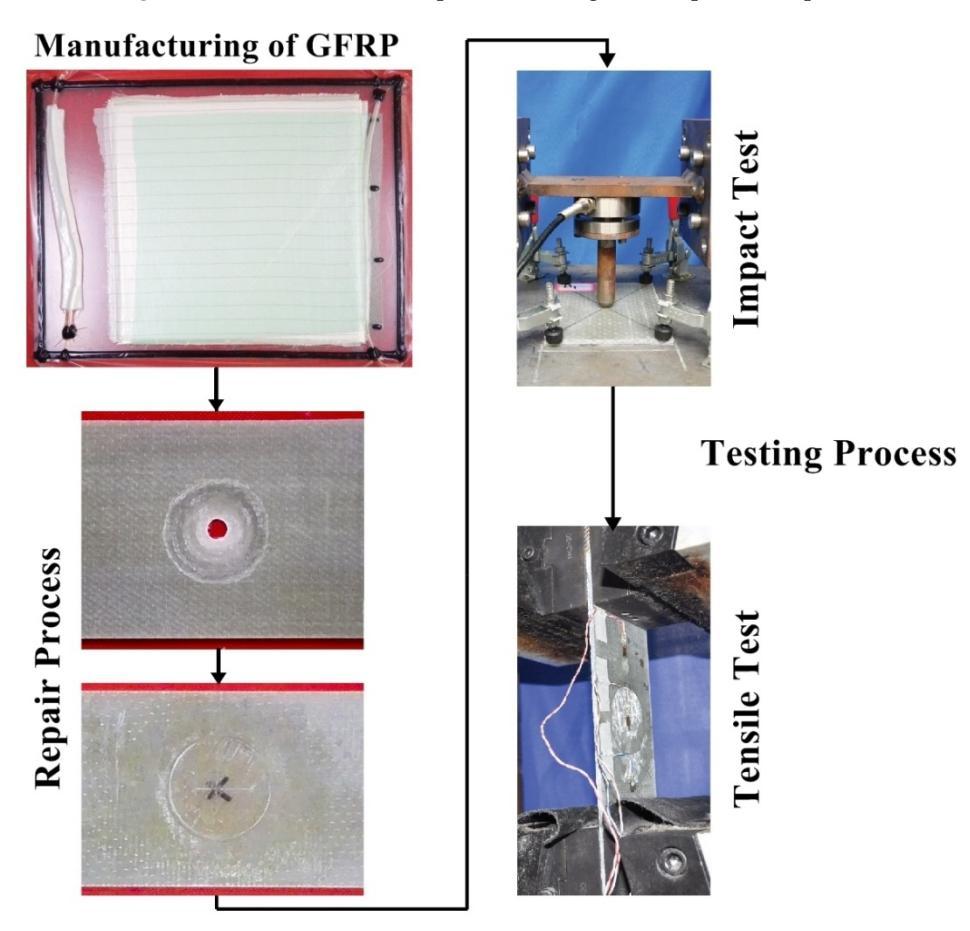
Figure 3. Manufacturing, repairing and testing procedure.

the samples and repaired samples were left for one week for post curing to dry and acquire good bonding strength. The whole repair process was performed at room temperature. The procedure for manufacturing, repairing and testing is explained in Figure 3.

After the damage area measurement and visualization of the repeated impact damage to the repaired and original composite sample, the residual strength of multi-impacted samples tested under tensile loading (Figure 3). The prepared sample was fitted to the universal testing machine (UTM) jaw and set crosshead speed (2 mm/min) [6]. After achieving the ultimate load, the sample was removed from the UTM jaw and photos were taken to visualize the damage mechanism. Three samples were tested, and the mean value was used in calculation and graph plotting. The connection of the data acquisition device, sensor and computer is illustrated in Figure 4.

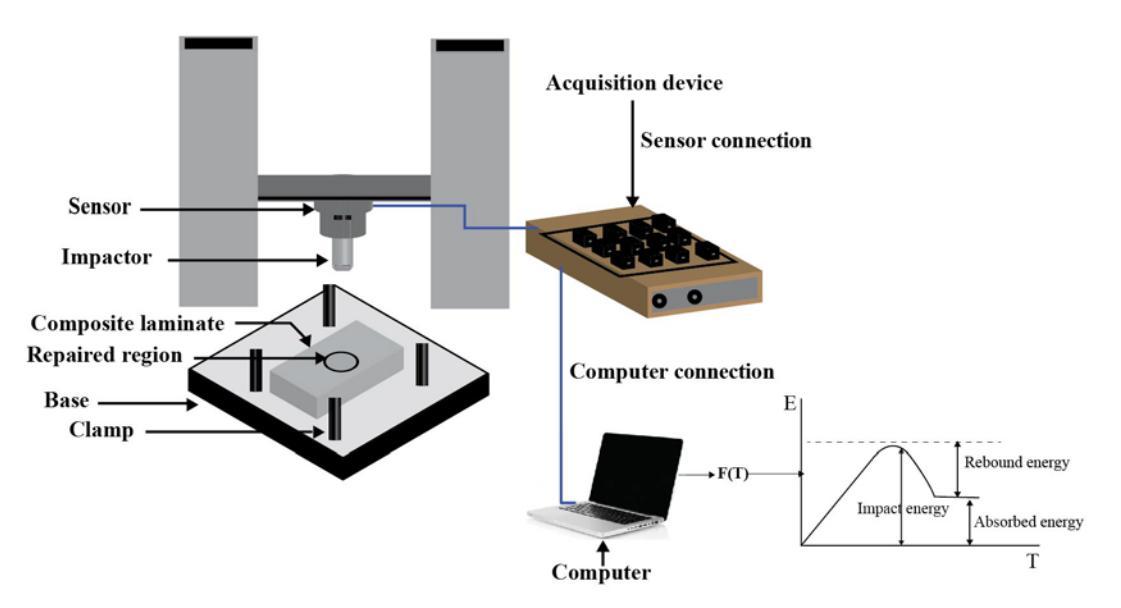
Figure 4. Schematic diagram of drop weight impact machine.

After performing the repair technique, both original and repaired composite samples were marked and subjected to the low-velocity impact test using drop weight-impact machine (Figure 4). A dart of 8 mm radius, 8.9 kg weight and hemispherical geometry of the impact was used in this work. The extended part of dart was fitted with ball wearing that allowed it to move freely on the guide rail. A force sensor was mounted on the impact dart and connected to the acquisition device to record force-time history for each impact. The required initial velocity was obtained after some modifications in impact height. Samples were clamped to the test bench as per ASTM D7136 [31], it did not allow the sample to move due to vibration produced during the strike. Since in this work, visual inspection was preferred among all non-destructive techniques. Few samples with a dimension of 150×100 mm were cut and tested with various impact energies according to ASTM D7136 to obtain the visual damage at the impacted surface. For this particular study, impact energy of 15 J was found suitable for multi-impact in both original and repaired sample cases. The impact dart was fixed at 171.97 mm height from the GFRP composite sample to achieve impact energy of 15 J. The impact dart was released from the height and hit to the samples, while collision kinetic energy was transferred to the sample that caused damage. For each collision, data was recorded by the acquisition device and stored in the computer. After the first impact, the damage depth was measured through a dial indicator. Later, the impacted samples were unclamped and removed carefully from the fixture to take images of the damaged area than another sample was clamped for the second impact and impact dart was subjected twice at the center. After this, the damage depth of the second impacted sample was measured. The same procedure was followed for the third and fourth impact. After the impact tests, samples were removed from the test fixture and preserved for post impact visual inspection and photography was done using a digital camera (DSC-RX10 II, Sony Inc., Tokyo, Japan). For further analyses, damage area measurement of impacted samples was recorded, and different damage types were shown through the photographic images. The equations used in impact energy and absorb energy calculation is as:

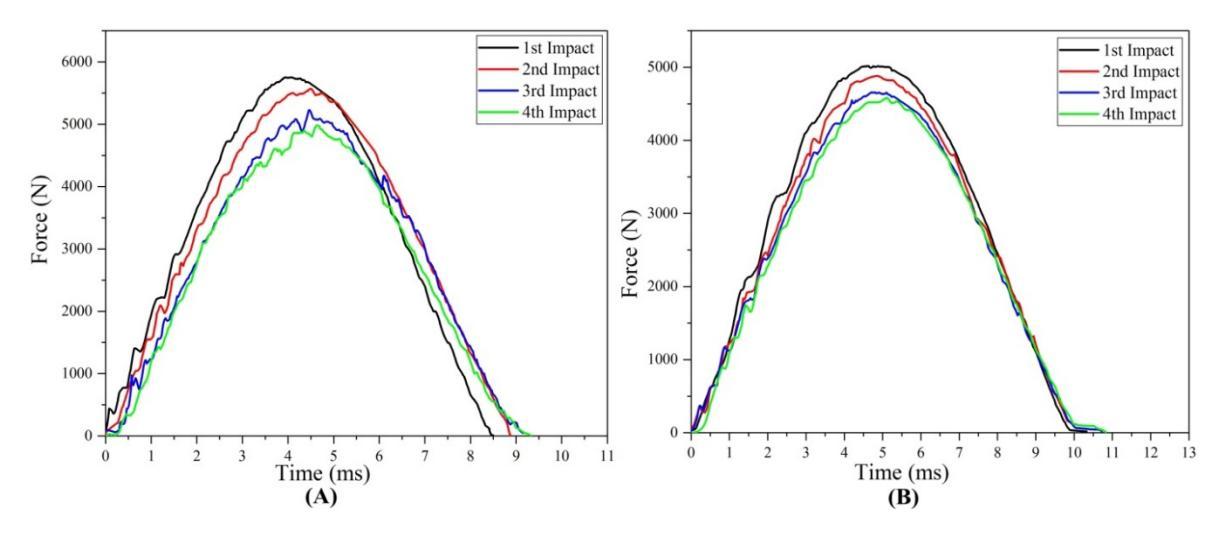
Figure 5. Force-time graph of (A) original and (B) repaired composite impacted composite samples.

The results of contact force-time, force-displacement, and absorbed energy-time curves for repaired and original test samples for each impact are shown in Figures 5–7. Figure 8A–F represents the comparison study of maximum contact force, maximum displacement, time duration, energy absorption, damaged area and damaged depth acquired by composites original and repaired samples respectively. Figures 9–12 shows the visual inspection result of original and repaired samples after multi-impacts. In Figure 5, the curve of original coupons showed almost the same response against impact; the curve raised with time and after obtaining peak force it started to decrease with time. The shape of the curve was an inverted "V". This showed that contact force was maximum at first impact and start reducing with several impacts. The contact force depicted the strength capability of the composites during low-velocity impact. The composite sample type A obtained the highest force with the intended lowest absorbed energy, as displayed in Figure 9A. It was revealed that the contact force was inversely proportional to the damage induced in samples after the impact test. Original composite samples attained maximum peak force compared to the repaired composite for each impact as shown in Figure 5. Contact force of the original and repaired composite can be ranked from higher to lower as follows: type A > type B > type C > type D and type P > type Q > type R > type S, respectively.

The contact force-time duration upon first impact was lowest and increased with the number of impacts for both repaired and original samples. At fourth impact, the time duration was highest. From this, it can be explained that if the time duration is higher, the composite obtains greater impairment. If the time duration is high it means the contact between impact dart and sample will be greater, which might have allowed the dart to penetrate more into the composite sample, hence more damage was induced. Time duration was directly proportional to the damage induced to the samples as reported by the previous study [11]. However, at the fourth impact time, duration was found to be maximum for repaired and original samples; repaired composite samples exhibited more time duration than the original composite laminates (Figure 5). Time duration during impact tests of the original and repaired samples can be ranked as following order: type A < type B < type C < type D and type P < type Q < type R < type S, respectively.

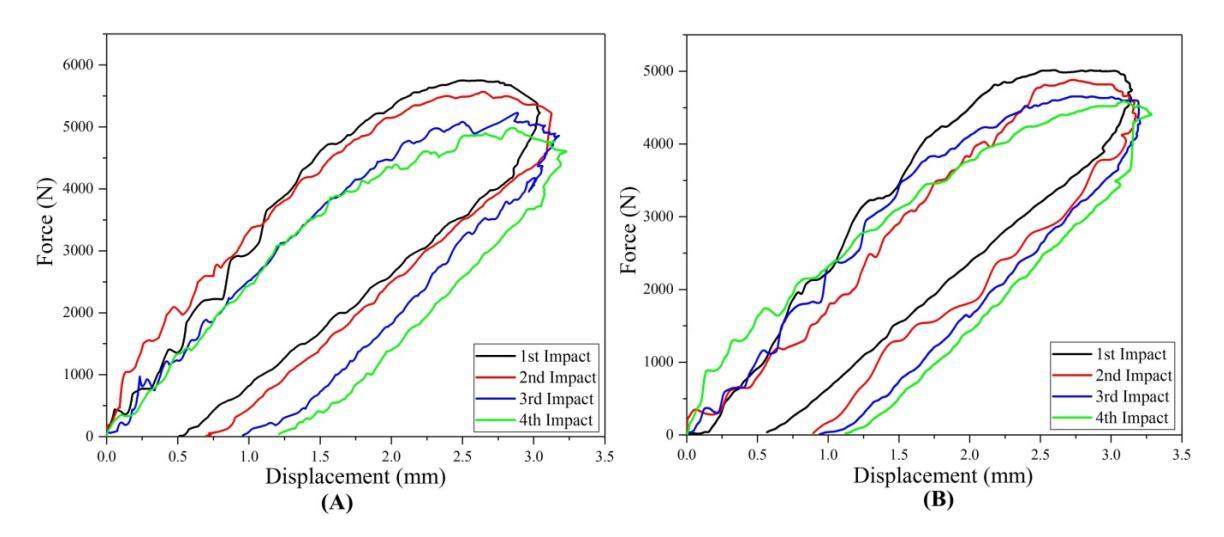
Figure 6. Force-displacement graph of (A) original and (B) repaired impacted composite samples.

Force and displacement curve of repaired and original composite samples for each impact is presented in Figure 6. For each impact, the contact force started from zero and increased with the displacement after reaching the peak force and maximum displacement started to decrease gradually. The closed curve of force verse displacement was obtained for original and repaired composite samples under multi-impact test. The samples obtained more displacement representing the less stiff nature of the composite and permanent deformation [24]. In both repaired and original cases, fourth impact on the composite demonstrated the highest value of displacement. Therefore, it was found that the fourth impacted coupons achieved the highest permanent deformation compared to all impacts as shown in Figure 8F. The maximum displacements obtained by the original and repaired coupon can be ranked as follows: type D > type C > type B > type A and type S > type R > type Q > type P, respectively.

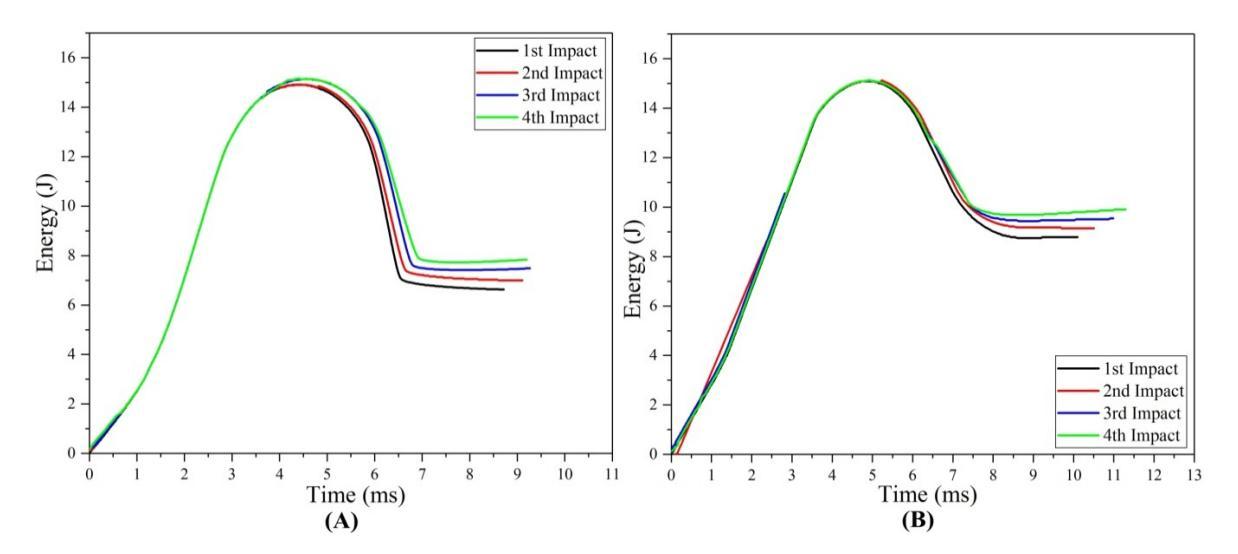
Figure 7. Absorbed energy- time curve of (A) original (B) repaired impacted samples.

Absorbed energy can be defined as the difference between rebound energy and impact energy. When the impact dart was released from a height, the initial and potential energies changed into kinetic energy. When the impact dart hit the composite sample, it absorbs a small amount of energy and the remaining energy stored back in the dart is determined as "rebound energy". The energy absorbed by the composite samples resulted in damages such as delamination, de-bonding, cracks, and fiber failure. This meant that the composite samples that absorbed more energy got more deformed and incurred more damage. With the addition of multi-impact, the absorbed energy increased, which was aligned with the previous study [21]. The energy absorption trends in original and repaired samples can be listed as: type D > type C > type B > type A and type S > type R > type Q > type P, respectively (Figure 7).

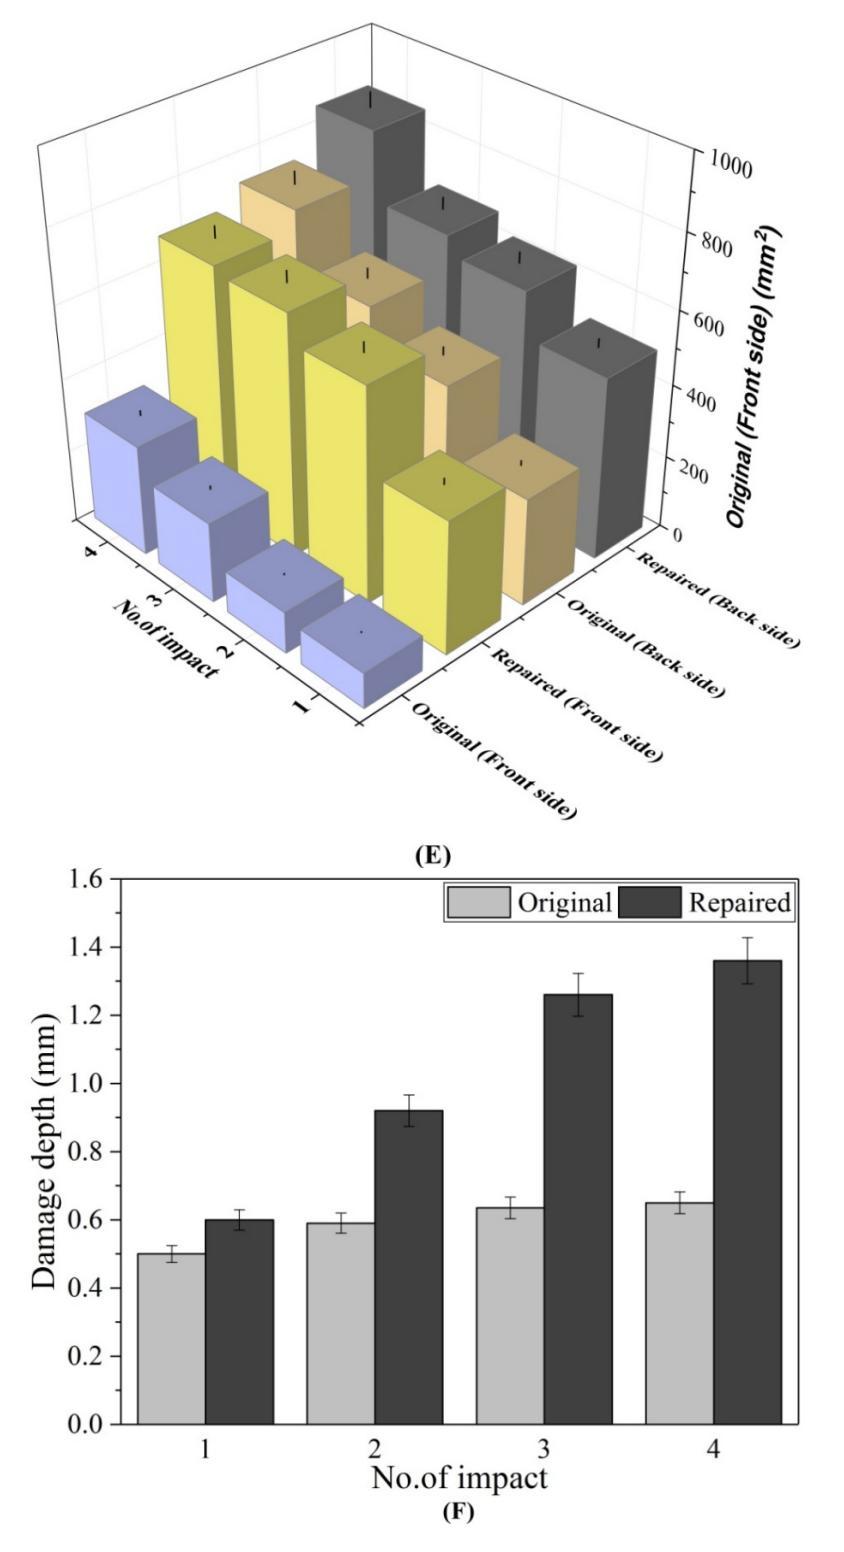
Figure 8. (A) Maximum contact force (B) maximum displacement (C) Time duration (D) energy absorption increment (E) damaged area (F) damaged depth obtained by composite original and repaired samples.

The value of maximum peak force of each impact for the original and repaired samples is plotted in Figure 8A. The bar graph shows that the original samples achieved higher impact contact force than repaired samples and it was reduced with the number of impacts. Peak contact force was highest for first impacted original sample and lowest for the four-times impacted original sample. The same observation was noticed for impacted repair sample. However, the obtained maximum force was significantly lesser than the original sample. The peak force order can be given as: A > B > C > D and P > Q > R > S for original and repaired samples, as is clear from Figure 8. The maximum displacement value of the repaired sample was higher than the original samples for each impact that revealed the brittle behavior of the repaired composites sample. These findings are in close agreement with the results reported by other researchers [24] (Figure 8). The addition of the matrix to the repaired GFRP laminate made it brittle and less stiff than the original sample as shown in damaged visual inspection photos (Figures 9–12). The maximum displacement data obtained from the fourth impact test was higher than all impact tests, thus the samples obtained more damage. The maximum displacement order for original and repair sample was observed as: D > C > B > A and S > R > Q > P, respectively. The contact time duration for original and repair samples can be given as: D > C > B > A and S > R > Q> P, respectively. Figure 8C also showed that the repaired samples got more penetration by impact dart which might have been a result of more contact time and more damage (studied from visual inspection impacted photos). From Figure 8D, it was obvious that energy absorbed by the original sample was less than the repaired sample. Both cases demonstrated that four-times impacted samples absorbed more energy and attained more damage. In all multi-impact cases, the repaired sample absorbed more energy in the form of matrix crack, fiber breakage, and delamination, which can be observed in damaged inspected photographs. From Figure 8D, the order of energy absorbed by original and repair sample can be ranked out as D > C > B > A and S > R > Q > P, respectively. The performances of the original and repaired samples under low-velocity impact are mentioned in Table 2. The bar chart between the number of impacts and the damaged area of the front- and

back-face samples is demonstrated in Figure 8E. The results showed that the damaged area increased with several impacts. It was also observed that the repaired sample occupied more damage than the original sample. The backside of each repaired and original sample attributed more damage than the front, can be observed during a visual inspection of sample. For both samples, front and back faces, the damaged area can be ranked from higher to lower in the following order: D > C > B > A and S > R > Q > P, respectively. The damage depth was measured after each impact sample and the order was D > C > B > A and S > R > Q > P for original and repair sample, respectively.

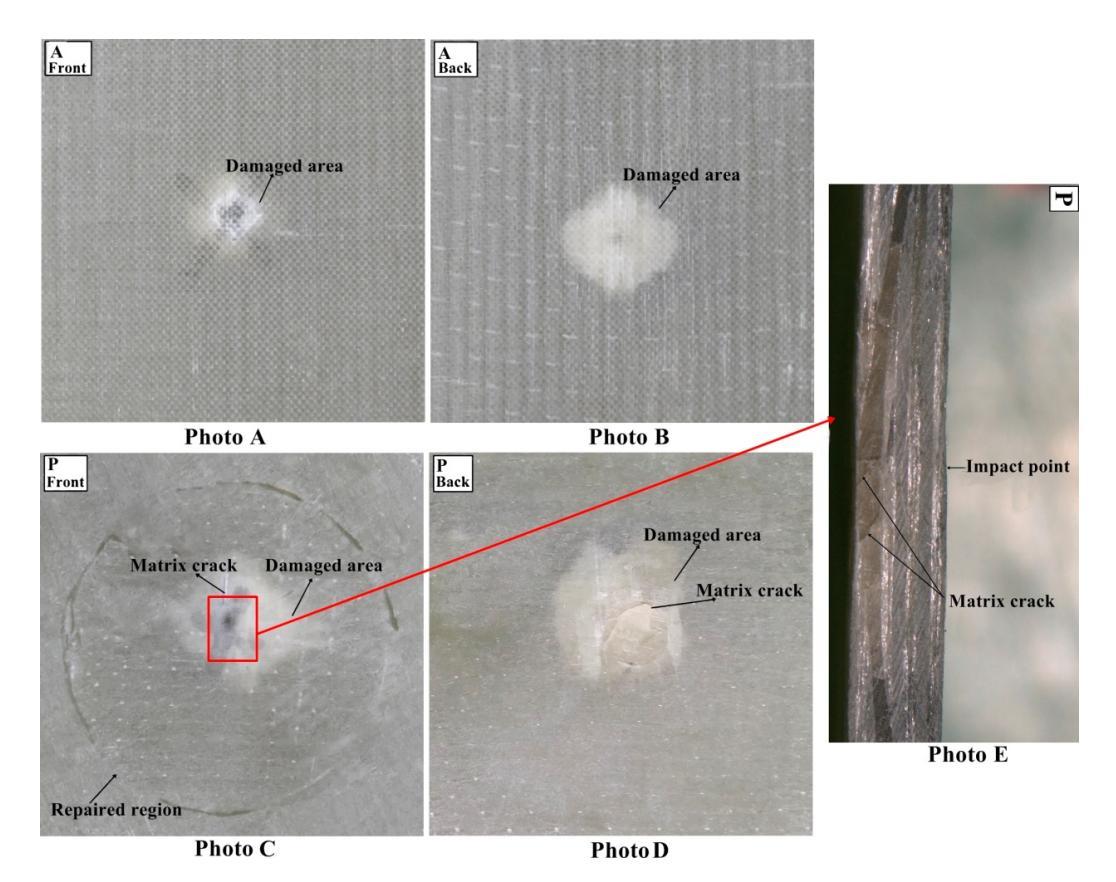
Figure 9. (**A**) Front face of original (**B**) back face of original (**C**) front face of repaired (**D**) back face of repaired impacted (**E**) cross-sectional view of the repaired composite sample after first impact.

The multi-impacted composite sample was investigated through visual inspection. It was noticed that front faces of all composites got more damage than back faces (Figures 9–12). There was no major damage except for local matrix failure in the original sample, whereas matrix cracks on the patch and parent of repaired composite appeared after the first impact loading, as shown in Figure 9. At second impact, multiple cracks were formed on the back face of the repaired samples, while there was no major damage incurred to the front and back of the original sample. The cracks that developed upon the first impact were enlarged upon second impact in the repaired sample and spread towards patch edge sides (Figure 10). At the third impact, a small matrix crack was observed on the front face of the impacted original sample and local matrix with increased damaged area experienced a trough as shown in the visually inspected images of Figure 11A,B. Cracks at the repaired hole area were raised for composite samples; at the front face, matrix cracks expanded, whereas multiple matrix cracks around the repaired hole appeared including little fiber breakage at the damaged hole edge area along with partial delamination (Figure 11C,D). Upon fourth impact, multiple cracks were formed at the front face of the original multi-impacted samples, and on the back face of the local matrix, damage increased. On the back face of the repaired composite, fiber failure occurred along with multiple cracks (Figure 12D). However, visual inspection did not provide internal failure among fiber layers, which can be determined through other techniques, such as micrograph.

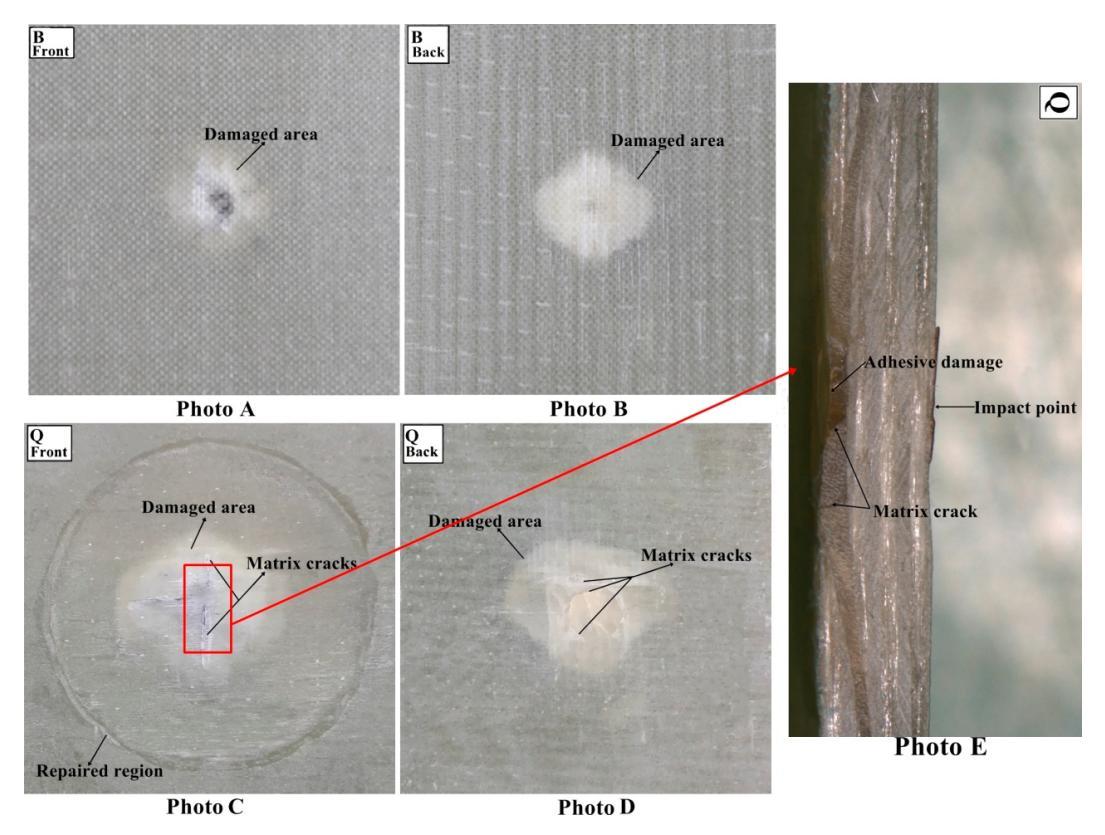
Figure 10. (**A**) Front face of original (**B**) back face of original (**C**) front face of repaired (**D**) back face of repaired impacted (**E**) cross-sectional view of the repaired composite sample after second impact.

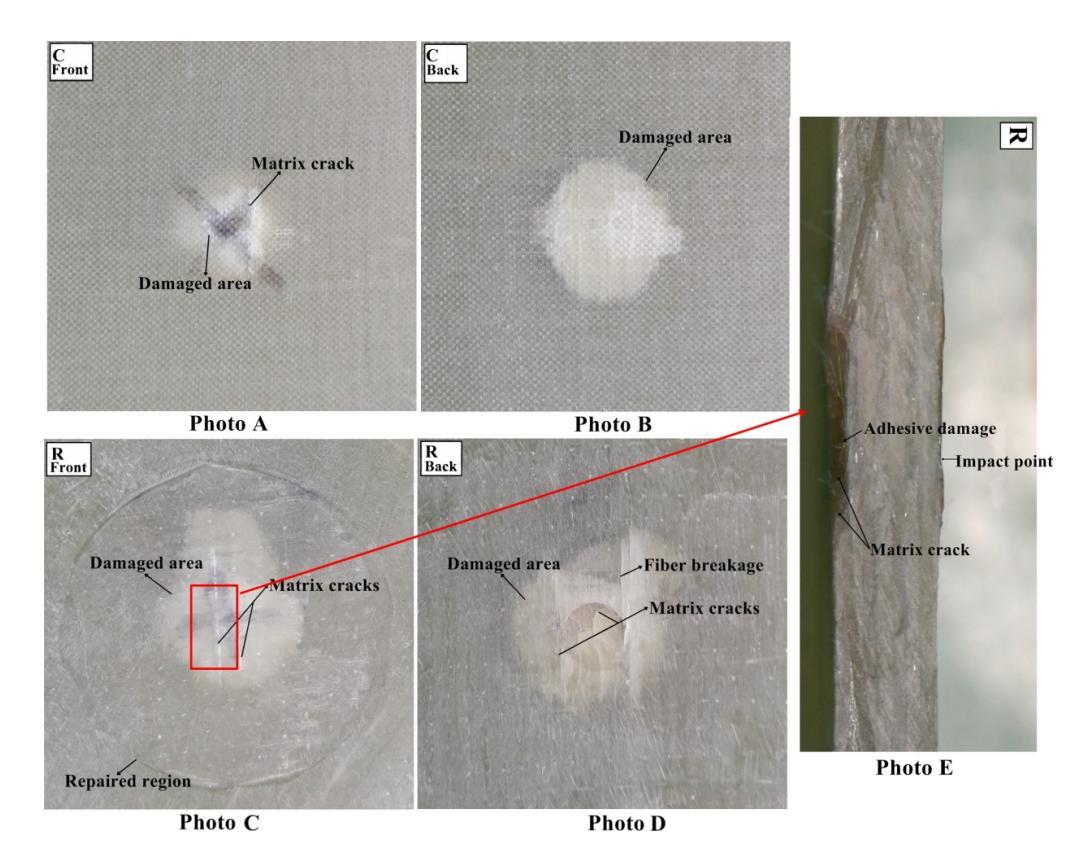
Figure 11. (**A**) Front face of original (**B**) back face of original (**C**) front face of repaired (**D**) back face of repaired impacted (**E**) cross-sectional view of repaired composite sample after third impact.

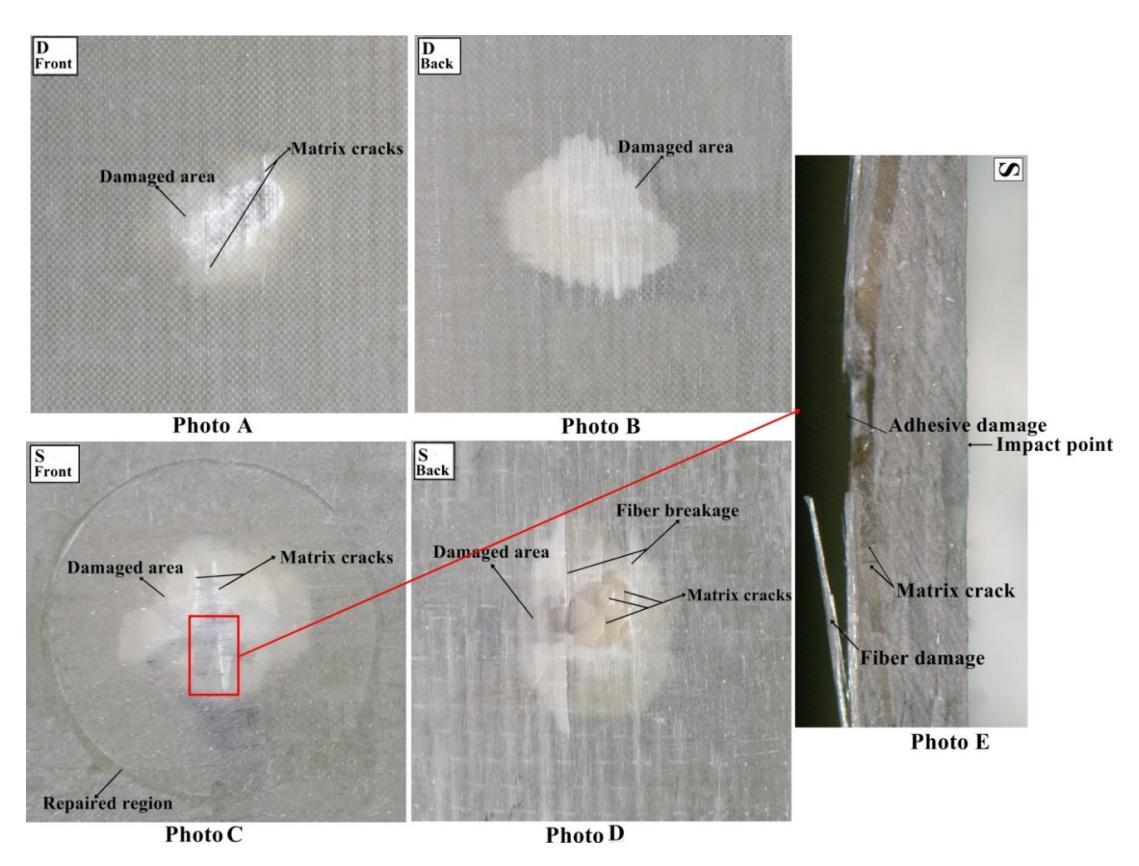
Figure 12. (**A**) Front face of original (**B**) back face of original (**C**) front face of repaired (**D**) back face of repaired impacted (**E**) cross-sectional view of the repaired composite sample after fourth impact.

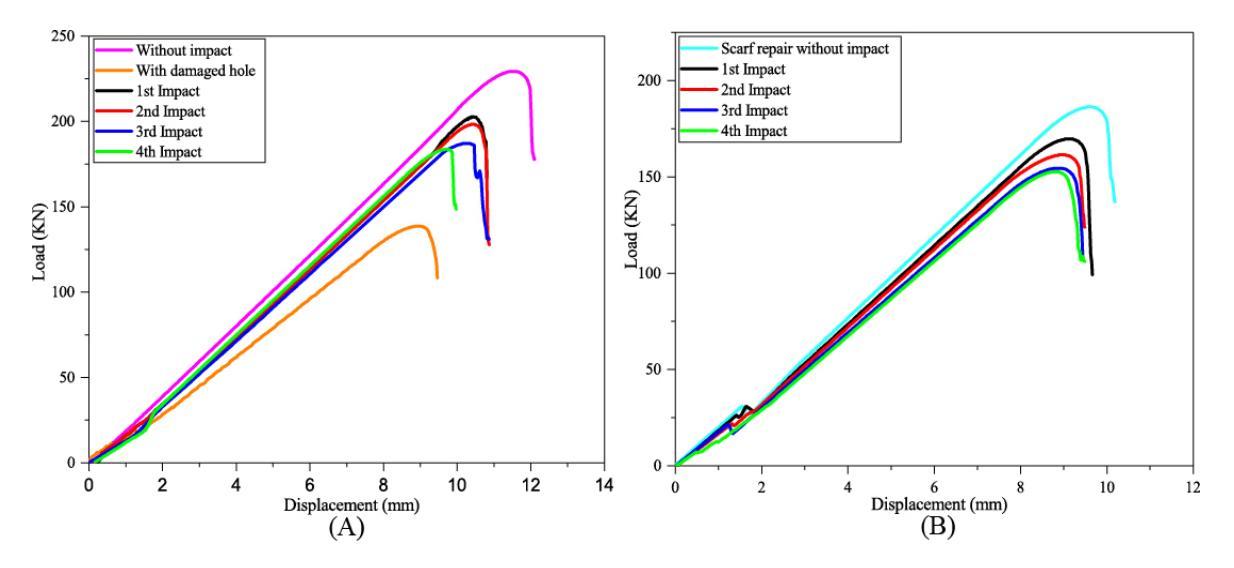
Figure 13. Residual tensile test result of multi-impacted (A) original and (B) repaired samples.

The residual strength of the multi-impact, for both original and repair composite samples was tested through tensile test, and the results are shown in Figure 13. The tensile load-carrying capacity of the impacted samples was compared with the normal samples (without impact strength). Samples without impact and damaged samples exhibited the highest load as expected during tensile loading. The tensile load-carrying order of original sample and scarf samples can be depicted as follows: Sample without impact > A > B > C > D > damaged sample and scarf sample without impact > P > Q > R > S, respectively. In both cases, the fourth impacted sample displayed the least load-carrying capacity. In Figure 14, the post-tensile response of repaired multi-impacted composite samples is illustrated. In the case of all repaired samples, the adhesive bond attachment between parent and the patch existed even after the tensile test except little detachment was observed on the patch edge towards the tensile direction. The stress concentration was generated at the scarfed repair region. As expected, the plane composite sample without being subjected to any impact depicted high tensile load and the least damage, whereas the four-times impacted coupon displayed the worst tensile response among all composite samples. Repaired composite samples demonstrated less tensile load compared to the original composite, as mentioned in Figure 15.

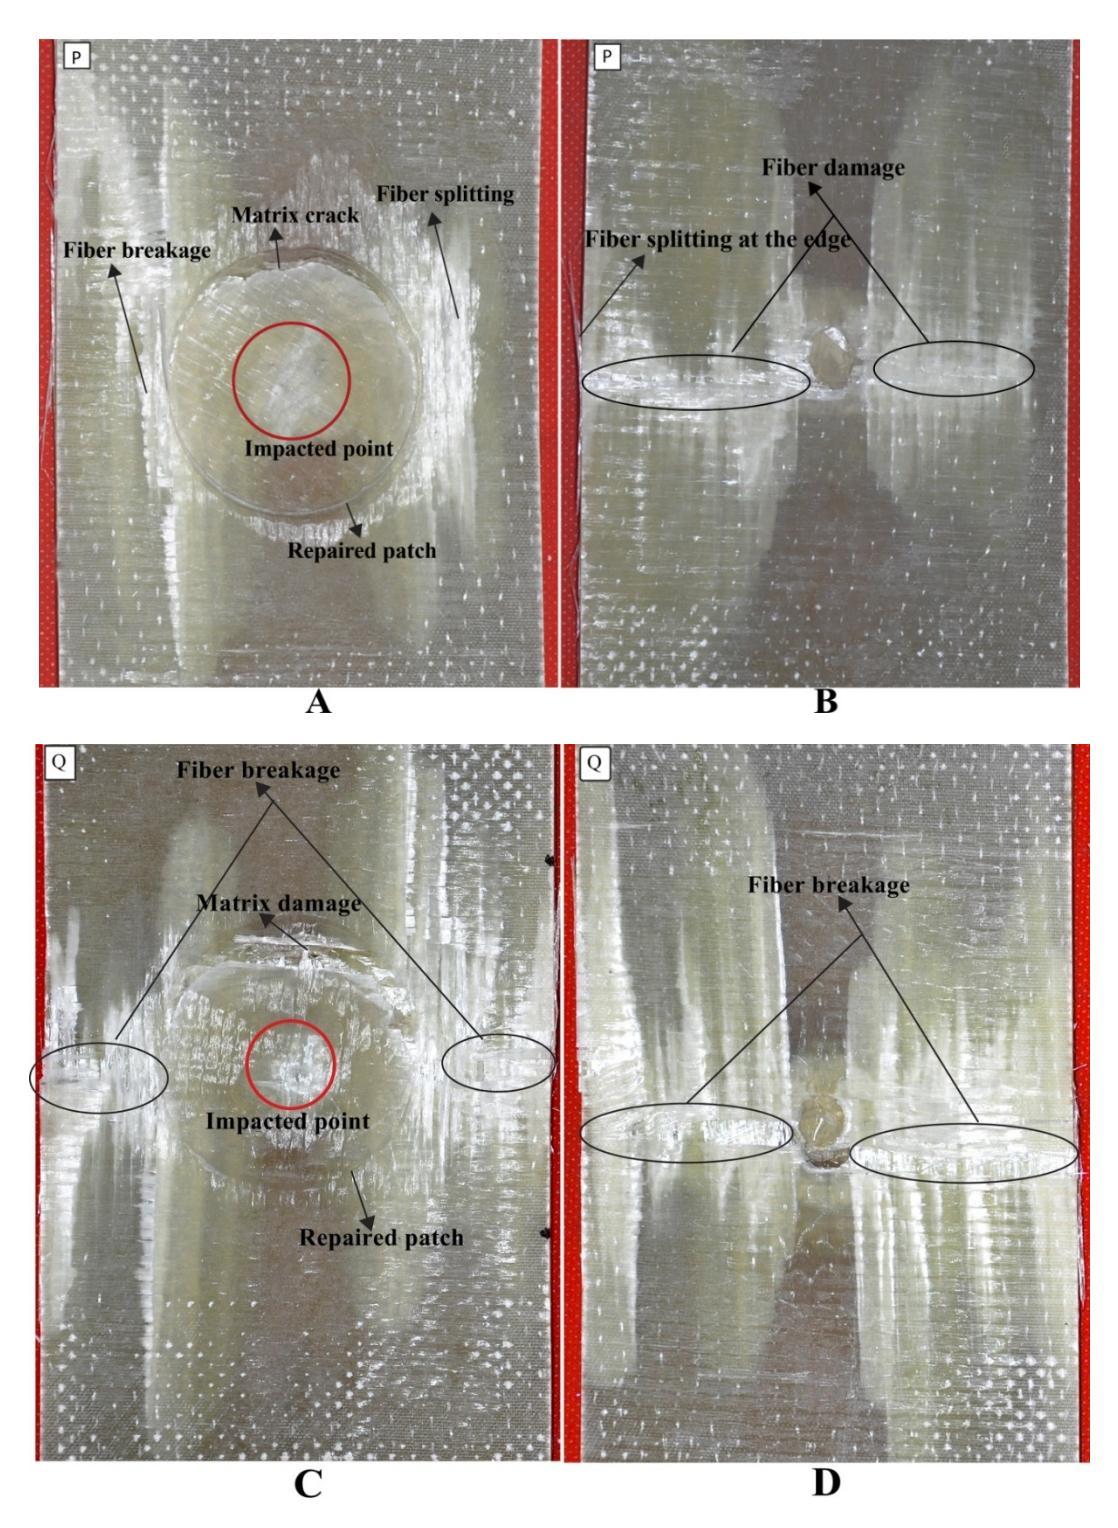
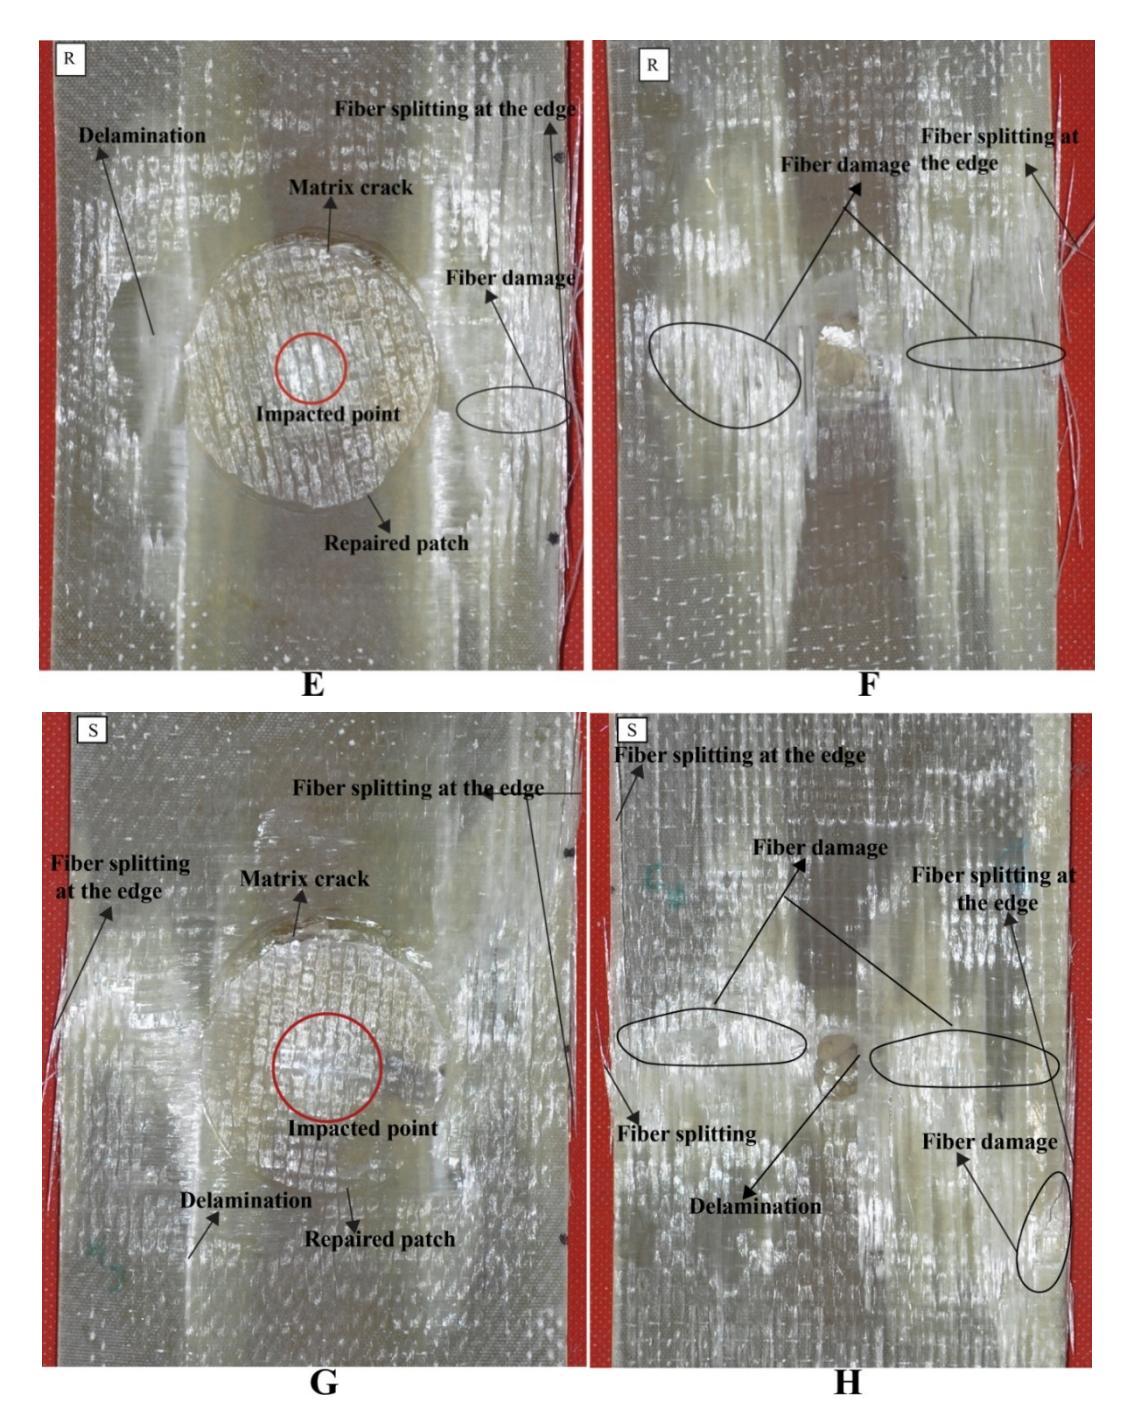
Figure 14. (**A**) Front face of repaired GFRP after first impact (**B**) Back face of repaired GFRP after first impact (**C**) Front face of repaired GFRP after second impact (**D**) Back face of repaired GFRP after second impact (**E**) Front face of repaired GFRP after third impact (**F**) Back face of repaired GFRP after third impact (**G**) Front face of repaired GFRP after fourth impact (**H**) Back face of repaired GFRP after fourth impact after tensile test.

The main reason for conducting the tensile test on original and repaired composite was to demonstrate residual tensile strength after the impact test. During the tensile test, a crack sound was heard but there was no sign of damage or crack detected through visual inspection, while the graph kept going after a little fluctuation in the curve and dropped after achieving the ultimate load. It implies that internal damage might have occurred. It was also noticed that the crack sound came only for repaired samples. The tensile test result of the P sample revealed that the fracture occurred at the scarf-repaired zone, fiber breakage, and delamination, as can be seen in Figure 15A. A small amount of matrix failure, fiber fracture with splitting was noticed on the backside. The fiber

splitting occurred at the edge of the composite sample. Sample Q demonstrated more fracture damage than sample P. At second impact, the center part zone obtained more damage and failed before the P coupon; fiber damage was identified on the front face while on the back-face fiber opening and disintegration occurred. Meanwhile the patch remained stuck to the parent laminate. Delamination and fiber splitting was also developed no the front face of R composite samples after three multi-impact and tensile tests. Delamination occurred around the scarf periphery due to high stress concentration under tensile loading. The third impact developed internal damage to the repaired coupon. When the tensile load was applied to it, the fiber was pulled out and splitting came out from the edge of the sample as presented in Figure 15F. The matrix failure occurred at the repaired area but the patch remained attached to the parent laminate after complete fiber failure under tensile loading condition. Due to highest energy absorption during impact test, the S coupon failed early during the tensile test (Figure 14B). It obtained more damage among all repaired coupons as displayed in Figure 15G,H. Delamination, fiber damage, and fiber splitting damage type appeared on the front face while fiber breakage and fiber splitting were developed at both the edge of the back face, in the case of S composite sample.

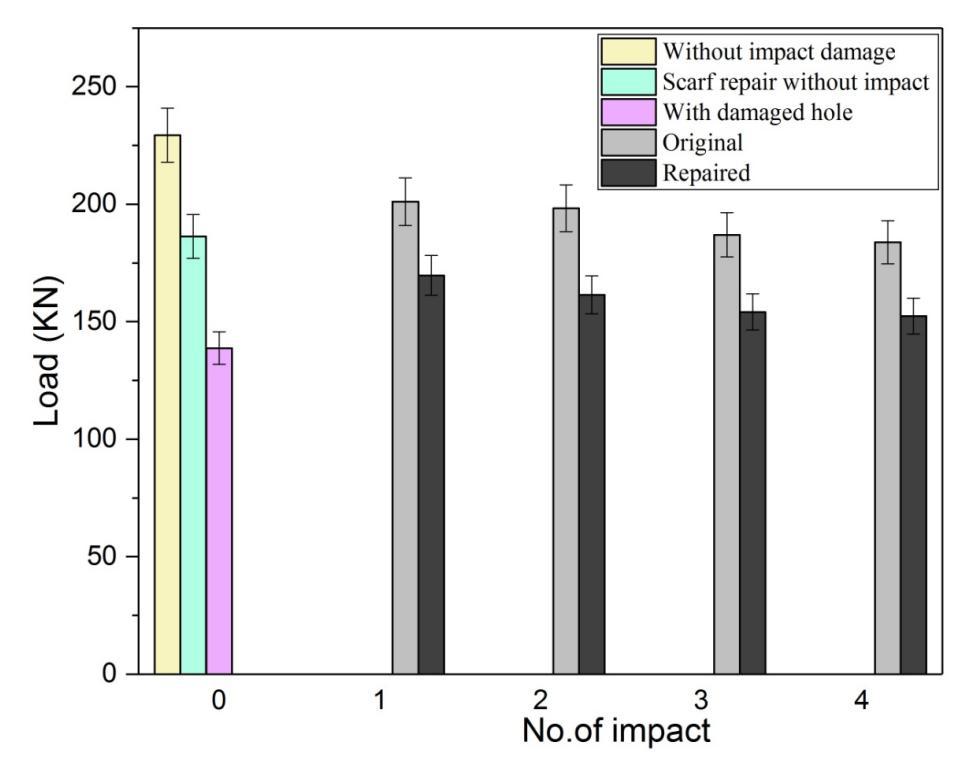
Figure 15. Tensile maximum load verse number original, repaired, damaged samples.

With the number of impacts, the tensile load-carrying capacity of both repaired and original composite was reduced. Scarf repair samples without impact were able to recover 81.23% of the strength as shown in the curve (load vs. displacement) of the tensile test (Figure 13). Percentage load variation of repaired samples with respect to the original sample at first, second, third and fourth impacts were calculated as 19.56, 18.6, 17.55 and 17.08%, respectively as mentioned in Table 3. However, the percentage load variation of original samples with respect to original sample without impact for first, second, third and fourth impact was computed as 9.32, 13.55, 18.48 and 19.89%, respectively. While the tensile load percentage variation of repaired samples with respect to the repair without impact sample at first, second, third and fourth impacts were found to be 10.27, 13.38, 17.26 and 18.23%, respectively.
