Article

Investigation of the Influence of Pre-Charged Hydrogen on Fracture Toughness of As-Received 2.25Cr1Mo0.25V Steel and Weld

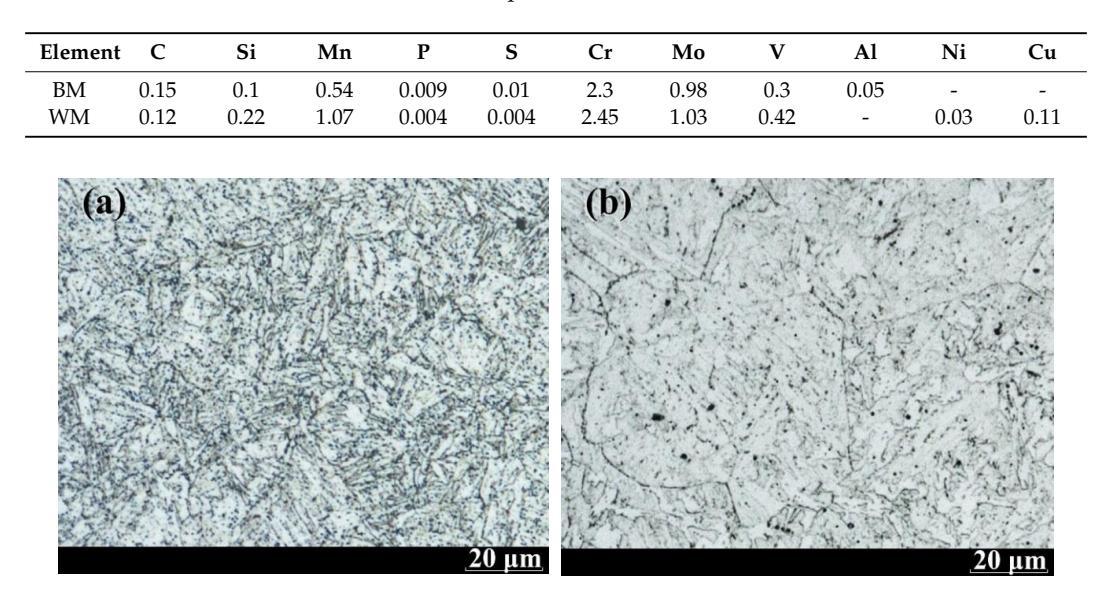
Figure 1. Optical microscopy (OM) images of 2.25Cr1Mo0.25V steel and weld: (**a**) base metal (BM) and (**b**) weld metal (WM).

The 2.25Cr1Mo0.25V steel plates, with dimension of 800 mm length, 320 mm width, and 98 mm thickness, were provided by ArcelorMittal Company (Luxembourg City, Luxembourg). The 2.25Cr1Mo0.25V steel plates were joined through the method of the narrow-gap welding, which was performed by Lanzhou LS Heavy Equipment Co., Ltd (Lanzhou, China). Welding details are as follows: current, 500 A; voltage, 32 V; and travel speed, 22 mm·min⁻¹. To avoid the effect of PWHT on experimental results, no PWHT was performed after welding process. Prior to the machining of specimens from the welded joint, the joints were examined by radiographic testing using X-rays to locate defects. Figure 1 presents the typical microstructures of BM and WM of 2.25Cr1Mo0.25V steel welded joint, clearly exhibiting the existence of bainitic microstructures in both the cases. However, the grain size of WM is larger than that of BM. The chemical composition of 2.25Cr1Mo0.25V welded joint (i.e., BM and WM) is provided in Table 1.

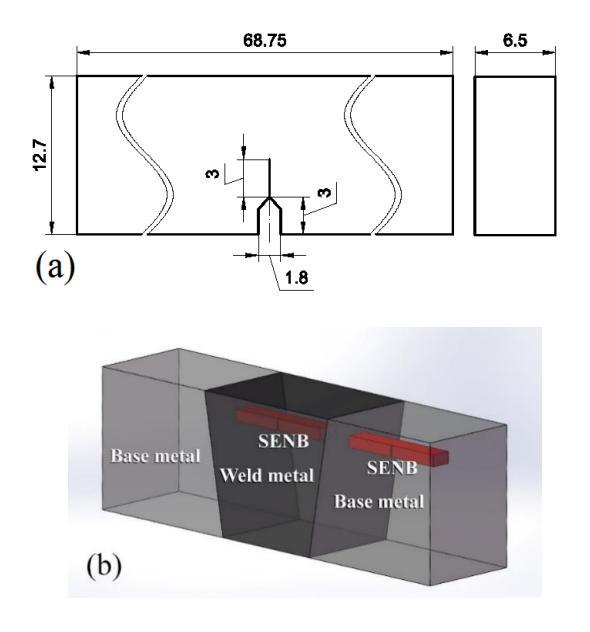
Figure 2. Single edge notched-bend (SENB) specimens: (**a**) Dimension of BM and WM three points specimen (units: mm); (**b**) Schematic of positions of the SENB specimens' sampling.

Based on ISO 12135 standard [10], the BM and WM single edge notched-bend (SENB) specimens were machined from 2.25Cr1Mo0.25V welded joint. Figure 2 exhibits the geometric dimensions and positions of the SENB specimens. The SENB specimens for Base Metal (BM) and Weld Metal (WM) were machined near the top surface of the welded joint. The notch of BM and WM is in the Base Metal and Weld Metal, respectively. The specimens were obtained with the weld longitudinal with respect of the pre-crack. All specimens were ground sequentially with 1500 grit abrasive paper and mirror polished. using 1 μ m diamond paste. After the grinding process, the specimens were cleaned with de-ionized water and methanol, and then dried with the help of a stream of cold air. Finally, the specimens were corroded using a 5% Nital solution and immediately cleaned with methanol. Metallurgical microscopy was employed to observe metallographic structure of BM and WM.

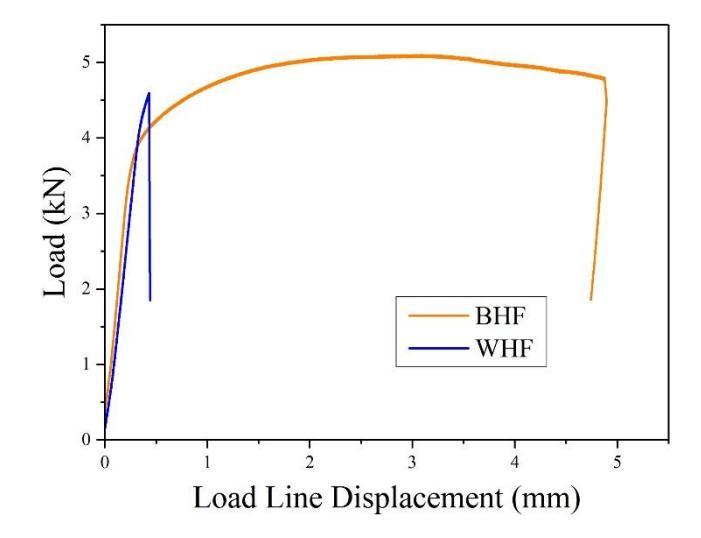
Figure 3 displays the typical load-displacement curves for the BM and WM specimens without hydrogen charged condition (BHF and WHF, respectively). Apparently, there exists remarkable differences in their mechanical properties. First, an obvious two-stage characteristic process consisting of the elastic and plastic deformation stages is observed in the BM specimen, whereas only elastic deformation stage is shown for the WM specimen. Furthermore, for the BM specimen, before the final drop of load, a prominent load plateau is evidently seen because of the significant plasticity-induced strain-hardening phenomenon and the blunting of newly generated crack tip. However, this figure clearly shows that for the WM specimen, load plateau is not observed, and the load suddenly drops

down after the elastic deformation stage. Such pronounced difference revealed that BM possessed significantly superior toughness compared to the WM specimen. In addition, the maximum load of the BM specimen was obtained to be higher than that of the WM specimen. Thus, the coexistence of prominent plasticity and higher load in the BM specimen indicated superior fracture toughness to that of the WM specimen.

Figure 3. The variation of load with respect to the displacement for hydrogen free specimens.

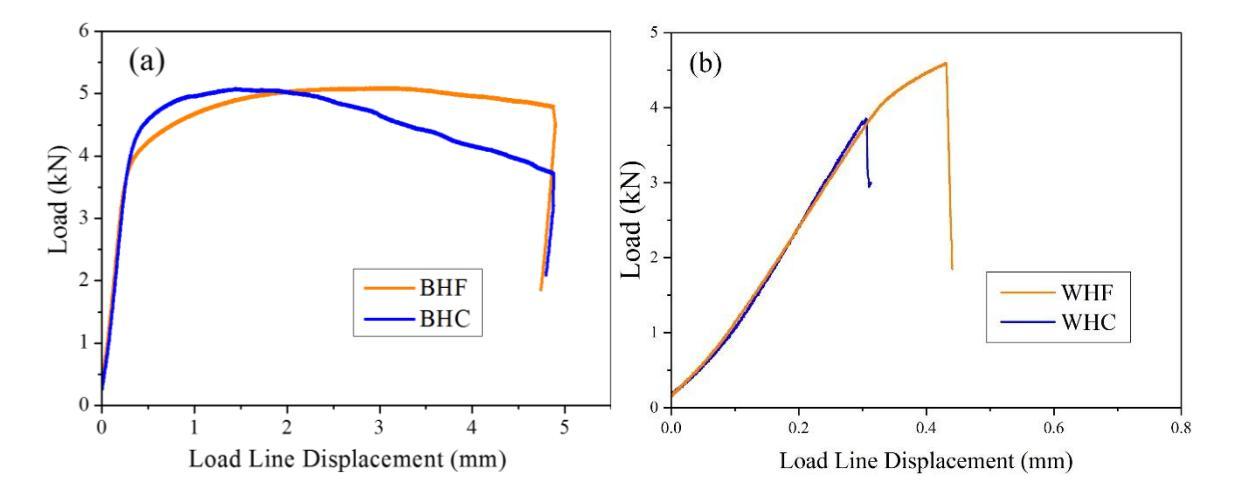
Figure 4 displays the typical load-displacement curves for the BM and WM specimens under both hydrogen-free (HF) and hydrogen-charged (HC) conditions. On one hand, for BM specimens, similar load line displacements can be seen under both HF and HC conditions, suggesting the similar stable crack propagation distances. However, a less pronounced load plateau is observed under the HC condition. The load reaches the maximum value with only a minor displacement, and subsequently decreases continuously. On the other hand, WM specimens show the only occurrence of elastic deformation stages. However, a decreased maximum load is found under the HC condition compared to that under the HF condition. Consequently, the fracture toughness of both base metal and weld metal specimens under the HF condition was found to be superior to that under the HC condition. The detrimental influence of pre-charged hydrogen on fracture toughness could be clarified based on the fracture morphology, which is discussed in the following section.

Figure 4. The variation of load with respect to the displacement. (**a**) and (**b**) represent BM and WM specimens under hydrogen-free (HF) and hydrogen-charged (HC) conditions.

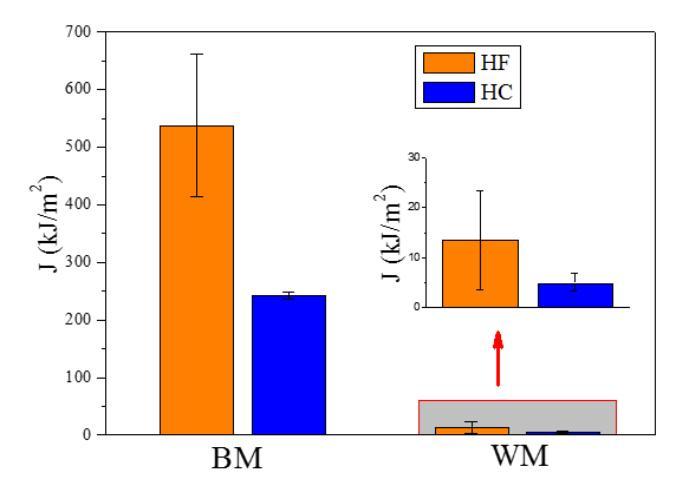
Figure 5 exhibits the results of J-integral. The average J-integral values of BM and WM specimens in the condition of HF were calculated to be 538.1 and 13.6 kJ·m⁻², respectively. According to literature, the critical fracture toughness J_{IC} calculated by ISO 12135 standard for 2.25Cr1Mo0.25V steel was 555 kJ·m⁻² [14], which was in accordance with results in this work. The very low fracture toughness of WM was attributed to the absence of plastic deformation stage in load-displacement curve. In addition, notably, the pre-charged hydrogen contributed to a remarkable decrease of the fracture toughness. The average J-integral of base metal specimen under the HC condition decreased to 242.3 kJ·m⁻²; however, the value of weld metal specimen reduced to 5.1 kJ·m⁻², despite the absence of plasticity.

Figure 5. J-integral values of BM and WM specimens under both HF and HC conditions. The red arrow points to the magnification of the fracture toughness values of WM.

where *J* and *J*_{*H*} represent average J-integral values gained from fracture toughness tests under HF and HC conditions, respectively. The δ_H values were estimated to be 54.9% and 62.5% for BM and WM specimens, respectively. These significant values indicated that the pre-charged hydrogen caused serious HE in both BM and WM of 2.25Cr1Mo0.25V steel and weld, causing a remarkable decrease in fracture toughness and may ultimately leading to HE failures of hydrogen storage vessels. Therefore, significant attention should be paid to the structural health monitoring on hydrogen-contacting equipment to avoid HE failures during the operation and maintenance of equipment due to the high sensitivity of 2.25Cr1Mo0.25V steel and weld to hydrogen.

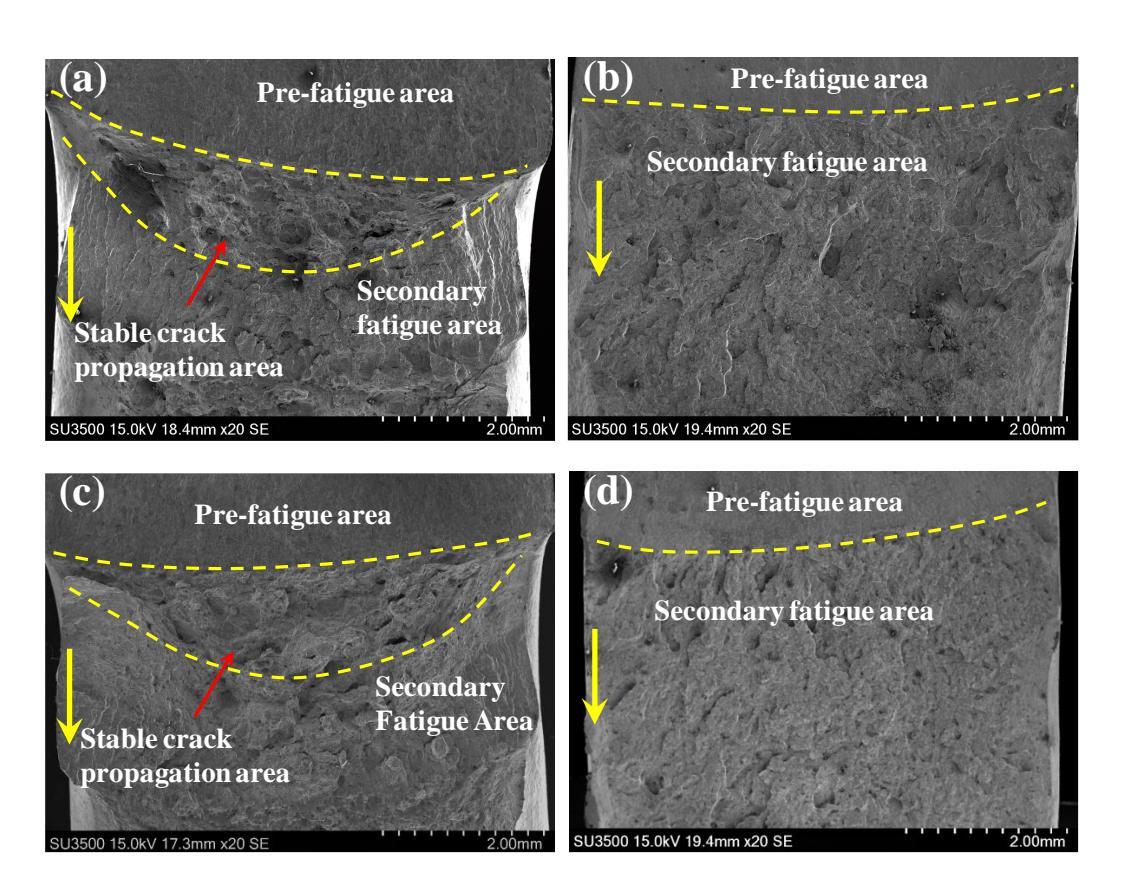
To provide complete insight into HE mechanisms, the fracture appearance of BM and WM specimens under both HF and HC conditions was investigated by SEM. Figure 6 exhibits the macroscopic fracture surfaces of base metal and weld metal specimens under different conditions. Obviously, the fracture surfaces of BM specimens include three distinct regions, that is, the pre-fatigue area, the stable crack propagation area, and the secondary fatigue area, as shown in Figure 6a and c. However, no evident stable crack propagation region is found on the fracture surfaces of WM specimens, and the interfaces between the stable crack propagation area and secondary fatigue area are indistinct. This result is consistent with the above-mentioned load-displacement results, indicating completely brittle features of the WM specimen.

Figure 6. The macroscopic fracture surface. HF condition: (**a**) BM and (**b**) WM. HC condition: (**c**) BM and (**d**) WM. The yellow dash lines differentiate the different areas on fracture surface, and the yellow arrows mark the direction of crack propagation.

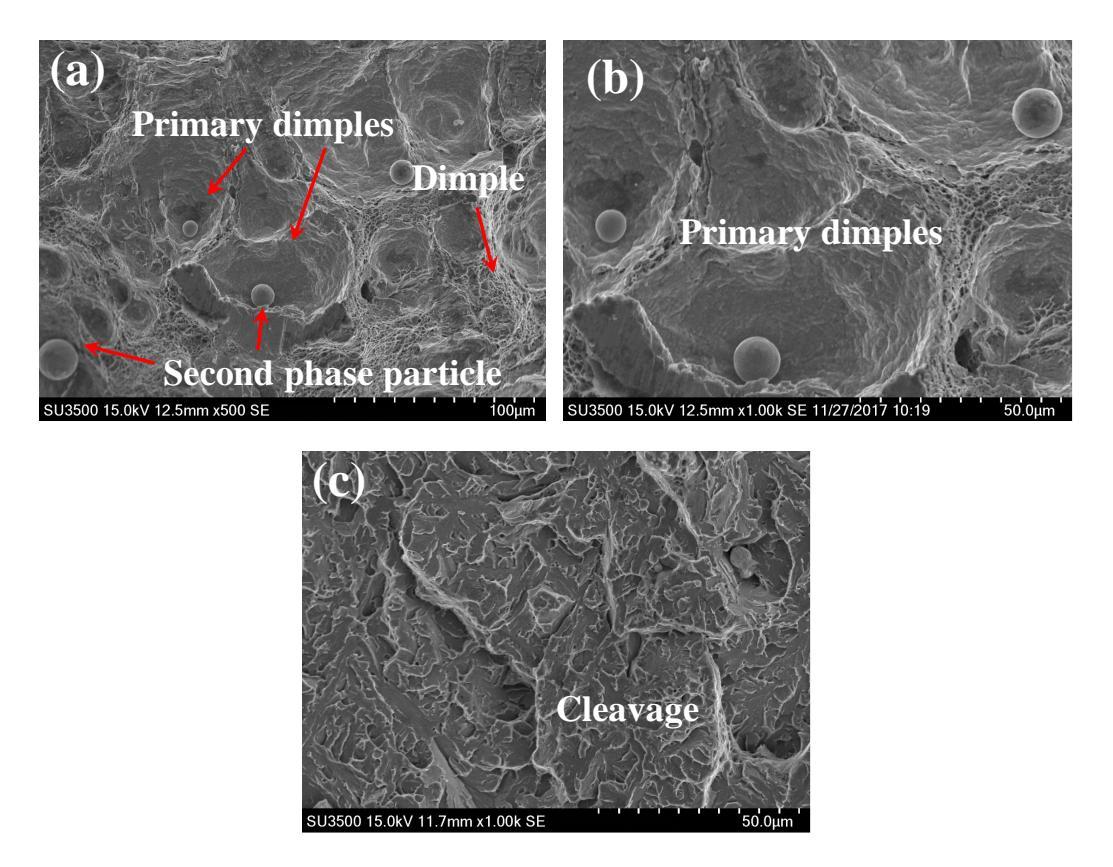
Figure 7 shows the detailed fracture appearance of BM and WM specimens under the HF condition. Figure 7a clearly demonstrates that fracture surface of base metal specimen is composed of numerous large primary dimples with diameters of 10–50 μ m and a number of fine dimples. Figure 7b indicates the magnification of primary dimples in Figure 7a. Such remarkable features apparently suggest that the fracture micro-mechanism of BM is ductile fracture, which is predominantly governed by micro-voids nucleation, growth and coalescence [15]. Moreover, some second phase particles and inclusions (5–20 μ m in diameter) are also located in the center of primary dimples, indicating that the dimples were liable to form from the second phase particles and inclusions. On the other hand, Figure 7c exhibits the existence of the cleavage fracture feature on the fracture surface of WM specimen, indicating completely brittle fracture. Previous studies have demonstrated that in high strength steel, more plastic energy will be consumed so as to generate larger sized voids [7]. Therefore, the appearance of ductile dimples contributed to superior fracture toughness in BM.

Figure 7. The microscopic fracture surface under HF condition: (**a**, **b**) BM and (**c**) WM. (**b**) is the magnification of primary dimples in (**a**).

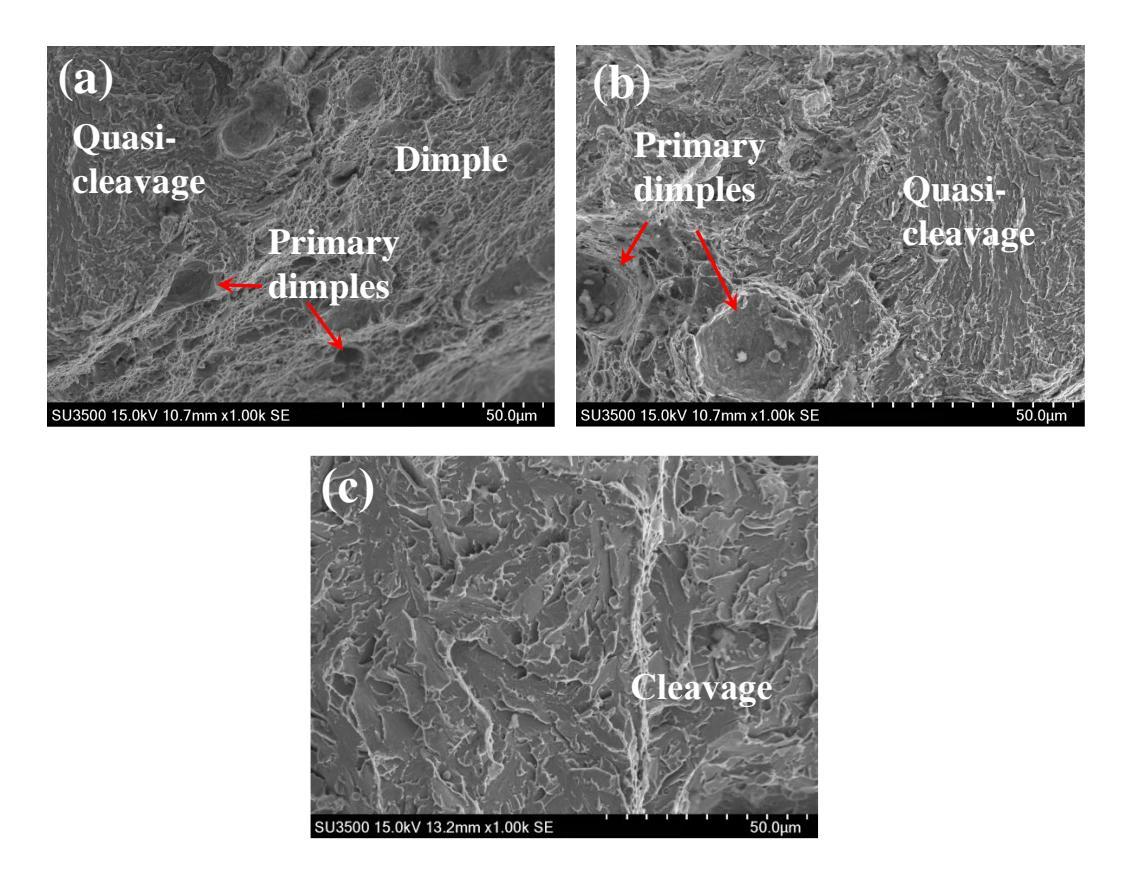
Figure 8a and b demonstrate that compared to the HF condition, the detailed fracture morphology of BM specimen under the HC condition shows a mixed ductile and brittle feature. Figure 8a exhibits two different regions, namely, the quasi-cleavage region with river line pattern and ductile regions containing shallow dimples and small-sized primary dimples. Figure 8b shows ductile feature with primary dimples and more prominent quasi-cleavage fracture feature with river lines. The size of primary dimples mainly ranges from 4 to 25 µm, which are significantly smaller compared to those under the HF condition. The reduced size of primary dimples indicated a lower resistance to crack propagation as less dissipated energy was required for generating dimples with small size. Moreover, the appearance of quasi-cleavage regions indicated a major brittle feature, indicating the occurrence of a local quasi-cleavage due to the presence of hydrogen. In contrast, Figure 8c demonstrates that the WM specimen under the HC condition shows a complete cleavage fracture feature because of the absence of the plastic deformation stage. Therefore, the coexistence of brittle regions and the dimples with decreased size contributed to a prominent decrease of fracture toughness of BM specimen under the HC condition. The fracture toughness J-integral values, SEM features and fracture mechanisms are summarized in Table 2.

Figure 8. The microscopic fracture surface under HC condition: (a, b) BM and (c) WM.
