Article

Influence of Multi-Holes on Fatigue Behaviors of Cast Magnesium Alloys Based on In-Situ Scanning Electron Microscope Technology

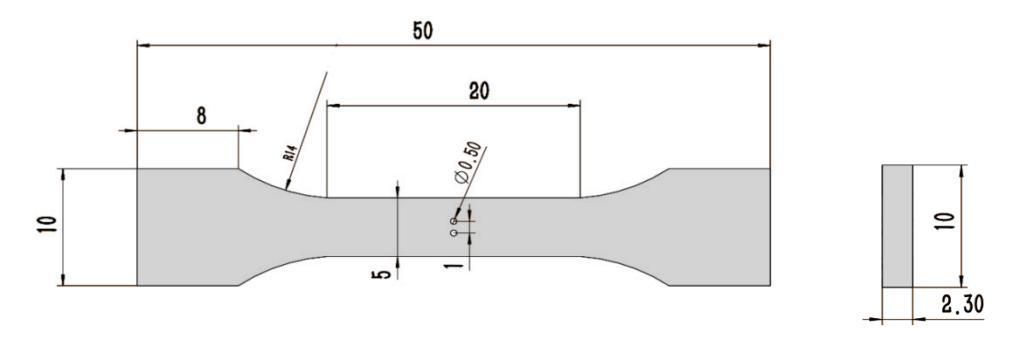
Figure 1. Schematic illustration and size of the specimen; all dimensions' unit: mm.

The plate specimens for the cast AM50, AM60B and AZ91 alloys used in this study were supplied by Norsk Hydro Inc. (Oslo, Norway). Their chemical compositions and main mechanical properties are listed in Table 1. The flat cast of the Mg-Al alloy was processed into the experimental specimens with a 20 mm gage length and about 4.5–5.0 mm (width) by 2.3 mm (thickness) gage cross section by using a wire-electrode cutting method. Every specimen has two through holes in the middle region and the diameter of every through hole is about 0.5 mm, in which the spatial distance (λ) between two through holes is 1.0 mm (2D), 1.5 mm (3D), 2.0 mm (4D) and 3.0 mm (6D), respectively. The tilted angle, α , is defined as the angle between the line connecting the center of two holes and the applied loading direction. In this work, two values, that is, $\alpha = 45^{\circ}$ and $\alpha = 90^{\circ}$, were considered for the tilted angle, as shown in Figure 1. The two through holes were fabricated by the mechanical drilling method from Westmoreland Mech. Testing & Research, Inc., Youngstown, PA, USA in order to avoid the heat affecting. Therefore, the edge of a through hole has still some micro notches to be caused by the slight vibration in the drilling process. Therefore, the fatigue data of cast AM50 alloy with and without a single notch were compared with that of other cast Mg-Al alloys under the different conditions as shown in Figure 2. To investigate the effect of multi-holes on fatigue behavior of cast AM60B and AZ91 alloys, the in-situ SEM (by Shimadzu, Kyoto, Japan) observation technology must be used in this work. The detail results were shown in the next section of analysis or discussion.

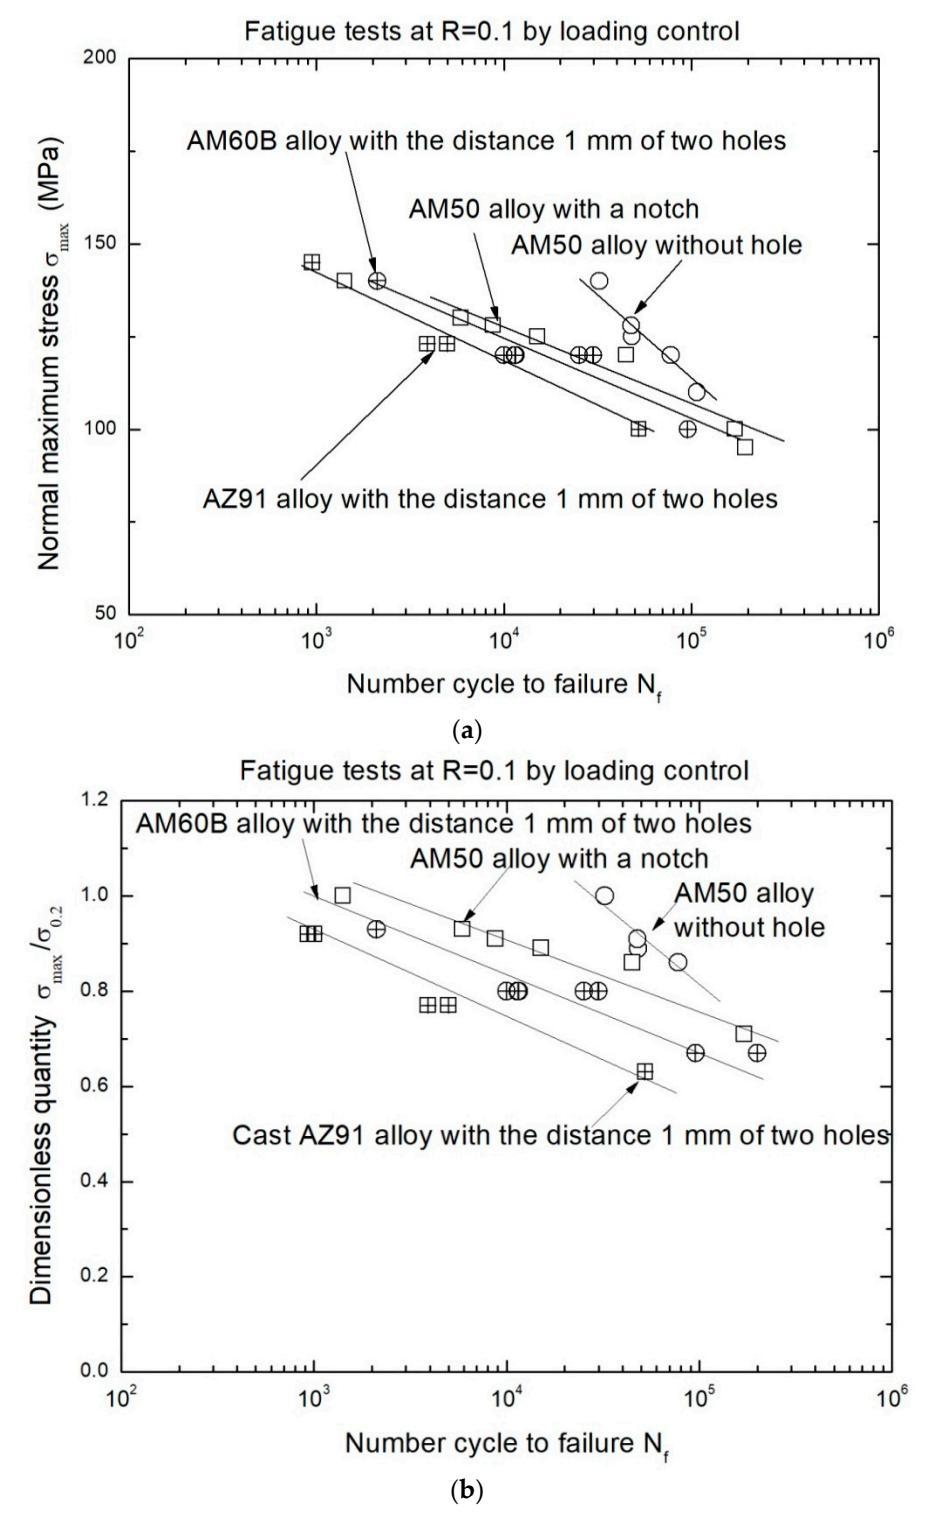
Figure 2. S-N curves of cast Mg-Al alloys under different testing conditions. (**a**) S-N curves of cast Mg-Al alloys with the σ_{max} parameter; (**b**) S-N curves of cast Mg-Al alloys with the λ ($\sigma_{max}/\sigma_{0.2}$) parameter.

The fatigue data of the cast magnesium alloys (AM50, AM60B and AZ91) under different conditions is shown in Figure 2, where the cases for AM60B and AZ91 were chosen as one of the typical results with two through holes for spacing 1.0 mm, 45° tilted to the applied loading direction. And the fatigue data of AM50 alloy in the S-N curves were in order to compare with the difference of two types samples with a single notch and without hole or single notch, in which its radius of curvature is about 0.5 mm and the depth of notch is about 0.6 mm to be equivalent to the diameter of a small hole by using mechanical machining method. Figure 2a indicates that the fatigue performance of the AZ91 alloy is the lowest among three cast magnesium alloys but the S-N curves for the three cases (AM50, AM60B and AZ91) exhibit similar changing trend with roughly the same slope for different artificial defects including notch and holes. The differences of the fatigue life/performance in these S-N curves depend mainly on both the yield stresses of materials and artificial defect types. It reflects the fact that the raising of the fatigue life is with the increase of elongation of cast magnesium alloys. It also hints that the LCF damage behavior of cast Mg-Al alloys may be dominated by the deformation capability but not the static tensile strength of cast Mg-Al alloy as shown in Table 1. Therefore, one of potential ways to enhance the fatigue performance is to improve the plastic deformation capability of cast Mg-Al alloys. For example, by changing the β -phase (Mg₁₇Al₁₂) size or sharp or the refining the α -phase grain the plastic property of cast Mg-Al alloys can be improved [12–15]. In addition, the effect of deflects (such as single notch and multi-holes) on the fatigue performance of cast Mg-Al alloys cannot be ignored, as shown in Figure 2a. In order to reduce the influence of the yield stresses or elongation rates on the fatigue performance of cast Mg-Al alloys, the relationships between relative fatigue strengths (defined as $\lambda = \sigma_{max}/\sigma_{0.2}$) versus the number cycle to failure of three cast Mg-Al alloys were plotted for the alloys. It can be found that the fatigue performance of cast AM60B alloy is superior to that of cast AZ91 alloy under the same condition. By comparing the effects of the single notch and the two holes with a distance 1.0 mm and a tilted angel of 45° on the relative fatigue performance, we see that the relative fatigue performance of cast AM50 alloy with a single notch is obviously better than that of AM60B alloy which has two small holes with the distance of 1.0 mm as shown in Figure 2b but the difference of fatigue performance both single notch and distance $\lambda = 1.0$ mm, tilted 45° of two small holes is not obviously in Figure 2a.

small holes on the fatigue crack propagation behavior according to the results in Figure 3e,f. Therefore, the fatigue crack growth rate of cast AZ91 alloy is about slightly two times than that of cast AM60B alloy which verified that the results in S-N curves is creditability as shown in Figure 2b.

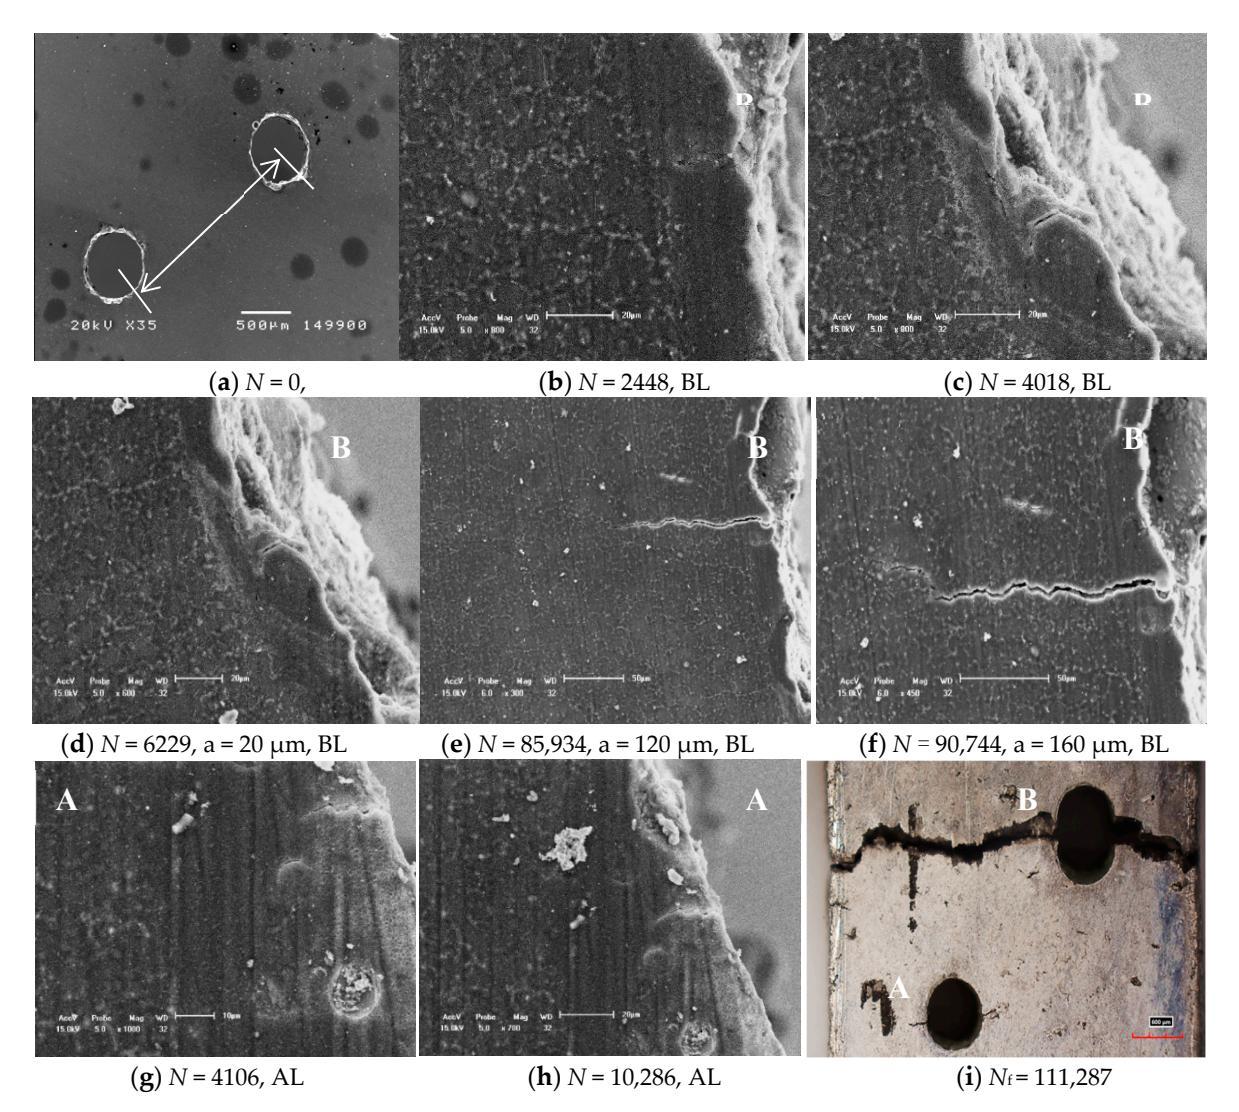
Figure 3. Fatigue crack initiation and propagation behaviors of cast AM60B alloy with tilted 45° and hole distance 1.5 mm (3D) at the maximum stress level of 100 MPa, R = 0.1, $N_f = 111,287$.

In order to quantitatively to explain the effects of the distances between the two holes distance and the tilted angles on the differences of the LCF life of cast AM60B alloy, the results for a typical fatigue crack initiation and propagation characteristics of cast Mg-Al alloys are shown from Figures 3–5, respectively. For example, the fatigue crack initiation and propagation characteristic for cast AM60B alloy with the distance $\lambda = 1.5$ mm (3D) and $\alpha = 45^{\circ}$ as a typical case is shown in Figure 3. The in-situ SEM measured results showed that the tilted angle of the two holes affects significantly the fatigue crack behaviors of cast AM60B alloy at the stress level of 100 MPa and the stress ratio R = 0.1. When the cyclic number is N = 2448, a small crack with an initiation length of about 15 μ m occurred at the root of the closed notch on the left side of Hole B (denoted by BL) as shown in Figure 3a,b, while no small crack was found on both sides of Hole A after about 2500 cycles. Therefore, the fatigue crack initiation time exists in the precedence for the Hole A and Hole B, in which there are still the different burrs on the edge of a through hole caused by the slight vibration in the drilling process as shown in Figure 3a. However, after N = 4018 and N = 4106 cycles respectively at BL and at the edge of Hole AL (the left side of Hole A) seats as shown in Figure 3c-f, these fatigue crack propagation behaviors indicated that the fatigue crack propagation path at BL deviated obviously from the previous crack initiation direction. In addition, although the fatigue crack at the left side of Hole A was found after N = 4106 cycles or N = 10286 cycles, the crack growth rate at the two sides of Hole A were much

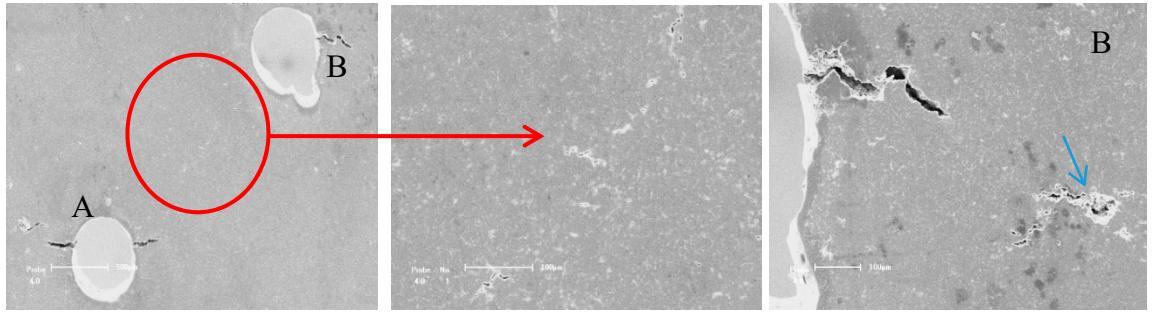
Figure 4. Fatigue crack initiation and propagation behavior of cast AM60B alloy with tilted 45° and hole distance 2.0 mm (4D) at the maximum stress level of 120 MPa, R = 0.1, $N_f = 61,562$. (a) N = 7956, (b) N = 7956, (c) N = 9640.

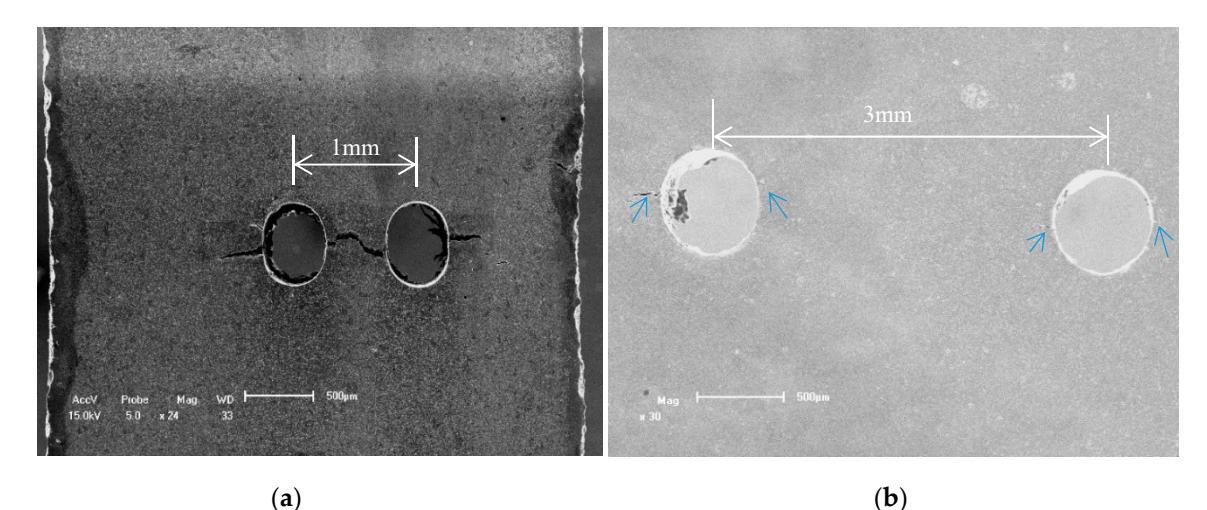
Figure 5. Fatigue crack initiation and propagation behavior of cast AM60B alloy with tilted 90° and different hole distances of two small holes. (a) N = 9446 ($N_f = 17,433$), $\sigma_{max} = 120$ MPa, 2D, R = 0.1. (b) N = 25,046 ($N_f = 25,202$), $\sigma_{max} = 120$ MPa, 6D, R = 0.1

Another typical case of the fatigue cracking characteristics of cast AM60B alloy is showed in Figure 5, in which there are the changes of tilted angle and different distances of two small holes compared with above mentioned case of the fatigue crack characteristic of cast AM60B alloy. These results indicated that the effect of 90° tilted to the loading direction and distance 2D or 6D between two small holes on the fatigue crack initiation and propagation behavior can be defined as the same of fatigue damage model (Mode-I). After 9446 cycles, the fatigue crack initiation and propagation has been occurred at every root of notch and the fatigue cracks have been linked between two holes as shown in Figure 5a. However, with the increasing of distance between two small holes, the increasing of fatigue life is obvious as shown in Figure 5b, in which multi-cracks occurred respectively at the sides of two holes when N = 25,046 cycles. After 25,046 cycles, the LCF cracks between two holes were not linked but the fatigue fracture occurred fleetly between two holes when the cycle increased to 25,202 cycles. It is obvious that the smaller distance (D) between two holes is, the short of LCF life is. In addition, the fatigue crack initiation and propagation behavior depends strongly on the distance of two small holes, 45° or 90° tilted to the applied loading direction and the applied stress amplitude because of the stress concentration degree or fatigue damage model difference.

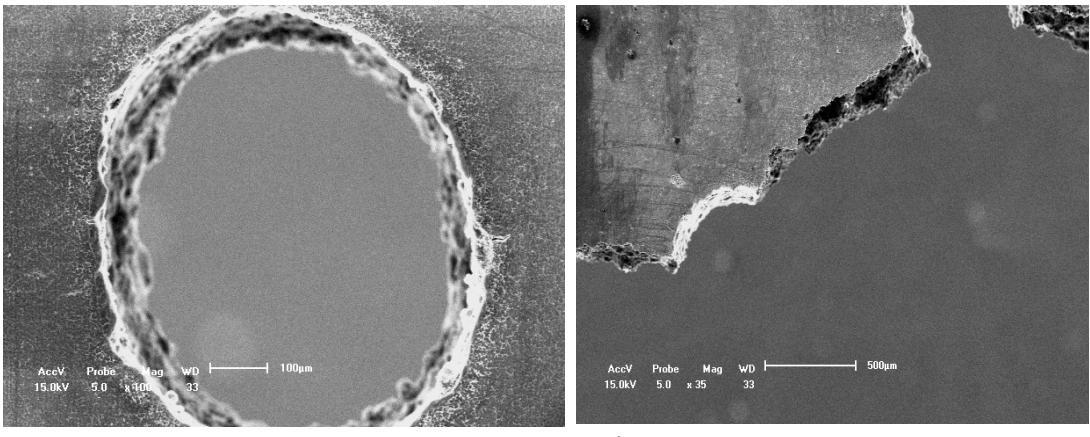
(a) $\sigma_{\text{max}} = 145 \text{ MPa}, \lambda = 0.906, 3D, N = 902$

(**b**) $\sigma_{\text{max}} = 145 \text{ MPa}, \lambda = 0.906, 3D, N_f = 952$

Figure 6. Effect of 45° tilted and distance 1.5 mm of two through holes on the fatigue crack propagation behavior of cast AZ91 alloy.

Figure 6 showed another typical case of fatigue initiation and propagation characteristics of cast AZ91 alloy under the σ_{max} = 145 MPa, R = 0.1, 1.5 mm (3D), in which the result indicated that fatigue crack initiation occurred still at the edge of each small hole when the cycle is 902 cycles as shown in Figure 6a. The fatigue crack propagation path in the linked region of two small holes was fleetly amalgamated as shown in Figure 6b so that the fatigue life of cast AZ91 alloy with two holes was rapidly decreased. An important reason is due the elongation of cast AZ91 alloy is about 3.5% and less than of cast AM60B alloy as shown in Table 1. As above mention the fatigue damage of cast Mg-Al alloy, the fatigue damage behavior of cast AZ91 alloy when λ is over than 0.700 is similar to that of cast AM60B alloy in which the fatigue damage of cast AM60B or AM50 alloy is mainly dominated by the plastic deformation as the result of mismatch of deformation in the interface both α -Mg and β-Mg₁₇Al₁₂. It is due the plastic deformation of cast AZ91 alloy is relative smaller, the LCF crack initiation might occur in randomly but these fatigue multi-cracks in the linked region of two small holes were amalgamated. Therefore, the effect of multi-holes on the fatigue crack propagation behavior of cast AZ91 alloy cannot be ignored. In addition, the fatigue cracks to occur at the notch roots of each hole propagated preferentially between the two holes from statistical data and propagated concurrently along a projected direction as shown in Figure 6b. Compared with the results above mention, whether the fatigue crack propagated of cast AZ91 alloy with the tilted 45° of two small holes not only depends on the distance of two small holes but also on the applied maximum stress amplitude or plastic strain

As the effect of tilted angles (α) on the fatigue crack initiation and propagation behavior of cast AZ91 alloy, it is similar to that of cast AM60B alloy when the tilted 90° and two holes distance λ = 2.0 mm (4D) as shown in Figures 6 and 7, respectively. These results indicated that no matter what the distance between two small holes is, the fatigue crack initiation occurred successively and randomly at the root of holes as shown in Figures 6a and 7b,c, in which the experimental conditions are after N = 902 cycles, at $\sigma_{max} = 145$ MPa, R = 0.1, N = 47,587 cycles, 47,896 cycles, at $\sigma_{max} = 100$ MPa, R = 0.1, respectively. For example, the LCF cracks at left and right sides of Hole B occurred after N = 47,587 cycles, 47,896 cycles respectively. Its length is respectively about 110 μ m as shown in Figure 7b and 400 µm as shown in Figure 7c. Especially, the LCF crack growth length in right side of Hole B is about four times than that in left side of Hole B as shown in Figure 7c. One of reasons is the boundary effect of sample as the LCF crack asymmetric propagation behavior in the Hole B. In addition, there are the different burr formation vestiges on the edges of Hole A and B as shown in Figures 6a and 7a. These burrs are an important influence factor of the early fatigue crack initiation and propagation. Once the fatigue crack was evolved into the macro crack (such as over than 1–2 mm) length including the contribution of two through holes, the fatigue fracture of cast AZ91 alloy is easily to occur. This is due these fatigue cracks were fleetly combined in the projection direction of applied loading as shown in Figure 7c, in which $N_{\rm f}$ is 52,522. In order to further to evaluate the fatigue crack growth rate at the right side of Hole A (AR) under the above mentioned experimental conditions, the fatigue crack lengths after the different cycles were shown in Figure 7a,d–f by using in-situ SEM observation technology. Why did choose the LCF crack propagation behavior at the right side of Hole A as shown in Figure 7a? It is because of without considering the influence of the edge of sample and holes on the fatigue crack propagation in which the influence of the sample edge is greater than that of two holes when the distance of two holes is over than 2 mm (4D). Due the width of sample is about 4.5–5.0 mm in this work, the distance between Hole A or Hole B and edge of sample is less than 1.5 mm if the distance of two holes is over than 2 mm. After N = 5612, the LCF crack initiation length is about 10 µm as shown in Figure 7d at the root of notch for Hole A. With increasing of the cycle (N = 20,284,42,324, respectively), the fatigue crack propagation length extends to about 40 μ m and 300 µm as shown in Figure 7e,f, respectively. Compared with the above mention changes of cycles and crack lengths as shown in Figure 7d-f, the estimated fatigue crack growth rate of cast AZ91 alloy is about 1.38×10^{-8} m/cycle within 300 µm under the applied stress of 100 MPa, R = 0.1. And the fatigue crack growth rate of cast AM60B alloy is approximately estimated to about 0.83×10^{-8} m/cycle within 300 μ m at the applied stress level of 100 MPa, R = 0.1 without also considered the effect of two

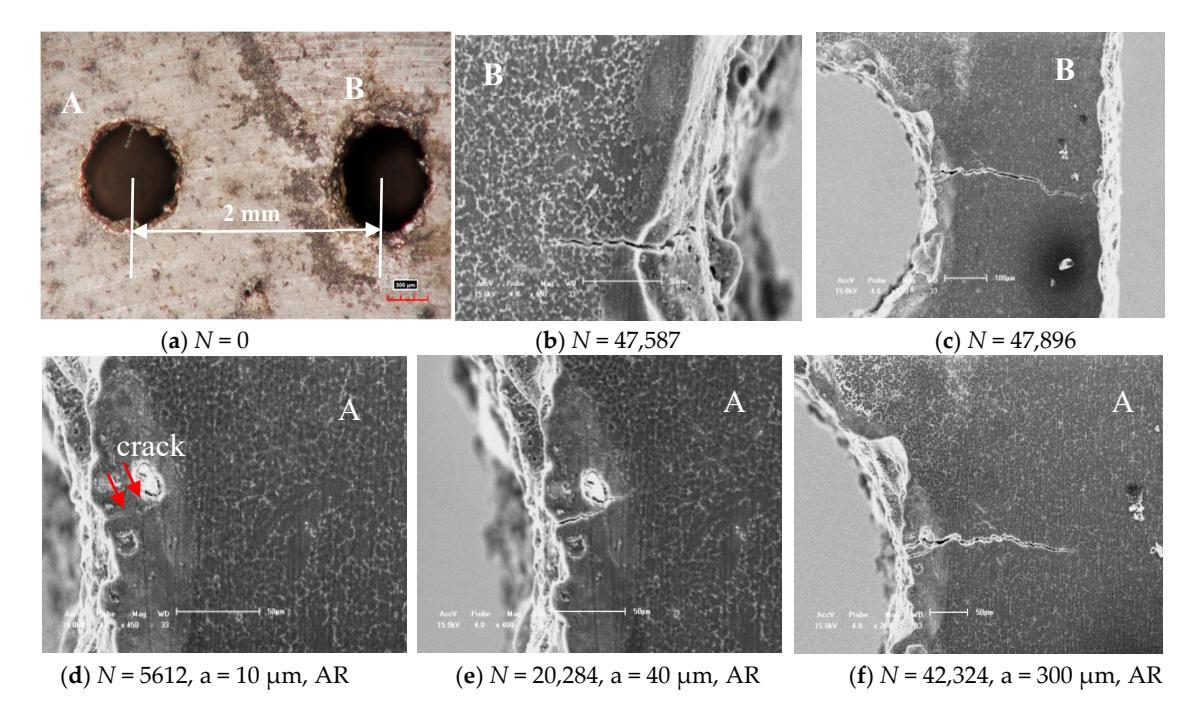
Figure 7. Effect of 90° titled and distance 2.0 mm of two through holes on the fatigue crack initiation and propagation of cast AZ91 alloy at the maximum stress level of 100 MPa, R = 0.1.

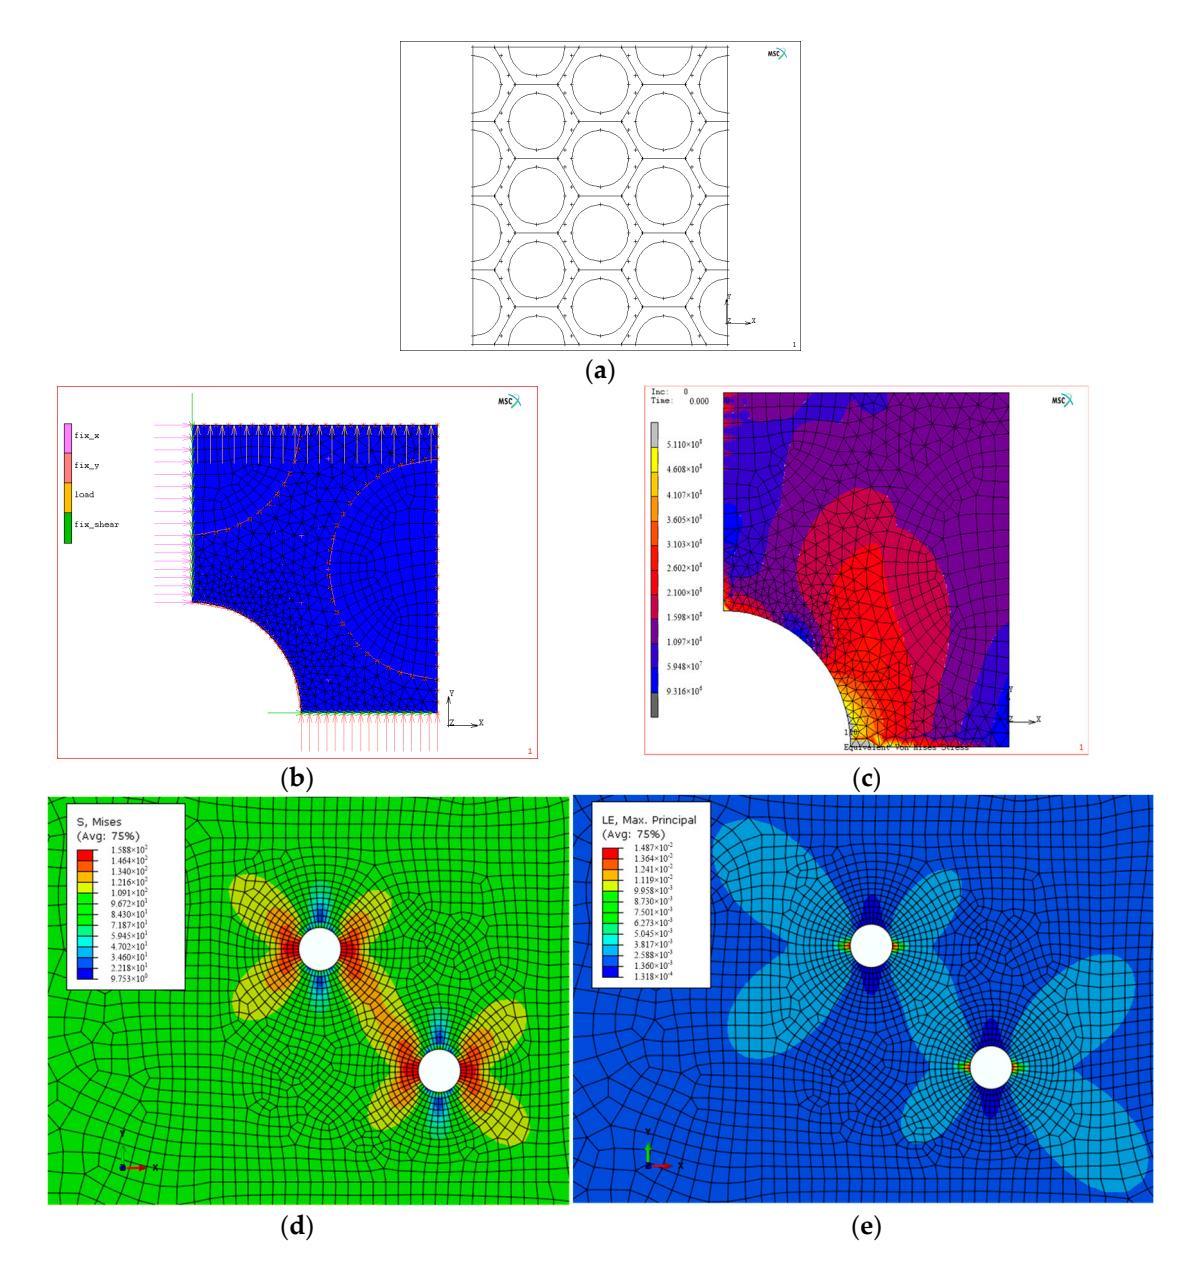
Figure 8. Contour plots of different stresses and plastic strain of cast AM60B alloy. (**a**) FE modeling of cellular texture; (**b**) boundary conditions; (**c**) von Mises stress amplitude distribution (unit: Pa); (**d**) max stress amplitude distribution in one cycle (unit: Pa); (**e**) max plastic strain amplitude distribution in one cycle.

In order to understand the above mention experimental phenomena and characteristics of LCF crack initiation positions and propagation paths of cast Mg-Al alloys (AM60B and AZ91) based on the fatigue damage or fatigue fracture theory, the finite element method (FEM) was carried out as a typical case in Figure 8 under one cyclic loading. The mechanical parameters such as the Young modulus and Poisson ratio and so forth, used in the finite element (FE) analysis are listed in Table 2, in which there is the roughly same relative ratio D-values (25.86% and 24.43%) of α -Mg and β -Mg₁₇Al₁₂ for the Young modulus [such as $(E_{\beta} - E_{\alpha})/E_{\beta} = 25.86\%$] and the micro hardness. The difference in the mechanical properties both α -Mg and β -Mg₁₇Al₁₂ caused the mismatch of deformation and the fatigue cracks occurred easily at the interface [11,13,16–19]. In order to estimate quantitatively the mechanical responses, including stress and strain in the local region under remote loading, the FE modeling was carried out and the results are shown in Figure 8a,b. Figure 8c indicated that the maximum von Mises stress is mainly along tilted 45° and 90° directions development and the maximum stress value occurred always at the edge of hole. It means that the fatigue crack is the most likely to initiate at the edge of a hole, which is in good agreement with the experimental results as shown in Figures 3c, 4c, 5a,b, 6a and 7b–d. It has been indirectly proven that the LCF crack initiation behavior is dominated by the stress concentration at the edge of hole. However, the FE analyses as shown in Figure 8d-e indicated the maximum stress and deformation distribution characteristics exist slightly different around the hole under a cyclic stress, respectively. These differences can explain the LCF crack propagation paths of cast Mg-Al alloys by using the material fracture criterion or different strength theories. Compared with the maximum stress or plastic strain distribution characteristics of cast Mg-Al alloy with two through holes for 45° tilted to applied loading direction, the effective sharing part of the load is main the plastic strain as shown in Figure 8e. It hints that the fatigue multi-cracks occurred randomly in the region between the two small through holes and other fatigue cracks were amalgamated if the elongation of cast Mg-Al alloy was relative smaller. This is due to the fact that the effect of two small

through holes on the fatigue crack propagation behavior cannot be ignored. The fatigue damage of cast Mg-Al alloy with a small elongation was dominated by the plastic strain which agrees with the experimental results.
