# Article Multi-Scale Structural Assessment of Cellulose Fibres Cement Boards Subjected to High Temperature Treatment

**Abstract:** The methodology of multi-scale structural assessment of the different cellulose fibre cement boards subjected to high temperature treatment was proposed. Two specimens were investigated: Board A (air-dry reference specimen) and Board B (exposed to a temperature of 230 °C for 3 h). At macroscale all considered samples were subjected to the three-point bending test. Next, two methodologically different microscopic techniques were used to identify evolution (caused by temperature treatment) of geometrical and mechanical morphology of boards. For that purpose, SEM imaging with EDS analysis and nanoindentation tests were utilized. High temperature was found to have a degrading effect on the fibres contained in the boards. Most of the fibres in the board were burnt-out, or melted into the matrix, leaving cavities and grooves which were visible in all of the tested boards. Nanoindentation tests revealed significant changes of mechanical properties caused by high temperature treatment: "global" decrease of the stiffness (characterized by nanoindentation modul

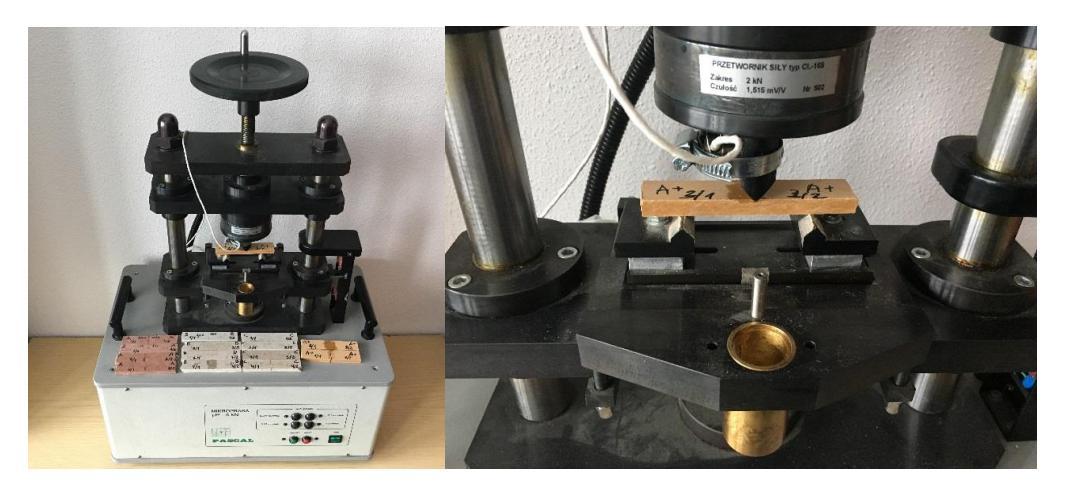
Figure 1. Test stand for bending strength measurements, and fibre-cement board during test.

Comparisons of tested panels are presented in Table 1 and the set of equipment for bending strength measurements is shown in Figure 1.

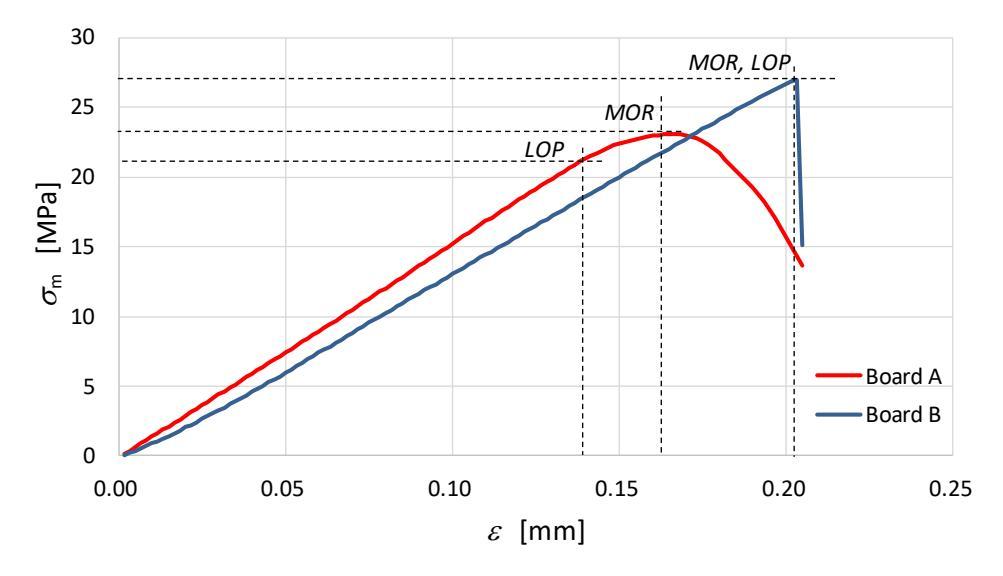
Figure 2 shows an exemplary  $\sigma$ - $\varepsilon$  curve of the tested fibre-cement boards under bending. The trace of flexural strength  $\sigma$ , bending strength *MOR*, limit of proportionality (*LOP*) and strain  $\varepsilon$  were analyzed. Bending strength *MOR* was calculated from the standard formula [27]:

**Figure 2.** Diagrams of the  $\sigma$ - $\varepsilon$  dependence under bending for fibre-cement boards.

The results presented in Table 1 and Figure 2 show that, under high temperature, the bending strength *MOR* increases. The increase (in average sense) from 23.54 to 26.86 MPa is observed. For fibre-cement Board B, it was also observed that under the influence of a temperature of 230 °C, the structure of the Board Becomes more brittle; after peak value of stress, a sudden drop of strength is observed (Figure 2). An analysis of the classical macroscale results showed that for fibre-cement Board B the extent of the nonlinear increase in bending stress is reduced until the bending strength *MOR* comes to be level with the proportionality limit *LOP*. In the case of the reference board, the *MOR* and *LOP* values were clearly separated. It should be noted that the reference samples were under an air-dry condition and their bulk moisture content amounted to 6–8%.

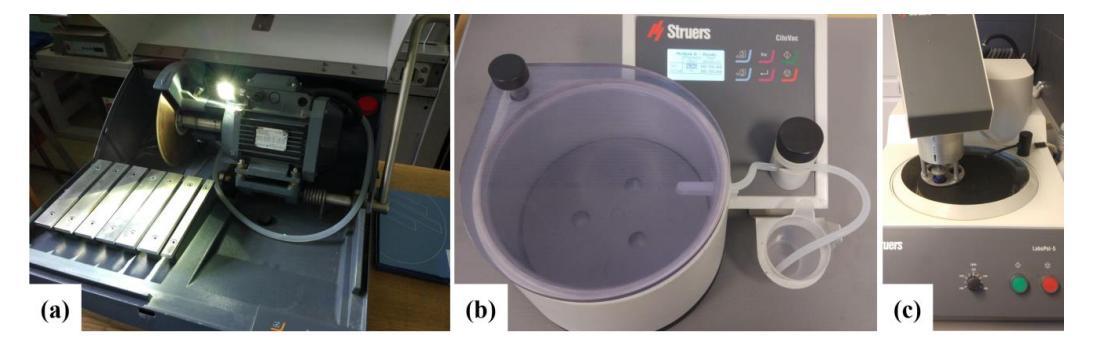
**Figure 3.** Equipment used for sample preparation: (**a**) Struers Labotom-5, (**b**) Struers CitoVac, (**c**) Struers LaboPol-5.

Next the boards were investigated in terms of nanoindentation approach. It is commonly known that the process of sample preparation for nanoindentation is of primary importance for getting reasonable results. In general, we can assume that the results from nanoindentation can only be as good as the sample used for testing. Hence, the aim of the preparation process was to obtain a satisfactory quality of: parallelism and roughness of surfaces, cleanness of the sample and sample tilt. We followed a common rule-of-thumb contained in the ISO standard for nanoindentation (ISO 14577) as well as requirements, concerning surface roughness criteria for cement paste nanoindentation, provided in [25]. Preparation of the samples for nanoindentation consisted of cutting fibre boards to required dimensions (approximately  $1 \times 1$  cm), mounting specimens in the epoxy resin and thorough grinding and polishing process of the specimen surface. High-speed diamond saw Struers Labotom-5 (Copenhagen, Denmark) (Figure 3a), Struers CitoVac vacuum chamber (Copenhagen, Denmark) (Figure 3b) and Struers LaboPol-5 grinder (Copenhagen, Denmark) (Figure 3c) were used for the sample preparation. The photos of the samples after the preparation procedure are presented in Figure 4.

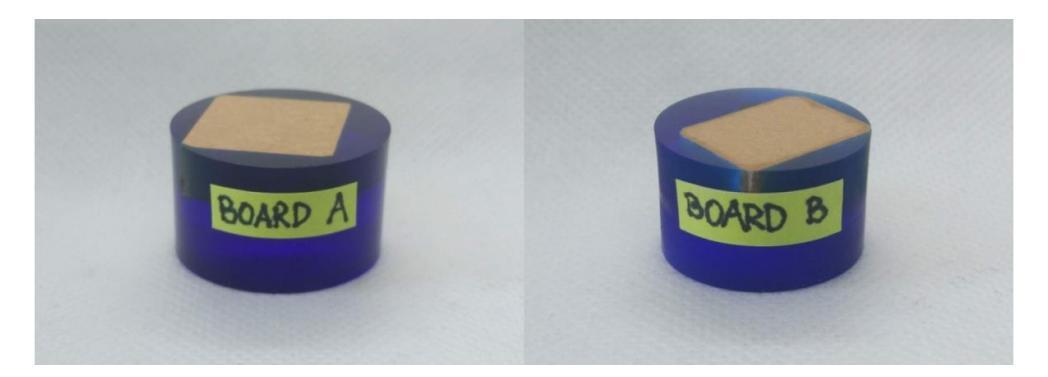
Figure 4. Samples prepared for the indentation.

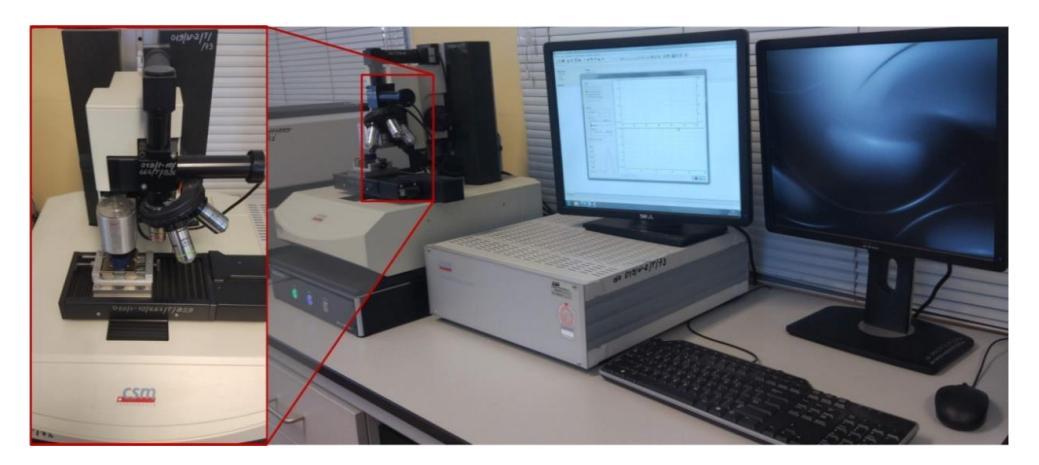
Nanoindentation tests were performed using Nanoindenter CSM TTX-NHT (Neuchatel, Switzerland) (Figure 5) equipped with a diamond Berkovich tip (Poisson's ratio  $v_i = 0.07$ , elastic modulus  $E_i = 1000$  GPa,  $\beta = 1.034$ ).

Figure 5. Nanoindentation test stand.

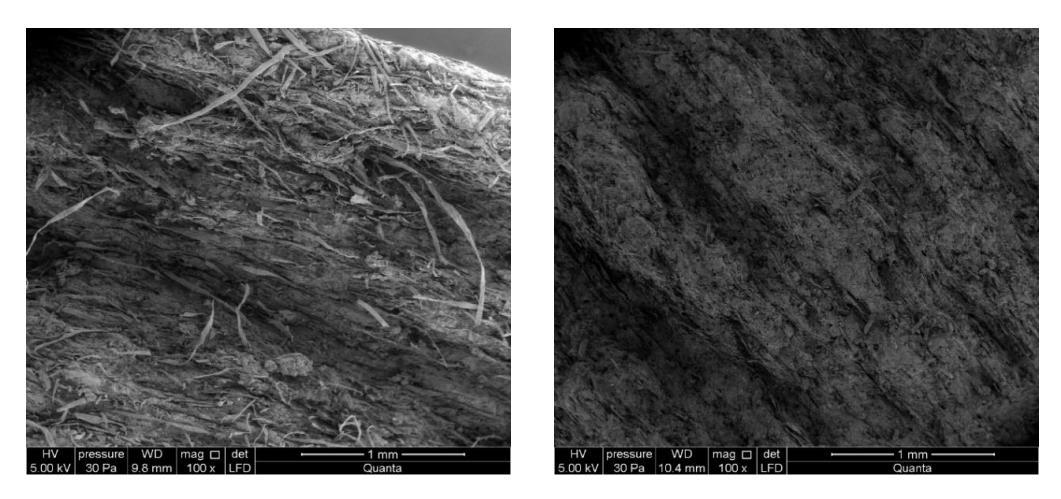
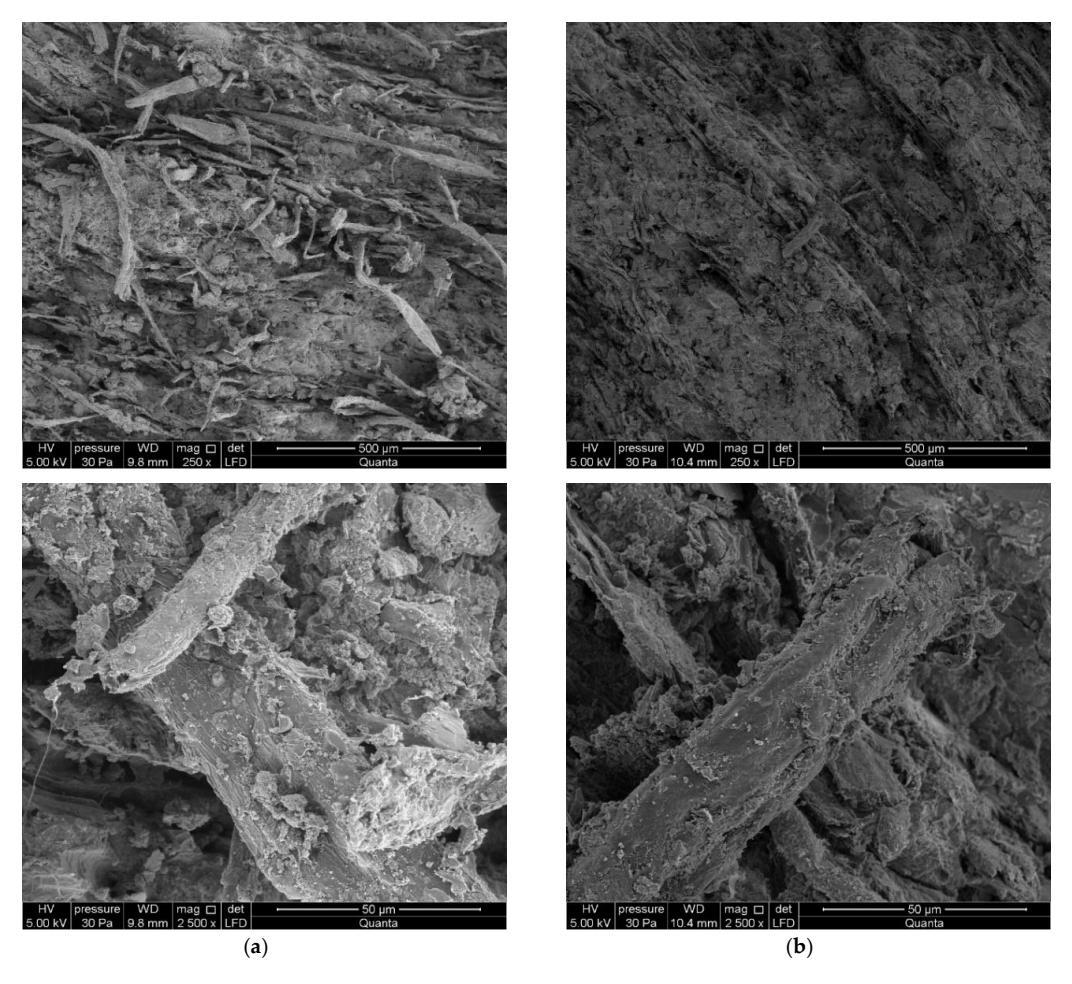
In this Section the results obtained with SEM imaging are presented. In particular, Figure 6 shows the microphotographs of the applied fibres. Note that left (right) panel of Figure 6 presents the microstructure of reference (subjected to high temperature) sample.

**Figure 6.** The microscopic observations of the applied fibres, in scanning electron microscope (SEM) with scale bar in sequence 1 mm, 500  $\mu$ m and 50  $\mu$ m: (**a**) air-dry condition (reference board), (**b**) board exposure to temperature of 230 °C-3 h.

An analysis of the images obtained from the scanning electron microscope and the EDS analyzer shows that the fibre cement Board A has a compact microstructure (Figure 6a). Microscopic examinations revealed a fine-pore structure, with pores of up to  $50 \ \mu m$  in size. Cavities and grooves, up to  $500 \ \mu m$  wide, were visible in the fracture areas where the fibres had been pulled out. Cellulose fibres and PVA fibres, are clearly visible in the images. Various forms of hydrated calcium silicates of the C-S-H type occur. Both an "amorphous" phase and a phase built of strongly-adhering particles predominate. An analysis of the fibre composition showed that fibre elements and some cement elements were present. An analysis of the chemical composition of the matrix showed elements that are typical of cement (Figure 7). The surface of the fibres was covered with a thin layer of cement paste and hydration products. The fact that there are very few areas with a space between the fibres and the cement paste, indicates that the fibre-cement bond is strong.

A microscopic analysis of the fibre cement Board B, which was exposed to a temperature of 230 °C for 3 h, shows a clear change in the colour of the samples (Figure 6b). Most of the fibres in the board were found to be burnt-out, or melted into the matrix, leaving cavities and grooves which were

visible in all of the tested boards. The structure of the few remaining fibres was strongly degraded. An examination of the cement particles on the fracture surface revealed burning-out of their structure. The structure of the matrix was found to be more granular, showing many delaminations (Figure 6b). Numerous caverns and grooves left by the pulled-out fibres, as well as the pulled-out cement particles, were observed.

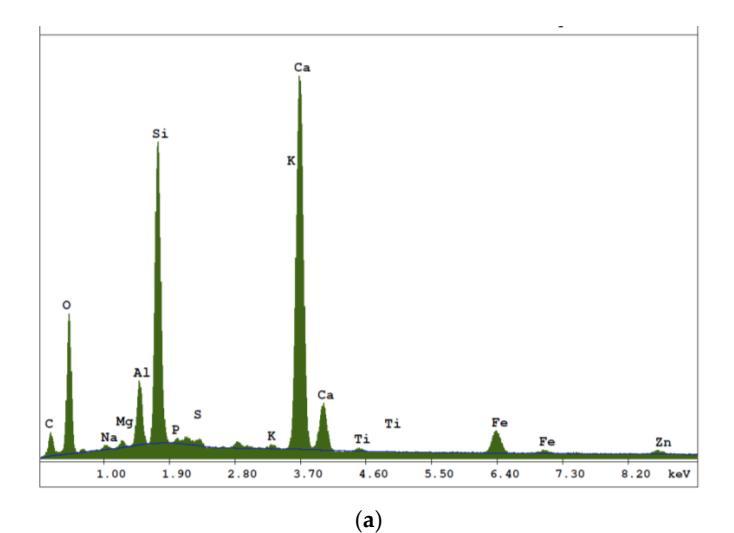
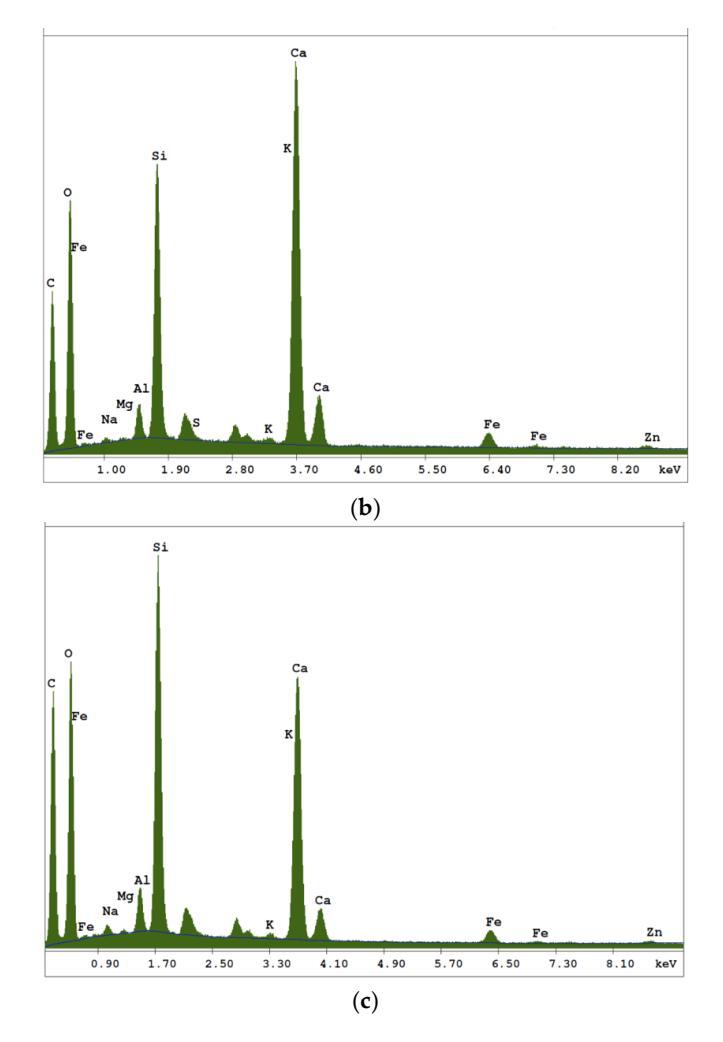
In Figure 7 elemental composition (results of EDS analysis) of tested samples is graphically presented. The investigation was carried out separately for matrix (Figure 7a), fibre of air-dry condition (reference board, Figure 7b) "fibre" of board exposed to temperature of 230 °C for 3 h (Figure 7c).

**Figure 7.** Composition analysis (EDS) of tested boards: (**a**) matrix, (**b**) fibre of air-dry condition (reference board) and (**c**) "fibre" of board exposure to temperature of 230 °C-3 h.

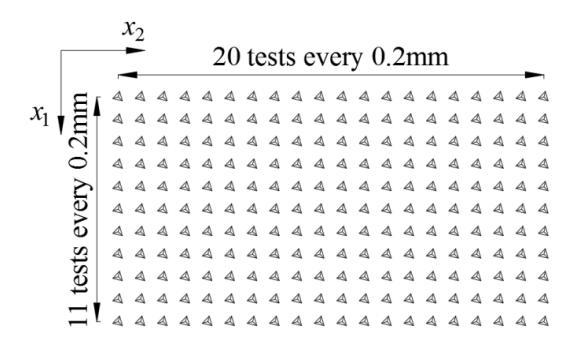
The assessment of mechanical parameters of the fibre cement boards was carried out using the method formulated for heterogeneous materials with a cement matrix. This technique, the Grid Indentation Technique (GIT), was introduced in [18]. For each specimen a regular grid of 220 tests was applied (Figure 8). The relevant grid parameters, such as the distance between indenter locations, the number of tests and the single test's maximum load were determined by trial nanoindentation tests in accordance with the recommendations presented in [18].

Figure 8. Applied nanoindentation grid.

In Figures 13 and 14 the variation of mean values averaged along two independent directions, respectively for  $x_1$  and  $x_2$  (see coordinate system shown in Figure 8), is presented. The black color corresponds to the board subjected to heating and blue (hardness) and red (indentation modulus) colors are representing the results obtained for the reference sample.

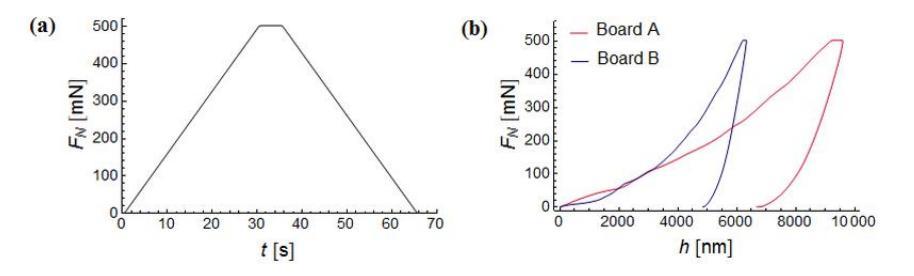
In every grid point, a single standard nanoindentation test [19,28,29] was performed with the maximum load of 500 mN. The test runs as follows: continuous increase of force up to a fixed value  $F_{\text{max}}$ , then a short period in which the set maximum value of force is maintained, after that it is followed by unloading which is also carried out continuously (Figure 9a). During the test, the relation between the force *F* and the depth of penetration *h* is recorded. An example of *F*-*h* curve obtained for a single test is presented in Figure 9b. For every test two indentation parameters were calculated, namely hardness ( $H_{\text{IT}}$ ) defined as follows:

Figure 9. (a) Load function used for single nanoindentation, (b) and example of *F*-*h* curve.

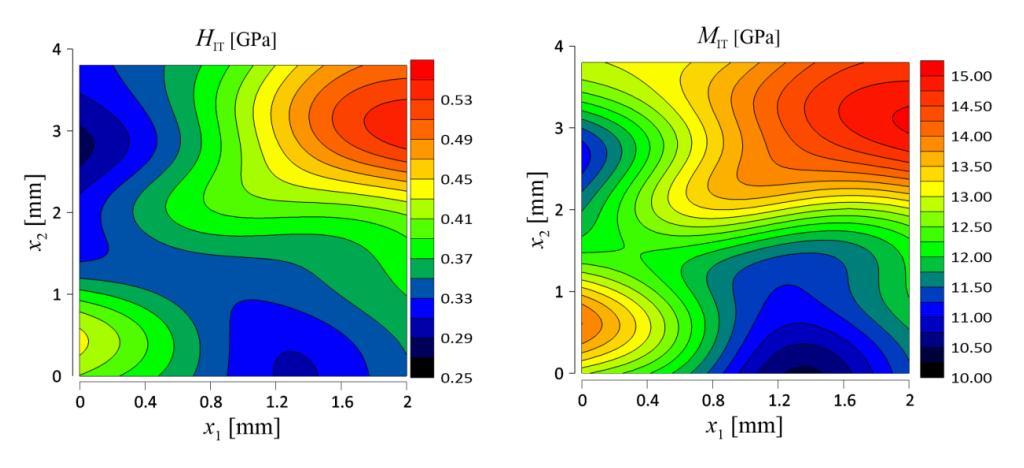
As a consequence of performed tests, distribution of the mechanical parameters on the surface of the samples was evaluated. Contour maps of hardness and indentation modulus distribution are presented in Figures 10 and 11 for Board A and Board B, respectively.

Figure 10. Distribution of hardness and indentation modulus for Board A (reference material).

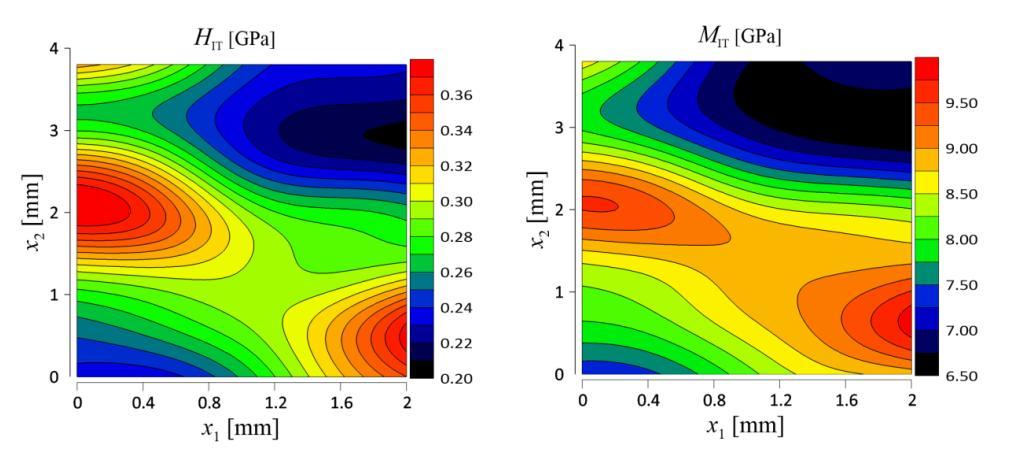
Figure 11. Distribution of hardness and indentation modulus for Board B.

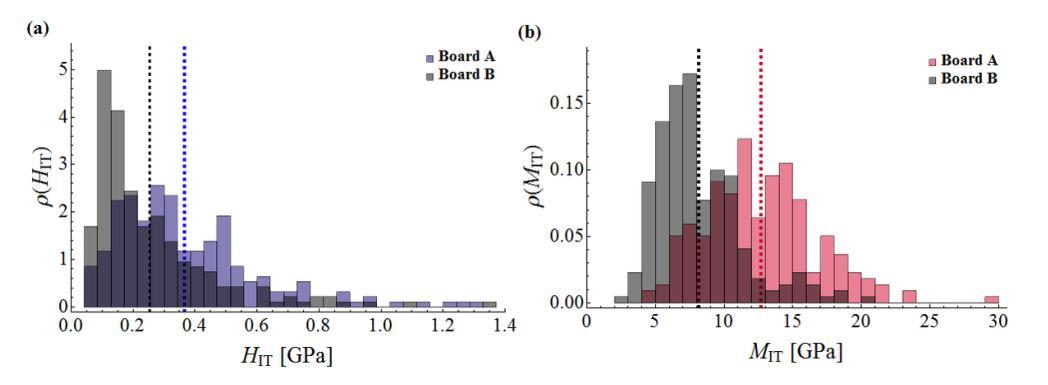
All obtained values are presented in the form of histograms in Figure 12a,b. The results corresponding to the case of high temperature heating (230 °C-3 h, Board B) are displayed in grey. Red and blue colors are corresponding to the results obtained for reference samples (Board A). In particular, the red color represents the distribution of the indentation modulus, whereas the blue one represents the frequency of hardness values. The vertical dashed lines refer to the mean values averaged over 220 individual results. Furthermore, exact values of statistical measures, i.e., mean values  $\mu$  and standard deviations  $\sigma$ , are summarized in Table 2.

Figure 12. (a) Histograms of hardness; (b) histograms of indentation modulus.

Noticeable changes of mechanical morphology of the analyzed boards due to the influence of high temperature is observed within the nanoindentation approach. The average value of the indentation modulus, being the measure of the elastic response of the material, after the exposure to the temperature of 230 °C for 3 hours, significantly decreased (see Figure 12b). The histogram for the Board B (grey colour) concentrates around lower values of modulus compared with the histogram for Board A. In addition, according to Table 2 the average value of the indentation modulus, after heating at the temperature of 230 °C, decreased from 12.686 GPa to 8.147 GPa which equals to an almost 50% drop in the elastic stiffness of examined material. Furthermore, as shown in the right panels of Figures 13 and 14, the mean value of indentation modulus is significantly smaller for Board B compared to the values obtained for Board A in the entire range of  $x_1$  and  $x_2$  values. These observations are in a very good agreement with SEM analysis. A decrease of elastic response of material's microstructure, its stiffness in fact, is mostly due to the changes in the microstructure geometry observed in SEM. The presence of cavities and grooves in Board B can be a direct cause of decrease in  $M_{\rm IT}$  values. It is worth noticing that the changes of geometrical (SEM analysis) and mechanical (nanoindentation) morphology of Board B is a direct cause of the macroscale behavior; by observing Figure 2, one can simply notice that the stiffness of Board B is reduced compared to the one evaluated for Board A (the slope of  $\sigma$ - $\varepsilon$  curve decreased after exposure to the temperature); and it was observed in case of all boards under bending.

Slightly different conclusions can be drawn for the hardness of the material. In general, the average hardness value, as a result of exposure to the temperature 230 °C, decreased, from 0.382 GPa for the Board A, to 0.285 GPa for the Board B (see Figure 12a and Table 2). On the other hand, observing the left panels of Figures 13 and 14 one can notice that "locally", i.e., for given ranges of  $x_1$  or  $x_2$  values, the decrease of  $H_{\text{IT}}$  is not observed. As shown in [30,31] it is the hardness  $H_{\text{IT}}$  which is the parameter determining the strength of the microstructure. This is due to fact that the strength is proportional to the hardness of individual microstructure components; the higher the hardness, the higher the strength of microstructure. Therefore the phenomenon observed e.g., in the left panels of Figure 13 (in the range of  $x_1$  from 0 to 0.5 mm) and Figure 14 (in the range of  $x_2$  from 0.5 to 2.0 mm), where no decrease in  $H_{\text{IT}}$  is observed, can justify the macroscale bending strength results. As shown in Table 1, the bending strength of Board B is slightly higher than the one evaluated for Board A; this is in the average sense since the values in Table 2 represent mean values. However, during individual bending tests we also observed the cases when the strength was not increased or even slightly decreased. This is the effect of the fact that "locally" hardness does not change under the influence of temperature, and hence, this can cause such macroscopic behavior of the boards.

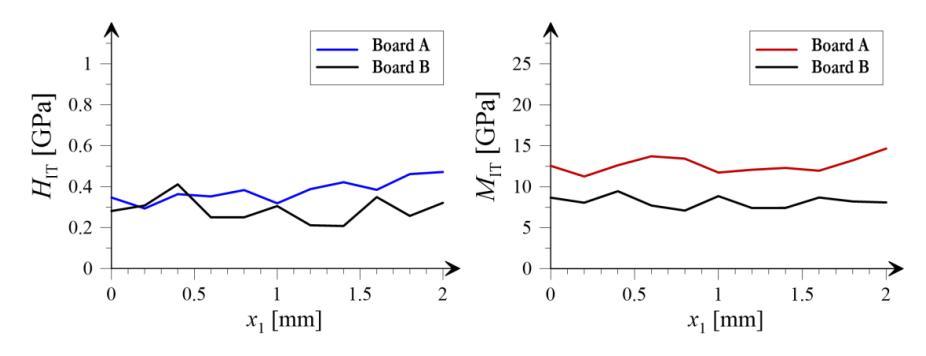
**Figure 13.** Average values of hardness ( $H_{\rm IT}$ ) and indentation modulus ( $M_{\rm IT}$ ) in the  $x_2$  direction.

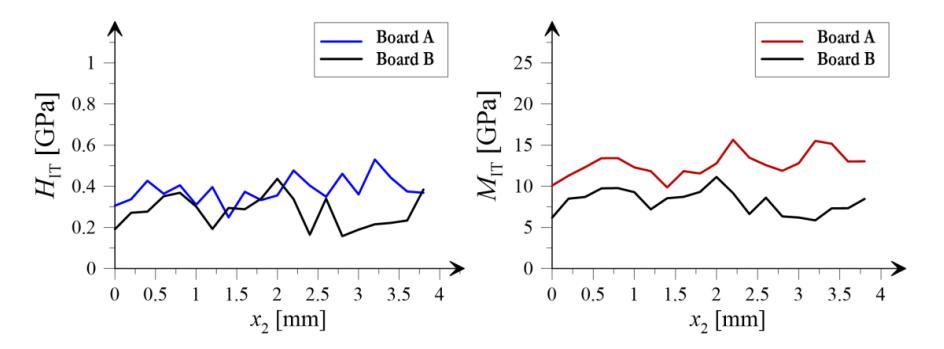
**Figure 14.** Average values of hardness ( $H_{\rm IT}$ ) and indentation modulus ( $M_{\rm IT}$ ) in the  $x_1$  direction.
