Article

Experimental Study on Shear Capacity of Reinforced Concrete Beams with Corroded Longitudinal Reinforcement

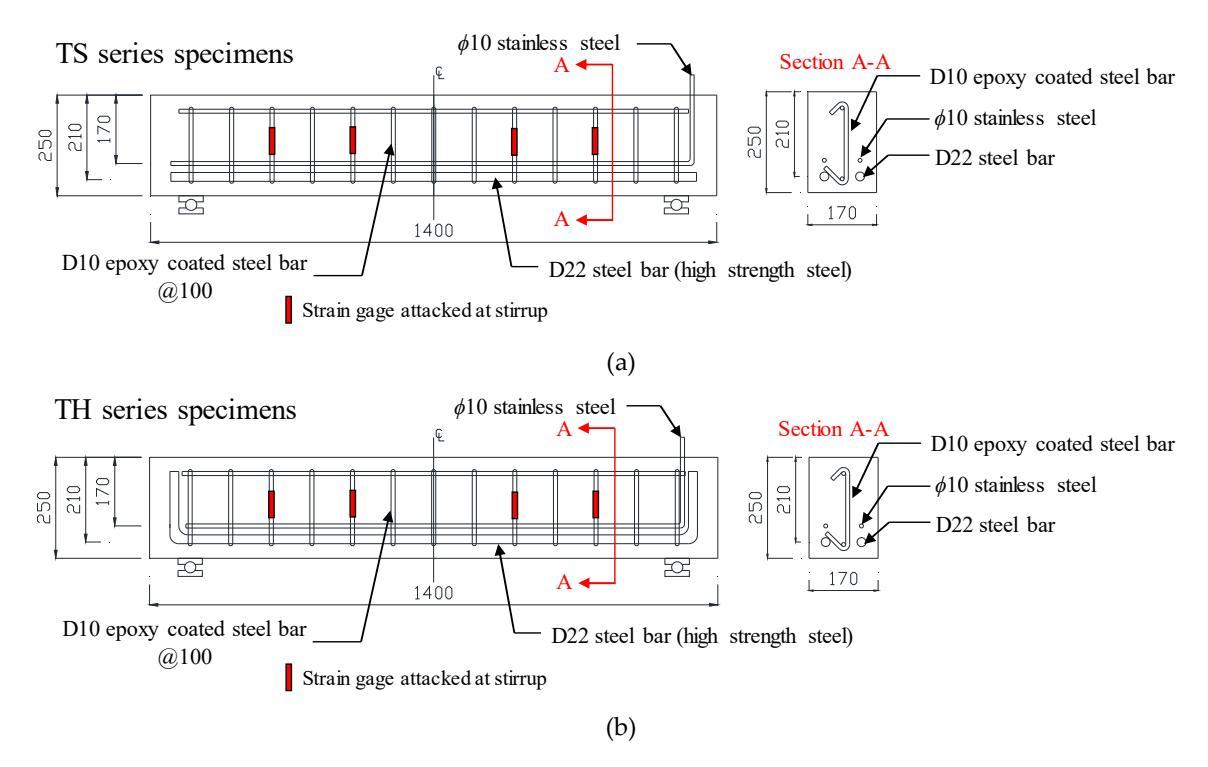
Figure 1. Details of test specimens (Unit: mm). (a) TS series specimens; (b) TH series specimens.

Table 1 and Figure 1 show the details and material properties of the test specimens, where the test groups are divided into the TS and TH series, respectively. As shown in Figure 1, the longitudinal tension reinforcement of the TS series specimens was anchored with a straight type end, while that of the TH series specimens was anchored with a 90-degree hooked type end. The test specimens of each test group were designed to have four target corrosion rates ($\omega_{corr} = 0\%$, 3%, 8%, and 15%). The widths (b_w), heights (h), and lengths (L) of all specimens were 170 mm, 250 mm, and 1400 mm, respectively. Two rebars with a diameter of 22 mm were placed on the tension side. To induce shear failure of the member, high strength steel bars with a yield strength of 635 MPa were used for tension reinforcement. In addition, 10 mm diameter shear reinforcements were placed at 100 mm intervals to satisfy the minimum shear reinforcement ratio specified in the ACI 318-14 building code [25], and strain gauges were attached to the shear reinforcement. Since this study aimed to investigate the effects of longitudinal reinforcement corrosion on the shear capacity of RC members with transverse

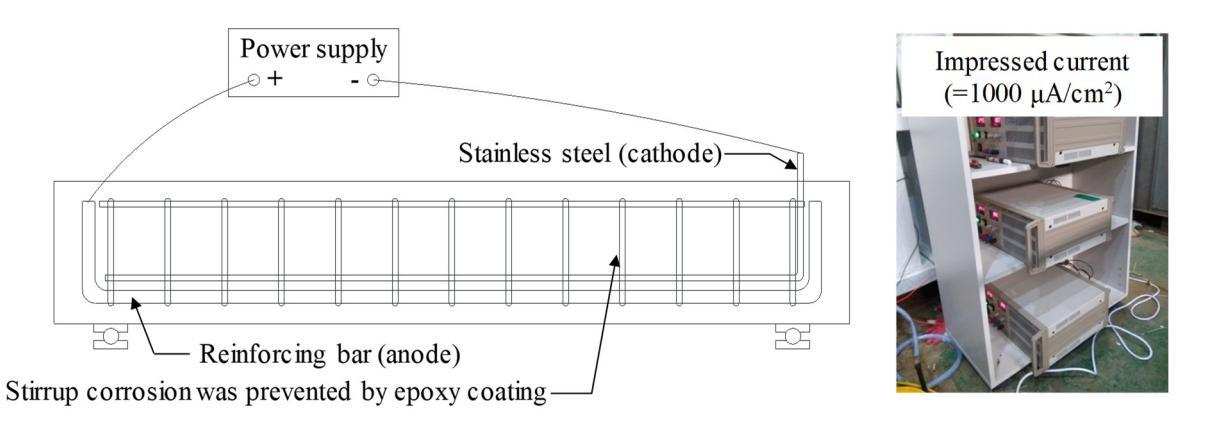
Figure 2. Schematic description of accelerated corrosion test.

Figure 2 shows a schematic description of the accelerated corrosion test. After the age of 28 days, the specimens were precipitated in a 5% NaCl solution, and then dried in air for a week. After the wetting-drying cycle, the specimens were precipitated again in the 5% NaCl solution, and a constant current was provided by connecting the steel bar and stainless steel to direct current (D.C.) power supply with 5.0 A capacity so that the D22 tensile reinforcement could act as the anode and the D10 stainless steel could act as the cathode. Andrade et al. [26] and Al-Harthy et al. [27] reported that the current density (i_{corr}) measured in actual RC structures is less than 0.1 μ A/cm², but previous

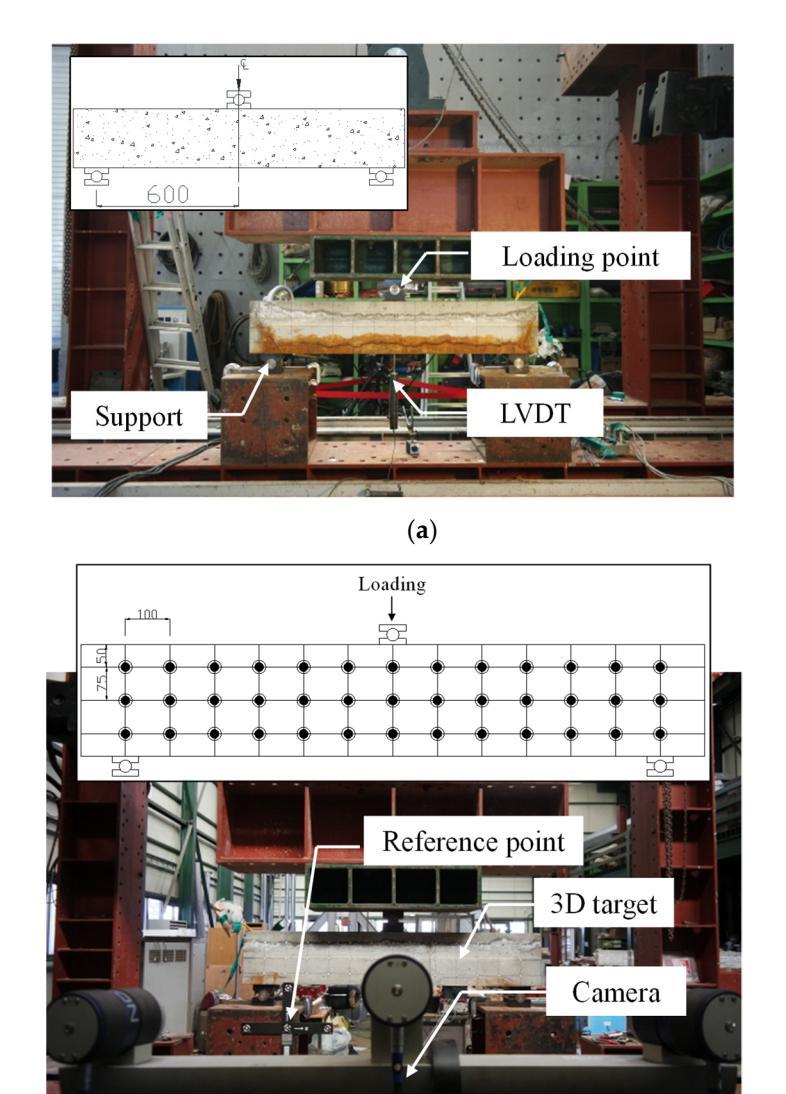
Figure 3. Shear test set-up. (a) Test set-up for one-point loading; (b) Image-based displacement measurement system.

Figure 3 shows the test setups for the shear test. The shear span (*a*) was constant for all specimens at 600 mm, and the shear span to depth ratio (a/d_s) was 2.86. As shown in Figure 3a, the specimens were subjected to one-point loading at the center of the span, and the mid-span deflections of the specimens were measured using a linear variable differential transformer (LVDT) installed on the bottom of the section located at the loading point. In addition, an image-based displacement measurement system [23,24] was used to measure the shear strain distribution of the concrete web, as shown in Figure 3b.

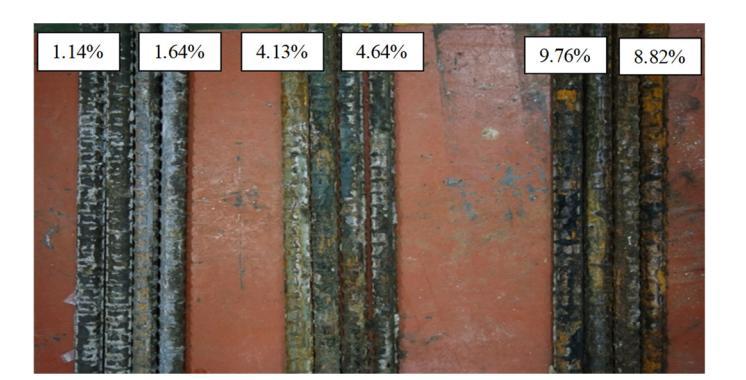
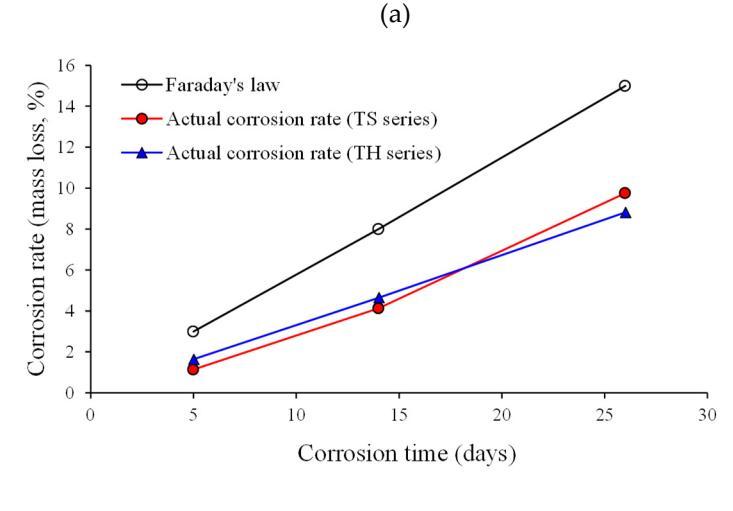
Figure 4. Accelerated corrosion test results. (**a**) Corroded longitudinal reinforcement extracted from test specimens; (**b**) Target and measured corrosion rates of test specimens.

Table 2 and Figure 4 show summaries of the corrosion rates of longitudinal steel reinforcement as calculated using Equation (1). While the target corrosion rates of the specimens were 3%, 8%, and 15%, the measured corrosion rates were 1.14%, 4.13%, and 9.76% in the TS-3, TS-8, and TS-15 specimens, respectively, and 1.64%, 4.64%, and 8.82% in the TH-3, TH-8, and TH-15 specimens, respectively. The reason for why the actual corrosion rates of the specimens are smaller than the target corrosion rates is as follows. As the corrosion of reinforcement progresses, the corrosion product surrounds the reinforcement, thus, interfering with the supply of oxygen (O₂) and water (H₂O) needed to form corrosion cells. In addition, as mentioned above, it is estimated that the magnitude of corrosion current density ($i_{corr} = 1000 \ \mu\text{A/cm}^2$) used in the accelerated corrosion test is considerably large, which leads to a difference between the corrosion rate, it is desirable to perform the accelerated corrosion test.

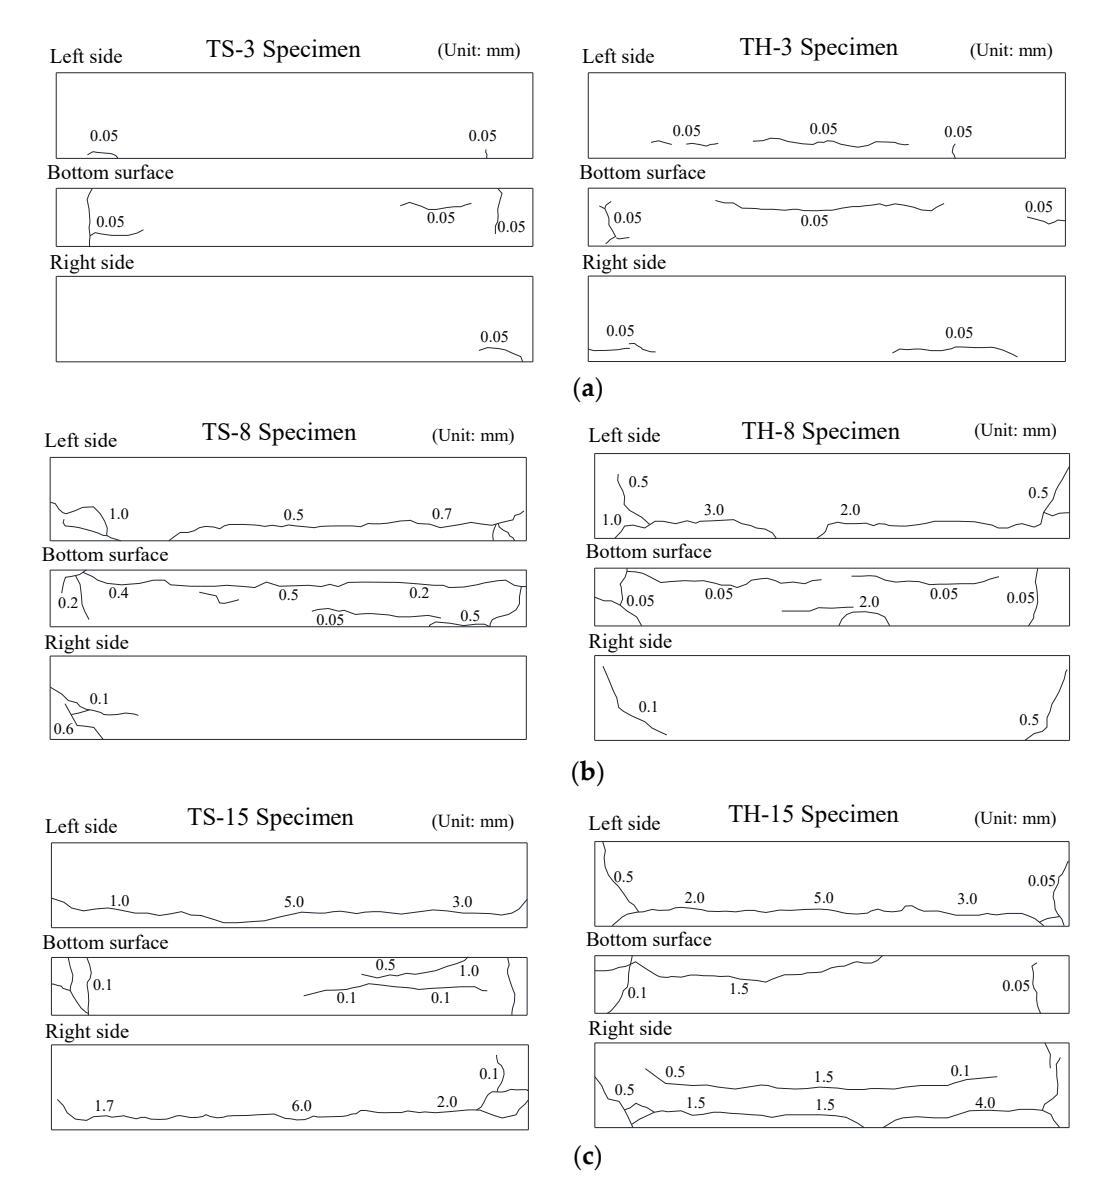
Figure 5. Crack patterns induced by corrosion in longitudinal reinforcement. (**a**) Target corrosion rate of 3%; (**b**) Target corrosion rate of 8%; (**c**) Target corrosion rate of 15%.

Figure 5 shows the crack patterns induced by longitudinal reinforcement corrosion. According to previous studies [8,31], the concrete cover cracks occur in the corrosion rate range of about 1 to 3%, which is the so called corrosion crack. In addition, as the corrosion progresses, the bond performance between reinforcement and concrete decreases sharply with increasing widths of the corrosion cracks. In the TS-3 and TH-3 specimens ($\omega_{corr} = 1.14\%$ and 1.64%, respectively) with a target corrosion rate of 3%, only small crack widths of less than 0.05 mm were measured. However, in the TS-8 and TH-8 specimens ($\omega_{corr} = 4.13\%$ and 4.64%, respectively), crack widths of more than 0.5 mm were measured along the longitudinal reinforcement layers, and more serious damages to the concrete cover were observed from the TS-15 and TH-15 specimens ($\omega_{corr} = 9.76\%$ and 8.82%, respectively), whose crack widths were up to 6.0 mm or more.

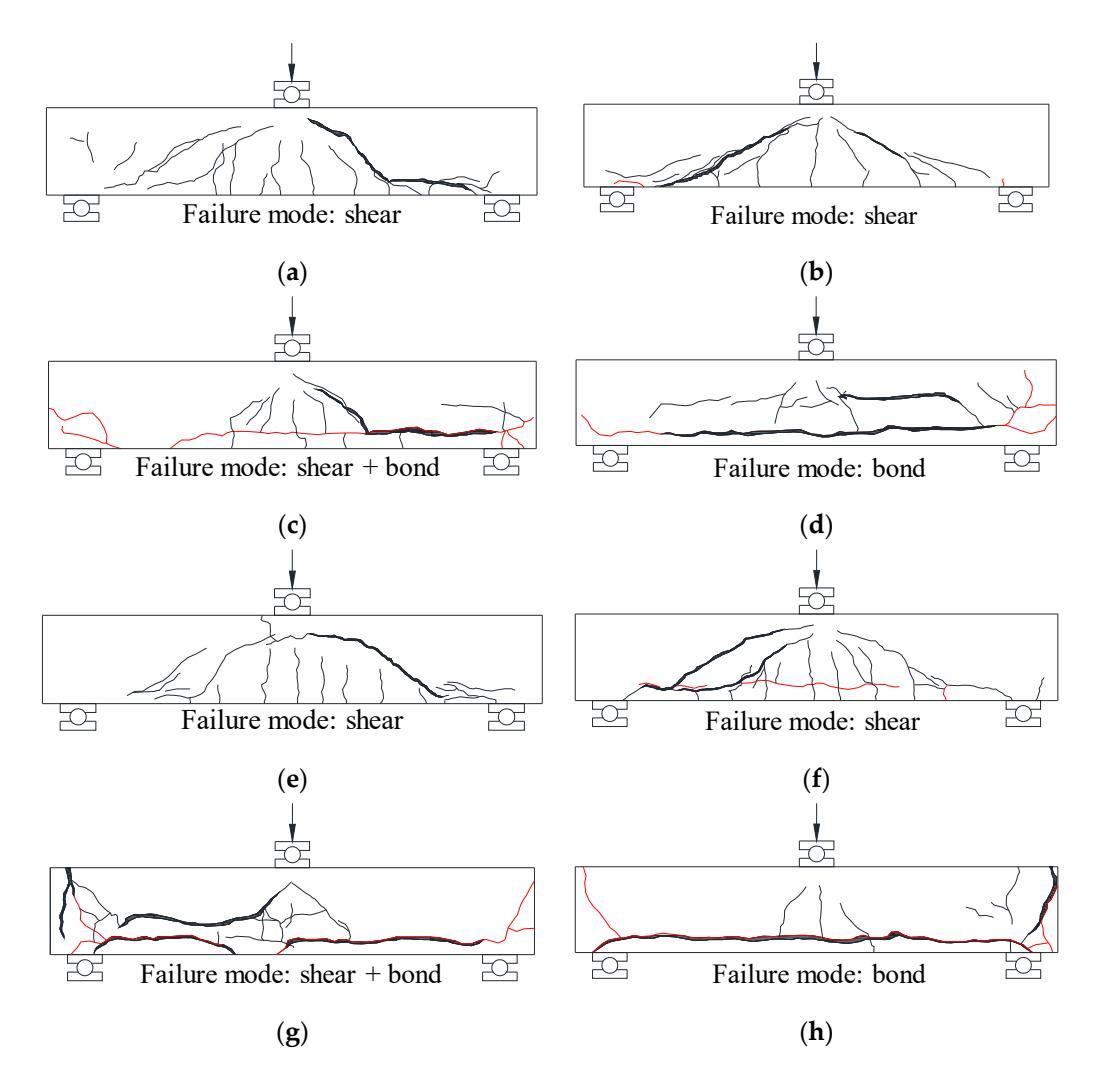
Figure 6. Crack patterns of test specimens after failure. (a) TS-0 specimen; (b) TS-3 specimen; (c) TS-8 specimen; (d) TS-15 specimen; (e) TH-0 specimen; (f) TH-3 specimen; (g) TH-8 specimen; (h) TH-15 specimen.

Figure 6 shows the crack patterns of the specimens at failure, where the cracks induced by longitudinal reinforcement corrosion (i.e., corrosion cracks) are represented as red lines. The TS-0, TS-3, TH-0, and TH-3 specimens with no corrosion damage or with insignificant damage showed the typical shear failure modes. Meanwhile, the TS-8 specimen ($\omega_{corr} = 4.13\%$) with relatively large corrosion damage exhibited a shear-bond failure mode as shear cracks were connected with corrosion cracks, and the crack width increased rapidly. In the TH-8 specimen ($\omega_{corr} = 4.64\%$), the widths of the corrosion cracks tended to increase with increasing shear crack widths as the load increased, and failure occurred rapidly as anchorage cracks progressed at the end of the member. The TS-15 ($\omega_{corr} = 9.76\%$) and TH-15 ($\omega_{corr} = 8.82\%$) specimens with severe corrosion damage showed the typical bond failure modes. The number of flexural cracks in these specimens was smaller than that in other specimens due to the decreased bond performance between tension reinforcement and concrete. Furthermore, as the load increased, the splitting cracks caused by corrosion became wider, resulting in spalling of concrete cover.

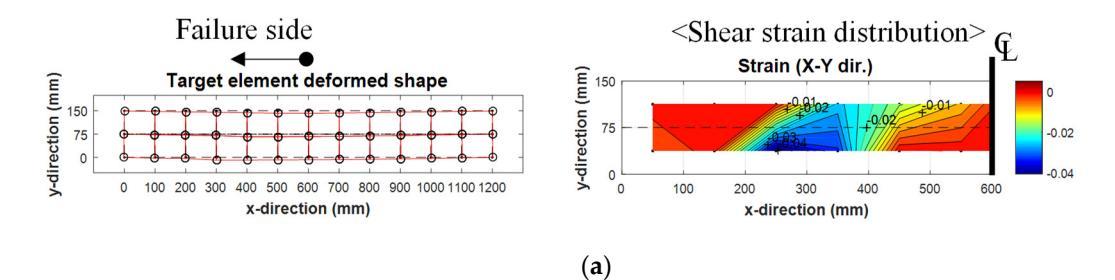
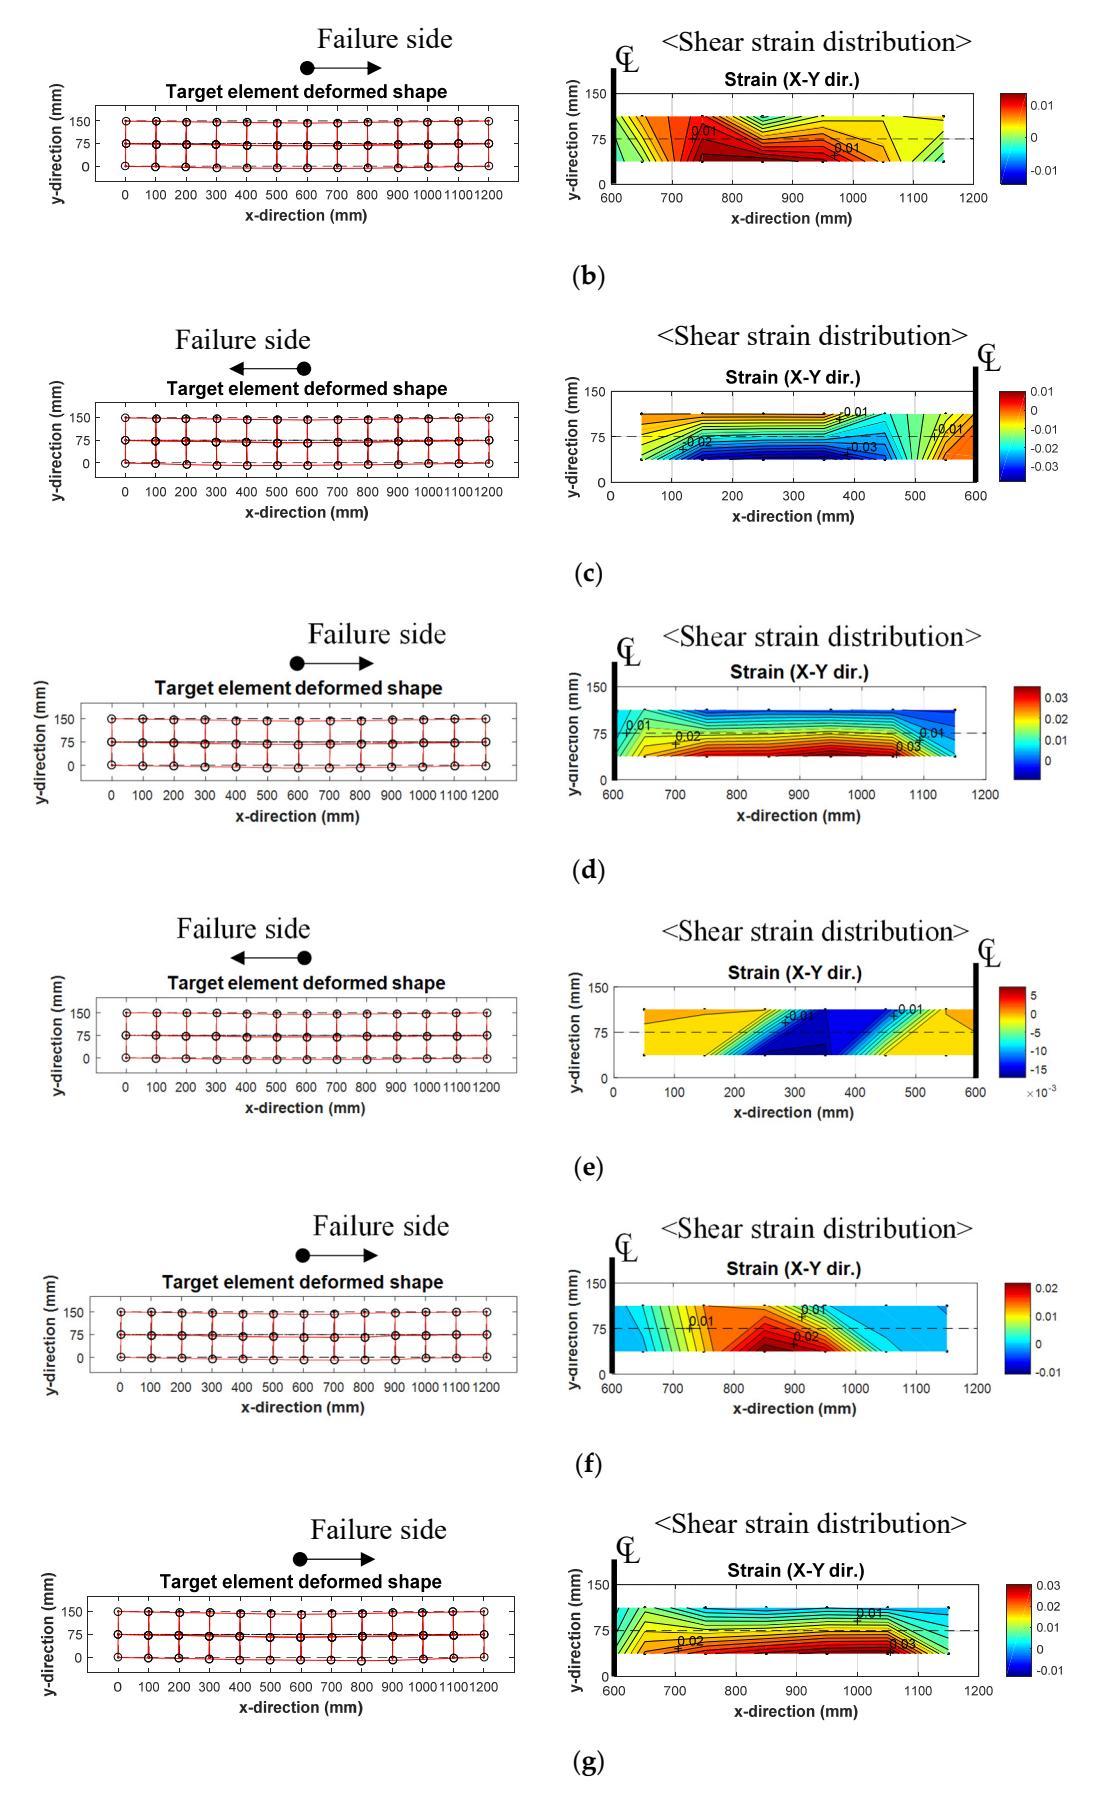
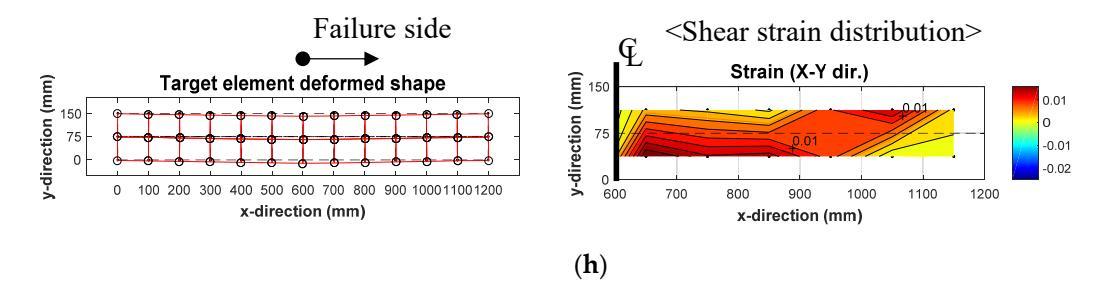
Figure 7. Shear strain distributions at failure loads. (a) TS-0 specimen; (b) TS-3 specimen;
(c) TS-8 specimen; (d) TS-15 specimen; (e) TH-0 specimen; (f) TH-3 specimen; (g) TH-8 specimen;
(h) TH-15 specimen.

Figure 7 shows shear strain distributions measured using the relative displacement of the target shown in Figure 3b. For the TS-0, TS-3, TH-0, and TH-3 specimens, in which no tension reinforcement corrosion was introduced or in which corrosion levels were relatively low, the members failed in shear as shear deformation was concentrated in the concrete web. In addition, the TS-8 and TH-8 specimens showed the shear-bond failure modes, resulting from combined deformations due to the shear force and the bond loss. In the cases of the TS-15 and TH-15 specimens with very high corrosion rates, the deformations due to bond loss were found to dominate the failure modes of the specimens.

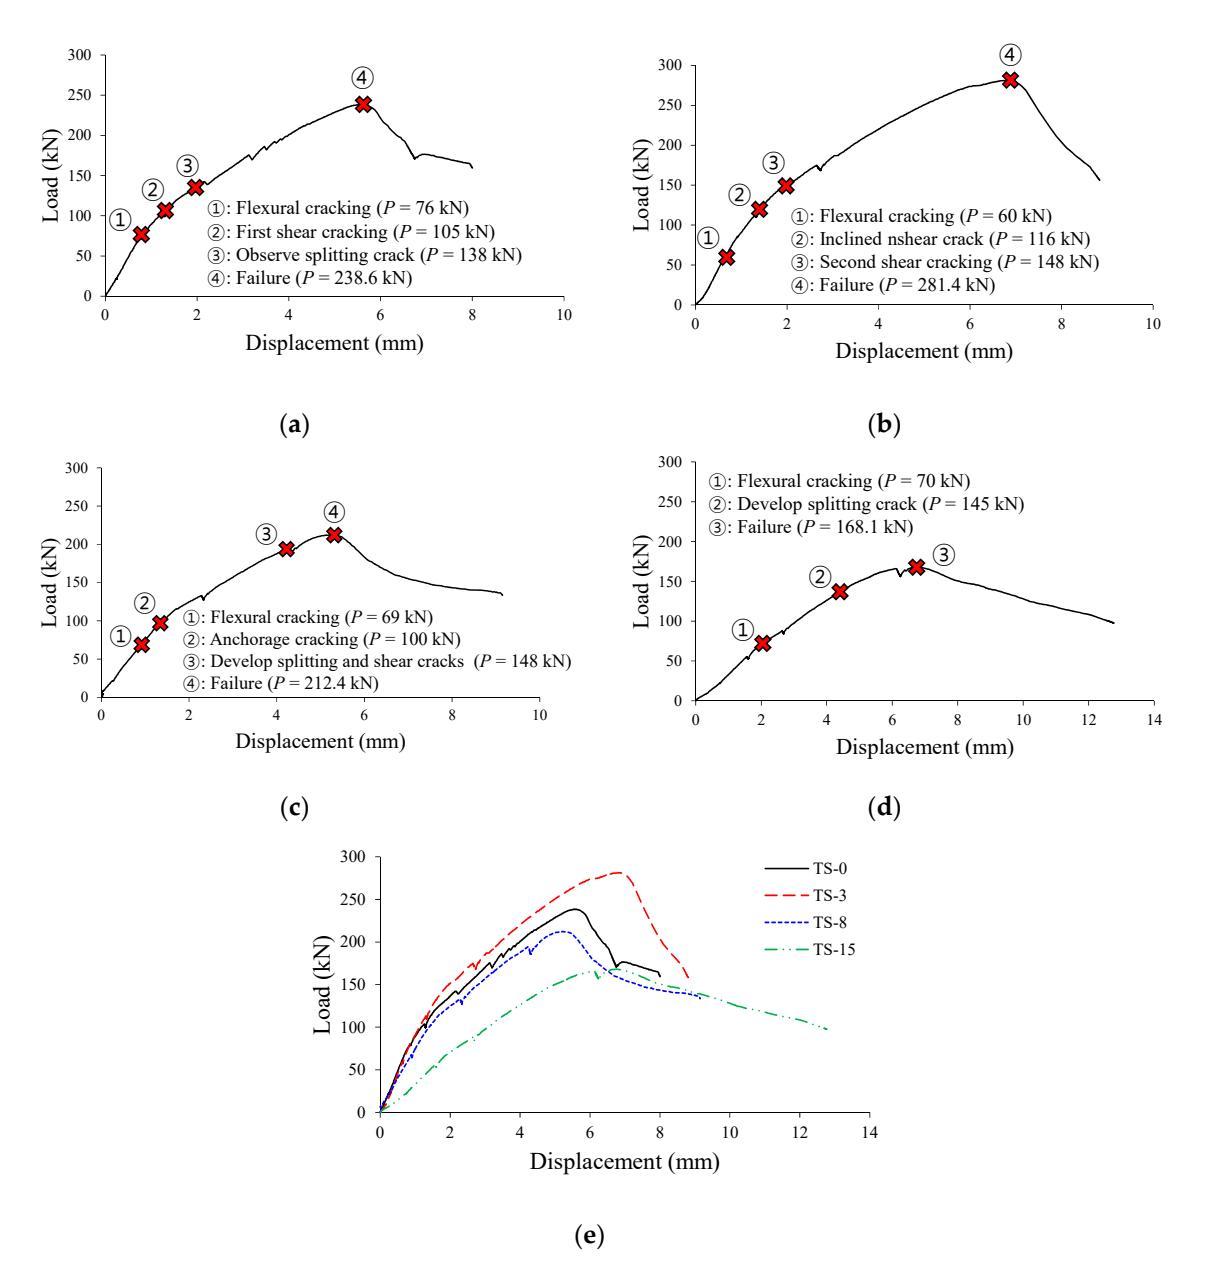
Figure 8. Load-displacement responses of TS series specimens. (**a**) TS-0 specimen; (**b**) TS-3 specimen; (**c**) TS-8 specimen; (**d**) TS-15 specimen; (**e**) Comparison of TS series test results.

Figures 8 and 9 show the shear behaviors of the TS and TH series specimens, while Table 3 summarizes the shear test results. In the TS-0 specimen, the reference specimen of TS series, the initial shear crack occurred at a load of about 105 kN. Then, a horizontal bond crack toward the support was observed at a load of 138 kN, and shear failure occurred at a load of 238.6 kN. In the TS-3 specimen ($\omega_{corr} = 1.14\%$) with a target corrosion rate of 3%, the initial shear crack occurred at a load similar to that of the reference specimen (P = 116 kN), and then underwent shear failure at a load of 281.4 kN. The TS-3 specimen showed a shear capacity of about 18% higher than that of the TS-0 specimen. This is because, at a low corrosion rate of less than 2%, the expansion pressure (i.e., corrosion pressure) of the reinforcement caused by the corrosion contributes to the improvement of bond performance between reinforcement and concrete [8,31], and this phenomenon was observed in the experiment conducted by Lachemi et al. [21]. In the TS-8 specimen (ω_{corr} = 4.13%) with a target corrosion rate of 8%, a decrease in bond performance due to tension reinforcement corrosion caused a detrimental effect on the member behavior. An anchorage crack was observed at a load of about 100 kN. The splitting crack progressed at the same time when the shear crack occurred at a load of 148 kN, then the member failed at a load of 212.4 kN. The shear capacity of the TS-8 specimen was 11% smaller than that of the TS-0 specimen. The TS-15 specimen (ω_{corr} = 9.76%) with a target corrosion rate of 15% showed distinct reductions in stiffness and capacity due to corrosion. As shown in Figure 8e, the TS-15 specimen, as compared to the TS-0 specimen, showed very low stiffness from the beginning of the behavior, and the widths of the corrosion cracks became significantly larger with the increasing loads. As a result, bond failure occurred at a load of 161.1 kN, a reduction of 30% as compared to the failure load of the TS-0 specimen. This is because the corroded reinforcement could not exert the tensile stress required to resist the external moment due to bond loss between the reinforcement and concrete.

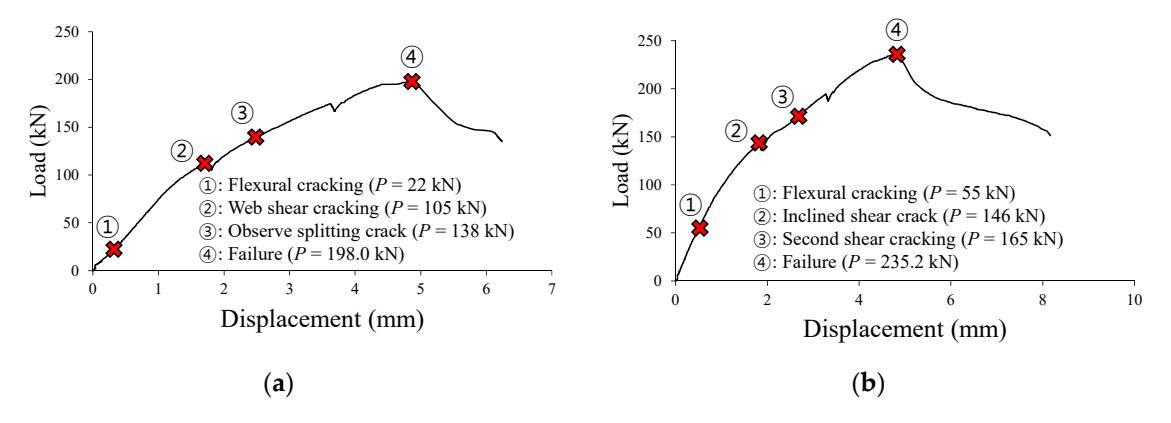
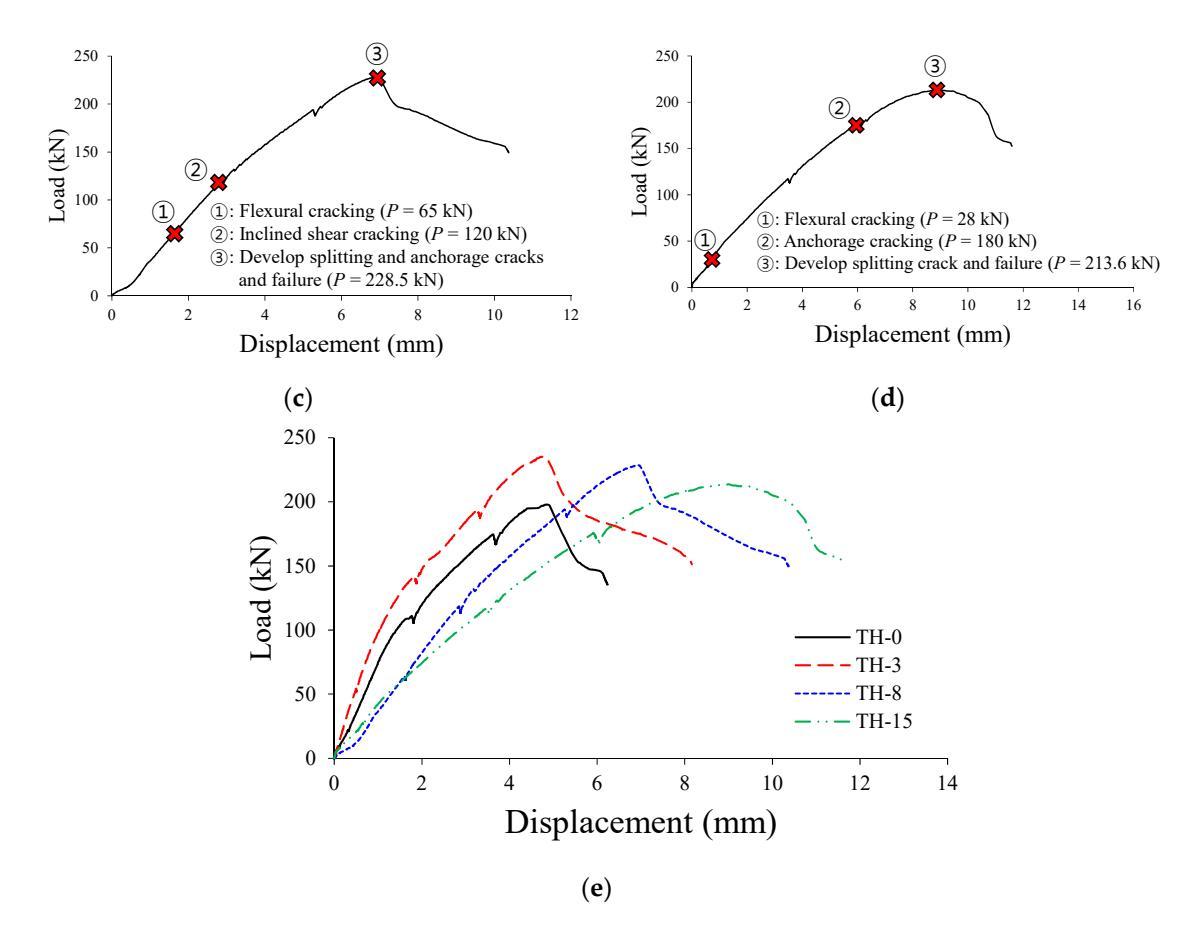
Figure 9. Load-displacement responses of TH series specimens. (**a**) TH-0 specimen; (**b**) TH-3 specimen; (**c**) TH-8 specimen; (**d**) TH-15 specimen; (**e**) Comparison of TH series test results.

Figure 9a shows that in the TH-0 specimen, the reference specimen of TH series, a web-shear crack was observed at a load of about 105 kN, a horizontal crack toward the support took place at a load of 138 kN, and then shear failure occurred at a load of 198 kN. As shown in Figure 9e, the TH-3 specimen (ω_{corr} = 1.64%) showed greater stiffness than the TH-0 specimen from the beginning of the behavior, and also underwent shear failure at a load of 235.2 kN, which is about 19% higher than the load at which the TH-0 specimen underwent shear failure. The reason for why the TH-3 specimen showed greater stiffness and capacity than the TH-0 specimen is that, as mentioned previously, the bond performance between the reinforcement and concrete improves at a low corrosion rate. The initial stiffness of the TH-8 specimen (ω_{corr} = 4.64%), which has a relatively high corrosion rate, was smaller than that of the TH-0 specimen. The reason for this is that the widths of corrosion cracks in the TH-8 specimen were much larger than those generated in the TS-8 specimen, as shown in Figure 5b. This suggests that the reduction of bond performance in the TH-8 specimen is greater than that in the TS-8 specimen. It is noted that the initial stiffness of the TS-8 specimen was almost the same as that of the TS-0 specimen, as shown in Figure 8e. However, unlike in the TS-8 specimen without a proper anchorage (ω_{corr} = 4.13%), the failure load of the TH-8 specimen was 228.5 kN, indicating a 15% improvement as compared to the TH-0 specimen with no corrosion damage. This is because the tension reinforcement that has been properly anchored at the end could exert the tensile stress required to resist the external moment, even if the bond performance between the reinforcement and concrete decreased rapidly as the corrosion progressed. The initial behavior of the TH-15 specimen ($\omega_{corr} = 8.82\%$), which has a very high corrosion rate of tension reinforcement, was similar to that of the TH-8 specimen (ω_{corr} = 4.64%). However, in the TH-15 specimen, inclined shear cracks were not observed during the loading process, as only a few flexural cracks took place at the tops of the corrosion cracks, as shown in Figure 6h. These crack patterns occur when the crack control capability is

insufficient, as the bond performance between the reinforcement and concrete is reduced by corrosion. Nevertheless, the capacity of the TH-15 specimen was 213.6 kN, which is about 8% higher than that of the TH-0 specimen. This is because, as mentioned previously, even if the bond performance of the reinforcement decreased due to corrosion, the longitudinal reinforcement could exert tensile stress due to the development of bearing stress at the hooks of the reinforcement anchored at the ends of the member. Therefore, unlike the TS-15 specimen that underwent premature bond failure, the TH-15 specimen exhibited sufficient load-carrying capacity.

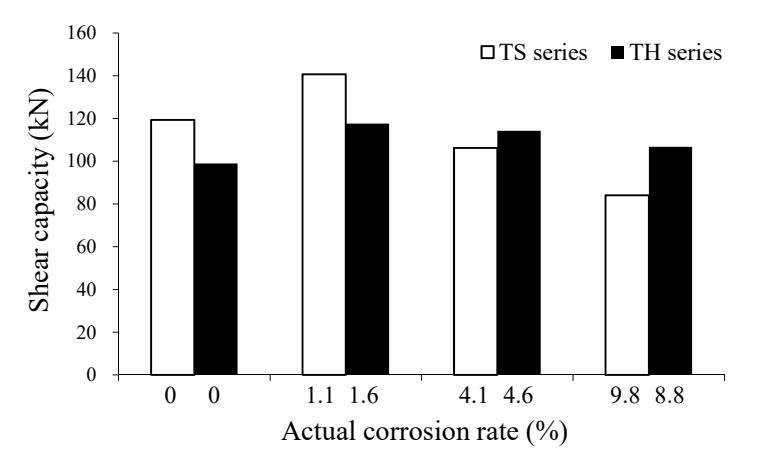
Figure 10. Effects of corrosion rates on shear capacities of test specimens.

As shown in Figure 10, the shear capacities of the TS-3 and TH-3 specimens with low reinforcement corrosion levels (i.e., lower than about 2%) tended to increase by about 20% as compared to those of the reference specimens. However, in the cases of the TS-8 and TS-15 specimens with a high corrosion rate of more than 4%, in which the tension reinforcement had not been properly anchored at the ends of the members, the capacities of the specimens decreased sharply as the corrosion rate of the longitudinal reinforcement increased. By contrast, in the TH-8 and TH-15 specimens in which the tension reinforcement had been properly anchored at the ends of the members in the form of hooks, an increase in corrosion rate did not lead to a capacity reduction of the member, and instead the capacity tended to further increase as compared to the reference specimen.

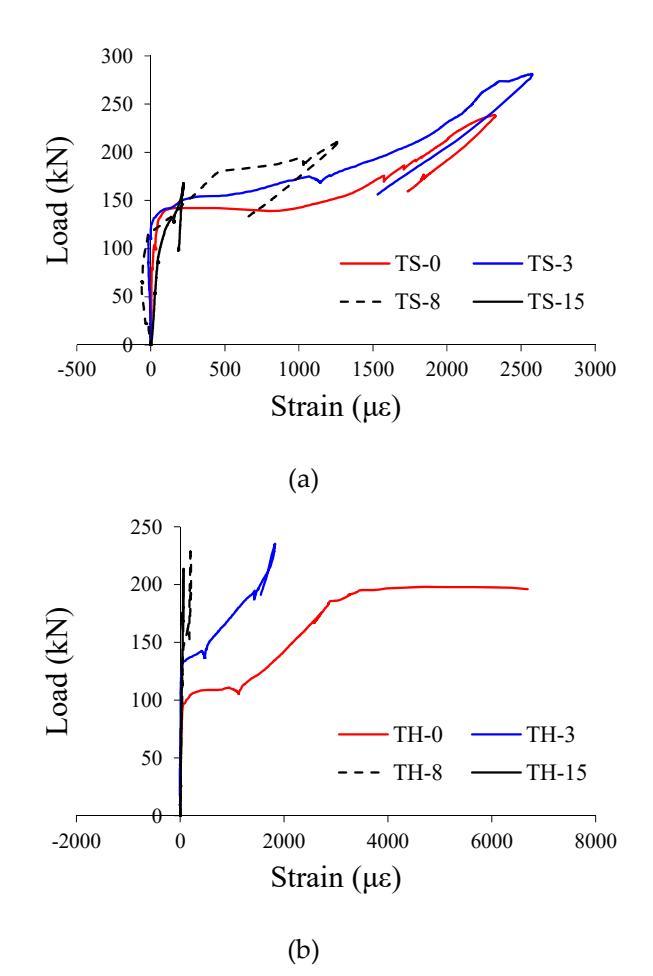
Figure 11. Measured strains of stirrups. (a) TS series specimens; (b) TH series specimens.

Figure 11 shows the strains measured from the gauges attached to the transverse reinforcement in test specimens. It should be noted that epoxy coated transverse reinforcement was used in this study to prevent corrosion of stirrups. In the TS-0, TS-3, TH-0, and TH-3 specimens, which showed typical shear failure modes, the strains of shear reinforcement increased sufficiently from the shear cracking loads. This suggests that the shear reinforcement contributed to the shear resistance mechanism of the member. By contrast, almost no strains of shear reinforcement or very small strains of shear reinforcement were measured in the TS-15 and TH-15 specimens with very high corrosion rates of tension reinforcement. This is because the failure of these specimens was dominated by the bond loss between the longitudinal reinforcement and concrete rather than the shear.

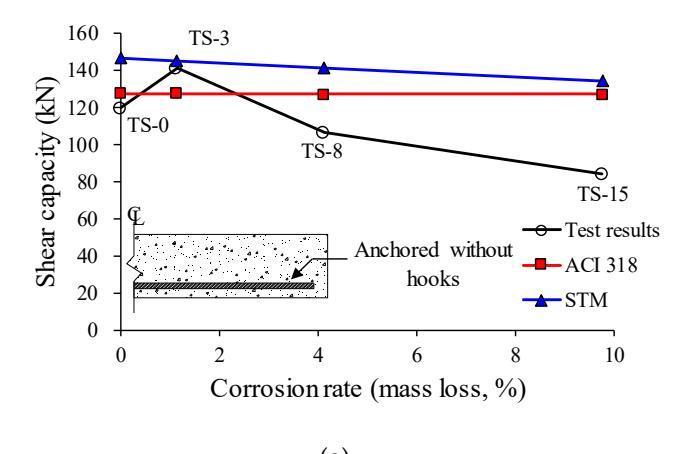
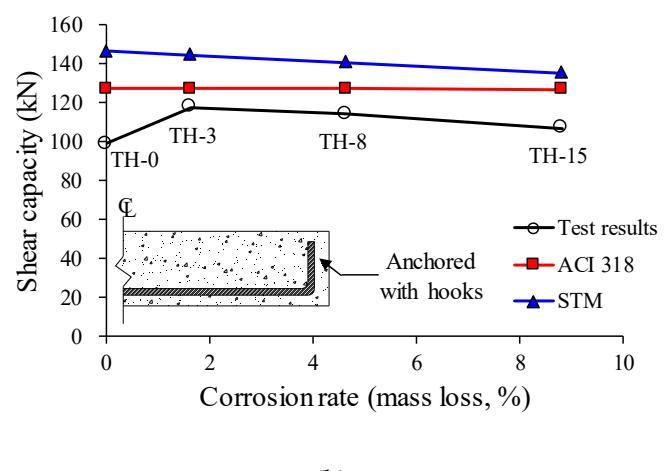
Figure 12. Comparisons of test and analysis results. (a) TS series specimens; (b) TH series specimens.

Figure 12 shows a comparison of the test and analysis results. The shear capacity equations presented in the current ACI 318-14 building code provided a relatively close evaluation on the shear capacities of RC specimens with a corrosion rate of less than 2%, but significantly overestimated the shear capacities of the TS-8 and TS-15 specimens with a corrosion rate of more than 4%, and the tension reinforcement that had not been properly anchored at the ends of the member. This suggests that the shear capacity is affected more by the reduction of bond performance than by the decrease in the sectional area of tension reinforcement due to corrosion. By contrast, in the TH-8 and TH-15 specimens in which the tension reinforcement had been properly anchored at the ends of the members, there was no substantial difference between the analysis and test results, as the corrosion of longitudinal reinforcement did not significantly affect the capacities of the members due to arch action.

As shown in Figure 12a, the STM provided an excessive overestimation on the shear capacities of the TS-8 and TS-15 specimens. This is because the tension ties of the TS series specimens had not been properly anchored, while a precondition of the application of the STM is that the tension ties should be properly anchored at the ends of the members. Unlike in the cases of the TS series specimens, as shown in Figure 12b, the STM provided a relatively approximate prediction on the tendency of shear capacity changes in the TH-3, TH-8, and TH-15 specimens, in which the tension reinforcement had been properly anchored at the ends of the members. However, even though the arch-action was reflected in the shear transfer mechanism through the application of the STM, the test and analysis results differed because the STM cannot appropriately reflect the changes of bond performance due to the corrosion of tension reinforcement. Therefore, further research is still required to clearly understand the shear capacity of corroded RC members with proper anchorage details, based on which a more proper method for considering the change in the bond performance of the tension reinforcement due to corrosion can be developed.
