Article

Characterization of Sheared Edges in Warm Blanking of Magnesium Alloy AZ31B

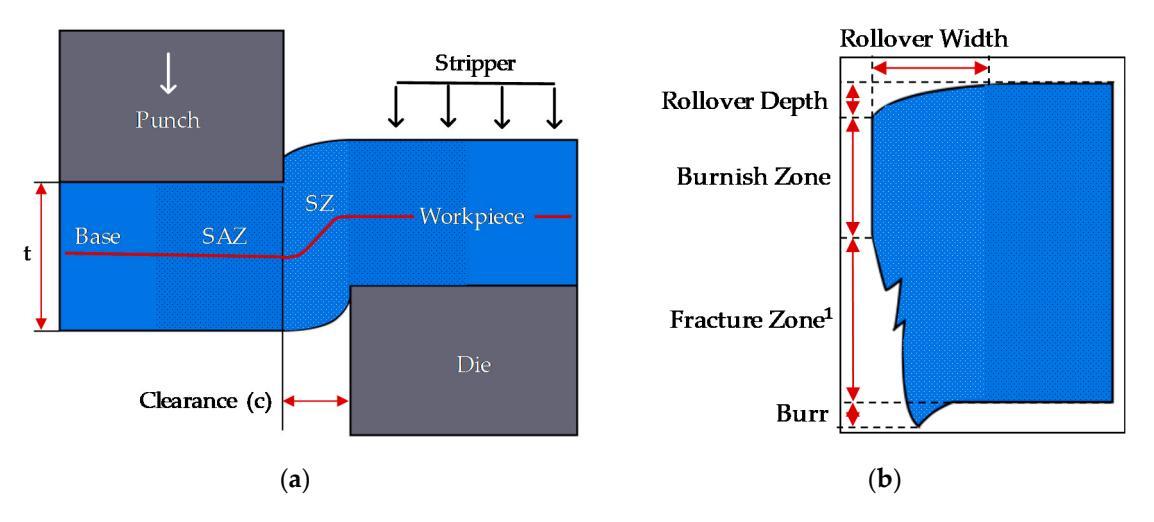
Figure 1. (a) Schematic of the blanking process; (b) illustration of the sheared edge profile, consisting of rollover region, burnish zone, fracture zone, and burr. ¹ Fracture zone value excluding burr.

Primarily the sheared edge formed through the blanking process is distinguished by regions known as the rollover depth, rollover width, burnish zone, fracture zone, and burr, as illustrated in Figure 1. Their characteristic dimensions are measured by using either optical or scanning electron microscopy TESCAN VEGA3 (Seoul, Korea). The assessment reveals the morphology of the fracture profile, in correlation with the sheared edge quality.

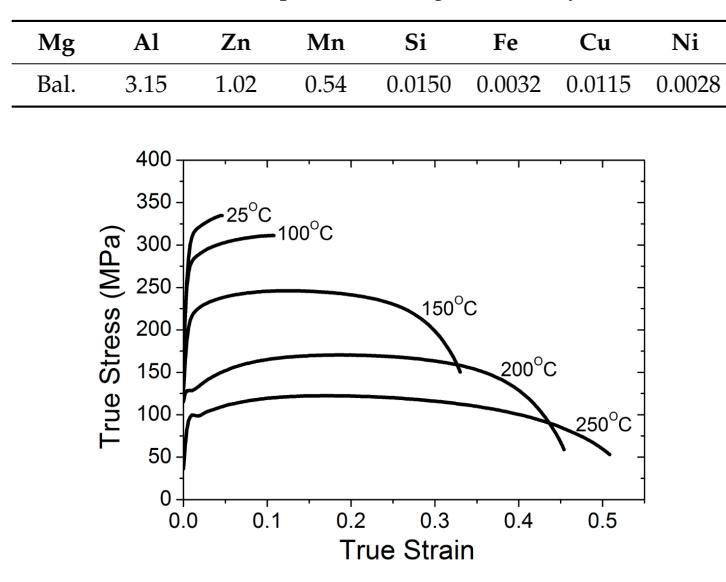
Figure 2. Stress–strain curves of the uniaxial tensile tests at various temperatures for the magnesium alloy (AZ31B), along 0° to the rolling direction and 0.16/s strain rate, obtained from the NUMISHEET 2011 benchmark study (BM 2) [25].

The blanking workpieces were taken transverse to the rolling direction of the magnesium alloy (AZ31B) sheet. The final workpiece had a rectangular shape and a thickness of 1 mm. The chemical composition of the magnesium alloy (AZ31B) is shown in Table 1. The material data for the magnesium alloy at temperatures of 25 °C, 100 °C, 150 °C, 200 °C, and 250 °C is shown in Figure 2.

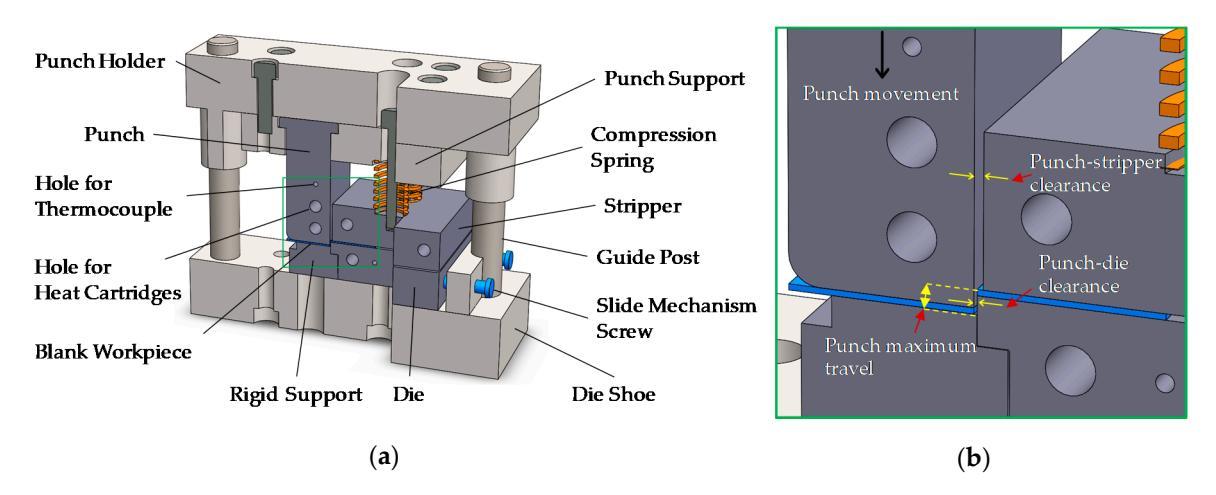
Figure 3. (a) Main components of the blanking device (sectional view); (b) magnified illustration of the selected blanking parameters.

Shearing tests were employed on an in-house blanking device and a 100 kN mechanical press (UTM). The sectional view of the blanking device used for the experiments is shown in Figure 3a,b. Both the punch and die were fabricated with Cr-alloy tool Steel SDK61. For the efficient stripping of blank from the punch, the blank holder was spring-loaded. The punch-die clearance was controlled by the side-screw implement that enabled horizontal movement of the die. In addition, punch, die, and blank holder were pre-drilled and reamed to aid the insertions of heat cartridges.

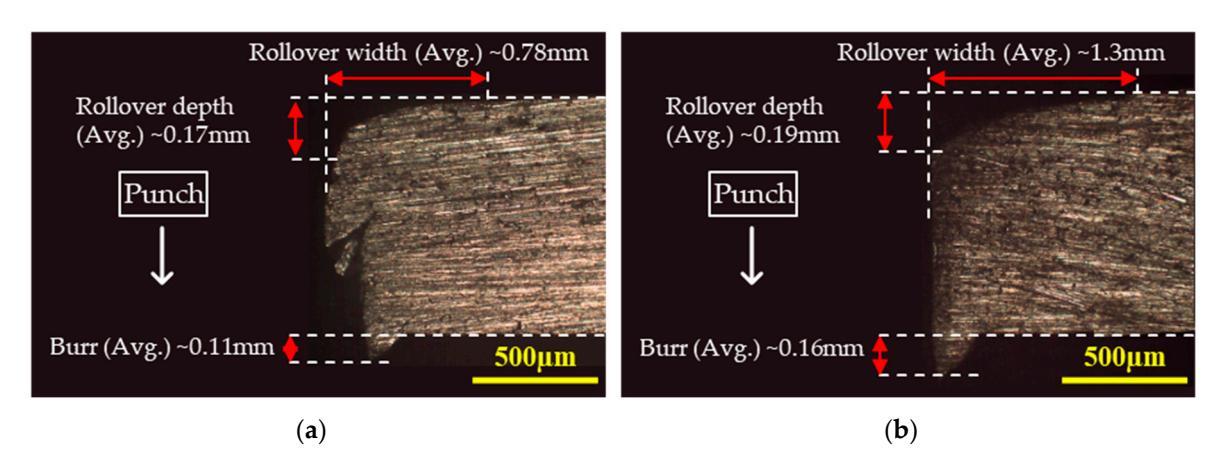
Figure 4. Side-view (OM) of the blanked edge obtained from experiments for 20% clearance at (**a**) 25 °C, indicating primary jagged fracture geometry and secondary curved fracture profile, and (**b**) 250 °C, indicating smooth sheared edge.

- 1. Rollover depth, rollover width, and burr heights for each blank were measured and averaged from its two side-view OM images. The side-view morphology corresponding to 20% clearance (expressed as the percentage ratio of punch–die clearance to the workpiece thickness) and temperatures of 25 °C and 250 °C are shown in Figure 4a,b respectively.

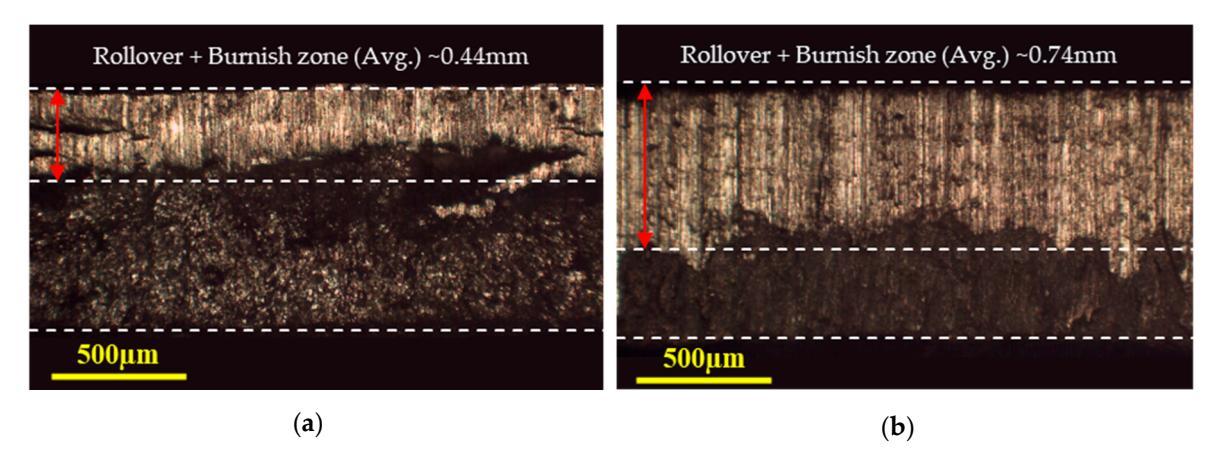
Figure 5. Front view (OM) of the blanked edge obtained from experiments for 20% clearance at (**a**) 25 °C, indicating micro-cracks in the burnish zone and loose fragments, and (**b**) 250 °C, indicating positively improved sheared edge.

- 2. Burnish zone and fracture zones were quantified from the normal morphologies of the sheared edges. The dimensions were measured at various positions and averaged to account for variations. The front-view morphology corresponding to 20% clearance and temperatures of 25 °C and 250 °C are shown in Figure 5a,b respectively.

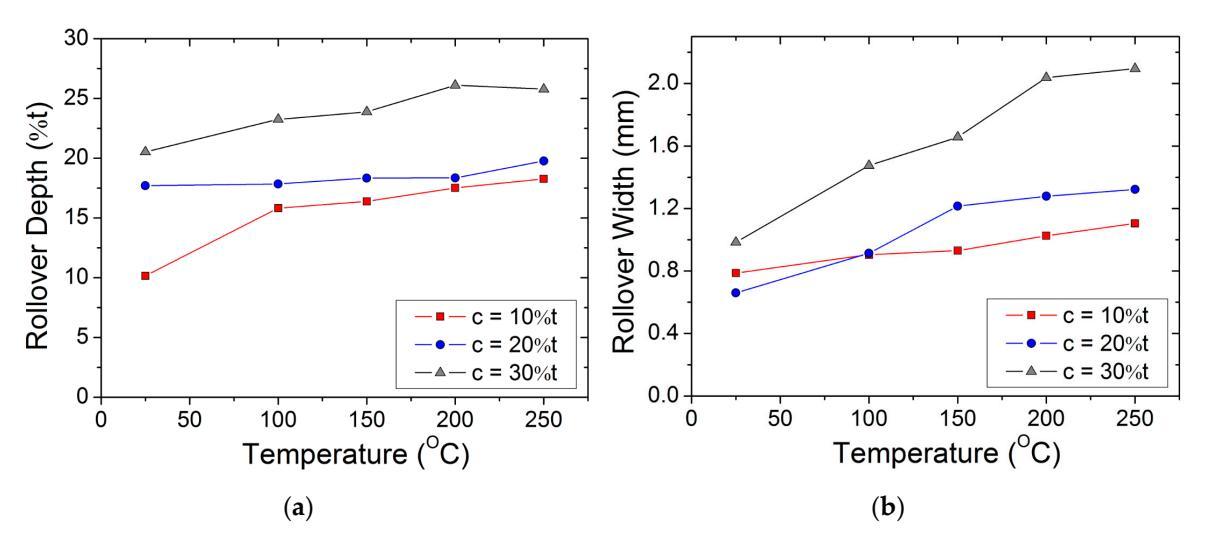
Figure 6. (a) Variation of the rollover depth (expressed as a percentage of the workpiece thickness) with temperature for various punch–die clearances; (b) variation of the rollover width with temperature for various punch–die clearances.

The rollover depth was measured as the vertical distance between the upper plane of the workpiece and the onset of the burnish zone. It was observed that the rollover depth increases with the increase in temperature and punch–die clearance. The rollover depth at 10% clearance increased from approximately 0.1 mm at ambient temperature to approximately 0.18 mm at 250 °C. Similarly, at 30% clearance and 250 °C, the rollover depth increased up to approximately 0.25 mm. Increase in temperature (increase ductility) and clearance (wider processing zone) delayed punch penetration of the workpiece, hence, significant rollover region was observed. Variations in rollover depth, along with temperature, are shown in Figure 6a.

The rollover width defines the extent of bending deflection in the blank caused by the punch contact. It was measured as the horizontal distance between the beginning of the bent and the burnish zone. It is observed that the rollover width increases with the increase in temperature and clearance. For instance, the rollover width at 10% clearance increased from approximately 0.78 mm at ambient temperature to approximately 1.3 mm at 250 °C. The rollover width against the temperature plot is shown in Figure 6b.

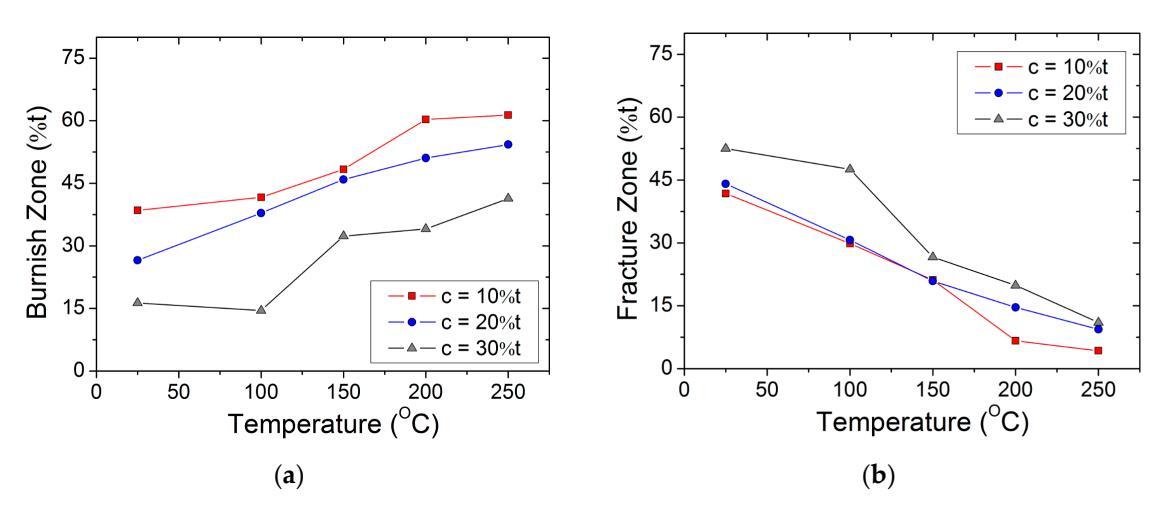
Figure 8. (a) Variation of the burnish zone (expressed as a percentage of the workpiece thickness) with temperature for various punch–die clearances; (b) variation of the fracture zone (expressed as a percentage of the workpiece thickness) with temperature for various punch–die clearances.

The burnish zone features a set of vertical marks on the sheared edge, caused by the compression forces between punch and workpiece. It was observed that the burnish zone increases with the increase in temperature and decreases with the increase in clearance. At ambient temperature, additional micro-cracks are observed in the burnish zone, parallel to the sheet plane. Further punch penetration results in the fragment (loose particles) chipping away and then initiating the main crack to propagate through the material thickness. However, with an increase in temperature (or to an increase in ductility), no micro-cracks or loose particles were observed in the burnish zone. In addition, at a lower clearance regime (or an increase in hydrostatic stresses), the burnish zone may also stretch up to the lower plane of the sheet. The relationship between the sheared edge (%) of the characteristic region at 10 t and 20 t clearances are illustrated in Figure 7a,b, respectively. Variations in burnish zone height, along with temperature, are shown in Figure 8a.

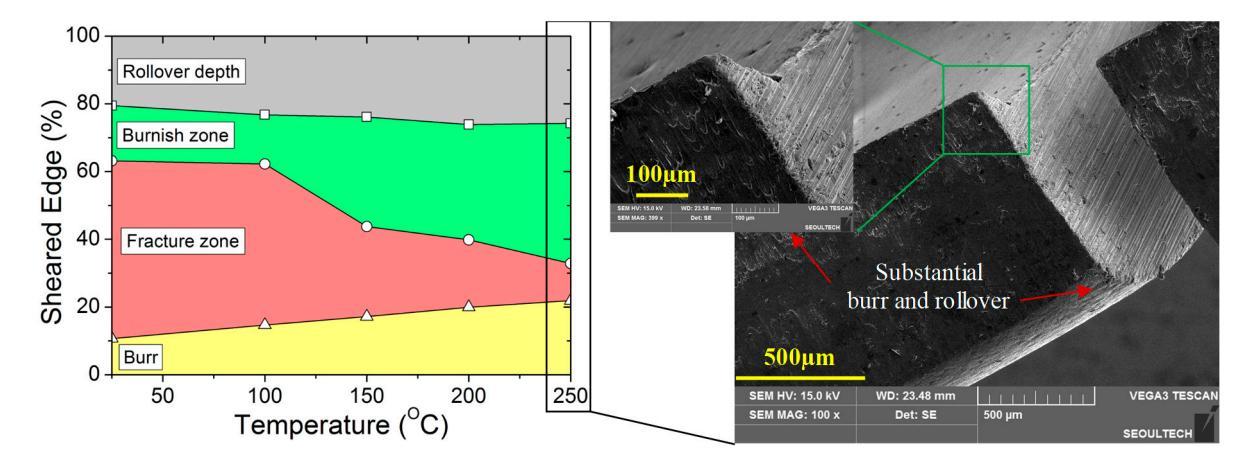
Figure 9. Relationship between characteristic dimensions of sheared edge (%) and temperature at 30% clearance, indicating a substantial rollover region and burr feature.

The fracture zone features rough surfaces on the sheared edge, caused by the material splitting. In this paper, fracture zone value was measured as the vertical distance up to the lower plane of the workpiece, excluding burr. It was observed that the fracture zone is reciprocal to the burnish zone, hence, its value decreases with the increase in temperature. Variations in fracture zone height, along with temperature, are shown in Figure 8b. However, the fracture zone shows an increasing trend with the increase in clearance and, therefore, even at 250 °C, the fracture zone value is observed to increase from approximately 0.043 mm at 10% clearance to approximately 0.11 mm at 30% clearance. Furthermore, the increase in temperature and clearance also resulted in a substantial rollover region and burr in the blank, as illustrated in Figure 9.

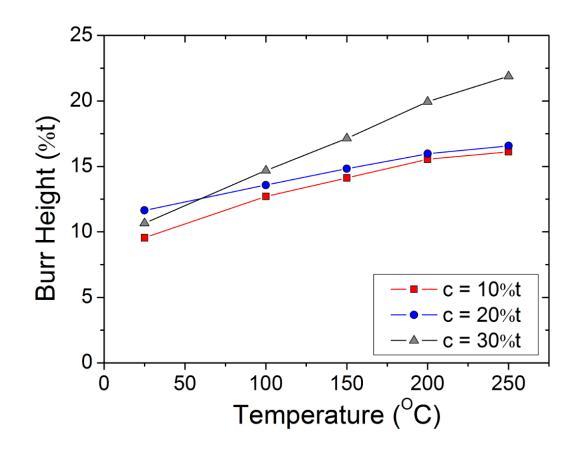
Figure 10. Relationship between burr height (expressed as a percentage of the workpiece thickness) and heating temperature for various punch–die clearances.

The burr height was measured as the vertical distance between the lower plane of the workpiece and the end of the metal fragment. It was observed that the burr increases with the increase in temperature and clearance. The burr height at 10% clearance increased from approximately 0.09 mm at ambient temperature to approximately 0.16 mm at 250 °C. Similarly, at 30% clearance and 250 °C, the rollover depth increased up to approximately 0.21 mm. Variations in burr height, along with temperature, are shown in Figure 10.

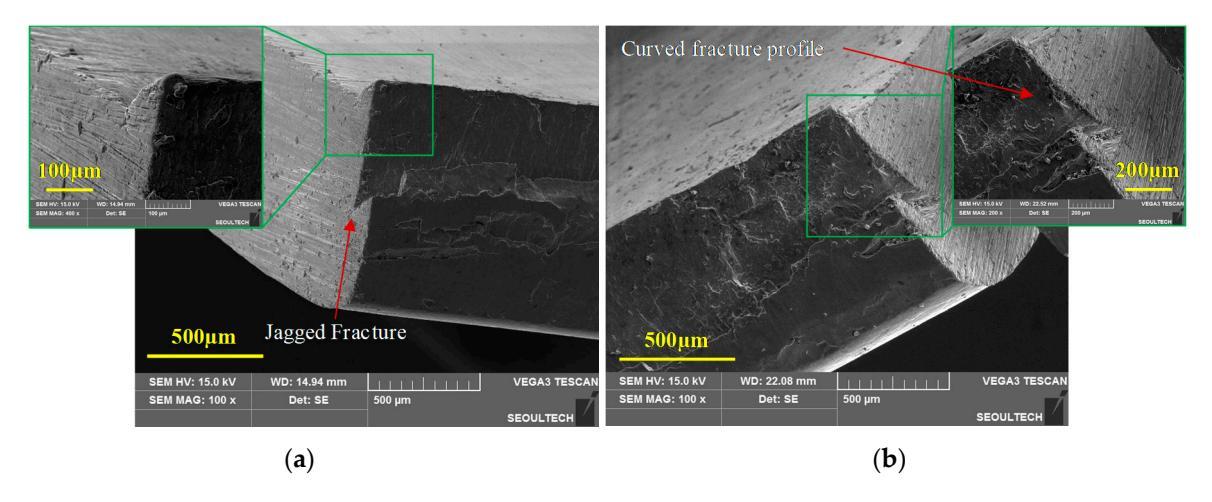
Figure 11. Oriented view (SEM) of the blanked edge obtained from experiments for 20% clearance at 25 °C: (**a**) Side 1, illustrating primary jagged fracture geometry; (**b**) Side 2, illustrating secondary curved fracture profile.

Blanking of a magnesium alloy sheet at room temperature results in an unstable propagation of cracks after its initiation across the material thickness. The instability in crack evolution can pave additional cracks to take multiple paths and lead to micro-cracks. The random crack pattern influences the sheared edge geometry to develop a jagged fracture profile, evident from the previous sectional images. This behavior can be attributed to the strong in-plane anisotropy of AZ31B sheets along the normal direction (ND) at temperatures below 150 °C. In addition, the optical micrographs also revealed the formation of a secondary curved fracture profile in the sheared edges of 25 °C and 100 °C. Representation of scanning electron microscopy at 25 °C, corresponding to 20% clearance, is illustrated in Figure 11a,b. The morphologies are in an oriented view of the two sides of the same blank. Similarly, SEM micrographs at 100 °C and 20% clearance show identical defects of a jagged-plus-curved fracture profile, as shown in Figure 12a. This unusual zig-zag fracture profile at the sheared edge may lead to premature failures during further forming operations. However, the problem of the jagged fracture as well as curved fracture profile was completely suppressed at blanking temperatures of 150 °C and

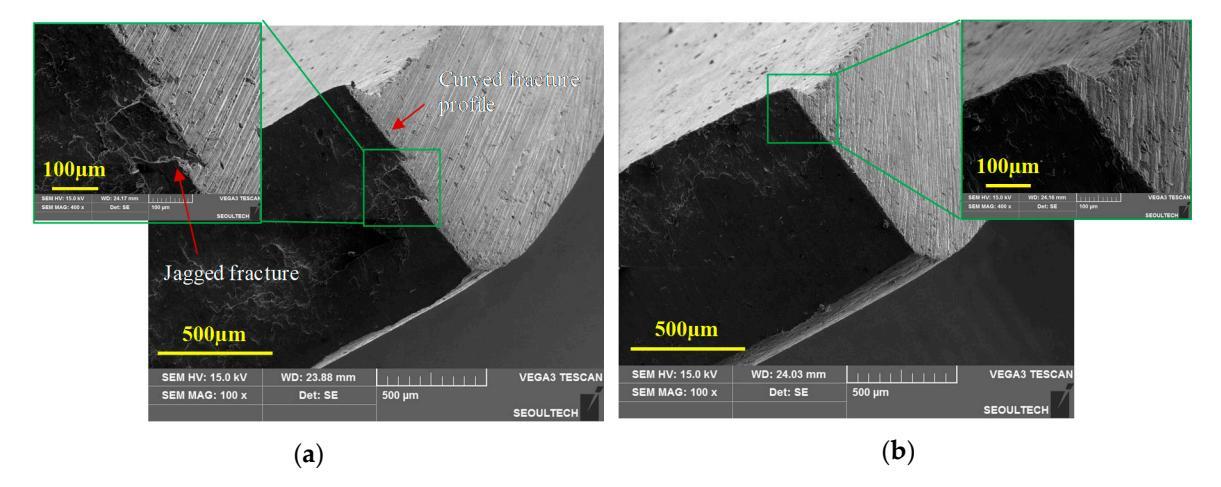
Figure 12. Oriented view (SEM) of the blanked edge obtained from experiments for 20% clearance at (**a**) 100 °C, illustrating jagged-plus-curved fracture profile, and (**b**) 250 °C, illustrating smooth sheared edge.

beyond. The SEM image of the fracture profile at 250 °C, corresponding to 20% clearance, is shown in Figure 12b.

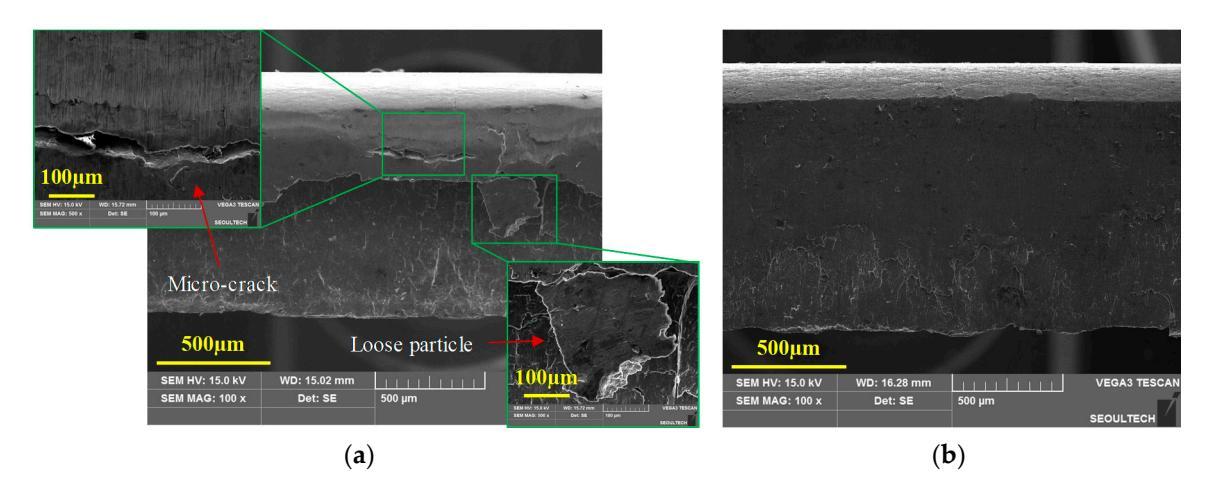
Figure 13. Front view (SEM) of the blanked edge obtained from experiments for 20% clearance at (a) 25 °C, illustrating micro-crack in the burnish zone and loose particles, and (b) 250 °C, illustrating positively improved sheared edge.

The normal morphology of the sheared edge at 25 °C and 20% clearance is shown in Figure 13a. These deformities at the sheared edge may lead to edge fracture during subsequent operations. However, the sheared edge quality of the magnesium alloy blanks is effectively improved with the increase in temperature. The normal SEM morphology of the sheared edge at 250 °C, corresponding to 20% clearance, is shown in the Figure 13b. Furthermore, normal SEM morphologies of the fracture surface at higher magnifications provided conclusive insights into the fracture mechanism of AZ31B sheet. It can be observed that the fracture surface of the blanks obtained at ambient temperature is highly random with no visible dimples. Representation of SEM micrographs (2000× magnification) at 25 °C, corresponding to 20% clearance, is illustrated in Figure 14a. However, at temperatures

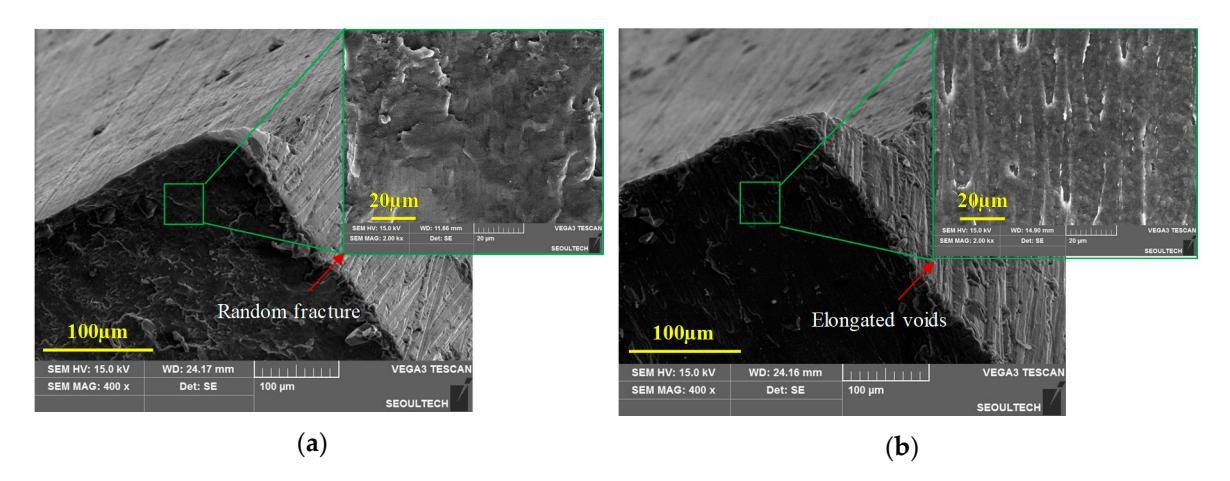
Figure 14. SEM image (2000×) of the fracture surface for 20% clearance at (**a**) 25 °C, illustrating highly random fracture surface with no visible dimples, and (**b**) 250 °C, illustrating elongated dimples in the fracture surface.

of 200 °C and beyond, elongated dimples in the fracture surface are observed, indicating a ductile fracture. The SEM image ($2000 \times$) of the fracture surface at 250 °C and 20% clearance is illustrated in the Figure 14b.

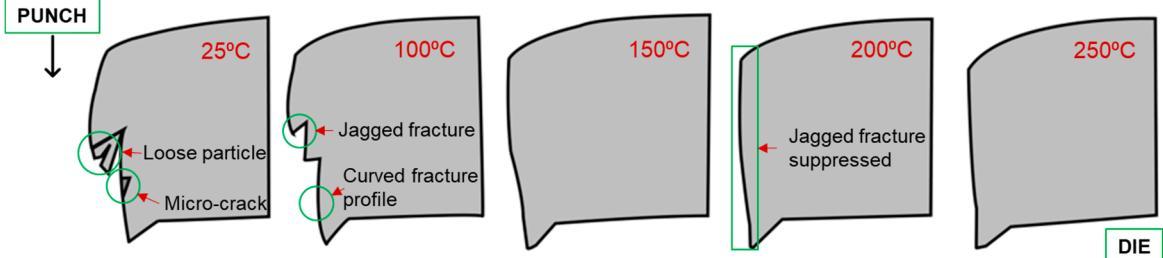
Figure 15. Schematic comparison of sheared edge profiles at temperatures ranging from 25–250 °C and punch–die clearance of 20%.

In conclusion, blanking operation of magnesium alloy (AZ31B) at 25 °C and 100 °C resulted in sheared edge defects, such as loose particles, microcracks, jagged fracture profile, and curved fracture profile. The schematic of the sheared edge profiles at 20% clearance and various temperatures is shown in Figure 15. These deformities may severely affect the formability of the consequent forming operations. On the contrary, blanking of magnesium alloy in warm forming conditions completely suppressed such defects. However, the increase in temperature also increased the rollover region and burr, which are also important quality benchmarks. Therefore, the blanks were further examined for strain hardening or increase/decrease in hardness in the following section.

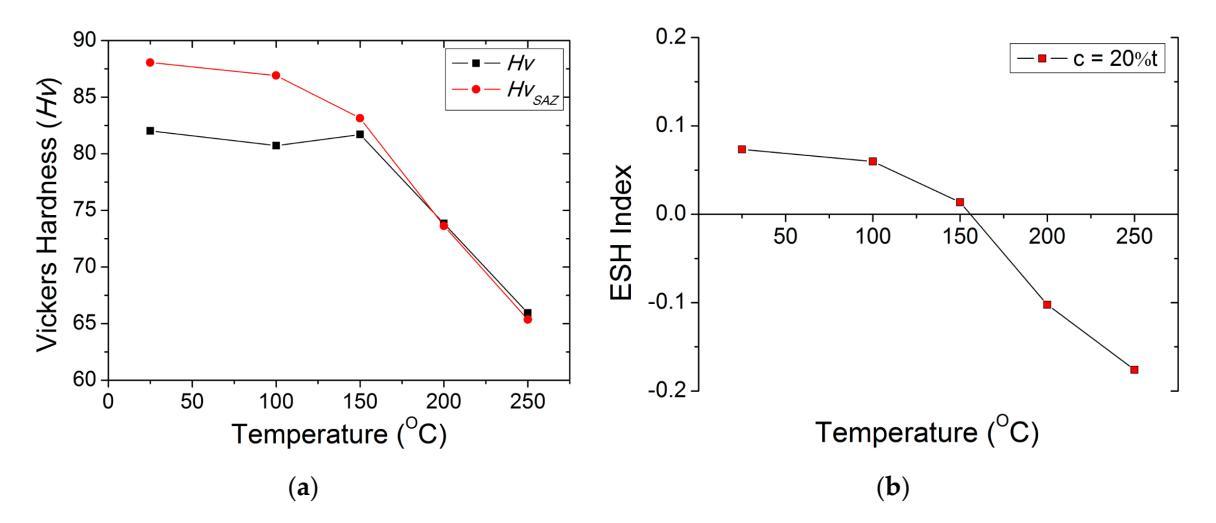
Figure 16. (a) Plot between Vickers hardness and heating temperature for the punch–die clearance of 20%; (b) plot between edge strain hardening (ESH) index and heating temperature for the punch–die clearance of 20%.

It can be observed that the hardness measurements are sensitive to the increase in temperature. One batch of samples with individual clearance was chosen to quantify the effect of temperature. Vickers hardness was measured as an average value of five measurements, performed separately near shear zone vicinities and the base substrate. It was observed that the material hardness decreases with the increase in temperature for both regions. The material hardness at the base substrate decreased from 82 μ H_V at the ambient temperature to 69 μ H_V at 250 °C, while material hardness near shear band vicinities decreased from 88 μ H_V at the ambient temperature to 68 μ H_V at 250 °C. The Vickers hardness test against the temperature plot is shown in Figure 16a. The hardness value in the base substrate at 25 °C was used as a reference hardness value (Hv_{base}) for the subsequent ESH index calculations. Variations in the ESH index, along with temperature, are shown in Figure 16b. The positive ESH index value indicates strain hardening at the shear zone vicinities, which decreases with the increase in temperature. After 150 °C however, the thermal effects in the blanks overcome strain hardening, hence, negative ESH index values are observed.

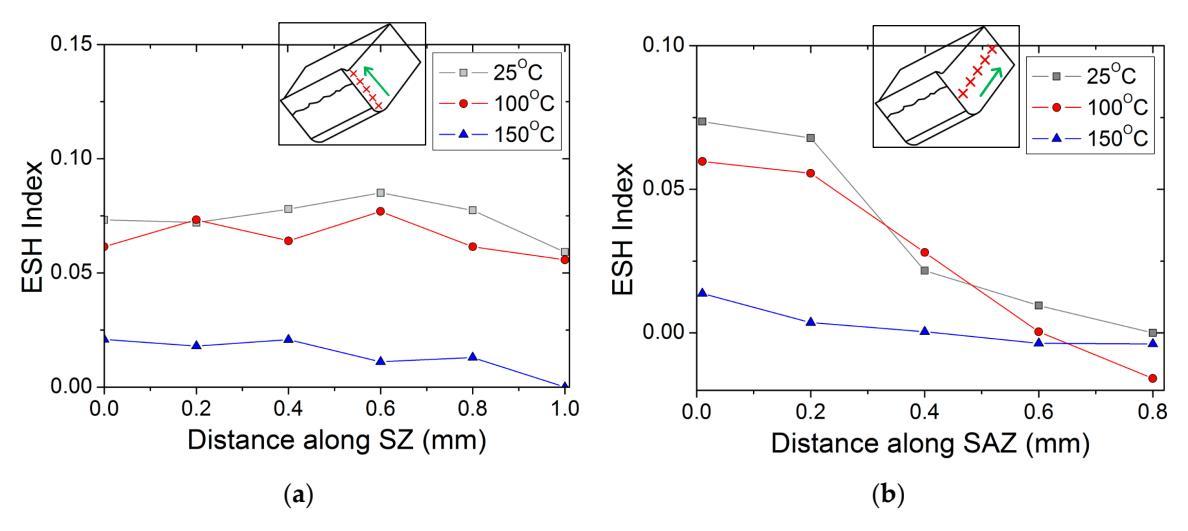
Figure 17. (**a**) Distribution of ESH index along shear zone; (**b**) distribution of ESH index along shear affected zone.

The distribution of the ESH index along the shear affected zone and shear zone quantifies the extent of strain hardening and damage caused by the blanking process. Micro-hardness was measured across the SZ, from the rollover region to the burr feature. The distribution of the ESH index is then calculated using the reference hardness value (Hv_{base}) and plotted against temperature in Figure 17a. It can be observed that the distribution of the ESH index along the sheared edge at 150 $^{\circ}$ C is approximately 80% lower than that of 25 $^{\circ}$ C.

Micro-hardness was measured across the SAZ, from the sheared edge to the base substrate. The distribution of the ESH index is then calculated using the reference hardness value (Hv_{base}) and plotted against temperature in Figure 17b. It was observed that the ESH index value decreases from the sheared edge to the interior. For instance, the shear affected zone at 25 °C is approximately 0.8 mm while at 150 °C, it is approximately 0.4 mm. However, at temperature 150 °C, the gradient of the ESH index virtually disappears in the SAZ with the increase in temperature.

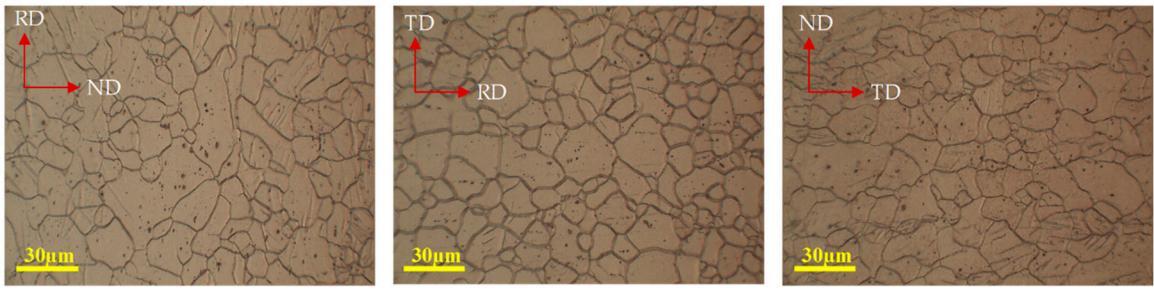
Figure 18. Initial microstructure of as-received magnesium alloy sheet AZ31B.

The etched samples of the sectioned blanks were examined under the optical microscopy for obtaining texture measurements. Grain sizes were measured by the linear intercept method, corresponding to ASTM standard E112 using OM. The initial microstructure of as-received magnesium alloy in the rolling (RD), transverse (RD), and normal (ND) direction is shown in Figure 18. The average grain size is $30 \,\mu$ m in the thickness direction.

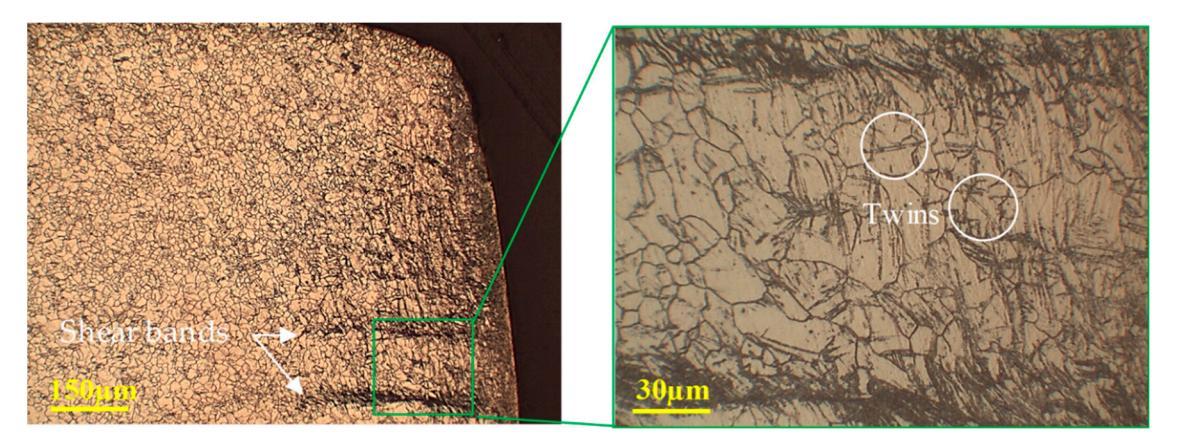
Figure 19. Optical microstructure of the shear zone at 25 $^\circ C$ and 20% clearance, illustrating shear bands and twinning at the sheared edge.

It can be observed that mechanical twining dominated the plastic deformations at temperatures below 150 °C in the magnesium alloy sheet. The sheared edge obtained at 25 °C exhibits evidence of twins, as illustrated in Figure 19, which induces barriers to slip deformation (strain hardening). As a result, stress concentrations at the barriers work to form shear bands across the grain boundaries. Further deformation causes micro-cracks to develop within shear bands. The propagation of

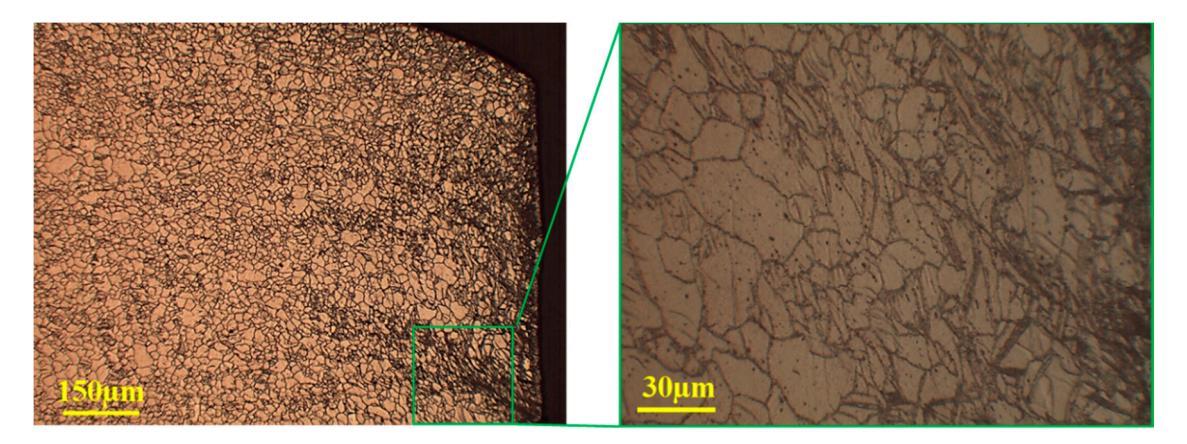
Figure 20. Optical microstructure of the shear zone at 150 °C and 20% clearance.

micro-cracks along the shear bands leads to the final fracture of the workpiece. At ambient temperature, the instability of crack evolution in magnesium alloy paves additional shear bands to take multiple paths and lead to a typical jagged fracture in the sheared edge. However, the fraction of twins decreases with increasing temperature, as illustrated in Figure 20, suppressing the jagged fracture in the sheared edge.

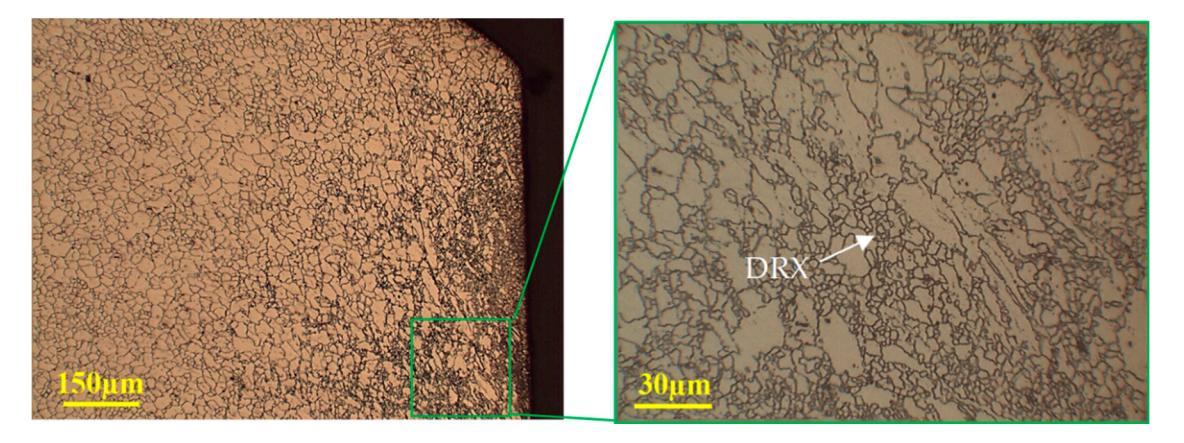
Figure 21. Optical microstructure of the shear zone at 250 °C and 20% clearance, illustrating dynamic recrystallization at the sheared edge.

Furthermore, the sheared edge obtained at 250 °C revealed dynamic recrystallization (DRX), with no evidence of twinning. The microstructure contains a bimodal distribution of recrystallized and elongated grains, as shown in Figure 21. The decrease in the ESH index with temperature in the previous section can also be attributed to the formation of DRX. Therefore, the microstructure evolution during shearing of magnesium alloy at various temperatures indicates a correlation to its mechanical behavior.

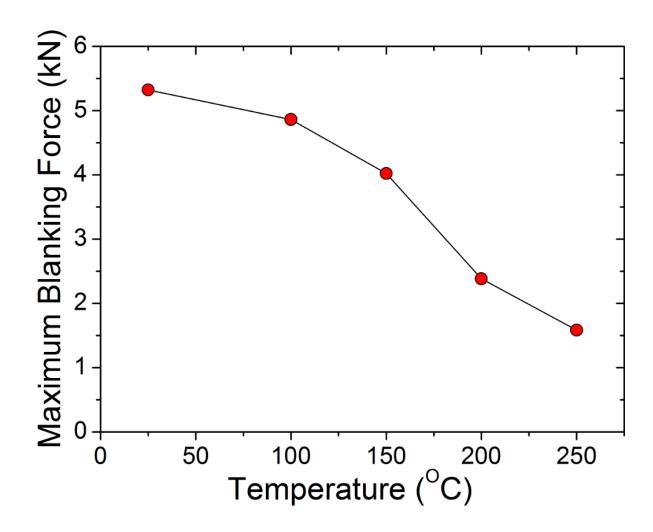
Figure 22. Relationship between maximum blanking force (as kN) and heating temperature for the punch–die clearance of 10%.

The load response measured by the load cell was a combination of spring reaction and blanking force. Hence, the reaction force was adjusted to segregate spring reaction and the blanking force. It was observed that, irrespective of the clearance value, the maximum blanking force decreases with the increase in temperature. The maximum blanking force at 10% clearance decreased from approximately 5.3 kN at ambient temperature to approximately 1.6 kN at 250 °C (30% of the cold blanking force). Variations in the maximum blanking force, along with temperature at 10% clearance, are shown in Figure 22.
