Tribological Aspects of Cutting Tool Wear during the Turning of Stainless Steels

Magdalena Zawada-Michałowska *, Paweł Pieśko * and Jerzy Józwik *

Faculty of Mechanical Engineering, Lublin University of Technology, 20-618 Lublin, Poland

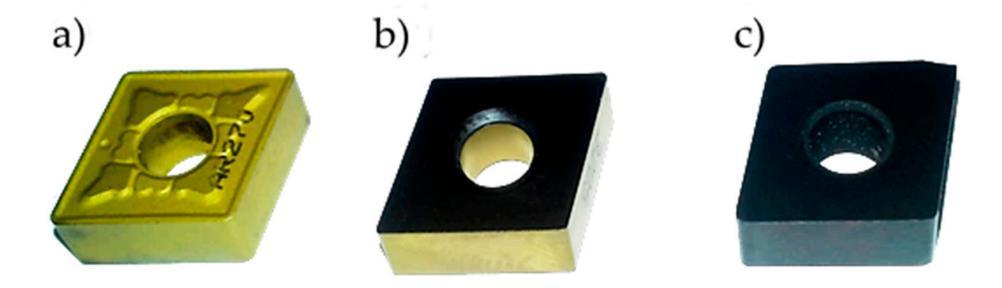
Figure 1. Indexable inserts used in the tests: (**a**) CNMG 12 04 08 ZSZ, (**b**) CNMA 12 04 12-KR 3205, and (**c**) CNGA 12 04 08 T0102 WG 650.

- Indexable insert (CNMG 12 04 08 ZSZ)—material: carbide with a CVD-applied TiN coating (Figure 1a)—material trade name: BP30A;
- Indexable insert (CNMA 12 04 12-KR 3205)—material: carbide with a CVD-applied Ti(C,N) + Al₂O₃ + TiN coating (Figure 1b)—material trade name: GC3205;
- Indexable insert (CNGA 12 04 08 T0102 WG 650)—material: mixed ceramic (Al₂O₃-based), without coating (Figure 1c)—material trade name: CC650.

The inserts used in the tests have a diamond shape (C shape) with a corner angle of 80° and a clearance angle of 0° .

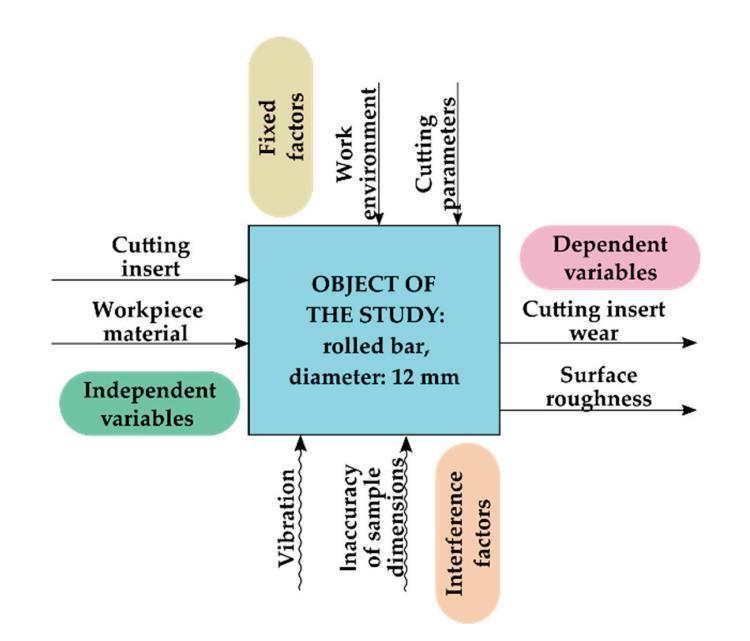
Figure 2. Research plan.

The research plan is shown in Figure 2. The independent variables were the cutting insert and the workpiece material, while the dependent variables were the cutting insert wear and the surface roughness. The fixed factors were the work environment and the cutting parameters, as well as the interferences were the vibration and the inaccuracy of sample dimensions.

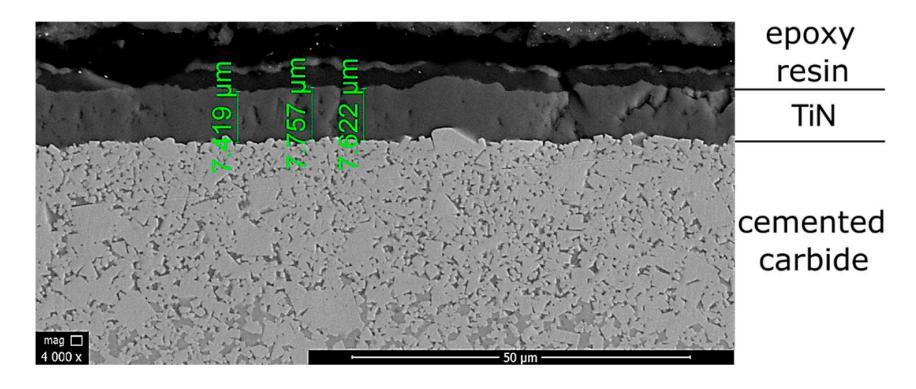
Figure 3. Coating thickness of CNMG 12 04 08 ZSZ carbide cutting insert (×4000).

In the first instance, the thickness of coatings used in carbide cutting inserts was determined. Figures 3 and 4 present SEM micrographs of coatings thickness of tested CVD-coated carbide cutting inserts. The estimated coating thickness of CNMG 12 04 08 ZSZ insert is about 7 μ m. For CNMA 12 04 12-KR 3205, the sum of three layers equals approximately 13 μ m.

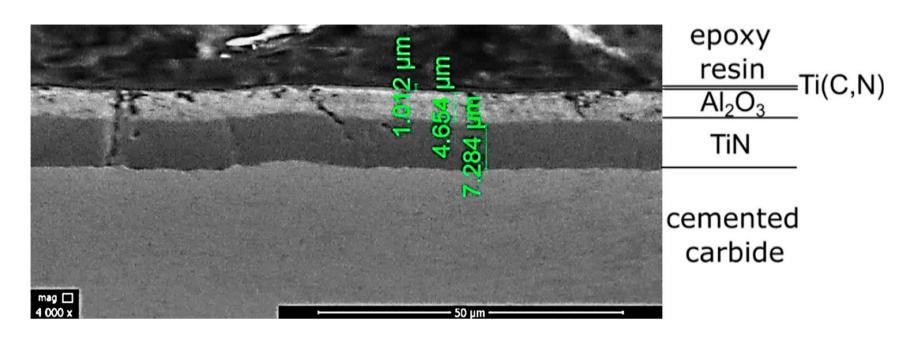
Figure 4. Coating thickness of CNMA 12 04 12-KR 3205 carbide cutting insert (×4000).

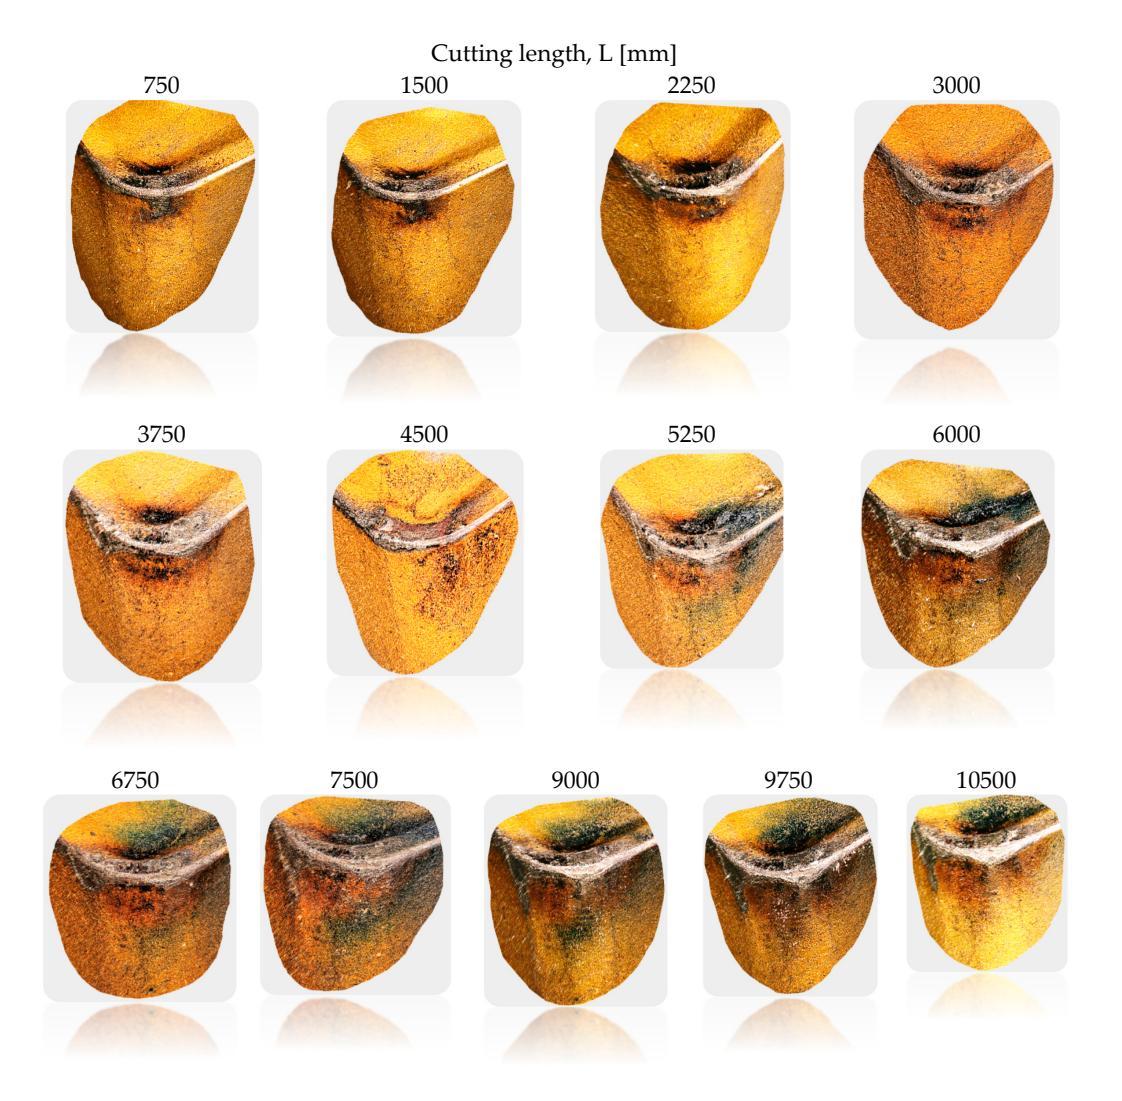
Figure 5. Exemplary wear phases of CNMG 12 04 08 ZSZ indexable insert for X8CrNiS18-9 stainless steel depending on the cutting length *L* [20].

The research involved analysing the impact of the cutting edge wear on the changes of the Ra parameter and selected direct wear indicator, VB_{Bmax} , for three cutting inserts and two stainless steel grades. Figure 5 presents exemplary wear phases of CNMG 12 04 08 ZSZ indexable insert for X8CrNiS18-9 stainless steel depending on the cutting length L.

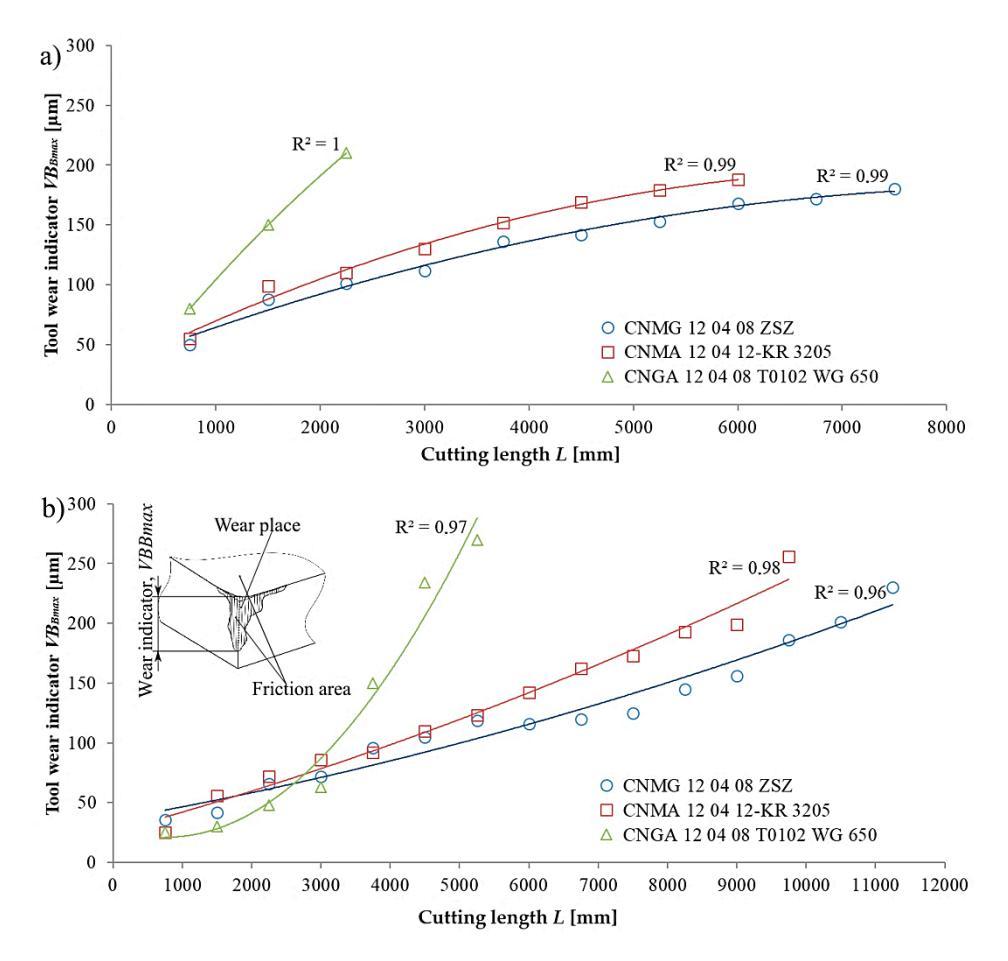
Figure 6. Course of wear for the VB_{Bmax} indicator as a function of the cutting length *L* obtained for the following cutting inserts: CNMG 12 04 08 ZSZ, CNMA 12 04 12-KR 3205, and CNGA 12 04 08 T0102 WG 650, and the studied stainless steels (**a**) X20Cr13 and (**b**) X8CrNiS18-9.

The VB_{Bmax} indicator was determined as a cutting-length function *L*. Different cutting lengths *L* for individual inserts result from their varying durability. Figure 6 shows the measurement results for the VB_{Bmax} indicator obtained for two stainless steels, X20Cr13 and X8CrNiS18-9, and the tested cutting inserts.

The test results for VB_{Bmax} indicator were approximated with a second-degree polynomial function. Equations (2) and (5) show the trend of VB_{Bmax} for the CNMG 12 04 08 ZSZ insert. Equations (3) and (6) present the trend of VB_{Bmax} for the CNMA 12 04 12-KR 3205 insert. Equations (4) and (7) show the trend of VB_{Bmax} for the CNGA 12 04 08 T0102 WG 650 insert.

Based on the presented results pertaining to the VB_{Bmax} direct indicator, it was concluded that in the case of each of the inserts, the course of the wear was of a linear-like nature. For the CNGA 12 04 08 T0102 WG 650 insert, which due to its material is susceptible to vibrations of the machine tool-workpiece-fixture-tool system, it was found to have approximately 60% and 45% shorter cutting length than for the CNMA 12 04 12-KR 3205 insert during turning X20Cr13 and X8CrNiS18, respectively. It was the result of quickly appearing catastrophic wear in the form of cutting edge crushing in the case of CNGA 12 04 08 T0102 WG 650 insert. An analogical reliance was noted in relation to CNMG 12 04 08 ZSZ; however, differences amounted to 70% and 55%. Comparing CNMA 12 04 12-KR 3205 and CNMG 12 04 08 ZSZ, which had higher durability of 25% and 15% in reference to X20Cr13 and X8CrNiS18-9, produced CNMG 12 04 08 ZSZ.

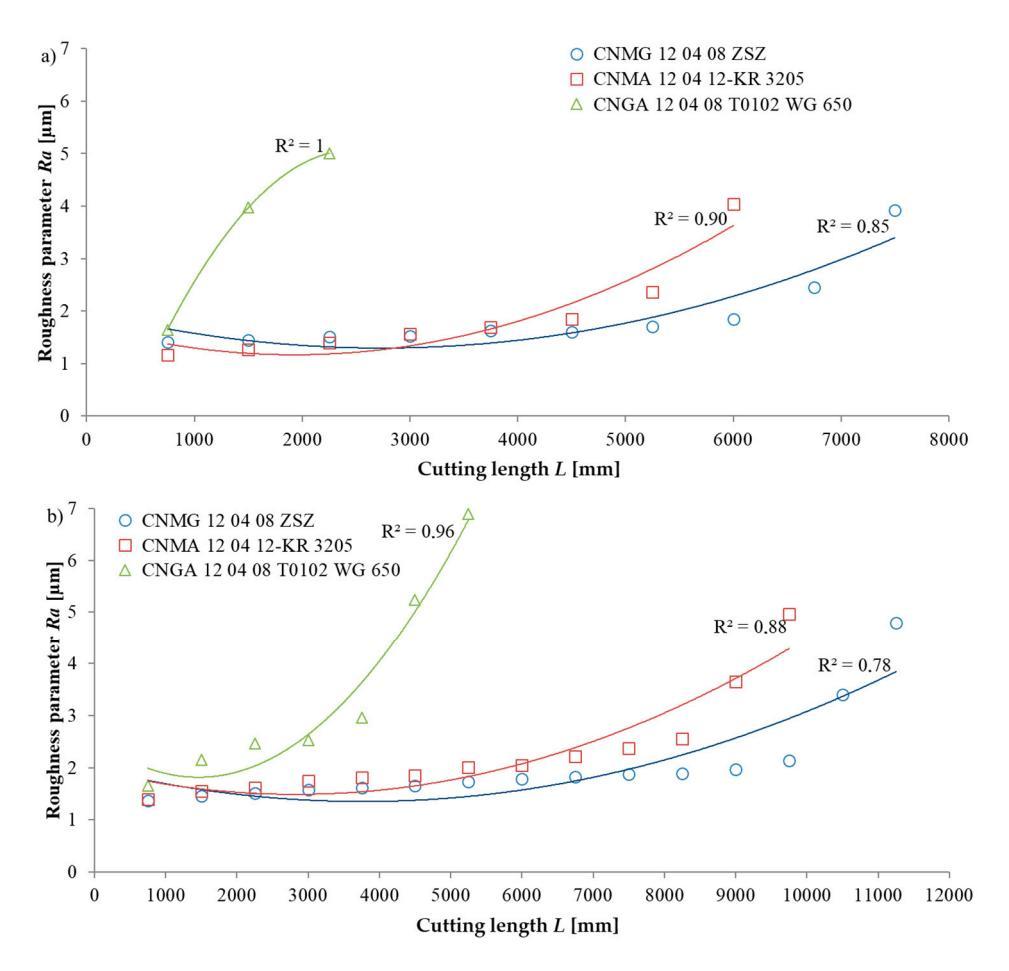
Figure 7. Changes of the Ra roughness parameter value obtained when turning with the following cutting inserts: CNMG 12 04 08 ZSZ, CNMA 12 04 12-KR 3205, CNGA 12 04 08 T0102 WG 650, and the studied stainless steels (**a**) X20Cr13 and (**b**) X8CrNiS18-9.

Figure 7 shows the values of the *Ra* roughness parameter obtained during turning X20Cr13 and X8CrNiS18 stainless steel grades with three cutting inserts. The *Ra* surface roughness parameter was also shown as a function of the cutting length *L*. When monitoring the condition of the cutting edge, its significant wear, preventing further machining, in each case translated to a sudden increase of the *Ra* roughness parameter value.

The test results for *Ra* indicator were also approximated with a second-degree polynomial function. Equations (8) and (11) present the trend of *Ra* for the CNMG 12 04 08 ZSZ insert. Equations (9) and (12) show the trend of *Ra* for the CNMA 12 04 12-KR 3205 insert. Equations (10) and (13) present the trend of *Ra* for the CNGA 12 04 08 T0102 WG 650 insert.

Based on the obtained results for both the X20Cr13, as well as the X8CrNiS18-9 steels, a step-wise increase of surface roughness upon the appearance of significant cutting edge wear was noted. Comparing the values of the *Ra* parameter for individual inserts, it was concluded that the worst quality was characteristic for the surface after turning with the CNGA 12 04 08 T0102 WG 650 insert and the best quality was characteristic after the CNMG 12 04 08 ZSZ insert. Verifying the direct and indirect indicators, it can be concluded that they are convergent. Upon the deterioration of the surface quality, also greater values of the selected geometric measure of wear on the flank face were identified.

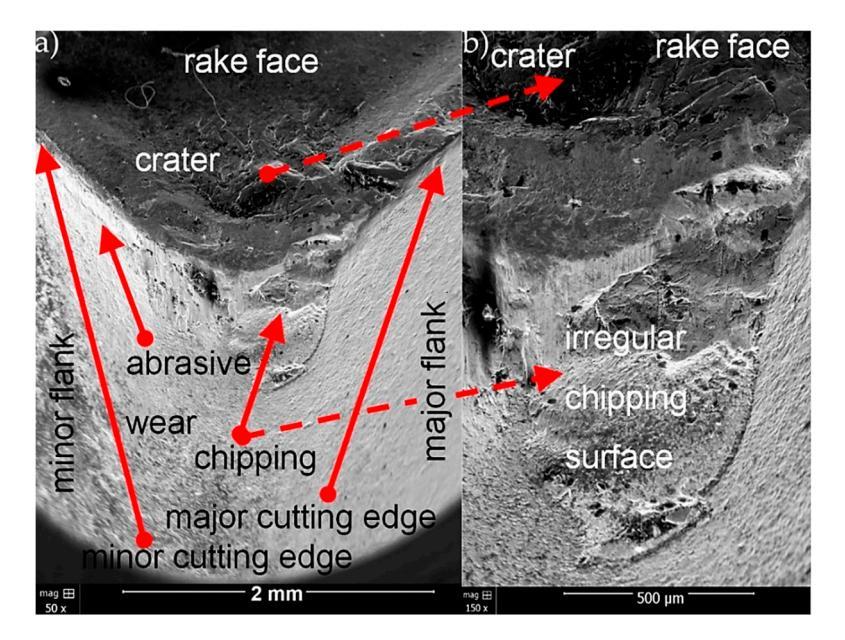
Figure 8. SEM micrographs of wear for CNMG 12 04 08 ZSZ insert with TiN coating for two magnifications (**a**) 50× and (**b**) 150×.

The abrasive character was the dominant of wear mechanism for CNMG 12 04 08 ZSZ insert with TiN coating (Figure 8). Progressive abrasive wear led to the destruction of TiN coating and corner weakness. As a consequence, the corner was broken in the final phase. The chipping surface has an irregular surface structure. Crater on the rake face was also observed.

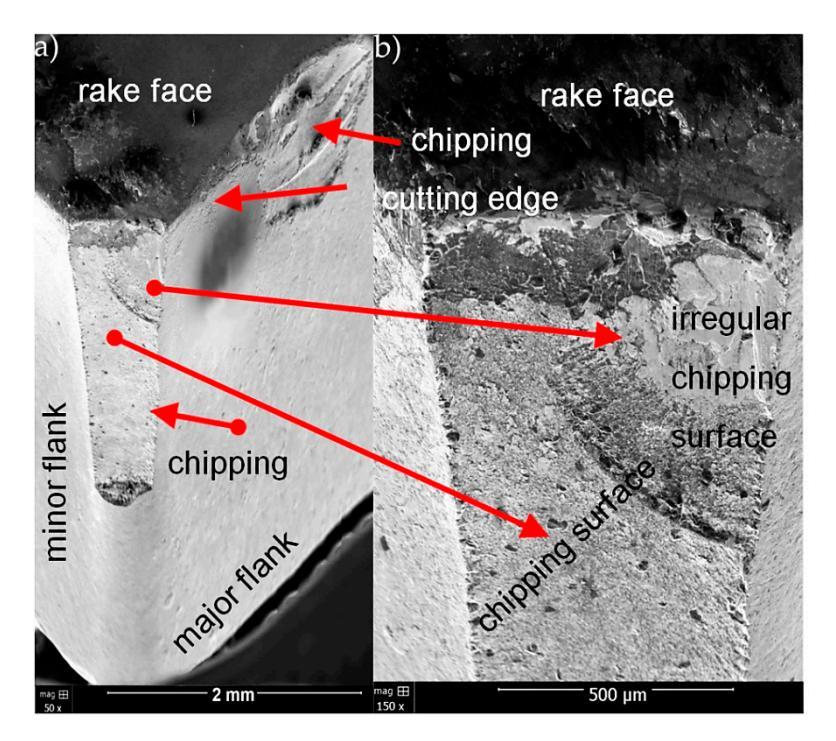
Figure 9. SEM micrographs of wear for CNMA 12 04 12-KR 3205 insert with $Ti(C,N) + Al_2O_3 + TiN$ coating for two magnifications (**a**) 50× and (**b**) 150×.

For CNMA 12 04 12-KR 3205 insert with $Ti(C,N) + Al_2O_3 + TiN$ coating, apart from chipping of the corner (similar to CNMG 12 04 08 ZSZ insert), the cutting edge was wiped and chipped (Figure 9).

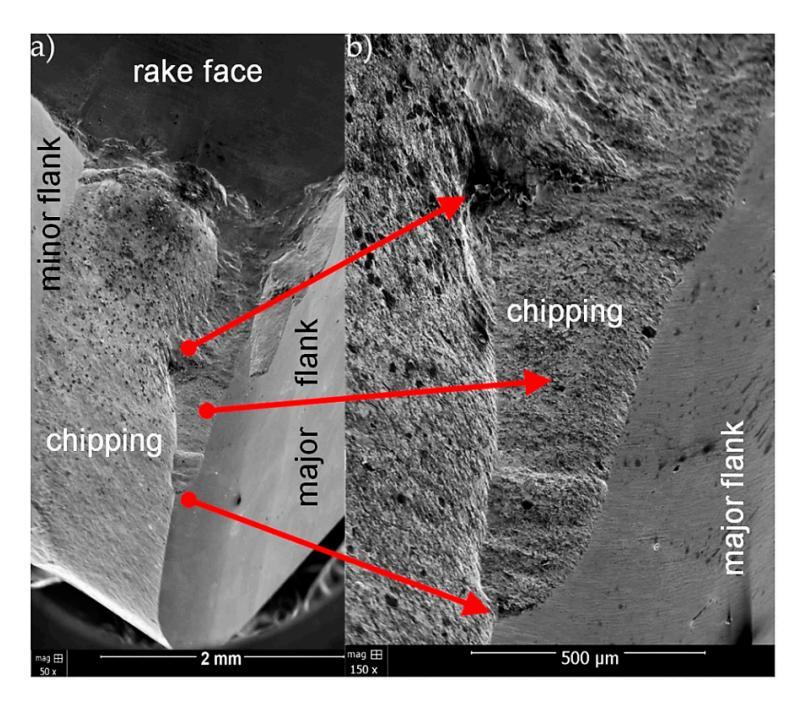
Figure 10. SEM micrographs of wear for CNGA 12 04 08 T0102 WG 650 insert without coating for two magnifications (**a**) 50× and (**b**) 150×.

In the case of CNGA 12 04 08 T0102 WG 650 insert, as in the previous cases, in the final stage of machining, the cutting wedge was catastrophically dulled and, as a consequence, the corner was broken along the entire thickness of the insert (Figure 10).
