Article

Feasibility Study of Digital Image Correlation in Determining Strains in Concrete Exposed to Fire

Katarzyna Mróz^{1,*}, Marcin Tekieli² and Izabela Hager¹

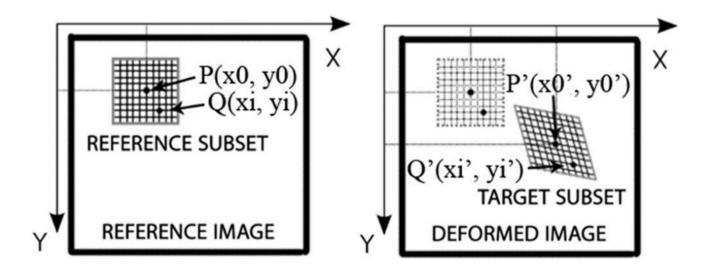
Figure 1. Image subsets before and after deformation [14].

The optical measurement system (CivEng Vision) used in this research was previously developed by Tekieli and Słoński at Cracow University of Technology [12,13]. In the laboratory of the Cracow University of Technology, the DIC method is widely used for tests for many purposes. Both brittle and flexible materials can be investigated [14]. The pictures taken are used as a 2D matrix of pixels and each picture is correlated with the reference one (Fig. 1). The points of the grid based on the specified image subsets are matched and identified as that associated with the highest value of the correlation coefficient. This coefficient is calculated between the reference subset "f" and the target subset "g", whose dimensions are equal and are M × N pixels using the zero-mean normalized cross-correlation method, as described by Equation (1), where u_f is the intensity of the reference subset and u_g is the intensity of the target subset form (Figure 1). A detailed description of the method is presented in [14].

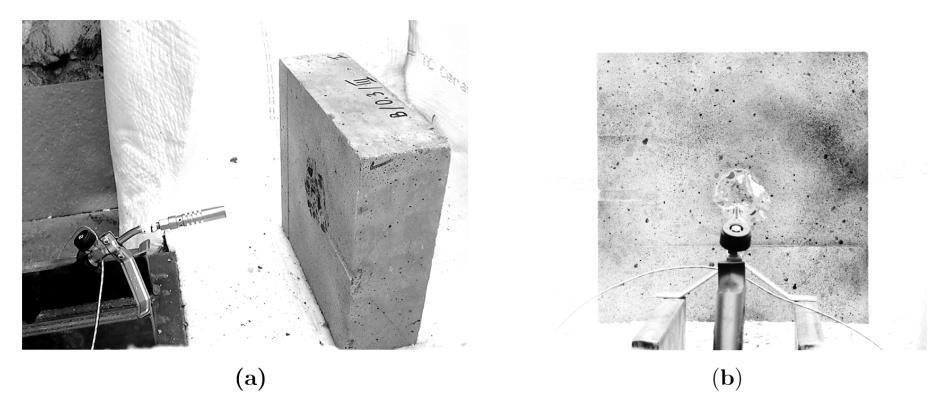
Figure 2. The experimental test stand and the concrete element with a size of $0.3 \text{ m} \times 0.3 \text{ m} \times 0.1 \text{ m}$: (a) Side view; (b) Front view.

The experimental test method was inspired by the reaction to fire tests—part 2: single-flame source test, according to ISO 11925-2b [15]. The single test consisted of using a small propane-butane gas burner (torch) placed in front of the concrete element (Figure 2). In all tests, the angle and the distance between the burner and the specimens were the same. The mean flame temperature at the concrete surface was measured with a thermal camera as ca. 800 °C and remained constant during the test. Additionally, the thermal camera was used to point out the area that was directly exposed to the fire. Figure 3 presents the directly affected circle zones with respect to the size of the specimen. The zones with a temperature higher than 200 °C as observed with the infrared camera are marked in dark blue, while the temperature of 800 °C is marked in red. The directly fire-exposed area was a round surface with diameter ca. Ø0.15 m regardless of the element size. The single test lasted 20 min.

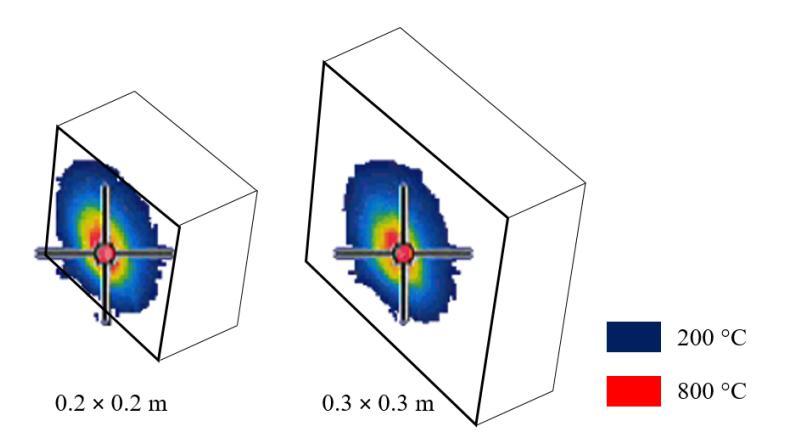
Figure 3. The directly fire-affected zones for the tested concrete element.

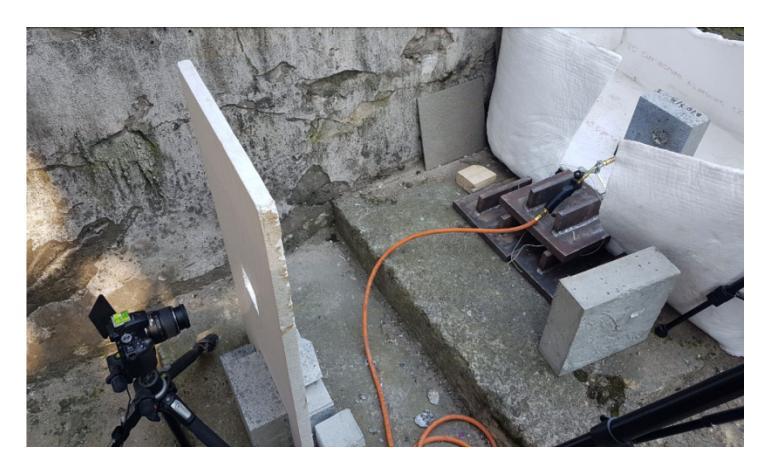
Figure 4. Test stand used for the simple flame test.

In the case of a fire test with the use of a small torch, it is possible to take pictures in front of the fire-exposed side. The test stand employed is presented in Figure 4. Due to the dynamic destruction of the samples, the camera on the heated side was protected with a styrofoam shield cover with a hole for the camera lens. The surface of the specimen was prepared in a similar way to the standard approach, but heat-resistant black spray paints were used to produce a random black and white pattern as shown in Figure 5.

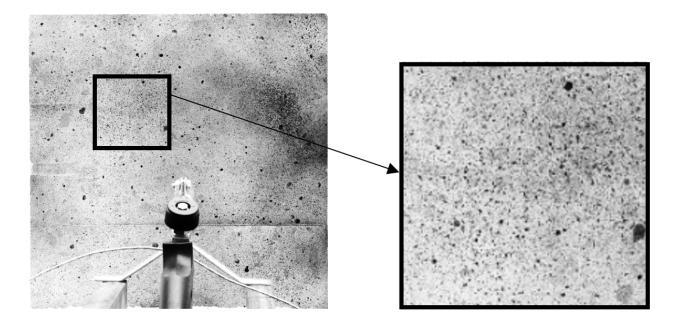
Figure 5. Pattern of randomly distributed black dots to be tracked by digital image correlation (DIC).

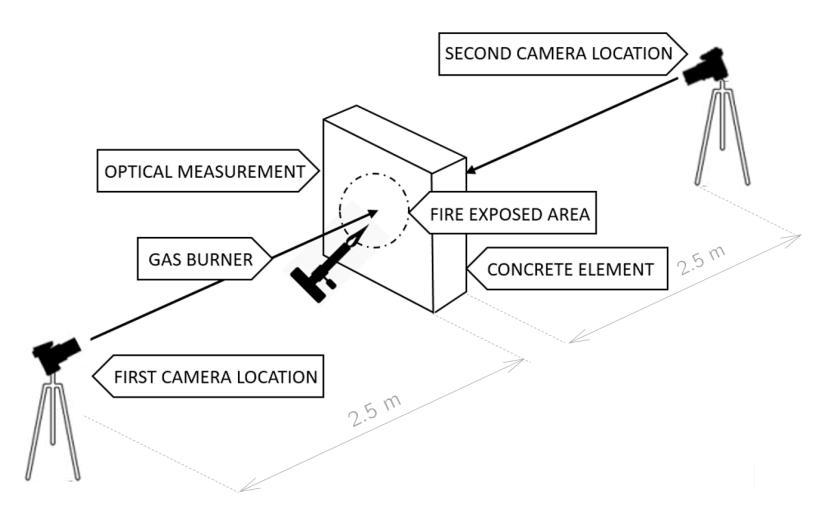
Figure 6. Scheme of the experimental stand.

Each specimen was observed using two DSLR cameras connected by one automatic trigger: one set on the heated side and one located on the opposite side (Figure 6). The pictures were taken every 10 s during fire exposure.

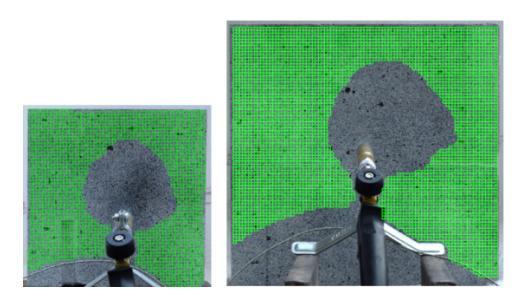
Figure 7. Grid of subsets in medium (200×200 mm) and large (300×300 mm) specimens.

Since the central part of the specimen was very quickly destroyed by the falling pieces of concrete and the random pattern was degraded, the masking procedure was used on the deformation maps so that only the effects around the damaged fragment were visible (Figure 7).

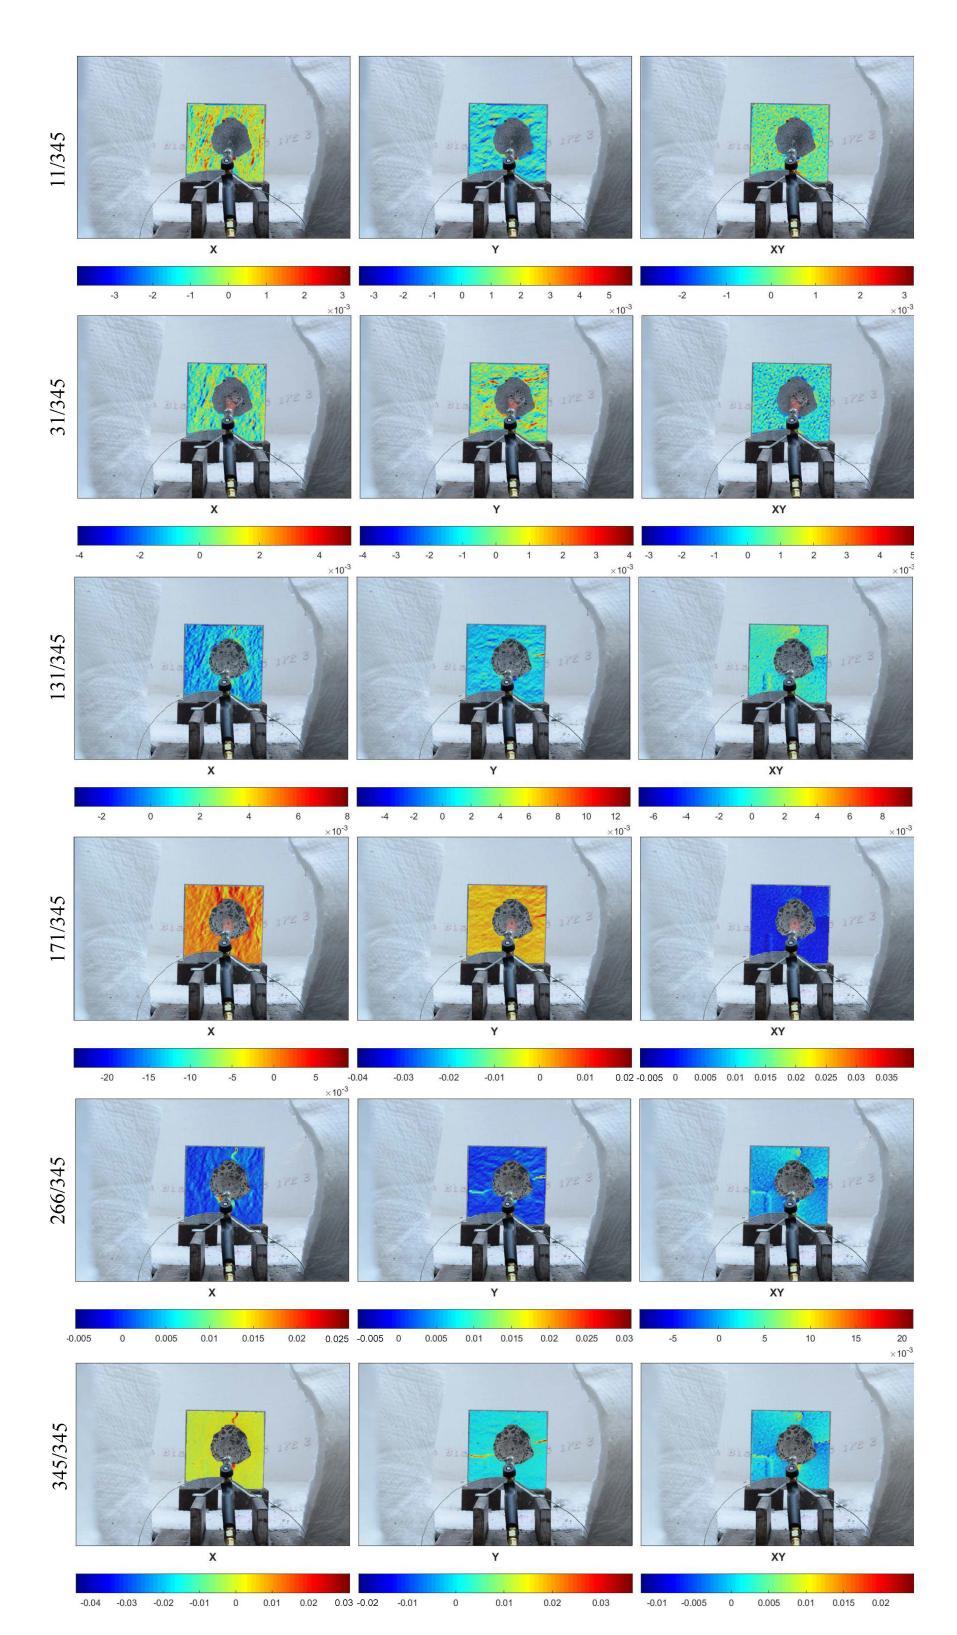
Figure 8. Deformation fields in the x- and y-directions for the medium specimen (200×200 mm).

Figure 8 presents the deformation fields in the x- and y-directions for the medium specimen (200 \times 200 mm), while Figure 9 shows the results for the largest specimen (300 \times 300 mm) during the small flame test. In the deformation fields, a red color means expansion while a blue one indicates contraction.

In the case of the medium specimen, 345 pictures were taken during the fire exposure period, while in the case of the large specimen, 441 pictures were collected. The six pictures presented for the medium (Figure 8) and large (Figure 9) specimens were chosen as representatives of different points in the period of fire exposure. Moreover, the presented points in time were very close to the time of the spalling event. In the case of the medium specimen, the pictures with the numbers 31/354 and 171/354 were taken at the exact time of the spalling event. Similarly, for the large specimen, the pictures with the numbers 11/441 and 146/441 represent the spalling event. In the pictures, it can be seen that during heating, the surface was divided into expanding and contracting lanes, in both the x- and y-directions. Such behavior of the heated side continued until the spalling event stopped. When it stopped, the deformations were regulated. Furthermore, the previously created cracks in the surrounding unexposed part of concrete continued to develop and the remaining area worked in compression.

Moreover, the deformation fields of the exact spalling event show that the very early spalling event in the form of aggregate popcorn spalling provided slightly enhanced deformations in at least one direction (Figure 8—31/354 and Figure 9—11/441). However, when it comes to surface spalling (Figure 7—171/345, and Figure 8—146/441), it was characterized by a greater intensity and continuous form and took place at a later stage of the fire exposure, with the deformation field colors in red (tension) being displayed across the entire surface. Such deformation fields are unique within all 345 pictures for the smaller specimen and 441 pictures for the larger specimen. It should be emphasized that in the case of the smaller specimen, the picture 171/345 was taken exactly during the spalling event, while for the larger specimen, the picture 146/441 was taken just after it. This may explain why the deformation field in the x-direction for the larger specimen is not colored in red—it has already returned to the natural stage of deformation.

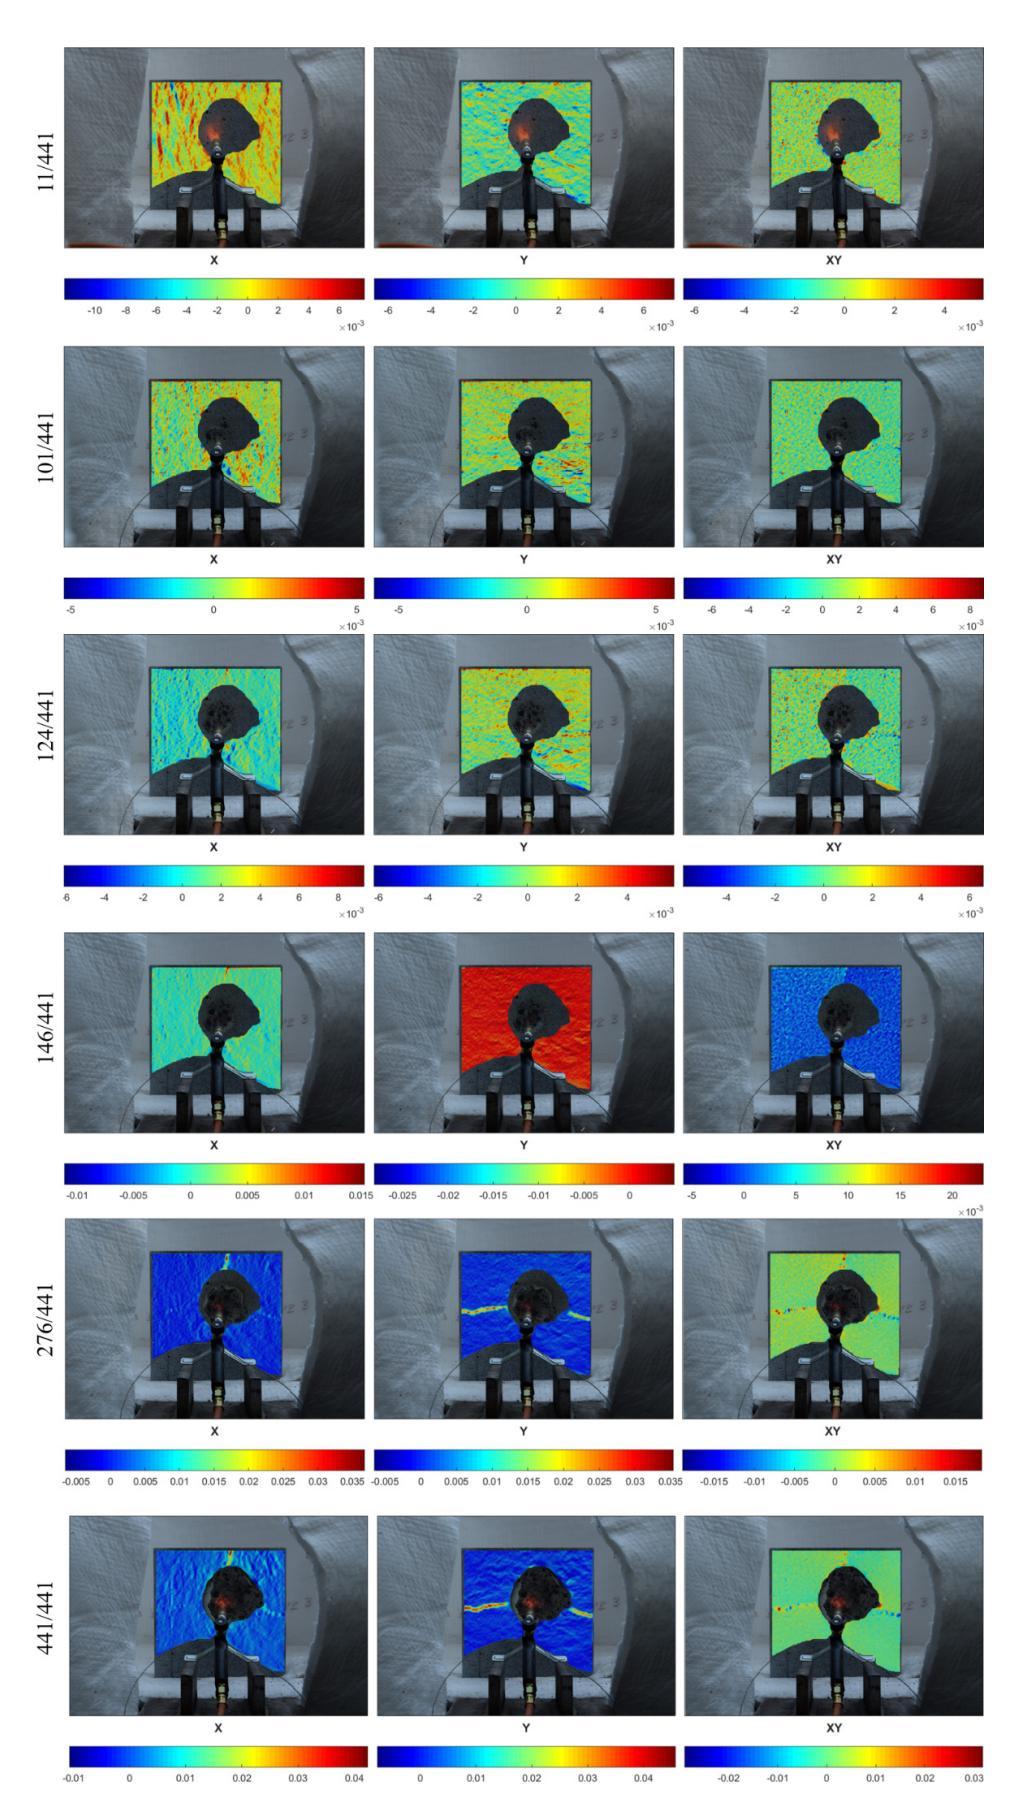
Figure 9. Deformation fields in the x- and y-directions for the largest specimen (300×300 mm).

Finally, explosive spalling took place in the larger specimen just after the picture 276/441. It can be seen that the deformation observed in the neighboring pictures (271/441 and 281/441) was stable, which confirms that explosive spalling resulted from internal water pore pressure rather than thermal stress (Figure 10).

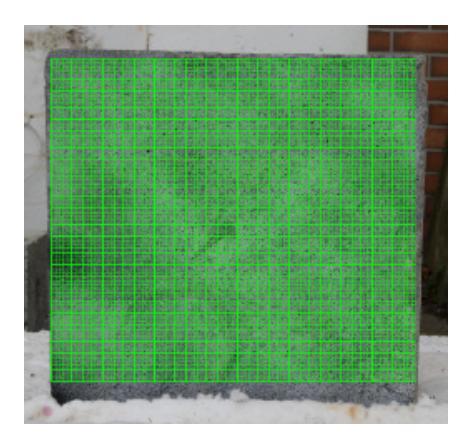
Figure 11. Grid of subsets in the unheated surface.

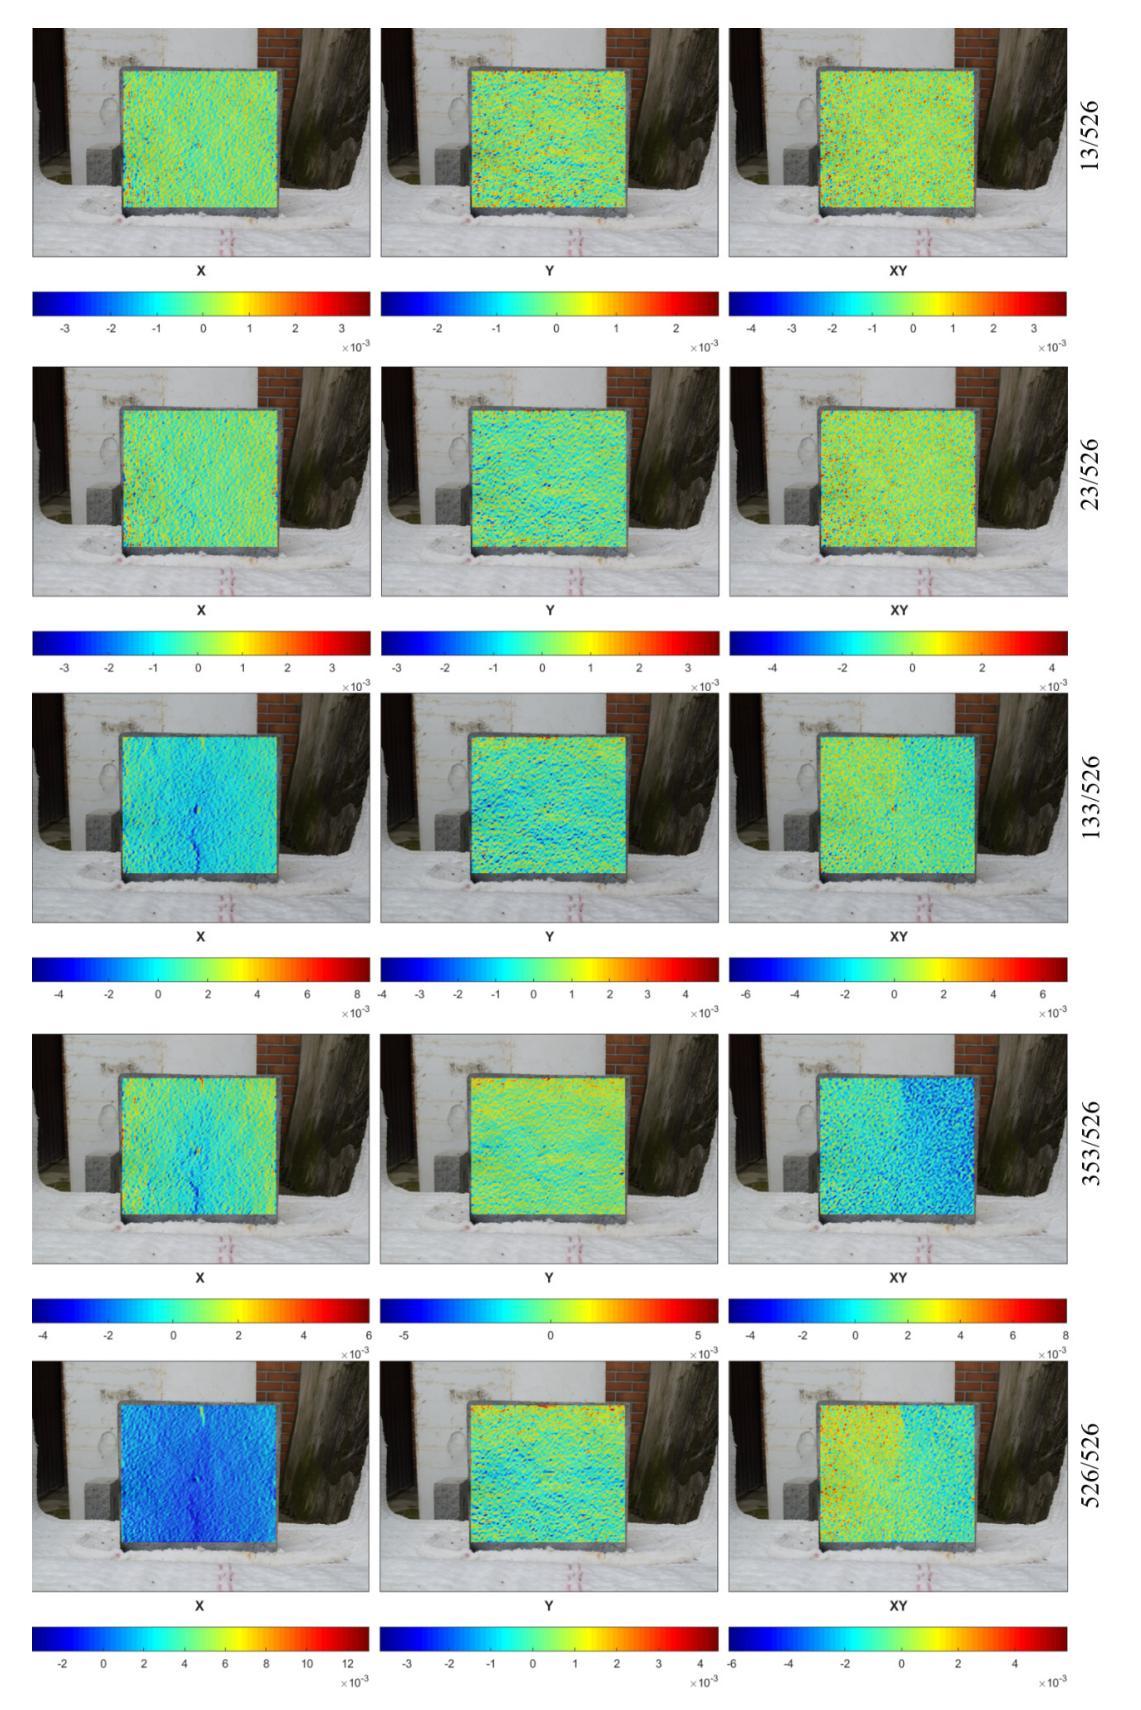
Figure 12. Deformation fields in the x- and y-directions in the unheated surface of specimen 1.

Figure 12 presents the deformation fields obtained for the opposite side of the tested specimen. During fire exposure, the deformation of the back surface developed in a similar manner to that of the fire exposed side. Until the time of the occurrence of the first crack, the surface was divided into expanding and contracting lanes. Moreover, in the x-direction, when a microcrack was formed at the top of the specimen, a compression zone appeared in the bottom part of the specimen. This observation was made for 2 of 2 tested specimens. Therefore, it is claimed that the cause of such deformation was the test configuration. The specimen lay on the ceramic wool that insulated the specimen from water evaporation. As a result, evaporated water moved toward the upper part of the specimen, enhancing the crack creation on the top of the slab. This could also be confirmed by the deformation fields in the y-direction, where the expanding and contracting lanes were concentrated in the upper part of the element.

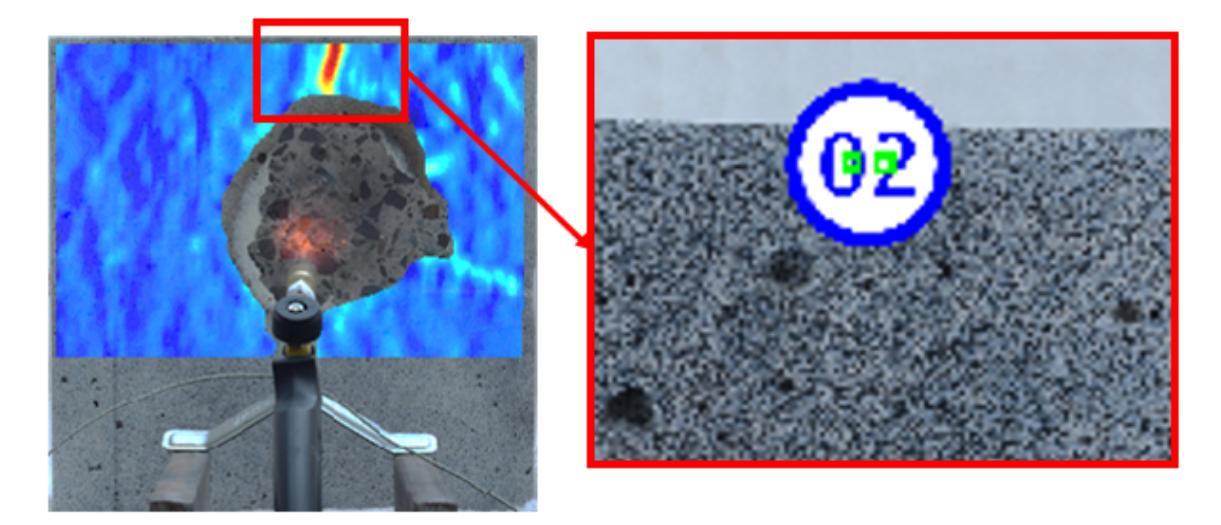
Figure 13. Virtual extensometer used for crack width measurement.

With the use of the DIC method, the cracking process is estimated during the post-processing stage. As a result, the exact number, pattern, and development of cracks within the entire test can be presented. Moreover, with the use of a virtual extensioneter, the evolution of the crack width can be measured. This is obtained by measuring the changing distance between two points that are near enough to both sides of the crack development (Figure 13). The conversion from pixels to metric units is done by calculating the proportion between the length of the known object that is specified in standard length units (e.g., ruler) and its length in the image in pixels.

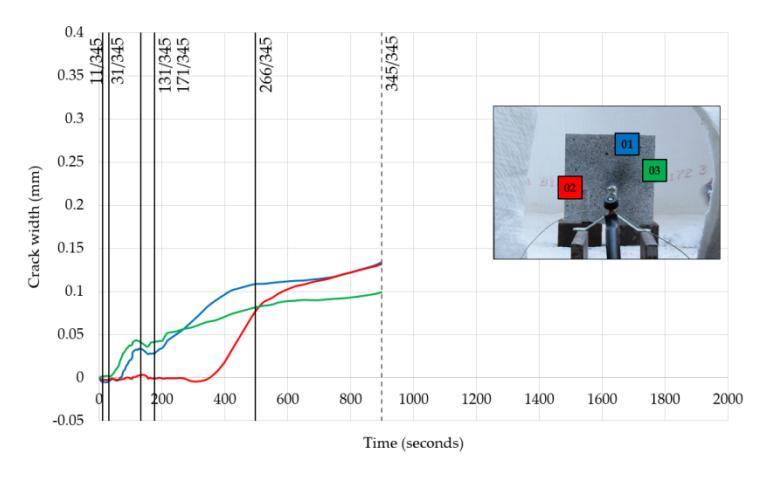
Figure 14. Evolution of crack width for the specimen with a size of 200 × 200 mm.

In Figures 14 and 15, the evolution of crack width for the smaller and larger specimens is presented, respectively, while in Figures 16 and 17, the spalling pattern for six points during the period of fire exposure is shown. Those six points in time are also indicated in diagrams of the cracking development.

Three cracks for both specimens were seen to have developed during the tests. Therefore, for each specimen, three virtual extensioneters were employed to measure their evolution.

As can be seen in the diagrams, at least one crack started to develop in the first few minutes of fire exposure. It can be seen that the sensitivity of the measurement method was very high. Not only the process of crack creation but also the end of this process were made visible by the virtual extensometer.

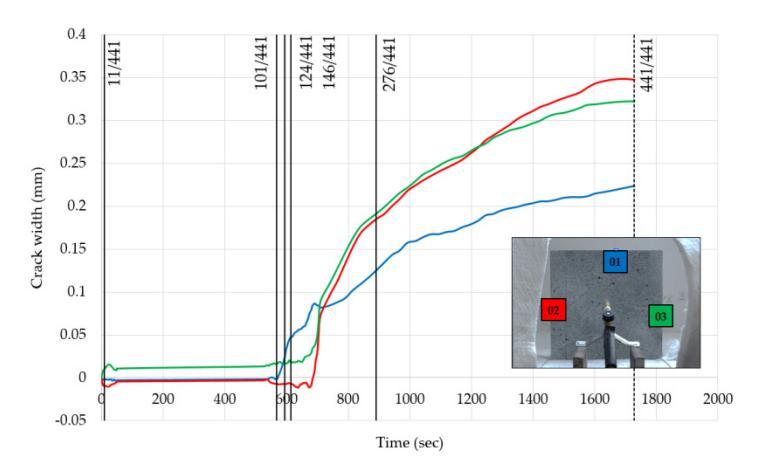
Figure 15. Evolution of crack width for the specimen with a size of 300×300 mm.

It can also be observed that the development of cracks increased when the more frequent surface spalling events stopped. Finally, as the diagram for the larger specimen shows, explosive spalling (no. 276/441) did not affect crack development.

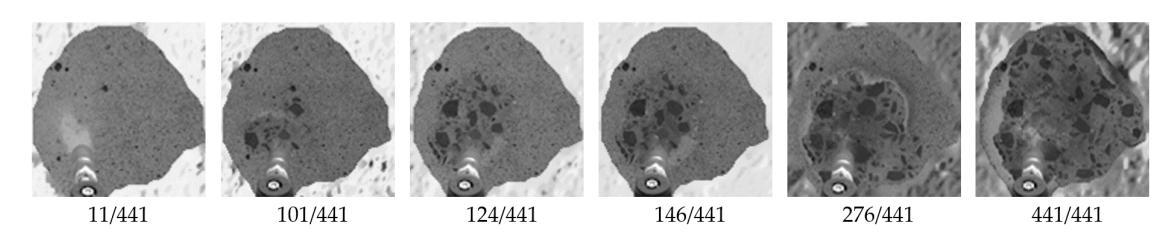
Figure 16. Spalling pattern for six points during fire exposure for the specimen with a size of 200×200 mm.

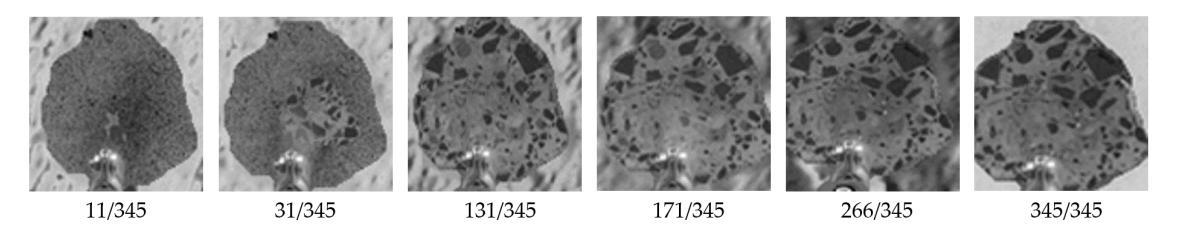
Figure 17. Spalling pattern for six points during fire exposure for the specimen with a size of 300×300 mm.

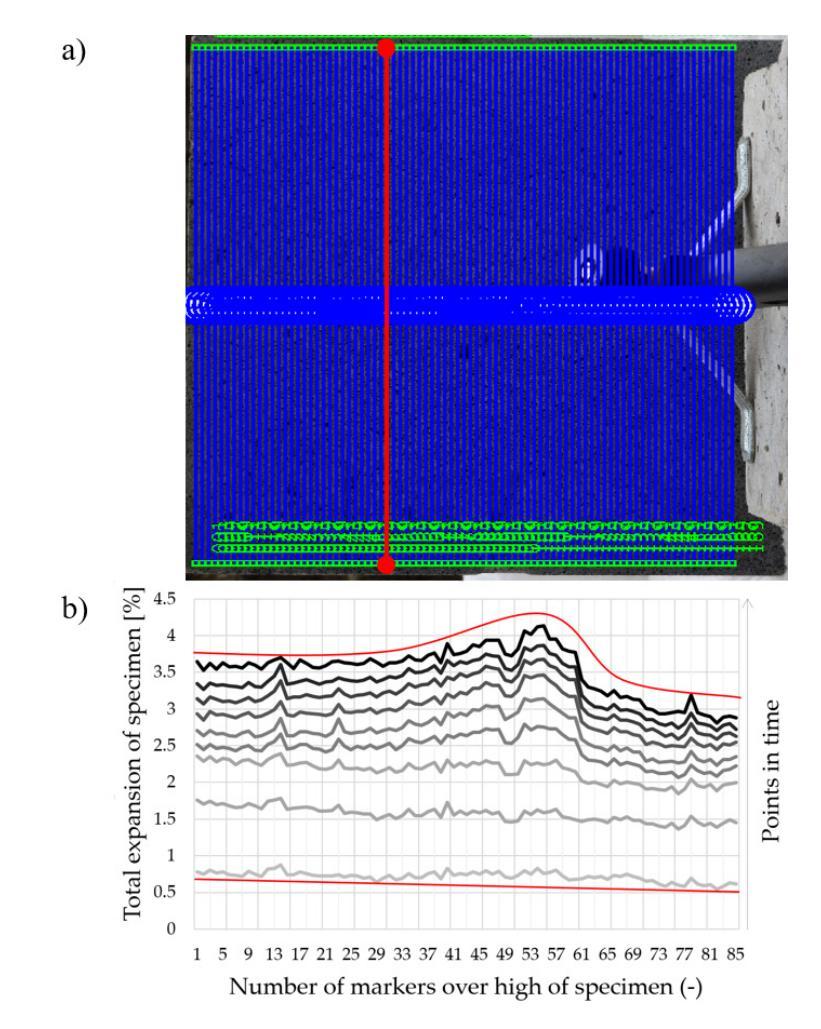
Figure 18. Measurement of the total expansion of the specimen: (**a**) two markers linked together to measure the distance between them, and (**b**) results of the analysis of the total expansion of the specimen along its height and over time.

Finally, the DIC method also allows any two points of the tested specimen to be linked and the change in the distance between them to be analyzed. The authors proposed the calculation for the total expansion of the specimen along its height during the test. For this purpose, two markers were linked together: one from the left edge and one from the right edge (the scheme of this procedure is shown in Figure 18a as two red connected dots). The subsequent linked markers had a distance of ca. 3.5 mm. As a result, the 85 pairs of markers were analyzed (in blue in Figure 18a) Furthermore, several points in time during the fire exposure were recorded.

Figure 18b presents the results of an analysis of the total expansion of the specimen along its height and over time. It can be seen that within the first few minutes of the test, the specimen expanded uniformly; however, the top side expanded a little more than the bottom part of the specimen. Furthermore, when surface spalling took place, the central part of the specimen started to expand significantly. Finally, the central part was more expanded than the surrounding part of the concrete.

As in the later stage of the test, the crack appeared in the top part of the specimen, and it could be naturally observed that the top side was more expanded than the bottom part.
