# Article Flexural Behavior of Fire-Damaged Prefabricated RC Hollow Slabs Strengthened with CFRP versus TRM

Abstract: In this paper, carbon fiber reinforced polymer (CFRP) and textile reinforced mortar (TRM) strengthening techniques were proposed to retrofit and strengthen fire-damaged prefabricated concrete hollow slabs. A total of six slabs, from an actual multi-story masonry building, were tested to investigate the flexural performance of reinforced concrete (RC) hollow slabs strengthened with TRM and CFRP. The investigated parameters included the strengthening method (CFRP versus TRM), the number of CFRP layers, and with or without fire exposure. One unstrengthened slab and one TRM strengthened slab served as the control specimens without fire exposure. The remaining four slabs were first exposed to ISO-834 standard fire for 1 h, and then three of them were strengthened with CFRP or TRM. Through the four-point bending tests at ambient temperature, the failure modes, load and deformation response were recorded and discussed. Both CFRP and TRM strengthening methods can significantly increase the cracking load and peak load of the fire-damaged hollow slabs, as well as the stiffne

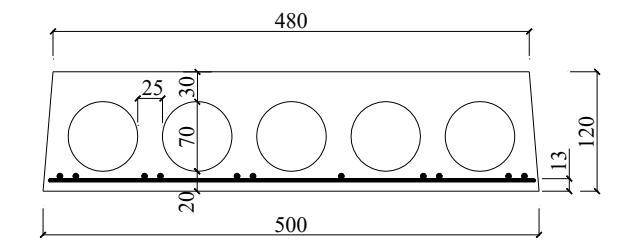
Figure 1. Details of the hollow slab (all dimensions in mm).

Five holes, with a diameter of 70 mm and spaced at 25 mm, was designed at the cross-section for each RC hollow slab, while positioned 30 mm and 20 mm away from the top and bottom of the slab, respectively. Each slab has 11 longitudinal prestressed steel rebars with a nominal diameter of 4 mm, while the same rebars spaced at 200 mm were used as the transverse reinforcement. The clear concrete cover to the longitudinal rebars was 13 mm.

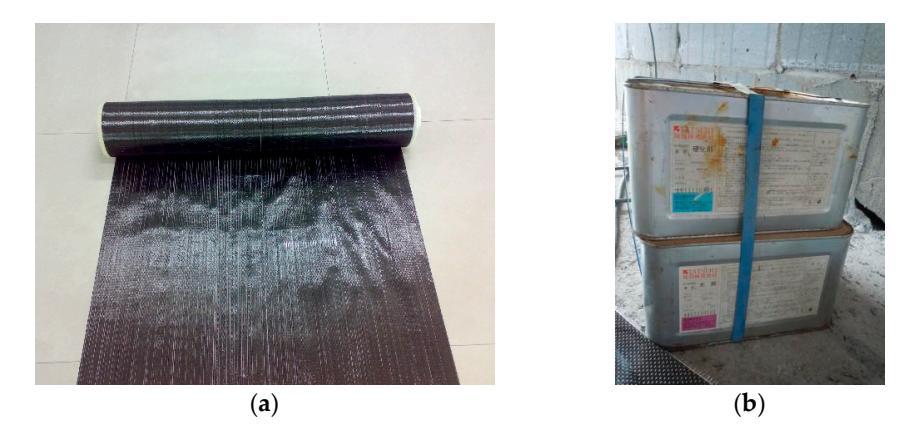
**Figure 2.** Materials in carbon fiber reinforced polymer (CFRP) strengthening method. (**a**) CFRP sheets; and (**b**) Epoxy resin.

Since the hollow slabs were from the existing structure, the material properties of concrete and steel rebars were measured by laboratory tests. The average concrete strength was 40.1 MPa, measured by the rebound method according to Chinese code JGJT 23 [40]. To measure the strength of prestressed steel rebars, six rebar samples were taken out from the slabs, three of which were tested before fire exposure, while the other three samples after fire exposure. Taking the strength corresponding to 0.2% residual plastic strain as nominal yield strength, the yield strength of steel bar is 500 MPa before fire exposure, and 400 MPa after fire exposure. The ultimate strength is 660 MPa, regardless of whether fire exposure or not. CFRP sheets HT300 as the external reinforcement in the tests were supplied by Japanese Tatsuhi Co., Ltd., (Tokyo, Japan) as well as the matched epoxy adhesive TH-RESIN (Figure 2).

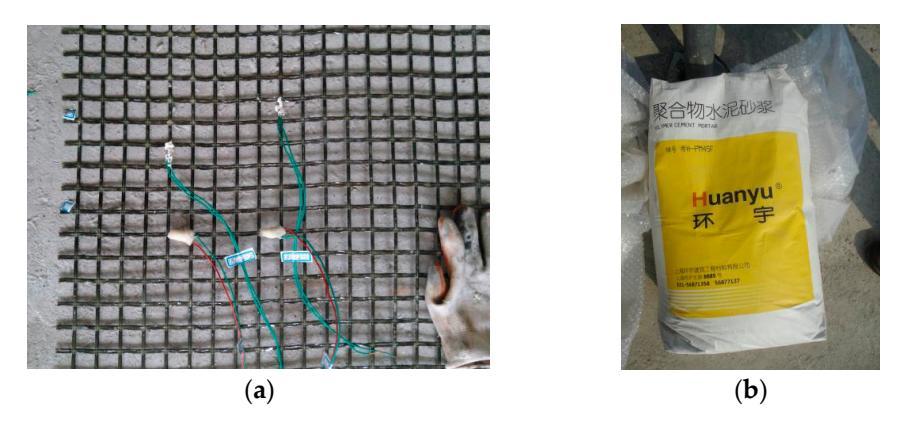
**Figure 3.** Materials in textile reinforced mortar (TRM) strengthening method. (**a**) Basalt fabric mesh; and (**b**) Polymer cement mortar.

The TRM strengthening layer consists of fiber fabric mesh and polymer cement mortar, as illustrated in Figure 3. The polymer cement mortar is a type of cement-based mortar modified by polymer material to improve adhesion, flowability, and strength. In this test, polymer cement mortar PM45F was used as the reinforcement matrix, which was provided by Shanghai Huanyu Construction Engineering Materials Company. According to the standard JGJ/T 7 [41], three mortar cubes with dimensions of 70.7 mm × 70.7 mm × 70.7 mm were made to measure the strength and elastic modulus. The average compressive strength of the polymer cement mortar after 28-day curing was 43.5 MPa. The properties of the polymer cement mortar, given by the test results and the manufacture's datasheets, are described in Table 3.

In practical engineering, the fiber fabric mesh is an excellent building material for enhancing the anti-seepage and crack resistance of cement concrete. In the TRM strengthening technique, like the steel rebars, fiber fabric mesh was employed as the tensile member in the strengthening layer to bear the load. The fiber fabric mesh BGA25 used in the test was supplied by Dongguan Guangdong Russia & Gold Basalt Fiber Co., Ltd. As can be seen in Figure 3a, the fabric mesh was two-way weaved by basalt fabrics, with a mesh space of 25 mm in both longitudinal and transverse directions.

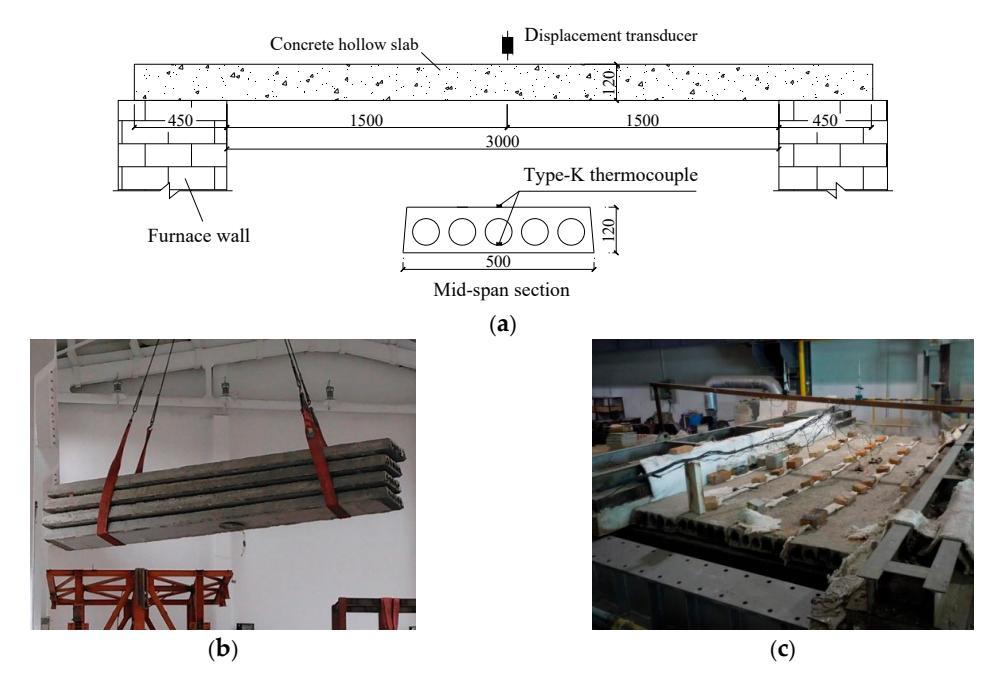
**Figure 4.** Test details for fire exposure (unit: mm). (a) Instrumentations of the specimens (all dimensions in mm); (b) Specimens before fire; (c) Specimens in fire test.

Four specimens, including SF0, SFC1–2, and SFT2, were placed one by one along the width direction of the furnace chamber and then exposed to standard fire. As shown in Figure 4, all the four slabs were tested at one time, and the clear span of the slabs in the furnace was 3000 mm. The two ends of the slabs were simply supported on the furnace wall in an unloaded condition, and then rock wool blankets were used to fill and cover the gaps between two adjacent hollow slabs and between the slabs and the furnace covers to form enclosed space and reduce the heat loss. It should be noted that these specimens have not been strengthened yet, and there is an 8 mm thickness plastering layer attached to the bottom of the slabs.

Ten internal thermocouples monitor the furnace temperature during a fire test, and a total of four type-K thermocouples were placed in the mid-span section of two slabs to record the temperature of core holes and the top surface of slabs. Besides, mid-span deflections were measured by displacement transducers.

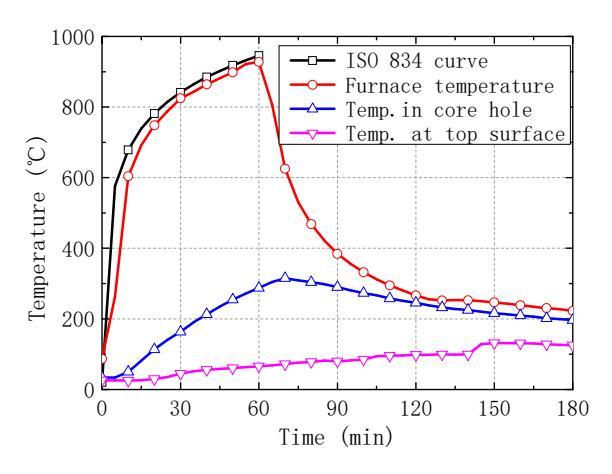
Figure 5. Time-temperature curves for slabs.

In the fire test, the furnace temperature was following the time-temperature curve of ISO 834 standard fire. The maximum temperature automatically recorded in the chamber was 927.3 °C. During the fire and cooled process, the average temperature at the top of slabs was only 70 °C at 60 min, and up to 130 °C at 150 min (Figure 5), due to the heat transition from the bottom to the top of slabs in the enclosed furnace. The average temperature in the holes reached 290 °C at 60 min of fire exposure and then elevated to a maximum value of 320 °C at 10 min after the fire stopped. From that it can be deduced the max temperature of prestressed rebars was more than 320 °C during the test, which may lead to some strength degradation.

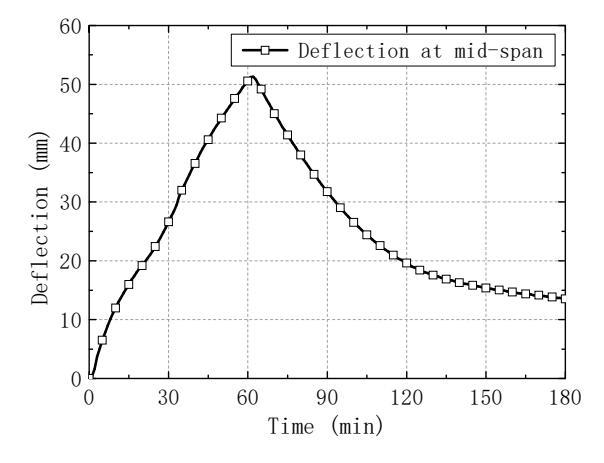
Figure 6. Time-deflection curve for slabs.

As also shown in Figure 6, the deflection of the slabs increased linearly and reached 50 mm when the test ended at 60 min. The deflection change can be mainly contributed to the uneven expansion between the upper and lower section of concrete slabs. After that, the deflection reduced to 13.5 mm at 180 min, and 5 mm after cooled for one day to room temperature.

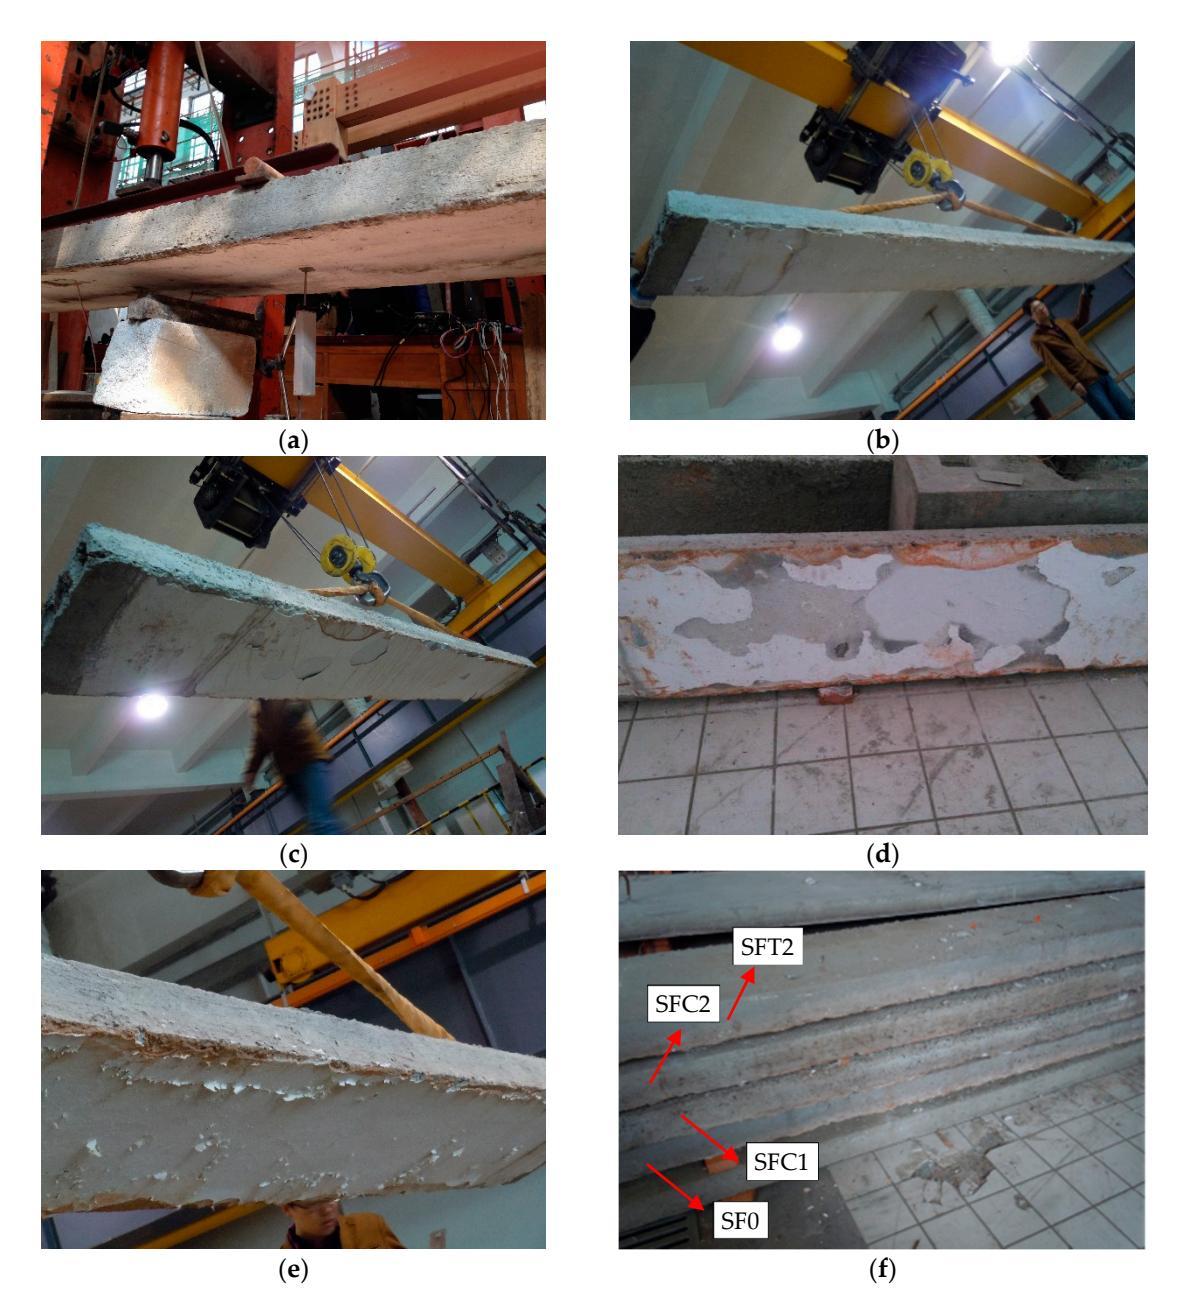
**Figure 7.** Observations after the fire test. (**a**) Non-fire exposed S0; (**b**) Fire-damaged SF0; (**c**) Fire-damaged SFC1; (**d**) Fire-damaged SFC2; (**e**) Fire-damaged SFT2; (**f**) The side surface.

After being cooled down naturally for one day, the temperature of the whole hollow slabs had dropped to room temperature, and the specimens were removed from the test furnace. As a reference, Figure 7a shows a picture of the bottom surface of non-fire exposed specimen S0, from which the intact plastering layer with no damage was observed. Then it could be observed from Figure 7b–e that few mortars of the plastering layer fell off, and some temperature cracks appeared on the surface of the plastering layer. On the side surface of the slabs, the concrete about a quarter height from the bottom changed color to pink, along with some small cracks on it in the mid-span region, as shown in Figure 7f. Due to the thermal isolation effect of the 8 mm thick plaster layer and the poor thermal conductivity of concrete, no concrete burst and no substantial changes occurred on the upper section of the slabs.

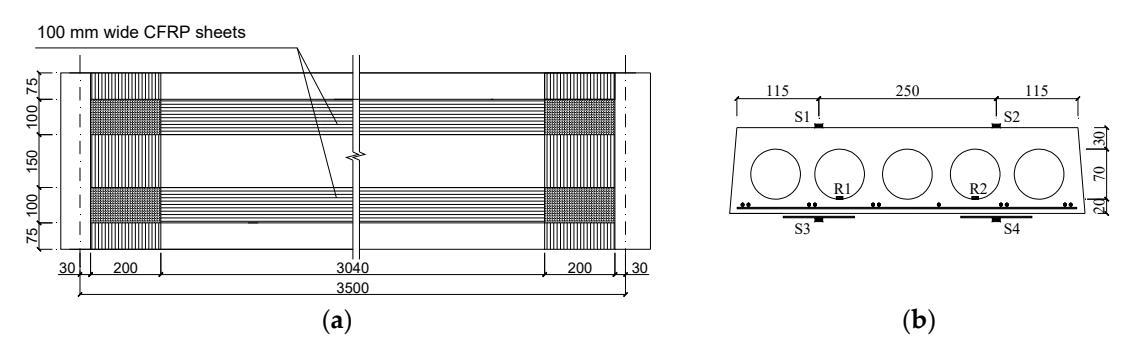
**Figure 8.** Schematic diagram of SFC1 and SFC2 (unit: mm). (a) The bottom surface of slabs; (b) The cross-section at mid-span.

For FRP retrofitted specimens SFC1 and SFC2, Figure 8 shows the details of the strengthening design and the arrangement of gauges. The strengthening procedure composed of four steps. First, make concrete surface treatment. After the plastering layer under the slabs was removed, as shown in Figure 9a, the concrete surface was polished and roughened by an angle grinder. The slurry layer, where the CFRP was applied, was removed up to expose to the coarse aggregate (i.e., about 3–5 mm thick). Second, apply the primer resin (Figure 9b). The two-component epoxy resin was used as the primer adhesive, which can permeate into the concrete surface in an hour and enhance the interfacial bonding property. Next, paste the CFRP sheets when the primer was touch dry (Figure 9c). Two pieces of 100 mm wide CFRP sheets were parallelly placed at the bottom surface of the slabs with a center-to-center space of 250 mm and a length of 3440 mm. After that, a piece of transverse CFRP sheet with a width of 200 mm was used at each end to improve the anchorage effect. Before and after placing each CFRP sheet, one layer of epoxy resin (TH-RESIN) was applied using a plastic roller, to achieve a better bond between the carbon fibers and the surrounding matrix. The above steps were repeated for specimen SFC2 when another layer of CFRP sheet was used. Finally, cure in an open environment (Figure 9d). After curing for about one day, the resin changed from fluid to solid with lower bond strength, and most of the ultimate strength can be achieved after curing for seven days.

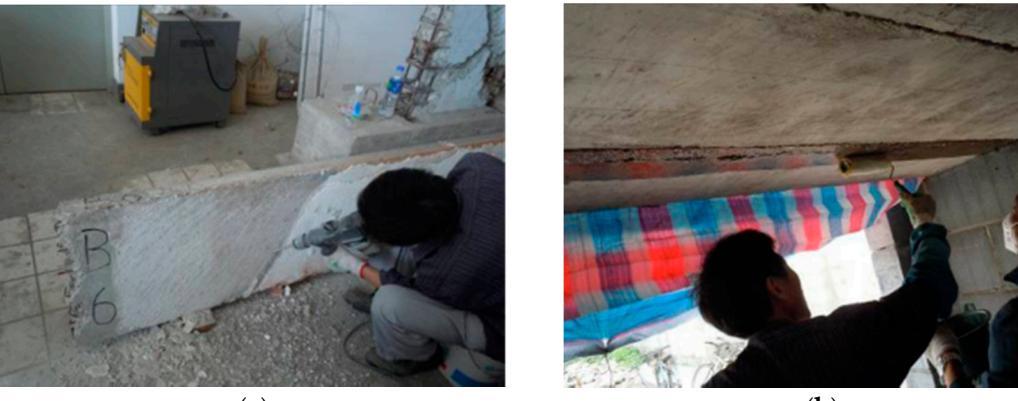
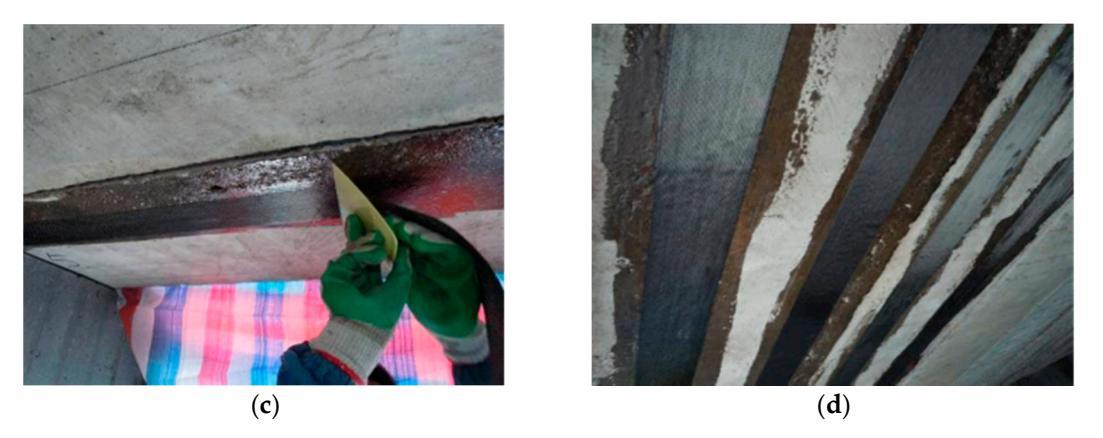
**Figure 9.** CFRP strengthening procedure of the specimens SFC1and SFC2 (unit: mm). (**a**) Surface treatment; (**b**) Apply the primer resin; (**c**) Paste the CFRP sheets; (**d**) Cure in an open environment.

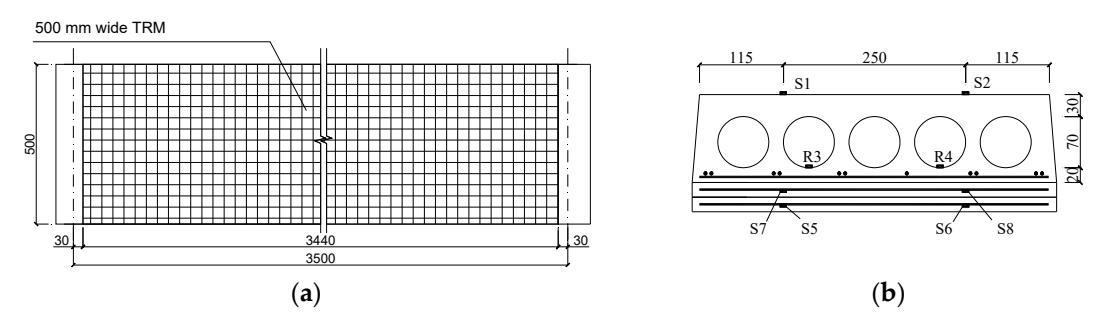
**Figure 10.** Schematic diagram of SFT2 and ST2 (unit: mm). (**a**) The bottom surface of slabs; (**b**) The cross-section at mid-span.

For TRM retrofitted specimens SFT2 and ST2, Figure 10 shows the details of the strengthening design and the arrangement of gauges. The TRM strengthening steps were similar with the FRP retrofitted specimens. In the step of surface treatment (Figure 11a), some transverse grooves with a depth of about 2 mm were set on the soffit of the slabs using a churn drill, to improve the bond between the concrete and the external polymer cement mortar. After that, a thin layer of about 1.5 mm thick polymer cement mortar was sprayed onto the moistened concrete substrate as the adhesion agent.

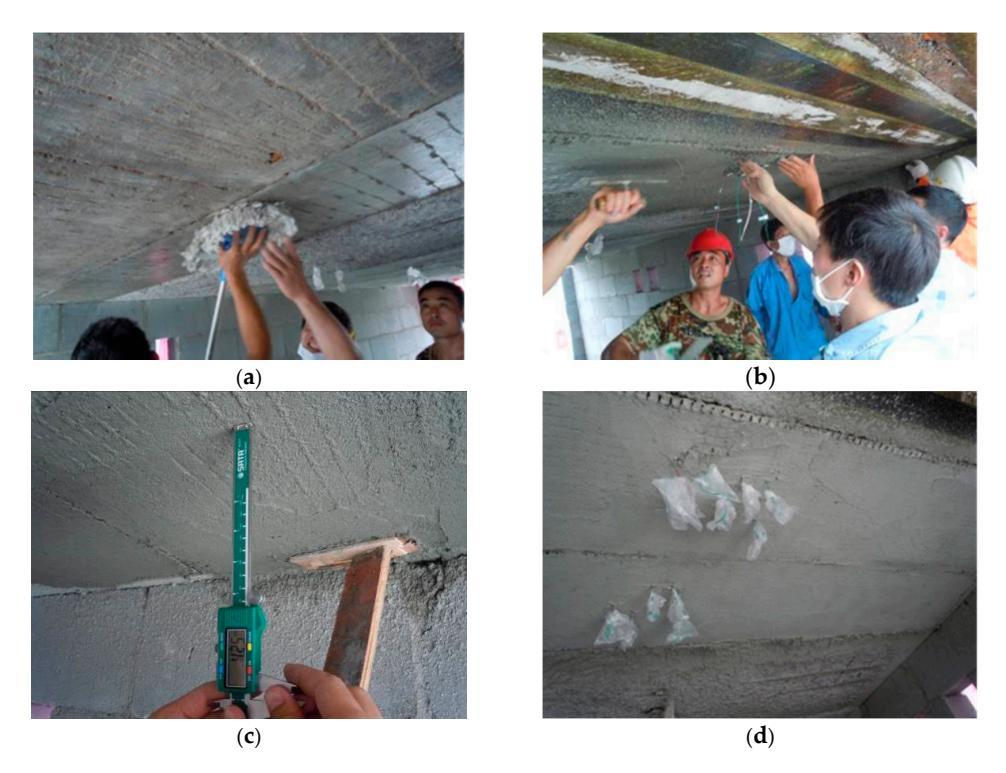
**Figure 11.** TRM strengthening procedure of specimens SFT2 and ST2 (unit: mm) (**a**) Surface treatment; (**b**) Apply the fiber mesh; (**c**) Thickness measurement; (**d**) Curing naturally.

Before the installation of the TRM strengthening system, the basalt fabric mesh was impregnated with TH-resin for 2 days in advance to enhance the interaction behavior of basalt fibers. Two strain gauges were attached to the fabric mesh in the mid-span. First, a layer of polymer cement mortar PM45F with a thickness of 8 mm was sprayed directly onto the surface of the adhesion agent, and one layer of impregnated basalt fabric mesh was immediately applied and pressed horizontally and evenly into the polymer cement mortar (Figure 11b). Then, the second mortar layer of 8 mm thickness was sprayed. The same steps were used for the outer TRM layer, consisting of the second basalt fabric mesh and the third layer of polymer cement mortar. The thickness of each layer was measured by a Vernier caliper to meet the design requirement (Figure 11c). After the entire retrofit procedure was finished, the TRM strengthened specimens were naturally cured for 28 days, as shown in Figure 11d.

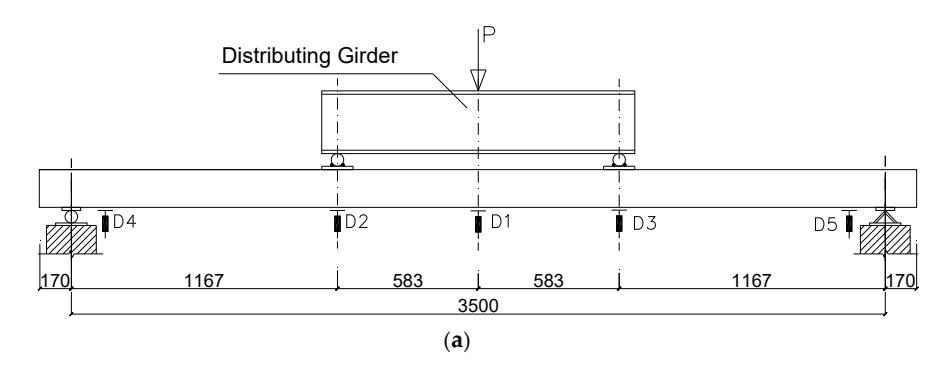
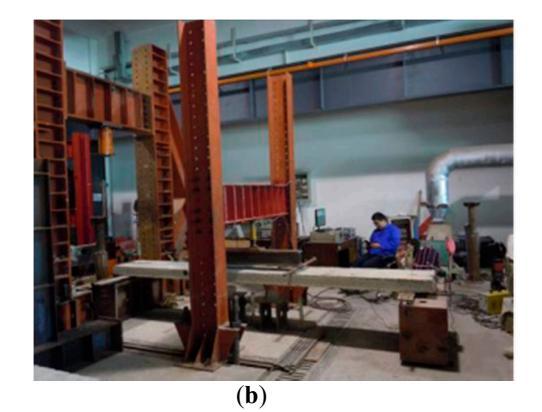
**Figure 12.** The set-up of the four-point bending test. (**a**) The details of test set-up (all dimensions in mm); (**b**) General view for the bending test.

The flexural bending tests were conducted on all the six specimens, including two unstrengthened hollow slabs and four strengthened slabs (see more details in Table 1). The two-point loading system was adapted in the test, as shown in Figure 4. A distributing girder was used to distribute the load from a servo-hydraulic actuator with a maximum load capacity of 100 kN to the two loading points on the concrete hollow slab. The distance between the loading points was 1167 mm, and the clear span of the specimens was 3500 mm.

For each specimen, five displacement sensors, D1–D5, were used to measure and record the deflection of the specimens at mid-span, one-third span, and support location, as shown in Figure 12a. Additionally, the strain measurement of the top surface of concrete, CFRP sheet and basalt fabric at mid-span was made by eight strain gauges, S1–S8, as shown in Figures 8b and 10b. It should be noted that only the CFRP strain at the outer layer was measured, while the TRM strain measurement was set for each layer. The crack load, peak load and crack development of the specimens were investigated. A photograph of the four-point test on CFRP versus TRM strengthened fire-damaged hollow slabs is shown in Figure 12b.

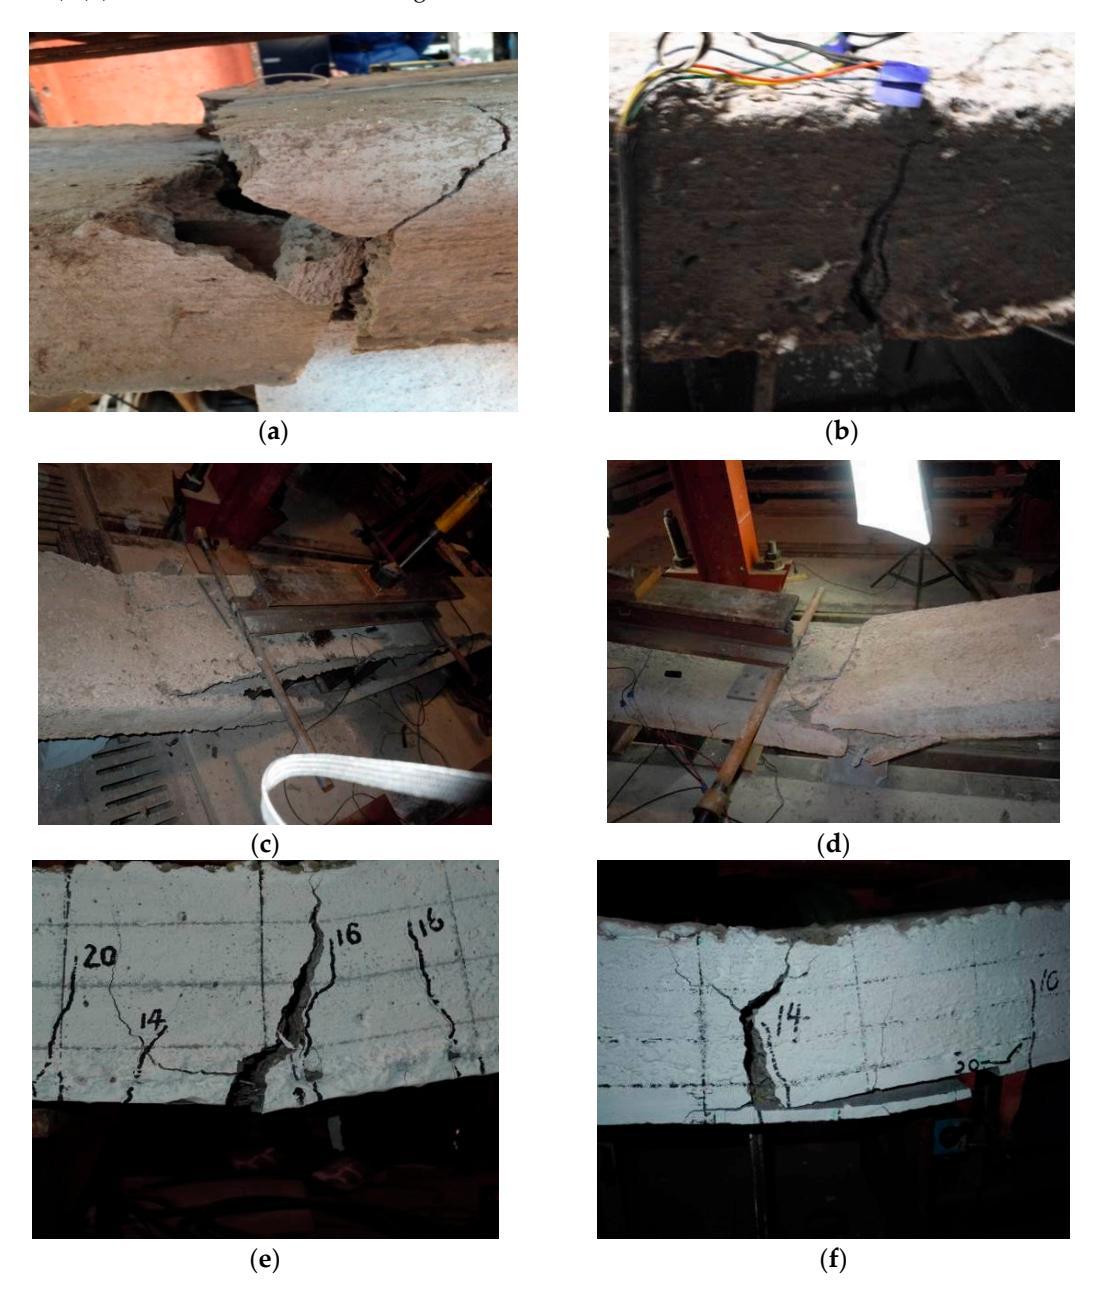
Figure 13. Failure mode of the specimens. (a) S0; (b) SF0; (c) SFC1; (d) SFC2; (e) SFT2; (f) ST2.

Figure 13 shows the failure modes of specimens after the flexural bending test. During the test, the main crack on specimen S0 appeared in the middle zone of the span, and finally the hollow slab broke into two parts along the mid-span crack (Figure 13a), which was the bending failure due to the rupture of prestressed steel rebars. For specimen SF0, an arched crack appeared around the left support in the early stage. However, the reason caused to the bending failure was also the rupture of prestressed steel rebars at mid-span (Figure 13b).

Specimen SFC1 was strengthened with one layer of the CFRP sheet after fire exposure. The main crack in the bending test happened at the section, 800 mm away from the support. The crack developed with an approximately 30 degrees inclination. Finally, the failure mode of SFC1 was a shear failure, due to the premature falling of local concrete on the side face (Figure 13c). Specimen SFC2 was strengthened with two layers of CFRP after fire exposure. In the test, the diagonal cracks in the shear zone were rapidly developed and penetrated through the entire section. At last, the CFRP sheets peeled off from the slab soffit, and the shear fracture of the hollow slab was observed around the right loading point (Figure 13d).

Both specimens SFT2 and ST2 strengthened with two layers of TRM were bending failure. For specimen SFT2, fracture failure of fabric mesh and pre-stressed steel bar occurred in the constant moment region around the right loading point (Figure 13e). Due to the mistake in the on-site lifting process, specimen ST2 had a transverse crack on the top surface near the mid-span before TRM retrofitted treatment. Under static loading, the initial crack in the compressive zone closed, which has little influence before the peak load reached. However, with the increasing of the load, the bending cracking occurred and developed from the bottom to the top part of cross-section, finally it happened to bend failure at the section where the initial crack located. As shown in Figure 13f, the pre-stressed steel bar ruptured and the TRM layer peeled off from the original concrete slab at the main crack zone.

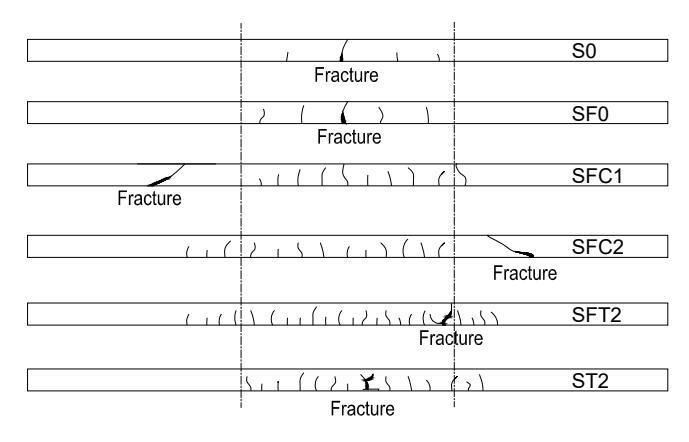
Figure 14. Cracks distribution in each specimen.

The final crack distribution at the side face was also observed and plotted in Figure 14 for each specimen. The dotted lines in figure marked the position of two loading points, between which the section moment kept constant.

As shown in Figure 14, most cracks occurred in the pure bending section, and the average spacing was measured as 248 mm for S0, 233 mm for SF0, 130 mm for SFC1, 117 mm for SFC2, 78 mm for SFT2 and 97 mm for ST2. It is illustrated that both CFRP and TRM reinforcement can make concrete cracks more uniformly distributed and more compact than unstrengthened specimens S0 and SF0. Compared with CFRP strengthened specimens, TRM strengthened specimens had better work performance, because of the more compact and short cracks when the failure load was reached. Expect for specimens SFC1 and SFC2, all the other specimens behaved bending failure, and the failure cracks developed along the vertical direction within the constant moment region. Furthermore, both the two TRM strengthened specimens have short peeling cracks between polymer cement mortar layer and concrete substrate, with a length of only about 5 cm. Consequently, it can be concluded that the TRM strengthening method had a satisfactory bonding performance between the strengthened layer and the original structure.

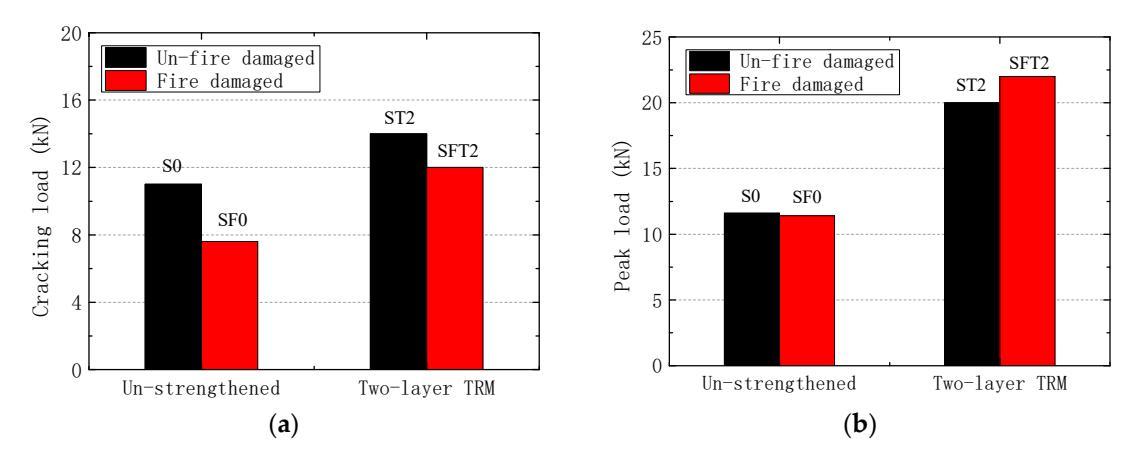
**Figure 15.** The comparison between undamaged and fire-damaged specimens. (**a**) Cracking load; (**b**) Peak load.

From Figure 15a, the cracking load of the fire-damaged specimens is generally less than that of the specimens without fire exposure, regardless of strengthened or unstrengthened slabs. The cracking resistance of the specimens mainly depended on the prestress level of the steel rebars and the tensile strength of the concrete. During the fire test, the bottom concrete was subjected to a high temperature of more than 320 °C, so the tensile strength was weakened even after cooled down to normal temperature. In addition, the prestressing loss was also caused by the fire-damage of the concrete around the prestressed rebars, which decreased the bond strength between concrete and steel rebars. However, after retrofitted and strengthened with TRM, no significant effect of the fire damage was found on the flexural bearing capacity of the prestressed hollow slabs. The failure load of fire-damaged specimen SFT2 and undamaged specimen ST2 was 22 kN and 20 kN (Figure 15b), respectively. The similar peak loads were contributed to the little strength change of concrete and prestressed steel rebars, and the initial crack on the top surface of ST2. During the fire test, the concrete of the upper section always kept a lower temperature with a maximum temperature of 130 °C at the top surface, so the compressive strength of the concrete was not damaged. Moreover, the material test showed that the tensile ultimate strength of the steel rebar was still 660 MPa, due to the thermal protection by the concrete cover and plaster layer. It also should be mentioned that the little lower peak load of ST2 might result from the initial crack on the top surface.

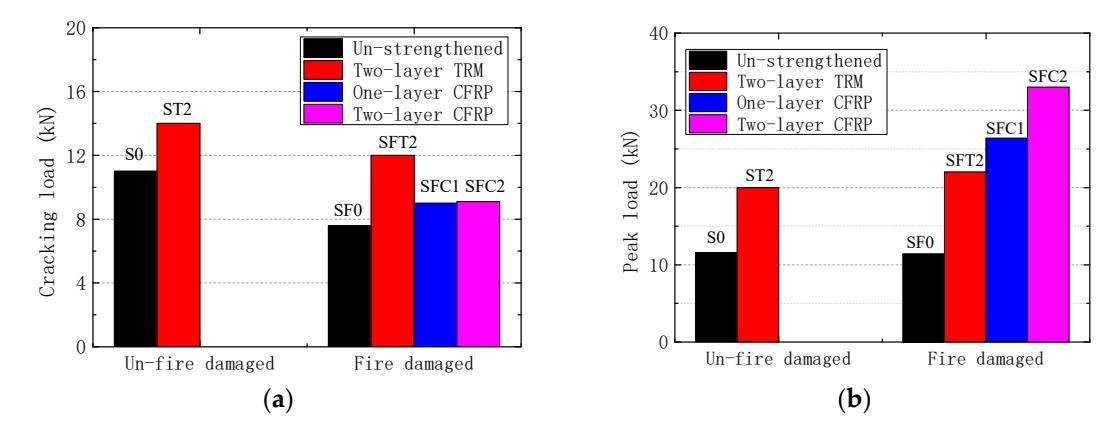
**Figure 16.** The comparison of specimens strengthened with different methods. (**a**) Cracking load; (**b**) Peak load.

As can be seen from Figure 16, the cracking load of SFC1 and SFC2 were not different, but the peak load of SFC2 increased up to 57% than that of SFC1. On the other hand, the ultimate deflection of SFC2 was lower by 22.3% than the specimen SF1 but higher by 90.9% than the unstrengthened fire-damaged specimen SF0. The results in Figure 16 and Table 5 show that with the increase of CFRP layers, the ultimate bearing capacity of the strengthened specimens increased, and the ductility reduced with the failure deflection from 135 mm to 105 mm.

In comparison, the CFRP strengthened specimens SFC1 and SFC2 had the higher peak loads, respectively by 20% and 50% than TRM strengthened fire-damaged slab SFT2. Two main reasons resulting in the variation of load capacity are the differences in the reinforcement amount and stress transfer mechanism. According to the different reinforcement amounts, the ultimate tensile load of reinforcements is about 80.7 kN for SFT2, 112.9 kN for SFC1, and 225.7 kN for SFC2. Furthermore, the reinforcements in CFRP method have a better continuous strain compatibility with the concrete slab, which could make the interface stress transfer more uniform and effective. In the case of TRM method, the cracking of the mortar matrix results in the tension stiffening effect inside the TRM layer, and the basalt fabric near the cracks will be premature tensile rupture due to the non-uniform stress. On the other hand, the cracking load of specimen SFT2 is higher than that of CFRP strengthened slabs, which indicated that TRM reinforcement can effectively improve the stiffness and capacity of the fire-damaged slabs in the elastic stage. The test results also show that the crack resistance and bearing capacity were improved greatly for TRM strengthened hollow slabs ST2 and SFT2, compared to that of unstrengthened slabs S0 and SF0.

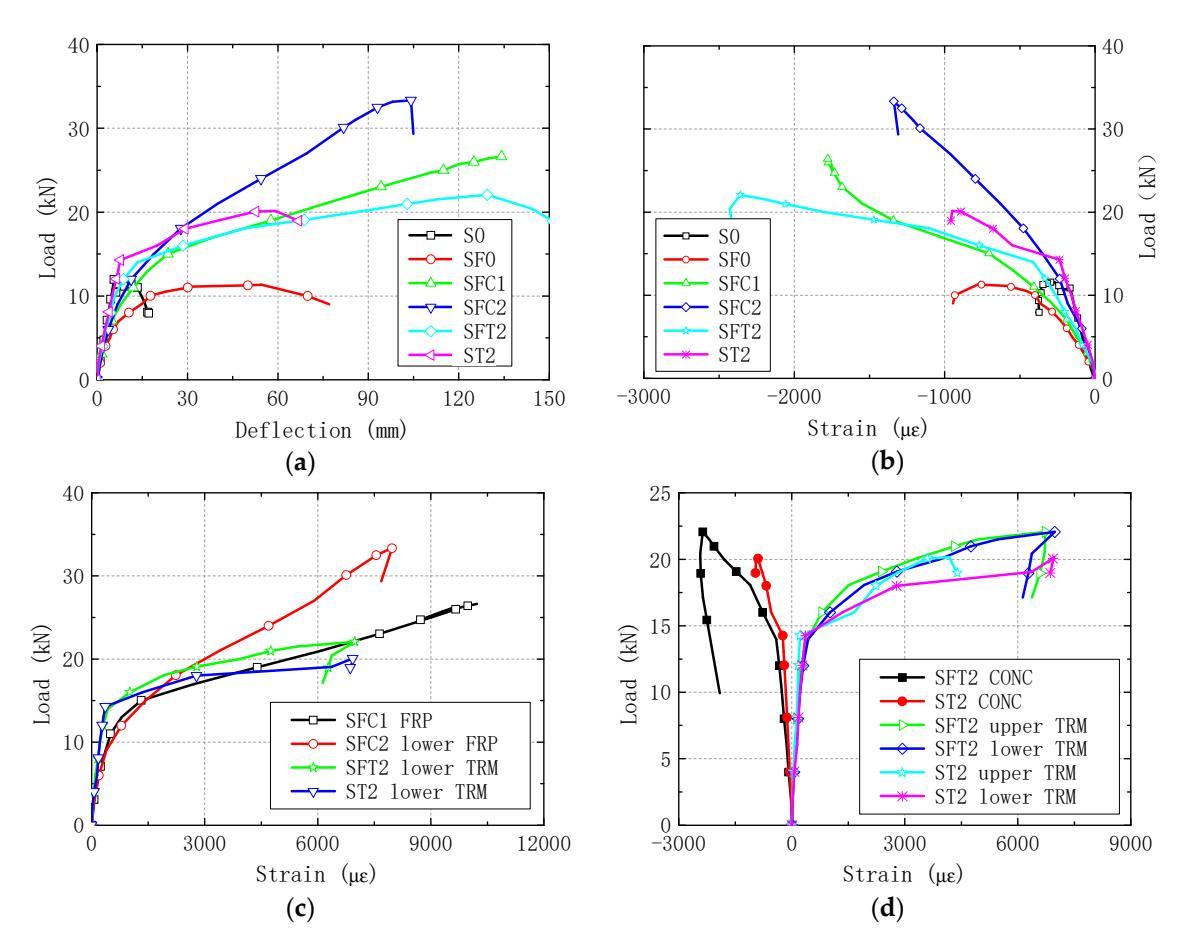
Figure 17. Load-deformation curves. (a) Load-deflection; (b) Load-concrete strain; (c) Load-CFRP/TRM strain; (d) Load-strain in SFT2 and ST2.

Figure 17a depicts the load-deflection curves for all the six specimens. Although having the same peak load, the stiffness of specimen SF0 after cracking is always less than that of the non-fire specimen S0. It is indicated that the elastic modulus of concrete decreased under the effect of high temperature. After strengthened with CFRP or TRM, the stiffness, bearing capacity, and ductility of the fire-damaged specimens (SFC1, SFC1, and SFT2) were all improved obviously. Compared to specimens SFC1 and SFC2, the specimen SFT2 exhibited a higher cracking load with a smaller cracking deflection, and a lower peak load with a larger failure deflection. The reason is that the increase of section height by TRM method enhanced the flexural stiffness of hollow slabs, which is larger than the CFRP strengthened slabs before concrete cracks occurred. In the following stage of bending test, the integral rigidity of TRM strengthened slab reduced greatly with the growth of cracks.

It can be seen from Figure 17b that in the elastic stage, the slope of strain growth for non-fire exposed specimens were larger than the fire-damaged specimens, which reflects again the influence of fire. However, after the strengthening treatment, the concrete compressive strain of the hollow slabs can continue to grow in a higher load lever until shear or bending failure. These changes have demonstrated that the CFRP and TRM flexural reinforcement can effectively improve the strength utilization ratio of concrete in the compression zone.

For specimen SFC1 and SFC2, the CFRP strain growth is almost the same in the early of the bending test (Figure 17c). After the load exceeded 15 kN, the strain growth of SFC2 postponed behind that of specimen SFC1, which indicates that the bearing capacity of the specimens increases with the increase of CFRP layers. Compared SFC2 with SFT2 in Figure 17c, the basalt fabric strain of SFT2 has an obvious delayed increase in the early stage of loading, while increased much rapid than the strain

As can be seen in Figure 17d, the concrete strain of ST2 postponed behind that of SFT2 obviously, which may attribute to the stiffness change of initial concrete slab after fire exposure. The strain curves of the upper and lower TRM layers are synchronous, which indicated that the basalt fabric mesh at the upper and lower layers could work well together.
