Article

Durability of Metal-Composite Friction Spot Joints under Environmental Conditions

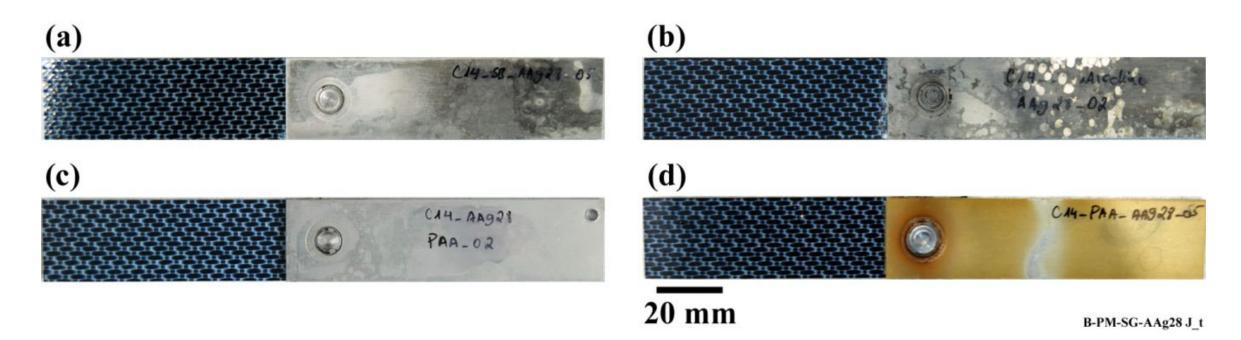
Figure 1. Top view of the SLS FSp joints after 28 days of aging; (a) SB, (b) CC, (c) PAA, and (d) PAA-P.

First of all, the joints were visually inspected as soon as they were taken out of the aging chamber. Figure 1 shows the top view of the SLS FSp joints after 28 days of the aging experiment, and Figure 2 the same joints before aging. Noticeable changes could be seen in the SB and CC pre-treated specimens on the aluminum part. Dark regions were identified both on the top and bottom surfaces of the SB and CC pre-treated aluminum. Aluminum oxide, formed on the surface of the SB and CC pre-treated specimens, interacts with the humidity in the aging chamber, which leads to the formation of a weak aluminum hydroxide layer. It is well known that an aluminum surface undergoes hydration in the presence of a high level of humidity or when immersed in water [33]. Despite the PAA and PAA-P samples having slight water stains on the aluminum, no notable changes could be identified. PAA pre-treatment is known to produce an oxide layer that is more corrosion resistant than CC [34]. This could be the reason that the PAA pre-treated specimen did not exhibit any noticeable surface changes after 28 days of aging. Moreover, phosphate ions in the AlPO₄ monolayer that is formed on the aluminum surface after PAA pre-treatment reduce the hydration rate of the aluminum, as reported in [20,35]. On the PAA-P specimen, the primer is a thick, corrosion resistant layer [36–38], which inhibits the interaction of the underlying aluminum oxide with humidity. That is why no visual changes could be observed on the PAA-P sample. Finally, the composite parts did not show any visual changes after 28 days of aging. This was expected, because PPS is a highly moisture-resistant polymer [29].

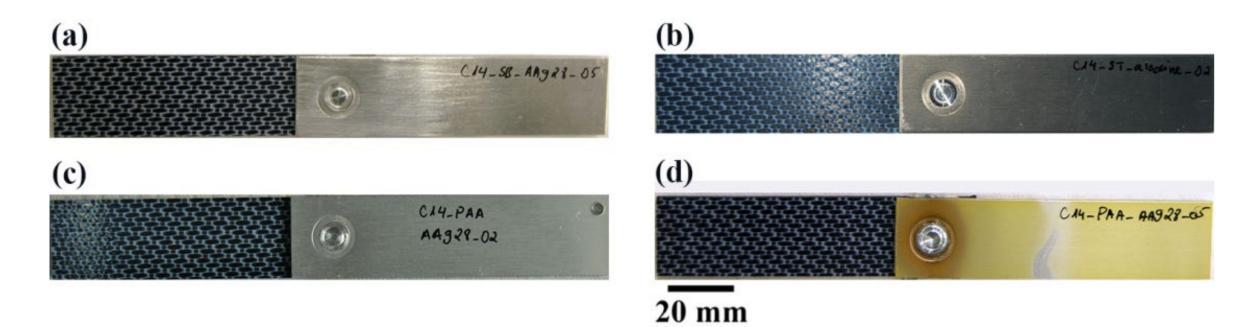
Figure 2. Top view of the SLS FSp joints prior to aging; (a) SB, (b) CC, (c) PAA, and (d) PAA-P.

In contrast to the SB and CC specimens, the PAA and PAA-P samples did not show any noticeable changes on the aluminum surface after aging, as visually compared in Figures 1 and 2. The SEM images of the aluminum surface, illustrated in Figure 5, appear very similar to the ones before aging (Figure 6). The PAA specimen (Figure 5a) showed an open porous structure with some coalesced pores, similar to its surface before aging (Figure 6a). The compact structure of the PAA-P specimen was also retained with the whisker-like particles of chromium and strontium oxides, as shown in Figure 5b.

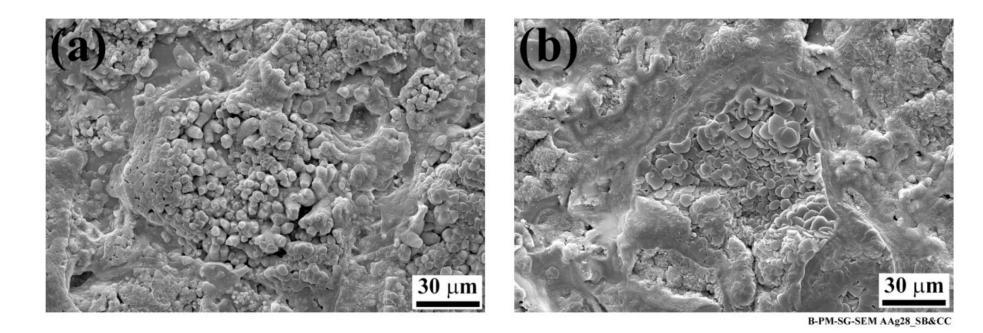
Figure 3. High-magnification SEM images of the aluminum affected areas after 28 days of aging; (**a**) SB and (**b**) CC specimens showing nodular, flake-like structures.

To further analyze the aluminum surfaces, high-magnification SEM images were taken from the affected areas on the specimens. Both SB and CC specimens showed compact areas consisting of the very fine nodular and flake-like structures that are related to the weak aluminum hydroxide formation (Figure 3).

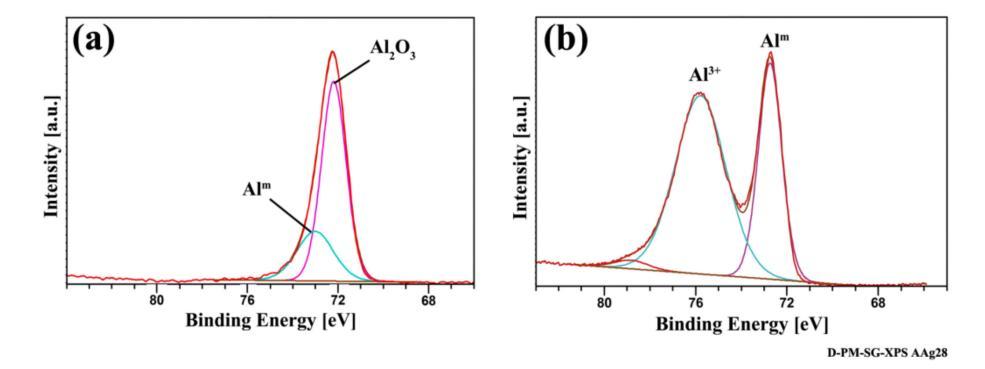
Figure 4. High-resolution Al 2p XPS region spectra of the SB specimen (a) before aging and (b) after aging.

Furthermore, an XPS analysis could further confirm the conversion of the oxide layer into aluminum hydroxide. Figure 4 shows a high-resolution Al 2p region of the SB specimen before and after accelerated aging. The aluminum before aging (Figure 4a) revealed two peaks at approximately 72 eV and 72.8 eV that are related to aluminum oxide [39–41] and metallic aluminum [39,42,43] respectively. After aging, the peak at 72.8 eV (related to the metallic aluminum) was still detectable, but the peak at 72 eV disappeared, and a new peak at approximately 76 eV was identified. The appearance of this peak might be due to the aluminum hydroxide formation [41]. It was reported that aluminum oxyhydroxide (AlOOH) is the most common form of aluminum hydroxide generated on the aluminum surface in the presence of humidity and at a temperature range of 25–100 °C [44–47]. However, it has also been suggested that, after further aging, the hydration of the AlOOH leads to the formation of Al(OH)₃ [21]. Regardless of the type of aluminum hydroxide present, the hydration of aluminum oxide was confirmed through an XPS analysis.

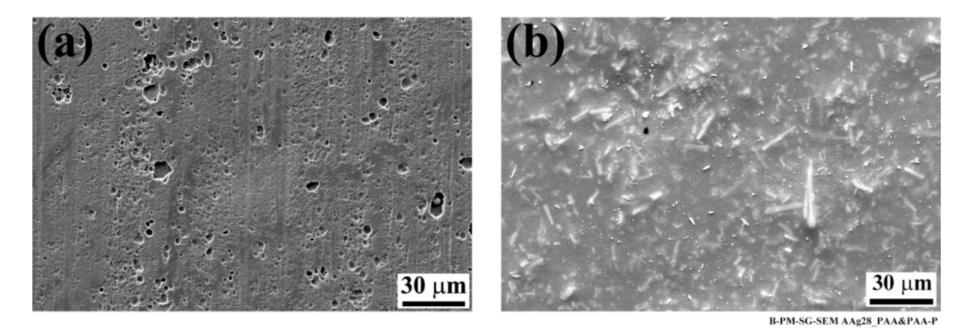
Figure 5. SEM images of the aluminum side of the joint after 28 days of aging; (**a**) PAA and (**b**) PAA-P specimens.

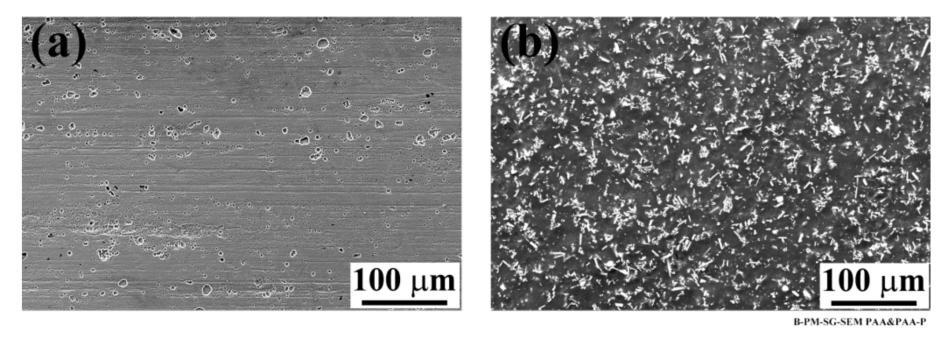
Figure 6. SEM images of the pre-treated aluminum surface (**a**) PAA and (**b**) PAA-P specimens. Reproduced with permission from [30].

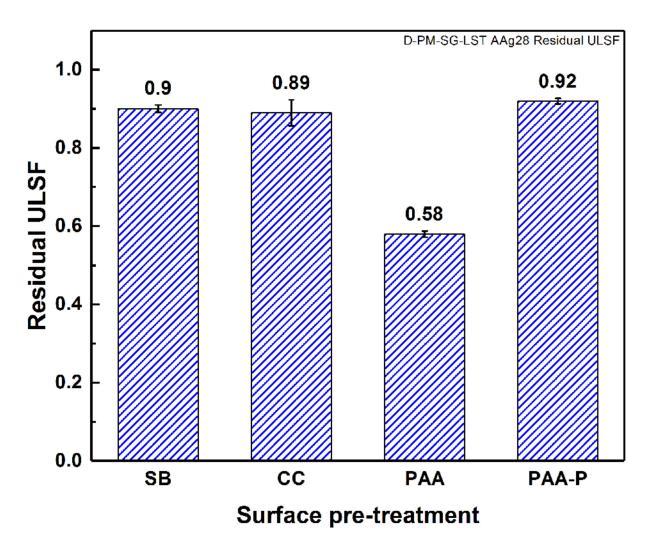
Figure 7. Residual strength of the SLS FSp joints after 28 days of accelerated aging.

The joints were mechanically tested to evaluate their lap shear strength shortly after the removal of the joints from the aging chamber (within 1 h). The obtained lap shear strengths of the SLS joints were divided by their initial strength before aging, and the results were reported as the residual strength of the joints, as illustrated in Figure 7. The SB, CC, and PAA-P specimens had only a small reduction in strength, but the PAA specimen was approximately 42% reduced, compared to their initial strength. Such results are in agreement with those reported in the literature for adhesively bonded aluminum joints, for example in [49].

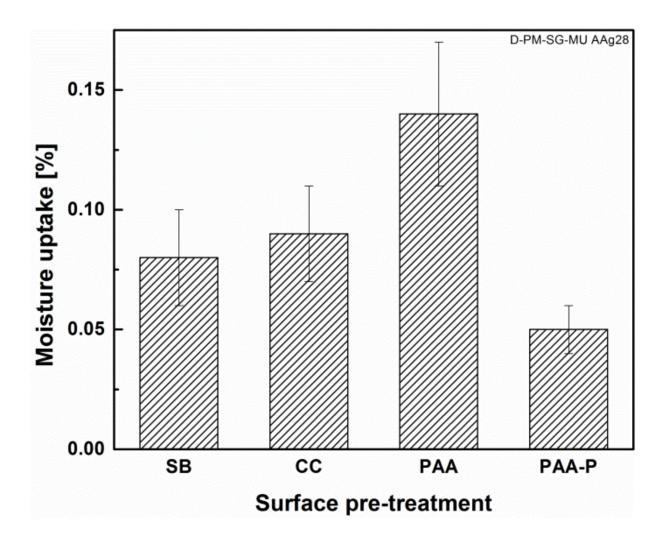
Figure 8. Moisture uptake of the FSp joints after 28 days of accelerated aging.

It is believed that both the morphology and chemical composition of the aluminum surface play important roles in the durability of FSp joints. The SB pre-treatment generated large pores and crevices on the surface of the aluminum that could be filled almost completely by the molten PPS throughout the bonding area. Since molten PPS wet and fill such crevices, moisture cannot penetrate easily or rapidly into the interface between the aluminum and PPS, which in turn reduces the degradation kinetic of the joints. Furthermore, the chemical bonding between the aluminum and PPS, in the cases of CC and PAA-P pre-treatments [30], reduces the moisture path into the joints. In all three cases, the moisture diffusion was not completely inhibited, but the diffusion kinetic was significantly reduced. This is the reason for the small reductions in strength, compared to the initial strength of the joints. By contrast, it seems that the moisture could penetrate more easily and much more rapidly with the PAA pre-treated joint, leading to aluminum-PPS interface degradation and hence a reduction in mechanical performance. Figure 8 demonstrates the amount of moisture uptake of the FSp joints after the aging time. One observes that the PAA pre-treated joints showed the highest moisture uptake, approximately twice that of the SB pre-treated samples. The moisture was absorbed primarily at the interface between the aluminum and composite, degrading the bonding between the parts and hence the mechanical performance of the FSp joints. The larger reduction of the lap shear strength of the PAA pre-treated joints can therefore be related to the higher moisture uptake and humidity penetration into the bonding area.

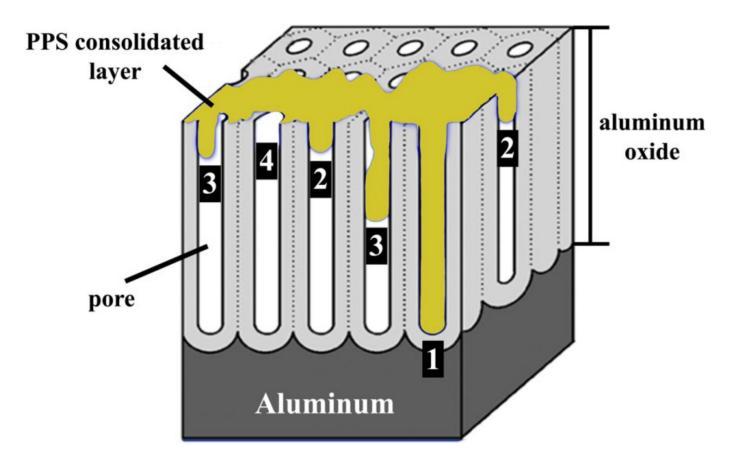
Figure 9. Schematic illustration of aluminum oxide after PAA pre-treatment, adapted from [51], and the proposed model of pore filling by the PPS. (1) Complete wetting and pore filling, (2) complete wetting, incomplete pore filling, (3) partial wetting and incomplete pore filling, and (4) no wetting and no pore filling.

In the PAA pre-treated specimen, the diffusion of moisture into the interface may be related to the morphology of the oxide layer formed and the extent of pore filling by the PPS. A model with four possible situations for aluminum oxide pore filling by PPS is proposed here, as illustrated in Figure 9. The four possible pore filling cases can be summarized as follows:

- (1) Complete wetting and pore filling
- (2) Complete wetting, incomplete pore filling
- (3) Partial wetting or pore filling
- (4) No wetting or pore filling.

Incomplete pore filling (Cases 1 and 2) could still result in adequate micro-mechanical interlocking and an acceptable initial strength. The initial strength of the PAA specimens was higher than for the SB specimens (Figure 10) because of the presence of a much larger amount of pores, which could be filled (partially or completely) by the molten polymer. However, such incomplete pore filling is detrimental to the durability of the joints. According to the proposed model, while the joint is in contact with a humid atmosphere, the diffusion of the humidity into the interface depends on the pore filling situation. In Case 1 and Case 2, where the wetting between pore walls and the PPS is complete, the humidity diffusion is expected to be sluggish. By contrast, in Case 3 and particularly in Case 4 the humidity can penetrate much faster into the pores and into the interface of the aluminum-PPS. This leads to the degradation of the interface and hence the mechanical strength of the joint. These results are in agreement with the theories reported in the literature. Kinloch et al. suggested that in adhesively bonded aluminum, interfacial micro-voids in PAA pre-treated aluminum allow for the penetration of the water (or humidity) into the interface between the aluminum and adhesive [35]. The penetration of water was reported to be detrimental to the durability of the adhesive joint. Moreover, Digby and Packham stated that, in adhesive bonding, obtaining durable joints depends on the penetration of the adhesive into the aluminum oxide pores [50]. Such a penetration was considered to be dependent on several factors, such as the pore dimensions, adhesive viscosity, and the viscosity characteristic of the adhesive at a working temperature. Incomplete pore filling was reported to be the main reason for the reduced durability of the joints for specific surface pre-treatments such as PAA [50]. Therefore, it is believed that complete wetting and pore filling, as well as strong chemical bonds, are important aspects in achieving durable FSp joints.

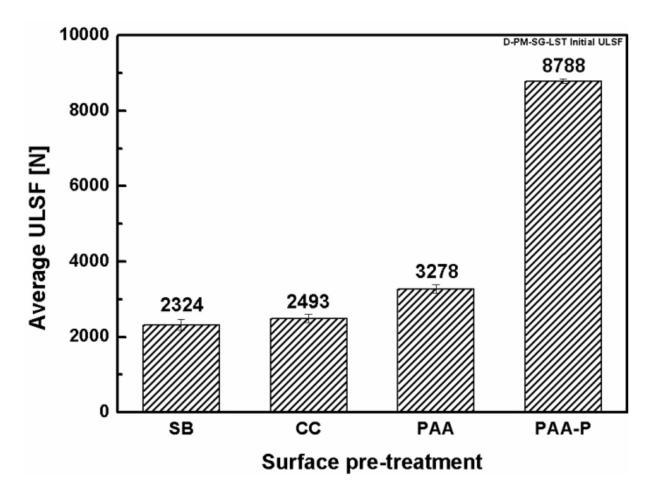
Figure 10. Initial strength of the SLS FSp joints before accelerated aging.

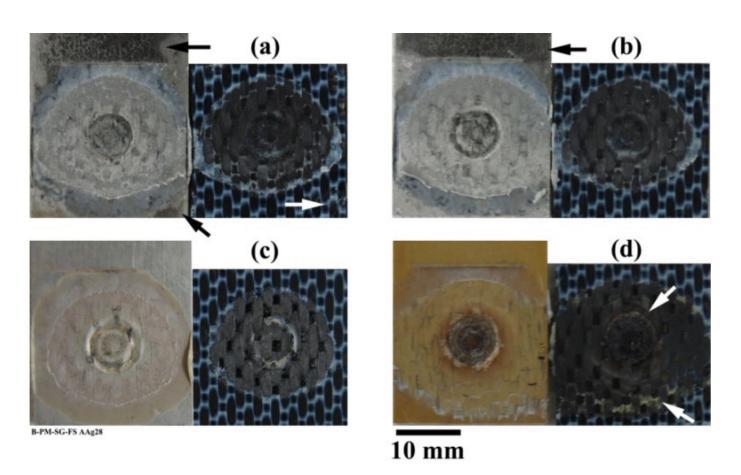
Figure 11. Fracture surface of the SLS joints after 28 days accelerated aging; (**a**) SB, (**b**) CC, (**c**) PAA, and (**d**) PAA-P. The black arrows in (**a**) and (**b**) indicate the aluminum hydroxide formation. The white arrow in (**a**) indicates small features outside the AZ. The white arrows in (**d**) indicate the primer remaining attached to the CF-PPS.

Figure 11 shows the fracture surface of the four pre-treated joints after 28 days of accelerated aging. The dark aluminum hydroxide layer can be observed on the SB and CC pre-treated specimens even very close to the consolidated molten PPS (known as the Adhesion Zone (AZ) [4,52]), as indicated by the black arrows in the figure. However, in none of the joints could any indication of aluminum hydroxide formation inside the bonding area be detected. In FSpJ, strong micro-mechanical interlocking and/or adhesion forces between the aluminum and consolidated molten PPS significantly reduce the moisture diffusion into the Plastically Deformed Zone (PDZ) [4,52], the area inside the consolidated molten PPS. Therefore, the rate of the interface deterioration is reduced, as was observed from the residual strength of the joints, shown in Figure 7. Although, the PAA specimen did not show any significant changes on the fracture surface (Figure 11c), humidity diffusion was expected to take place faster than with the other surface pre-treatments, as was also explained by the moisture uptake. The PAA-P specimen also showed very similar features to the specimen before aging (refer to [30]), such as the primer remaining attached to the composite, as indicated by the white arrows in Figure 11d.

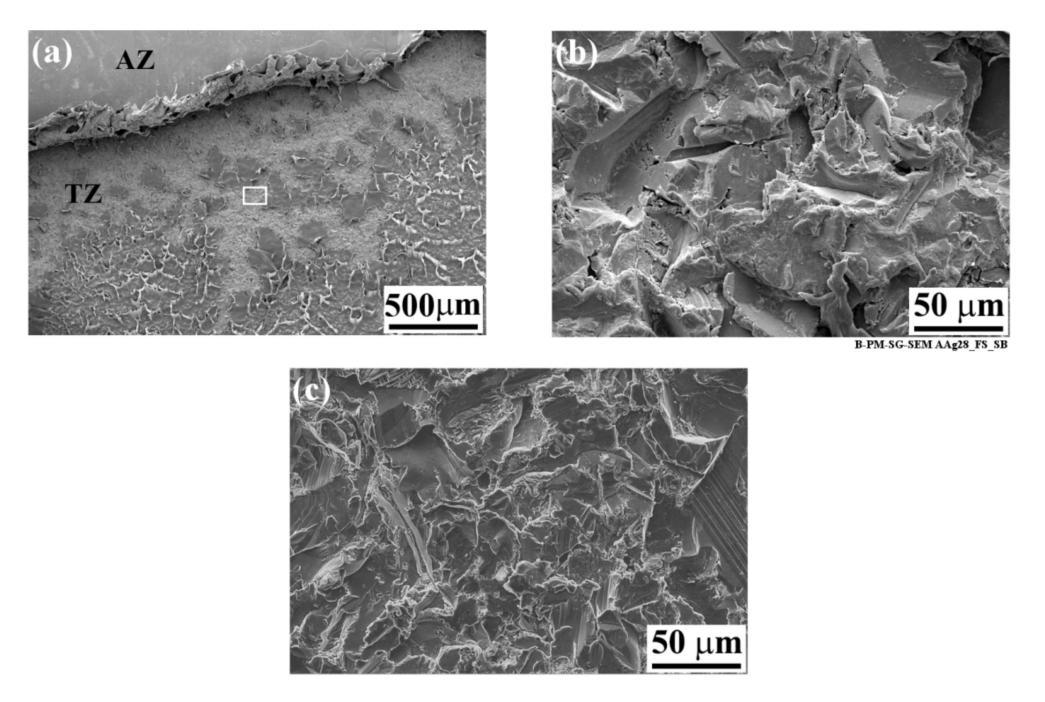
Figure 12. SEM image of the fracture surface of the SB specimen on the aluminum side after 28 days of accelerated aging. (**a**) Low-magnification image of the AZ-TZ area, (**b**) high-magnification image of the white rectangle indicated in (**a**), and (**c**) high-magnification image of the TZ area prior to aging.

Figure 12a shows the fracture surface of the SB specimen on the aluminum side of the joint. The image illustrates the AZ with a very smooth surface at the top of the image followed by a Transition Zone (TZ) [4,52]. The TZ shows typical features, where PPS remains attached to the aluminum as individual islands [52]. Figure 12b is a high-magnification image of the exposed SB aluminum indicated by the white rectangle in Figure 12a inside the TZ. No obvious alteration of the aluminum surface could be identified when compared to the SB surface before aging (see Figure 12c). This confirms that a large amount of moisture did not penetrate inside the bonding area, nor did it convert aluminum oxide into aluminum hydroxide in the bonding area. The same hypothesis seems to be valid for the rest of the surface pre-treatments, with the exception of PAA.

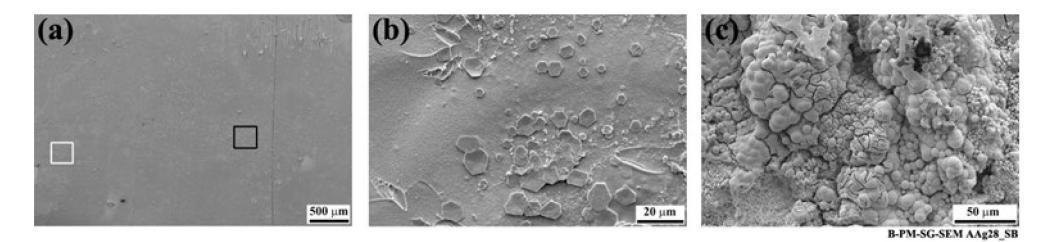
Figure 13. SEM image of the fracture surface of the SB specimen on the composite side after 28 days of accelerated aging. (a) Low-magnification image from the area indicated by the white arrow in Figure 11a; (b) high-magnification image from the black rectangle indicated in (a), and (c) high-magnification image from the white rectangle indicated in (a).

As indicated by the white arrow in Figure 11a, small features could also be observed on the composite side of the fracture surfaces outside the AZ. As an example, Figure 13 shows such features on the CF-PPS of the SB specimen. Although the low-magnification image (Figure 13a) did not reveal any specific features, the high-magnification images (Figure 13b,c) show flake-like features and agglomerates of small particles. As this area on the CF-PPS corresponds to the aluminum hydroxide on the aluminum side of the joints, it is believed that these particles are the hydroxide layer removed from the aluminum and remaining attached to the composite. Despite the fact that these particles were outside the bonding area, they remained attached to the composite. This may be attributed to the weak nature of the hydroxide layer, which was easily detached from the underlying aluminum oxide as a result of frictional forces between the aluminum and composite during the lap shear testing of the joint.

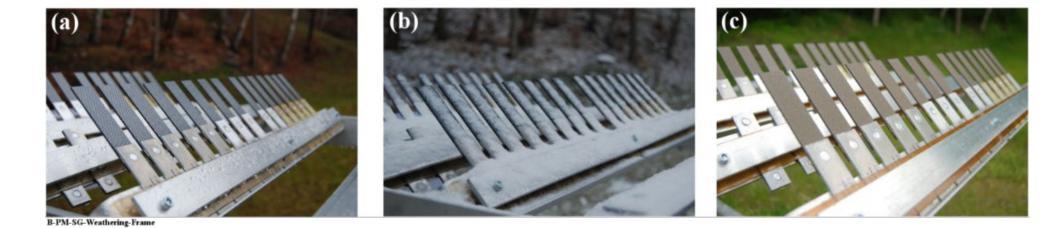
Figure 14. Outdoor natural weathering of the AA2024-T3/CF-PPS friction spot joints; specimens (**a**) during the first month, (**b**) during the third month, and (**c**) during the sixth month showing the discoloration of the composite.

In addition to the accelerated aging, the SLS specimens were placed outside in natural weathering conditions for one year, as can be seen in Figure 14. Note that in this case three aluminum surface pre-treatments were selected: SB, CC, and PAA-P. PAA pre-treated specimens were not included as a result of their lower performance during accelerated aging experiments. Different climate data were recorded in this time frame, as follows [53]: an average temperature between –12.9 °C and 33 °C; a relative humidity of 3% to 100%; an average precipitation (both rain and snow) of 16.3 mm to 112.2 mm per month; an average UV index between 1 and 6; and a wind speed of 0.4 km/h to 62.6 km/h.

The aluminum/composite FSp joints were influenced both by humidity and moisture absorption as well as UV irradiation. CF-PPS showed discoloration as a result of the UV irradiation, as demonstrated in Figure 14c. It was reported by Batista et al. that such discoloration of CF-PPS is due to photolysis and photo-oxidation, resulting in an increase in the glass transition temperature [16]. Furthermore, surface embrittlement of the composite was observed as a result of the extensive cross-linking of polymer chains [16].

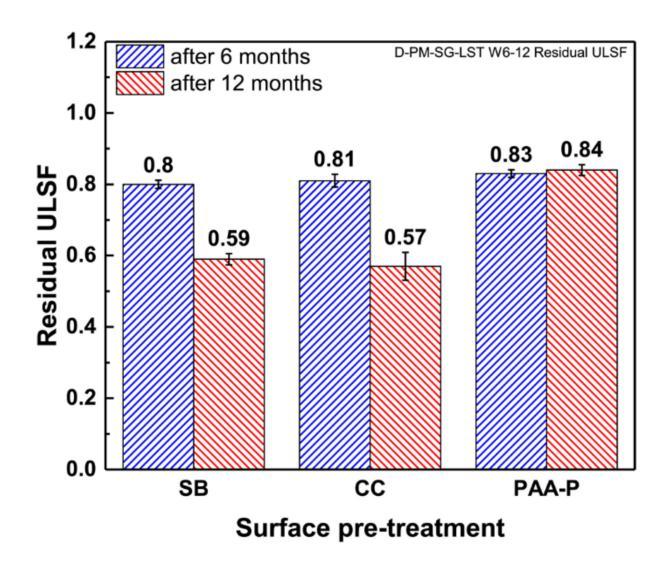
Figure 15. Residual strength (ULSF) of the SLS FSp joints after six and 12 months of outdoor weathering.

The specimens were mechanically tested in two time intervals: six and 12 months. The obtained lap shear strengths of the SLS joints were divided by their initial strength prior to weathering, and the results were reported as the residual strength of the joints, as illustrated in Figure 15. Both SB and CC specimens showed a similar trend. In the first six months a reduction of 20–30% in the lap shear strength was observed. The trend of reduction in strength was also observed in the next six months. However, after one year both sets of joints retained more than 50% of their initial lap shear strength. These results are similar to those reported for the induction welding of the metal-composite joints after weathering conditions [24].

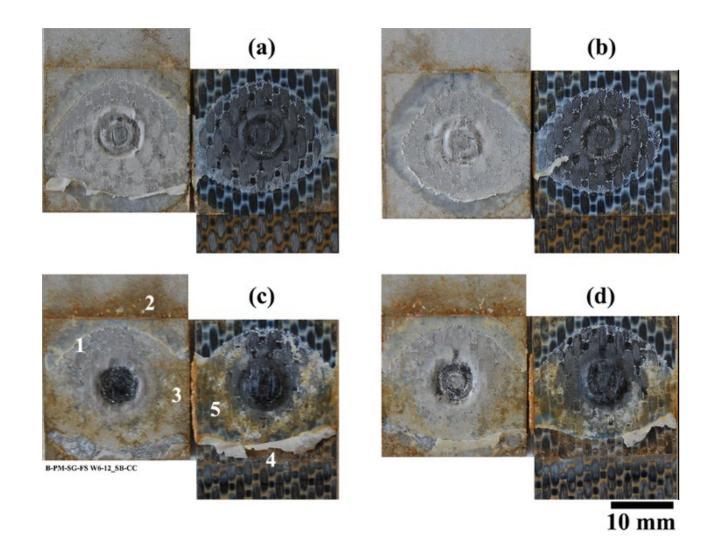
Figure 16. Fracture surface of the pre-treated joints after outdoor weathering. (**a**) SB and (**b**) CC after six months, (**c**) SB and (**d**) CC after 12 months.

It can be argued that the moisture and humidity could penetrate slightly into the overlap area, deteriorating the bonding between the aluminum and composite, especially in the area of the consolidated molten PPS (known as AZ). Because AZ is the weakest part of the bonding area in a FSp joint [4,6,52], the penetration of the moisture inside this layer should be easier. As the fracture surface of the joints shows in Figure 16a,b, no visual changes were observed within the bonding area of SB and CC specimens after six months. Despite the lack of apparent changes on the fracture surfaces, it is valid to argue that the penetration of the moisture into the bonding area may happen slowly, which could weaken the bonds on the microscale. Moreover, one should consider the fact that the precipitation in areas near the ocean contains salty elements. Such elements have indeed a different (perhaps harsher) influence on the aluminum-polymer bonds rather than a pure humid atmosphere (as in the accelerated aging experiments). In contrast to the first six months, the fracture surfaces of the SB and CC joints after

12 months demonstrated the penetration of the moisture and humidity into the bonding area, as shown in Figure 16c,d. That is the reason for the further decrease in the residual strength of the joints.

The clear distinction between the fracture surface of the specimens after six and 12 months (both for SB and CC) is that after 12 months a large amount of the consolidated molten PPS remained attached to the composite. This is in contrast with the fracture surface of the joints prior to the weathering and those after six months of outdoor weathering, in which the consolidated layer was attached almost fully to the aluminum.

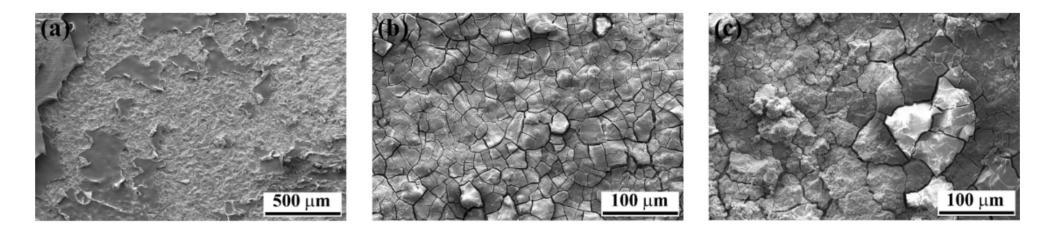
Figure 17. SEM images of the fracture surface of the SB specimen on the aluminum side after 12 months of outdoor weathering. (a) TZ from the area (1) in Figure 16c; (b) high-magnification image from the area (2) in Figure 16c, and (c) high-magnification image from the area (3) in Figure 16c.

The SEM analysis of the fracture surface on the aluminum side reveals interesting features, as shown in Figure 17. The TZ from the unaffected region (Figure 17a) shows similar features (PPS remained attached to the aluminum as individual islands and a sandblasted aluminum surface) to the joints before weathering. However, the aluminum surface from the affected regions (Figure 17b,c) demonstrates a very cracked surface. The phenomenon is similar to the intergranular corrosion of the aluminum 2xxx alloys [54]. Since the precipitation (particularly in areas near the ocean, where this work was carried out) may contain small amounts of sodium and chloride ions [55], corrosion may have slightly occurred in these specimens.

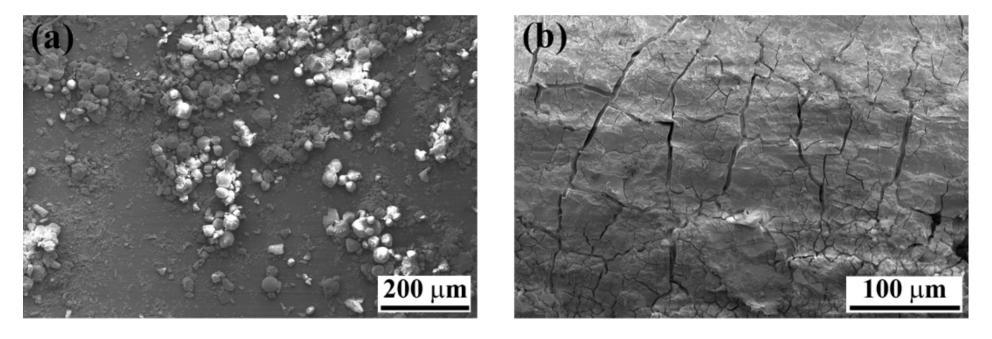
Figure 18. SEM images of the fracture surface of the SB specimen on the composite side after 12 months of outdoor weathering. (a) high-magnification image from the area (4) in Figure 16c, and (b) high-magnification image from the area (5) in Figure 16c.

Furthermore, the SEM images from the composite side (Figure 18) show similar features as for the aluminum surface. Spherical features were observed on the composite outside the bonding area (Figure 18a), whereas a cracked surface was detected inside the bonding area (Figure 18b).

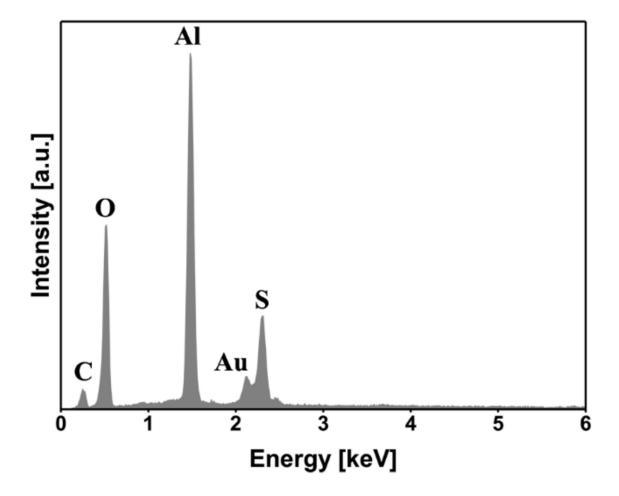
Figure 19. EDS area analysis of the fracture surface shown in Figure 18b.

The EDS analysis of the cracked surface in Figure 18b on the composite side is illustrated in Figure 19. In addition to sulfur and carbon (from the PPS), aluminum and oxygen peaks were also detected. This confirms that the cracked region is the aluminum, which remained attached to the composite. It is believed that the aluminum was slightly corroded starting outside the bonding area and penetrated beneath the PPS consolidated molten layer. One may identify the corroded/aged aluminum outside the bonding area as a weak point. During the mechanical testing, cracks may initiate from this weak corroded layer and propagate inside the aluminum in the bonding area. This is the reason why a part of the aluminum remained attached to the consolidated molten PPS on the composite side. Therefore, the lower mechanical strength of the SB and CC joints after 12 months of natural aging is believed to be the result of the weakening of the aluminum alloy rather than the bonding area.

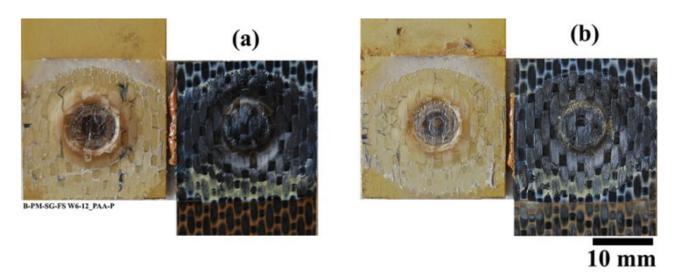
Figure 20. Fracture surface of the PAA-P pre-treated joints after (**a**) six months and (**b**) 12 months of outdoor weathering.

In contrast to the SB and CC specimens, the PAA-P pre-treated joints showed a reduction in the lap shear strength in the first six months, while retaining their residual strength on the same level afterwards. PAA-P pre-treatment led to strong chemical carbon-carbon bonds between CF-PPS and aluminum [6,30]. It seems that moisture does not have a great influence on such chemical bonds, and the joint retained more than 80% of its initial strength. Moreover, the fracture surface of the PAA-P joints did not reveal any apparent changes as a result of the moisture penetration in the bonding area, as demonstrated in Figure 20.

It is worth noting that, although CF-PPS showed discoloration due to the UV irradiation, no changes in color could be observed inside the overlap area, as illustrated in Figures 16 and 20. Therefore, it is not expected that UV irradiation had any significant effect on the deterioration of the mechanical strength of the joints.
