# In Situ Scanning Electron Microscopy Observation of Crack Initiation and Propagation in Hydroxide Films Formed by Steam Coating on Aluminum-Alloy Sheets

## Hongmei Li<sup>1,\*</sup>, Naoki Takata<sup>1</sup>, Makoto Kobashi<sup>1</sup> and Ai Serizawa<sup>2</sup>

**Abstract:** Hydroxide film was formed on 6061 Al-alloy (Al-1.00Mg-0.62Si(wt.%)) sheets by steam coating with the temperature of 220 °C for 24 h. During bending test of the coated specimens, the crack initiation and propagation processes in the hydroxide film were investigated using in situ SEM observations. The hydroxide film formed exhibited a dual-layer structure composed of an inner amorphous layer and an outer polycrystalline  $\gamma$ -AlO(OH)-phase layer. On the compressively strained surface, lateral cracks are preferentially initiated inside the inner amorphous layer, and propagate either inside this layer or on its interface with the outer  $\gamma$ -AlO(OH) layer. Digital image correlation analyses of the in situ observed SEM images suggested that the concentrated tensile strain along the surface normal localized at some parts of the amorphous layer could contribute to the crack initiation. On the tensile-s

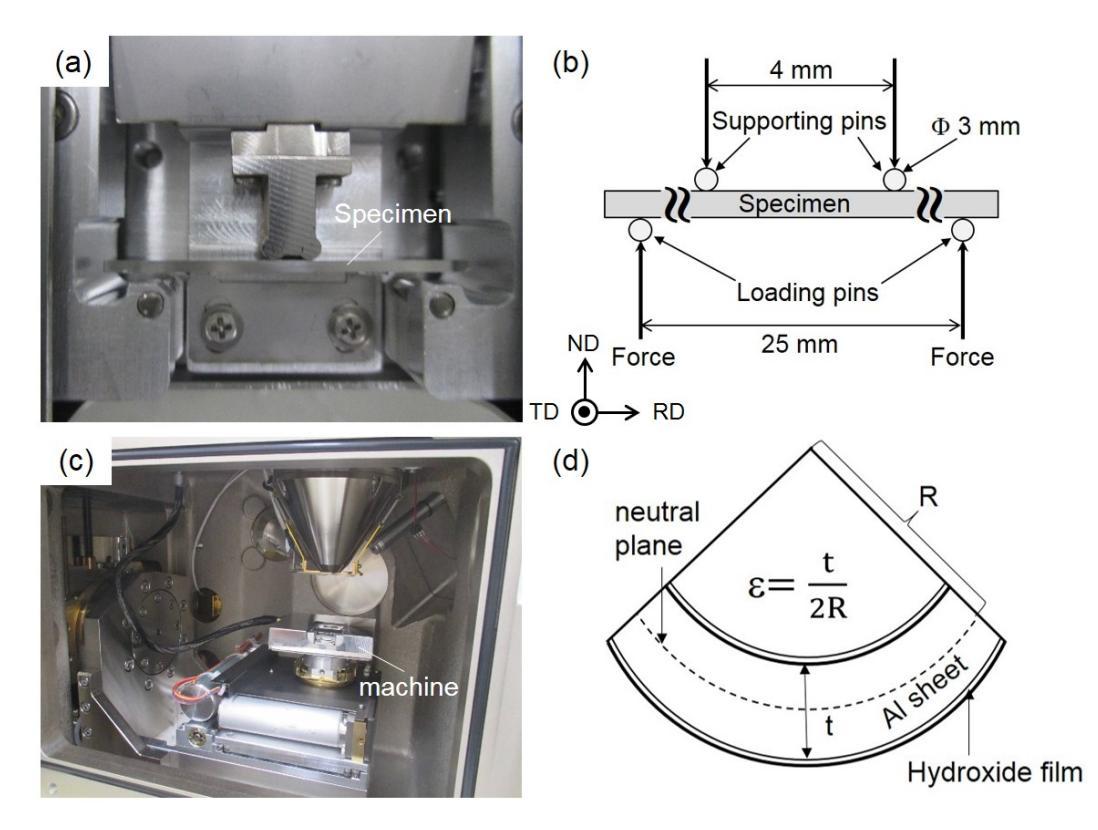
**Figure 1.** (a) Photograph of the specimen set in the miniature-sized bending test machine; (b) Schematic geometry used for the 4-points bending test; (c) The miniature-sized bending test machine placed in the SEM vacuum chamber for in situ observation; (d) Schematic of the bent specimen's geometry. TD: transverse direction, RD: rolling direction, ND: normal direction, strain:  $\varepsilon$ , t: specimen thickness, R: radius of curvature.

Load-displacement curves of bent specimens were obtained by 4-points bending tests using a newly designed miniature-sized bending test machine (Figure 1a) at room temperature and a constant displacement rate of  $5.8 \mu m/s$ .

The geometry in the 4-points bending test is schematically presented in Figure 1b. The bending test machine loaded with a used specimen was placed inside the vacuum chamber of the SEM instrument (JEOL JSM-6610) for in situ observation of the ion-polished surfaces, as presented in Figure 1c. The strain ( $\epsilon$ ) applied to the surface of the bent specimen was calculated by the following equation:

where *t* is the specimen thickness and *R* is the radius of curvature, as schematically shown in Figure 1d. *R* was determined from the low-magnification in situ SEM image during the bending test in the SEM chamber. The local strain distribution around the hydroxide/Al interface in the bent specimens was quantified by digital image correlation (DIC) analysis [15,16] using the in situ observed SEM images at different states of deformation. In the present study, DIC analyses were performed using high-magnification SEM images at a subset size of approximately  $81 \times 81$  pixels.

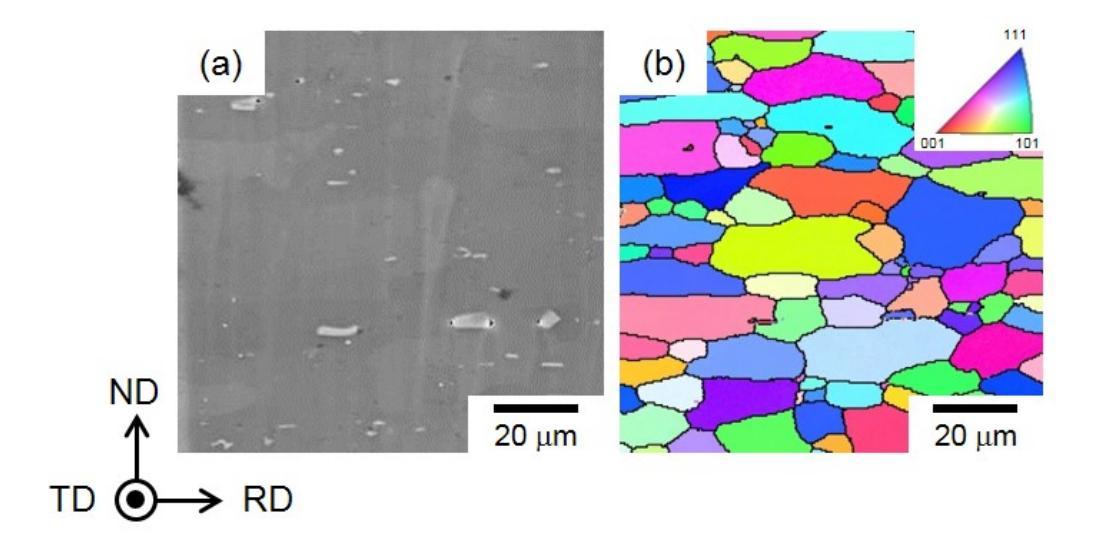
**Figure 2.** (a) Secondary electron image (SEI) and (b) corresponding orientation color maps (obtained by electron backscattered diffraction (EBSD) analysis) showing the microstructure of the polished cross section in steam-coated 6061 alloy.

Figure 2 presents secondary electron image (SEI) of the  $\alpha$ -Al (face-centered cubic (fcc)) matrix in the steam-coated specimen and corresponding orientation color map (measured by EBSD analyses). In the map, the color code key for the transverse direction (TD) orientation of the  $\alpha$ -Al matrix is represented in the unit triangle.

The white and black particles were distributed in the  $\alpha$ -Al matrix (Figure 2a), and they correspond to the Mg<sub>2</sub>Si phase with dark contrast [17] and the  $\beta$ -AlFeSi ( $\tau_6$ -Al<sub>9</sub>Fe<sub>2</sub>Si<sub>2</sub>) phase with bright contrast [18] formed in the  $\alpha$ -Al matrix [12]. The orientation map indicates that the  $\alpha$ -Al matrix exhibits relatively equiaxed grains with a mean size ranging from approximately 5 to 20 µm (Figure 2b).

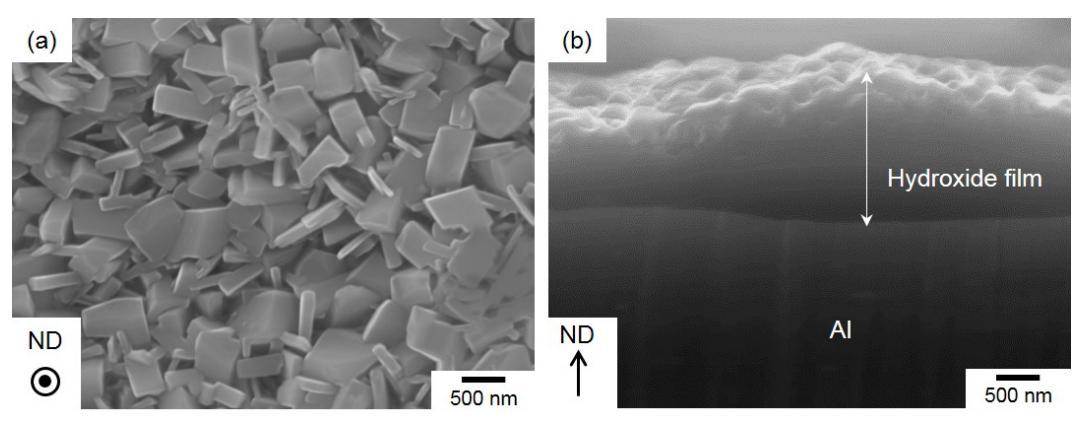
**Figure 3.** High-magnification SEIs showing the (**a**) top view and (**b**) cross-sectional view of the hydroxide films on the steam-coated Al-alloy sheets.

Figure 3 presents the top and cross-sectional views of the hydroxide film in the steam-coated specimen.

The film consisted of numerous polyhedral particles approximately 300 nm in size (Figure 3a), which corresponds well to previous reports on the surface morphologies of hydroxide films [19–21]. Cross-sectional observation revealed that the thickness of hydroxide film was approximately 2  $\mu$ m, noting that the top surface shows an irregular shape and bottom had a flat interface on the Al-alloy substrate (Figure 3b).

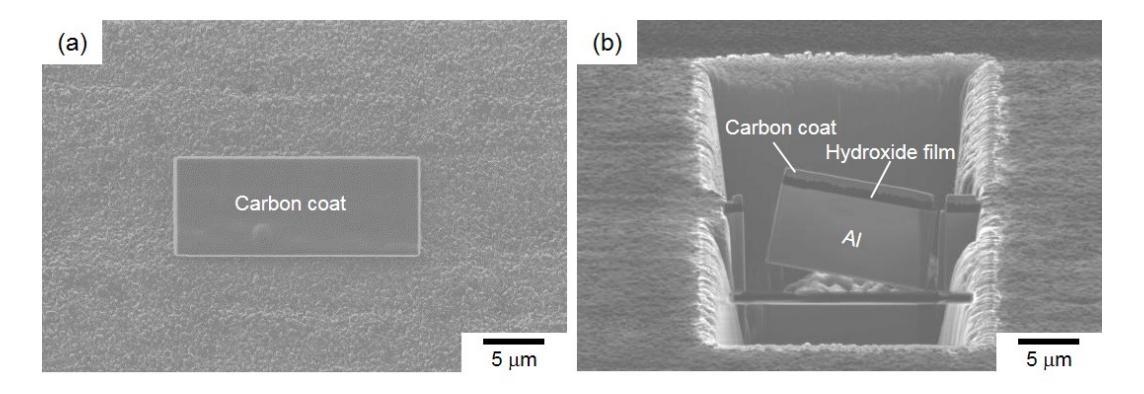
**Figure 4.** Preparation process of site-specific TEM samples of Al-alloy sheet (containing a hydroxide film) using a focused ion beam (FIB) pickup technique: (**a**) a deposited carbon layer on the surface of hydroxide film on the steam-coated Al-alloy sheet; (**b**) a cross-section sample milled out by FIB.

Figure 4 presents the preparation process of the TEM sample using a FIB pickup technique for observation of the hydroxide film. The sample surface was ion-milled by using FIB operated at an accelerating voltage of 30 kV and various probe current values ranging from 50 to 5000 pA. A deposited protection layer (carbon layer) was used to avoid Ga ion damage to the surface of hydroxide film (Figure 4a).

A thin cross-section sample with the thickness of less than 100 nm (containing with hydroxide film) was milled out from Al-alloy sheet by FIB (Figure 4b). This sample was picked up using a glass probe and then put on the Cu-grid mesh coated with an organic film. The obtained TEM bright-field images and selected-area electron diffraction (SAED) patterns of local hydroxide films are presented in Figure 5.

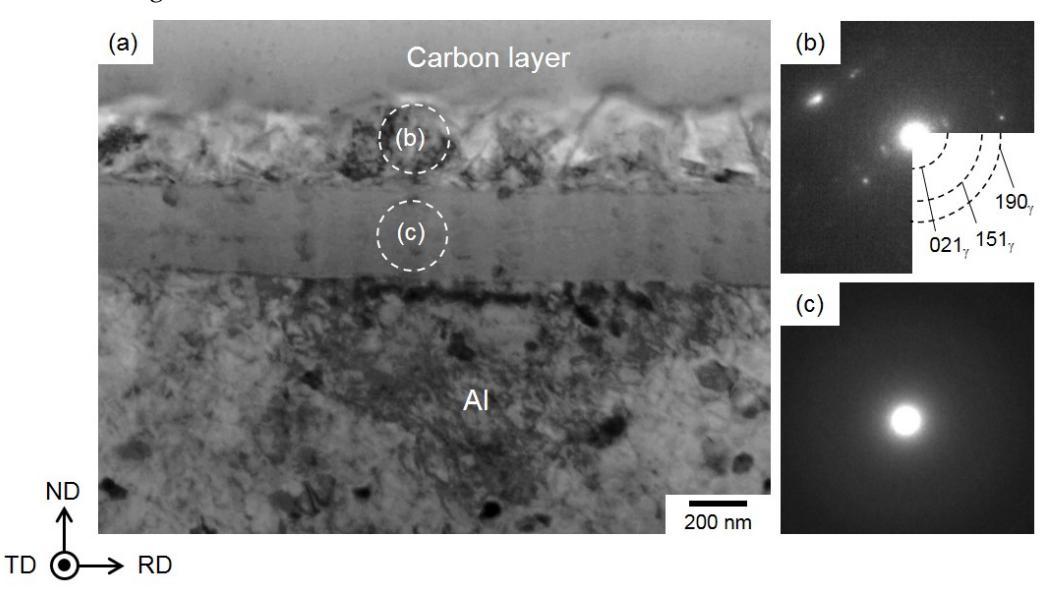
**Figure 5.** (a) TEM bright-field image and (b, c) selected-area electron diffraction (SAED) patterns for (b) the top  $\gamma$ -AlO(OH) layer and (c) the bottom continuous amorphous layer of hydroxide film that was formed on the steam-coated Al-alloy sheet.

The hydroxide film shows a dual-layer structure with the two layers having almost the same thickness (Figure 5a). The  $\gamma$ -AlO(OH) phase in the upper layer was determined by the SAED pattern (Figure 5b). The captured diffraction spots obviously indicate a polycrystalline  $\gamma$ -AlO(OH) phase composed of a number of fine  $\gamma$  crystals with a mean size below 300 nm (Figure 5a). Note that no clear diffraction spots were detected in the SAED pattern of the lower layer within the hydroxide film (Figure 5c), indicating that this layer adjacent to the Al-alloy substrate was amorphous. The EDS composition analyses revealed that the Al and O elements were enriched inside the hydroxide film (Figure 6a–c), and there was no clear difference in their contents between the upper and lower layers. Hence, Mg- and Si-alloy elements were not enriched in the hydroxide film, indicating that the composition of the second phases (Mg<sub>2</sub>Si phase and  $\beta$ -AlFeSi phase) did not obviously affect the initial formation of hydroxide film.

In the present study, we observed the bending-induced fracture process of hydroxide film in steam-coated Al-alloy sheets at the elevated temperature of 220 °C. With a dual-layered structure, the film comprised an amorphous layer on inside and an  $\gamma$ -AlO(OH)-phase layer on the outside (Figure 5). Bending tests revealed that the fracture morphology of the hydroxide film depends on the applied strain state (Figure 9). In situ SEM observation (Figures 10 and 11) demonstrated that the cracks are preferentially initiated inside the lower amorphous layer during sample bending. A number of vertical cracks occurred on the hydroxide film on the tensile-strained surface, but the hydroxide film was not removed from the Al sheet (Figure 11). On the compressively strained surface, lateral cracks propagate into the lower amorphous layer or along its interface with the upper  $\gamma$ -AlO(OH) layer (Figure 10). The propagation of lateral cracks could be responsible for the local delamination observed on these film surfaces (Figure 9a). The preferential cracking might be due to the peculiar dual-layered structure of the hydroxide film. In compressive deformation (Figure 10), concentrated stress/strain might be localized near the interface between the amorphous layer and Al-alloy substrate, resulting in crack initiation in the amorphous layer.

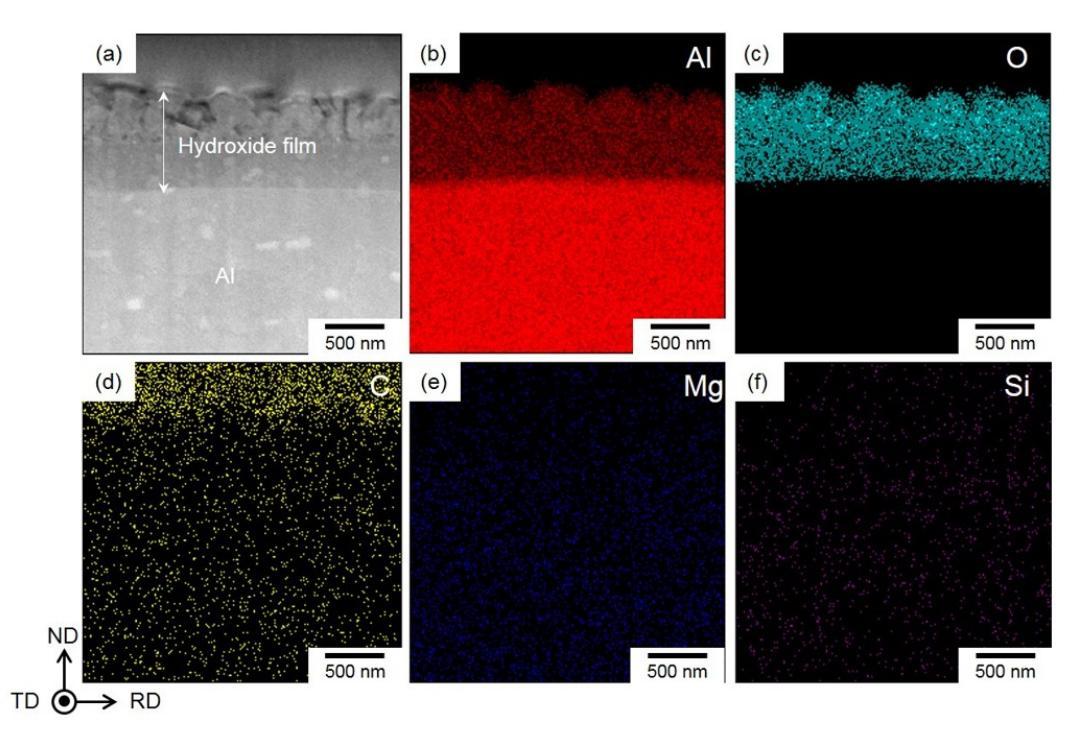
**Figure 6.** (a) Scanning TEM (STEM)–high-angle annular dark field (HAADF) image showing the hydroxide film formed on the steam-coated Al-alloy sheet and the corresponding (b) Al; (c) O; (d) C; (e) Mg and (f) Si element maps by energy dispersive X-ray spectroscopy (EDS) analysis.

These microstructural characteristics indicated that the hydroxide film formed had a dual-layered structure, composed of an outer  $\gamma$ -AlO(OH)-phase layer on the surface and a continuous inner amorphous layer on the Al substrate.

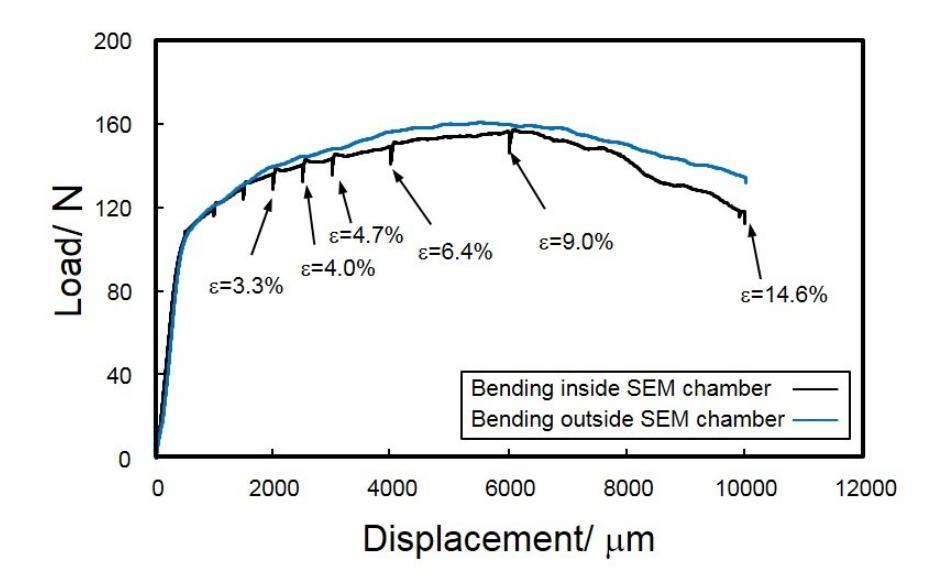
Figure 7. Load-displacement curves of the steam-coated Al-alloy sheets obtained from 4-points bending tests.

Figure 7 presents two representative load-displacement curves of steam-coated specimens in the bending tests.

Stress drops are often observed in the flow curve of bending tests conducted in the SEM chamber, when the bending must be interrupted to allow minute SEM observations of microstructure. These stress drops correspond to the stress relaxations in the specimen during the interrupting bending test for in situ SEM observations. Nevertheless, the flow curves exhibit a yielding and subsequent strain hardening behavior and agree well with the curve from uninterrupted bending tests conducted outside the SEM chamber. Low-magnification in situ SEIs obtained during the bending test are displayed in Figure 8. The specimen was uniformly deformed with an increasing punch stroke (displacement). For the specimens deformed at different displacements, the radius (R) of curvature was experimentally measured using the in situ observed

The measured *R* values can be used to calculate the macroscopic strains ( $\varepsilon$ ) of the specimen following Equation (1) (as schematically illustrated in Figure 1(d). The calculated  $\varepsilon$  ranged from 3.3% to 14.6% for different displacements, as labeled on the flow curve in Figure 7.

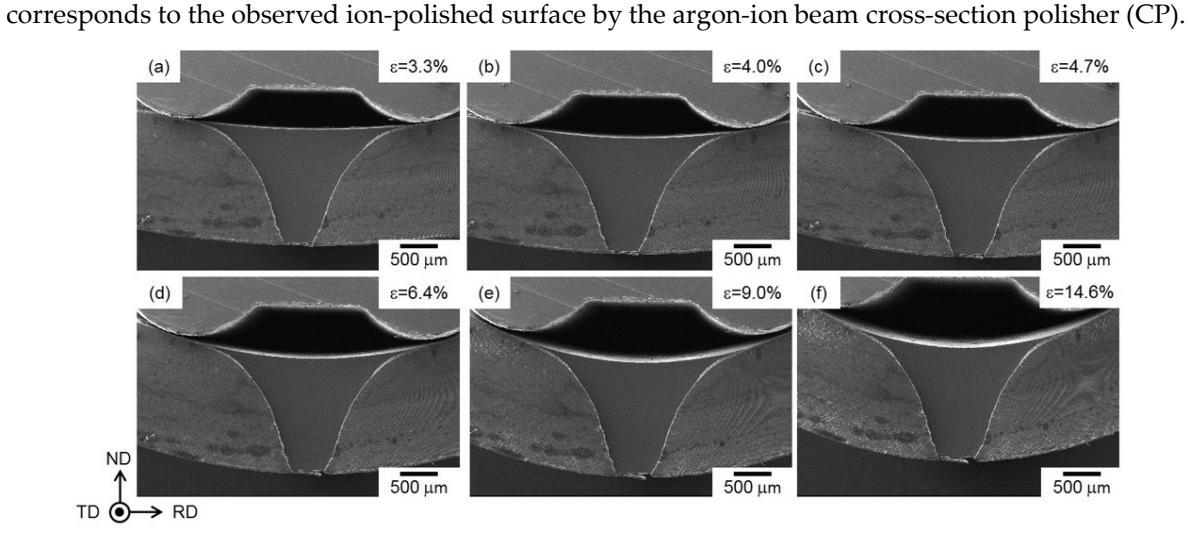
**Figure 8.** SEIs showing the bent steam-coated specimens, in which the applied strain was measured to be approximately (**a**) 3.3%, (**b**) 4.0%, (**c**) 4.7%, (**d**) 6.4%, (**e**) 9.0%, and (**f**) 14.6%.

SEIs (Figure 8). Note that the observed V-shaped area on the cross section of the specimen

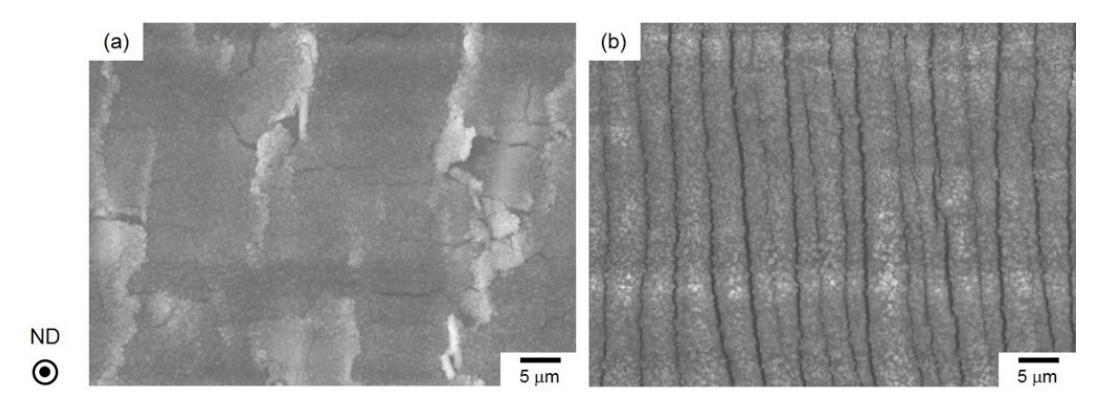
**Figure 9.** Top-view SEIs showing the fracture morphology in the (**a**) compressively and (**b**) tensile-strained surfaces of hydroxide films on the steam-coated 6061 alloy sheet with the higher applied strain of 14.6%.

Figure 9 displays representative SEIs of the hydroxide film after the specimen was deformed at a large displacement of 10 mm.

The applied strain was calculated as 14.6%. The fracture morphology depends on the strain state of the surface. Local delamination occurs for the hydroxide film on the compressively strained

surface (Figure 9a), while parallel cracks with a spacing of approximately  $2.5 \mu m$  were found on the tensile-strained surface (Figure 9b). These results correspond well to the previous study about fracture morphologies of hydroxide film on the Al-alloy sheet [12]. It is noteworthy that no peeled parts of a lower amorphous layer on the Al substrate were observed on either surface, suggesting the hydroxide film on the Al-alloy substrate has a higher cohesive strength.

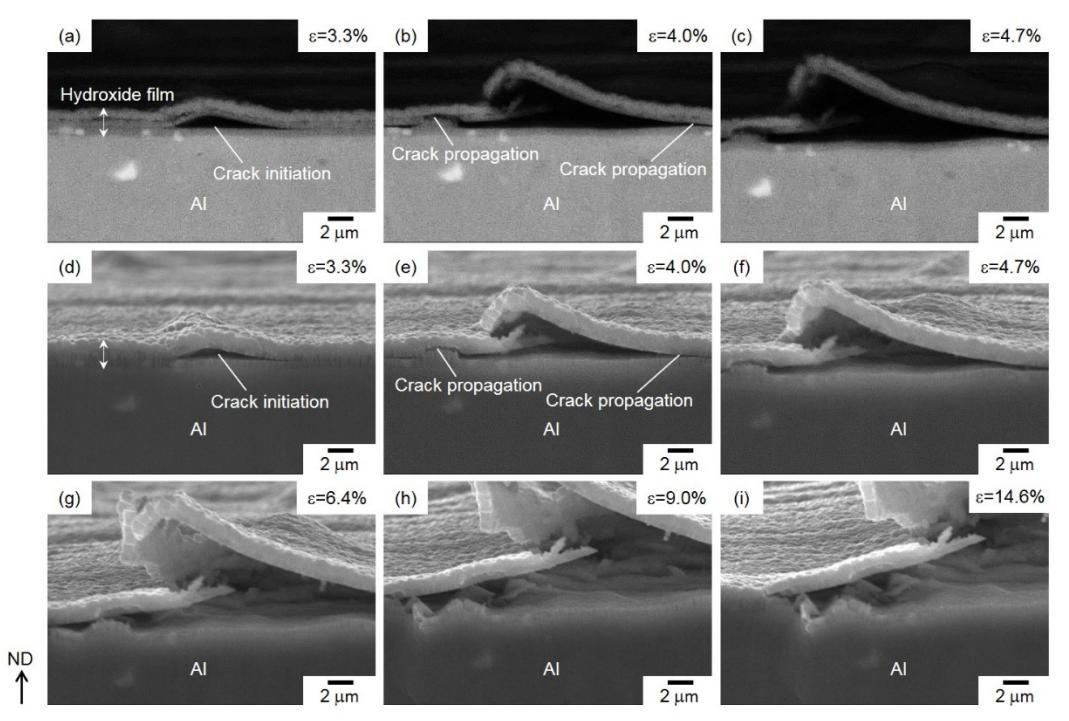
**Figure 10.** (**a**–**c**) High-magnification backscattered images (BEIs) and (**d**–**i**) SEIs showing cracks initiated and propagated on the compressively strained surface of hydroxide films formed on Al-alloy sheet, under a growing macrostrain of approximately (**a**, **d**) 3.3%, (**b**, **e**) 4.0%, (**c**, **f**) 4.7%, (**g**) 6.4%, (**h**) 9.0%, and (**i**) 14.6%.

Figure 10 presents high-magnification, in situ observed backscattered images (BEIs) and SEIs, in order to show the cracking process of the hydroxide film on the compressively strained surface of the bent specimen.

A selected area of the deformed specimen was captured using both BEI (Figure 10a–c) and SEI (Figure 10d–i) modes. These images show that a lateral crack was initiated inside the hydroxide film when the specimen was under a macroscopic strain of  $\varepsilon$  = 3.3% (Figure 10a,d). The BEI (Figure 10a) clearly demonstrates that the crack was initiated within the lower amorphous layer. This lateral crack propagated not only inside the amorphous layer but also along the interface between the lower amorphous layer and the upper  $\gamma$ -AlO(OH) layers (Figure 10b,e). In addition, note that the cracking process of hydroxide film was not affected by the second  $\beta$ -AlFeSi phase with bright contrast. The propagated lateral crack appeared to distort the hydroxide film, resulting in the fracture of the upper  $\gamma$ -AlO(OH) layer (Figure 10c,f) by applying a higher strain of  $\varepsilon$  = 4.7%. The fracture process proceeded under further strain, leading to the delamination of the upper  $\gamma$ -AlO(OH) phase and top portions of the amorphous layer (Figure 10g–i). This result corresponds to the delamination of the hydroxide film that occurred locally along the surface normal (Figure 9a). For in situ SEM observation, on the other hand, it demonstrated that the lower amorphous layer did not peel off from the Al-alloy substrate even under a high applied strain of 14.6% (Figure 10i).

To confirm the speculated mechanism, the strain distribution around the hydroxide film was quantified by DIC analysis of the in situ observed SEM images showing the fracture process (as displayed in Figure 10). The results from the DIC analysis are summarized in Figure 12.

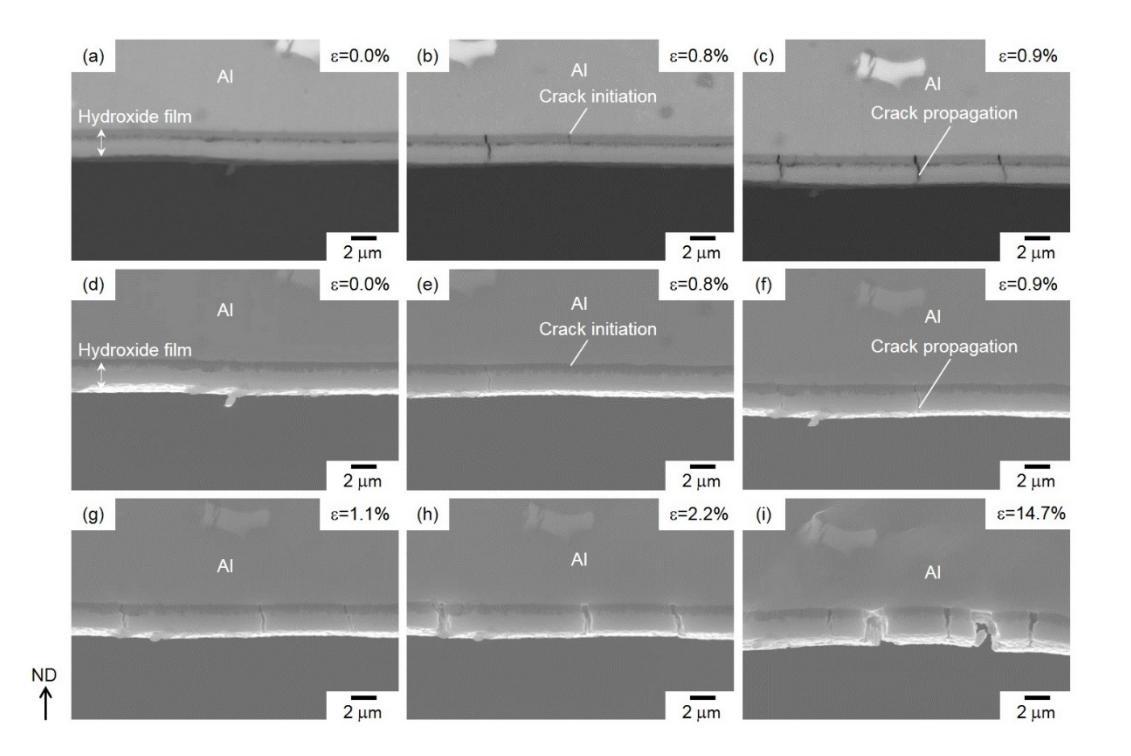
**Figure 11.** (**a**–**c**) High-magnification BEIs and (**d**–**i**) SEIs showing cracks initiated and propagated in the tensile-strained surface of hydroxide films on the Al-alloy sheet with increasing applied macrostrains of approximately (**a**, **d**) 0.0%, (**b**, **e**) 0.8%, (**c**, **f**) 0.9%, (**g**) 1.1%, (**h**) 2.2%, and (**i**) 14.7%.

Figure 11 displays the high-magnification in situ observed BEIs (Figure 11a–c) and SEIs (Figure 11d–i) in the hydroxide film on the tensile-strained surface of the bent specimen.

No cracks were found inside the hydroxide film before the bending test (Figure 11a,d), while at a relatively low  $\varepsilon = 0.8\%$ , a couple of vertical cracks were initiated in the lower amorphous layer (Figure 11b,e). The initiated vertical cracks penetrate the upper  $\gamma$ -AlO(OH)-phase layer along the surface normal (Figure 11c,f). Under further tensile loading, different vertical cracks were initiated and passed through both the upper and lower layers (Figure 11g). The opening of the propagated cracks was clearly observed by further straining (Figure 11h,i), resulting in a constant spacing of the cracks observed along the surface normal (Figure 9b). These vertical cracks were arrested around the Al-alloy substrate, where removal of a lower amorphous layer on the Al substrate was not found, even on the highly strained surface (Figure 11i), implying a high cohesive strength of the lower amorphous layer on the Al-alloy substrate.

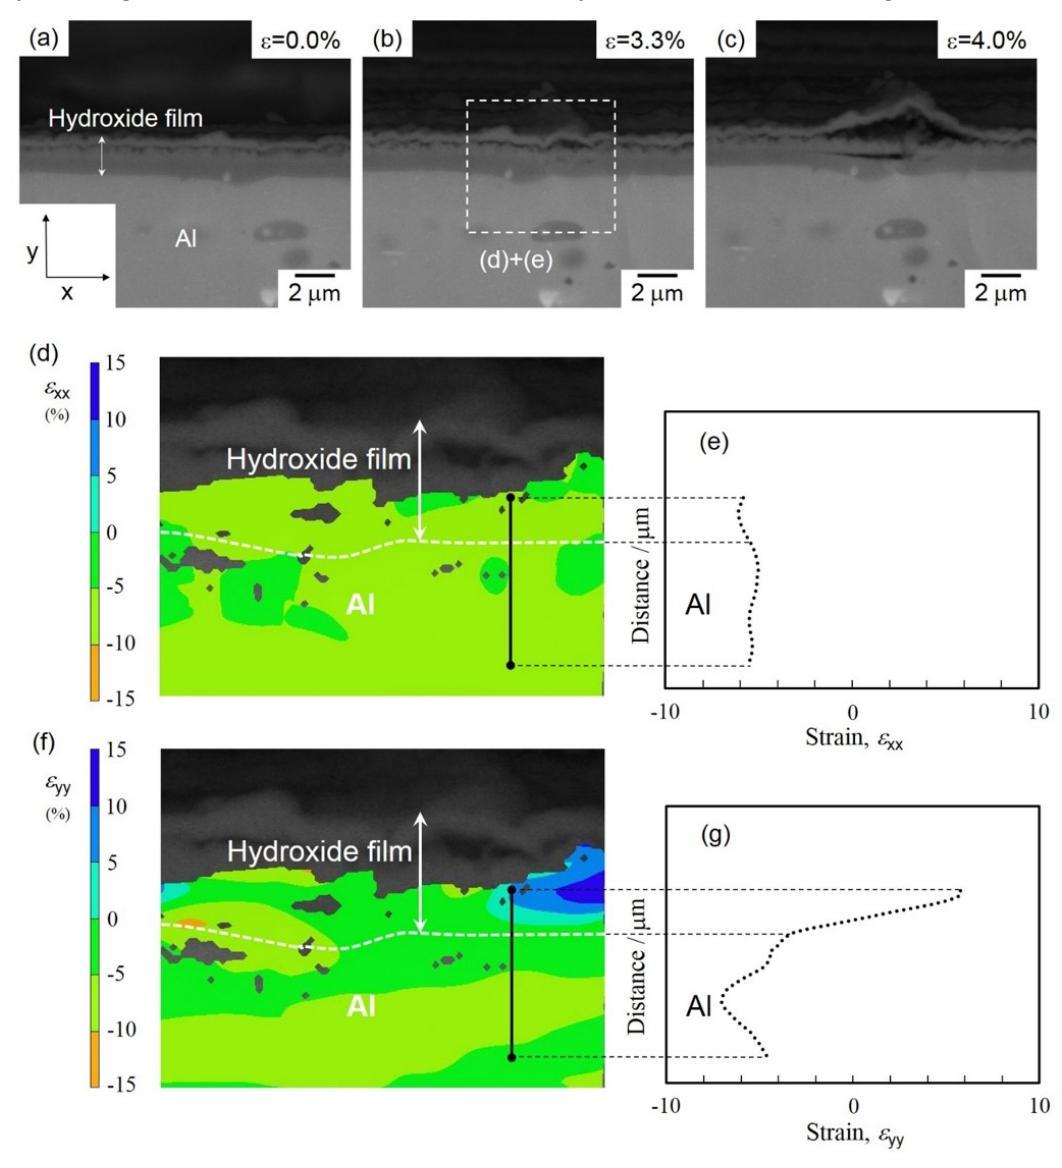
**Figure 12.** (**a**–**c**) High-magnification BEIs showing cracks initiated and propagated in the compressively strained surface of hydroxide films on the Al-alloy sheet under an increasing compressive strain. The applied macrostrain was calculated to be approximately (**a**) 0.0%, (**b**) 3.3%, and (**c**) 4.0%. The corresponding (**d**, **f**) strain distribution maps for the selected area in (**b**) and (**e**, **g**) strain-distribution profiles for the selected line containing the initiated cracks in hydroxide film of (**d**, **e**)  $\mathcal{E}_{\text{XX}}$  and (**f**, **g**)  $\mathcal{E}_{\text{YY}}$  (obtained by digital image correlation (DIC) analysis) along the x and y directions.

No cracks were observed inside the hydroxide film before the bending test (Figure 12a). At a low strain of 3.3%, one crack appeared in the outer  $\gamma$ -AlO(OH) layer, but there was none in the lower amorphous layer (Figure 12b). Further straining ( $\varepsilon$  = 4.0%) led to crack initiation in the amorphous layer and the associated delamination of the  $\gamma$ -AlO(OH) layer (Figure 12c). In order to investigate the effect of concentrated strain on crack initiation, the strain distribution around the hydroxide film deformed at  $\varepsilon$  = 3.3% was quantified by DIC analyses. The visualized strain maps of  $\varepsilon_{xx}$  and  $\varepsilon_{yy}$  and the corresponding strain profiles are presented in Figure 12d–g, with the horizontal and vertical directions defined as x and y directions, respectively. In the distribution map of the  $\varepsilon_{xx}$  component (Figure 12d), negative values from -5% to -10% were found in all analyzed areas in the amorphous

layer (Figure 12b). The strain profile in Figure 12e along a line across the amorphous layer (as indicated in Figure 12d) shows an almost constant strain of approximately -6%. These results obviously indicate a uniform compressive strain (along the x direction) applied by bending deformation. In contrast, the distribution of the  $\varepsilon_{yy}$  component in the hydroxide film was inhomogeneous: negative values of  $\varepsilon_{yy}$  (compressive strain) were found in the Al-alloy substrate, whereas positive values (tensile strain) were detected inside the amorphous layer (Figure 12f). In other words, the sign of  $\varepsilon_{vy}$  changes near the interface between Al-alloy substrate and the amorphous layer, as presented by the line profile of  $\varepsilon_{yy}$  strain in Figure 12g. Importantly, it was found that the compressive strain (along the surface normal) was applied in the Al-alloy substrate, whereas the tensile strain (along the surface normal) was localized at the neighbor amorphous layer on the compressively strained surface of specimens deformed by bending. The site of localized tensile strain corresponds well to that of crack initiation (Figure 12c). Thus, the variation of strain state around the amorphous layer could facilitate the opening of cracks near the amorphous layer/Al-alloy interface. Since the Al substrate is more ductile than the adjacent amorphous layer, cracks are preferentially initiated inside the latter. This varied strain state around the hydroxide film might be responsible for a difference in elastic deformation between the amorphous phase and  $\alpha$ -Al (fcc) matrix. Overall, the present strain-distribution analysis demonstrates that the concentrated tensile strain along the surface normal (positive  $\varepsilon_{yy}$ ) at some parts of the amorphous layer contributed to crack initiation in this layer (as presented in Figure 10).
