# Article Friction and Wear Characteristics of 18Ni(300) Maraging Steel under High-Speed Dry Sliding Conditions

# Kun Sun \*<sup>(D)</sup>, Weixiang Peng, Binghui Wei, Longlong Yang and Liang Fang

State Key Laboratory for Mechanical Behavior of Materials, Xi'an Jiaotong University, Xi'an 710049, China; thunder0@stu.xjtu.edu.cn (W.P.); wfzgb8210@stu.xjtu.edu.cn (B.W.); yanglonglong@stu.xjtu.edu.cn (L.Y.); fangl@xjtu.edu.cn (L.F.)

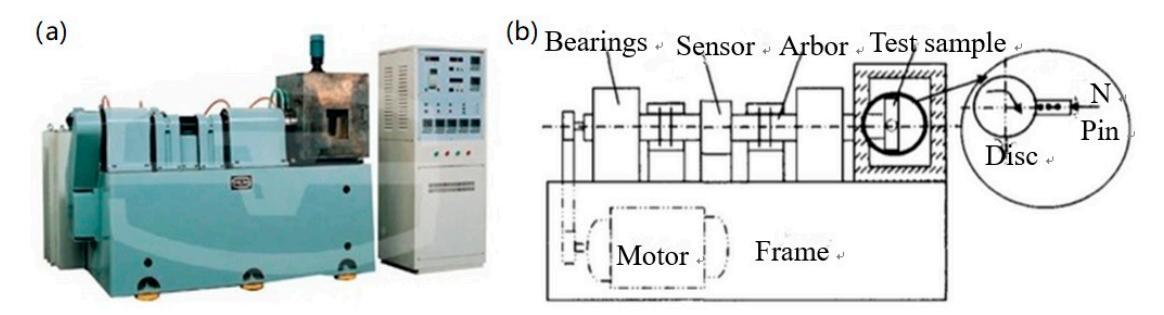
Figure 1. (a) The pin-on-disk tester; (b) a schematic illustration of the tester.

The dry sliding wear tests were conducted under atmospheric conditions on a pin-on-disk high-speed tribo-tester (MMs-1G type, Shijing Machine Factory, Jinan, China). A schematic diagram of the wear tester used in this study is shown in Figure 1. The disk is fixed to the rotating shaft in the tester. The pin specimen is pressed against the bottom surface of the disk under a constant vertical load. 18Ni(300) maraging steel, manufactured by double vacuum melting, was employed to fabricate the pin specimens. Disk specimens were fabricated using commercial 100Cr6 steel. Chemical compositions of pin and disk specimens are shown in Table 1.

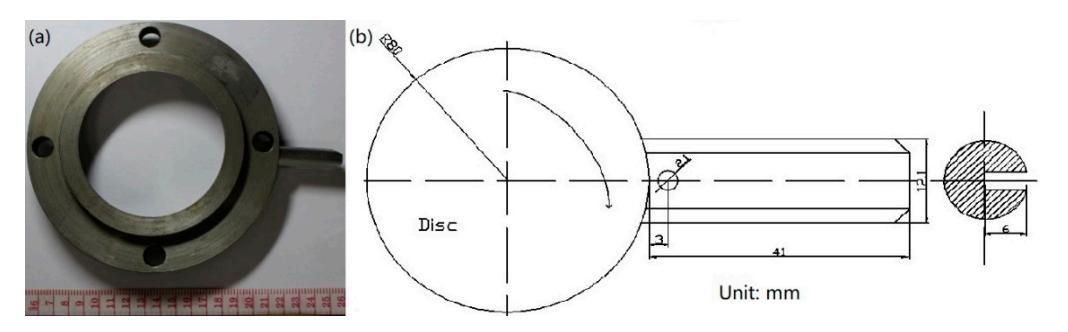
Figure 2. (a) Pin and disk specimens; (b) shape and size of specimens.

The pin and disk specimens are illustrated in Figure 2 and have the dimensions of  $\phi$ 12 mm × 41 mm and  $\phi$ 160 mm × 30 mm, respectively. The 18Ni(300) maraging steel was solution-treated at 820 °C for 60 min, then aged at 480 °C for 6 h and cooled in air. After heat treatment, the microstructure of the pin specimens was a martensite structure with a dispersedly distributed metal compound strengthening phase, as shown in Figure 3. The yield stress and hardness of the pin specimens were 1930 MPa and HRC53, respectively. After quenching and tempering, the hardness of the 100Cr6 steel specimens was 58 HRC.

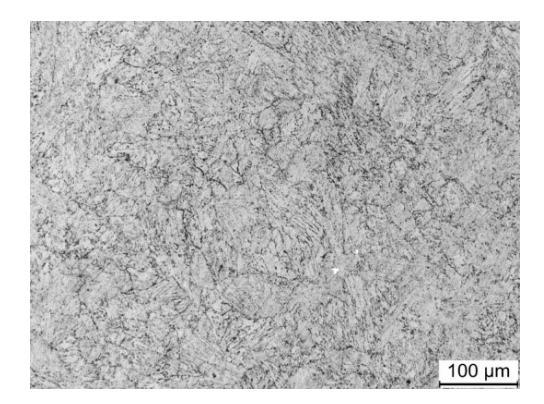
Figure 3. SEM image of 18Ni(300) maraging steel after heat treatment.

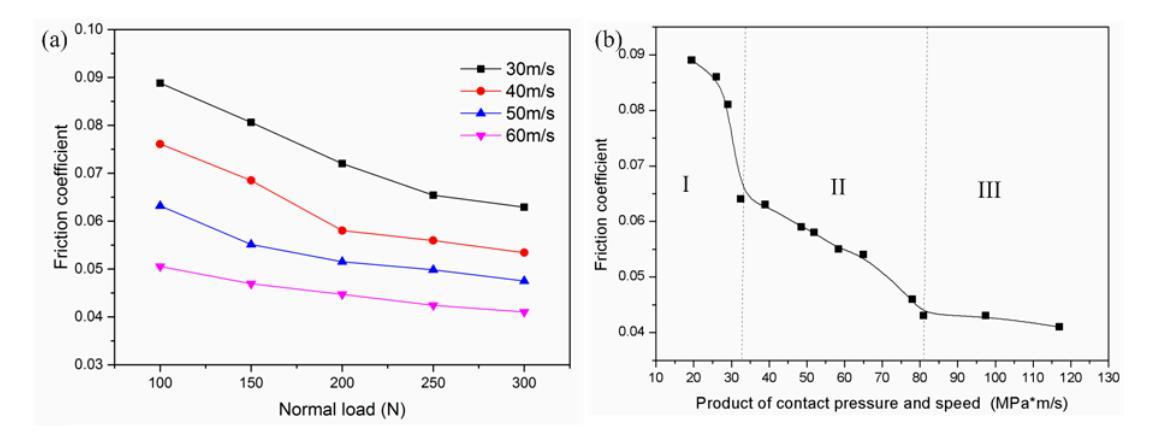
Figure 4. Friction coefficients: (a) at various loads vs. (b) the product of contact pressure and speed.

The friction coefficients of 18Ni(300) maraging steel under various load and speed conditions are shown in Figure 4a. It can be found that the friction coefficient decreased with the speed and load increasing. The main reason for the decrease can be attributed to high values of normal loads combined with high slip speeds, which generate substantial heat at the contact interface [9,10]. This friction heat softens the material at contact junctions and reduces their shear strength resisting plastic deformation. Thus, the frictional resistance and friction coefficient are decreased in turn. The friction coefficients as a function of the product of contact pressure and sliding speed are plotted in Figure 4b. It can be found that the friction coefficient steadily decreased with the increasing product of speed and contact pressure. The variation of the friction coefficient may be divided into three regions according to the descending rate of the friction coefficient shown in Figure 4b. In region I, the friction coefficient abruptly drops when the product is less than 33 MPa·m/s. In region II, the friction coefficient normally falls when production is from 33 to 81 MPa·m/s. When the product is larger than 81 MPa·m/s, the variation of the friction rate of the friction coefficient reveal that there may be a transformation of the wear mechanism of 18Ni(300) maraging steel during the high-speed sliding process. This is further investigated in the next section.

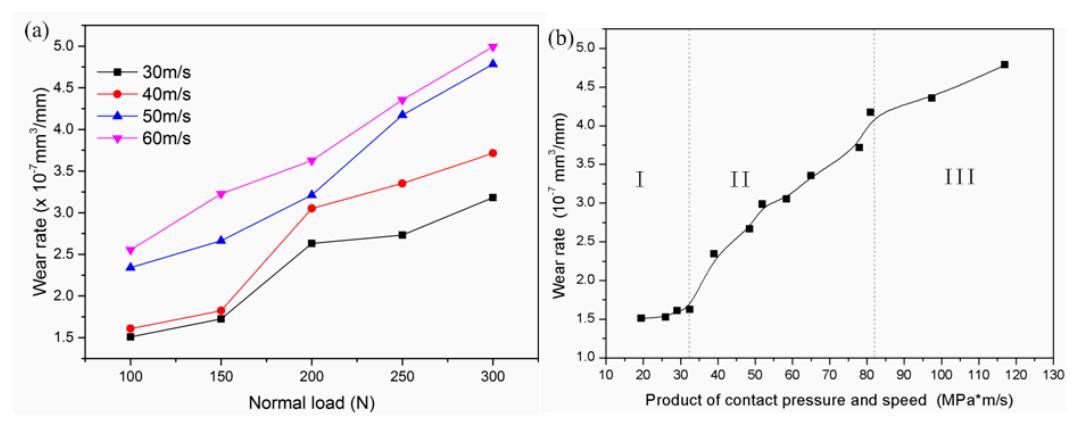
Figure 5. Wear rate: (a) at various loads vs. (b) the product of contact pressure and speed.

where  $\Delta V$  is the wear loss volume and *d* the sliding distance. The curves of wear rate vs. load at various sliding speeds are displayed in Figure 5a. It can be observed from Figure 5a that the wear rate generally increased with the increasing of loads and sliding speeds, and curves of wear rate at 30 and 40 m/s were in similar form. When the sliding speed was lower than 50 m/s, the wear rate of 18Ni(300) maraging steel slowly increased under low loads 100 and 150 N, then rapidly increased as the load was elevated from 150 to 200 N. It is clear that a transition of mild to severe wear occurred with the increasing of load at 50 and 60 m/s. This reveals that at higher sliding speed (>50 m/s), the wear mechanism of 18Ni(300) maraging steel is stable, and wear severe. The wear rate as a function of the product of contact pressure and speed is shown in Figure 5b. It is similar to the variation of the friction coefficient and can be divided into three regions, correspondingly. When the product is less than 33 MPa·m/s in region I, the wear rate is smaller, and increasing slowly. In region II, the wear rate normally elevates when the product is rising from 33 to 81 MPa·m/s. When the product is larger than 81 MPa·m/s, the wear rate slowly increases again. These changes of wear rate also reveal the dominant wear mechanism transferred from one region to the next region.

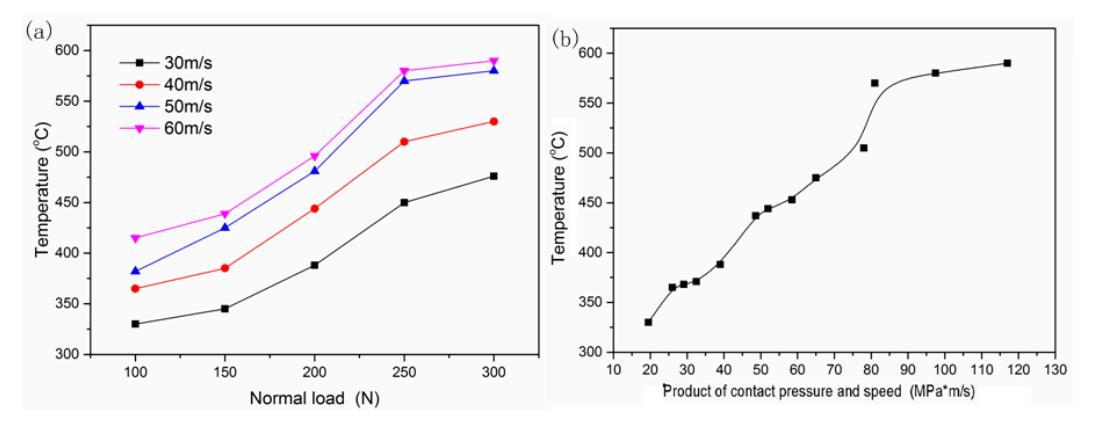
**Figure 6.** The temperature of contact surface: (**a**) at various loads vs. (**b**) the product of contact pressure and speed.

The nominal temperatures of the worn surface at various rubbing conditions are shown in Figure 6. It can be detected from Figure 6a that the effects of sliding speed and load on the temperature are similar and obvious. The nominal temperature of the contact area was about 330 °C at speed 30 m/s and load 100 N and then reached a critical 590 °C at speed 60 m/s and load 300 N. The contact temperature

was high enough to cause local junction region oxidation; the oxidation products of worn surfaces are investigated in detail in the following section. It can also be found that the contact temperature was a function of the product of contact pressure and speed, shown in Figure 6b. With the product increasing, the contact temperature rose. However, the increasing rate was obviously slower when the product was larger than 81 MPa·m/s.

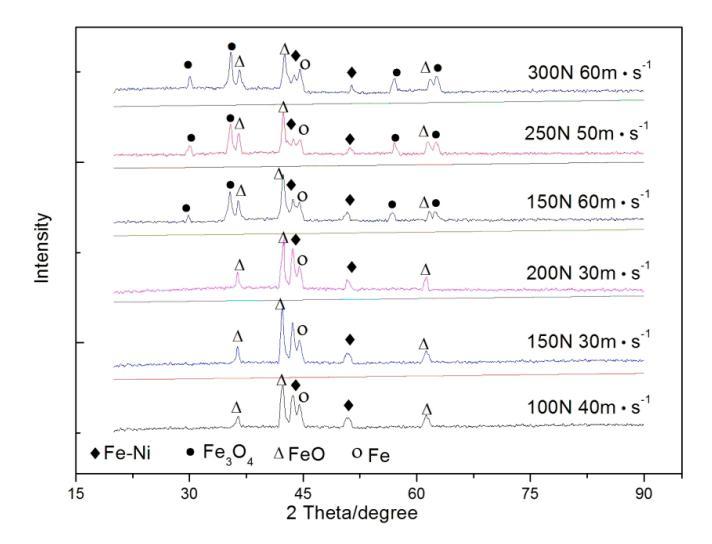
Figure 7. XRD patterns of worn surfaces of 18Ni(300) maraging steel.

XRD patterns of pin specimens under different sliding conditions are shown in Figure 7. At 100 N and 40 m/s (namely 26 MPa·m/s), ferrous oxides (FeO) were formed on worn surfaces. With increasing load and speed, the peak height of FeO approached or surpassed that of steel substrate. This means that massive FeO formed on worn surfaces of pin specimens. When sliding speed reached 60 m/s and load was 150 N (namely 58.5 MPa·m/s), a new type of oxide, spinel oxide (Fe<sub>3</sub>O<sub>4</sub>), also appeared on worn surfaces. However, FeO was still identified as a predominant oxide at this time. With further raising of the load, the amount of Fe<sub>3</sub>O<sub>4</sub> increased substantially and significantly surpassed that of FeO. According to the result of XRD analyses, it is reasonable to deduce the predominant wear mechanism of 18Ni(300) maraging steel under high-speed dry sliding conditions may be oxidation wear, because a great amount of tribo-oxides appeared on worn surfaces of the steel [11].

When sliding speed was greater than 50 m/s, the predominant composition of oxide film changed from FeO to Fe<sub>3</sub>O<sub>4</sub> on worn surfaces (seen in Figure 7). It was found that the sliding speed had remarkable effects on the production rate and type of tribo-oxides. In these conditions, friction heat, q, was larger, and caused continuous, smooth, and thick (about 28 µm) tribo-oxide films to be formed on the worn surfaces (seen in Figure 8d). Those oxide films prevented direct metal–metal contact during the sliding process, resulting in the friction coefficient decreasing (seen in Figure 4). However, with load increasing, plastic deformation was more and more severe in the contact region. Consequently, fatigue cracks not only formed in the surface, but also in the subsurface of the matrix. Then oxide films were broken into small pieces, and delaminated from worn surfaces. The wear mechanism was a typical mild oxidative wear in this situation [11,12,18].

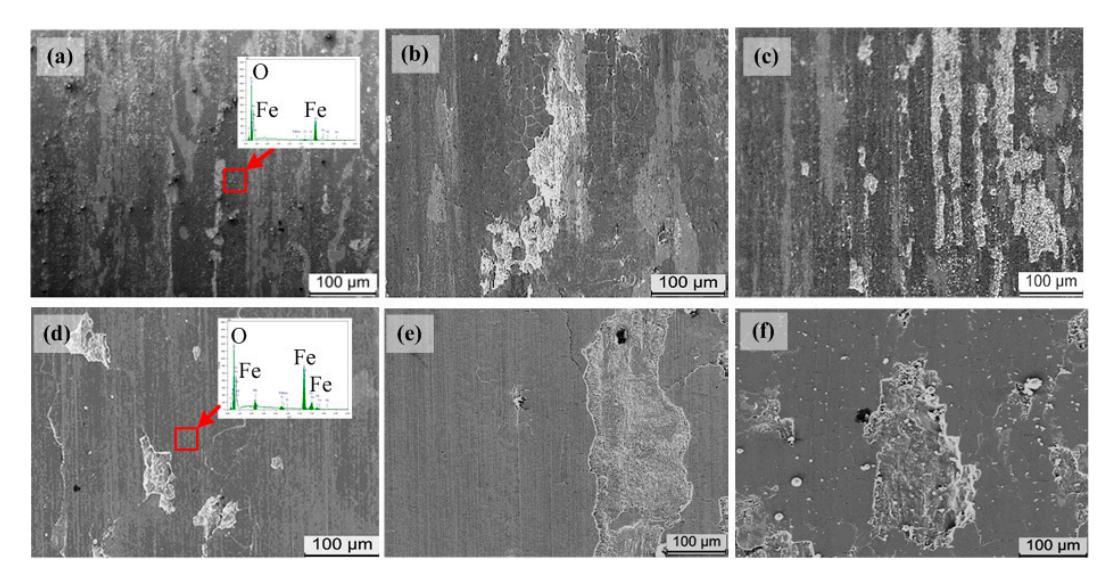
**Figure 8.** Morphologies of worn surfaces of 18Ni(300) maraging steel under (**a**) 100 N and 40 m/s, (**b**) 150 N and 30 m/s, (**c**) 200 N and 30 m/s, (**d**) 150 N and 60 m/s, (**e**) 200 N and 50 m/s, and (**f**) 300 N and 60 m/s.

SEM images of the worn surface of pin specimens under different load and speed conditions are shown in Figure 8. It can be found that adhesion occurred on worn surfaces, from Figure 8a. At

the same time, composition of worn surfaces in red squares was analyzed using EDS. According to the EDS results, it was found that some regions of the worn surfaces were oxidized at 100 N and 40 m/s (namely, 26 MPa·m/s). Combining the XRD results (seen in Figure 7), the predominant oxide in these regions was detected as FeO. With the increase of load and speed as shown in Figure 8b,c, the adhesive wear changed from mild to severe. Some micro cracks appeared in the tribo-oxide films, and part of the films spalled off and delaminated from worn surfaces [11,12]. These phenomena reveal that a transition of wear mechanism of 18Ni(300) maraging steel occurs at 150 N and 30 m/s (namely, 33 MPa·m/s). On the other hand, it is interesting to find that the worn surfaces were very smooth at higher load and sliding speed (Figure 8d-f). Moreover, the predominant oxide transfers from FeO to Fe<sub>3</sub>O<sub>4</sub>, according to XRD results shown in Figure 7. Simultaneously, it could be observed that delaminated regions became larger and deeper on the worn surfaces of pin specimens, and severe oxidative wear prevailed [11,12]. Under severe wear conditions, the increasing of speed and load caused a massive amount of frictional heat, which raised the worn surface temperature and caused a greater temperature gradient within the rubbing metal. The result was huge thermal stress in the subsurface layer of rubbing pairs. At interaction of the thermal stress and contact shear stress, more micro fatigue cracks were initiated and grew in the substrate of the rubbing metals, and between the oxide film and the substrate. These enhanced the delaminating of oxide films. Consequently, the wear rate increased with the product of contact pressure and sliding speed increasing.

According the above XRD and SEM results (Figures 7 and 8), we can see that the main wear mechanism of 18Ni(300) maraging steel is mild adhesive wear when the oxide of friction and wear surface is FeO. With increasing speed and load, mild adhesive wear will transform to oxidative wear as the predominant oxide changes from FeO to  $Fe_3O_4$ . The  $Fe_3O_4$  oxide films densely covered worn surfaces of pin and disk, and prevented metal–metal direct contact and adhesion [13,14], resulting from the decrease of the friction coefficient. However, with increasing sliding speed and load, the contact temperature between the pin-disk rubbing pairs rose, which caused larger plastic deformation in  $Fe_3O_4$  oxide films and the subsurface of the matrix. As a result, the protective oxide film was broken into many small pieces by surface cracks and spalled off from the worn surfaces. Simultaneously, the shedding oxide debris scratched the rubbing surface as an abrasive, which further worsened the friction and wear properties of materials.

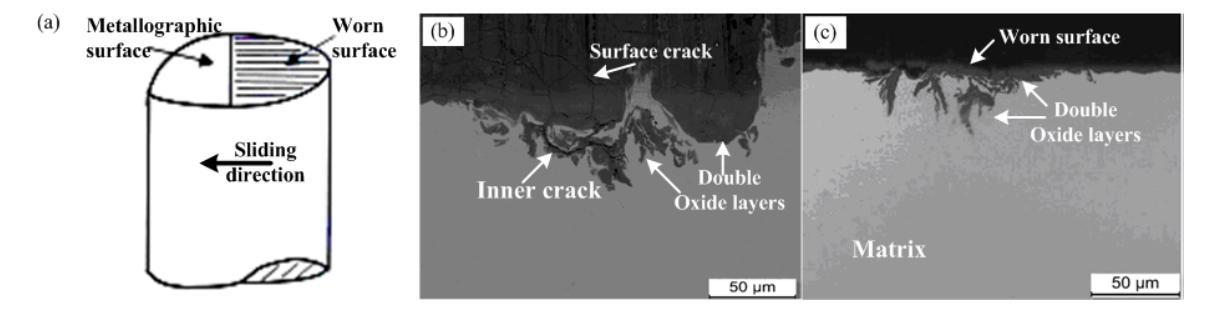
**Figure 9.** Section morphologies of worn surface of 18Ni(300) maraging steel under 300 N and 60 m/s: (a) schematic diagram of the clip section; (b) clip section morphology; and (c) cross section morphology.

Morphologies of clip sections and cross sections of worn pin specimens at 300 N and 60 m/s (namely, 117 MPa·m/s) are shown in Figure 9b,c. A schematic diagram of the clip section is present in Figure 9a, and the clip plane is inclined to the worn surface about 20°. It can be found from Figure 9b that some cracks formed in oxide films of worn surfaces, then propagated within the matrix. Eventually, these cracks in the subsurface led to a massive oxide film breaking into lots of small pieces and peeling off. The thickness and shape of the oxide layer can be also observed and measured from the morphology of cross sections. The thickness of the oxide layer is about 40  $\mu$ m in Figure 9c. Meanwhile, double-layer tribo-oxides were formed in the cross section of worn surfaces under larger load and higher speed conditions, such as 300 N and 60 m/s. The appearance of double-layer oxides should be attributed to two reasons [15,16]: One reason is that there was severe plastic deformation and high thermal softening in the contact region under larger load and higher speed conditions, which caused the oxide films on worn surfaces to break and mechanically mix into the subsurface layer of the matrix; the other reason is that the deformation and softening also caused lots of micro cracks to form in the subsurface of the matrix and then expand to the worn surfaces, which accelerated oxygen penetrating into the inner matrix. Combining the result of wear rate tests (Figure 5), it can be found that the wear rate of 18Ni(300) maraging steel is very high when multi-layer tribo-oxides film form in matrix, and about thrice that at low load and speed (e.g., 100 N, 30 m/s). Thus, the wear mechanism in this situation should be distinguished as severe oxidative and plastic wear.

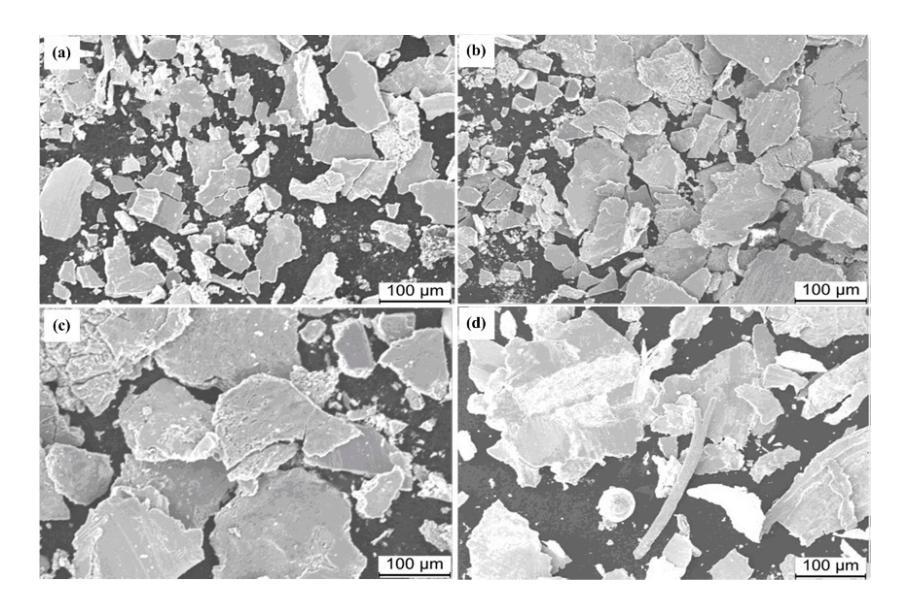
**Figure 10.** Morphologies of worn debris of 18Ni(300) maraging steel under (**a**) 100 N and 30 m/s, (**b**) 150 N and 40 m/s, (**c**) 250 N and 50 m/s, and (**d**) 300 N and 60 m/s.

SEM micrographs of debris of pin specimens under different speed and load conditions are presented in Figure 10. When sliding speed and load were relatively small, the debris was mainly little pieces of flake and chip, shown in Figure 10a,b. With increasing sliding speed and load, the shape of debris changed from little flakes to massive blocks, shown in Figure 10c. These massive blocks of debris were thick and irregular, which is the result of severe plastic deformation. With the sliding speed increasing, some spherical debris appeared, as shown in Figure 10d. It was the result of melted material extruding from the worn surface, and spontaneously solidifying into spherical shape during the cooling process in order to reduce the surface energy. When fine particles are found in debris (Figure 10d), this means that the wear transformed from adhesive and mild oxidative wear to severe oxidative and plastic wear.
