# Article Microstructure and Degradation of Mortar Containing Waste Glass Aggregate as Evaluated by Various Microscopic Techniques

# Przemysław Czapik

Department of Building Engineering Technologies and Organization, Kielce University of Technology, Al. Tysiaclecia Państwa Polskiego 7, 25-314 Kielce, Poland; p.czapik@tu.kielce.pl

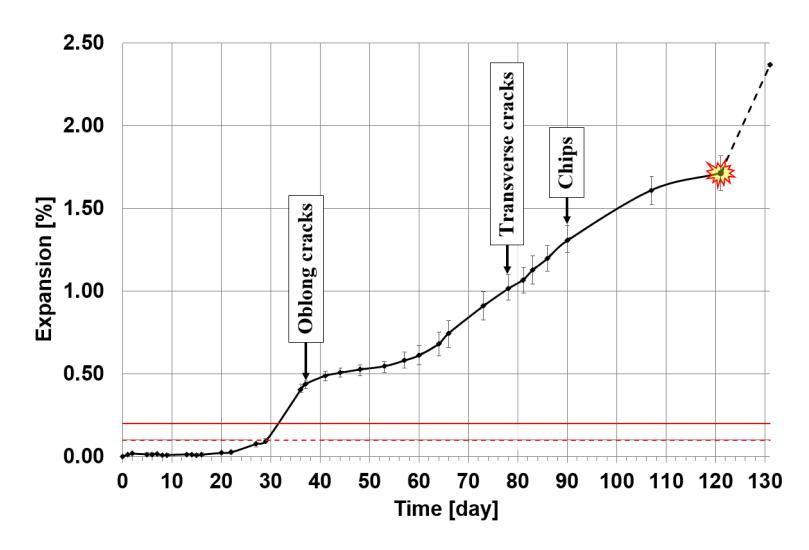
**Figure 1.** Expansion in the mortar with waste glass measured according to the ASTM C 1260 standard [38]. Measurement from 3 specimens until day 121 and measurement from 1 specimen conducted between day 121 and 131.

Figure 1 shows the progress of the expansion of mortar bars in which sand was replaced with waste glass.

Despite the fact that waste glass is made of very reactive amorphous silica, in the early stage of the test period no significant expansion was observed as in [21,29]. Initially, the specimen containing waste glass did not show any significant dimensional changes, as reported in other studies [19,30]. In this study, this stable period lasted for as long as 22 days, well beyond the 14-day duration of the standard test after which the specimen could be considered as non-susceptible to ASR degradation. After 22 days of testing, the mortar began to expand progressively. Expansion proceeded slowly up to day 29, without exceeding the threshold of 0.1% at which the specimen could be considered to be potentially at risk from ASR. However, the rapid increase in expansion between 29 and 36 days showed that the tested mortar degraded due to ASR. A visible trace of this was the appearance of longitudinal cracks on the surface of the specimens observed on after 38 days. After that time the rate of expansion growth decreased and was relatively insignificant until 64 days. Since then the rate of expansion growth increased significantly, although it was not as high as between 29 and 38 days. Subsequently, a new damage indicating specimen degradation was observed (Figure 2). Transverse cracks appeared at 78 days, and spalling started at 90 days. Finally, after 131 days, two out of three specimens collapsed and no further measurements could be made. The results of the previous expansion measurement on all three specimens at 121 days was 1.71%. Over the next 10 days, the last specimen expanded further by 0.66%. These expansion results are higher than those reported in many other studies [18,20–22,27,29,30,36] conducted as per ASTM C 1260 [38] for a shorter period. This allows expecting more significant microstructural changes in the mortar under test.

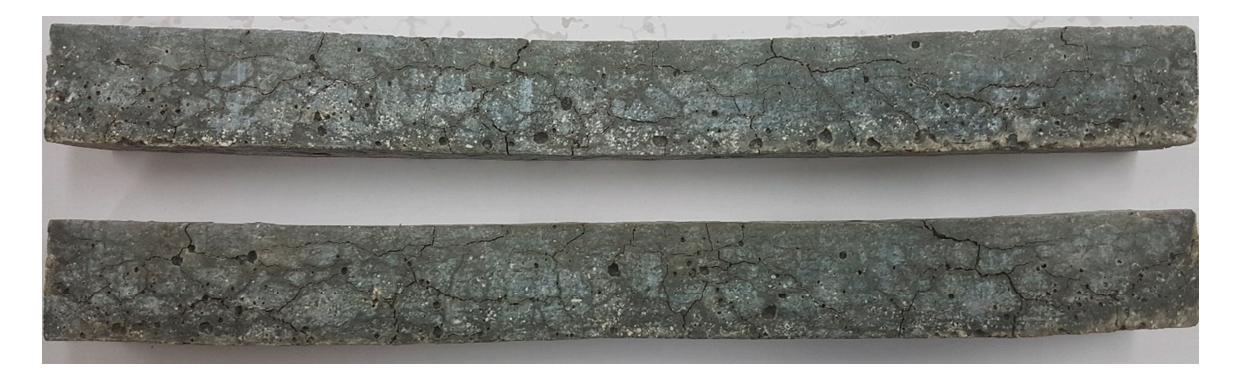
Figure 2. Cracked mortar specimens at 107 days of immersion in NaOH solution.

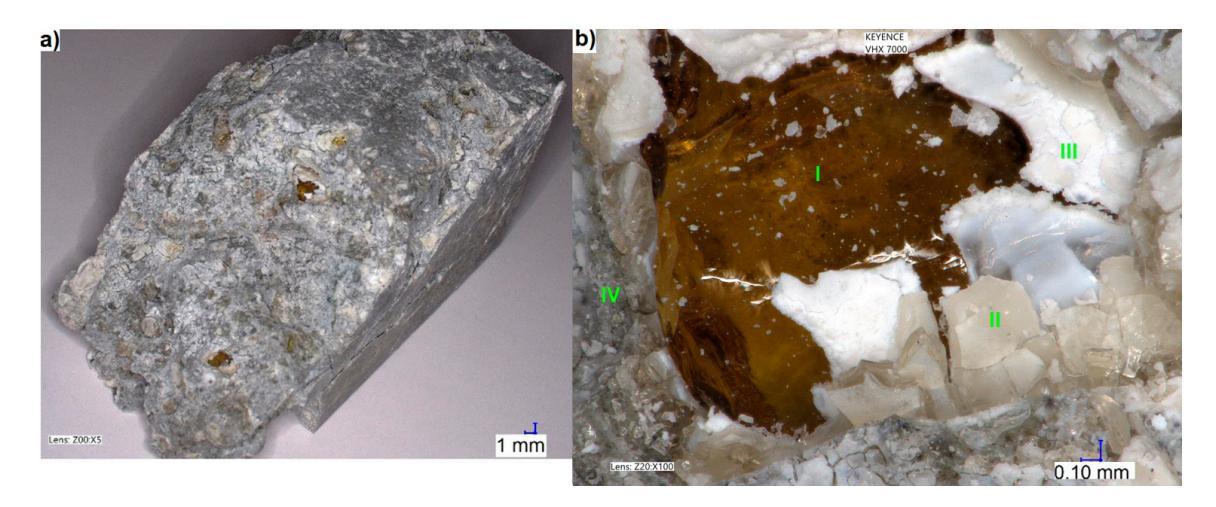
Figure 3. (a) Mortar bar with a natural crack surface; and (b) a degraded waste glass particle.

For microscopic examination, one of the mortar bars damaged by immersion in the 1M NaOH solution at 80 °C for 131 days was selected. First, without preparing any special test sections, the surface of the crack, responsible for breaking the continuity of the bar, was visually inspected (Figure 3). The exposed waste glass particles could be distinguished on the extensively cracked surface of the fractured bar (Figure 3a). Looking at it, one can notice that the core of unchanged brown glass (I) is surrounded by cracked, discoloured glass (II). Between the undamaged and cracked glass, there is a white alkali silica gel (III), an ASR product [52,54,55]. Cracked cement paste (IV) is observed around the glass particle.

As in Figure 3b, an area of degraded glass around the core can be distinguished, separated from the core by the alkali silica gel. When two polarizers are used, the degraded glass (III) looks similar to the impregnating substance, however, in contrast to it, it is a discontinuous phase. Also, when tested with one polarizer, the colour of degraded glass is darker than that of non-degraded glass and the

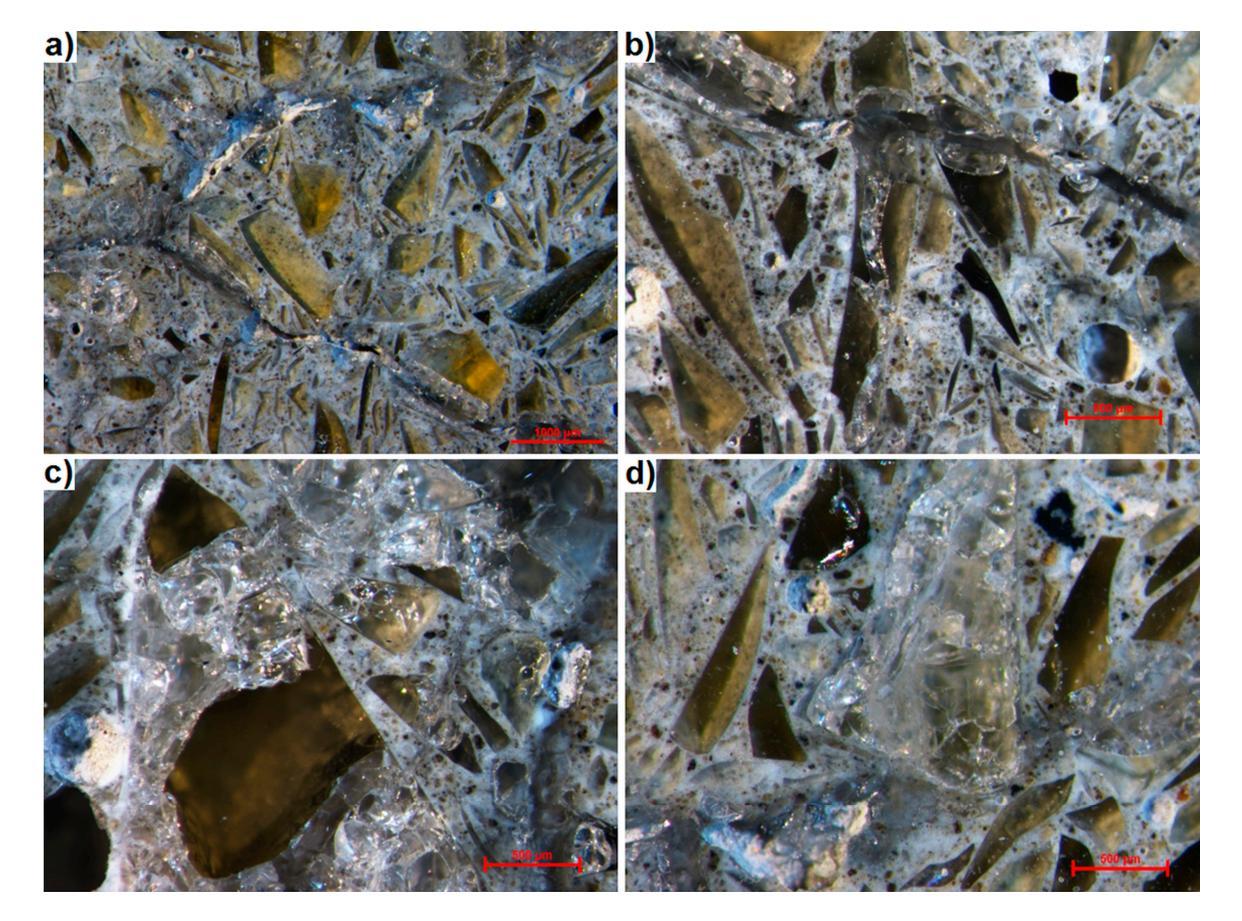
**Figure 4.** Polished section of mortar containing waste glass, obtained from reflected light microscopy, at (a) 20×; and (b), (c), (d) 40× magnification.

Figure 4 shows images of the polished section examined with optical microscopy in reflected light. These images show clearly yellow-brown, transparent glass particles embedded in the cement paste matrix. As in Szelag et al. studies [55], no cracked region or a region with increased porosity is visible between the particles and the paste, which confirms a good bond between the particles and the paste. There is also no reaction rim around the glass grains that is sometimes observed around natural aggregates. [52,53]. The cracks of widths up to 0.36 mm are visible in the paste (Figure 4a), which is indicative of significant degradation of the mortar. They do not run along the glass-paste boundaries, but mainly throughout the paste. On the walls of these empty cracks, a white coating indicates the presence of alkali silica gel and other by-products (trona or thermonatrite) resulting from the immersion of the mortar in NaOH solution [56,57]. There are no alkali-silica reaction products in the air voids, as opposed to their very typical occurrence in this type of ASR concrete degradation [53].

A different degradation type is observed in large glass particles and in some finer ones. Extensively cracked and discoloured regions are observed (Figure 4c), but the mechanisms of glass discolouration, which can vary, were not determined [58]. A network of small cracks with widths much smaller than the widths of cracks running throughout the paste is formed. A single glass particle may contain degraded and undamaged zones. Undamaged zones may also occur on the particle surface in direct contact with the cement paste. Thus, for such a particle, it is impossible to claim that the degradation starts on its surface and leaves an unreacted core when penetrating inward.

Extensively cracked glass particles larger than 1 mm, completely discoloured, are observed on the polished sections (Figure 4d) in the direct vicinity of large cracks propagating throughout the paste.

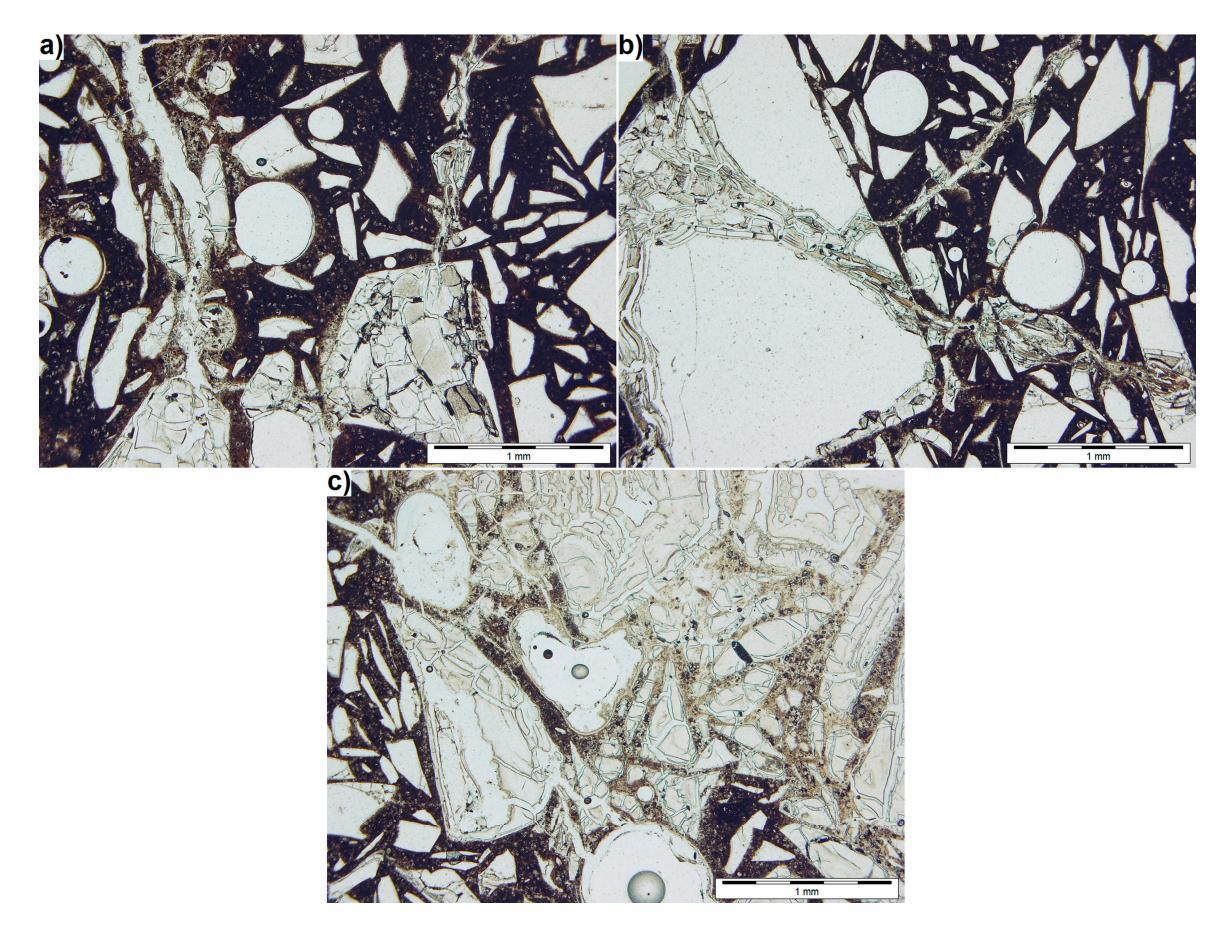
**Figure 5.** Thin section observed in transmitted light using a single polarizer. (**a**) typical area of cracked mortar with waste glass, (**b**) large waste glass grain having a single fracture, (**c**) strongly degraded mortar area.

Figure 5 shows the images of thin section obtained from transmitted light microscopy examination using one polarizer. Light-coloured glass particles and spherical pores are suspended in the dark cement matrix. As found in previous studies, glass particles adhere well to the paste but some of

them being extensively cracked. This is particularly true for the particles with sizes exceeding 1 mm. Their whole surface may be degraded (Figure 5a), or the degradation of the particle may spread only along certain cracks formed in the particle (Figure 5b).

This technique allows distinguishing between the cracks and cement matrix. In Figure 5a,b, the cracks with widths up to 0.35 mm propagate from the large glass particles and run throughout the smaller particles, thereby degrading them. At the same time, the small particles located far away from the cracks show no signs of degradation. It is easier to recognize the propagation path of cracks in the mortar thereby making easier to confirm that the cracks propagate in the manner characteristic of ASR [52]. The difference is also significant in the case of testing degraded large glass grains, which in reflected light are more difficult to distinguish from the paste because of the discolouration.

In the immediate vicinity of the crack running through the paste, a discolouration of the paste can be observed (Figure 5a). It is more light-coloured, which can be explained by the formation of micro-cracks in the paste, increasing the degree of light transmission in this area. This also makes it possible to quickly identify regions where the ASR-induced degradation occurs to a greater extent. The image in Figure 5c is clearly brighter at the top, in the centre and on the right. In these regions, all the glass particles are cracked and the paste is highly transparent. At the bottom and left-hand side of Figure 5c, where more particles smaller than 0.5 mm are located, degradation occurs to a lesser extent. There are only single cracks in the glass and the paste is dark.

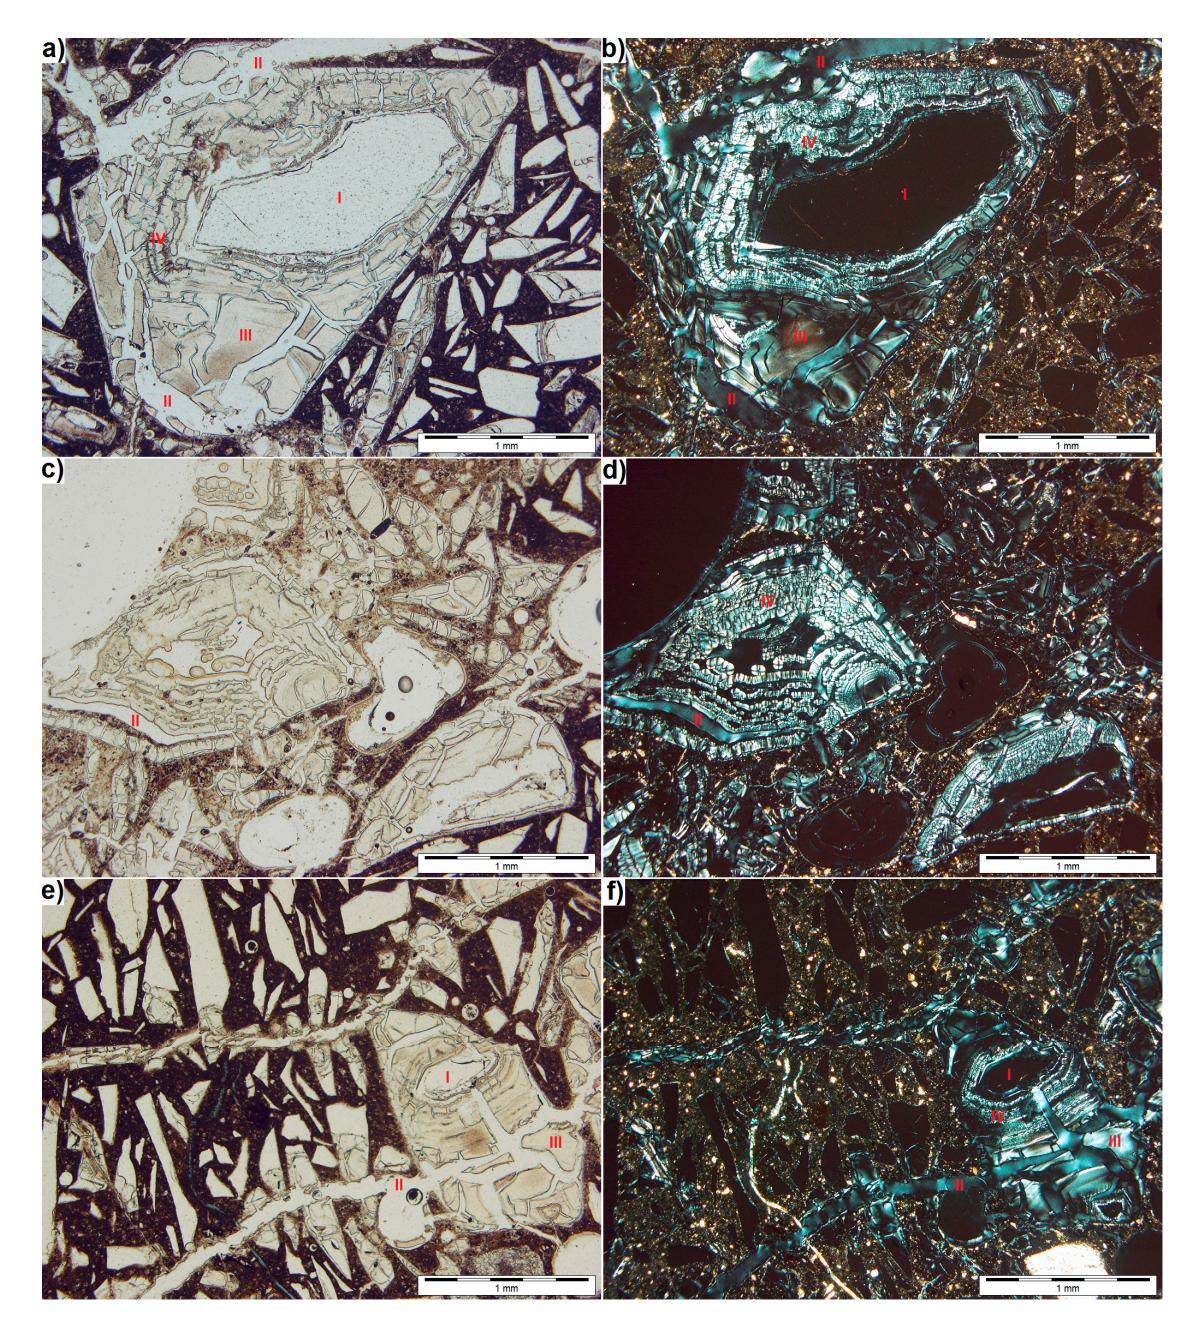
**Figure 6.** Thin section observed under transmitted light, obtained with one (left) and two polarizers (right); I – non-degraded glass, II – impregnating agent, III – degraded glass, IV – alkali silica gel. (a), (b) cracked large grain of waste glass; (c), (d) gel in the place of glass grain next to the air pore; (e), (f) cracks around the degraded glass grain.

Figure 6 compares images for the same regions obtained with transmitted light using one (Figure 6a,c,e) and two crossed polarizers (Figure 6b,d,f). The second polarizer allowed better identification of the composition of degraded mortar with waste glass and confirmed that many glass

particles of size above 1 mm retained the core of undegraded glass (I). When only one polarizer is used, the colour of this core is similar to that of the impregnating agent used during thin section preparation. Examination with two polarizers reveals a distinct 'opalescent' colour of the agent (II). It can thus be concluded that all cracks are filled with the impregnating substance (Figure 6f), though it is not found in large air pores (Figure 6d).

impregnating agent. This is due to the lower light transmittance of such glass. In the test using non-polarized light, it is difficult to distinguish between ASR-degraded glass and the resulting gel. In Figure 6a only, one can see a rim of dendritic crystallites formed in the gel around the unreacted core. When two crossed polarizers are used, a typical microstructure (IV) of the gel is visible making it easily distinguishable from the glass. It can be seen that the gel inside the glass forms multiple layers up to 0.13 mm thick around the unreacted core (Figure 6b).

On the left-hand side of Figure 6d, there is a large particle of waste glass that turned into gel almost completely. In contrast to other degraded particles (Figure 6b,f), no degraded glass that may derive from alkali-silica reaction was observed around this particle, likely due to its location next to the large air pore visible in the upper left corner of Figure 6c. A large amount of NaOH solution could potentially accumulate in it, which would affect the ASR rate. The significant degree of degradation is also evidenced by the light-coloured paste observed in non-polarized light (Figure 6c). This indicates that the zone of more degraded mortar around the air pore is 2.3 mm deep.

Observations of the undegraded glass particles smaller than 0.5 mm revealed discontinuous, thin, bright rims (less than 0.01 mm wide) around them (Figure 6f). Their formation may be caused both, by the pores of the aggregate-paste interface being filled with the impregnate and by the formation of ASR products. This can be determined using the SEM analysis.

As a result of ASR, the outer layer of glass is discoloured and cracked as the expanding alkali silica gel is formed underneath (Figure 6) [2]. Glass particle degradation is similar to that of opal aggregate, built exclusively of amorphous phase [40]. As the silica gel swelling, not only the outer layer of the glass is damaged but the resultant cracks propagate to the paste. Spreading in the paste, the cracks may encounter other glass particles on their way and cause their cracking. These cracks are the pathway that leads the hydroxide solution directly to the cracked aggregate. Subsequently, the alkali-silica reaction is initiated from the site where the crack is formed (Figures 4b, 5b and 6e,f). Thus, the process can be described as secondary degradation of glass aggregate due to ASR. The process occurs mainly in the particles smaller than 0.5 mm, which are less susceptible to ASR-induced degradation than the larger particles. This is consistent with the findings of Lee et al. [27] who found that the reduction of glass particle size below 0.6 mm may result in the reduced ASR expansion. At the same time, it is impossible to confirm that the finer fractions of the waste glass entered the pozzolanic reaction. The mortars were made to ASTM C 1260 [38] without glass aggregate grains less than 150 µm and thus it is safe to say that glass grain having pozzolanic properties were not used [20,25,26].

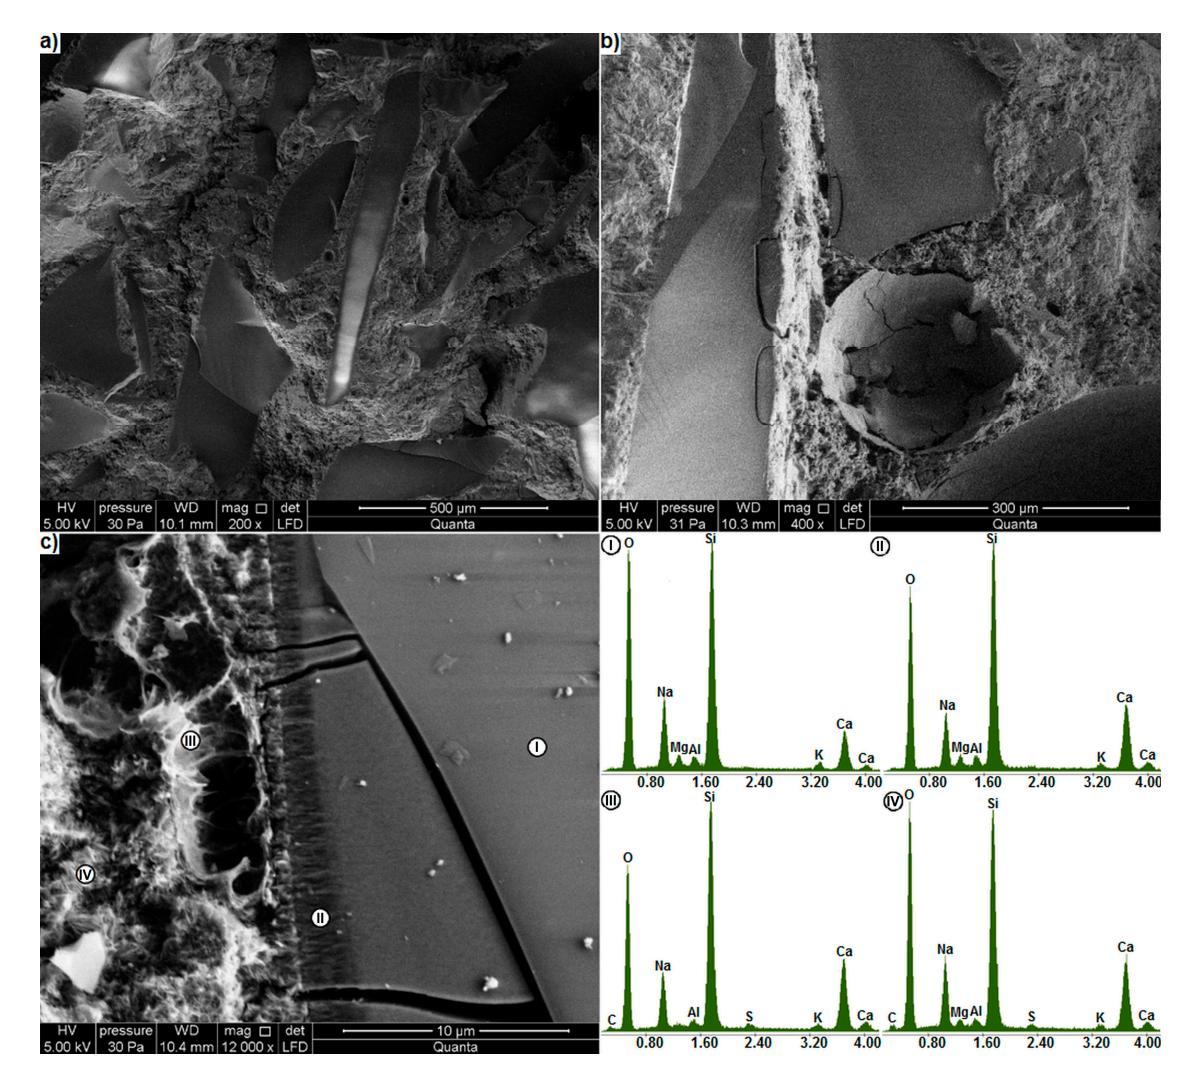
**Figure 7.** Mortar microstructure after 14 days of ASTM C 1260 test (SE). (**a**) General view, (**b**) cracked glass particles, (**c**) changes on the cracked glass particle surfaces, with EDS analysis in points I, II, III and IV.

Figure 7 shows the microstructure of the glass mortar after 14-day exposure in the NaOH bath at 80 °C. The test results confirm that within the ASTM C 1260 test duration [38], the alkali-mortar reaction does not cause any considerable changes in the mortar structure. No cracks are found in the mortar microstructure after 14 days of exposure to NaOH, and the glass particles adhere well to the cement matrix (Figure 7a). Single glass particles with minor cracks on their edges were detected (Figure 7b), mainly in the immediate vicinity of air pores. These can be residual cracks formed during glass grinding [36]. In their immediate vicinity no evident changes in the glass microstructure can be seen, unlike directly at its surface, which can be associated with a small width of the residual cracks, which is less than 2 µm.

The interface between such a particle and the paste observed at higher magnification showed other changes in the glass morphology, which may be attributed to the onset of ASR. A 2.75  $\mu$ m thick fibrous gel layer can form in the glass near the surface (Figure 7c). Similar amorphous fibres at the edges of the aggregate particles were identified as ASR products in gneiss by Boehm-Courjault et al. [42]. The fibres in that layer were oriented perpendicularly to the surface and calcium in so altered glass gave more intense readings (II) than in the unaltered glass (I). A thin layer of gel products with a thickness of up to 1  $\mu$ m formed also on the glass surface. Voids with single fibres of gel phase (III) can be seen between this layer and the cement paste (IV). For the phases occurring outside the glass particle ((I) and (IV)), the presence of sulphur was detected, which is related to ettringite produced during cement hydration [2].

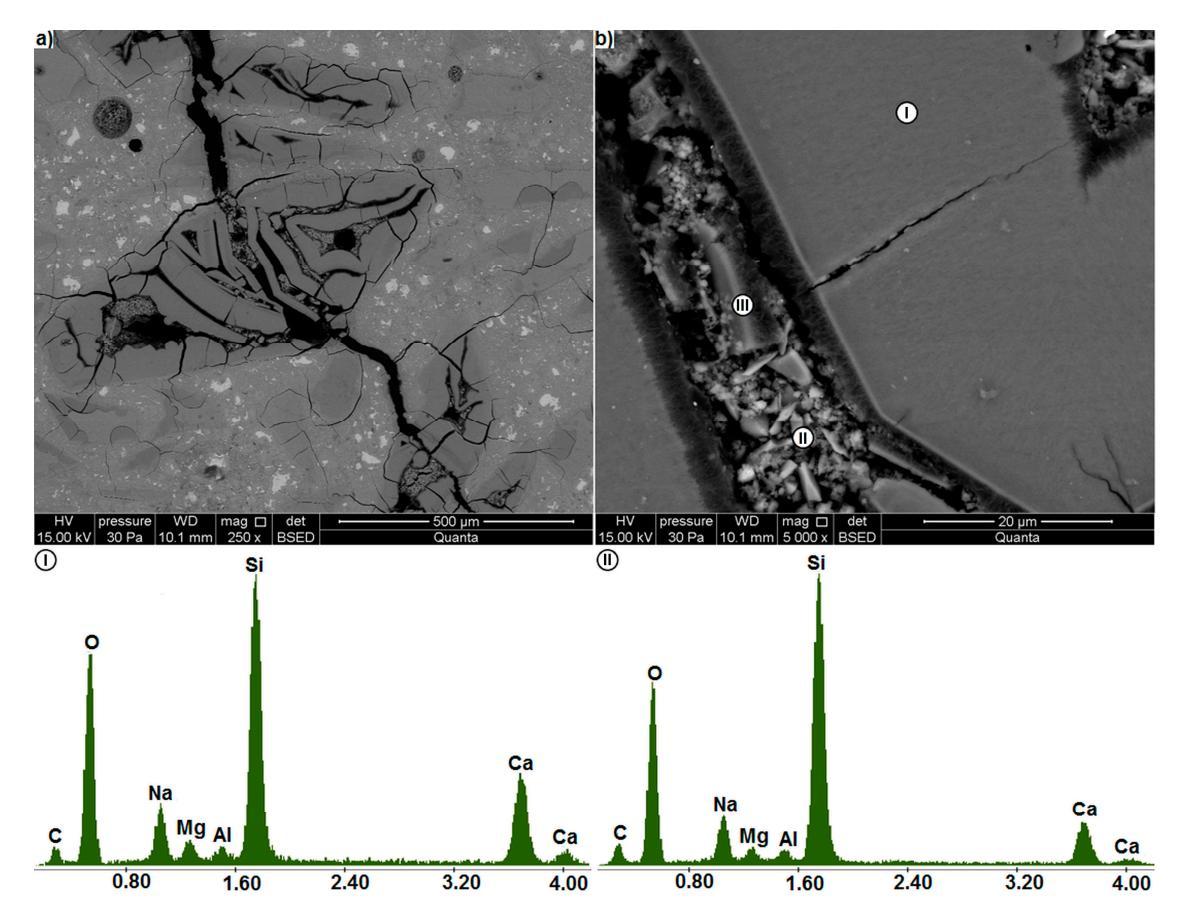
**Figure 8.** (a) Degraded mortar containing cracked waste glass particles, (b) a crack in the glass (BSE); EDS analysis at points I and II.

Figures 8–10 show the microstructure of the glass mortar specimen after 131 days of exposure to 1 M of the 80 °C NaOH solution. Significant changes took place in the mortar microstructure between 14 and 131 days of the test. Just as optical microscopy, the SEM analysis showed the formation of a dense network of cracks. Figure 8 shows a crack that runs through the mortar and passes through glass particles smaller than 0.5 mm. The densely cracked, glass particles contribute to the degradation of the mortar. The mortar itself, however, is cracked only in the immediate vicinity of degraded glass grains and to a relatively small extent compared to the studies of Shin et al. [6] or Idir et al. [19].

The cracks in the glass may be empty the spaces or may be filled with crushed material (II) (Figure 8b). A 4.7  $\mu$ m layer of gel was formed on the cracked surface of the glass. This gel is not as compact as the gel observed by Almesfer and Ingahm [51] or Shin et al. [6] during their studies on type 2 cracks. Inside the cracks, the broken fragments of the top layer of glass together with the gel were observed (III). This may suggest that the layer is not durable and, with the progress of ASR, it may deteriorate and be replaced by another, identical layer. Analysis of the elemental composition did not reveal significant differences between the glass composition (I) and the composition of the material filling the cracks (II). In the crack filling material, only the concentration of calcium is lower.

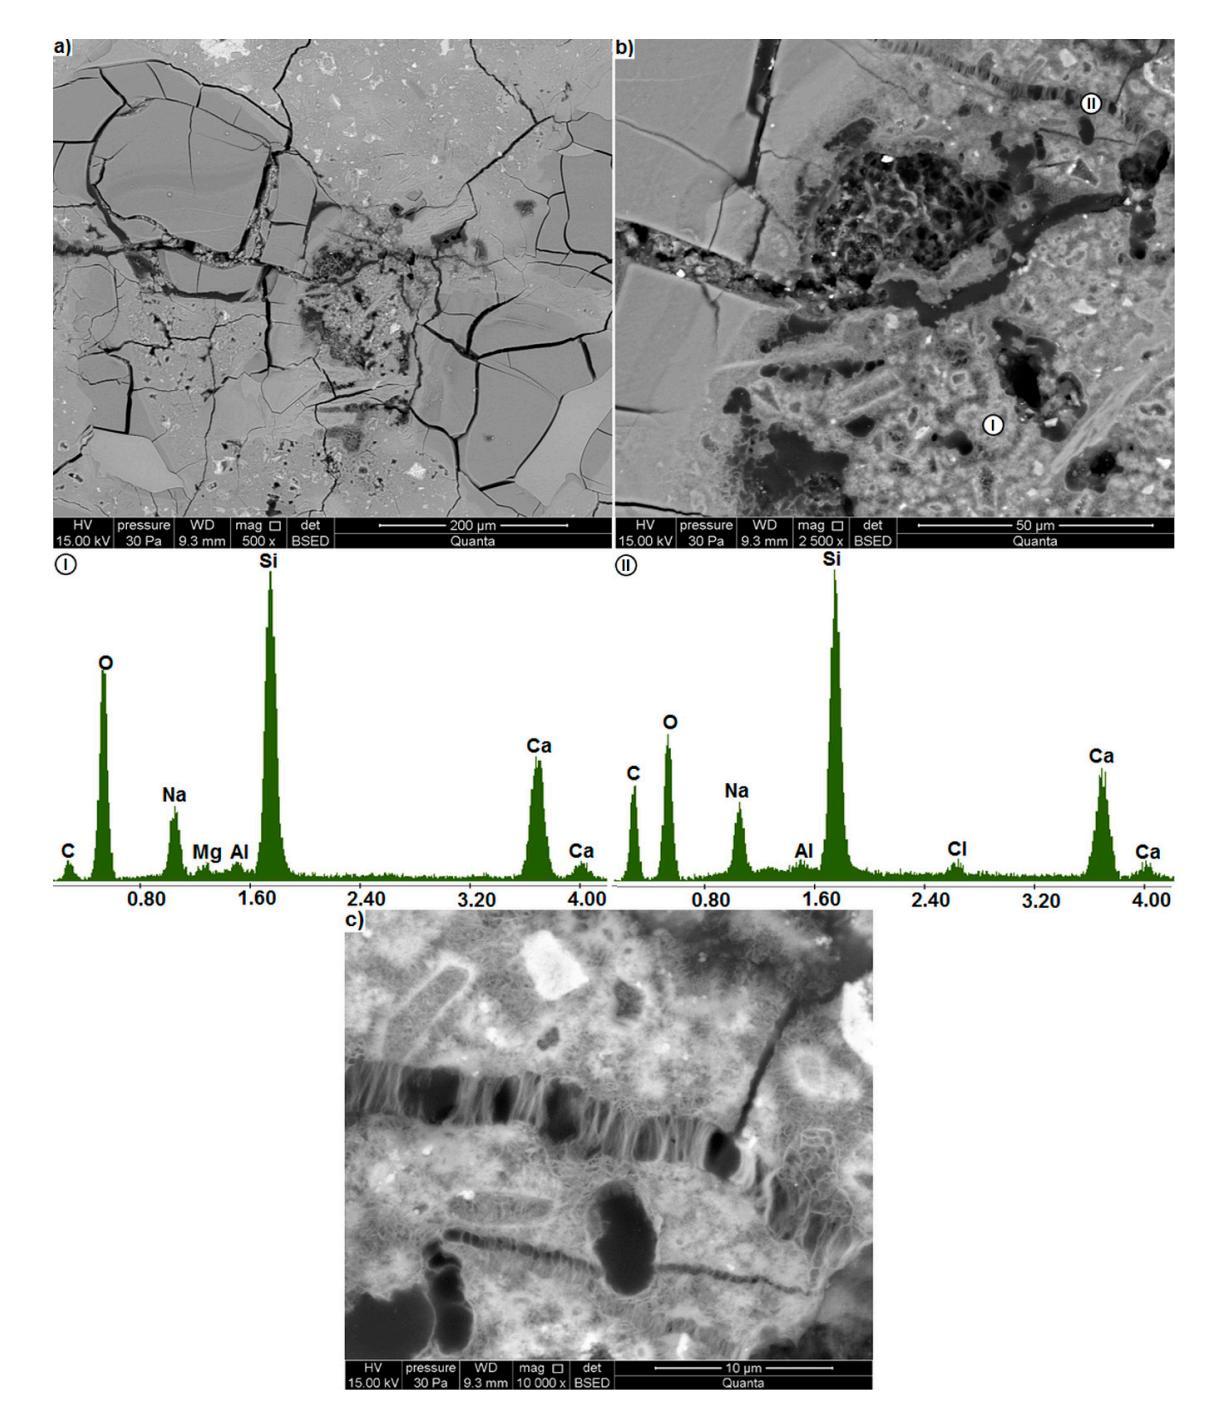
**Figure 9.** (**a**) extensively cracked region in the microstructure of the mortar containing waste glass (**b**) region of porous gel (BSE); EDS analysis at points I and II, (**c**) cracks in the gel.

Figure 9a shows a densely cracked region in the mortar. The cracks propagate predominantly through the glass particles. Between them, there is a region of gel products of higher porosity (II) (Figure 9b). In this area, high silicon content was found; this can be attributed either to the glass particles proximity or to the gel being formed as a result of the waste glass reaction. The cracks spreading in the gel (I) were sealed by the products formed in them (Figure 9c). In addition to other elements present in that area, chlorine was also detected in the cracks. The microstructure of the examined gel resembles that observed on the shist particle in the studies of Leemann and Holzer [47]. Contrary to their findings, in the present study gel concentrations in mortar rarely occurred outside the cracked aggregate. Due to the limited area they occupy, they can be assumed to have formed at the sites of completely transformed aggregate grain. In the samples tested, there were no areas of cracked, compact alkali gel that often forms layers around the aggregate grains and fills the air pores in the mortars in which alkali-silica reaction occurs [7,8,19,20,29,53].

As shown in Figure 9a, glass particles of different colour shades were found. In BSE analysis, brighter spots are obtained where nuclei of elements with high atomic number are present. In the

examined mortar microstructure, no crack propagation was observed in the light-coloured glass. Cracks propagated predominantly in the darker glass. This was particularly evident for glass particles larger than 1 mm (Figure 10a) and led to the conclusion that the degradation of darker glass particles was due to ASR. The darker colour of the glass can be related to linking atoms of light elements,

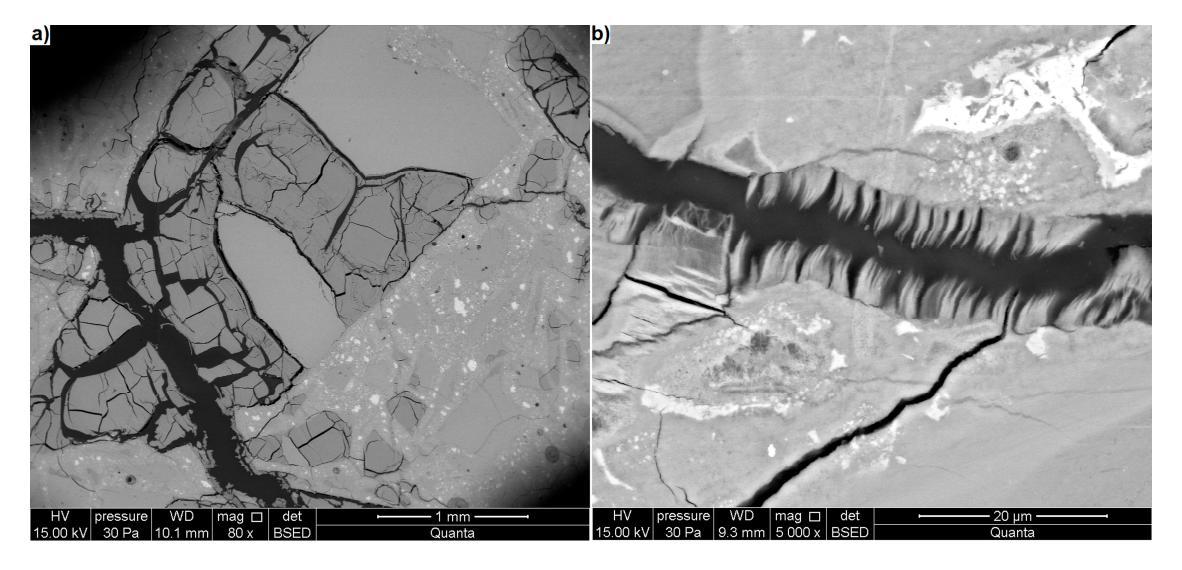
**Figure 10.** (**a**) large glass particle with a variable degradation level, (**b**) a crack running through the cement paste (BSE).

On the walls of cracks spreading through the paste (Figures 9c and 10b), as in the cracks in the glass, the fibrous ASR products are visible (Figure 8b). Their appearance differed depending on the

location. In the cracked glass particles, the fibres formed a relatively compact layer on the glass surface. In the paste, individual fibres up to 5  $\mu$ m in length formed brush-shaped clusters.

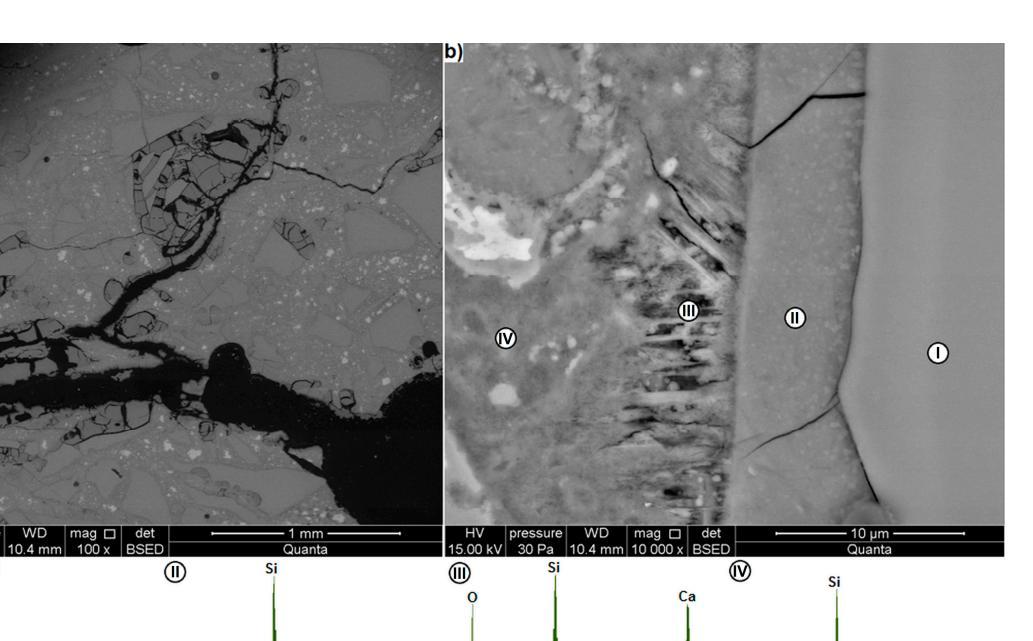
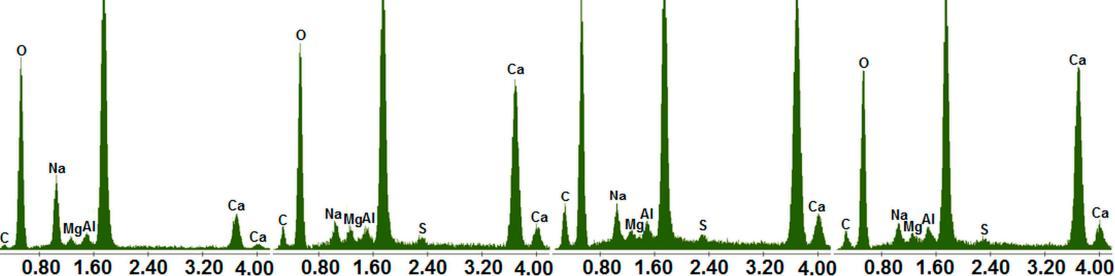
**Figure 11.** Microstructure of the mortar containing waste glass as examined on a thin section (BSE) (**a**) area around a large crack, (**b**) glass-paste interfacial zone; EDS analysis at points I, II, III and IV.

Figures 11 and 12 illustrate the images of thin sections of the specimens showing the microstructure of the mortar with waste glass. The microstructure observed on the thin section is similar to that on the polished section. Figure 11a shows a large 0.3 mm wide crack spreading through the mortar. In its immediate vicinity there are large, extensively cracked glass particles. In deeper parts of the paste there are smaller, undamaged or slightly cracked glass particles. Only single cracks run through the cement paste, which in the glass particles larger than 0.5 mm develop into a dense network of cracks. The glass-paste interfacial zone is typically only slightly damaged. A thorough visual inspection (Figure 11b) shows that undamaged glass (I) is the phase for which sodium shows relatively high concentration and simultaneously calcium - the lowest. In the surface layer of the glass (II) with single cracks, the intensity of the sodium peak decreases significantly and the intensity of the calcium peak increases. The results obtained are similar to those for the C-S-H phase (IV) surrounding the glass particles. This shows that the waste glass transformation occurs in the cement paste.

At the same time, an increase in the carbon peak was found (Figure 11). Carbon gives the most intense readings from the paste region near the surface of glass particles, which has the highest porosity (III). Differences in the intensity of carbon peaks can be attributed to the differences in the number of voids in the studied area. This is because they are filled with the carbon containing a polymeric impregnating substance. The carbon content increases by filling both cracks in the glass and the pores in the cement paste. The increased calcium content at the glass-paste interface, together with the plates arranged perpendicularly to the surface of the particles, indicate the presence of portlandite. This is a typical structure of the paste-aggregate interfacial zone with increased porosity in relation to the cement matrix [2].

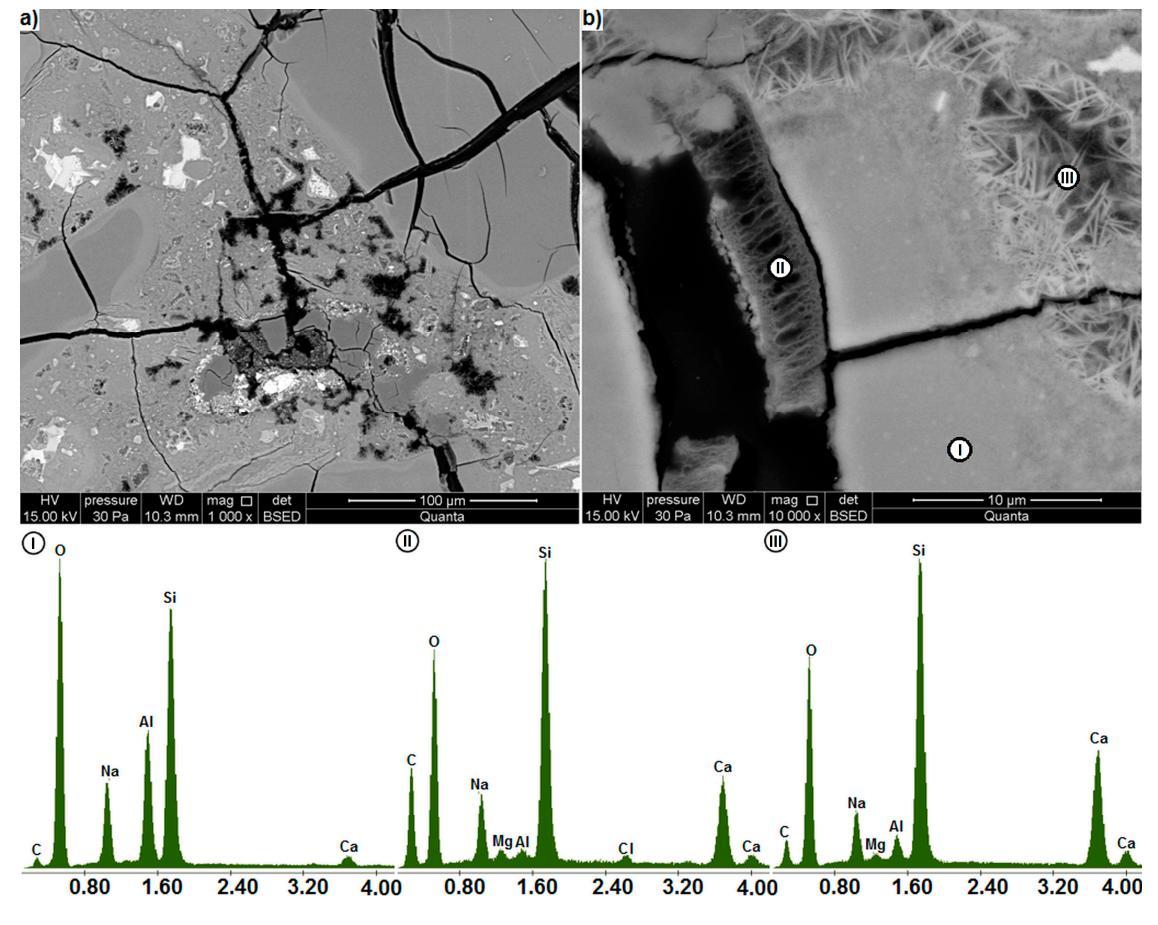
**Figure 12.** (**a**) extensively cracked area in the microstructure of the glass-containing mortar, (**b**) damage to waste glass particles (BSE); EDS analysis at points I, II and III.

As in Figure 9, a densely cracked area of mortar containing waste glass is visible in Figure 12a. There is also an area of porous gel between the glass particles. In the cracks running through the glass particles (Figure 12b) there are cracked layers of gel, up to 4.1 µm thick, similar to those in Figure 8b. However, only one such layer can be seen here, which, cracking transversely, splits between the two sides of the crack. A similar cracking mode was observed for the gel layers in nanocracks of reactive gneisses [42]. The thin cracks between the gel layer and the glass to which it adheres indicate its separation from the glass. In Almesfer and Ingham [51] microstructural studies of glass waste it is also visible. This is important because it shows that after a certain period of expansive gel formation, the gel layer disrupts and allows the alkaline solution to flow into the still unreacted glass. This mechanism can be used to explain the presence of crushed material observed in the cracks in Figures 8b and 9a.

As in Figure 11b the EDS analysis in Figure 12b indicates that with the increased presence of voids in the region under examination, the intensity of signals from carbon increases. The strongest peaks are observed for the porous gel layer in the crack (II) and the weakest for the homogeneous glass (I). Around the glass, there is also a calcium-rich, porous layer filled with needle-like products (III), which may be portlandite and ettringite [2].
