Article

Wear Behavior of Conventionally and Directly Aged Maraging 18Ni-300 Steel Produced by Laser Powder Bed Fusion

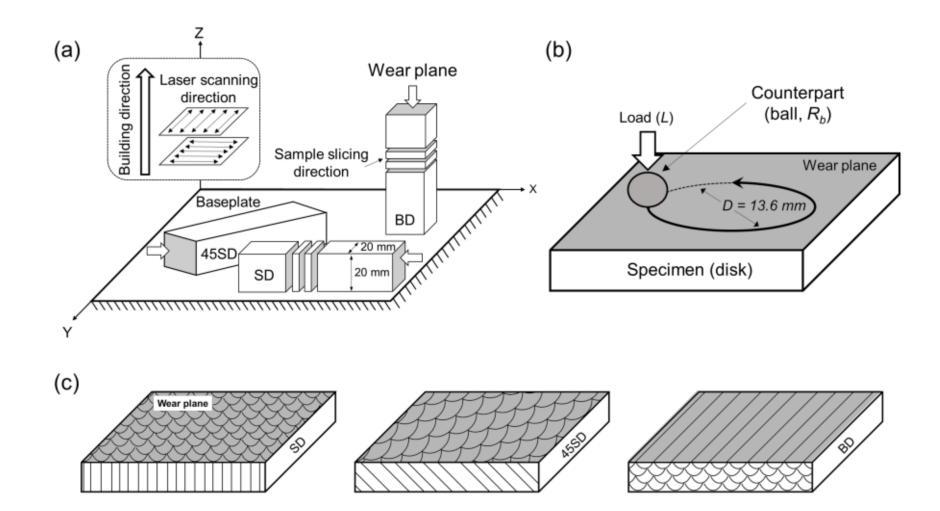
Figure 1. (a) Schematic of sample geometries, LPBF scanning strategy, building direction, and wear test directions, (b) schematic of the ball-on-disk wear test system, and (c) schematic of each sample and wear plane.

To examine the anisotropy of the wear behavior of the samples, three types of samples were built along with three directions with the LPBF building axis. The samples were then sliced in $20 \times 20 \times 3$ mm³ blocks for the wear tests, as shown in Figure 1a. The wear tests were performed in the vertical and parallel directions to the baseplate (Figure 1a). The samples with wear planes at 0° and 45° to the laser-scanning direction were designated as SD and 45SD, respectively, whereas the samples with a wear plane vertical to the building direction were designated as BD. The heat-treated SD, 45SD, and BD samples were marked as SD-HT, 45SD-HT, and BD-HT, respectively.

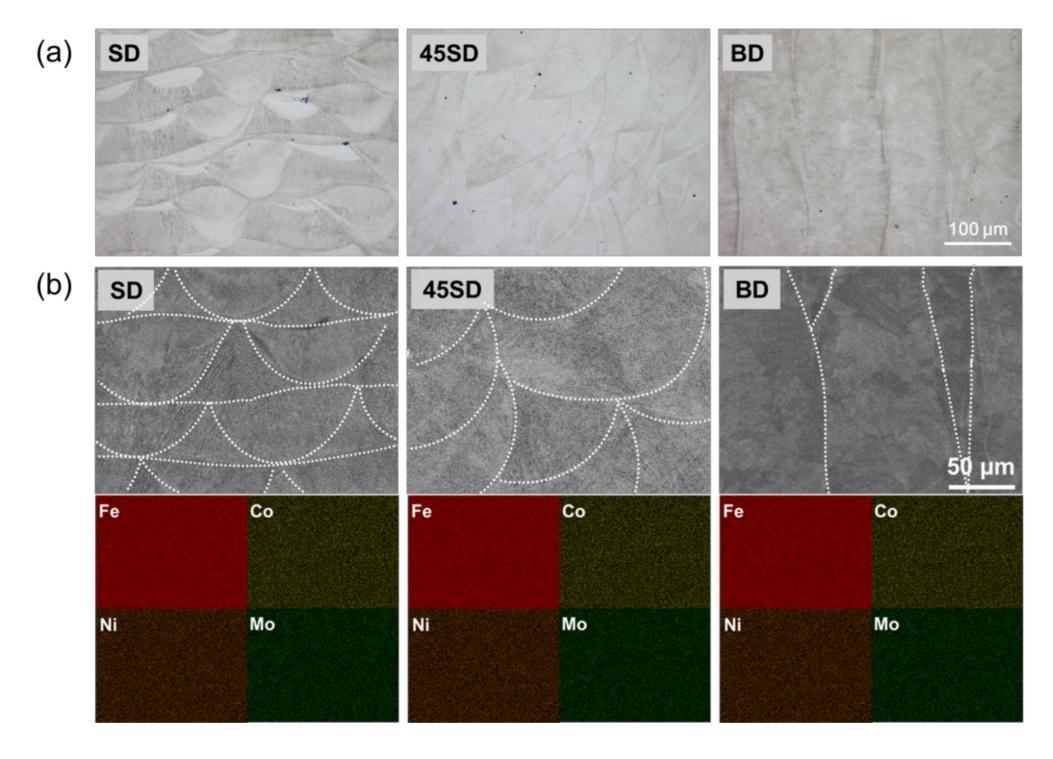
Figure 2. (a) OM images (\times 200) and (b) SEM images (\times 500) and EDS mappings of the wear plane of each as-built sample.

The microstructures of the three different wear planes of the as-built sample were investigated and the results are shown in Figure 2. Figure 2a displays the microstructure observed with the OM. The melt pool boundaries can be clearly observed. The width and height of the bead were approximately 150 and 40 μ m, respectively, which were equal to the lamination thickness used during the LPBF process. The EDS analysis was performed for the samples manufactured by the LPBF process to examine the chemical homogeneity. The results are shown in Figure 2b along with corresponding SEM images. The chemical homogeneity was clearly observed in all samples and no differences were observed depending on the building direction. In addition, the beads generated during the LPBF process are observed in the wear plane of each specimen (white line). Further details regarding the microstructure, and tensile behavior of the LPBF-processed maraging steels used in this study can be also found in [22].

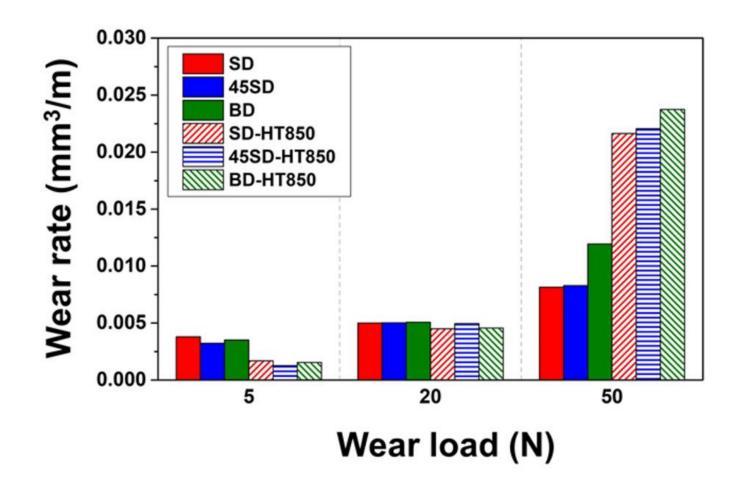
Figure 3. Comparison of wear rates after the wear tests with a total wear distance of 90 m under various wear loads using the AISI 52100 steel for the counterpart material.

Figure 3 shows the differences in the wear rates between the as-built and HT850 samples under the various wear loads. Both the as-built and HT850 samples do not show a pronounced building direction dependency under the wear load of 5 and 20 N. When the wear load was 50 N, both the as-built and the HT850 samples showed strongly anisotropic wear behavior, i.e., wear rates that strongly depend on the wear loading direction with the LPBF building direction. For as-built specimens, more severe wear occurred in the BD specimen than in the SD and 45SD specimens. As shown in the previous study [22], the yield strength of the maraging steel is the weakest in the BD direction among the three directions tested in both as-built and heat-treated states. Thus, the slightly higher wear rates in the BD specimens can be explained by the more severe plastic deformation by wear loading in this direction than in the other two directions tested. This assumption is supported by the fact that pronounced building direction dependency is observed only when the applied wear load is the highest.

At the wear load of 5 N, the HT850 samples exhibited ~50% of the wear rate of the asbuilt samples in all directions because of increased hardness. When the wear load increased to 20 N, the difference in the wear rate between the as-built and HT850 samples drastically decreased. For the wear load of 50 N, despite the higher hardness, the HT850 samples showed more severe wear than the as-built samples. This seemingly counter-intuitive wear behavior at the high wear load is considered to be from the third body wear by the particles formed from the wear of the counterpart ball. As will be shown in the following sections, the wear of the counterpart AISI 52100 bearing steel ball occurs much more severely for the HT850 samples than the as-built samples.

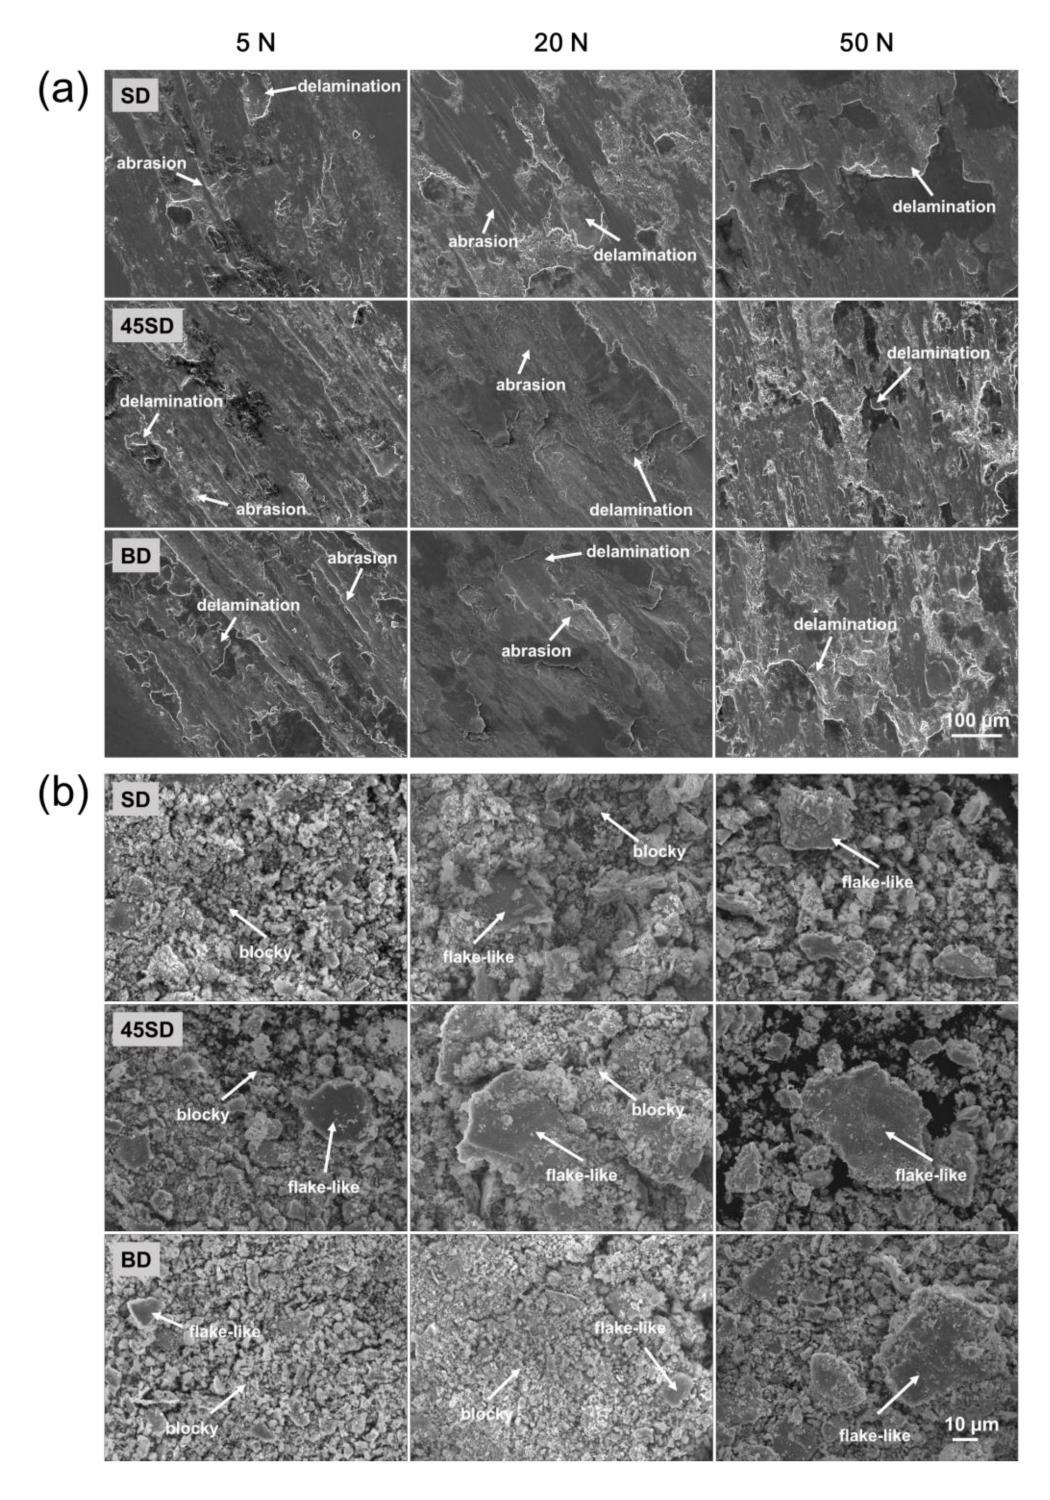
Figure 4. SEM images of (**a**) worn surface and (**b**) wear debris of as-built samples worn against AISI 52100 steel ball with different wear loads.

To accurately analyze the wear mechanisms as per the wear conditions, Figures 4 and 5 show the SEM images of worn surface and debris, respectively. Figure 4 shows worn surfaces and debris as per the various wear loads of the as-built sample. At the wear load of 5 N, worn surface morphologies indicated mixed abrasive and adhesive wear mechanisms are observed, as shown in Figure 4a. As shown in Figure 4b, under this wear loading condition, certain flake-like debris along with the blocky debris were reported. The fine blocky debris is believed to be formed by the abrasive wear of the maraging sample, whereas the flake-like debris originates possibly from the delamination of the locally strain-hardened thin film. These results are observed equally in every three-building direction.

With increase in wear load, the delamination marks became larger and the size of the flake-like debris gradually increased, as shown in Figure 4. This behavior can be understood by increasing the depth of the locally strain-hardened film by increasing the wear load. The thicker the hardened film, the easier the delamination damage occurs; consequently, the wear rate will be increased.

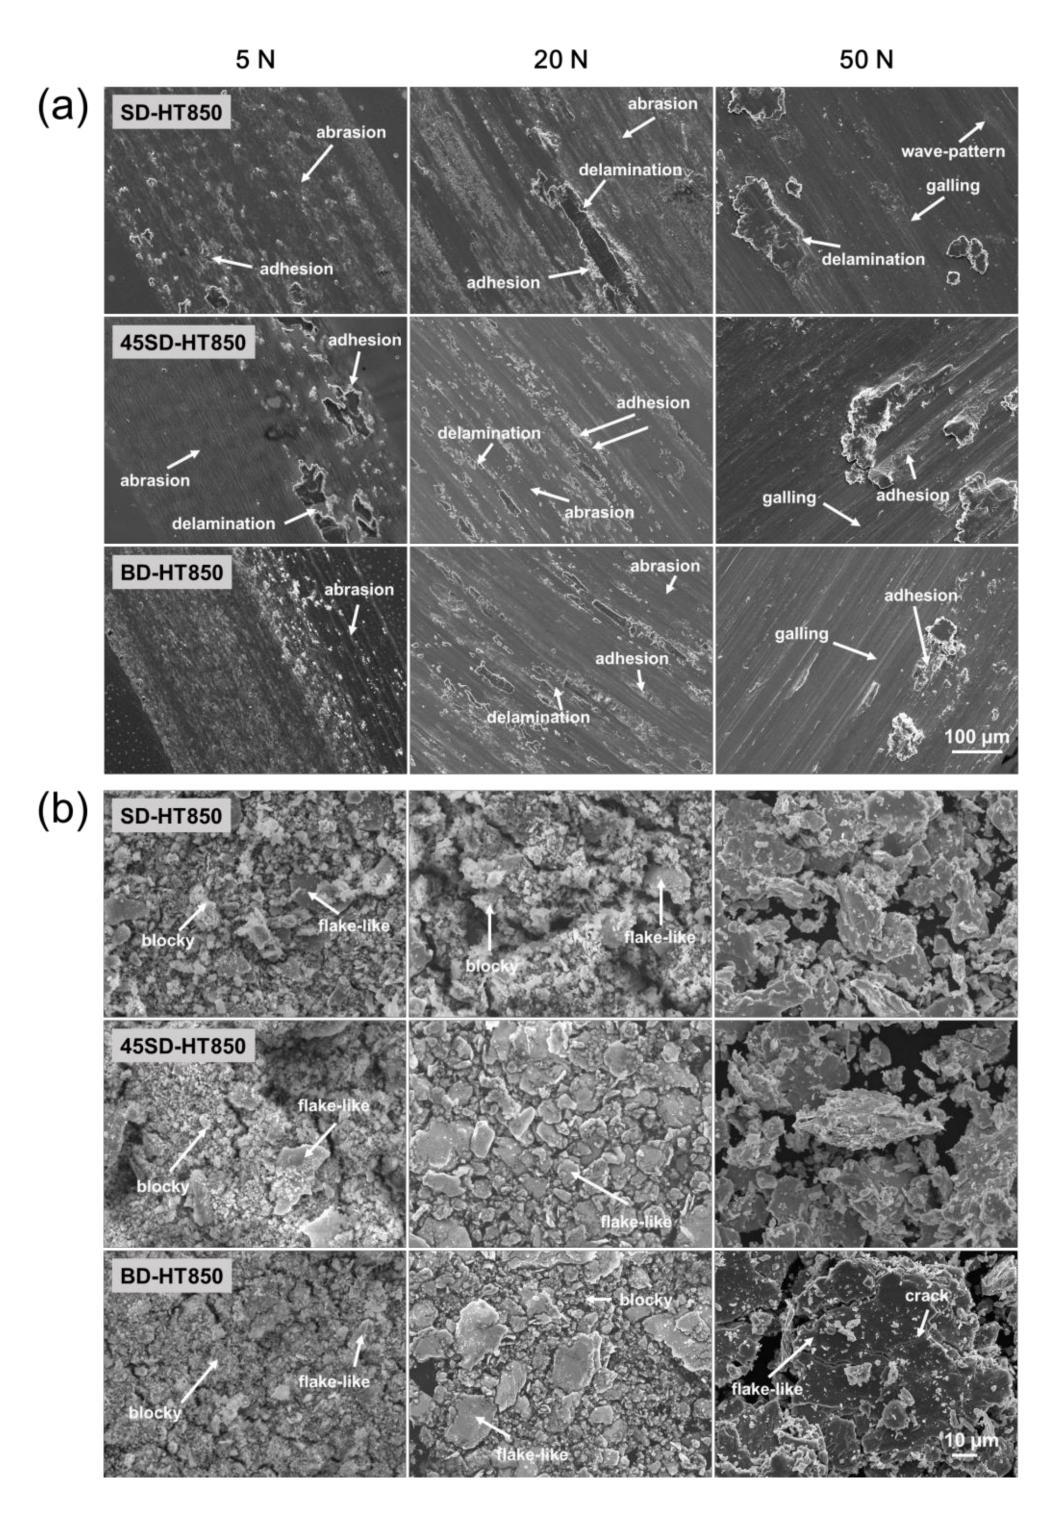
Figure 5. SEM images of (**a**) worn surface and (**b**) wear debris of HT-850 samples worn against AISI 52100 steel ball with different wear loads.

Figure 5 shows the worn surfaces and debris of HT850 samples. At the wear load of 5 N, abrasive and adhesive worn surfaces are observed together in all specimens, as shown in Figure 5a. The higher hardness of the HT850 sample than the as-built sample promotes adhesive wear of the counterpart-bearing steel balls. The worn surfaces showed marks as per the delamination fractures. The wear scars from the delamination fractures in the HT850 samples were smaller than those of the as-built samples, indicating that the delamination followed by the formation of a locally strain-hardened thin film is less pronounced for the heat-treated samples due to their high hardness. As shown in Figure 5b, the wear debris primarily comprise fine and blocky wear debris, which is produced by abrasive wear. Moreover, there

is a small amount of flake-type wear debris because of the delamination fractures. For the wear load of 5 N, the morphology of the wear debris of all samples is similar, indicating that the same wear mechanism was active regardless of the sample building direction and the wear load.

Figure 5a shows the worn surfaces reveal the increasing adhesive wear action with increase in wear load. At a 50 N wear load, the worn surface indicates that the wear is dominated by adhesive and delamination fracture without significant abrasive wear damage. Furthermore, marks from galling damage are observed in this condition.

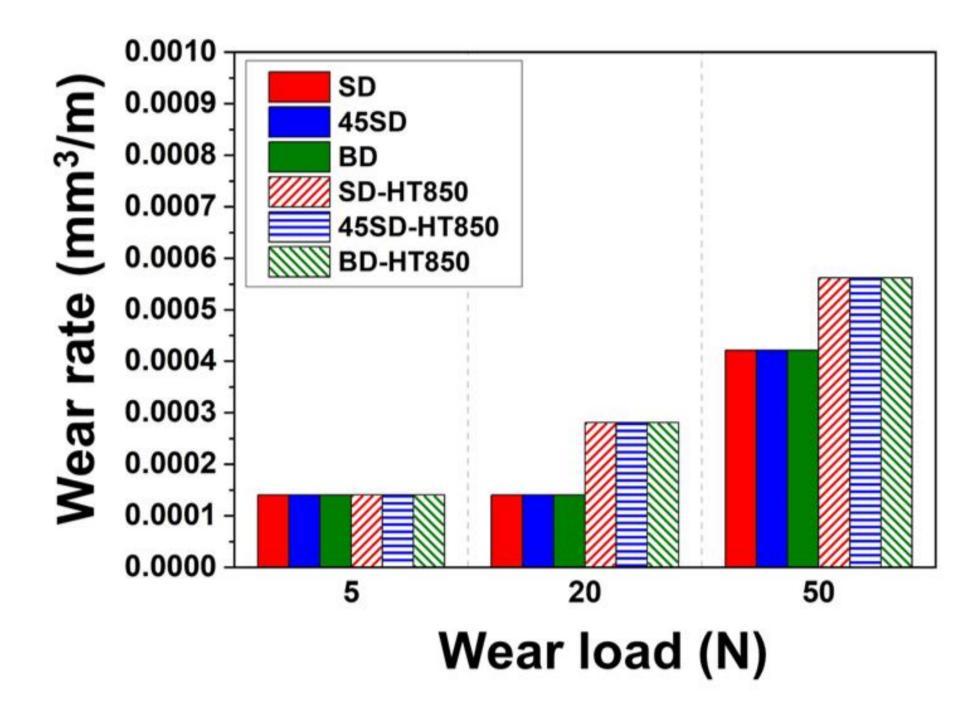
Figure 6. Comparison of the wear rate of AISI 52100 steel counterpart balls.

Figure 6 shows the comparison results of the wear rates of the AISI 52100 bearing steel counter balls for as-built and HT850 samples. There was no dependence on the building direction of the wear rate of the bearing steel counterpart balls. The wear rate of the ball increased with an increased wear load. The wear of the ball was more severe when the maraging sample was heat-treated, which supports the assumption that the third body wear by the particles formed from the wear of the counterpart ball is the primary reason for the faster wear rate in the heat-treated maraging steel compared to that of the as-built state, when the wear load was 50 N.

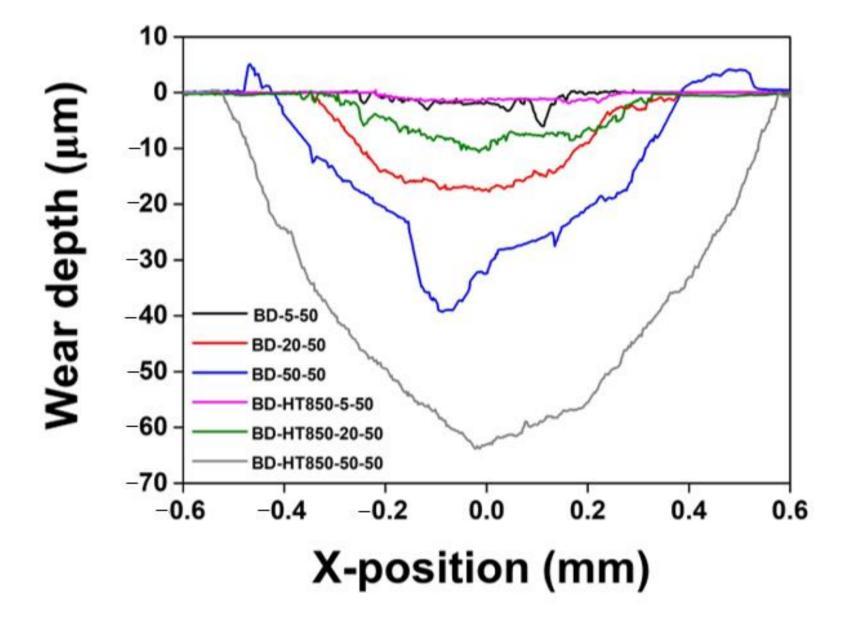
Figure 7. Comparisons of wear track profiles between as-built and HT850 samples worn under various wear loads.

Figure 7 shows the comparison results of the wear depth and width of BD samples for the as-built and HT850 samples. Overall, the worn surface profile results show the same tendency as the wear rates shown in Figure 2. At wear loads of 5 N, the wear depth of the BD sample is deeper than that of the BD-HT850 sample. For the wear loads of 5 and 20 N, there was no significant difference in the width of the wear tracks between the as-built and HT850 samples. For the wear load of 50 N, however, the wear track width of the HT850 sample was pronouncedly deeper than that of the as-built sample, which can be associated with the severe wear of the steel ball for this wear loading condition when the maraging steel sample was heat treated. Owing to the progression of wear on the steel ball, the contact area of the steel ball became wider; eventually, the area that touched the maraging steel sample increased, resulting in a wider wear area of the sample [27].

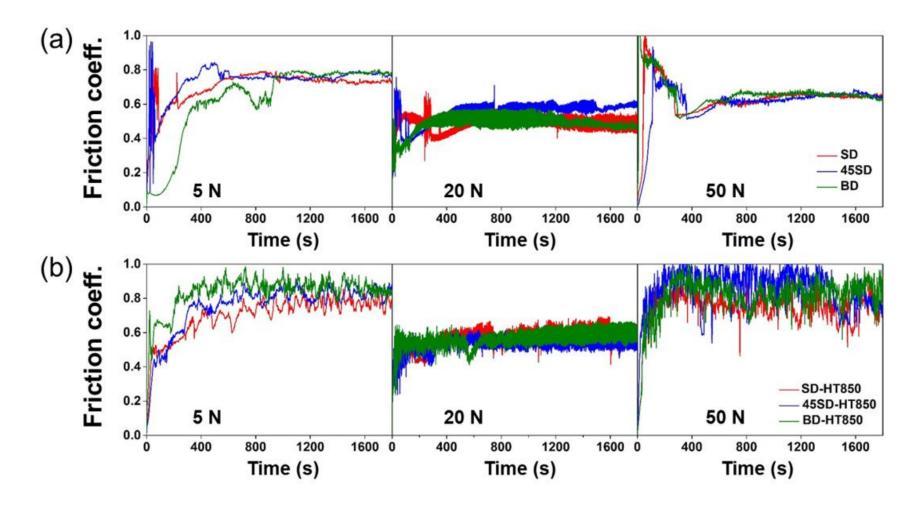
Figure 8. Evaluation of COF with time during wear tests against AISI 52100 bearing steel ball of samples in (**a**) as-built and (**b**) HT850 heat treatment.

Figure 8 shows the evolution of the COFs with time during the wear tests against AISI 52100 bearing steel balls. After the initial period where the sample and ball were adapted to each other, the as-built samples exhibited stable COF evolutions until the test was completed in all wear load conditions, as shown in Figure 8a. There was no clear difference in the stable COF values between the samples SD, 45SD, and BD, indicating that the COF does not depend on the LPBF building direction. At the wear load of 5 N, the COF soared at the beginning of the wear and then stabilized at a value of ~0.7–0.8. The stable COF values for the wear loads of 20 and 50 N were ~0.4–0.6.

For HT850 samples, the COFs evolved similarly to those of the as-built samples for the wear loads of 5 and 20 N. However, for the wear load of 50 N, evolutions of the COFs were slightly different from the as-built samples, as shown in Figure 8b. The COFs evolved relatively unstable and had an amplitude that was greater than the as-built sample. This is probably attributed to the progressive wear of the bearing steel ball during the wear tests.

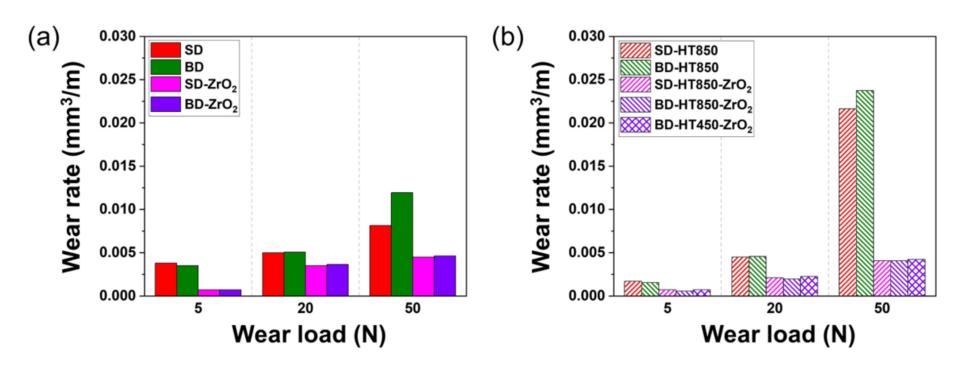
Figure 9. Comparison of the wear rates after the wear tests using AISI 52100 steel and ZrO_2 balls as counterpart materials. (a) As-built and (b) heat-treated samples.

Figure 9 shows the wear rates of the maraging steel using the bearing steel and ZrO_2 balls as the counterpart materials. Because there was almost no difference in the wear rates between the SD and 45SD samples when they wore against the bearing steel, the wear tests against the ZrO_2 balls were conducted by the SD and BD samples. The influence of direct aging on wear resistance was investigated by comparing the wear rates of the BD-HT850 and BD-HT450 samples worn against the ZrO_2 balls.

Figure 9 shows the comparison of the wear rates between two counterpart balls show that the wear rates of the maraging steel were much lower when the ZrO_2 ball was used as the counterpart material rather than the bearing steel ball. This behavior was observed for the maraging steel samples in both the as-built and heat-treated states. Moreover, the wear rates of the heat-treated samples were slower than the as-built samples in every condition tested when the ZrO_2 ball was used as the counterpart material.

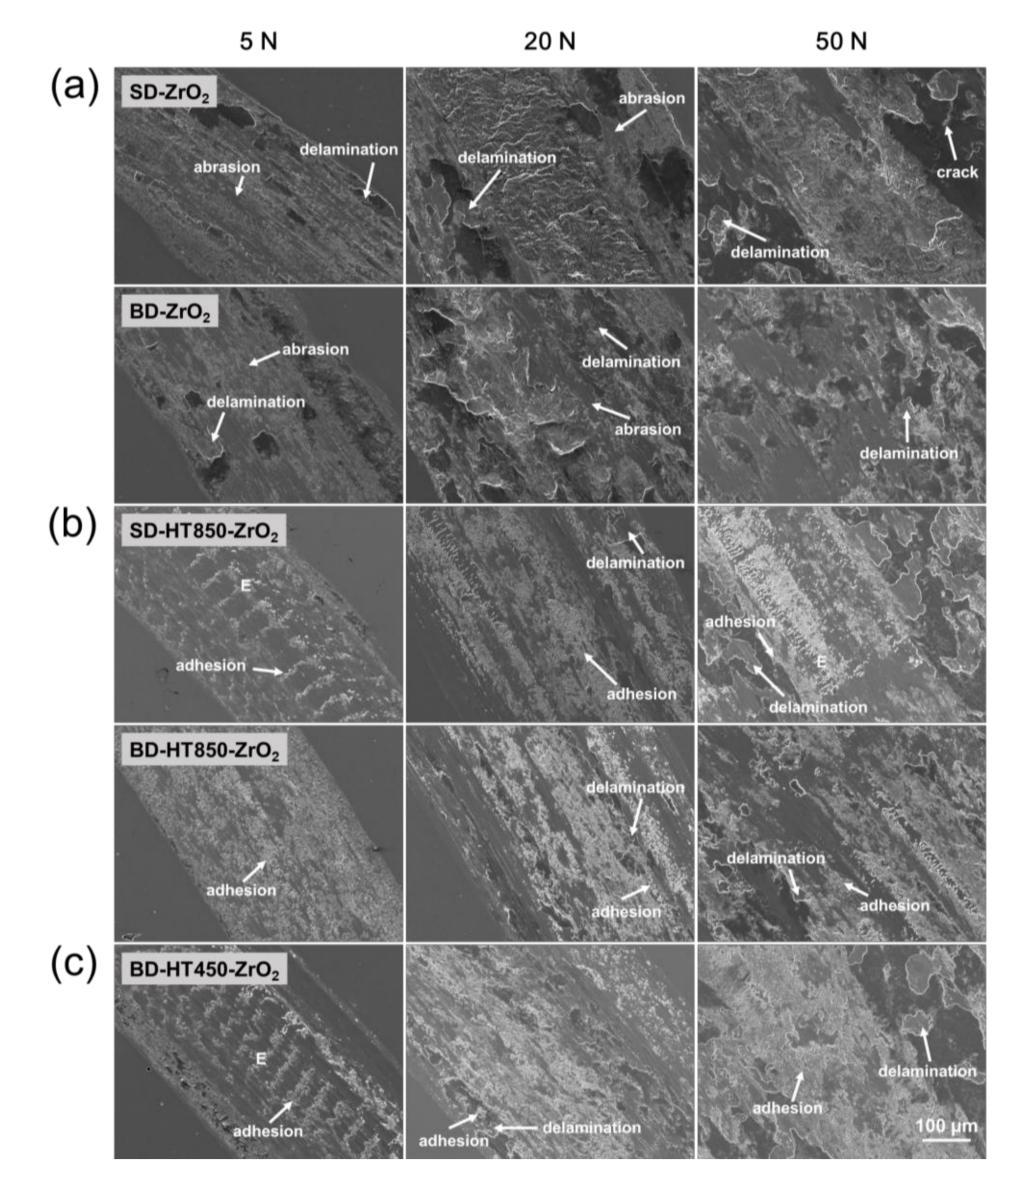
Figure 10. SEM images of the worn surface of maraging steel worn against ZrO₂ balls: (**a**) as-built, (**b**) HT850 and (**c**) HT450 heat-treated samples.

Figures 10 and 11 show the worn surfaces and debris of the maraging steel samples produced by the LPBF after the wear tests against ZrO₂ balls. In the as-built state, the worn surface morphologies of the maraging steel samples were similar to those worn against the bearing steel balls, as shown in Figure 10a. The wear debris morphologies in these cases were nearly the same as the cases against the bearing steel balls, i.e., fine blocky debris with flake-like delaminated particles, as shown in Figure 11a. Hence, the primary wear mechanisms in these cases are considered to be the same as the cases when the bearing steel ball was used as the counterpart material, i.e., severe abrasive wear with delamination fracture of a work-hardened thin layer. For heat-treated samples, the worn surfaces reveal that the dominant mechanism is severe adhesive wear. Furthermore, patterns indicative of fine particles embedded in the worn surface are observed (marked as "E" in Figure 10b,c). The formation of such a pattern is evidence of hard ceramic debris in the worn surface during the wear test and adhesive wear occurs in these areas [28,29]. Therefore, these patterns probably are from a fine and hard ZrO₂ debris formation during the wear tests. Delamination fractures are observed on the worn surfaces of the heat-treated

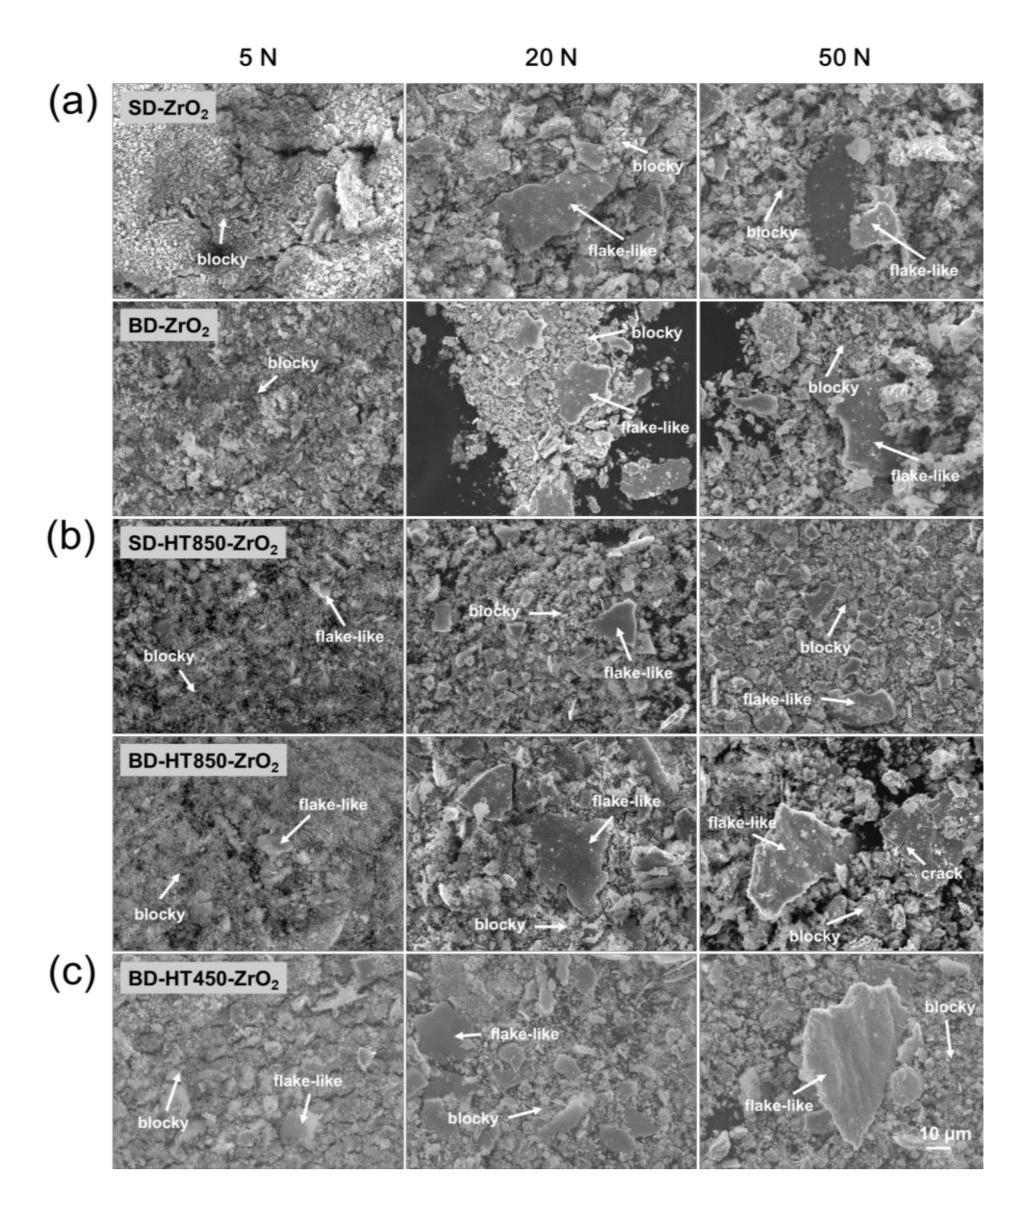
Figure 11. SEM images of the debris of maraging steel worn against ZrO₂ balls: (**a**) as-built, (**b**) HT850 and (**c**) HT450 heat-treated samples.

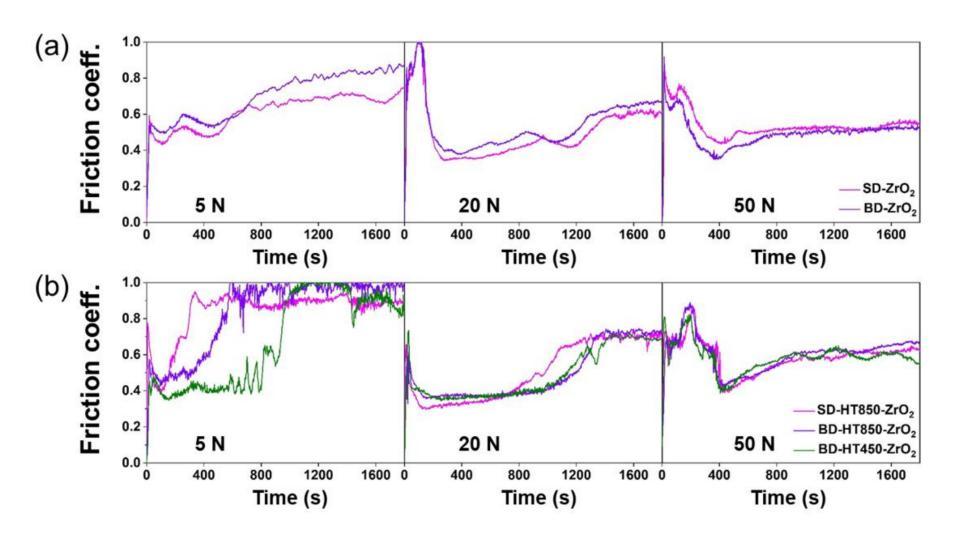
Figure 12. Evolutions of COF with time during the wear test using ZrO₂ ball as counterpart material: (a) as-built and (b) heat-treated states.

Figure 12 shows the evolutions of the COFs during the wear tests of the as-built and post heat-treated maraging steel samples produced by the LPBF when the ZrO_2 balls were used as the counterpart material. The graphs indicate much more stable evolutions of the COFs with far less amplitude compared to the COF evolution when the bearing steel balls were used as the counterpart material. One possible reason for these stable COF evolutions is the ZrO_2 ball being less worn out during the wear tests. At the wear load of 5 N, the COFs tend to increase gradually until the end of the wear test. This phenomenon is considered because of the slow and progressive adhesive wear action of the ZrO_2 as the wear sliding slowly occurs. For wear loads of 20 and 50 N, the COFs rise rapidly at the early stages, stabilized, and then gradually increased again during the wear tests. The rapid rise of the COF at the beginning of the wear test is considered to be attributed to the abrasive wear action by the narrow contact area between the ball and the flat surface. The second gradual increases in the COFs are possible because of the formation of the adhesive hard ZrO_2 particles on the worn surface of the maraging steels. The stable COF values were ~0.4–0.5, which were slightly smaller than those observed from the bearing steel balls.

The evolutions of the COFs of the HT850 and HT450 samples were similar in every wear condition tested. The values of the stable COFs were nearly the same. The evolution of the COFs with the observations of the worn surfaces and debris indicates that direct aging without solution treatment will not cause any major problems under these wear conditions.
