Corrosion Assessment of a Weathering Steel Bridge Structure after 30 Years of Service

Keywords: weathering steel; protective ability index; bridge inspection

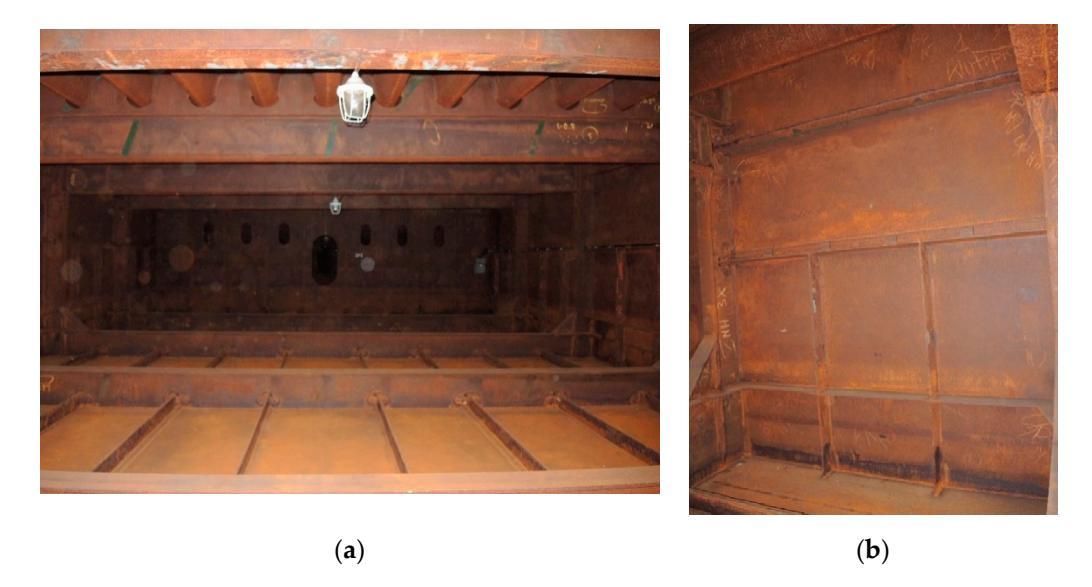
Figure 1a,b shows the typical appearance of weathering steel sections in the interior of the box girder and on the web. Inside the box girder, the colour of the patina on individual parts of the structure is varied. On the side wall of the girder, the patina ranges from light brown (rusty) to dark brown. Darker colours occur especially in the zone of the bottom of the structure and the lower parts of the webs, probably due to the zone of immersion of the section (up to approximately 90 cm) during floating of the elements by the river. Besides these places, patina discolouration in the form of smudges occurs mainly in the zone of the orthotropic section plate. Table 3 shows the appearance of patinas observed on various structural members of the protective layer. According to the literature [3,4,20,21], at the initial stage of corrosion of weathering steel, the patina formed is light brown in colour and, as the phase transformations continue, the patina layer darkens to a dark brown colour. The thickness of the patina increases gradually to hundreds of micrometres. If the patina layer is too thick, it tends to peel off and the steel surface is not protected.

Figure 1. Typical appearance of weathering steel plates in the interior of a box girder (a) and on the side wall of a box girder (b).

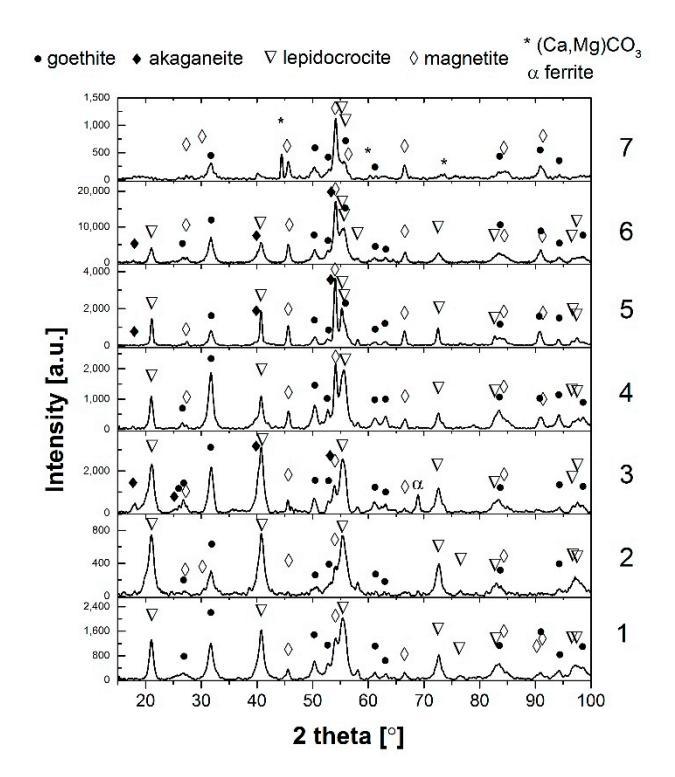
Figure 2 shows X-ray diffractograms of patinas formed on the analysed areas of the weathering steel with the results of qualitative analysis. Table 4 shows the mass fraction of individual crystalline phases in the patina volumes and the calculated PAIs. The rust layer formed on the weathering steel inside the boxes is mainly composed of α -FeOOH (goethite), γ -FeOOH (lepidocrocite) and spinel Fe₃O₄ (magnetite). Additionally, β -FeOOH (kageneite) was also observed in samples 5 and 3, (Ca, Mg)CO₃ was present in sample 7 and some ferrite traces were observed in sample 3. Hara et al. [17,22] found that β -FeOOH and Fe₃O₄ can be formed in the presence of chlorides and magnetite Fe₃O₄, as a spinel phase is often formed by the reduction of kageneite, especially when the patina layer remains wet for a long time.

Figure 2. X-ray diffractograms of patinas from the analysed areas shown in Table 4, with qualitative analysis results.

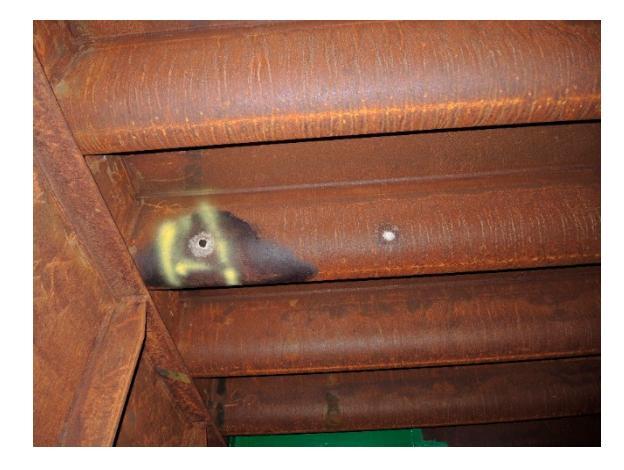
$PAI_{\alpha} < 1$ and $PAI_{\beta} > \approx 0.5$ indicates that the majority of the patina components is composed of reactive phases other than goethite, which corresponds to samples 5, 6 and 7. In this condition, the patina layer typically reaches a thickness of > $400 \mu m$ [3,4] and may peel or fall off in fragments, as observed in samples 6 and 7. Furthermore, the predominant components of the patina in sample 7 are phases other than goethite, such as magnetite and calcium magnesium carbonate (Ca, Mg) CO_3 , hence the unusual red/orange colour of the patina. When most of the components of the kagenei layer on the steel are reactive components other than goethite (PAI $_{\alpha}$ < 1) and PAI $_{\beta}$ > \approx 0.5, the patina does not properly perform its barrier function. Sample 5 was taken from the bottom of the ribs of an orthotropic plate and exhibits a very high content of kageneite at about 40% by weight, which forms in the presence of chloride ions [8,9]. This type of patina was formed due to leakage in the bridge insulation and water pooling inside the ribs. Under long-term immersion in fresh or sea water, the corrosion rate of weathering steel is the same as for carbon steel [12]. Upon further inspection of the bridge, it was observed that in areas of black patinas at the bottom of the ribs, corrosion of the steel locally occurs to the point of perforation with distinct salt crystals (mainly hydrated sodium carbonate Na₃H $(CO_3)_2$ —2H₂O) around the perforation, as shown in Figure 3.

Figure 3. Perforation of an orthotropic plate rib at a patina area containing a high mass fraction of kageneite, as in sample 5.

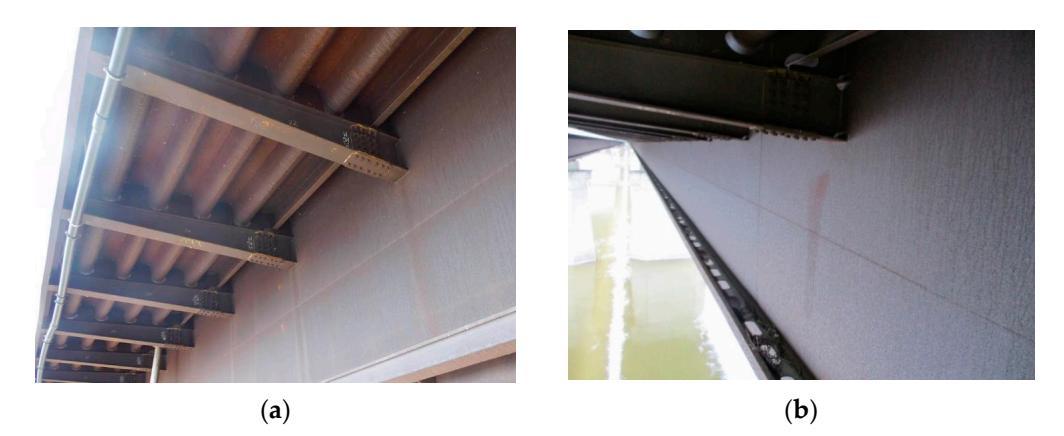
Figure 4a,b shows the deck structure in the support section and the typical appearance of the weathering steel plates on the outside of the box girder. In contrast to the patina colours found inside the box girder, the patina formed under external conditions is dark brown and brown. A layer of patina of varying thickness and smudges was observed on the girder webs. Table 5 shows the appearance of patinas observed on various structural members of the bridge on the outside of the box girders, with characteristics regarding the colour and adhesion of the protective layer.

Figure 4. The bridge structure in the support part (**a**) and the typical appearance of plates made of weathering steel on the external side of a box girder (**b**).

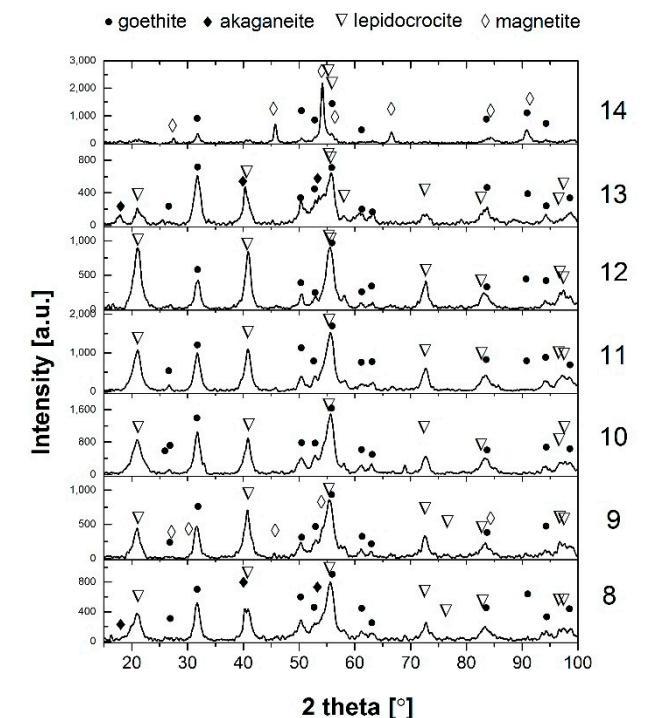
Figure 5 shows X-ray diffractograms of patinas from the analysed areas with the results of qualitative analysis. Table 6 shows the weight fraction of each crystalline phase in the patina volumes and calculated PAIs. The rust layer formed on the weathering steel on the outside of the boxes is mainly composed of α -FeOOH (goethite) and γ -FeOOH (lepidocrocite). Additionally, β -FeOOH (akaganeite) was observed in samples 8 and 13, and spinel Fe₃O₄ (magnetite) was present in samples 9 and 14. According to the literature [23,24], the development of corrosion products on weathering steels strongly depends on the local microclimate nearby the bridge structure, as some surfaces can be rained down.

Figure 5. X-ray diffractograms of patinas from the analysed areas shown in Table 6, with qualitative analysis results.
