Article

Effect of Thermal Degradation of FKM on Three-Body Abrasion under Dry Sliding: Severe Damage Led by the Particle Detention

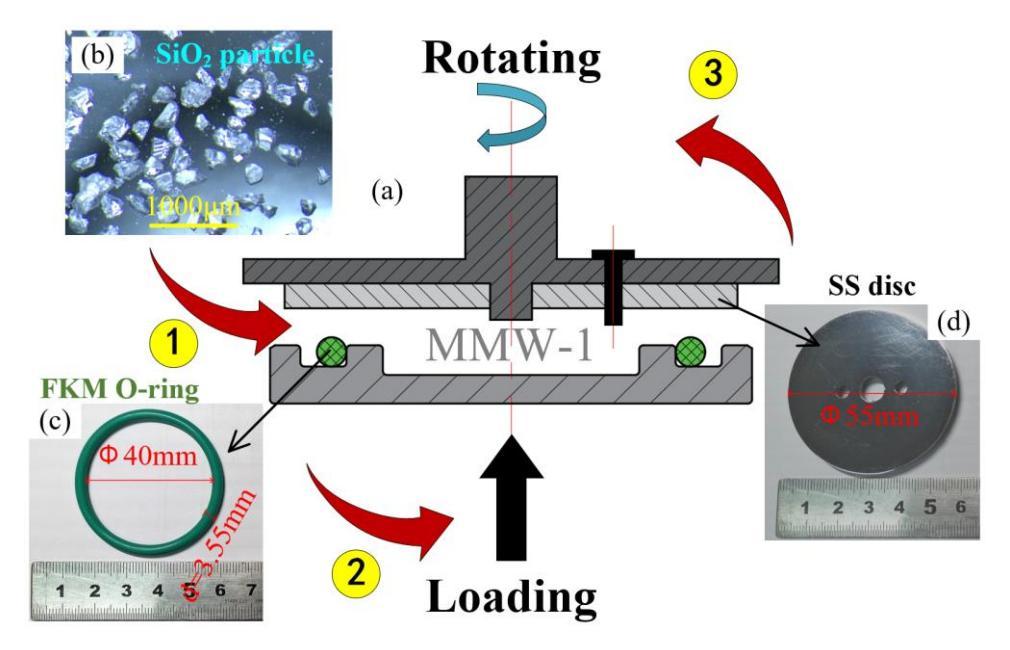
Figure 1. Schematic diagrams of (**a**) MMW-1 wear test rig (not to scale), and the inserts are (**b**) the optical micrograph of abrasive particles and (**c**) the pictures of the FKM seal and (**d**) metal disc, respectively.

The abrasive particles used in the three-body abrasion tests were supplied by the Fucai Mineral Products Material Co., Ltd. (Lianyungang, China). The composition of the hard particles is mainly SiO₂, which is also the main component of rock. The SiO₂ particles have a Mohs hardness of 7. After passing through the 70 mesh sieve, the particle size is $212 \pm 10 \ \mu\text{m}$. Figure 1a shows the optical microscope image of abrasive particles and the optical image of the FKM seal and metal disc.

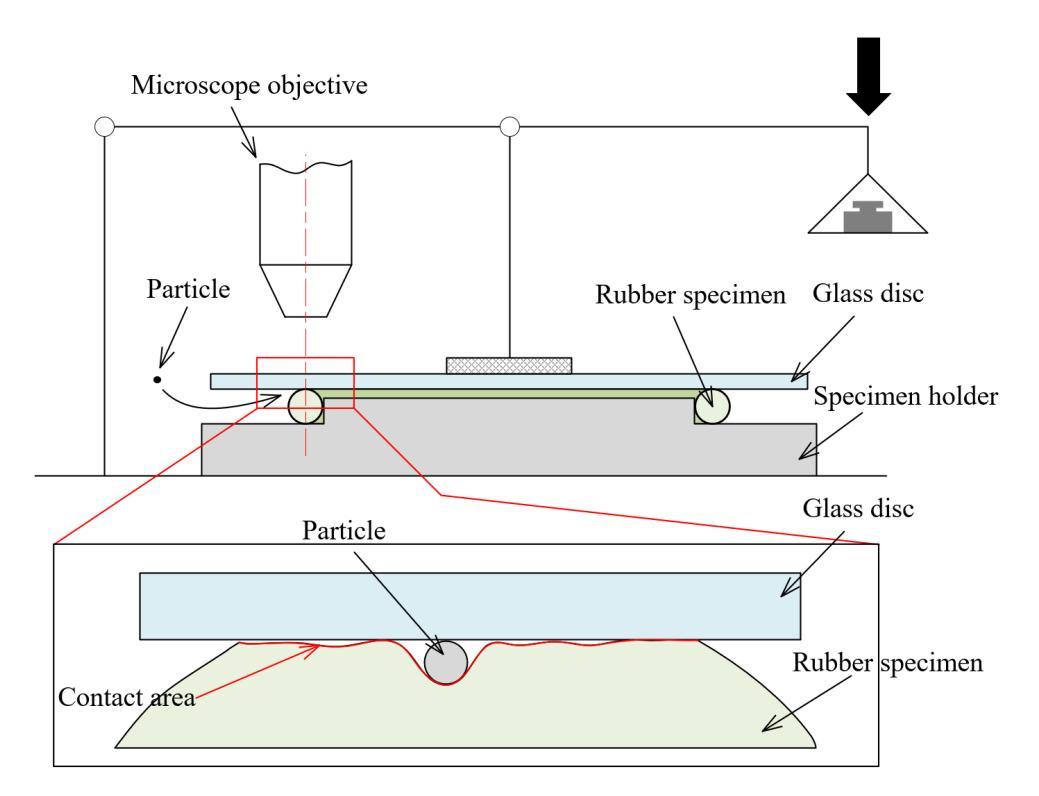
Figure 2. Schematic diagrams of the in situ observation device (not to scale).

Considering the difference in contact widths caused by possible changes in hardness, an in situ device was designed to test and measure the contact area between the FKM O-ring and the hard counterpart. As shown in Figure 2, a glass disc was used to replace the metal disc so that the contact area could be observed, and the normal load was applied to the glass disc by the lever. A microscope (Olympus SZX7, Tokyo, Japan) was used to observe the soft–hard contact area in situ.

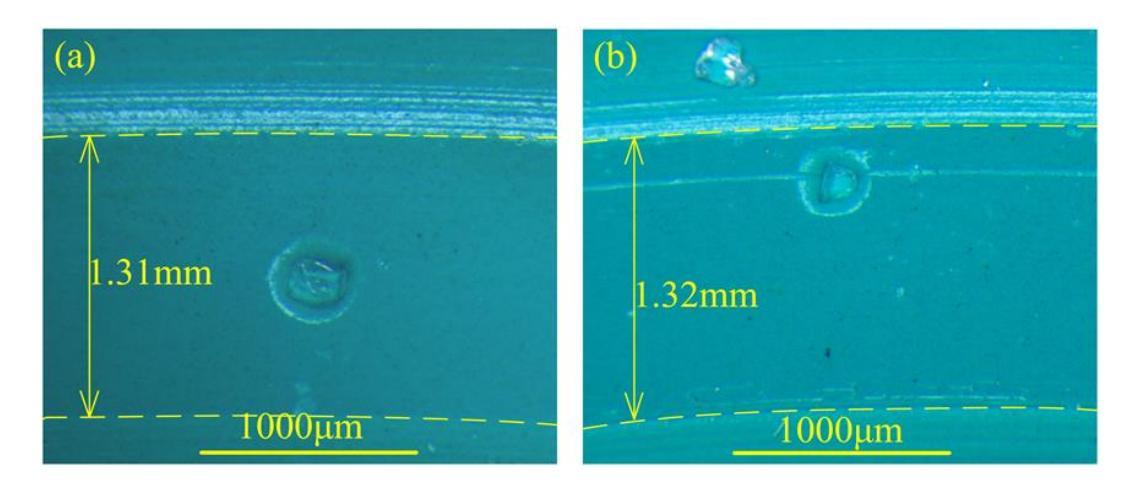
Figure 3. The optical micrograph of in situ observation of the contact area of (a) untreated seal and (b) thermally treated seal.

The normal force N is related to the deformation depth and the hardness of the friction pair. As shown in the in situ observation of the contact interface, the deformation depth, whether before or after aging, led by the particle did not significantly change. In contrast, the hardness of the FKM increased after the thermal treatment, although it was slight. The normal force N thus increased. Therefore, in the initial friction state, the particle motion is sliding.

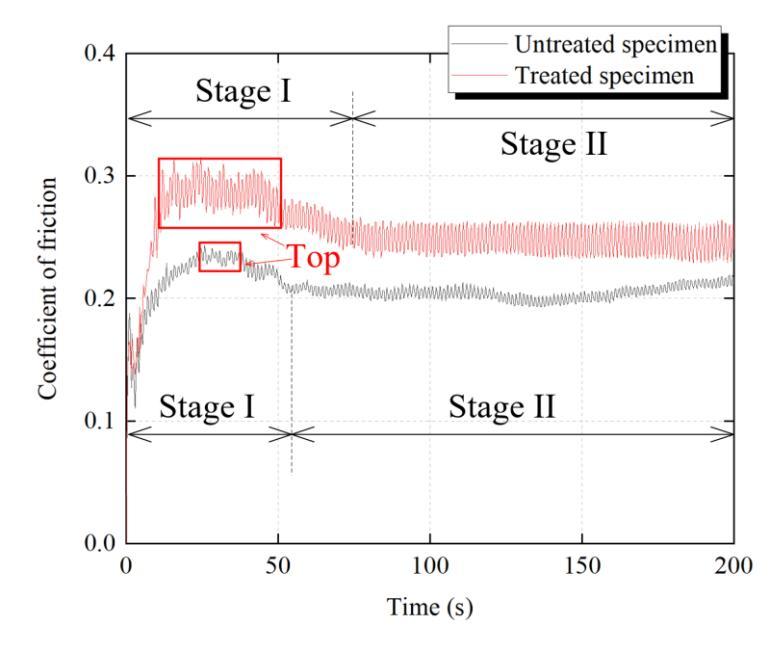
Figure 4. Coefficients of friction between the metal disc and untreated specimens and treated specimens.

After at least three tests, the identical evolution law of the coefficient of friction (COF) as a function of time was observed, and the representative results of TS and UTS are shown in Figure 4. The same trend can be found in both curves, i.e., the COF was achieved at the top then decreased to stabilization gradually. For UTS, the highest value of COF was about 0.24, and the steady value was about 0.2. In contrast, for TS, the highest value of COF was about 0.29, and the steady value was about 0.25. When the COF reached the top, the friction coefficient of the TS obviously continued for a longer period compared with the UTS, as shown in Figure 4 Through the whole test, the friction coefficient of the treated group was in an unstable state (stage-I) for longer.

The collecting effect of the cave on the particle delays the escape of the particles from the friction interface. Due to there being more caves generated on the surface of untreated specimens, more abrasive particles may strand in the tribological interface. This results in the friction interface being in a three-body abrasion. Hence, the frictional coefficient of a treated test group is in stage-I longer (Figure 4) compared to the untreated group.

Finally, a severely worn rubber surface and metal surface results in the friction coefficient of the stage-II of TS to be higher than that of UTS (Figure 4).

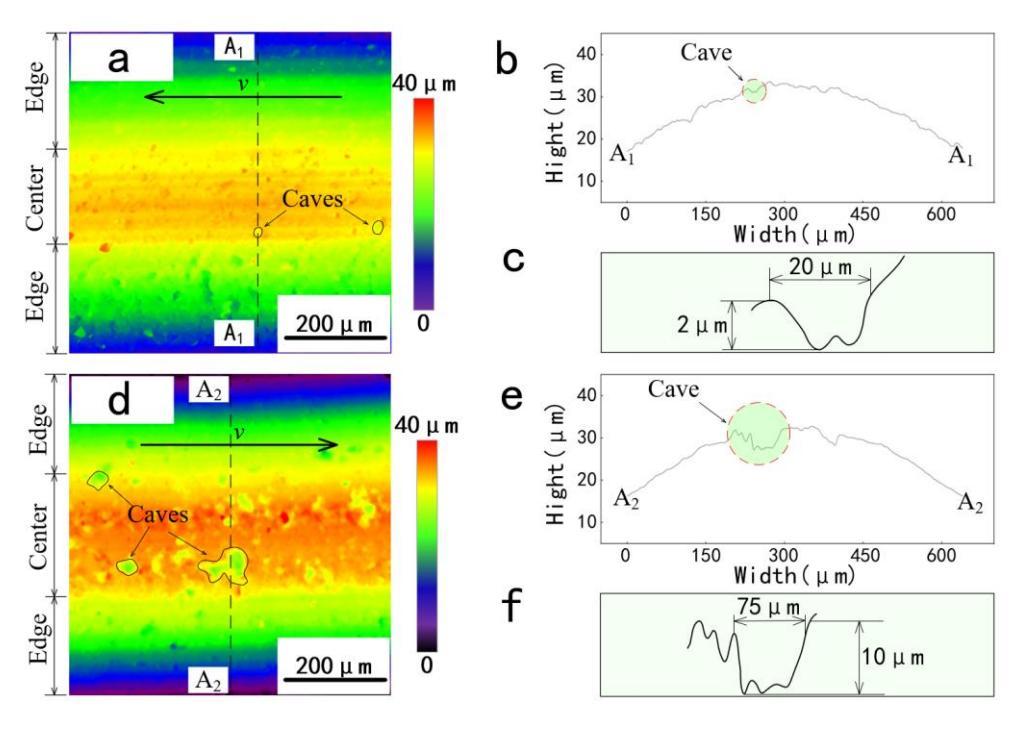
Figure 5. Top views of the three-dimensional topography of (**a**) untreated specimens and (**d**) treated specimens after wear tests and their two-dimensional profiles of (**b**,**e**) worn scars (marked with dashed lines A_1 - A_1 and A_2 - A_2) and (**c**,**f**) caves.

To understand the differences in COF, the wear surface of the tribo-pair was investigated. Figure 5a,d shows the top views of the three-dimensional topography of the worn surface. On the wear surface, higher areas were marked with warm colors, while lower areas were marked with cool colors, and areas with similar heights were marked with similar colors. Significantly, the height of the upper-end face of the worn surface was relatively uniform (marked in red or orange). The area with a warm color can be defined as the center area, and the area with a cool color can be defined as the edge area. Considering the section of an O-ring specimen is a circle (parabolic shape), the flatland of the center area reflects that the surface removal led by the three-body abrasion in this area was more serious than in the edge area. This is because for the contact pair of the O-ring seal and the metal disc, the highest contact pressure is located in the center, and the contact pressure along the sealing edge is lower. Under the high contact pressure, more wear volume was generated in the center area of TS may indicate that the wear of the thermally treated FKM O-ring seal is more serious.

In the center area, spots with cool colors can be found. The spot in Figure 5a is significantly smaller and less than that in Figure 5d. To confirm the depth of the spot, the two-dimensional profiles of the worn surface were measured at the positions marked by the dashed lines A_1 - A_1 and A_2 - A_2 . As shown in Figure 5b,c,e,f, the depth of the spot on the untreated specimen is shallower than that on the treated specimen. After several measurements, it was found that the depth of the spots on the treated specimens was in the range of 2–5 μ m, while the depth of the untreated specimens was in the range of 5–12 μ m.

Overall, the wear scar at the center contact area is obviously more rough and jagged than the worn surface at the edge of the contact area. The wear characteristic that appeared in the center area and the edge area exhibited that the wear mode of the rubber specimens depends on the contact force applied to the particles. For example, as the contact force increases, the wear characteristics of the rubber surface deteriorate, gradually from surface penetration to surface tearing to surface flake peeling. This reflected that the damage degree at the center area is more serious than at the edge area, which agrees with the results shown in Figure 5.

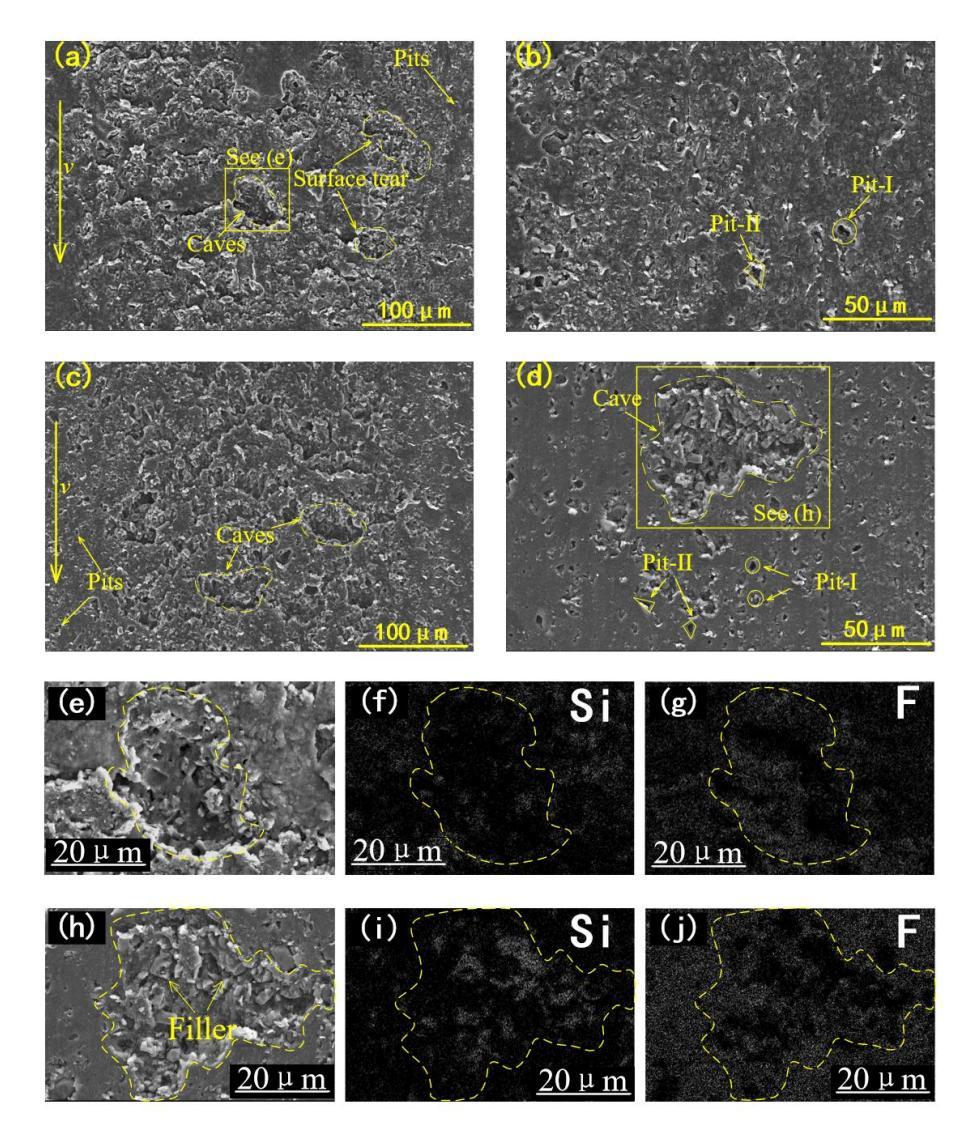
Figure 6. SEM micrograph of the worn surface of untreated specimens (**a**) in the center area and (**b**) in the edge area; the wear surface of treated specimens (**c**) in center area and (**d**) in edge area; (**e**) the cave in the center area of untreated specimens and its element mapping of (**f**) silicon and (**g**) fluorine; (**h**) the cave in the edge area of treated specimens and its element mapping of (**i**) silicon and (**j**) fluorine.

To further confirm the wear characteristics, the wear scars of the rubber O-rings were scanned by the scanning electron microscope. The SEM micrographs of the worn surface of two kinds of specimens in the center area and edge area are shown in Figure 6a–d.

At the center of the untreated specimen, two kinds of wear morphologies can be observed (Figure 6a). One is the parallel waves that are perpendicular to the sliding direction, which is known as the Schallamach-type wave (STW) [22–24]. Another wear morphology is the micro-scar with an ellipse-shaped contour (marked with the dotted lines). Some of the micro-scars are relatively deeper, which can be defined as the cave. The same wear morphologies are also found on the wear scar of the thermally treated specimens. The difference is that the cave almost dominates the wear scar of the TS, while the wave rarely appears. According to the top view of the 3D topography (Figure 5), the number and the size of the caves of TS are both more remarkable than that of UTS. In addition, the two-dimensional surface profiles of the war surface indicated that the cave on the surface of the TS was deeper than that of the UTS, as shown in Figure 5b,e. The depth of the cave on the untreated specimens is about 2–5 μ m (Figure 5c), while on the treated specimens it is about 5–12 μ m (Figure 5f).

At the edge of the contact area, the wear morphology of the micro pit is found, whose size is about $1\sim5 \mu$ m. The outline of some pits was rounded (pit-I), while some pits' outlines were sharp (pit-II). Significantly, more pits were found on the surface of treated specimens. The cave is also observed at the edge area of the TS, but no significant cave is found in the same area of the UTS. It was noticed that the morphology of the bottom of the caves at the center area and the edge area was not the same. As shown in Figure 6e, pits with a round outline are found at the bottom of the cave observed in the center area. While in the edge area, small particles are observed at the bottom of the cave beside the pit (Figure 6h). To verify the identity of the particles, the energy dispersive spectrometer was used to reveal the identity of small particles. The enriched Si element indicates that the small particles are SiO₂ fillers (Figure 6e). Therefore, the micro pit found in the bottom of the cave at the center area may be led by the shedding of fillers. Similarly, pit-I may also be caused by this reason. Moreover, pit-II is caused by the penetration of the rubber surface. More pit-II observed on the surface of the treated specimen is easier to penetrate.

However, rubber fillers observed at the bottom of the caves were found in the edge area (Figure 6h). This indicated that the cave at the edge of the contact area seems to not have stranded the particles and, thus, was not scraped during the re-circulation of the particles. To clearly understand the trajectory of the particle, a simplified model of the three-body abrasion is illustrated in Figure 11.

In the edge area, as the normal contact force applied on particles (F_z) is decreased, the restriction of the particles on the contact interface is reduced. It becomes easier for particles to escape the contact area. Therefore, the particles in the edge area tend to leave the frictional interface rather than re-circulate. Consequently, there are only a few pits in the edge area that develop into caves (Figure 6b).

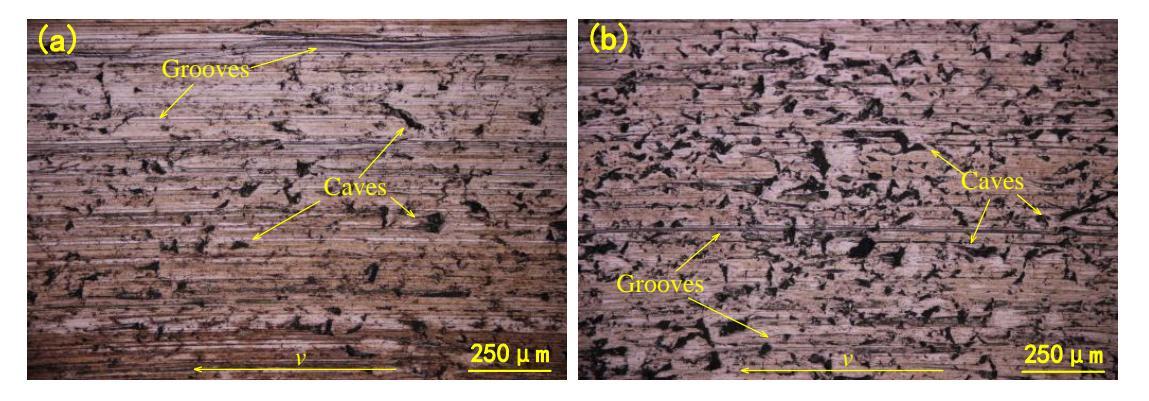
Figure 7. Wear surfaces of metal disc of (a) untreated specimens and (b) treated specimens.

Abrasive wear also caused the wear of the metal counterpart. As shown in Figure 7, the wear morphology of the stainless steel discs of the two groups is mainly grooves and caves. The grooves are parallel to the sliding direction, and the outline of the cave is sharp. The size of the cave on the SS disc was about 10–80 μ m.

In three-body abrasion, the difference in the wear morphology of the hard tribo-pair is often related to the motion form of the abrasive particles. For example, it is believed that when the particles are embedded in the rubber surface, the particles are stationary relative to the rubber and scratch to form a furrow on the hard friction part. This is known as the grinding wheel effect [25]. In contrast, when free particles are rolling in the friction interface, the damage mode of the metal changes to the cave. These two particle movements, rolling and sliding, are dependent on the contact state of the abrasive particle. Compared with the wear track of the untreated group, significantly more caves were observed in the thermally treated group. This indicated that the particles tended to roll more in the frictional interface after the thermal treatment.

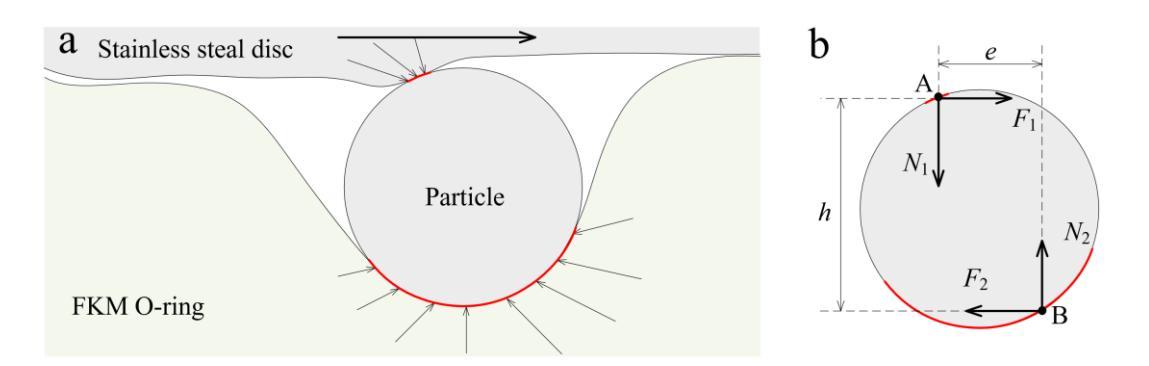
Figure 8. Schematic diagram of (**a**) forces on the particles in the three-body contact of the sealing interface, and (**b**) the sum of forces on an abrasive particle.

It is reported that the different movements of the particle depend on the force state of the particle in the friction interface. In the sliding interface, a particle is mainly subject to contact pressure and friction applied by the tribo-pairs.

As illustrated in Figure 8b, points A and B are assumed to be the central contact points of distributed forces on the particle by the metal surface and rubber surface [9–12]. The total forces acting on the particles by the stainless steel disc are the frictional force (F_1) and the normal force (N_1) at point A, and the total forces acting on the particles by the FKM O-ring are the frictional force (F_2) and the normal force (N_2) at point B. When the particle is in equilibrium, it can be gained that

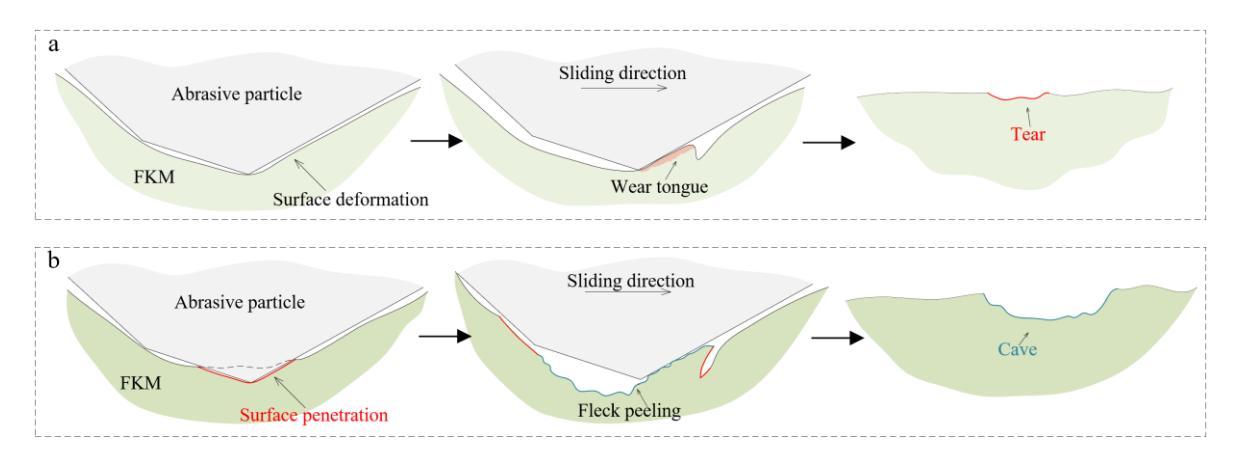
Figure 9. Wear mechanisms of (a) surface tear and (b) abrasion cave.

In this state, the wear mechanism of the particle sliding in the friction interface is illustrated in Figure 9. In the three-body contact, the abrasion makes the untreated rubber surface deformed. Then, under the sliding of the particle, the rubber surface is stretched and torn by the particle (Figure 9a). In this process, the wear loss mainly occurs at the root and the tip of the wear tongue. After the thermal treatment, the degradation of the mechanical properties results in the rubber surface being easier to penetrate. More minor surface defects, such as micro pits, were observed on the wear trace (Figure 6d). Then, with the sliding of the particle, the wear mechanism changes to fleck peeling (Figure 9b) [17].

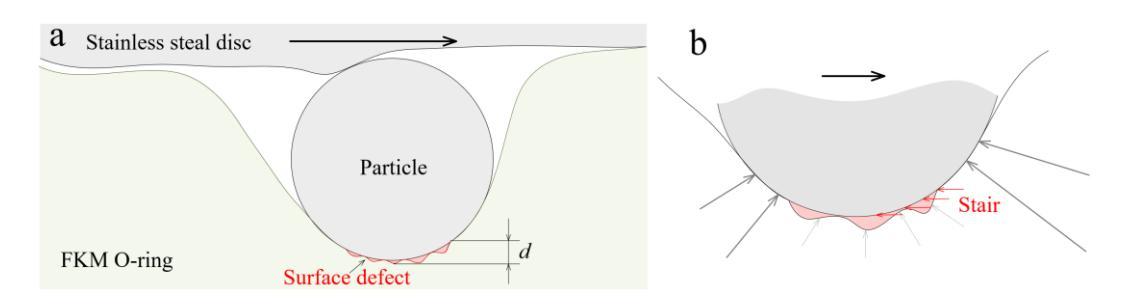
Figure 10. Schematic diagram of (**a**) the three-body contact with the surface defect, and (**b**) the forces on an abrasive particle contact with the surface defect.

After intruding into the sealing interface, the particles act as the third body and participate in the friction between the rubber seal and the hard counterpart. During the three-body abrasion, the particles do not leave the friction interface immediately but after a period of time. This means that the particles circulate at the sealing interface instead of once through. Therefore, a sealing interface belongs to the "closed group" of the three-body abrasion. The appearance of the defects, such as the cave and surface tear, changes the contact state of the particles (Figure 10a) during the re-circulation of the particles.

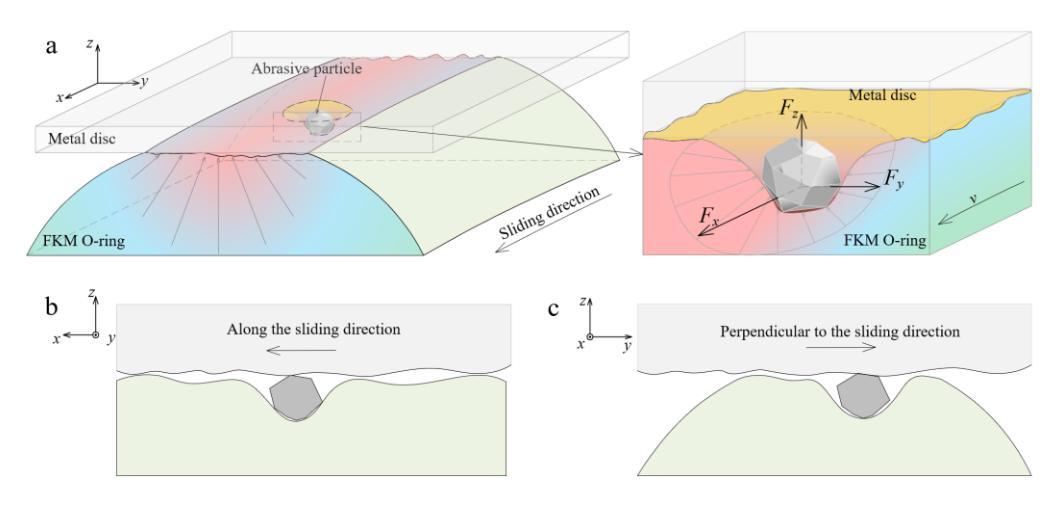
Figure 11. Schematic of (**a**) three-body abrasion of FKM O-ring, and the particle movement (**b**) along the sliding direction and (**c**) perpendicular to the sliding direction.

Due to the cross-section shape of the O-ring being round, the contact stress gradually decreases from the center to the edge of the contact area (Figure 11a). When the particle rubs in the contact area, the resultant force applied on the particle that is perpendicular to the sliding (F_y) always points to the direction that is away from the contact interface. With the effect of the F_y , the trajectory of the particles means they gradually escape from the contact interface. Therefore, the two directions of the particle movement need to be considered: (i) movement parallel to the sliding direction (Figure 11b) and (ii) movement vertical to the sliding direction (Figure 11c).
