# Article Experimental Investigation of Fatigue Crack Growth Behavior of the 2.25Cr1Mo0.25V Steel Welded Joint Used in Hydrogenation Reactors

Yan Song, Mengyu Chai \* and Zelin Han

School of Chemical Engineering and Technology, Xi'an Jiaotong University, Xi'an 710049, China; songyan1211@mail.xjtu.edu.cn (Y.S.); hanzelin@stu.xjtu.edu.cn (Z.H.)

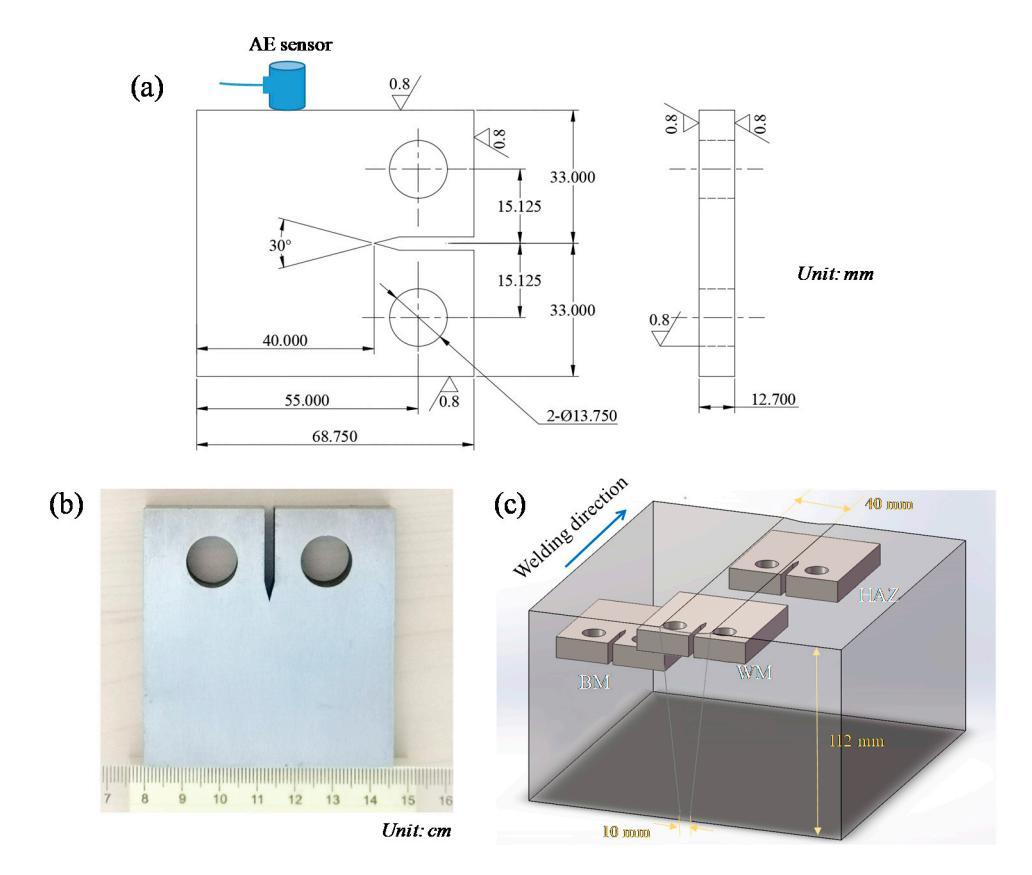
**Figure 1.** (a) Dimensions of the compact tension (CT) specimen. All units are in mm. (b) Macrographic photo of the CT specimen. The unit is in cm. (c) Schematic of positions of the CT specimens' sampling.

Co., Ltd (Lanzhou, China). In particular, the shielded metal arc welding (SMAW) was first applied for root welding, and the remaining passes were performed by submerged automatic arc welding (SAAW). During the SAAW process, the current, voltage and travel speed were maintained at 580 A, 32 V and 316 mm/min, respectively. The choice of these welding parameters were based on the actual manufacture procedure of hydrogen reactors made of CrMo steels. More relevant information for welding can be found in our previous studies [22,23]. After welding, the welded joints were analyzed using X-radiography (XLBG-350TX-5, Xinli, Dandong, China) for locating any defects. The chemical composition of BM and WM of the 2.25Cr1Mo0.25V steel welded joint was measured by spark atomic emission spectrometry (Spark-AES, S600, Boyue Instrument, Nanjing, China) according to ASTM E415 standard [24], and the result is provided in Table 2. The BM, HAZ and WM compact tension (CT) specimens, with a width of 62.5 mm and a thickness of 12.7 mm (see Figure 1a), were machined from the as-welded material according to ASTM E647 standard [25]. The macrographic photo of the CT specimen is shown in Figure 1b. The CT specimens were machined near the top surface of the welded joint and along the welding direction. The sharp notches were located in BM, HAZ and WM to facilitate crack initiation and propagation, respectively, as shown in Figure 1c.

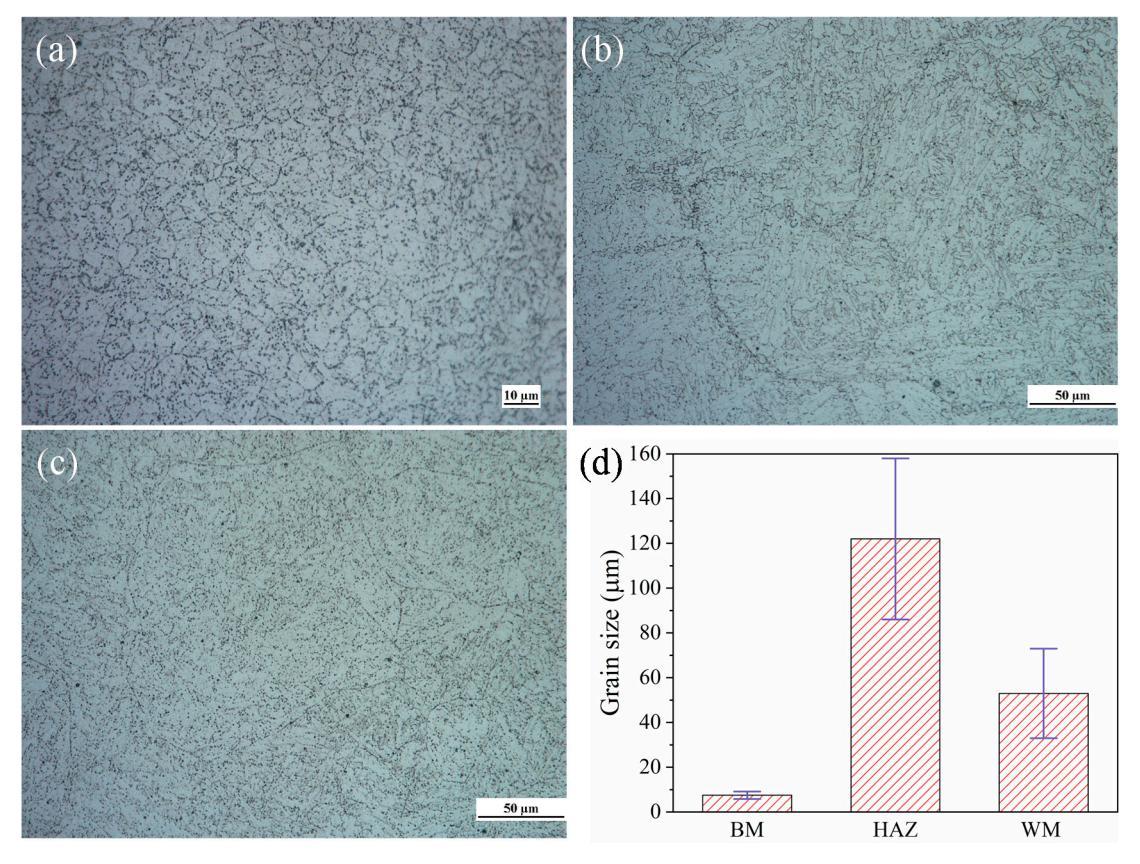
**Figure 2.** Microstructures of the 2.25Cr1Mo0.25V steel welded joint for (**a**) base metal (BM), (**b**) heat affected zone (HAZ) and (**c**) weld metal (WM), and (**d**) grain size distribution of different zones. Note that the scale bar in (**a**) BM is 10  $\mu$ m, while in (**b**) HAZ and (**c**) WM is 50  $\mu$ m. The error bars in (**d**) represent the standard deviation.

Figure 1 shows the typical microstructures of BM, HAZ and WM in the 2.25Cr1Mo0.25V steel welded joint. It is obvious that the main microstructure of BM is fine granular bainite, while WM exhibits coarse bainite grains, whose grain size are much larger than BM. Moreover, the microstructure of HAZ exhibits the lath-like bainite morphology with coarse grains (see Figure 2b). It is noteworthy that the grain size in HAZ is much larger than that in other regions of the welded joint. During welding, the HAZ, located next to the fusion line, attains a very high peak temperature thermal cycle, which allows the previously precipitated carbides to enter into solution, promoting a significant grain growth [29,30]. As a result, after cooling, the HAZ is characterized by a coarse-grained microstructure. The grain sizes were determined by ImageJ software (National Institutes of Health, NIH, Bethesda, MD, USA) using at least 10 metallographic figures obtained on different areas of

each specimen. Figure 2d shows the grain size distribution results. The average grain sizes of the BM, HAZ and WM were obtained as 7.5, 121 and 53  $\mu$ m, respectively. Moreover, the microstructures of HAZ and WM exhibit significant inhomogeneity due to large dispersion of their grain sizes. Thus, different FCG and AE behaviors are expected for the three regions in the welded joint.

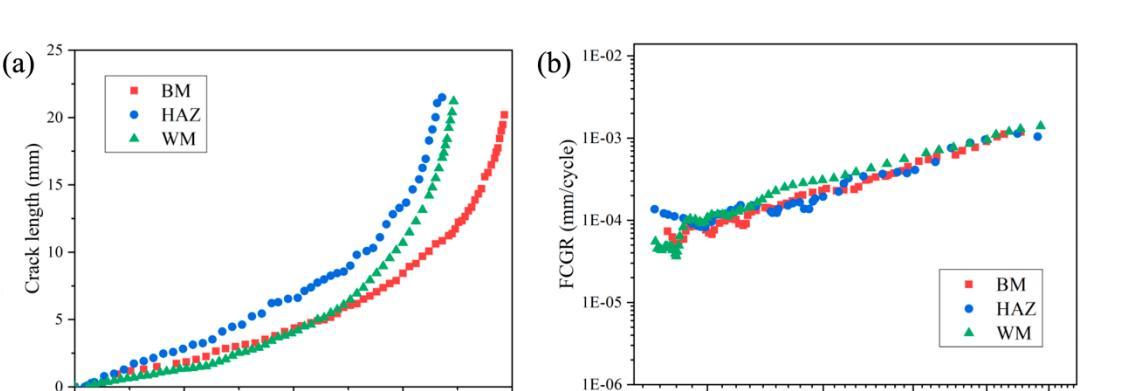
Figure 3. (a) Fatigue crack length versus fatigue cycles. (b) Fatigue crack growth rate versus the stress intensity factor range.

The stress ratio of 0.1 and the frequency of 15 Hz were used to test the FCG behaviors of different zones in the welded joint. The relationship of fatigue crack length with fatigue cycles is shown in Figure 3a. It is obvious that the fatigue crack propagates more rapidly in HAZ specimen, whereas BM shows the most superior fatigue resistance with the longest fatigue life. The fatigue crack growth rates (FCGRs) of different specimens were calculated by using the seven-point incremental polynomial method according to ASTM standard E647 [25]. The relationship of FCGR to the stress intensity factor range ( $\Delta K$ ) is displayed in Figure 3b. In particular, the stress intensity factor range indicates the crack driving force, and the  $\Delta K$  of CT specimen can be calculated according to the following equation [25]:

In Figure 3b it is obvious that FCGR almost linearly decreases with  $\Delta K$  for BM specimen, whereas several inflection points can be observed in FCGRs for HAZ specimen. This is probably due to the non-uniform microstructure with much coarser grains in HAZ, as shown in Figure 2. At low  $\Delta K$ , the HAZ shows much higher FCGRs than those of BM and WM, indicating the weakest fatigue crack growth resistance in the whole welded joint. Specifically, the FCGR of HAZ in this region is approximately two times higher than that of BM and WM. This is expected since the coarse-grained materials generally possess low fatigue strength. Deng et al. [13] reported that, in the dissimilar 9Cr-CrMoV welded joint, the 9Cr-HAZ and CrMoV-HAZ with narrow size were the weaker parts because of the lower FCG threshold compared to BM and WM. This is consistent with our results that HAZ possesses higher FCGR at low  $\Delta K$  values. With further propagation of crack, the FCGR becomes comparable with that of BM.

On the other hand, the FCGR of WM reached as much as 1.5 times larger than that of BM in the intermediate region, which is probably due to the effect of tensile welding residual stress in WM specimen [31]. Previous work performed by our group measured the welding residual stress of the 2.25Cr1Mo0.25V welded joint by using the hole-drilling method, and the results showed that tensile residual stress was mainly distributed in the fusion zone [22]. Some studies have pointed out that the welding residual stress would partly retained in fracture mechanics specimens extracted from the welded joints [32,33]. Moreover, it has been reported that the FCGR of the WM can be significantly increased by the retained tensile residual stress [31], which is consistent with the present results. With further increase of  $\Delta K$ , the slope of the FCGR of WM gradually decreases and finally the FCGR becomes comparable with that of BM.

This equation means that the relationship between FCGR and  $\Delta K$  is linear in the double logarithmic axes, as shown in Figure 3b. The Paris–Erdogan law coefficients and the corresponding correlation coefficient R<sup>2</sup> are given in Table 3. The obtained values of R<sup>2</sup> close to 1 show a good fit to the Paris–Erdogan law. It is obvious from Table 3 that the FCGR data of BM shows the best correlation with  $\Delta K$ , while the HAZ shows the poorest.

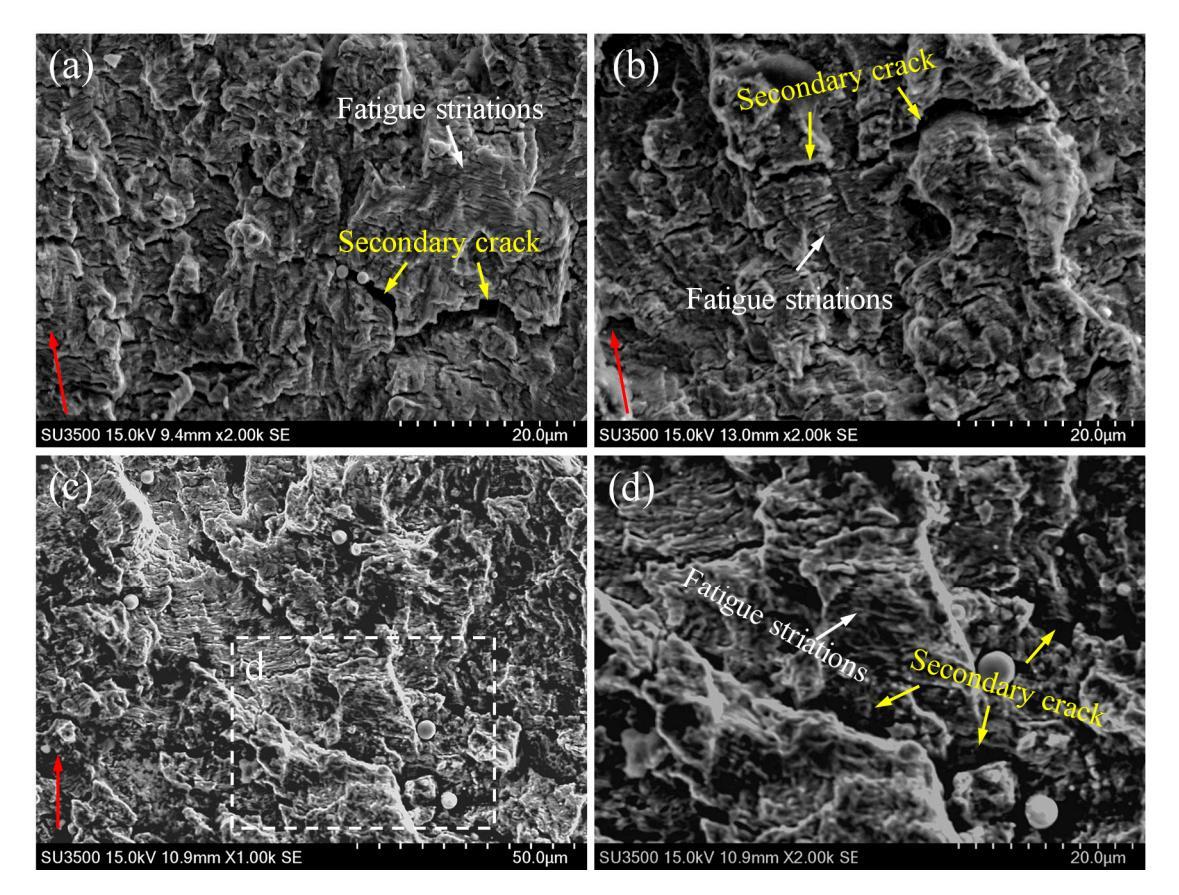
**Figure 4.** Fatigue fracture surfaces of (**a**) BM, (**b**) HAZ and (**c**,**d**) WM specimens at  $\Delta K$  value of approximately 28.5 MPa·m<sup>1/2</sup>. Typically, the red arrows represent the crack growth direction, the white arrows represent the fatigue striations, and the yellow arrows indicate the secondary cracks.

To investigate the fatigue mechanisms of different zones in the 2.25Cr1Mo0.25V steel welded joint, the fracture surfaces of the fatigued CT specimens were analyzed by using SEM. Typical fatigue fracture surfaces of BM, HAZ and WM at different stress intensity factor amplitudes  $\Delta K$  (approximately 28.5, 33 and 55 MPa·m<sup>1/2</sup>) are displayed in Figures 4–6. These figures obviously show transgranular fatigue fracture for all specimens. Fatigue striations, which are essentially a series of parallel and slightly curved stripes perpendicular to the crack growth direction, were frequently observed in the fracture surfaces of all specimens, as shown by the white arrows. The formation of fatigue striations can be explained by the crack-tip blunting mechanism proposed by Laird [35]. When the stress reaches the maximum compressive stress in a cycle, the crack tip is fully closed and sharpened. With the increase of the stress to maximum tensile stress, the crack tip reopens and becomes blunted. The crack tip becomes sharpened again when the stress changes to compressive stress. Thus, with the fatigue cycle going, the crack constantly propagates forward, leaving a series of striations on fracture surface. Moreover, the fatigue striation generally corresponds to the crack growth rate. It can be seen from these figures that the fatigue striation spacing becomes large and evident for each specimen with the increase of  $\Delta K$  and FCGR.

Besides fatigue striations, numerous secondary cracks can be observed in all specimens, as shown by the yellow arrows in these figures. It is apparent that a large majority of the secondary cracks are perpendicular to the crack growth direction (i.e., parallel to fatigue striations). This secondary cracking phenomenon has been well explained by Gauthier et al. [36] and supported by many experimental observations and results [37]. During fatigue loading, tension stresses appear at the bottom of each striation, and they might be high enough to promote the transformation of some micro-striations into microcracks, consequently leading to a large amount of secondary cracks parallel to fatigue striations in the fracture surface [36]. On the other hand, several secondary cracks parallel to the crack growth direction (i.e., perpendicular to fatigue striations) are also observed, as shown in Figures 5d–f and 6d,e by the yellow arrows. Additionally, fractographic examinations at a higher magnification reveal that inclusions are embedded in some secondary cracks, as displayed in Figures 5b and 6d. Energy dispersive spectrum (EDS) analysis results (see Figure 7) further reveal that the chemical composition of inclusion contains higher contents of C and O than those in the matrix, indicating that the presence of inclusions assisted the initiation and growth of secondary cracks.

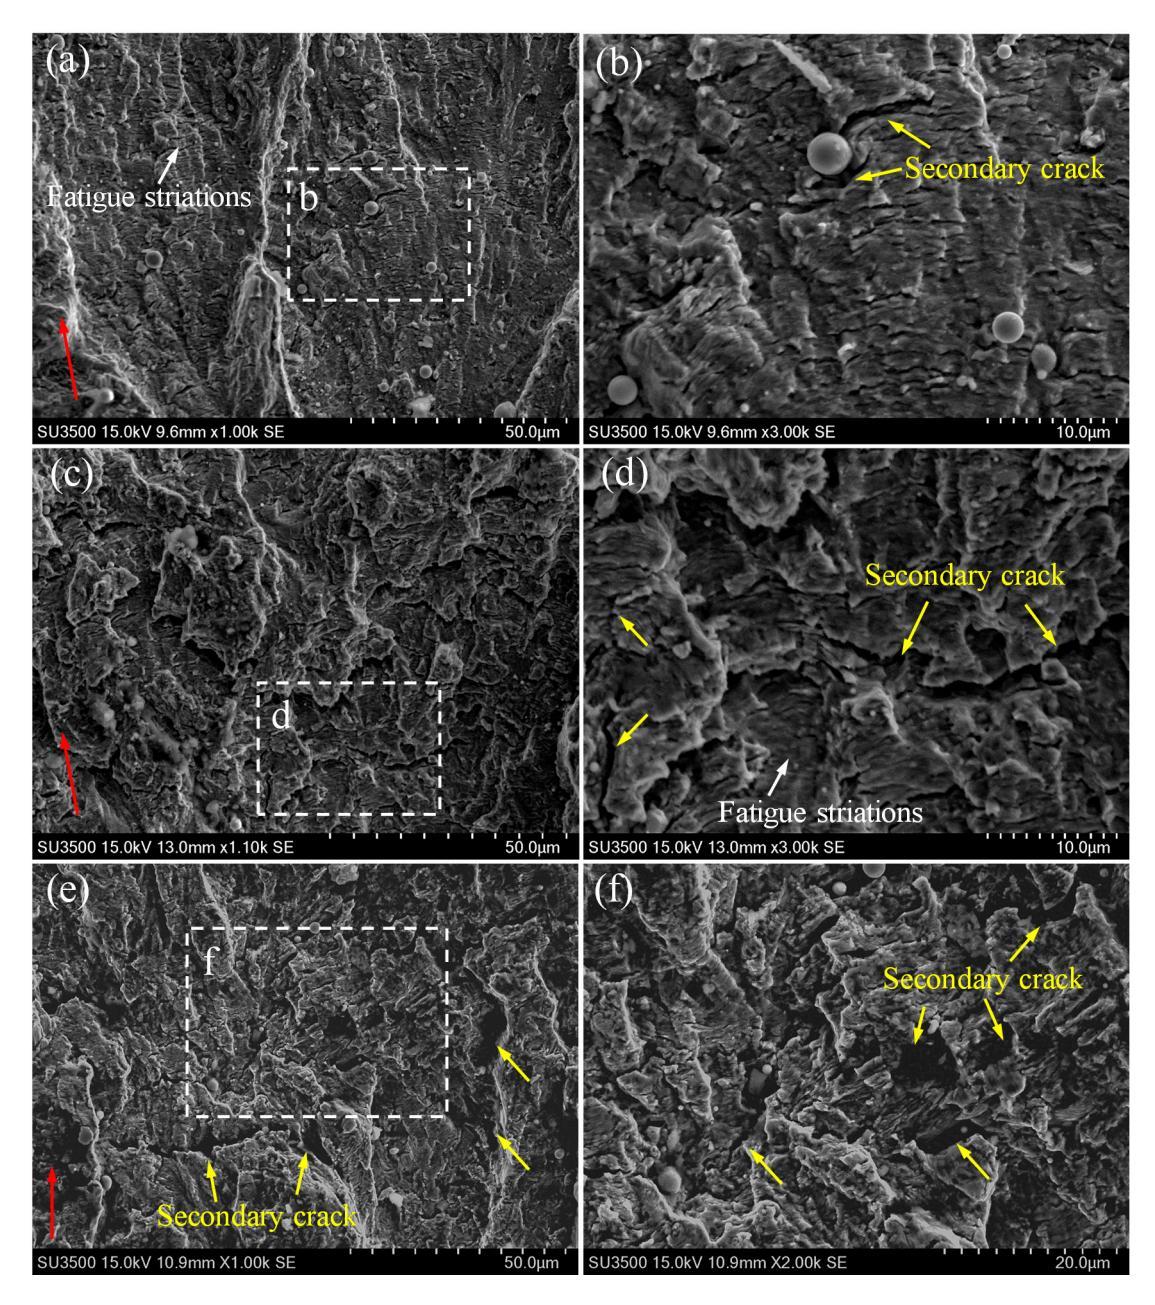
**Figure 5.** Fatigue fracture surfaces of (**a**,**b**) BM, (**c**,**d**) HAZ and (**e**,**f**) WM specimens at  $\Delta K$  value of approximately 33 MPa·m<sup>1/2</sup>. Typically, the red arrows represent the crack growth direction, the white arrows represent the fatigue striations, and the yellow arrows indicate the secondary cracks. Some secondary cracks perpendicular to fatigue striations can be found in (**d**–**f**).

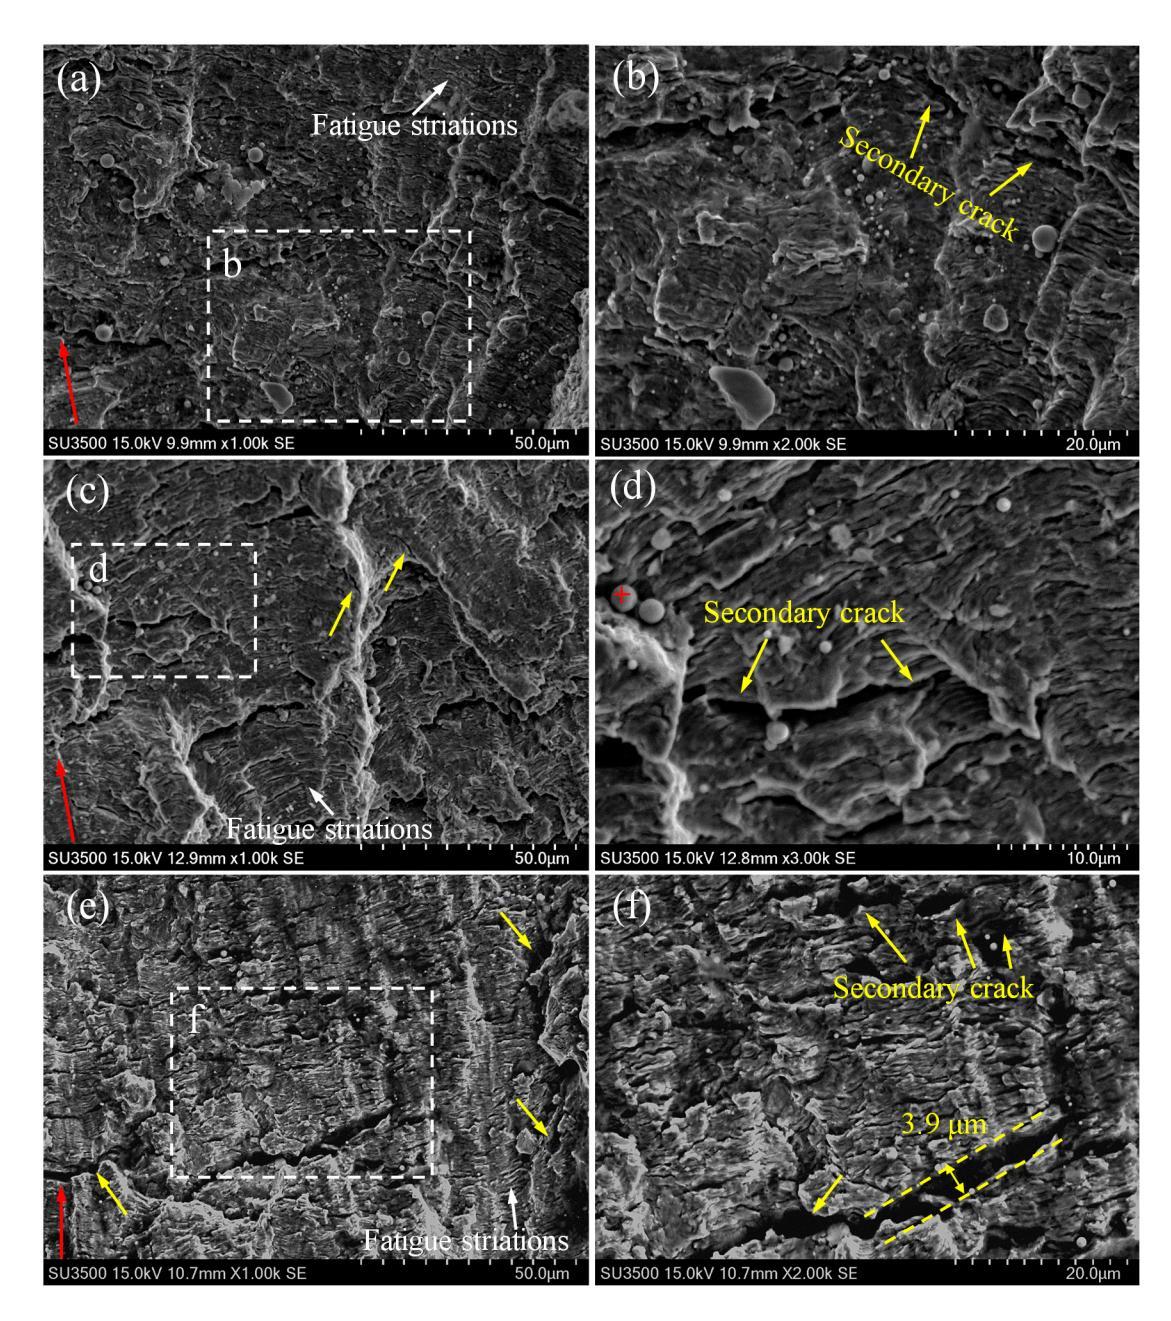
**Figure 6.** Fatigue fracture surfaces of (**a**,**b**) BM, (**c**,**d**) HAZ and (**e**,**f**) WM specimens at  $\Delta K$  value of approximately 55 MPa·m<sup>1/2</sup>. Typically, the red arrows represent the crack growth direction, the white arrows represent the fatigue striations, and the yellow arrows indicate the secondary cracks. Some secondary cracks perpendicular to fatigue striations can be found in (**c**,**f**).

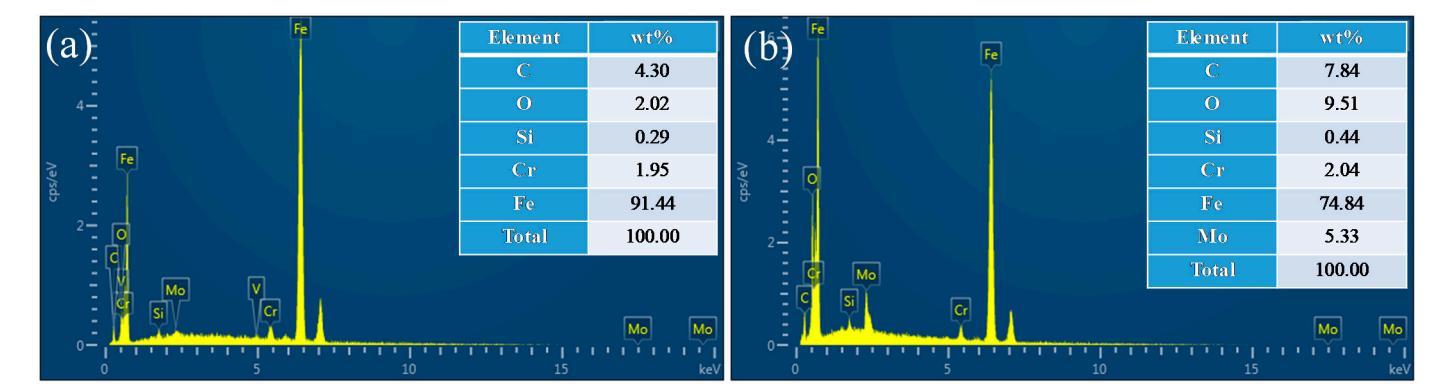
Figure 7. Energy dispersive spectrum (EDS) profiles of (a) the matrix, and (b) the inclusion marked by red "+" in Figure 6d.

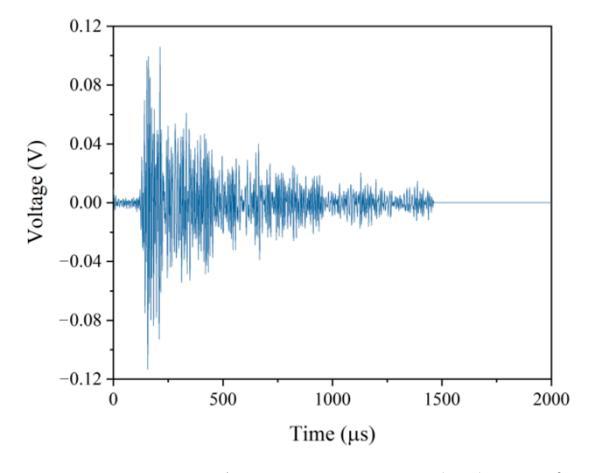
**Figure 8.** A typical acoustic emission (AE) waveform collected at fatigue loading time of 4284 s from FCG process of BM specimen. The energy and peak amplitude were calculated as 18 aJ and 61 dB, respectively.

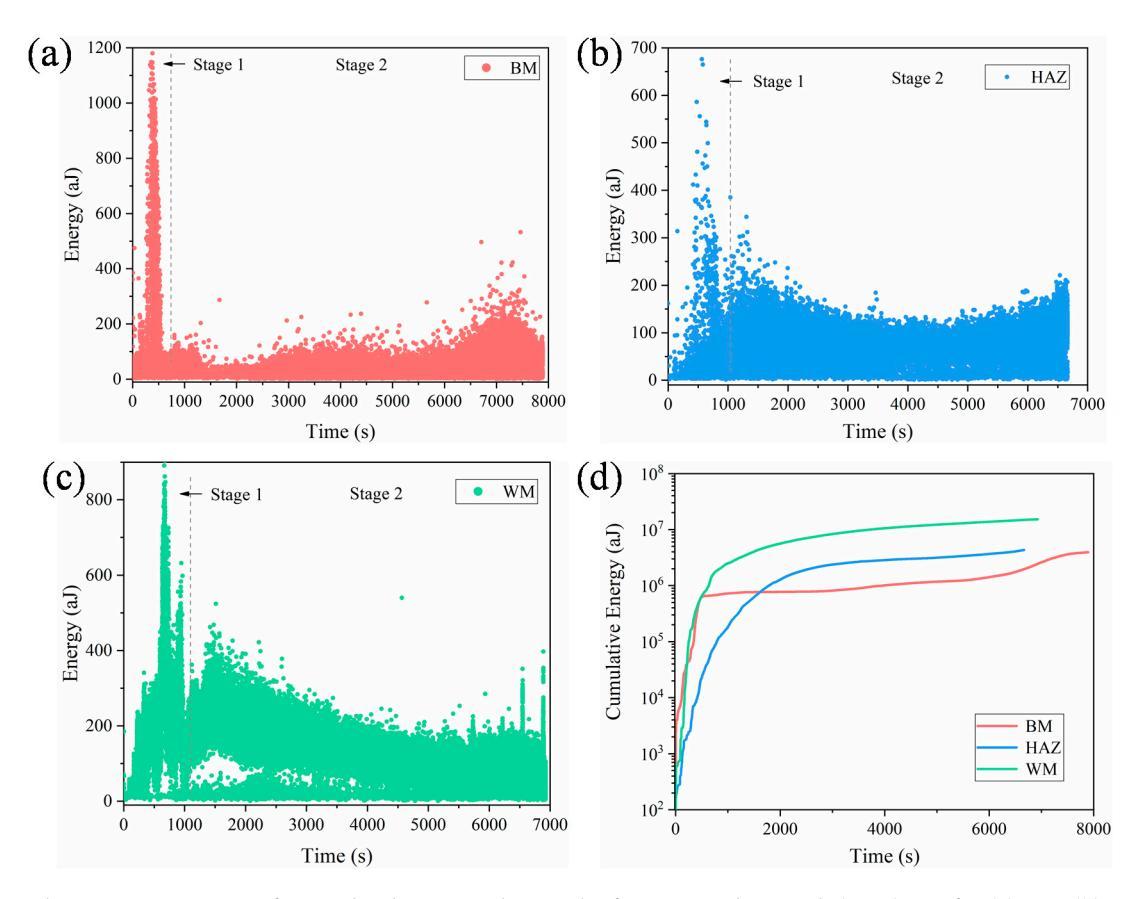
**Figure 9.** The AE energy versus fatigue loading time during the fatigue crack growth (FCG) test for (**a**) BM, (**b**) HAZ and (**c**) WM specimens. (**d**) Cumulative energy versus time of all specimens. Two obvious stages can be seen from the evolution of AE energy for all specimens.

The evolutions of energy with respect to fatigue loading time for different specimens were presented in Figure 9a-c. It is apparent from these figures that two damage stages can be easily discriminated. At the beginning of stage 1, signals with low energies occur due to extensive plastic deformation caused by stress concentration at the notch tip of CT specimens. Subsequently, a sudden increase of signals with high energies emerge, which is related to physical micro-crack initiation. The energy values in this stage are much higher than those in other fatigue loading time, and can be as high as 1200 aJ, as shown in Figure 9a for BM specimen. Several researchers have reported that the intensities of AE signals generated from crack initiation are much larger than those caused by plastic deformation and stable crack growth [16,44,45], which is consistent with our results. In stage 2, the variation of energy become constant and most of the energy values are below 200 aJ. This stage is reasonable related to stable crack growth stage, where the relationship between the FCGR and  $\Delta K$  follows the Paris law. It is also worth noting that an increase of energy occurs again at the end of stage 2, which is due to the rapid crack growth at high  $\Delta K$ . However, this sudden increase behavior is not very obvious as that caused by the crack initiation in stage 1. Based on above analyses, one can conclude that AE energy is successful in discriminating two damage stages during FCG process of the 2.25Cr1Mo0.25V steel welded joint. The first stage corresponds to crack initiation, and the second stage is related to stable and rapid crack growth.

Figure 9d shows the evolution of cumulative energy with respect to time for different specimens. It is obvious that the WM specimen possesses the largest cumulative energy in most of the fatigue life, while the BM specimen shows the lowest energy value despite its longest fatigue life among the three specimens. To further investigate the difference in AE signals of the three specimens, the statistical calculation of energy distribution was carried out, and the result is shown in Figure 10. It can be seen that more than 70 % of AE energies for BM and HAZ specimens are below 100 aJ, while AE energies of WM specimen distributes in much greater values. In particular, more than 60 % of AE energies are greater than 100 aJ, leading to the largest value of cumulative energy for WM. This means that the FCG of the WM specimen is able to generate AE signals with high energy. It is important to note that the fracture surface of WM specimen shows a significantly larger density of secondary cracks with larger size, compared to those of BM and HAZ specimens. The initiation and propagation of secondary cracks would consume additional energy of crack tip during FCG, thus generating AE signals with high energy. Han et al. [21] reported that the inclusions in the weld specimen of a micro-alloyed steel promoted the formation of micro-voids and micro-cracks, resulting in higher AE counts rate in weld specimen, which is consistent with our results. Therefore, the significantly enhanced AE energy in the WM specimen is mainly attributed to the formation and propagation of numerous secondary cracks.

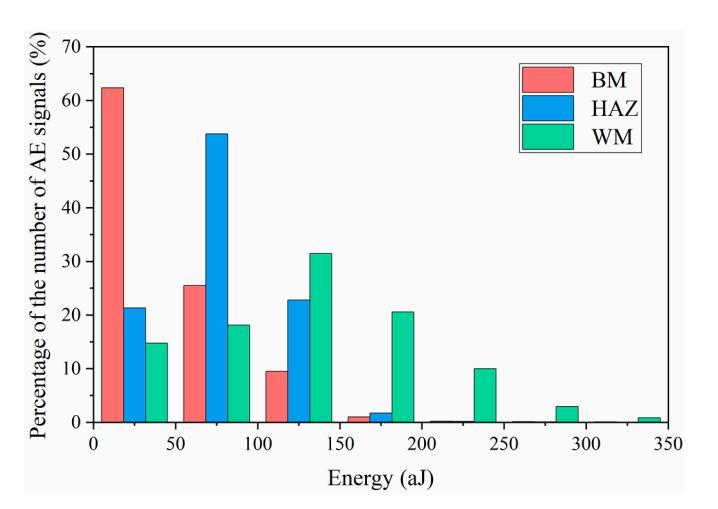
Figure 10. The statistical results of energy distribution of different specimens.

It can be also obtained from Figure 10 that the most of the AE energies in the BM specimen distributes in lower values than those in HAZ and WM specimens. This indicates that the fine equiaxed microstructures in the BM specimen are prone to generate AE signals with low energy, while the coarse heterogeneous microstructures would generate signals with high energy. Previous studies [18,19,46] have reported that the coarse-grained microstructures in various metallic materials can cause an important increase in the activity and intensity of AE signals during FCG, which agrees with the present results. This is probably due to the fact that the finer grain size with larger area of grain boundaries would impede the dislocation motion, which leads to a decrease of AE energy in the BM specimen. Figure 11 shows the evolutions of cumulative amplitude and cumulative count for different specimens, presenting similar result with that of cumulative energy. This indicates that AE is able to successfully characterize microstructural changes during FCG by extracting proper descriptors from AE waveforms.

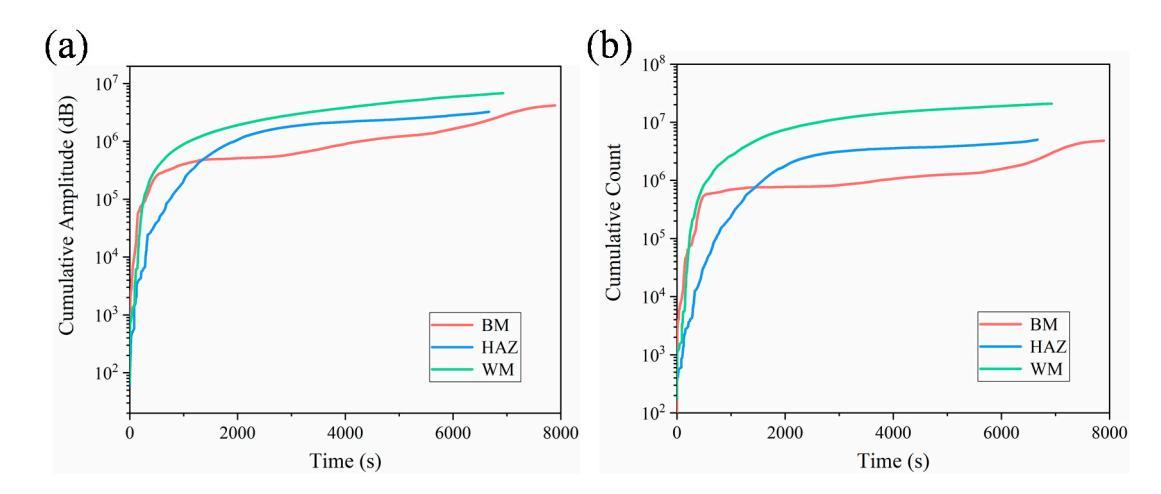
Figure 11. (a) The cumulative amplitude and (b) cumulative count with respect to fatigue loading time for different specimens.
