Article Effect of Fibre Orientation on the Quasi-Static Axial Crushing Behaviour of Glass Fibre Reinforced Polyvinyl Chloride Composite Tubes

Rahib A. Khan, Elsadig Mahdi * D and John-John Cabibihan

Mechanical and Industrial Engineering Department, College of Engineering, Qatar University, Doha P.O. Box 2713, Qatar; rk1107460@student.qu.edu.qa (R.A.K.); john.cabibihan@qu.edu.qa (J.-J.C.) * Correspondence: Correspondence: elsadigms@qu.edu.qa

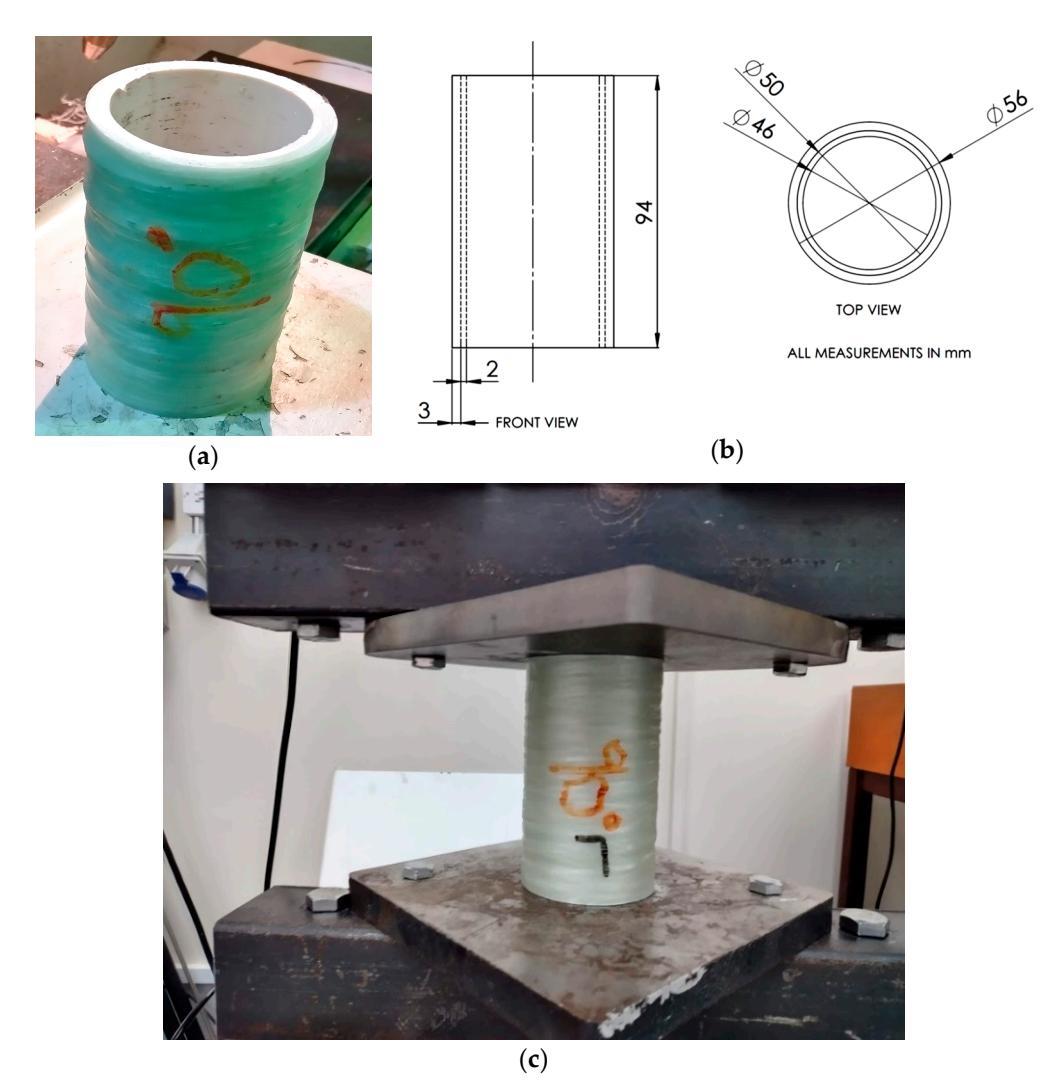
Figure 1. (a) Fabricated specimen; (b) schematic diagram of top and side views with average sample dimensions; (c) Sample positioned between compressive plates before the test.

GFRP was used to reinforce PVC tubes at four different fibre orienta-tions, 45°, 55°, 65° and 90°, where the reference axis 0° corresponds to the longitudinal ax-is of the tubes. The selection of the fibre orientation is random. The fabricated composite tubes were subjected to quasi-static axial compression tests to determine the effect of GFRP reinforcement and fibre orientation on their crashworthiness properties. The specimens prepared for compressive testing had a length of 94 mm. The PVC inner tube had an outer diameter of 50 mm and a thickness of 2 mm. The weight of the PVC inner tube on its own was about 0.038 kg. The thickness of the added glass fibre/epoxy reinforcement was an average of approximately 3 mm. Figure 1a,b show the GFRP/PVC sample being faced using a turning machine and the Schematic diagram of top and side views, respectively.

There were slight differences in the specimens' thickness. Accordingly, the thickness of the 45° specimens was closer to 2.5 mm, with the thickness increasing for increasing fi-bre orientation angle up to approximately 3.5 mm for the 90° specimens. The average weights of the tested 45°, 55°, 65° and 90° specimens were approximately 0.098, 0.129, 0.142 and 0.143 kg, respectively. As a standard, three tests were carried out for each of the four winding angles. Figure 1c shows GFRP/PVC tube positioned between compressive plates before the test.

The maximum capacity of the machine used was 250 kN. The machine's computerised data acquisition system automatically recorded the loading and displacement values. Videos of the crushing process for all specimens under compressive loading were recorded to provide the crushing process's history and allow the crushing mechanisms to be observed. Finally, small square samples were cut from the topmost side section of the crushed composite tubes. Scanning electron microscope (SEM) images were captured from these samples. The test setup is shown in Figure 1c

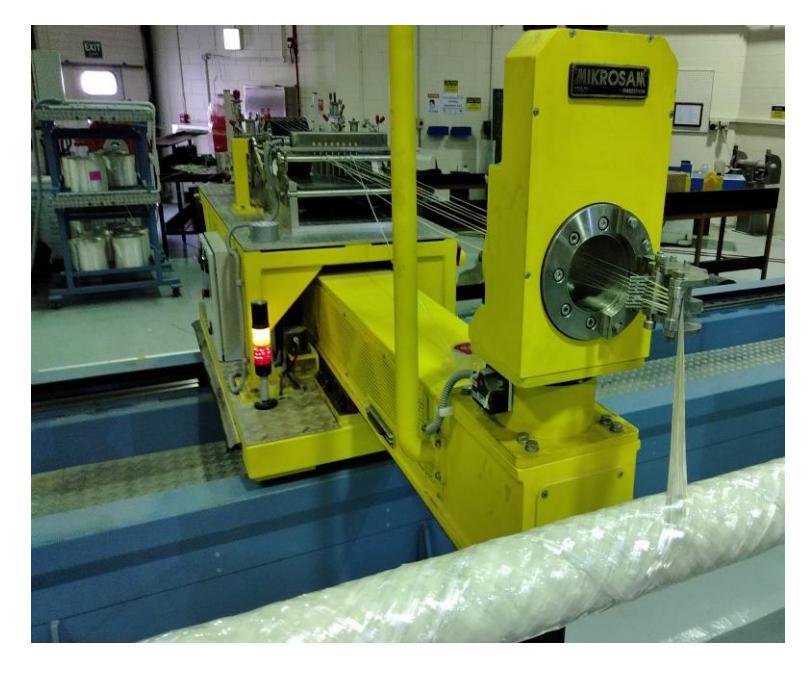
Figure 2. Fabrication of GFRP composite overwrapped plastic tube using five-axis filament winding machine.

Figure 2 shows the fabrication process. The ratio of hardener to epoxy resin was 30 parts to 100 parts. The reinforcement was laid down in a predetermined geometric pattern to provide maximum strength in the directions required. This process was used to reinforce long PVC tubes with glass fibre/epoxy at winding angles of 45°, 55°, 65° and 90°. For each angle, eight layers were applied before curing. Table 2 summarises the winding pa-rameters used to fabricate the GFRP/PVC tubes.

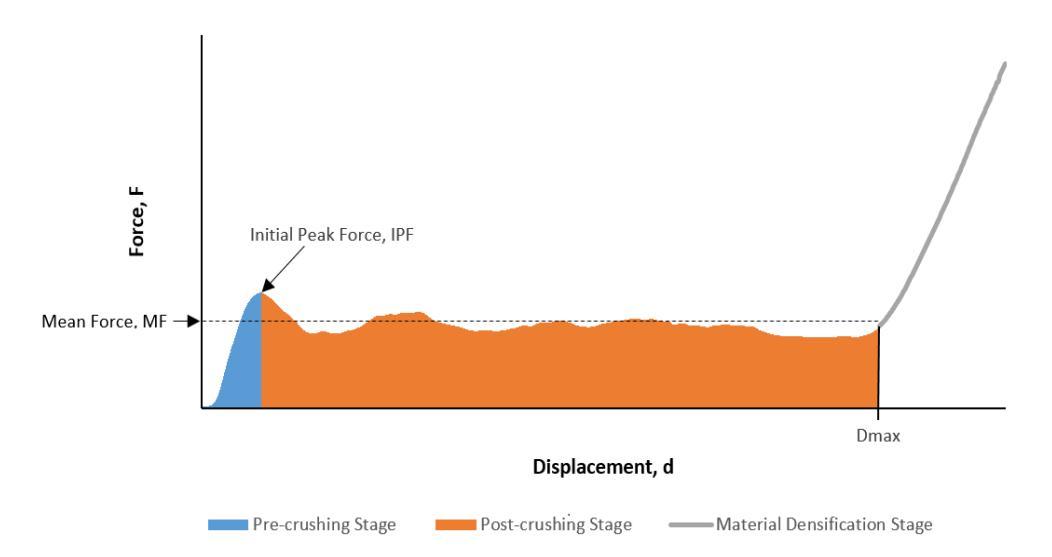
Figure 3. Typical load-displacement curve for the composite tube.

Generally, the load–displacement curves exhibit some similarities for all composite tubes, as illustrated in Figure 3. Initially, the load–displacement curve will have a straightline region for which the load increases in direct proportion to the displacement of the composite tube, referred to as the elastic region. For composite testing, the pre-crash stage includes the elastic region and ends at the displacement corresponding with the first turning point of the graph, at which the specimen experiences its first drop in load-bearing capability. The maximum load reached before this drop is the initial peak force. The region starting from the displacement where the initial peak force occurs up to the displacement at which densification begins is commonly referred to as the post-crash stage. After the post-crash stage, the load values increase dramatically in the densification stage. For all quasi-static axial compression tests conducted, videos were recorded and some images corresponding to the load–displacement behaviour of the tested composite tubes were extracted to assist in identifying the failure modes that the specimens experienced.

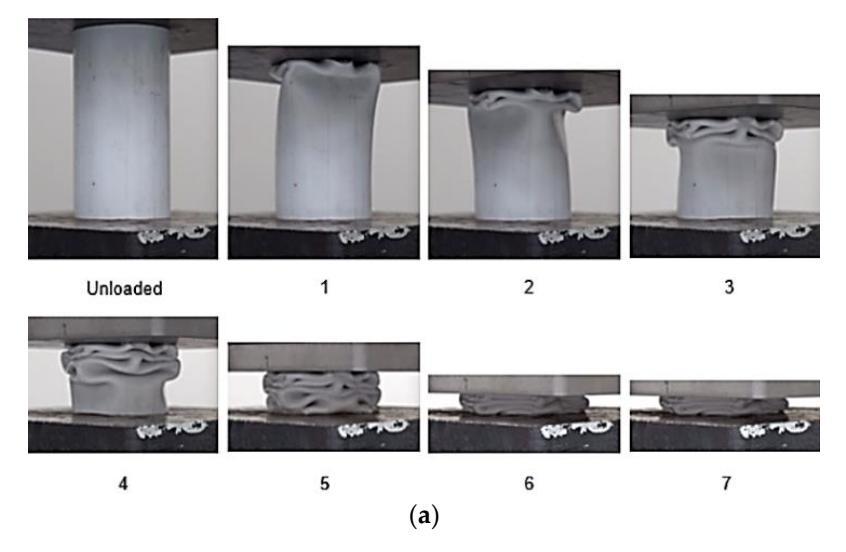
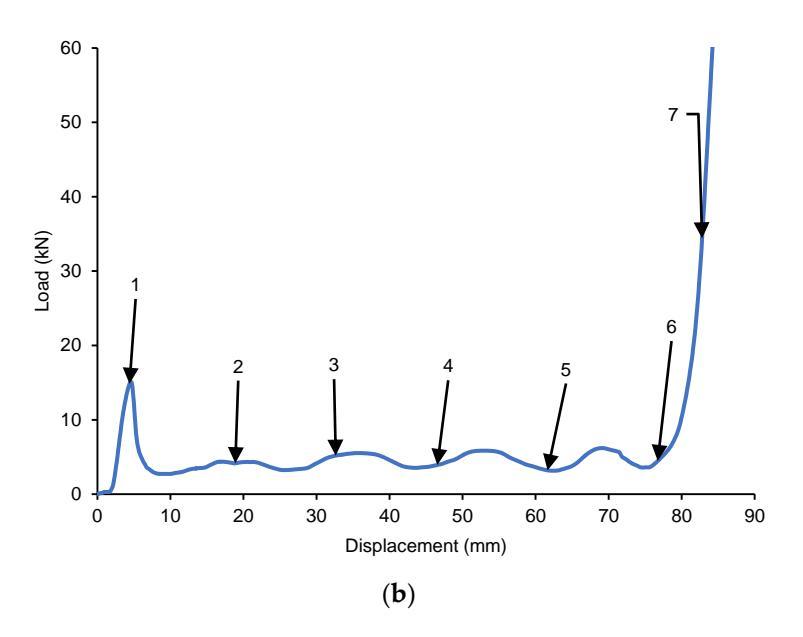
Figure 4. (a) Crushing history for PVC (b) Load–displacement curve for axial compression test of PVC sample.

To determine the effect of using GFRP to reinforce the PVC tubes used as the frame for the composite tubes, it was necessary to first observe the load behaviour of a PVC tube on its own, with the PVC tube having dimensions identical to those used in the composite tubes for the crushing tests. Figure 4 shows the load-displacement curve for the PVC tube and the corresponding images. Figure 4 shows that, initially, the graph has a straight-line region, where load increases in direct proportion to the displacement of the composite tube. The load eventually reaches a local maximum, the initial peak load, after which the load drops noticeably. For the PVC tube, the initial peak force had a value of approximately 15.14 kN and occurred at a displacement of about 4.599 mm. The images in Figure 4 show that the failure mechanism for the PVC tube was progressive folding. The progressive failure was expected as plastic tubes typically undergo progressive folding under compression, as is characteristic of Mode III failure. The compressive stress exerted on the PVC tube increased until it was large enough that it caused the tube wall to buckle locally and form a hinge. It was observed that the formation of the first hinge in the PVC tube happened simultaneously as the initial peak force was reached. After this, as the first fold formed, quite a considerable drop in load-bearing capability occurred as it dropped from 15.14 kN down to about 2.732 kN. Following this, folds continued to form, and, for each fold, stresses built up in the tube wall, forming a hinge, followed by a subsequent drop in the load-bearing capacity as folding occurred. However, for the second fold onwards, the load's rise and fall were not as high, and the failure was more stable as a result. The region starting from the displacement where the initial peak force occurred, 4.599 mm, up to the displacement at which densification began for the PVC tube, 77.56 mm, is the post-crush stage for the specimen. For the post-crush stage of the PVC tube, the average load was approximately 4.397 kN. After the displacement value of 77.56 mm, the load value increased drastically.

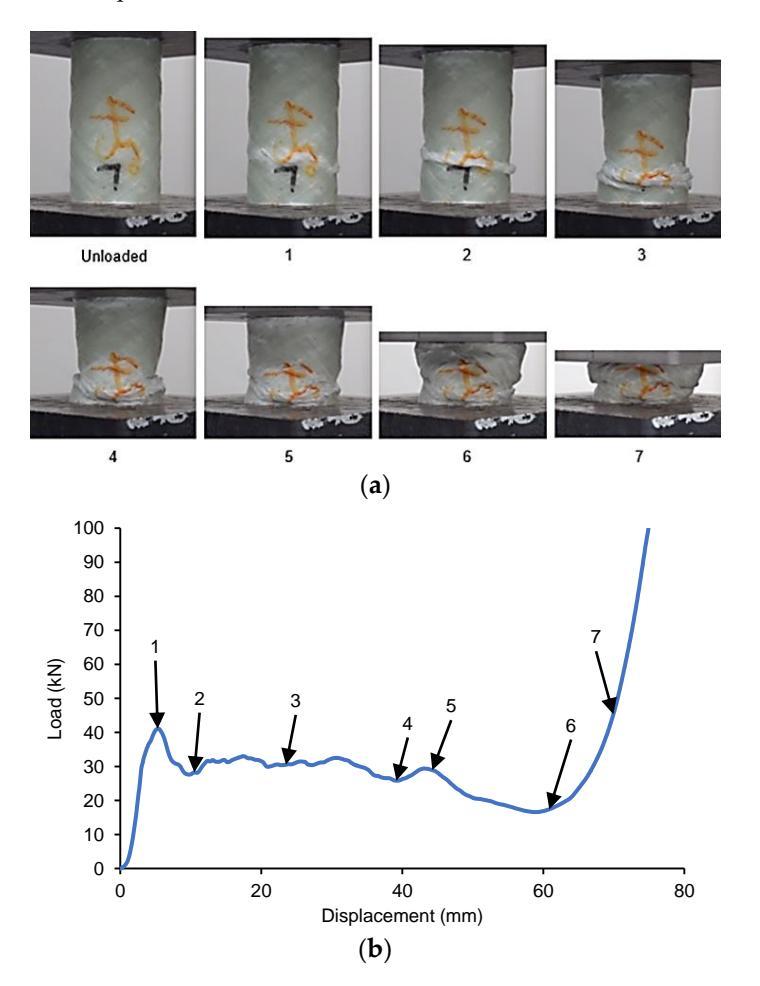
Figure 5. (a) Crushing history for GFRP/PVC 45° (b) Load–displacement curve for axial compression test of GFRP/PVC 45° sample.

Figure 5 shows the load-displacement graph for the GFRP/PVC 45° composite tube subjected to quasi-static axial crushing and the images corresponding to the labelled points in the graph. It can be seen that the failure mode first exhibited by this sample was Mode III failure as the initial failure of the tube occurred due to local buckling, with a hinge forming at the initial peak force of about 41.11 kN at a displacement of 5.409 mm. Once this fold formed fully, the load reached a local minimum of approximately 27.60 kN, while the displacement at this point was about 10.93 mm. After this, until a displacement of approximately 44.09 mm, the GFRP/PVC 45° composite tube continued to display Mode III failure as the load fluctuated about a mean value of 27.16 kN and a second fold formed in the composite tube. Subsequently, however, the top of the tube collapsed into itself, resulting in a noticeable drop in load-bearing capacity to a new overall minimum of 16.59 kN at a displacement of approximately 59.01 mm and severe matrix cracking. This drop in load-bearing capacity bore a closer resemblance to the kind of behaviour that would be expected of Mode II brittle failure. As shown in Figure 5, the GFRP/PVC 45° composite sample exhibited Mode III failure until a displacement of about 44.09 mm. After this, the failure mode changed to Mode II failure until, finally, the composite tube load rose steeply as the composite tube was compacted in the densification stage.

Although the damage to the GFRP/PVC 45° composite tube due to buckling, matrix cracking and the final collapse of the sample was considerable, it was seen that the adhesion between the GFRP and the PVC inner tube remained as the two components of the composite tube did not separate. Moreover, delamination during failure was negligible as even after densification; there were no noticeable hanging loose bunches of the GFRP. This observation was confirmed by examining a part of the sample, after crushing, that was not significantly affected by buckling and matrix cracking using an SEM. From the SEM image of a section of the GFRP/PVC 45° composite tube after crushing (see Figure 6a), it can be seen that the GFRP layers were relatively intact. Although matrix cracking occurred, the cracking severity was not as pronounced as for the other samples.

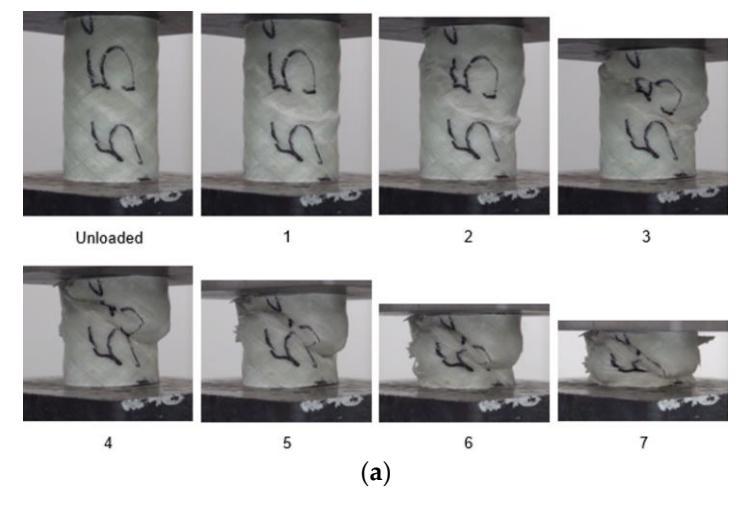
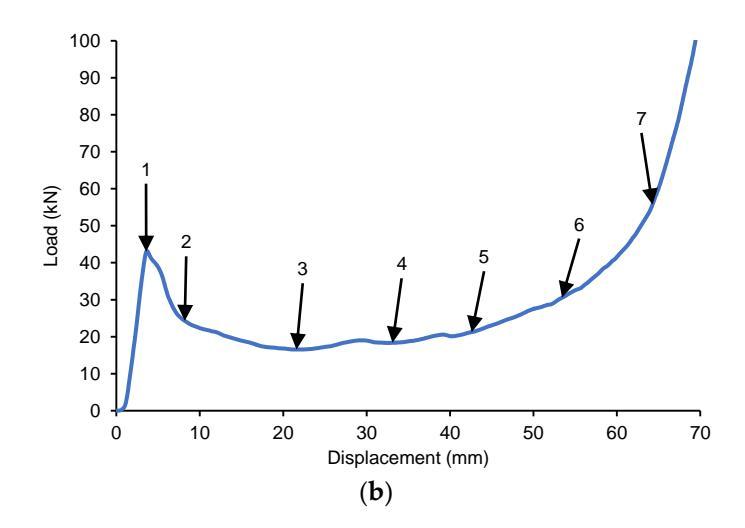
Figure 7. (a) Crushing history for GFRP/PVC 55° (b) Load–displacement curve for axial compression test of GFRP/PVC 55° sample.

Figure 7 shows the load–displacement graph for the GFRP/PVC 55° composite tube when subjected to quasi-static axial crushing and the images corresponding to the points labelled in the graph. During the pre-crush stage, the top section of the tube first shifted noticeably towards one side due to transverse shear failure. During this transverse shear failure, longitudinal cracking was almost negligible, and the cracks formed were predominantly along the angle of fibre orientation.

The transverse shear was not sufficient to cause complete separation across the fracture plane, and, eventually, the interpenetration of the two halves of the tube on either side of the fracture plane occurred at the initial peak force of 43.21 kN and a displacement of 3.666 mm. The two halves of the tube then continued to interpenetrate through one another, causing a considerable drop in load-bearing capacity and significant matrix cracking. This type of catastrophic failure is characteristic of Mode II failure. The bearing capacity reached a minimum of about 16.56 kN at a displacement of approximately 22.43 mm due to this. After this, the fold due to interpenetration enlarged, resulting in the matrix cracks lengthening noticeably. While the fold was enlarged, loading was relatively stable until a displacement of about 40.10 mm. Then, the interpenetration fold collapsed, and the two halves of the specimen began compacting together accompanied by a rise in load. Finally, the compaction of the composite tube continued throughout the densification stage. The compaction at the end of the composite tube failure caused noticeable delamination and fibre pull-out. From the SEM image of a section of the GFRP/PVC 55° composite tube after crushing (see Figure 6b), the extent of matrix cracking was noticeably more extensive than for the GFRP/PVC 45° sample, as evidenced by the more significant number of cracks and larger crack width.

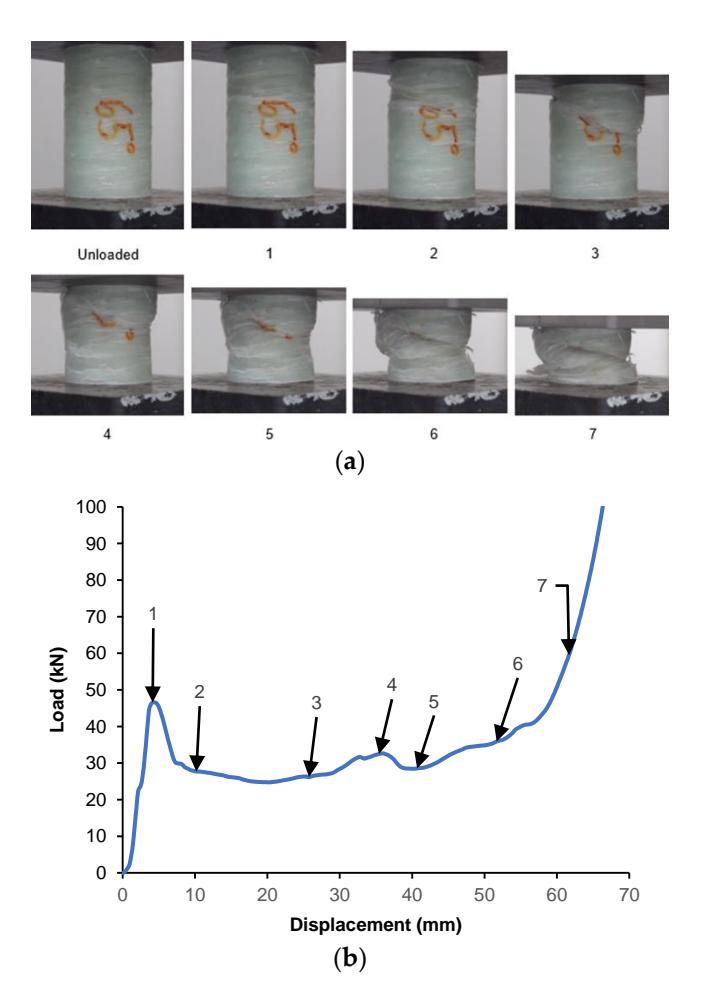
Figure 8. (a) Crushing history for GFRP/PVC 65° (b) Load–displacement curve for axial compression test of GFRP/PVC 65° sample.

Figure 8 shows the load–displacement graph for the GFRP/PVC 65° composite tube when subjected to quasi-static axial compression and the images corresponding to the points labelled in the graph. At first, due to the build-up of transverse shear stress, the top third of the composite tube specimen shifted slightly to the side, and a fracture plane was formed due to circumferential cracking. The fracture plane fully formed at the initial peak load of 46.62 kN, which occurs at a displacement of about 4.245 mm. The two sections of the tube then continued to interpenetrate through one another, while the matrix cracks caused by the split also lengthened, resulting in the tube's load-bearing capacity decreasing. Initially, the load dropped quite steeply until it reached a value of about 29.90 kN at a displacement of 7.625 mm. This type of catastrophic drop in load-bearing capacity is characteristic of Mode II failure.

After this, the specimen's load-bearing capacity decreased until the load reached a local minimum of approximately 24.77 kN, at a displacement of 19.76 mm. Then, another small split due to circumferential cracking formed in the bottom third of the composite tube. As the split formed, the specimen's load-bearing capacity also increased until a fracture plane fully formed at a local maximum load of about 32.61 kN, which occurred at a displacement of 36.10 mm. Again, the two newly formed sections on either side of the fracture plane interpenetrated one another, causing a slight drop in load-bearing capacity, up to a local minimum of 28.45 kN, which corresponded to a displacement of 40.01 mm.

The fold formed, and the three sections of the tube began to compact together. This compaction gives rise to an increase in the load-carrying capacity. This compaction continued throughout the densification stage; the rate at which the load-bearing capacity was rising increased as compaction progressed; and a noticeable amount of delamination also occurred. From the SEM image of a section of the GFRP/PVC 65° composite tube after crushing (see Figure 6c), one can notice the matrix cracking and delamination that occurred. The bottom of the captured image shows the surface of the composite sample that is relatively smooth, while the top of the captured image shows the glass fibres that were exposed due to delamination.

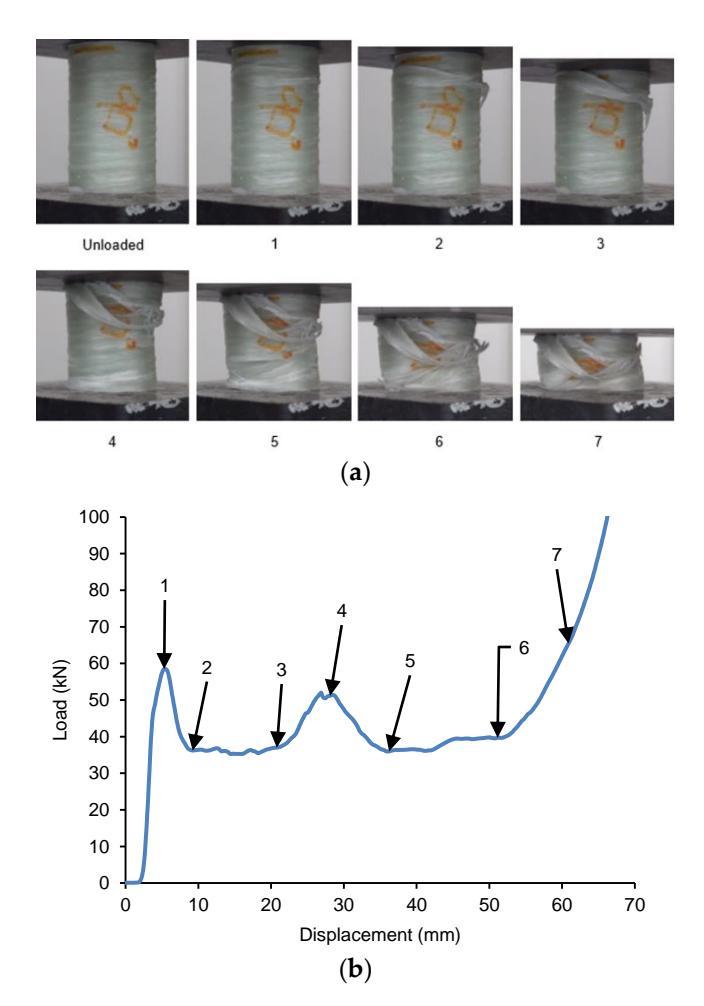
Figure 9. (a) Crushing history for GFRP/PVC 90° (b) Load–displacement curve for axial compression test of GFRP/PVC 90° sample.

The load-displacement behaviour for the GFRP/PVC 90° composite tube when subjected to quasi-static axial compression is shown in Figure 9, along with the images corresponding to the points labelled in the graph. As the compression test for this composite tube progressed, due to the build-up of buckling stresses in the composite tube, circumferential cracks formed a quarter of the way down from the tube's top end. These cracks caused a fracture plane to form, resulting in the occurrence of interpenetration failure. This was accompanied by some transverse shear, which resulted in the top section of the composite tube shifting slightly to one side as interpenetration took place. This fracture plane fully formed at the initial peak load for the specimen, which was about 58.51 kN and occurred at a displacement of approximately 5.4 mm. One can see a significant drop in the load-carrying capacity as the two sections of the tube continued to interpenetrate through one another until the load dropped to a value of about 36.22 kN, at a displacement of 9.299 mm. This drop in load was accompanied by significant delamination at the fold formed due to interpenetration failure, such that part of the GFRP could be observed hanging loose from the composite tube. From this, it could be seen that the GFRP/PVC 90° composite tube specimen underwent much more delamination than the other GFRP/PVC specimens, as all the other specimens only exhibited delamination in the densification stage. Although the interpenetration and consequent drop in failure that occurred were reminiscent of Mode II failure, the GFRP/PVC 90° composite tube's load-bearing capacity remained noticeably higher than the GFRP/PVC 45° composite tube, which underwent Mode III failure. This finding can be mainly attributed to the GFRP/PVC 90° composite tube's fibre orientation. As the loading direction was normal to the fibre orientation, the fibres provided a higher resistance to the compression loading than the other samples, and therefore a higher load was required to overcome this resistance. However, as a direct consequence, the GFRP/PVC 90° composite tube exhibited the most severe delamination of the tested samples.

Following this, the fold formed due to interpenetration collapsed, and the two sections of the tube resulting from the split were compacted together while delamination continued to occur. The compaction of the composite tube would typically have resulted in a rise in load, while delamination weakens composite tubes and would usually cause a drop in load. However, compaction and delamination co-occurred, and, for a time, they balanced each other out, resulting in a relatively stable failure until the displacement reached about 21.22 mm. Eventually, the rise in load due to compaction became more pronounced; meanwhile, local buckling occurred at the bottom end of the tube, resulting in a rise in load up to a local maximum of approximately 50.38 kN, at a displacement of 29.05 mm. After a hinge formed due to the local buckling at the tube's bottom end, there was a subsequent drop in load as the tube folded inwards at the hinge. After this, the two opposing failure mechanisms, compaction and delamination continued with a relatively stable load being maintained until a displacement of about 52.05 mm. Finally, in the densification stage, the amount of weakening due to delamination could not keep up with the increasing load due to compaction, and the rate at which the load-bearing capacity rose increased as the compaction progressed. After the compression tests were carried out from the specimens' state, the GFRP/PVC 90° specimen had a noticeably higher number of loose bunches of GFRP hanging from the specimen's other specimens. The comparatively severe fibre breakage and delamination that occurred can also be seen from the SEM image of a section of the GFRP/PVC 90° composite tube after crushing (see Figure 6d).

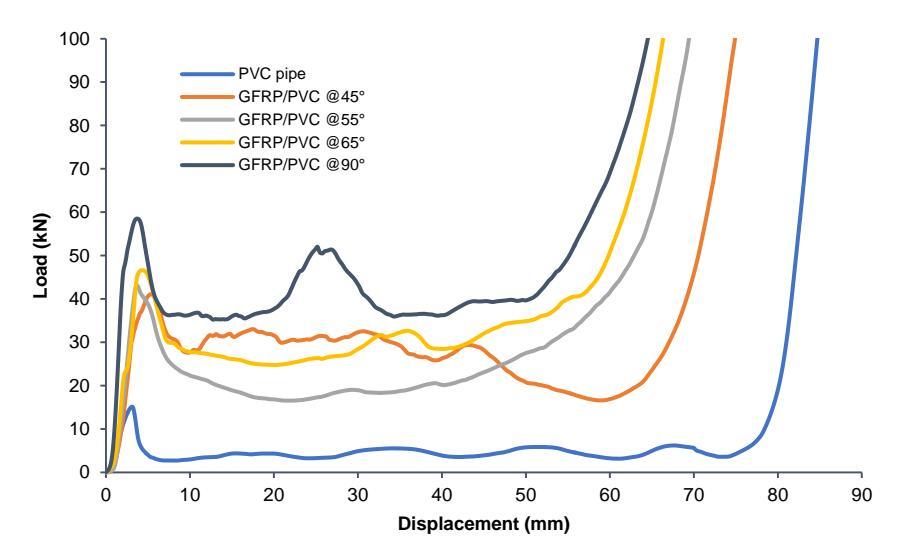
Figure 10. Load-displacement curves for axial compression tests of all GFRP samples vs. PVC tube.

To observe the effect of the GFRP and fibre orientation, the load-displacement curves for all the conventional circular composite tubes with different fibre orientation angles were plotted on the same graph as the load-displacement curve for the PVC tube. The loaddisplacement curves shown are for the average results for these tests for each specimen configuration. Figure 10 clearly shows that all of the GFRP specimens had a considerably higher load-bearing ability than the PVC tube on its own. For a more quantifiable comparison, the PVC tube can be compared to the GFRP/PVC tube with a fibre orientation of 45°, which has the lowest minimum load in the post-crush region besides the PVC tube for the displayed curves. Based on the initial peak forces, the PVC tube's initial peak force was 15.14 kN, while the initial peak force for the GFRP/PVC 45° composite tube was approximately 41.11 kN, more than double that of the PVC tube. In addition, if we compare the average loads for the post-crush stages for both the specimens, the PVC tube had an average load of 4.397 kN, while the GFRP/PVC 45° composite tube had an average load of about 27.16 kN, which is over six times that of the PVC tube. For the GFRP specimens, it was previously seen that local buckling and interpenetration failure were the causes of the initial failure in the tubes, and, as a result, all the tubes exhibited a noticeable drop in load-bearing capacity after the initial peak load was reached. It was observed that, as the fibre orientation angle of the tested specimens increased, the initial peak load also increased. The GFRP/PVC 90° specimen had the highest initial peak load of approximately 58.51 kN, while the GFRP/PVC 45° specimen had the lowest initial peak load of about 41.11 kN. There was an irregularity in this trend for the specimens' mean crushing force during the post-crash stage. The mean crushing force of the GFRP/PVC 55° specimen was determined to have the lowest value during the post-crush stage of 21.68 kN. As the specimens' orientation angle increased for the rest of the specimens, the mean crushing load also increased. The GFRP/PVC 45° composite tube had a mean crushing force of 27.16 kN for the course of the post-crushing stage, followed by the GFRP/PVC 65° specimen with a mean crushing load of 30.68 kN, and, finally, the GFRP/PVC 90° composite tube had the highest mean crushing load of 40.01 kN. Therefore, for overall load-bearing capability, the GFRP/PVC 90° composite tube performed the best. However, it was also observed that, for the GFRP/PVC 45° specimen, the displacement at which densification took place was noticeably more extensive than for the other specimens.

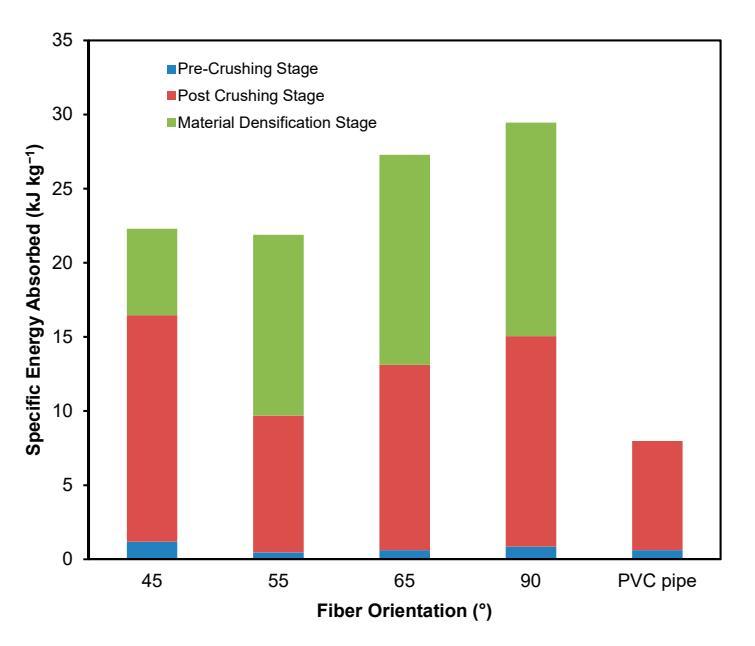
Figure 11. Specific energy absorbed by the GFRP PVC tubes and the PVC tube on its own.

Figure 11 shows the specific energy absorbed by the GFRP PVC tubes and the PVC tube on its own. The worst-performing GFRP PVC tube (i.e., GFRP/PVC 55°) had a higher value than that of the PVC tube on its own. The GFRP/PVC 55° specimen had a good specific energy absorption of 9.69 kJ kg⁻¹, which was approximately 21.49% higher than the 7.98 kJ kg⁻¹ value for the PVC tube on its own. For the total useful specific energy absorbed by the tested GFRP tubes, the GFRP/PVC 45° composite tube performed the best, with precrush and post-crush specific energy absorbed, adding up to approximately 16.47 kJ kg⁻¹. Although the GFRP/PVC 45° specimen's load-bearing capability did not stand out, due to its comparatively lower mass and delayed densification, it could perform well in energy absorption capability. The GFRP/PVC 90° specimen exhibited the next best performance with a total useful specific energy absorbed 15.05 kJ kg⁻¹. Finally, the GFRP/PVC 65° specimen had a good specific energy absorption of about 13.12 kJ kg⁻¹.
