Article Understanding the Failure Mechanism of Thermal Barrier Coatings Considering the Local Bulge at the Interface between YSZ Ceramic and Bond Layer

Keywords: thermal barrier coatings (TBCs); interface morphology; bulge; crack propagation; failure mechanism

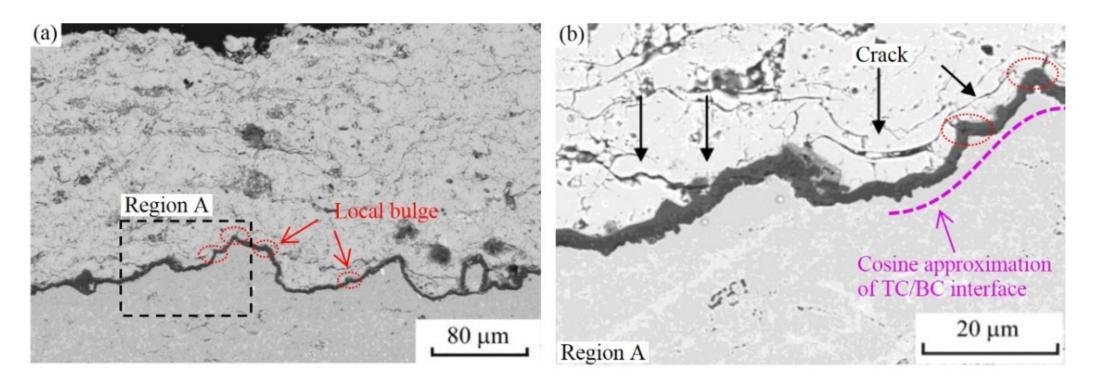
Figure 1. The cross-sectional morphology of APS TBC [50]: (**a**) local bulges at the TC/BC interface and (**b**) a magnification perspective of image in the region A.

The TC/BC interface in the APS TBC is not completely smooth. Some local bulges appear on the interface, as shown in Figure 1 [50]. The rough interfaces can lead to changes

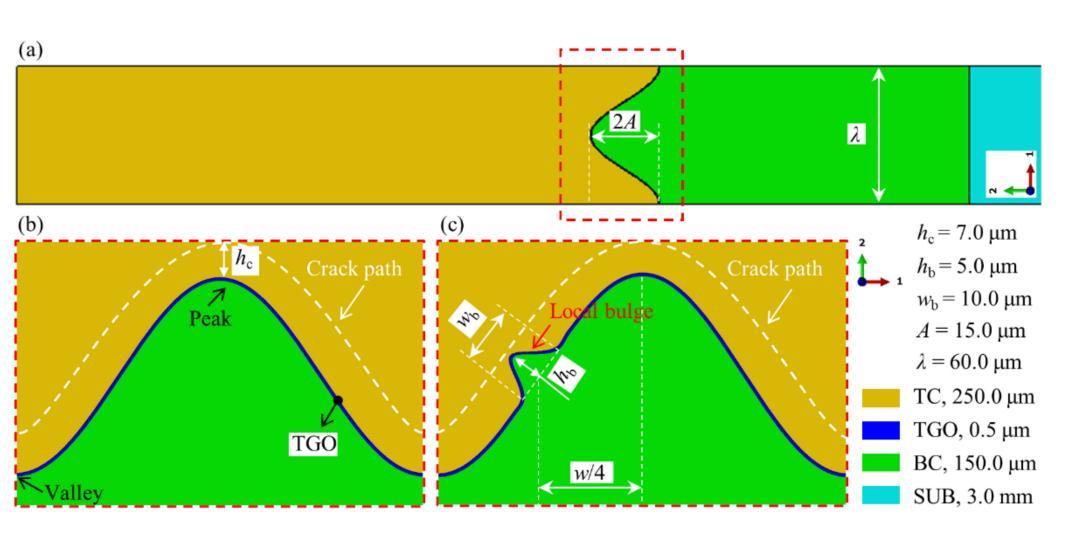
Figure 2. Geometric model of APS TBC: (**a**) overall model, (**b**) the TC/BC interface without bulge, and (**c**) the TC/BC interface with one bulge.

Here, the APS TBC is sprayed on nickel-based superalloy substrate (SUB) of 3.0 mm thickness. Figure 2 demonstrates the geometric model of the TBC system. The thicknesses of TC and BC are about 250.0 µm and 150.0 µm, respectively. The overall model is shown in Figure 2a. The interface morphology between TC and BC is often approximated by a cosine curve [23,36,45,52]. In this work, a cosine wave is investigated. Its wavelength and amplitude are $60.0 \,\mu\text{m}$ and $15.0 \,\mu\text{m}$, respectively. The ceramic layer prepared by APS is stacked by lamellae. The inter-lamella crack near the TC/BC interface tends to be parallel to the interface. The crack propagation occurs under thermal shock condition [53,54]. Therefore, the cracking path in the ceramic layer in this study is considered to be parallel to the TC/BC interface. Figure 2b shows the cracking path near the TC/BC interface without bulge. Its normal distance to the interface is 7.0 μ m. Figure 2c exhibits a geometrical model with one bulge in the middle of the TC/BC interface. The highest position of the bulge is perpendicular to the interface. Its height and bottom width are 5.0 μ m and 10.0 μ m, respectively. In this study, the bulge on the TC/BC interface has three locations: near-valley, middle, and near-peak. The distance between the bottom center points of these positions is 10.0 µm parallel to the interface. In order to prevent the early formation of mixed oxides during the thermal test, a uniform and dense α -Al₂O₃ layer is obtained after the coating deposition [12,55]. The initial TGO thickness in Figure 2 is $0.5 \,\mu m$.

The TBC geometry in this study is a representative volume element of the whole sample. Therefore, the x-direction freedom of the left boundary in the model shown in Figure 2b is constrained. The right boundary is subjected to a periodic boundary condition by exerting a multipoint constraint. Such constraint can make the nodes on the right boundary have the same displacement in the x-direction. Meanwhile, they can move freely in the y-direction. In order to prevent the occurrence of rigid-body displacement during the calculation, the y-direction freedom of the substrate bottom is constrained. The ceramic surface is free.

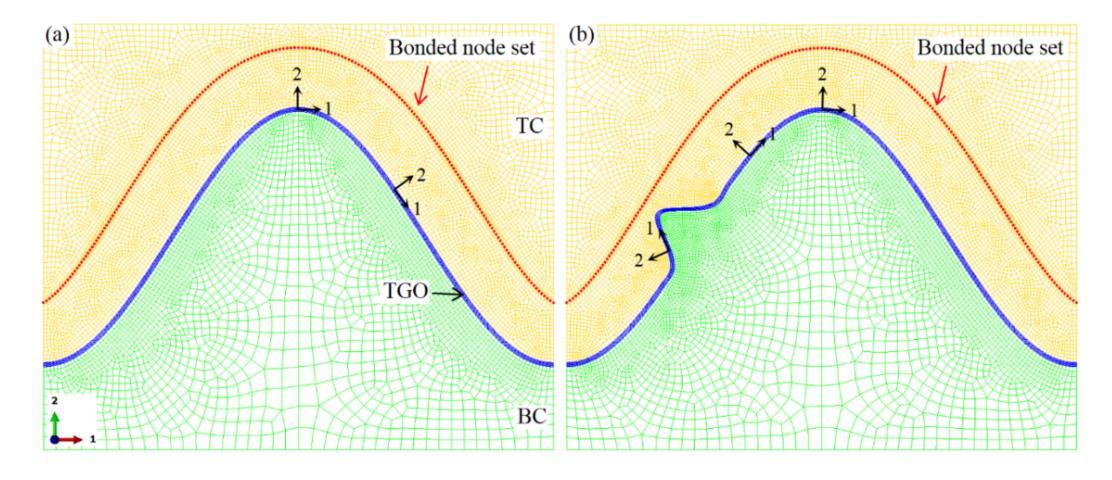
Figure 3. Finite element mesh near the TC/BC interface: (**a**) the mesh near the interface without bulge and (**b**) the mesh near the interface with one bulge.

The whole model is divided into quadrilateral grids. Since the ceramic cracking near the interface is considered, the dense meshes are used near the interface and cracking path, as shown in Figure 3. The characteristic element size is 0.45 μ m. The generalized plane strain element with reduced integral (CPEG4R) is used to analyze the stress field and crack evolution in the coating. There is no element distortion caused by hourglass in all calculations.

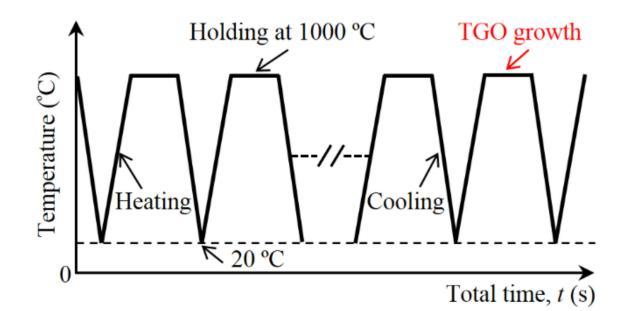
Figure 4. The cyclic thermal loading for all calculations (the number of thermal cycles is expressed by N).

The TBC system is often considered to be stress free at high temperature, which has been adopted in many studies [23,24,63,65]. In this study, the whole model is first cooled from 1000 °C to room temperature. Then it undergoes multiple thermal cycles. Finally, the model is reheated to a high temperature. The cyclic thermal loading for calculation is shown in Figure 4. A thermal cycle consists of three stages: heating, dwelling of 7200 s, and cooling. The TGO growth occurs in the dwelling stage. The effects of heating and cooling rate on the stress state are not considered here. Twenty cycles are investigated. The number of thermal cycles is expressed by N. A zero value for N represents the initial cooling process.

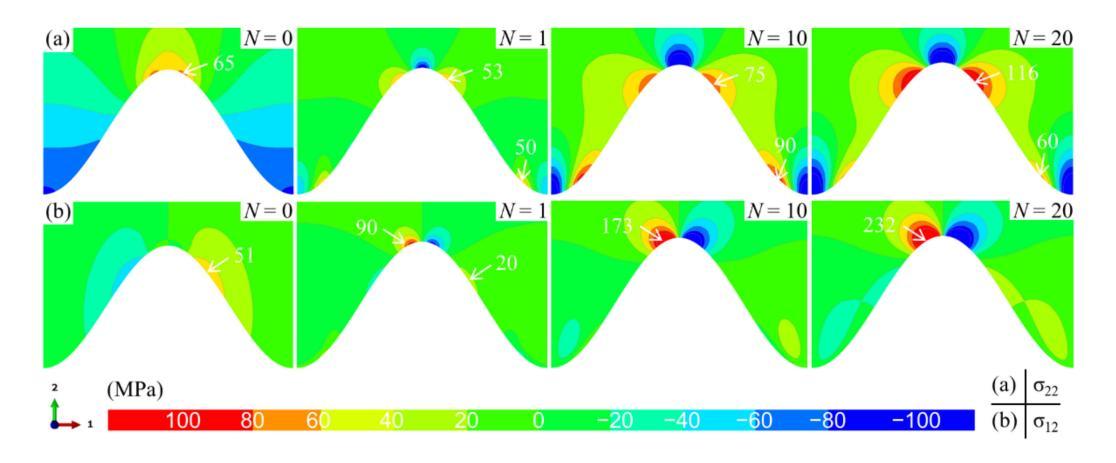
Figure 5. The stress distribution characteristic near the TC/BC interface without a bulge (at room temperature): (a) the normal stress σ_{22} and (b) the shear stress σ_{12} .

Under the current condition, the stress distributions in the ceramic layer near the standard cosine interface without bulge are first studied, which is used to compare the results in the model with the bulge. Figure 5 shows the evolution of normal and shear stress distribution near the bulge-free interface with the thermal cycle. For the normal stress (see Figure 5a), when the model is cooled from the initial temperature to room temperature (N = 0), the tensile stress is located at the peak, and the valley is compressed, which is attributed to the larger shrinkage strain of the substrate compared with the ceramic layer. After one cycle (N = 1), the tensile stress shifts to both sides of the peak. As the thermal cycle progresses, the stress state near the interface basically no longer changes. However, the magnitude of tensile stress increases continuously, which is mainly attributed to the TGO growth at high temperature [23,45,62]. For the shear stress (see Figure 5b), it is always on both sides of the peak. Its magnitude increases with the thermal cycles.

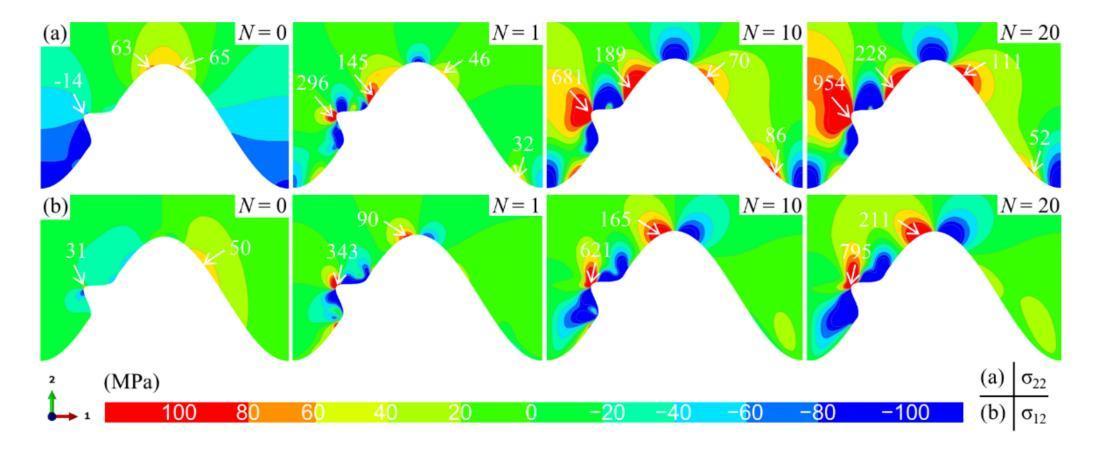
Figure 6. Distribution of the stress near the TC/BC interface with one bulge (at room temperature): (a) the normal stress σ_{22} and (b) the shear stress σ_{12} .

When a bulge appears in the middle of the TC/BC interface, the stress state near the interface is changed, which is shown in Figure 6. The stress distribution on the left side of the model is significantly different from that in Figure 5. However, the stress distribution and amplitude on the right side of the model are basically consistent with the results in Figure 5. These indicate that the bulge only affects the local stress state in the ceramic layer but does not change the far-field stress characteristics. For the normal stress, there is huge tensile stress at the top of the bulge (see Figure 6a). With the progress of the thermal cycle, the tensile area and magnitude increase continuously. The shear stress also exhibits a similar trend (see Figure 6b).

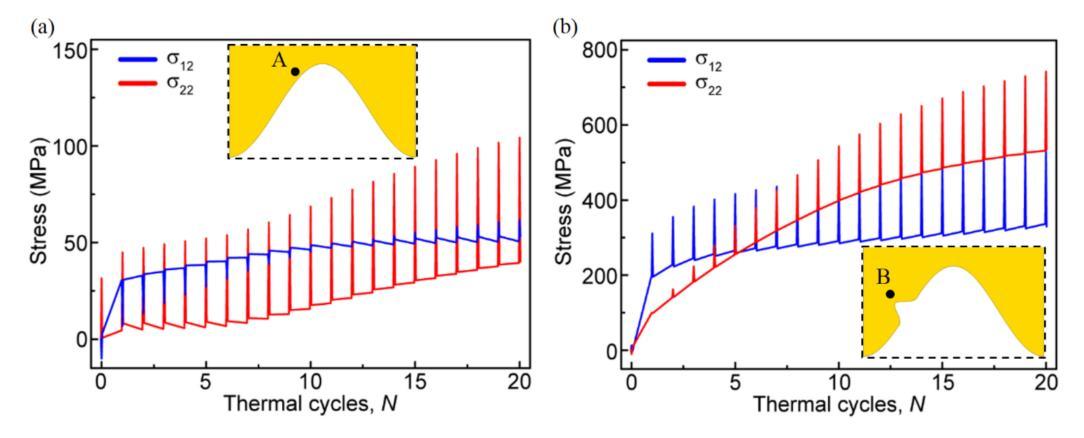
Figure 7. Variation of the normal and shear stress near the interface with the thermal cycles: (**a**) at point A near the interface without bulge and (**b**) at point B near the interface with one bulge.

In order to clarify the dynamic change process of stress in the ceramic layer, the variation of normal and shear stress near the interface with the number of thermal cycles are demonstrated in Figure 7. If no bulge occurs, the maximum tensile and shear stress in the ceramic layer appears near the peak. Therefore, the stress at point A is extracted (see Figure 7a). When there is a bulge on the interface, the maximum stress appears near the top of the bulge. Thus, the stress at point B is extracted (see Figure 7b). No matter whether a bulge occurs on the interface, the normal stress and shear stress in the ceramic layer near the interface shows a ratcheting increase with the thermal cycle. This is mainly due to the continuous accumulation of lateral growth strain in the TGO. In the model without bulge on the interface, the tensile and shear stress amplitudes in the ceramic layer are lower than those in the model with one bulge. In addition, it can be found that when there is a bulge on the interface, the stress in the ceramic layer has a higher increase rate. These mean that

the emergence of a bulge on the interface will lead to the rapid increase in local stress to the cracking stress in a short time, which may induce the early cracking in the ceramic layer.

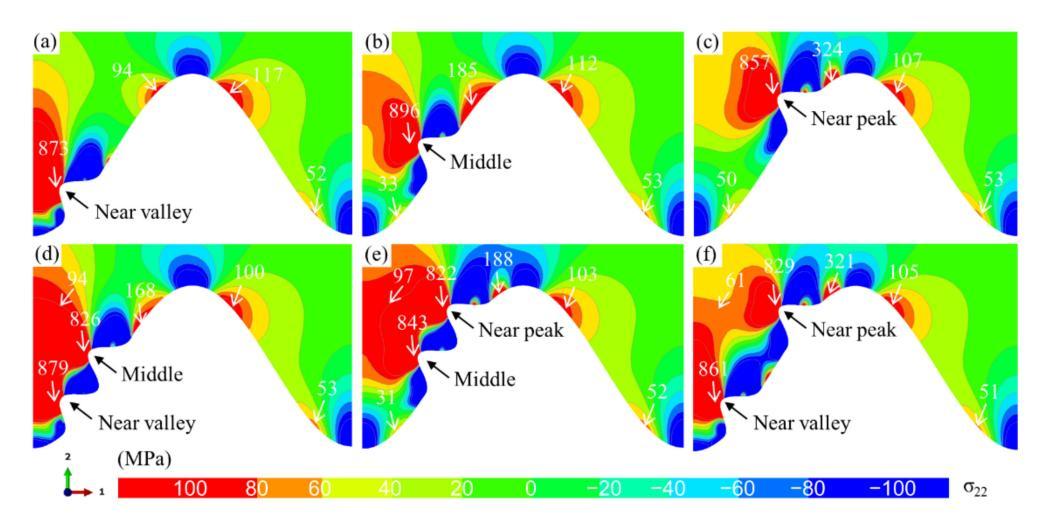
Figure 8. Effects of the location and number of bulges on the σ_{22} normal stress distribution (*N* = 20, at room temperature): (**a**–**c**) one bulge at the interface and (**d**–**f**) two bulges at the interface.

The distribution of bulges on the interface in APS TBC is not regular. Moreover, the number of bulges is not fixed. Therefore, it is necessary to study the influences of the location and number of bulges on the stress state in the ceramic layer. In this study, the bulge may appear at three locations on the interface: near-valley, middle, and near-peak. The normal stress distribution characteristics under different bulge configurations are demonstrated in Figure 8. It can be seen that the stress distribution in the right half of all models is not affected by the bulge. They show the same stress distribution and amplitude as the model with a standard cosine interface. When only one bulge appears (see Figure 8a–c), it can be found that there is also a tensile stress region between the bulge and interface peak. Moreover, when the bulge is at the near-peak, the tensile stress amplitude in this region is the largest. No matter where the bulge is, the maximum tensile stress in the ceramic layer always exists near the top of the bulge. When two bulges appear, the superposition of the stress field leads to a larger tensile stress area and magnitude, which is independent of the locations of the two bulges. These indicate that compared with the location, the number of bulges may more seriously affect the stress in the coating.

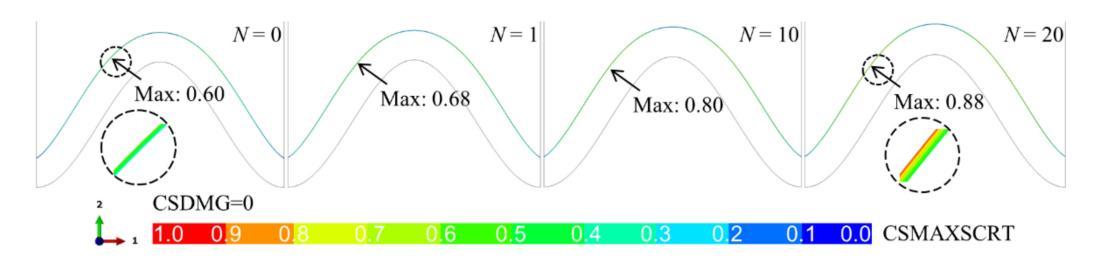
Figure 9. Evolution of damage initiation variable (CSMAXSCRT) in the ceramic layer near the interface without a bulge (at room temperature).

When there is no bulge on the interface, the stress in the ceramic layer does not increase much with the thermal cycle. After 20 cycles (N = 20), the stress magnitude is much lower than that in the model with a bulge (see Figure 7). This indicates that the possibility of ceramic cracking in the model without a bulge is much lower than that with a bulge. When there is no bulge on the interface, the low stress may not cause ceramic damage degradation, namely, CSDMG = 0. Figure 9 shows the variation of CSMAXSCRT along the cracking path in the model without a bulge. It is found that the maximum damage position appears on the left side of the peak, which is the same as the position of the maximum stress. The value of CSMAXSCRT increases continuously with the thermal cycle. After 20 cycles (N = 20), the maximum value is 0.88, indicating that the ceramic cracking does not occur in the model without a bulge.

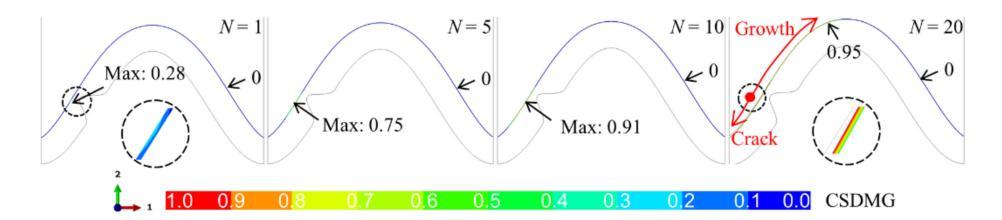
Figure 10. Evolution of damage degradation variable (CSDMG) in the ceramic layer near the interface including one bulge (at room temperature).

When there is a bulge in the middle of the interface, the huge tensile and shear stress near the bulge leads to damage degradation in the ceramic layer, as shown in Figure 10. It can be seen that when the system undergoes one thermal cycle (N = 1), the value of CSDMG near the top of the bulge is 0.28, which indicates that the damage degradation in the ceramic layer has occurred. The value of CSDMG increases with thermal cycling. When the cycle number reaches 10 (N = 10), the CSDMG has reached 0.91, which means that the ceramic cracking is about to occur. When the system undergoes more thermal cycles, the crack appears in the coating. It expands to the valley and peak. In a limited thermal cycle, the crack quickly propagates to the valley. Subsequently, the crack continues to expand to the peak. When the cycle number is equal to 20 (N = 20), the crack propagates to the near-peak. As the thermal cycle progresses, the CSDMG value in the right half of the model is always zero, indicating that the ceramic cracking in the left side does not affect the right side.

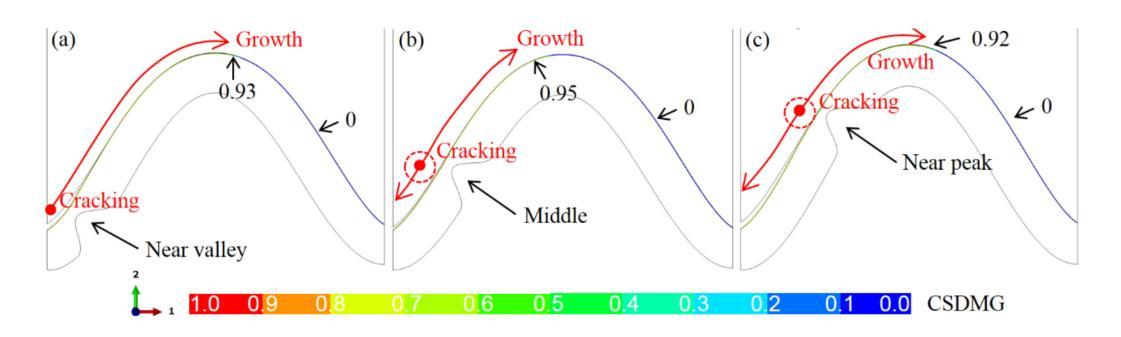
Figure 11. The CSDMG distributions in the ceramic layer under different locations of one bulge (N = 20, at room temperature): (**a**) near the valley, (**b**) middle, and (**c**) near the peak.

Because the ceramic crack first appears near the top of the bulge, the location of the bulge may affect the initiation and total length of the crack. Figure 11 shows the crack propagation in the ceramic layer under different bulge locations (N = 20). It can be seen that no matter where the bulge is, the ceramic cracking first occurs near the top of the bulge. When the bulge is located in the middle of the interface, the crack propagation does not cross the peak. Moreover, the crack opening at the valley on the left side of the model is also significantly smaller than that in the model with a bulge near the valley or peak.

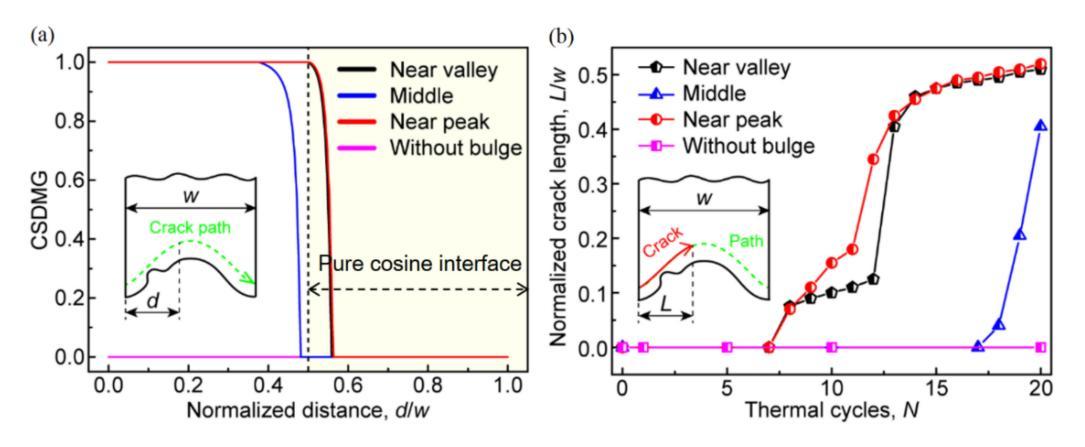
Figure 12. Effects of the location of one bulge on the ceramic cracking: (**a**) the CSDMG along the cracking path in the ceramic layer (N = 20, at room temperature) and (**b**) variation of the total crack length with the thermal cycles.

Besides the total length of the crack, the bulge location may also affect the cracking moment. Figure 12 shows the CSDMG distribution on the crack path and the change of the total crack length with the thermal cycles. It can be seen from Figure 12a that if there is no bulge on the interface, the CSDMG on the whole cracking path is 0.0. When the bulge is located near the valley or peak, the cracking area (CSDMG = 1.0) is significantly larger than that with a bulge in the middle of the interface. In addition, the damage degradation region (CSDMG > 0.0) on the cracking path is also obviously larger. It can be found from Figure 12b that the existence of bulge leads to the rapid increase in crack length, which is independent of the location of the bulge. When crack propagates to the near-peak region, the effect of the bulge is obviously weakened, so the total length of the crack increases at a lower rate with the thermal cycling.

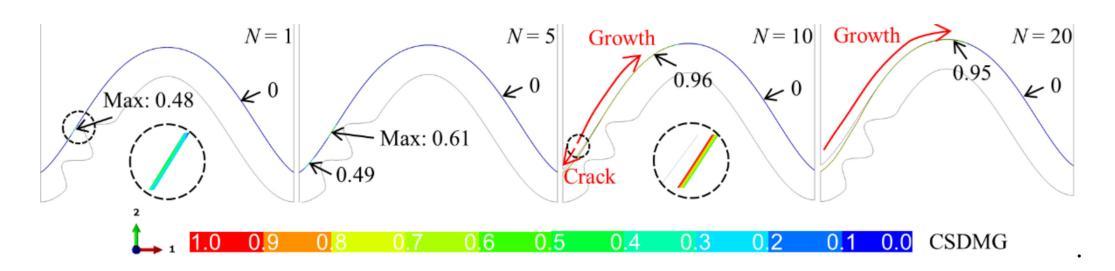
Figure 13. Evolution of the CSDMG in the ceramic layer near the interface including two bulges (at room temperature).

Based on the above stress results, it can be seen that the superposition of the bulgeinduced stress field will further increase the local tensile stress region and magnitude. This indicates that the number of bulges may affect the crack behavior in the ceramic layer. Figure 13 shows the evolution of cracks in the ceramic layer with the thermal cycles when bulge occurs at the near-valley and in the middle of the interface. It can be found that multiple damage regions appear at the same time (N = 5). When the number of thermal cycles reaches 10 (N = 10), the ceramic crack has initiated from the top of the bulge at the near-valley and expanded to the near-peak region. Note that when only one bulge is located in the middle of the interface, the ceramic cracking does not occur when the cycle number is equal to 10 (see Figure 10). In addition, it can also be seen from Figure 13 that the crack in the ceramic layer has extended to the peak when the thermal cycle reaches 20. Obviously, the crack length is also higher than that when there is only a bulge in the middle of the interface. This means that the increase in the bulge number may lead to the earlier cracking and coating spalling.

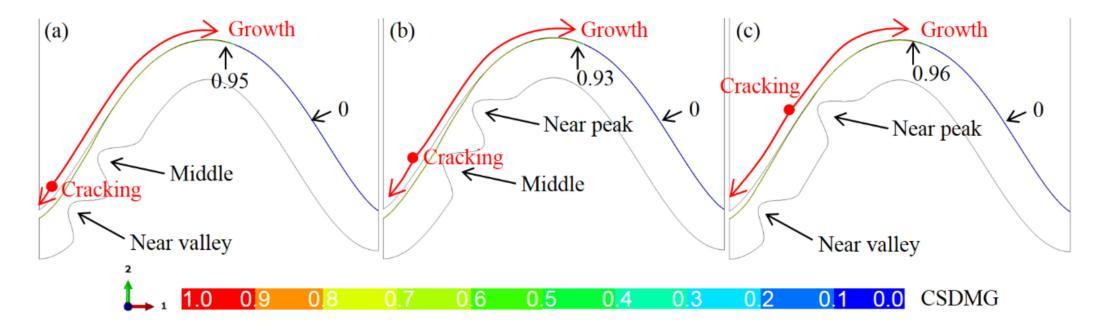
Figure 14. The CSDMG distributions in the ceramic layer under different locations of two bulges (N = 20, at room temperature): (**a**) near valley and middle, (**b**) middle and near peak, and (**c**) near valley and peak.

Figure 14 demonstrates the influence of the distribution of two bulges on the crack propagation in the ceramic layer. It is seen that no matter how the bulge is distributed, the cracks in the ceramic layer still initiate from near the top of the bulge. Under different bulge distributions, the cracks in the ceramic layer pass through the peak. They have a similar distribution. At the same time, it is also found that in the right region of the model, CSDMG is still 0.0, which is the same as that in the models with one or no bulge.

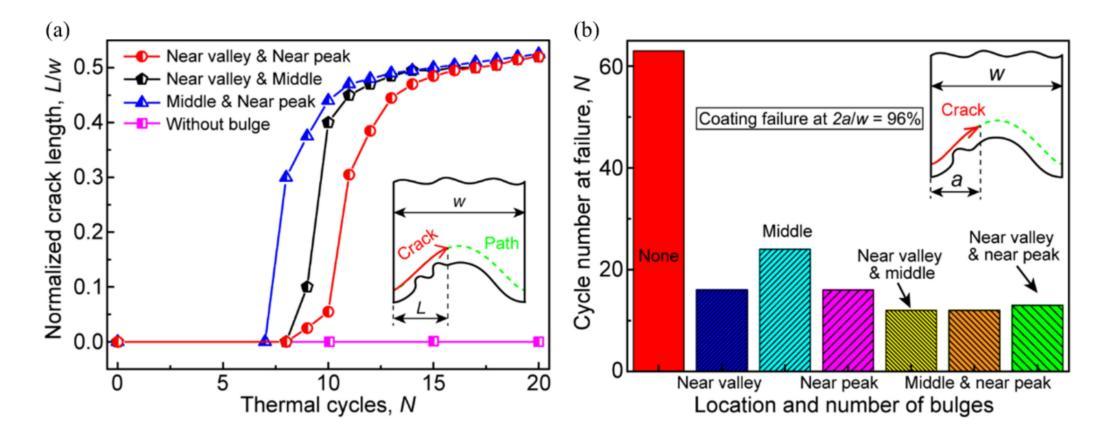
Figure 15. Effects of the location and number of bulges on the coating failure: (**a**) variation of the total crack length with the thermal cycles under different locations of two bulges and (**b**) the cycle number at the TBC failure under different bulge configurations.

In order to quantitatively reveal the effect of the bulge on the coating failure, Figure 15 shows the effects of the location and number of the bulge on the crack evolution. It can be seen from Figure 15a that the early cracking of the ceramic layer occurs after several cycles, which is independent of the distribution location of two bulges. Before the crack propagation reaches the peak, the crack length shows a sharp increase, which is different from the effect of a single bulge on crack propagation (see Figure 12b). Moreover, the crack propagation rate is also higher than that in the case of only a single bulge. It can be found from Figure 15b that when there is no bulge on the interface, the coating failure occurs after 63 cycles (N = 63). However, when a bulge appears at the near-peak or near-valley location, the coating failure occurs after 16 cycles (N = 16). If two bulges appear on the interface, the number of thermal cycles at failure will be further reduced, which is independent of the bulge distribution.
